# Home Inspection Report

15208 Harbor Lane, Clearlake, CA 95422

Monday August 21, 2023

3233

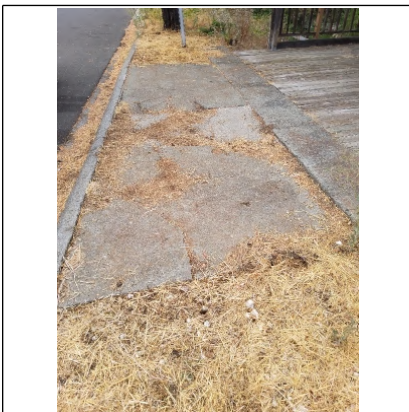
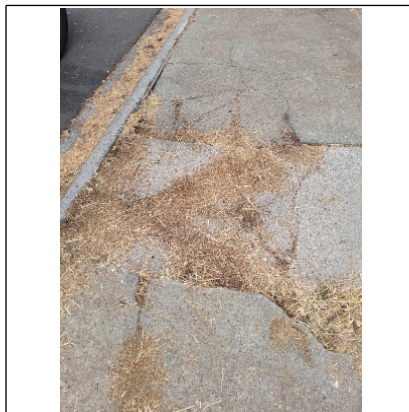
**Comments** 1. Driveway was in poor condition recommend repair and/or replacement.

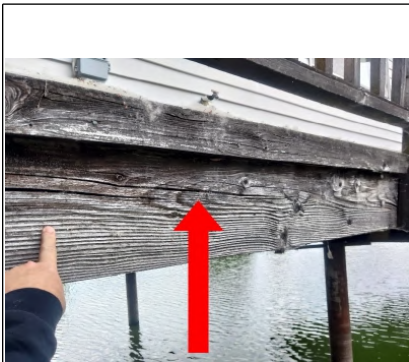
Rim joist is weathered and should be replaced. The 4x4 posts installed on the rim joist are considered a safety hazard because of the conditions of the rim joist they are in tied in. (Reference to first diagram picture)

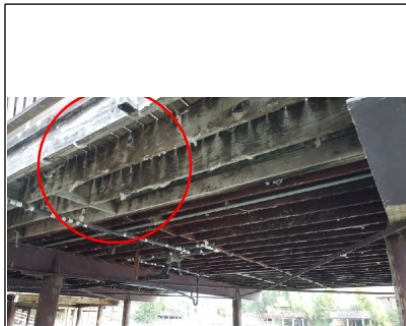
This is a view underneath of the recommended joist replacement. (Reference to first diagram picture)

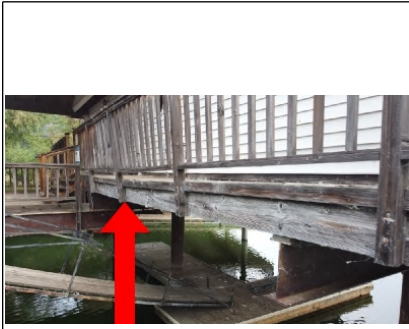
Dip in joist and rim members. This is in relation to the 1" dip that is referenced in the front room. However, the joist members are doubled up below the frame plate. Again, the home is structurally fine.

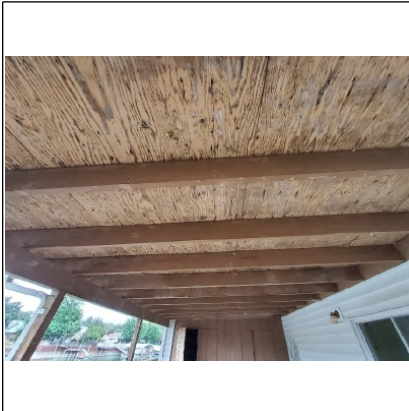
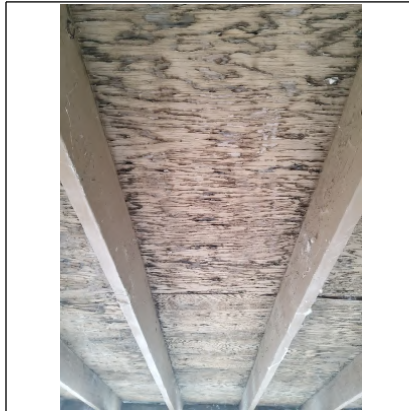
**Comments** **1. Recommend replacing moisture damaged sheathing. This should be handled when removing all of the existing 3-tab shingles and applying the correct material roll asphalt based on the roof pitch. The reason for the moisture damage and staining is that the water seeps through the shingles.**

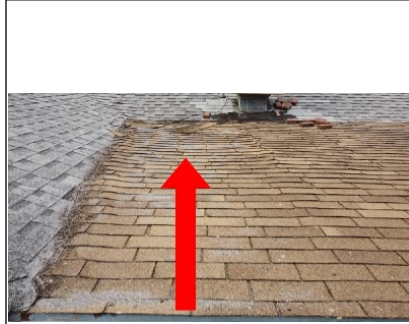
Reference location for prior slide of worst condition sheathing location.

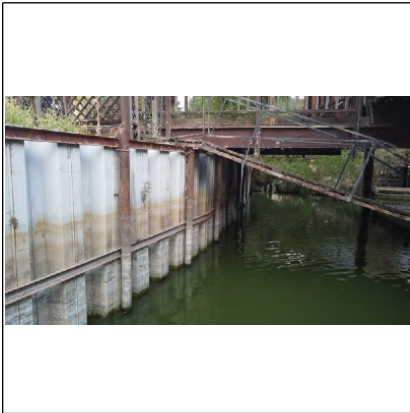
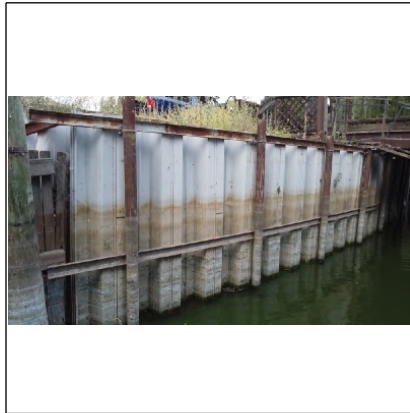
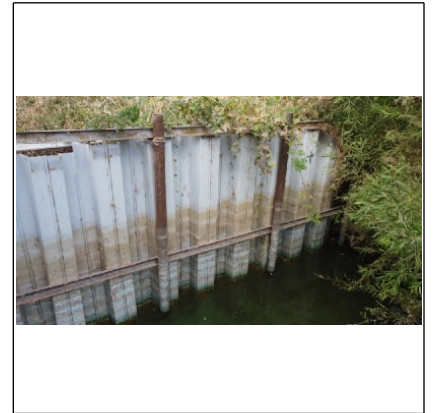
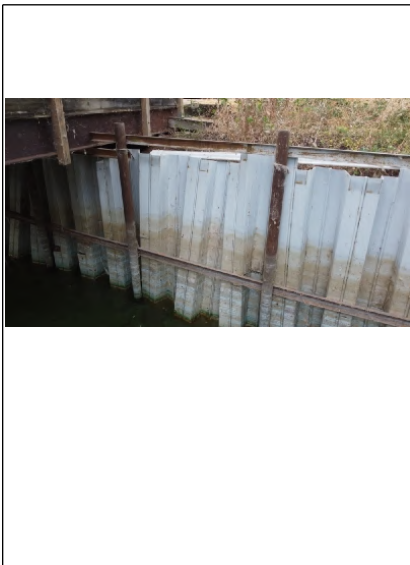
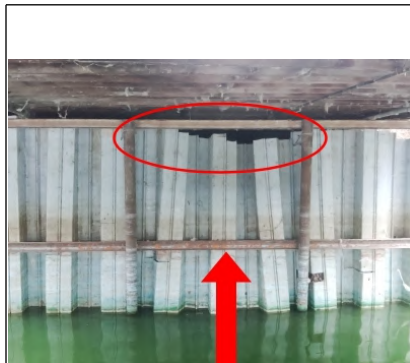
This does not appear to be of structural concern as the steel cross member below where the compaction is what matters the most.

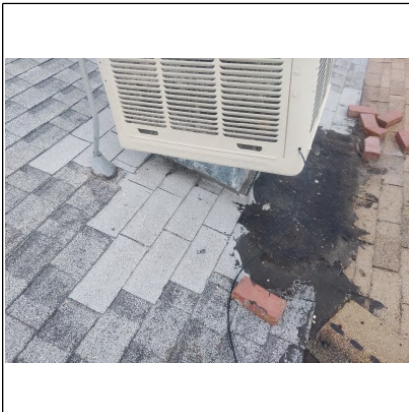
**Comments** **1. Repair work is noted around the swamp cooler with replaced shingles. However, Henry's Roof Sealant is to be only used for patch work for temporary repair.**

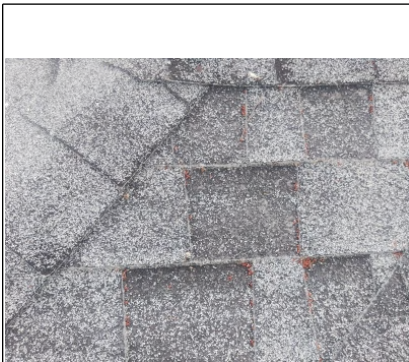
Reference section #4 with regards to worst conditioned shingle location. (Refer to diagram for locations)

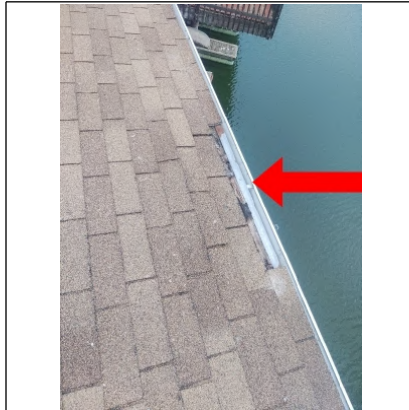
**Comments** 1. 3-Tab should not be installed on any pitch less then a 3/12 pitch. Recommend having all 3-Tab roofing removed as well as replacing all damaged roof sheathing by a Licensed General B Contractor or Licensed C39 Roofing Contractor. Roll asphalt should be used instead when the roof pitch is less then a 3/12 pitch.

Missing shingle location

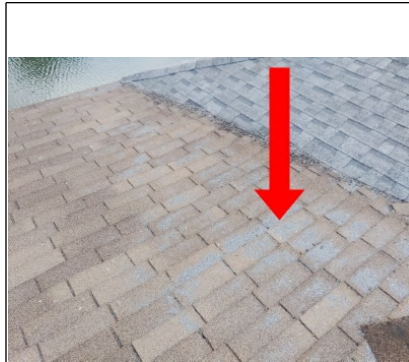
Moisture damaged sheathing location

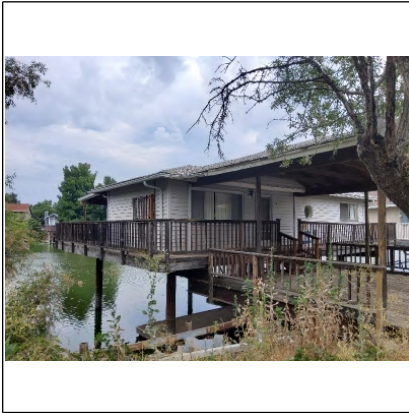
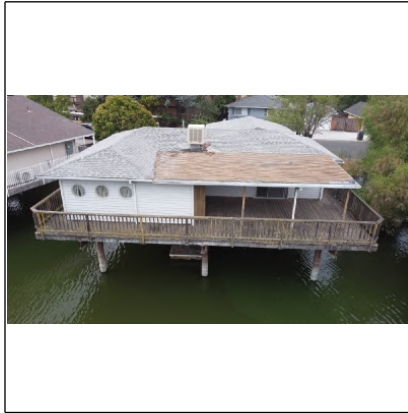
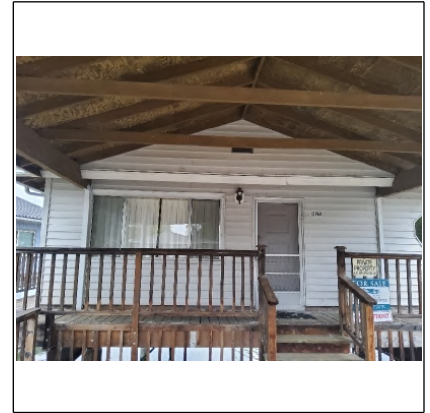
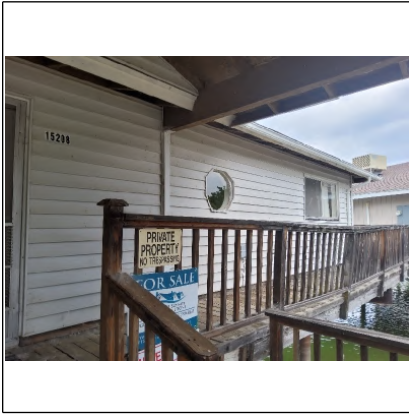
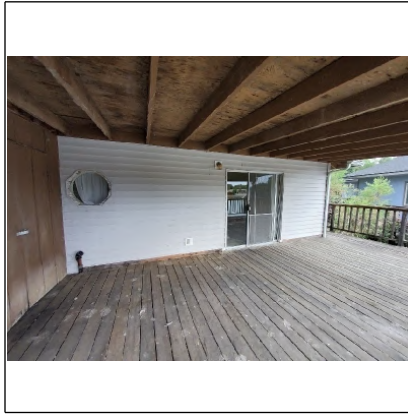
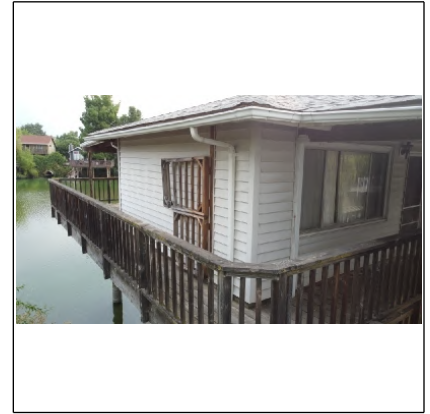
Recommend patching open location of siding. Vinyl was cut too short at the location. It is under a deck cover.

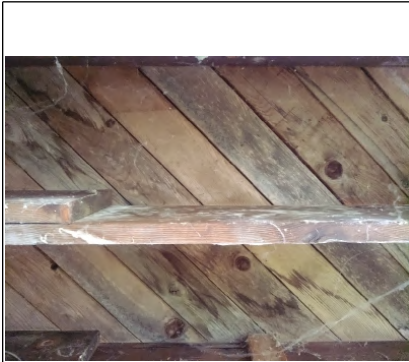
Appear to be old water stains.

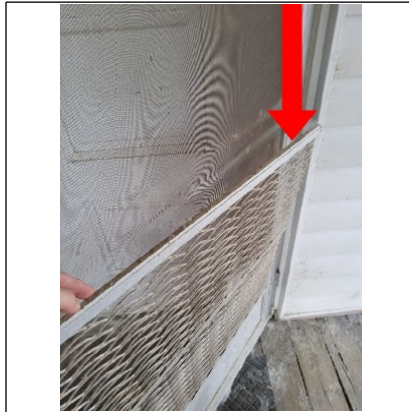
Damaged screen door.

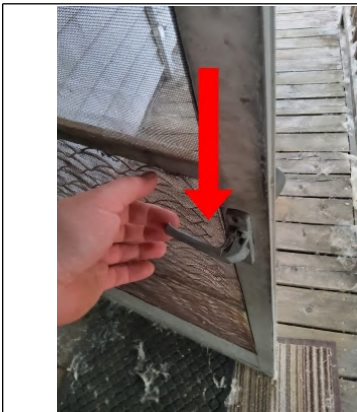
Loose handle

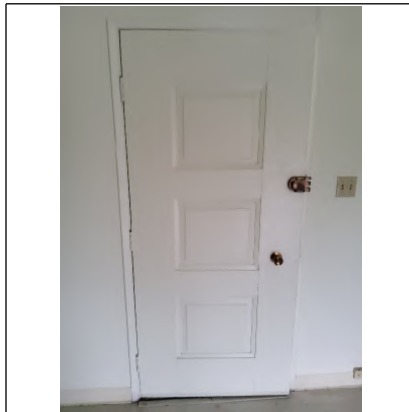
Recommend replacing door sweep to ease the operation of the exterior door.

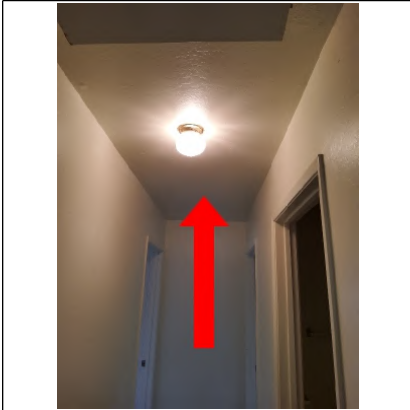
**Comments** **1. An attic access is not present. Recommend having an attic access with the minimum opening of 22" x 30" be installed by a Licensed Contractor in the hallway to evaluate the conditions of the sheathing and rafters of the roof.**

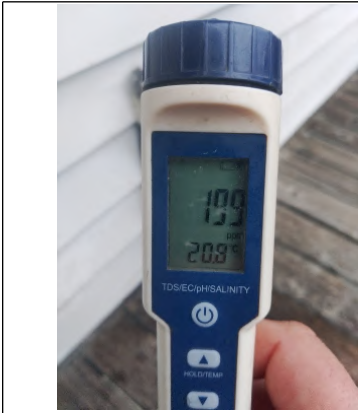
Water level shows 199 PPM which is considered to be hard water.

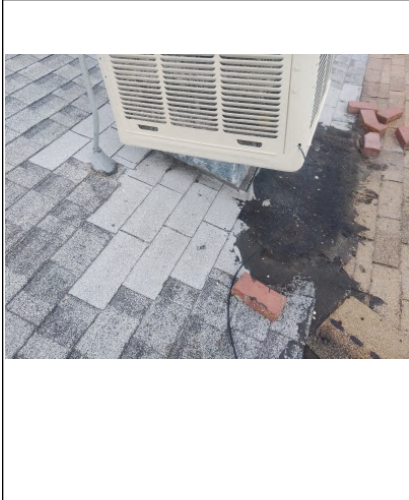
**2. Recommend having a 3/4" PVC drain line installed on swamp cooler.**

Recommend having a 3/4" PVC drain line installed on swamp cooler.

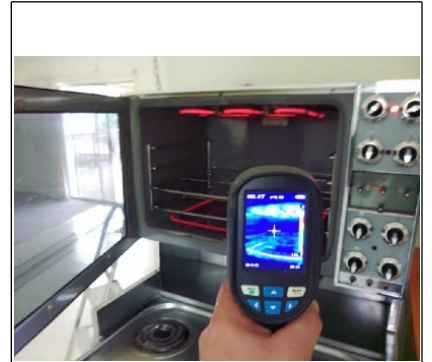
Thermal Imager shows oven properly operates.

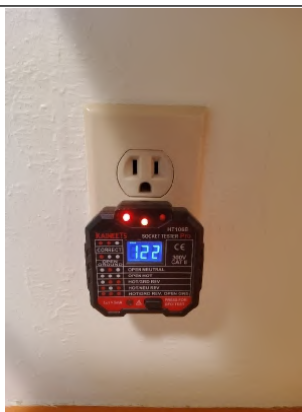
Electrical outlet shows proper operation, grounding and polarity.

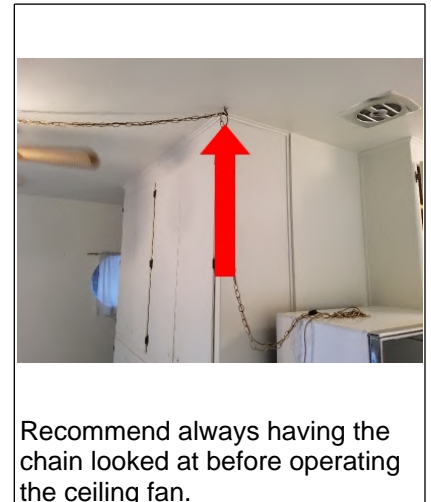
Recommend always having the chain looked at before operating the ceiling fan.

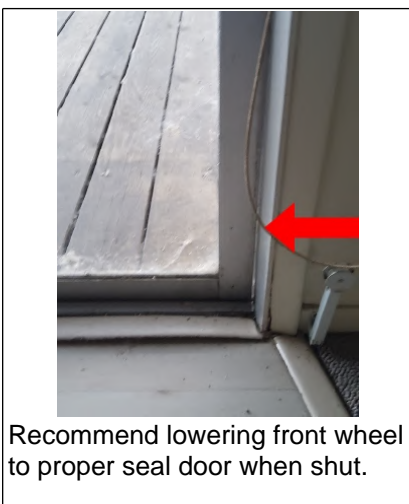
Recommend lowering front wheel to proper seal door when shut.

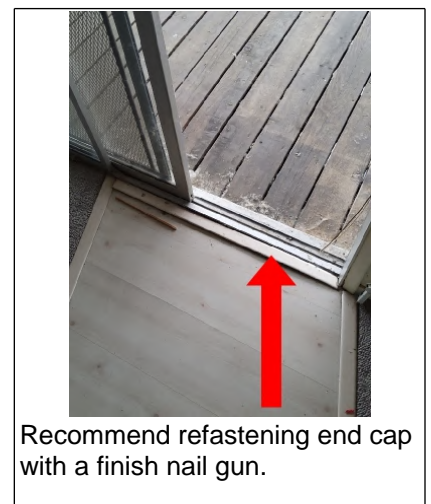
Recommend refastening end cap with a finish nail gun.

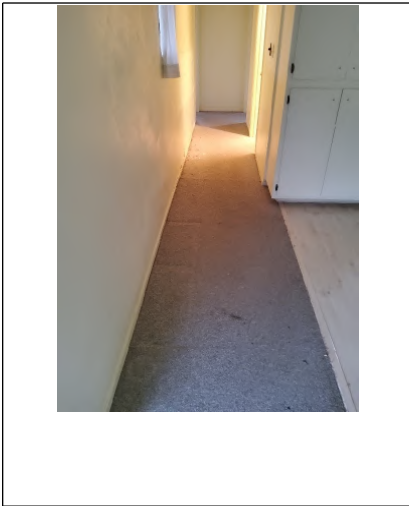
Damage is evident on drywall. Recommend having damaged drywall replaced and patched.

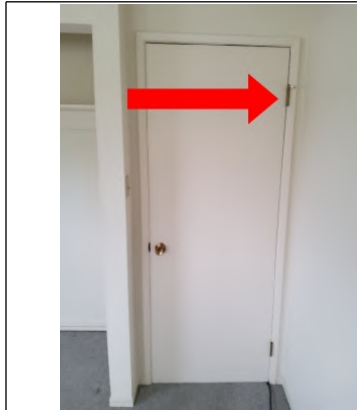
**3. Recommend tightening top hinge to properly latch door.**

Recommend tightening door jamb to properly latch door. Take off the middle screw on top of the hinge pre-drill with a drill bit then get a 3 screw with a large enough head to flush the hinge. This will tighten the jamb to the trimmer allowing the door to close with ease. Recommend taking the existing screw out to match heads with the new replacing screw.

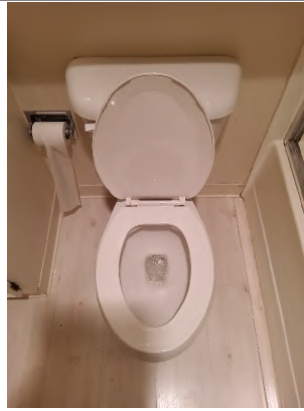
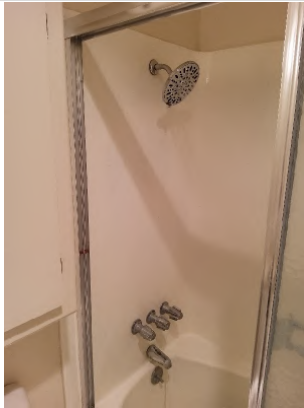
Water is entering both the shower head and spout at the same time. Recommend having diverter valve replaced by a Licensed Plumber.

**Comments** **1. Water is entering both the shower head and spout at the same time. Recommend having diverter valve replaced by a Licensed Plumber.**
