**HDX HOME  
INSPECTIONS**

## Home Inspection Report

**861 Test Street**

Inspected on Tue, Jan 18 2022 at 12:40 AM

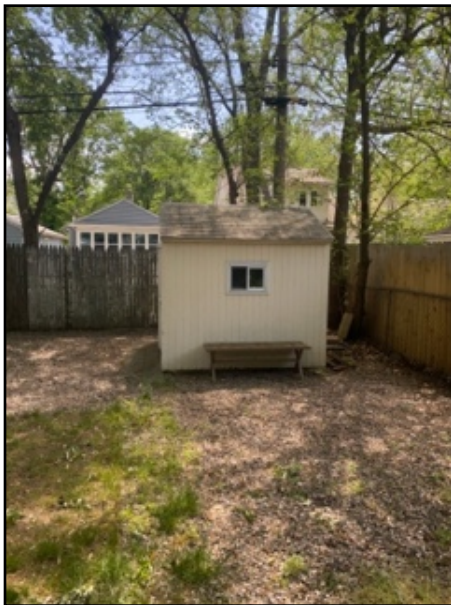
Figure 10-1

Sheds are not part of the visual inspection process.

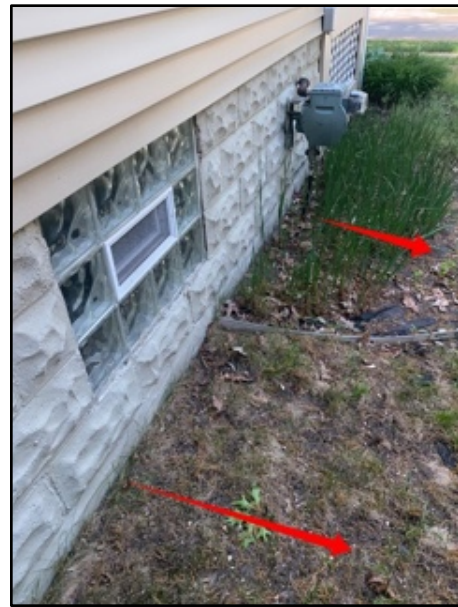
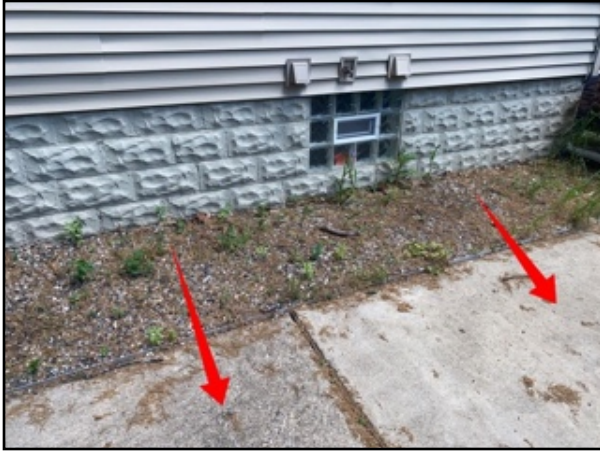
Condition: Repair or Replace

Regrade to pitch slope away from home to direct surface water away from foundation. This may assist in moisture entry to lower levels or structure of home. A positive slope directed away from the foundation is suggested.

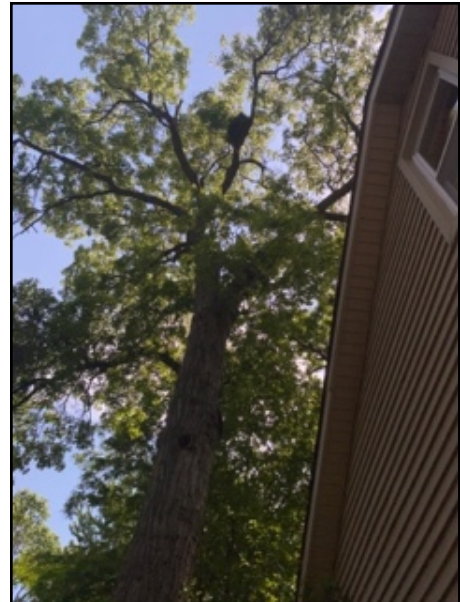
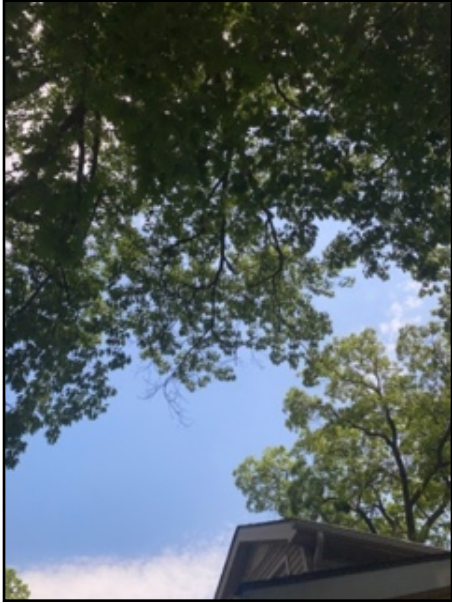
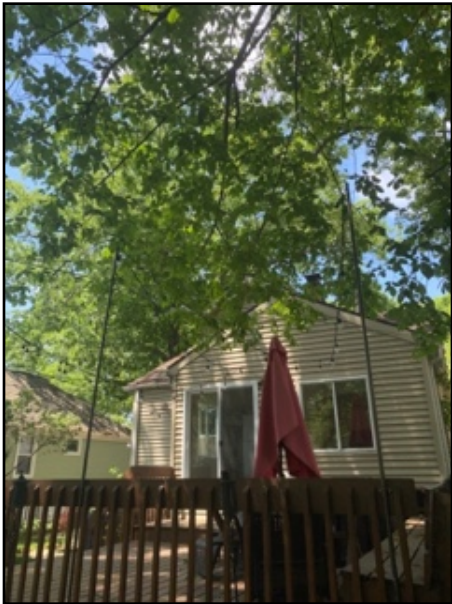
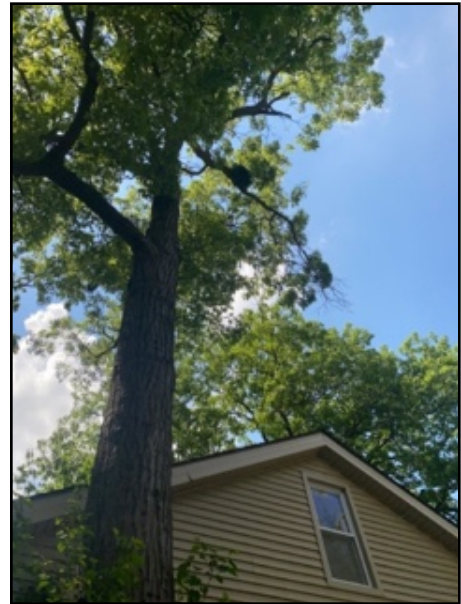
Growing Against Structure  
Condition: Repair or Replace

Trim trees and vegetation away from Structure and roof to prevent damages to home, siding or roofing materials.

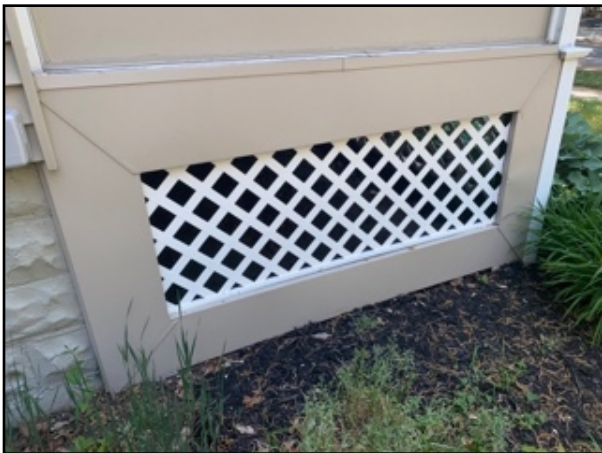
Figure 16-1

Cannot view porch structure due to skirting.

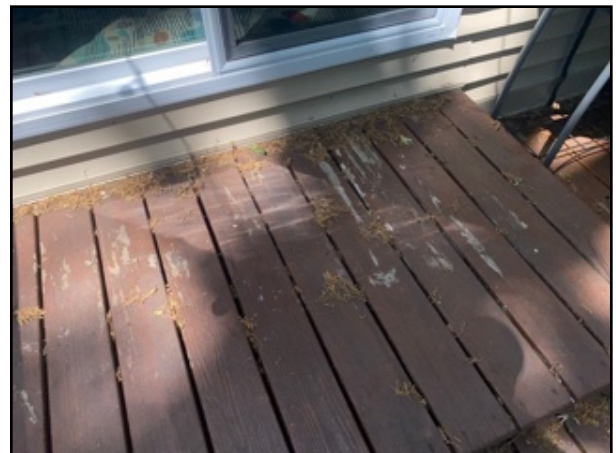
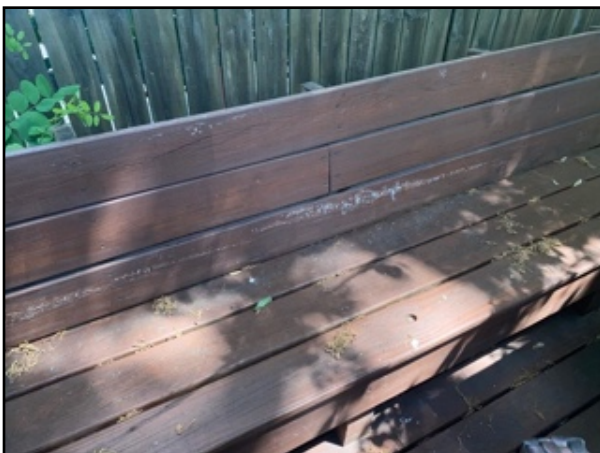
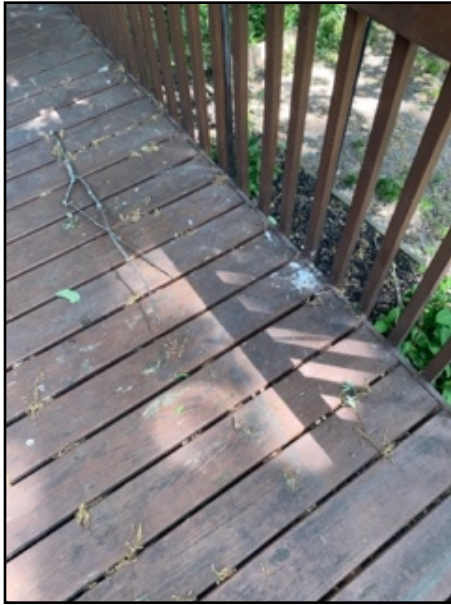
Repaint wood deck to prevent rot and deterioration. Deck shows signs of wear at wood members.

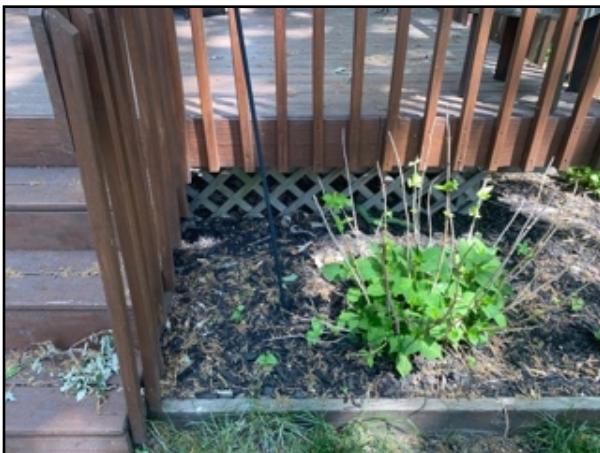
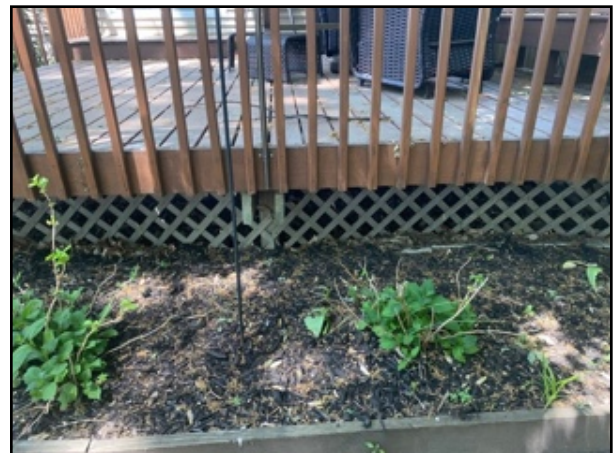
Deck structure was not fully viewed due to skirting at deck.

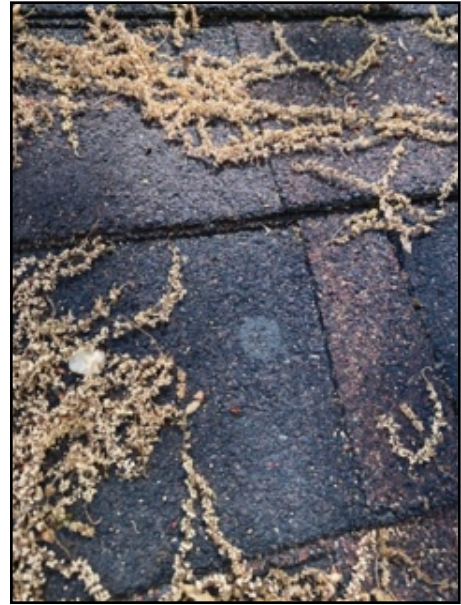
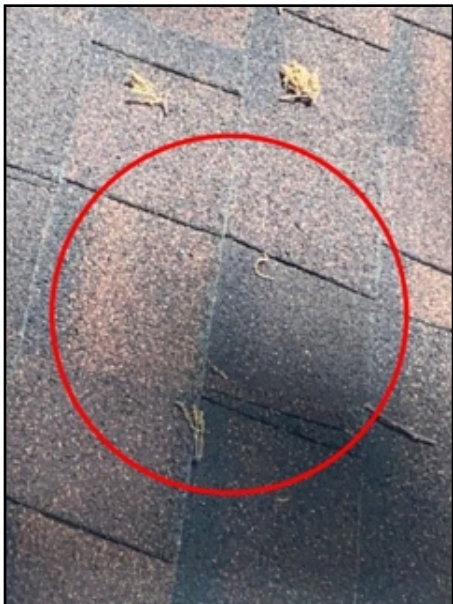
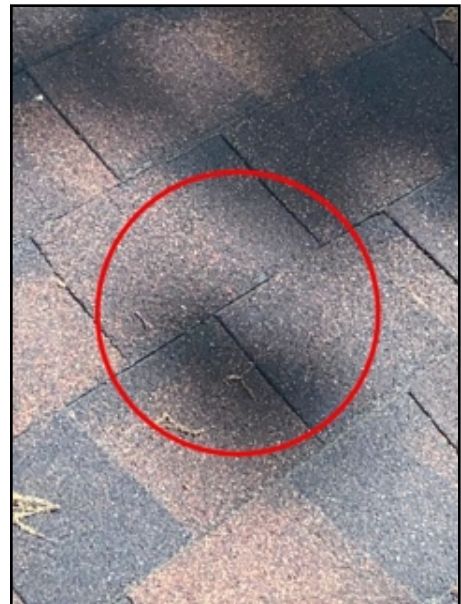
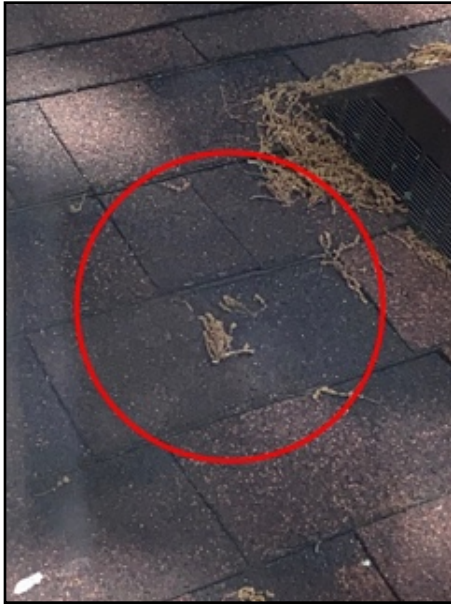
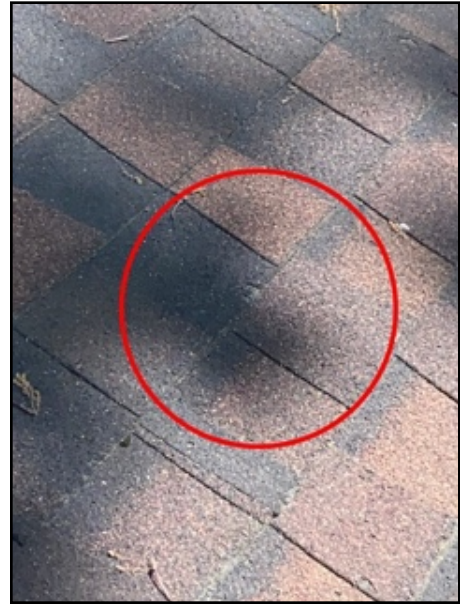
There is noticeable surface wear and aggregate loss at some areas of shingles. Continue to monitor. Repair may be necessary. Consult a licensed roofer to review damages, chipping and wear to shingles.

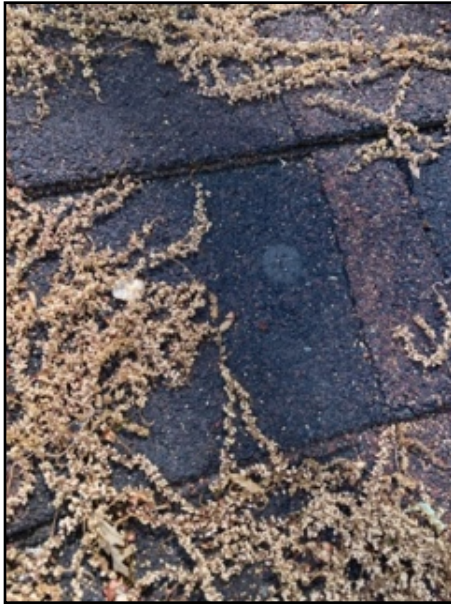
There is significant wear at some shingles. Consult a licensed roofer for full review.

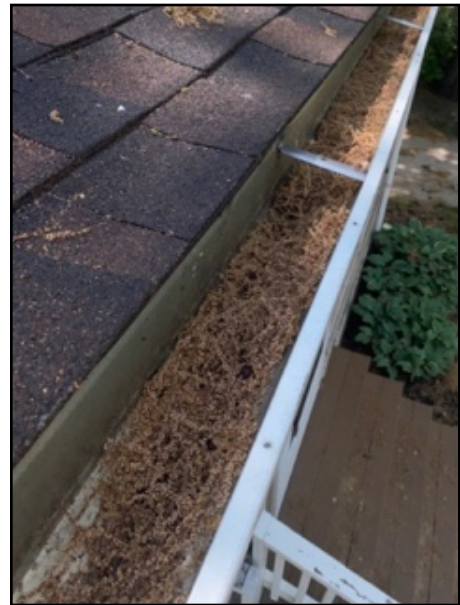
Figure 33-2

Recommended cleaning gutters as they are full of debris. This will not provide proper water runoff away from the roof and structure.

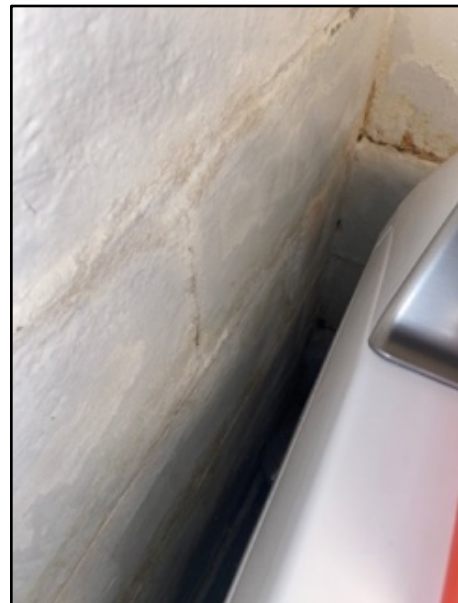
Figure 38-2

Some signs of water penetration and staining exists at basement walls or other areas. Continue to monitor. Regrade to pitch water away from home and direct downspouts further away from foundation to reduce risks for moisture intrusion.

Efflorescence exists at some areas of foundation block.

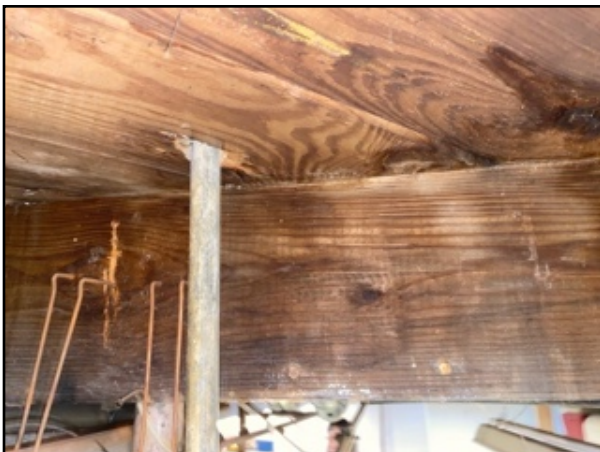
There is a mold like substance at some areas of floor joists and subflooring. Recommended remediation at any areas that show signs of organic growth

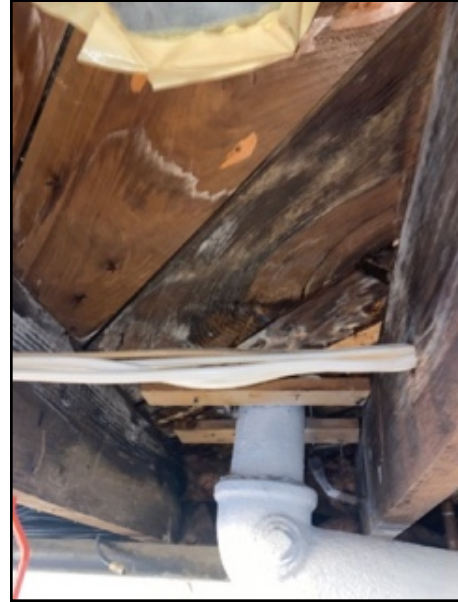
Figure 40-2

Monitor any areas of previous staining. Floor is currently dry. Continue to monitor.

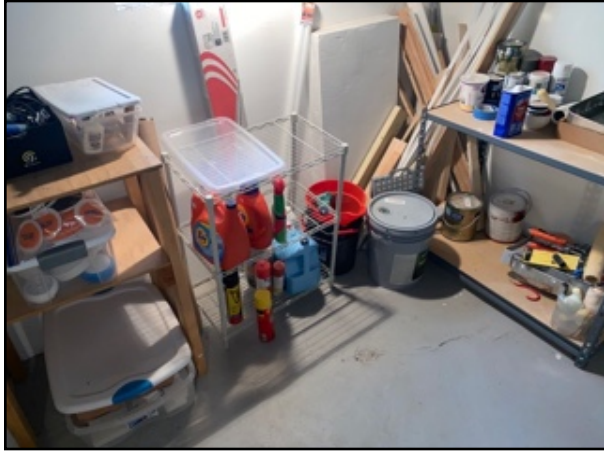
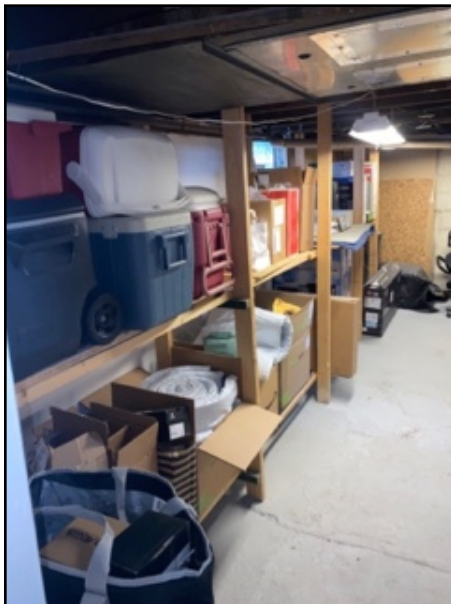
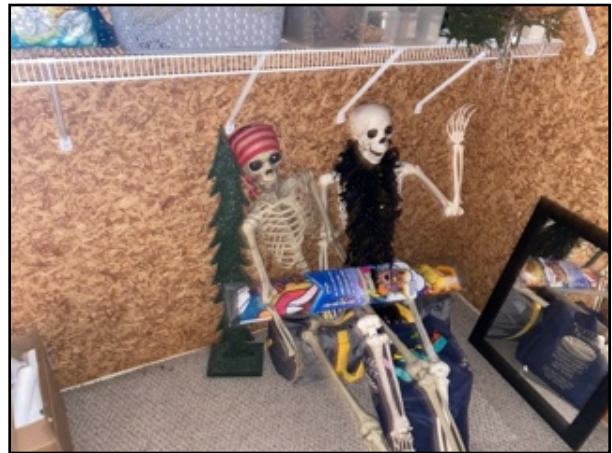
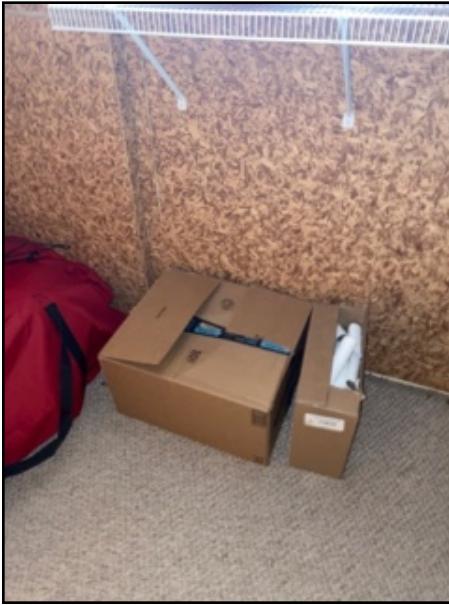
Storage conceals some areas of structure in basement. All areas are not viewable due to personal belongings

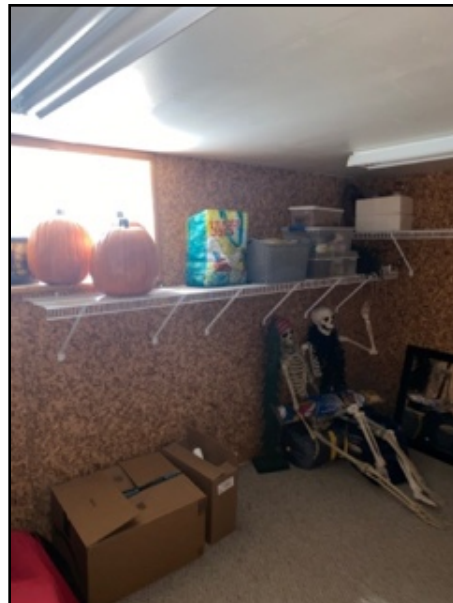
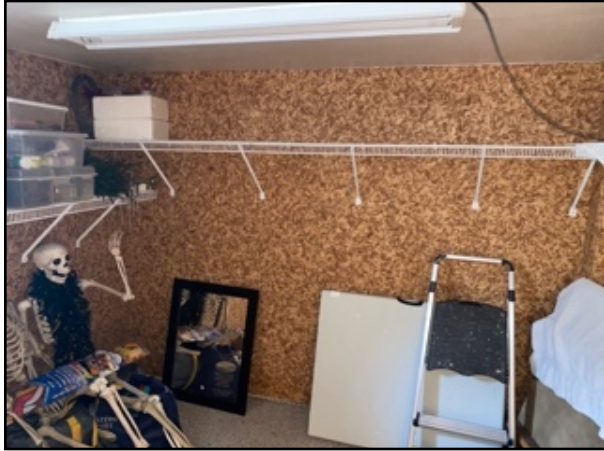
Finished walls conceal foundation in some parts of basement. This is a limitation to the inspection process

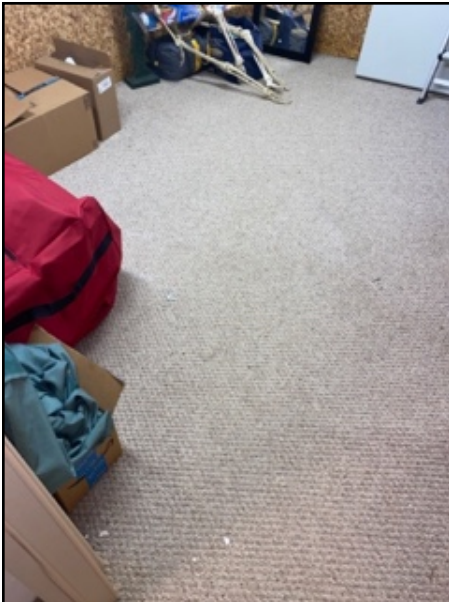
Figure 44-1

Comment 44:  
Carpet conceals some areas of floors in basement.

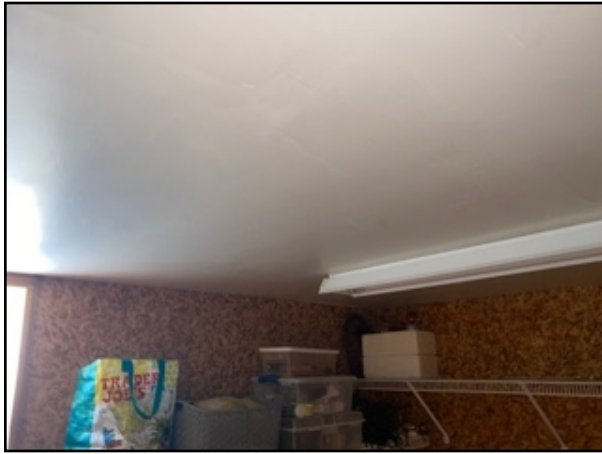
Figure 45-1

**Comment 45:**  
Finished ceilings conceal some areas of structure in basement.

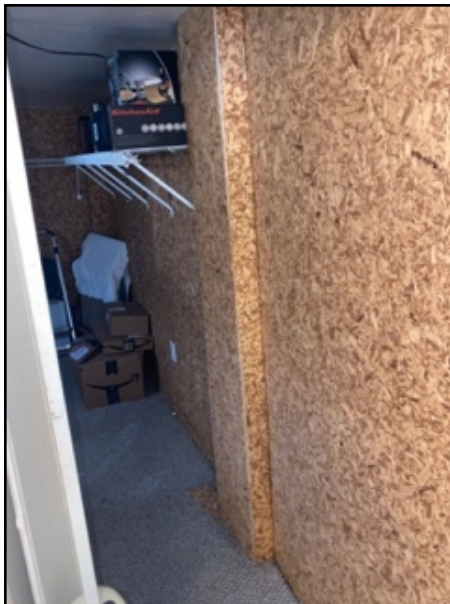
Figure 46-1

**Comment 46:**  
Structural posts are concealed by finishes in some areas.

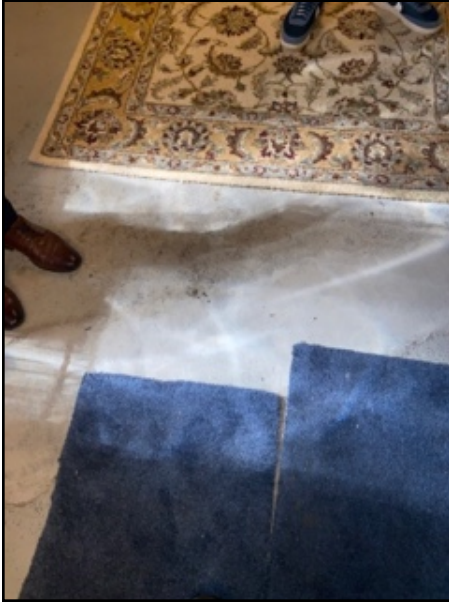
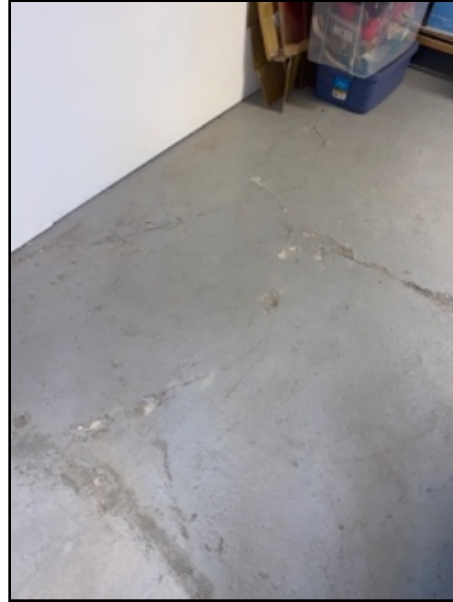
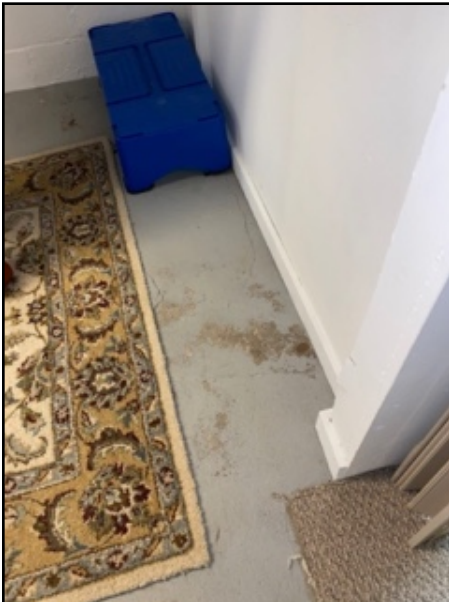
Basement floor shows signs of moisture staining from previous water entry. Clean gutters, extend Downspouts and direct any surface water away from home

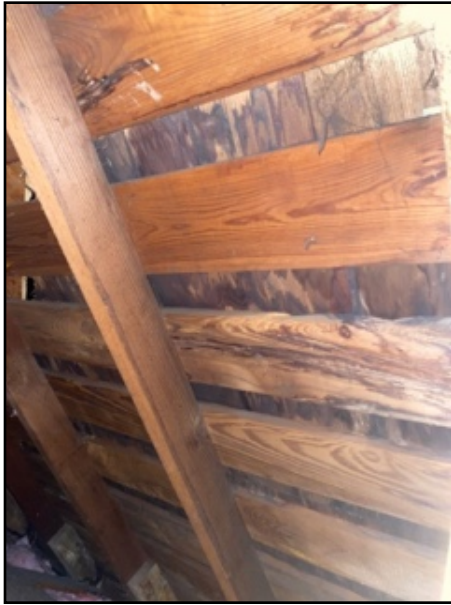
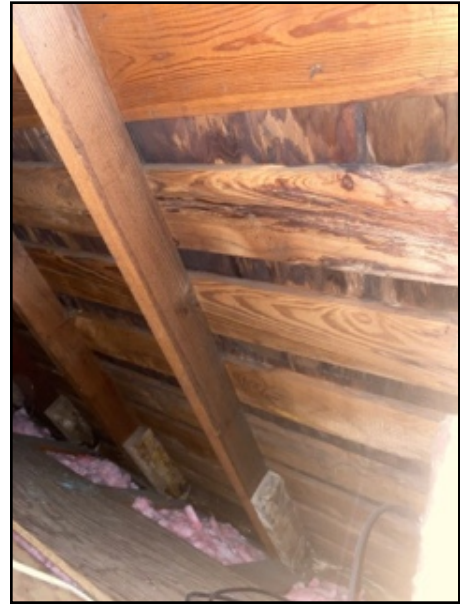
Roofing has been installed over older cedar boards. This is not a proper installation. Continue to monitor. Consult a roofer for further review.

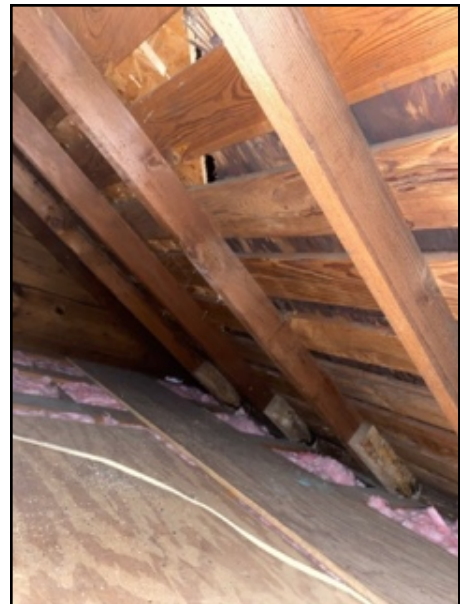
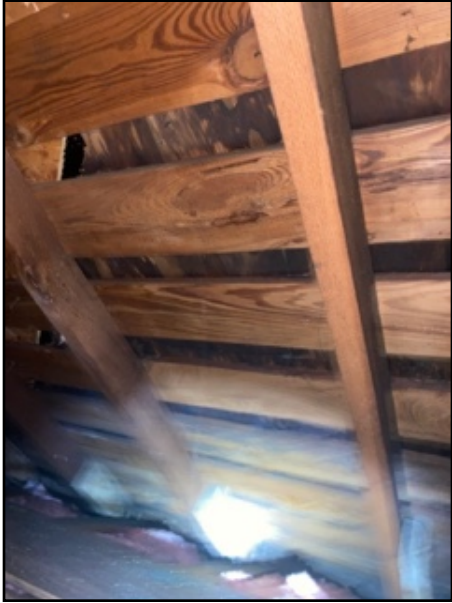
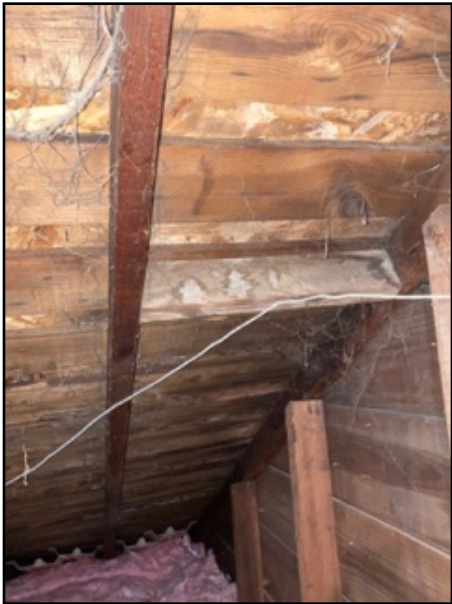
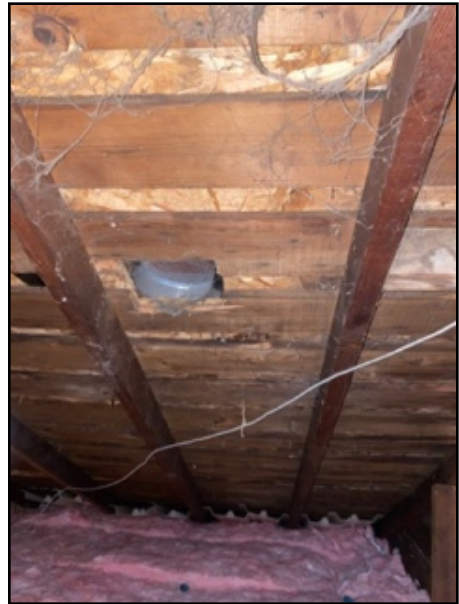
There is a mold like substance at areas of sheathing . A licensed environmental contractor should estimate these areas for remediation. Corrective measures may be required to add additional ventilation to reduce condensation damages

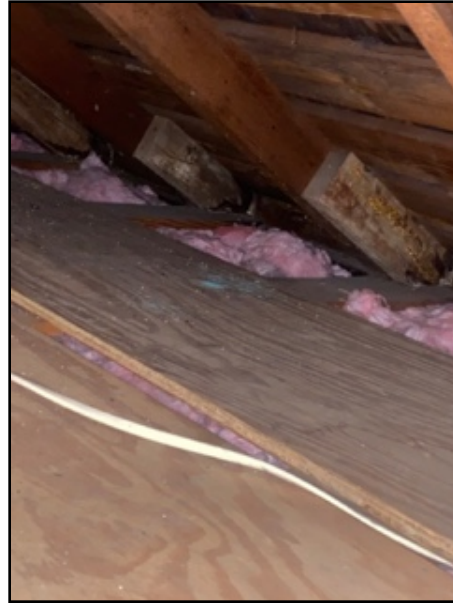
Wood shows visible signs of staining. Areas tested as dry. Continue to monitor.

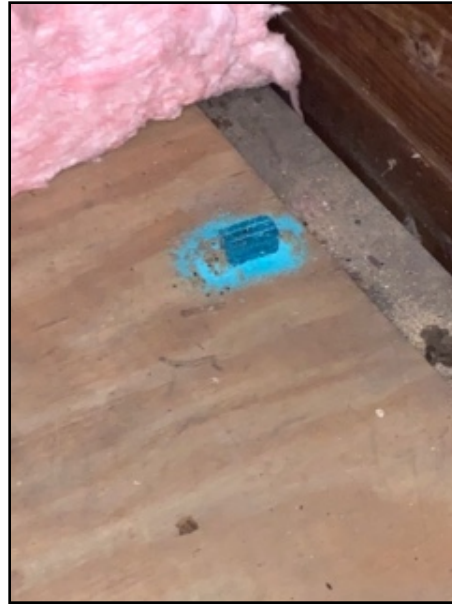
Figure 51-2

Noted pest baits in attic.

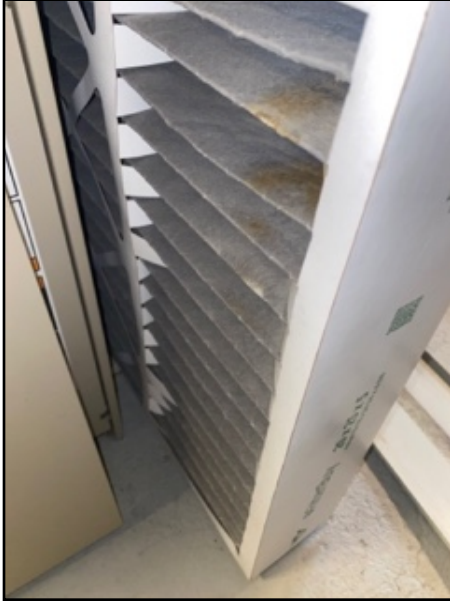
Figure 59-1

Replace filter at this time. Filter is covered in sediment and dirt.

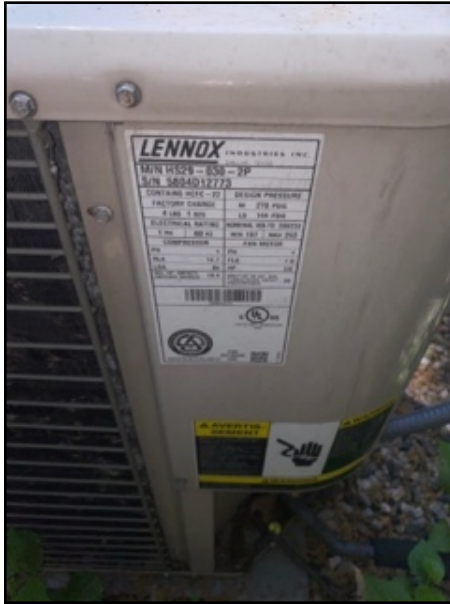
Figure 65-1

AC coils show some signs of damage related to age and wear. Some coils are corroded. Budget to repair and maintain

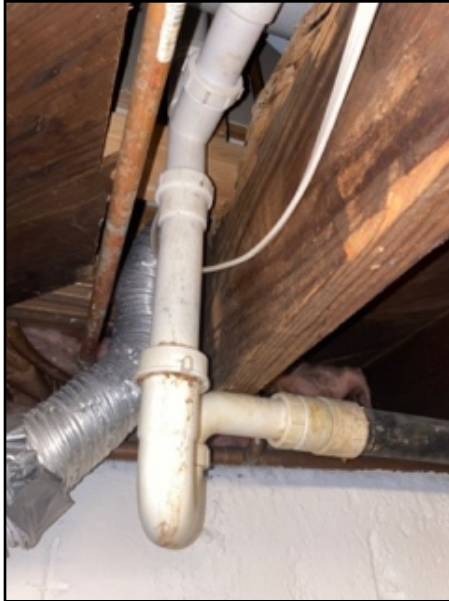
Figure 68-1

Main sewer line has been replaced. Consult with seller for any warranty documentation.

Replace any galvanized waste to prevent low water flow or poor drainage.

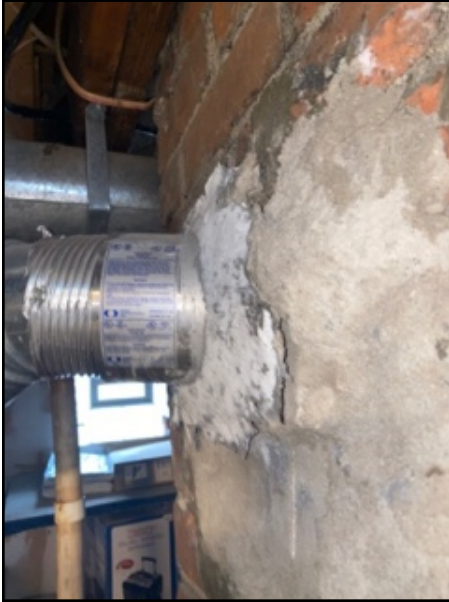
Figure 73-1

Recommended sealing any gaps at chimney where hot water heater vent meets system. This will prevent back drafting of gases into home.

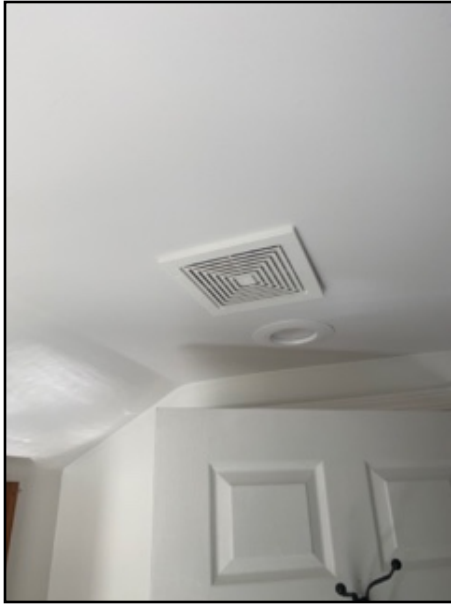
Figure 74-1

Did not locate switch for vent fan. Suggested installation. Review is necessary. Vent did not power on.

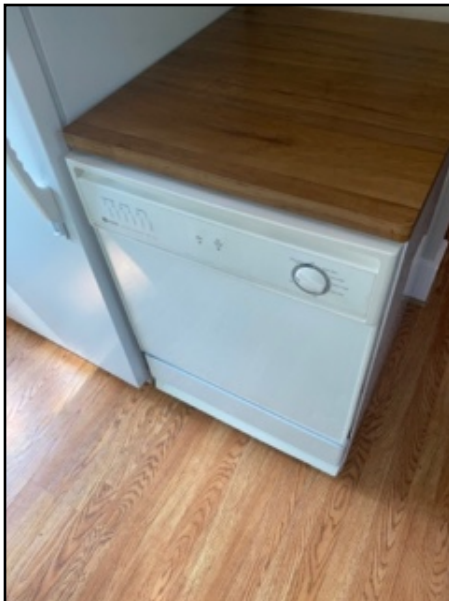
Figure 78-1

Comment 78:  
Portable dishwashers are not tested.

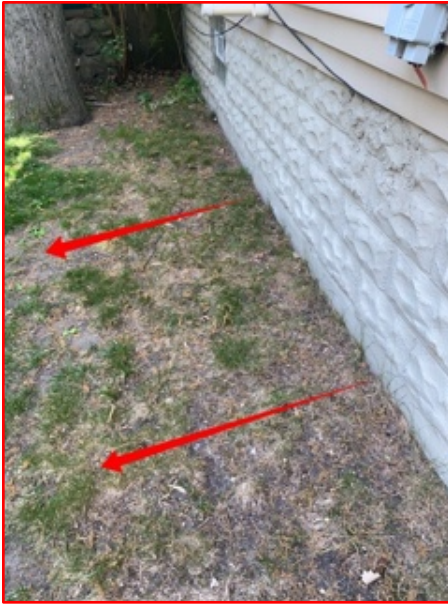
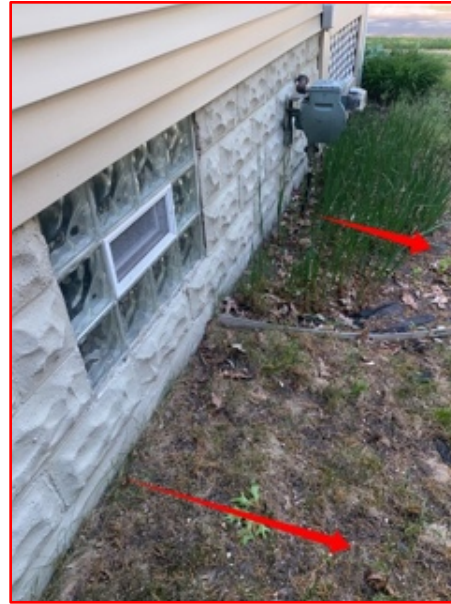
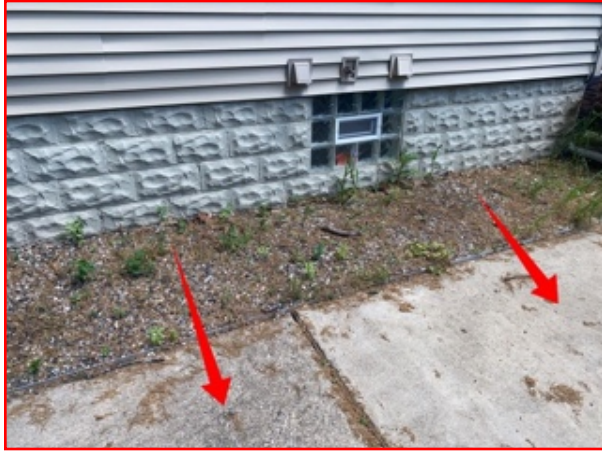
1) Regrade to pitch slope away from home to direct surface water away from foundation. This may assist in moisture entry to lower levels or structure of home. A positive slope directed away from the foundation is suggested.

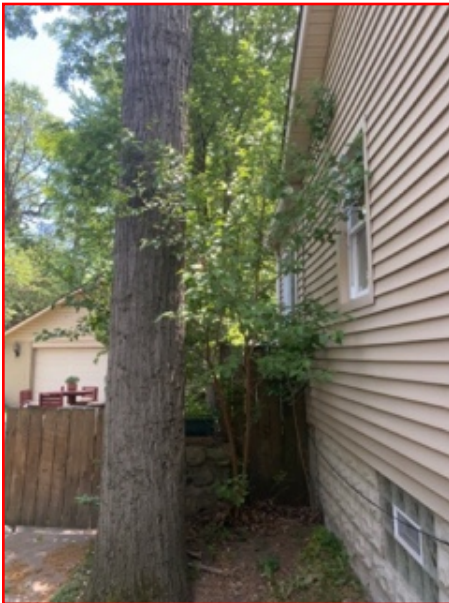
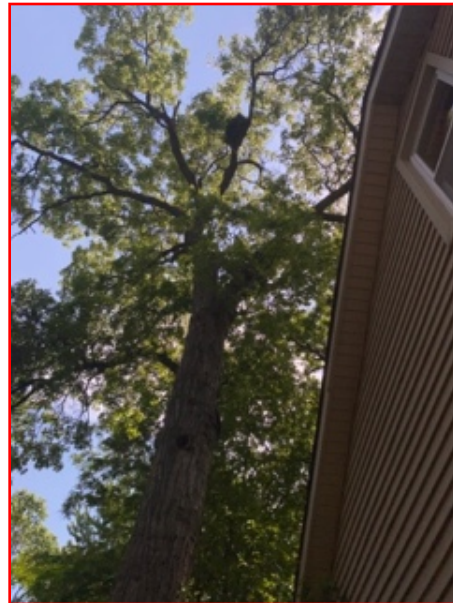
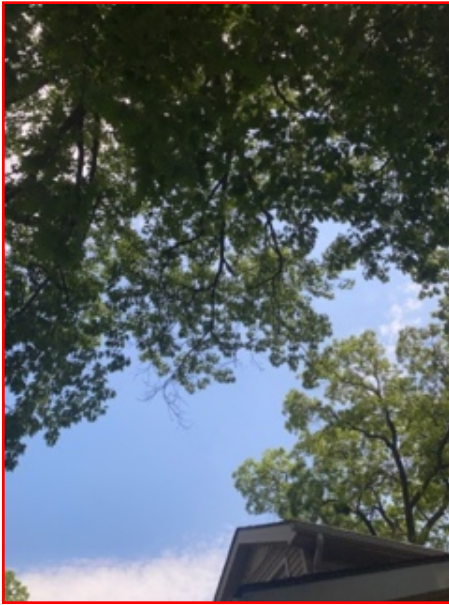
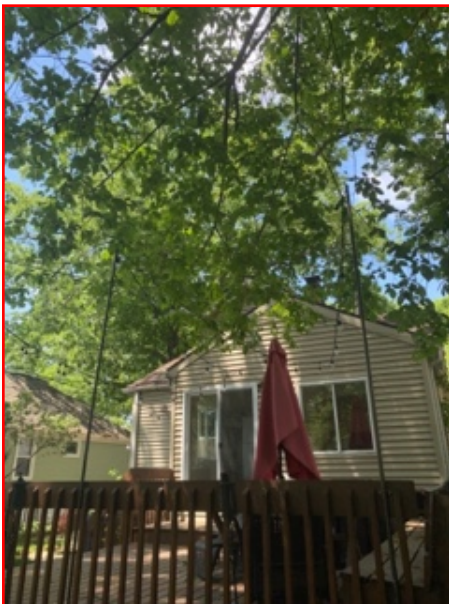
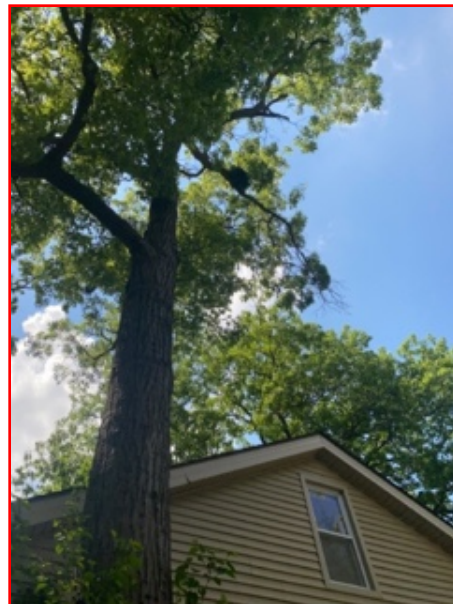
2) Trim trees and vegetation away from Structure and roof to prevent damages to home, siding or roofing materials.

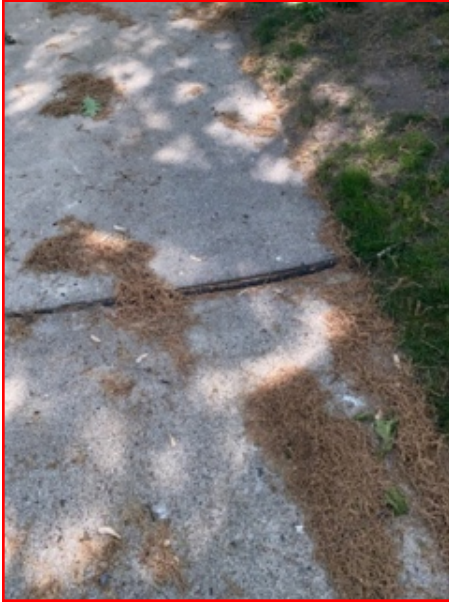
Figure 14-1

3) Driveway is unlevel from settlement. Have driveway leveled or mud jacked to prevent trip hazards.

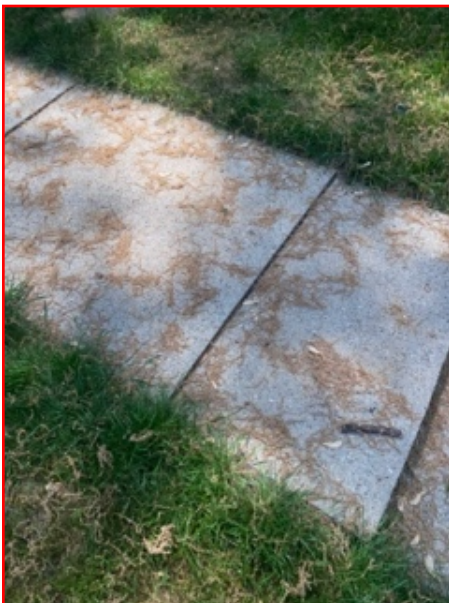
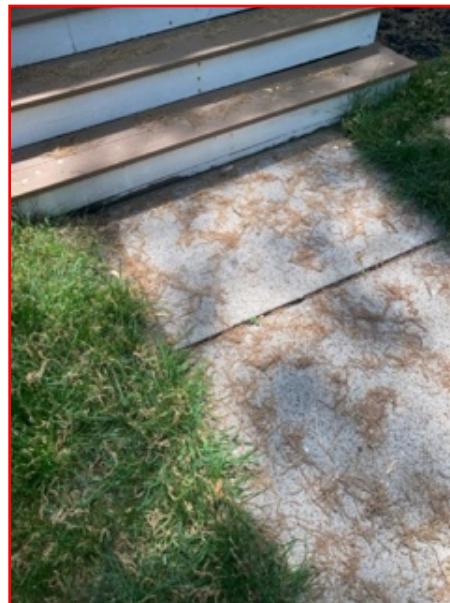
4) Walkway has settled. This may cause trip hazards. Have areas mud jacked or leveled to prevent safety issues or trip hazards. Walkways should be directed away from structure to assist in water dispersion away from home.

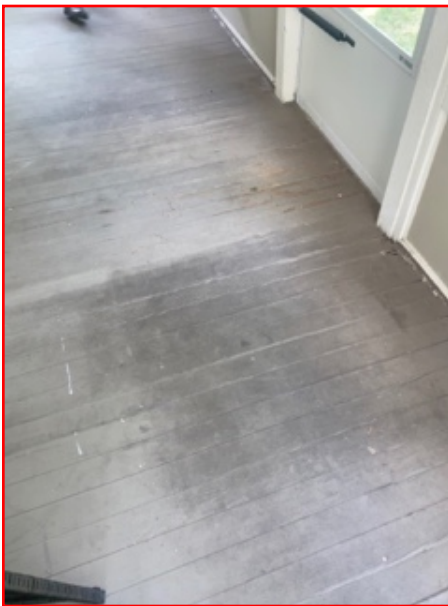
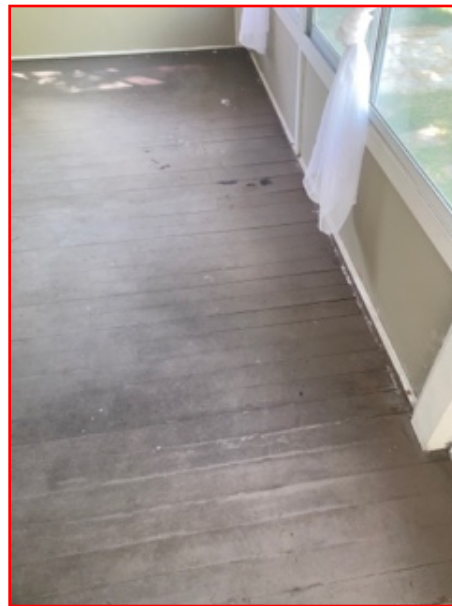
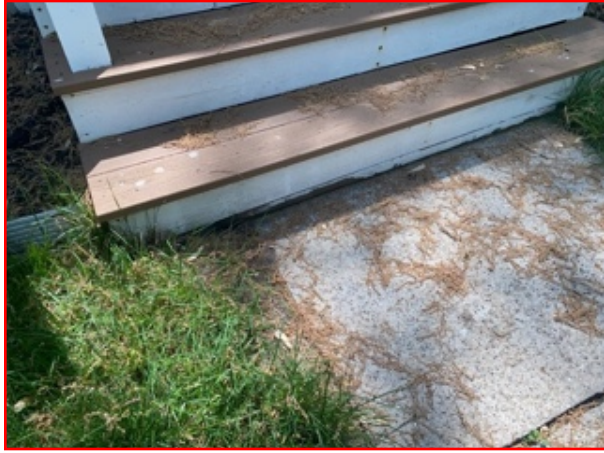
6) Repaint any areas where paint has faded or peeled. Repaint to prevent rot or deterioration at wood porch.

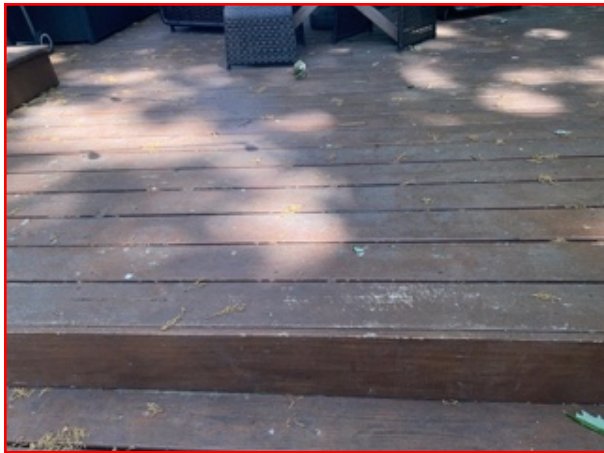
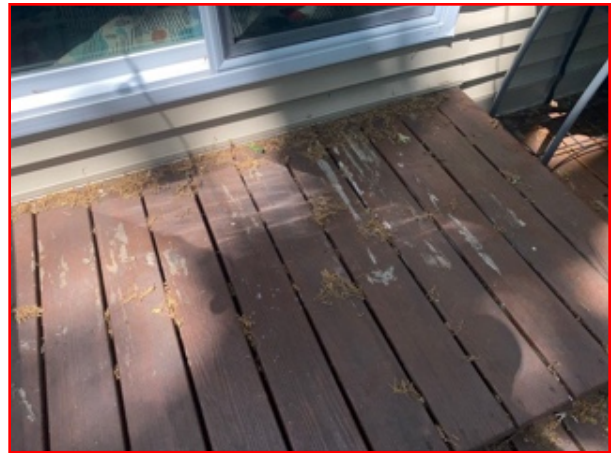
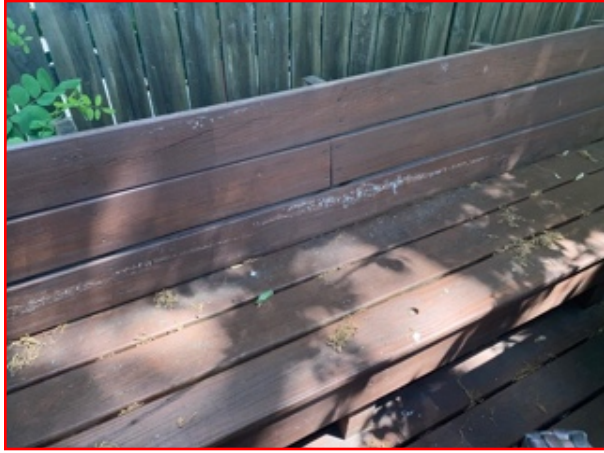
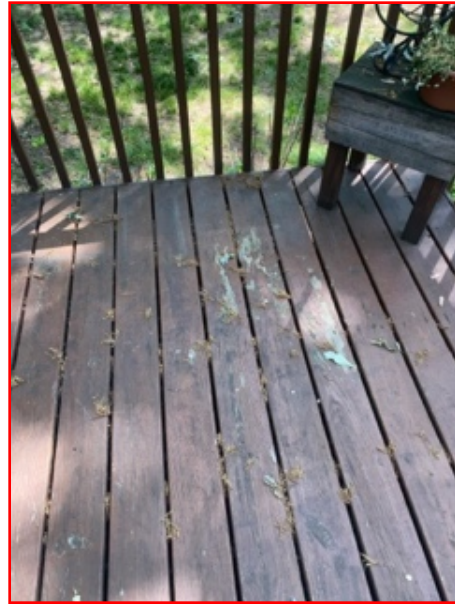
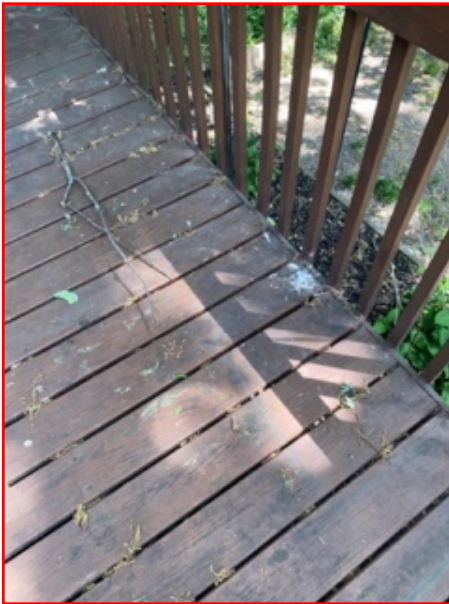
7) Repaint wood deck to prevent rot and deterioration. Deck shows signs of wear at wood members.

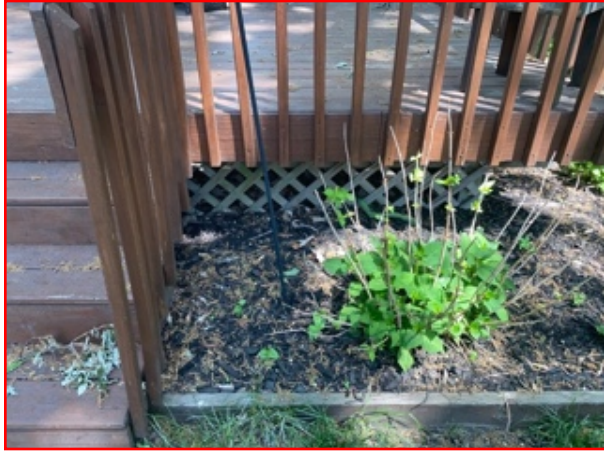
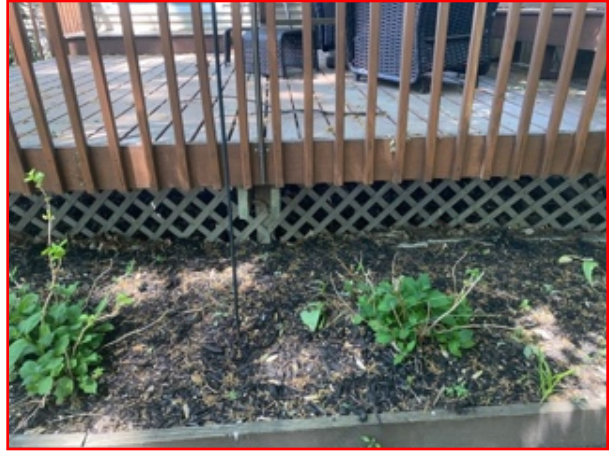
8) Deck structure was not fully viewed due to skirting at deck.

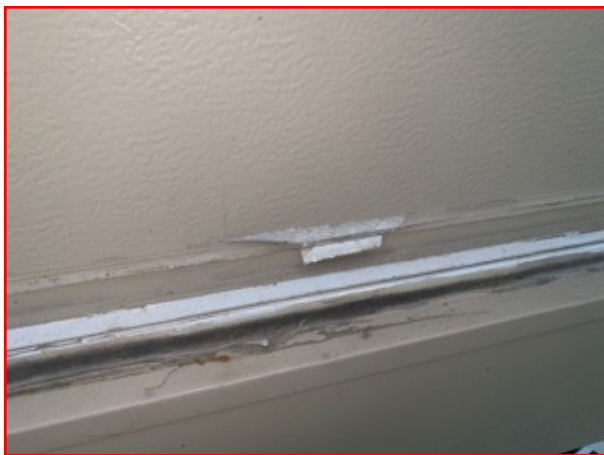
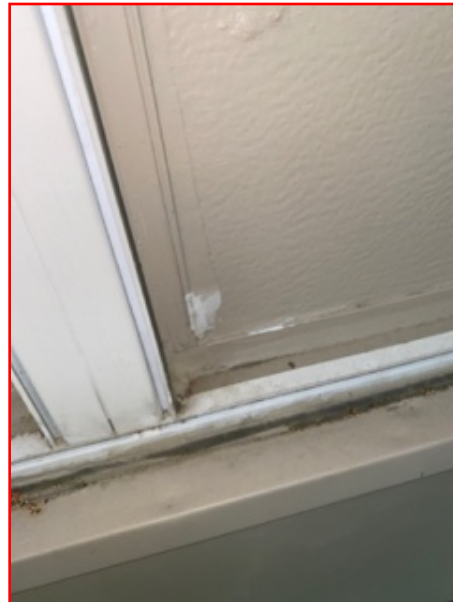
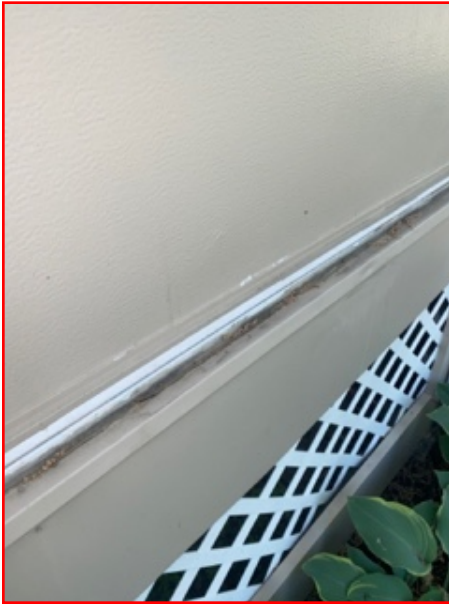
9) Repaint any areas at exterior walls where paint has peeled.

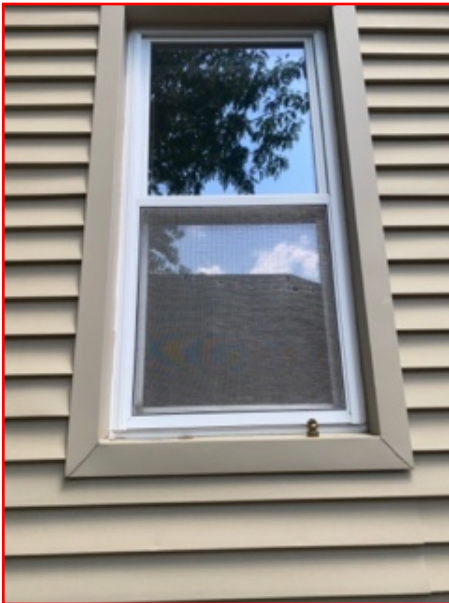
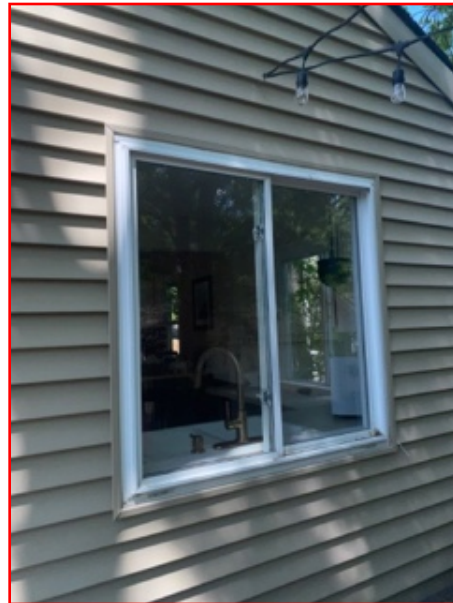
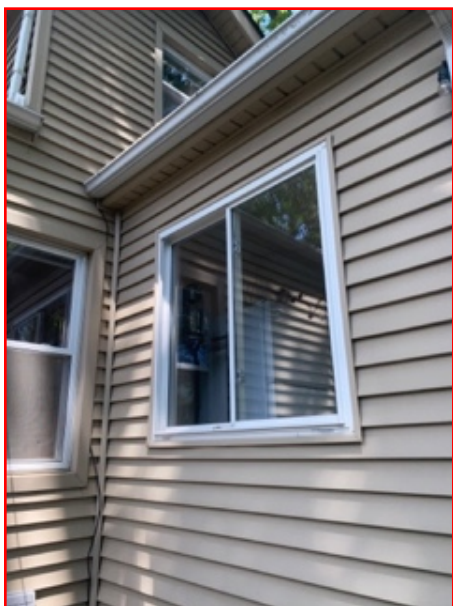
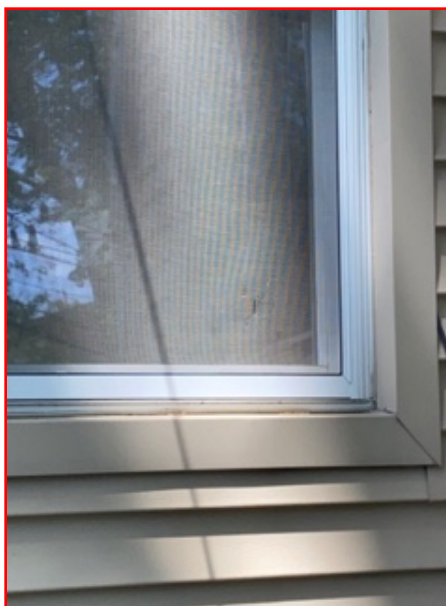
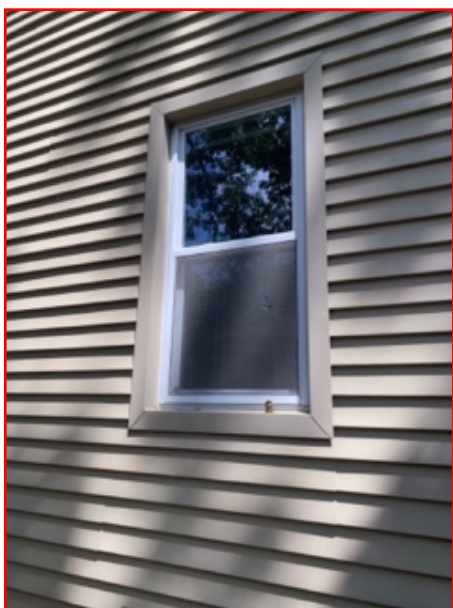
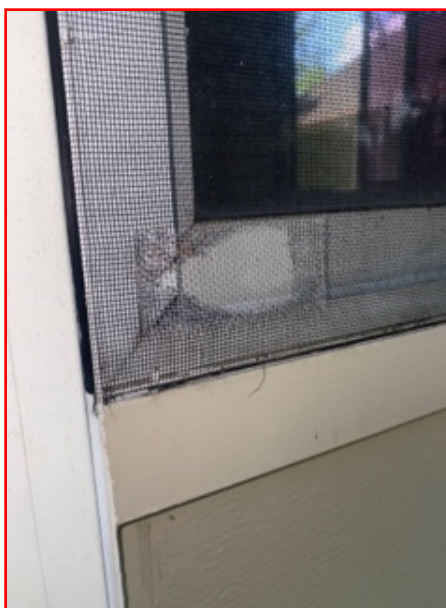
10) Replace any missing or damaged screens surrounding the home.

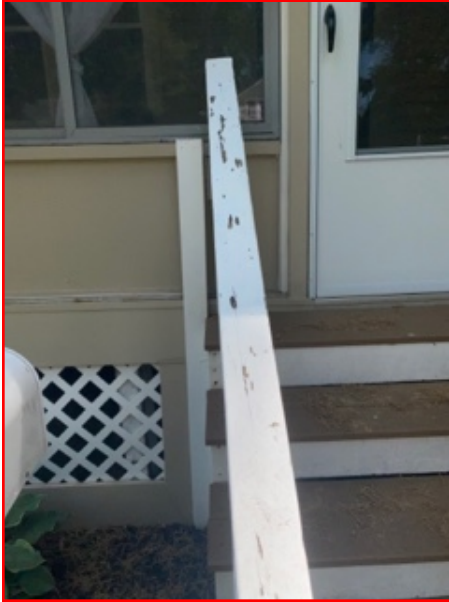
Figure 23-1

11) Some railings show signs of paint peel. Repaint to prevent further rot or damages. Replace any damaged sections.
