**HDX HOME  
INSPECTIONS**

## Home Inspection Report

**861 Test Street**

Inspected on Tue, Jan 18 2022 at 12:40 AM

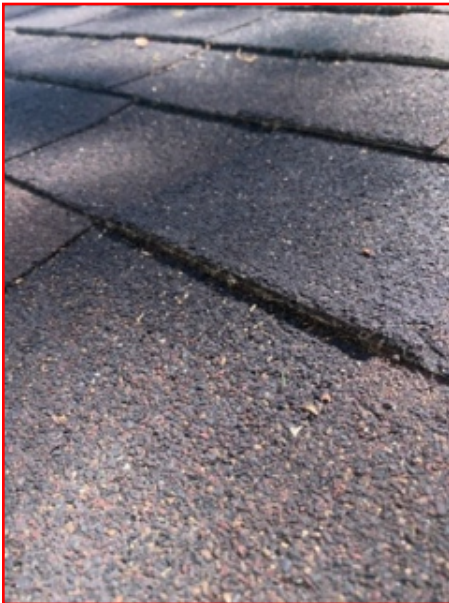
12) Clean any mold or moss at shingles to prevent further damages or deterioration at surfaces.

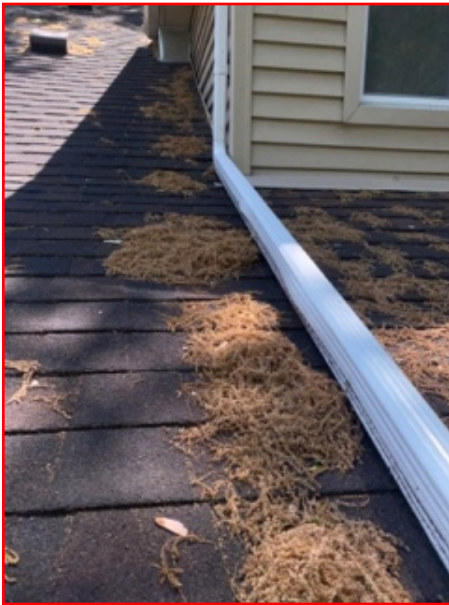
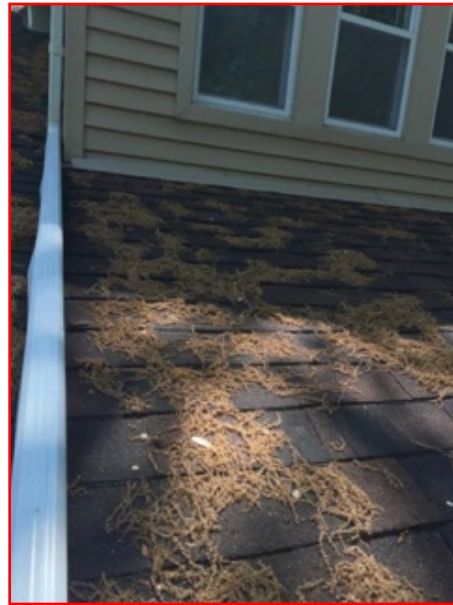
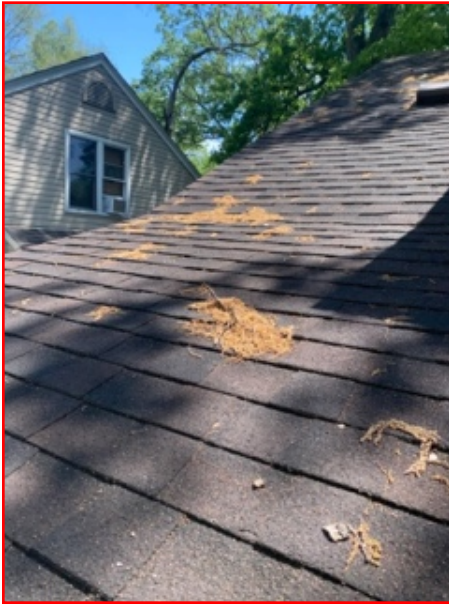
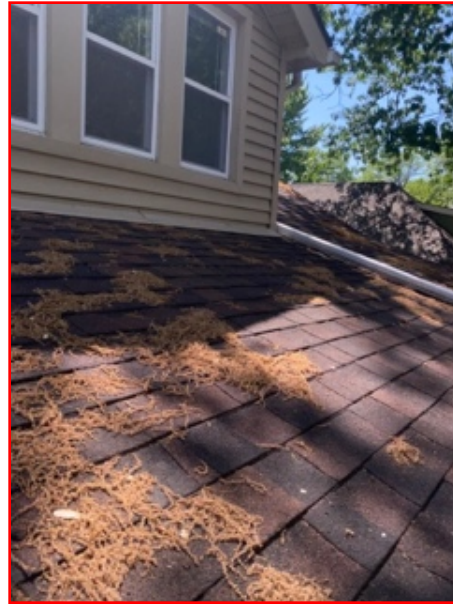
13) Recommended clearing any debris at roof surface to prevent damages or further organic growth at the shingles.

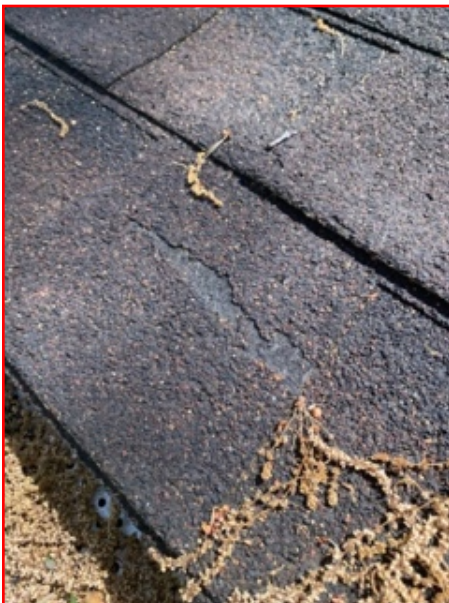
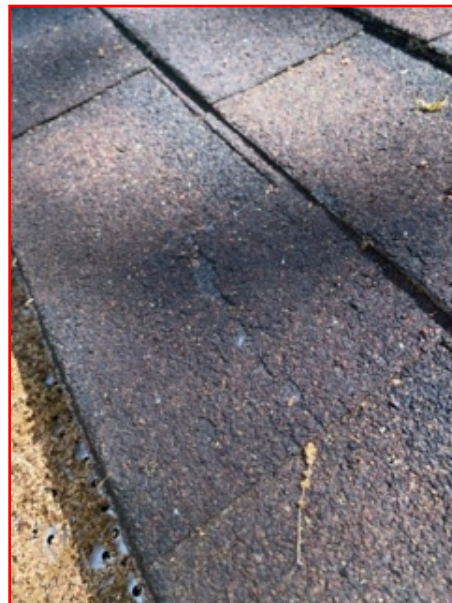
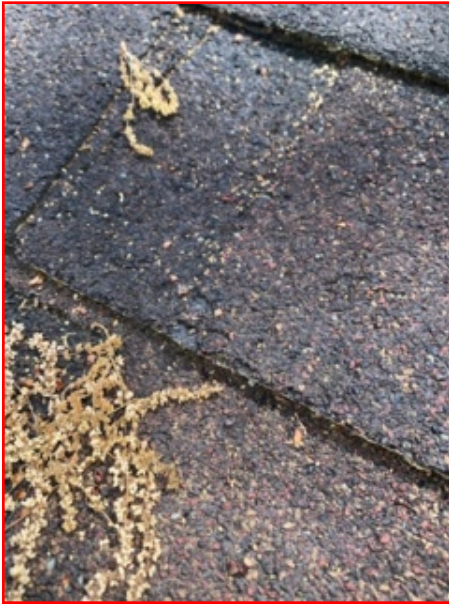
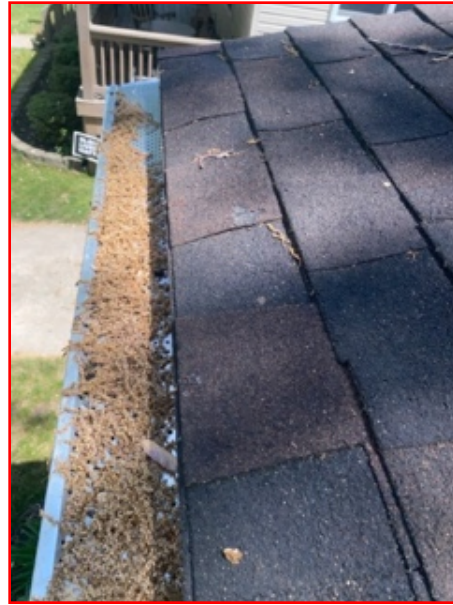
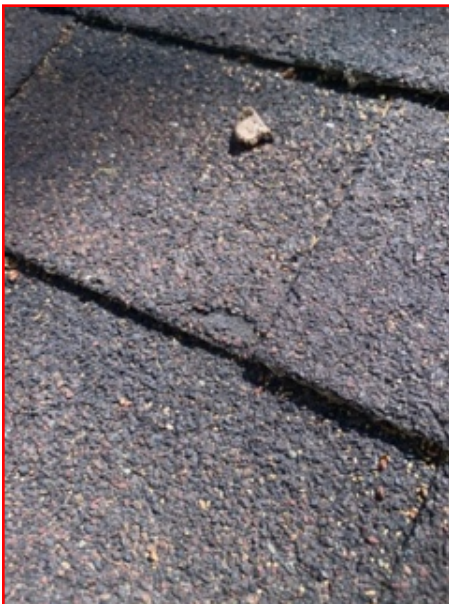
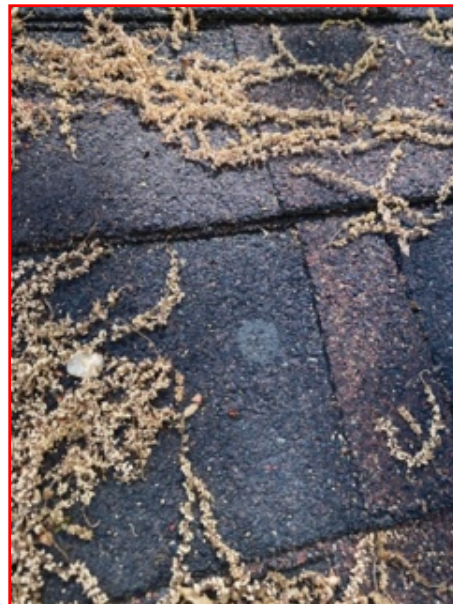
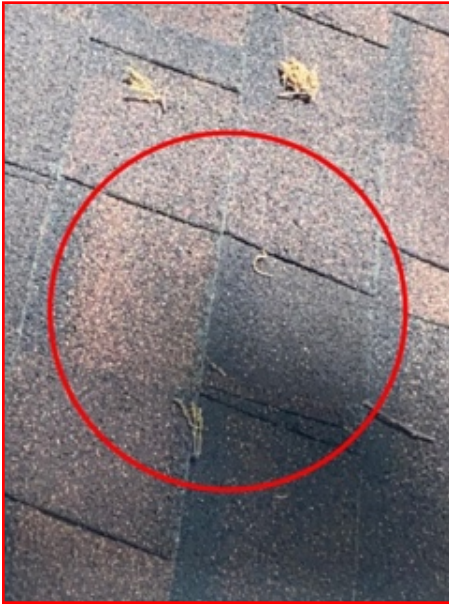
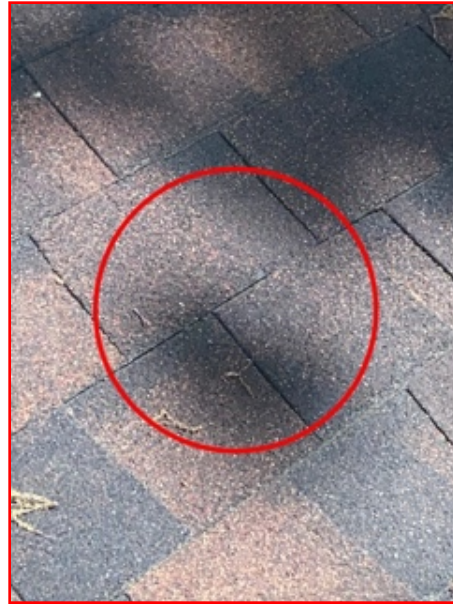
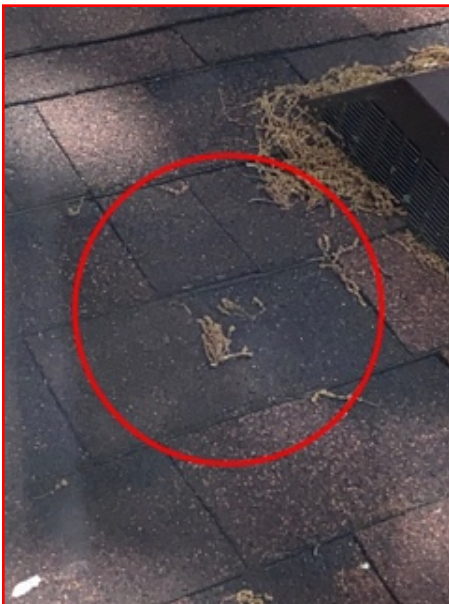
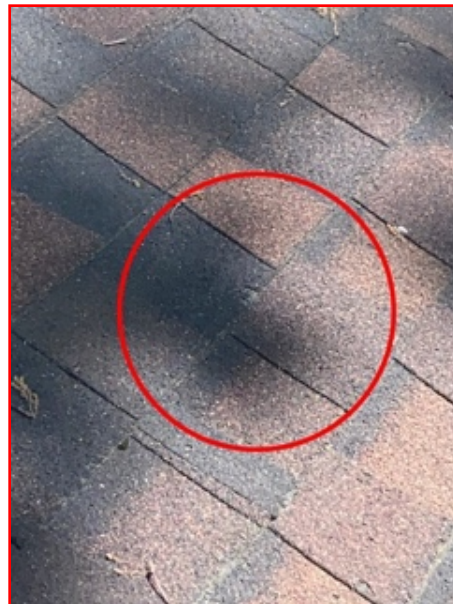
14) There is noticeable surface wear and aggregate loss at some areas of shingles. Continue to monitor. Repair may be necessary. Consult a licensed roofer to review damages, chipping and wear to shingles.

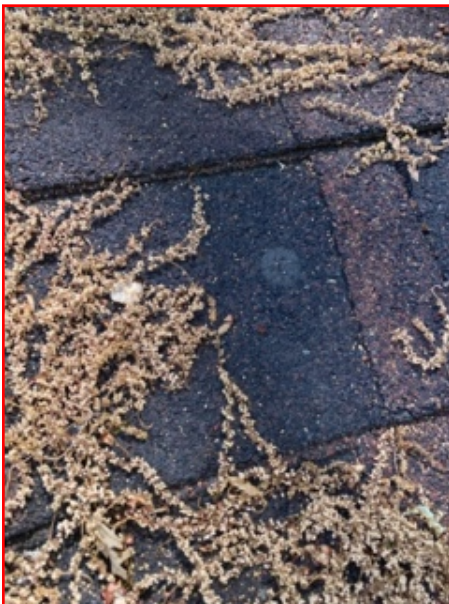
15) There is significant wear at some shingles. Consult a licensed roofer for full review.

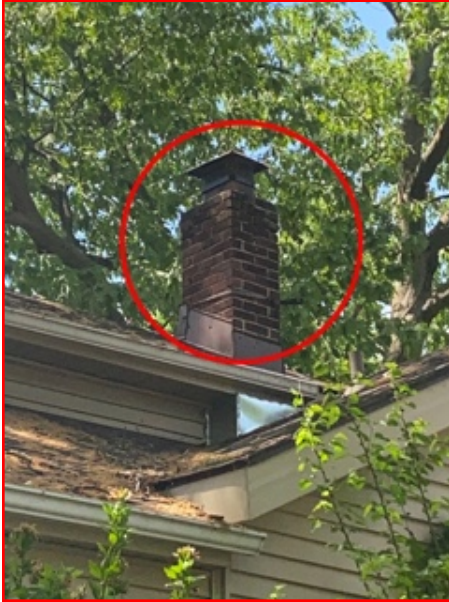
Figure 31-1

17) Chimney shows some signs of wear. Some tuckpointing is necessary. Consult a licensed brick mason for repair

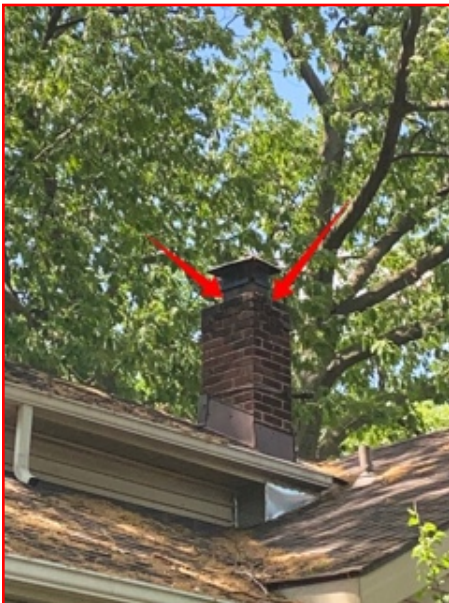
Figure 32-1

18) Chimney crown may require patching or repairs. Consult a licensed brick mason for estimate.

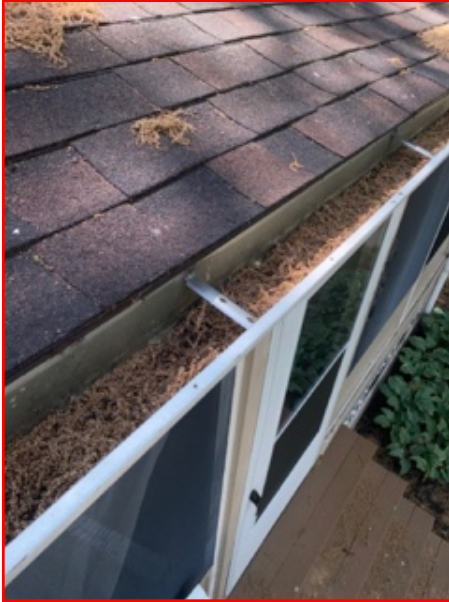
19) Recommended cleaning gutters as they are full of debris. This will not provide proper water runoff away from the roof and structure.

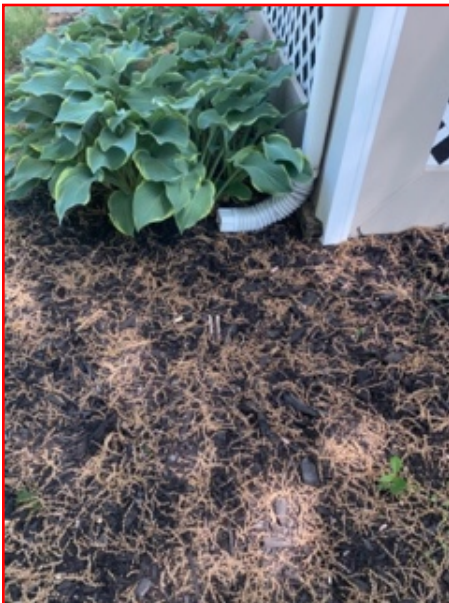
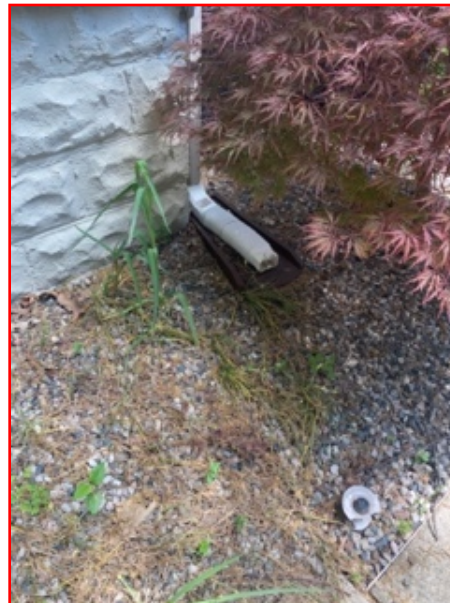
20) Extend downspouts away from home to direct water away from foundation. Extend 6-8 feet away from home

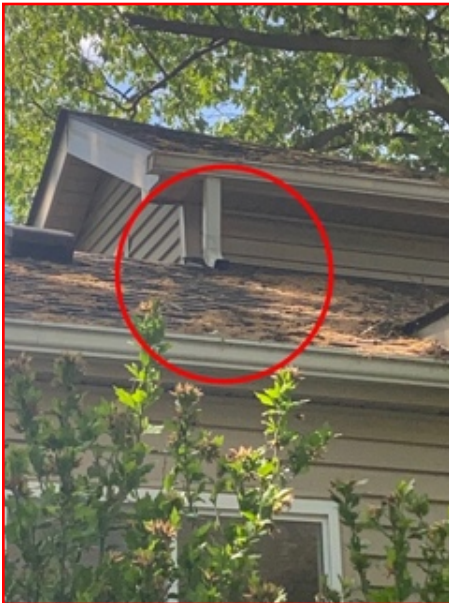
Figure 35-1

21) Extend leaders to lower gutter systems to direct water away from roof and to prevent wear to shingles. Any upper leaders should be directed to lower gutter system

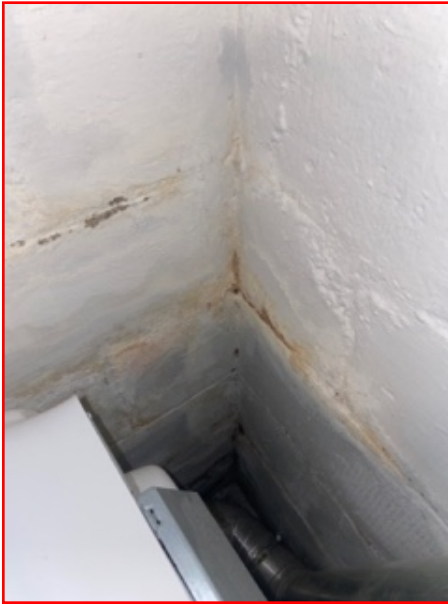
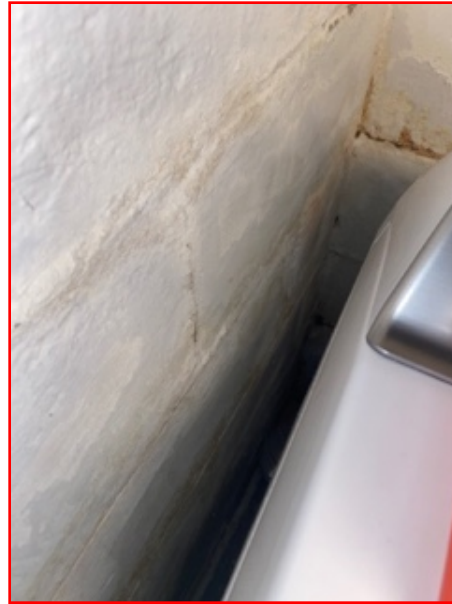
22) Some signs of water penetration and staining exists at basement walls or other areas. Continue to monitor. Regrade to pitch water away from home and direct downspouts further away from foundation to reduce risks for moisture intrusion.

Efflorescence exists at some areas of foundation block.

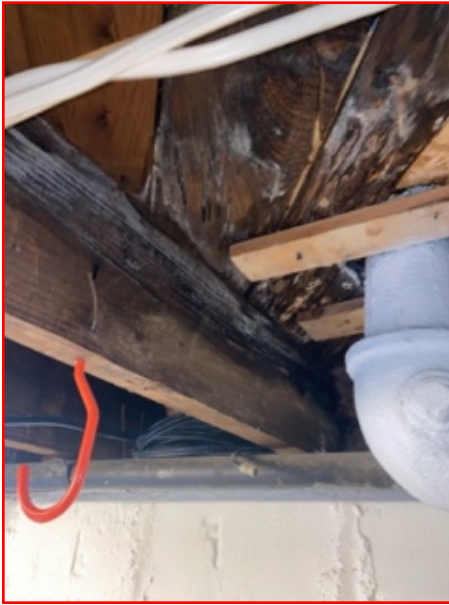
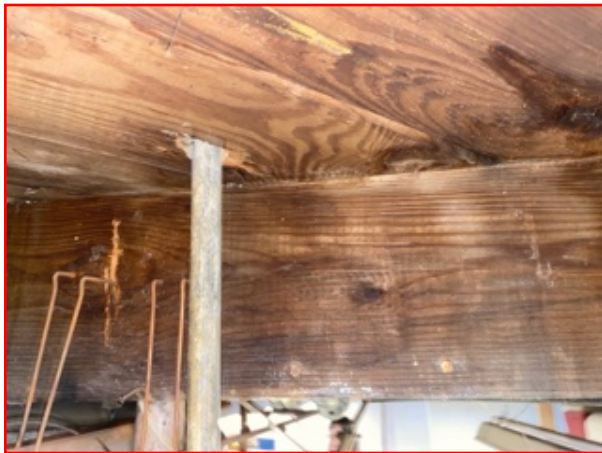
23) There is a mold like substance at some areas of floor joists and subflooring. Recommended remediation at any areas that show signs of organic growth

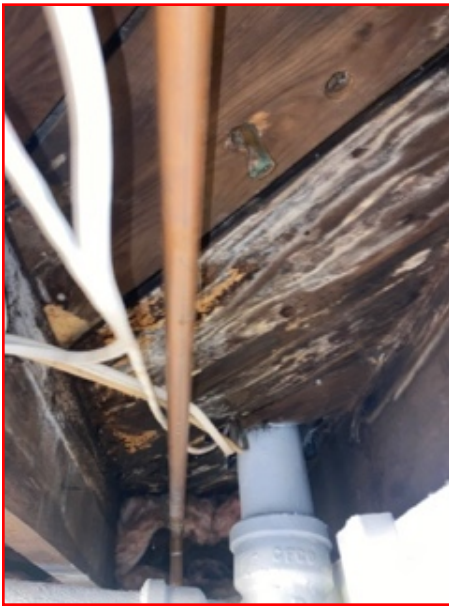
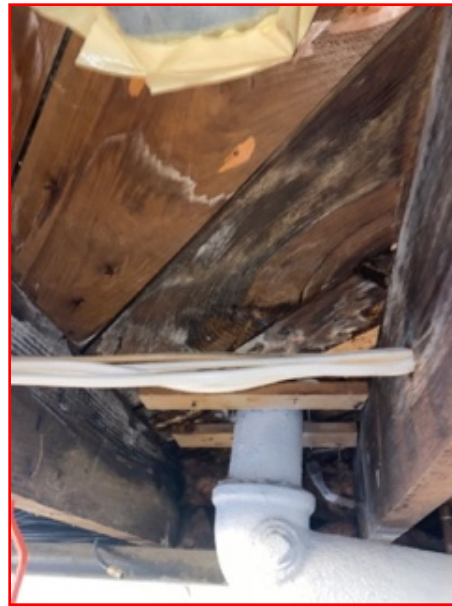
24) Monitor any areas of previous staining. Floor is currently dry. Continue to monitor.

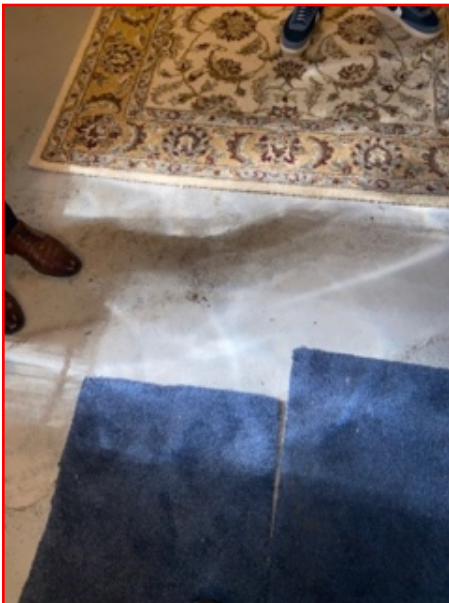
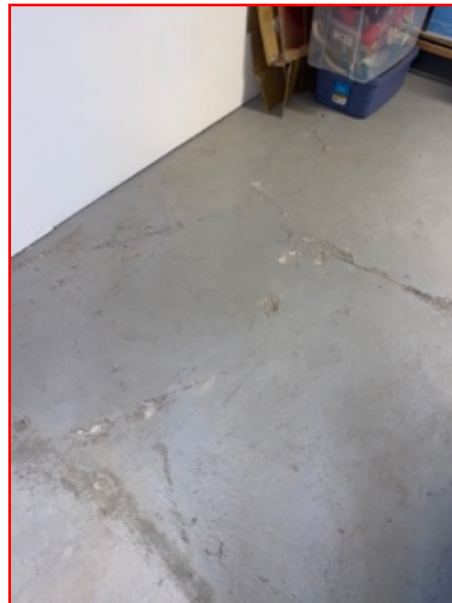
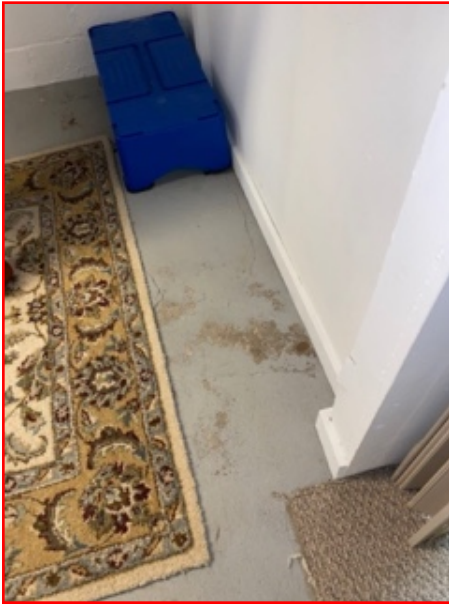
25) Basement floor shows signs of moisture staining from previous water entry. Clean gutters, extend Downspouts and direct any surface water away from home

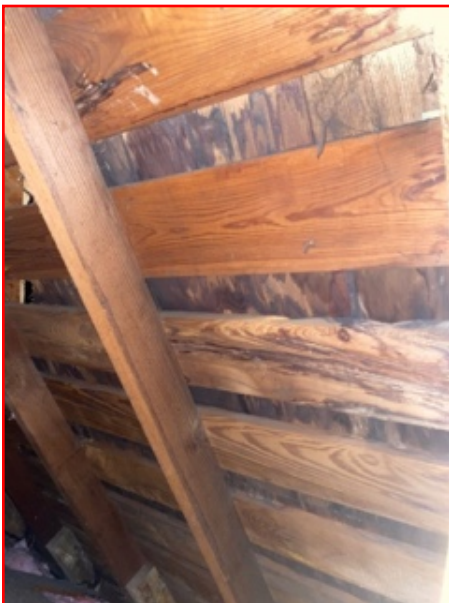
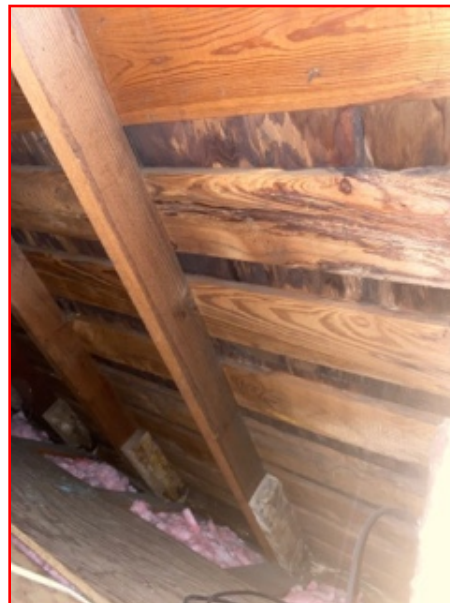
26) Roofing has been installed over older cedar boards. This is not a proper installation. Continue to monitor. Consult a roofer for further review.

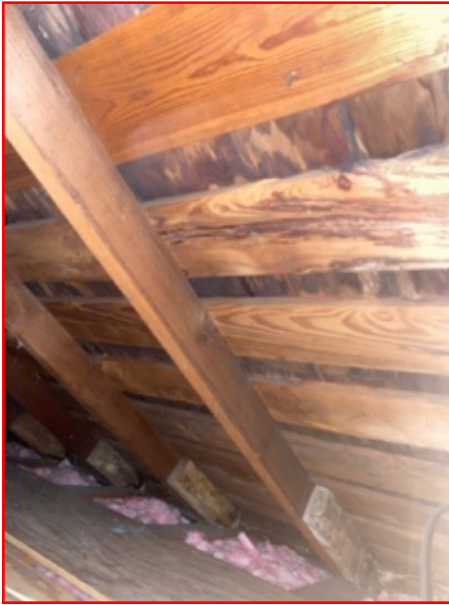
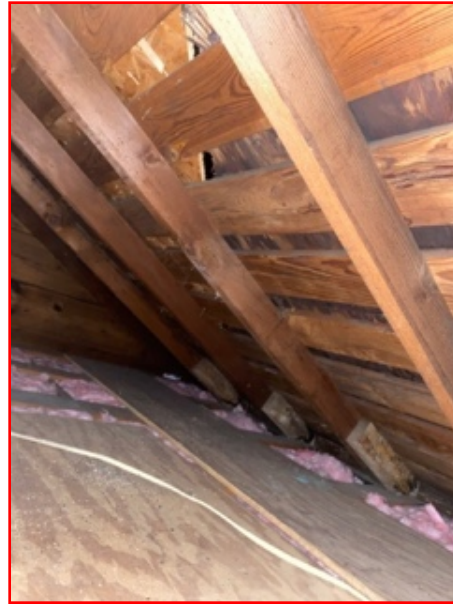
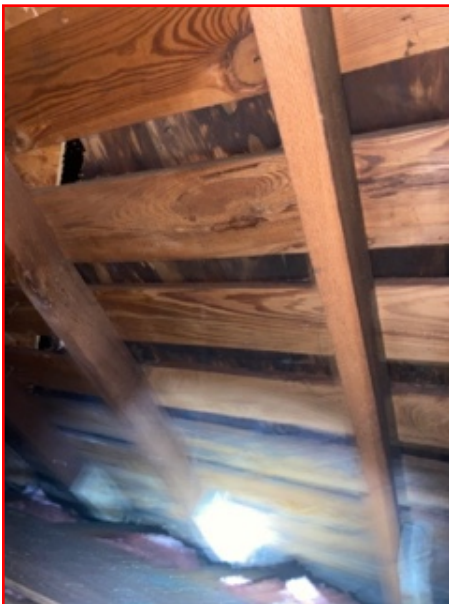
27) There is a mold like substance at areas of sheathing . A licensed environmental contractor should estimate these areas for remediation. Corrective measures may be required to add additional ventilation to reduce condensation damages

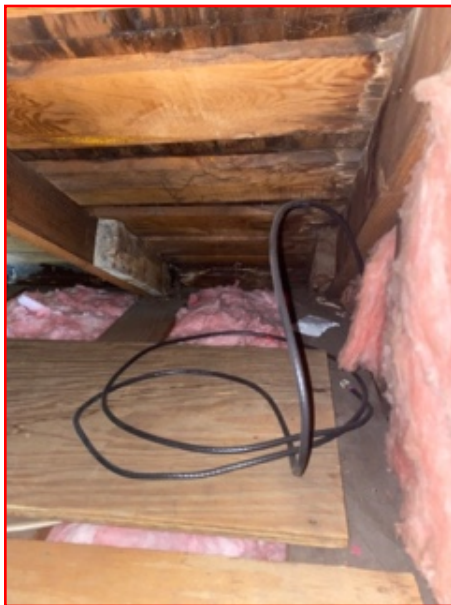
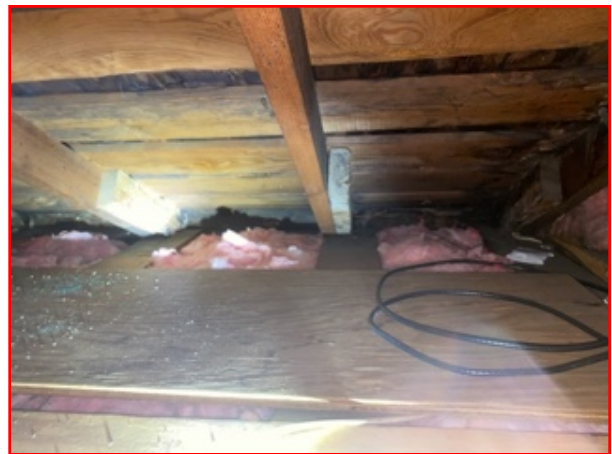
28) Wood shows visible signs of staining. Areas tested as dry. Continue to monitor.

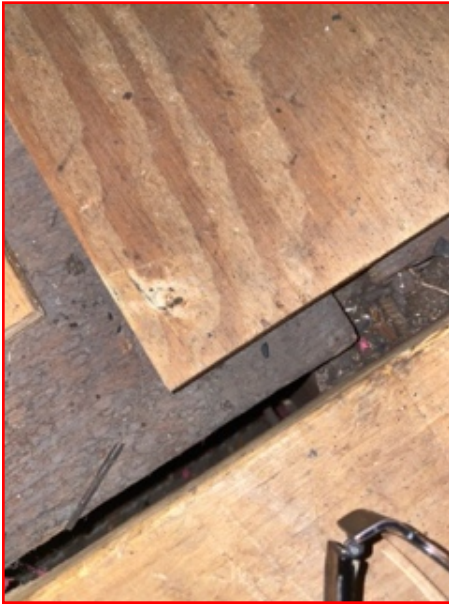
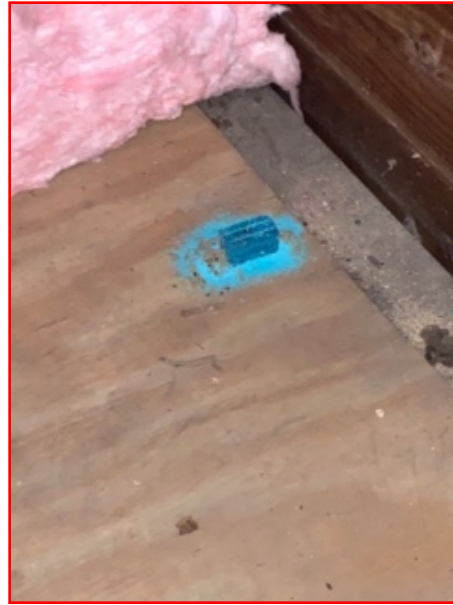
29) There are pest droppings in the attic. Consult a licensed exterminator for estimation of removal.

Noted pest baits in attic.

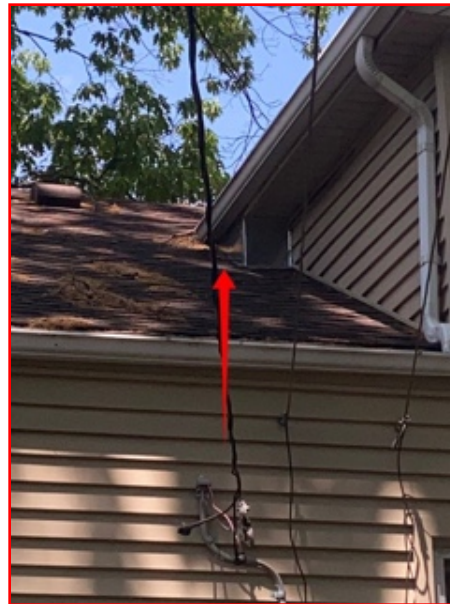
32) It is recommended to add a proper riser at the electrical drop. Consult an electrician for updates

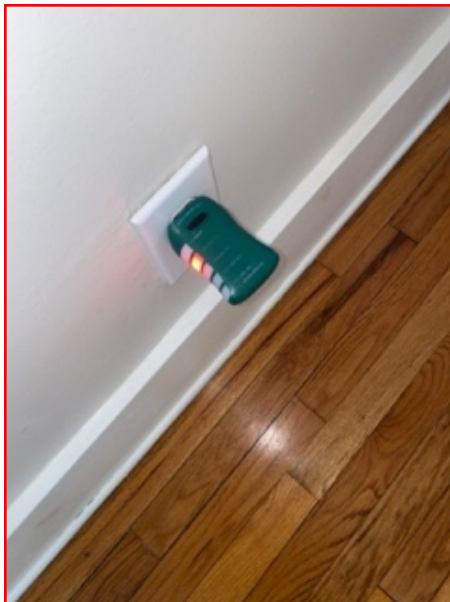
34) 3 prong outlets are ungrounded in some areas. It is recommended to ground outlets to meet current safety standards

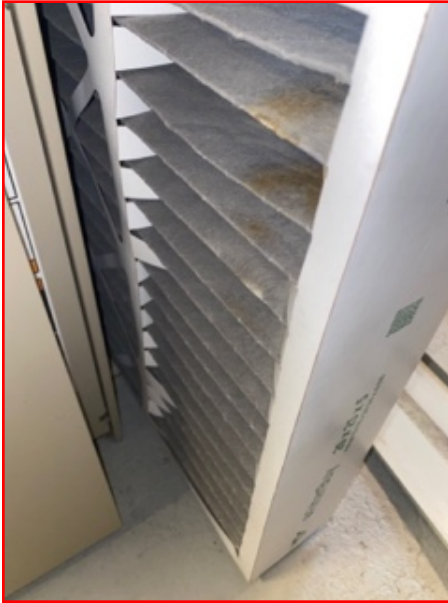
Figure 59-1

35) Replace filter at this time. Filter is covered in sediment and dirt.

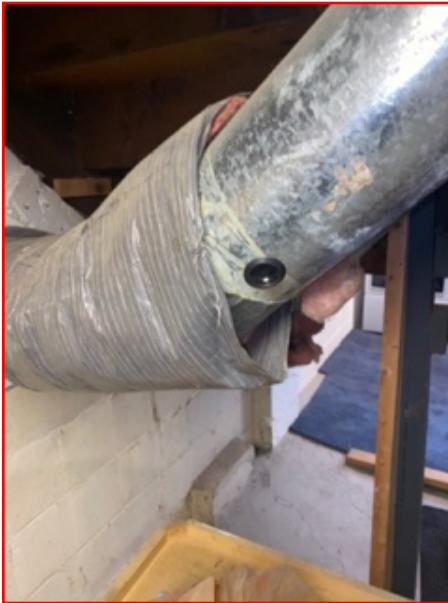
Figure 60-1

36) Recommended taping transitions to flexible ducting.

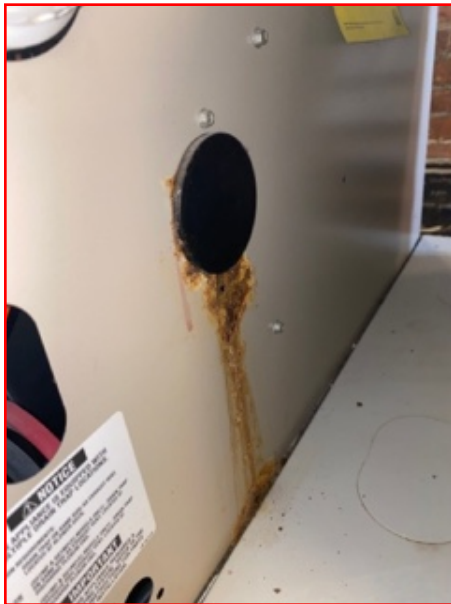
Figure 63-1

37) Housing shows some signs of corrosion. Repair may be needed in time.

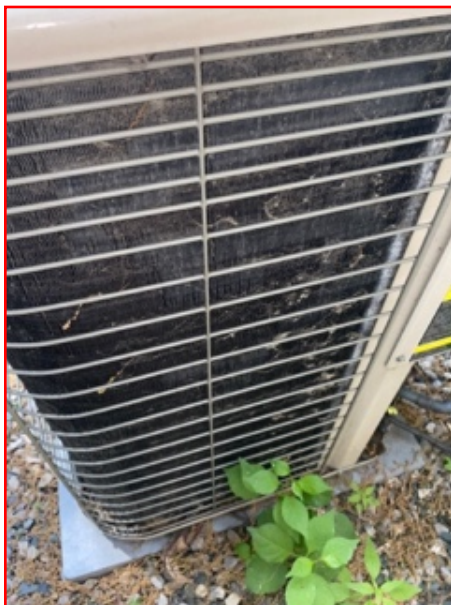
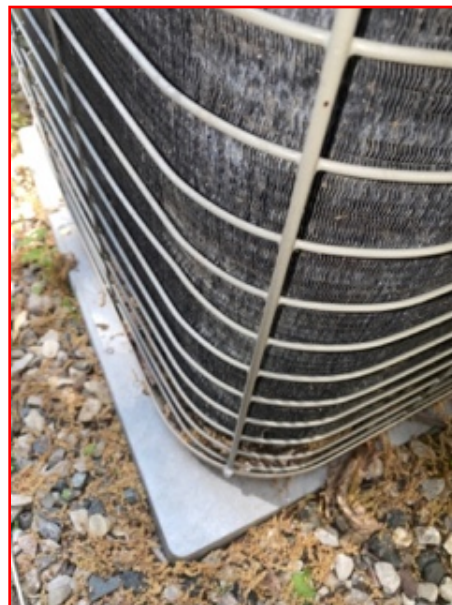
38) AC coils show some signs of damage related to age and wear. Some coils are corroded. Budget to repair and maintain

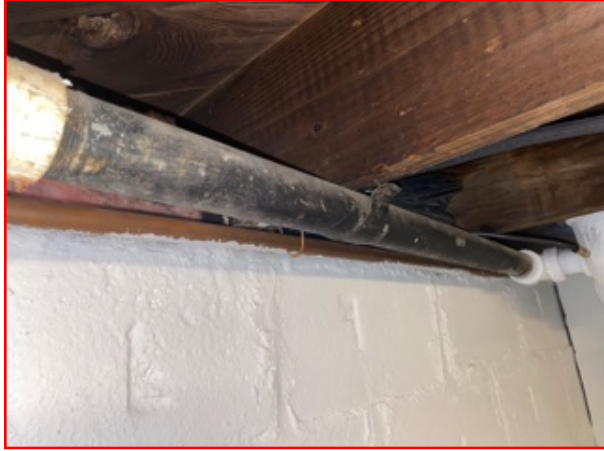
Figure 69-1

39) Replace any galvanized waste to prevent low water flow or poor drainage.

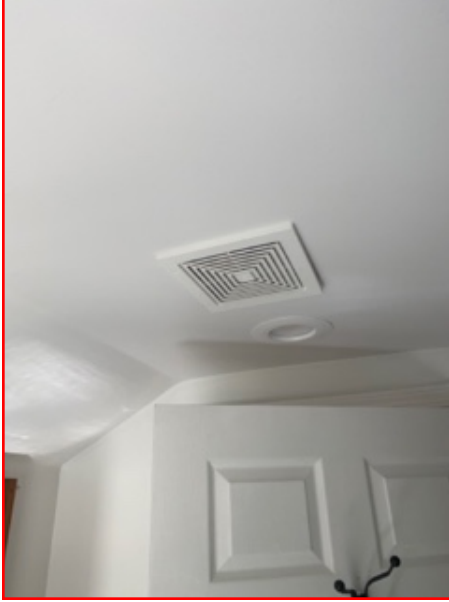
Figure 74-1

41) Did not locate switch for vent fan. Suggested installation. Review is necessary. Vent did not power on.

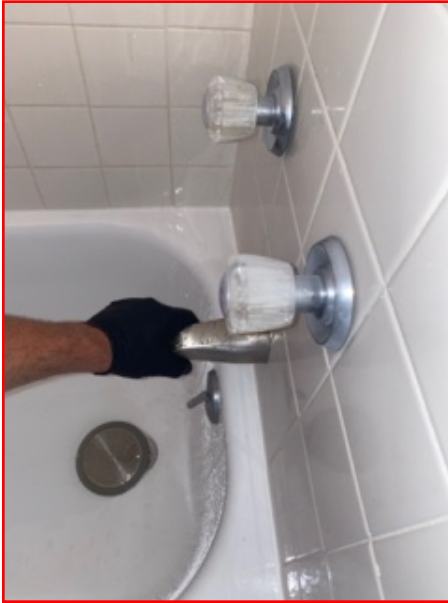
Figure 75-1

42) Secure loose shower hardware to reduce stress on plumbing and leakage.

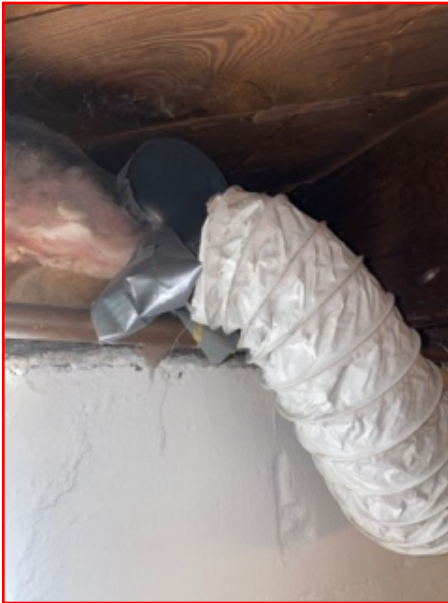
Figure 76-1

43) Reattach bathroom vent to exterior. System is loose.

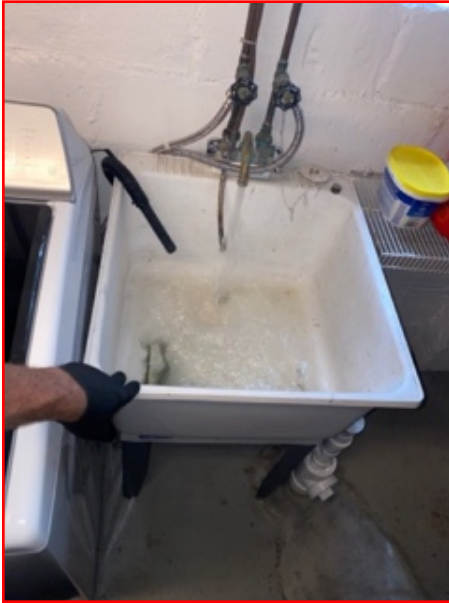
Figure 79-1

44) Secure laundry tub to floor to reduce stress on plumbing.
