# FULL RESERVE STUDY

## Canyon Gate at Cinco Ranch Owners Association, Inc.

**Katy, Texas**

**December 8, 2015**

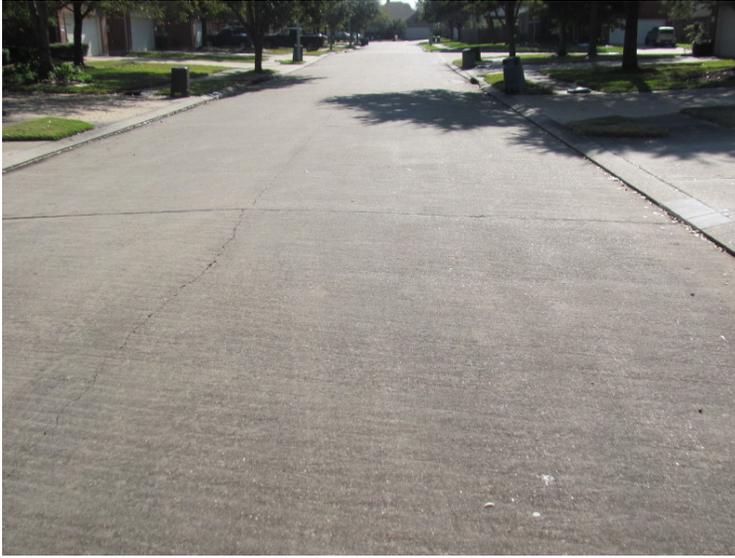
Concrete street

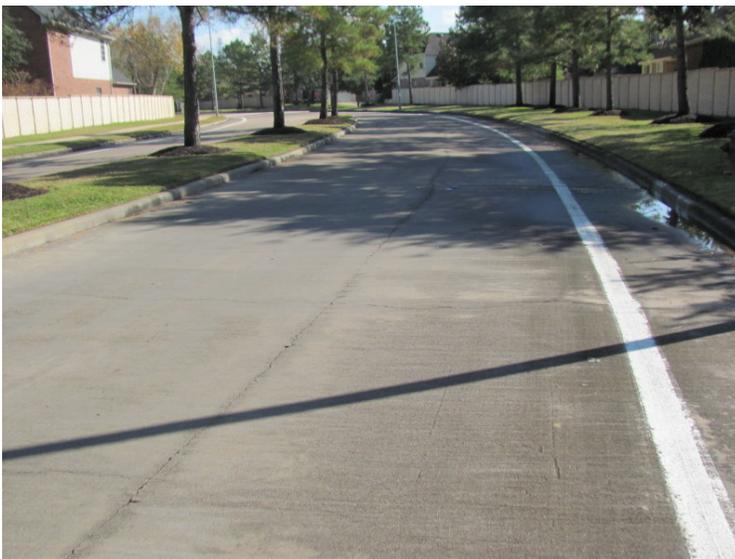
Concrete street

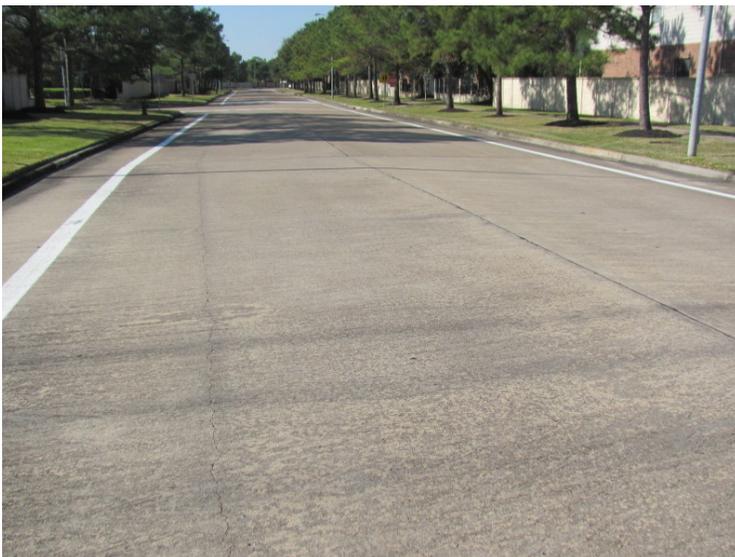
Concrete street

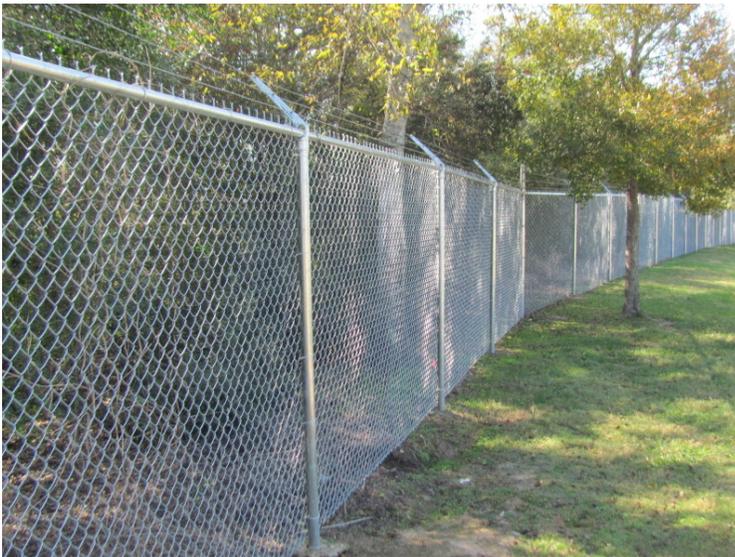
Chain link fence at south park

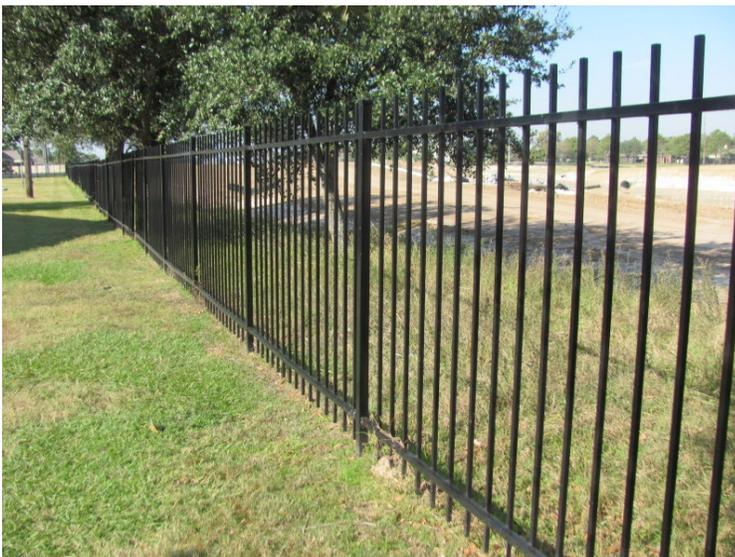
Steel fence at north perimeter

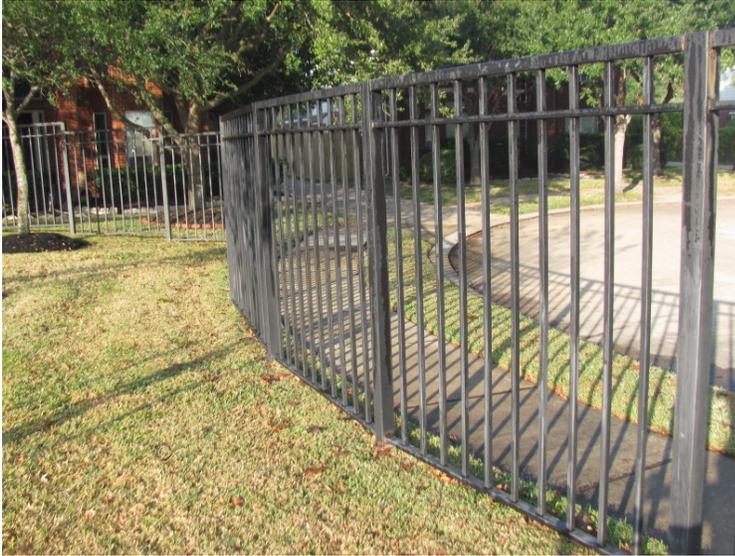
Steel fence at cul-de-sac

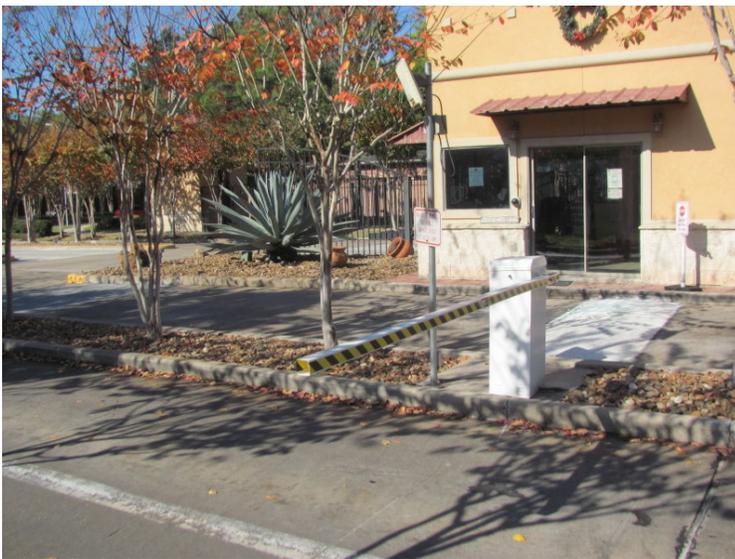
Gate operator and swing arm

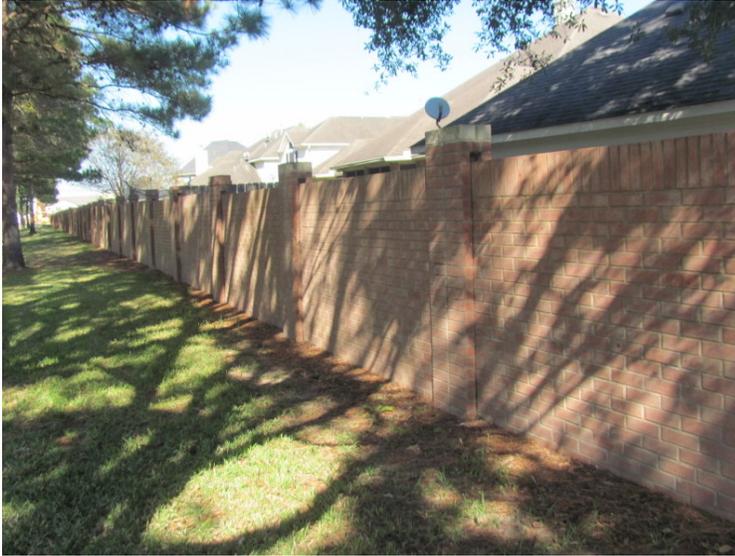
Panelized brick wall

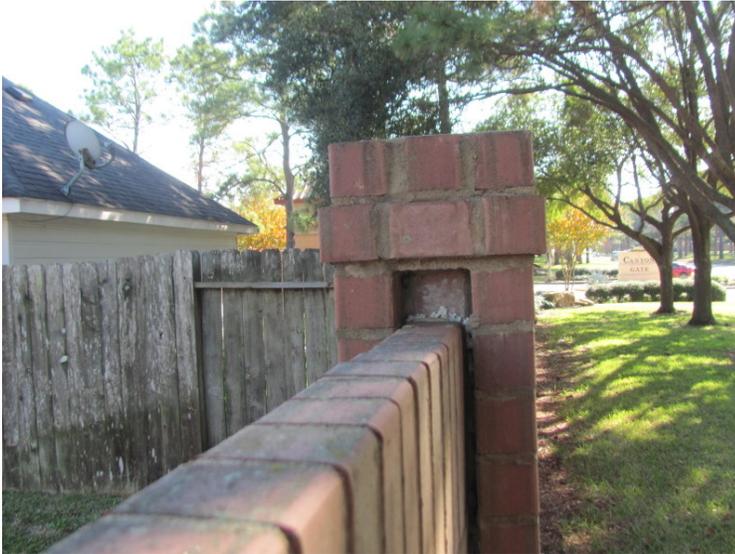
Panelized brick wall

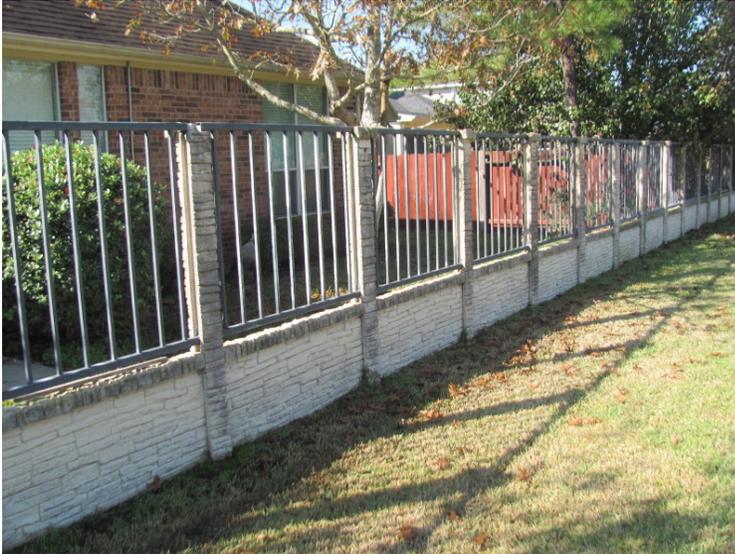
Panelized concrete wall with steel fence

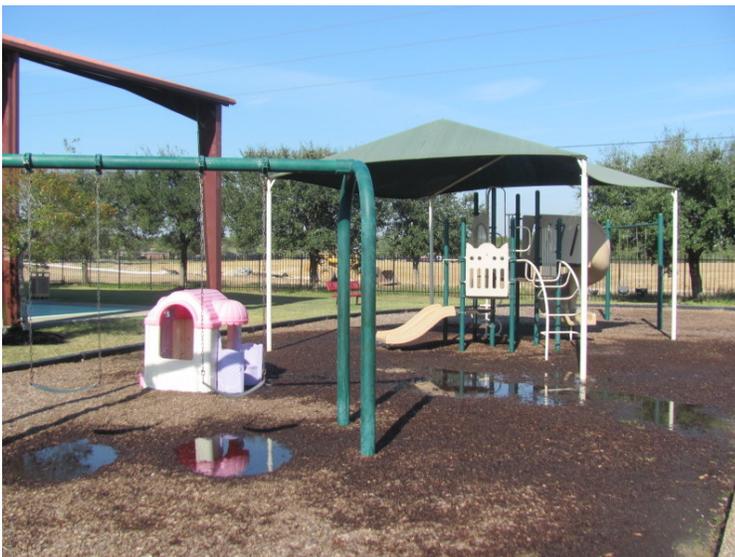
Playground equipment at clubhouse

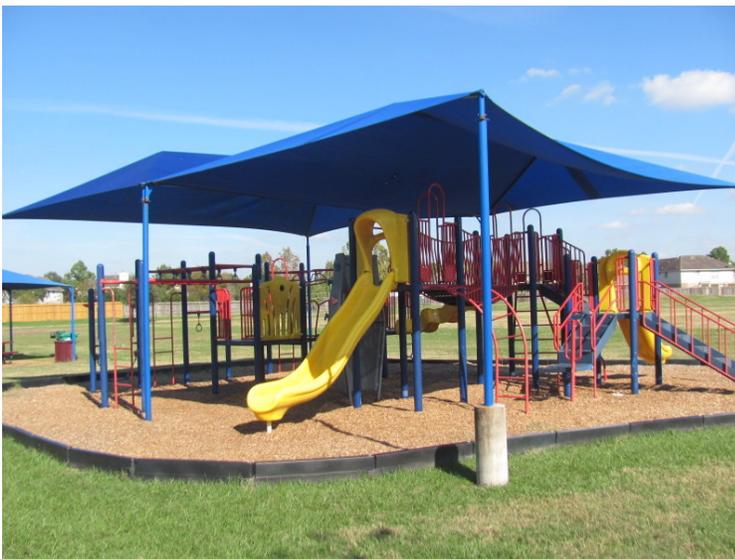
Playset at south park

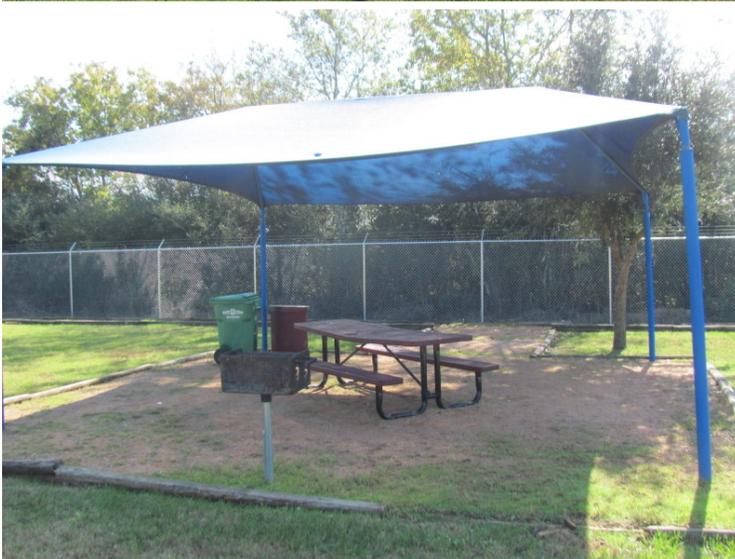
Shade structure at south park

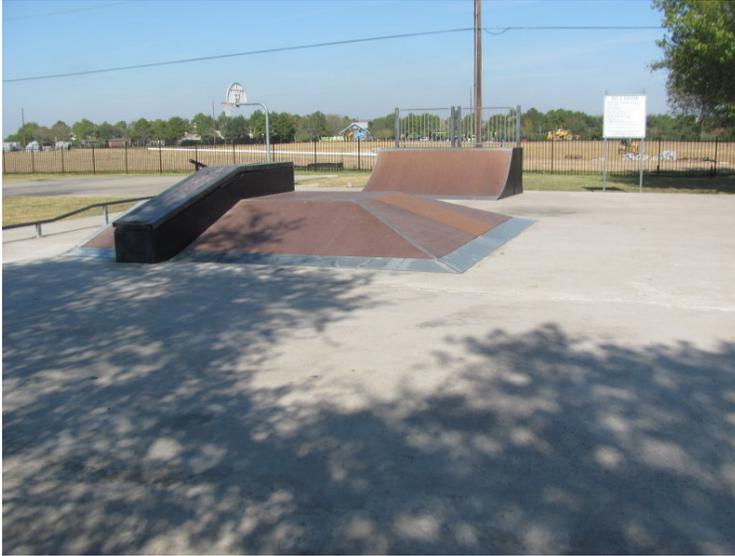
Skate park

*Note - concrete surface is long-lived*

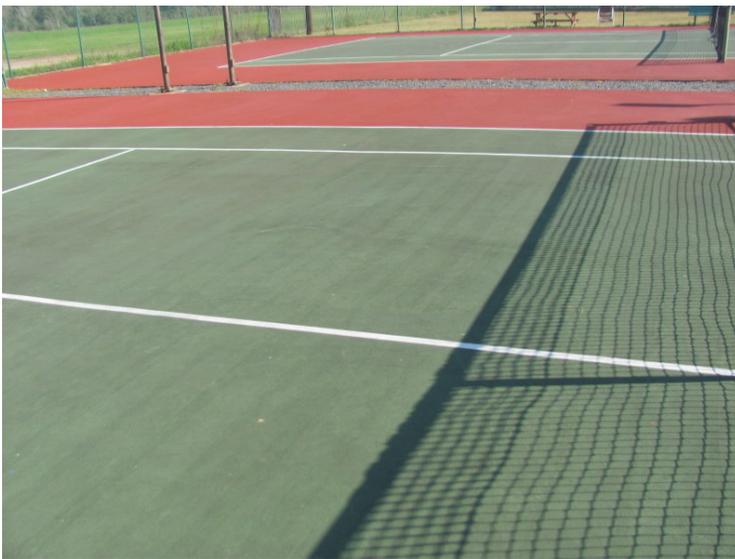
Tennis courts

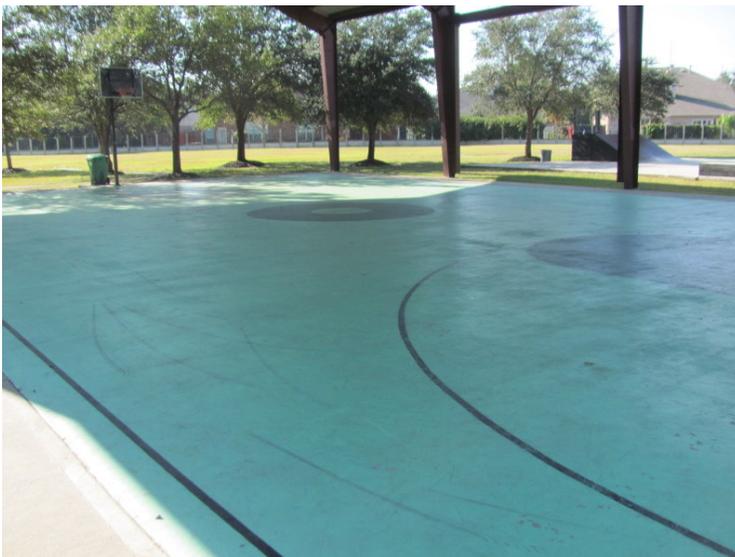
Basketball court at pavilion

*Note - maintain color coat through the operating budget*

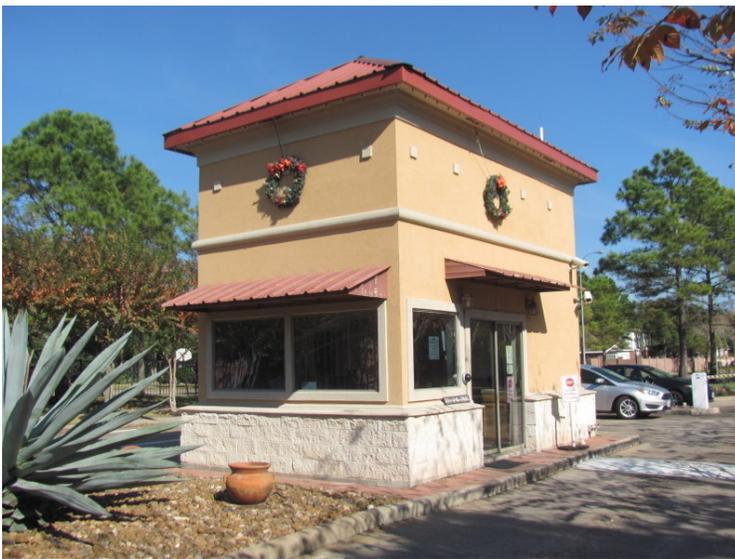
Guard house

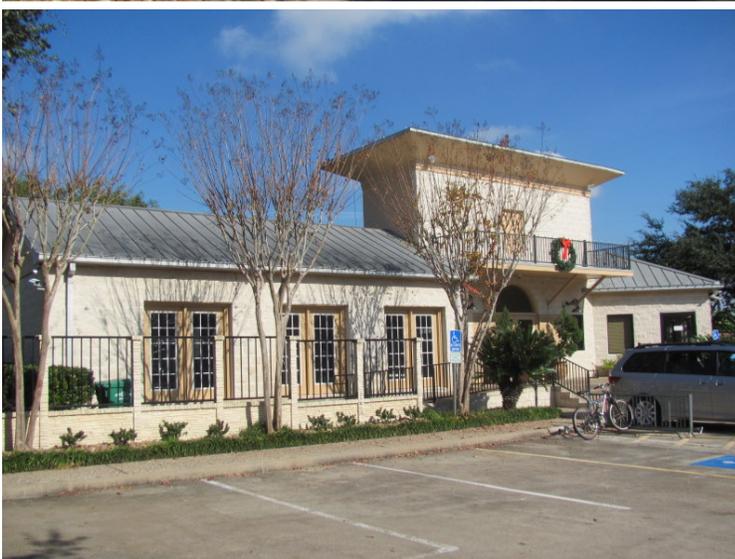
Clubhouse

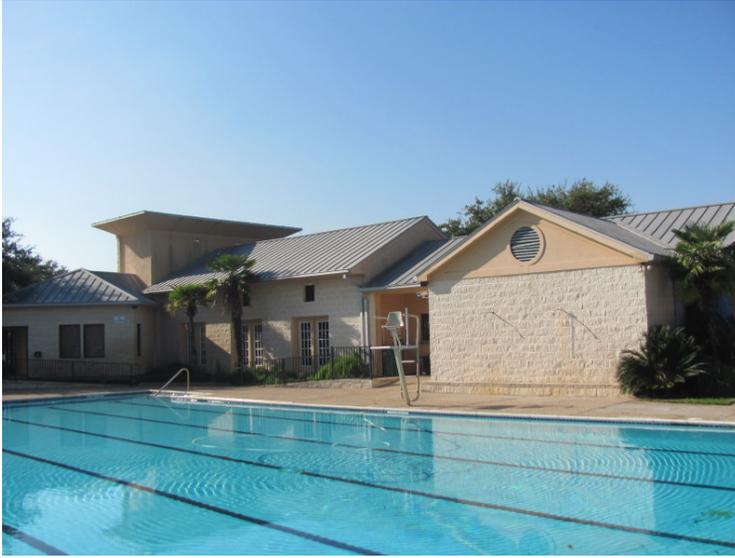
Clubhouse

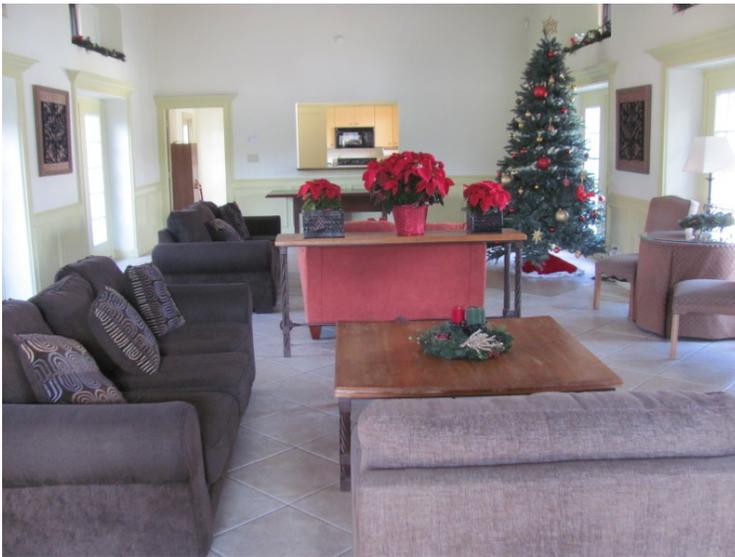
Clubhouse interior

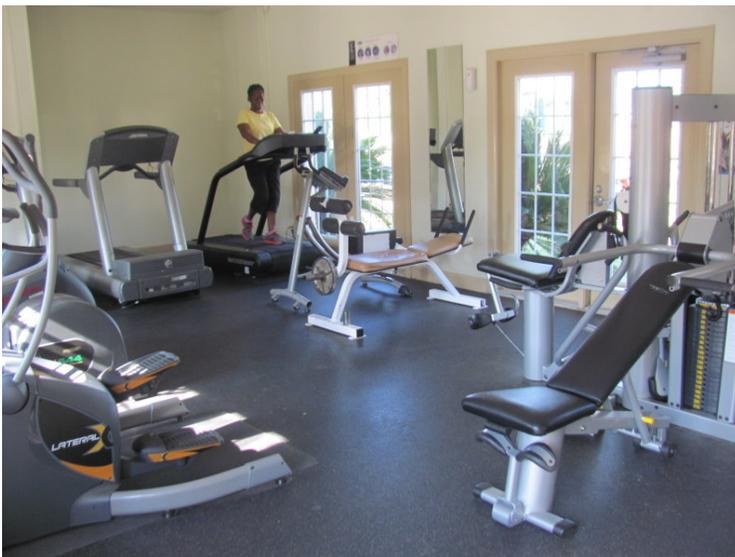
Exercise room

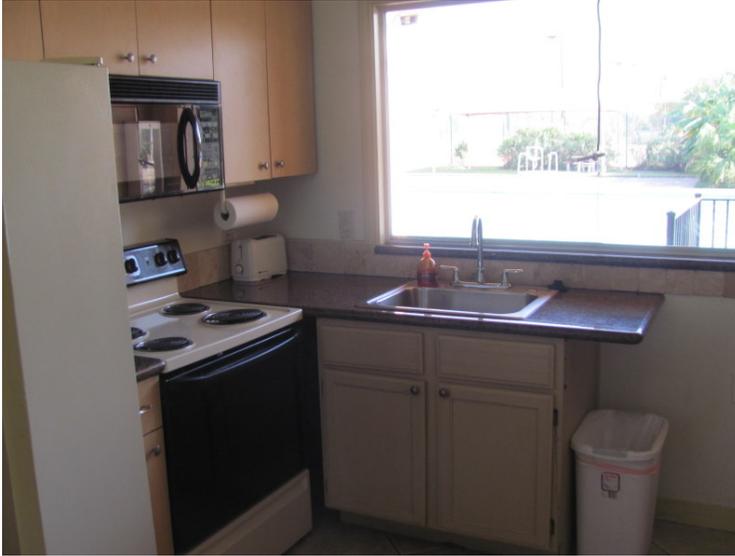
Kitchen

*Note - maintain through the operating budget*

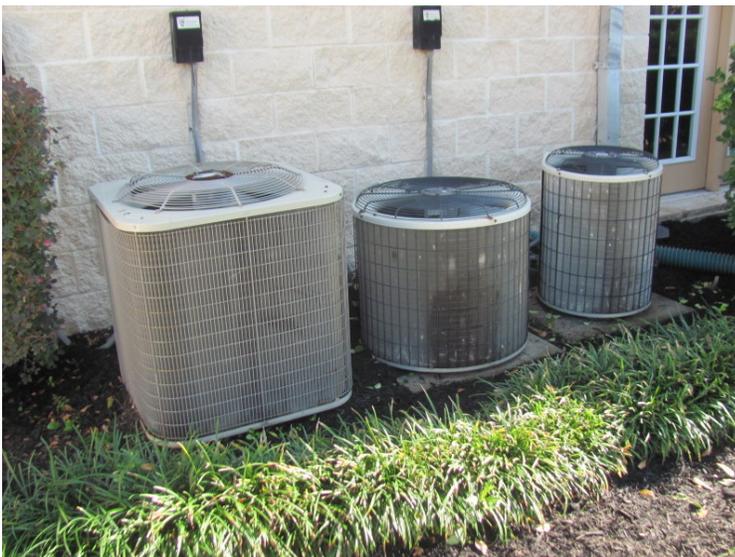
Split system condensing units

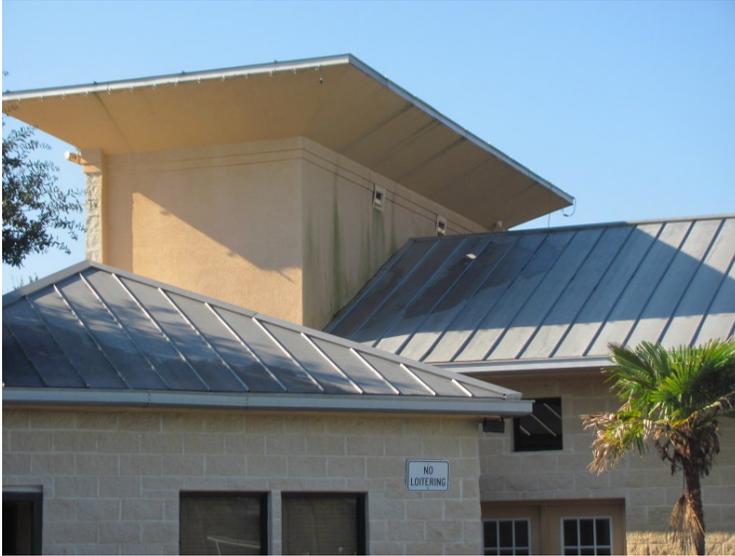
Standing seam metal roofing at clubhouse

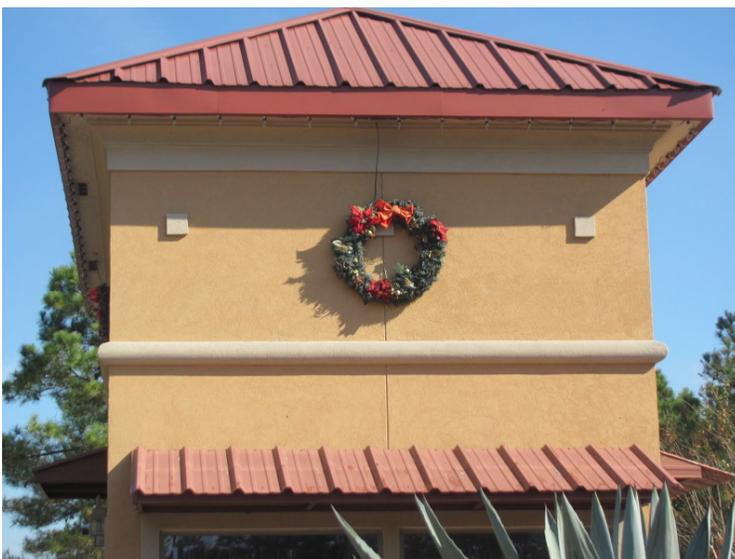
Corrugated metal roofing at guard house

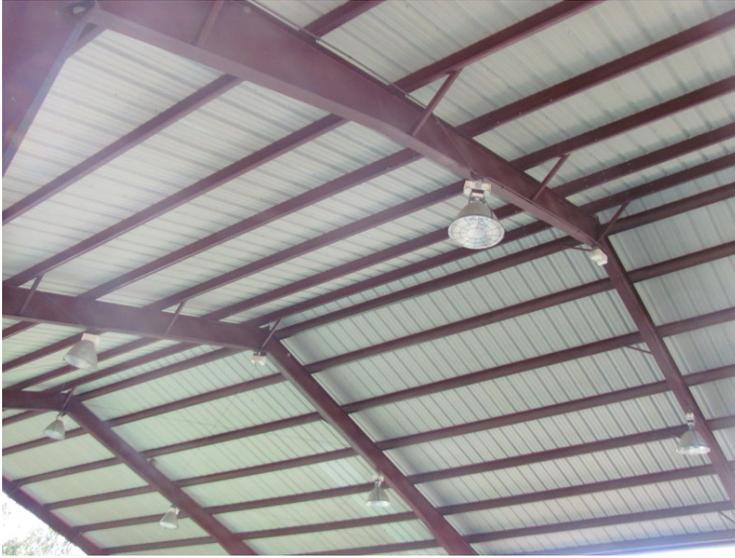
Metal roof and light fixtures at basketball court pavilion

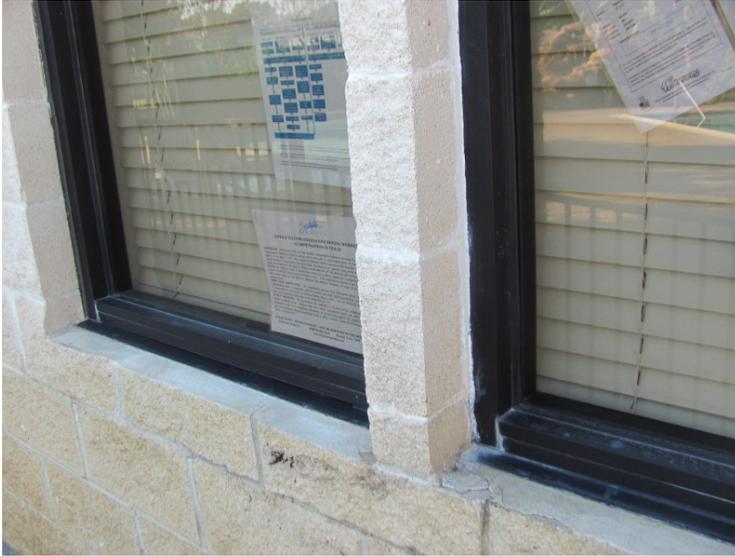
Aluminum frame windows at clubhouse

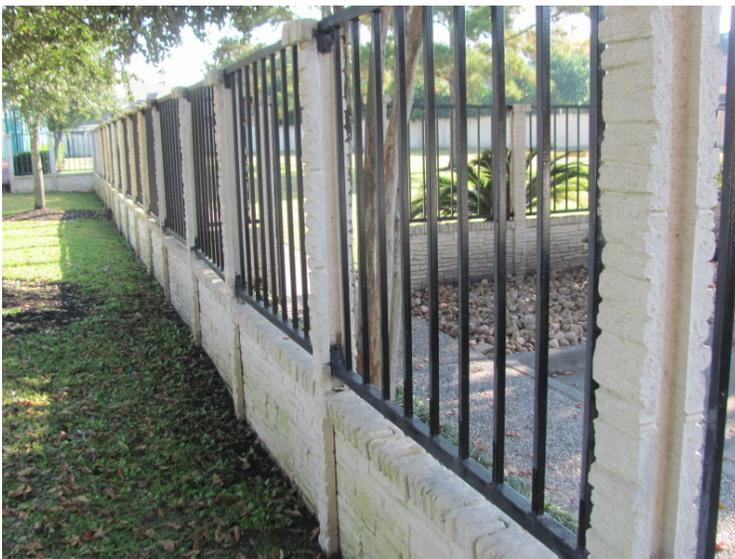
Steel and concrete fence panels at pool

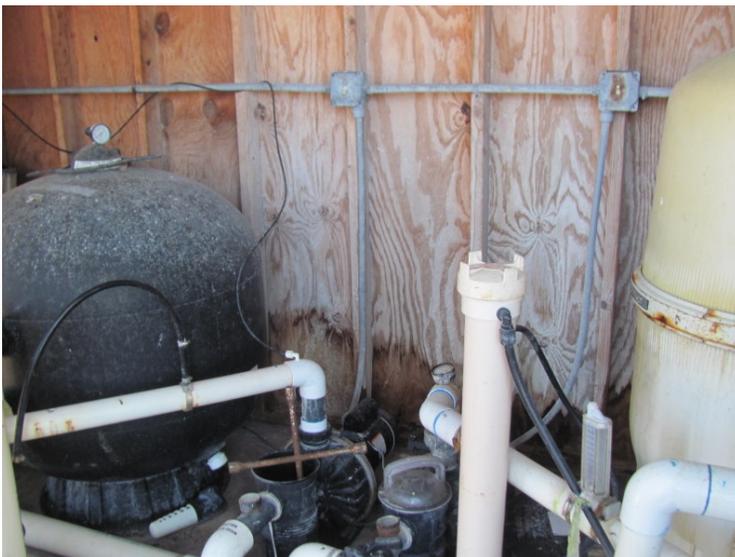
Pool mechanical equipment

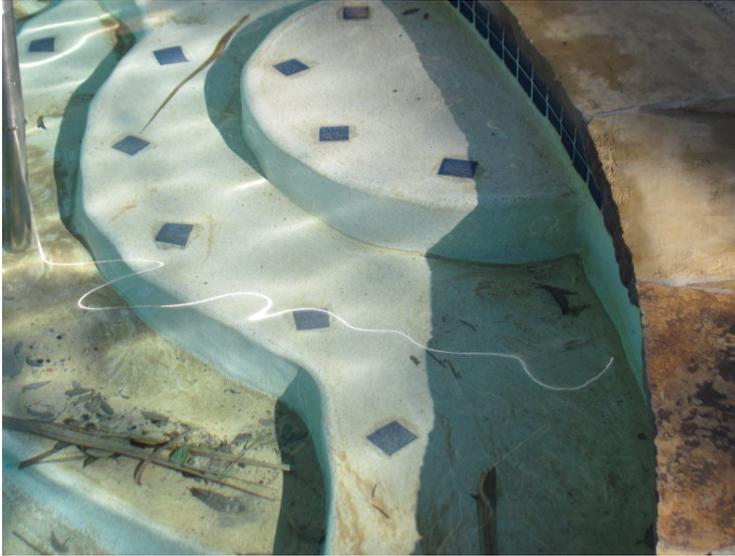
Pool plaster finish

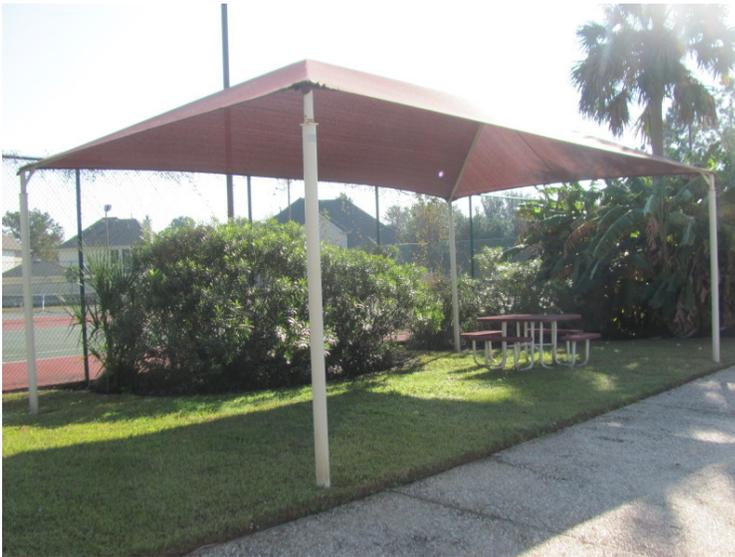
Shade structure at pool deck

*Note - fund for replacement through the operating budget*

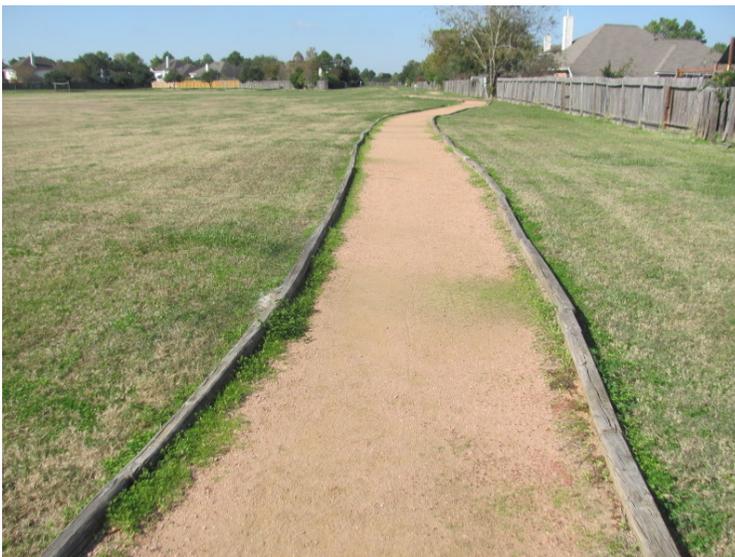
Walking/jogging trail at south park

*Note - maintain through the operating budget*
