**COGGESHALL  
HOME  
INSPECTIONS**

## Home Inspection Report

**2614 184th St., Redondo Beach , CA 90278**

Monday, March 11, 2019

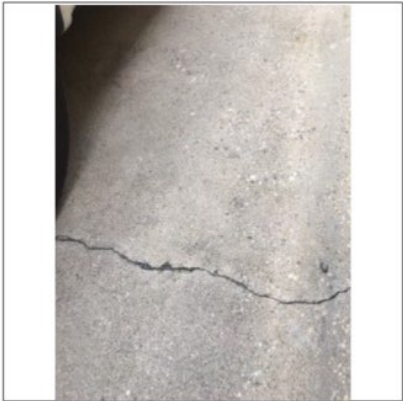
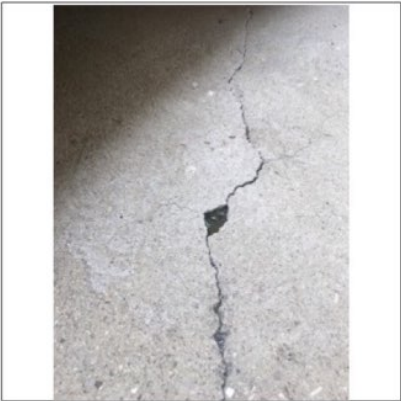
**Comments** Driveway had some settlement, but usable, recommend repair as needed.

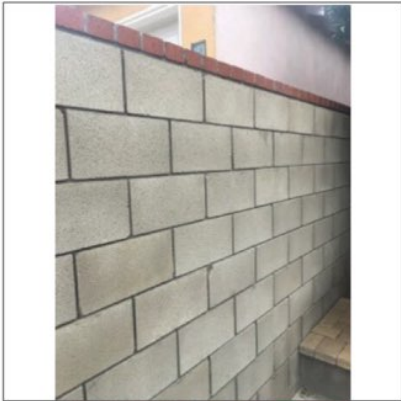
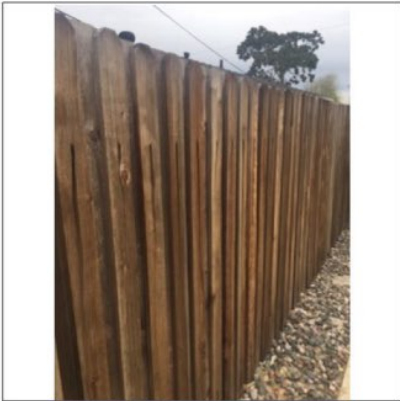
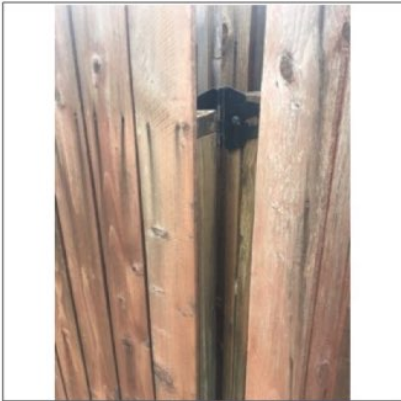
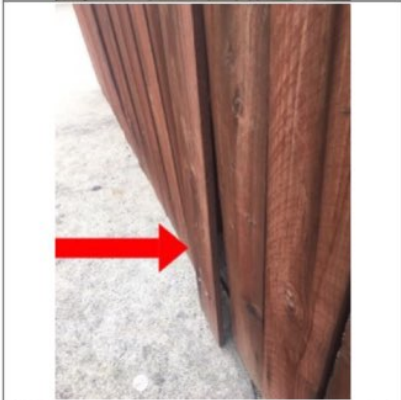
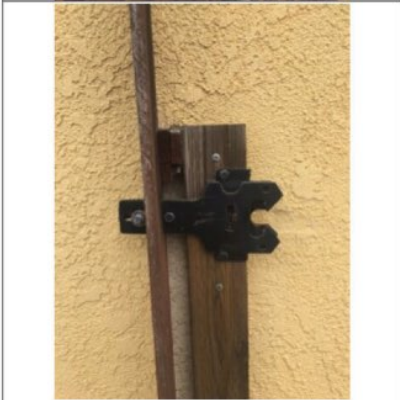
Driveway gate was damaged and bent. Does not close easily. Recommend repair or replace as needed.

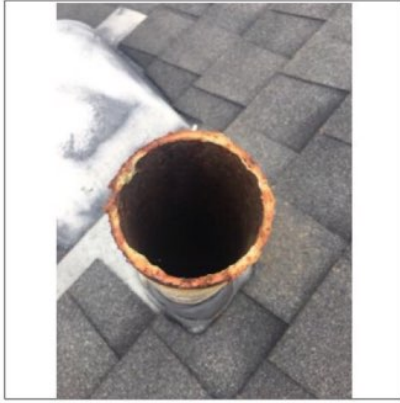
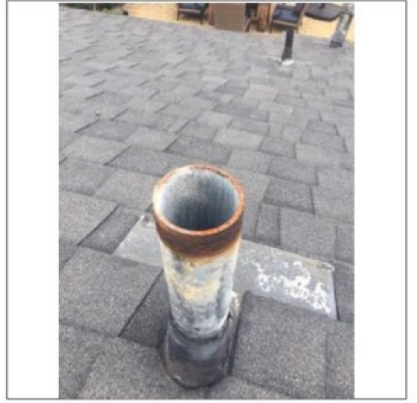
Vent stacks were in overall satisfactory condition but did have some rusting on entrance of hole. Recommend monitoring for replacement in future.

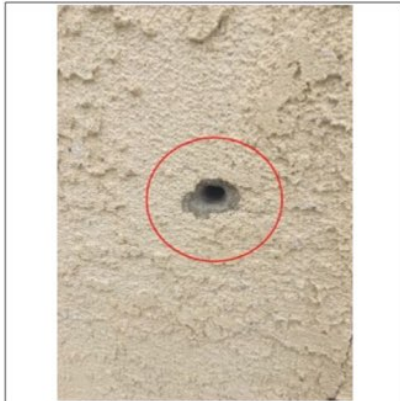
Cracks/holes in stucco siding recommend repair by licensed contractor.

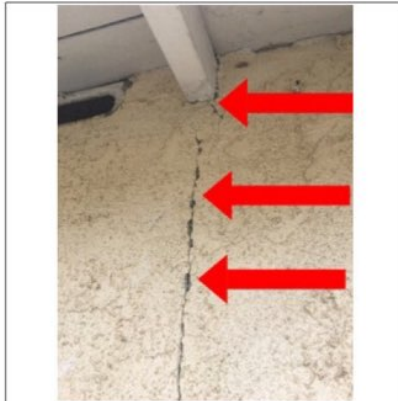
Cracks/holes in stucco siding recommend repair by licensed contractor.

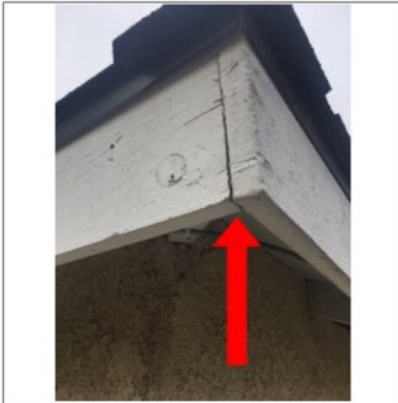
Trim had some deterioration recommend repair and painting. Some loose and missing trim recommend repair. Some rotted/damaged trim boards recommend repair/replacing damaged sections. Recommend repair of damaged trim by a qualified licensed contractor.

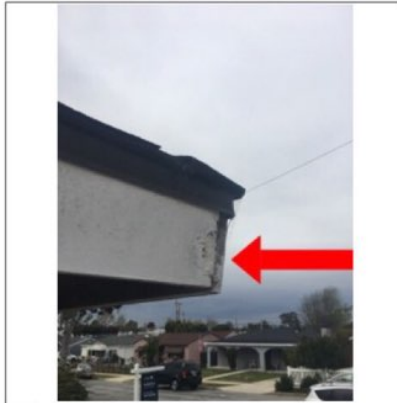
Trim had some deterioration recommend repair and painting. Some loose and missing trim recommend repair. Some rotted/damaged trim boards recommend repair/replacing damaged sections. Recommend repair of damaged trim by a qualified licensed contractor.

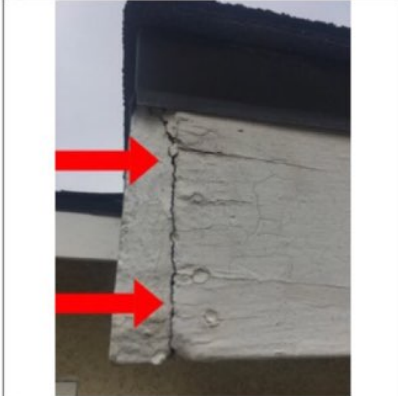
Trim had some deterioration recommend repair and painting. Some loose and missing trim recommend repair. Some rotted/damaged trim boards recommend repair/replacing damaged sections. Recommend repair of damaged trim by a qualified licensed contractor.

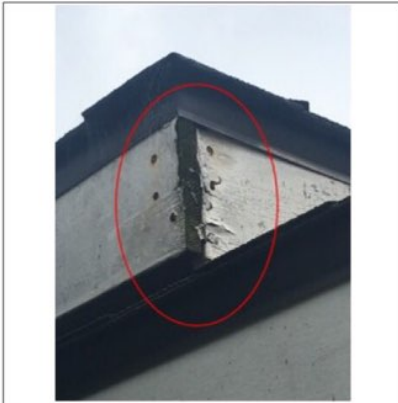
Trim had some deterioration recommend repair and painting. Some loose and missing trim recommend repair. Some rotted/damaged trim boards recommend repair/replacing damaged sections. Recommend repair of damaged trim by a qualified licensed contractor.

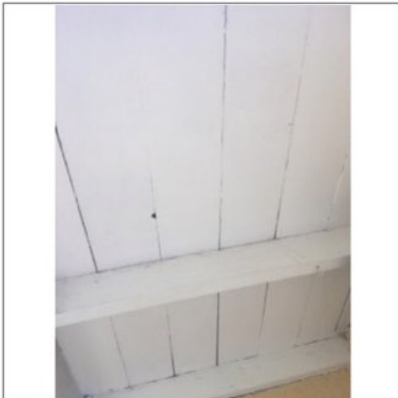
**Comments**  
 Soffit damaged/rotted, recommend repair by licensed contractor. Evidence of termite damage found in wooden soffit beams. Recommend licensed termite contractor inspect and evaluate further for repairs.

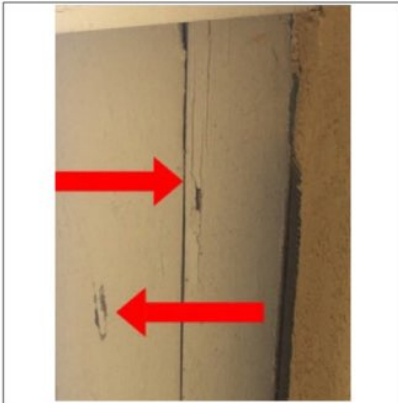
Soffit damaged/rotted, recommend repair by licensed contractor.

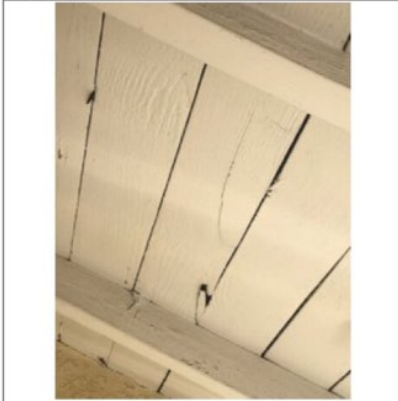
Recommend licensed termite contractor inspect and evaluate further for repairs.

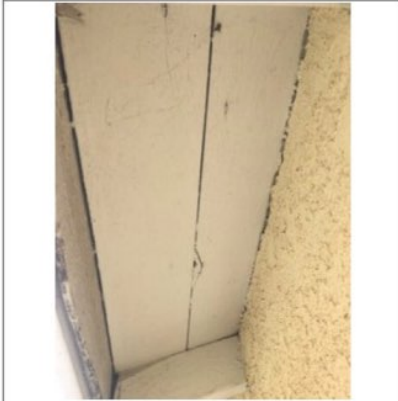
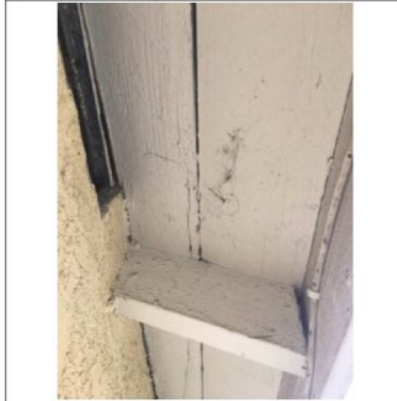
Soffit damaged/rotted, recommend repair by licensed contractor.

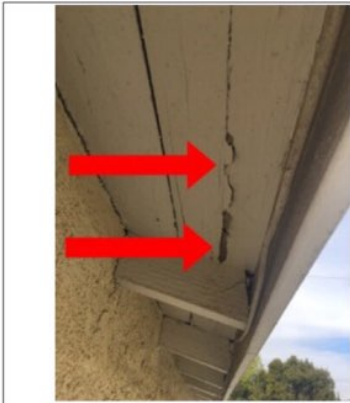
Soffit damaged/rotted, recommend repair by licensed contractor.

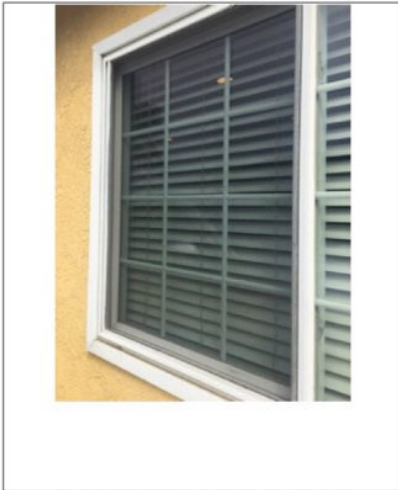
Trim around window was in need of maintenance, sanding, repainting.

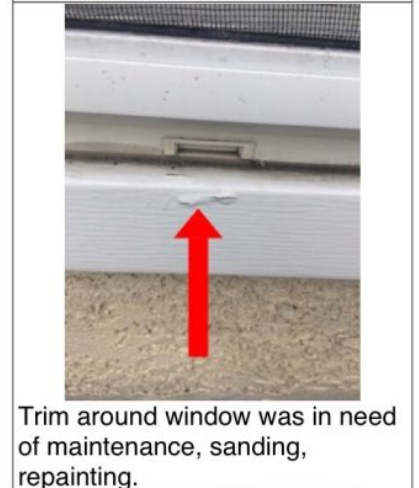
Trim around window was in need of maintenance, sanding, repainting.

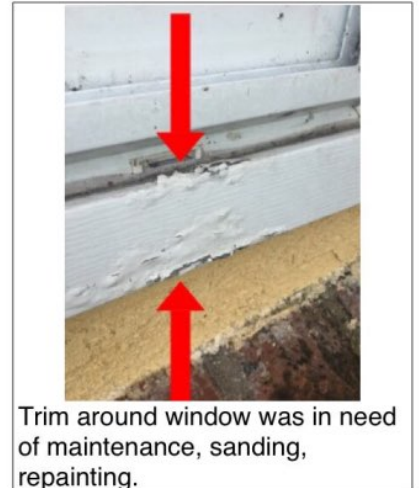
Trim around window was in need of maintenance, sanding, repainting.

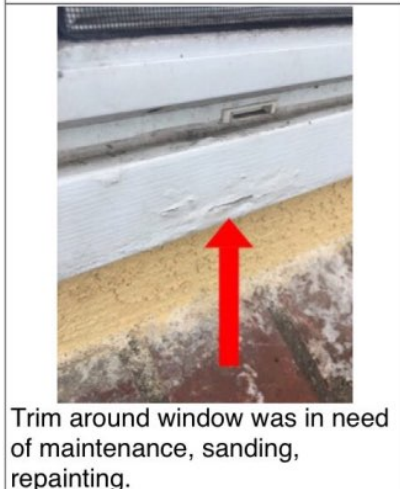
Trim around window was in need of maintenance, sanding, repainting.

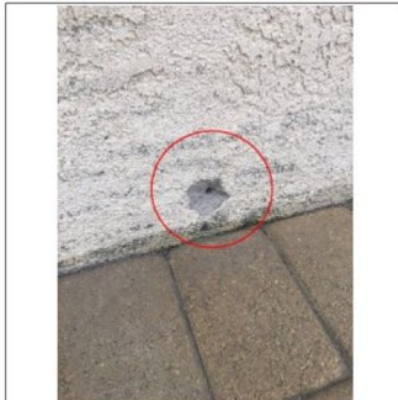
Siding had some damage/cracking recommend repair by licensed contractor.

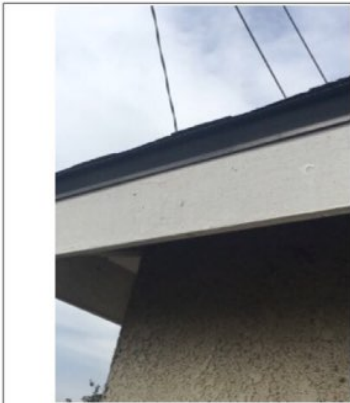
Garage Trim and soffit had some damage recommend repair by licensed contractor.

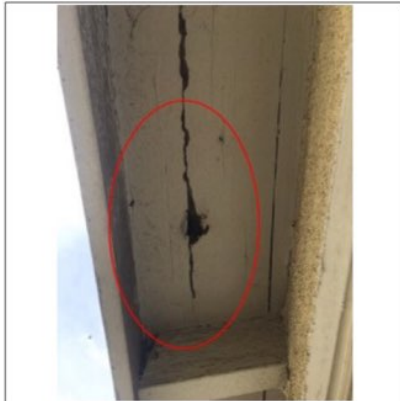
Garage Trim and soffit had some damage recommend repair by licensed contractor.

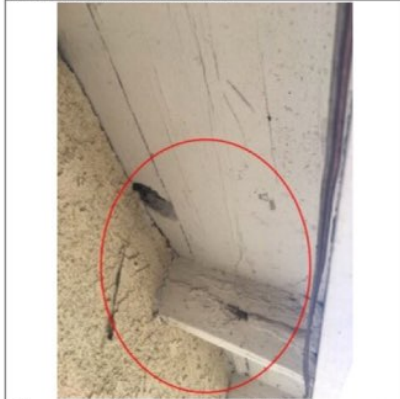
Garage Trim and soffit had some damage recommend repair by licensed contractor.

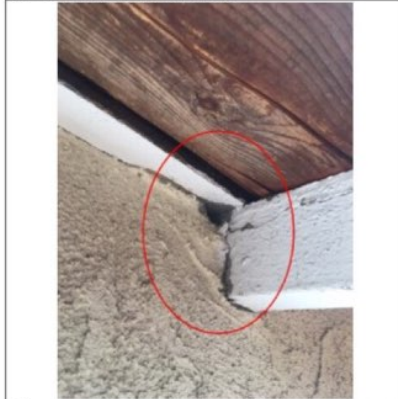
Garage Trim and soffit had some damage recommend repair by licensed contractor.

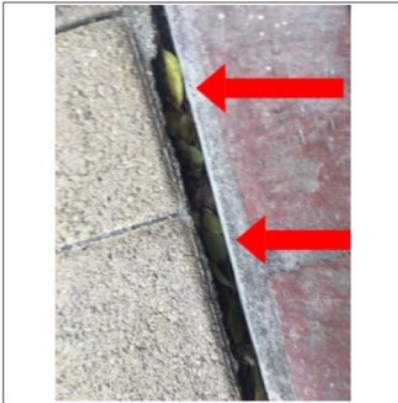
Entrance floor from service door to garage had large crack which is a possible entrance for moisture intrusion related to garage sill plate. Recommend licensed contractor inspect and evaluate further for repairs.

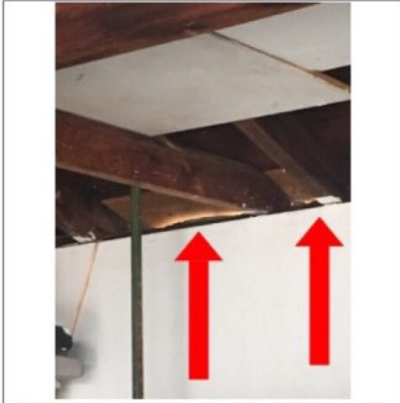
Recommend licensed contractor inspect and evaluate interior garage walls to repair visible gaps to exterior of garage wall.

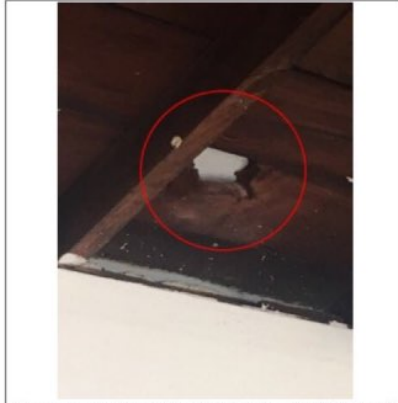
Damaged roof planks in ceiling of garage roof. Recommend licensed contractor inspect and evaluate further for repairs.

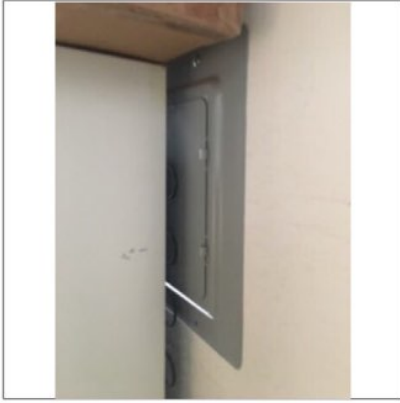
None apparent  
**Location(s)** Location 1: Garage wall  
 Location 2: None  
 Location 3: None  
**Evaluation**  Panel not accessible  Not evaluated  
 Reason: Behind garage refrigerator.  
 Recommend separating/isolating neutrals  Recommend electrician repair/evaluate box  
**Branch wire**  Copper  Aluminum  Safety hazard Neutral/ground separated:  Yes  No Neutral isolated:  
 Yes  No  
**Condition**  Satisfactory  Marginal  Poor  
**Comments**
