Milestone Phase I Report
Parador Condominium Association, Inc.

Report Date: ⌚ 6/26/2024

Inspection Date: ⌚ 4/17/2024

1200 Gulf Shore Blvd N, Naples, FL, 34102

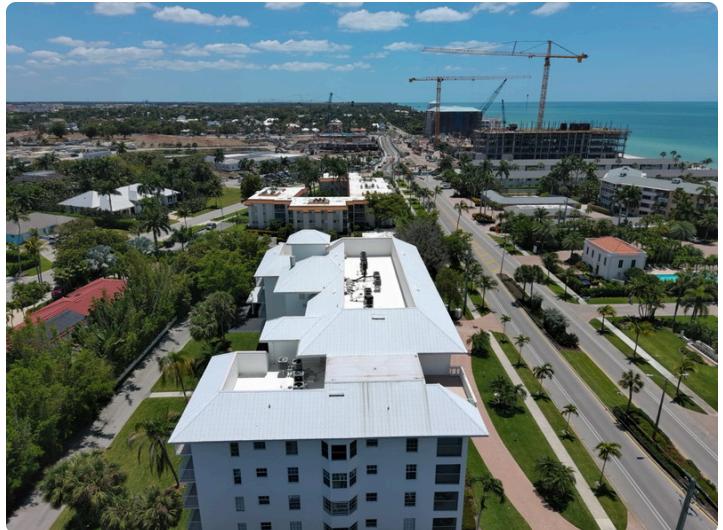
South roof overview

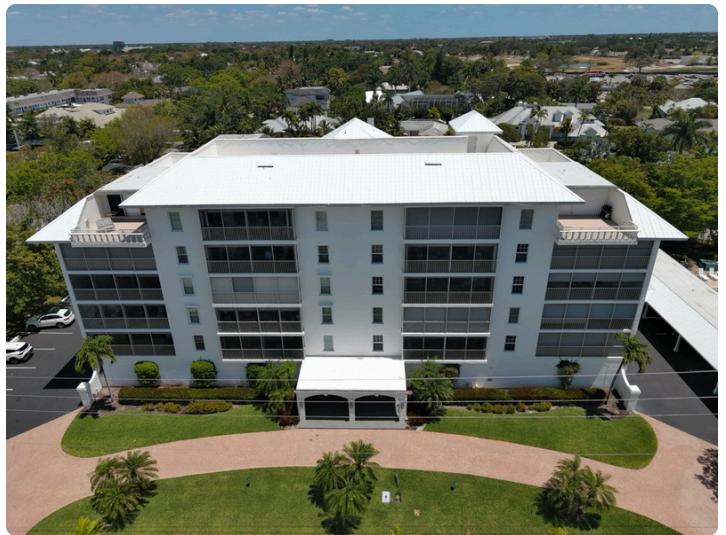
Front wall overview

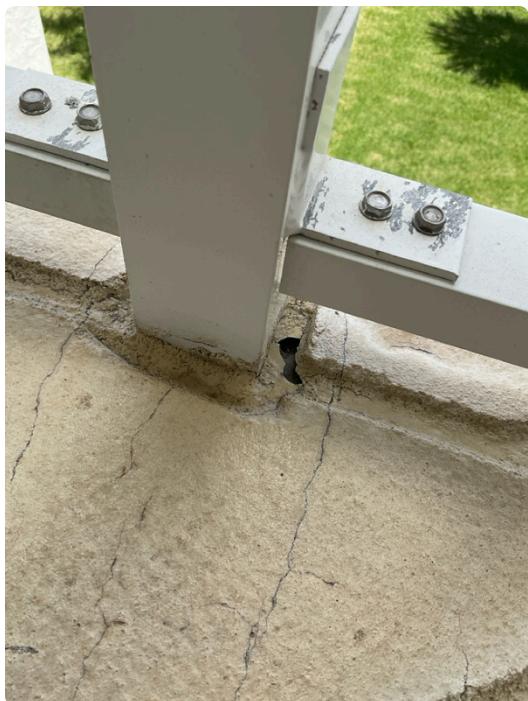
Cavity at the base of the railing post between at unit 402

Maintenance	Repair the crack on the ground floor walkway with concrete epoxy patch. Fill the cavity at the base of the railing post with structural-grade epoxy or grout. RegROUT all the applicable cracks on the walkways.
Condition	Average

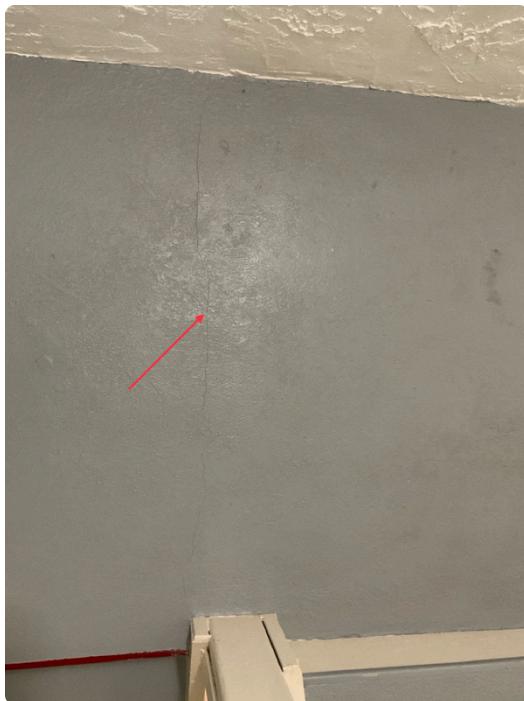
Crack on the landing if north stairs between 3rd and 4th floor

Maintenance	Treat corrosion on metal constituents beneath the treads of the south stair with a rust inhibitor followed by application of a corrosion-resistant coating. Repair edge chipping at the stairs by filling with a durable epoxy-based repair mortar. Rectify the crack on the landing of the south stairs by routing and sealing. Conduct regular inspections and maintenance to ensure the structural integrity and safety of the stairs.
Condition	Average

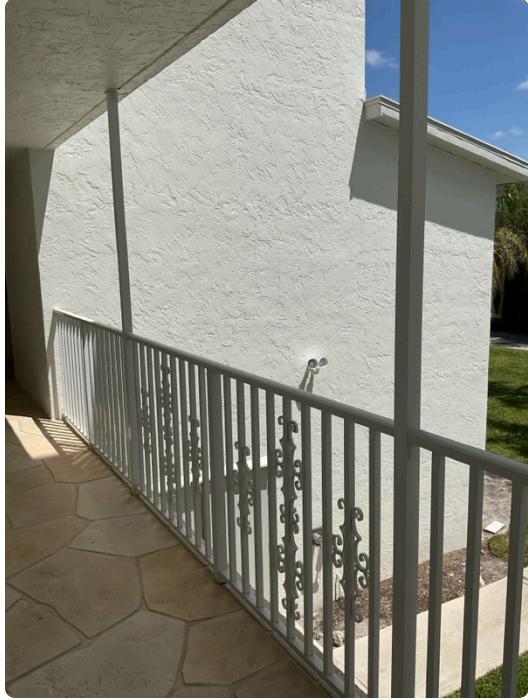
Railings in good condition

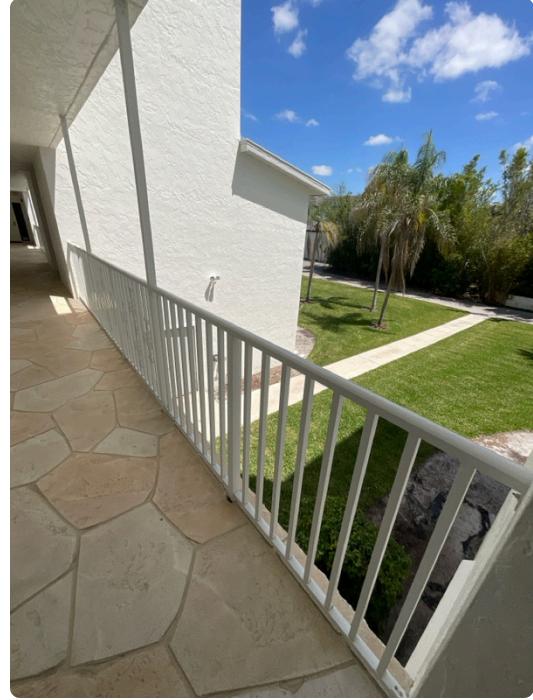
Railings in good condition

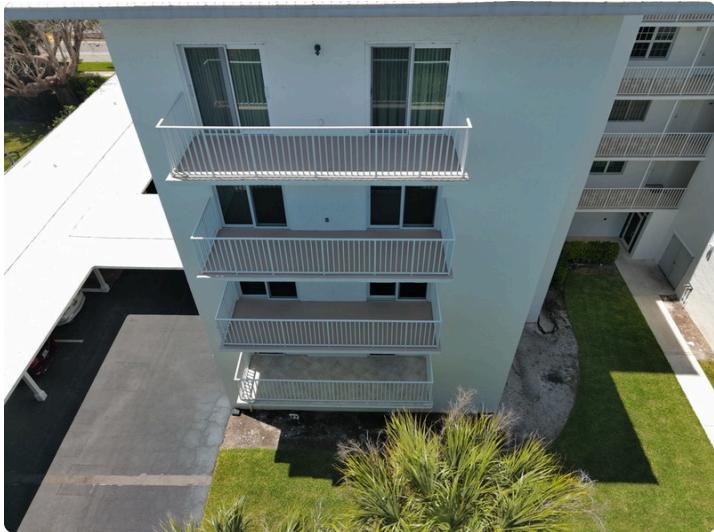
Balcony waterproofing in good condition

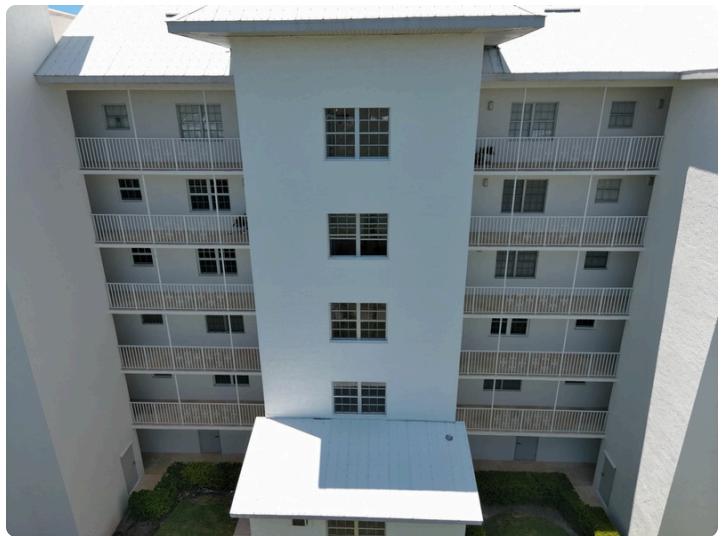
Wall waterproofing in good condition

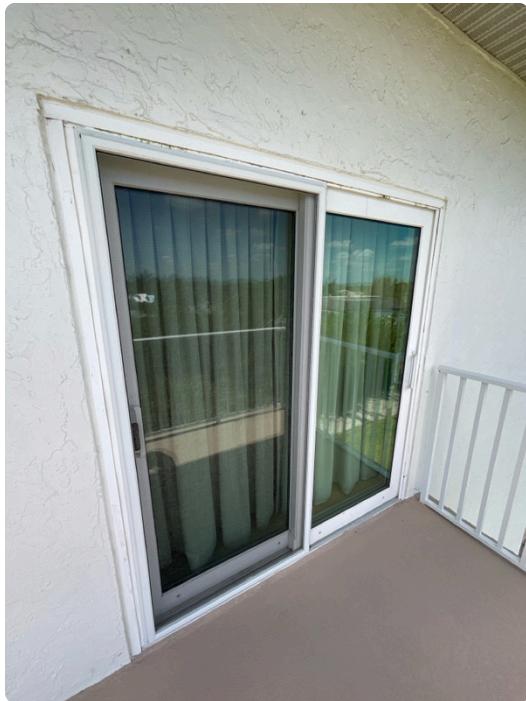
Balcony slider waterproofing in good condition

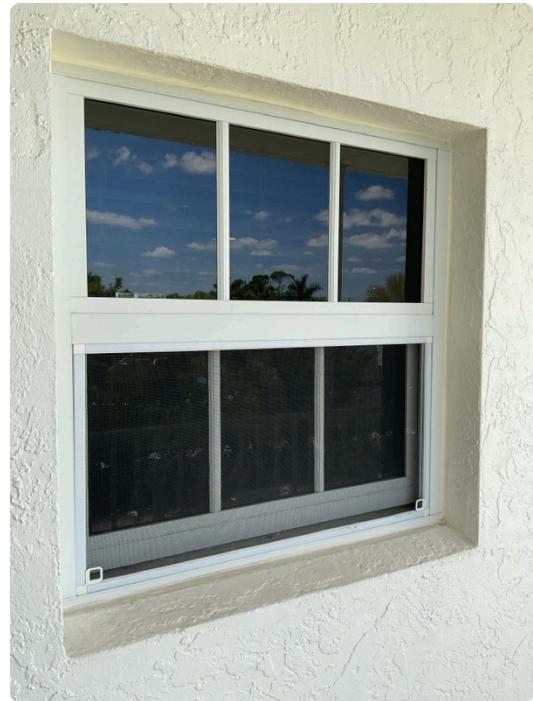
Window waterproofing in good condition

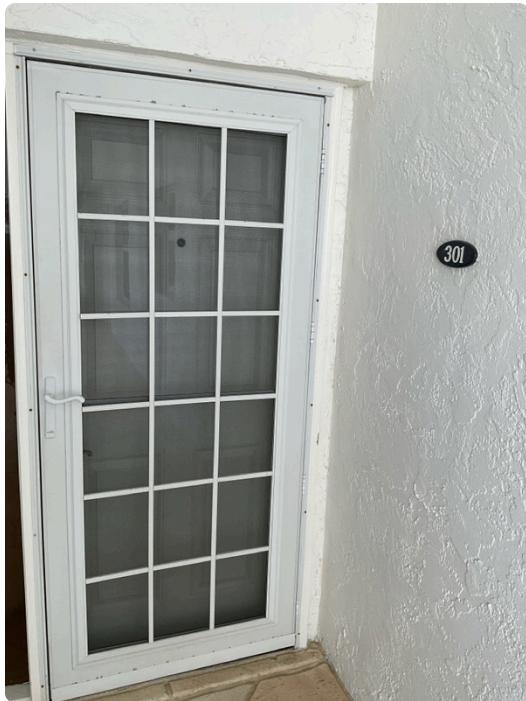
Door waterproofing in good condition

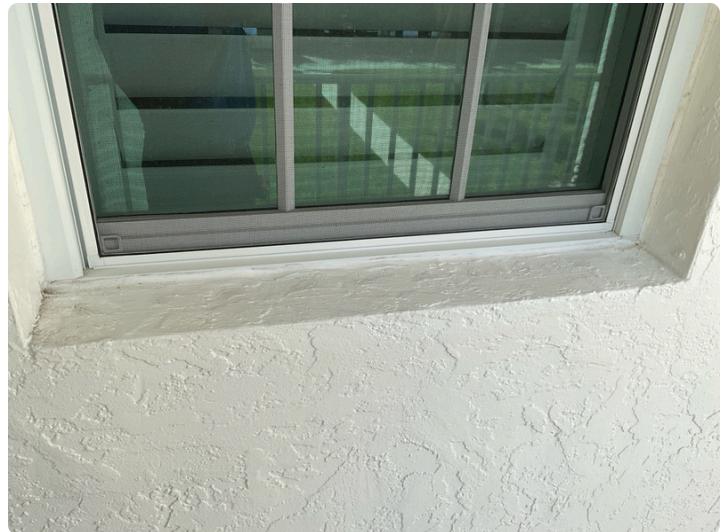
Window sealant in good condition

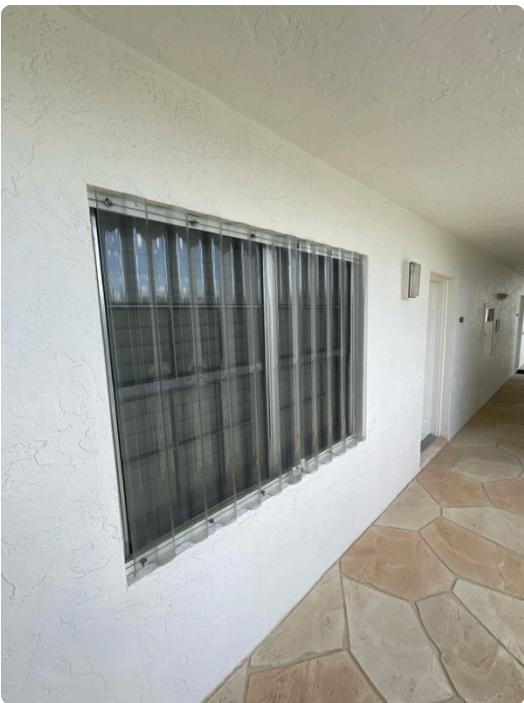
Window in good condition

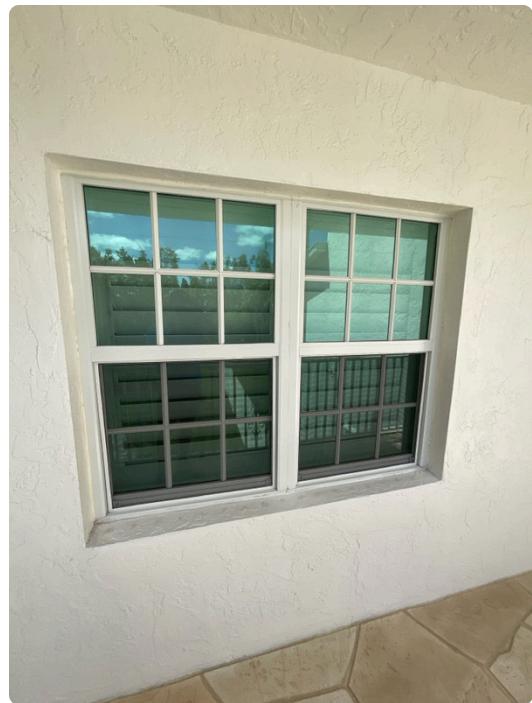
Window in good condition

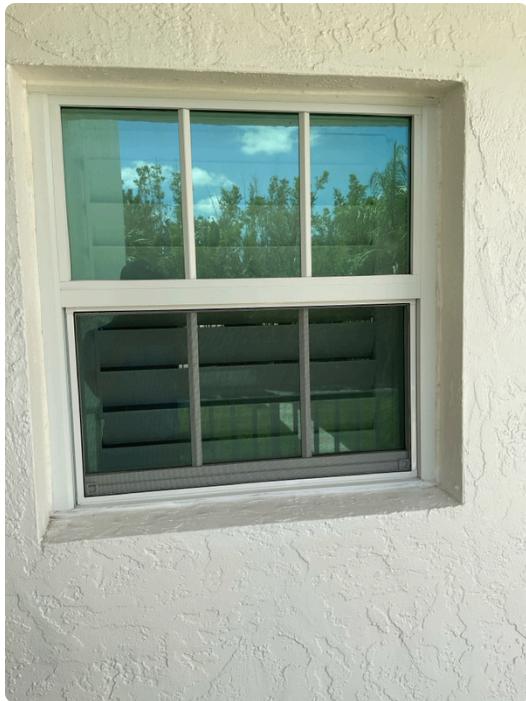
Window in good condition

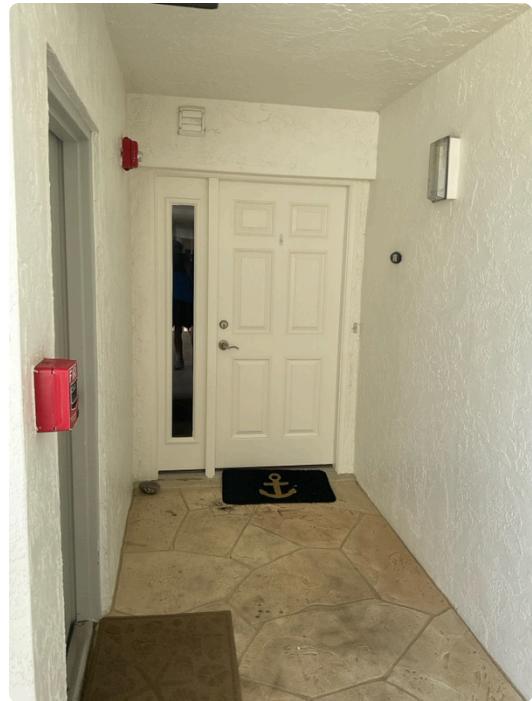
Door in good condition

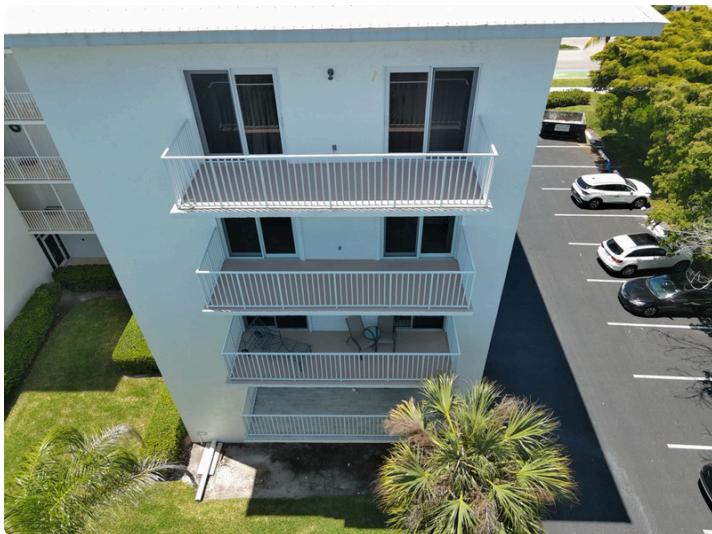
Southwest balcony in good condition

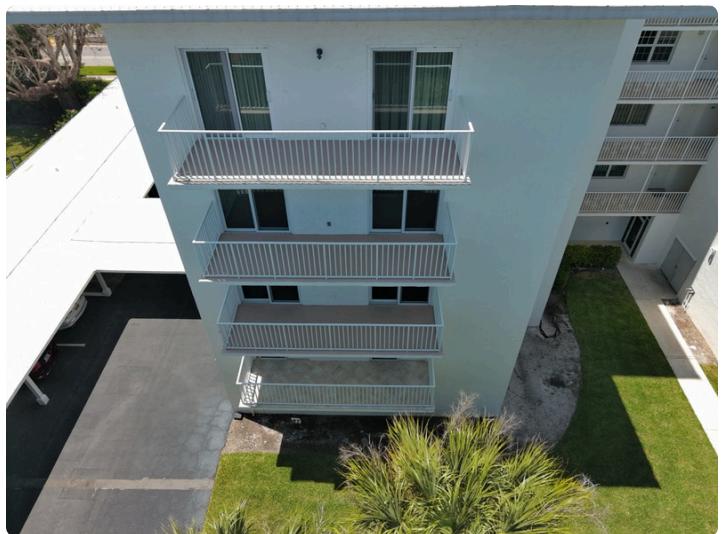
Northwest balcony in good condition

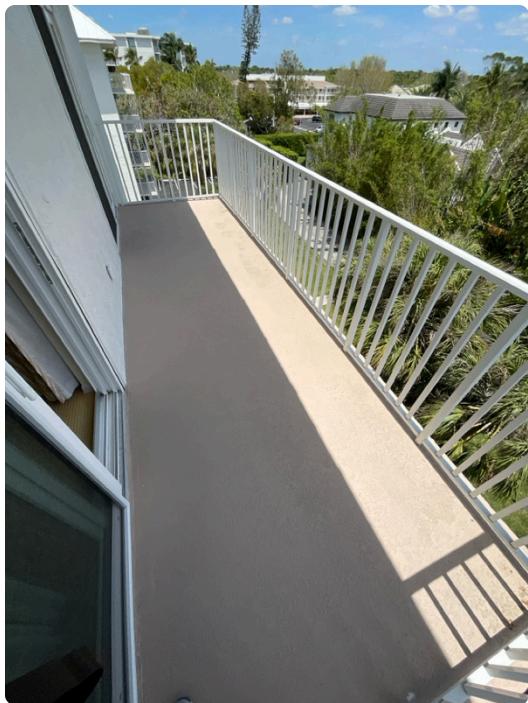
Overview of balcony slab in good condition

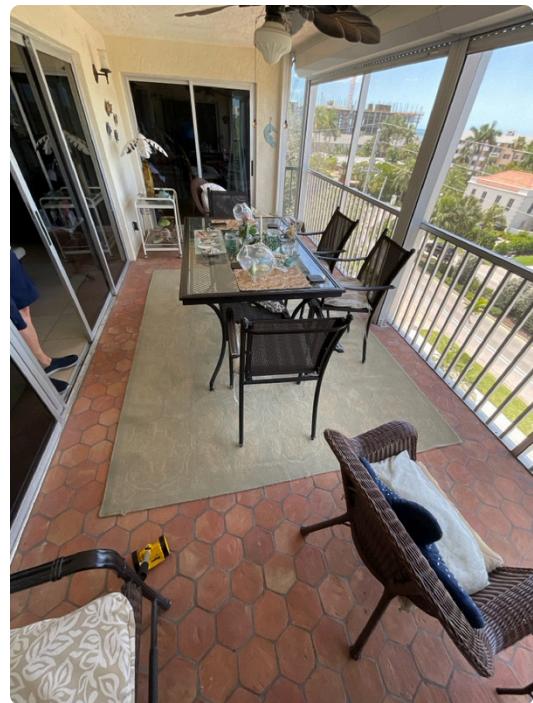
Overview of lanai slab in good condition

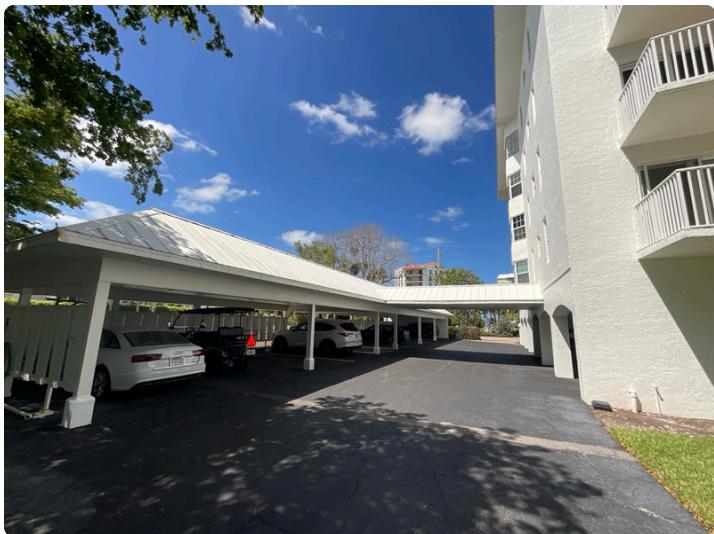
Overview of carport in good condition

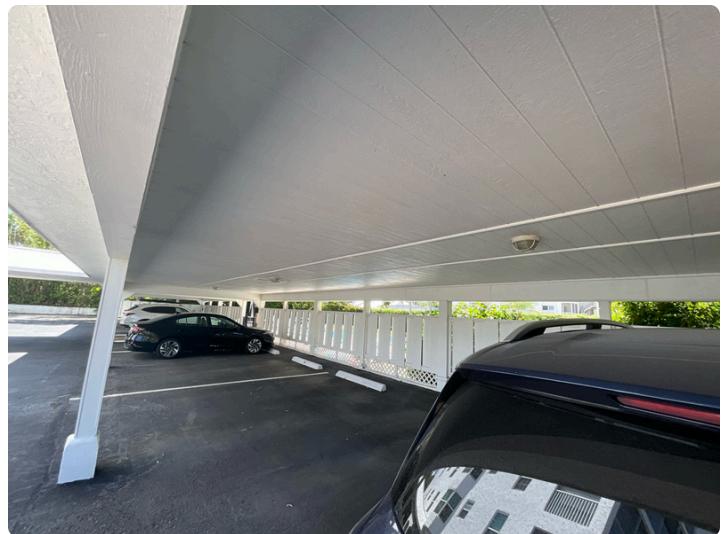
Carport interior in good condition

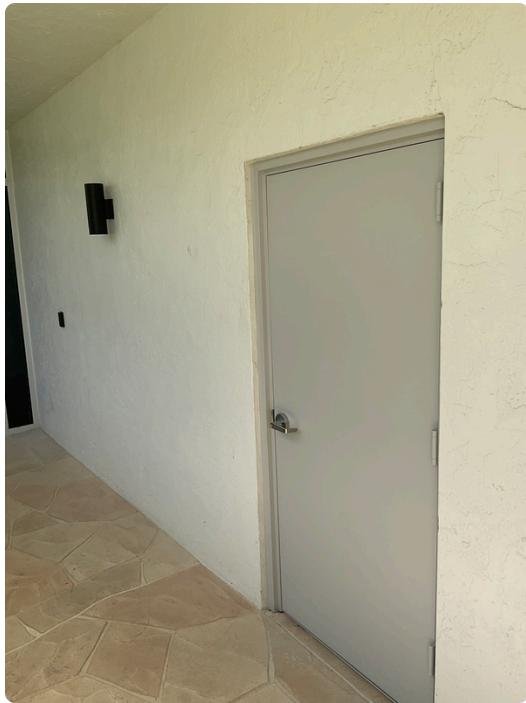
Exterior door to storage units in good condition

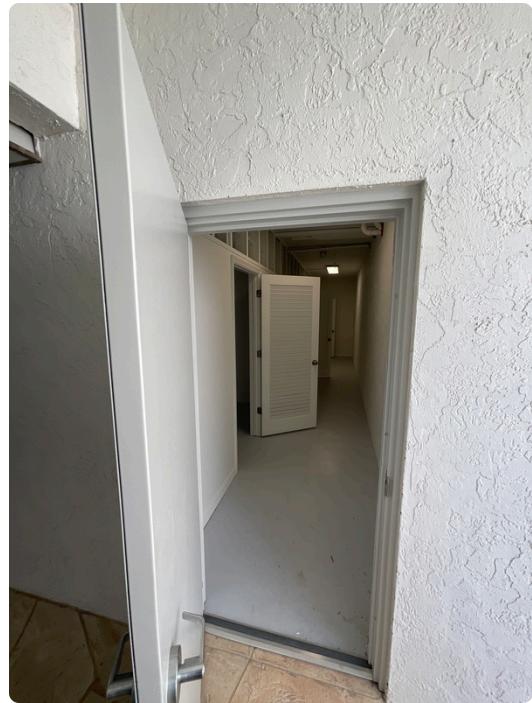
Storage unit's interior area in good condition

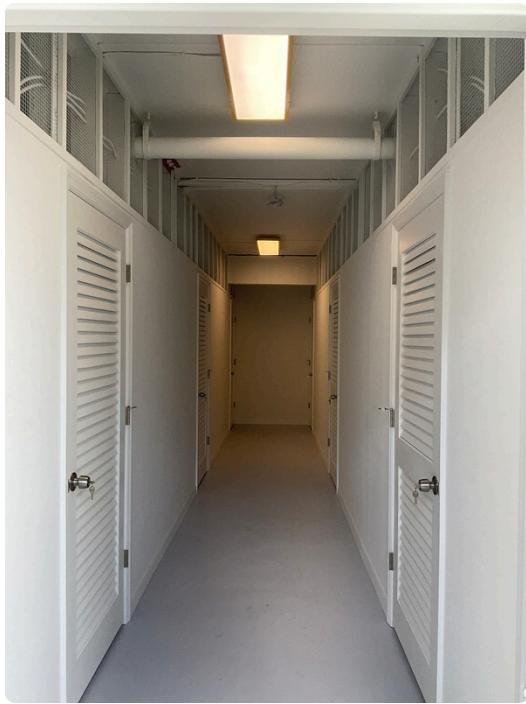
Sub storage units in good condition

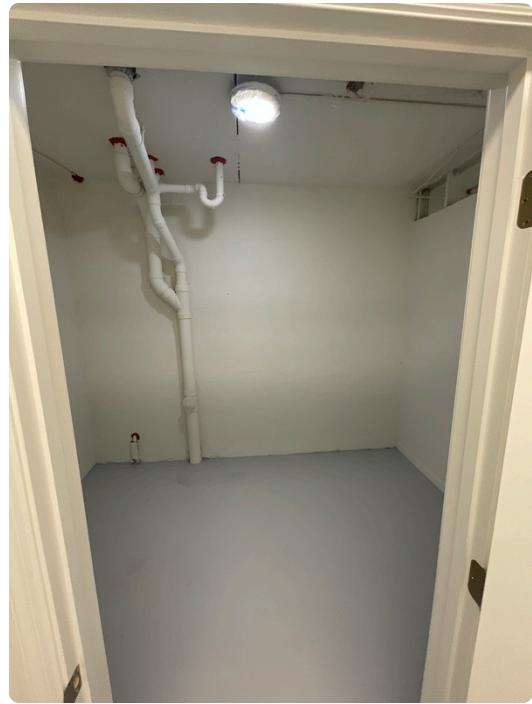
Sub unit's interior in good condition

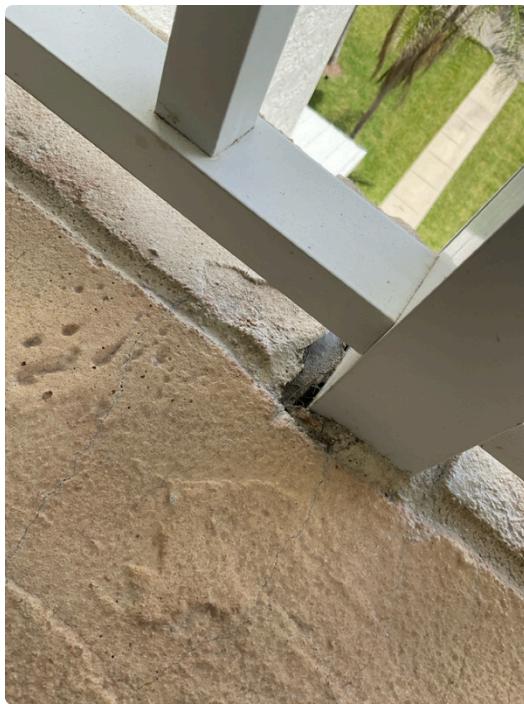
Cavity at the base of the railing post between at unit 402

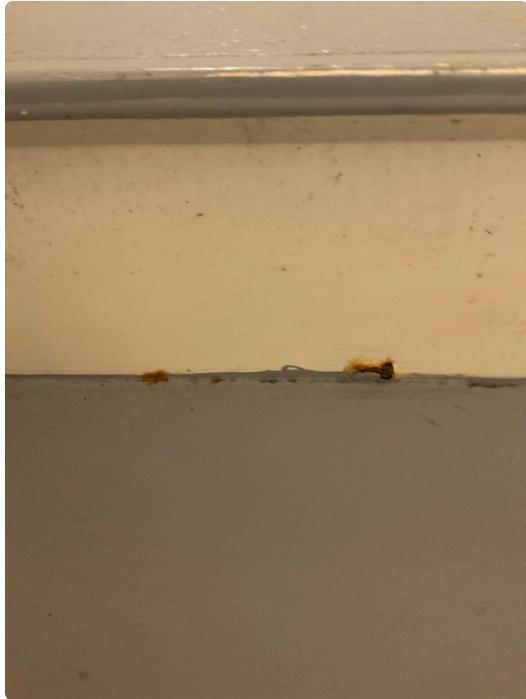
Signs of corrosion at south stairs at 3rd floor
