Wesley Szanyi
226 Timbercreek Pines Circle
Winter Garden, FL 34787

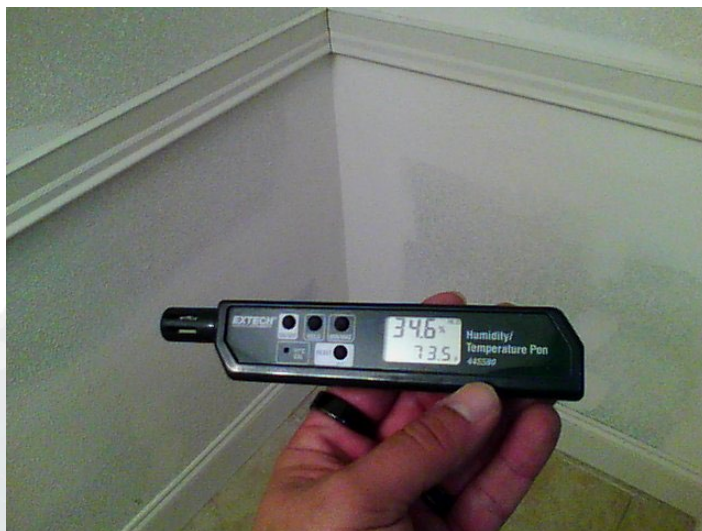
West and north drywall/baseboards removed and replaced by tenant prior to my visit

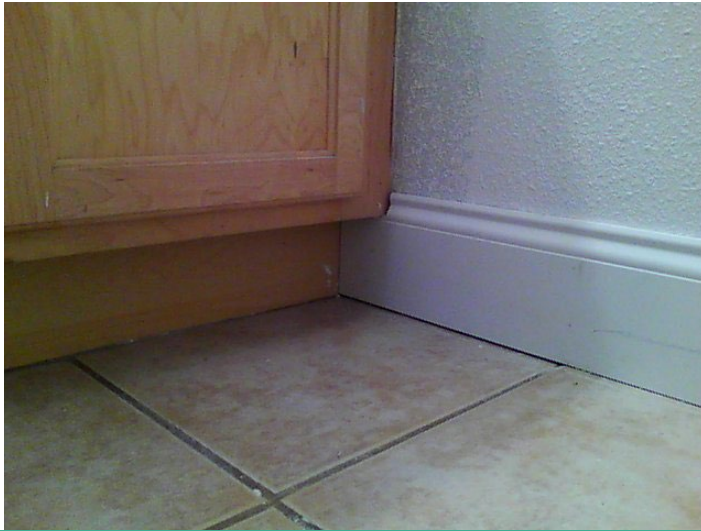
FLIR camera detected no thermal anomalies

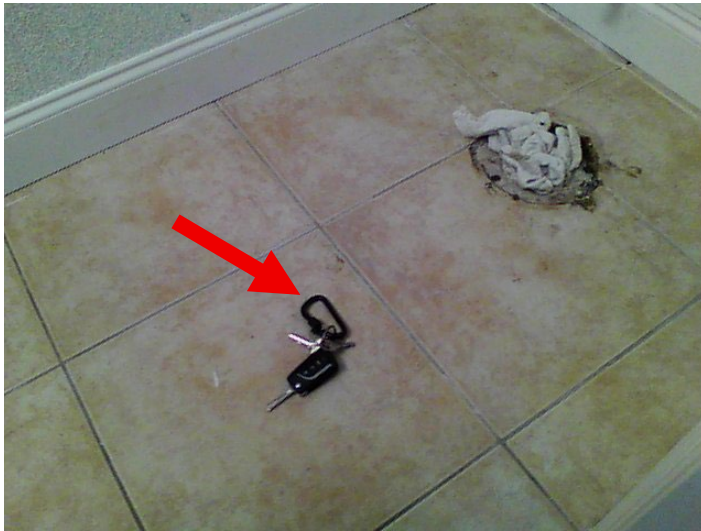
Hollow tile floor detected where keys lay

- Remove the affected bathroom/hall/den tile flooring, starting near the walls of the bathroom and wallboards adjacent to the bathroom, continuing two square feet past damage or wetness.

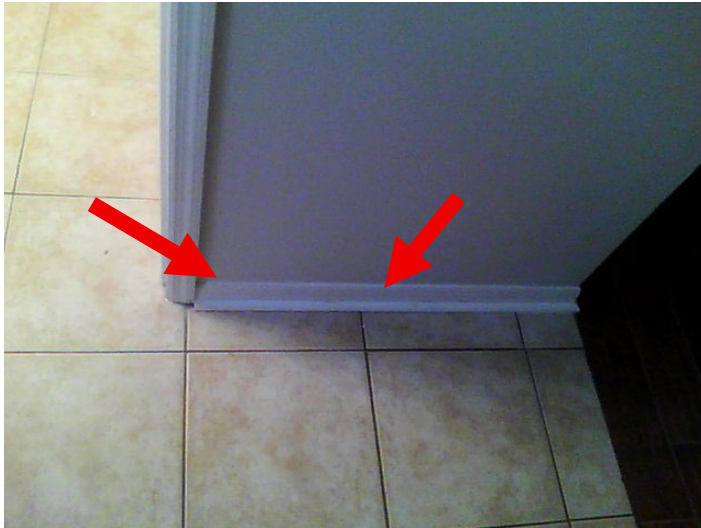
FLIR camera detected no thermal anomalies

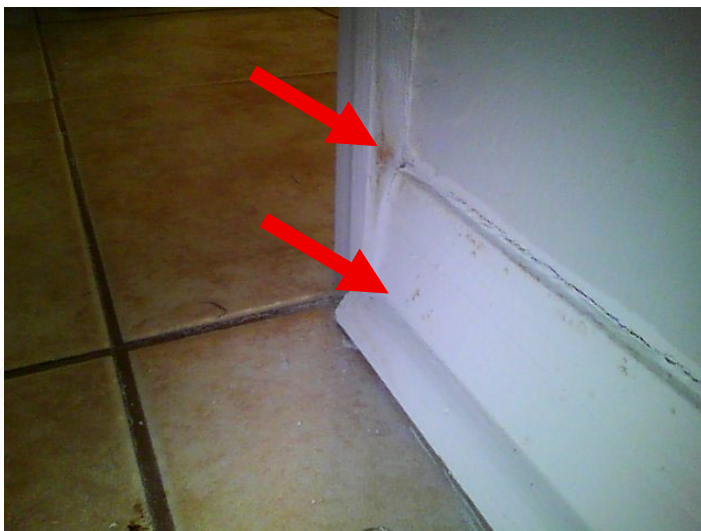
Visible Hallway Baseboard Staining

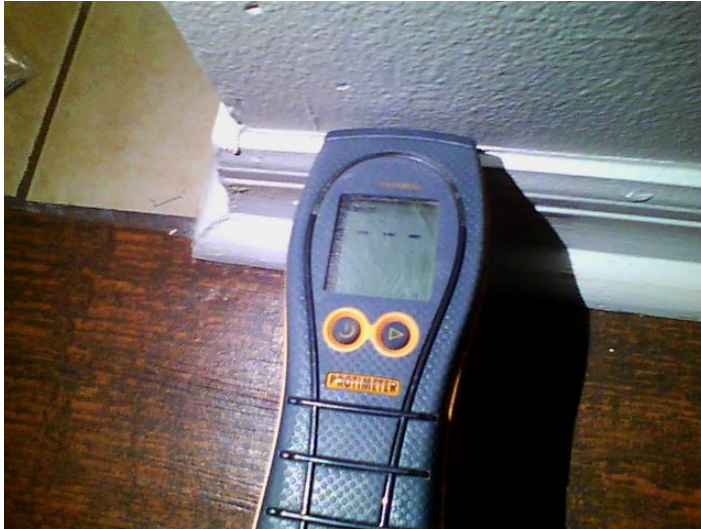
Drywall moisture reading <7%

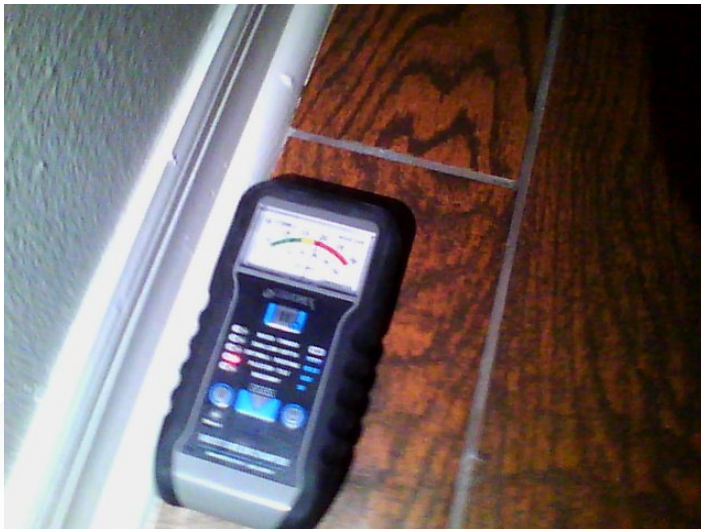
Den tile floor moisture reading 60%

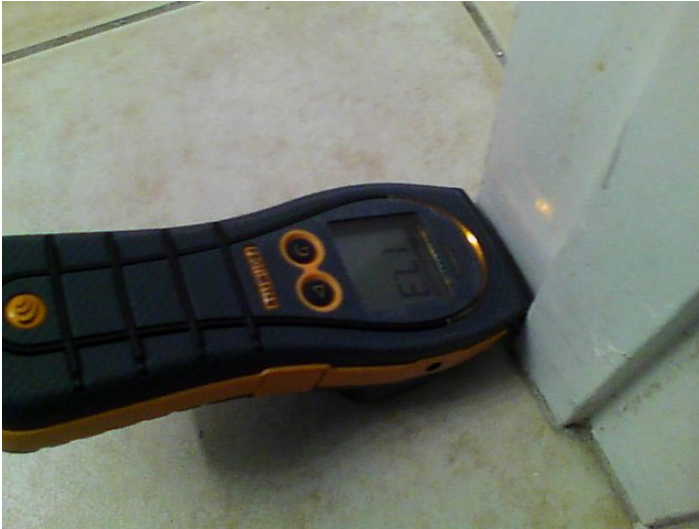
Bathroom door trim moisture reading 17.3%

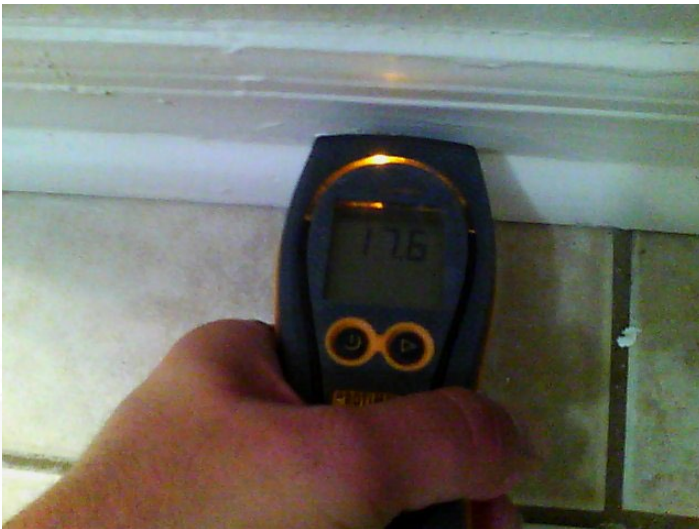
Baseboard moisture reading 17.6%

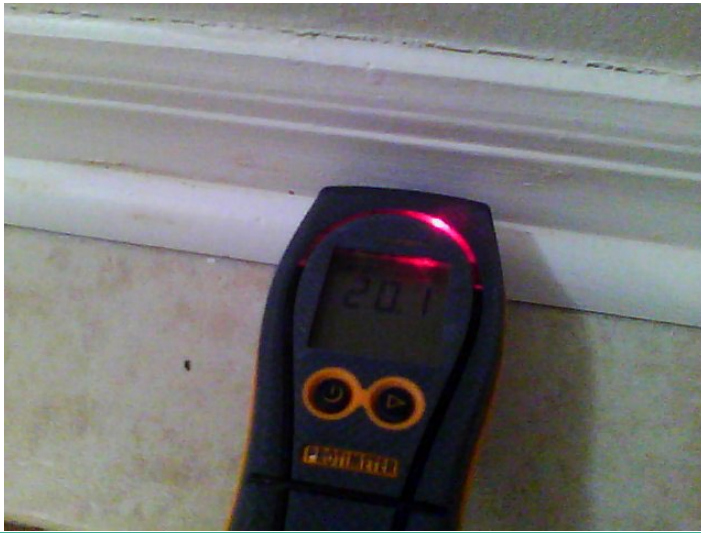
Baseboard moisture reading 20.1%

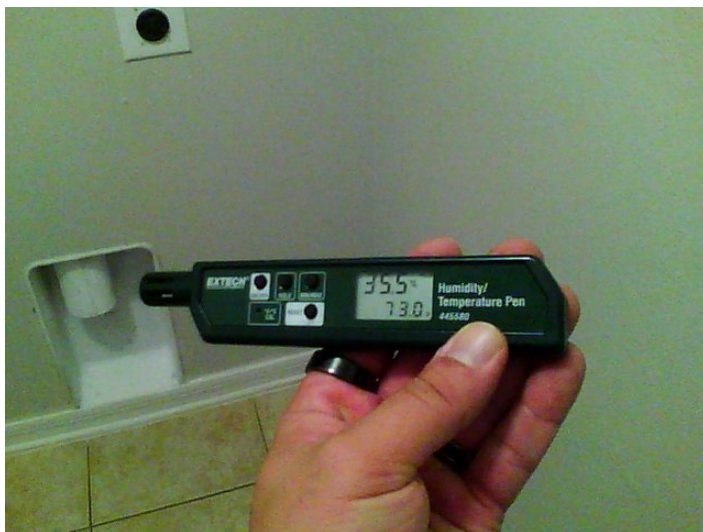
Laundry Room RH 35.5% / Temp 73.0 F

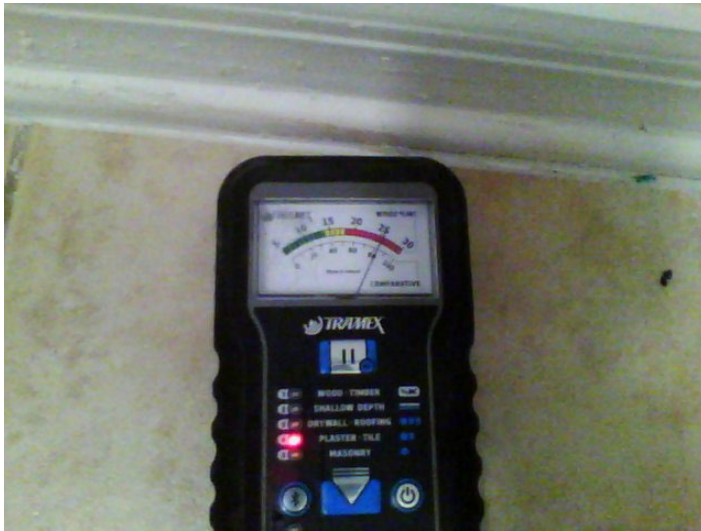
Tile floor moisture reading 81%

- Remove the affected wallboards and baseboards adjacent to the hallway bathroom and den, continuing two square/linear feet past damage, discoloration, or wetness.
- Remove the affected tile flooring, starting near the north and east wallboards and continuing two square feet past damage or wetness.
- Remove the affected insulation (if applicable), and assess for further damage.
- Detach all the nearby baseboards, and assess the underlying building materials for further damage. If damage is discovered, with photographic proof, remove as needed.
- Observe the underlying building material for further damage and, with photographic proof, remove as needed.

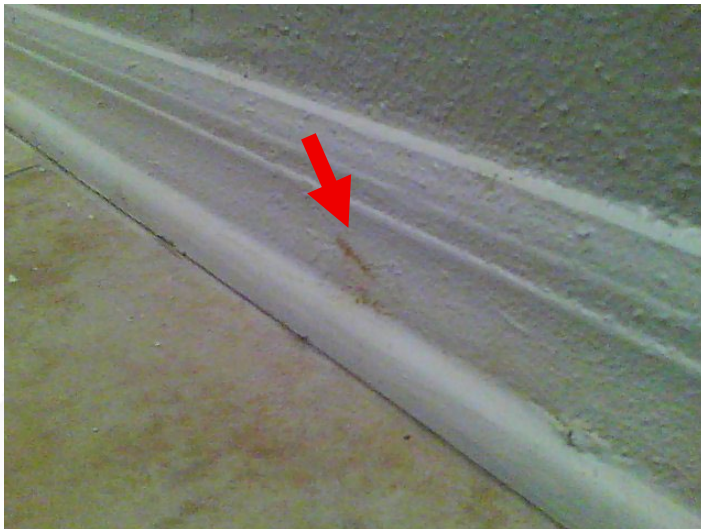
Visible Baseboard staining, up close

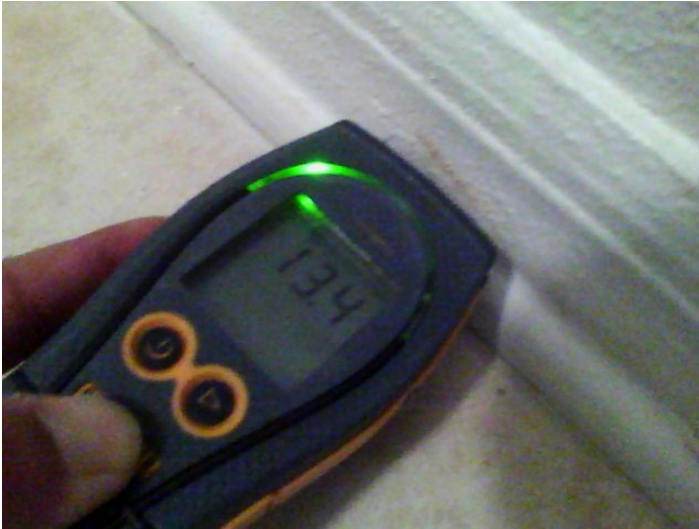
Baseboard moisture reading 13.4%

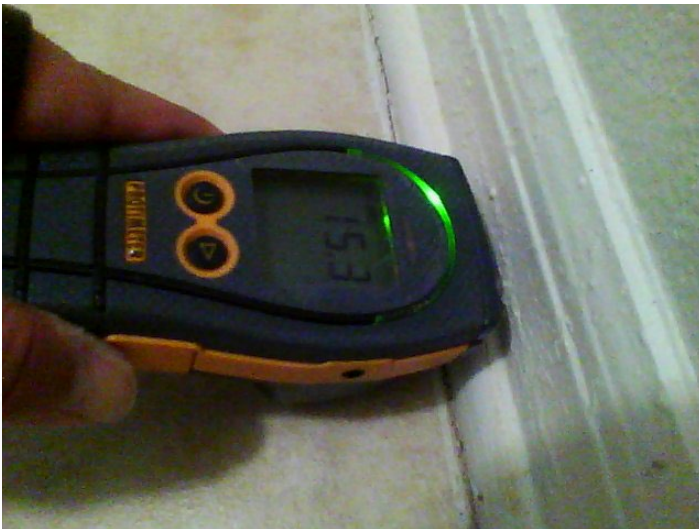
Baseboard moisture reading

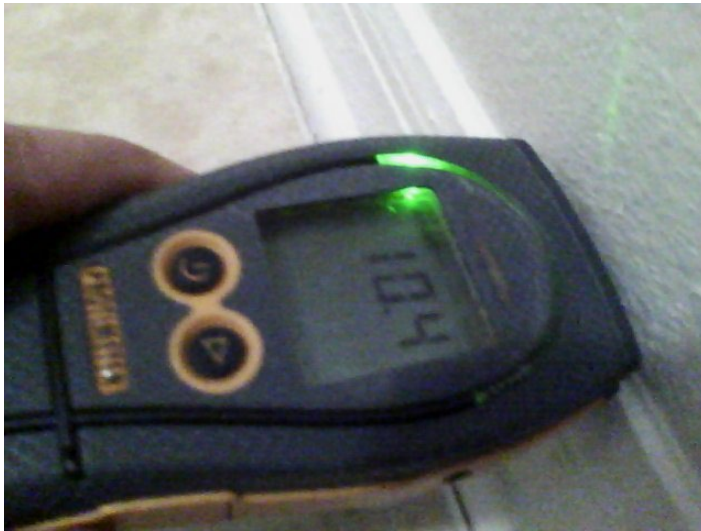
Drywall moisture reading 10.4%

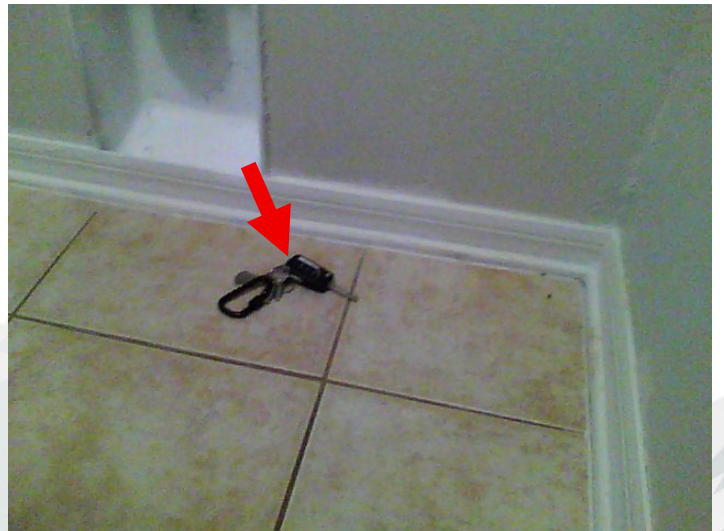
Hollow tile flooring detected where keys lay

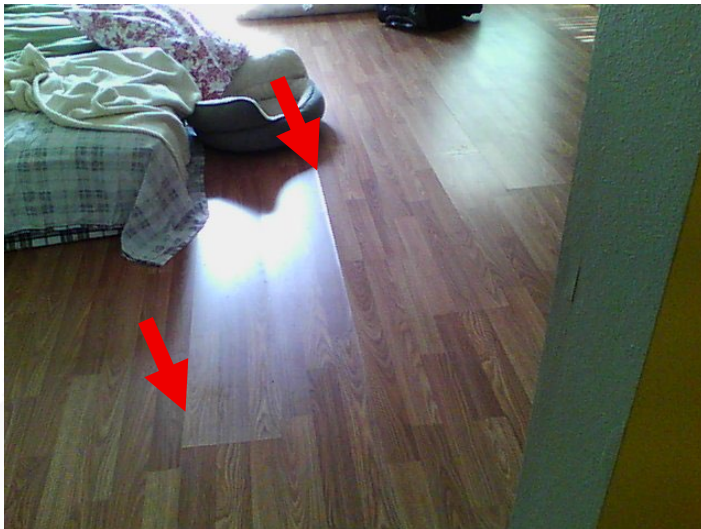
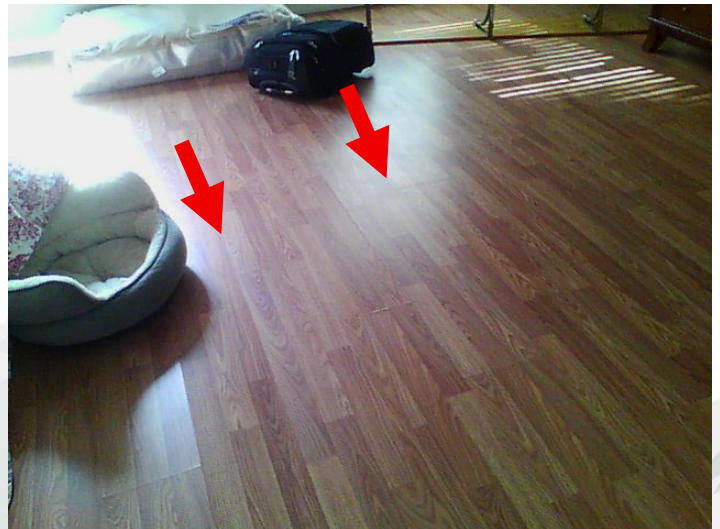
Bedroom flooring showed visible warping and crowning in multiple areas

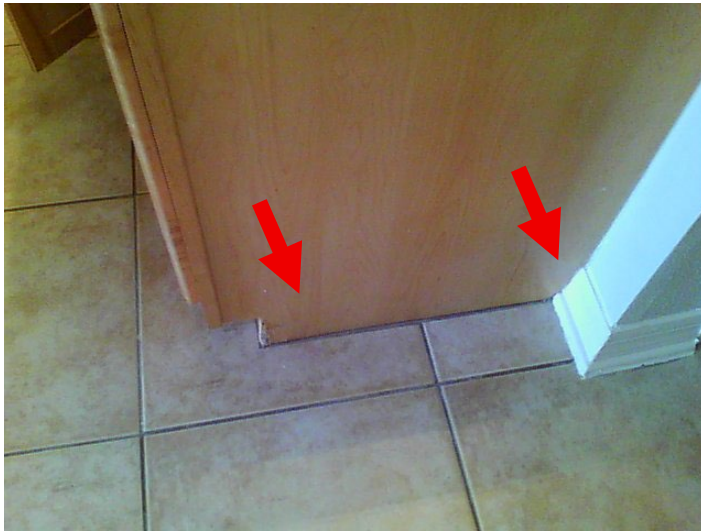
Visible Vanity bloating

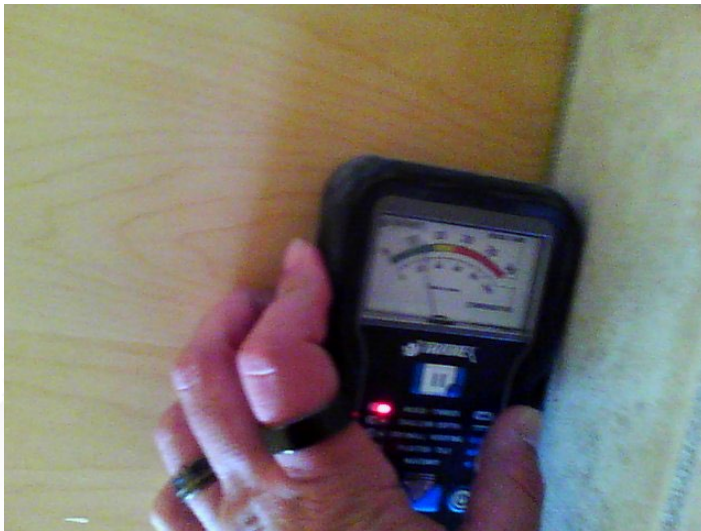
Vanity moisture reading 30%

- Detach the vanity, and assess the vanity backing and underlying building materials for damage. If damage is discovered, with photographic proof, remove as needed.

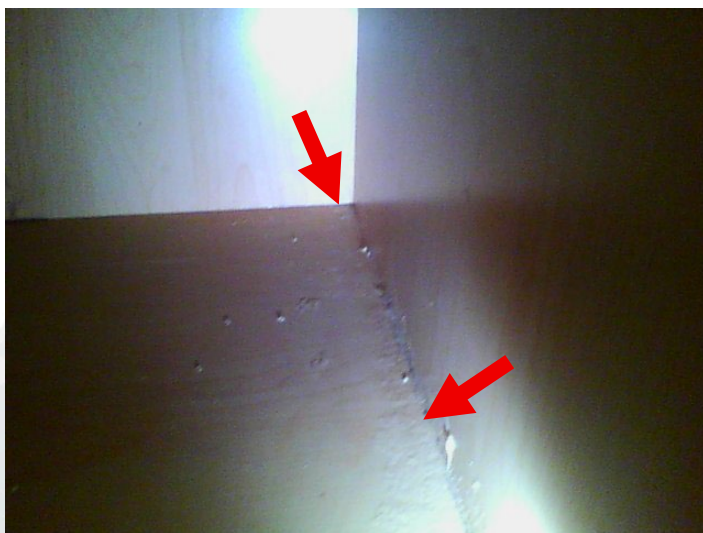
Vanity moisture reading 10%

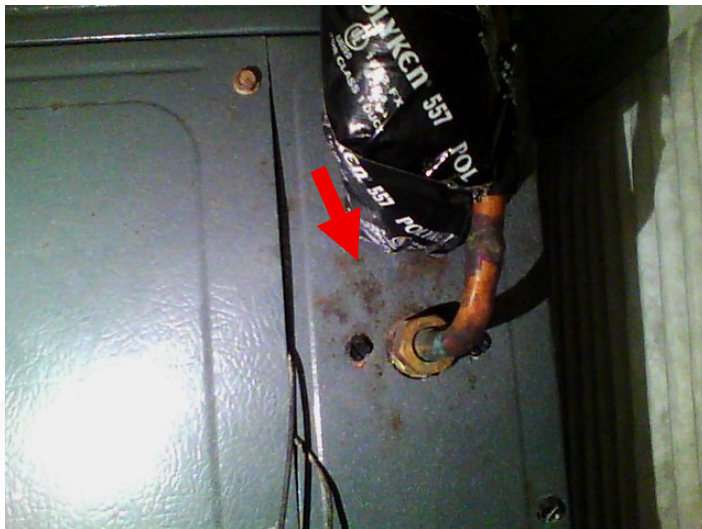
Visible staining and warping on the A/C shelf

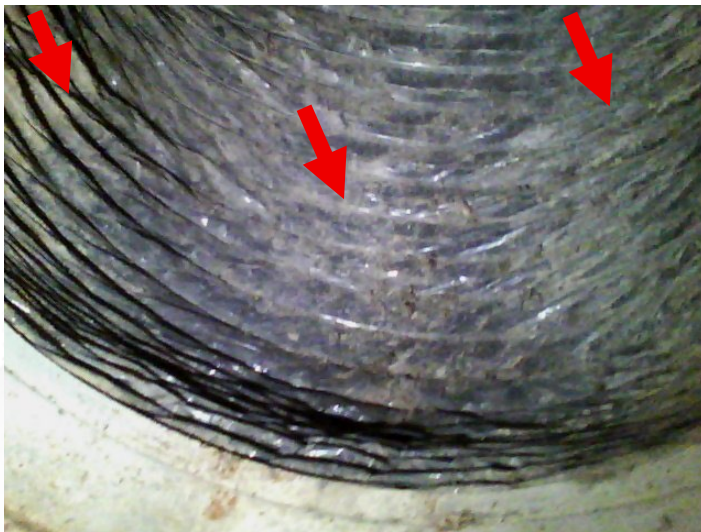
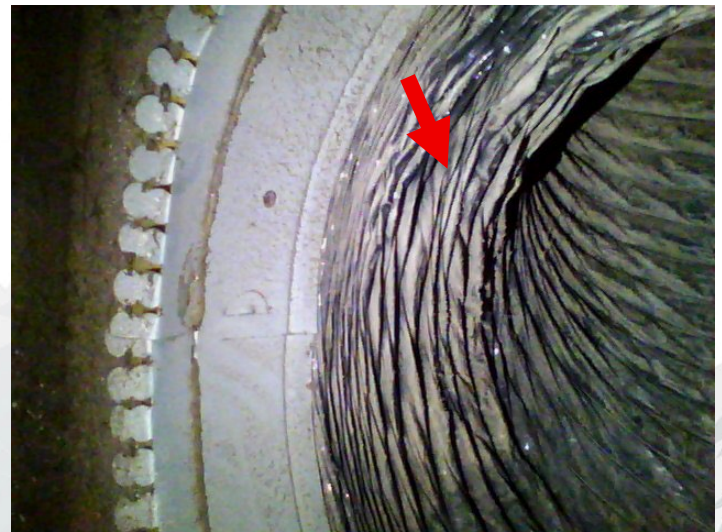
AC/ coils showed visible suspect growth and debris

- Professional cleaning of the air handler and ducts is recommended. A licensed HVAC contractor should assess the condition of the systems, the air handlers, and the ducts, following the National Air Duct Cleaners Association (NADCA) cleaning standard ACR 2021 – Assessment, Cleaning, and Restoration 2021, or the most recent version. The NADCA standard gives the contractor guidance as to what must be cleaned, how to clean, and when to replace HVAC systems and ducts.
