PROPERTY INSPECTION REPORT

123 Sesame Street, Virginia Beach, VA 23457

Inspection prepared for: Clint Dagger

Date of Inspection: 4/29/2020 Time: 12pm

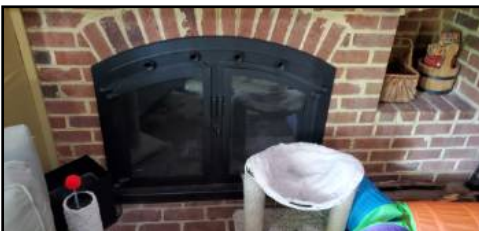
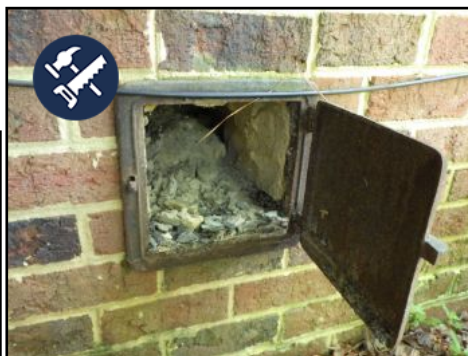
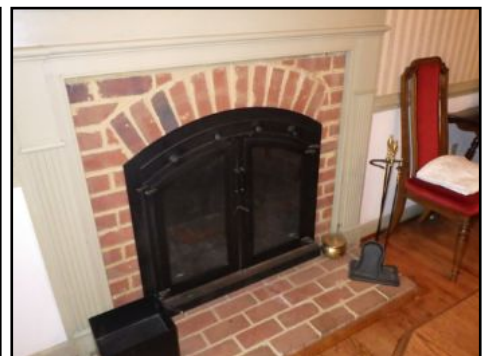
- Recommend professional cleaning of fireplace before first use to mitigate potential for chimney fires.

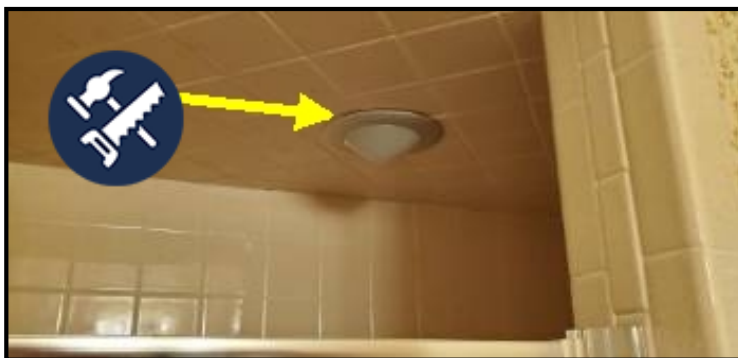
- Light fixture or bulb apparently inoperable at shower. Change bulb(s) and check functionality.

Light out

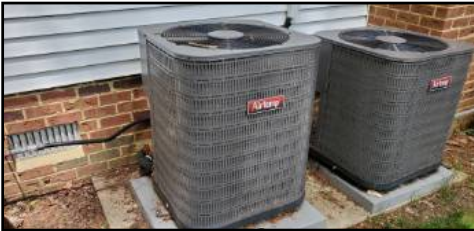
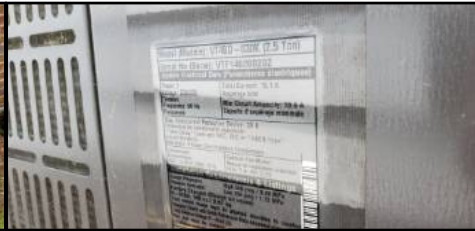
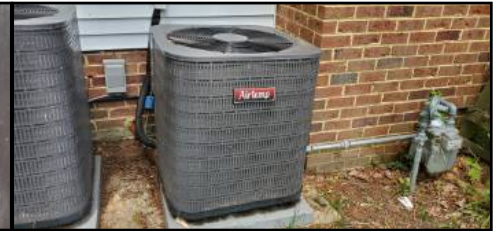
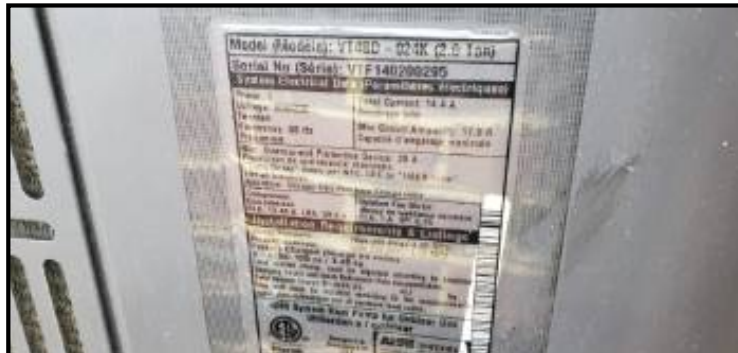
- The insulation is missing or damaged at exterior refrigerant line.
- Recommend replacement of insulation.

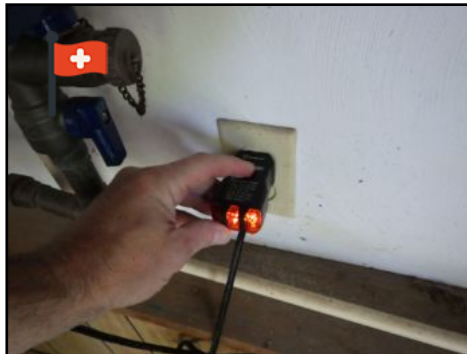
- No GFCI protection present, suggest installing GFCI protected receptacles for safety.

Add GFCI Outlets

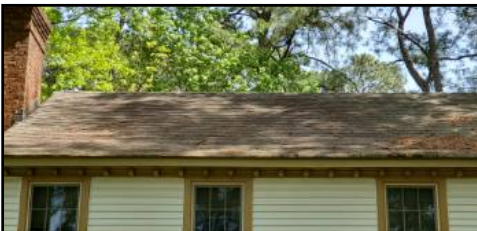
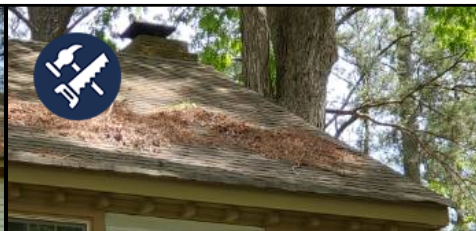
- Exposed nail heads observed on roofing materials. Recommend sealing all fastener heads.
- Clean Roof Areas: Significant amounts of organic debris was observed, which can lead to the premature failure of the roof and subsequent leaks.
- Excessive debris was observed on roof at time of inspection. Recommend cleaning debris from roof to preserve the remaining useful life of roofing materials.

Debris on Roof

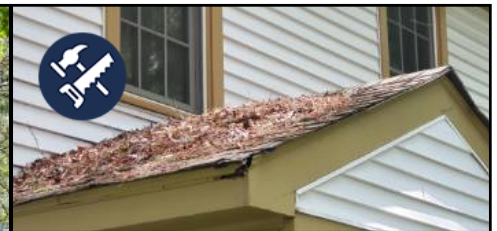
Debris on Roof

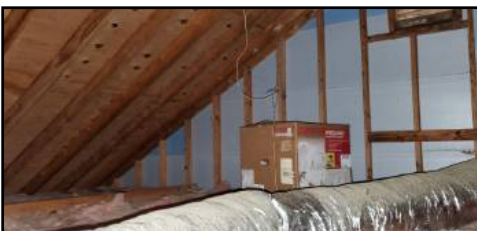
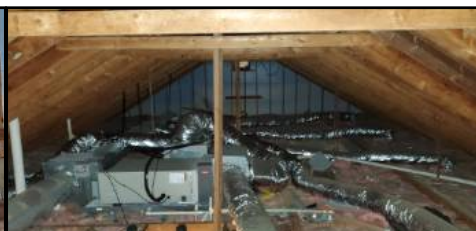
- Conventional or "Stick build" construction was observed in attic space with no issues noted.
- Evidence of past or present leaks, dry at time of the inspection. Monitor for leaks &/or have roofing contractor evaluate.
- Holes/gaps observed around penetrations into attic space with visible light shining through. Recommend sealing all gaps to prevent wildlife penetrations.

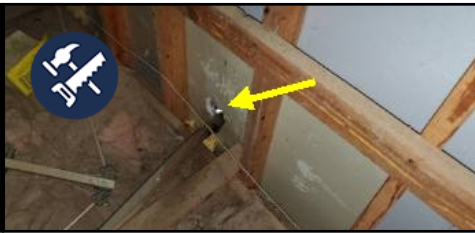
Seal holes

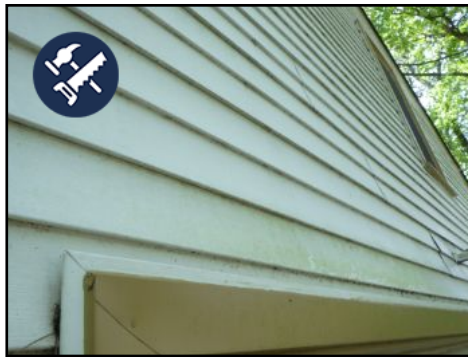
- Recommend power washing siding.
- Holes in vinyl siding observed in areas. Repair siding to prevent water penetration and damage.
- Loose vinyl siding was observed on back side of house. Recommend qualified contractor for repairs to prevent wind damage.

Holes in Siding

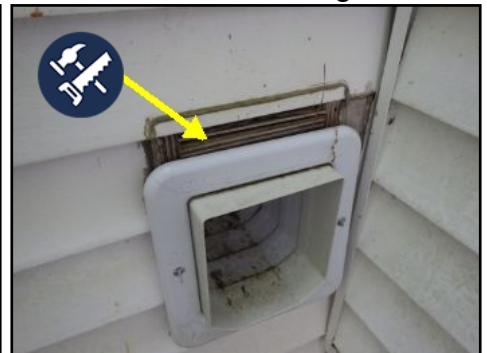
Holes in Siding

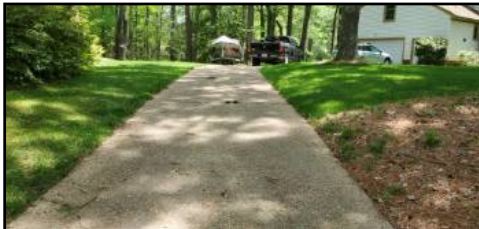
- Typical cracking was observed at the concrete surfaces. Further deterioration will occur as water expands and contracts from freeze and thaw cycles. Recommend sealing the cracks to prolong the life of the concrete.
- Moderate cracks in sidewalk. Repair and / or monitor for expansion and development of trip hazards.
- Driveway is settled and cracked in one area and is a potential trip hazard. Repairs are recommended for safety.

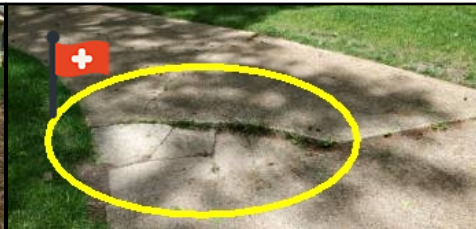
Raised/Settled

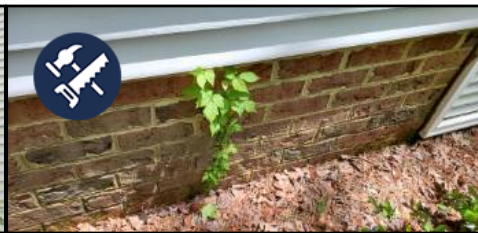
- Trim trees that are in contact or proximity to home, as branches can abrade roofing or siding. Tree limbs within 10 feet of roof be trimmed away to provide air and sunlight to roof, while minimizing debris & dampness. Will also help to minimize debris buildup in gutters to ensure full useful life of roof and soffits. Damage may occur if limbs are in physical contact with house.
- Ivy growth was observed on exterior of house. Recommend removing Ivy to prevent further growth on exterior portions of house.

Ivy

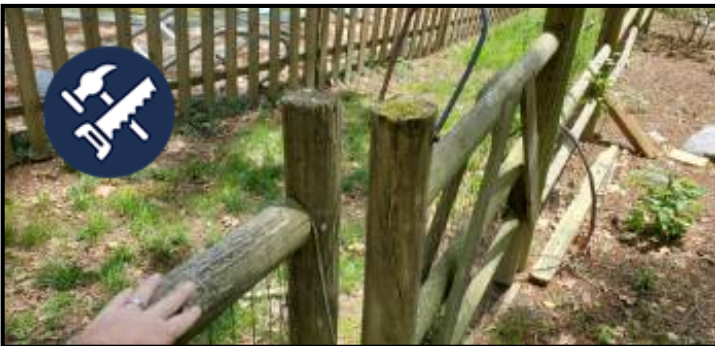
- Gates do not close easily and require adjustment for proper operation.

Adjust Closure

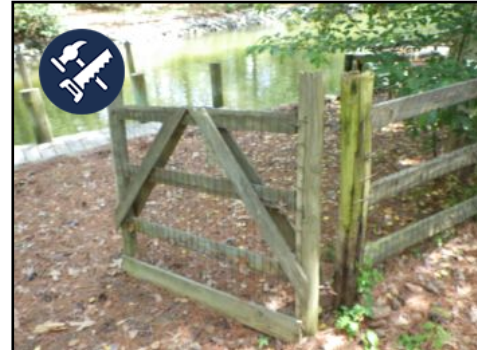
Adjust Closure

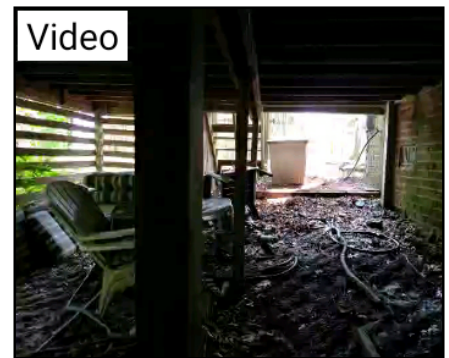
- Deck railings show signs of apparent woodpecker damage and require repairs by qualified contractor
- Recommend power washing and sealing deck on an annual basis to preserve the integrity of the wood components.
- Piers under deck are not properly secured at the ground and do not provide support for the middle portion of the deck. Recommend licensed and insured contractor for further evaluation and repairs.

Back Deck Support Piers

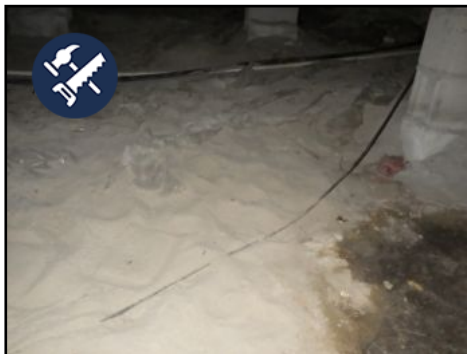
Add Poly

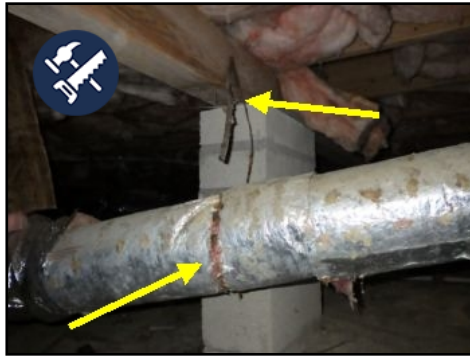
Fallen ductwork

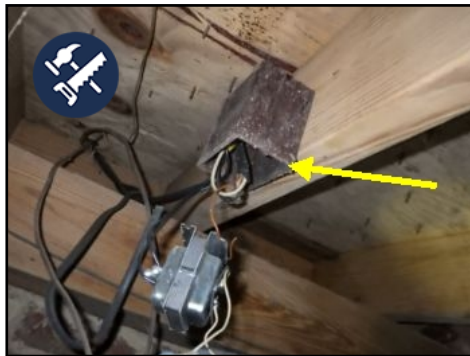
Open Junction Box

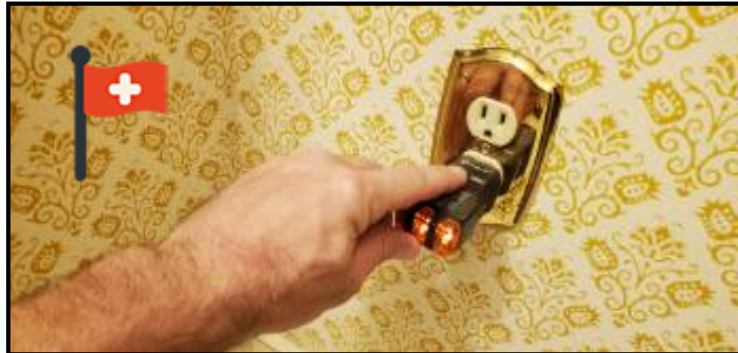
- No GFCI protection present, suggest installing GFCI protected receptacles for safety.

No GFCI Present

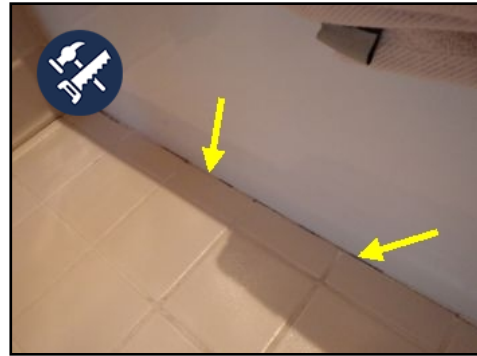
- Shower/Tub requires caulking along floor to prevent moisture damage to subfloor.
- Caulking is required at wall and tub/shower to prevent moisture damage to walls.

Caulk at floor

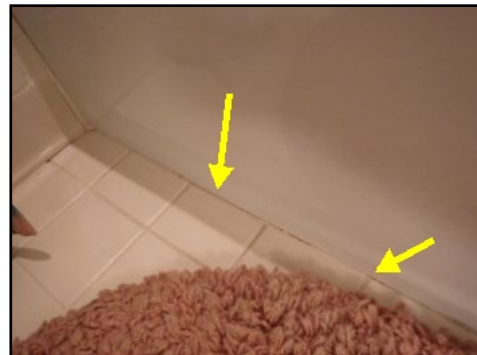
- Shower/Tub requires caulking along floor to prevent moisture damage to subfloor.
- Caulking is required at wall and tub/shower to prevent moisture damage to walls.

Caulk at floor
