**Revised**  
**FULL RESERVE STUDY**  
**Rio Del Sol**  
**Homeowners Association, Inc.**

**Lake Havasu City, Arizona**  
**Inspected - March 18, 2021**  
**Revised - July 7, 2021**

Rio Del Sol Homeowners Association, Inc.  
Lake Havasu City, Arizona

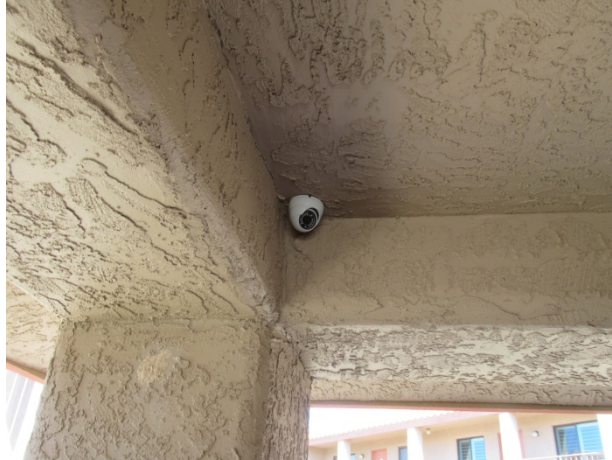
**Security camera**

**Condition:** Reported satisfactory though the Board reports the possible need to install additional security measures at the property entrances and exits.

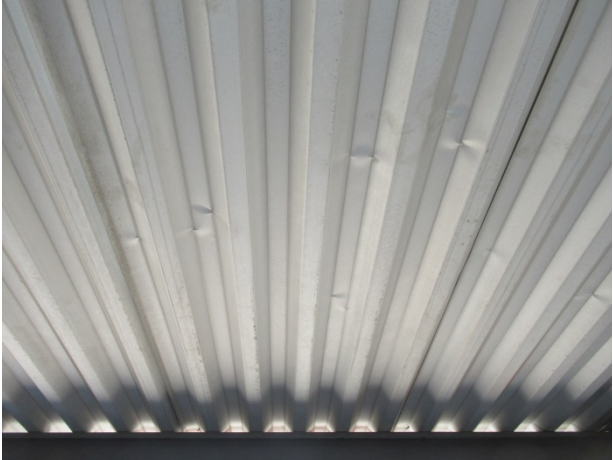
**Dented roofing**

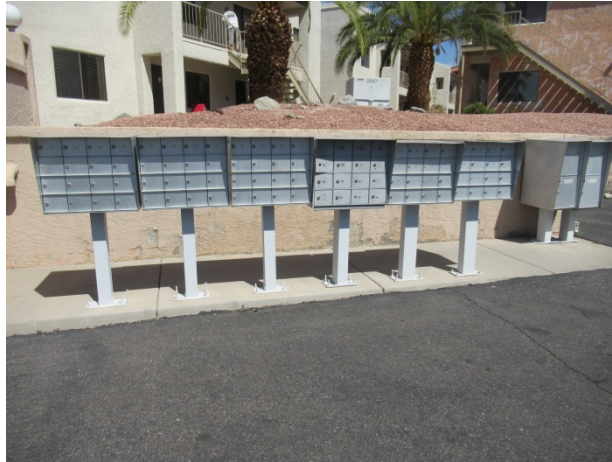
**Mailbox stations**

**Condition:** Fair overall

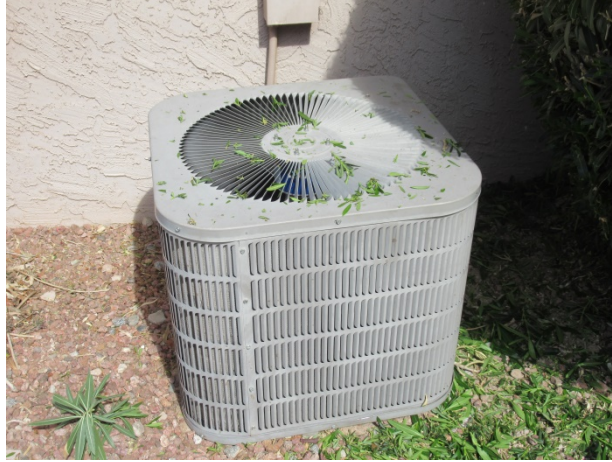
**Condensing unit**

**Condition:** Reported fair

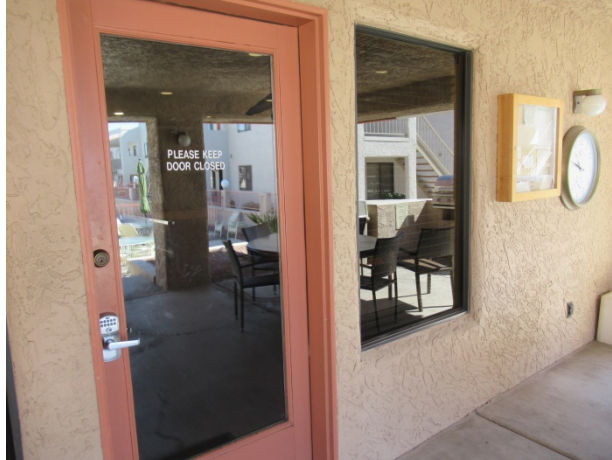
**Door and window**

**Condition:** Fair condition

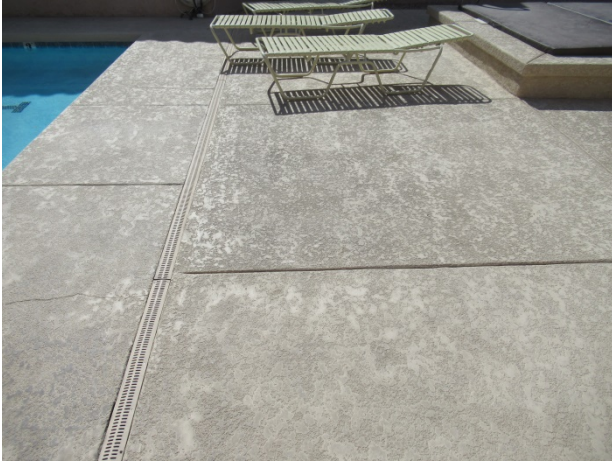
**Pool deck**

**Condition:** Good to fair condition with limited coating deterioration and isolated cracks evident
