PROPERTY INSPECTION REPORT

12345 Your Home Dr., Los Angeles, CA 90039

DATE OF INSPECTION: 3/4/2025

VILLA PROPERTY INSPECTIONS
www.inspectaproperty.com

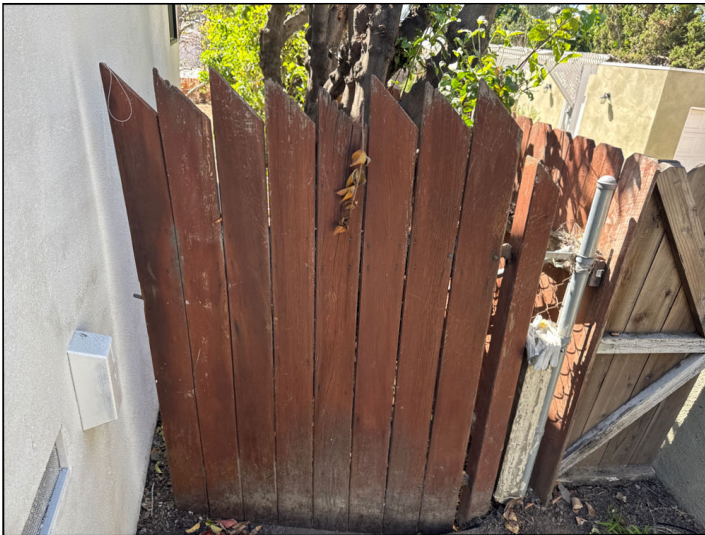
Gates do not close and or latch properly. Repair or replacement is needed.

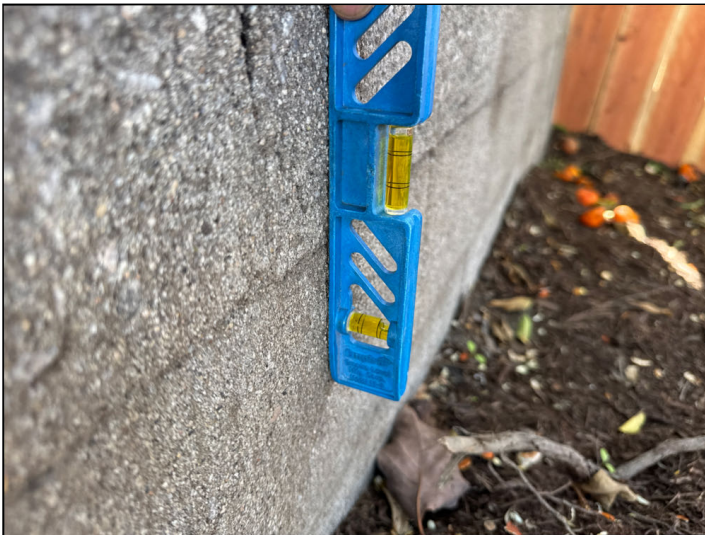
Block wall is leaning or falling. Repair or replacement is recommended.

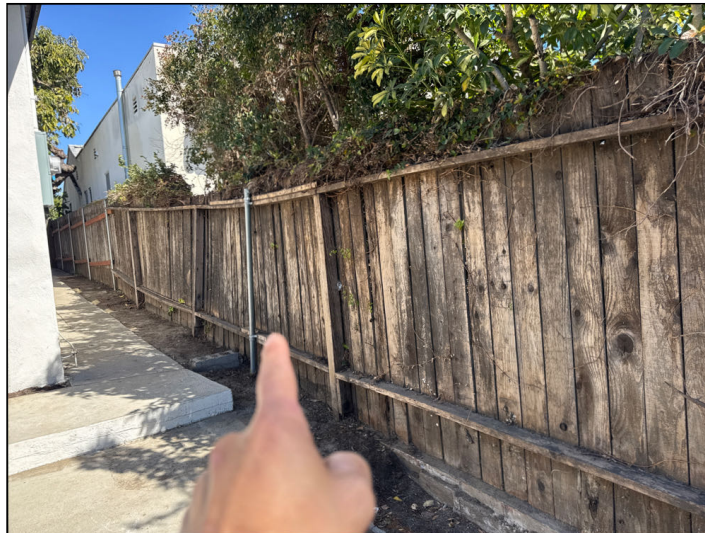
Fence is leaning or falling. Repair or replacement is recommended.

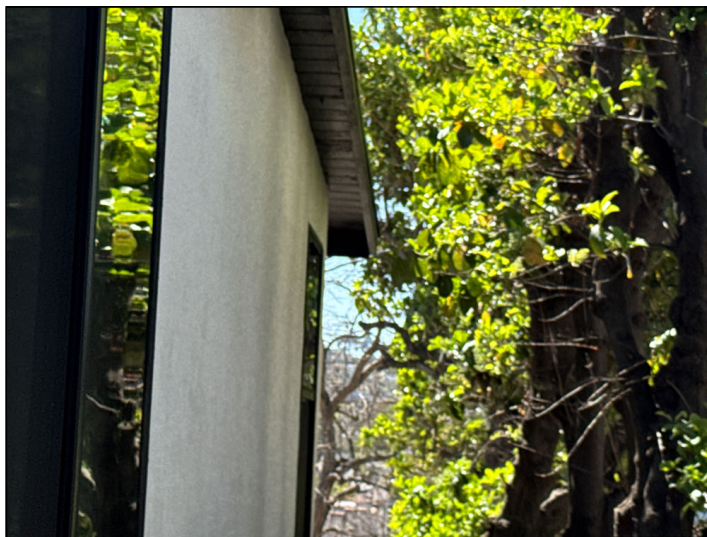
Tree limbs within 10 feet of roof should be trimmed away to provide air and sunlight to roof, while minimizing debris & dampness.

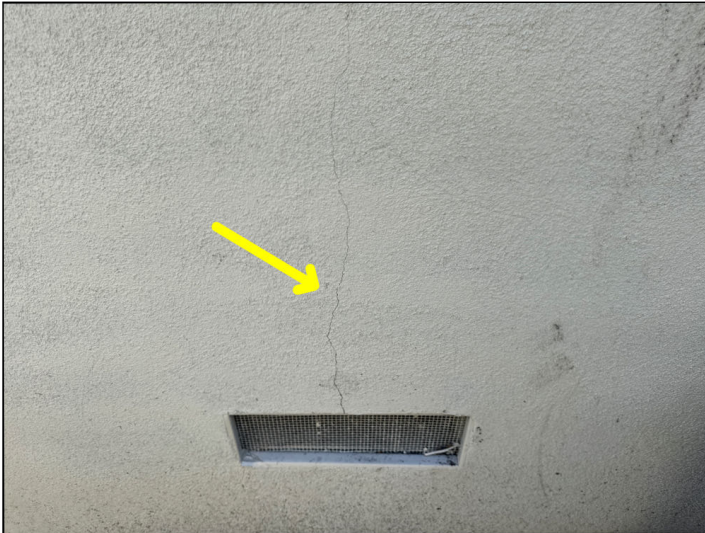
Cracks were noted on the walls.

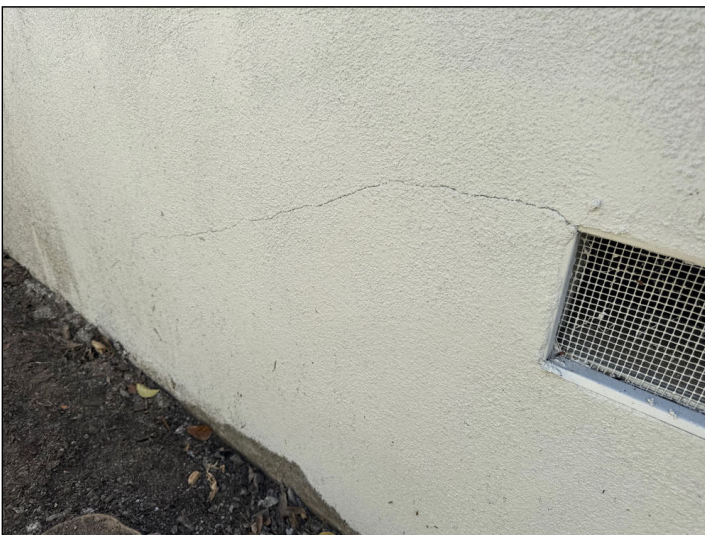
Cracks noted are moderate and may indicate foundation movement due to seismic activity or settlement.

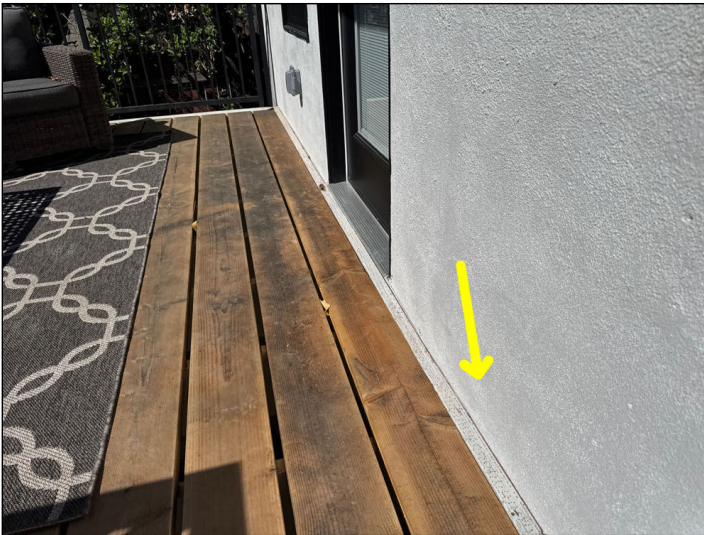
Flashings are not properly sealed at the floor to wall junction and may allow moisture penetration and damage.

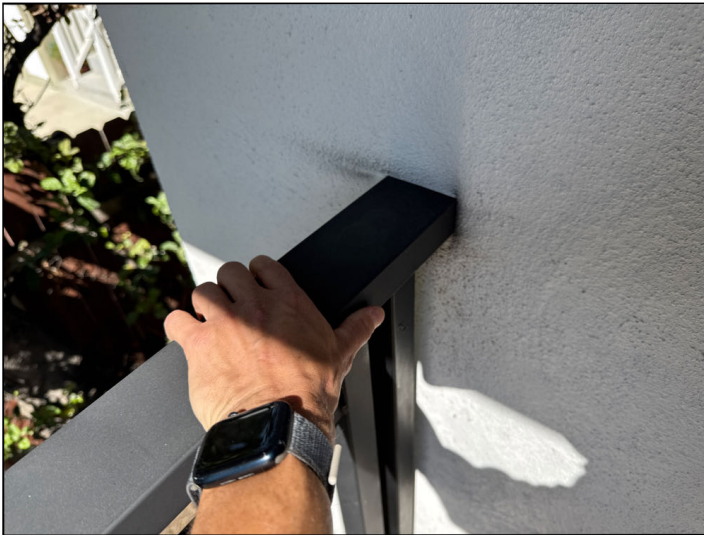
Hand or guard railing is loose or damaged. Repair or replacement is necessary.

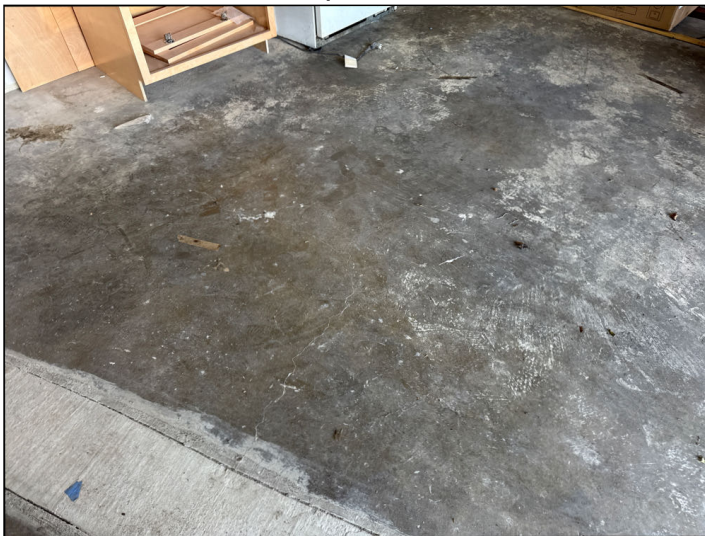
Typical cracks noted on the floor at time of inspection.

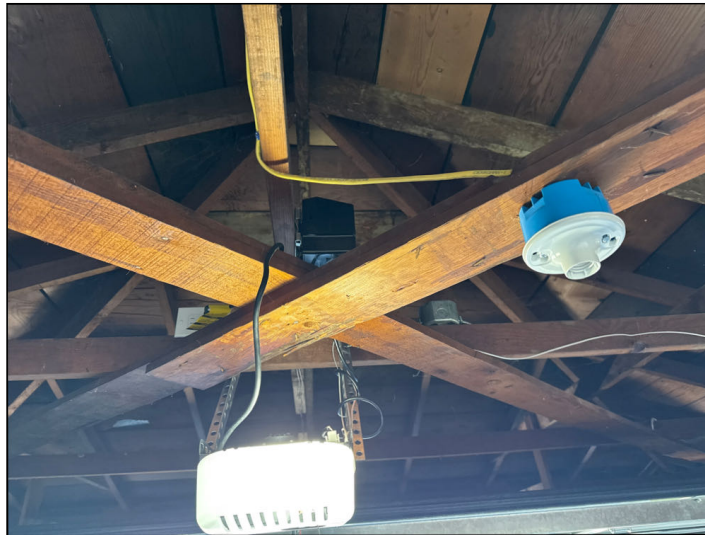
Exposed Romex wiring observed. Romex wiring is required to be protected/covered when less than 7 feet from the ground. Installation of a cover (drywall, plywood etc) or replacement with metal conduit is required.

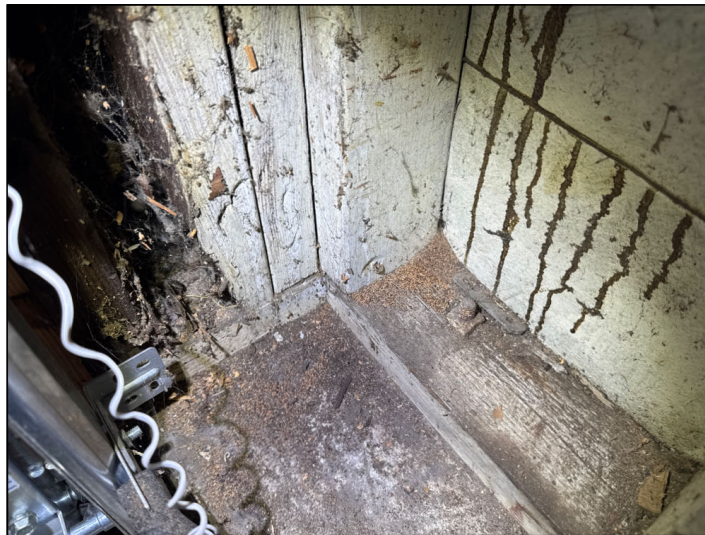
Observed rot/termite/moisture damage. Further evaluation by licensed termite inspector is recommended.

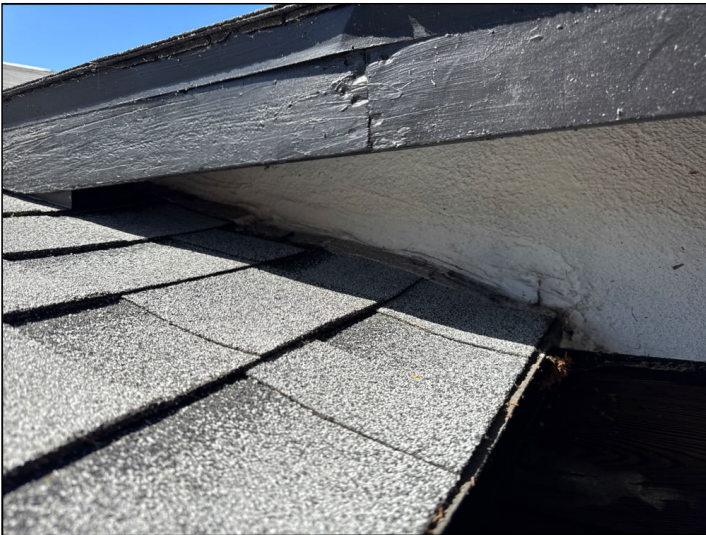
Flashing is not installed at the wall junctions.

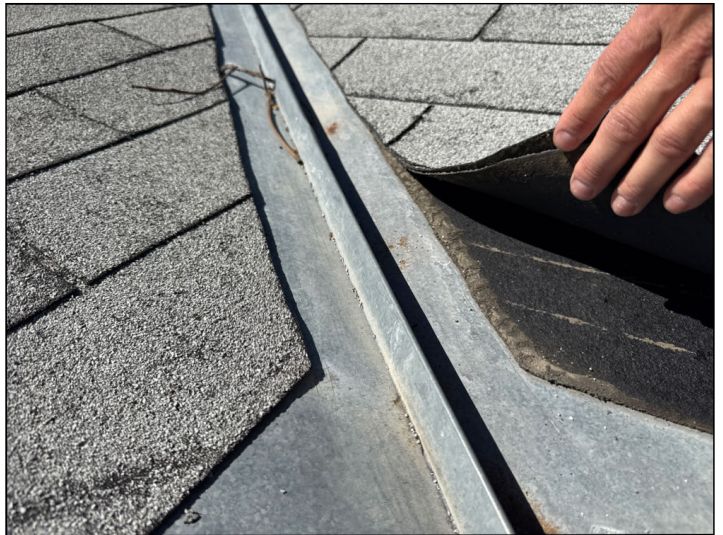
Flashings do not appear to be properly sealed at the valley.

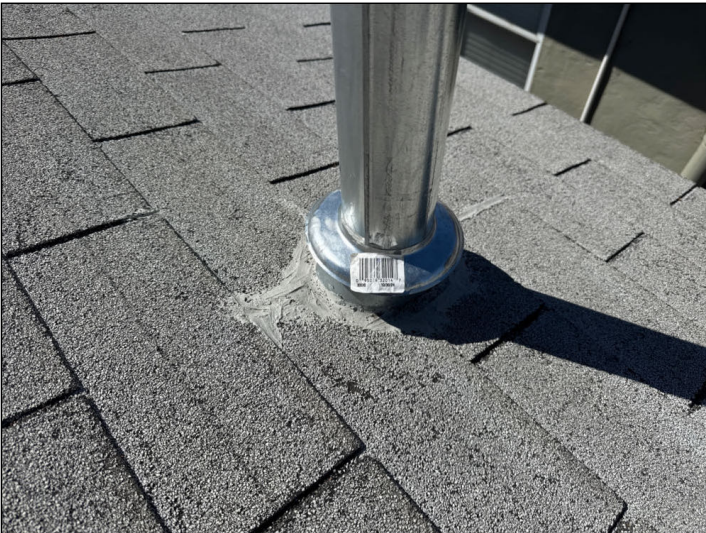
Flashings do not appear to be properly sealed at the vent pipes.

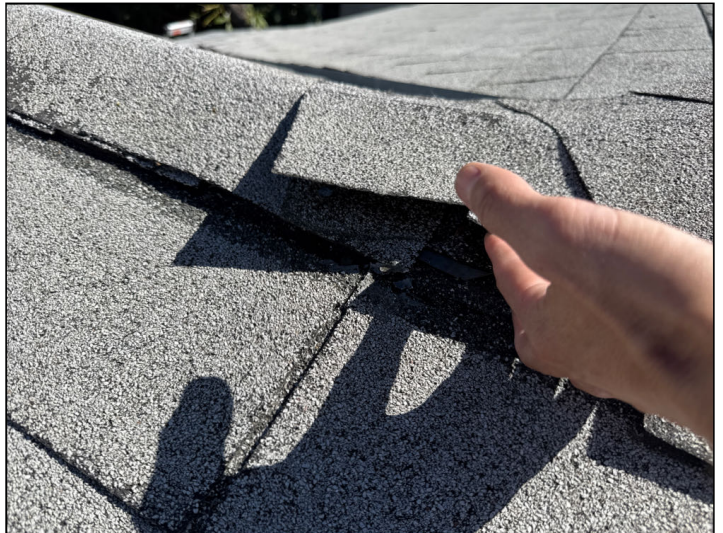
Flashings do not appear to be properly sealed at the valley.

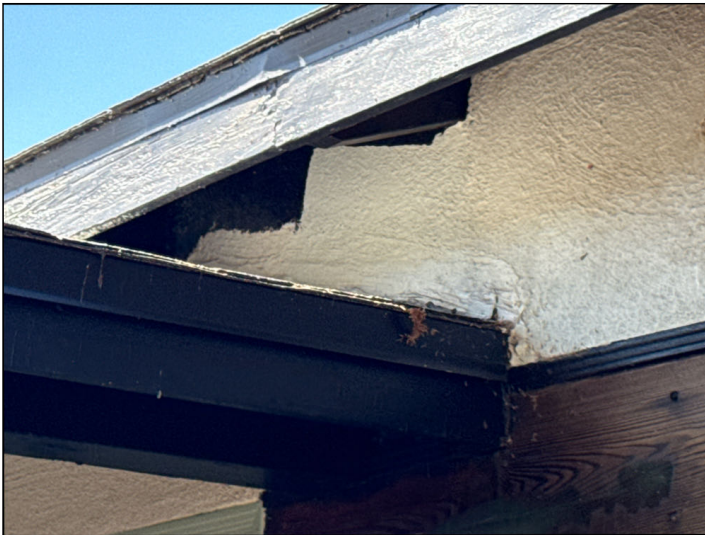
Kick out flashing is not installed at the wall to roof edge connection. Kick out flashing diverts water from cascading down a wall from a roof edge.
See sample photo.

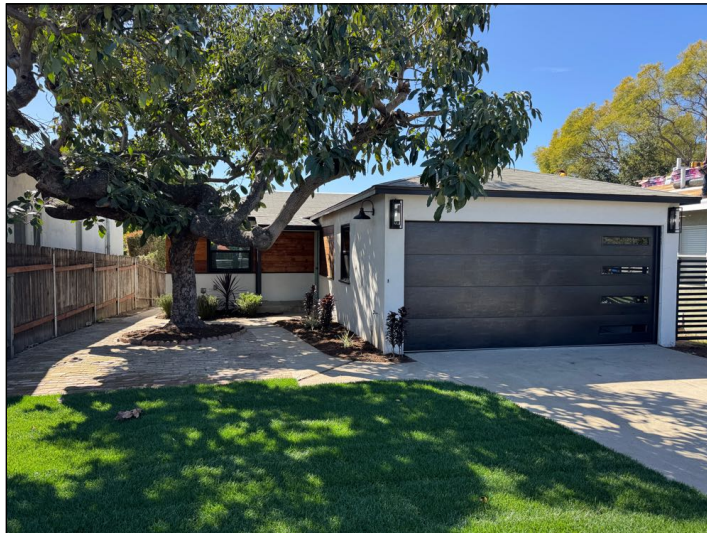
Fascia boards are missing or not installed. Repair or replacement is recommended.

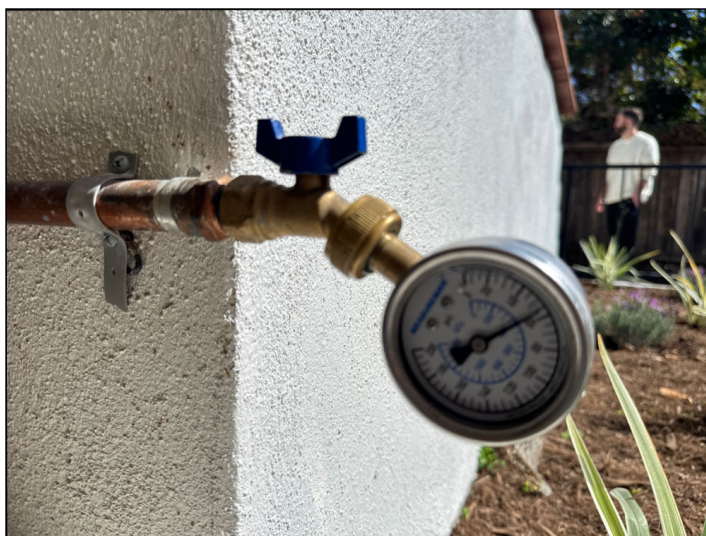
Water pressure appears to be low at the main shut off. The normal operating range for water pressure in a typical home is 65-80 psi. Further evaluation by a plumbing contractor may be necessary.

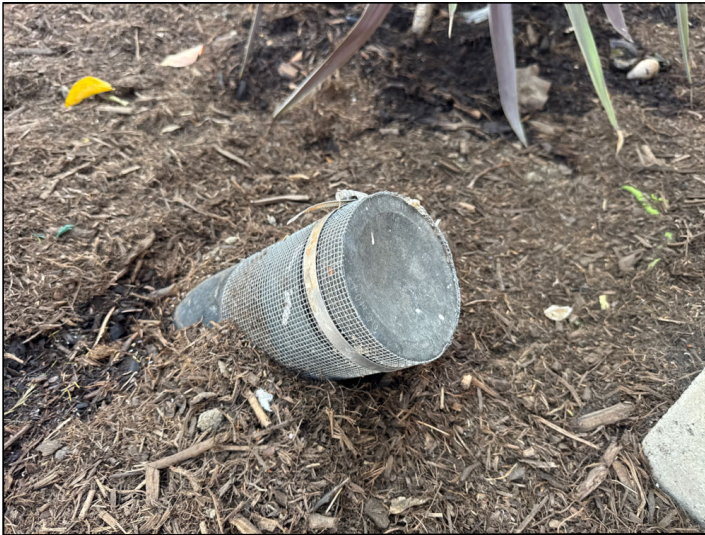
Drain line clean out is not readily accessible.
Installation of an extension on the pipe is recommended for easier access for inspection, maintenance and repairs of the sewer lines.

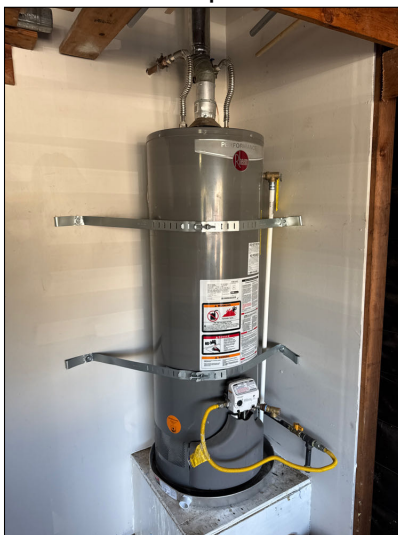
Water heater operated properly at time of the inspection.

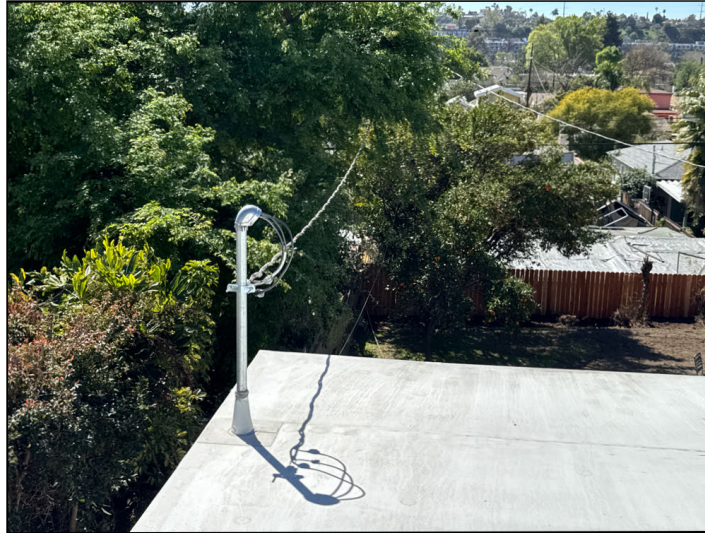
Overhead conductors have contact or run through the middle of a tree. Swaying tree limbs can damage or pull the electrical lines and cause them to disconnect. This is a possible hazard. Trimming the tree limbs away from the power lines is highly recommended for safety.

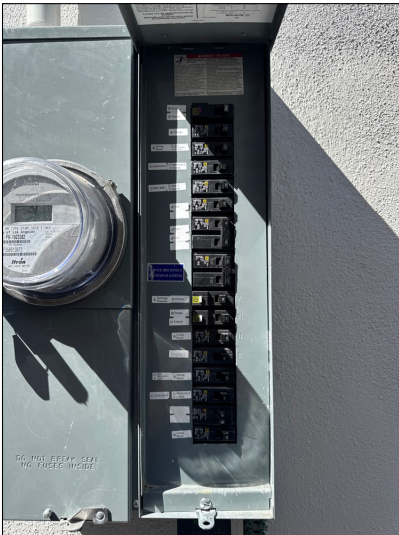
Main electrical panel appears to be in overall good conditions with no problems observed at time of the inspection.

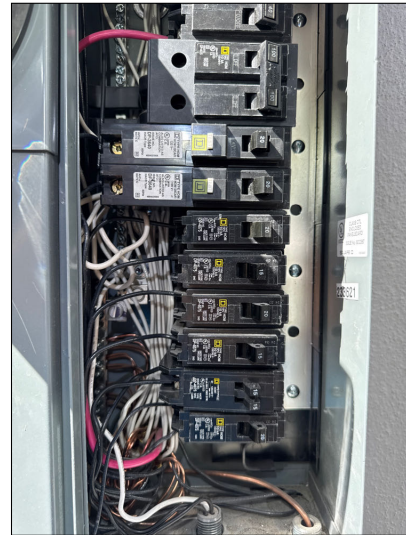
Circuit and wire sizing correct so far as visible.

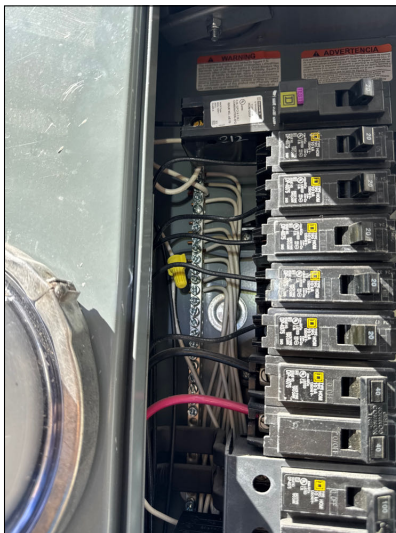
Grounding system is present.

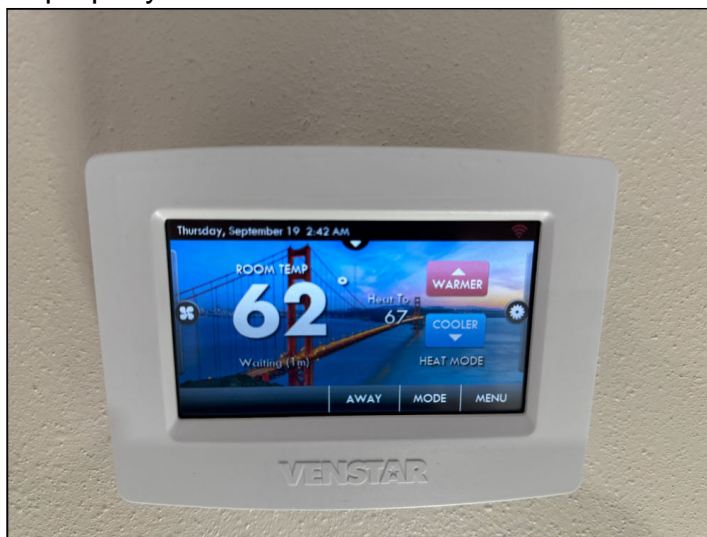
Normal controls operated properly.

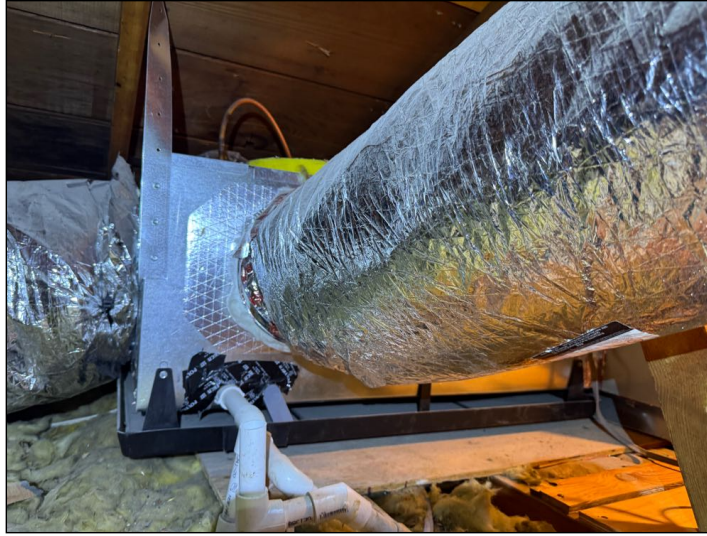
Air plenum appears adequate.

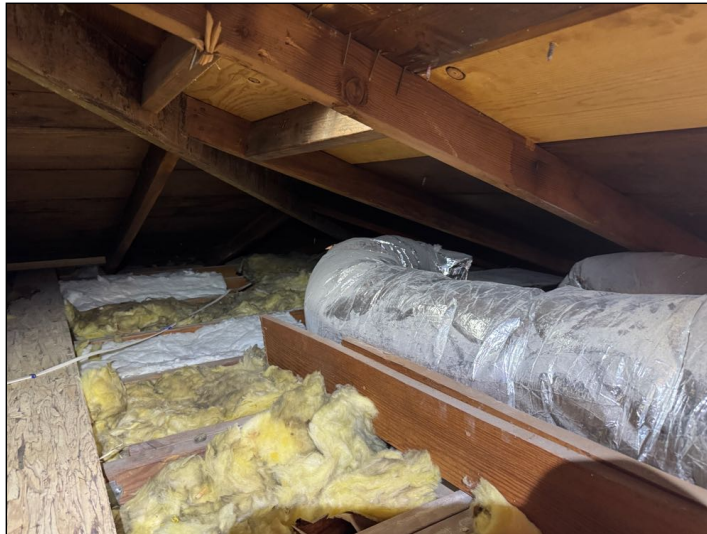
No visible problems observed at time of inspection.

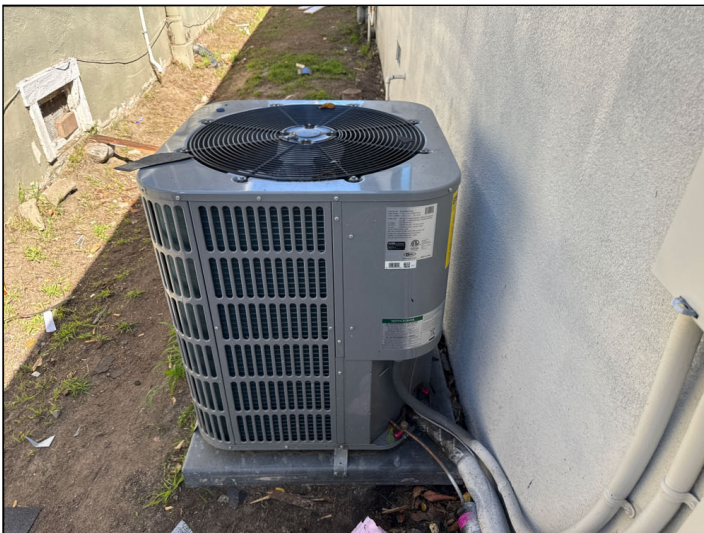
System operated properly at time of inspection.

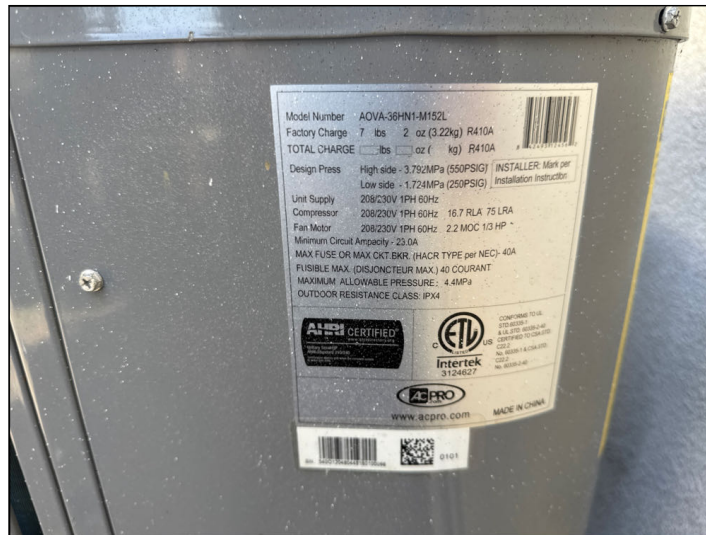
Condenser unit is visibly unlevel and may not allow proper operation of the refrigeration pump. Leveling is recommended.

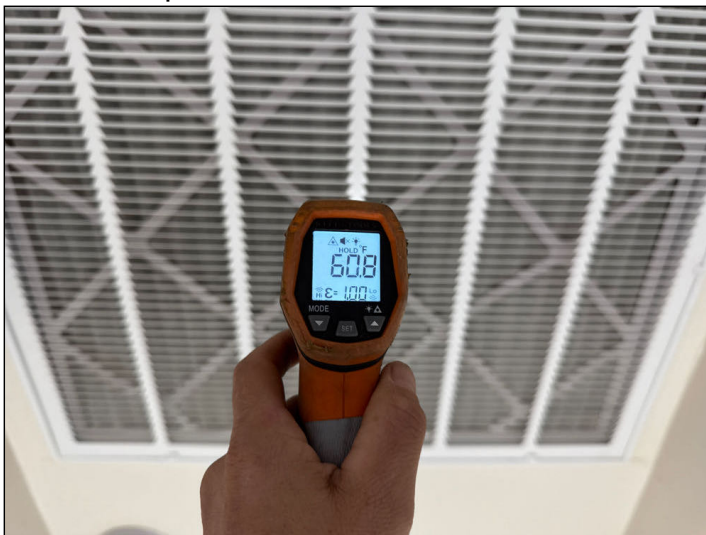
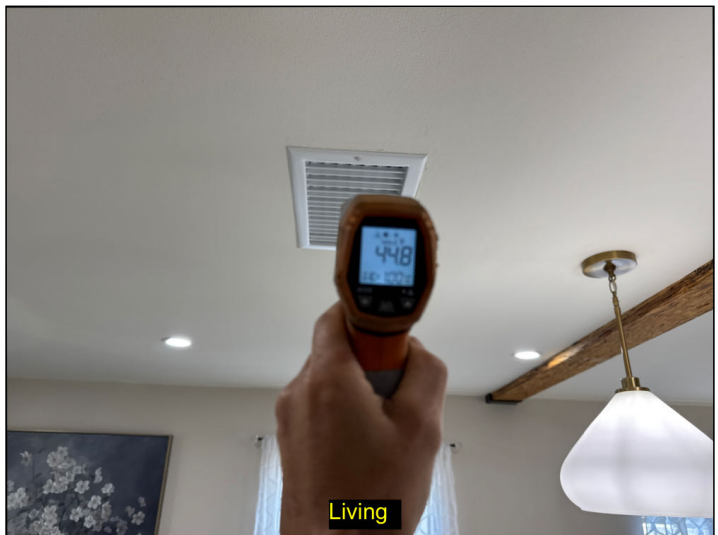
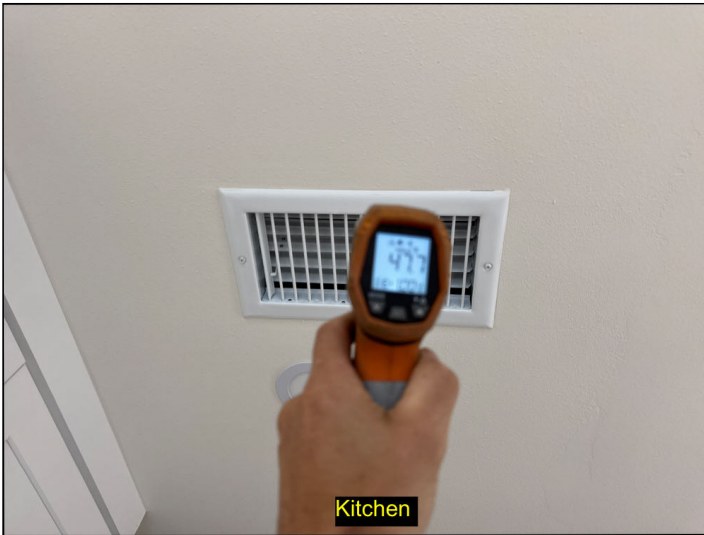
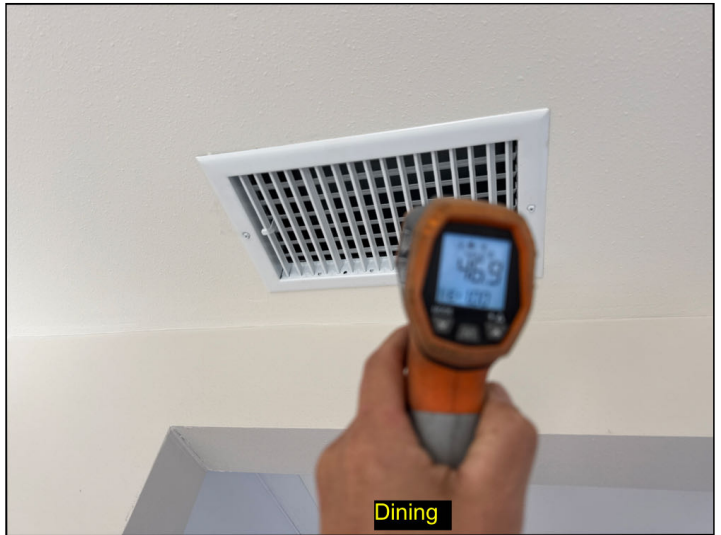
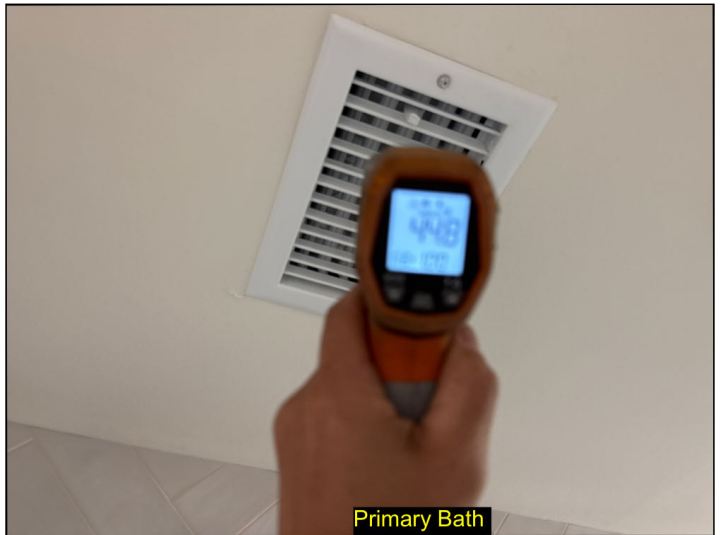
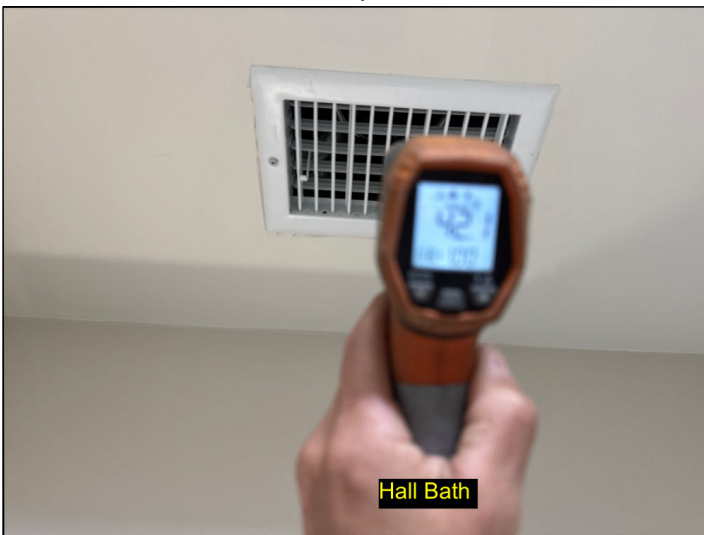
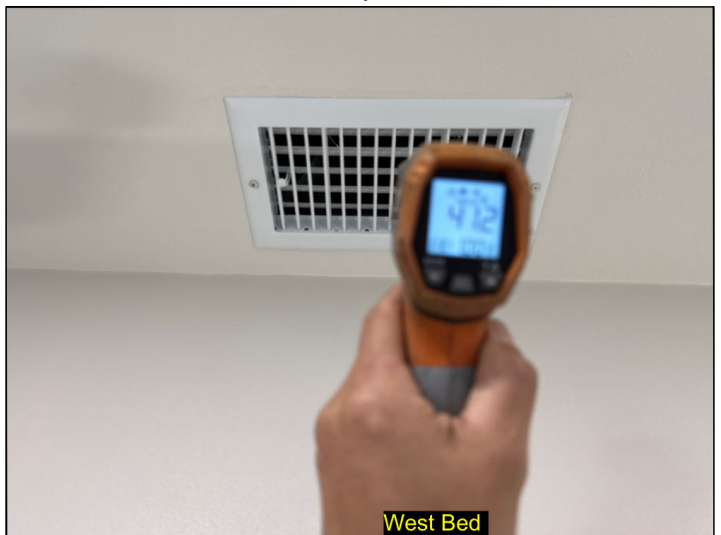
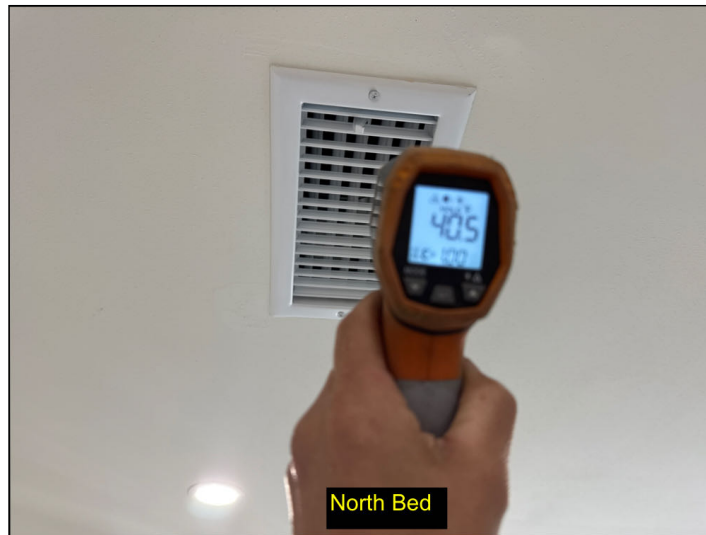
Normal operation.

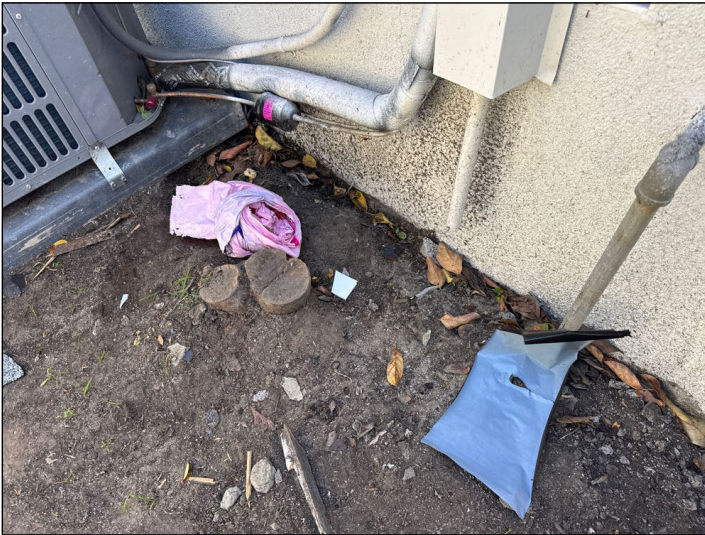
Air conditioning condensation line terminates next to exterior wall and foundation. It should be rerouted for proper drainage to prevent moisture intrusion.

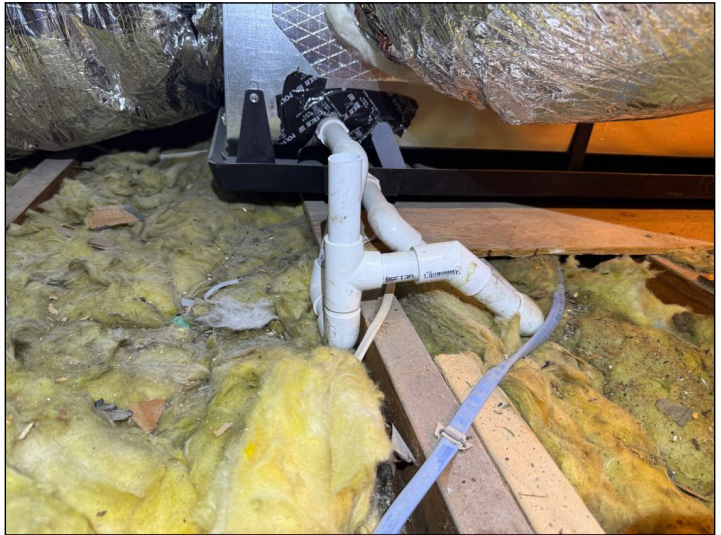
Line not fully visible.

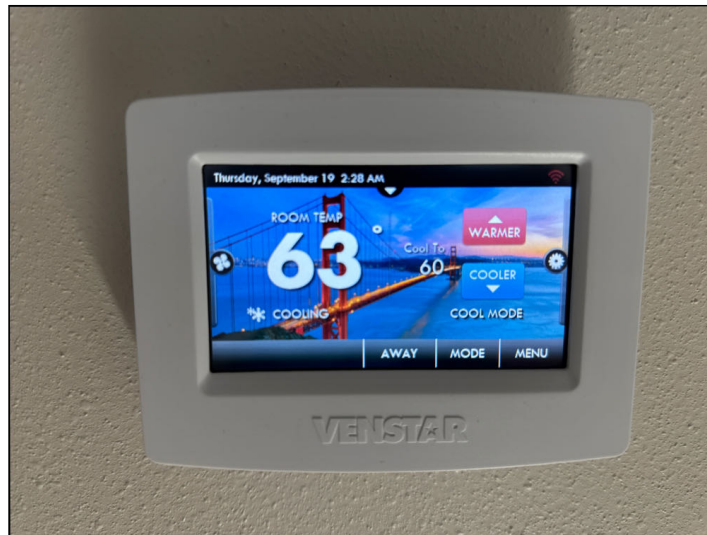
Normal controls operated properly.

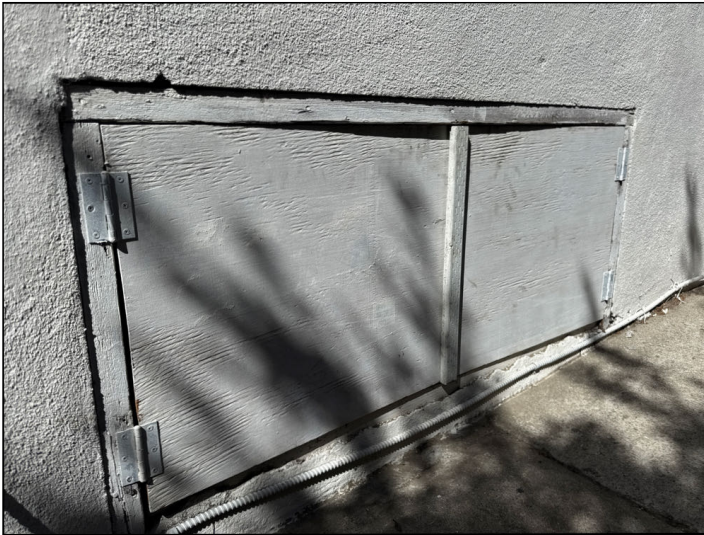
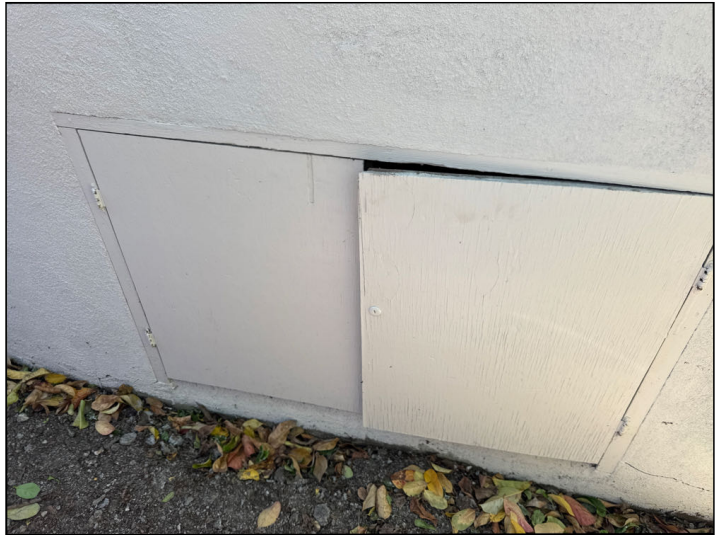
Access panel is functional.

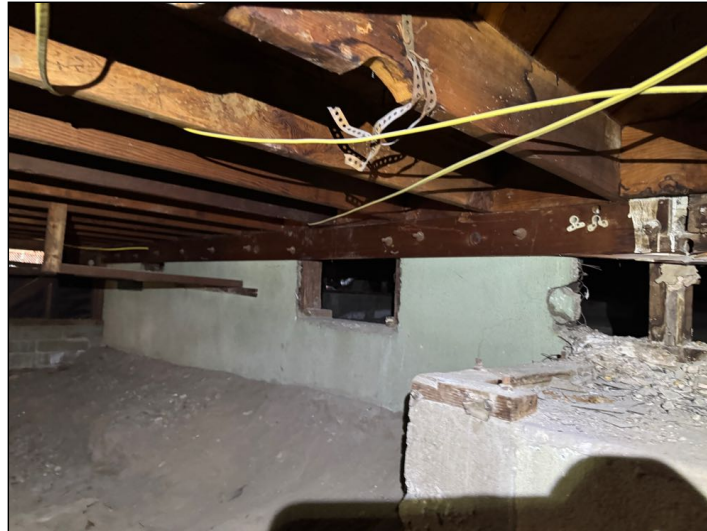
Access panel is not installed. Installation is recommended.

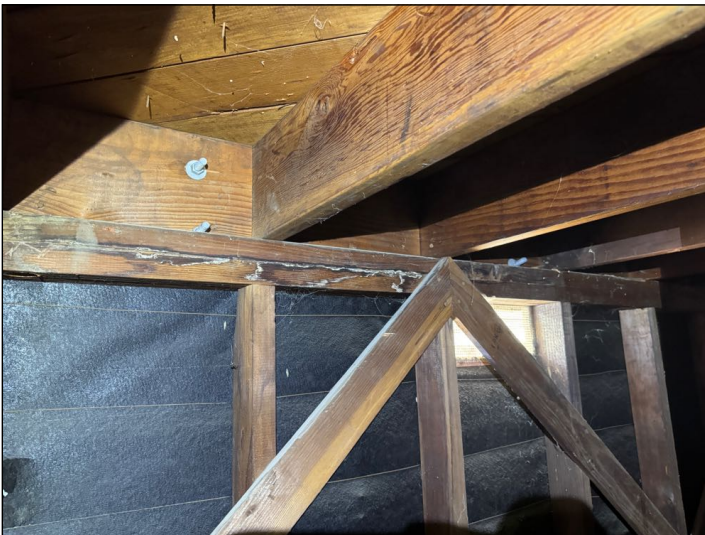
Moisture stains/damage observed at time of inspection.

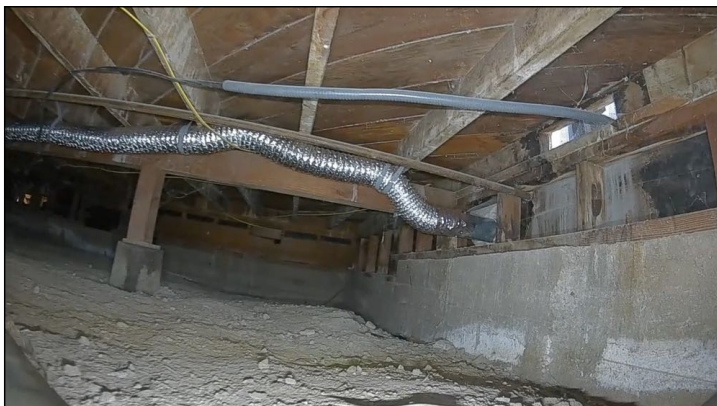
- See photos.
- Moisture stains/damage observed at time of inspection.

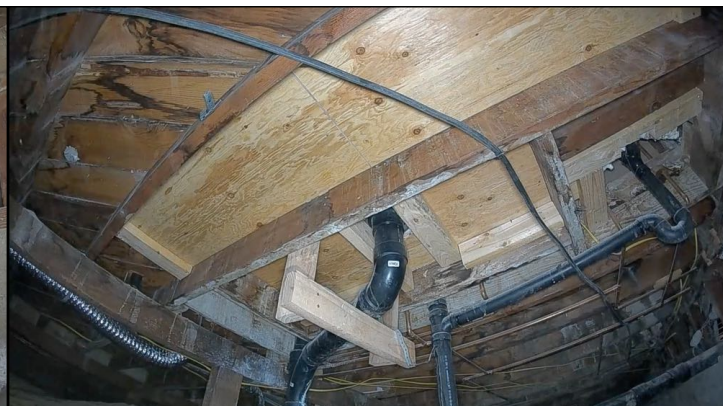
Moisture stains/damage observed at time of inspection.

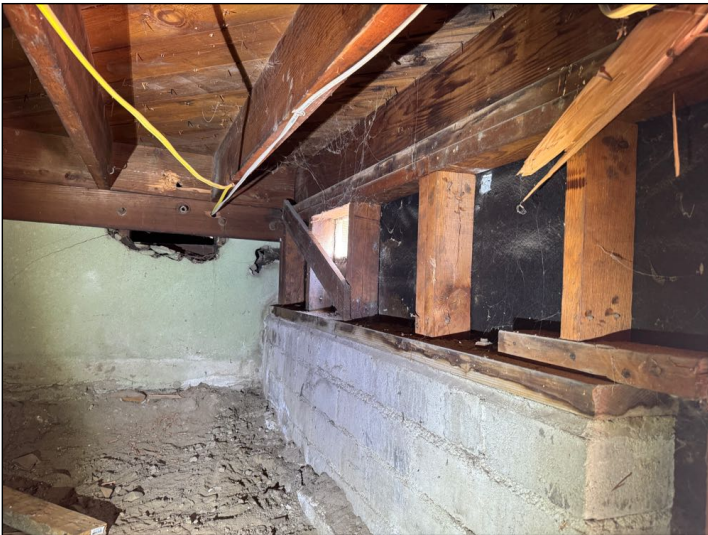
Anchor bolts are installed. Wood frame appears to be bolted to the foundation.

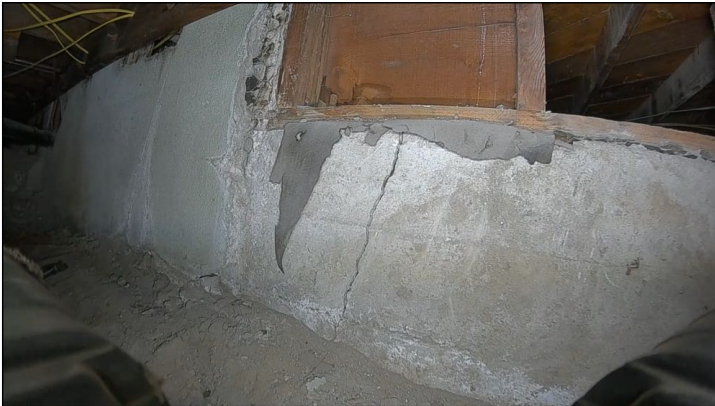
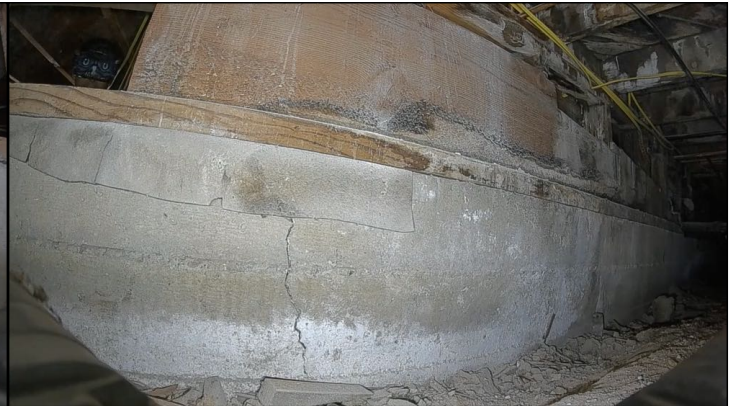
Minor settlement cracks noted on the foundation stem walls at one or more location. Cracks do not appear to be significant at this time.

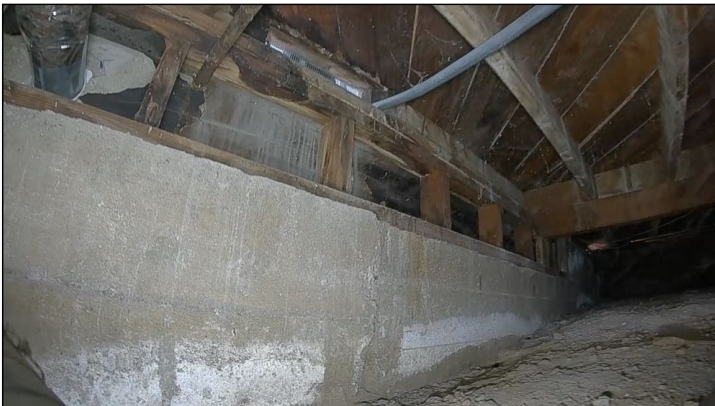
Efflorescence observed on walls indicates the presence of periodic moisture.

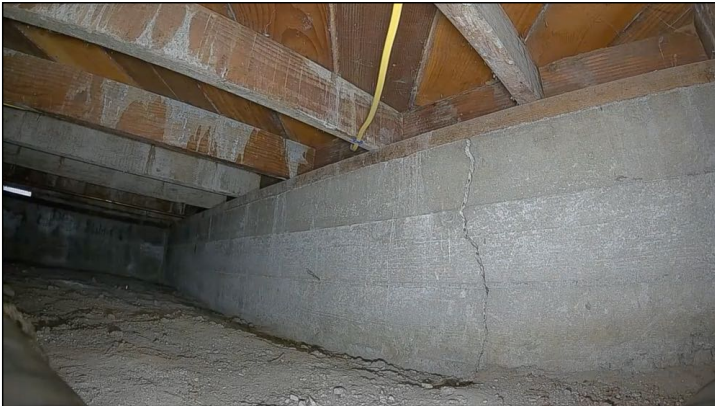
Efflorescence observed on walls indicates the presence of periodic moisture.

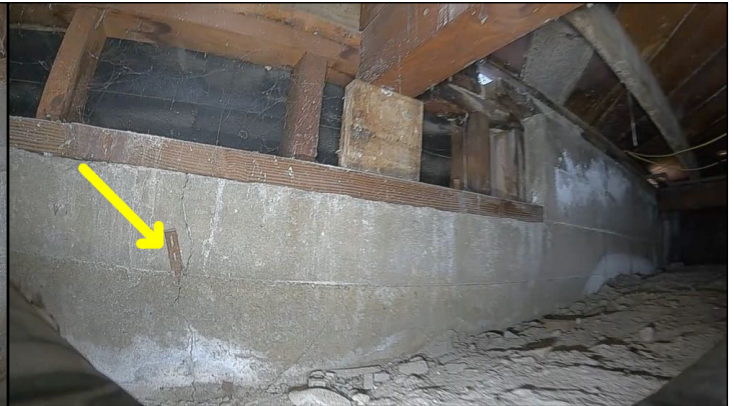
Moderate settlement cracks noted on the foundation stem walls at one or more location. Cracks do not appear to be significant at this time.

- A foundation contractor should be called to make further evaluation and recommendations as needed prior to the close of your transaction.

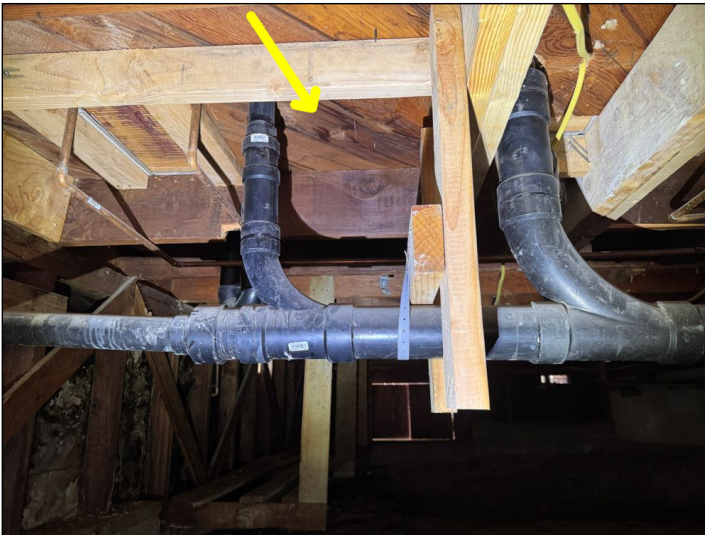
Moisture, rot or termite-like damage noted under the bathroom.

Inspection and repairs by a licensed termite inspector is recommended prior to the close of your transaction.

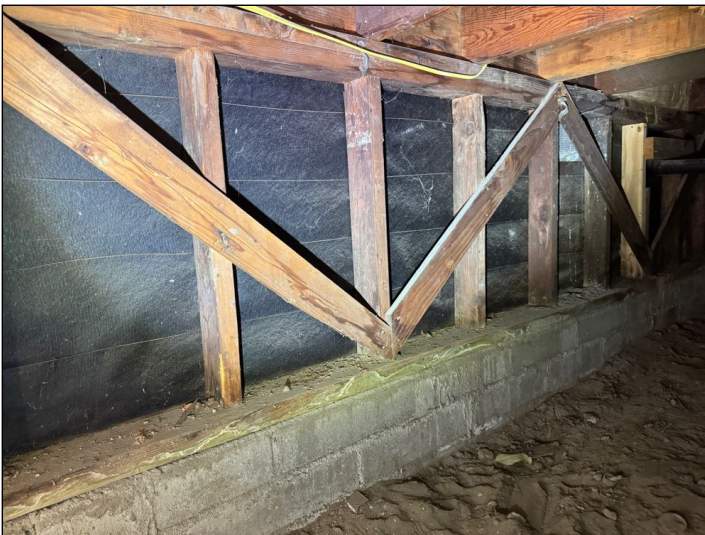
Moisture, rot or termite-like damage noted on the mud sills and or cripple walls.

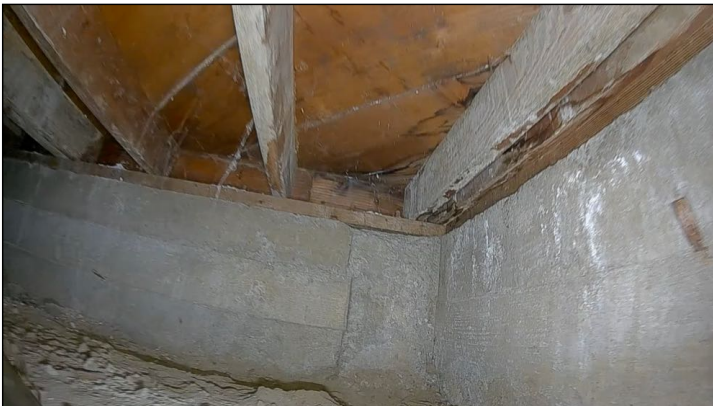
Moisture, rot or termite-like damage noted on the mud sills and or cripple walls.

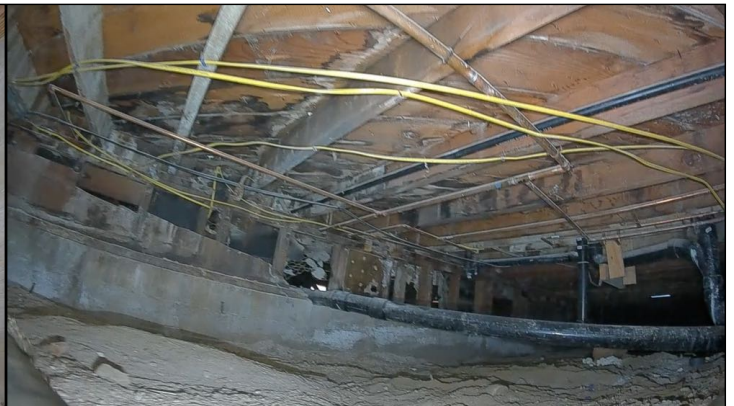
Moisture, rot or termite-like damage noted under the floor joists.

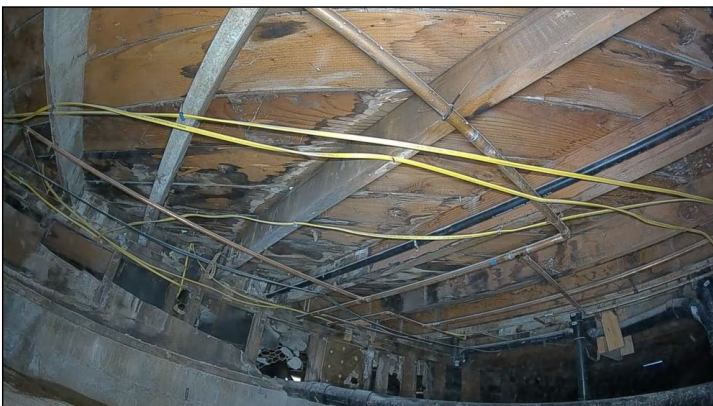
Damage is moderate.

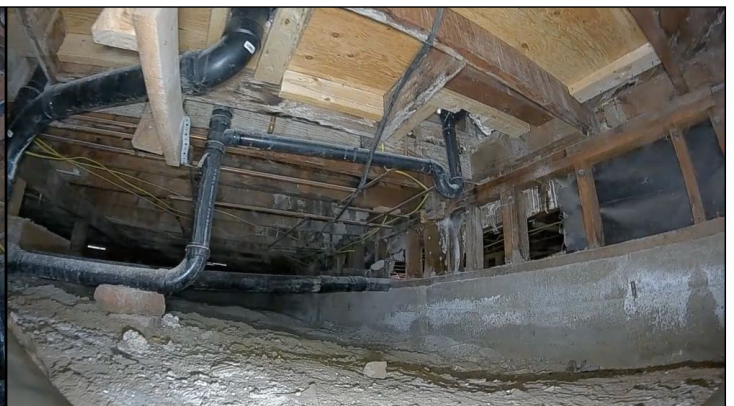
Moisture, rot or termite-like damage noted under the bathroom.

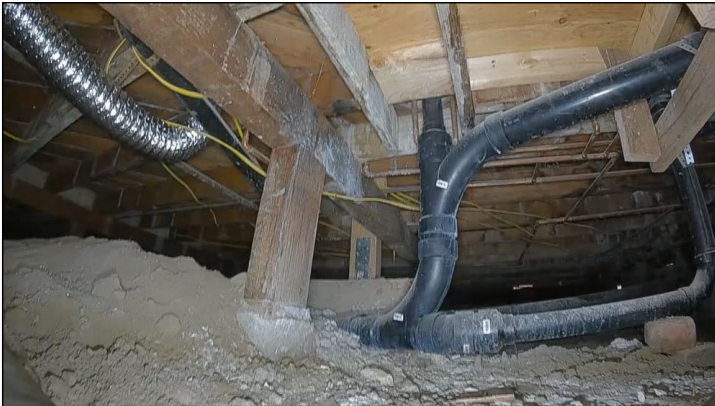
Earth to wood contact at the support posts. This will eventually rot the wood and weaken the floor support. Installation of a concrete pier is recommended.

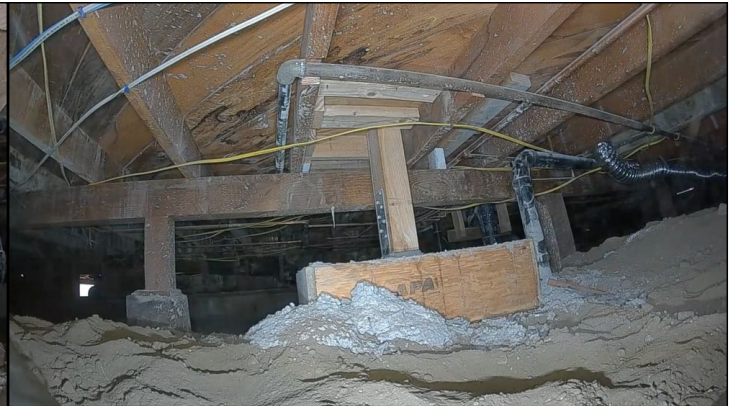
The wood form board used for the concrete pier were not removed when the concrete work was completed. This will attract moisture into the wood and attract wood destroying organisms and insects. Repair or correction by a licensed general contractor is recommended prior to the close of your transaction.

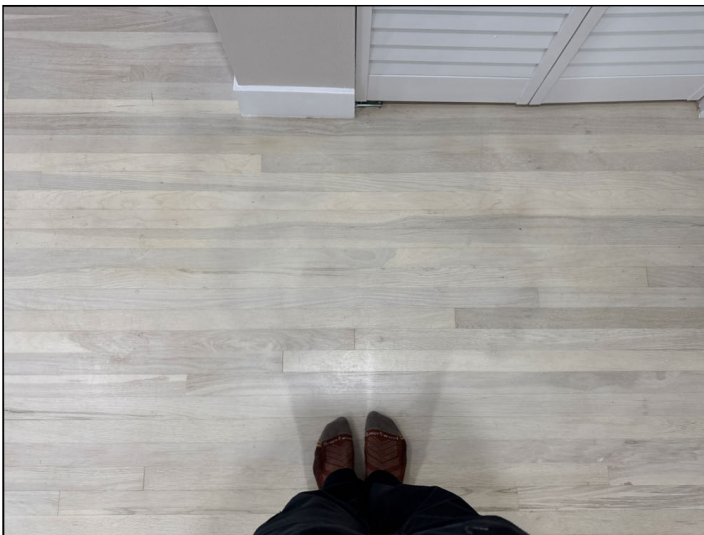
Floor boards are loose and noisy. Repairs are needed.

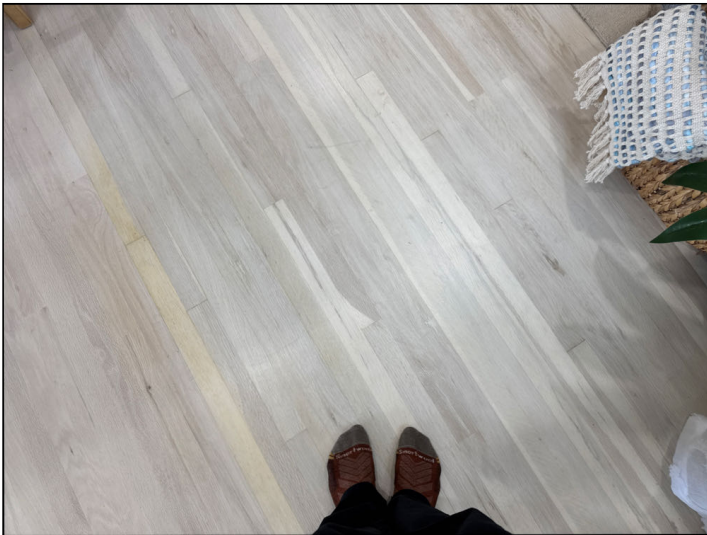
Floor boards are loose and noisy. Repairs are needed.
