PROPERTY INSPECTION REPORT

12345 Your Home Dr., Los Angeles, CA 90039

DATE OF INSPECTION: 3/4/2025

VILLA PROPERTY INSPECTIONS
www.inspectaproperty.com

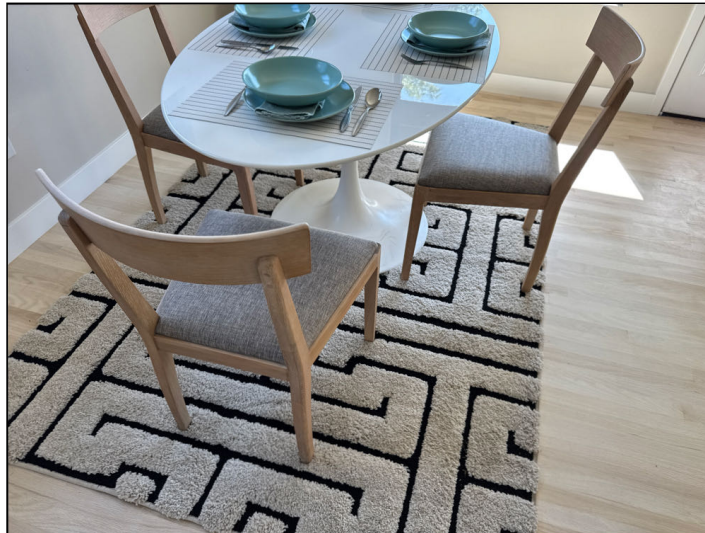
Rugs and floor coverings prevent viewing of primary floor materials.

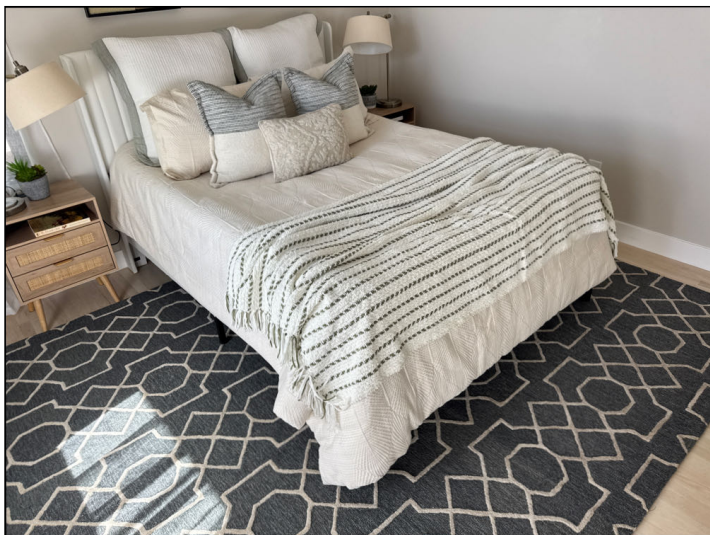
Stored items or furnishings prevent full inspection.

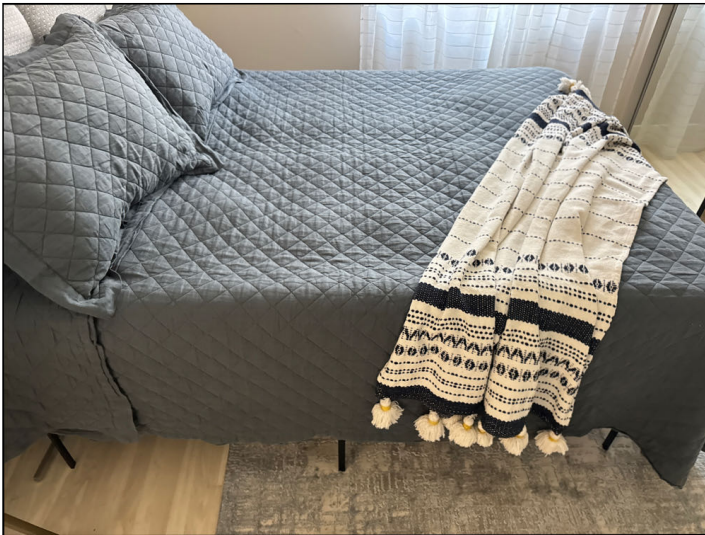
Stored items or furnishings prevent full inspection.

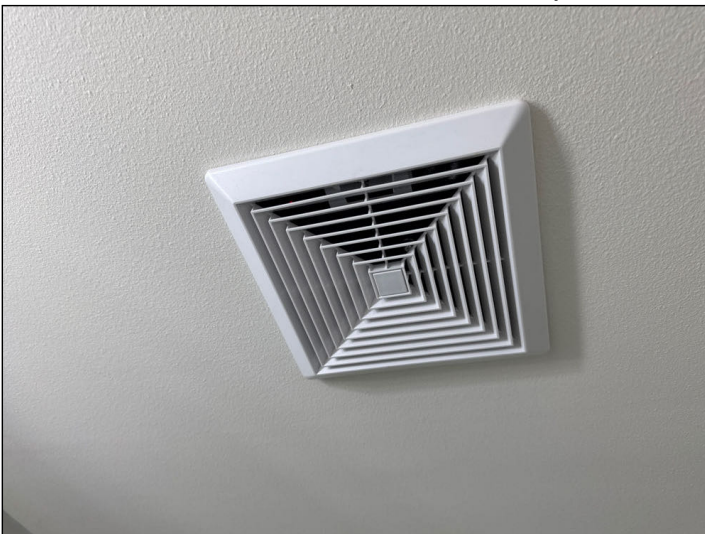
Exhaust fan is functional and or adequate.

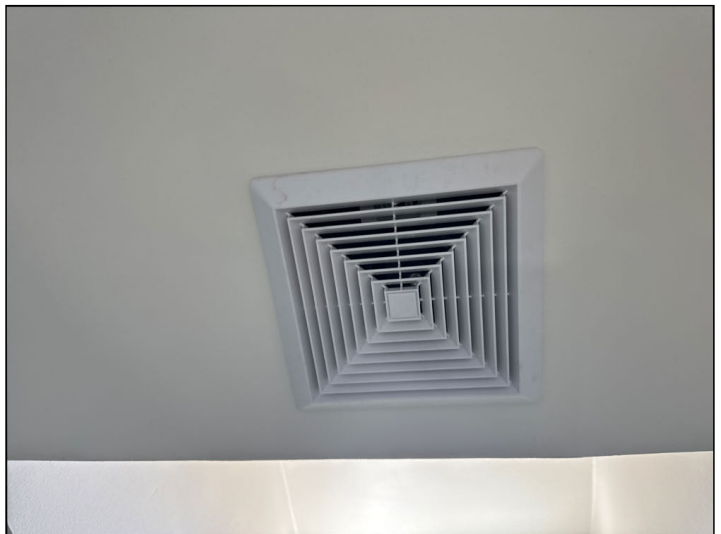
Exhaust fan is functional and or adequate.

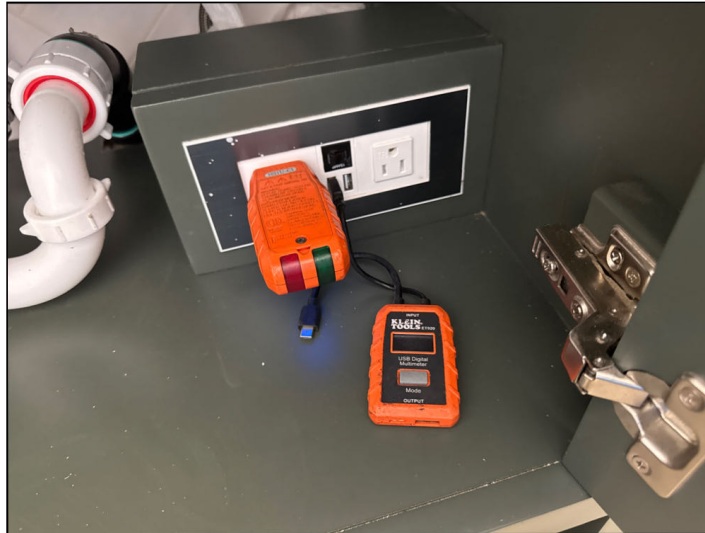
Outlet(s) were not functional at time of inspection. Further evaluation and repairs by a licensed electrical contractor are recommended prior to the close of your transaction.

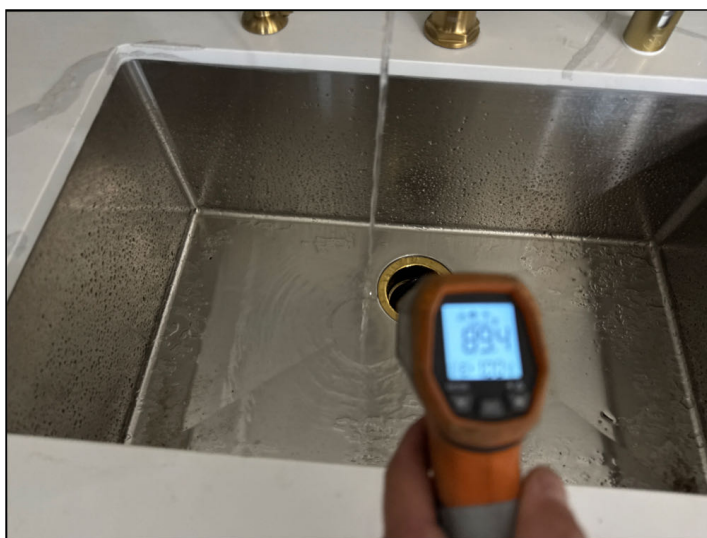
Faucet operated properly at time of inspection.

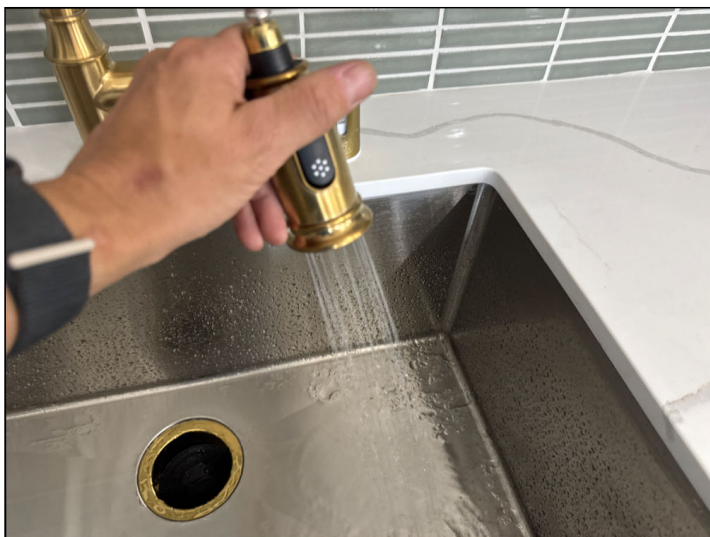
Hand sprayer operated properly at time of inspection.

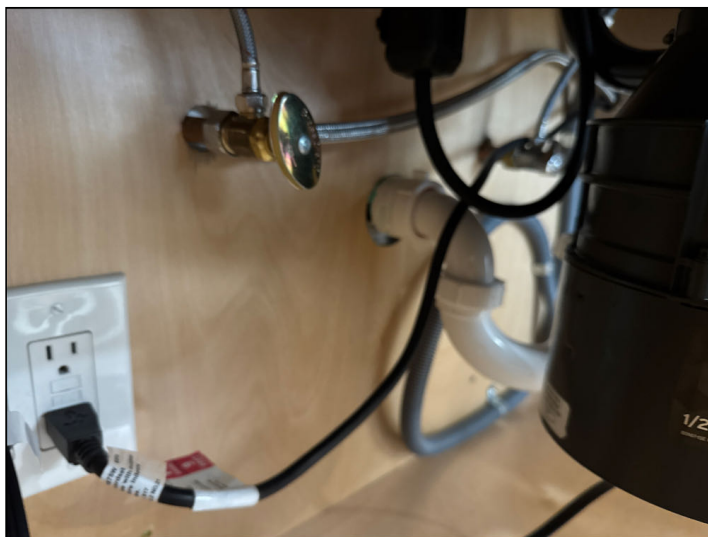
Drain lines under the sink appear functional.

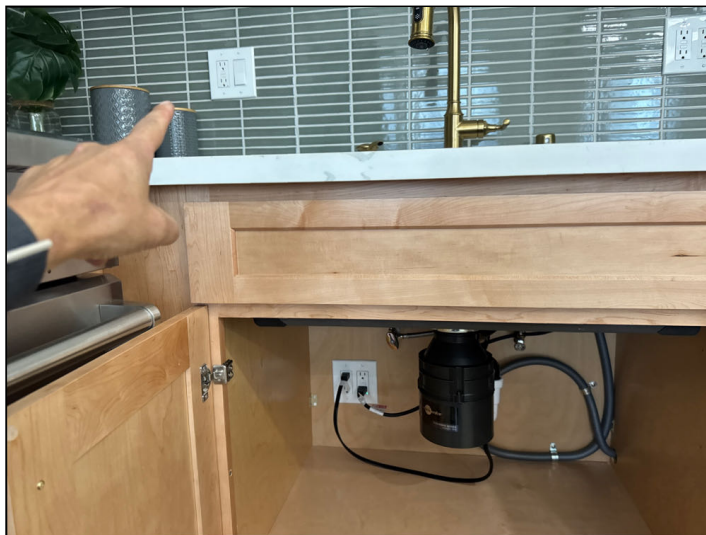
Disposal did not operate at time of inspection. Power was present. Repair or replacement is recommended.

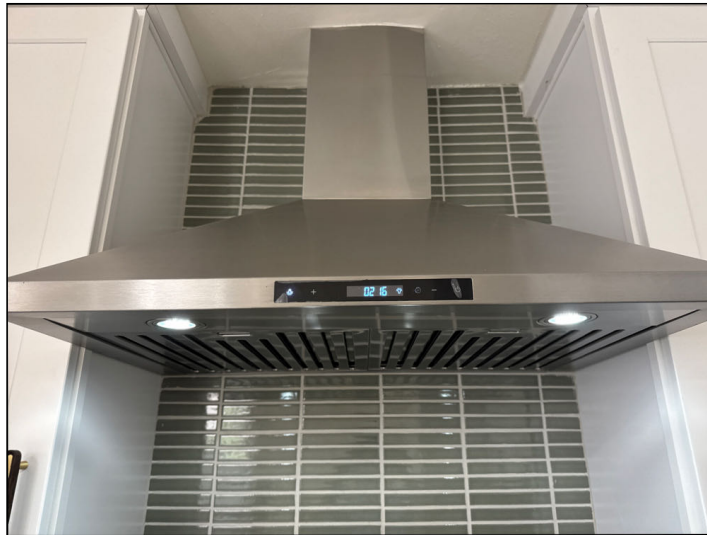
Range fan operated properly at time of inspection.

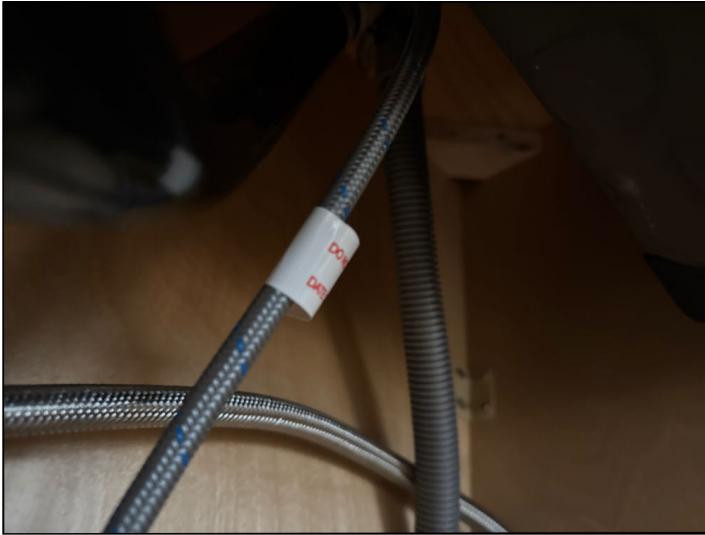
Air gap device or high-loop is present on drain line and proper.

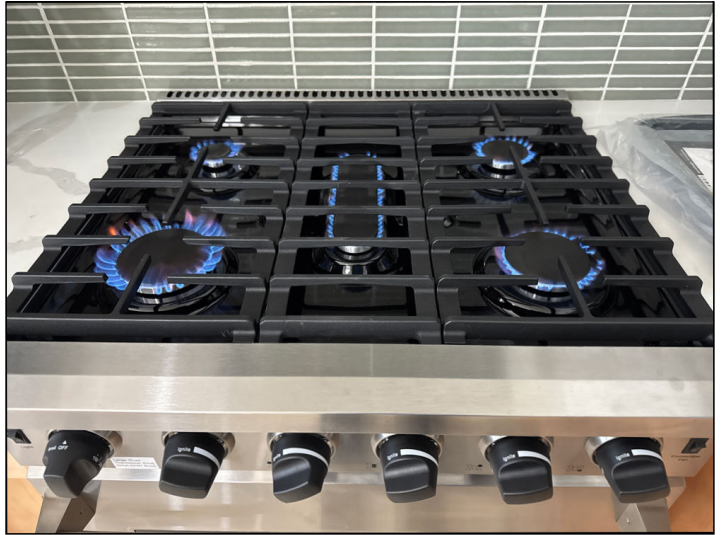
Range operated properly.

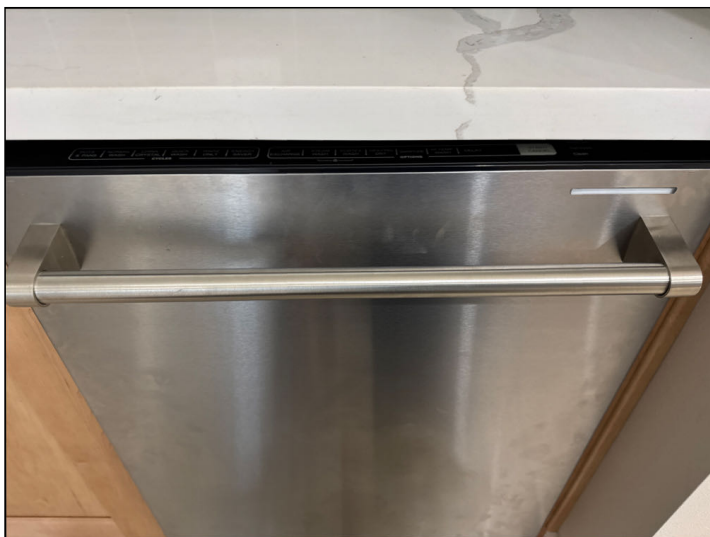
Dishwasher operated properly at time of inspection.

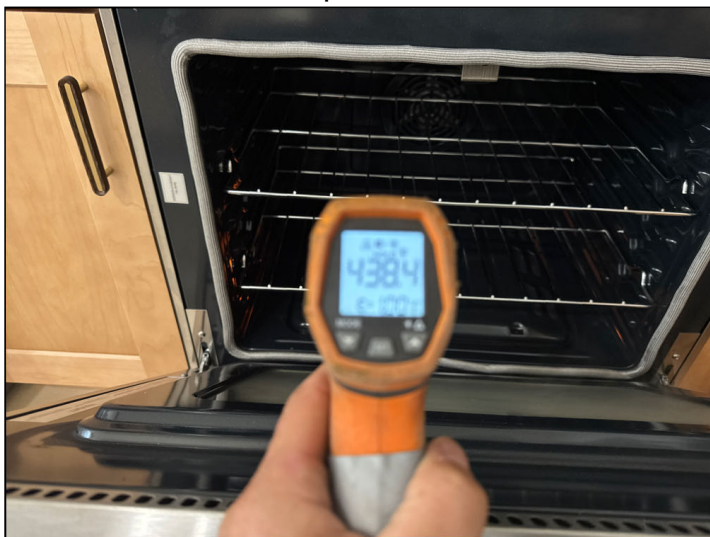
Oven operated properly.

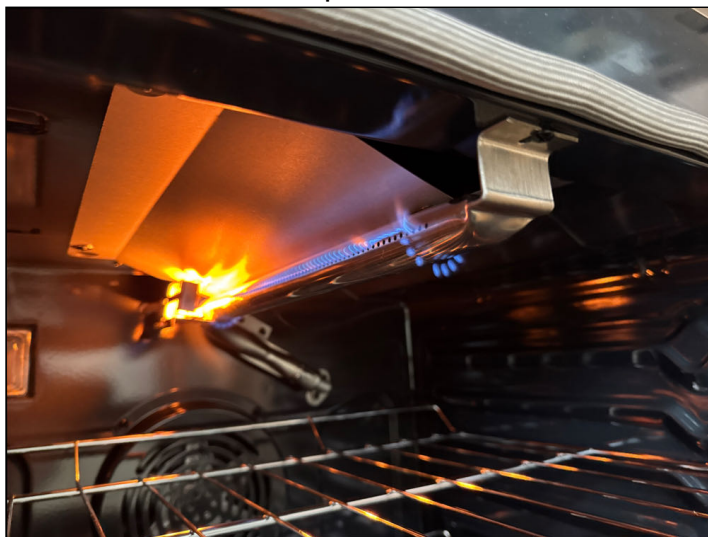
Oven operated properly.

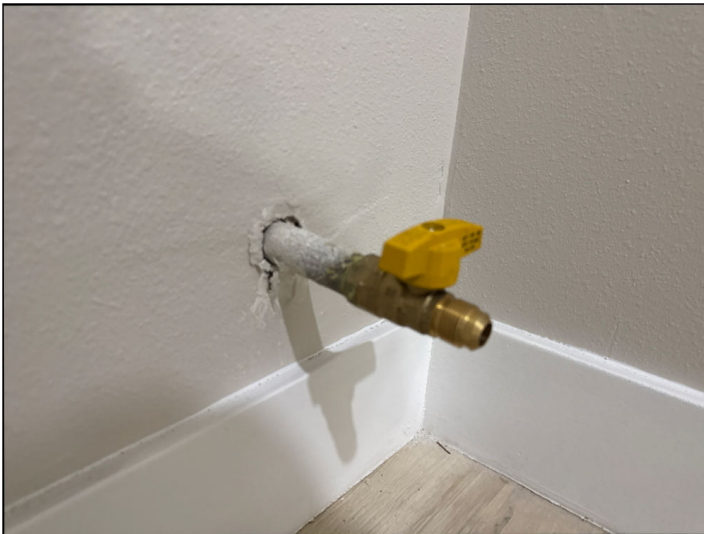
Gas service pipe is provided.

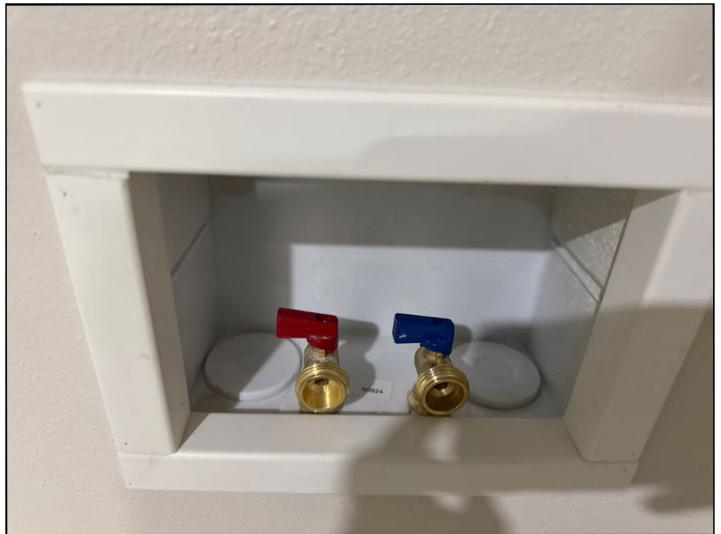
Plumbing appears serviceable.

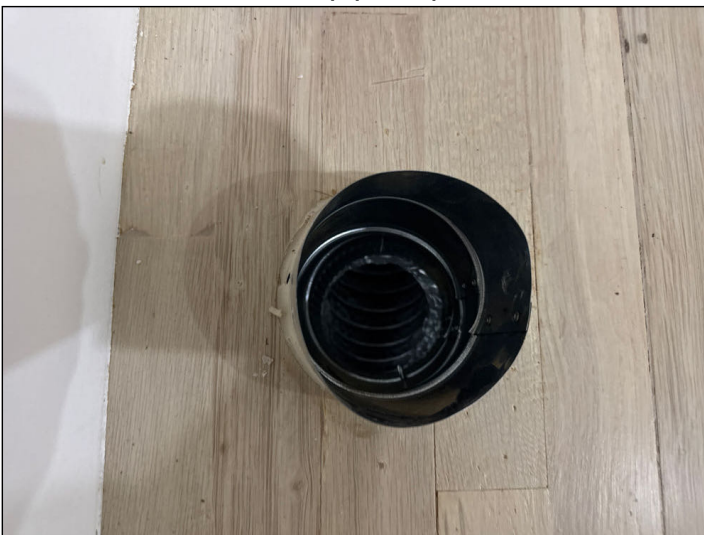
Dryer venting is provided.

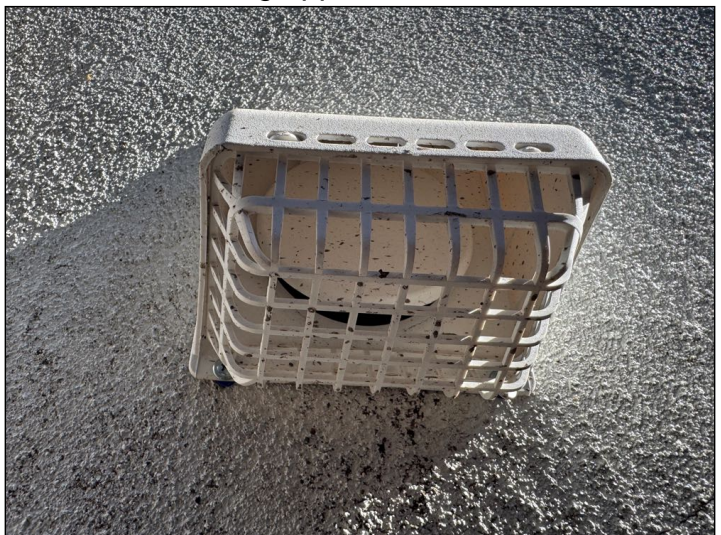
Dryer venting is provided.

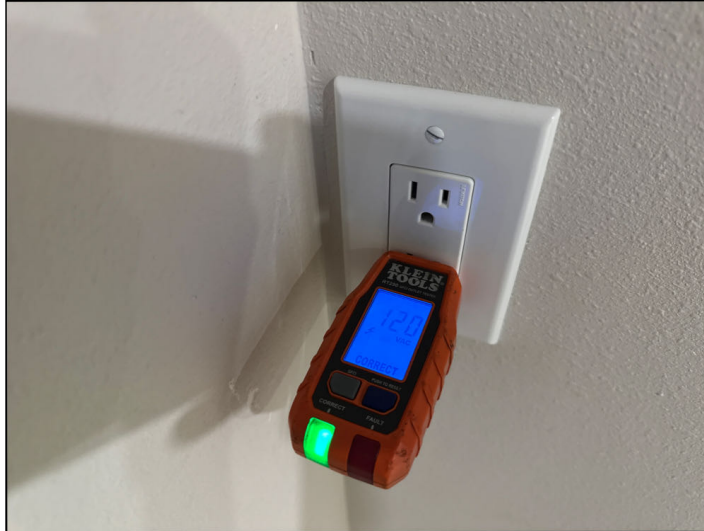
A representative number of outlets, switches and fixtures was operated and found to be in operable condition at time of inspection.

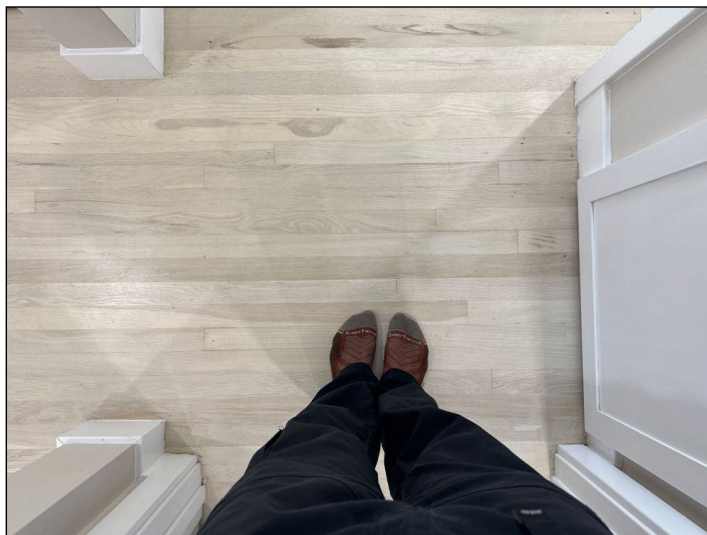
Floor boards are loose and noisy. Repairs are needed.

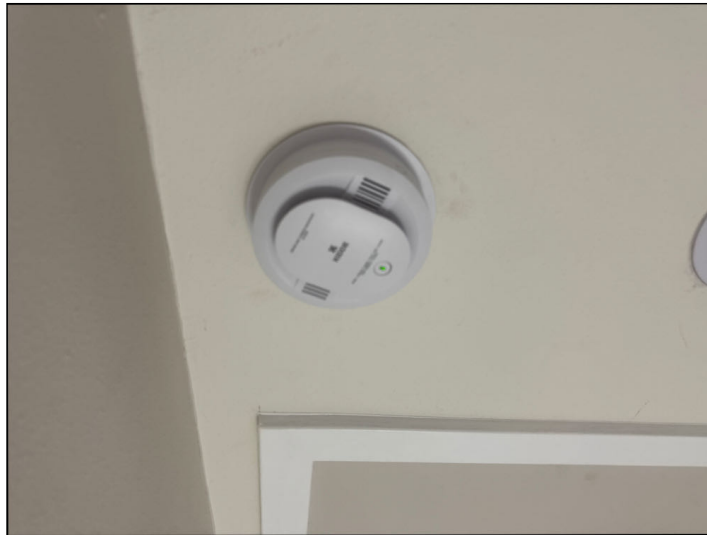
Carbon Monoxide alarm was installed at time of inspection.

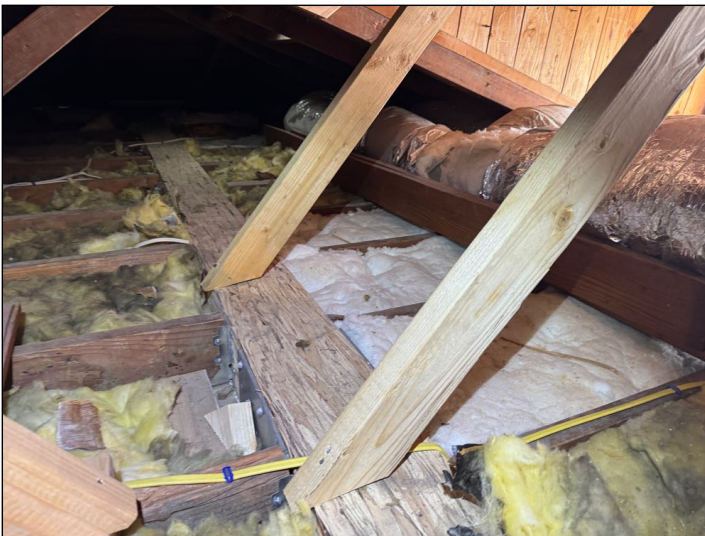
No visible structural problems noted at time of inspection.

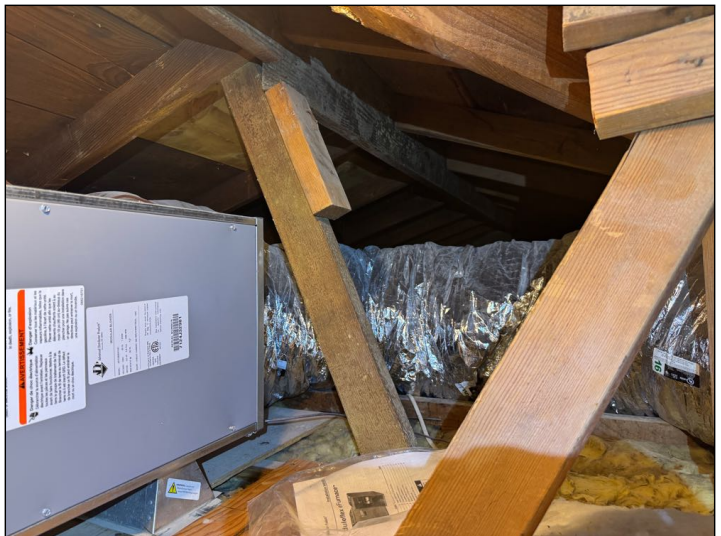
No visible structural problems noted at time of inspection.

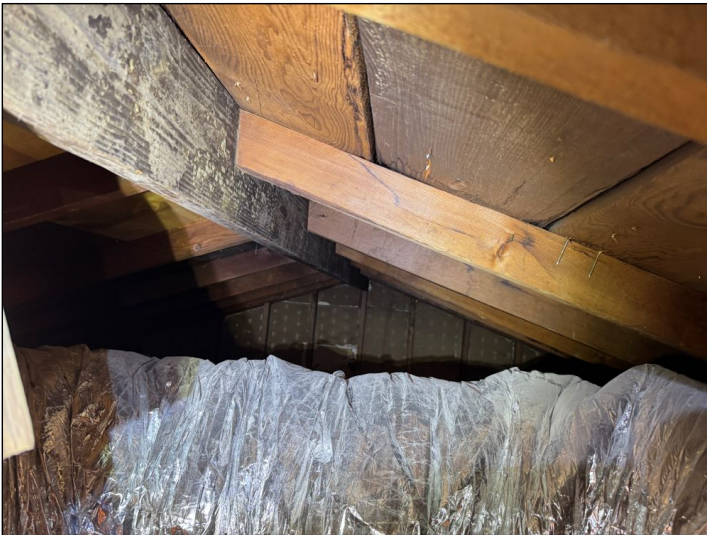
No visible structural problems noted at time of inspection.

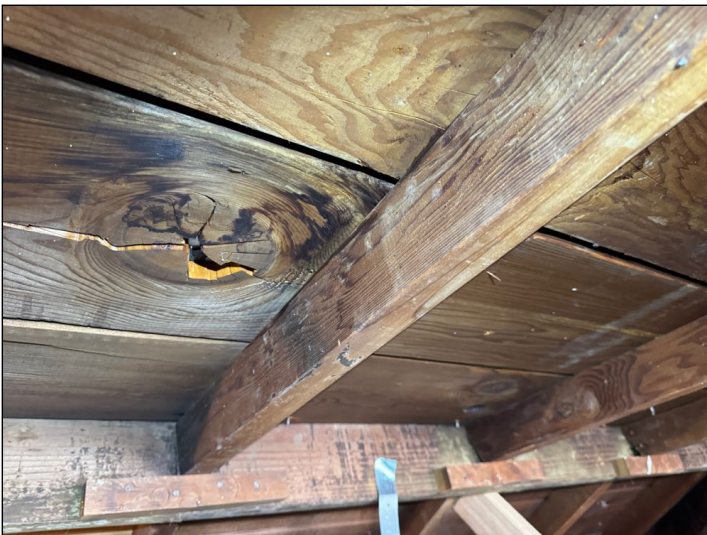
Minor staining was noted on the wood surfaces in the attic, indicating a possible roof leak.

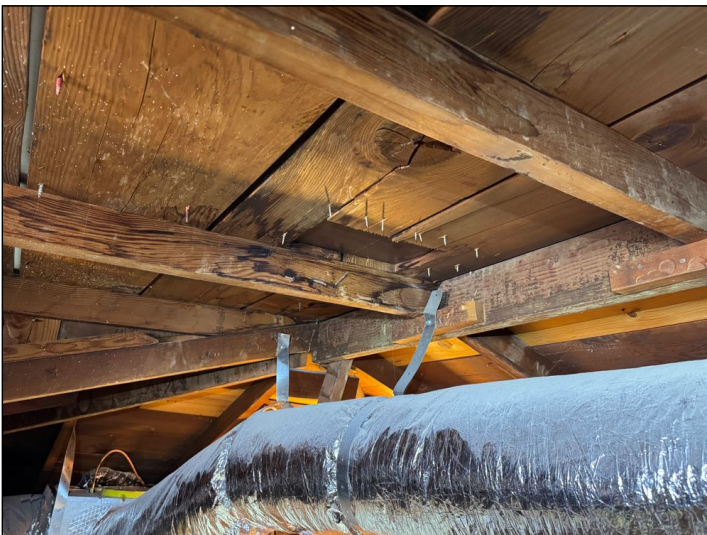
Unable to determine the status of the stains.
Active leakage may be present.

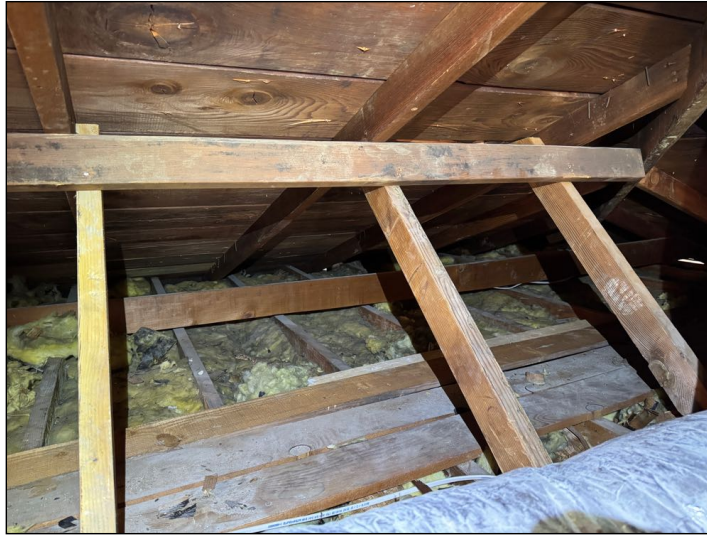
Insulation is somewhat compacted and the true R-factor at this point in time may be substantially less than that originally installed. Installation of additional insulation is recommended.
