PROPERTY INSPECTION REPORT

12345 Main St, Los Angeles, CA 9100

DATE OF INSPECTION: 11/20/2022

VILLA HOME INSPECTIONS

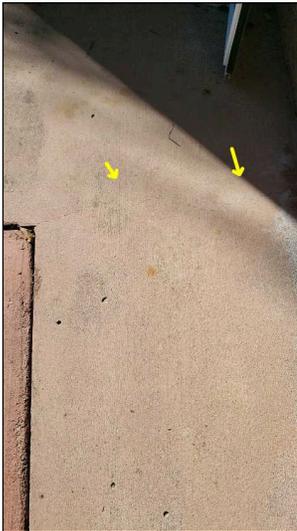
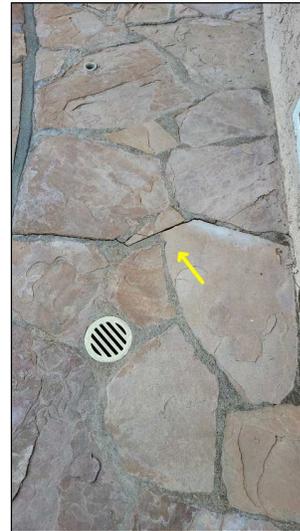
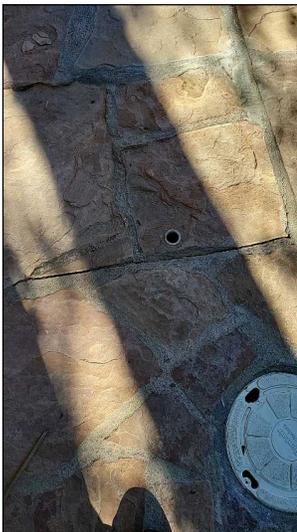
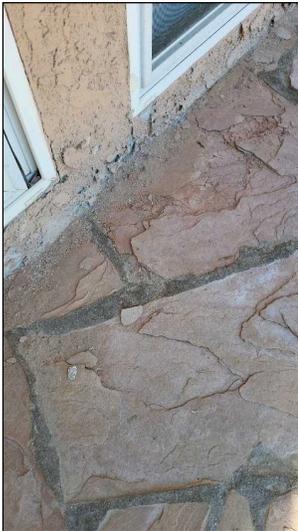
1. Driveway and Walkway Condition

- Walkway is damaged or broken. This may pose a trip hazard. Repair or replacement is recommended.
- Portions of the walkway are missing. Repair or replacement is recommended.
- See photo.

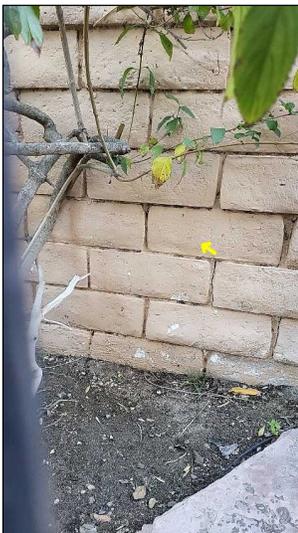
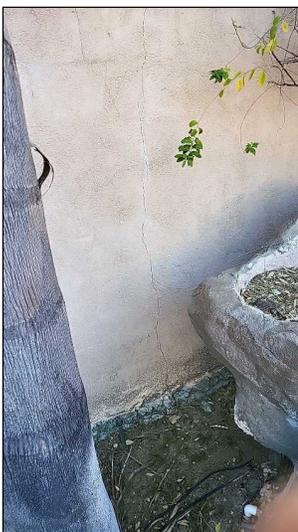
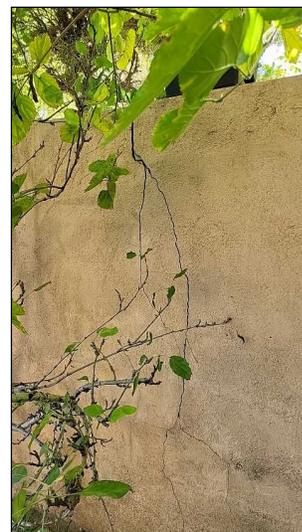
2. Fence & Walls Condition

- Moderate cracks noted on the block wall.

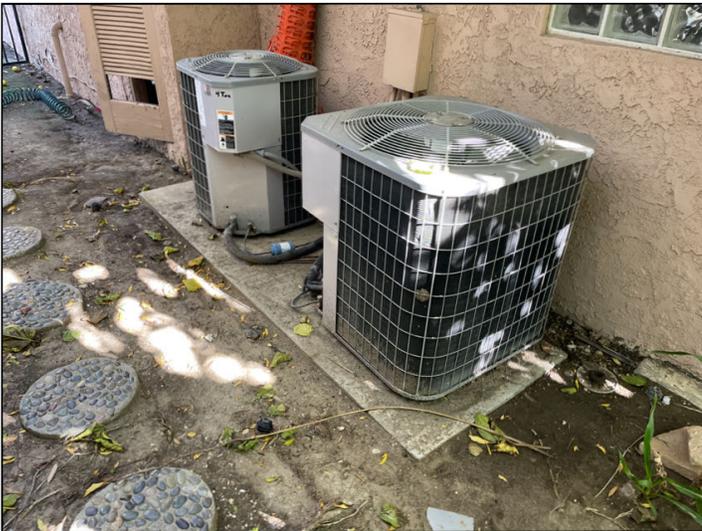
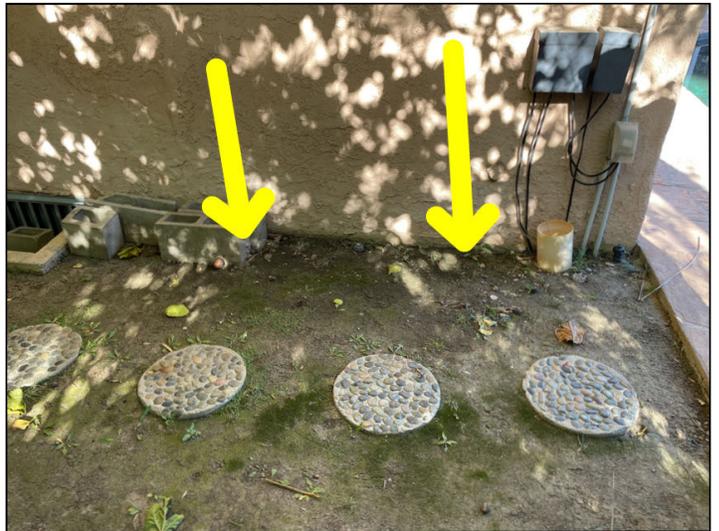
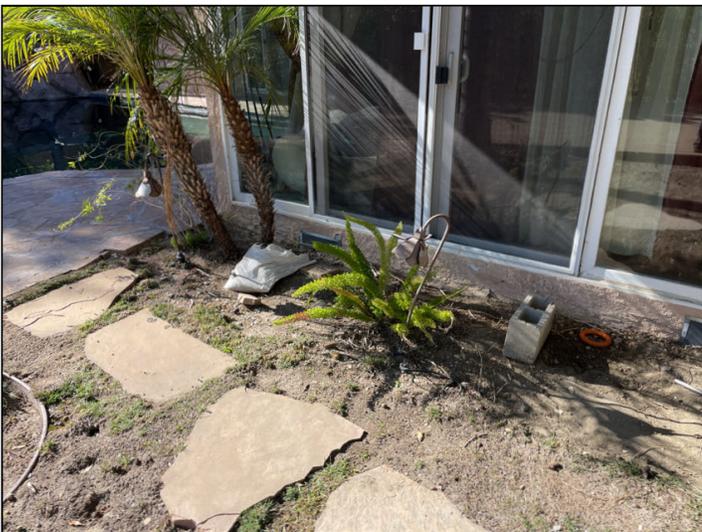
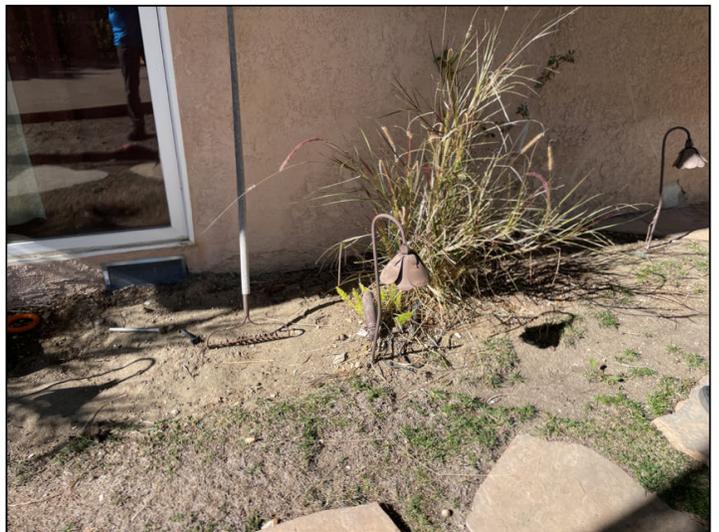
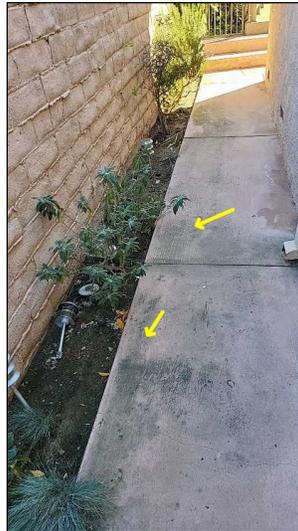
3. Grading & Site Drainage

- Signs of poor drainage observed at the West side of the property.
- Evidence of pooling water was observed at time of inspection.
- Planter areas near the house do not have a drainage system installed and retain water when it rains. This excess moisture, near the foundation of the house, can cause damage. Installation of a drainage system is recommended.
- See photos.

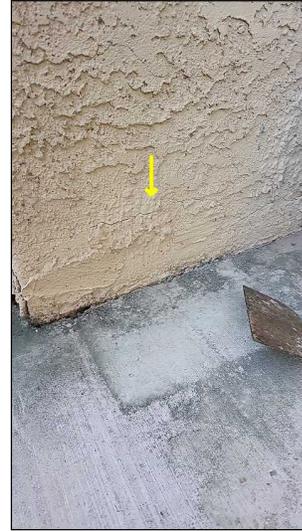
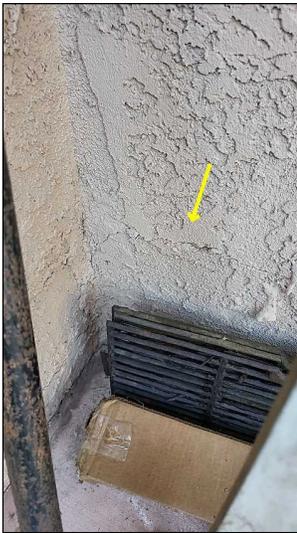
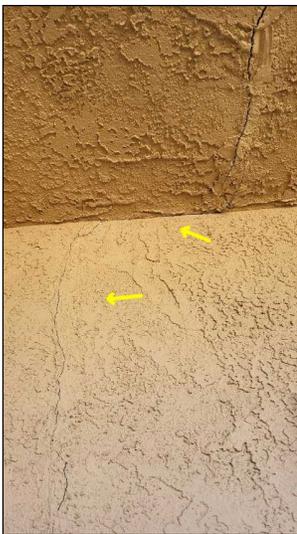
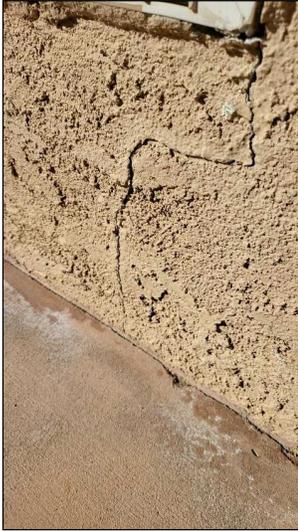
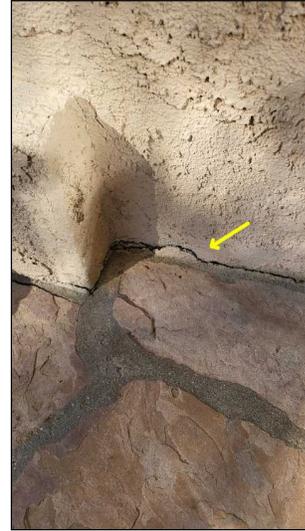
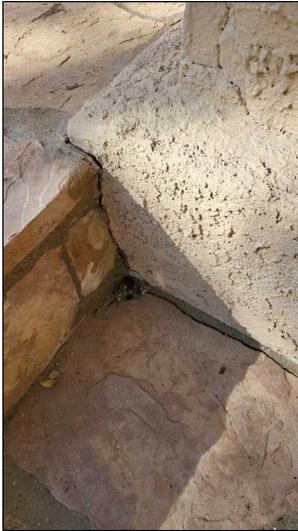
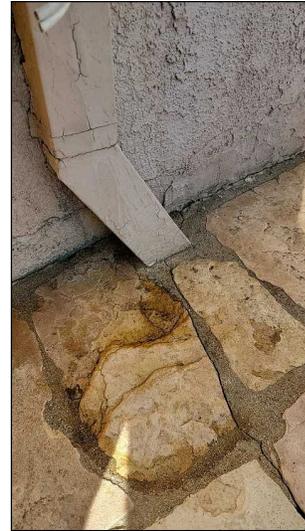
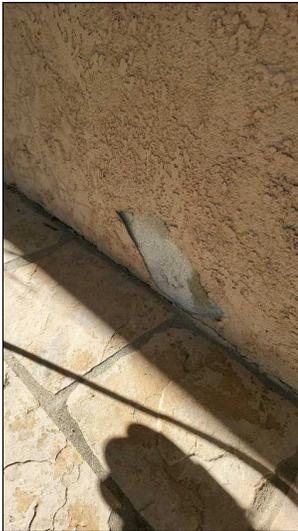
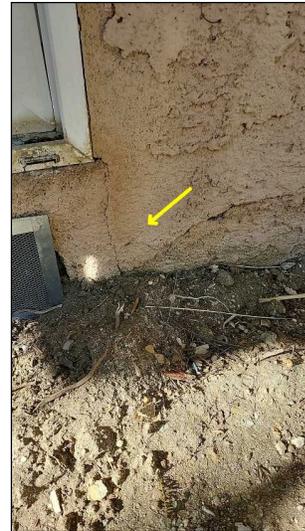
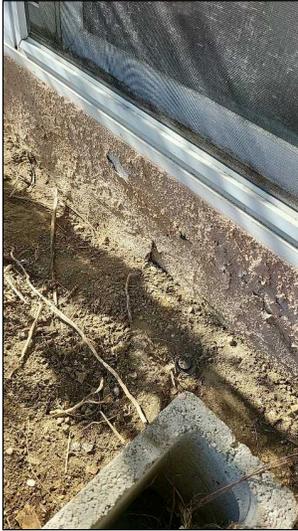
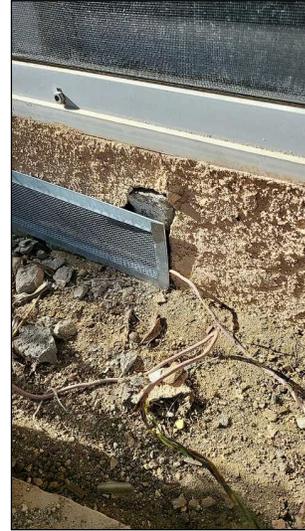
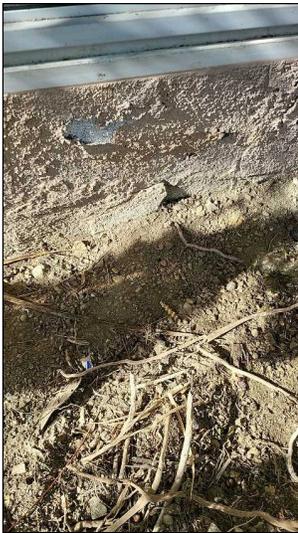
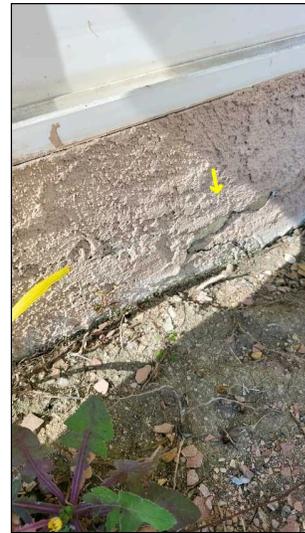
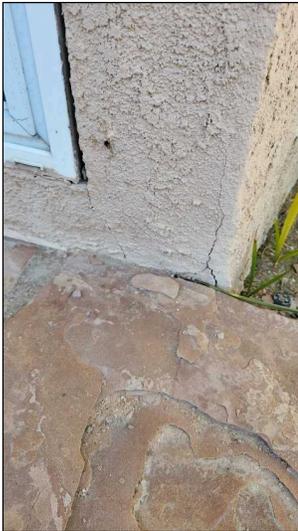
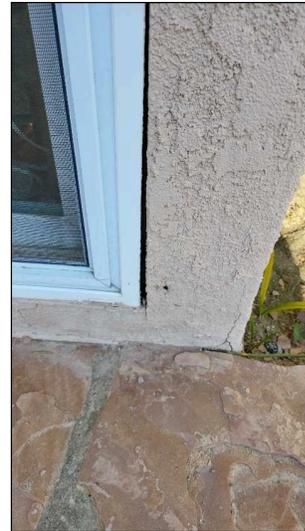
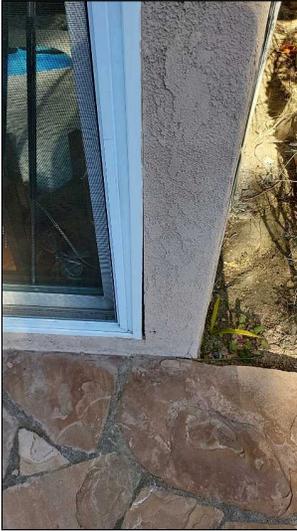
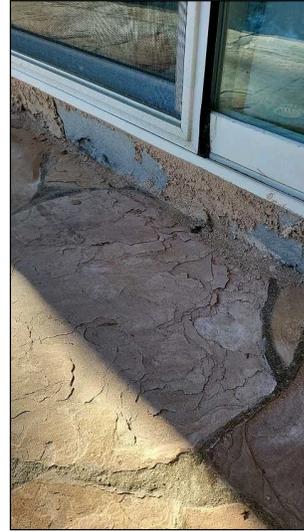
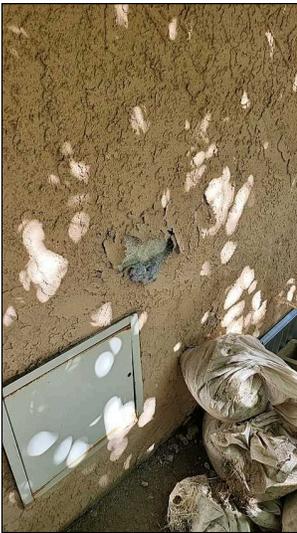
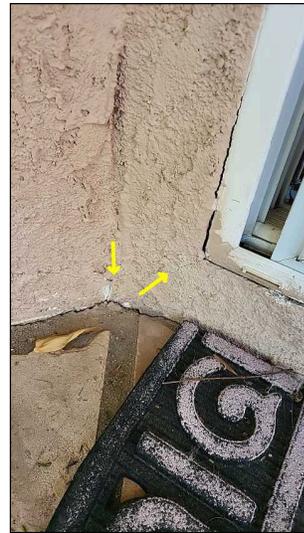
4. Exterior Wall Condition

- Cracks noted are moderate and may indicate foundation movement due to seismic activity or settlement.
- Cracks were noted on the walls.
- Paint finish is deteriorated or flaking. Repainting is recommended to prevent moisture damaged.
- Evidence of continual splashing was observed on the walls, due to lack of roof gutters. Over time, this may cause moisture damage and penetration.
- See photos.

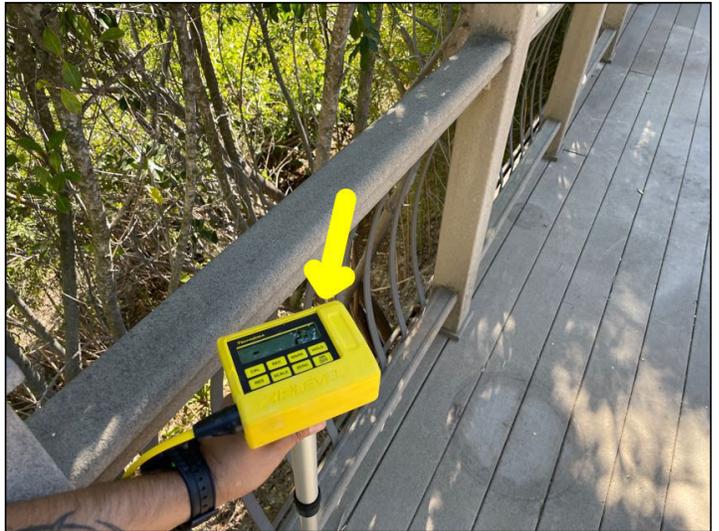
Significant settlement within a 10 foot span.

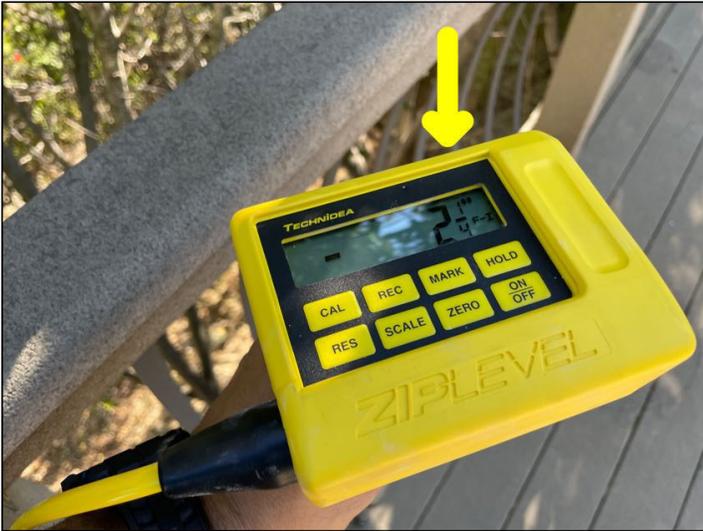
Significant settlement within a 10 foot span.

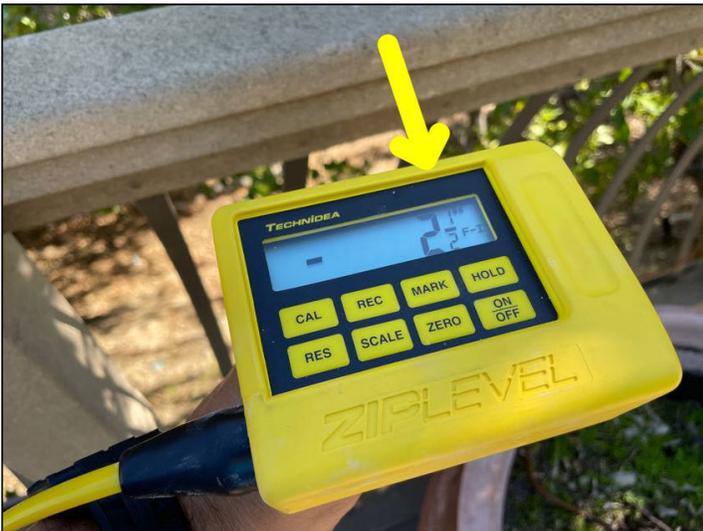
Significant settlement within a 10 foot span.

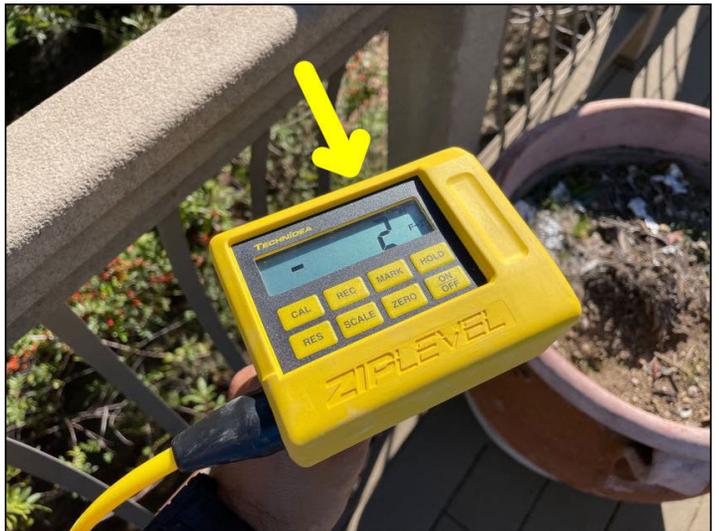
Significant settlement within a 10 foot span.

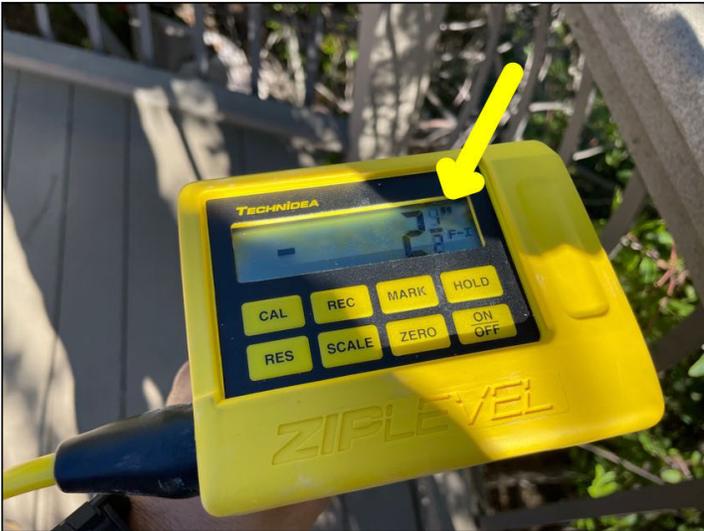
Significant settlement within a 10 foot span.

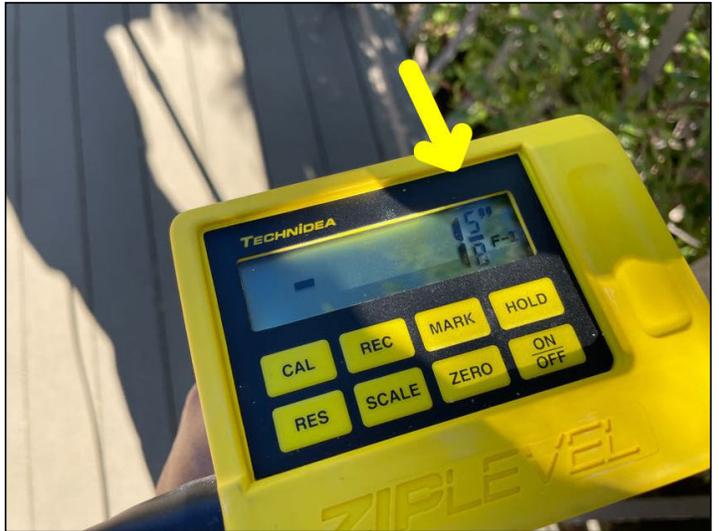
Significant settlement within a 10 foot span.

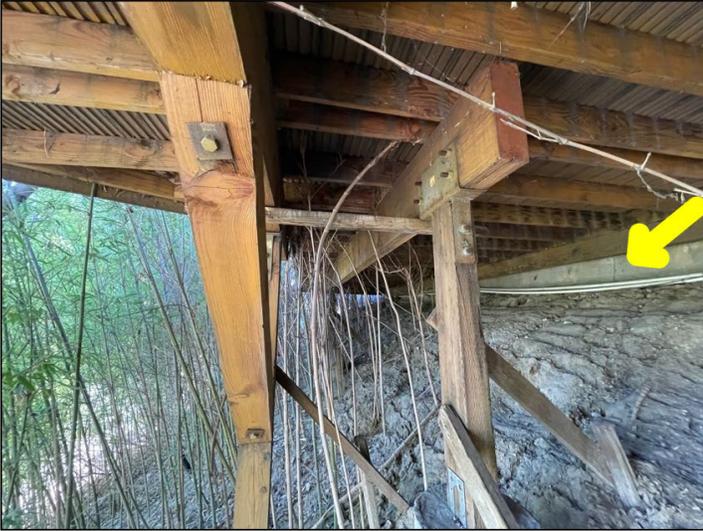
South deck not extended

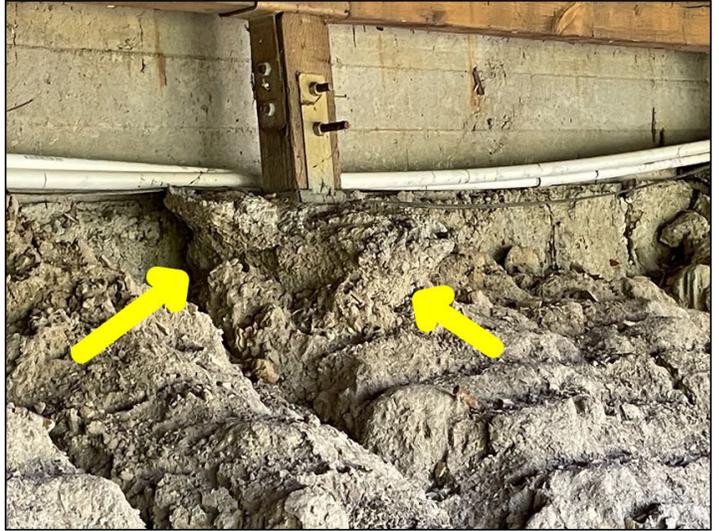
- 8) Soil has eroded significantly under the several concrete piers. One pier and post are visibly leaning.
- 9) Structural beams are inadequately secured to the concrete base and are only secured to the adjacent beam with a metal strap.

Significant soil erosion under concrete pier supporting the deck

Further evaluation by a licensed structural engineer is recommend.

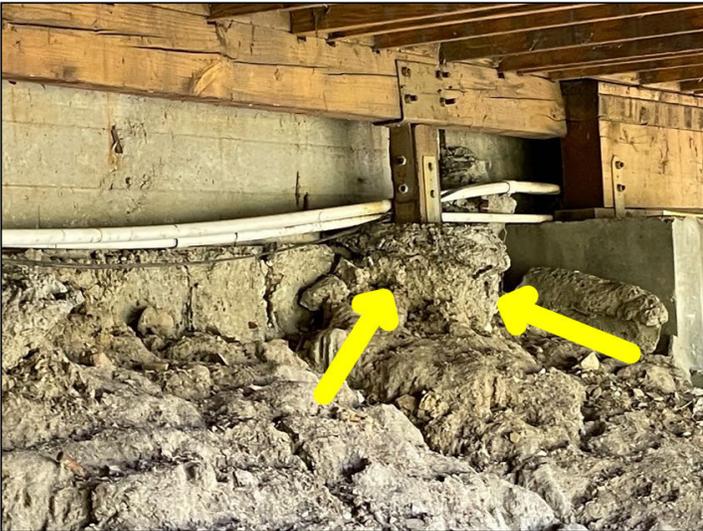
Significant soil erosion under concrete pier supporting the deck

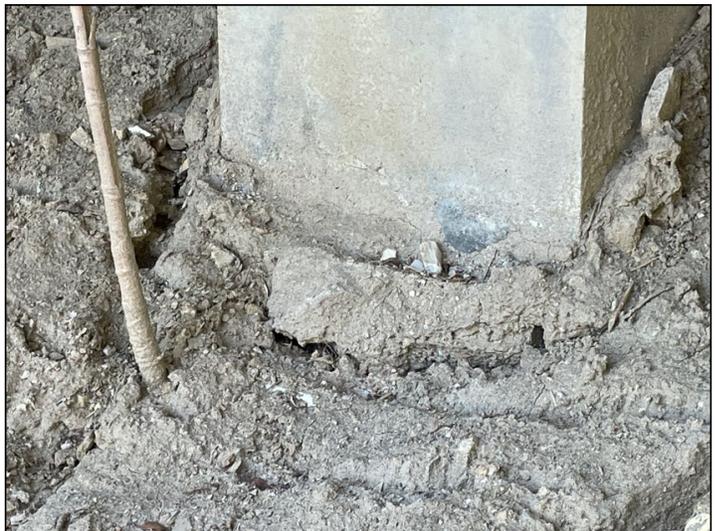
Significant soil erosion under the deck at the supports.

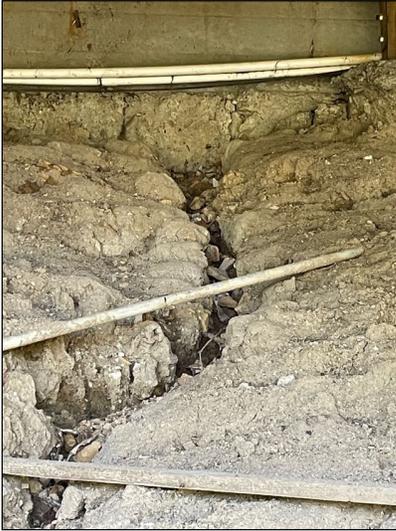
Significant soil erosion under the deck at the supports.

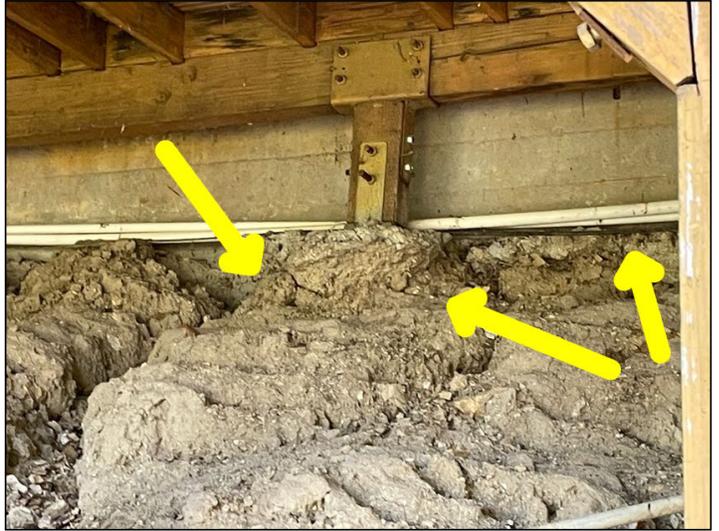
Significant soil erosion under the deck at the supports.

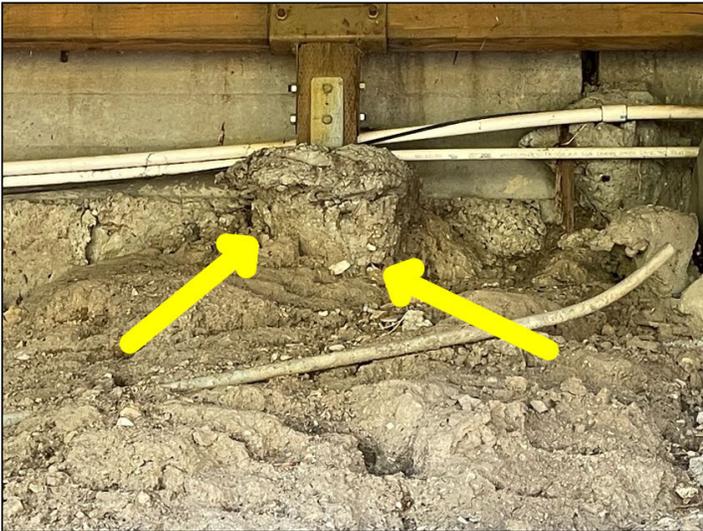
Significant soil erosion under the deck at the supports.

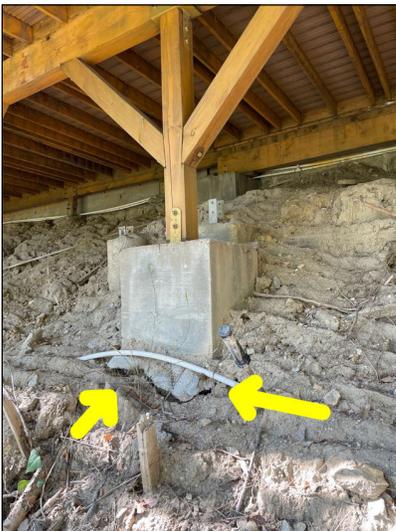
Significant soil erosion under the deck at the supports.

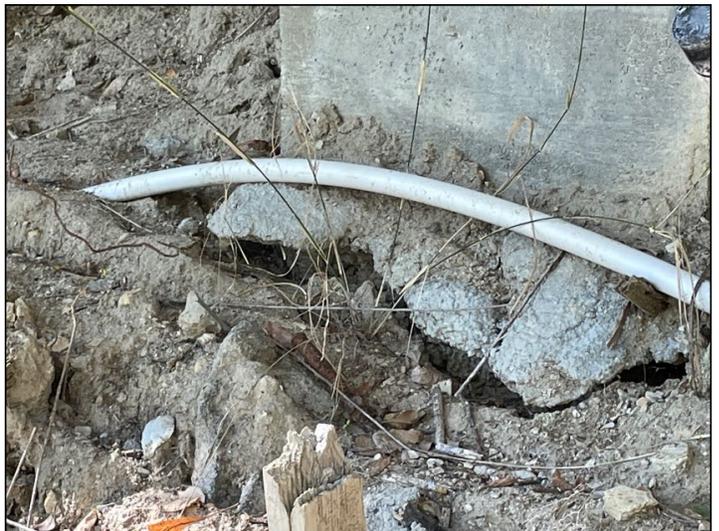
Significant soil erosion under the deck at the supports.

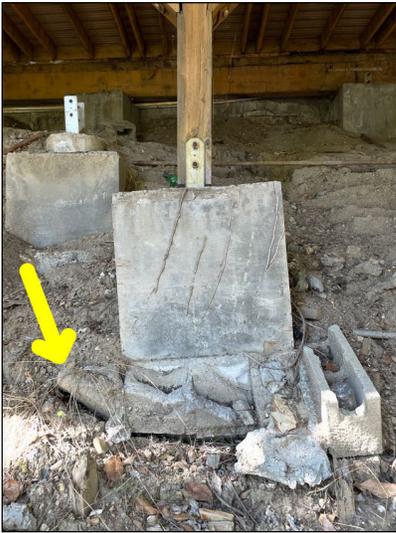
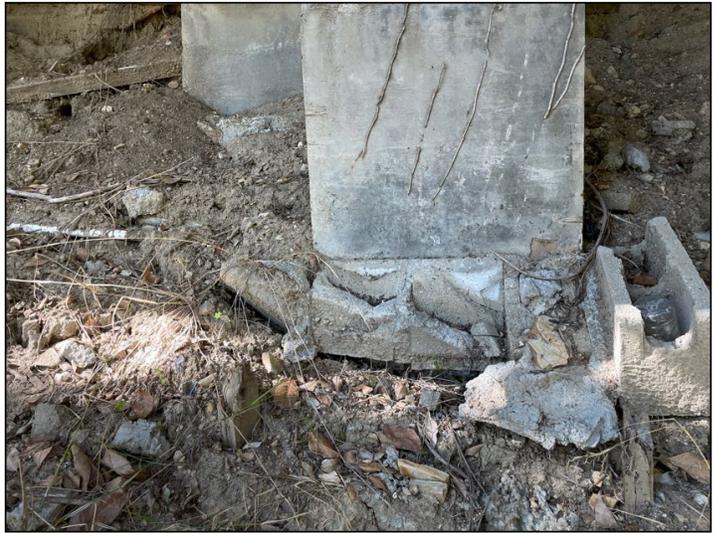
Significant soil erosion under the deck at the supports. Support is visibly leaning.

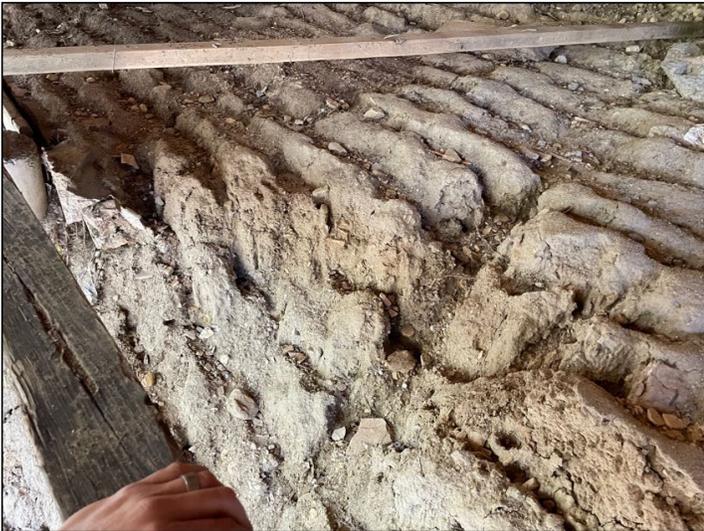
- 7) Significant soil erosion was observed on the east hillside, under the deck. Wooden boards have been installed under the deck to prevent soil erosion. However, these measures are grossly inadequate and the boards have collapsed. Erosion is likely caused by the lack of vegetation cover.

Significant soil erosion

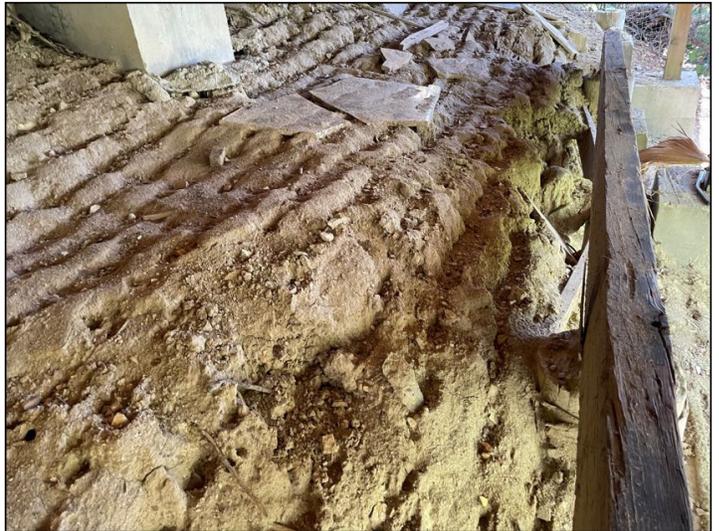
Significant soil erosion

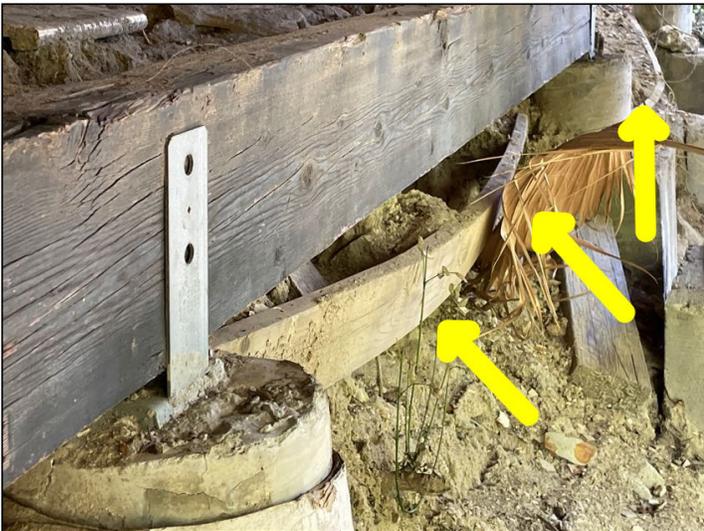
Soil erosion prevention boards collapsed.

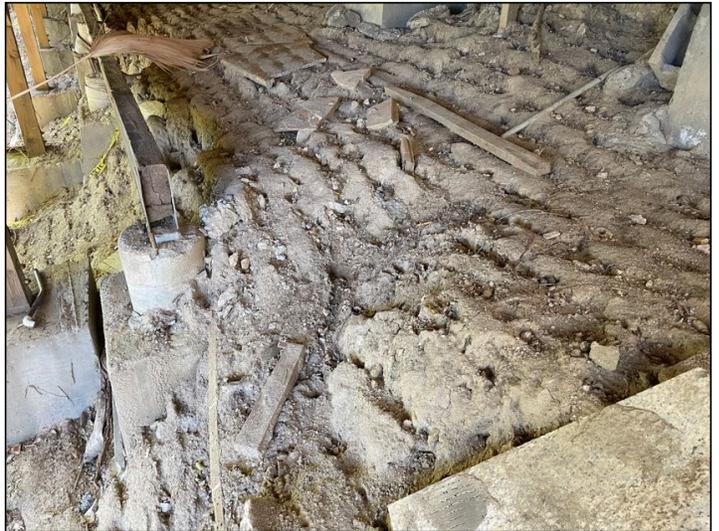
Significant soil erosion

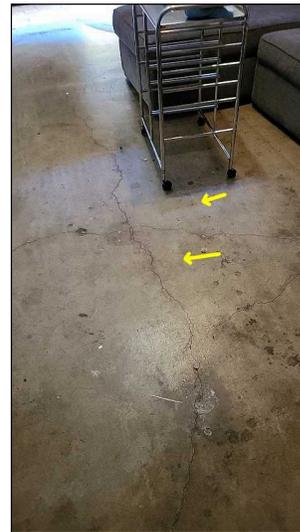
- Moderate cracks noted on the floor at time of inspection.
- Minor settlement of the floor was noted at time of inspection.
- See photos.

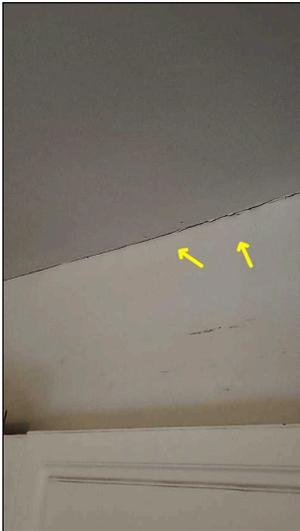
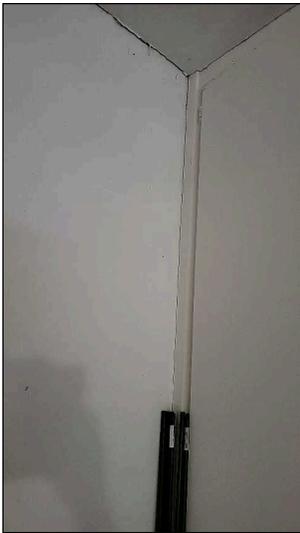
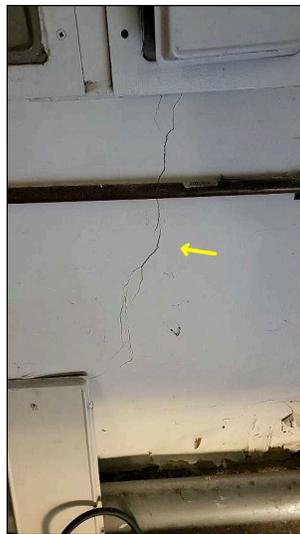
2. Walls & Ceiling

- Walls have been covered with drywall.
- Cracks are moderate. Periodic monitoring is recommended.
- See photos.

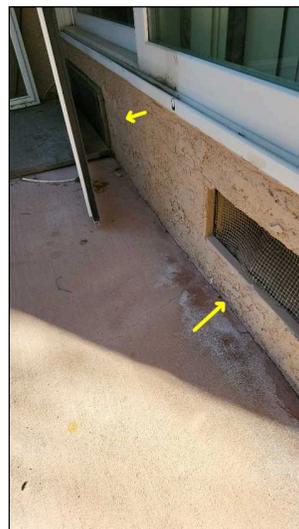
- It should be mentioned that at least one of the foundation vent openings is even with adjacent grade. This could be a source of water entry into the crawl area. Suggest improvements. Damaged screens noted at foundation opening. Install at this time to prevent animal entry.
- See photos.

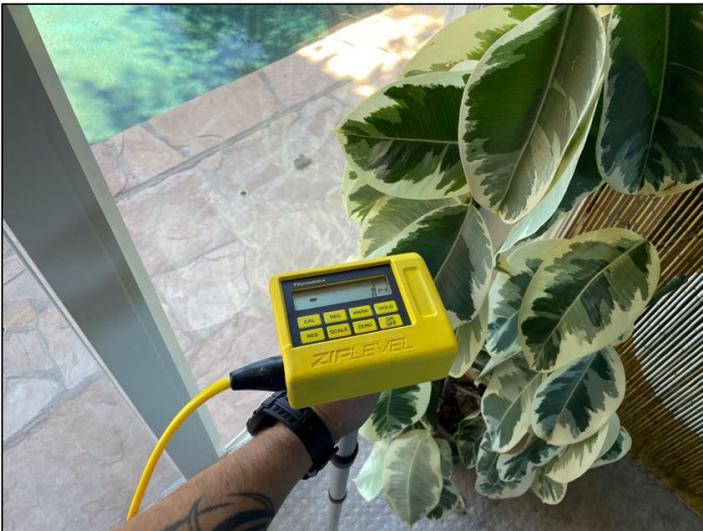
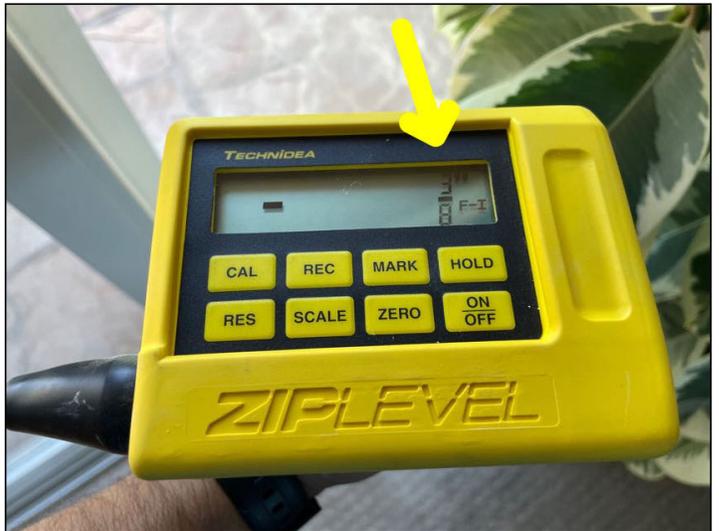
Significant settlement within 10 foot from zero.

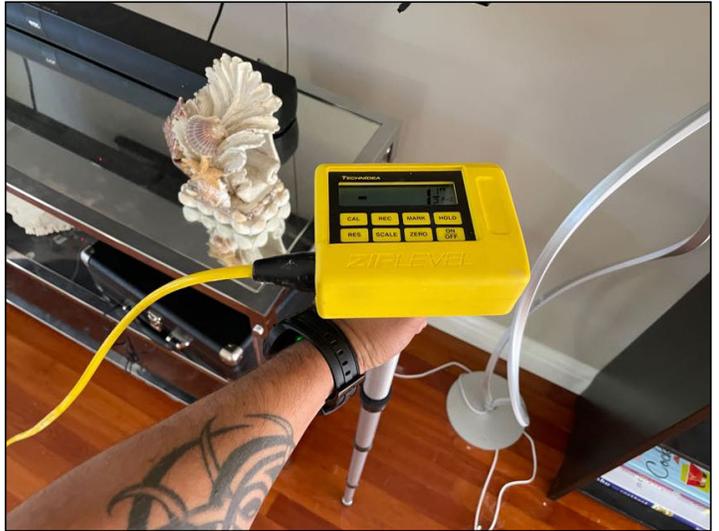
South bedroom. Significant settlement within 10 foot from zero.

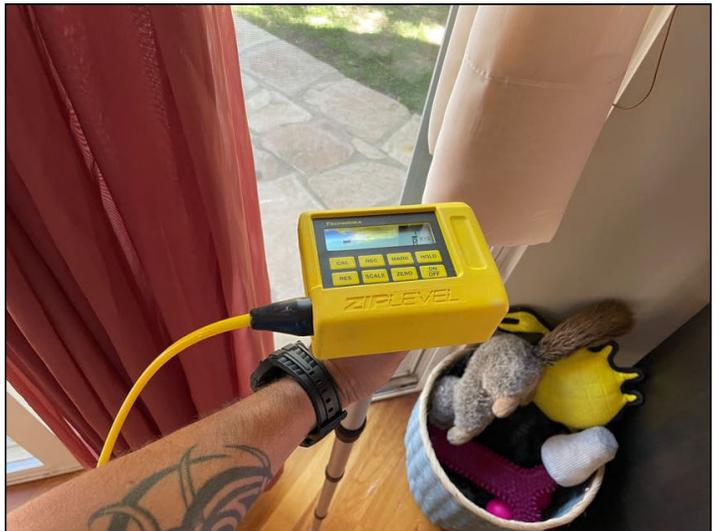
Living/family room. Significant settlement within 10 foot from zero.

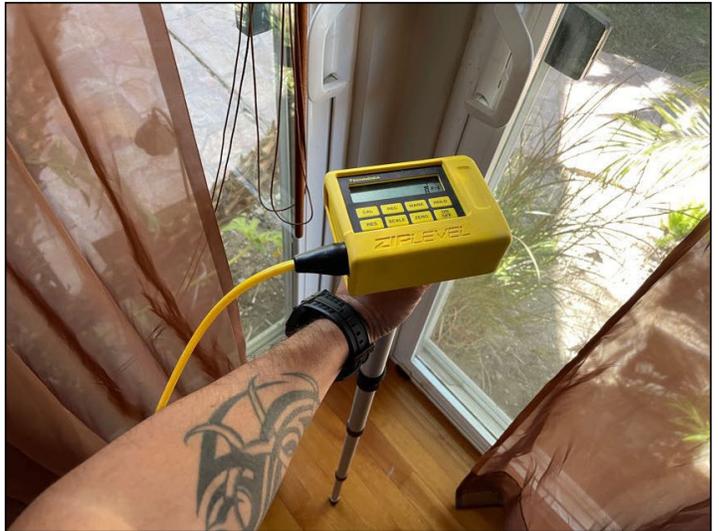
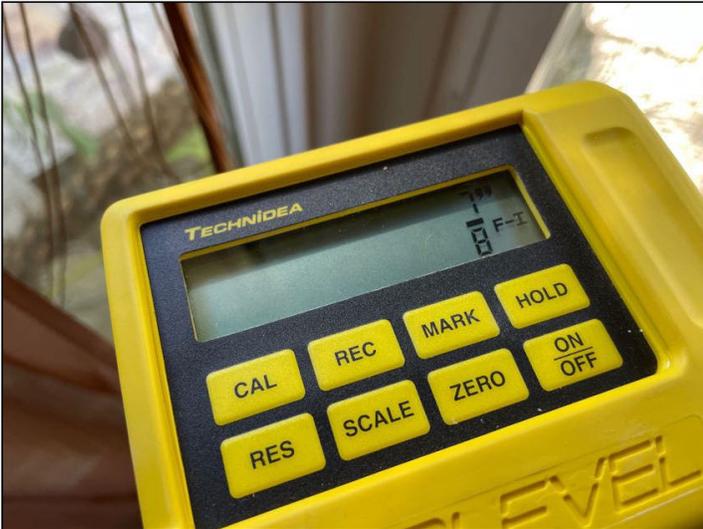
Abnormal settlement within 10 foot from zero.

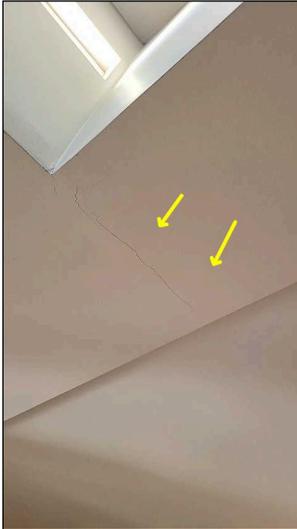
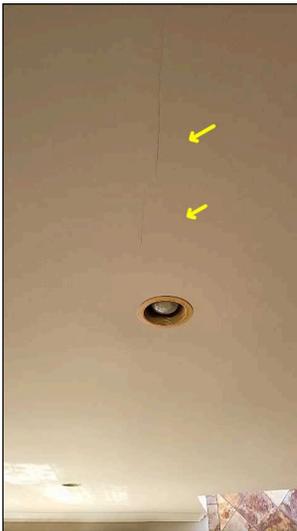
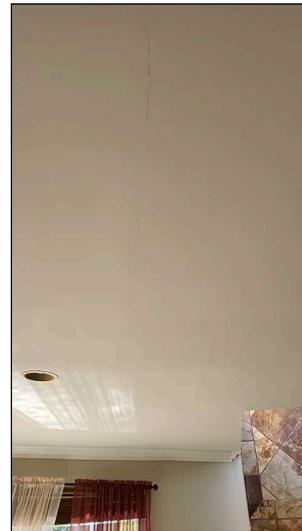
1. Walls & Ceilings Condition

- Typical cracks noted.
- Cracks above doors and/or windows noted.
- See Photos.

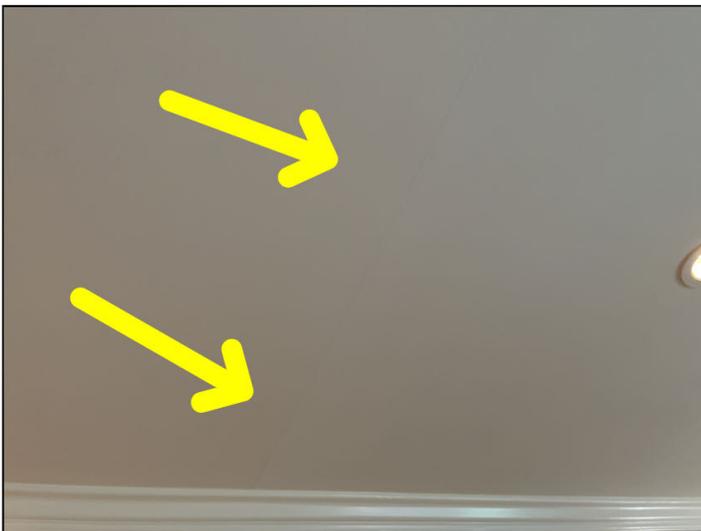
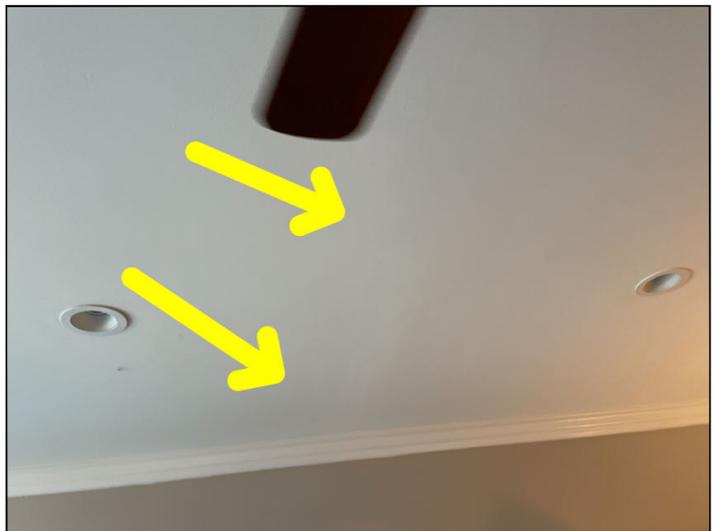
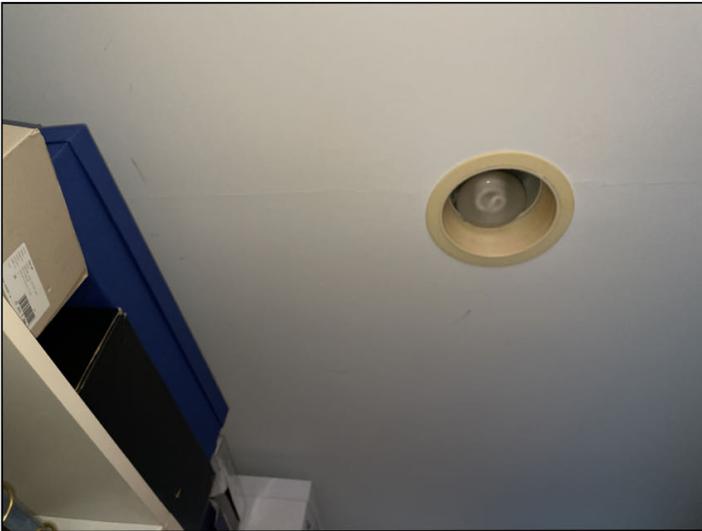
Master

- Significant cracks noted at time of inspection.
- Typical cracks noted.
- Cracks above doors and/or windows noted.
- See Photos.

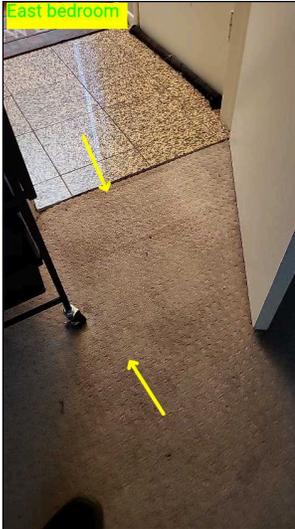
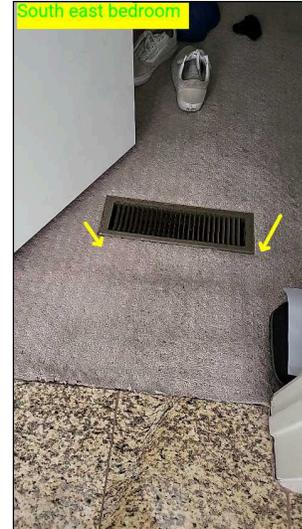
- Floor is visibly unlevel. Further evaluation is recommended.
- See photos.

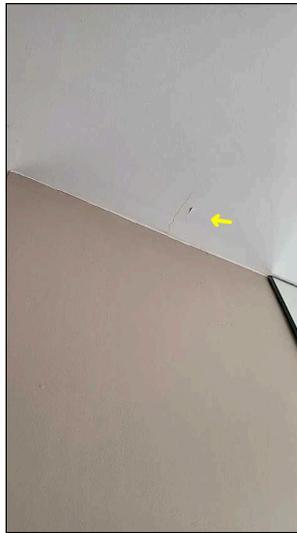
- Typical cracks noted.
- See Photos.

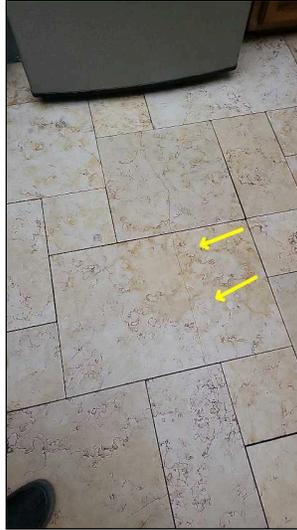
- Flooring is damaged or deteriorated. Repair or replacement is recommended.
- See photos.

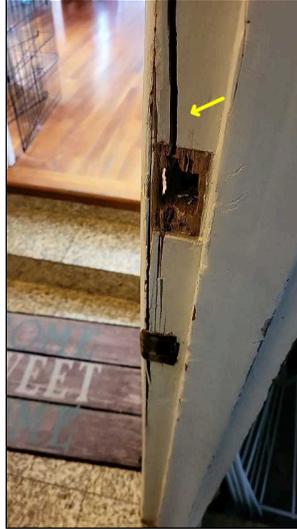
- Door jamb is damaged or broken. Repair or replacement is recommended.
- See photos.

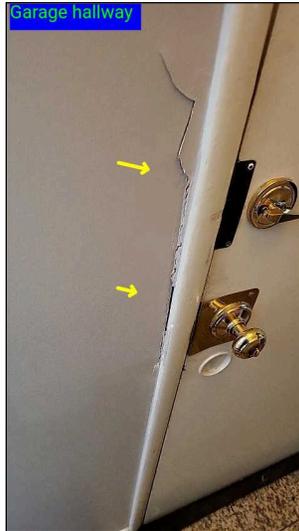
- Significant cracks noted at time of inspection.
- Cracks above doors and/or windows noted.
- See Photos.

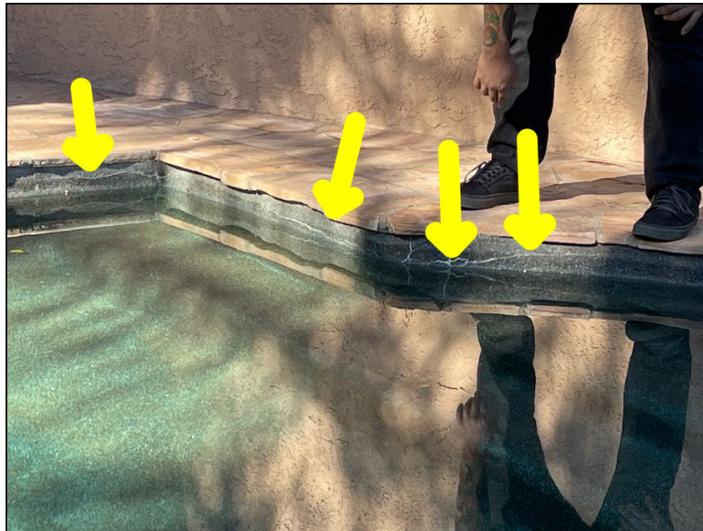
- Cracks noted on the pool surface.
- Cracks appear significant and may be caused by soil settlement due to inadequate hillside coverage and significant hillside soil erosion. See deck comments and photos. Determining underground leaks is beyond the scope of this inspection. Further evaluation by a licensed pool contractor is recommended.
