Inspection Report

Mr. Fuller RV Services

(7) 2009 Tiffin Phaeton 42QBH Floorplan

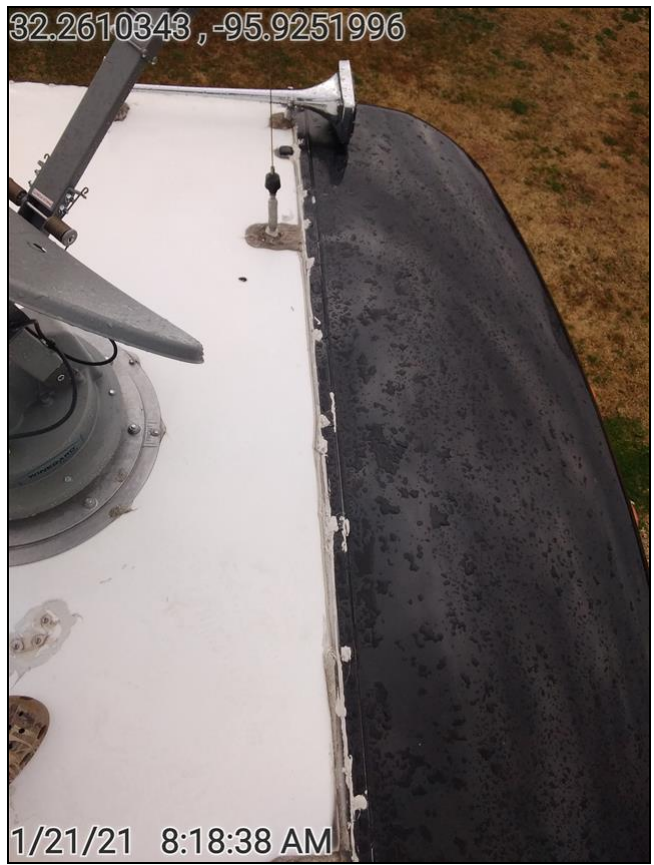
Front cap seam

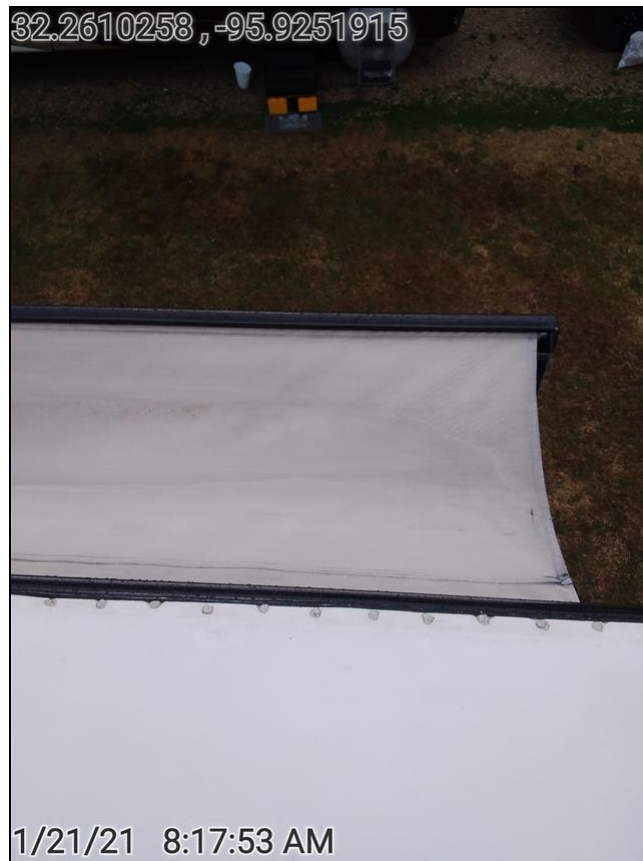
Awning Sag

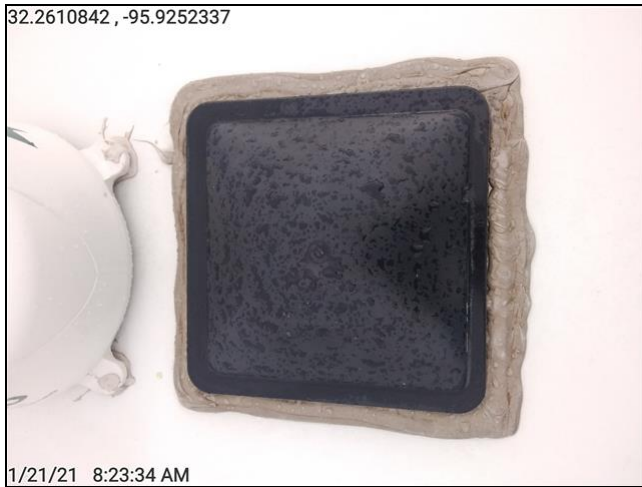
Front vent

The three powered vent covers are acceptable.

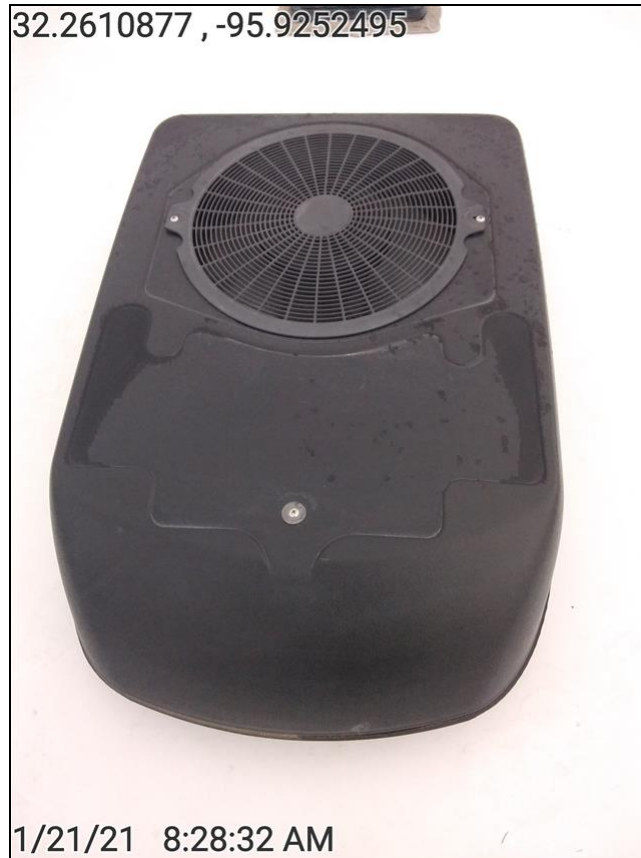
Front AC cover

The inspector observed that the AC shrouds are in acceptable condition.

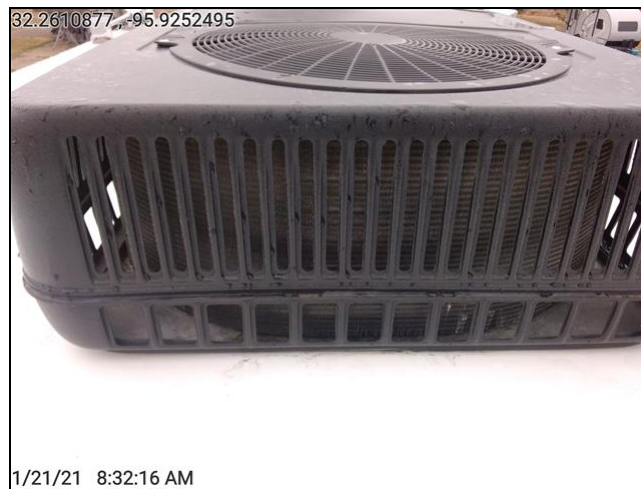
Front AC Coils

The inspector observed that the AC coils are maintained in acceptable condition.

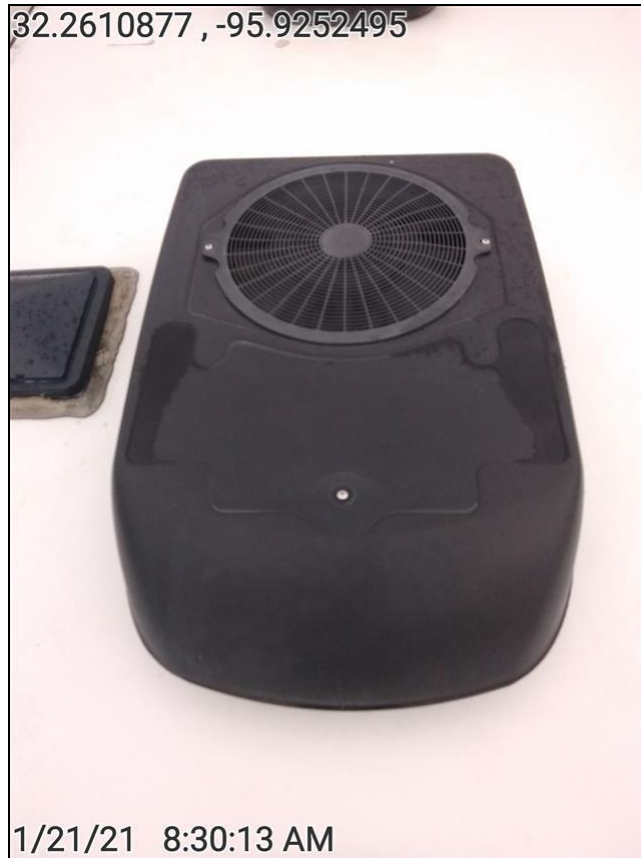
Center AC Shroud

The inspector observed that the AC shrouds are in acceptable condition.

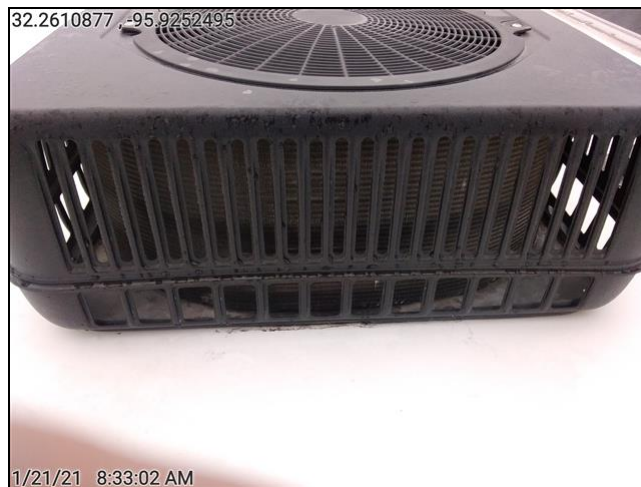
Center AC Coils.

The inspector observed that the AC coils are maintained in acceptable condition.

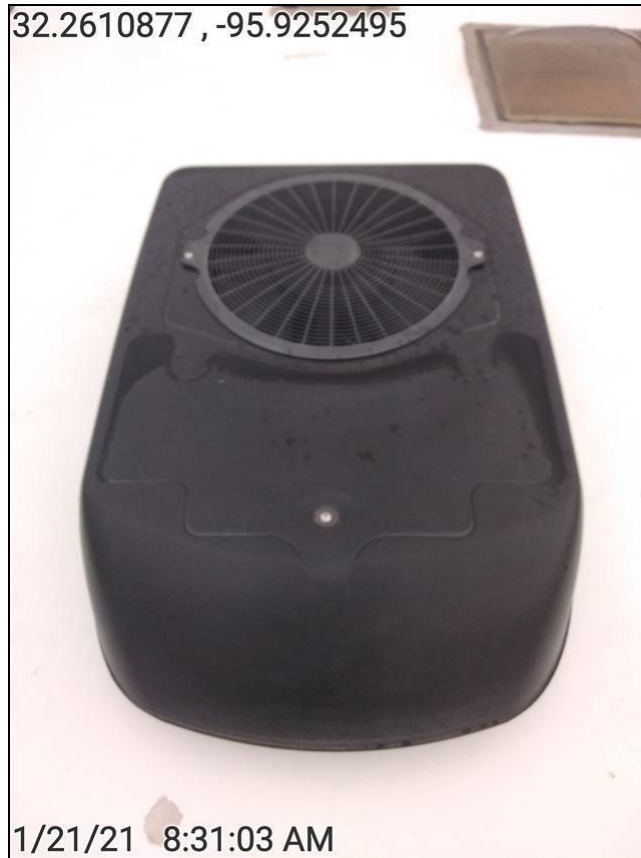
Rear AC shroud

The inspector observed that the AC shrouds are in acceptable condition.

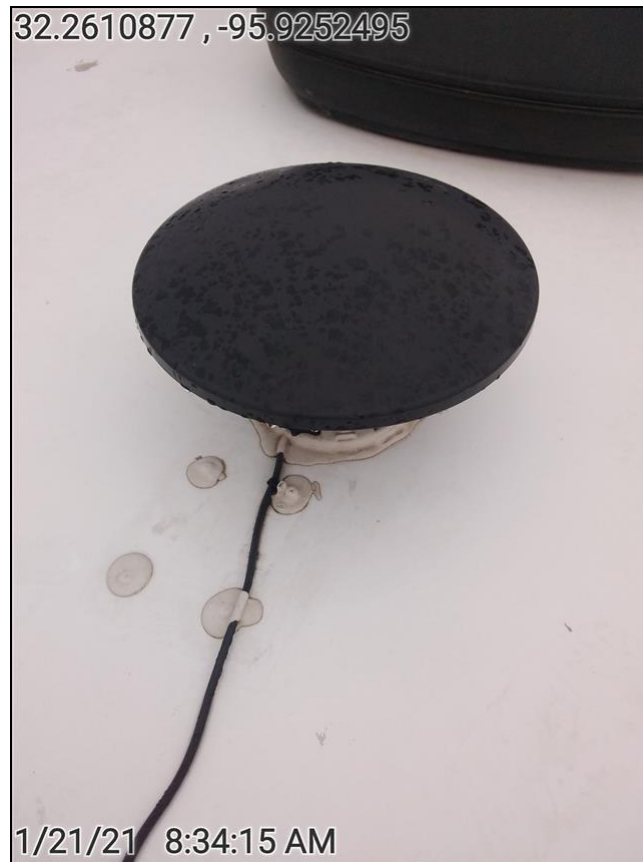
OverTheAir TV Antenna

The owner commented that the factor antenna has been replaced with a Magnadyne RVTV-B2 Omni-Directional Amplified TV/AM/FM Antenna and Distribution Plate.

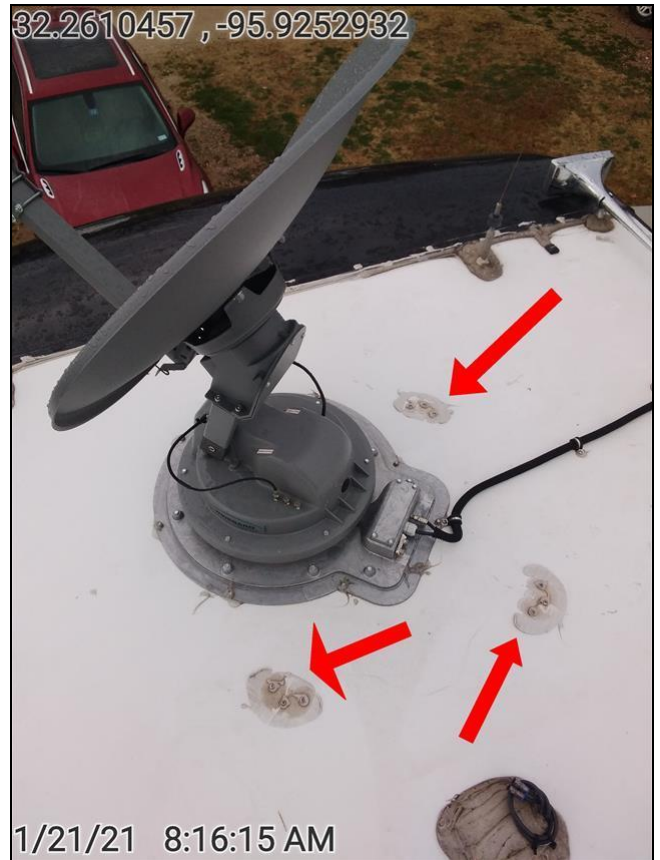
Penetrations Patched

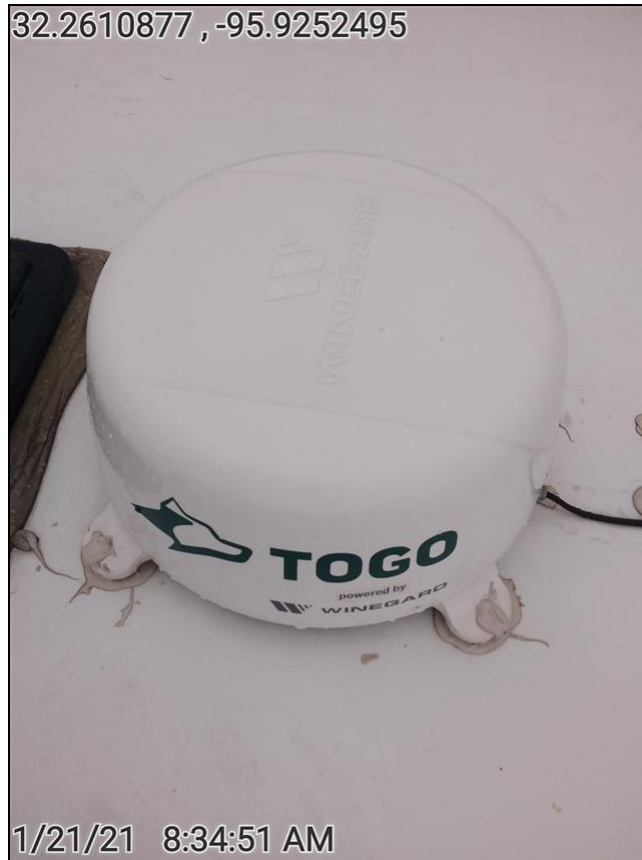
TOGO Data Dome

The owner reported that the TOGO Winegard antenna has been added.

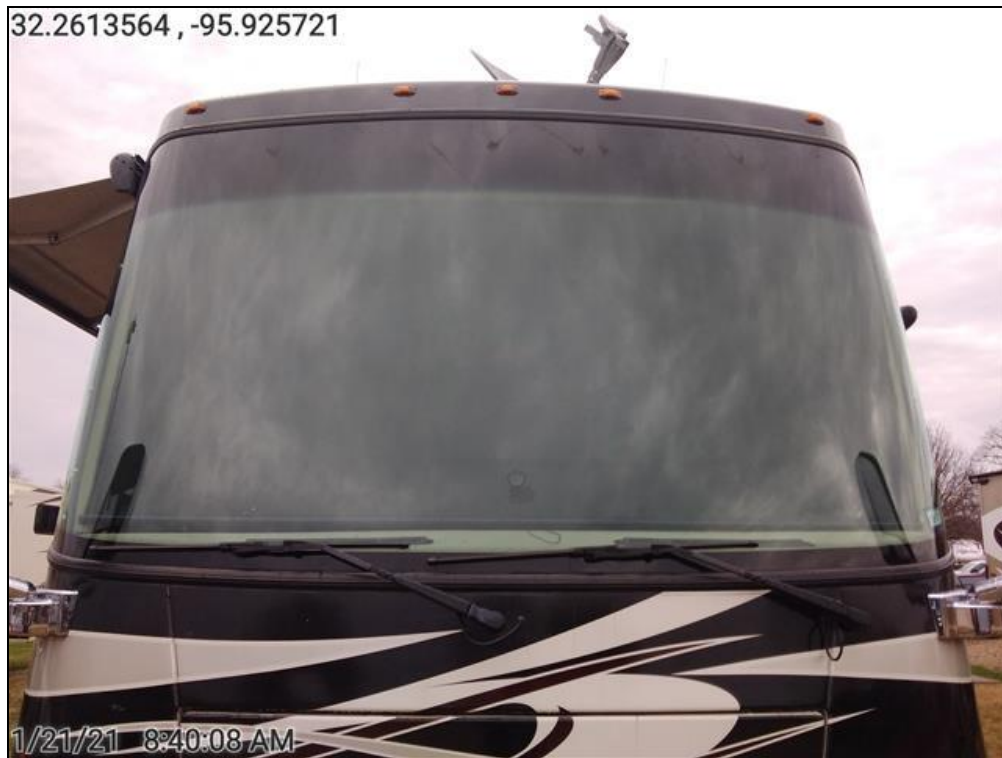
Windshield

The windshield is in acceptable condition.

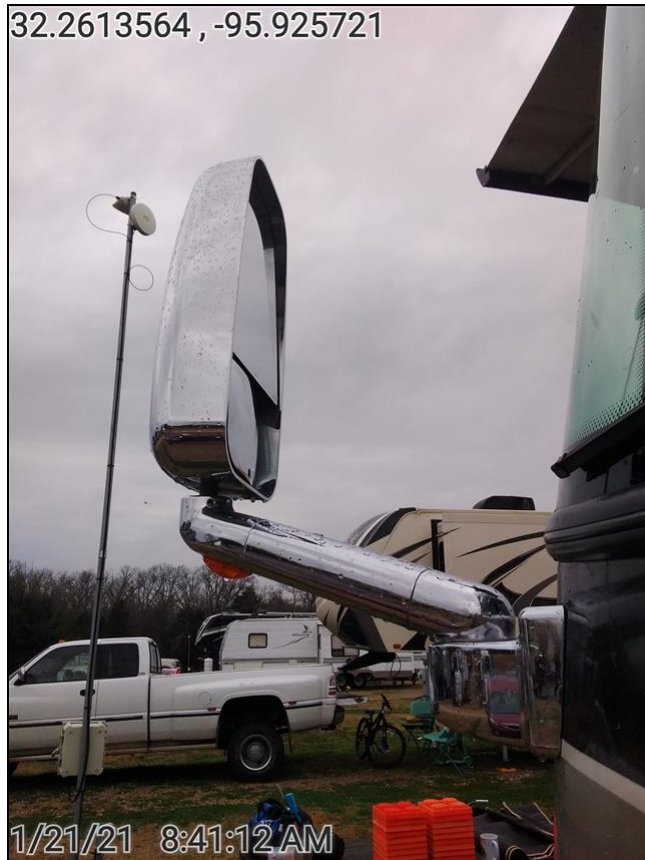
Curbside

The inspector tested mirror operation and observed that they operate in an acceptable manner.

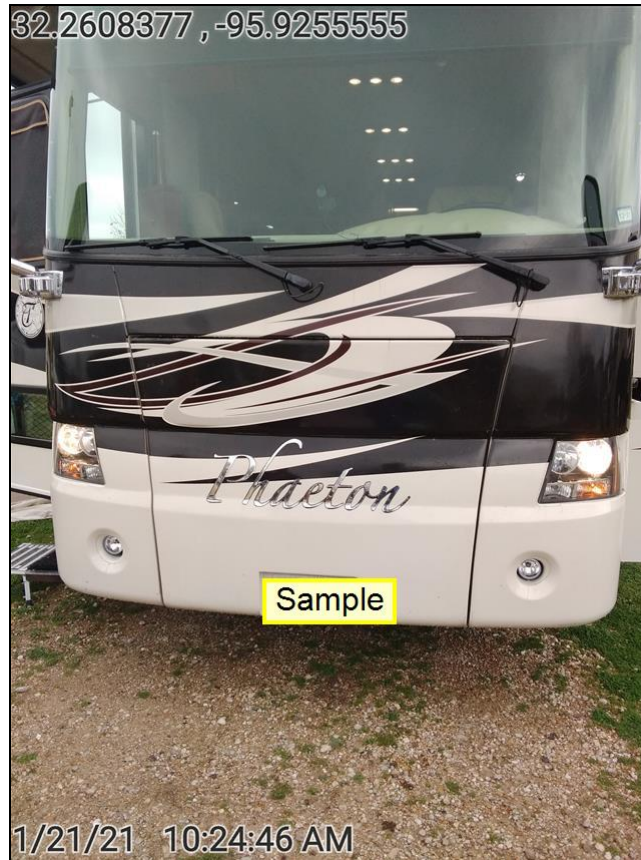
The headlights were observed to operate in an acceptable manner.

Headlights on

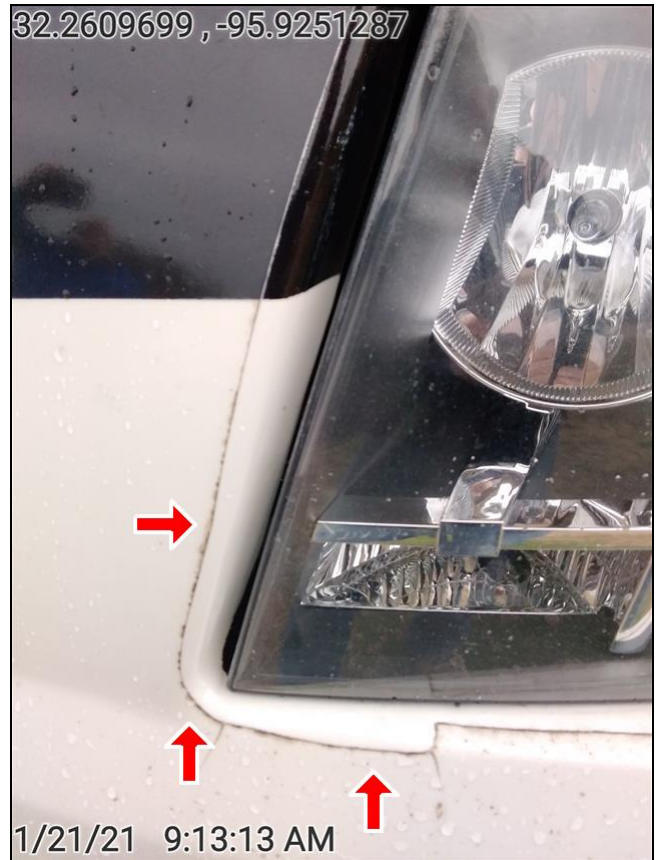
The front cap is protected by a plastic coating. The inspector observed that the edges of the plastic coating show signs of deterioration. It is recommended that the plastic coating be replaced/renewed by a qualified technician.

Edge of Diamond shield.

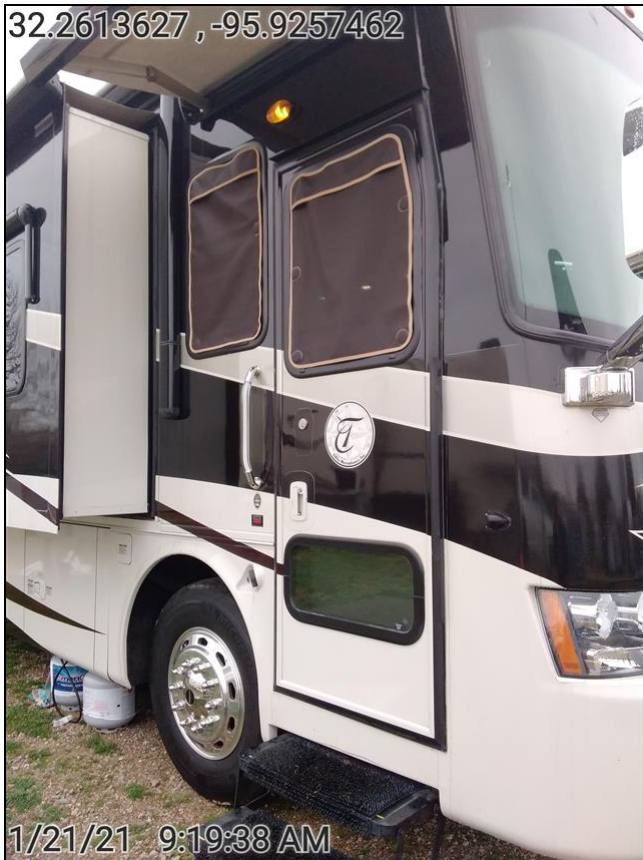
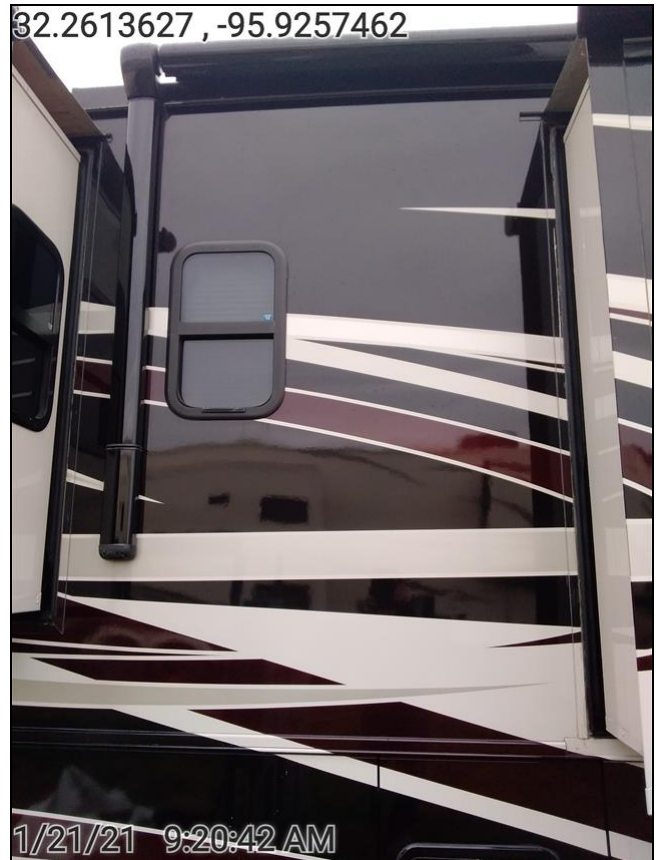
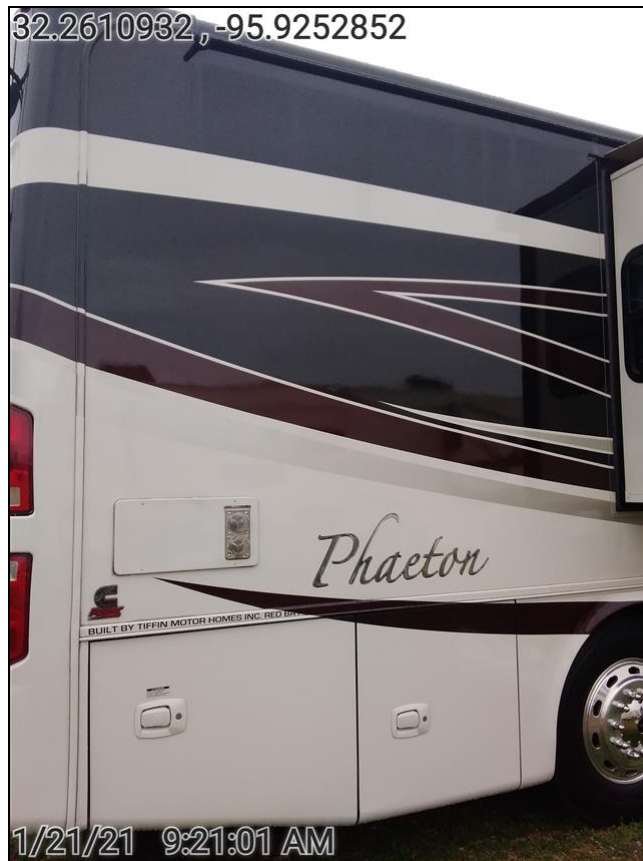
The inspector reported that the curbside sidewall is in acceptable condition.

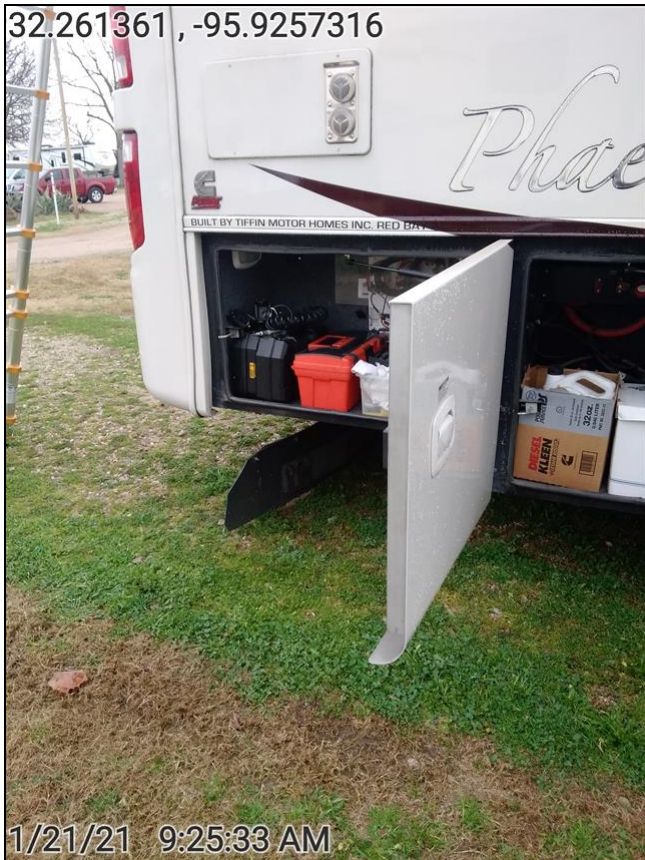
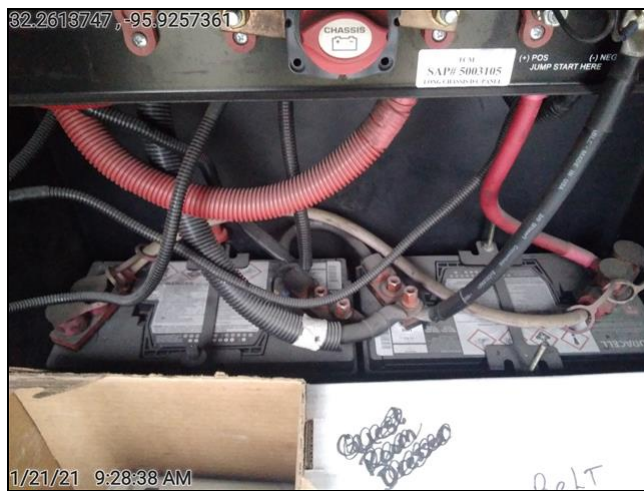
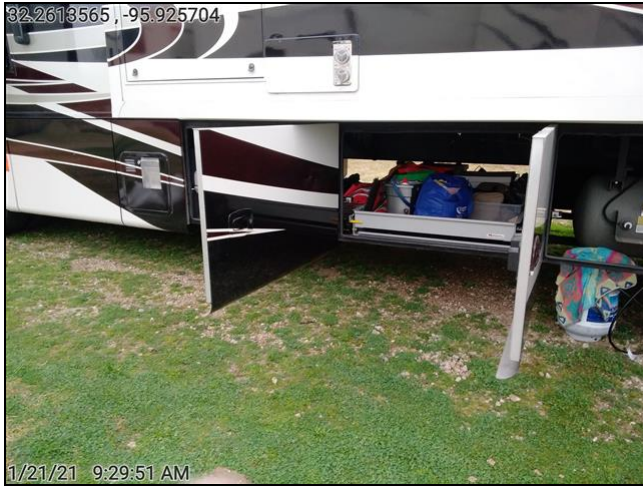
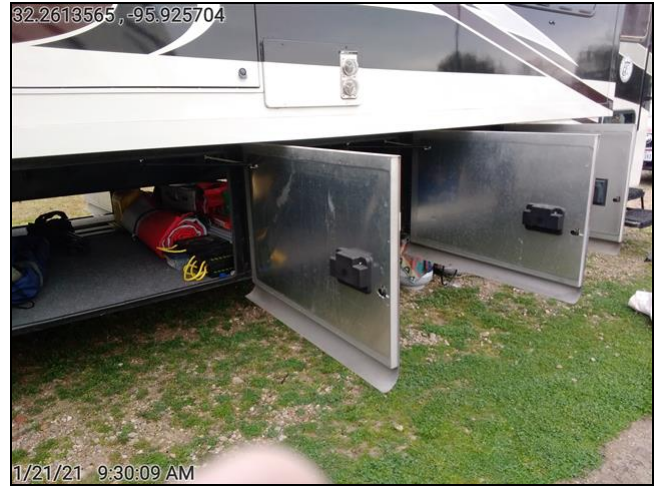
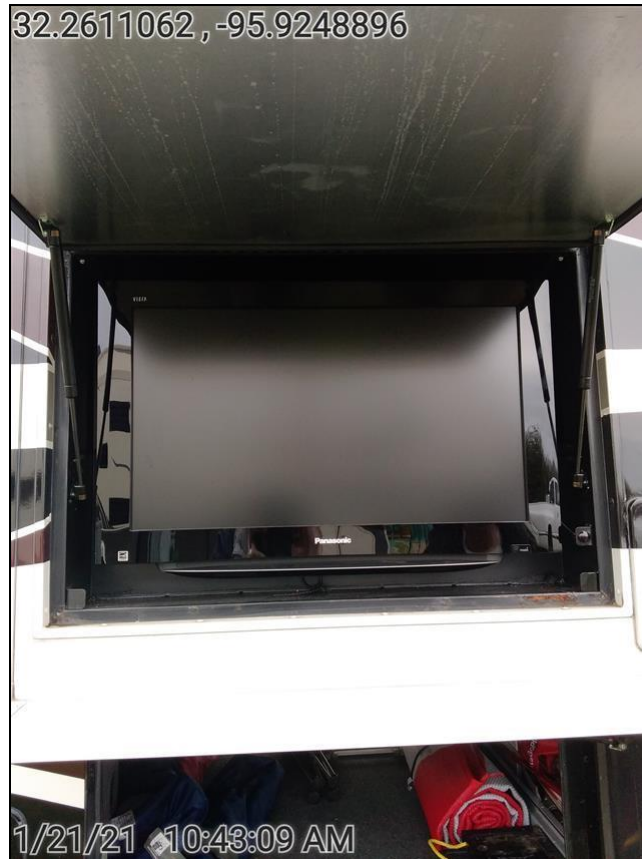
The curbside access cargo and access doors are in acceptable condition.

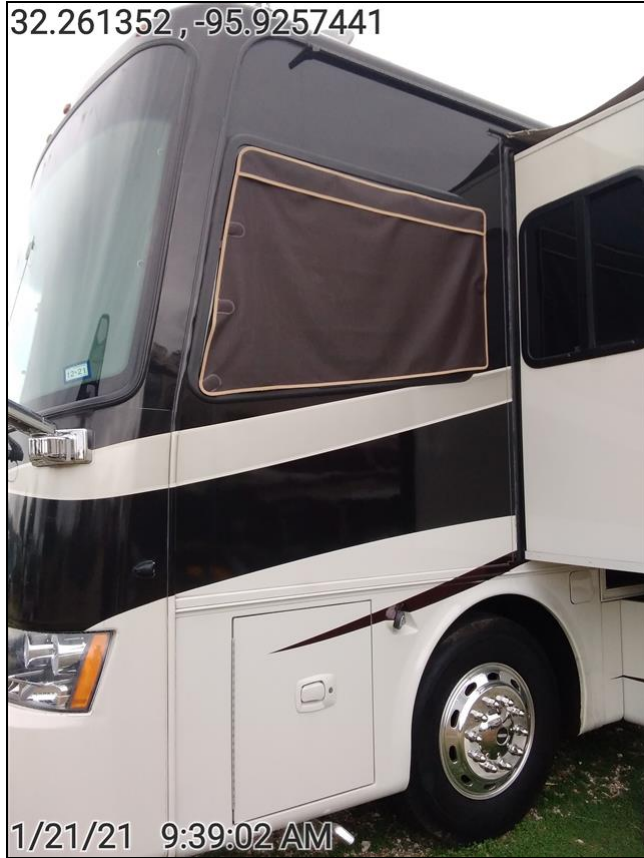
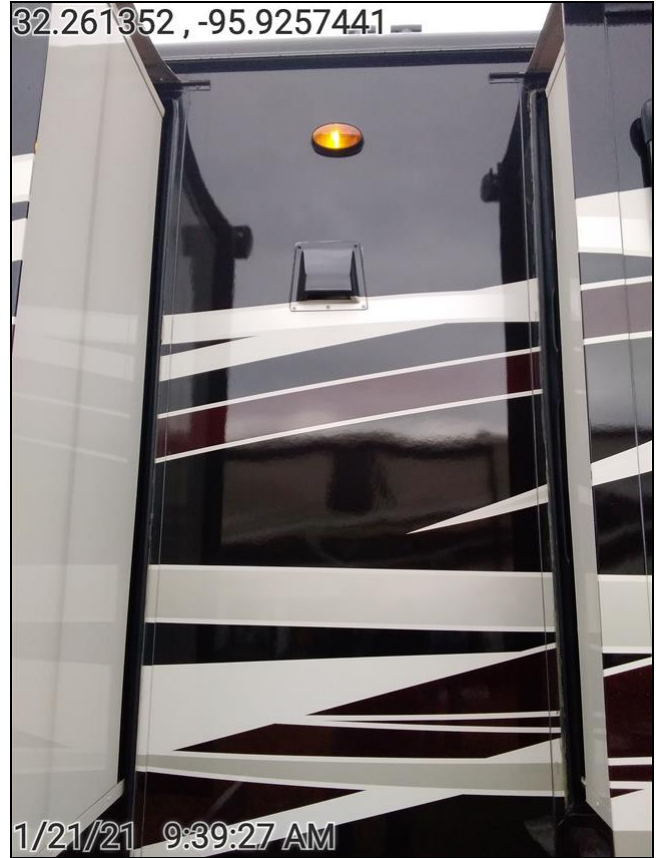
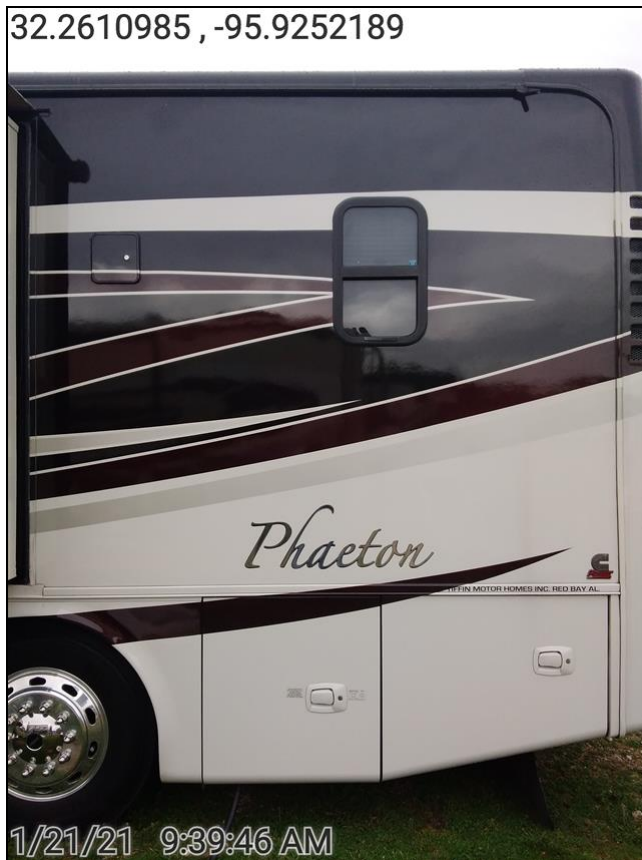
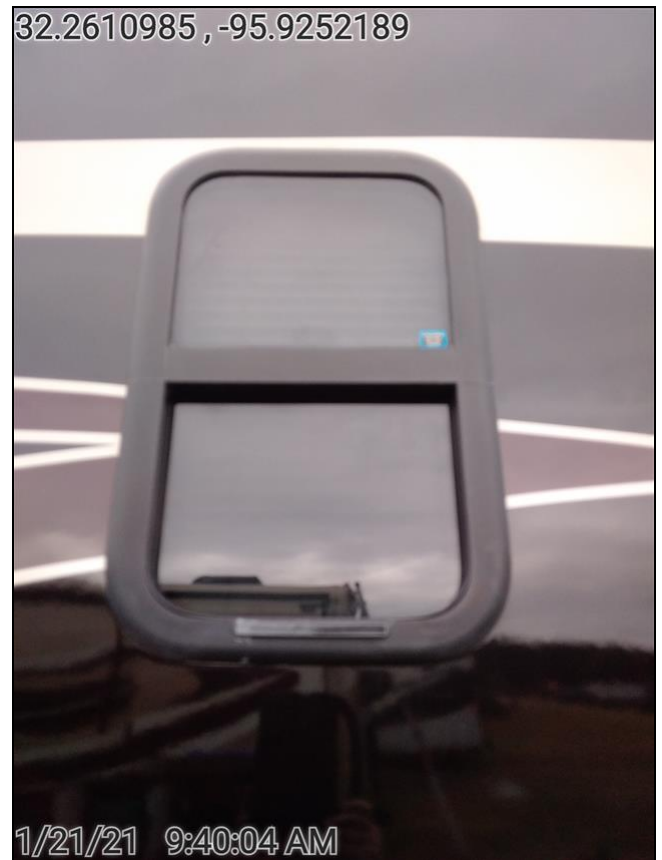
The streetside sidewalls are in acceptable condition.

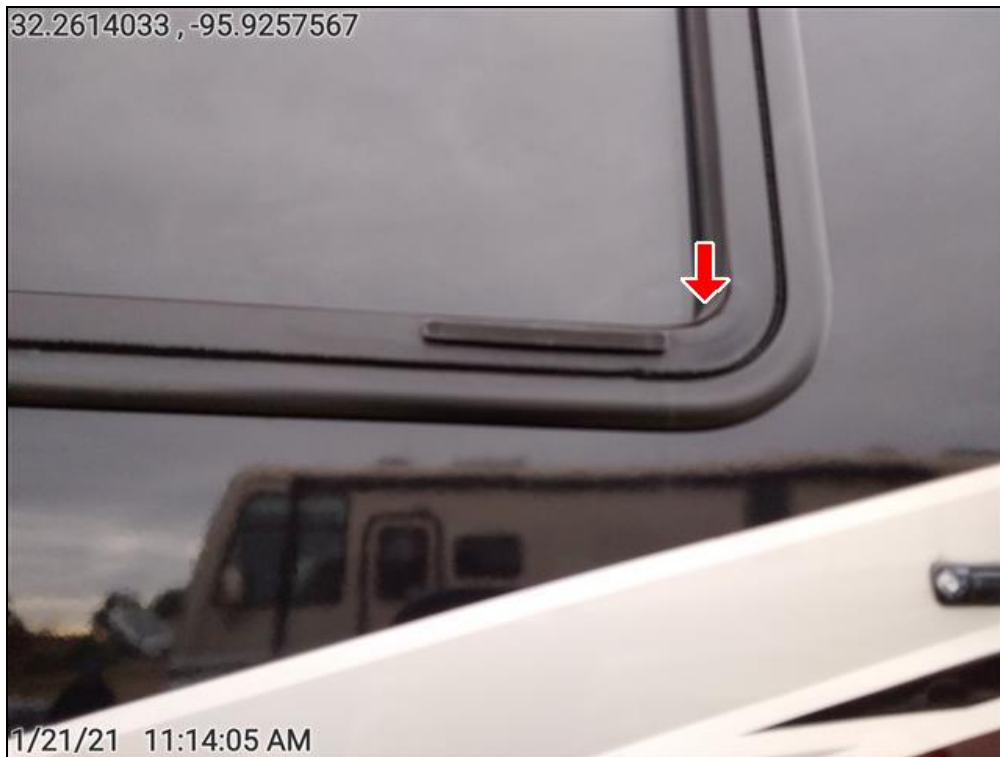
Streetside dining area window

(2) Edges of the window trim in the streetside dining area window are showing a small gap that could allow water penetration in the future. It is recommended that the window trim be repaired.

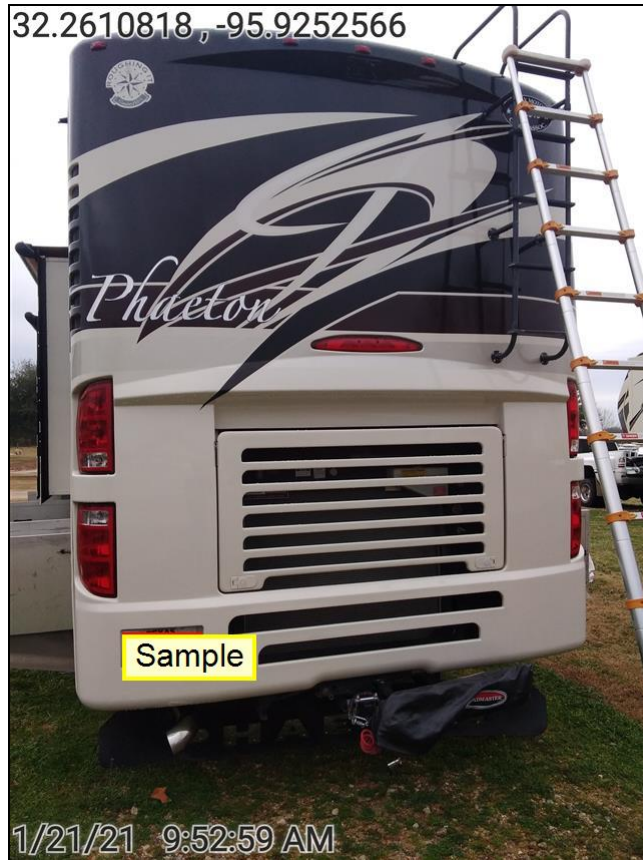
Rear Cap

The rear cap is in acceptable condition.

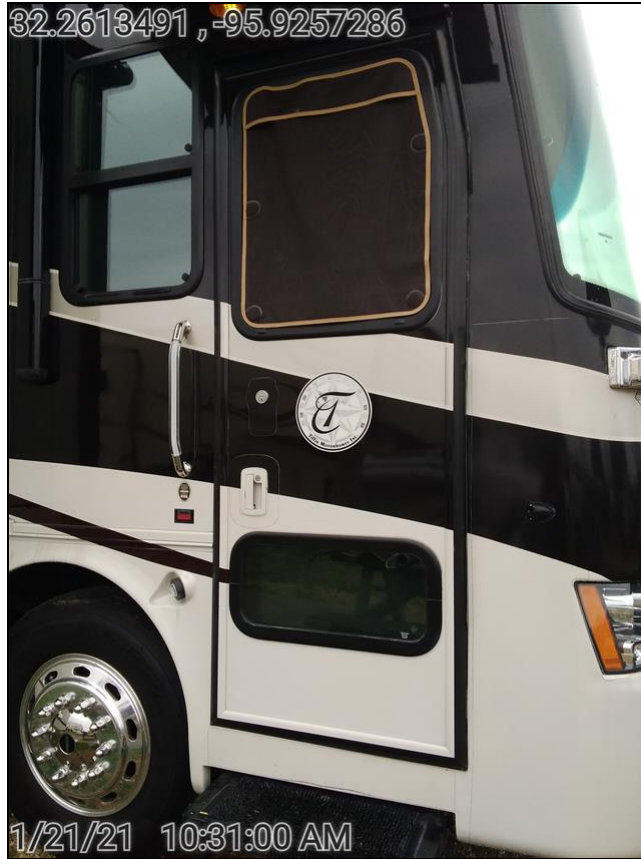
Main entrance door

The main entrance door is in acceptable condition.

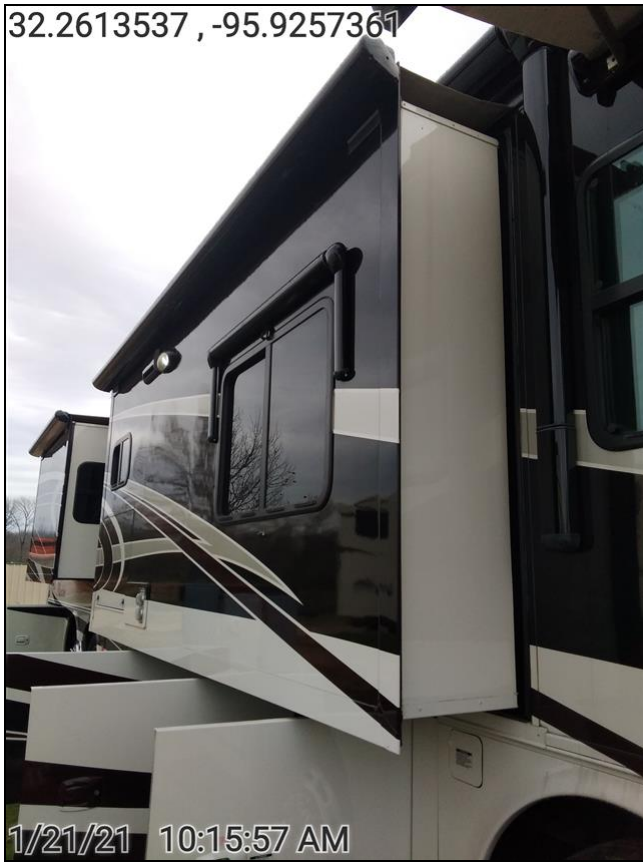
Curbside front

The curbside front slide is in acceptable condition.

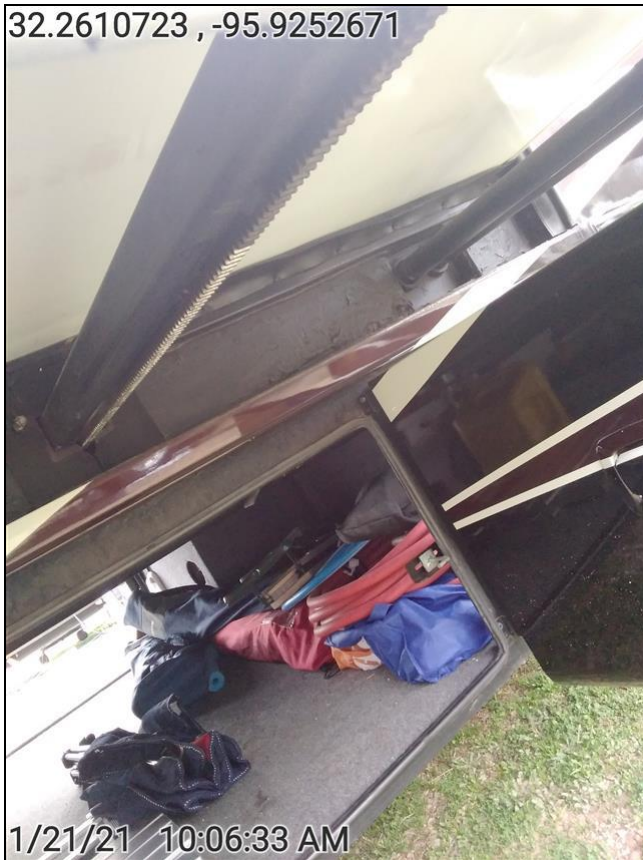
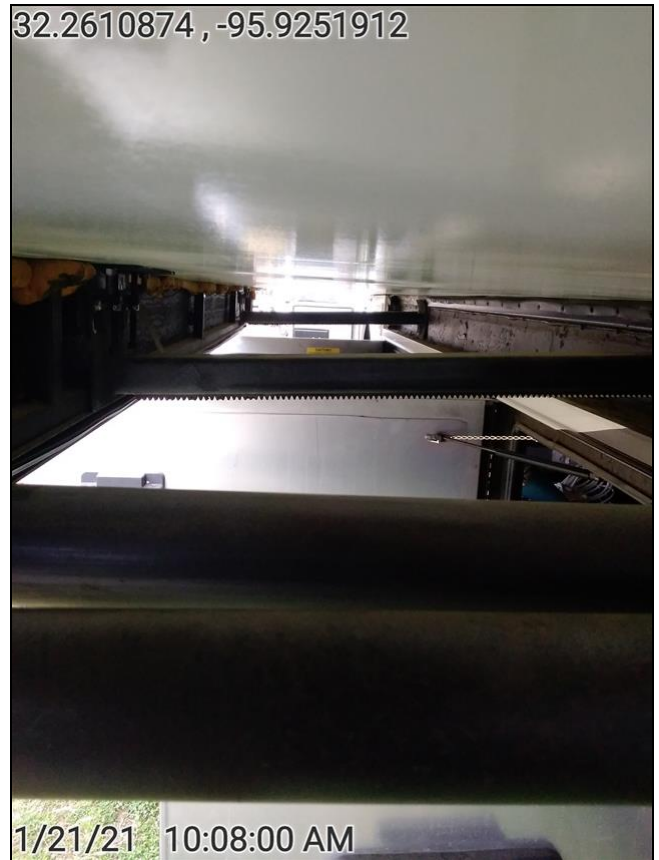
inspector observed that the slideout drive is in acceptable condition.

Gear rack system

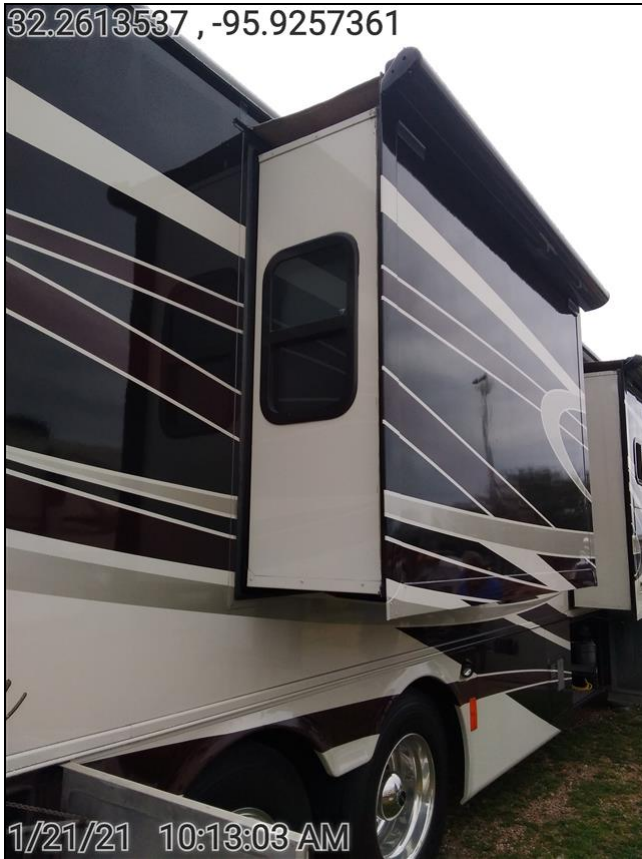
Curbside rear slide

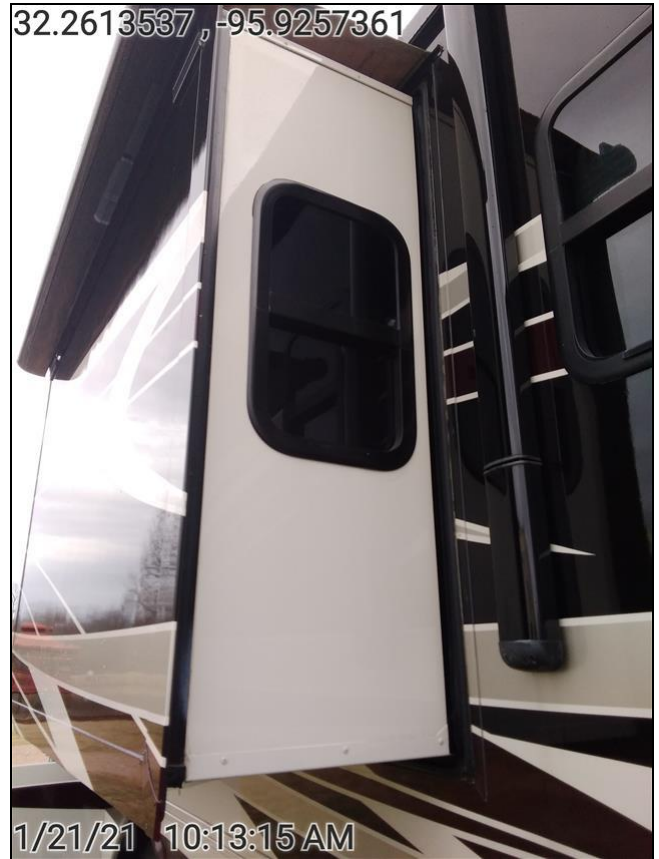
Curbside rear slide

The inspector observed that the slideout topper fabric is worn and nearing the end of it's useable life. It is recommended that the slideout topper fabric be replaced by a qualified RV technician.

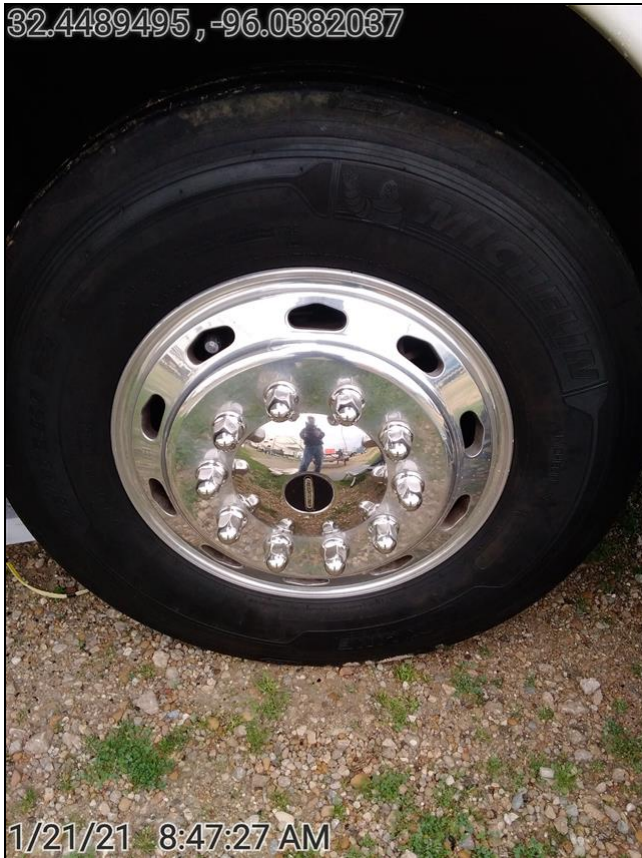
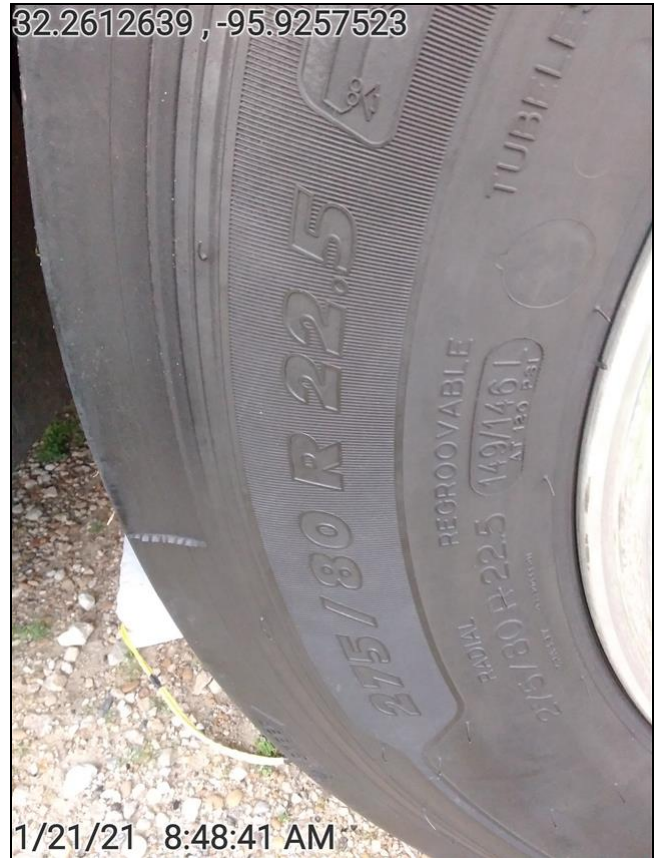
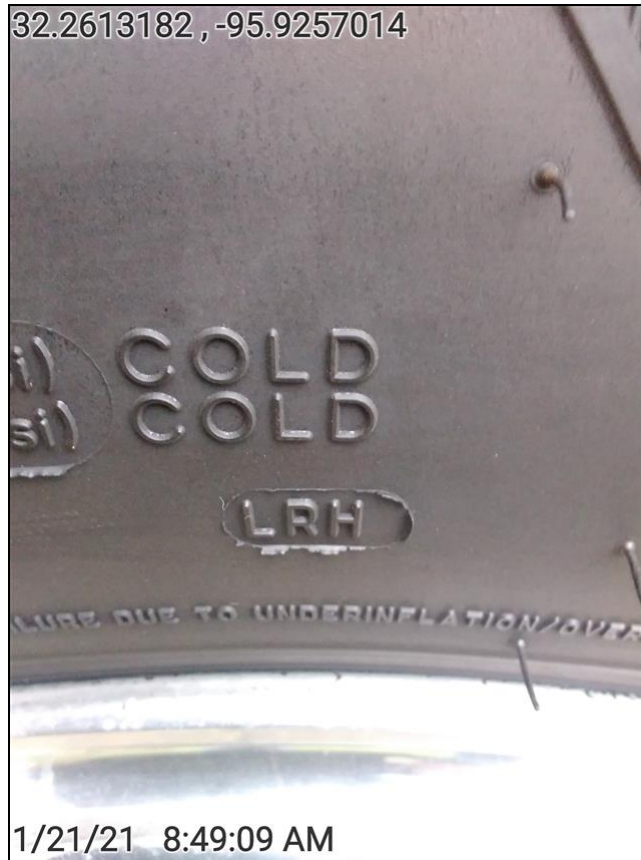
Curbside Front

8.0.A Tire Condition

Comments: Acceptable

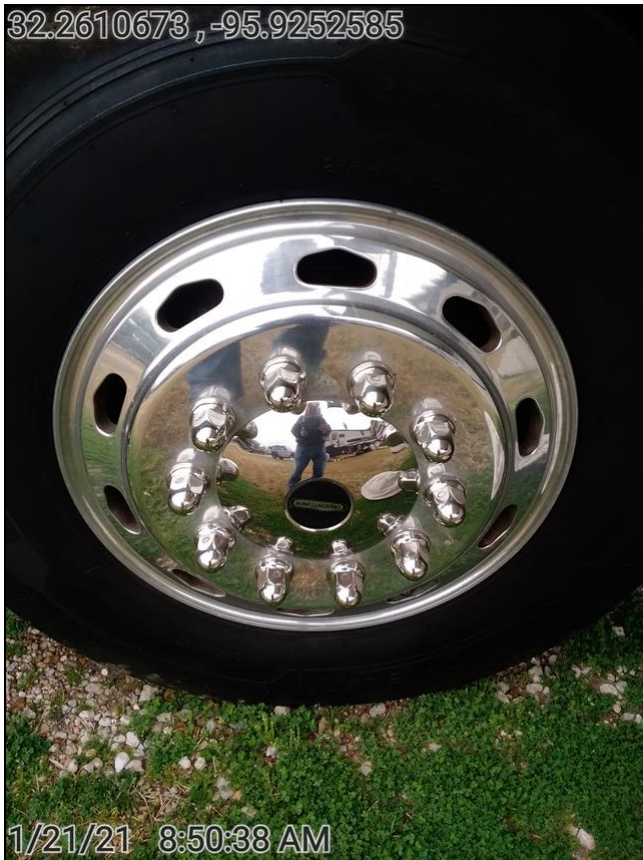
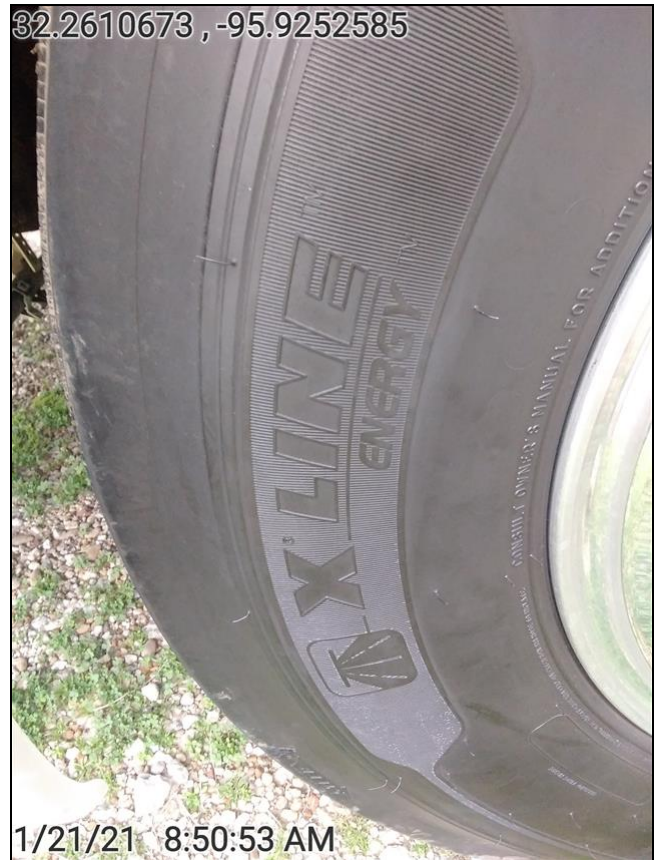
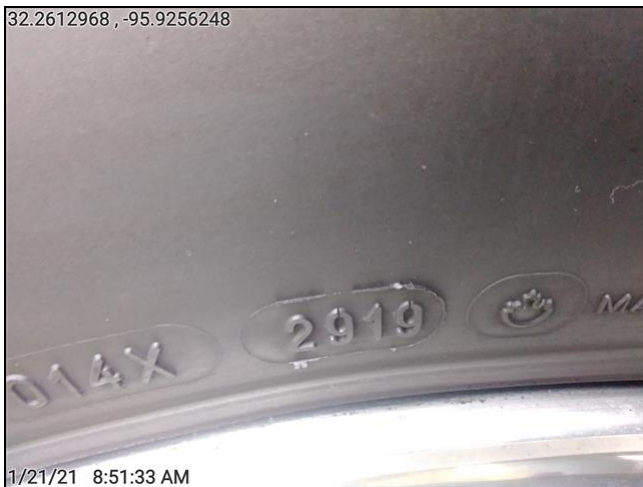
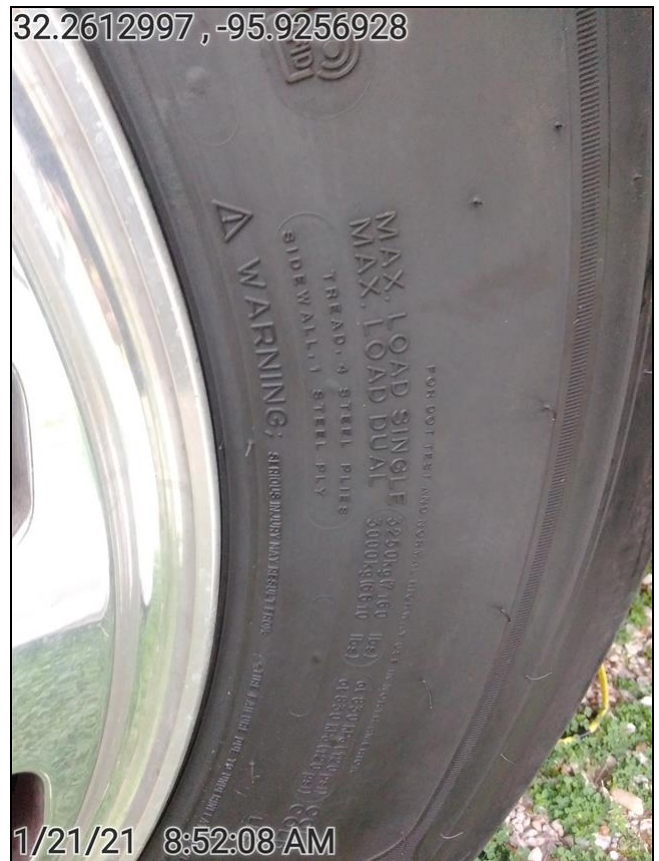
Streetside Front

8.0.H Tire Condition

Comments: Acceptable

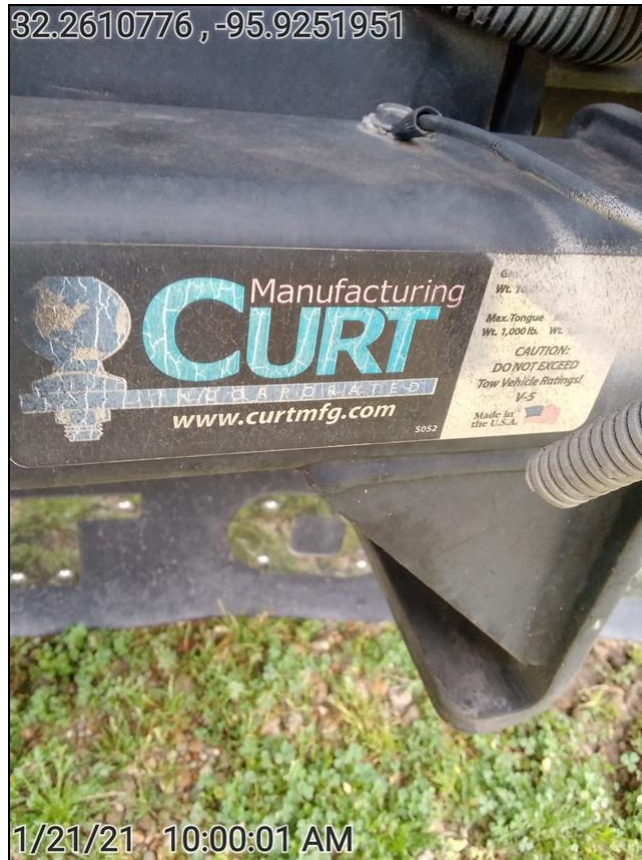
Receiver Hitch

Hitch receiver is in acceptable condition.
