Inspection Report

Mr. Fuller RV Services

(7) 2009 Tiffin Phaeton 42QBH Floorplan

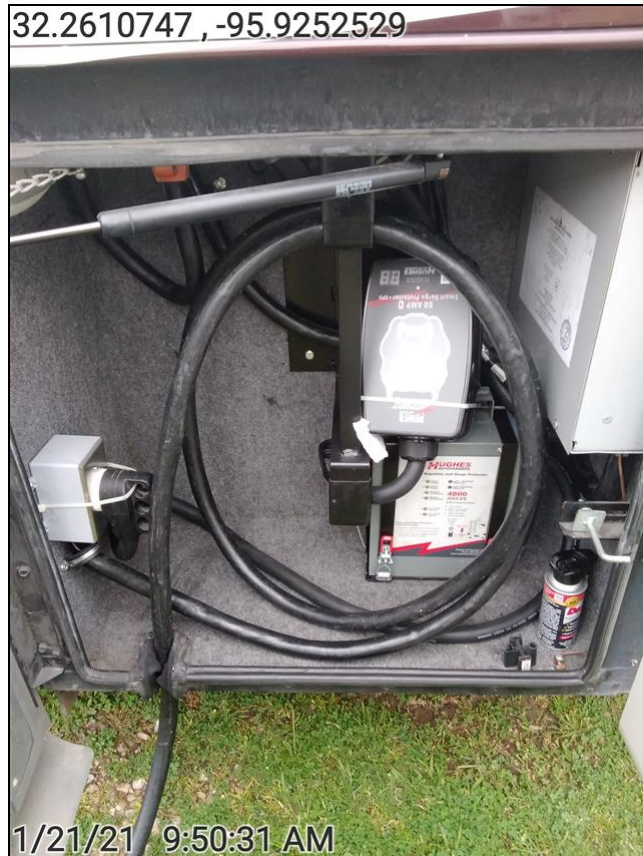
Shore power cord

The inspector noted that the shore power cord is in acceptable condition.

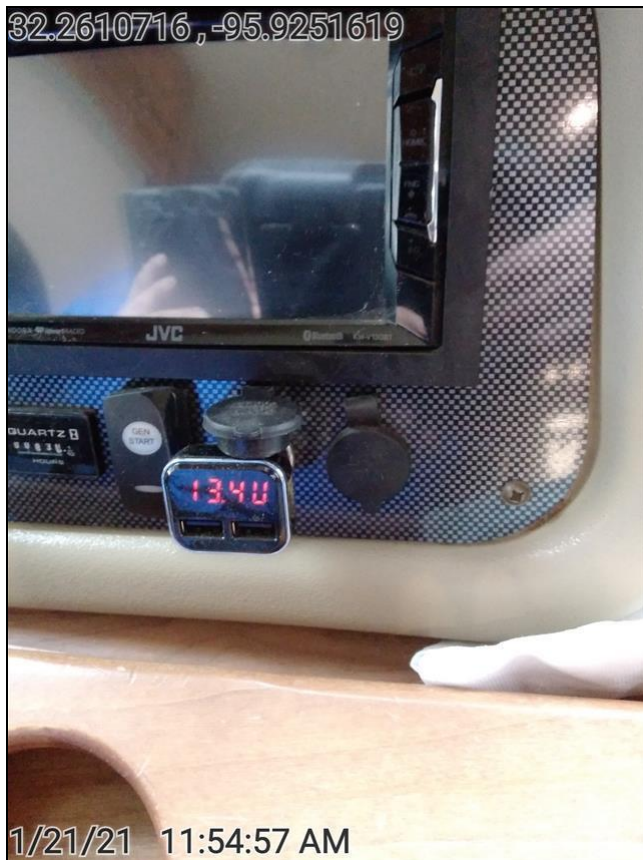
The power converter is performing in an acceptable manner.

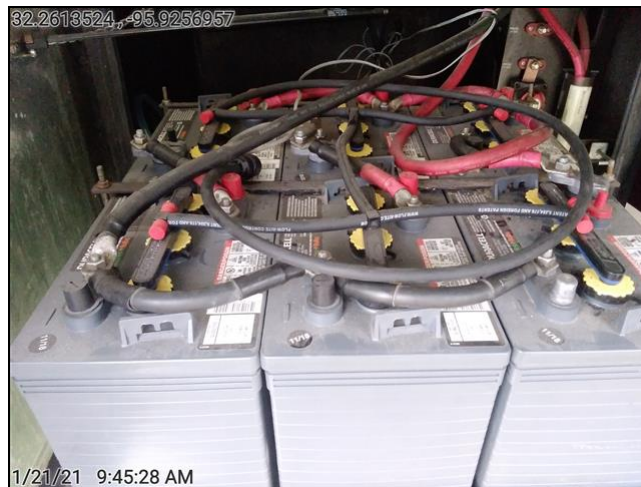
House batteries

The inspector noted that the house batteries are in acceptable condition.

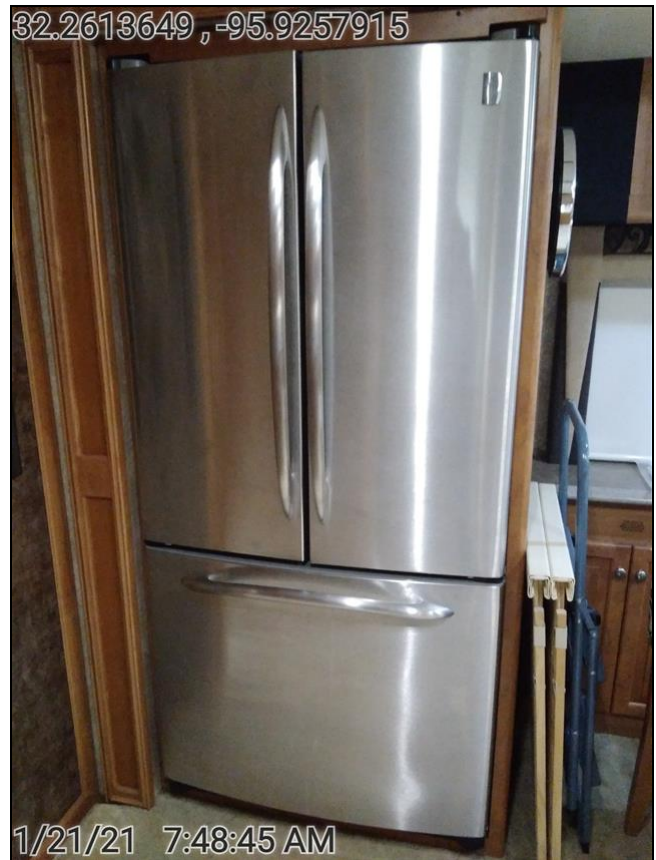
Refrigerator

The refrigerator is in acceptable condition.

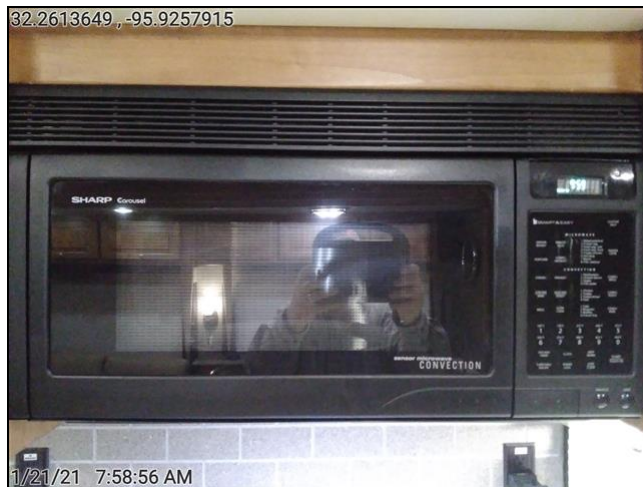
Microwave Convection Oven

The microwave oven is in acceptable condition.
