Engineering Report V1.0

# Engineer's Foundation Evaluation

On 1/10/2025 a foundation evaluation was performed at the property located at address 123 Sample, Address, TX, 12345, which consists of a 2621 square-foot single family attached structure built in 1978 (47 years old) with a slab on grade foundation.

### **On-Site Inspection Report with Photos Dated 1/10/2025**

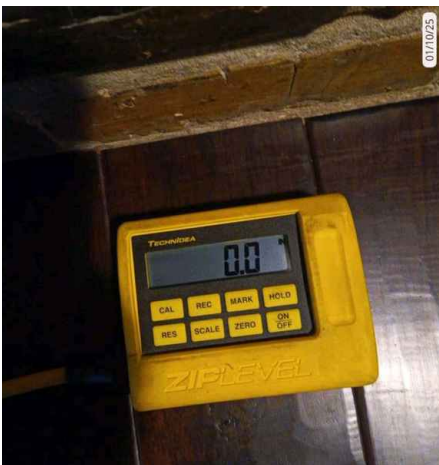
**Entry: Flooring difference factor**

Entry  
-0.1"

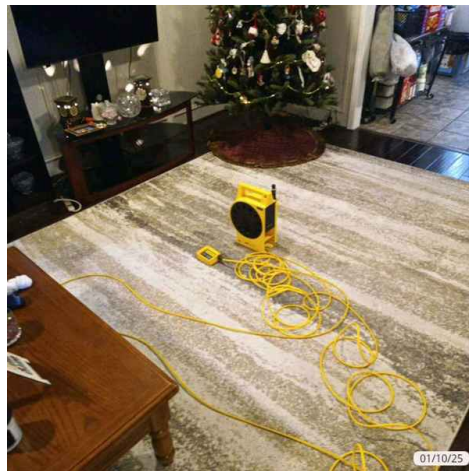
Rug elevation change. 0.2

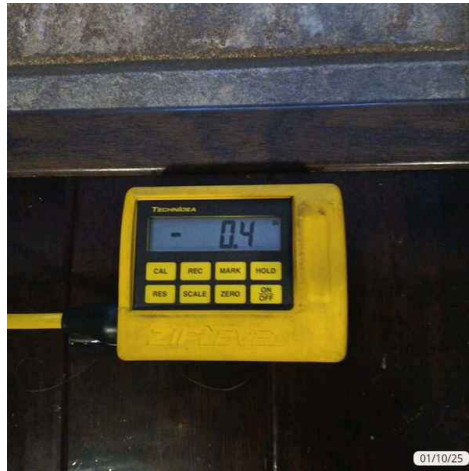
### Kitchen & Nook: Flooring difference factor

Same Elevation (0.0)

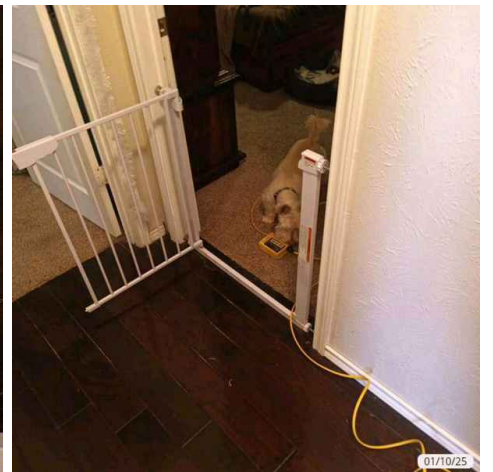
**Primary Bedroom: Flooring difference factor**

+0.1"

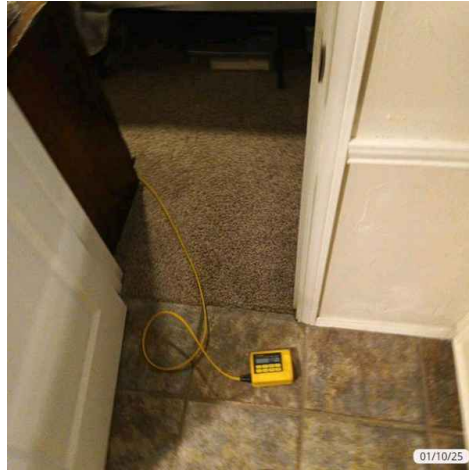
**Primary Bathroom: Flooring difference factor**

Carpet to tile transition

Same tile as entry and kitchen

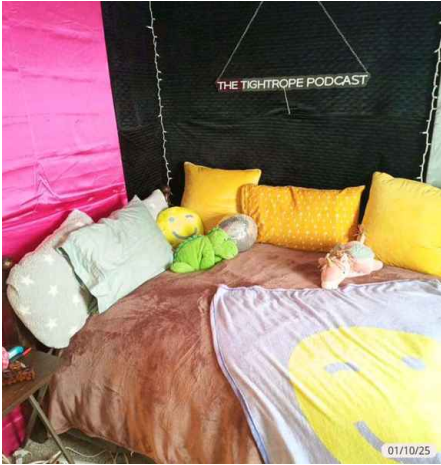
**Bedroom: Back-right elevation & photo**

Obstructed

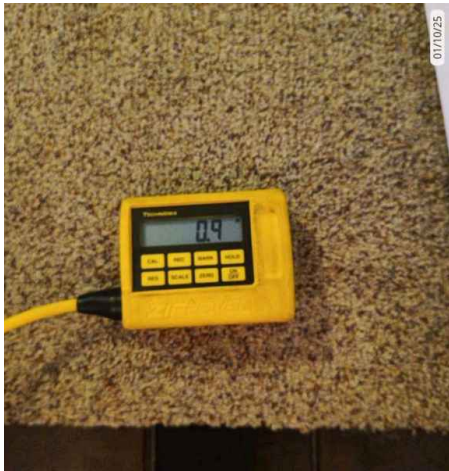
### Bedroom 3: Flooring difference factor

+0.3"

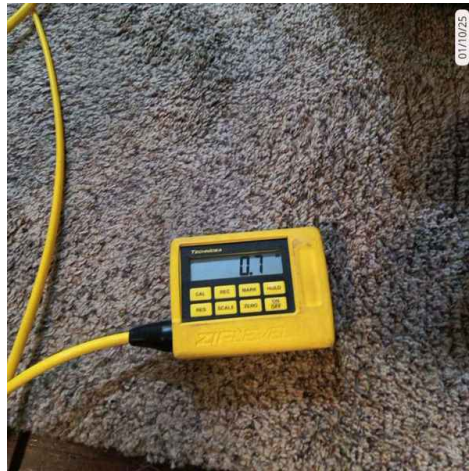
**Office - Room Addition : Flooring difference factor**

+0.3"
