INSPECTION REPORT

Prepared for: .
Inspection Date: Wednesday, August 26, 2020
Prepared by: Marlon Burwell

BURWELL HOME INSPECTIONS, LLC

RE: Report No. 1006

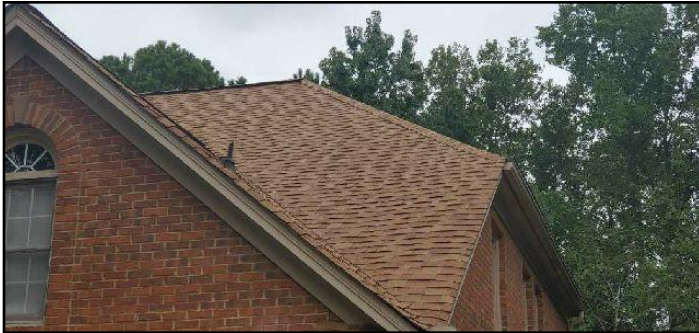
1. Asphalt shingles

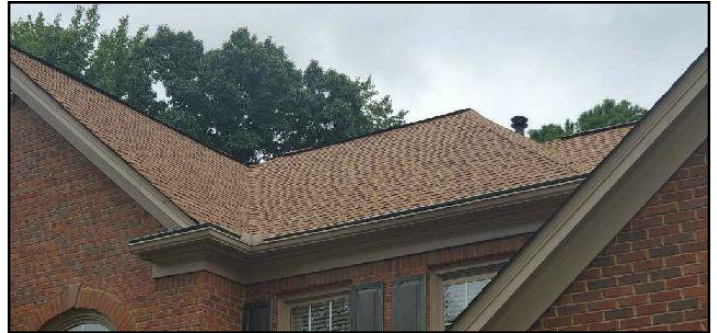
2. Asphalt shingles

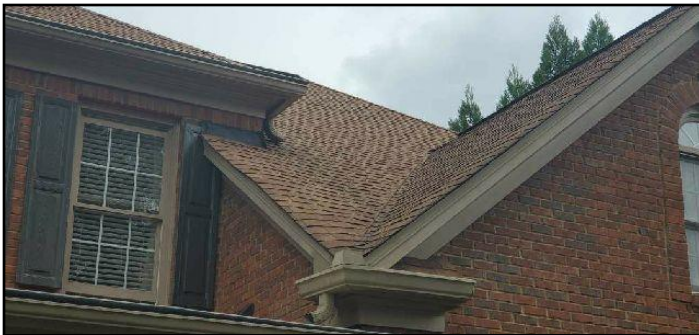
3. Asphalt shingles

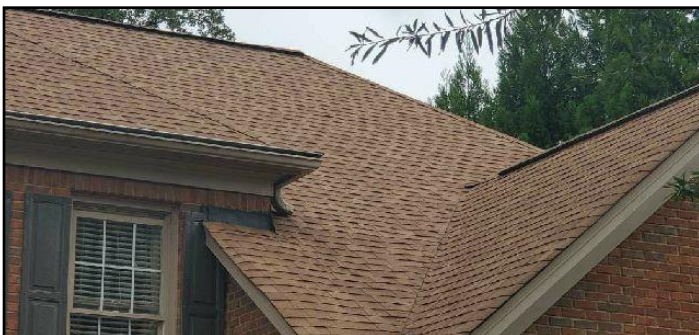
5. Asphalt shingles

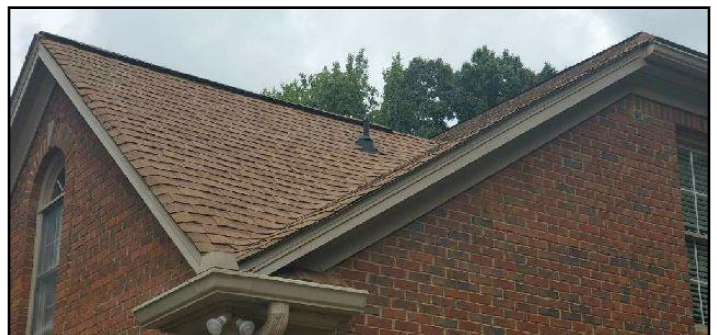
6. Asphalt shingles

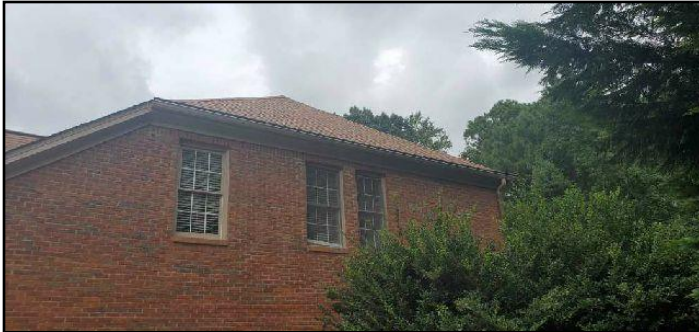
7. Asphalt shingles

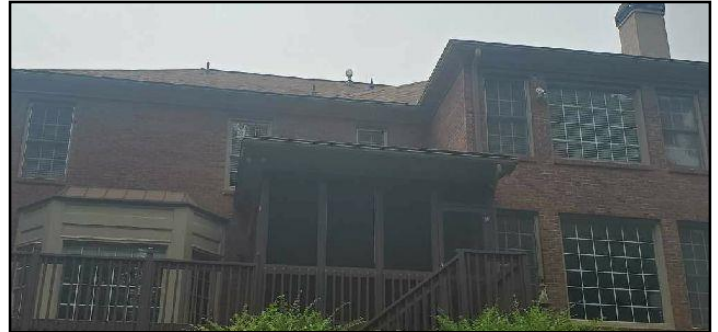
8. Asphalt shingles

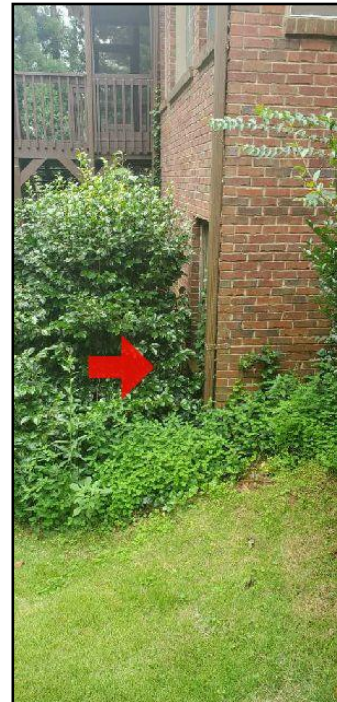
12. potential moisture intrusion

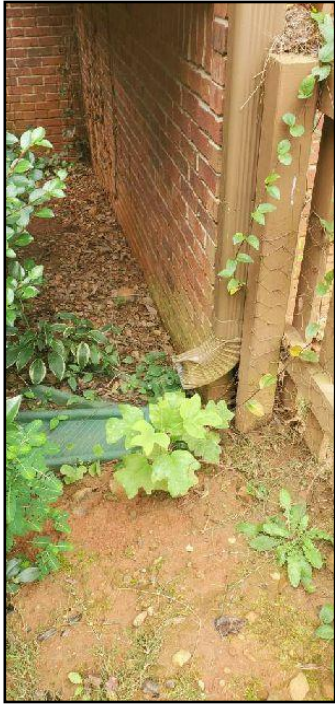
52. Above grade

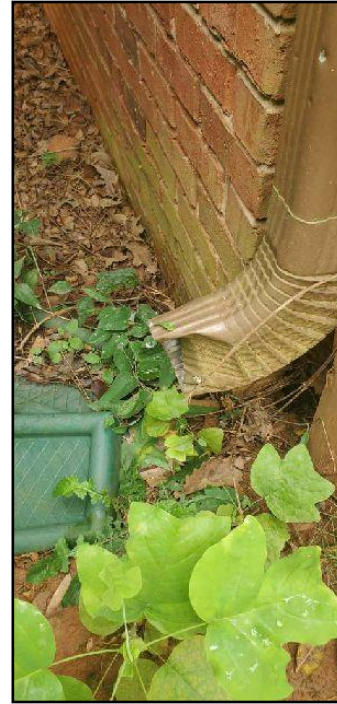
53. Above grade

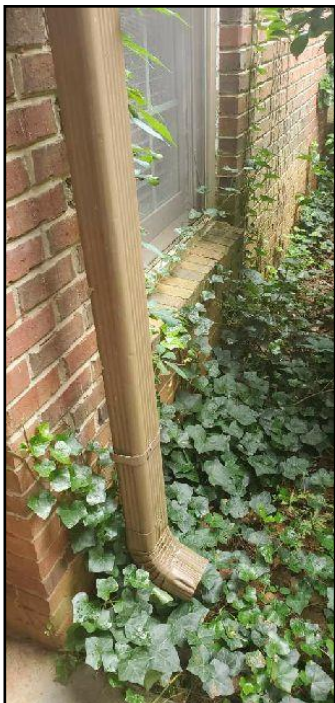
54. Above grade

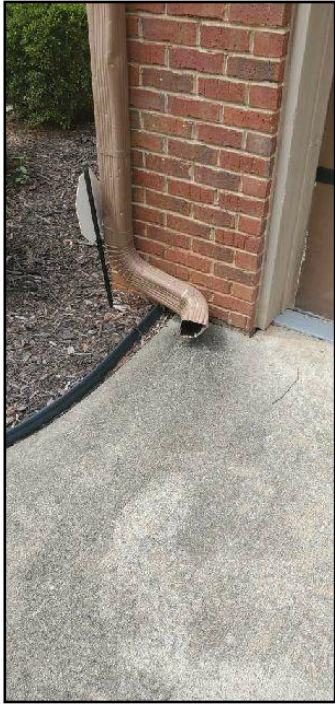
56. Above grade

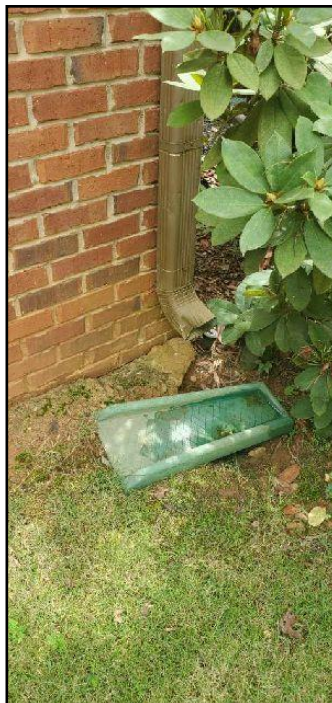
58. Above grade

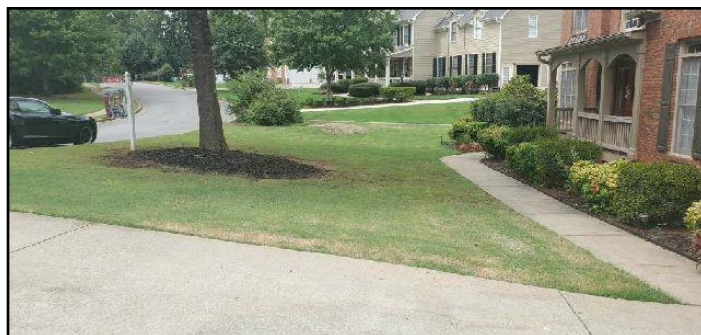
60. Towards building

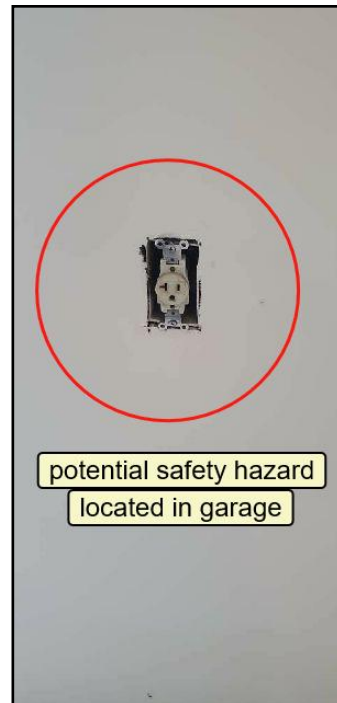
69. Attached

potential safety hazard
located in garage

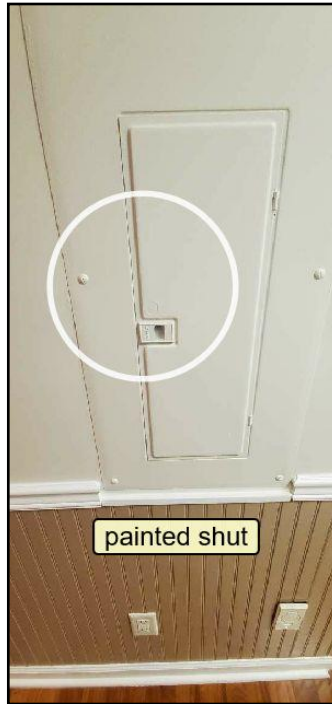
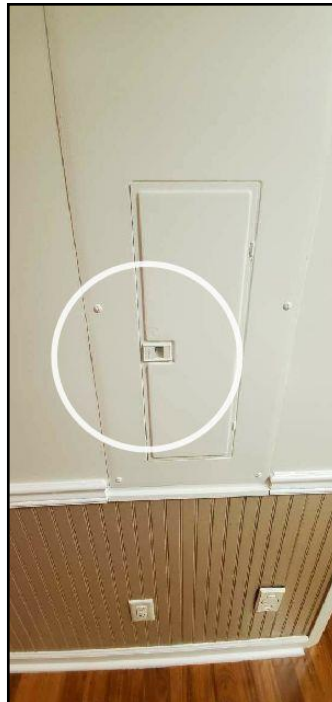
82. Breakers - basement

Painted shut

Distribution wire (conductor) material and type: • Unable to determine based on breaker box painted shut.

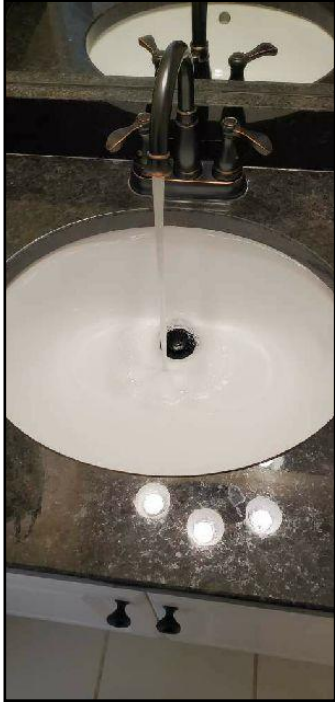
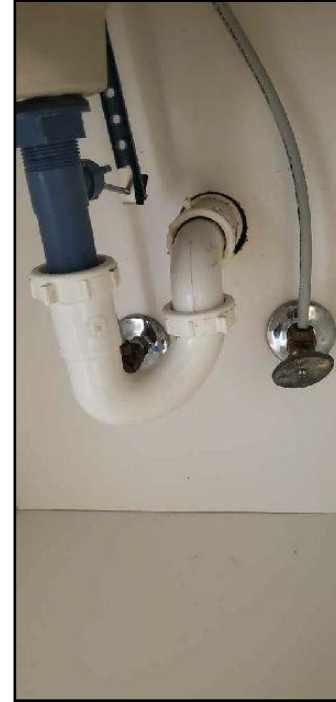
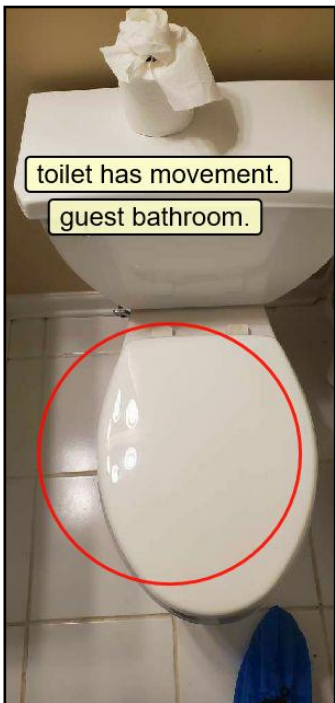
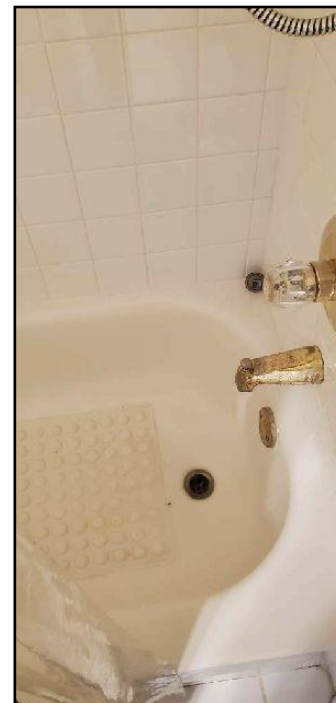
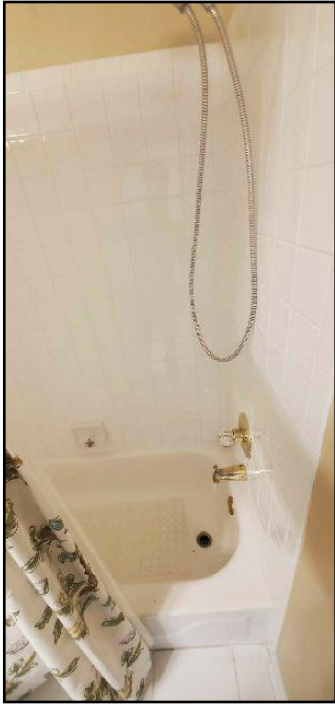
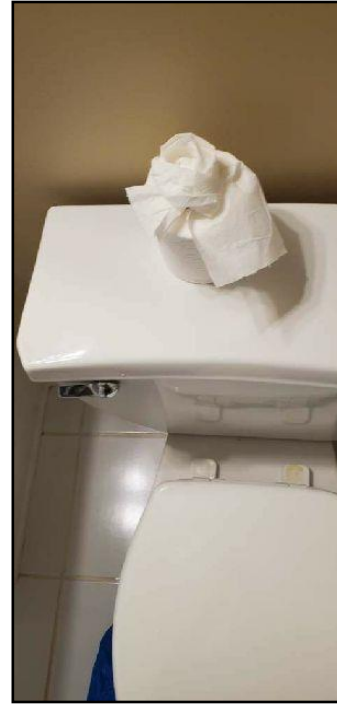
General: • Toilet has movement

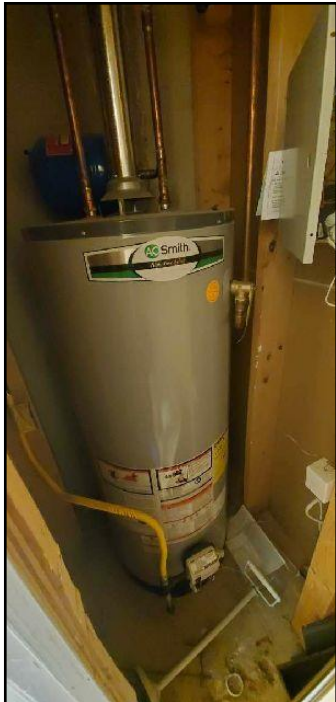
No drip pan

134. Conventional

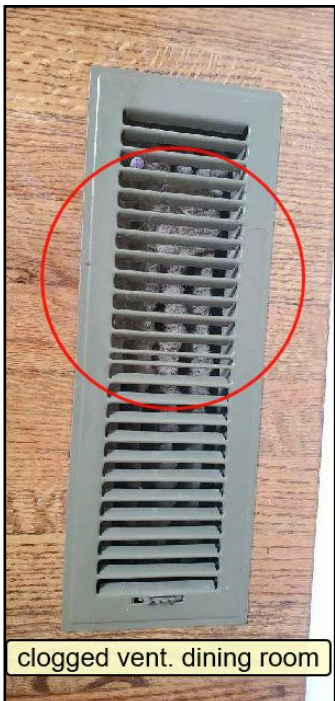
146.

clogged vent. dining room
