# ECO MONTHLY ENVIRONMENTAL MONITORING REPORT

Virginia Photo Voltaic (PV) Solar Facility 1, 2 and 3,  
Matjhabeng, Lejweleputswa District Municipality within  
the jurisdiction of the Free State Province.

January 2025

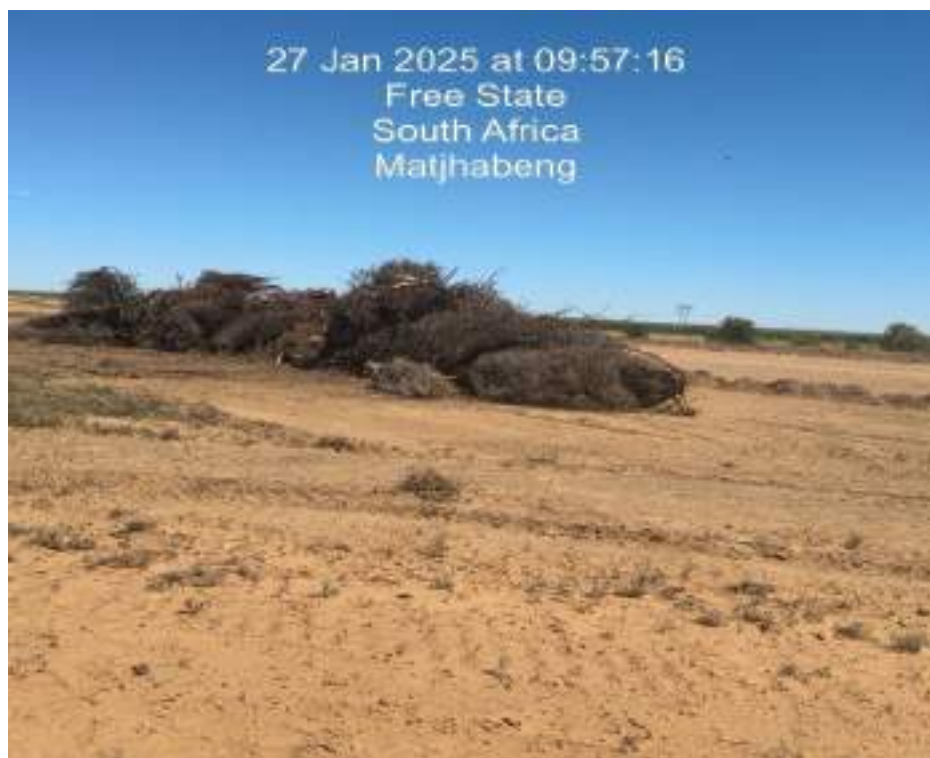
**Figure 4:** Fuel wood that can be given to the local communities

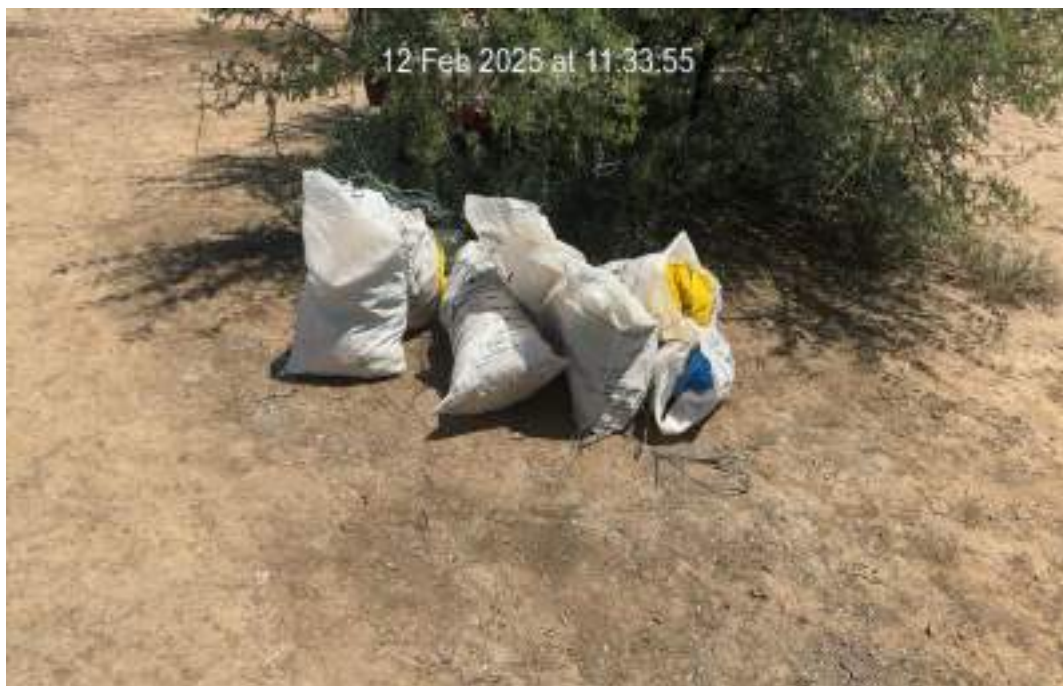
**Figure 4:** Bins must be provided for Waste management

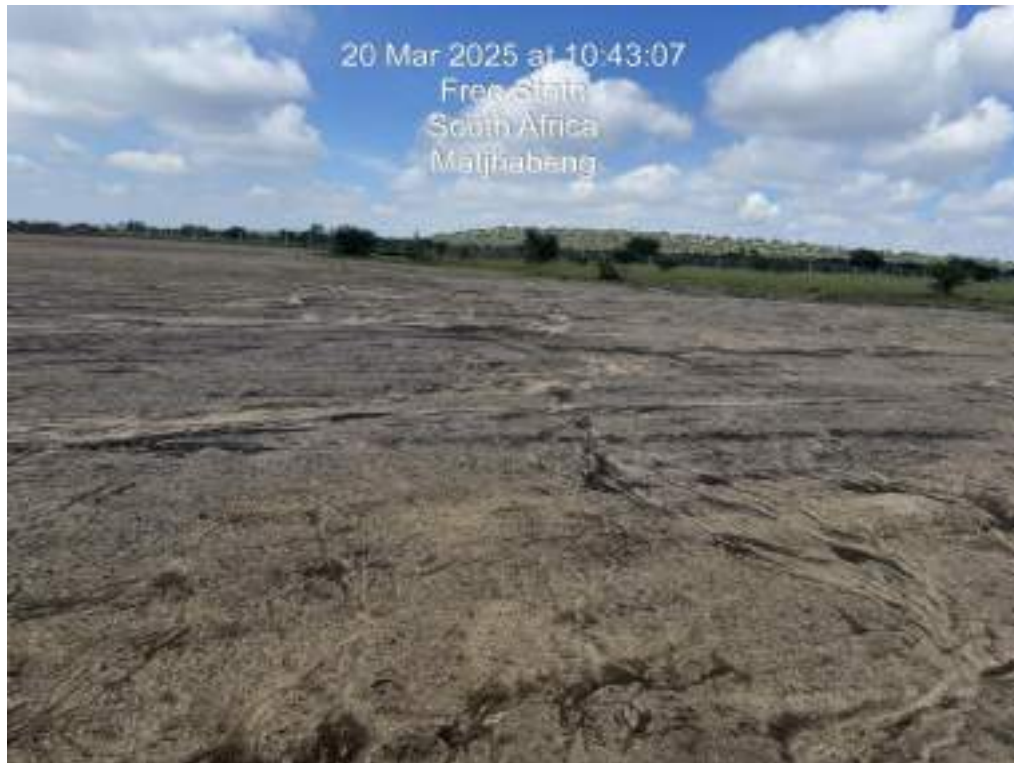
**Figure 5:** Erosion onsite

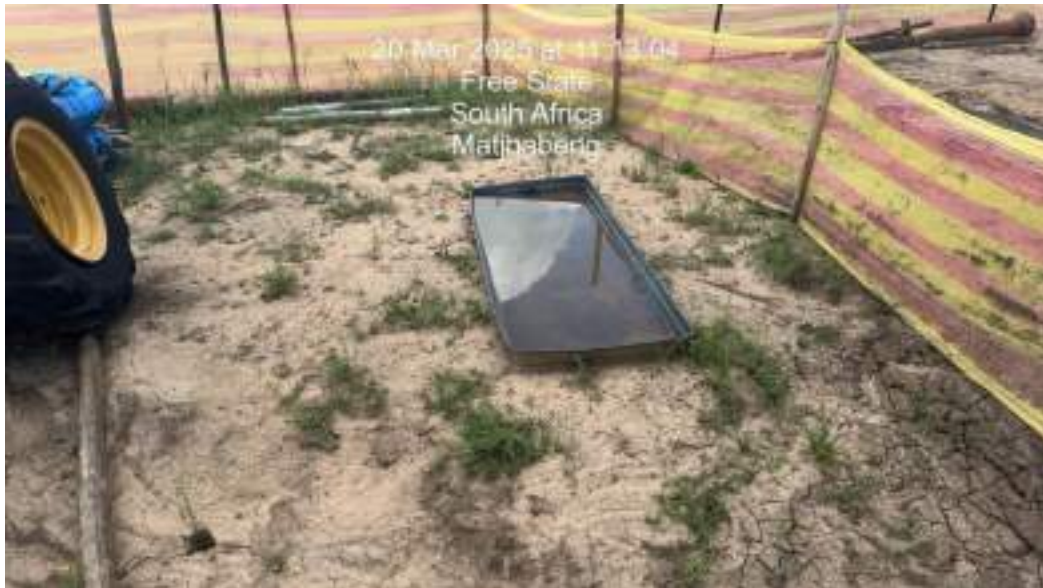
**Figure 9:** Drip tray with water

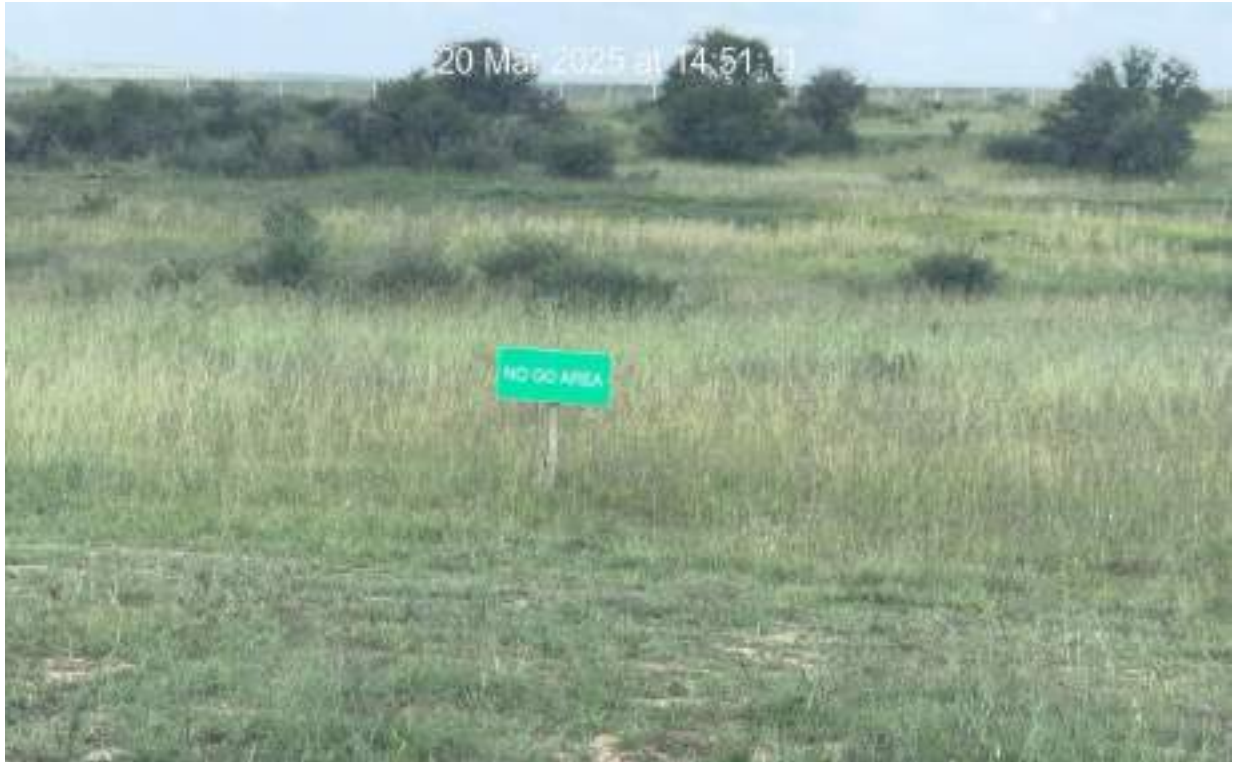
**Figure 11:** No-go signs that were placed

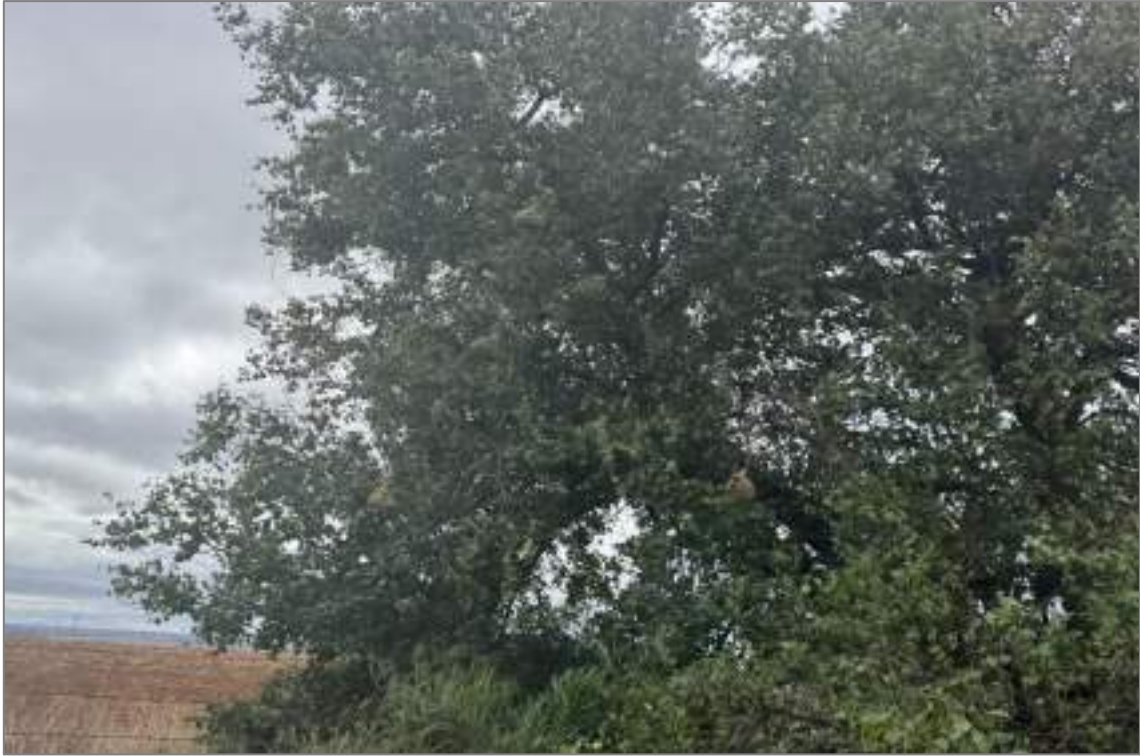
**Figure 3:** Birds nest that must be recorded.

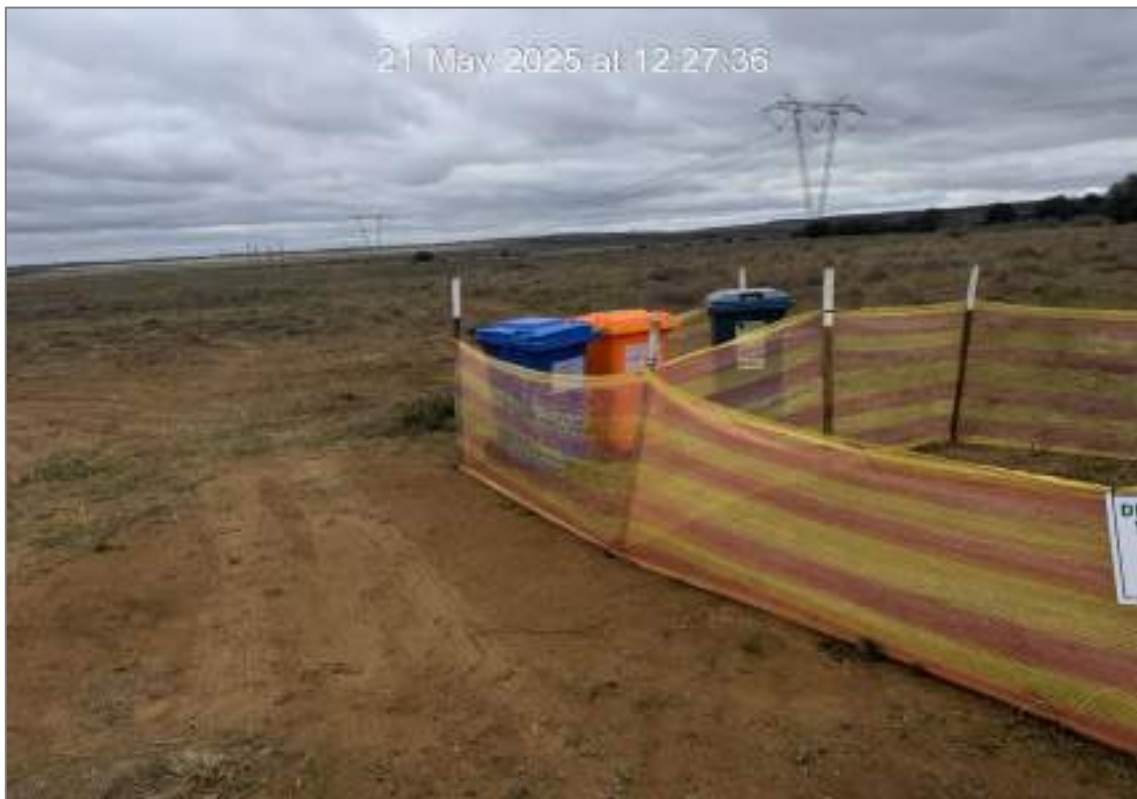
**Figure 6:** Bins provided for along the OHL line.

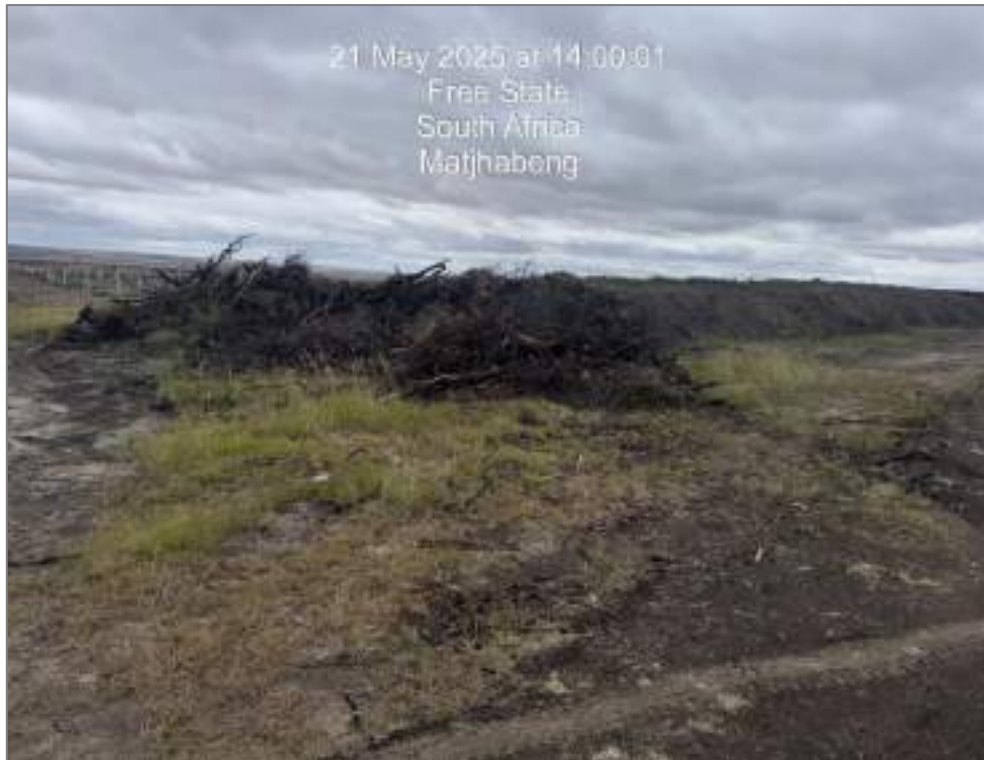
**Figure 5:** Cleared trees should be donated.

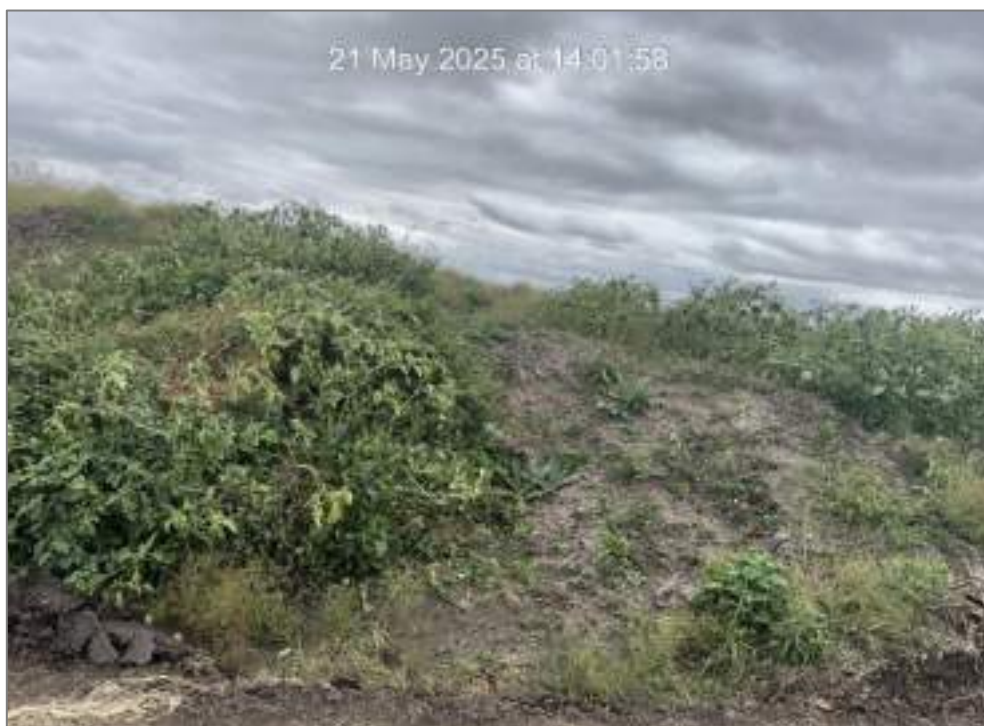
**Figure 6:** Alien vegetation on stockpiles

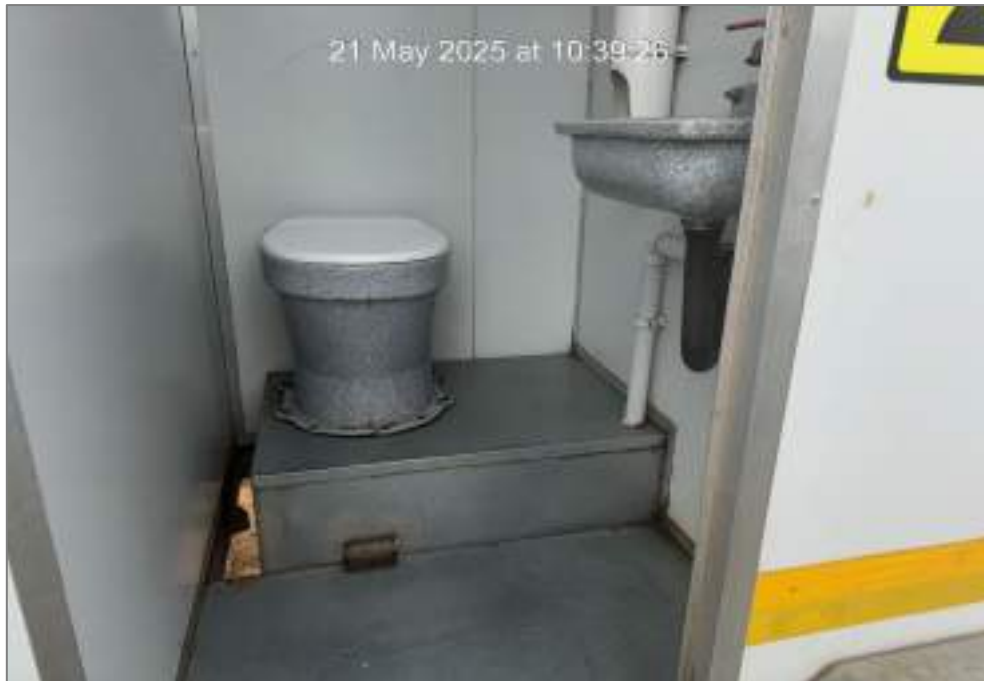
**Figure 7:** Clean toilets

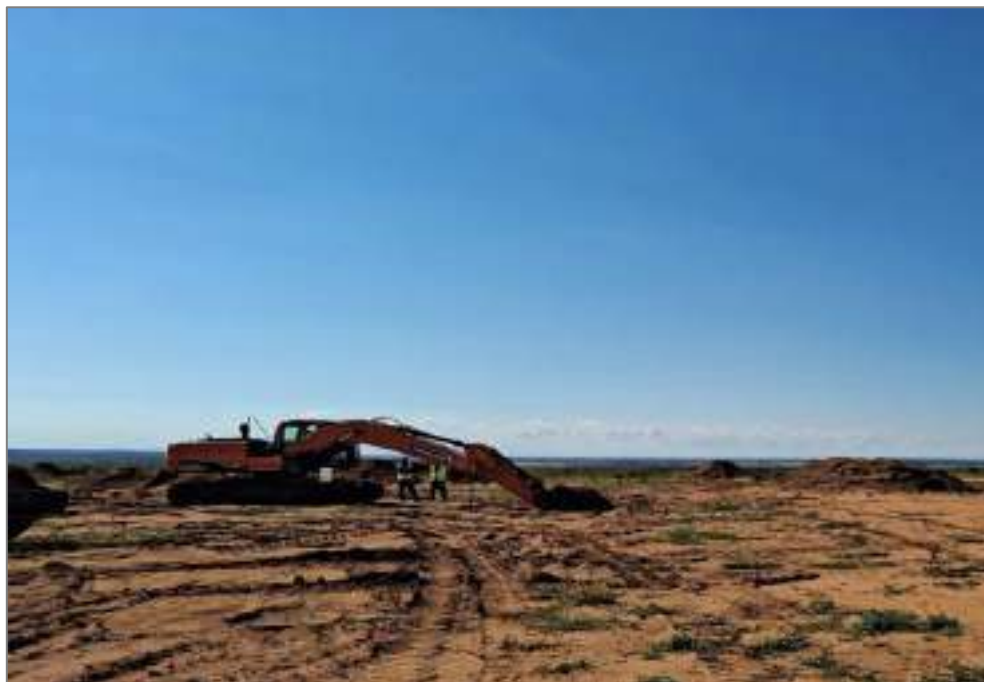
**Figure 8:** On-going clearance of alien vegetation.

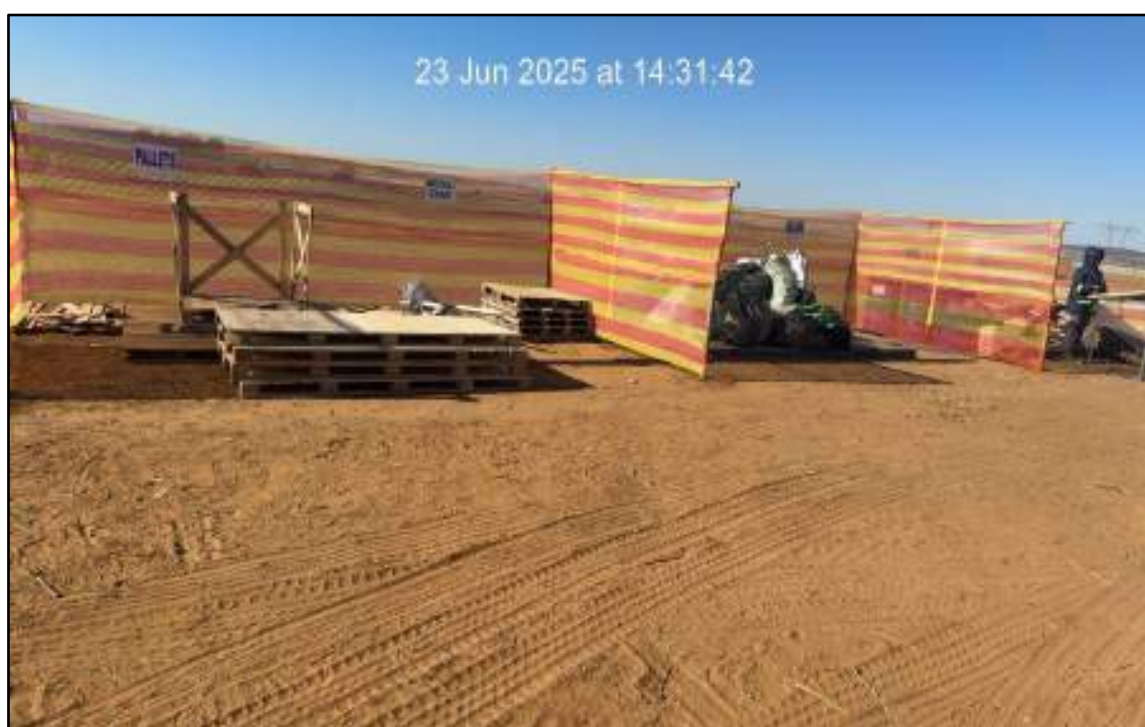
**Figure 2:** Waste Segregation compartments at the waste area.

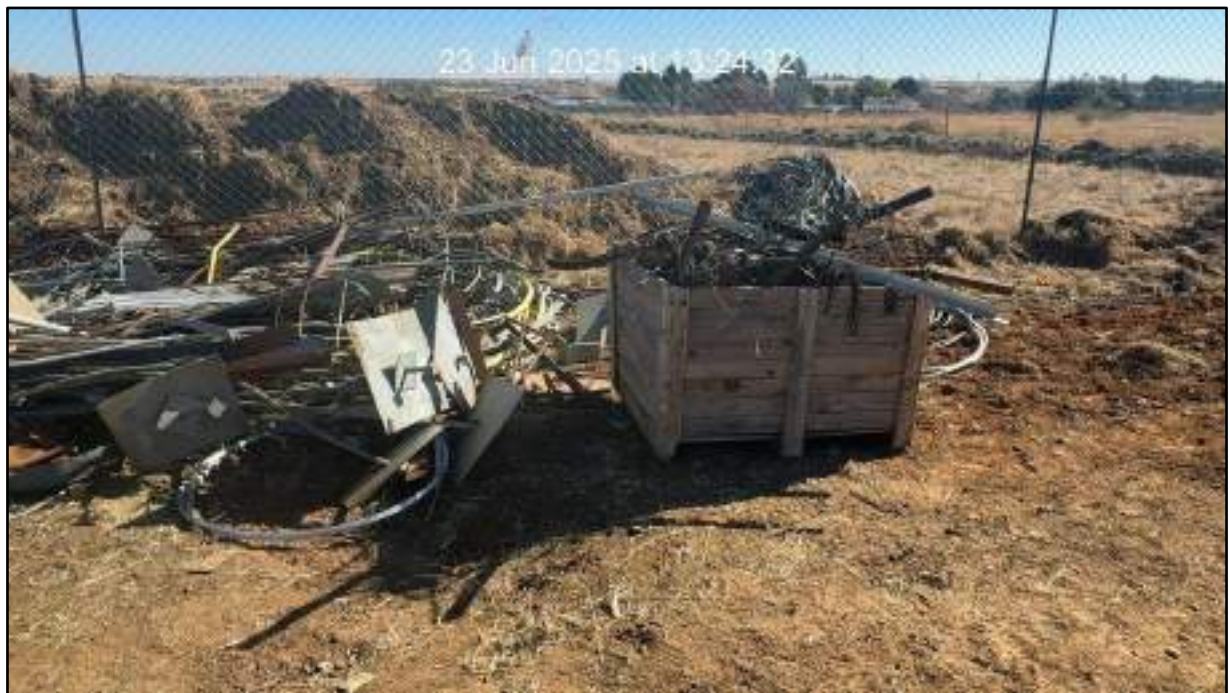
**Figure 4:** Scrap metal that must be recycled.

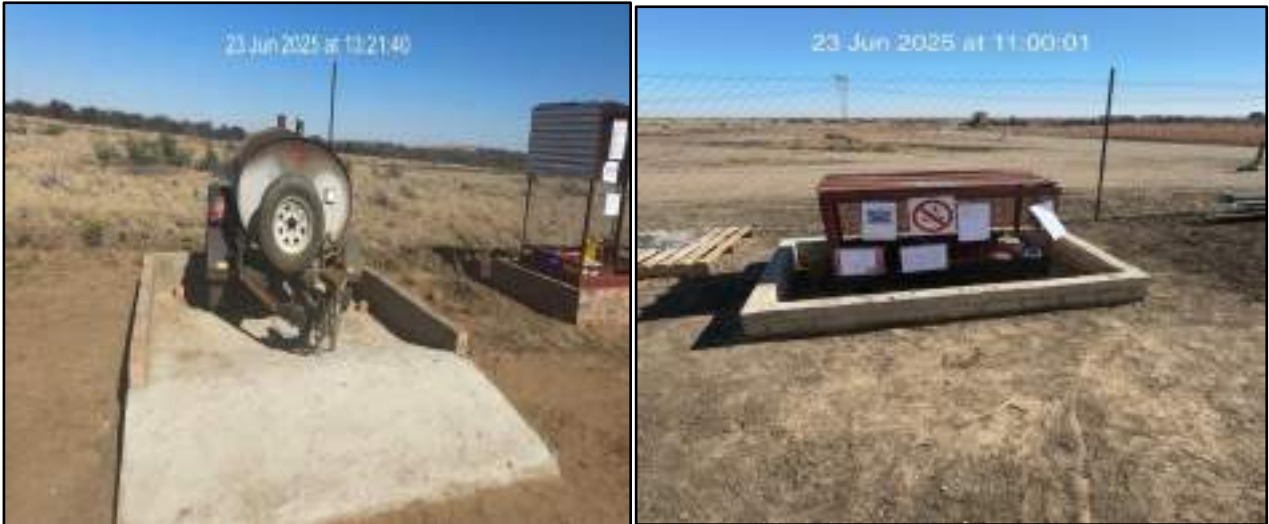
**Figure 5:** Diesel buzzer on an impervious surface and hazardous chemical bund.

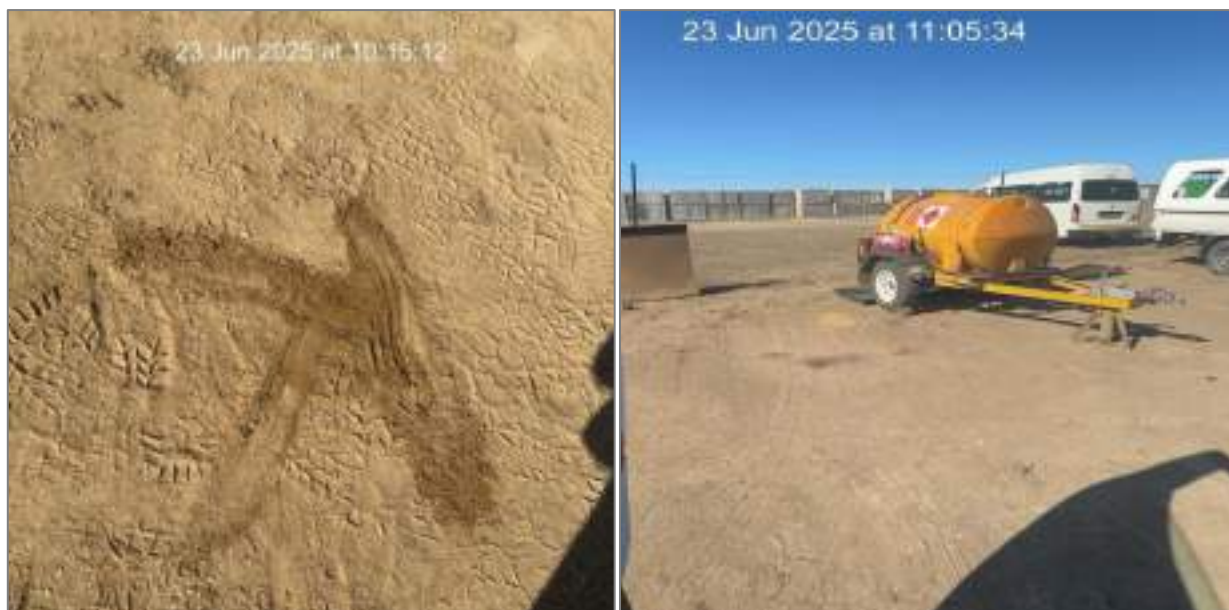
**Figure 1:** Oil spillages.

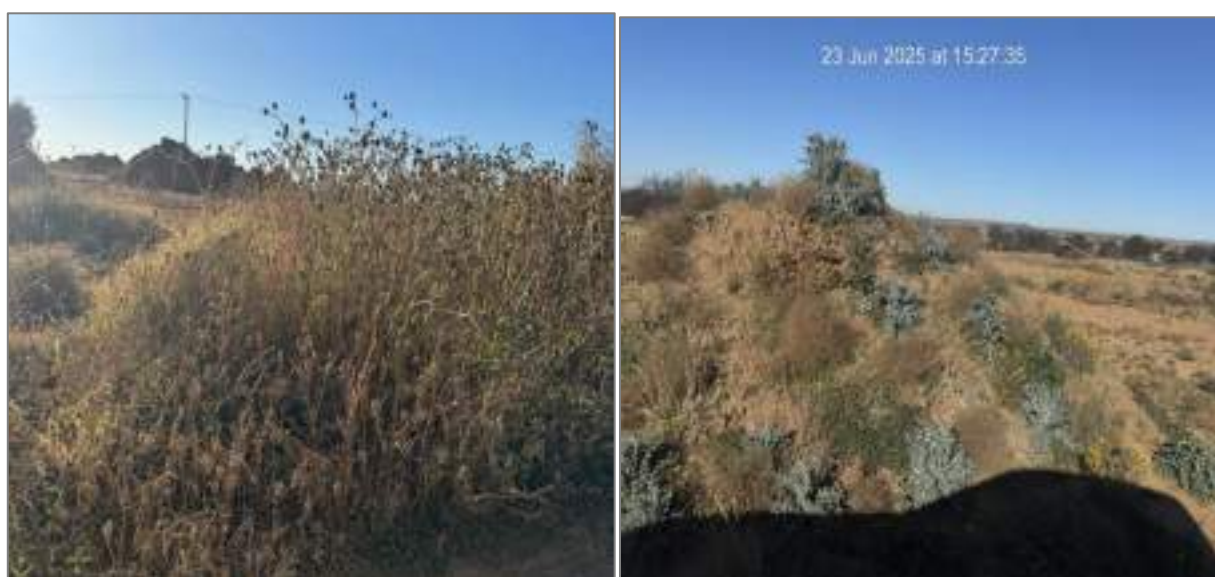
**Figure 2:** Overgrown alien vegetation

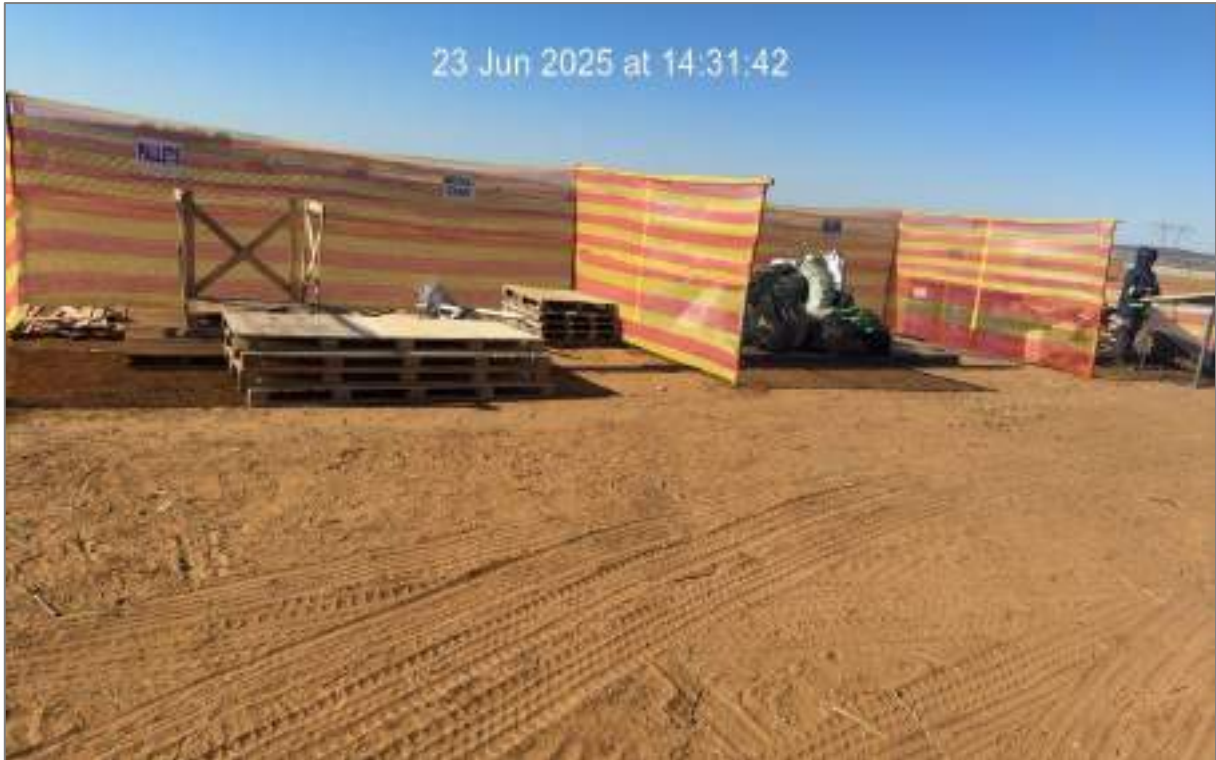
**Figure 7:** Waste Segregation compartments at the waste area.

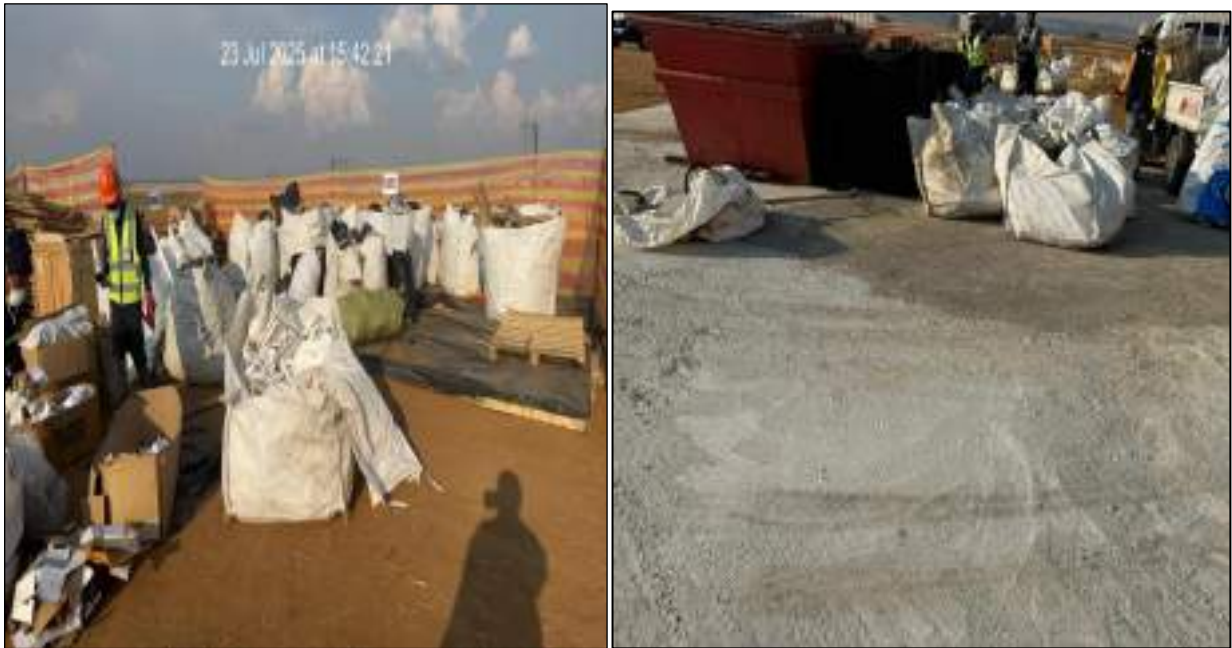
**Figure 1:** Waste being sorted and packaged at waste area.

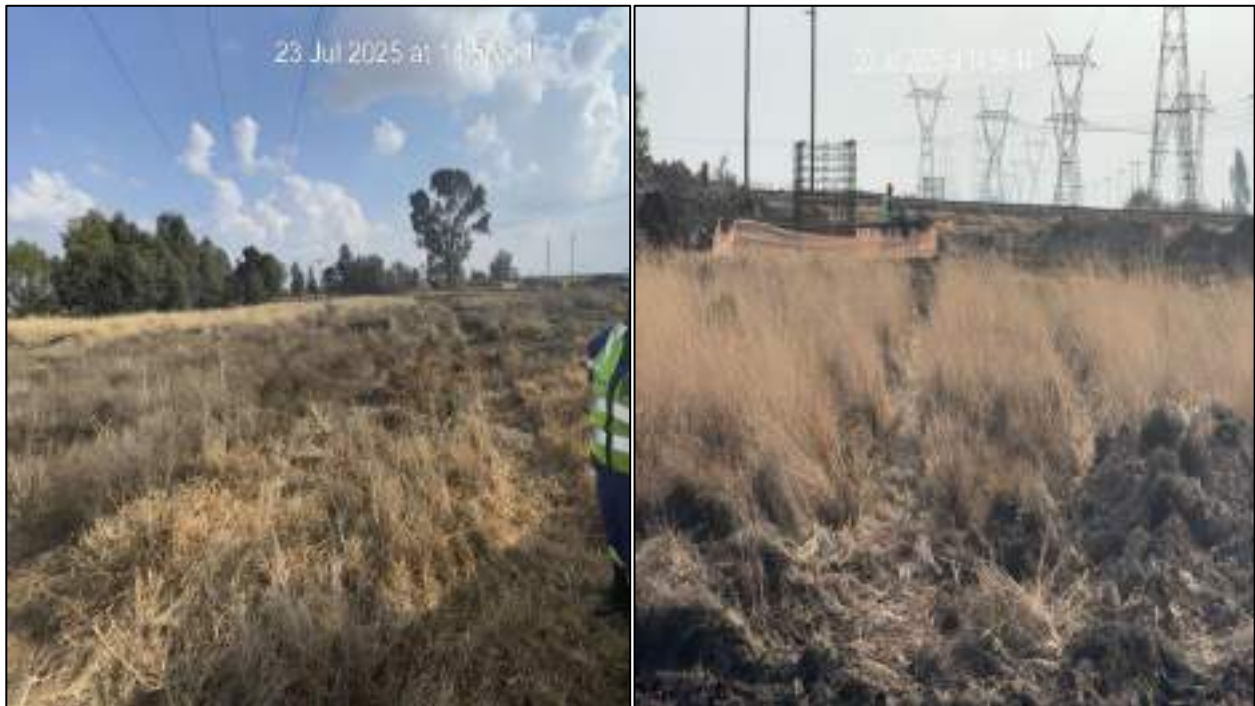
**Figure 2:** Wetland that has been transversed by trucks .

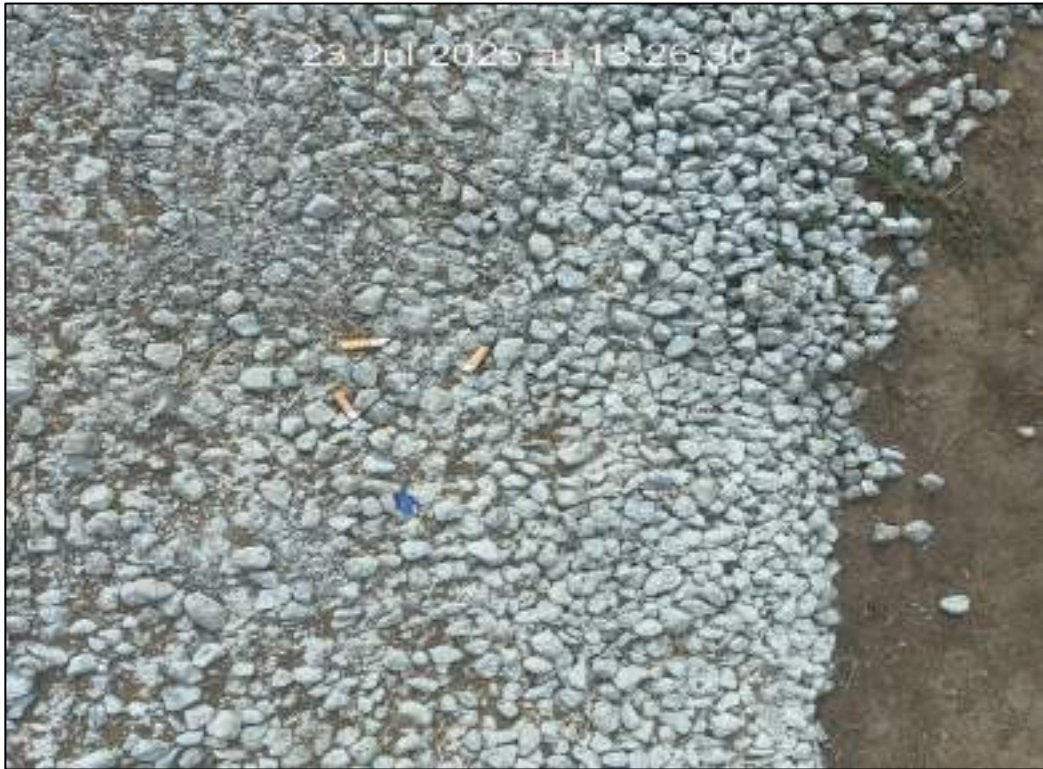
**Figure 3:** Cigarettes buds on the ground.

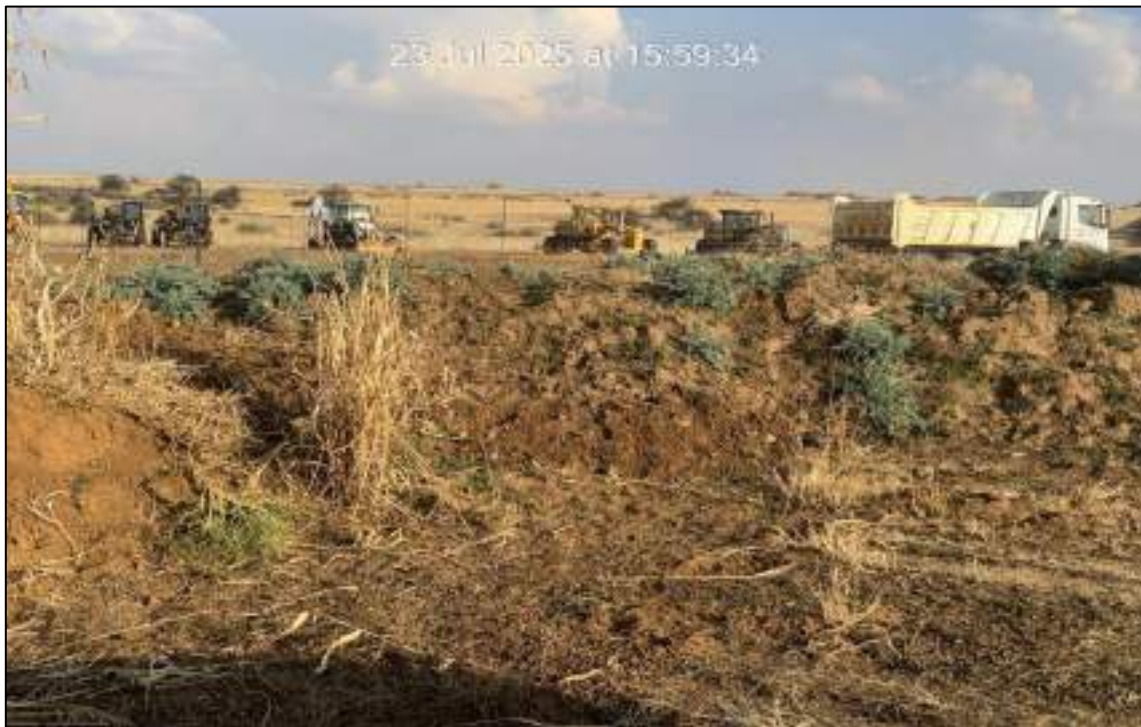
**Figure 6:** Alien vegetation.

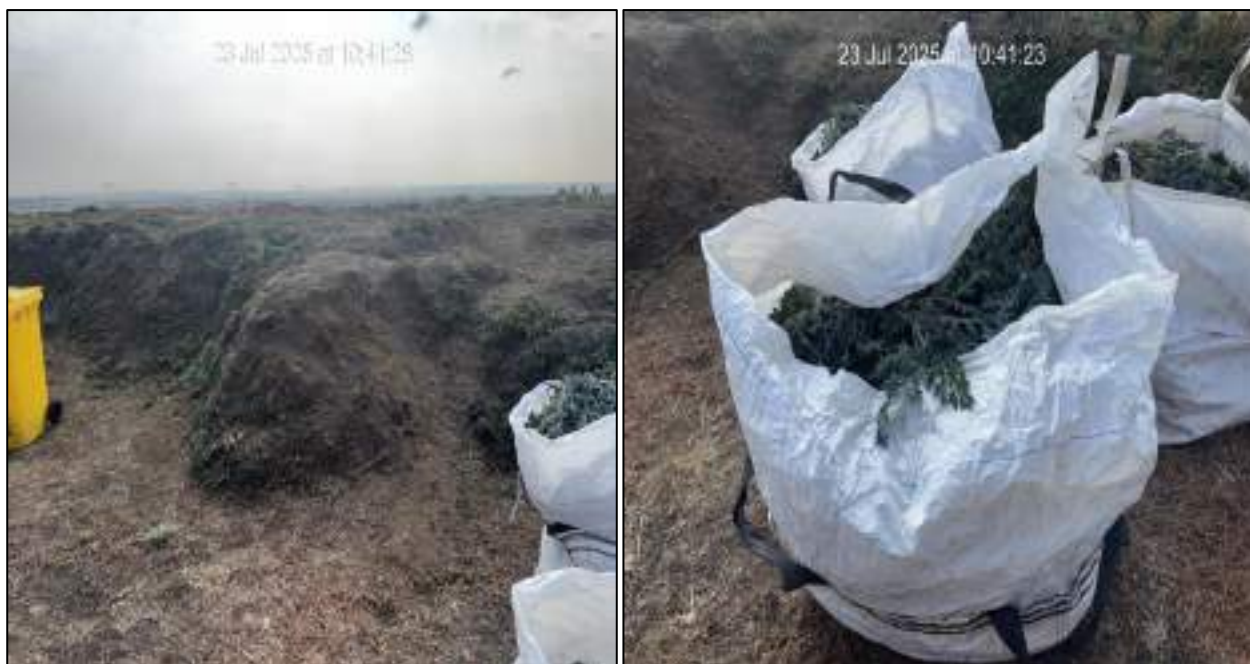
**Figure 9:** On -going Clearance of Alien Vegetation

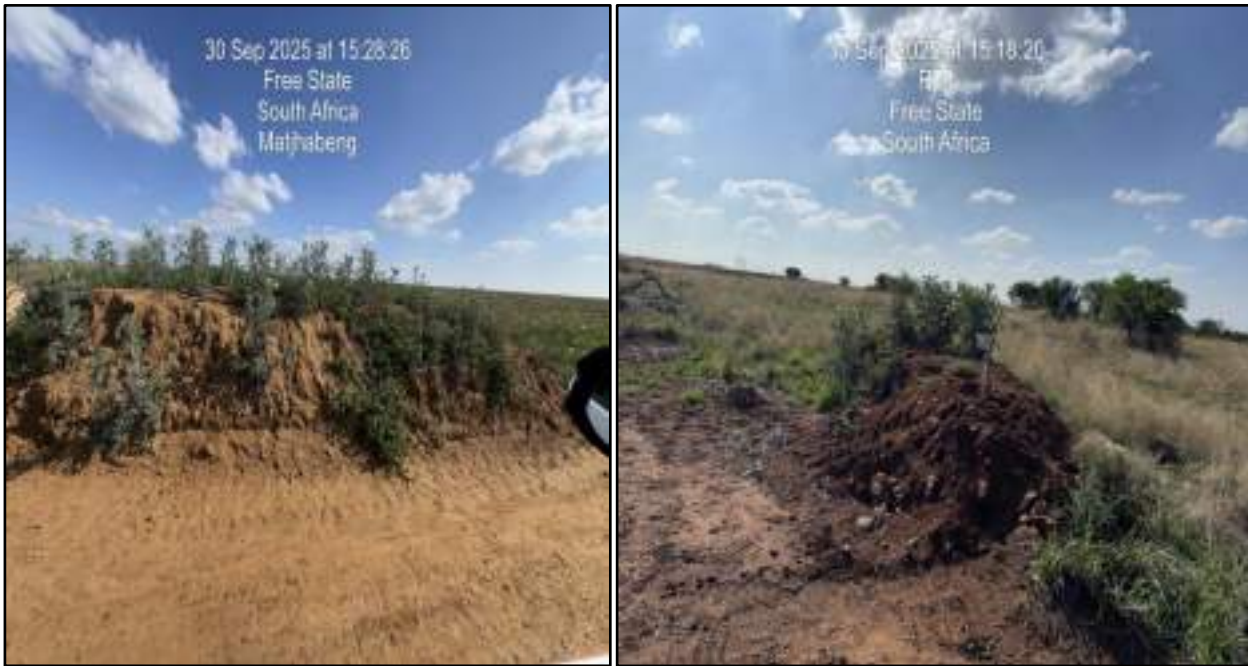
**Figure 2:** Alien vegetation on stockpiles.

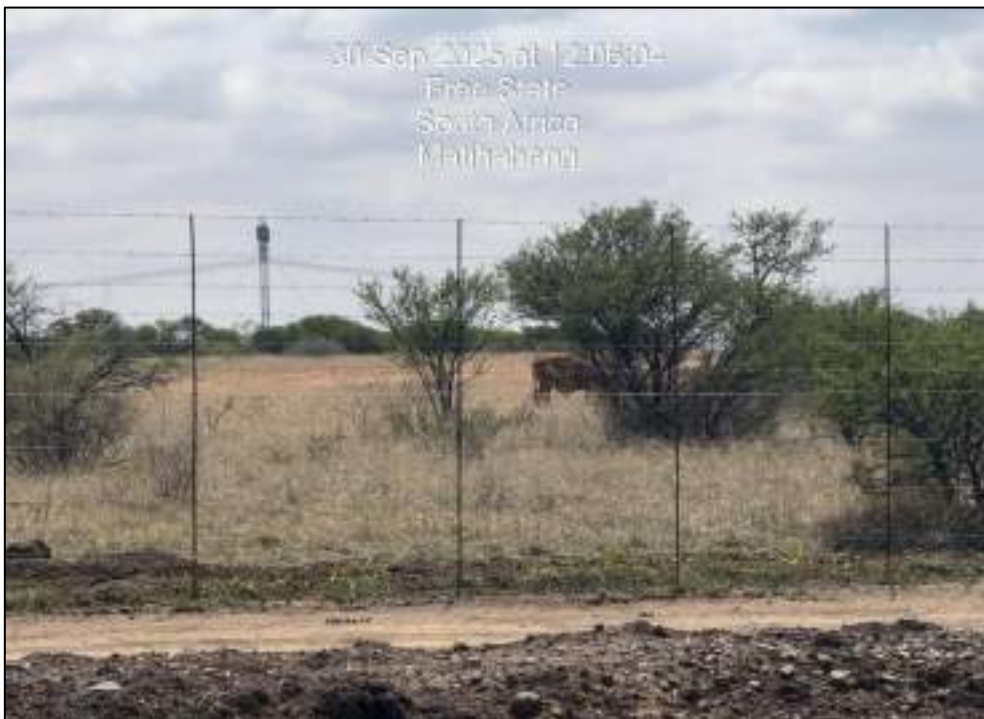
**Figure 6:** Cattle in the construction area.

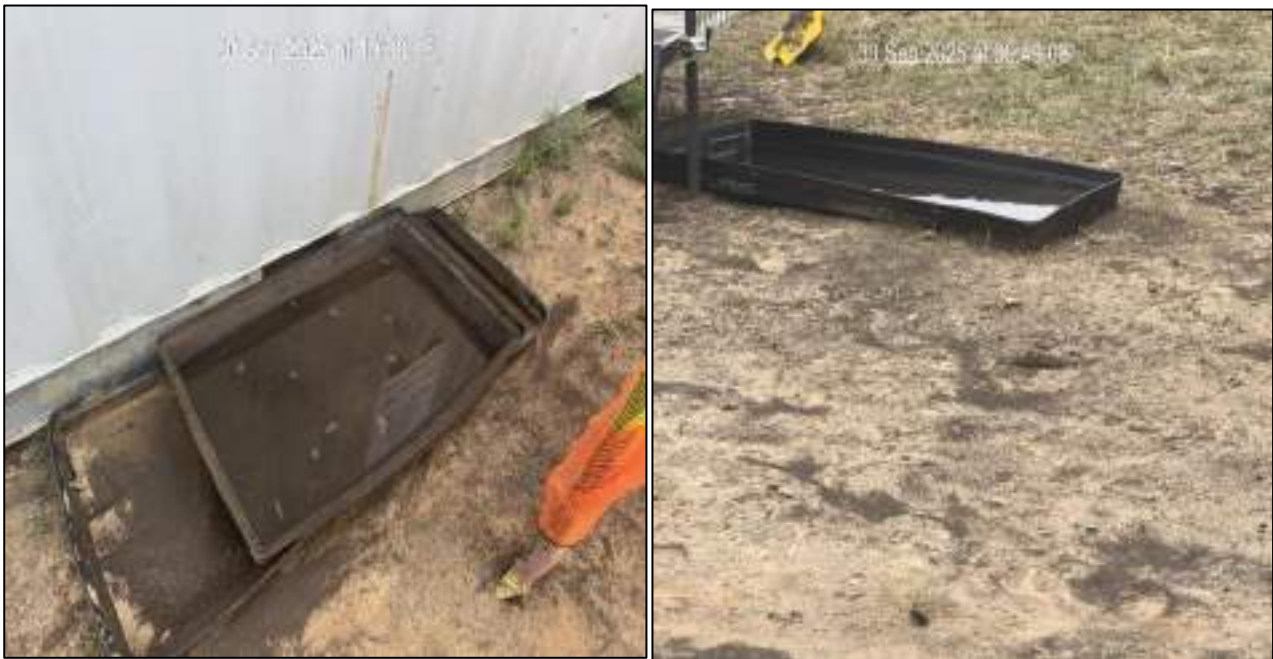
**Figure 8:** Drip Trays with water.

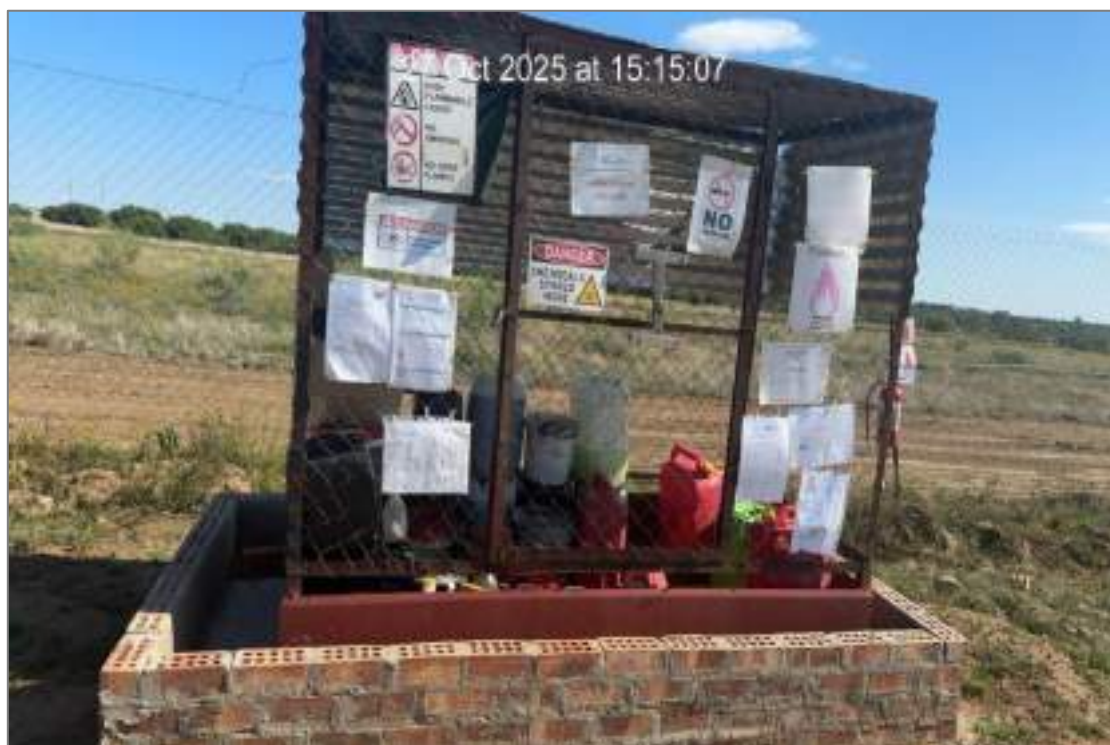
**Figure 2:** Overcrowded chemical bund.

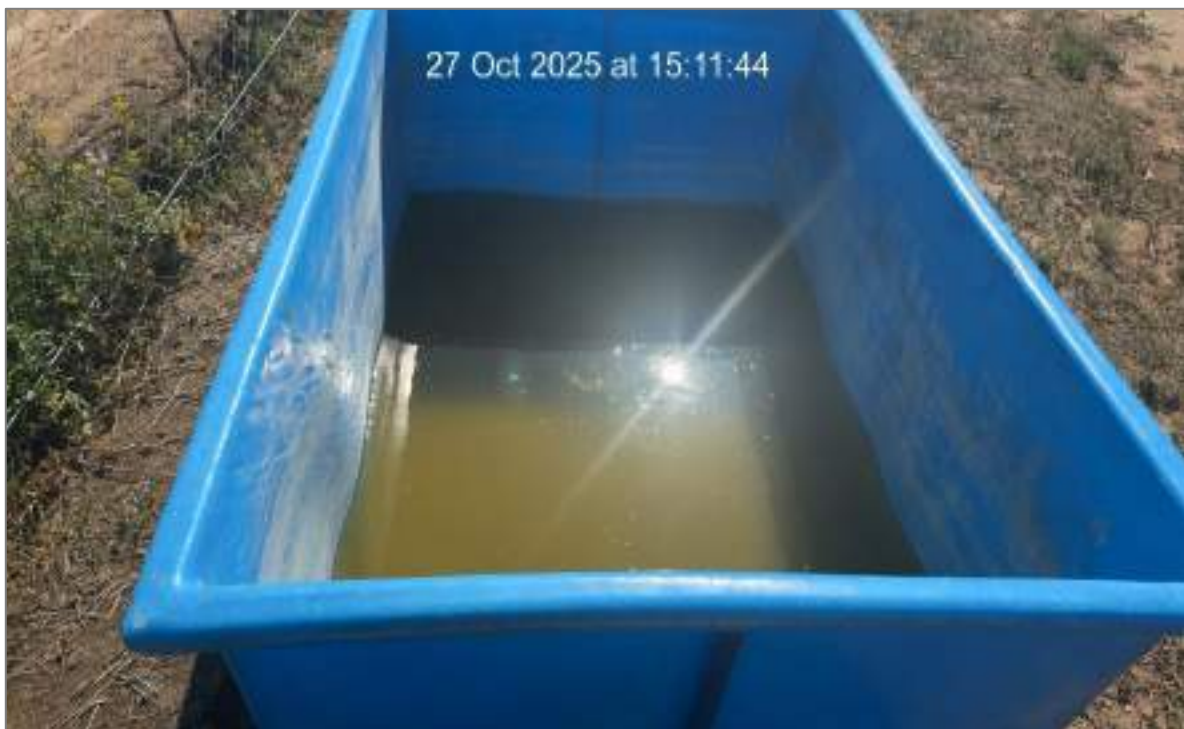
**Figure 4:** Container that must be emptied.

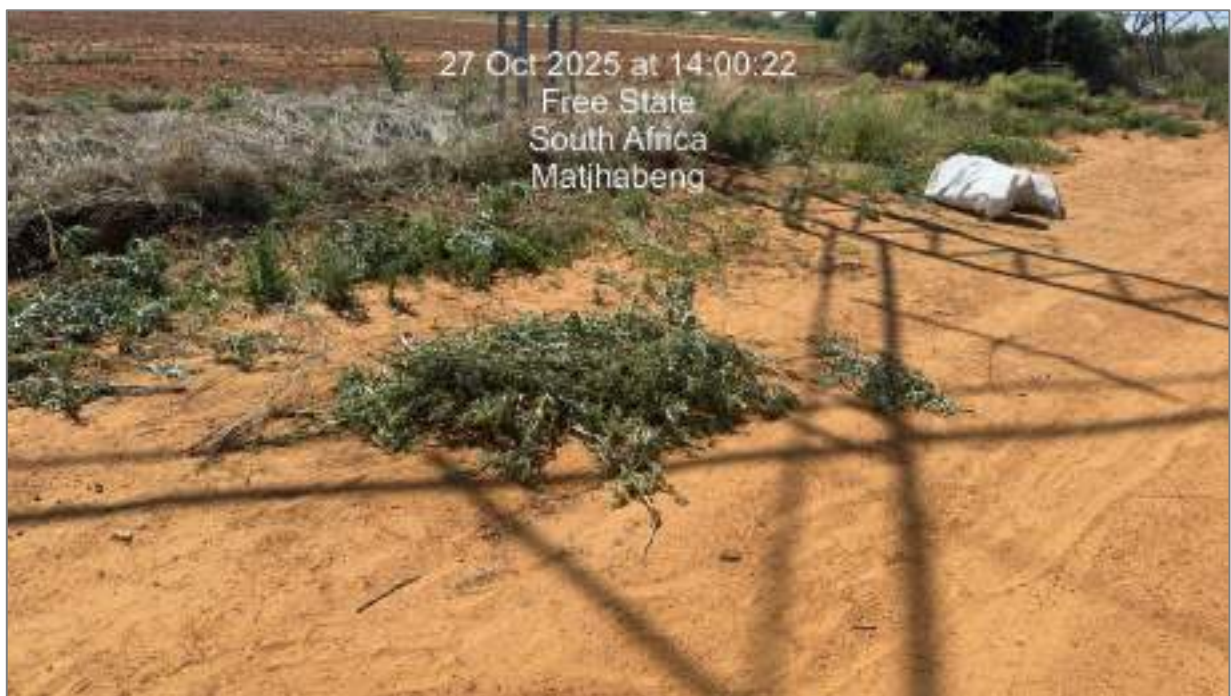
**Figure 8:** Alien vegetation being cleared.

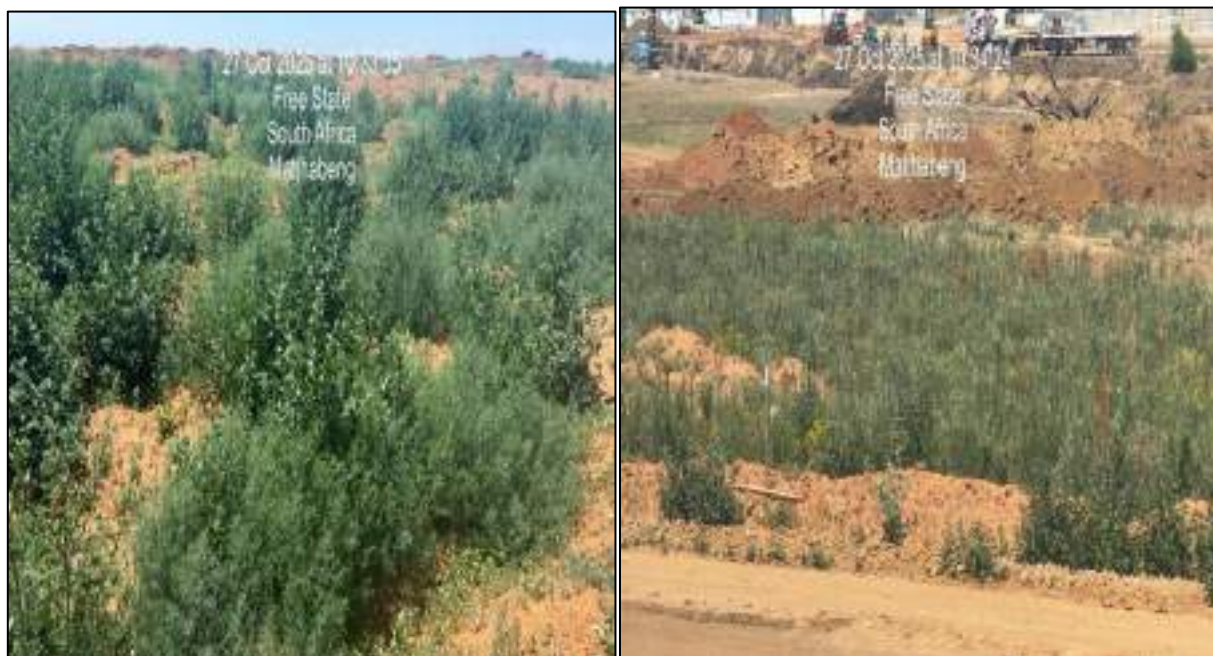
**Figure 2:** Alien Vegetation.
