# ECO MONTHLY ENVIRONMENTAL MONITORING REPORT

Virginia Photo Voltaic (PV) Solar Facility 1, 2 and 3,  
Matjhabeng, Lejweleputswa District Municipality within  
the jurisdiction of the Free State Province.

January 2025

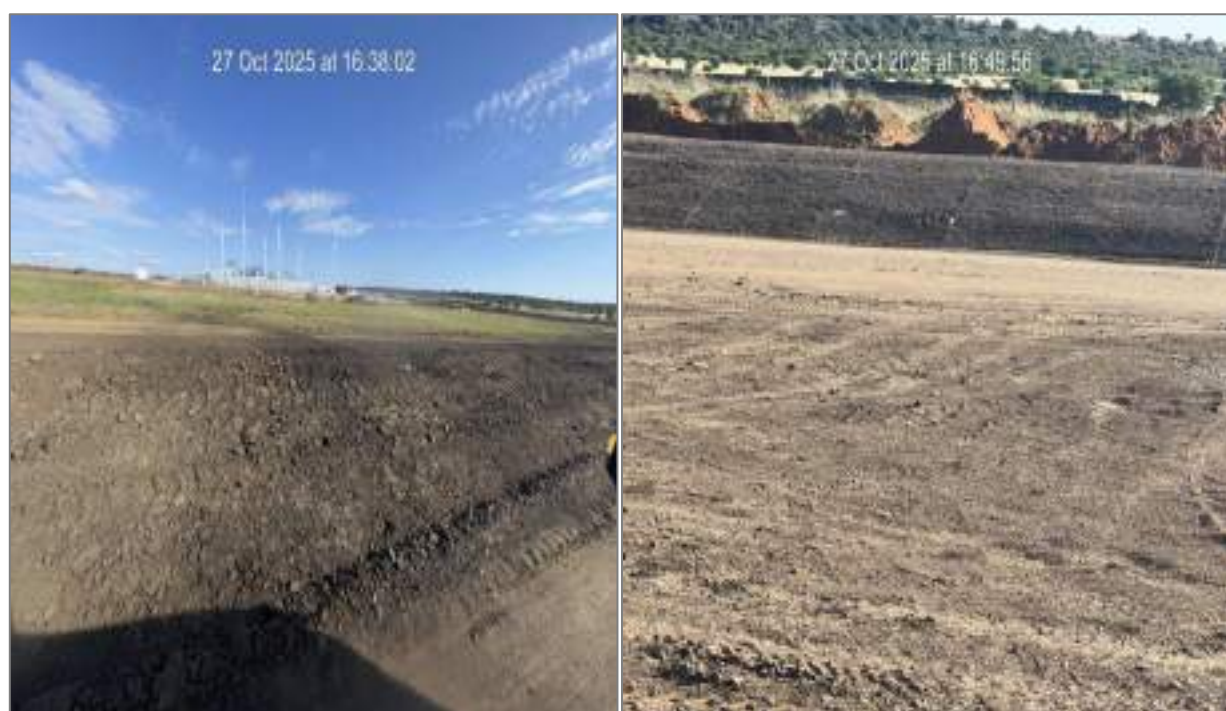
**Figure 4:** Berms that have been established

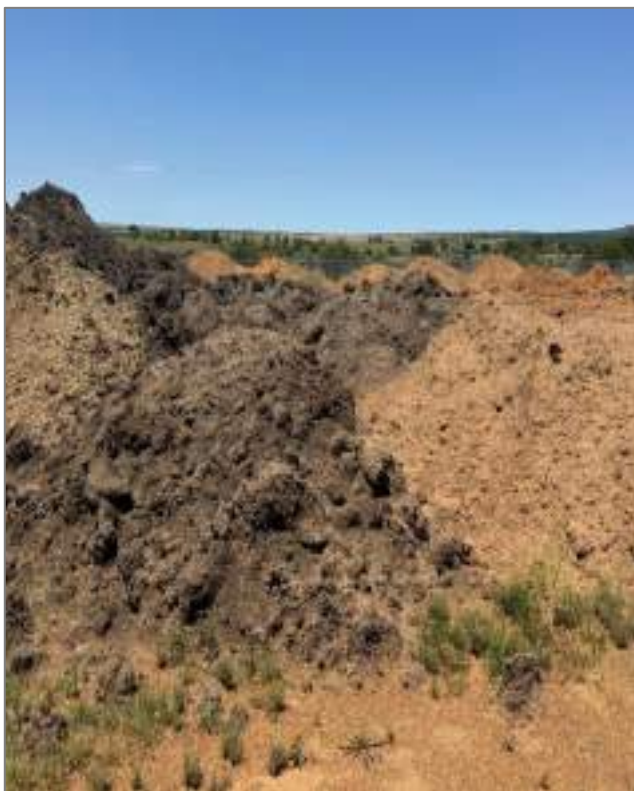
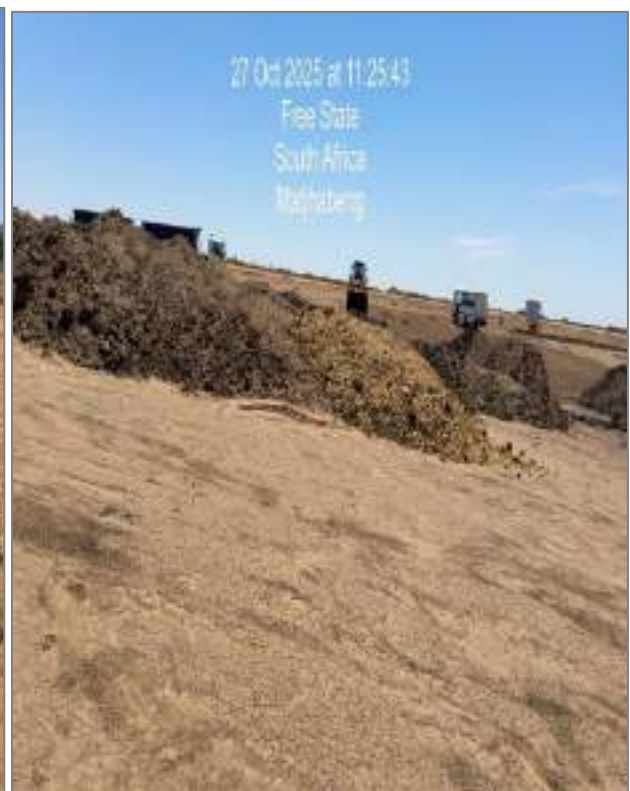
**Figure 6:** Topsoil being mixed with subsoil

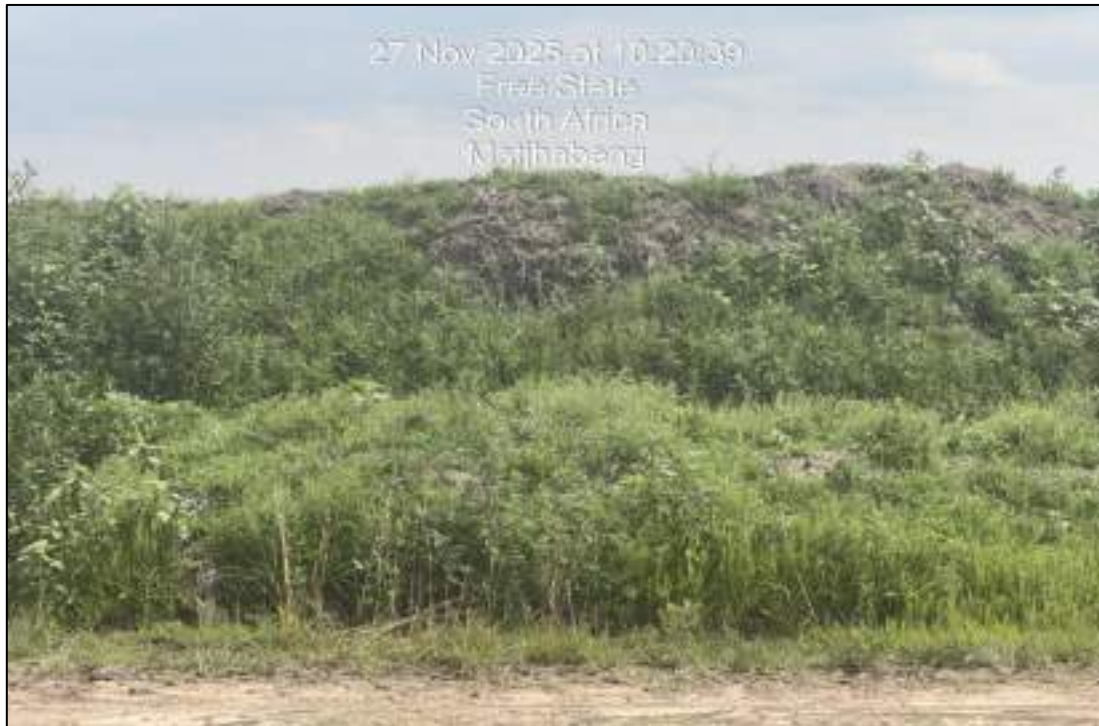
**Figure 7:** Alien vegetation that must be cleared.

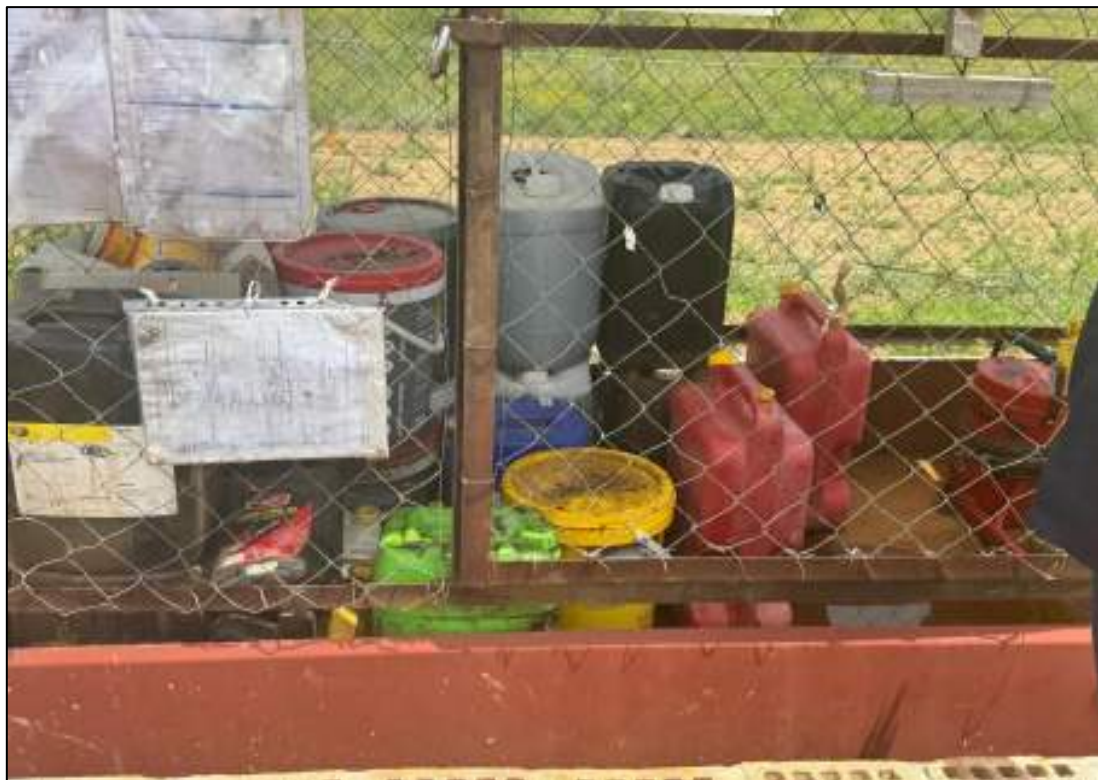
**Figure 10:** Crowded chemical bund

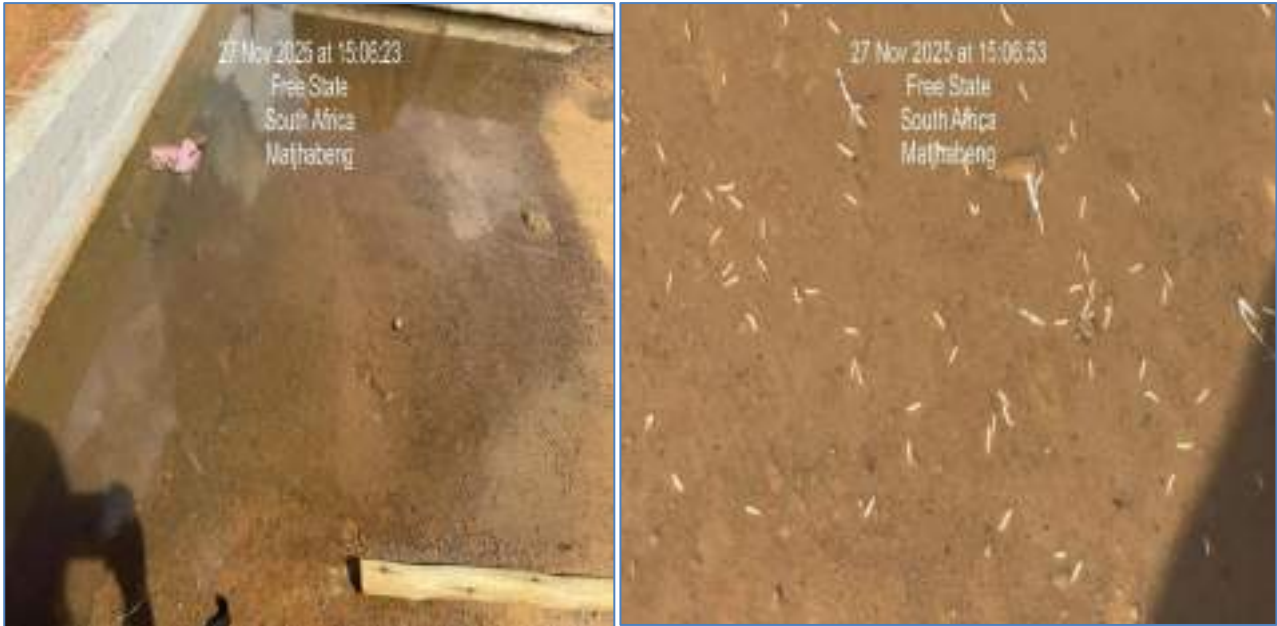
**Figure 5:** Maggots in standing water at the waste area.

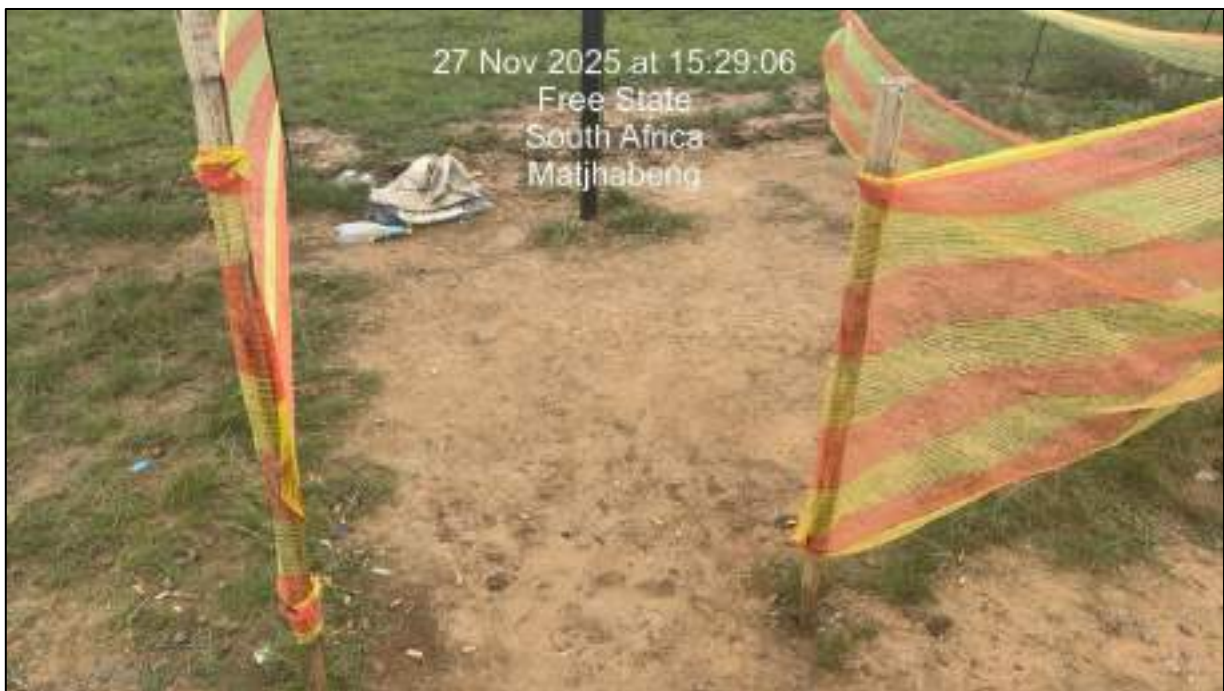
**Figure 6:** Cigarette buds on the ground

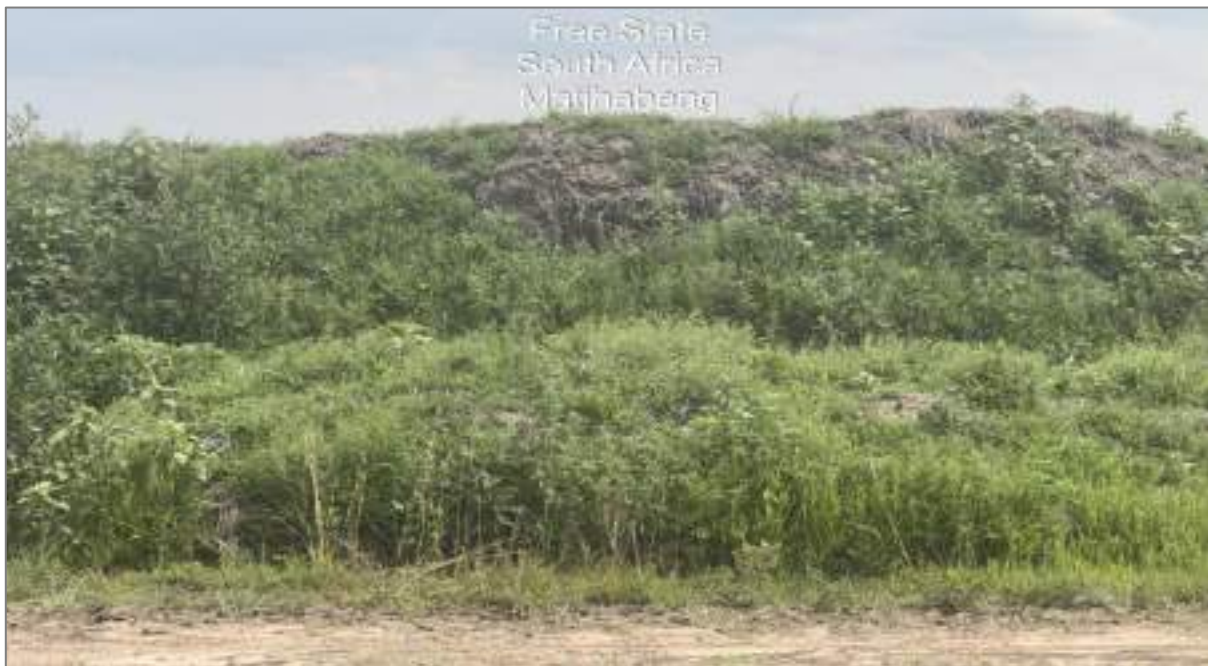
**Figure 6:** Alien vegetation that must be cleared.
