202501674
December 23, 2025

Property Condition Assessment (ASTM E 2018-24)

Motel 6
236 N Dixie Hwy
South Bend, Indiana 46637

Prepared By:
NV5
4580 Stephen Circle, Suite 300
Canton, Ohio 44718
800.787.8397

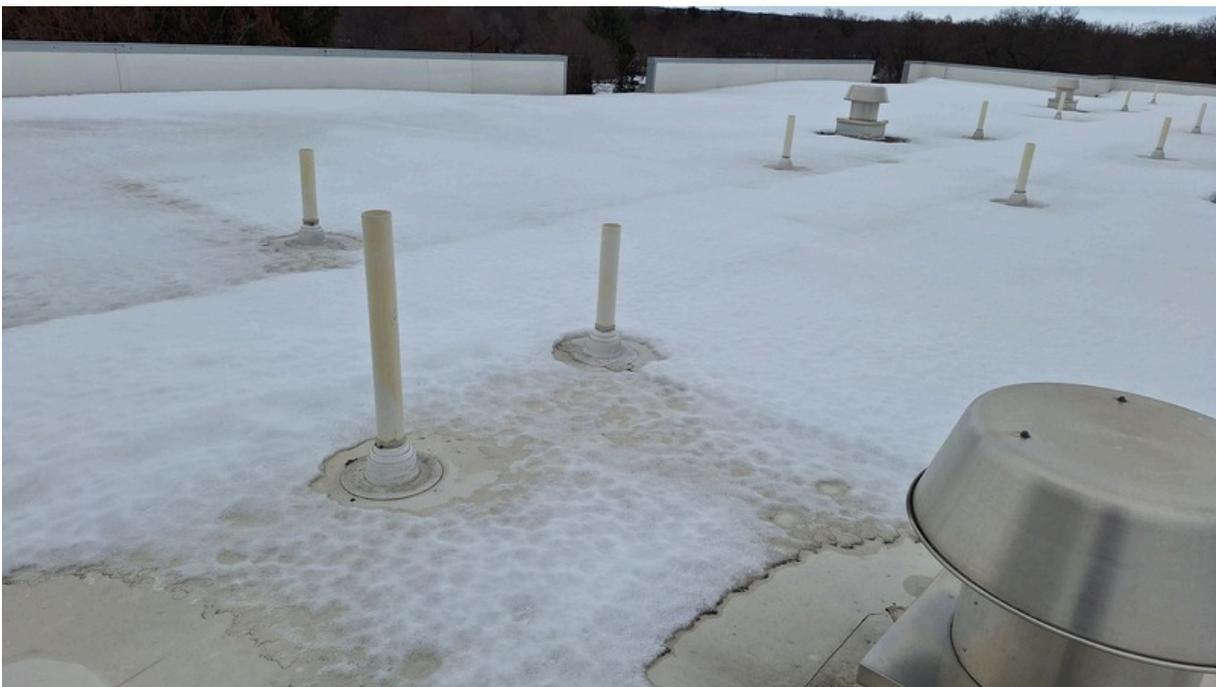
Roofing system

Cost Recommendation	EUL	EFF AGE	RUL	Year	Cost
Roof membrane - Replace	20	10	10	10	\$50,000
Total					\$50,000

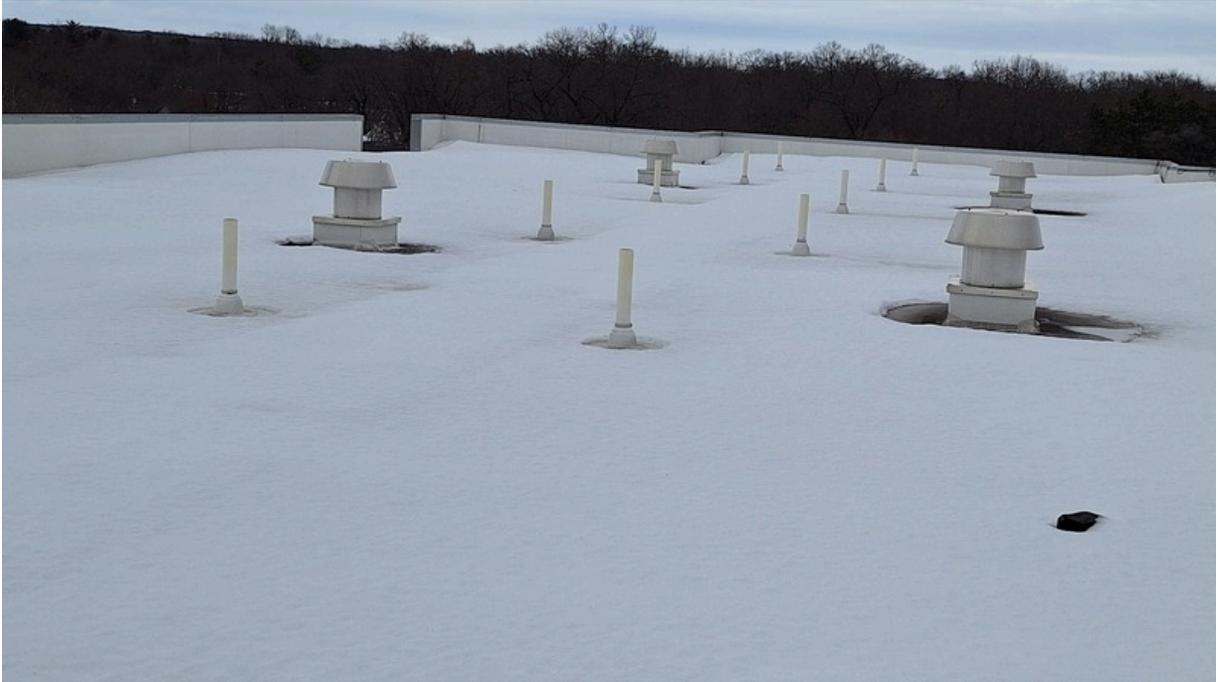
Roofing system

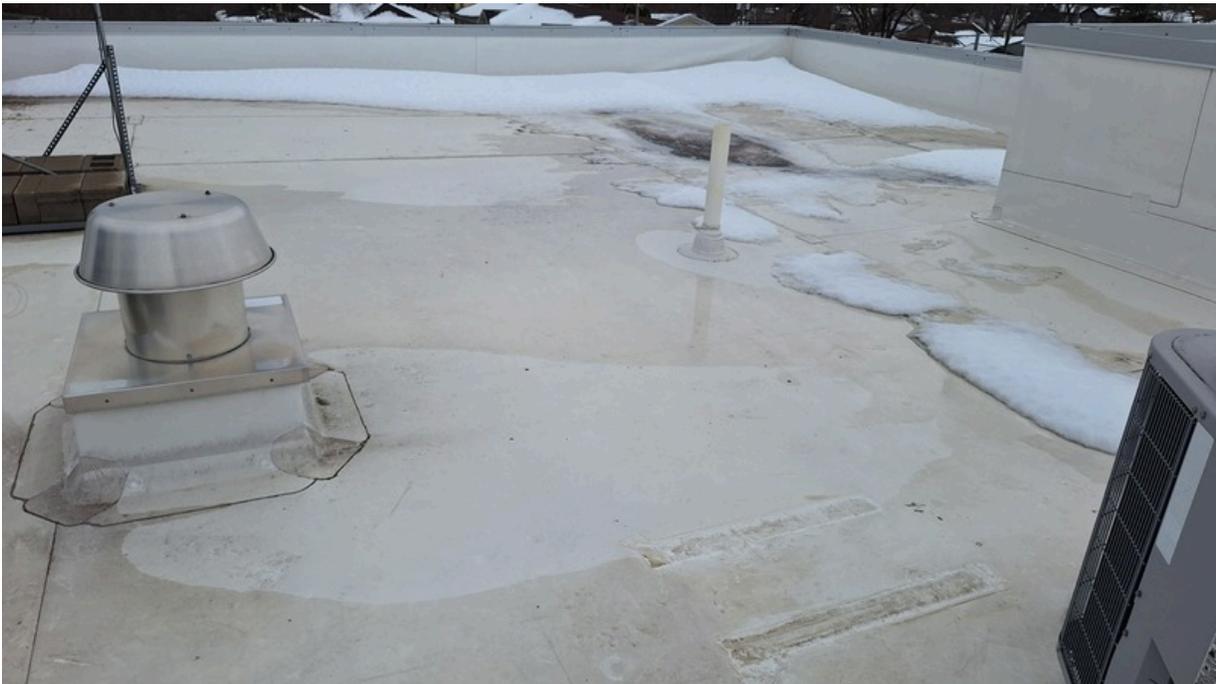
Roofing system

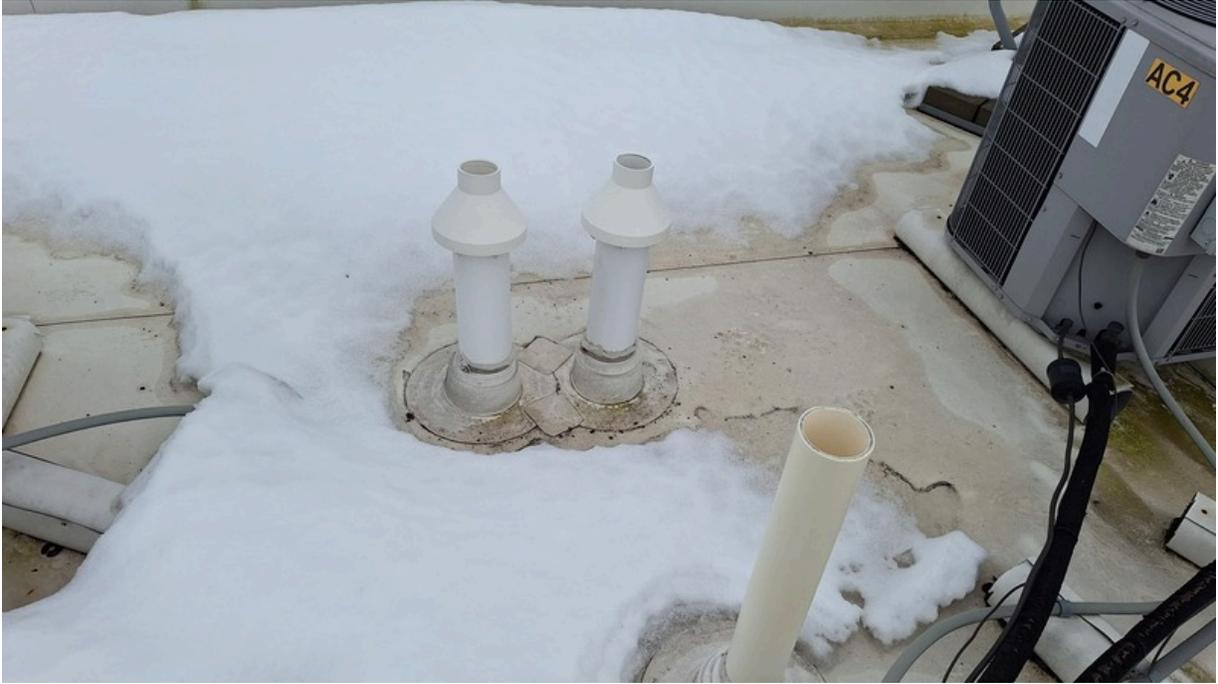
Roofing system

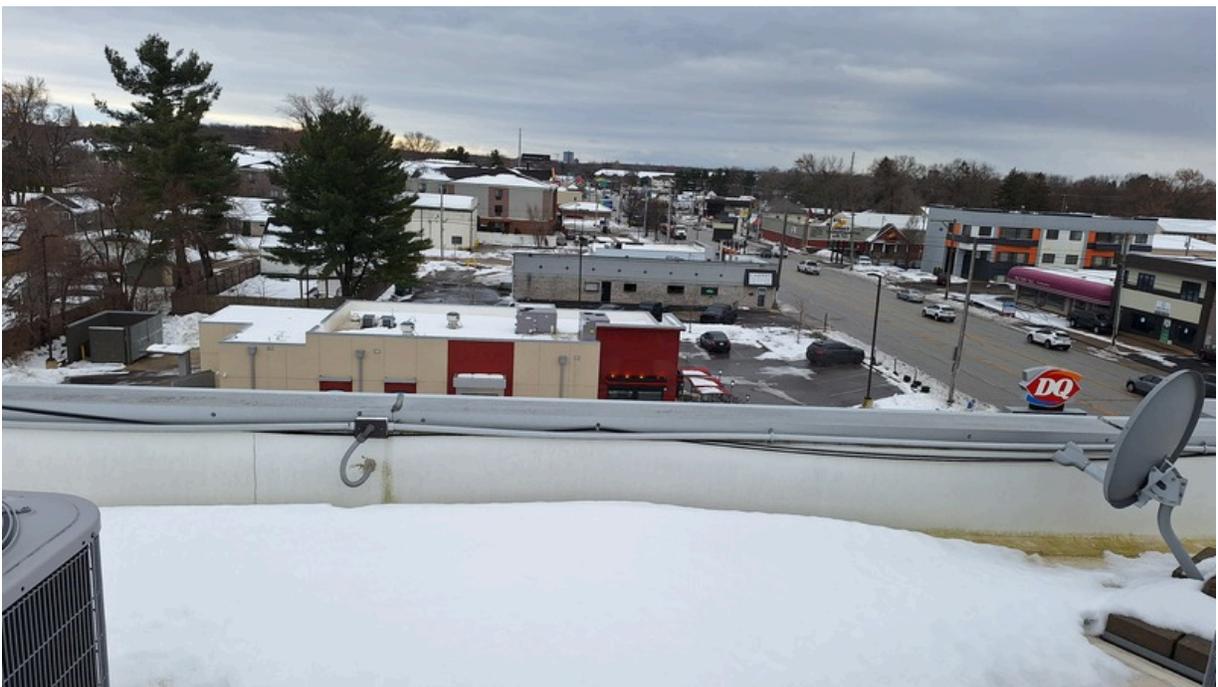
Roofing system

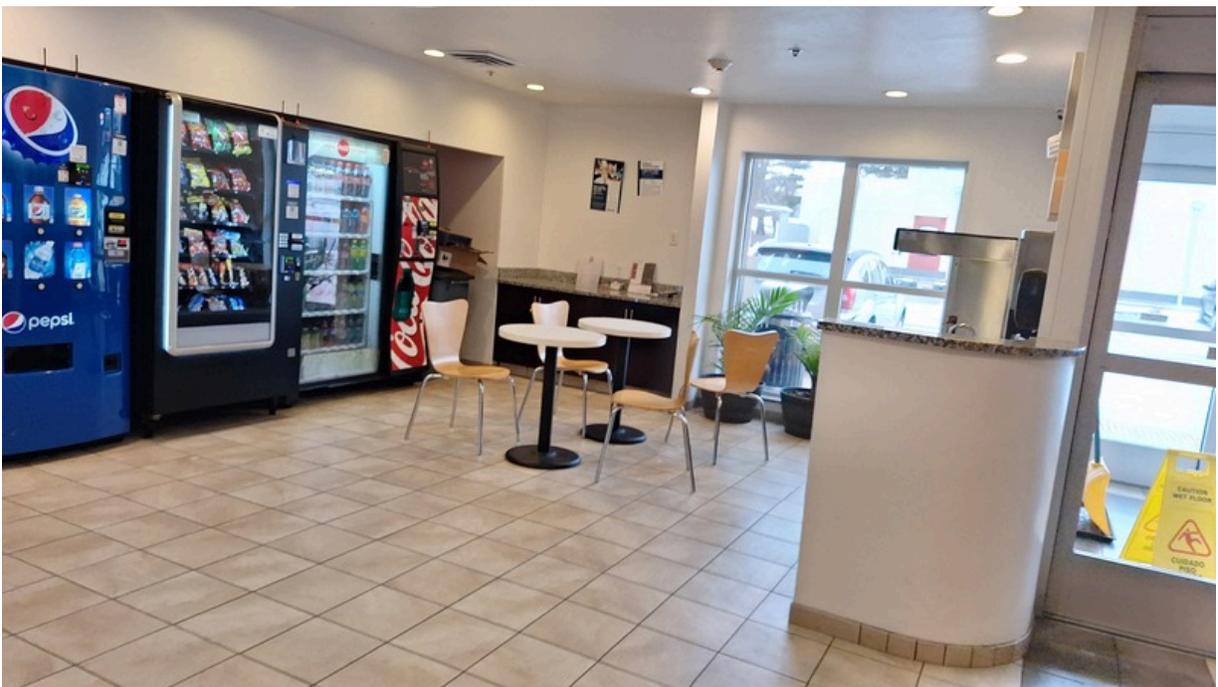
Common area finishes

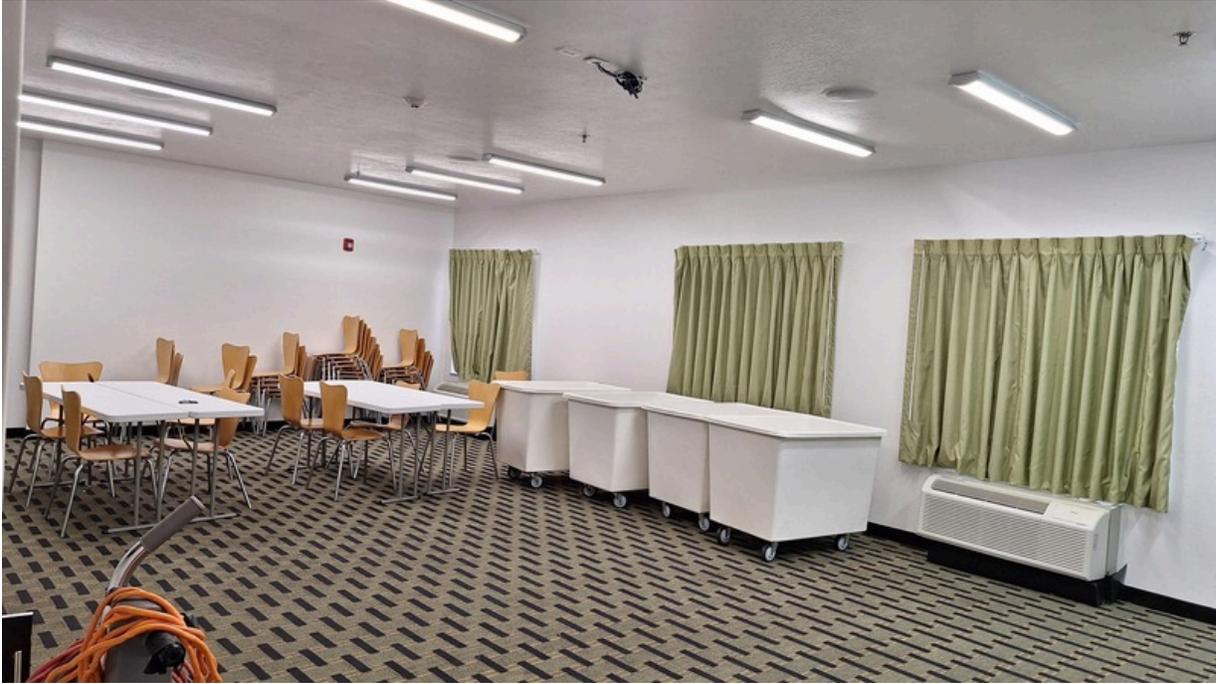
Common area finishes

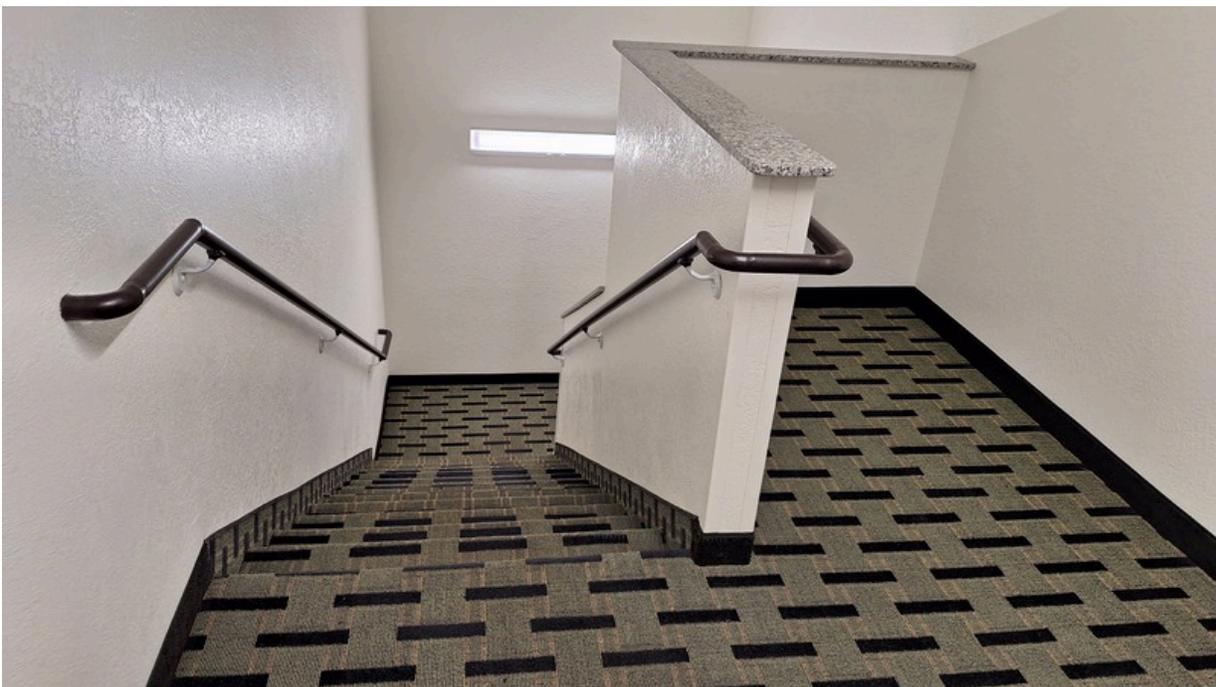
Common area finishes

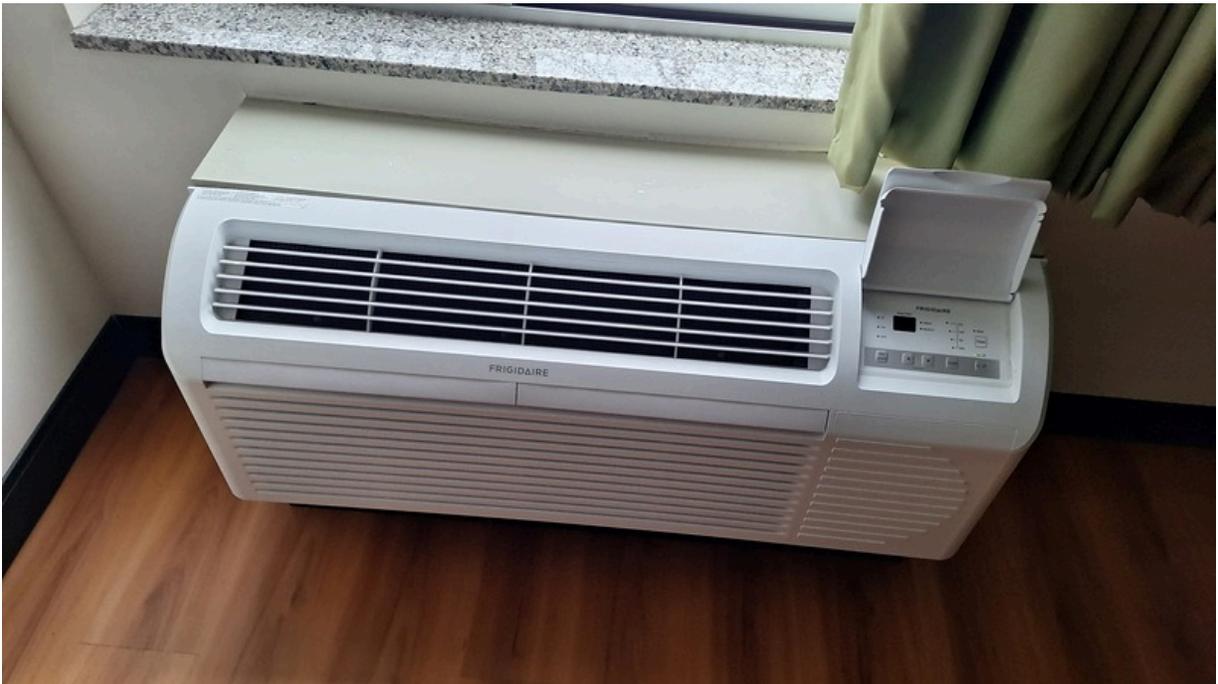
PTAC units

Given an EUL of 10-15 years for the PTAC units, split systems and mini split systems, replacement of some of the PTAC units and mini split/ split systems are anticipated, and an opinion of cost is included in the Replacement Reserves Table.

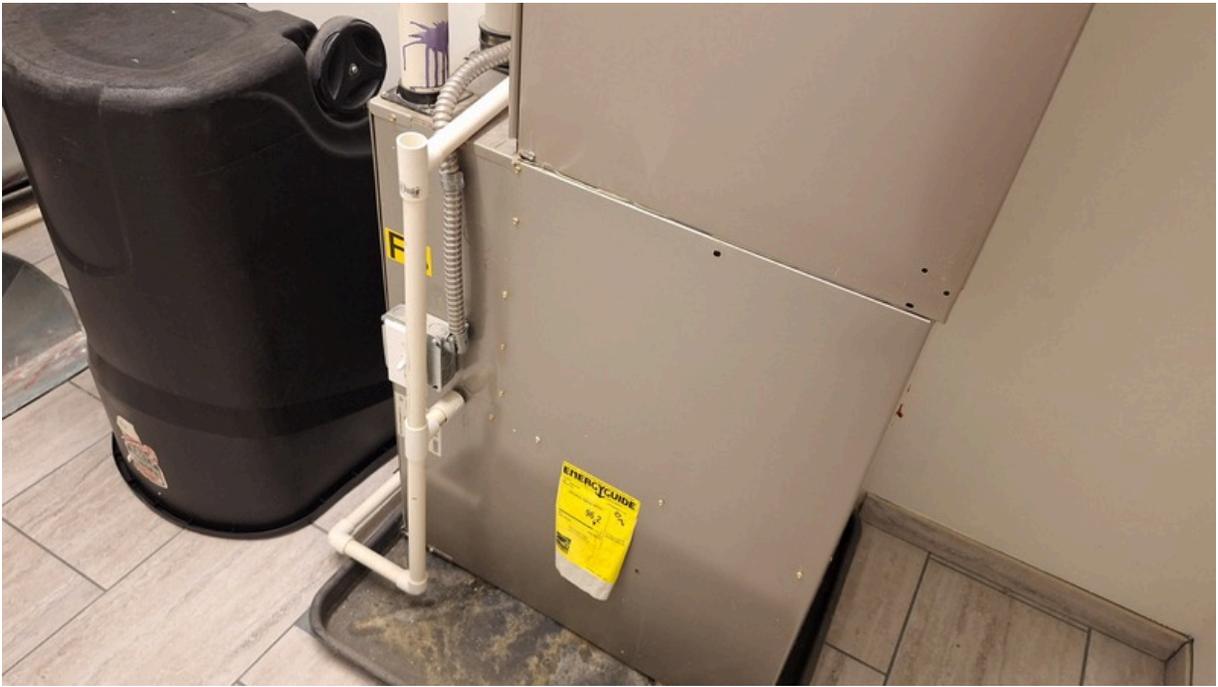
Gas furnace

Based on an EUL of 25 to 30 years for fan coil units or furnaces, no significant replacement is anticipated. These units generally have three, easily replaceable components that could fail. These components include a fan motor, heating coil/burner assembly and thermostat. Therefore, the furnace units should be maintained as part of routine maintenance.

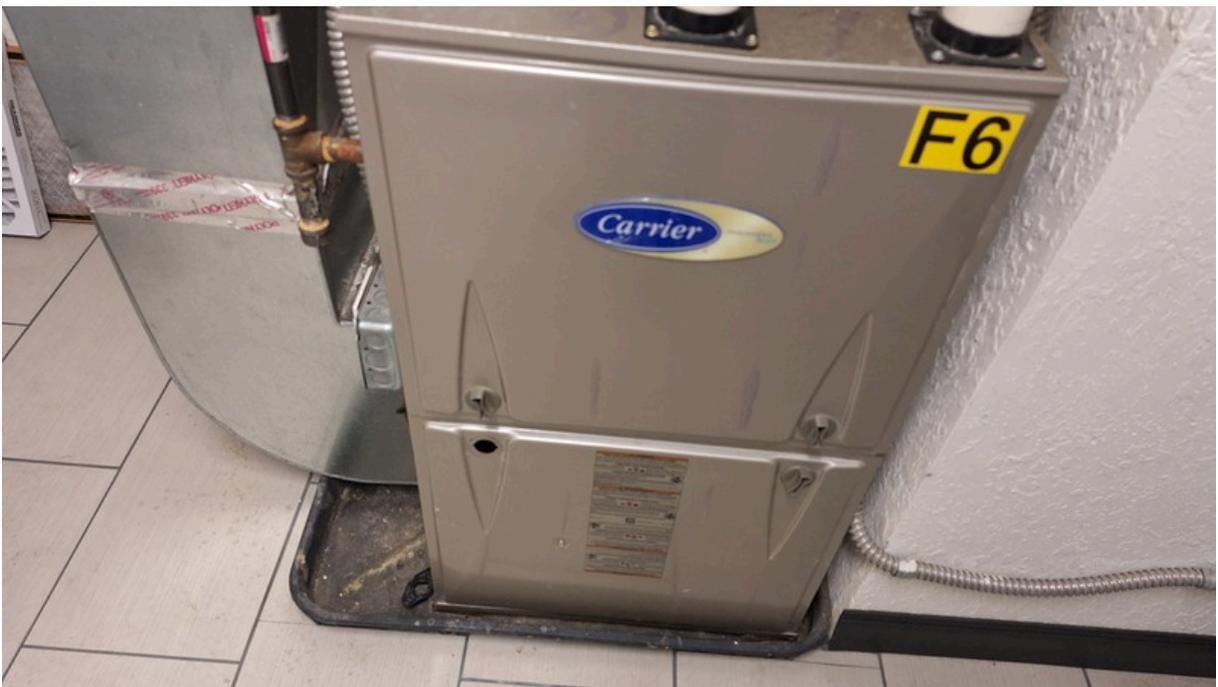
Gas furnace

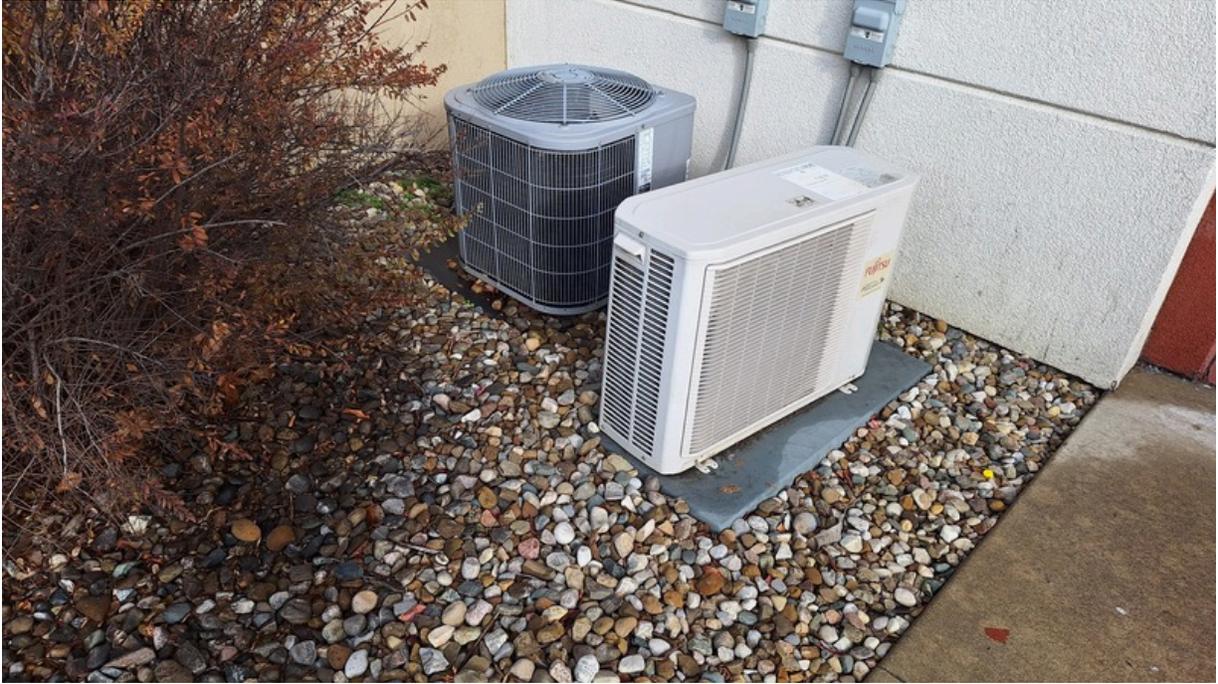
AC condensers and mini splits

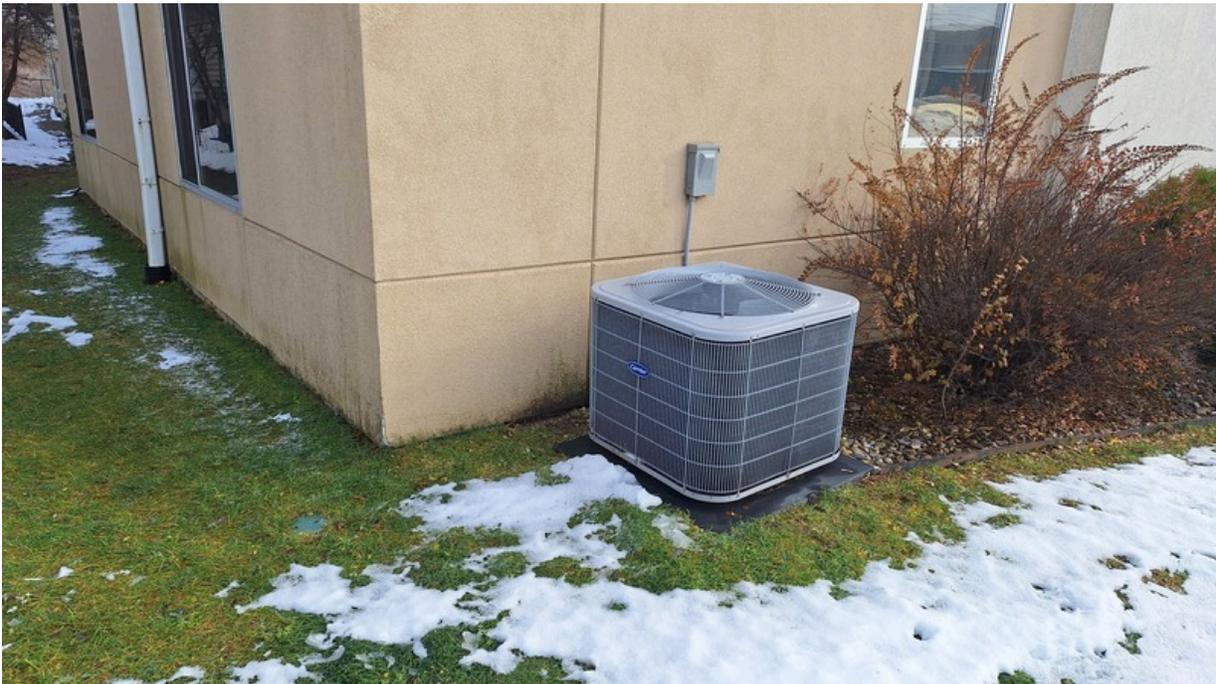
Condenser

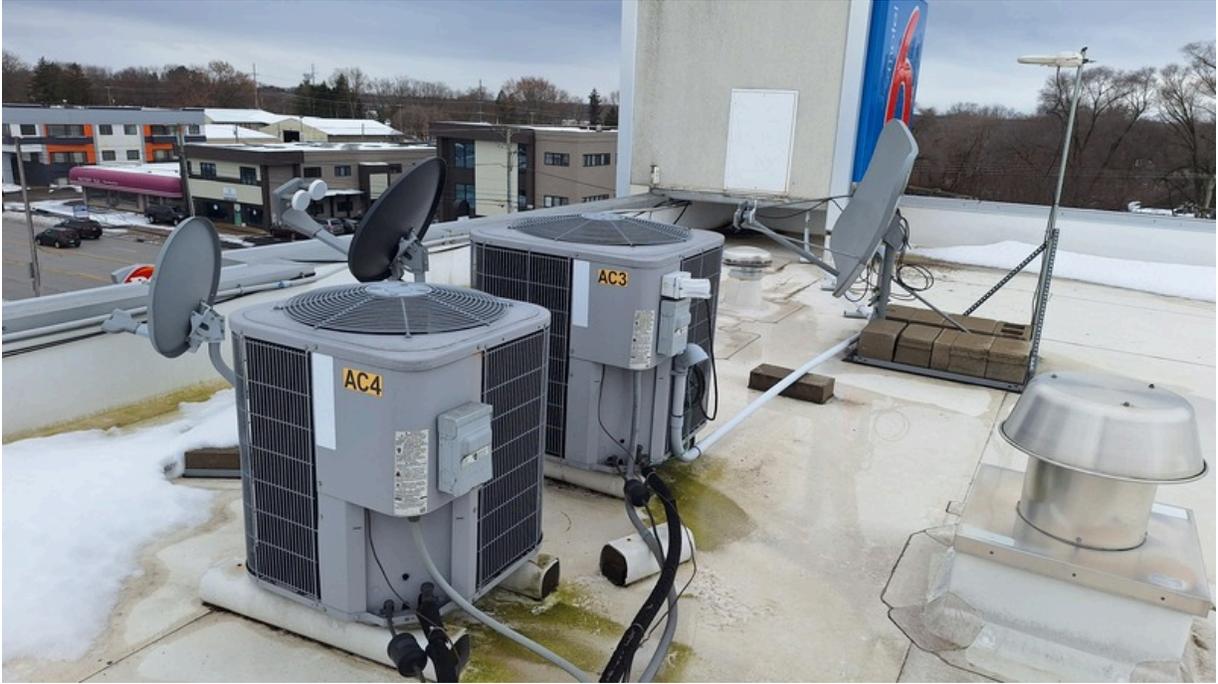
Rooftop condensers

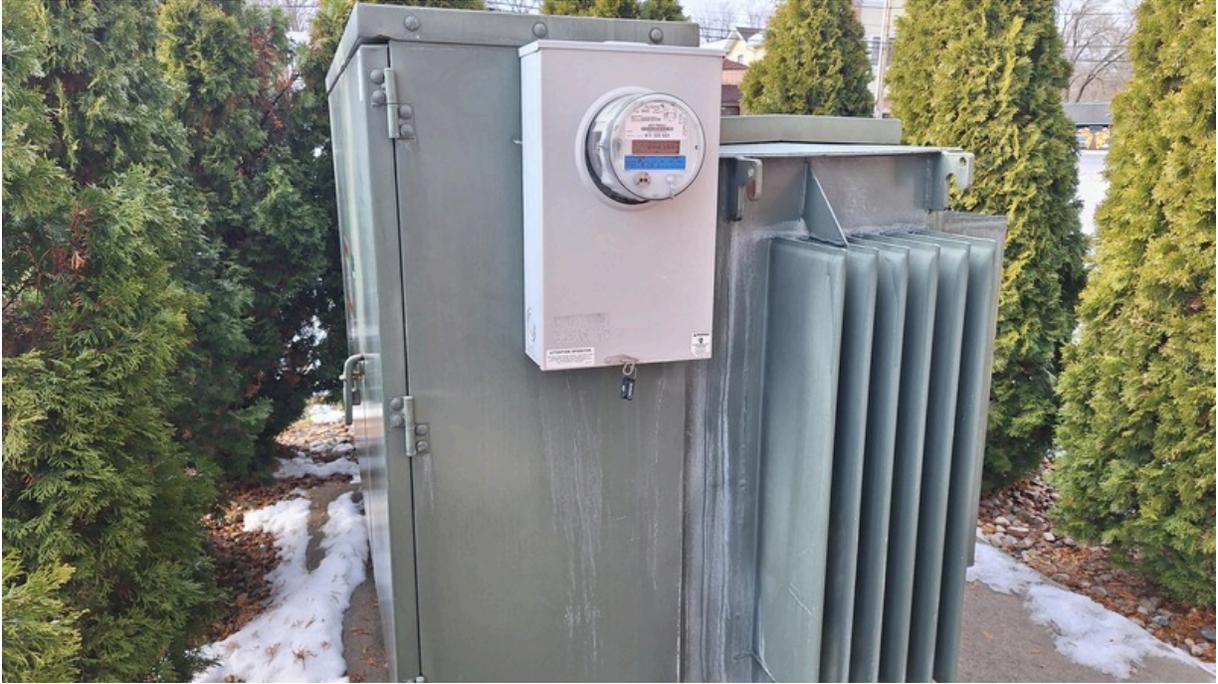
Transformer

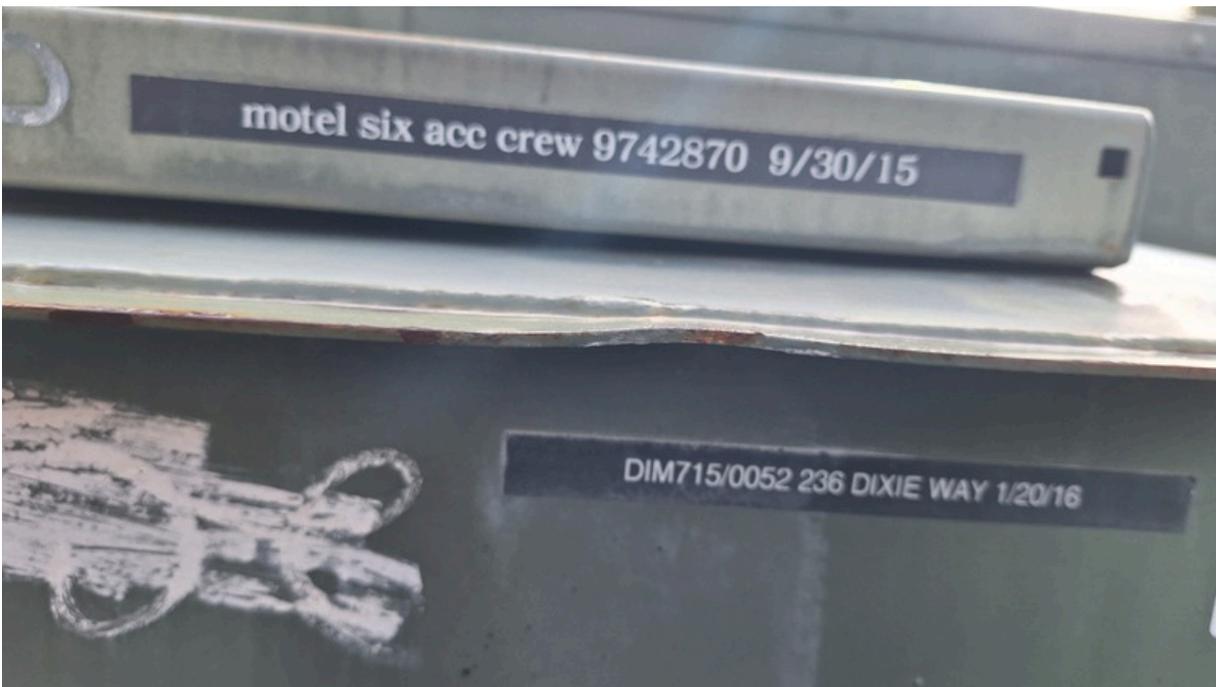
Transformer (label)

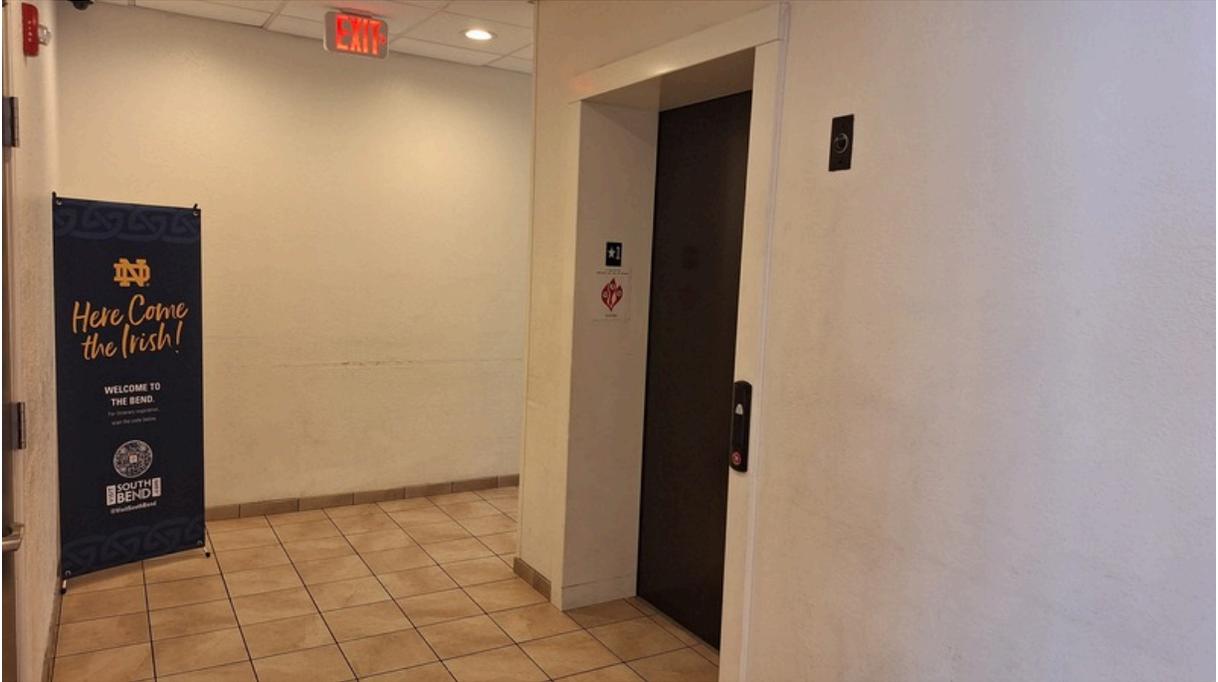
Hydraulic elevator lobby

No physical deficiencies/deferred maintenance or immediate/ short term needs were noted. Elevators typically need annual service, which is considered a routine maintenance item, cab renovations every 10-15 years, and a major overhaul of machinery every 25 years. Based on the age (10 years) of the elevator, interior renovations of the elevator cab are anticipated during the loan term; however, a major overhaul of equipment is not anticipated during the loan term. An opinion of cost for interior renovations of the elevator cab is included in the Replacement Reserve Schedule.

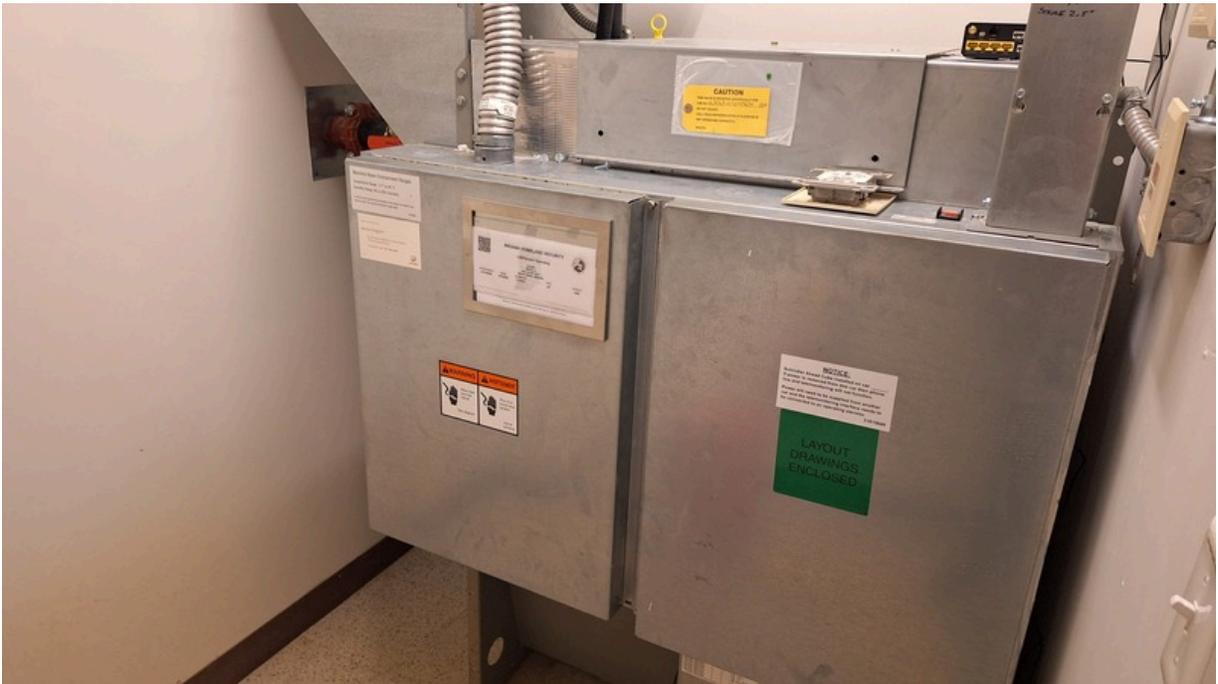
Elevator equipment room

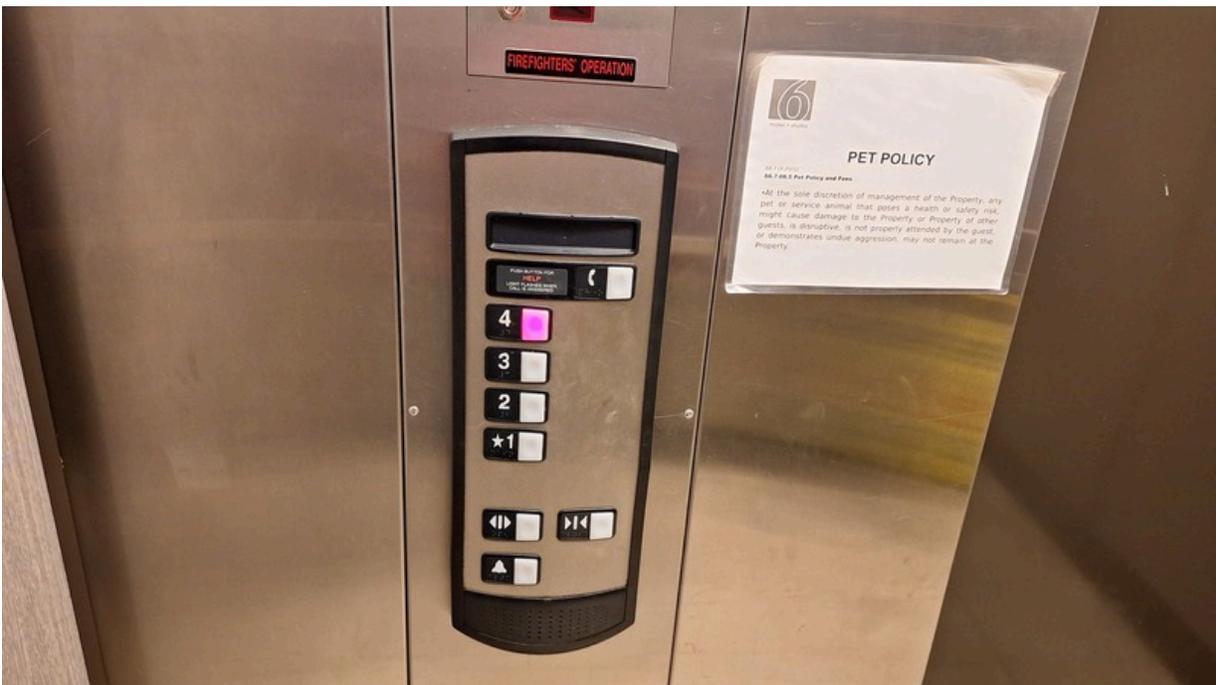
Elevator cab controls

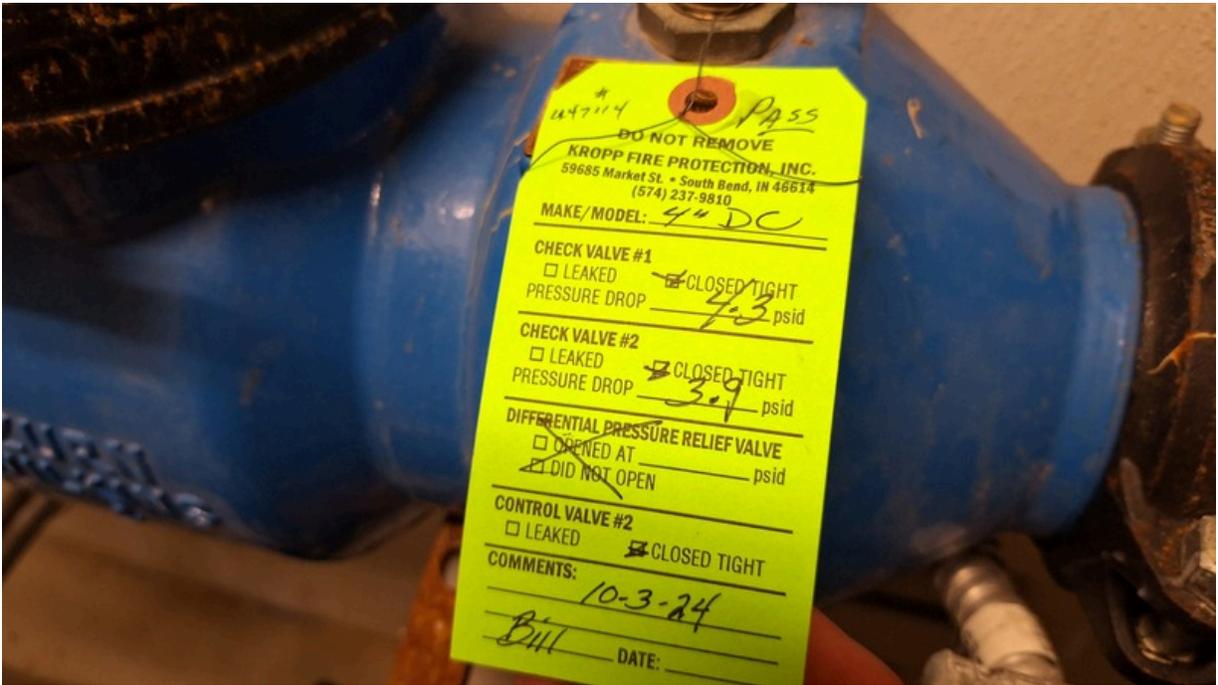
Out of date inspection:	The inspection certificates for the fire extinguishers were current and dated November 2025. The inspection certificate for the fire sprinkler system was expired, October 3, 2024.
Inoperable equipment:	No inoperable equipment was noted or reported.
Other:	No other concerns were noted

FIRE SUPPRESSION SYSTEM inspection tag - expired

The fire sprinkler riser inspection tag is expired. The licensed contractor should be notified. This inspection can be handled as part of routine maintenance.

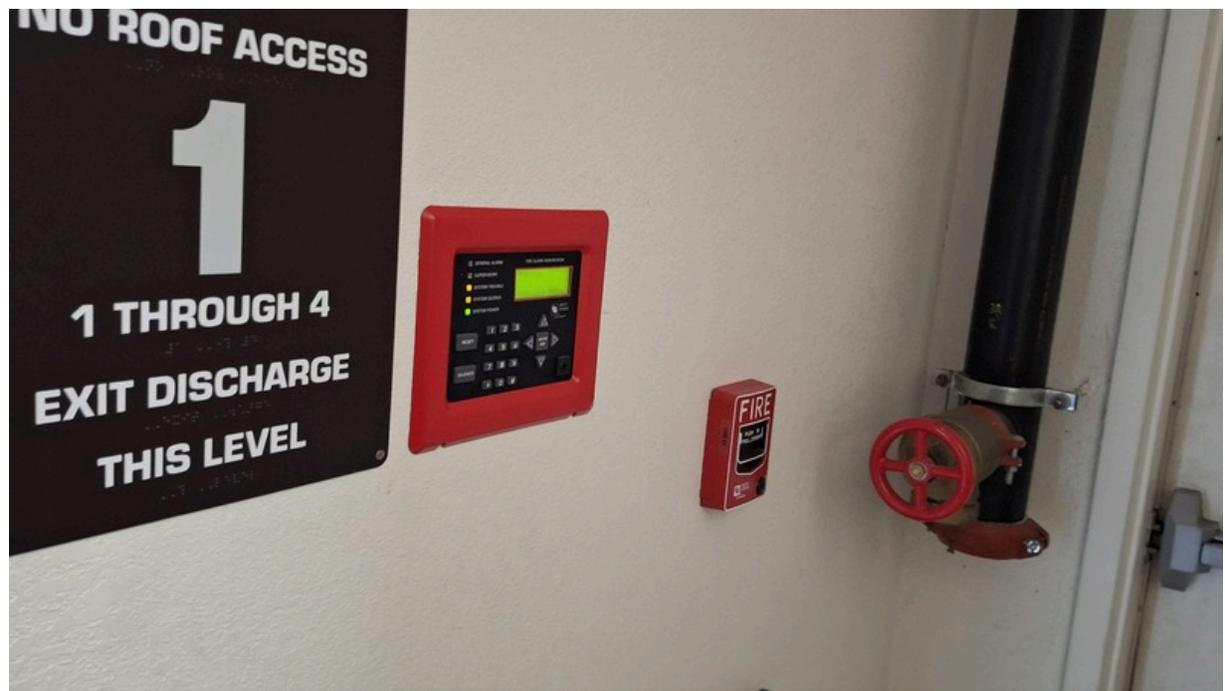
Alarm pull stations throughout

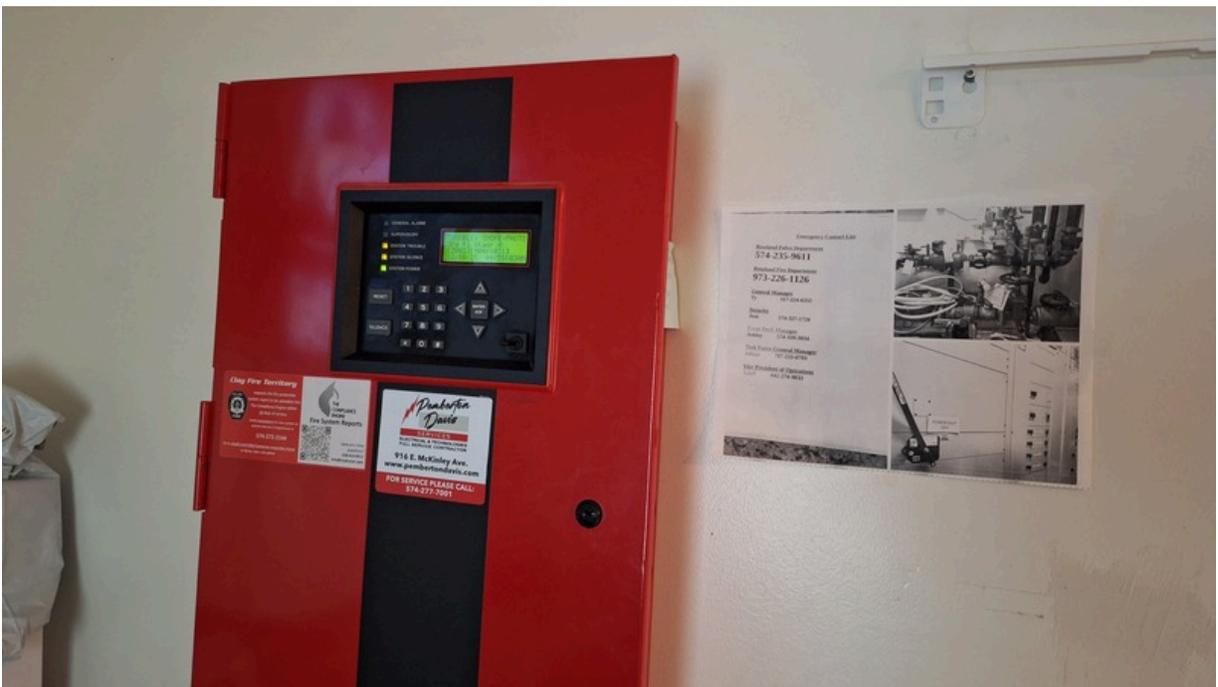
Main fire panel

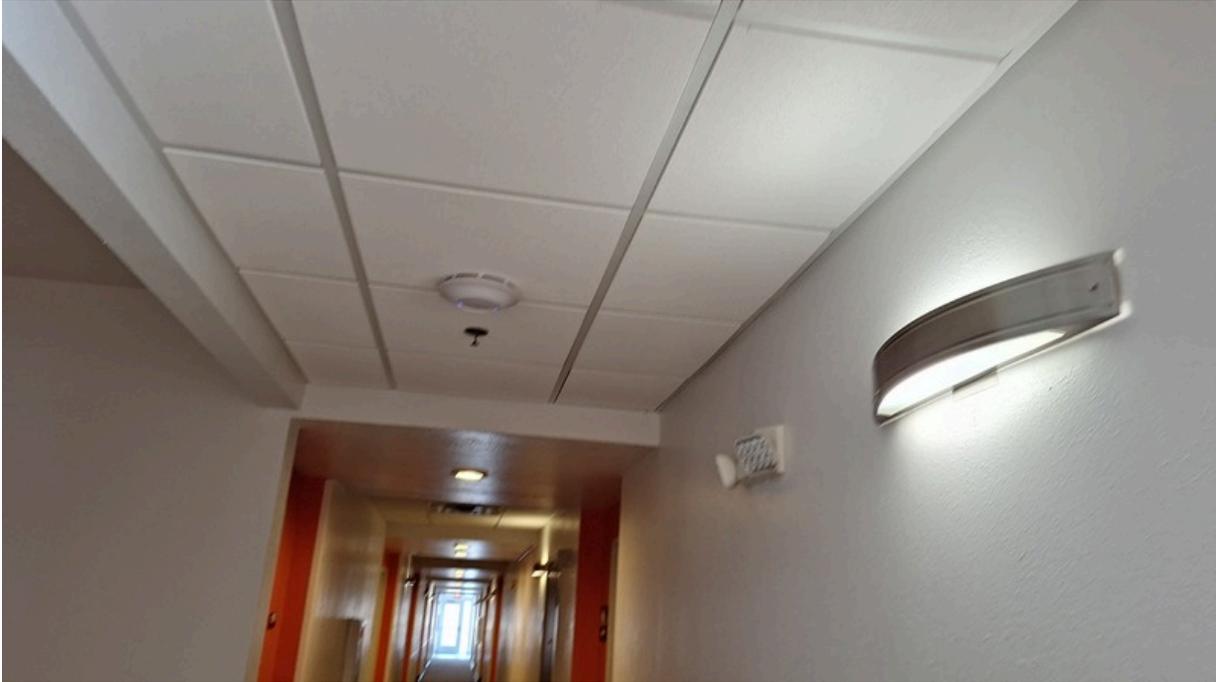
Emergency lights and smoke detector

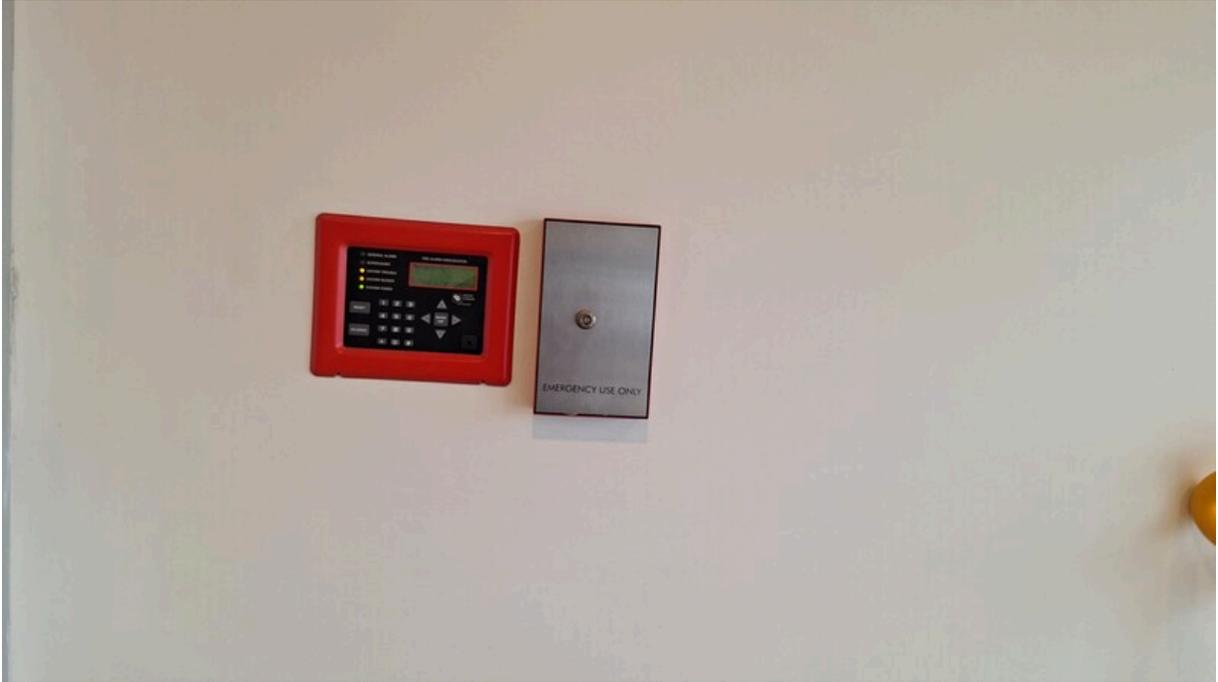
Vestibule fire panel

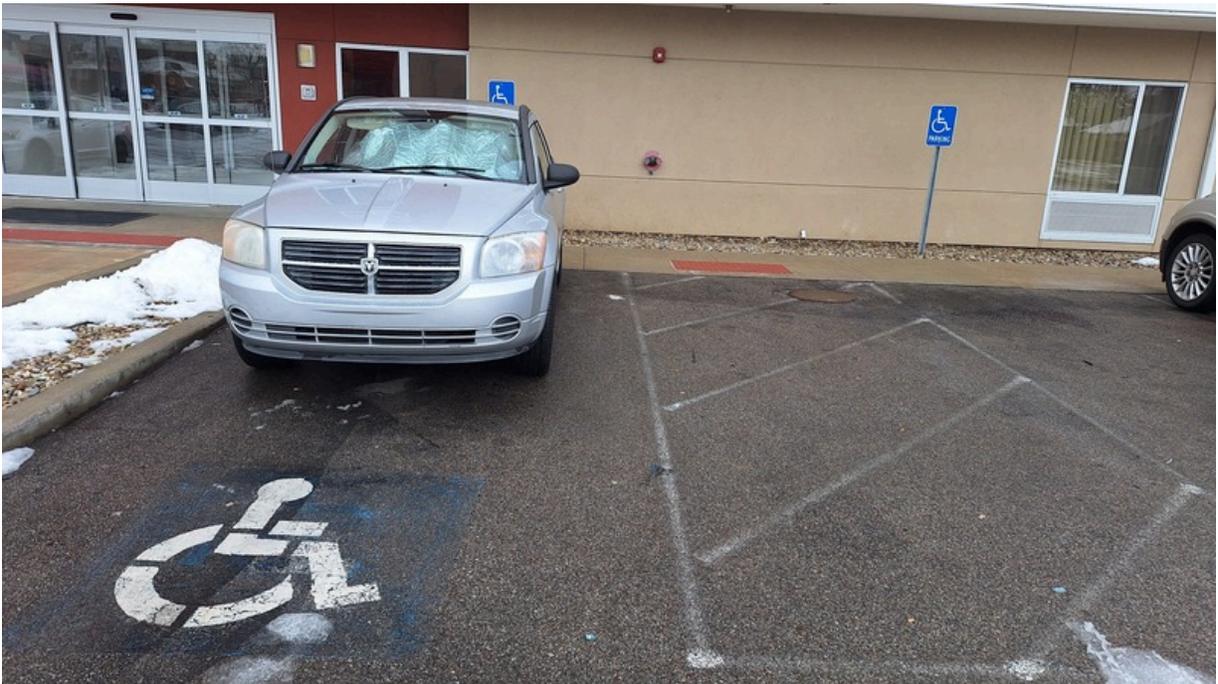
ADA spaces and walkway

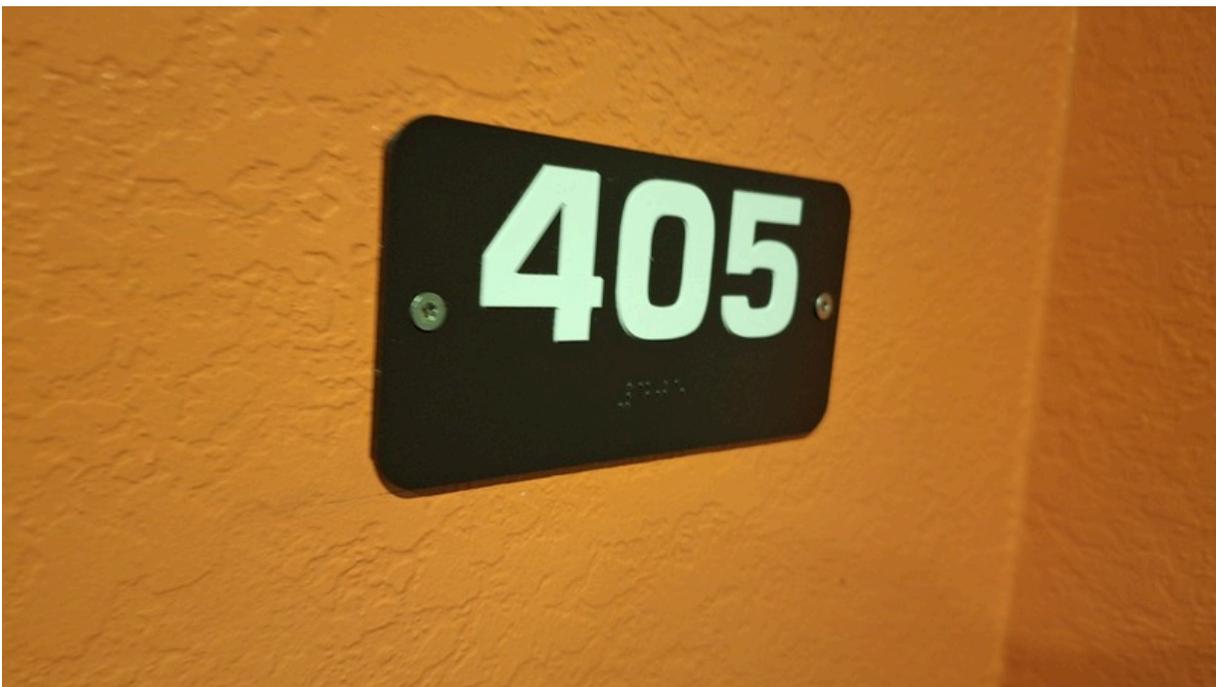
ADA hearing impaired
