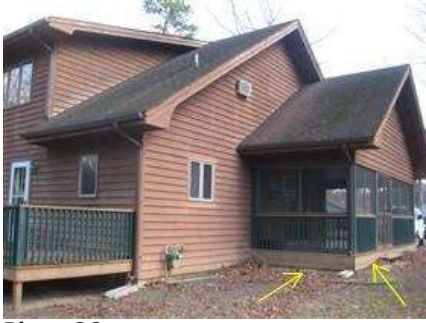
Photo 26

Some areas of the porch substructure were inaccessible due to limited space below. These areas couldn't be evaluated and are excluded from the inspection.

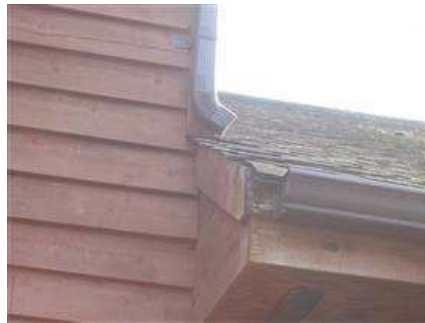
Photo 25

Some sections of siding and/or trim were deteriorated, damaged. Recommend that a qualified person repair, replace or install siding or trim as necessary.

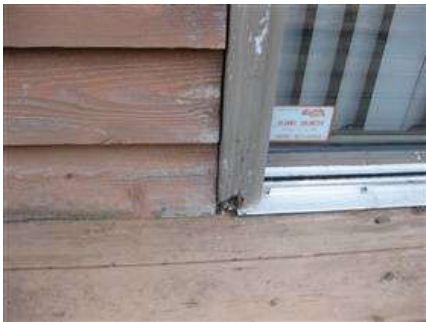
Photo 29  
2nd floor slider.

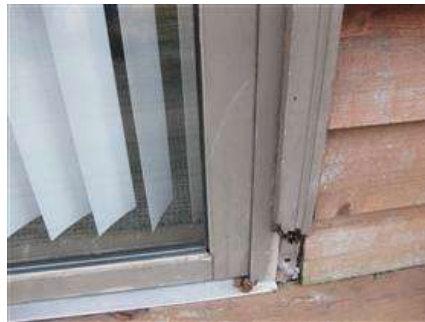
Photo 30  
2nd floor slider.

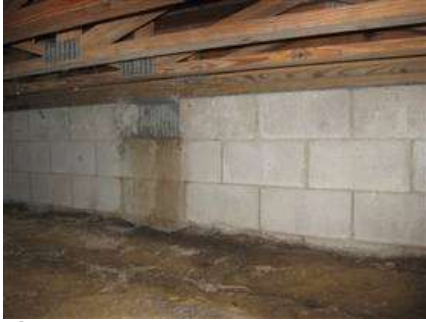
Evidence of prior water intrusion or accumulation was found in one or more sections of the crawl space. For example, sediment stains on the vapor barrier or foundation, and/or efflorescence on the foundation. Accumulated water is a conducive condition for wood-destroying organisms and should not be present in the crawl space. Recommend that the client review any disclosure statements available and ask the property owner about past accumulation of water in the crawl space. The crawl space should be monitored in the future for accumulated water, especially after heavy and/or prolonged periods of rain. If water is found to accumulate, then recommend that a qualified contractor who specializes in drainage issues evaluate and repair as necessary. Typical repairs for preventing water from accumulating in crawl spaces include:

**Photo 38**  
North side

- Repairing, installing or improving rain run-off systems (gutters, downspouts and extensions or drain lines)
- Improving perimeter grading
- Repairing, installing or improving underground footing and/or curtain drains

Ideally, water should not enter crawl spaces, but if water must be controlled after it enters the crawl space, then typical repairs include installing trenches, gravity drains and/or sump pump(s) in the crawl space.

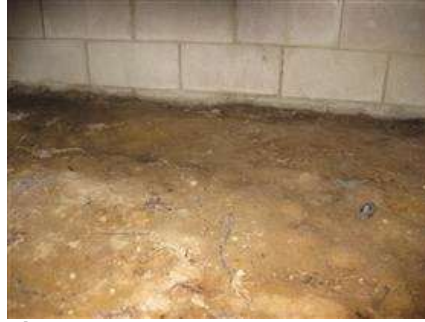
**Photo 39**  
North side

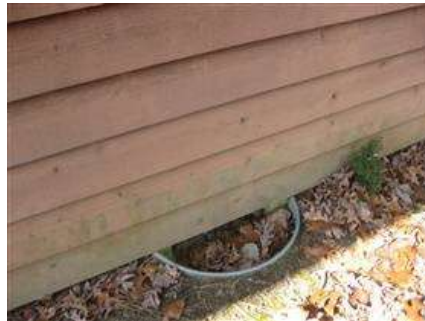
**Photo 17**

One or more crawl space vents were blocked by debris. This restricts ventilation in the crawl space and can result in increased levels of moisture inside. This is a conducive condition for wood-destroying organisms. Materials or items blocking vents should be removed as necessary.

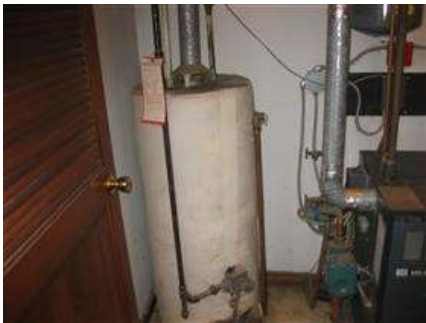
Photo 46

A permanently installed insulated jacket was installed on the water heater. It obscured the manufacturer's information label and/or most of the water heater. The inspector was unable to fully evaluate the water heater.
