### 1962 Southeast Alaska Limit Seiner "F/V: Karen Jean"

# **Report of Marine Survey**

**Report of Condition/Valuation**

**"F/V: Karen Jean"**

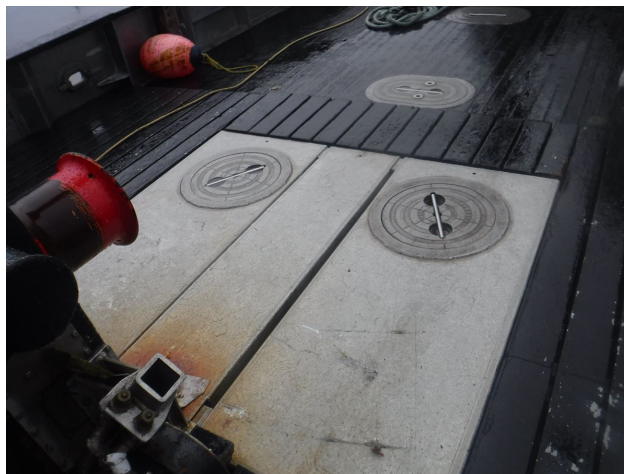
Raised wear deck, apitong wood at the waist surrounding the product holds. appears serviceable

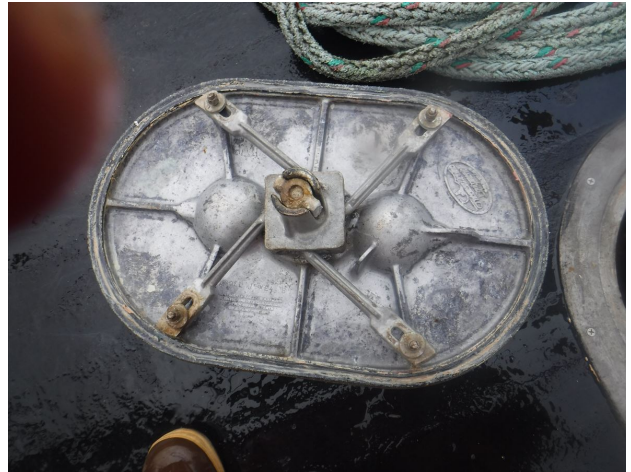
### HULL CLOSURES

Freeman oval aluminum, hose test for signs of leakage, replace gaskets and/or tighten adjustment bolts as needed. Currently the gasket is well conditioned and working as intended.

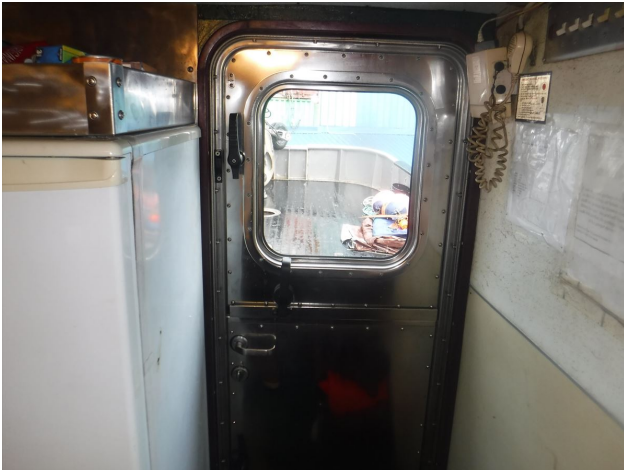
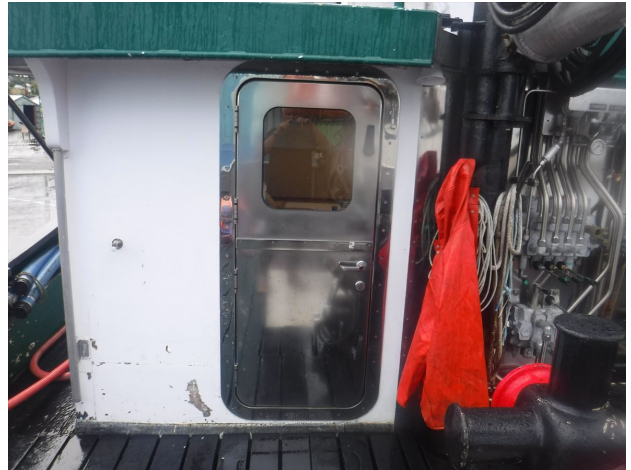
### EXTERIOR DOORS

Stainless steel aft cabin door, 2 dogs, double Dutch made by Freeman, 3 wood (starboard of center aft cabin wood door is a store room access, port side wood door is head access, forward cabin starboard wood door is for front cabin access and part of the secondary means of egress vessel emergency plan), 1 aluminum two dog windowed aft tophouse weather deck access.

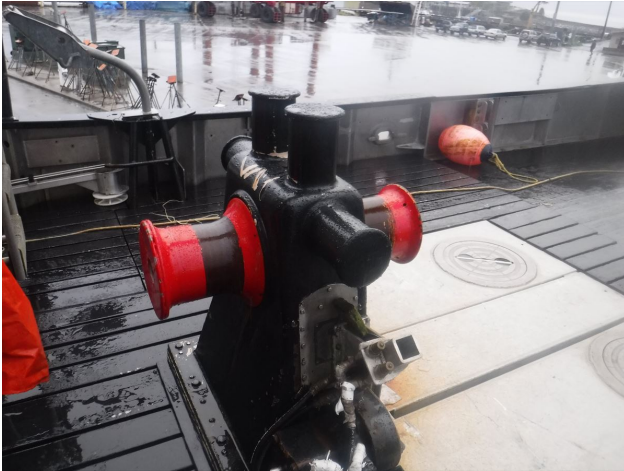
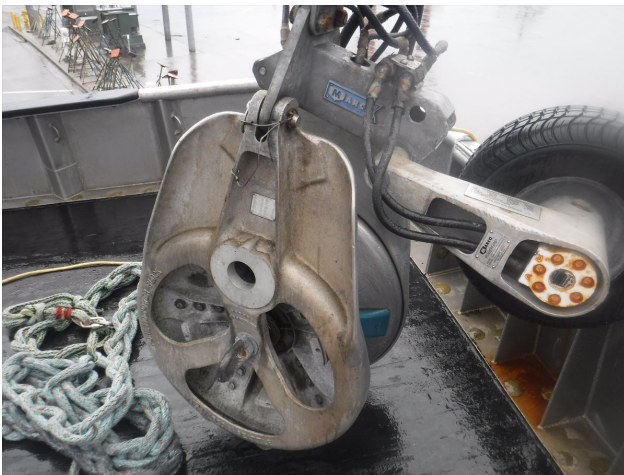
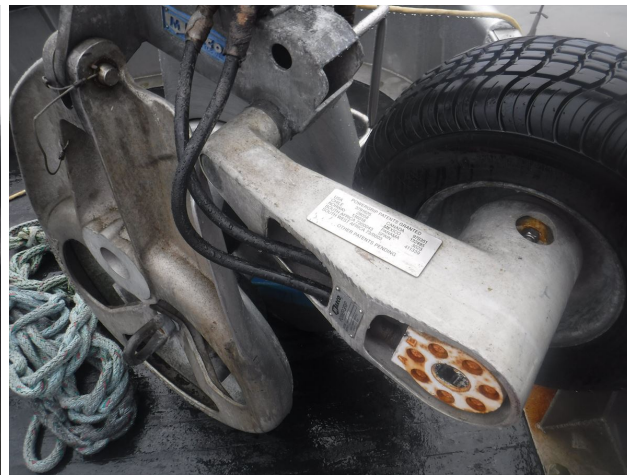
### FISHING EQUIPMENT

Rigged for purse seine with deck winch, power block, ring hook, and purse blocks Kolstrand deck winch (capstan) with slack-taker installed. Marco power block 28" w/ swivel and wheel.

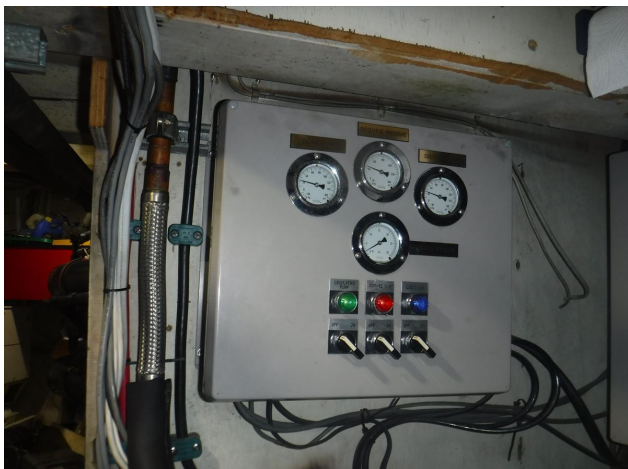
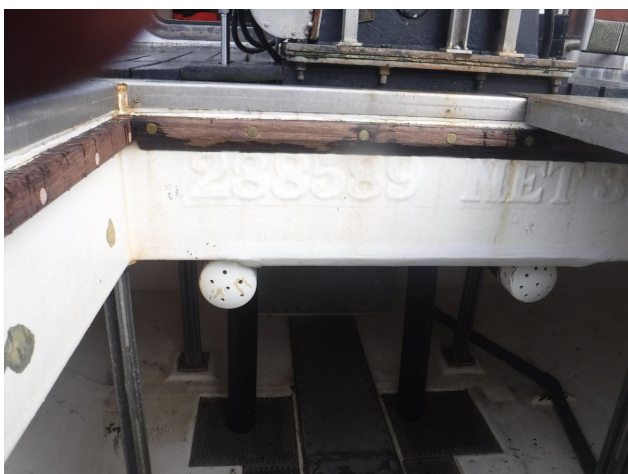
### HYDRAULIC FITTINGS/VALVES

Triple stage on the main w/ Electric clutch. 48/24/18. Remote secondary electric hydraulic pump for longline gear. Stainless steel tubing through out. Fittings are well protected from corrosion and appear serviceable. Extensive use of stainless steel piping through out. Elaborate valving on the aft cabin bulkhead. The valves appear new and flame sprayed.

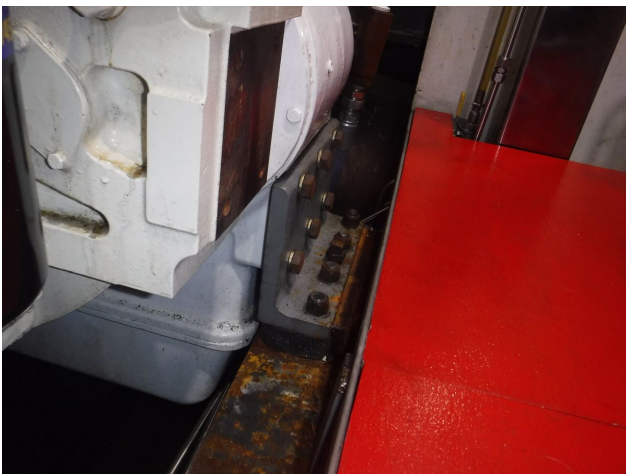
Adjustable motor mounts on STEEL FLATBAR mounted to the keelson. appeared servicable

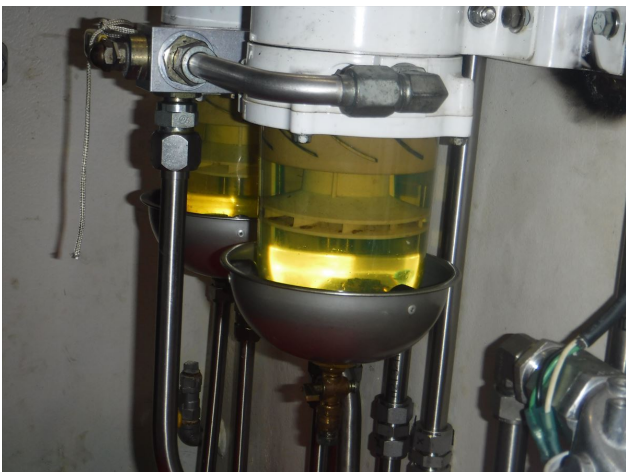
No significant sediment was observed in the Primary fuel filter's sight bowls. Monitor/service often.

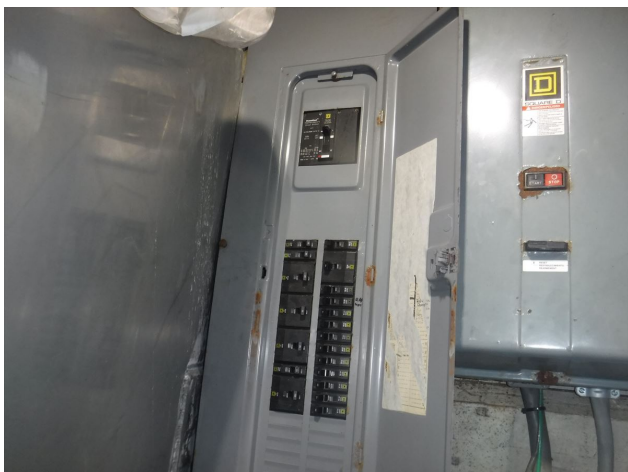
#### **MAIN DC BREAKERS**

The main DC breakers were installed in the engine room.

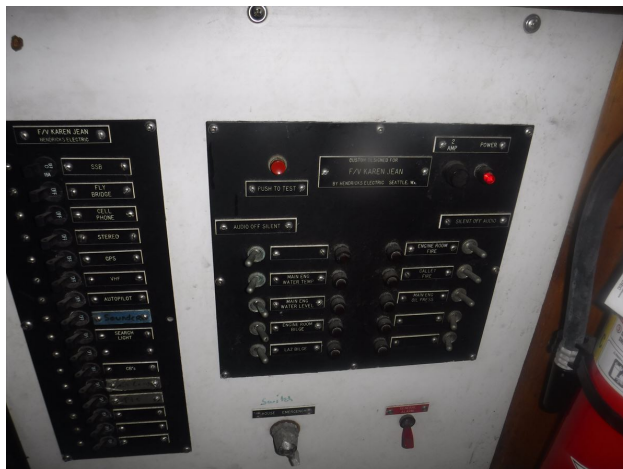
#### **DC ELECTRICAL PANEL BREAKERS/FUSES**

DC main breaker box in the engine room with branch breakers at the helm and in the engine room.

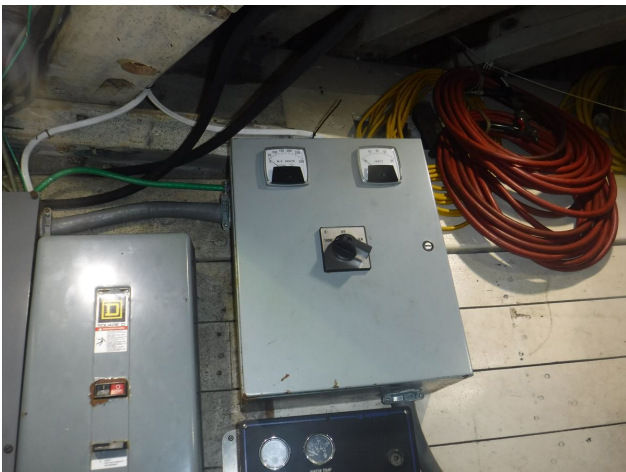
### AC ELECTRICAL SOURCE SELECTOR SWITCHING

Rotary switch in junction box in the engine room

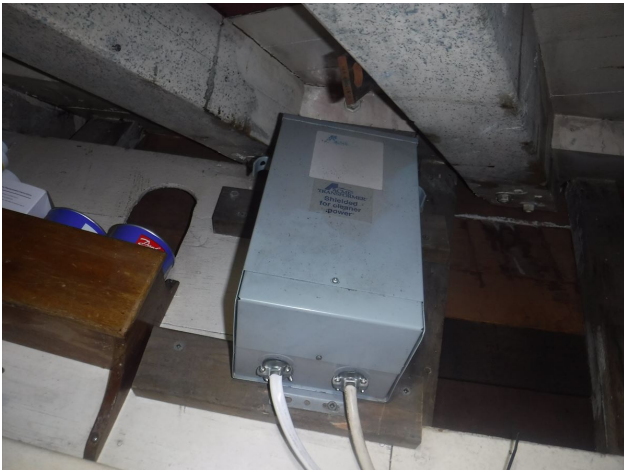
### GALVANIC ISOLATION SYSTEM (ABYC A-28)

Highly recommended, Demonstrated. Working as intended

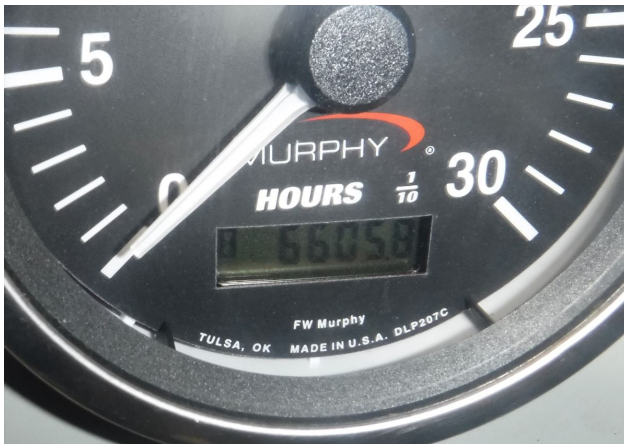
### GENERATOR HOURS

Hours observed on the generator mounted hour meter. 8931

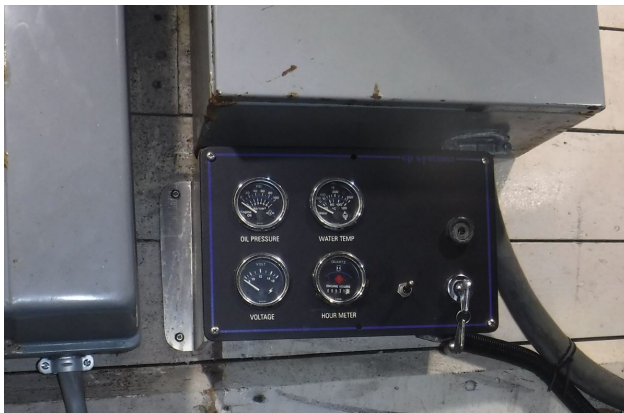
### GENERATOR INSTRUMENTATION GAUGES

Generator instrument panel installed at the generator, on the port hull

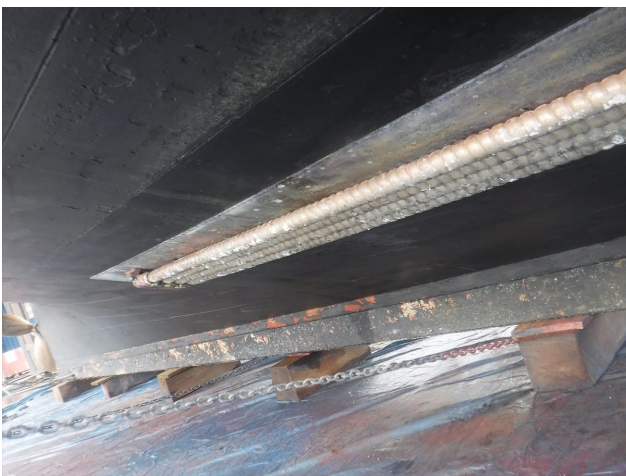
### GENERATOR COMMENTS

keel cooled. There is a dedicated 4 tube keel cooler on the starboard side exterior bottom.

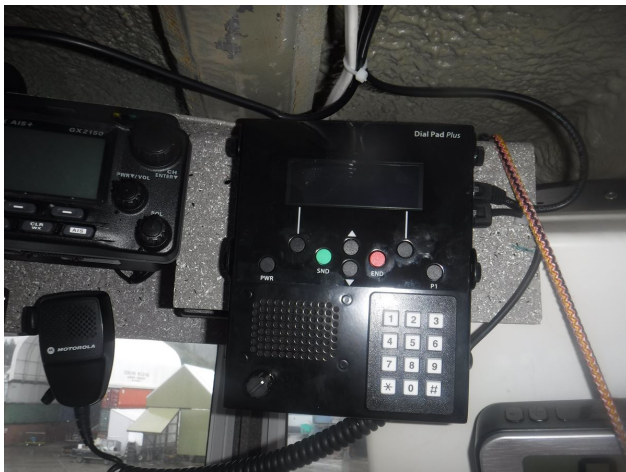
### SATELLITE TELEPHONE

Trac phone

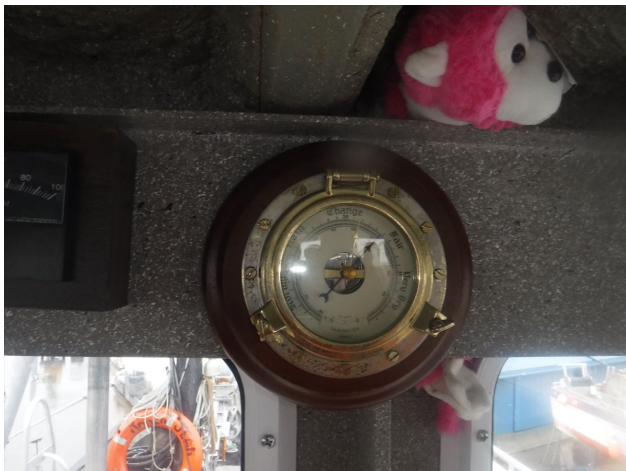
### BAROMETER

Bronze porthole on teak, make unknown

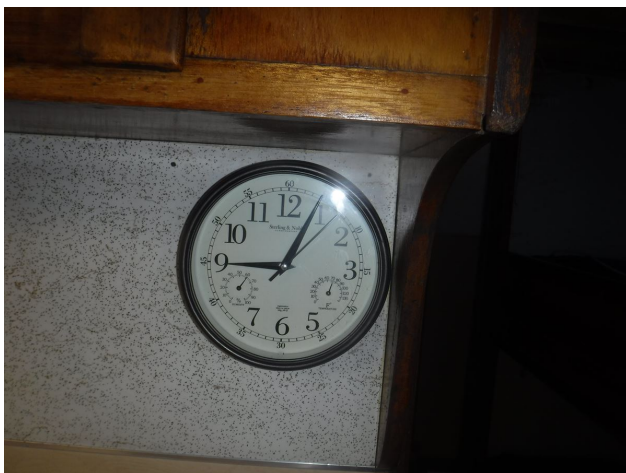
### SHIP'S CLOCK

Sterling and Noble

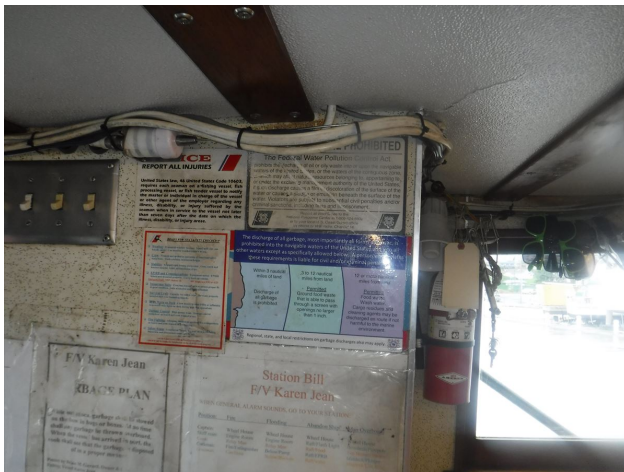
"TRASH DISPOSAL" PLACARD (33 CFR 151/155)  
Found properly displayed.

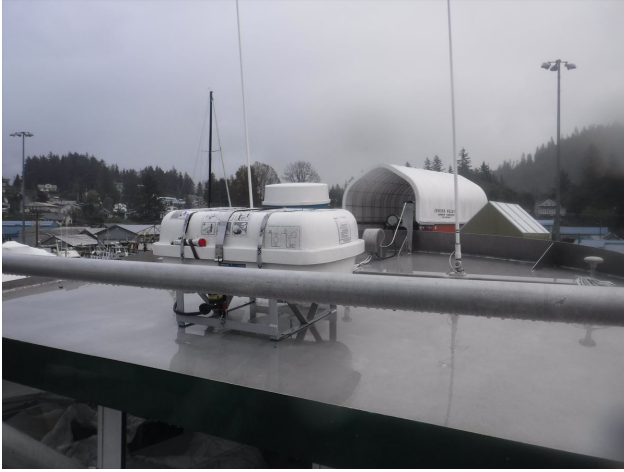
### LIFE RAFTS

Revere Coastal Commander 6 Person Life Raft.

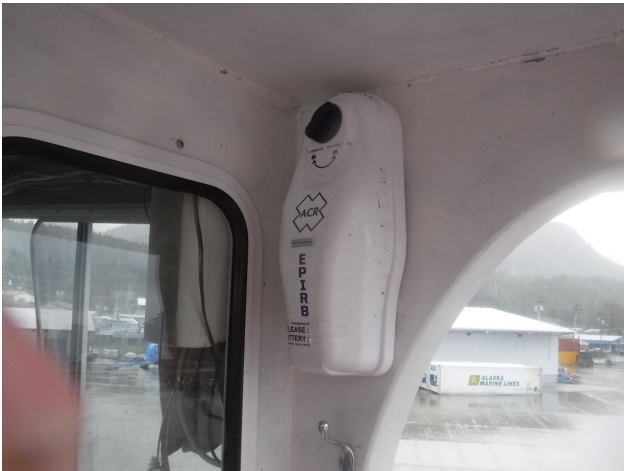
### E.P.I.R.B.

ACR Electronics Rapid-Fix 406 EPIRB (not tested).

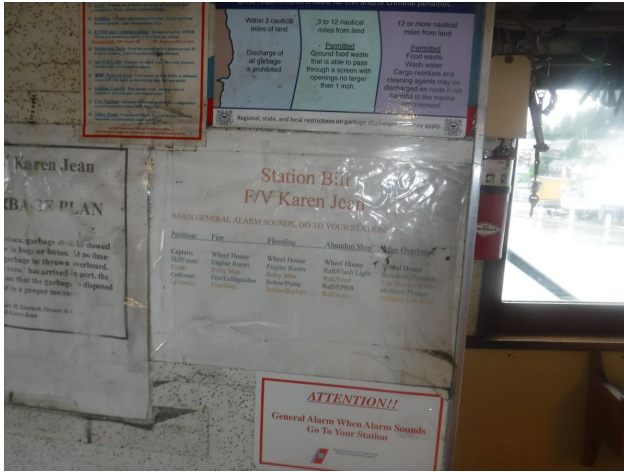
## VESSEL SAFETY PLAN

Displayed in the galley

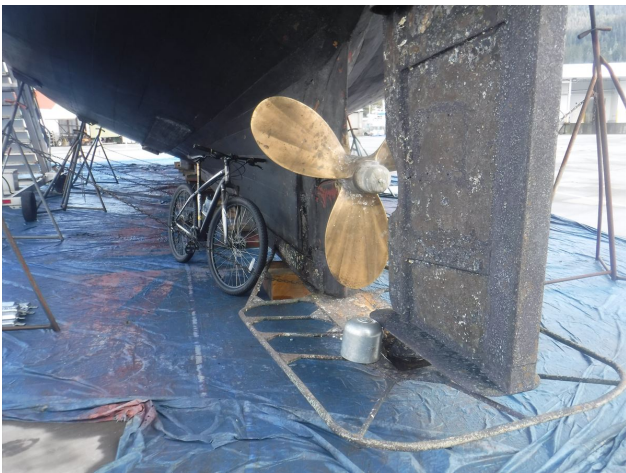
#### RUDDER MOUNTING

Skeg mounted.

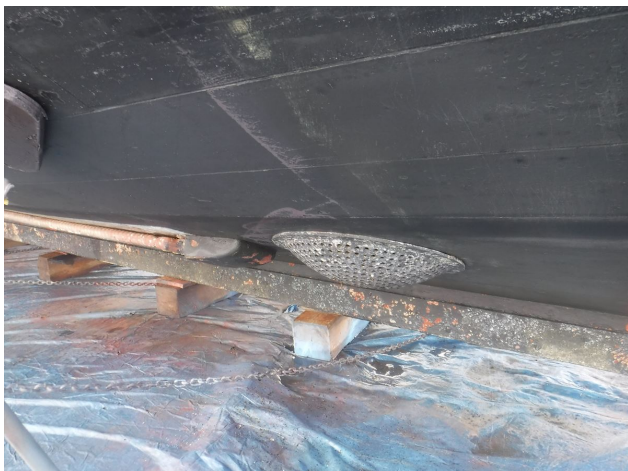
#### HULL SEA-STRAINERS

The hull was equipped with raw water strainer screens. Monitor/clean often.

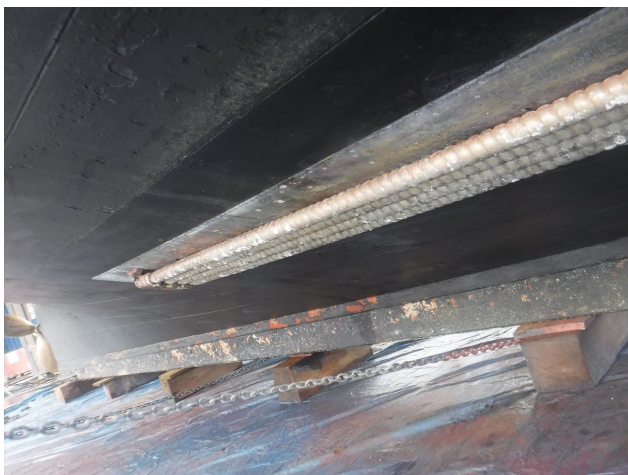
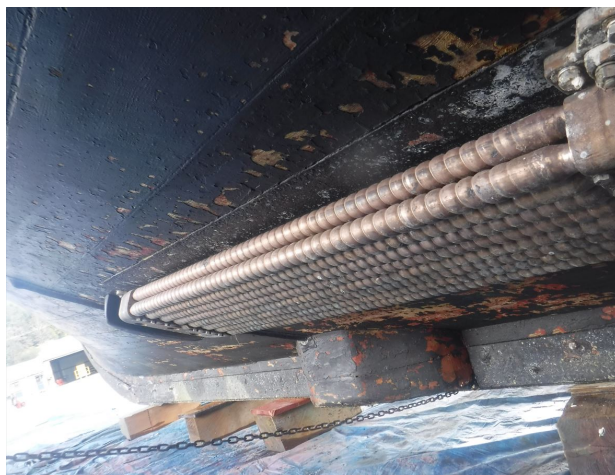
### KEEL COOLER

There are two keel coolers. One port and one starboard. The port cooler is a four tube dedicated to the auxiliary engine. The starboard cooler is a 16 tube.

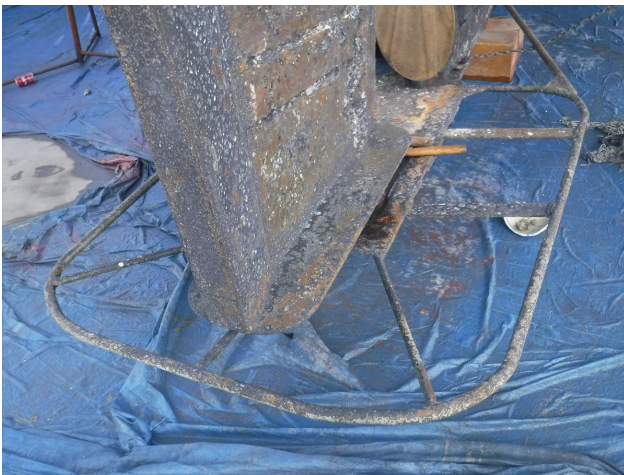
There is a skeg mounted steel tubed beaver tail

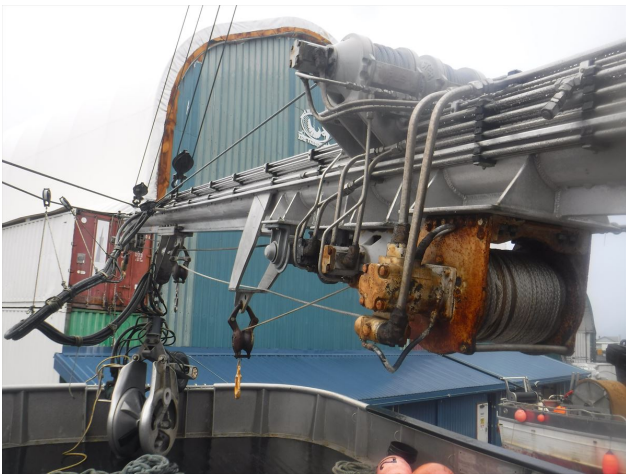
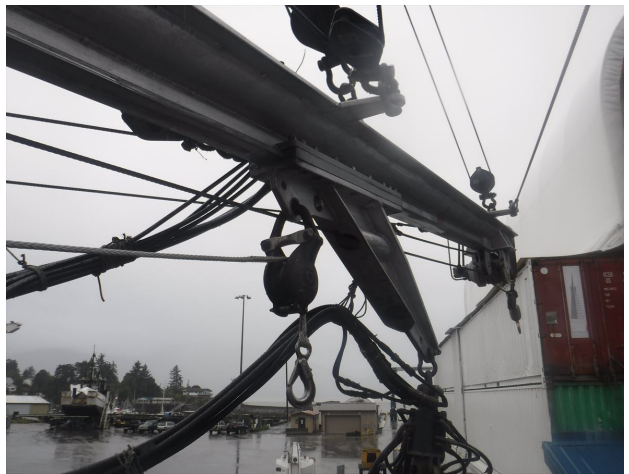
### BOOM

Aluminum Boom. Heavy duty seining with all ss. tube hydraulics. Boom trolley and 7 winches

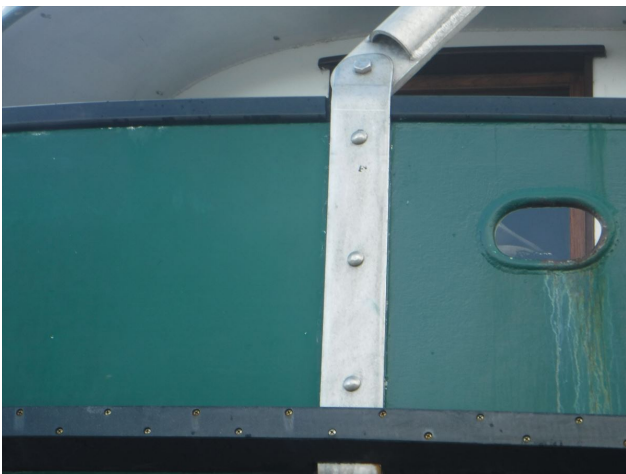
### RIGGING CHAIN PLATES

External stainless steel chain plates. Monitor frequently, and service as necessary.

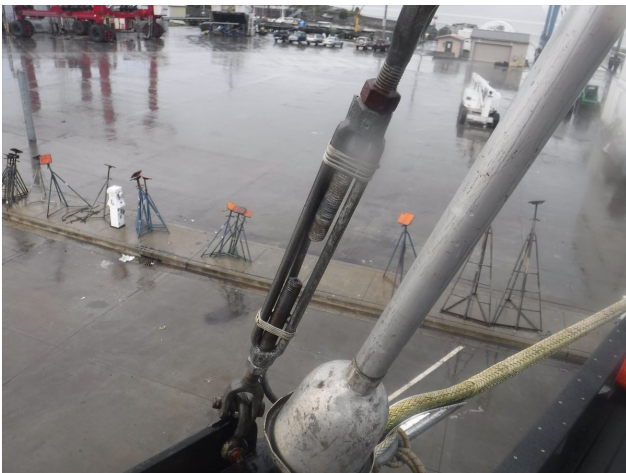
### RIGGING TURNBUCKLES

Open galvanized

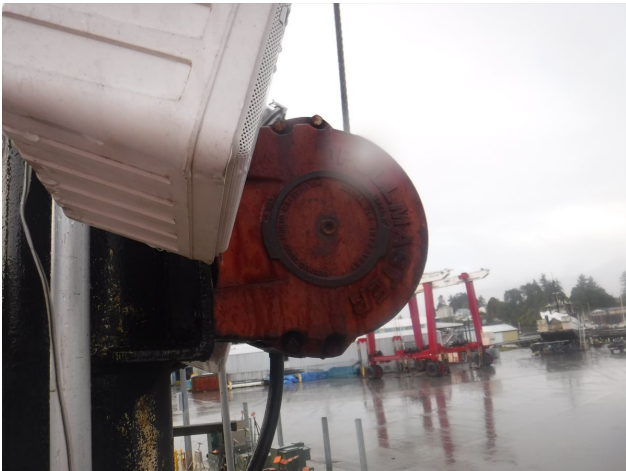
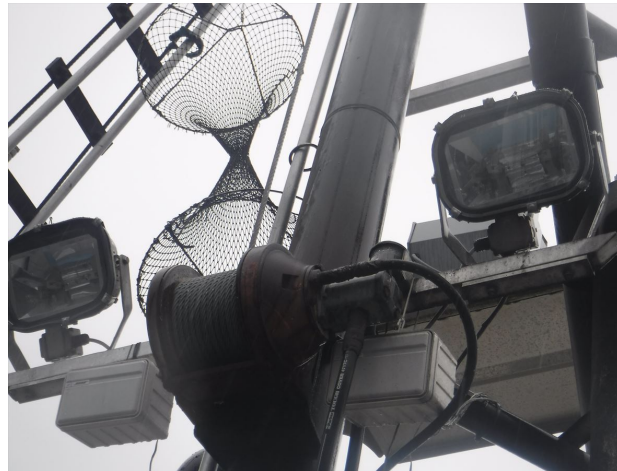
### TOPPING LIFT

The Boom's Topping Lift appeared serviceable. Pullmaster PI 5

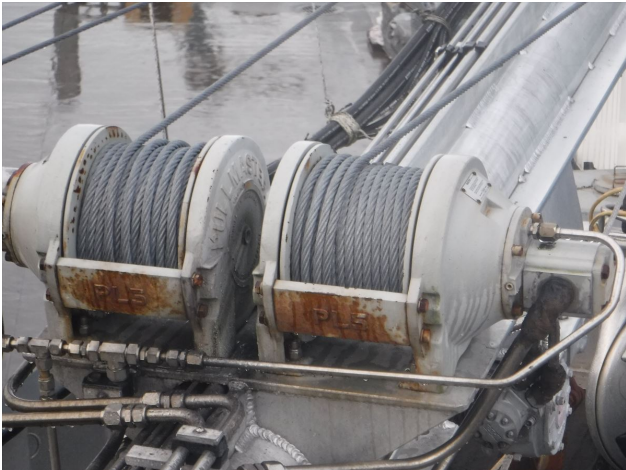
### VANGING WINCHES

2 Pullmaster PL 5 appeared serviceable

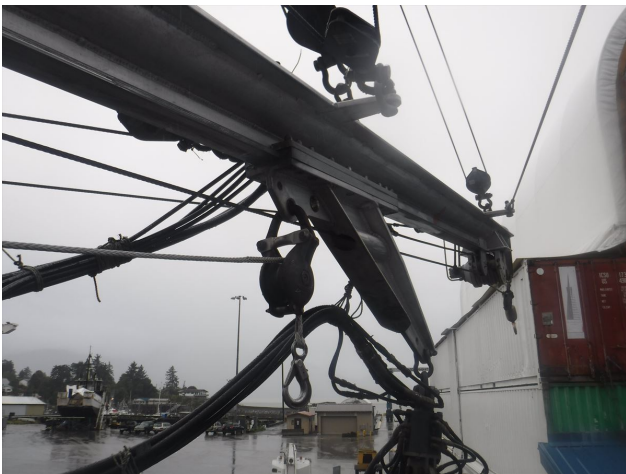
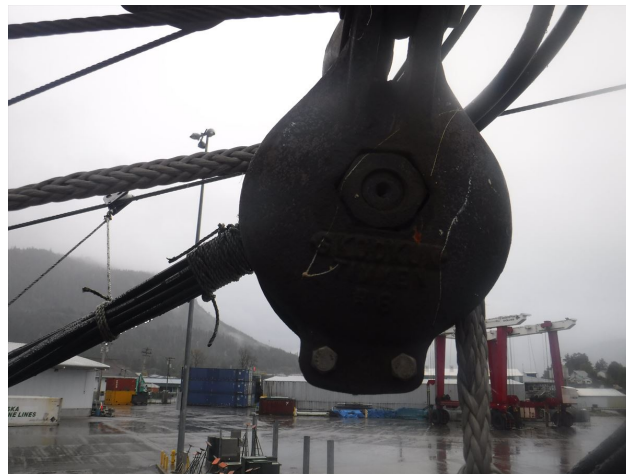
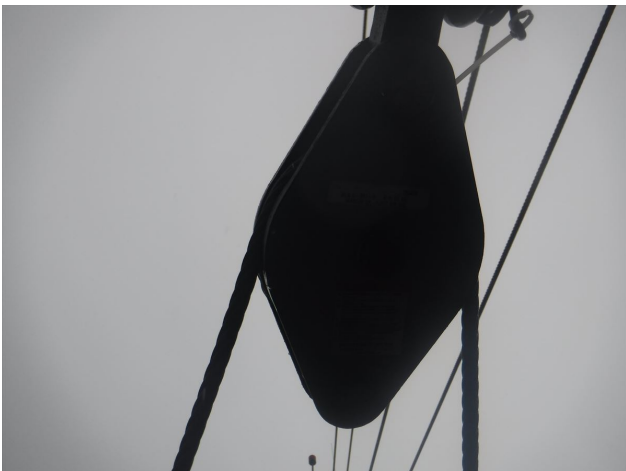
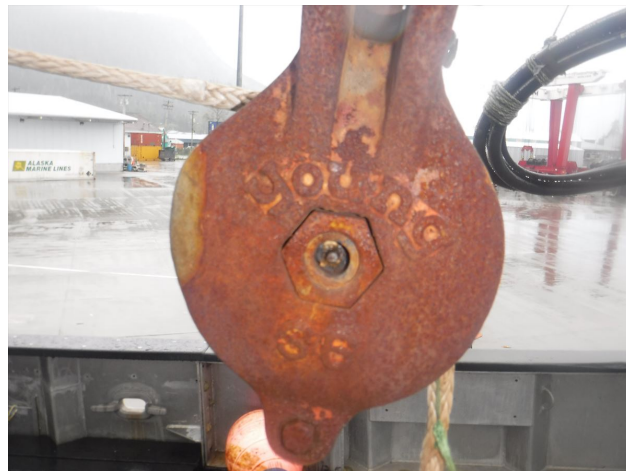
### SWIVEL BLOCKS

Heavy duty blocks (steel), all appeared servicable

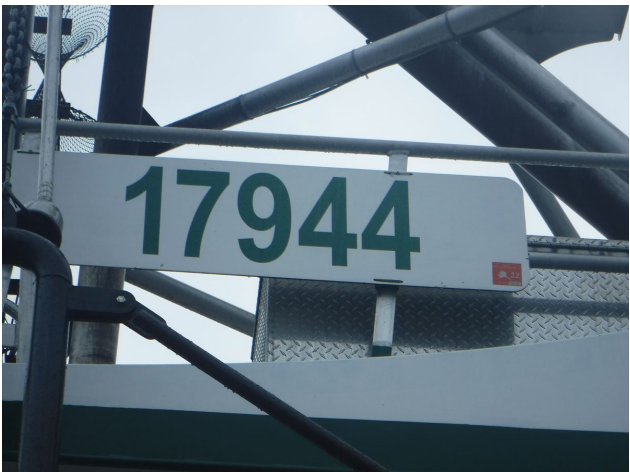
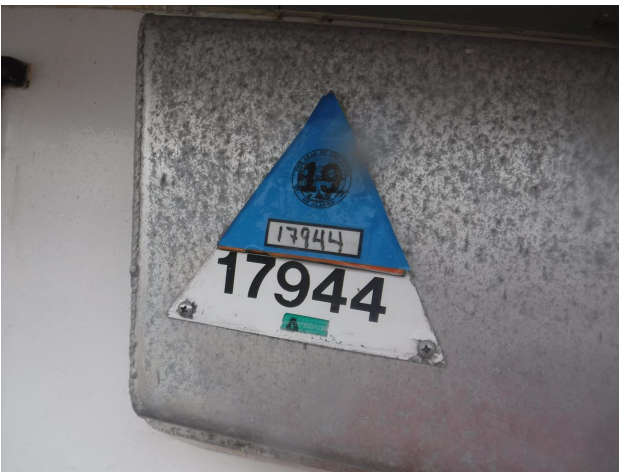
ADF&G #  
17944

STATE REGISTRATION COMPLIANCE (33 CFR 173)  
The vessel's port side State Registration Numbers and the required decal were displayed.
