1981 45' C&L Raised Pilothouse Trawler "SHENANDO"

Report of Marine Survey

Report of Condition/Valuation of the vessel

July 1, 2020

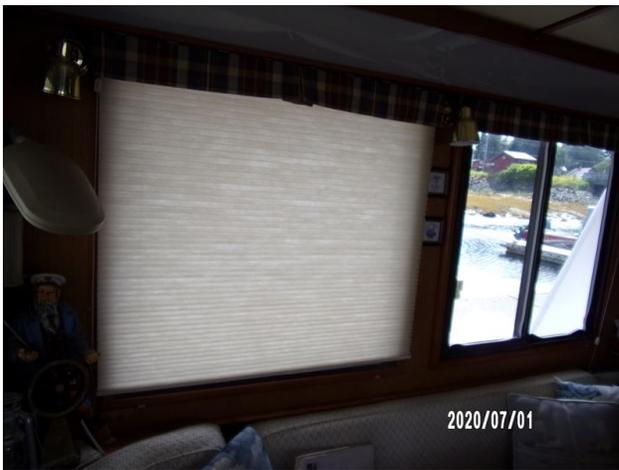
Pleated shades in the Salon. Demonstrated.

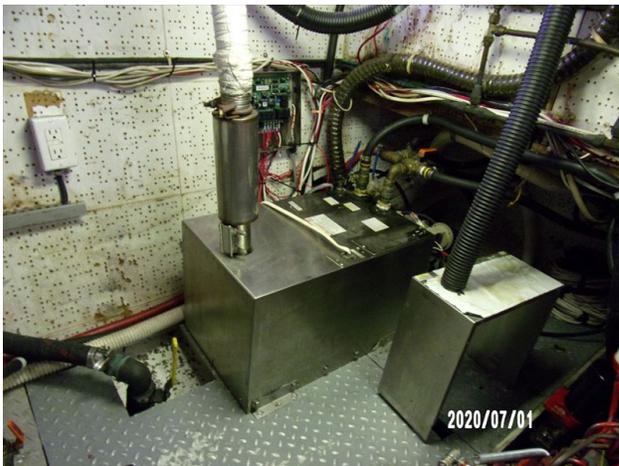
CABIN HEATING SYSTEM

Hurricane II diesel/electric furnace

(3) Real heat exchange/fan blower seen both 4" and 3" reported and or seen
112v wall mounted space heater forward cabin

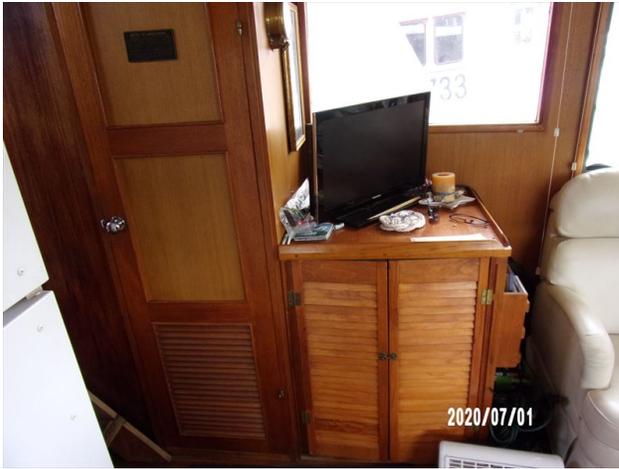
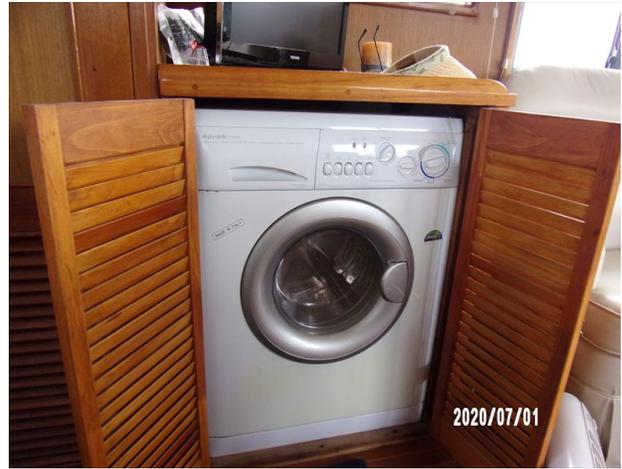
LAUNDRY SYSTEMS

Splendide 2100 Clothes Washer/Dryer Combo.

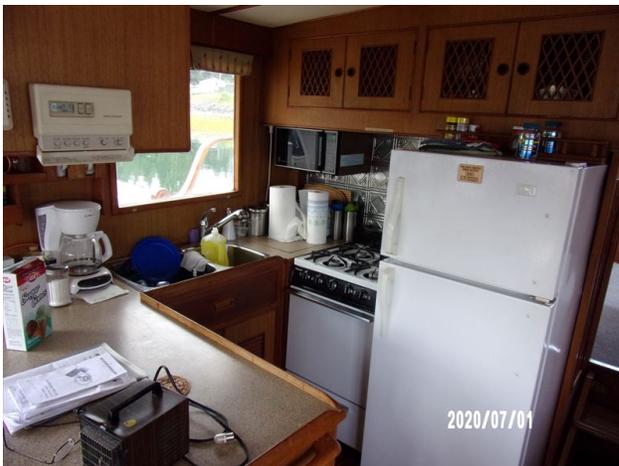
REFRIGERATION

Crossley Shelvadore refrigerator/freezer

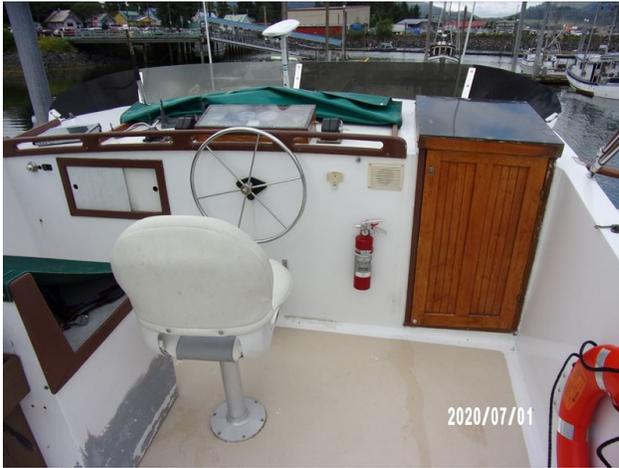
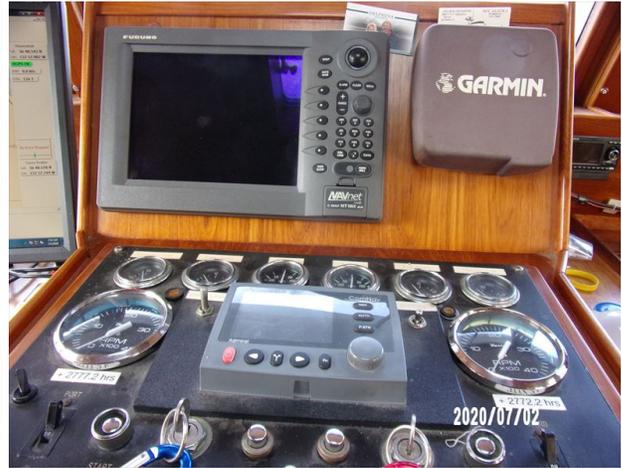
ENGINE INSTRUMENTATION

Main engine instrument gauges were installed at the helms.

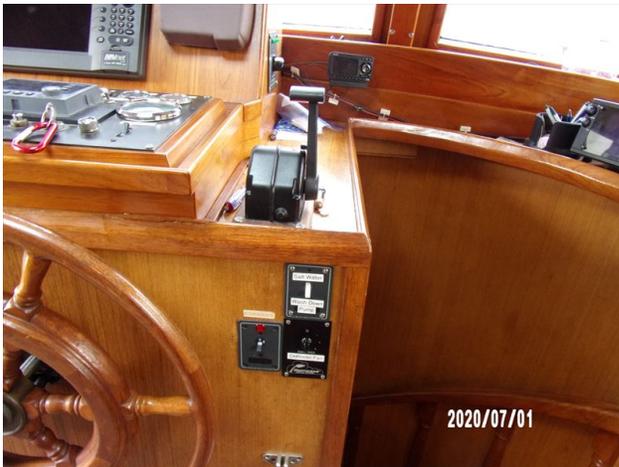
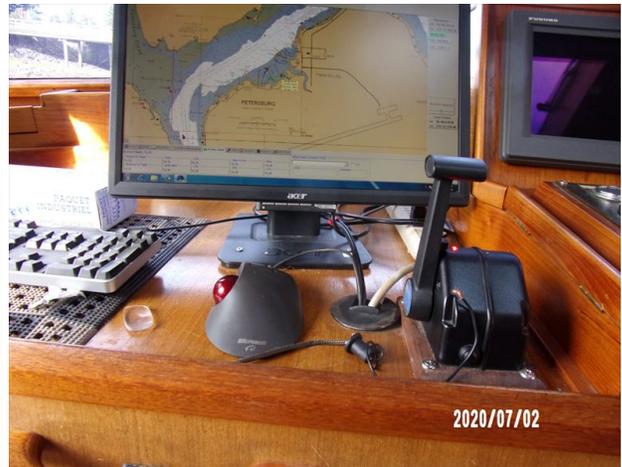
THROTTLE & SHIFT CONTROLS

ZF Mathers MicroCommander Electronic Throttle & Shift Controls.

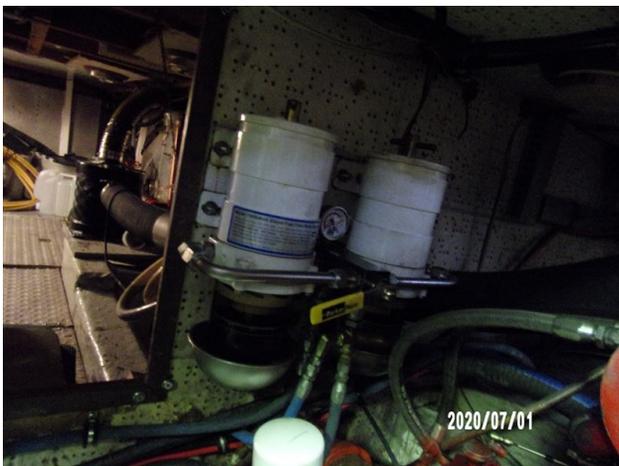
MAIN ENGINE PRIMARY FUEL FILTERS

Two (2) Racor 755900MAX-MAX Primary fuel filter/water separators. (Dual Racor set).

No significant sediment was observed in the Primary fuel filter's sight bowls. Monitor/service often.

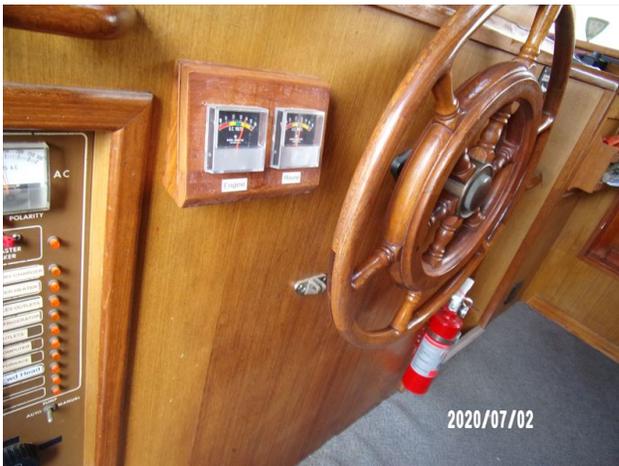
DC ELECTRICAL SYSTEM MONITORS

Digital DC voltage & amperage gauges in the main electric panel. Energy Monitor II

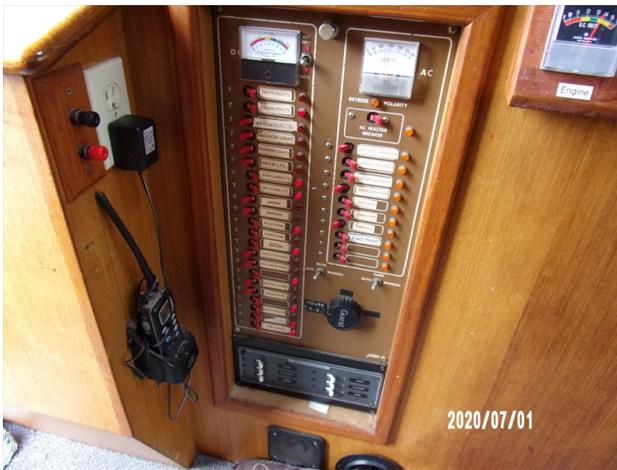
AC ELECTRICAL PANEL BREAKERS

AC branch breakers in the pilothouse's main AC electrical panel.

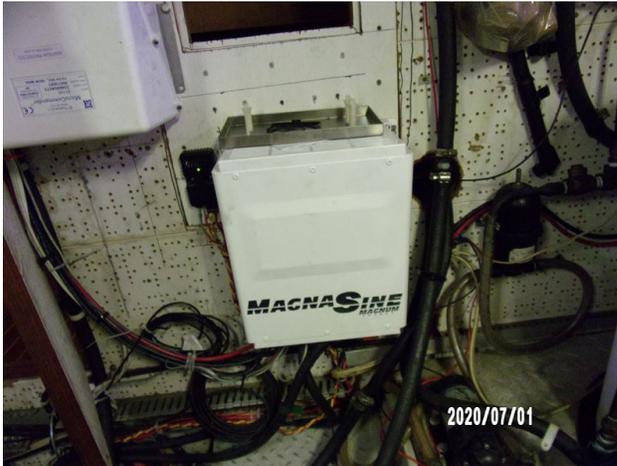
INVERTER SYSTEMS (ABYC E-11, A-31)

Magnum MS2812 pure sine with remote control

Starboard of centerline forward engine room bulkhead, adequate ventilation

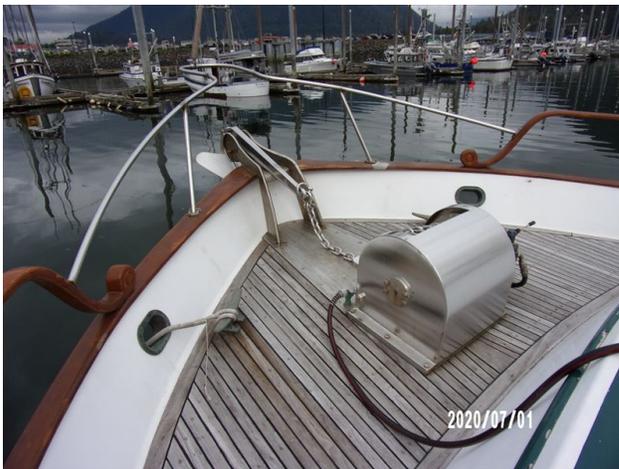
ANCHORS

45 lbs, stainless steel Suncor Plowmaster plow

Stainless steel chain, rode fiber and length and condition unknown (winch is full)

Highly recommend at least one additional spare anchor and rode for emergencies and added anchoring options.

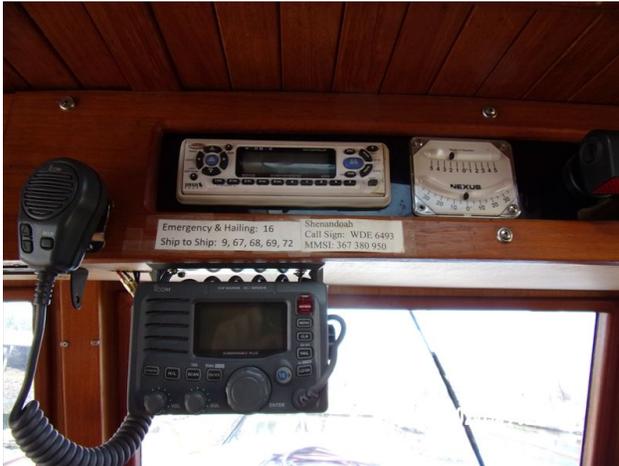
VHF RADIOS

Icom IC-M504 VHF Radio.

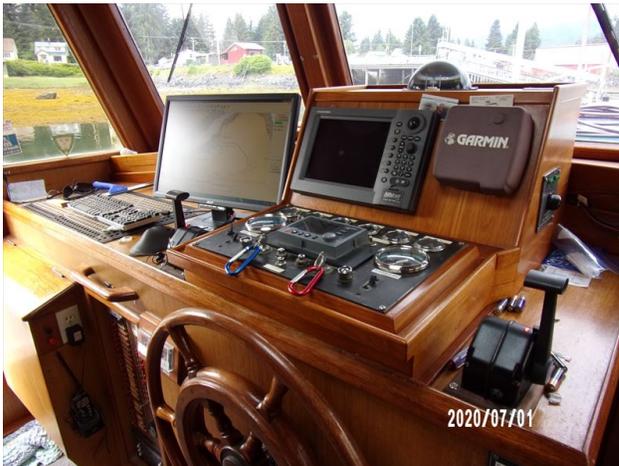
MULTI-FUNCTIONAL NAVIGATION DISPLAYS

Furuno NAVnet vx2 Multi-Functional Navigation Display, with Mile Marine Radar, GPS Chartplotter and Network Sounder.

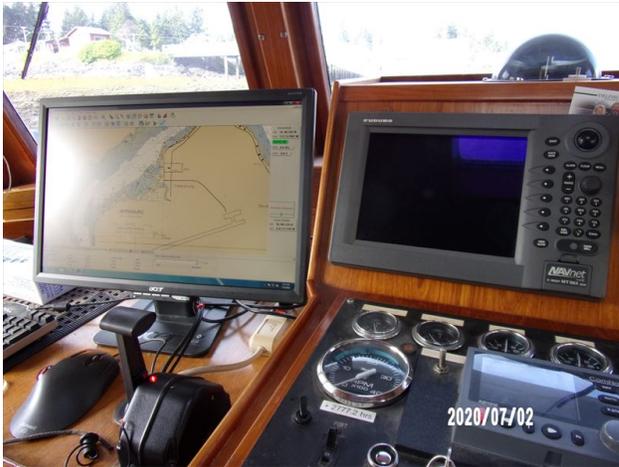
NAVIGATION COMPUTER

Dell desk top, Acer 28" monitor with Nobeltec and Rose point electronic charts

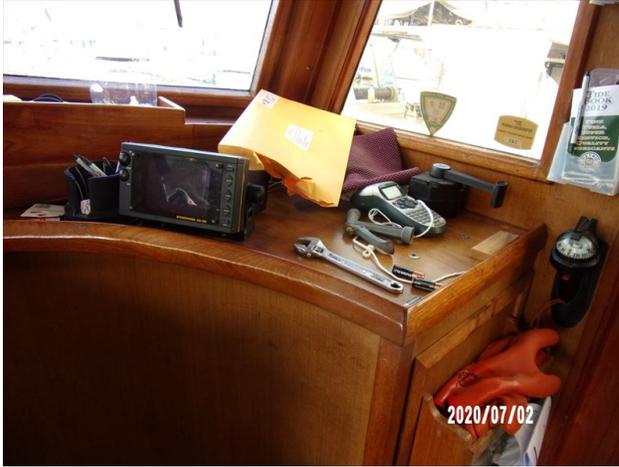
DEPTH SOUNDER

Interphase 20/20

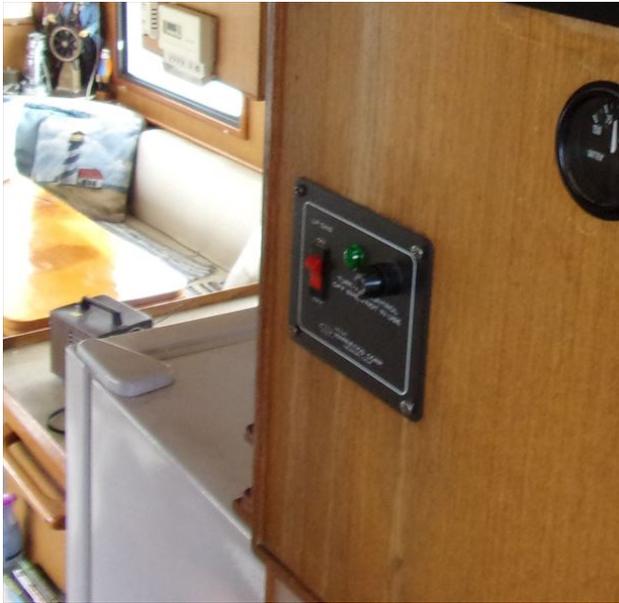
Valves at the tanks and Xintex electric LPG Controller/Gas Detector solenoid in the companionway.
