## Scott Heitman Marine Survey

**1977 60' Steel, Combination Fishing Vessel, Rigged for Summer Salmon Tendering.**

**"f/v: Demo Man's Fish Boat"**

**Report of Condition/Valuation**

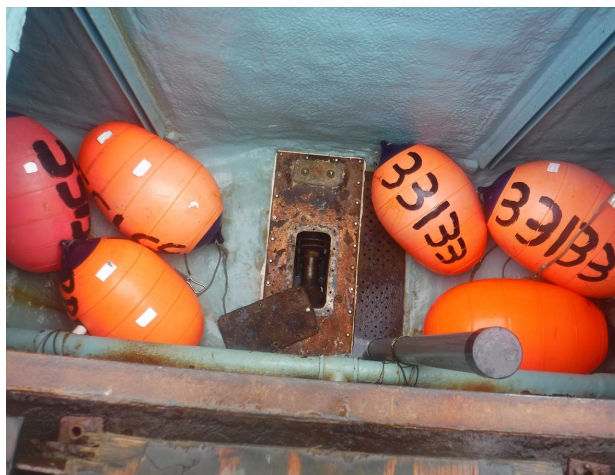
2 insulated, tanked, refrigerated 80,000 lbs. front hold; 25,000 lbs. rear, reported. The front hold was pressed up (full of water).

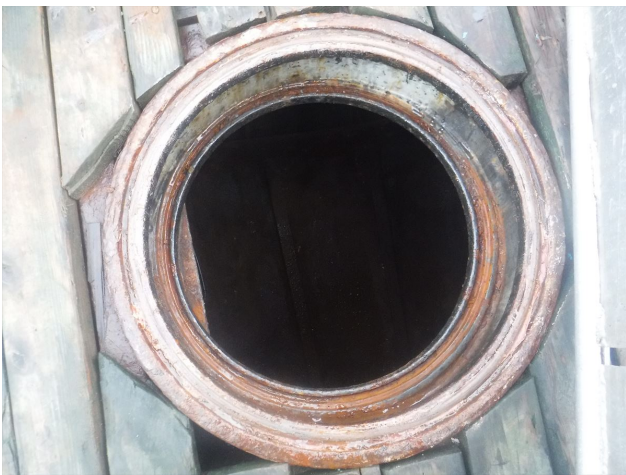
Lazarette hatch gasket appeared new.

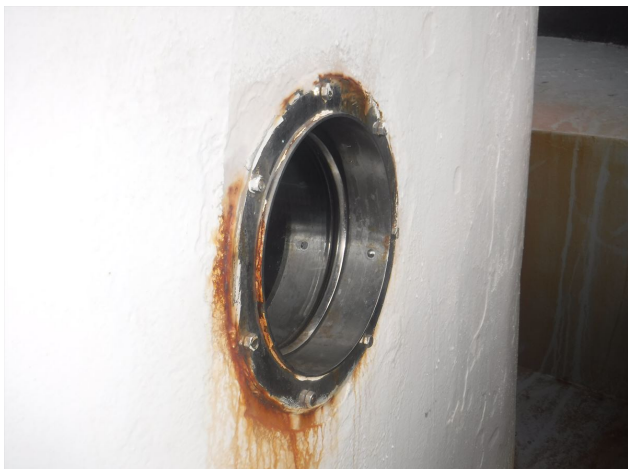
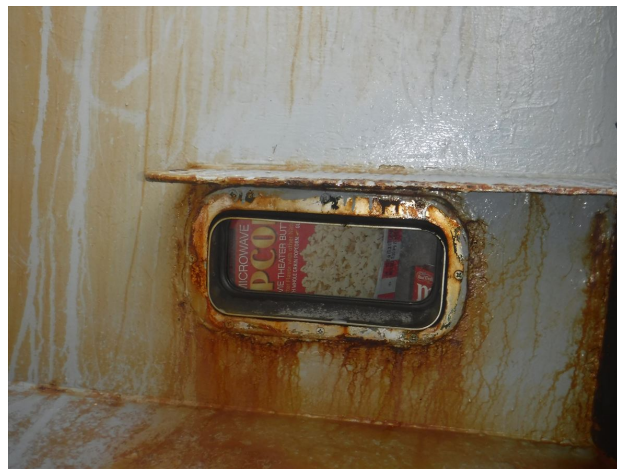
Stainless Steel Fixed portholes were located on the cabin sides. Monitor frequently for signs of leakage. Exterior is showing some rust bleeding from the fastenings. Rectangular portlight under the step leading to the fore deck also some rust bleeds

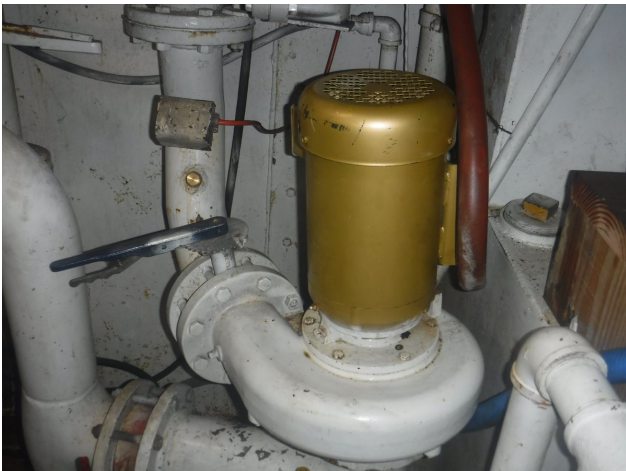
Fittings and valves appear serviceable. The fittings where seen were all encased in protective petro (Denzo) tape.  
The tape appears worn and dry. The fittings are due for retaping.

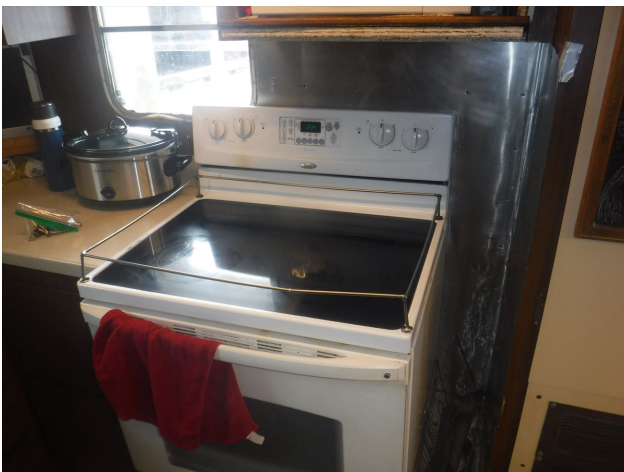
### STOVE

Whirlpool Gold four (4) burner Stove with Ceramic Glass Cooktop.

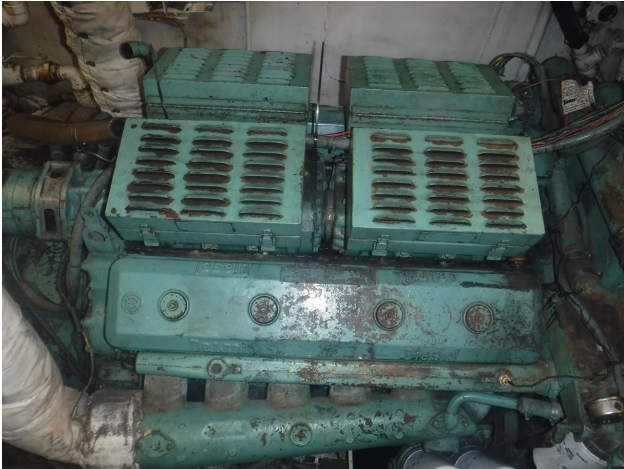
#### ENGINE MODEL

Detroit 12V-71N

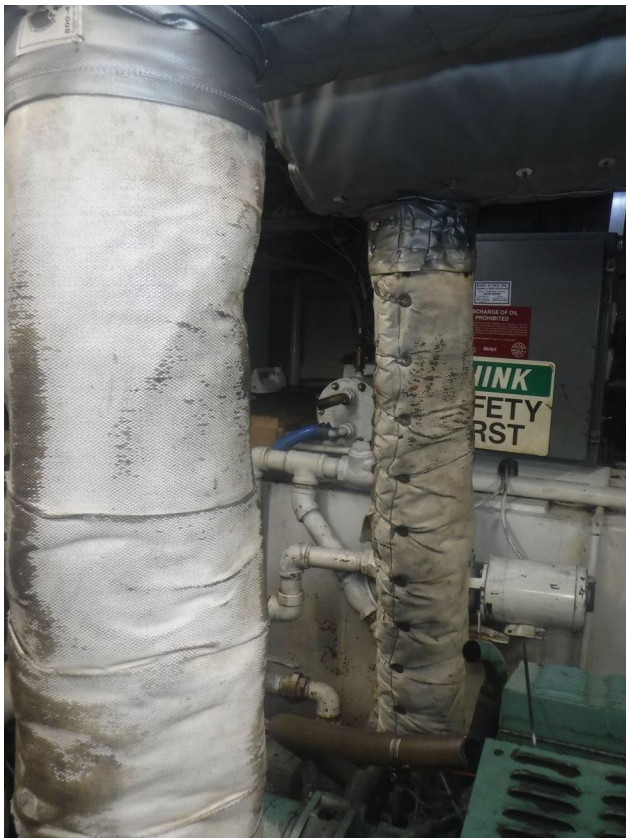
### ENGINE EXHAUST SYSTEM

Steel exhaust to the muffler, insulated in blankets and clear of all woodwork

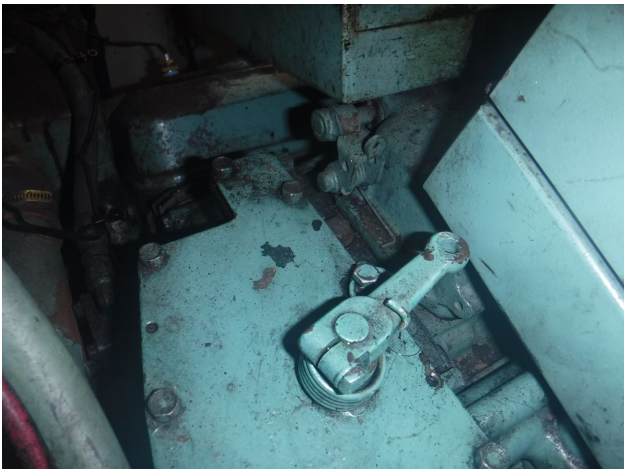
### EMERGENCY ENGINE SHUT-DOWN

Demonstrated. 3 shutdown methods. air , governor, or fuel cut-offs.

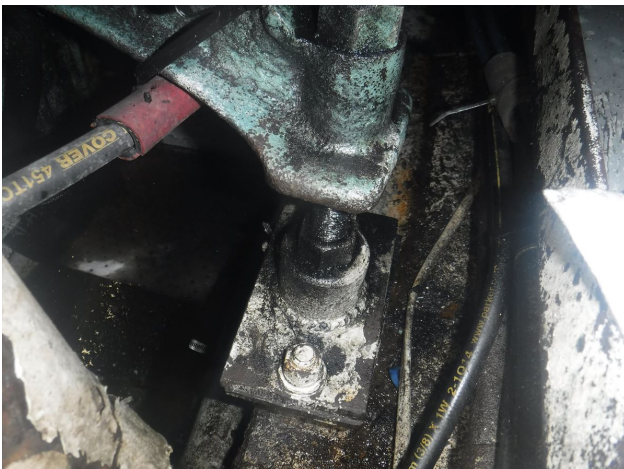
### ENGINE BED MOTOR MOUNTS

Steel longitudinal engine bed stringers with adjustable motor mounts.

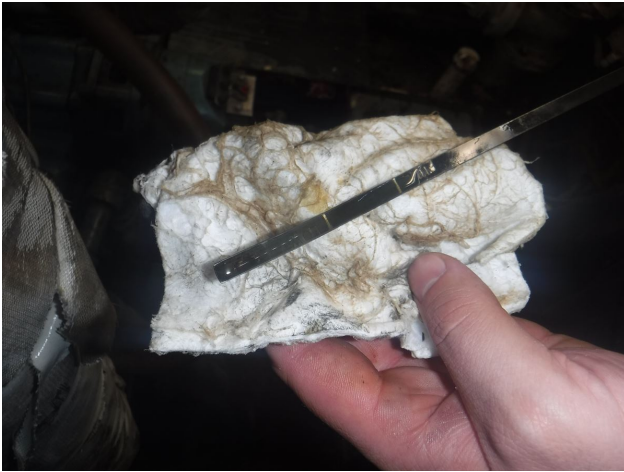
### MAIN ENGINE OIL LEVEL

Normal levels were observed on the engine sump dipsticks.

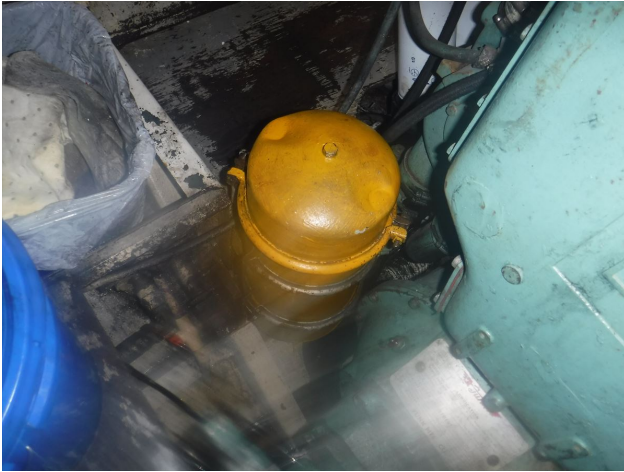
### MAIN ENGINE PRIMARY FUEL FILTERS

Remote & engine mounted, (spin-on and) canister type filter/water separators.

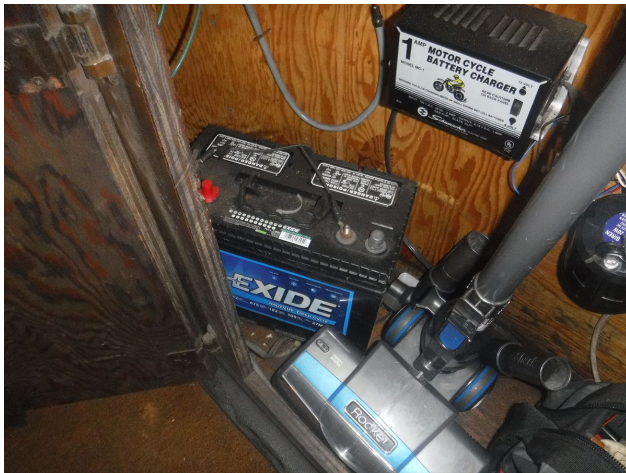
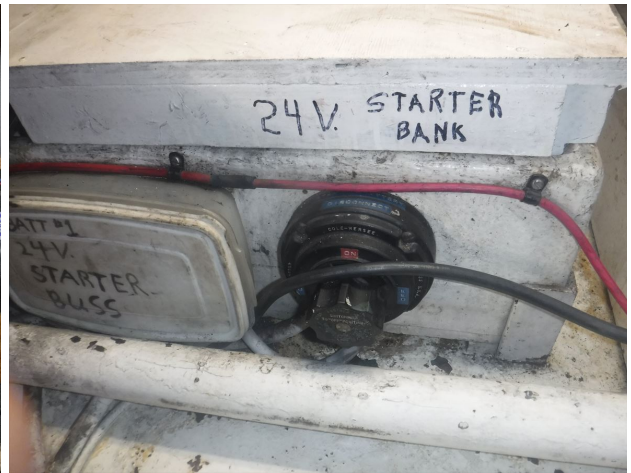
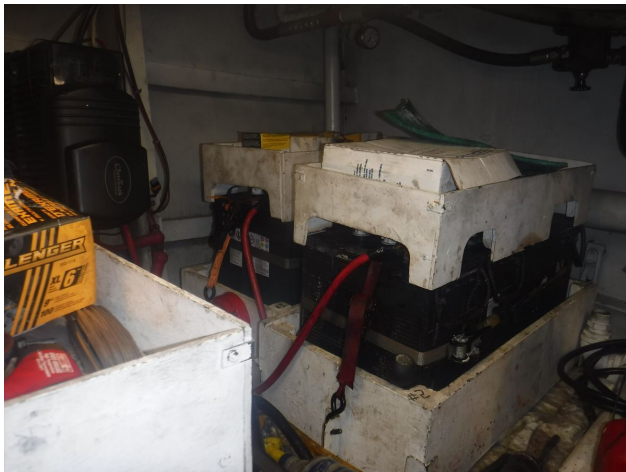
##### BATTERIES

4D8's in banks, starting and ships emergency service. 12 L 16's in 3 additional banks for inverting. 4D Alternate Navigation electronics power (emergency radio power) on the bridge.

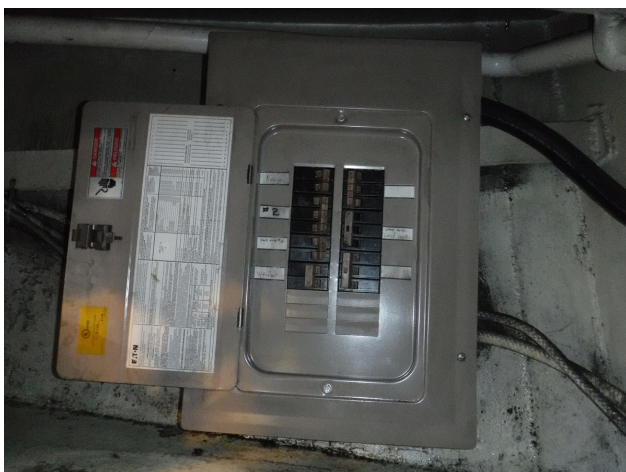
### MAIN DC BREAKERS

The main DC breakers were installed in the engine room.

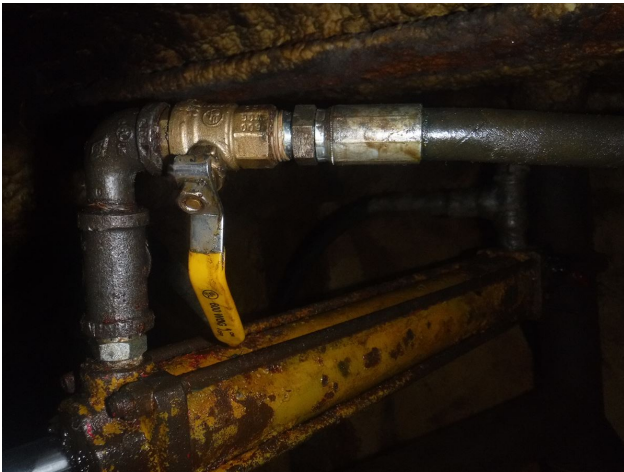
STEERING HOSES/LINES

Reinforced flexible hoses with metallic fittings. Appeared new

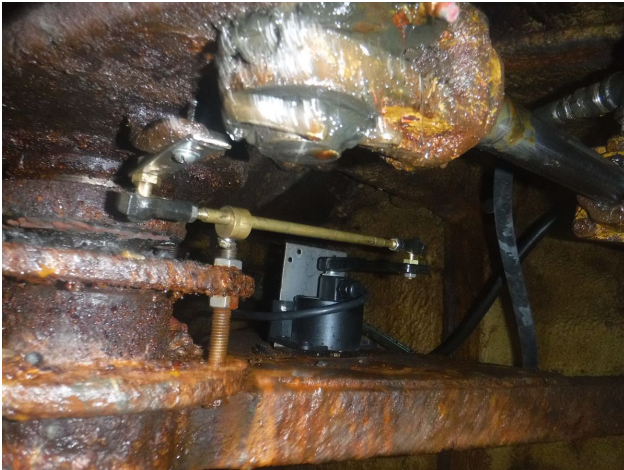
RUDDER POSITION INDICATOR SENDER  
Powered up. Demonstrated.

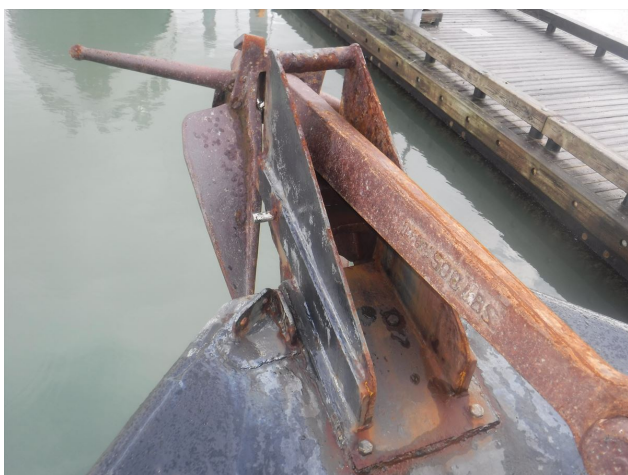
Danforth 500 pound Galvanized Anchor.

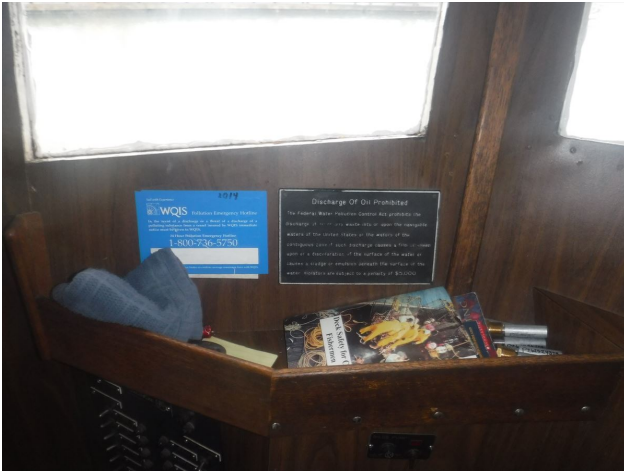
Found properly displayed.

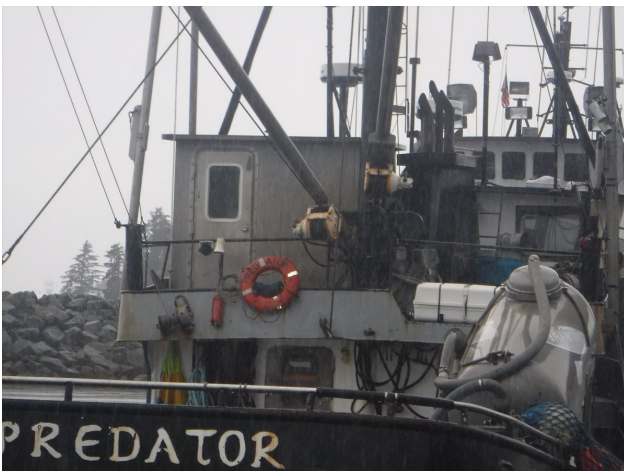
### MAST STEP

The main mast is stepped on the weather deck aft on the cabin roof. The auxiliary antennae are all stepped to the pilot house roof.

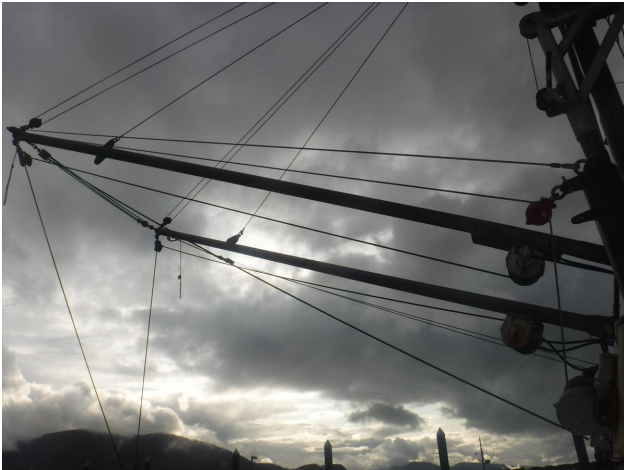
### BOOM

2 Aluminum booms rigged with lifting, topping and vanging winches.

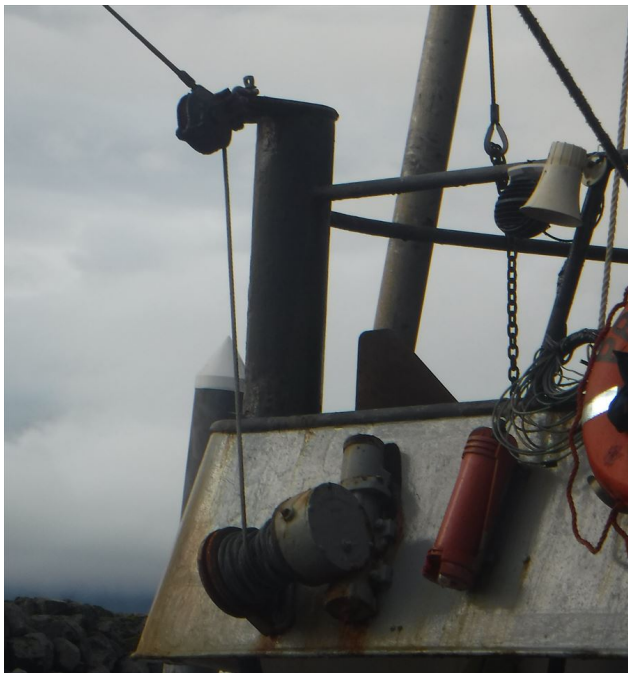
### VANGING WINCHES

on port and starboard aft cabin bulkhead, Kinematic TY-6's

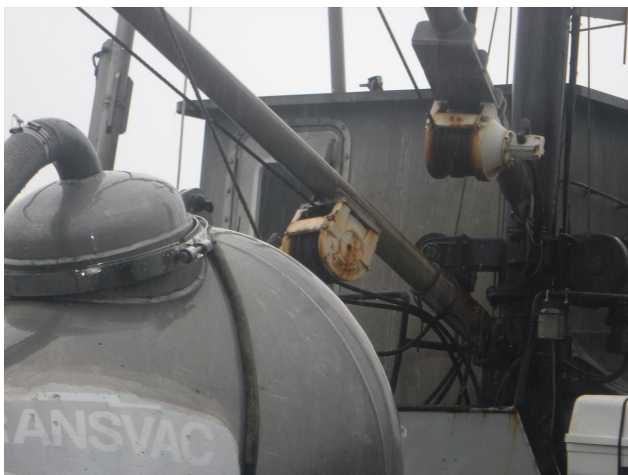
### SWIVEL BLOCKS

Heavy duty red snatch blocks (steel)

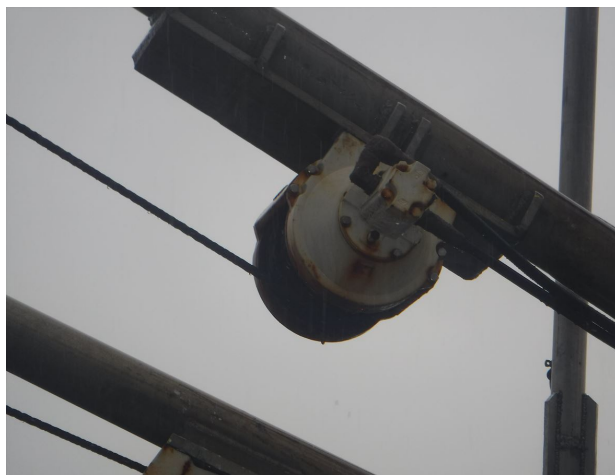
### WINCHES

2 Pullmaster PL-4, Powered up.
