1982 58' Delta Limit Seiner, Combination Fishing
"F/V: Artaios"

Report of Marine Survey

Report of Condition/Valuation of the Fishing Vessel

Inspected on November 21-22, 2020

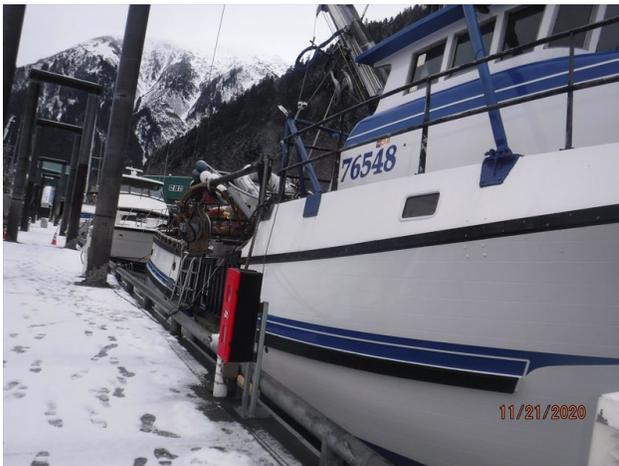
GENERAL EXTERIOR CONDITION

The exterior of the vessel appeared to be generally well kept and newly painted

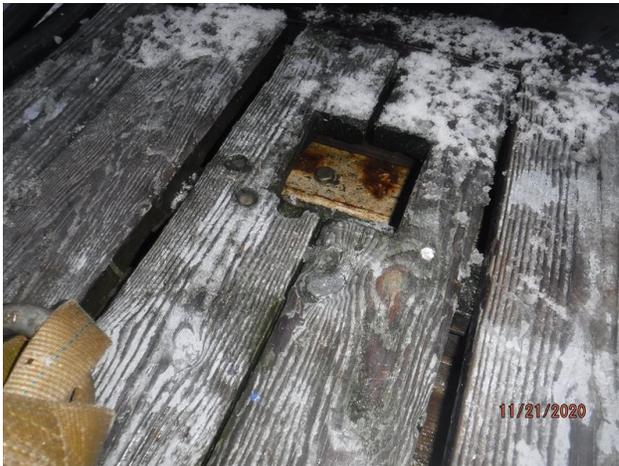
FALSE DECK

Raised wear deck, 2"x10" and 2"x6" Apitong decking wood well worn and in fair condition.

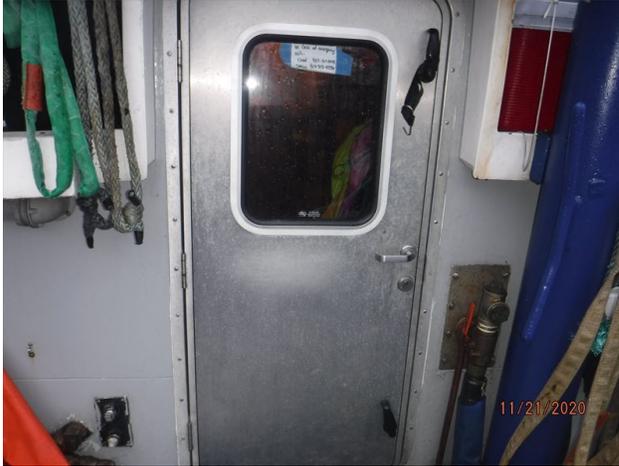
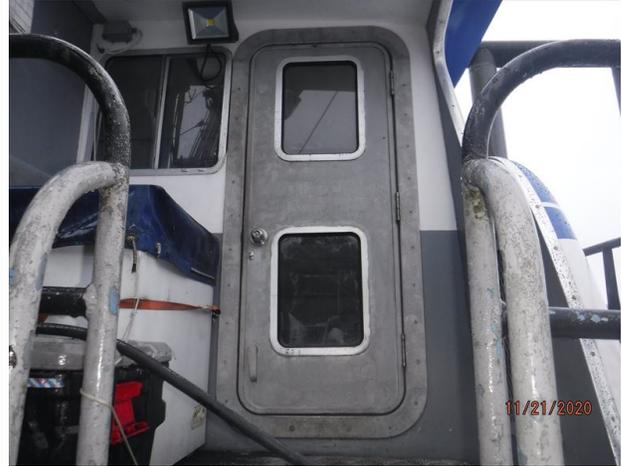
EXTERIOR DOORS

Aluminum Diamond Sea Glaze dogged door(5'4") is fitted into a snorkel at the aft cabin bulkhead port of center with a single window. The Top house exterior door is aluminum, fitted to the fore cabin bulkhead, starboard of centerline, with two stacked windows. The watertight exterior doors appeared serviceable.

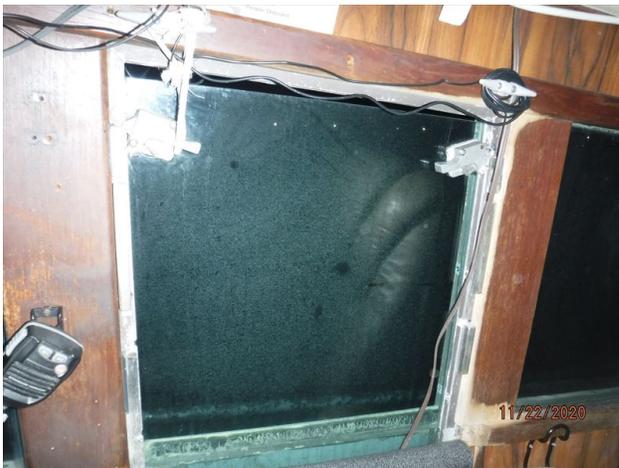
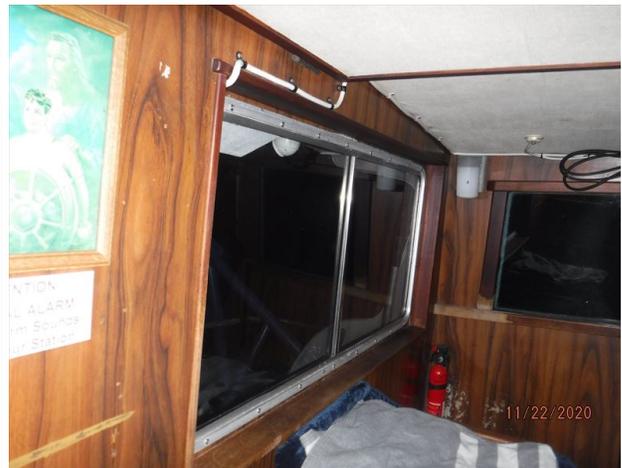
WINDOWS

Tempered, fixed windows in aluminum frames. Port and starboard heavy weather windows, in steel frames, opening

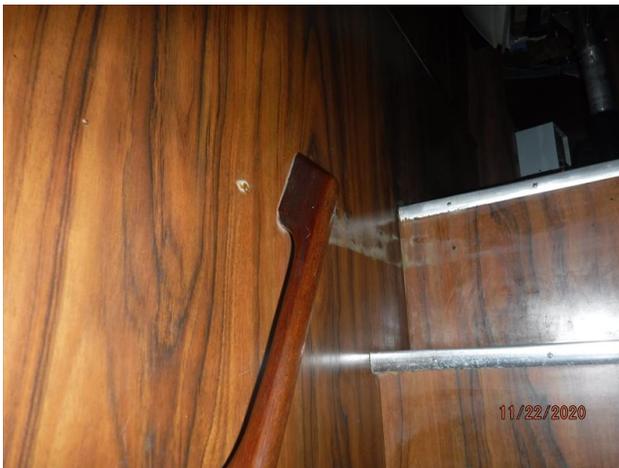
HAND RAILS/GRAB RAILS

Grab rails were seen around the perimeter of the cabin hand rails were located at convenient locations of the vessel.

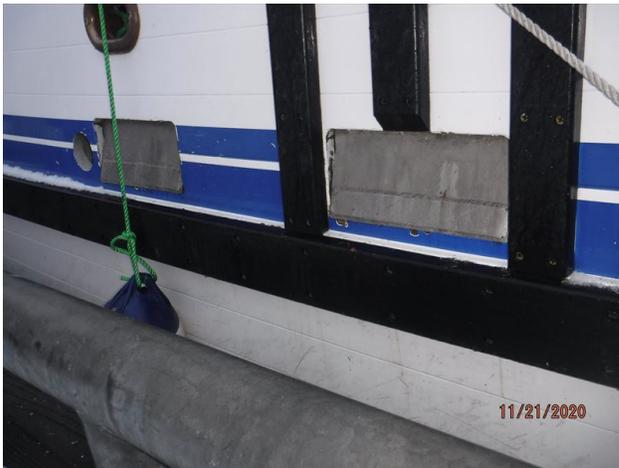
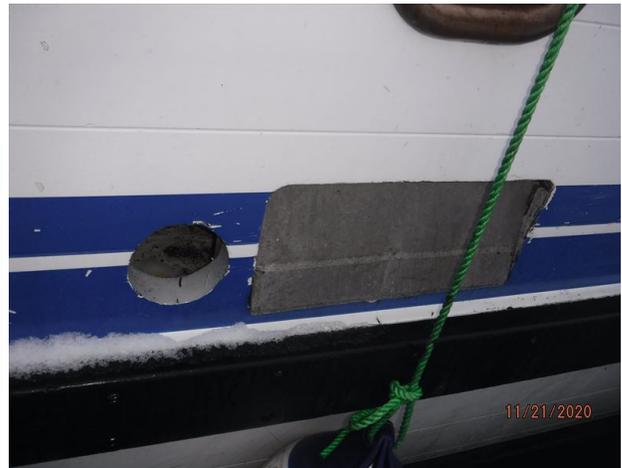
DECK DRAINAGE

Eight (8) 16"x8" self bailing deck drains and deck freeing ports.

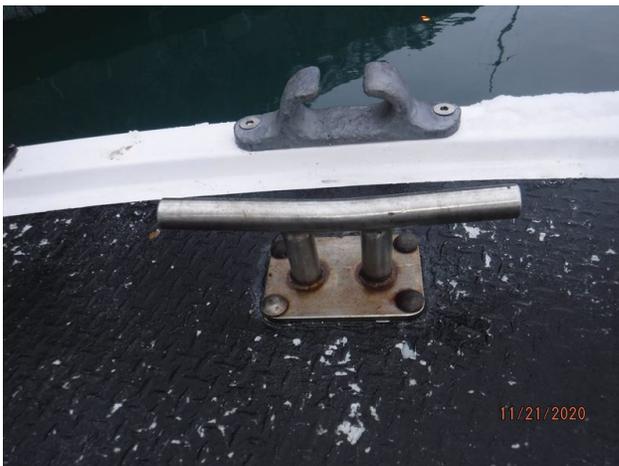
CLEATS

The whale back cleats are stainless steel. On the main deck the cleats are bronze hawse hole cleats

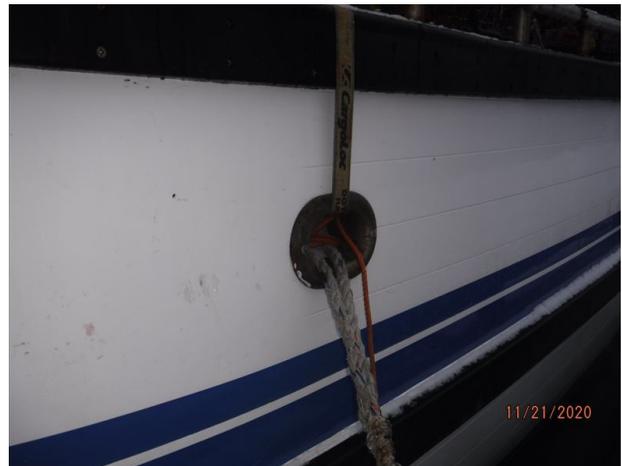
LINE HAWSE PIPES

Line hawse pipes were installed port & starboard at the stern, fore & aft side decks

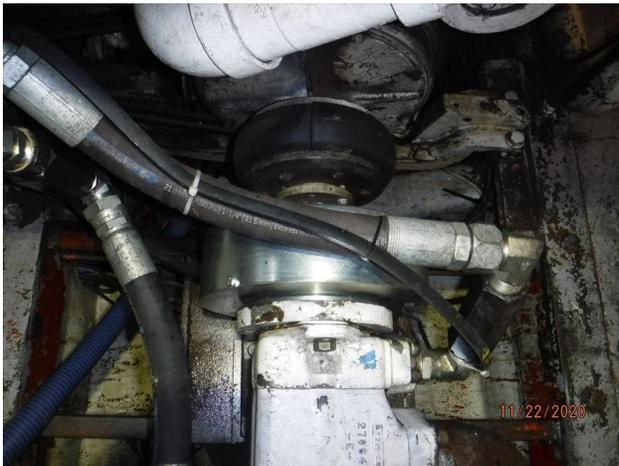
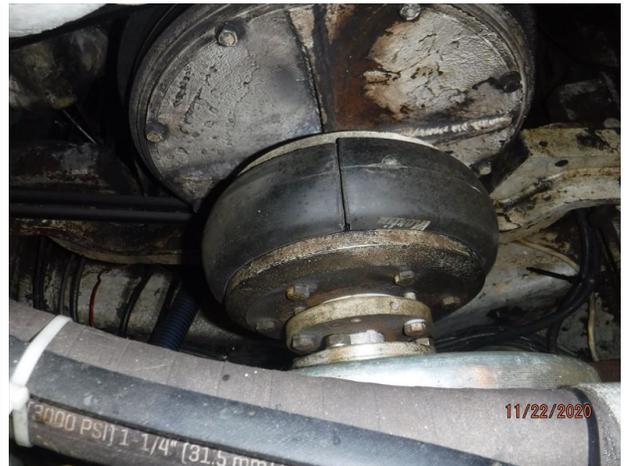
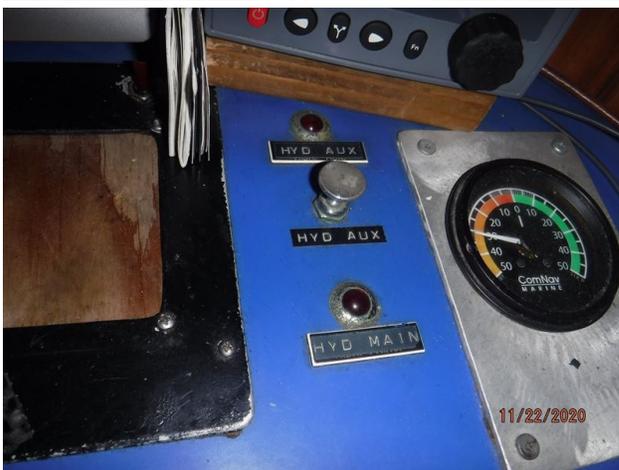
HYDRAULIC PUMPS AND POWER TAKE-OFFS

Commercial Shearing 60/40 mounted on the main engine forward with a Pitts PTO, clutch switch at the helm

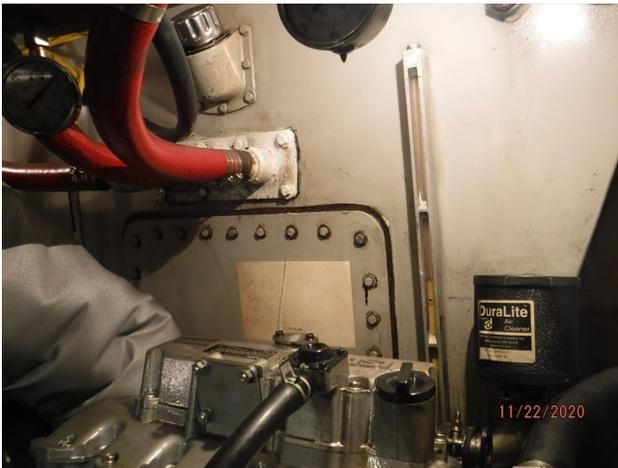
HYDRAULIC TANK

45 gallon estimated. Shares the same tank as lube oil

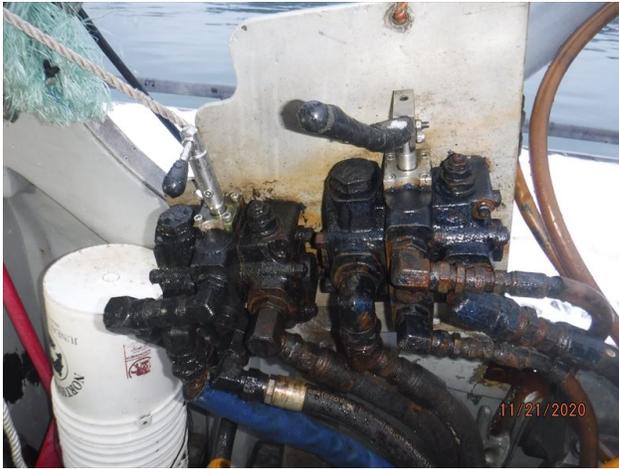
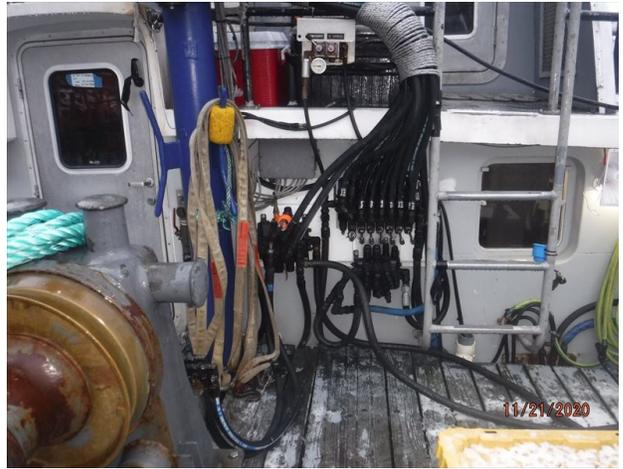
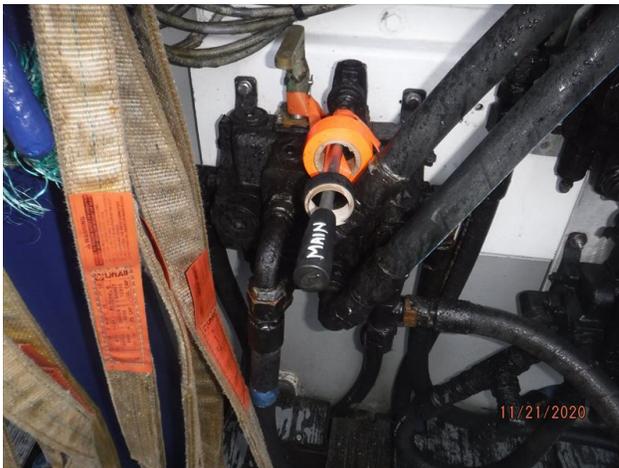
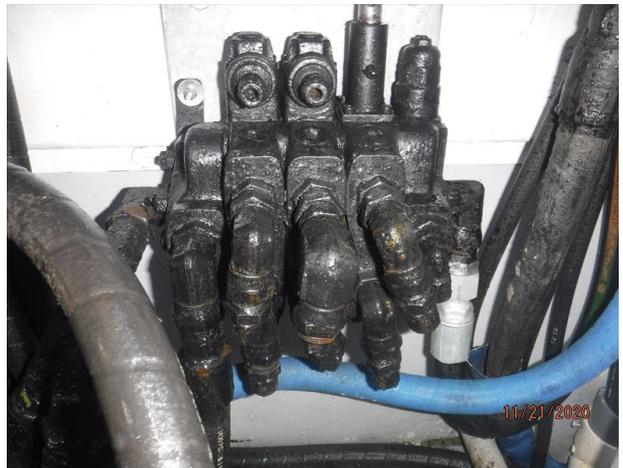
HYDRAULIC VALVES/BANKS

There are three Walvoil banks mounted on the aft cabin bulkhead. The 'big side' valve with an always on rotary handle runs either the deck winch and PL12 for seining, or feeds the starboard, rail mounted, crab block and davit banks. The 'small side' is a 7 spool Walvoil and will run all of the ancilliary picking and main boom winches, as well as, the power block. The King Coiler, crab conveyor, and bait grinder are all run through the lower 'small side' third Walvoil bank. The starboard rail has two banks mounted running a 22" Junes crab block and a davit. They are plumbed through the big side bank. The valves are all new this season and well marked.

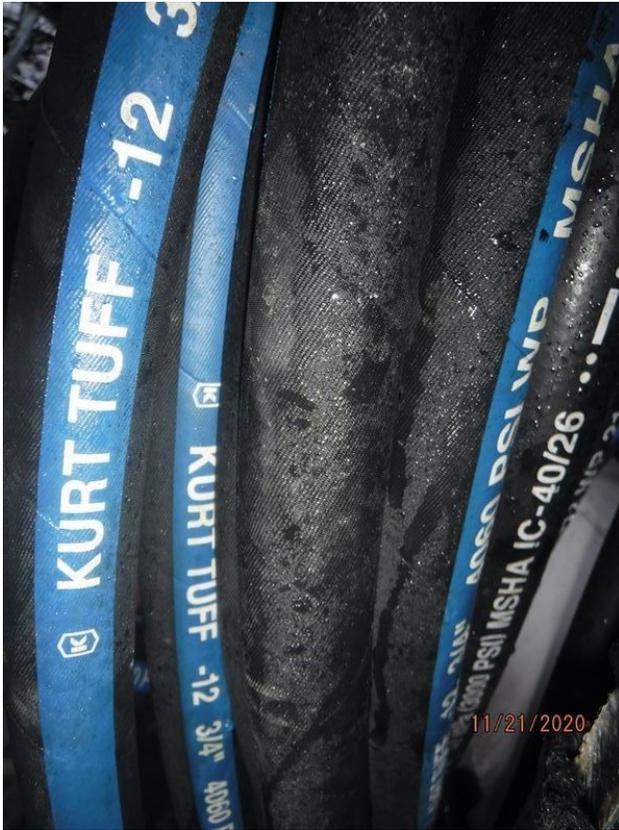
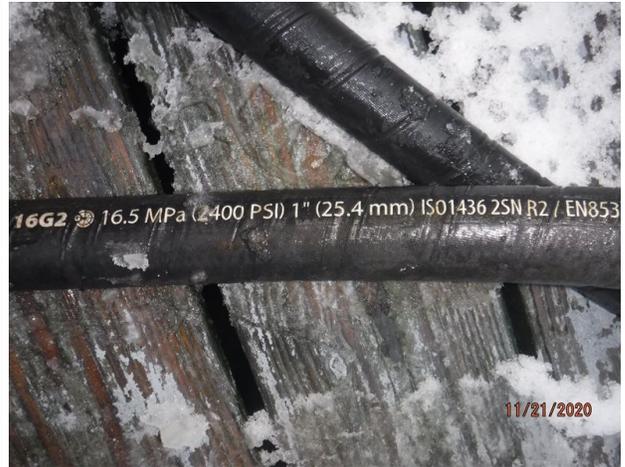
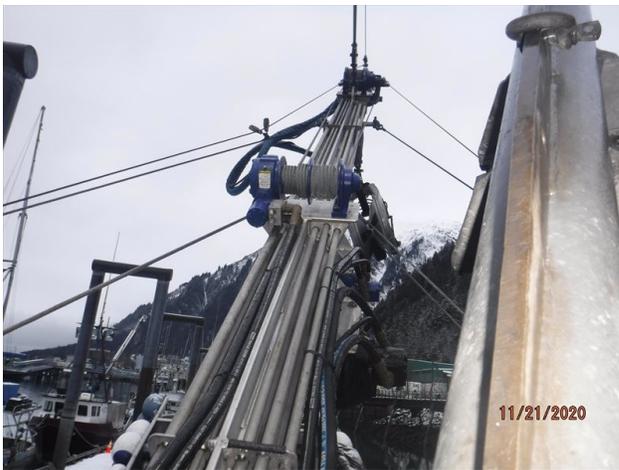
HYDRAULIC LINES/FITTINGS

The big side lines are new 1" Gates. The small side flexible lines are 3/4" Kurt Tuff. There is aluminum pipe or tube running up the main boom and in the engine room. All the lines are well marked ,organized, and chafe protected with 3/8" poly and/or water discharge hose, sheathing

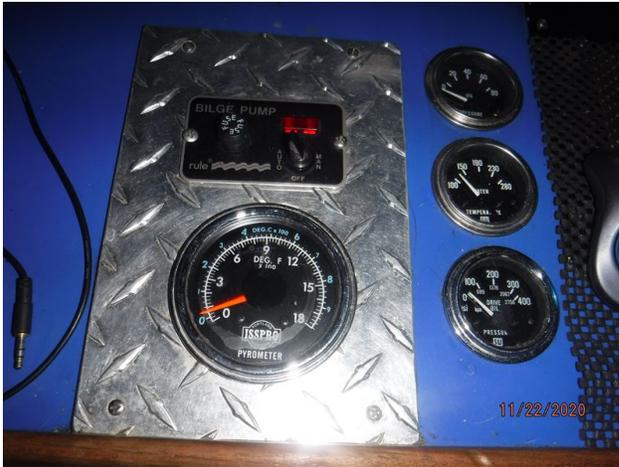
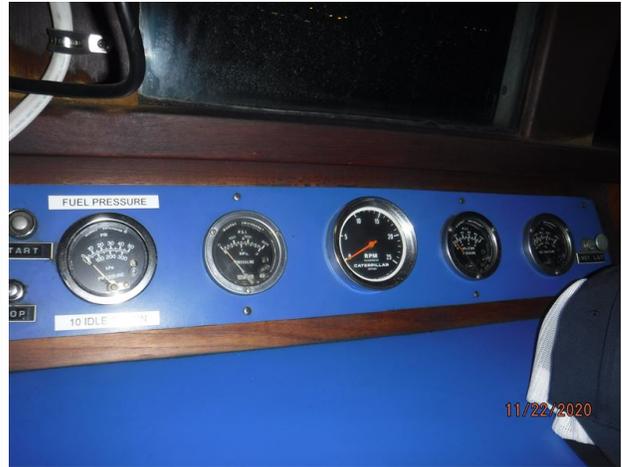
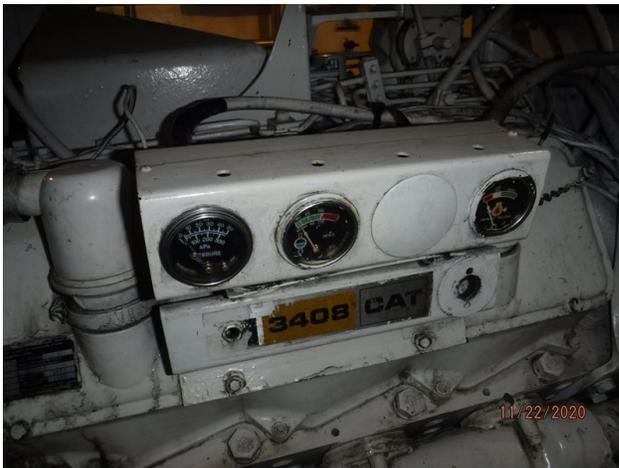
Main engine instrument gauges were installed at the helm. Additional main engine instrument gauges were installed in the engine room.

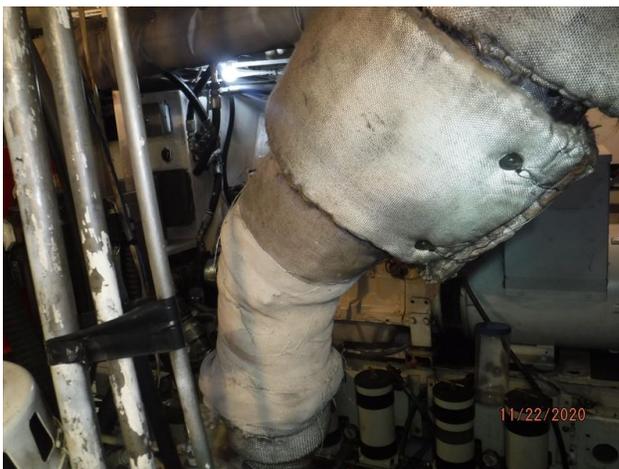
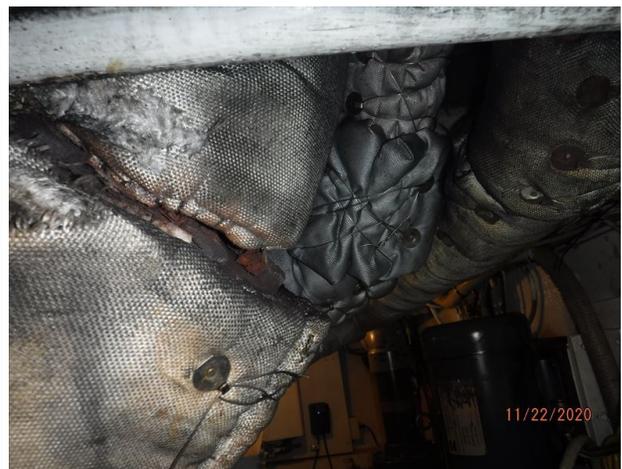
Insulated in hard frp then blankets

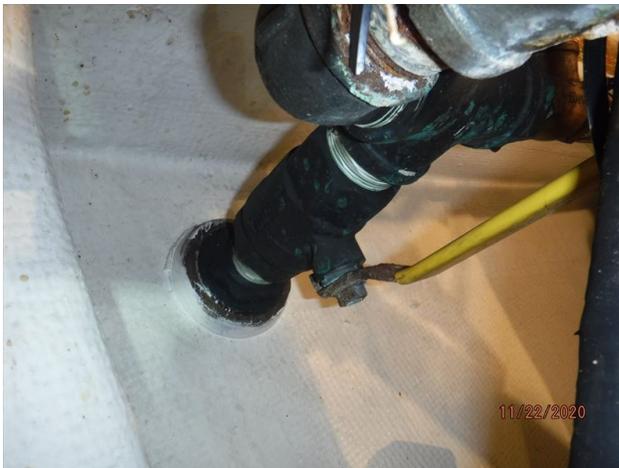
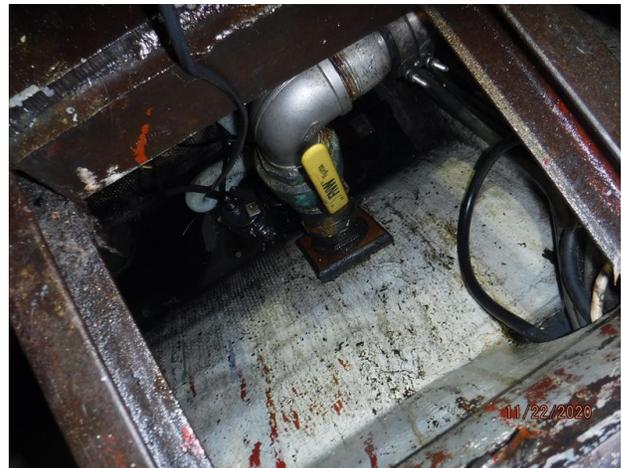
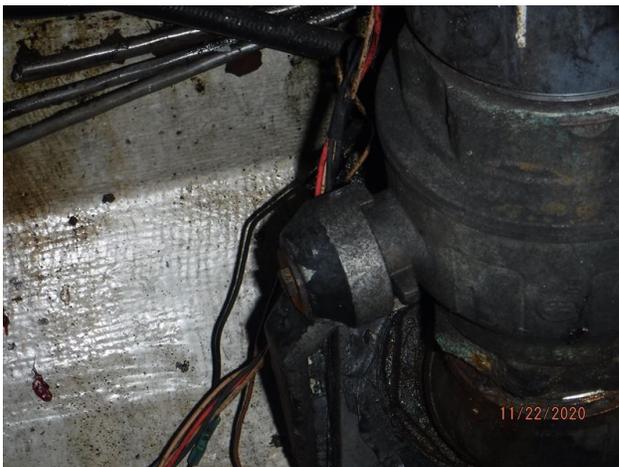
Groco bronze alloy with sight glass. Used for the RSW condenser pump

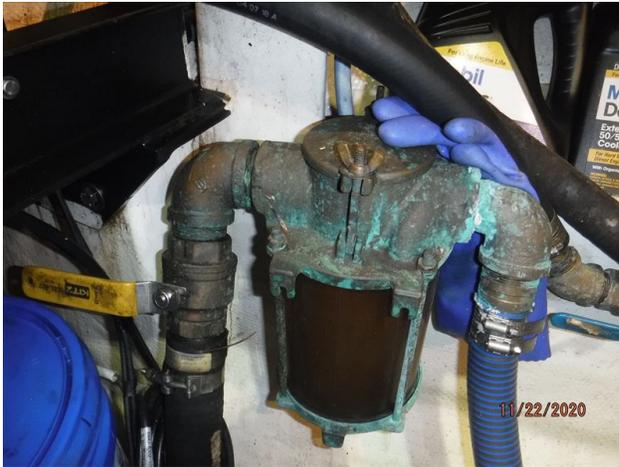
Appeared serviceable, where sighted. Monitor frequently for dry cracking, degradation, damage or chafing.

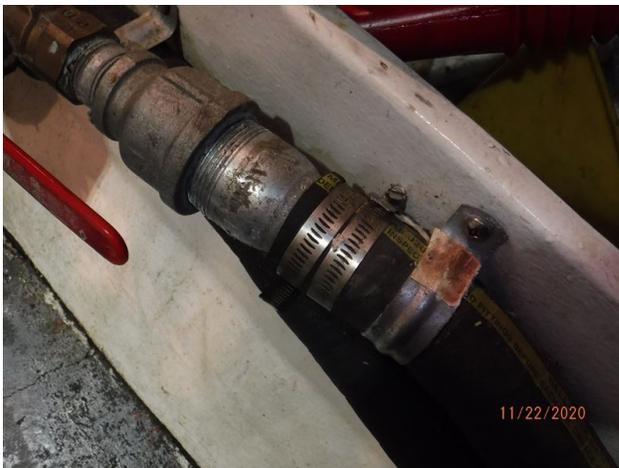
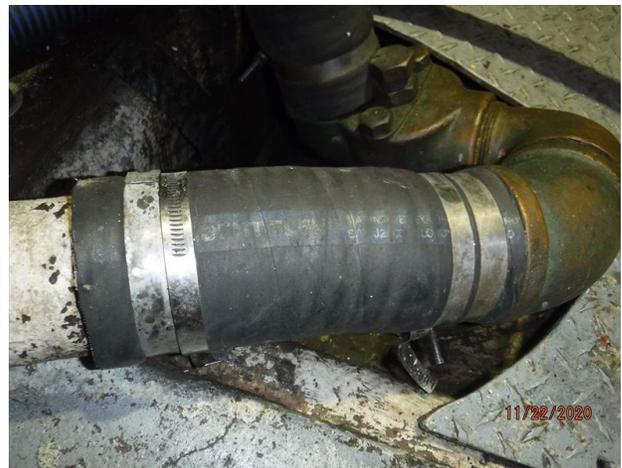
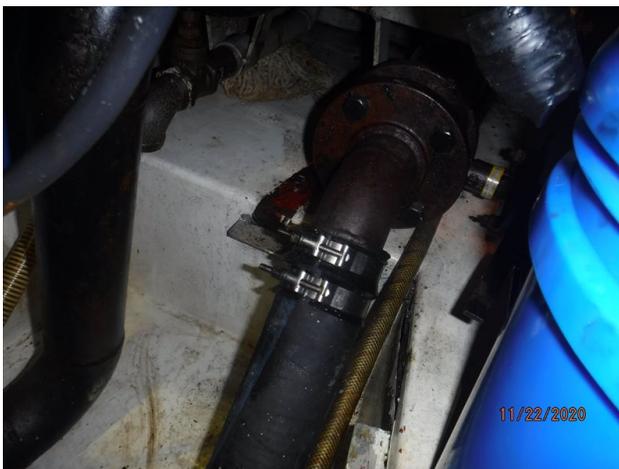
Double clamped where sighted. Some slotted stainless steel, some marine grade non-slotted T-bolt type

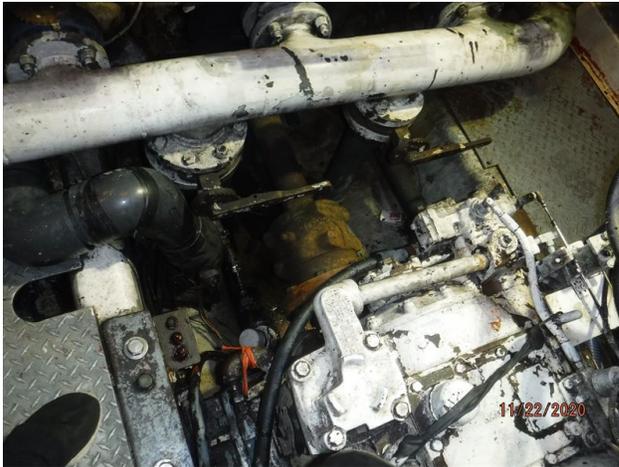
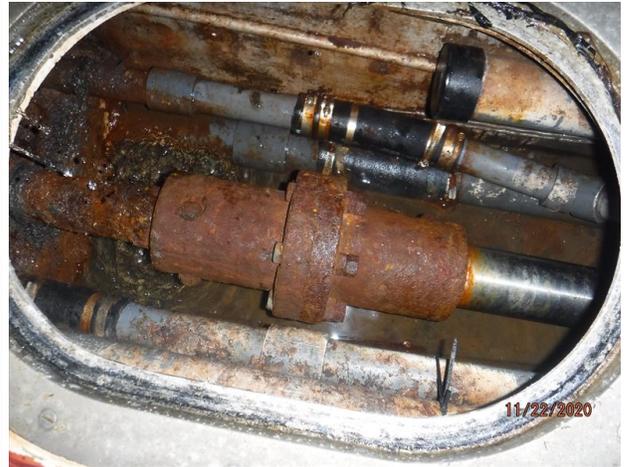
Flange & bolt stuffing box type packing glands. Monitor frequently.

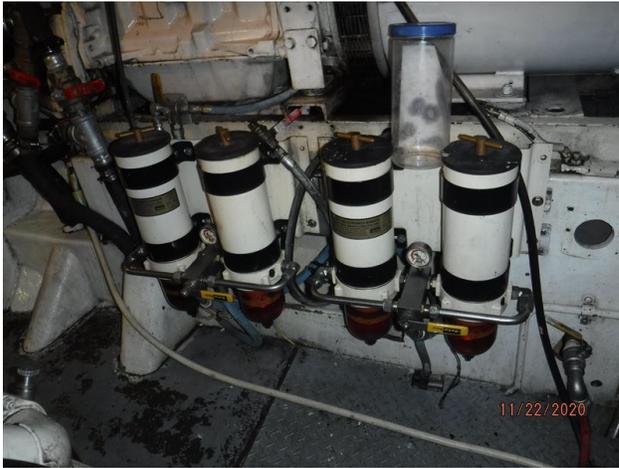
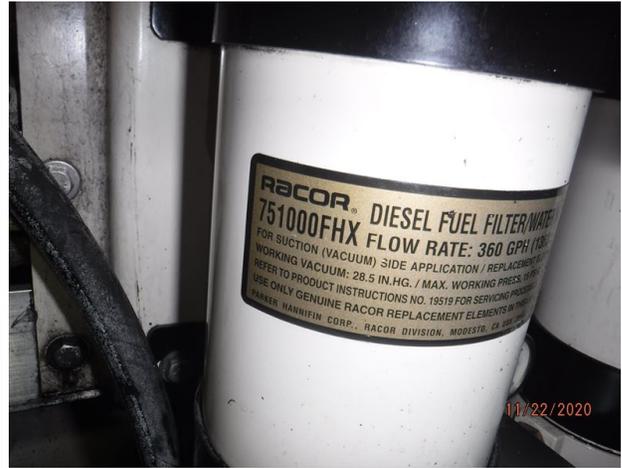
FINDING B-5

Dual Racor 75/1000FHX Primary fuel filter/water separators.

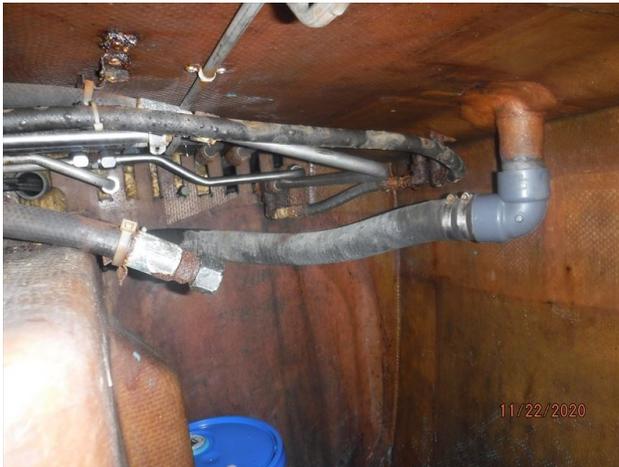
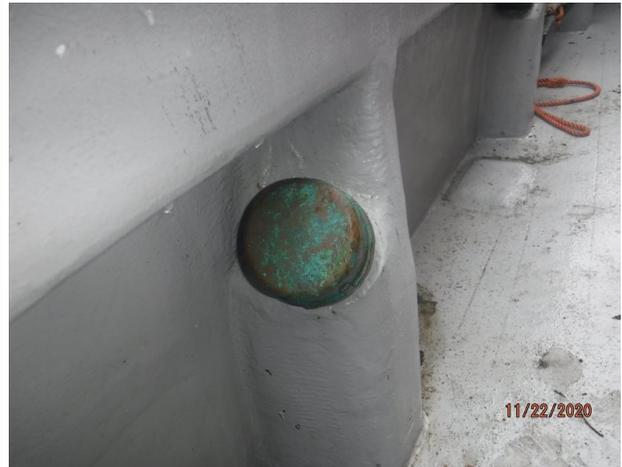
The water fill plumbing in the lazarette (photo below) shows double hose clamps. The fuel fill hoses are likely to be the same. Double clamped. Too verify this the deck fill fittings will have to be pulled. Pulling the fills may be impracticable and cost prohibitive

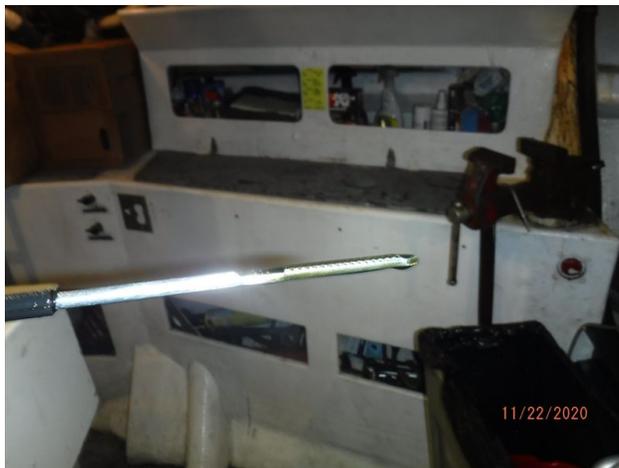
Oil level was normal on the generator's oil sump dipstick. The starboard genset dip stick is inaccessible

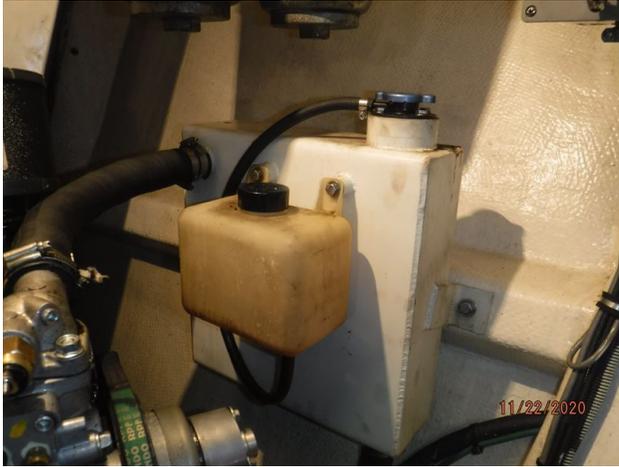
FINDING B-11

(Both) auxiliary generators Coolant Recovery Expansion Tanks appeared empty. (all of the three tanks)

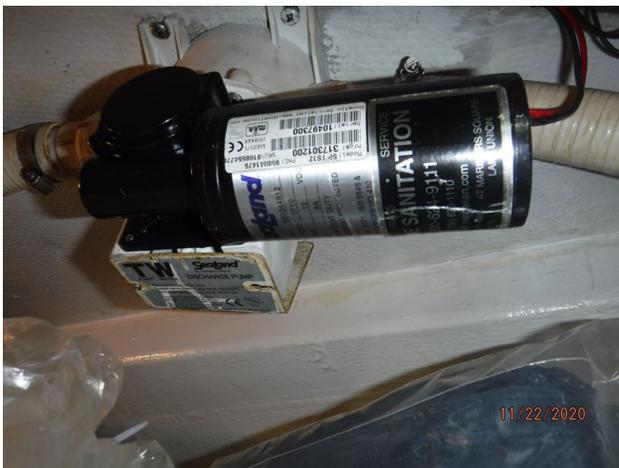
Type III MSD Waste System (utilizes a holding tank or similar device that prevents the overboard discharge of treated or untreated sewage). see appendix B-14

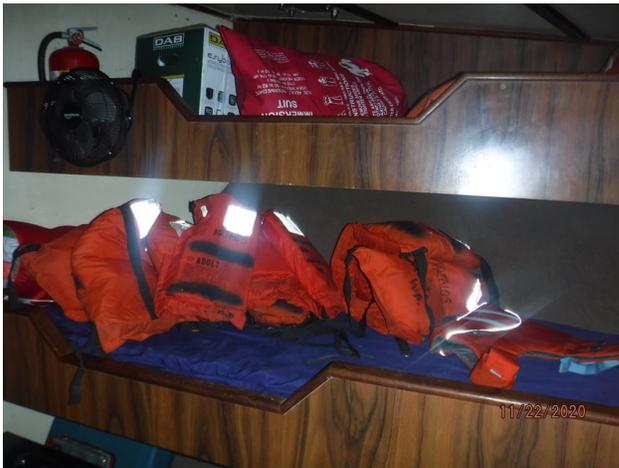
FINDING A-1

All the above devices were checked (46 CFR 28.115 – General Requirements/46 CFR 28.135 – Markings) for proper retroreflective tape, the proper markings, whistles and lights, current dated batteries, zipper operation and orientation. (see appendix)

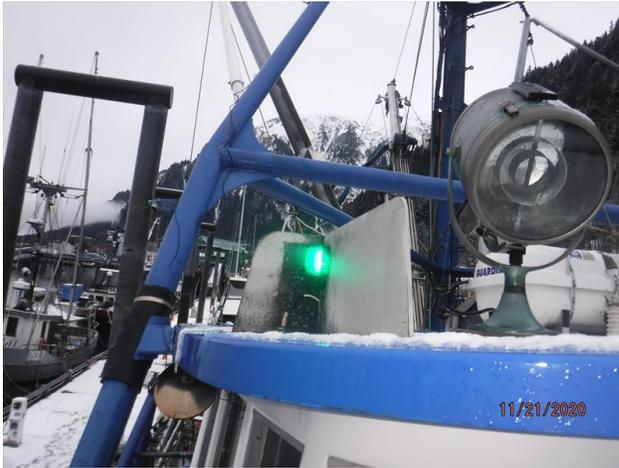
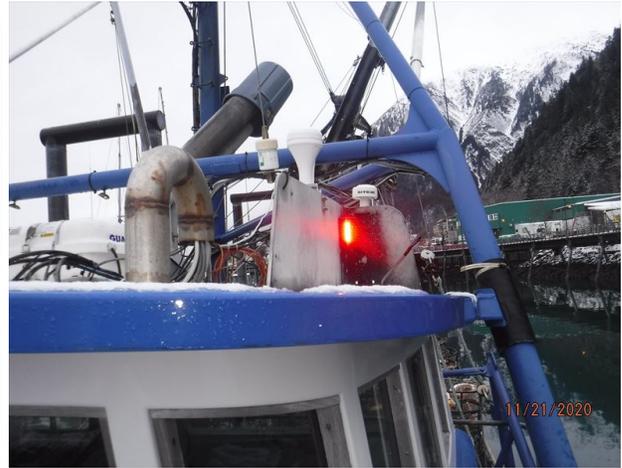
FINDING A-2

The Navigation Lights illuminated, except where noted.

Repair or replace the Anchor Light to comply with USCG Regulations.

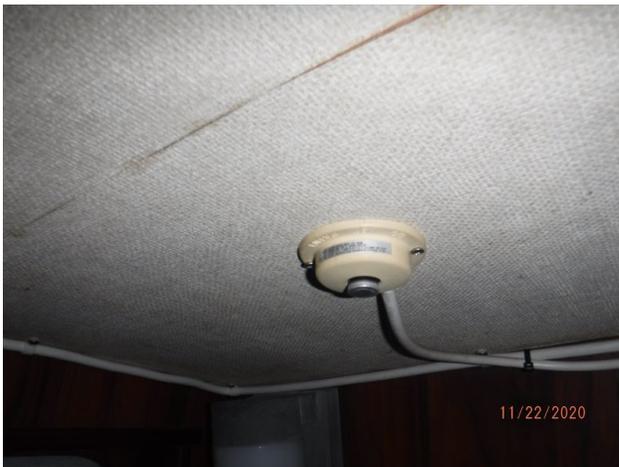
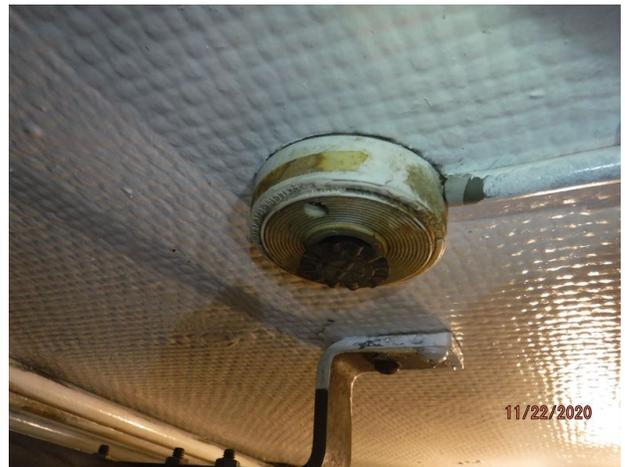
FIXED FIRE SUPPRESSION SYSTEM

Two (2) Carbon Dioxide Fixed Fire Suppression Tanks in the engine compartment. (ok on commercial boats) Automatic thermal and manual activation. Manual shut down buttons are in the companionway as are the blower on off switches. A system discharge indicator was not seen at the helm.

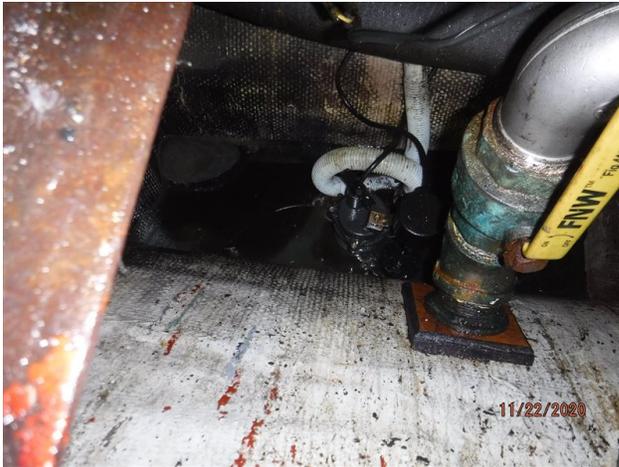
CRAB SUMP PUMPS

Deming 5x6 crab pump driven by a 208 volt ac 10Hp electric motor (grey color motor starboard side)

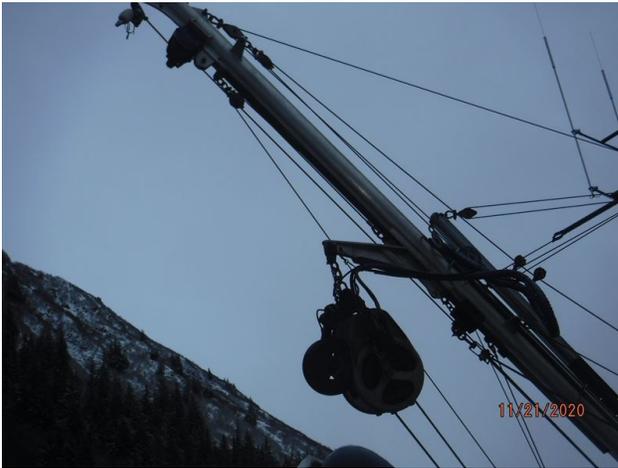
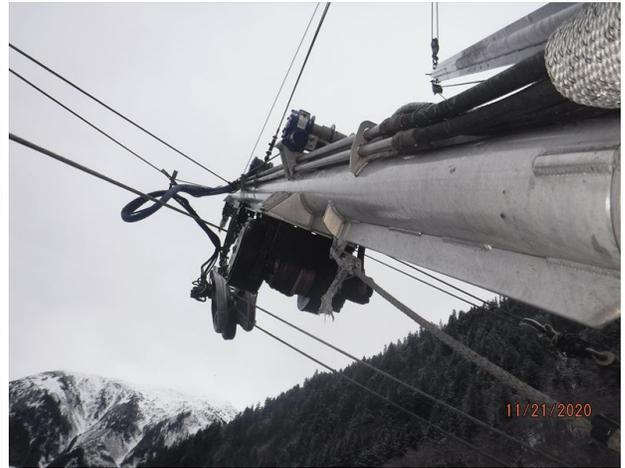
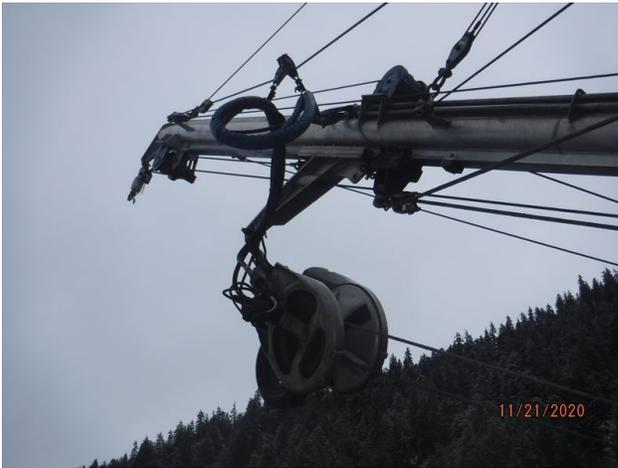
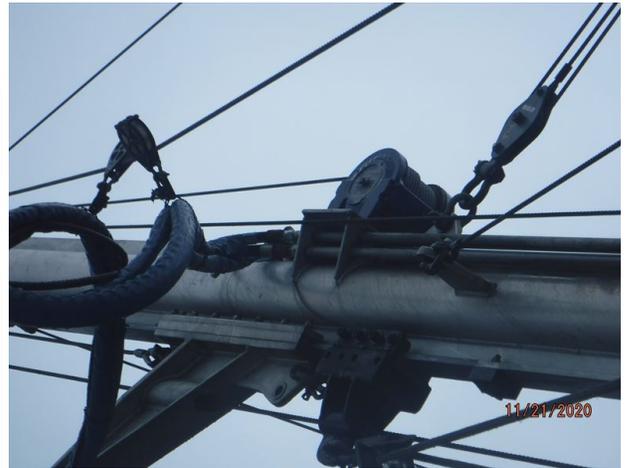
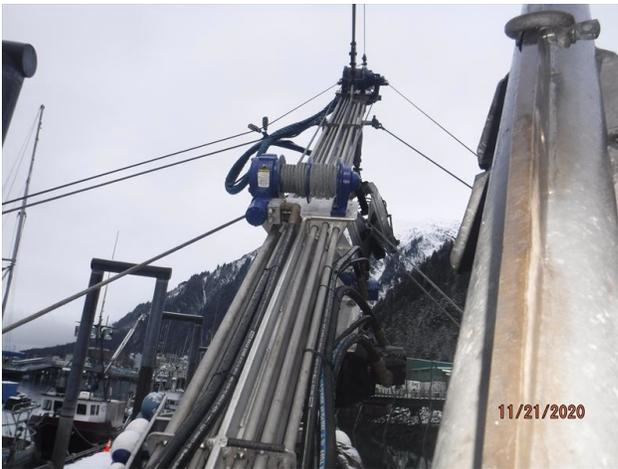
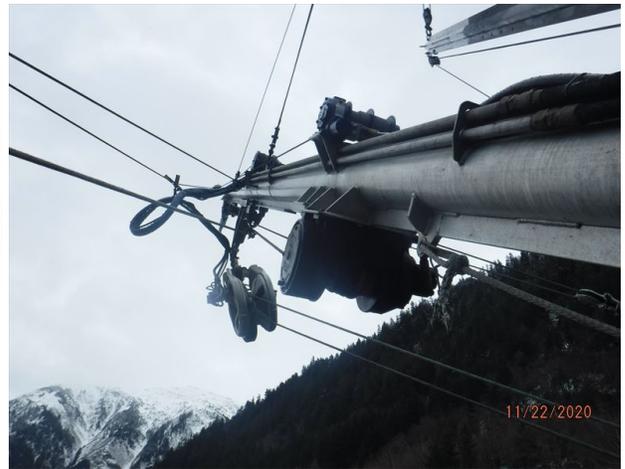
MAIN BOOM

New, 8" aluminum seine boom with a slider, tip winch, seine winch and mid boom topping winch, stainless steel pipe, hydraulic supply lines

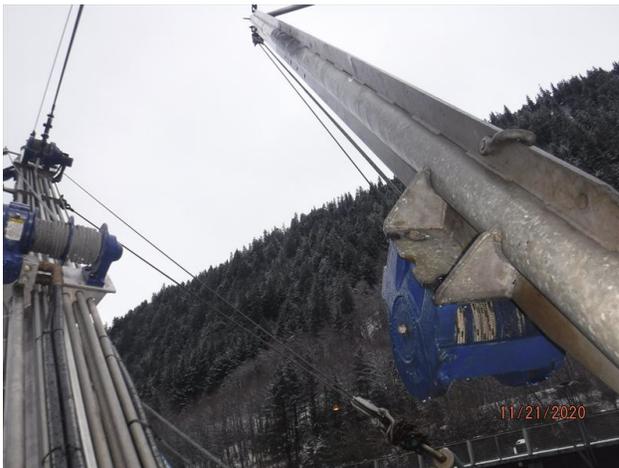
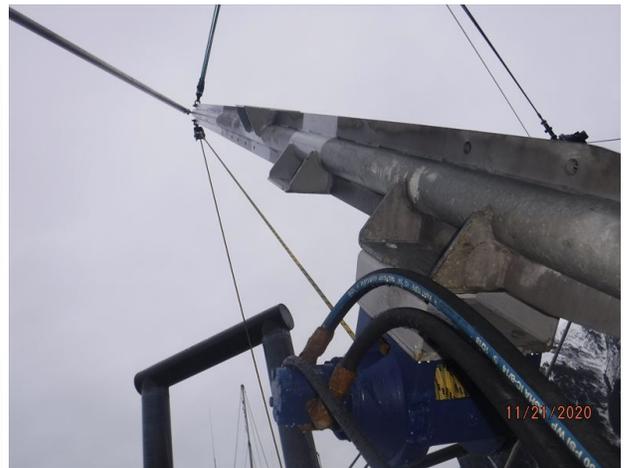
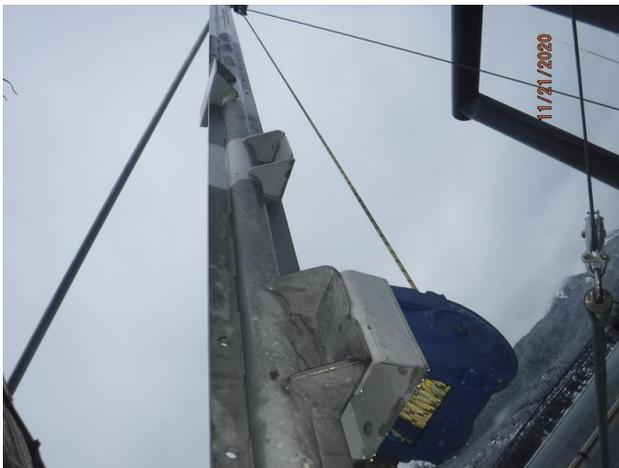
PICKING BOOMS

Two 4" aluminum with winch mounting plates and one winch each. Manual vanging rigged with aluminum pipe stiff arms both. The winches are spooled with covered KEVLAR line

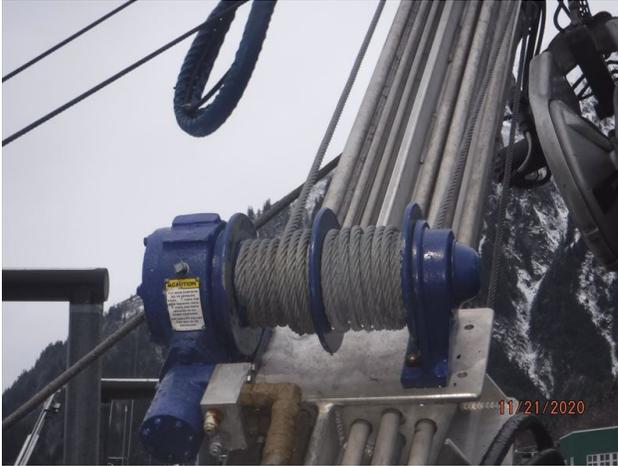
SWIVEL BLOCKS

Serviceable, new

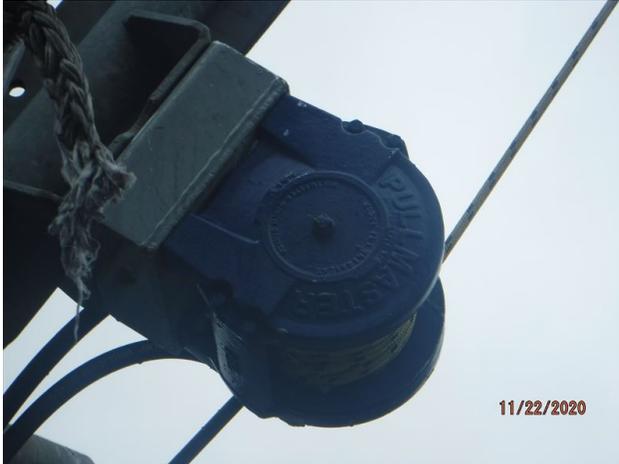
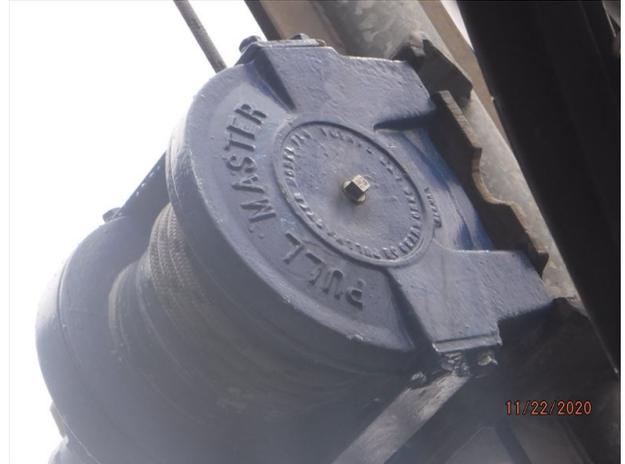
COMMENTS
spare PL4

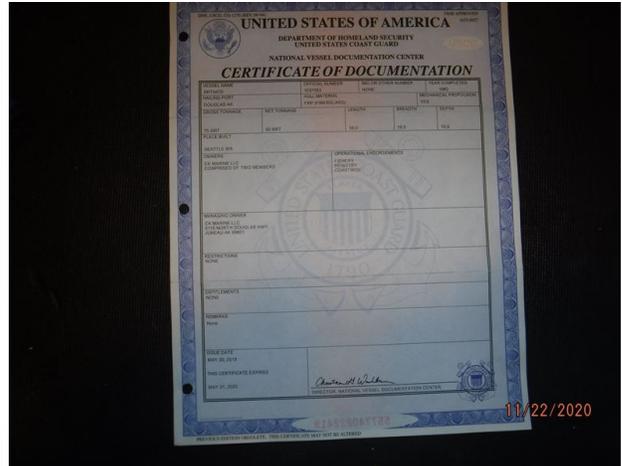
FINDING C-6

The vessel's HIN (Hull Identification Number) displayed on the starboard transom did not match the HIN recorded with U.S.C.G. Documentation. The federal Documentation lacks the Hull ID. It is likely that a HIN was never imprinted by Delta, and that the number pictured below is a Hull Number (HN) only

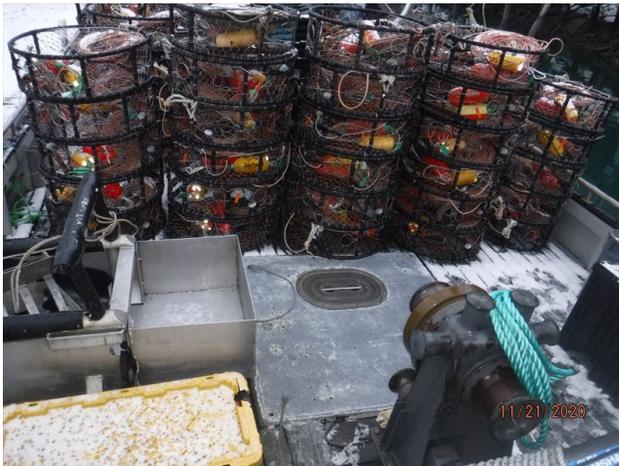
Unknown due to access the fish hold with the documentation #inscribed on the combing was not accessible at the time of the survey

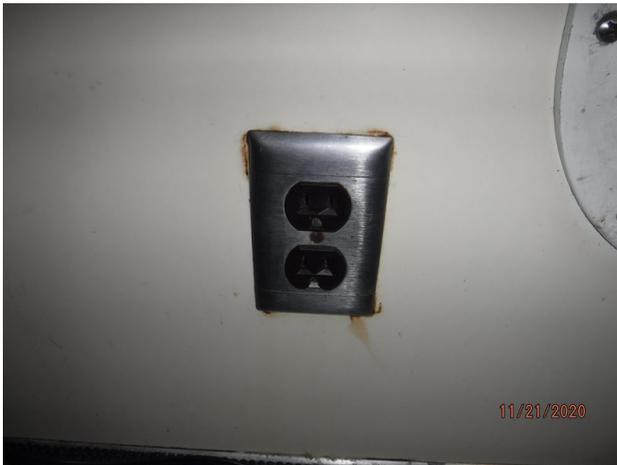
There were no GFCI protected AC outlets observed onboard.

Replace with GFCI protected outlets, as necessary. (At least one GFCI outlet per circuit)

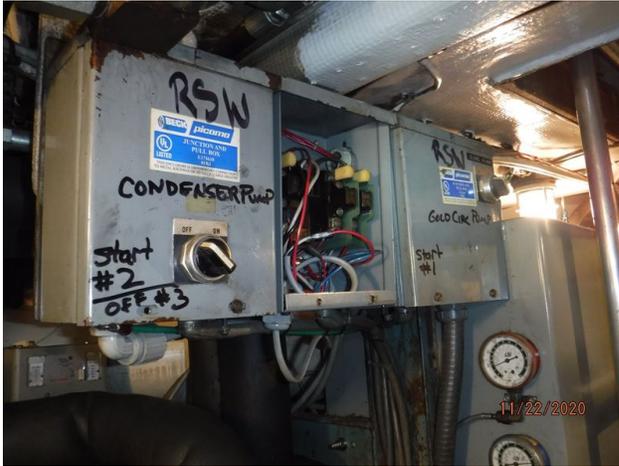
The high voltage AC wiring junction box's protective insulation cover was missing at the RSW switch box

Install an approved junction box cover, as necessary.
