**Inspection reference: 541**

**Confidential Inspection Report**  
**1781 Thomas Dehaven Lane**  
**Tracy, California 95376**

**August 19,2024**

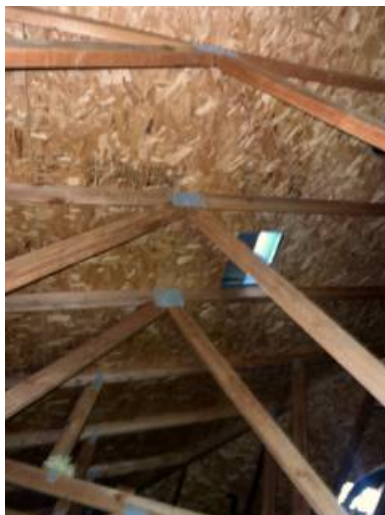
Insulation:

Blown in fibrous material. Blown in cellulose. Insulation is installed between roof rafters.

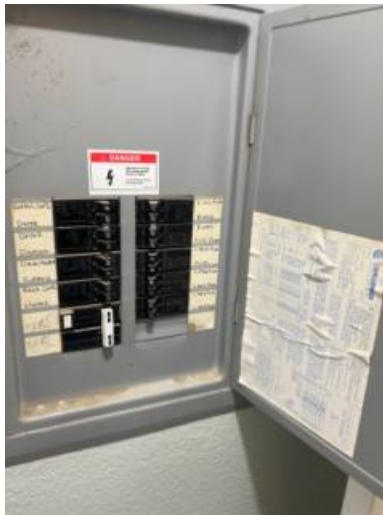
*Subpanels- Laundry Room:*

Appears serviceable, Fair overall.

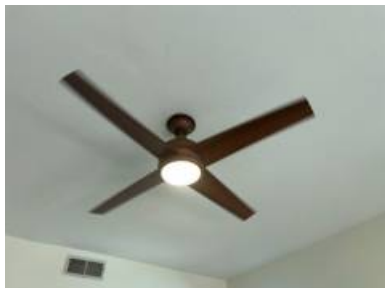
*Bedroom #2:*

The ceiling fan installed in this room did not function using normal controls.

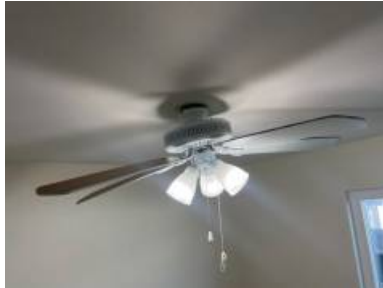
*Bedroom #3:*

The ceiling fan installed in this room did not function using normal controls. Due to the fan hanging I did not attempt to run the fan blades.

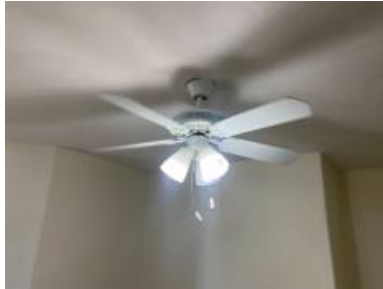
*Other Room:*

The ceiling fan installed in this room appears to need some adjustment. The fan blades wobble. Apparently the blades need to be balanced.

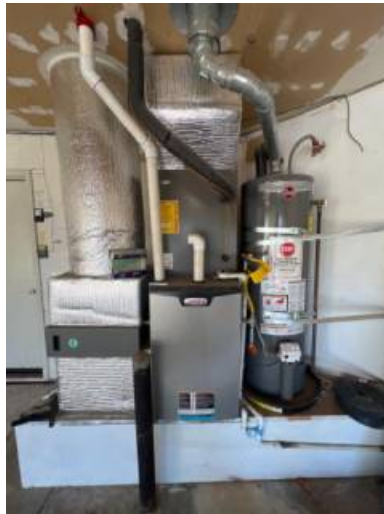
*Type & Location:*

Forced Air. The furnace is a newer high efficiency type with a fan installed in the vent pipe to push the burnt flue gases up and out the flue. Location- Garage.

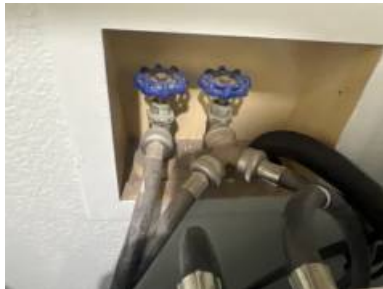
*Laundry:*

Plumbing appears serviceable, There is a connection box installed in the wall with both hot and cold water and a drain pipe. The drain pipe was not flood tested.

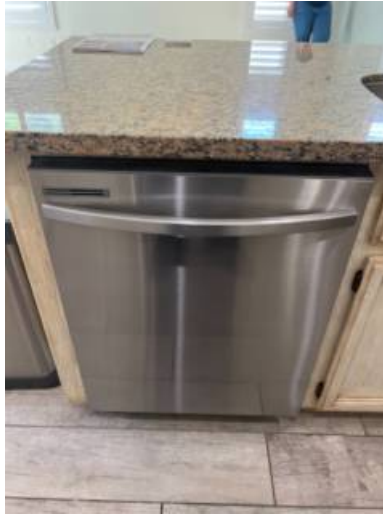
**Dishwasher:**

OK MM RR  
   Air gap device or high-loop is present on drain line- Proper.

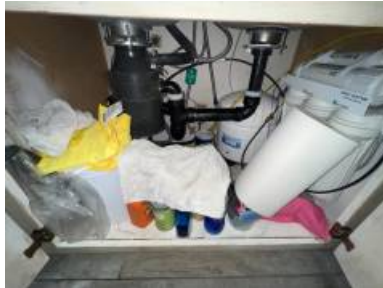
*Sink Cabinet:*

View was blocked by storage items.

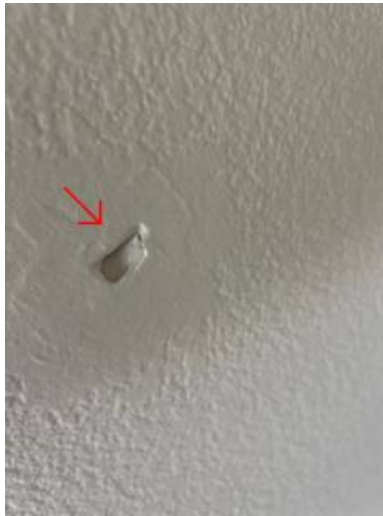
Other Room:  
Laundry:

No signs of damages at the time of inspection.  
**Damage noted.**

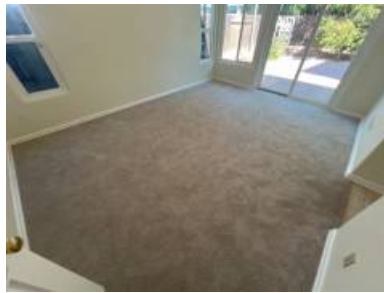
*Bedroom #2:*

The floor covering material is carpet. Good - The floor covering is newer, and it should provide years of service.

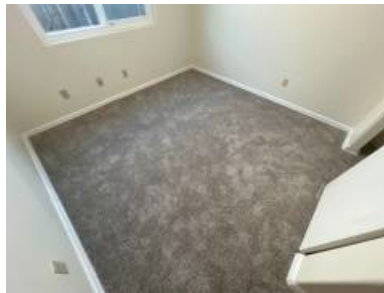
*Bedroom #3:*

The floor covering material is carpet. Good - The floor covering is newer, and it should provide years of service.

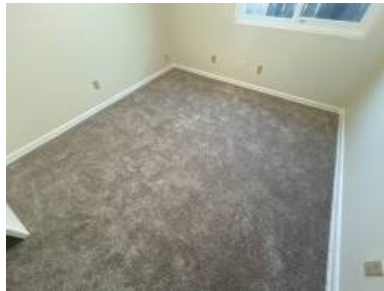
*Other Room:*

The floor covering material is carpet.

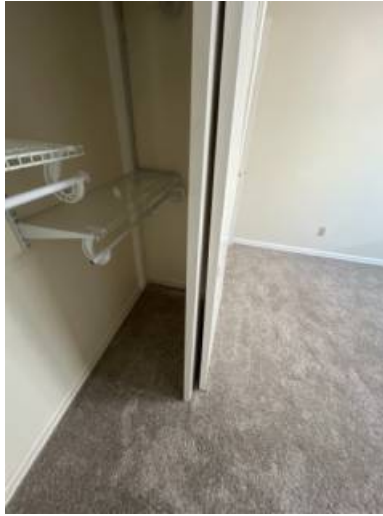
Bedroom #3:

Some portion of the closet door or interior fixtures needs repair or replacement. It is not functional as is. Slides or sliding hardware. Door missing. 1 or more of the closet doors are missing or damaged.

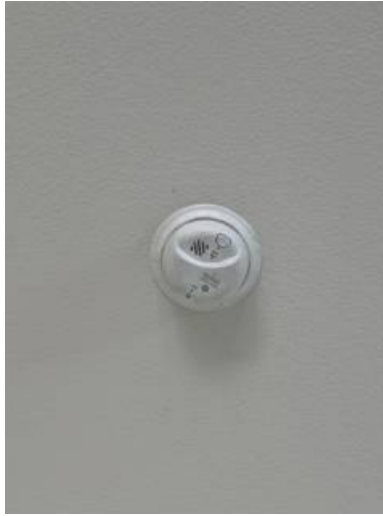
*Bedroom #2:*

There is a functional smoke detector installed in this room. It was undetermined if the unit is hardwired or is battery operated.

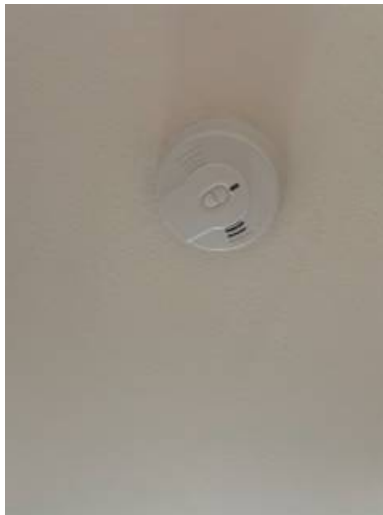
*Bedroom #3:*

There is a functional smoke detector installed in this room. It was undetermined if the unit is hardwired or is battery operated.

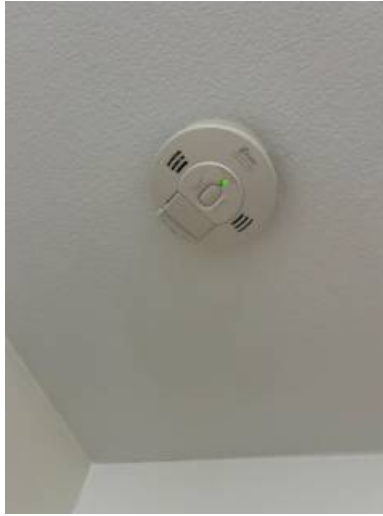
Other Room:

There is a functional smoke detector installed in this room. It was undetermined if the unit is hardwired or is battery operated.

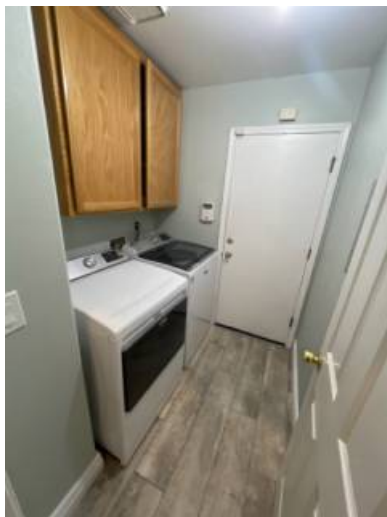
Service area main floor, Dryer venting is provided.

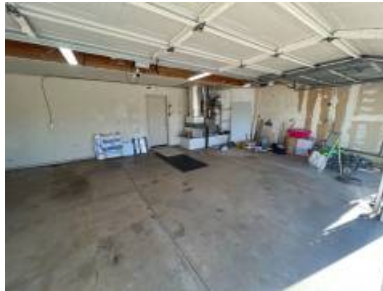
Attached, Three car.

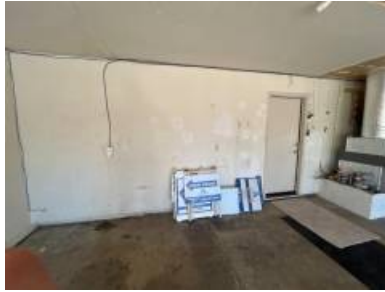
Typical cracks noted. Salt damage is noted.
