Town of Holden Beach Summary Report

Town Pier Preliminary Reconstruction

HDR Engineering, Inc. of the Carolinas
Project No. 10426190

August 4, 2025

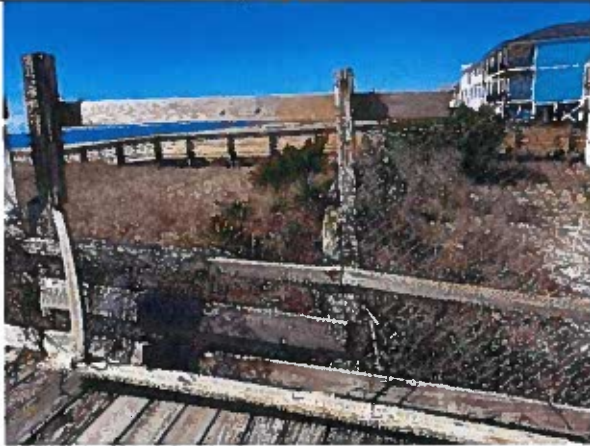
- As shown in Photo 1 of Appendix C, the typical side rails, toe boards, and chain link fencing are in POOR condition. There are over 12 locations where the toe boards, midrails, rail posts, and top rails are disconnected and/or split. The chain link fence has also been cut or disconnected in at least 3 locations. Structurally, the railings are POOR, and the deck boards appear SATISFACTORY. However, it was noted that the ramp does NOT meet federal ADA requirements for pedestrian access and would require to be reconfigured and/or replaced.

Photo 1: Typical Railing and Fence Damage near station 0+10

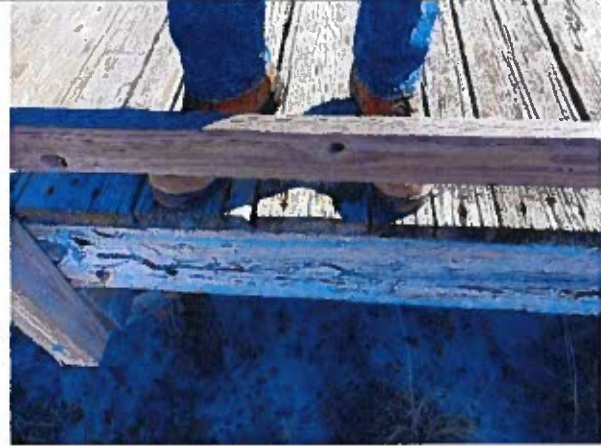
Photo 2: Typical Checking and Flaking at Joists near station 0+90

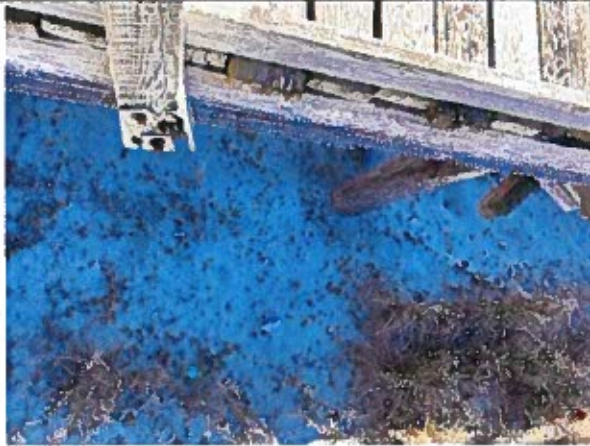
Photo 3: Typical Rail Post Connection Corrosion and Splitting near station 0+90

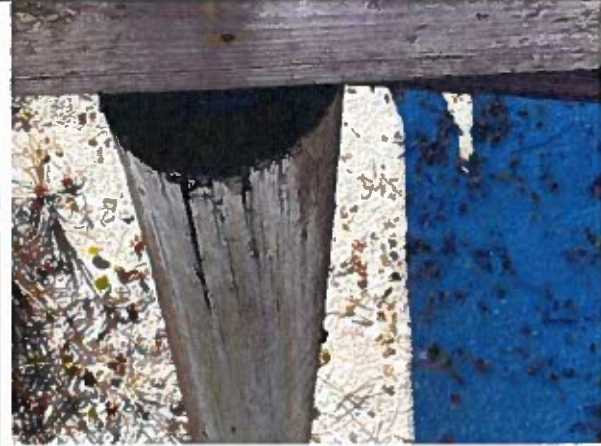
Photo 4: Typical Hollow Pile near station 0+90

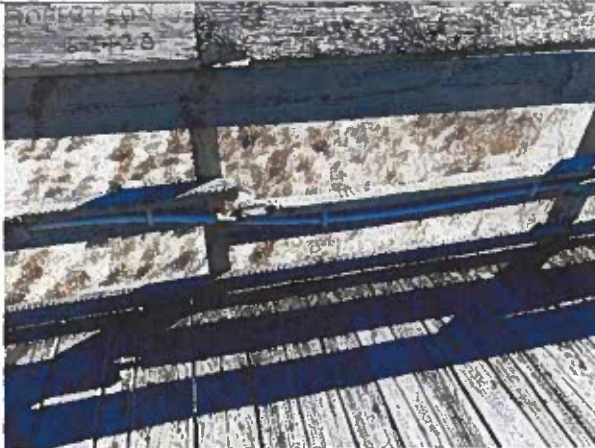
- Missing rail elements (Photo 7)
- Edge joist deterioration and splitting (Photos 8 and 11)
- Corroded connection hardware (Photo 11)
- Past joist splice/replacement (Photo 12).

Photo 7: Typical Midrail Separation near station 1+25

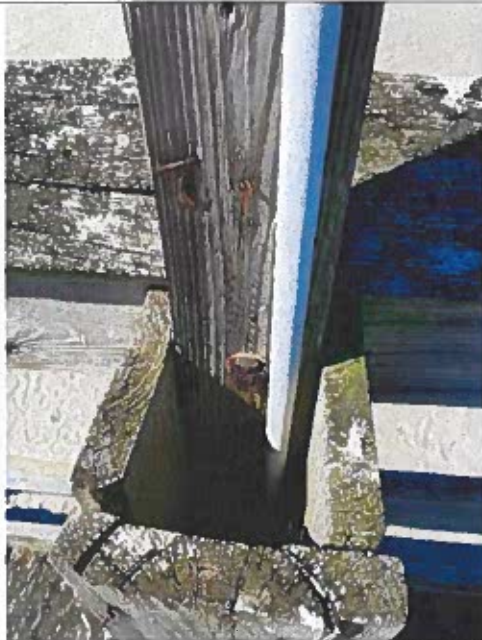
Photo 9: Typical Utility Conduit Timber Casing near station 2+00

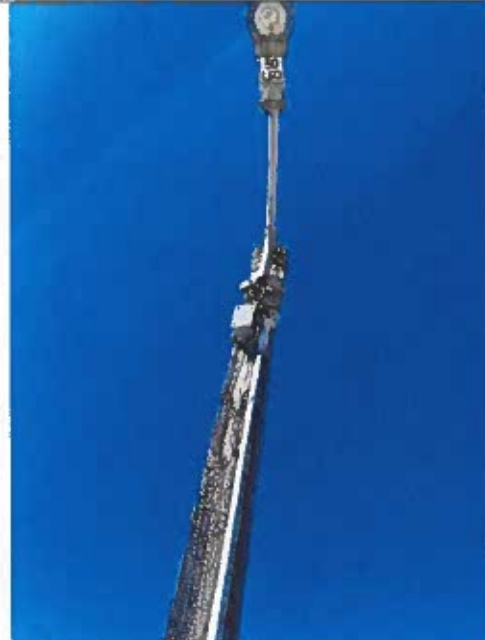
Photo 10: Typical Utility Post near station 2+00

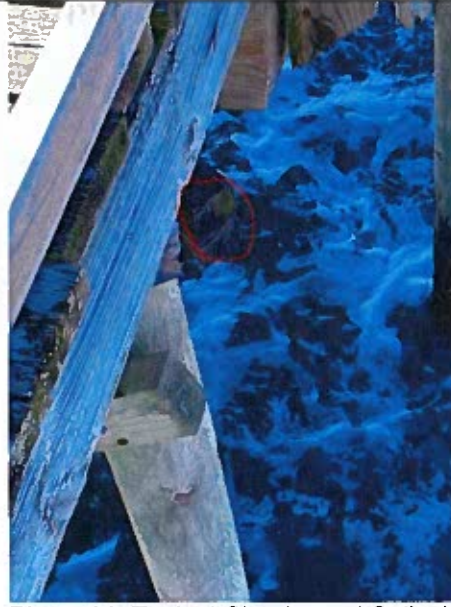
Photo 14: Typical Checks and Splits in the Cross Bracing near station 3+00

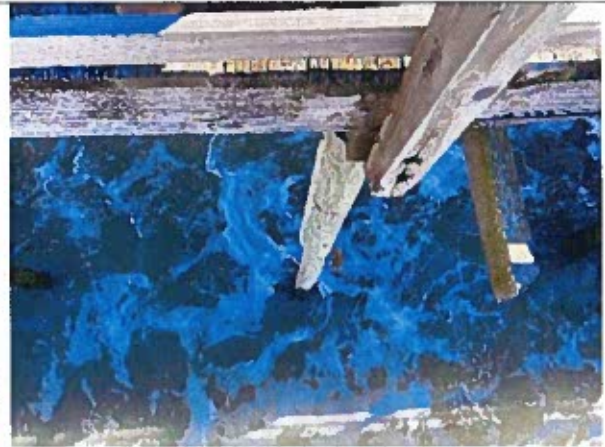
Photo 16: Typical Spliced Pile Repair. Pile with Observed Gouging near station 3+25

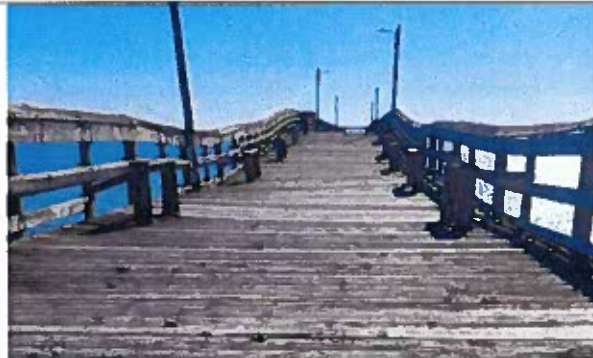
- Warping joist and top deck from Sta 3+25 to about 4+25 (Photos 17 and 18)
- Missing joists between Sta 3+80 to 4+10 (Photos 24 and 25)
- Observed 30-in joist spacing (Photo 24 and 25)
- Joist checking and splitting (Photo 15)
- Corroded connection hardware (various Photos 13-56)
- Disconnected or broken railing elements (Photos 13, 22, 42, 43, 45, 50, 53, & 54)
- Loose and soft deck boards from
 - Sta 3+55 to Sta 3+65
 - Sta 3+85 to Sta 3+95
 - Sta 5+00 to Sta 5+50
 - Sta 5+75 to Sta 6+50
 - Sta 6+75 to Sta 7+50
- Cracked PVC utility conduit (Photo 31)

Photo 17: Typical Deck Warping between station 3+25 and station 4+10

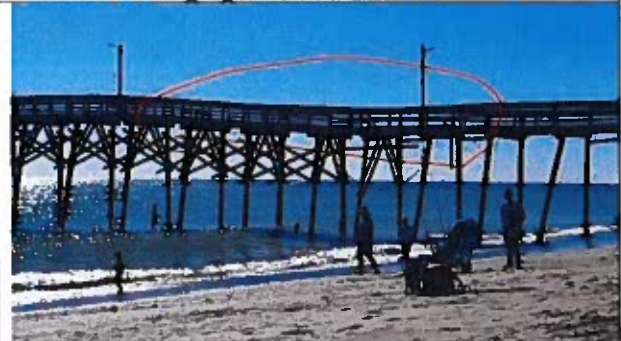
Photo 18: Typical Deck Warping between station 3+25 and station 4+10

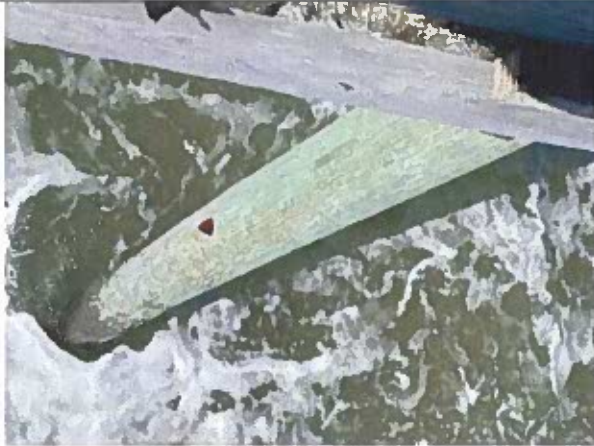
Photo 19: Typical Corroded Pile Bracing Connection with Missing Brace near station 3+25

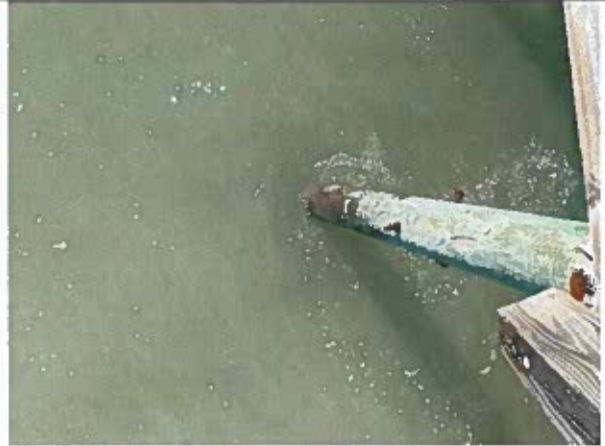
Photo 20: Typical Corroded Pile Bracing Connection with Missing Brace near station 3+75

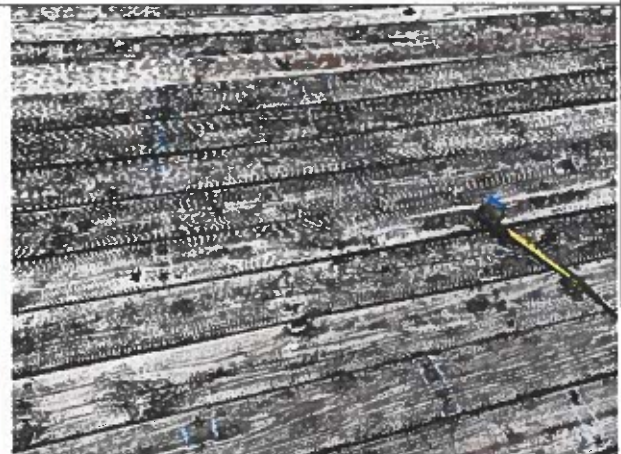
Photo 24: Typical Joist Replacement near station 4+00.

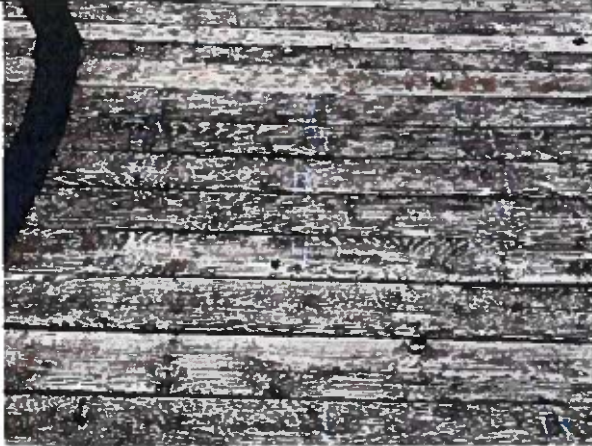
Photo 25: Typical Joist Replacement near station 4+00.

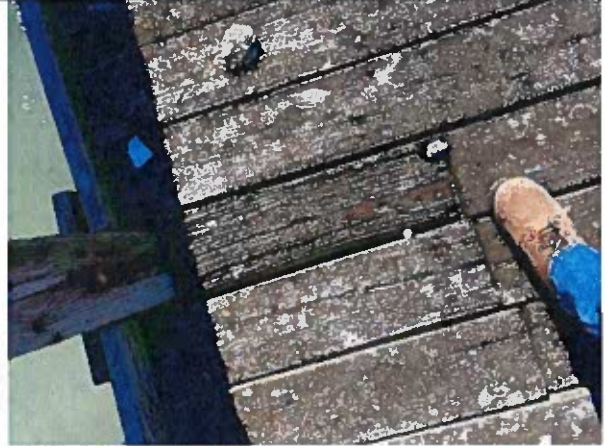
Photo 26: Typical Light Post Deterioration Near Base Connection near station 4+00

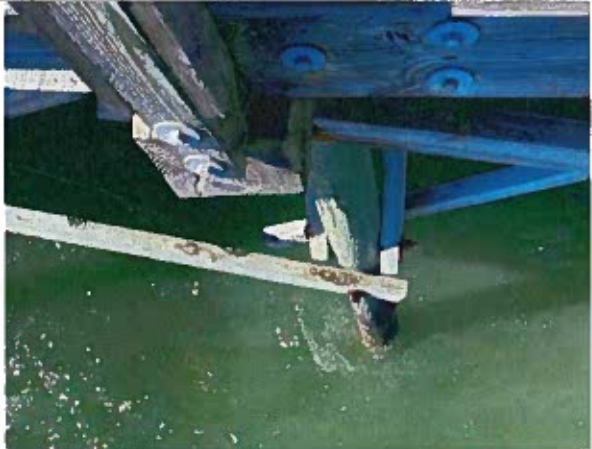
Photo 27: Typical Corroded Bracing Connection near station 4+25

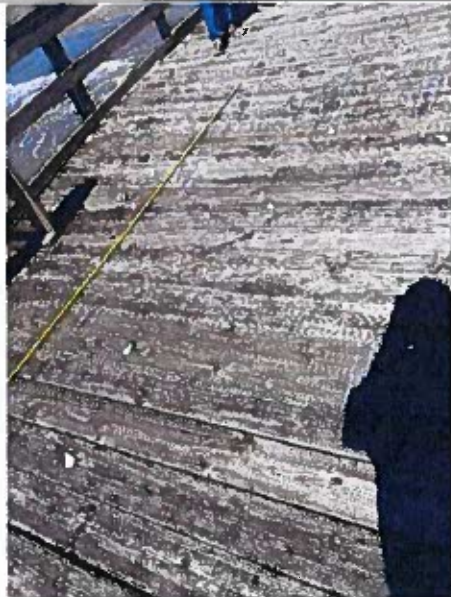
Photo 29: Typical Joist Replacement near station 4+25

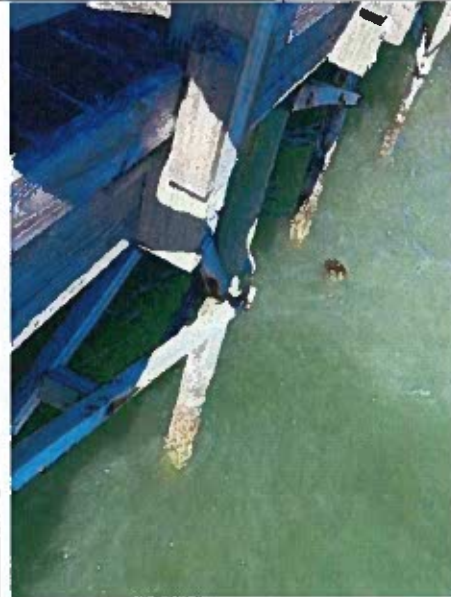
Photo 30: Typical Corroded Bracing and Pile Connection near station 4+25

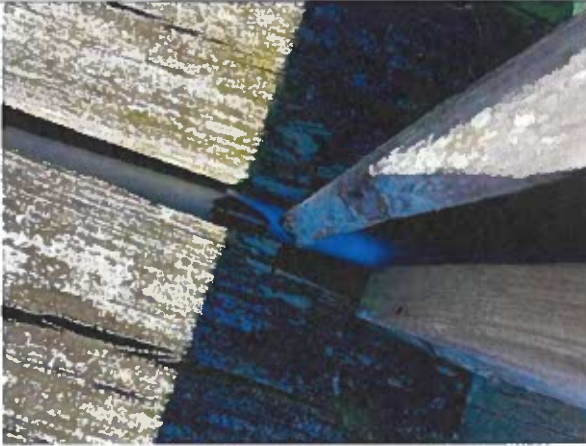
Photo 31: Typical Conduit Housing Damage near station 4+75

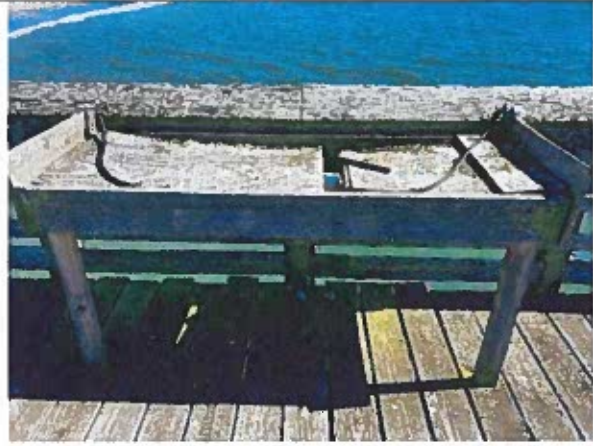
Photo 32: Fish Cleaning Station near station 5+00

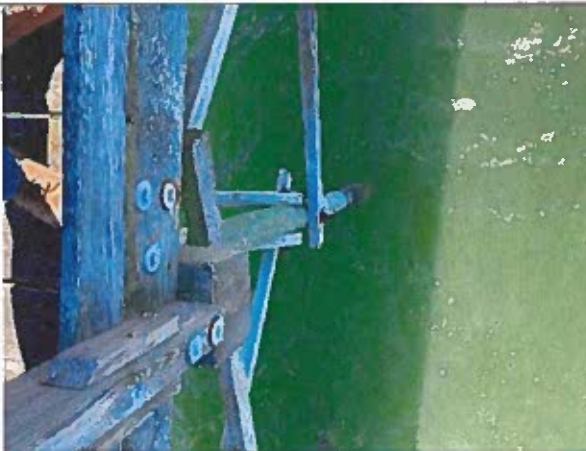
Photo 33: Typical Corroded Bracing Connection Bolts near station 5+00

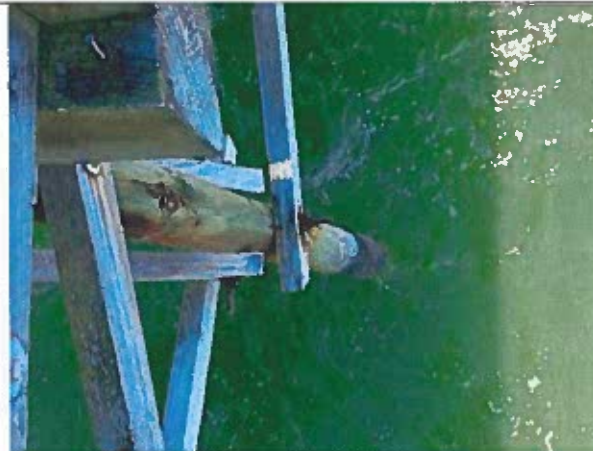
- Missing pile cross bracing between at least 10 different substructure bents (Miscellaneous Photos 19-56 and 79-90)
- Split or cracked piles (Photos 46 and 47)
- Pile necking, which refers to the reduction in critical pile diameter
- Corroded connections and steel hardware (Miscellaneous Photos 19-56 and Photos 80, 88, 89, and 90)
- Misaligned or damaged pile to pile cap connections (Photos 80, 81, 82, 88, and 89)
- Rotting pile caps and joists (Photos 85, 86, and 87)
- Pile gouging and flaking (Photos 34, 35, 37, 40, 51, 55, 56 and 83)

Photo 34: Typical Corroded Bracing Connection Bolts with Pile Gouging near station 5+50

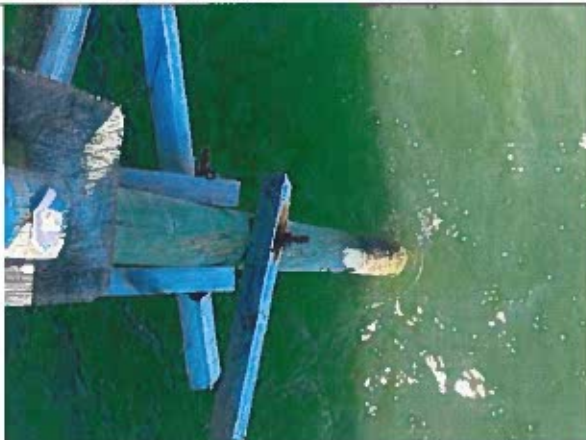
Photo 35: Typical Pile Flaking and Gouging near station 5+75

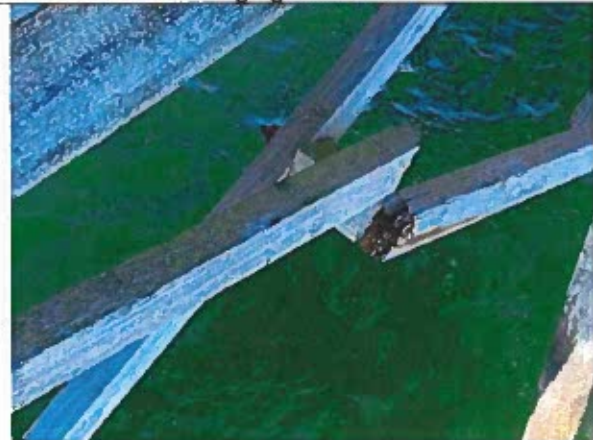
Photo 36: Typical Broken (Disconnected) Bracing near station 6+00

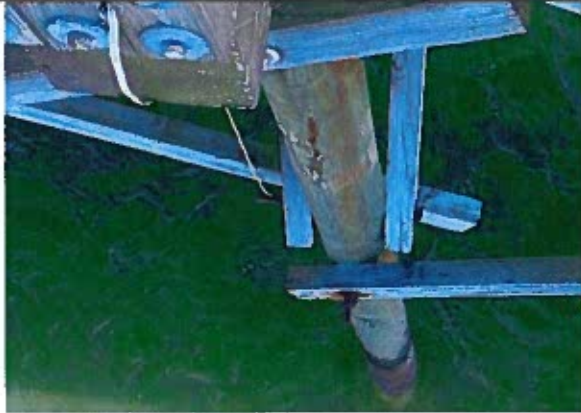
Photo 37: Pile Flaking and Gouging and Bracing Checking near station 6+00

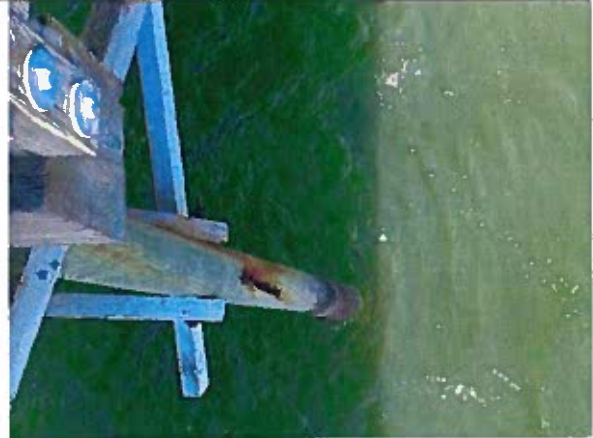
Photo 38: Typical Missing Bracing Member and Corroded Bolt near station 6+25

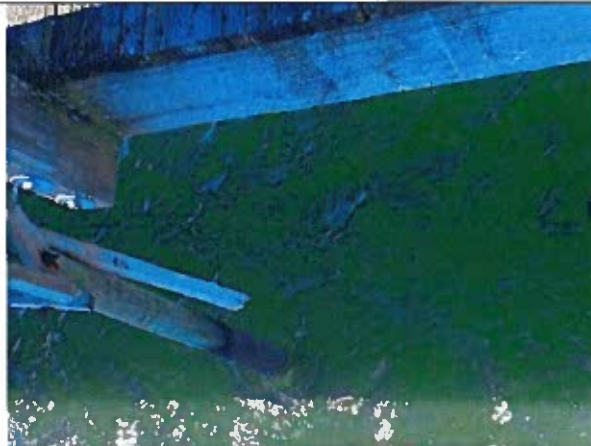
Photo 39: Typical Broken Bracing Member near station 6+50

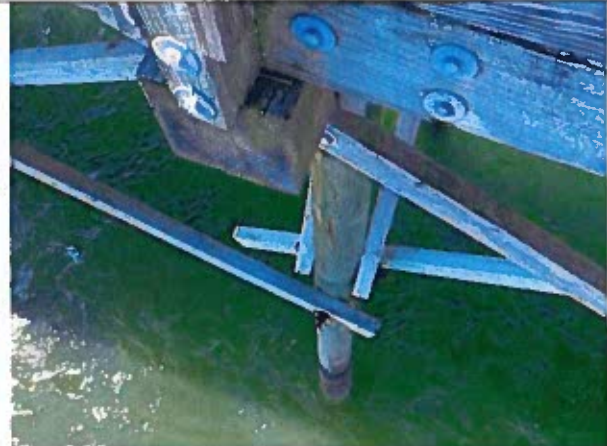
Photo 40: Pile Checking and Gouging near station 6+50

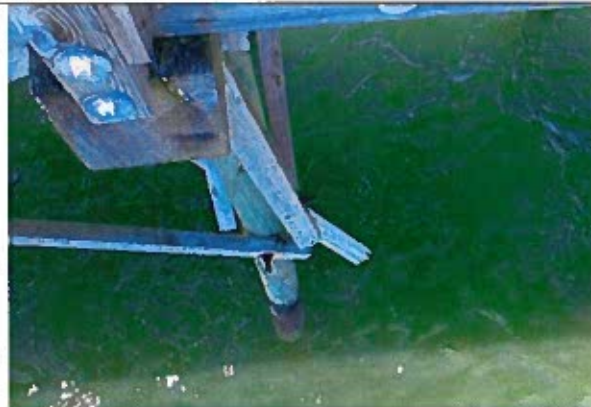
Photo 41: Typical Broken Bracing Member and Pile Cap Checking near station 6+75

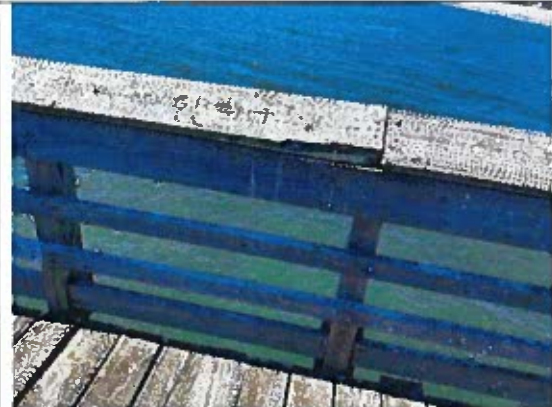
Photo 42: Typical Top Rail Disconnection near station 6+75

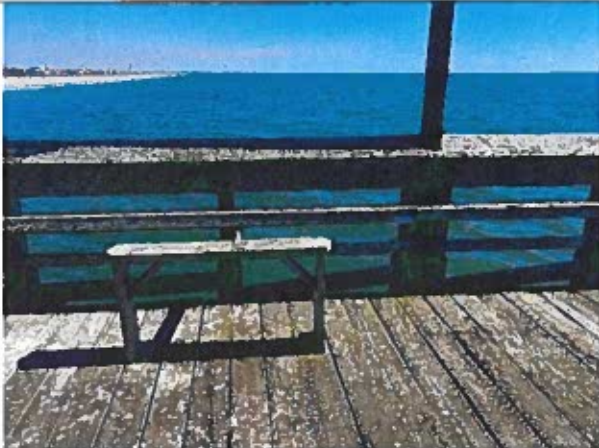
Photo 43: Typical Bench and Disconnected Toe Boards near station 6+75

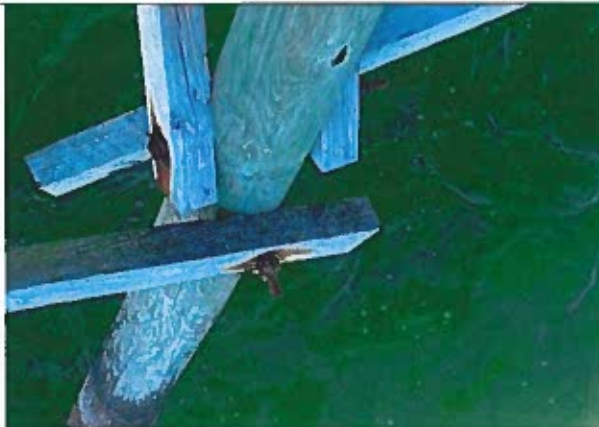
Photo 47: Cracked Pile near station 7+00

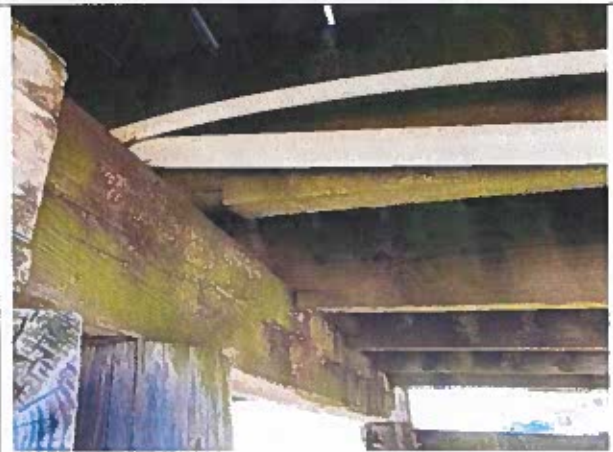
Photo 60: Typical Joist Notching at Support near station 0+75

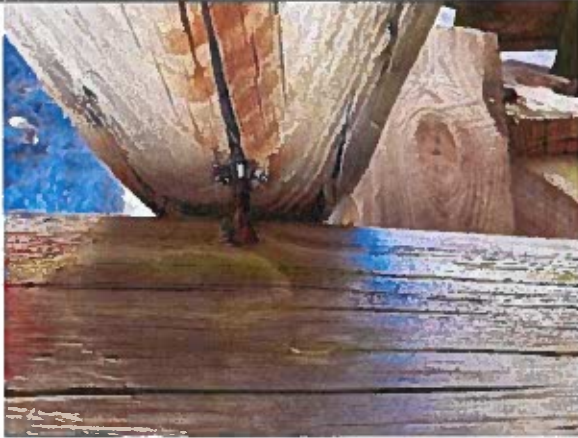
- Exterior rot and interior pile hollowing (Photos 57 and 58)
- Cross bracing splits and checks (Photos 59)
- Corroded connections between piles and cross bracing (Photos 61 and 62)

Photo 61: Typical Corroded Bolt Between Pile and Bracing Member near station 0+75

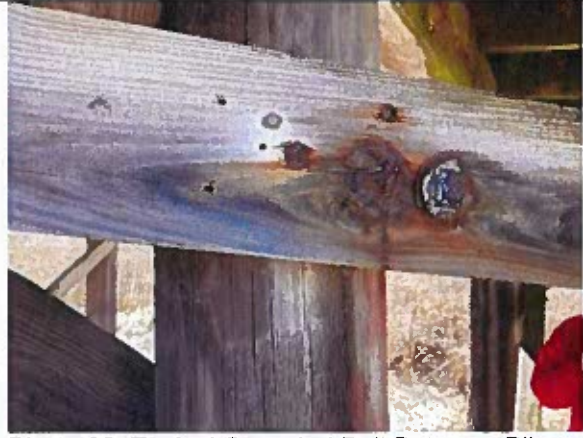
Photo 62: Typical Corroded Bolt Between Pile and Bracing Member near station 0+75

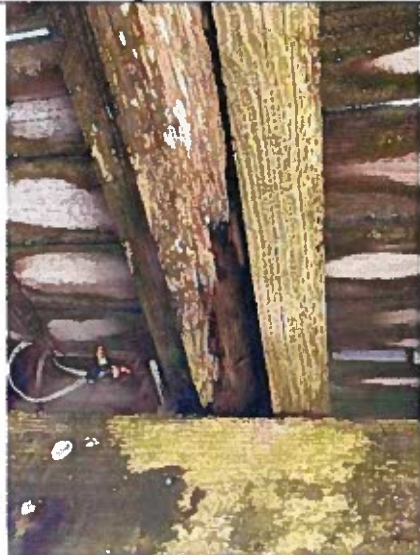
- Corroded connections and steel hardware
- Rotted and deteriorated members (Photos 63, 65, and 66)
- Detached railing includes a disconnection of joist from pile cap (Photo 64)
- Checking and splitting of cross-bracing and support members (Photos 67 and 68)

Photo 63: Typical Rotting Joist / Supports near station 0+90 Balcony

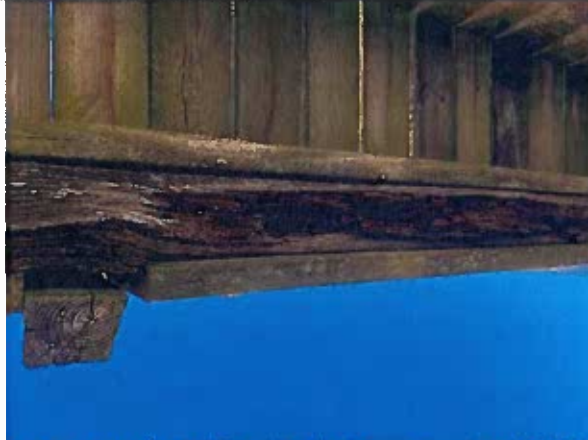
Photo 65: Typical Rotting Joist near station 0+90 Balcony

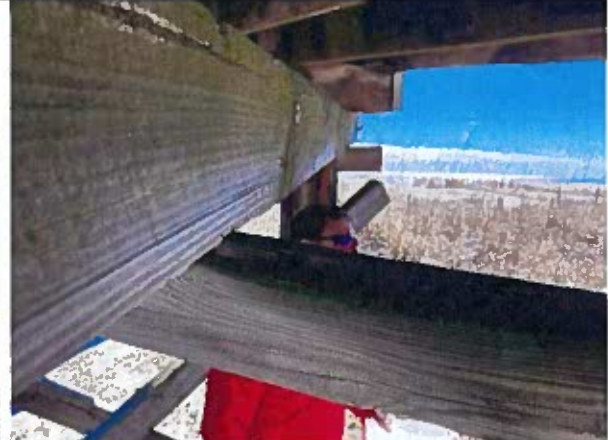
Photo 66: Typical Rotting / Hollow Bracing Member near station 0+90 Balcony

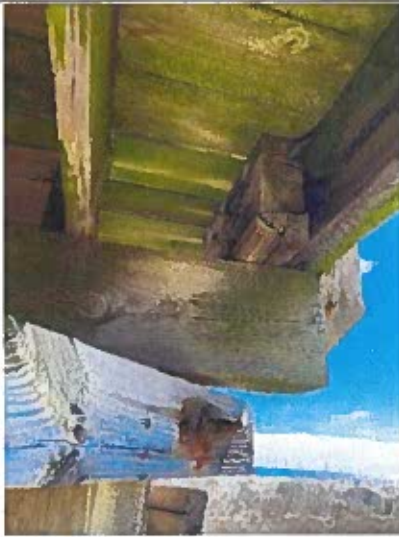
Photo 67: Typical Support Checking and Splitting near station 0+90 Balcony

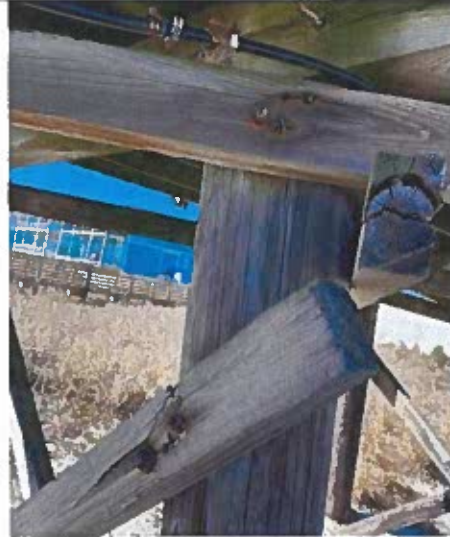
Photo 68: Typical Bracing Member Checking and Splitting near station 0+90 Balcony

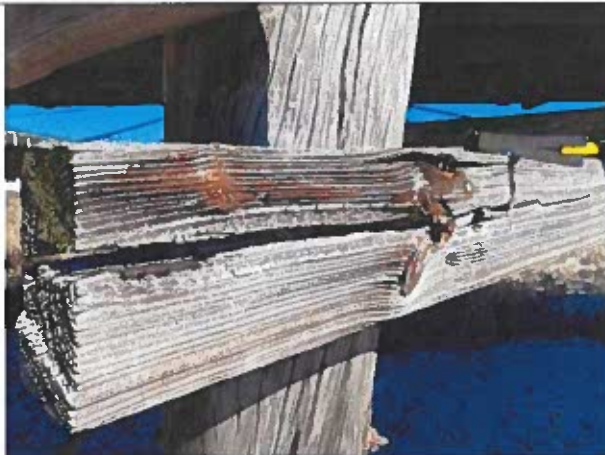
- Disconnected and failed bracing (Photo 73)
- Rotting pile caps (Photos 71, 72, and 74)
- Rotting and split joists (Photo 70)
- Checking and splitting of cross-bracing and support members (Photos 69 and 74)
- At least 3 hollow piles
- Corroded connections and steel hardware (Photos 75 and 76)

Photo 69: Cross Bracing Checking and Splitting near station 1+00

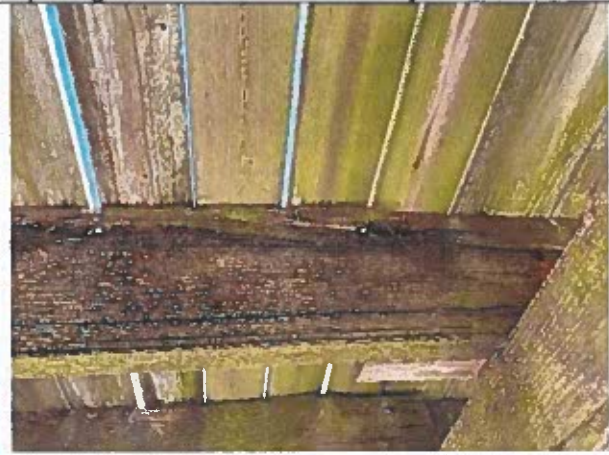
Photo 70: Typical Disconnected and Split Joist near station 1+00

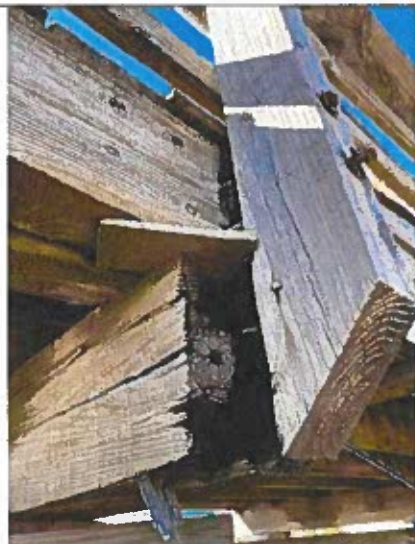
Photo 71: Typical Pile Cap End Rot and Detached Railing Post near station 1+25

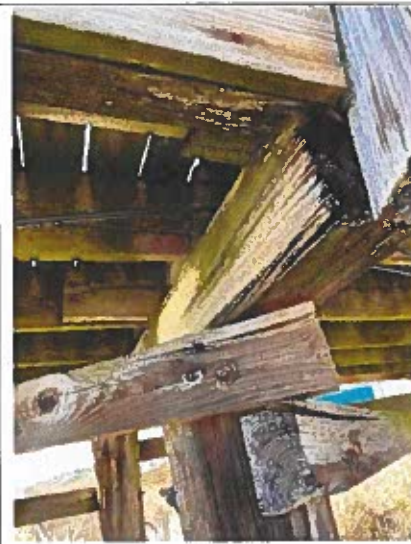
Photo 72: Typical Pile Cap End Rot near station 1+50

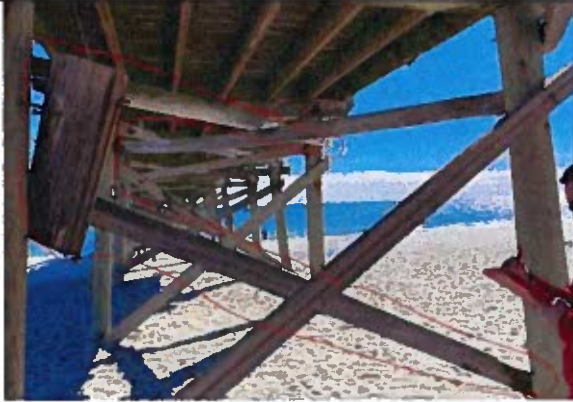
Photo 73: Disconnected Cross Bracing near station 2+25

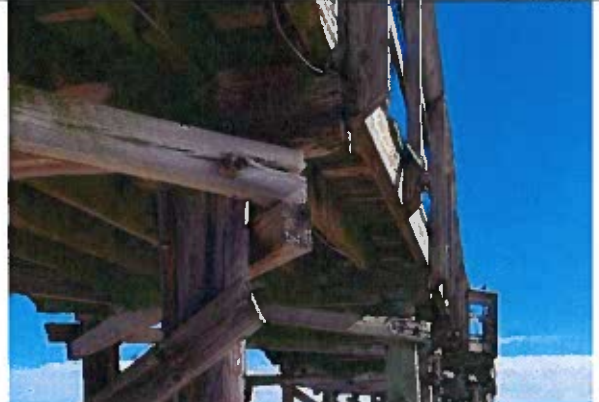
Photo 74: Split / Checked Cross Bracing and Pile Cap End Rot near station 2+25

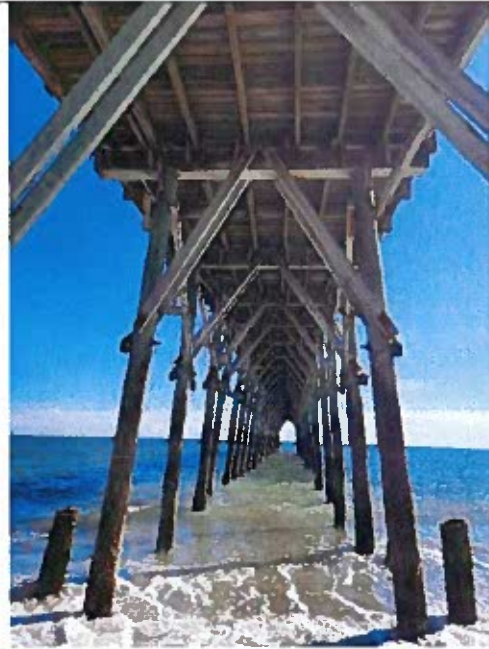
Photo 84: End of Observable Substructure Investigation near station 4+00

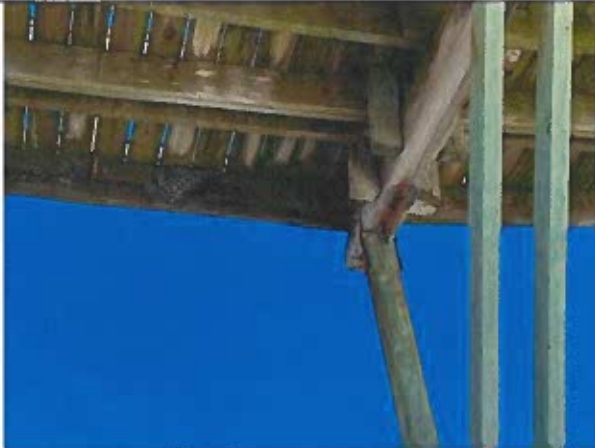
Photo 85: Typical Rotting Joist near station 4+00

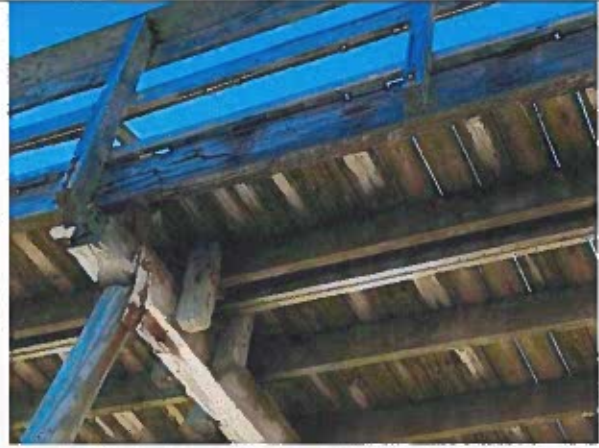
Photo 86: Rotting Joist and Pile Cap End Rot near station 4+00

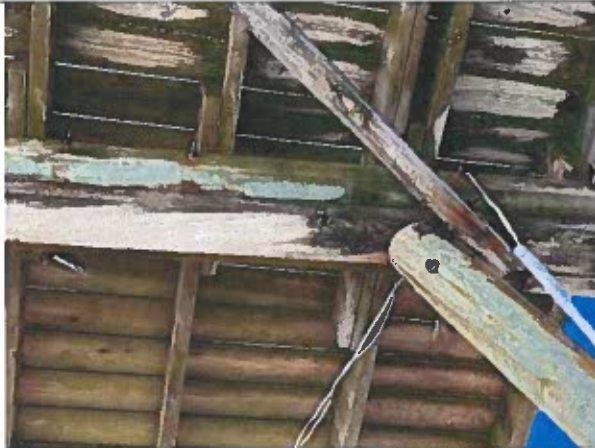
Photo 87: Pile Cap Splicing / Repair near station 4+00

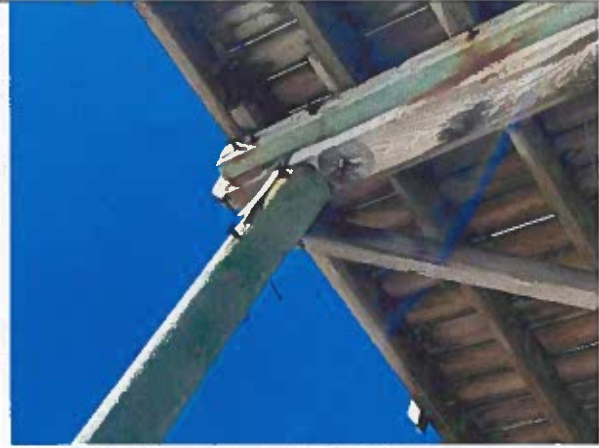
Photo 88: Disconnected Pile / Pile Cap Connection and Corroded Bolts near station 4+00
