Town of Holden Beach Draft Summary Report

Town Pier Preliminary Reconstruction

HDR Engineering, Inc. of the Carolinas
Project No. 10426190

July 2, 2025

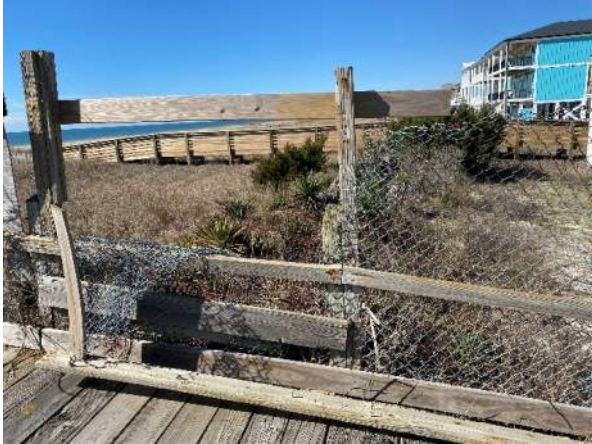
As shown in Photo 1 of Appendix C, the typical side rails, toe boards, and chain link fencing are in POOR condition. There are over 12 locations where the toe boards, midrails, rail posts, and top rails are disconnected and/or split. The chain link fence has also been cut or disconnected in at least 3 locations. Structurally, the railings are POOR, and the deck boards appear SATISFACTORY. However, it was noted that the ramp does NOT meet federal ADA requirements for pedestrian access and would require to be reconfigured and/or replaced.

Photo 1: Typical Railing and Fence Damage near station 0+10

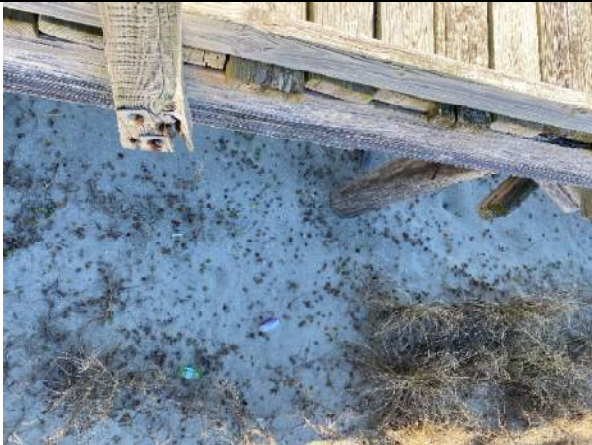
Photo 2: Typical Checking and Flaking at Joists near station 0+90

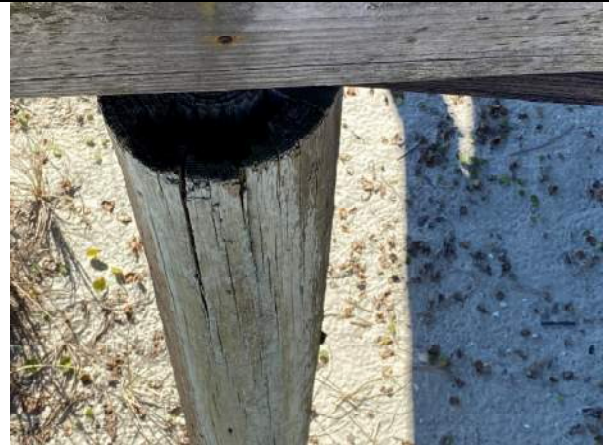
Photo 3: Typical Rail Post Connection Corrosion and Splitting near station 0+90

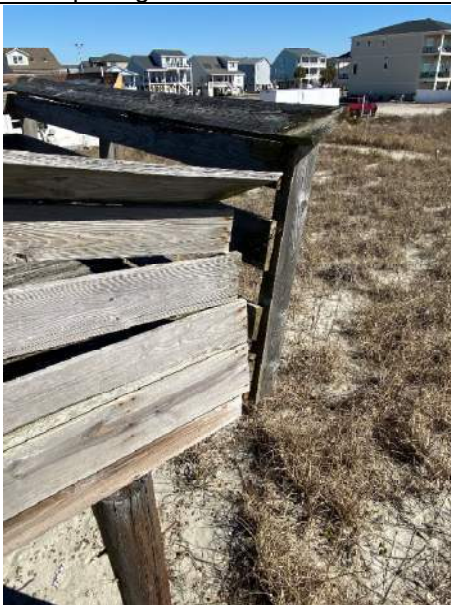
Photo 4: Typical Hollow Pile near station 0+90

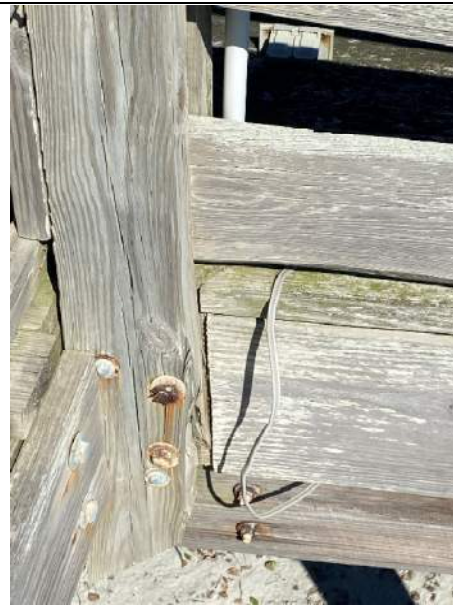
Photo 5: Typical Railing Detachment and Failure near station 0+90

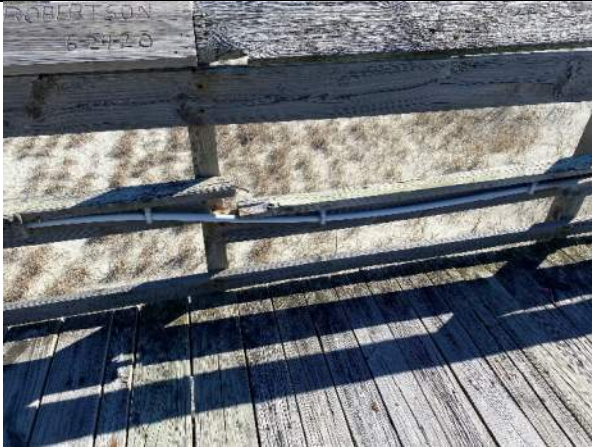
Photo 6: Typical Rail Post Gouging and Connection Bolt Corrosion near station 0+90

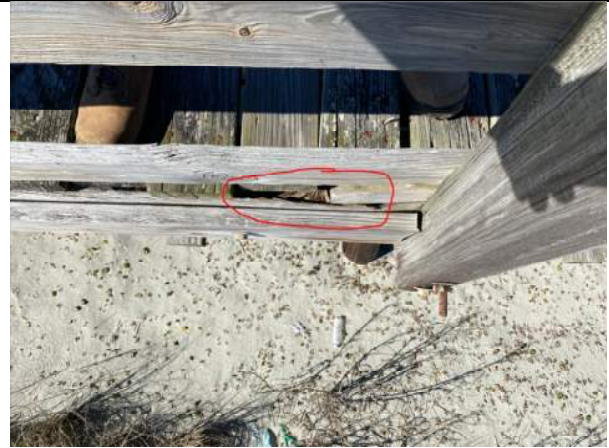
Photo 7: Typical Midrail Separation near station 1+25

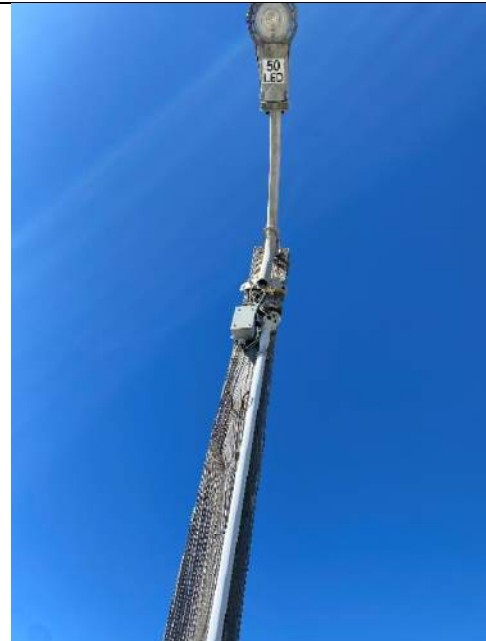
Photo 9: Typical Utility Conduit Timber Casing near station 2+00

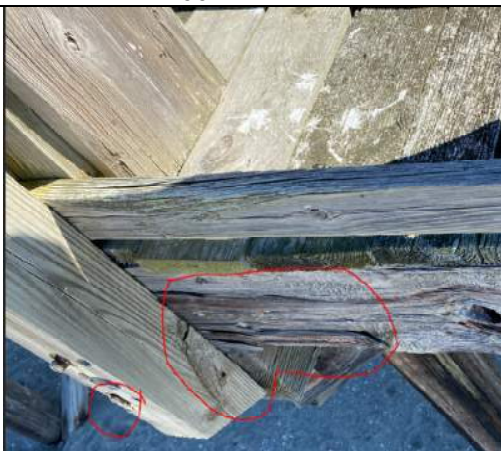
Photo 10: Typical Utility Post near station 2+00

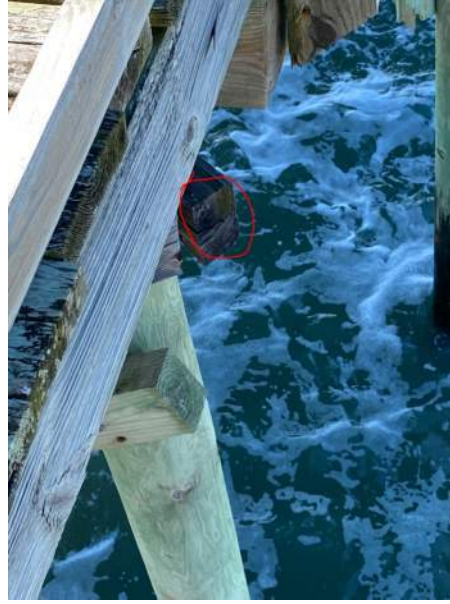
Photo 13: Top Rail Split and Conduit Running along Midrails near station 2+75

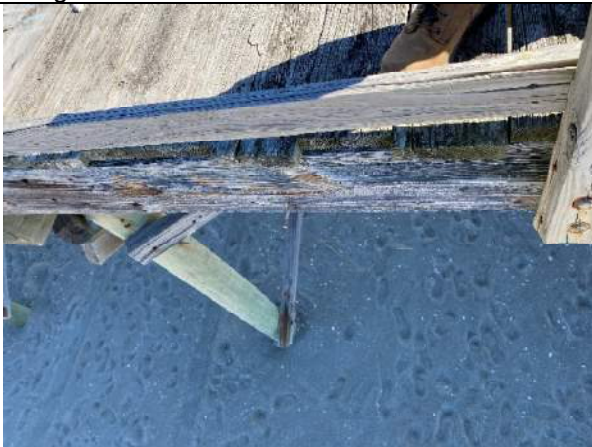
Photo 14: Typical Checks and Splits in the Cross Bracing near station 3+00

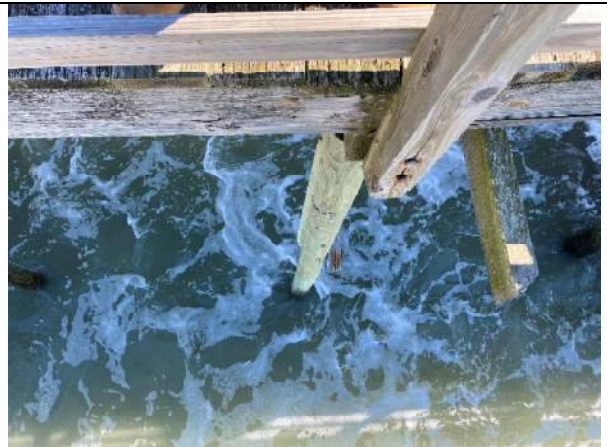
Photo 15: Typical Joist Checking near station 3+00

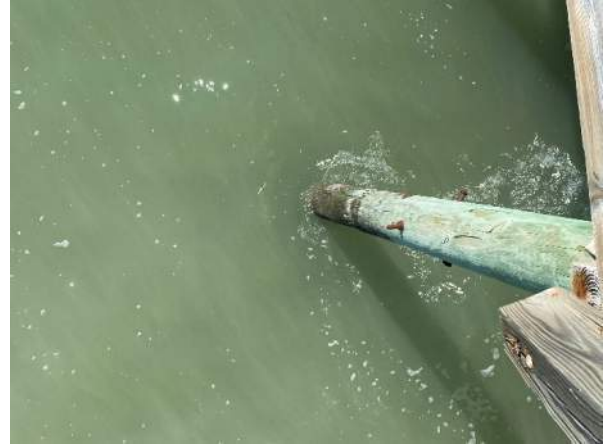
Photo 19: Typical Corroded Pile Bracing Connection with Missing Brace near station 3+25

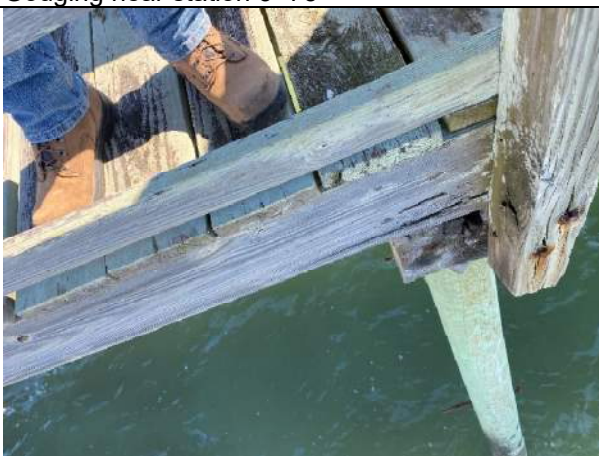
Photo 22: Rail Post Corroded Connection Bolt near station 3+75

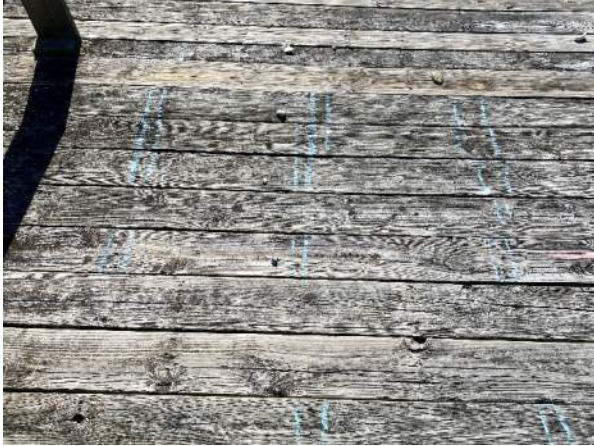
Photo 24: Typical Joist Replacement near station 4+00.

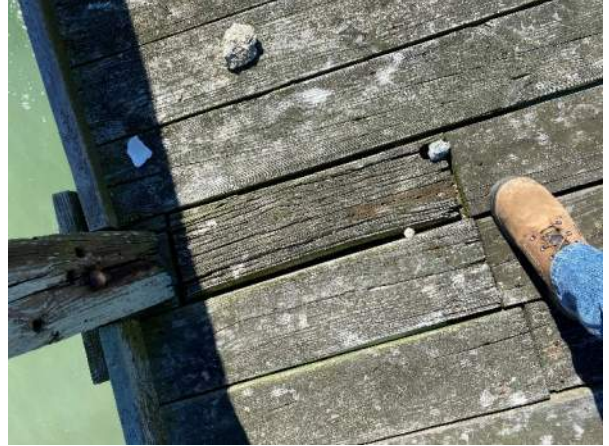
Photo 25: Typical Joist Replacement near station 4+00.

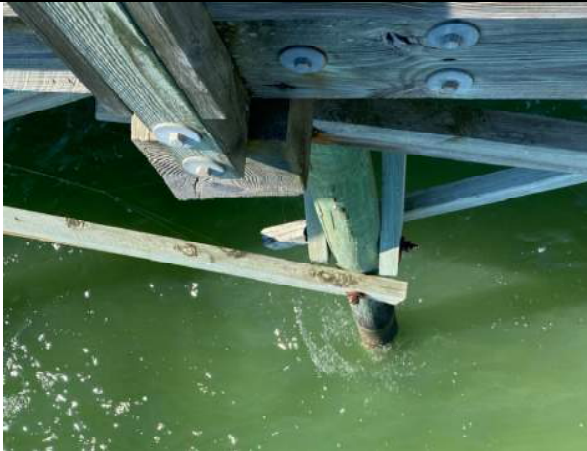
Photo 26: Typical Light Post Deterioration Near Base Connection near station 4+00

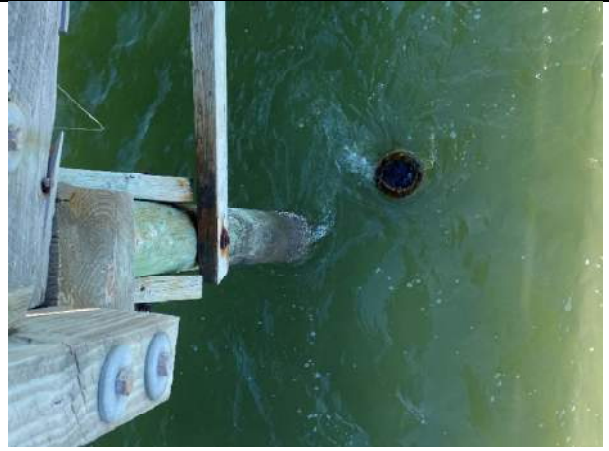
Photo 27: Typical Corroded Bracing Connection near station 4+25

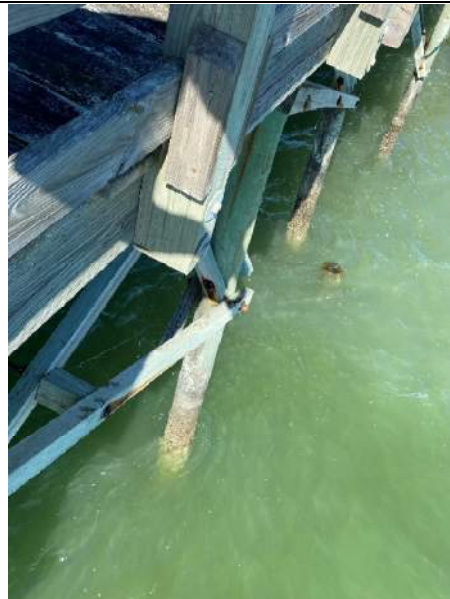
Photo 29: Typical Joist Replacement near station 4+25

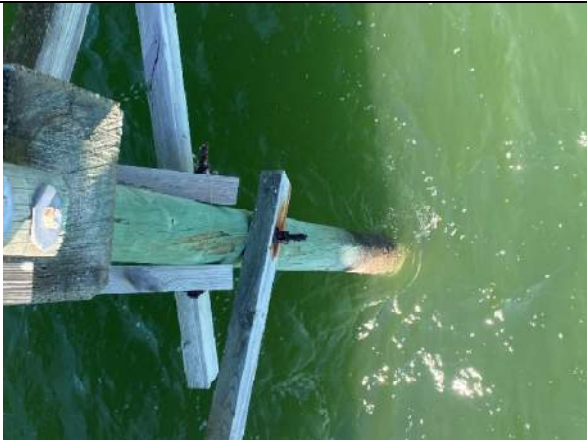
Photo 34: Typical Corroded Bracing Connection Bolts with Pile Gouging near station 5+50

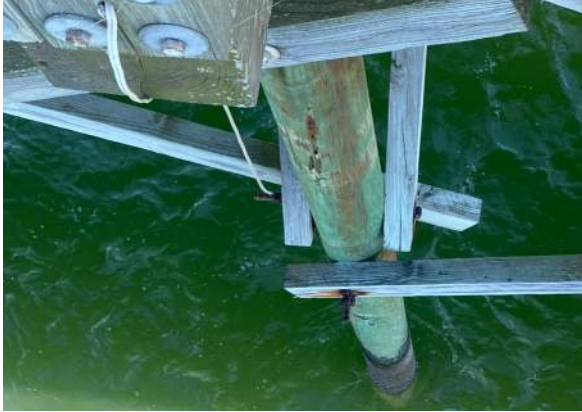
Photo 36: Typical Broken (Disconnected) Bracing near station 6+00

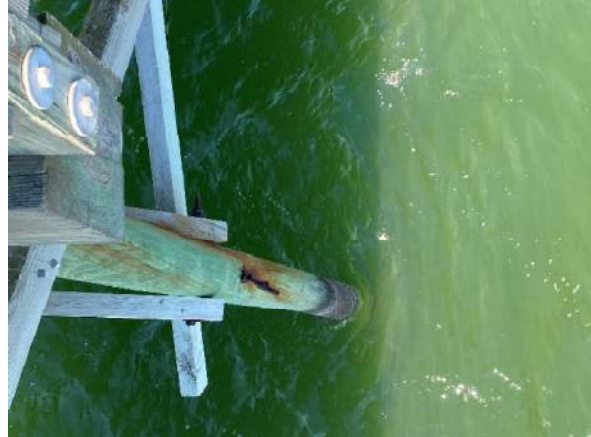
Photo 37: Pile Flaking and Gouging and Bracing Checking near station 6+00

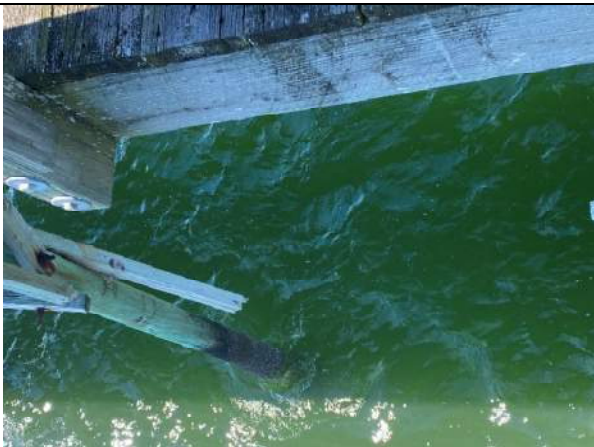
Photo 38: Typical Missing Bracing Member and Corroded Bolt near station 6+25

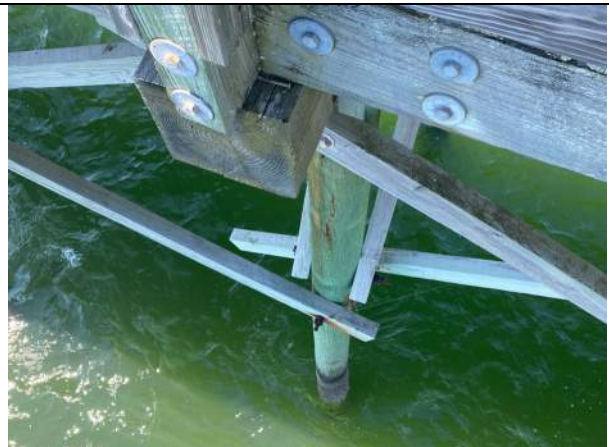
Photo 39: Typical Broken Bracing Member near station 6+50

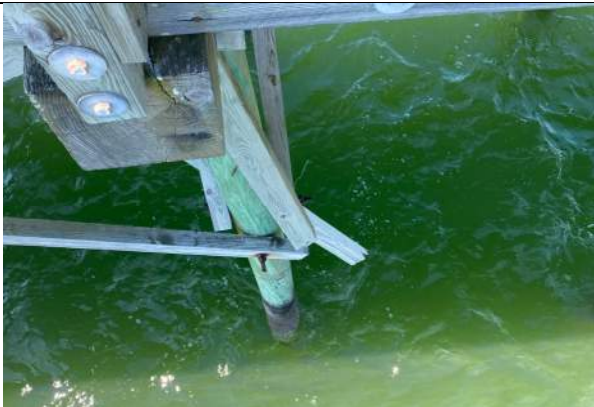
Photo 40: Pile Checking and Gouging near station 6+50

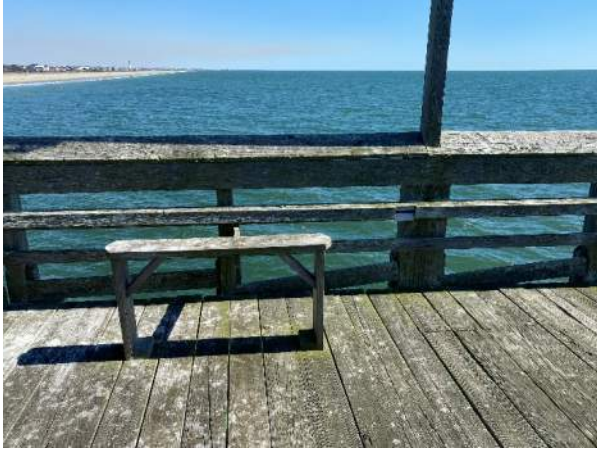
Photo 42: Typical Top Rail Disconnection near station 6+75

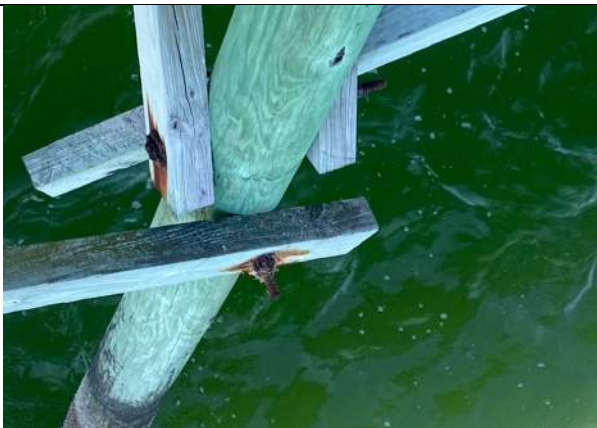
Photo 46: Cracked Pile near station 7+00

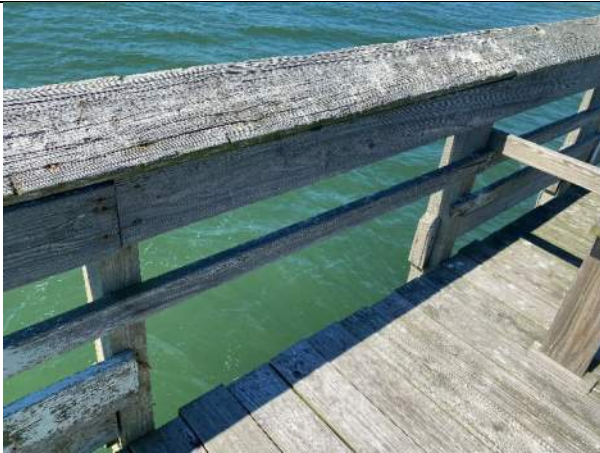
Photo 53: Typical Missing Midrail and Toe Board near station 7+50

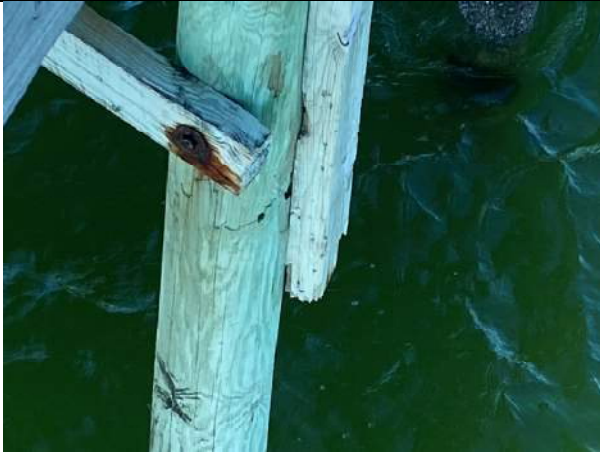
- Missing pile cross bracing between at least 10 different substructure bents (Miscellaneous Photos 19-56 and 79-90)
- Split or cracked piles (Photos 46 and 47)
- Pile necking, which refers to the reduction in critical pile diameter
- Corroded connections and steel hardware (Miscellaneous Photos 19-56 and Photos 80, 88, 89, and 90)
- Misaligned or damaged pile to pile cap connections (Photos 80, 81, 82, 88, and 89)
- Rotting pile caps and joists (Photos 85, 86, and 87)
- Pile gouging and flaking (Photos 34, 35, 37, 40, 51, 55, 56 and 83)

Photo 55: Typical Pile Gouging and Flaking near station 7+50

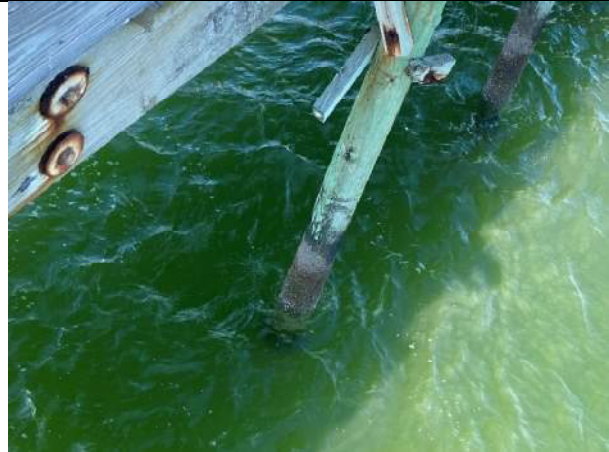
Photo 56: Typical Pile Gouging and Pitting with Broken Bracing near station 7+50

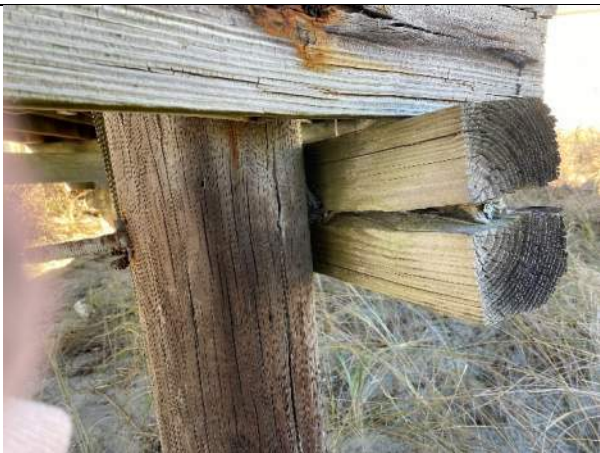
- Exterior rot and interior pile hollowing (Photos 57 and 58)
- Cross bracing splits and checks (Photos 59)
- Corroded connections between piles and cross bracing (Photos 61 and 62)

Photo 59: Typical Cross Bracing Checking and Splitting near station 0+50

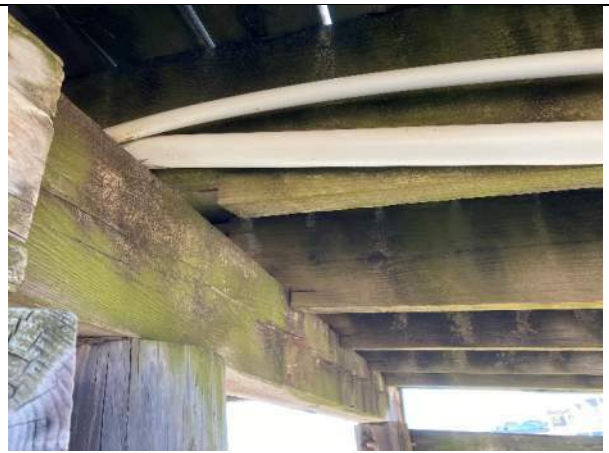
Photo 60: Typical Joist Notching at Support near station 0+75

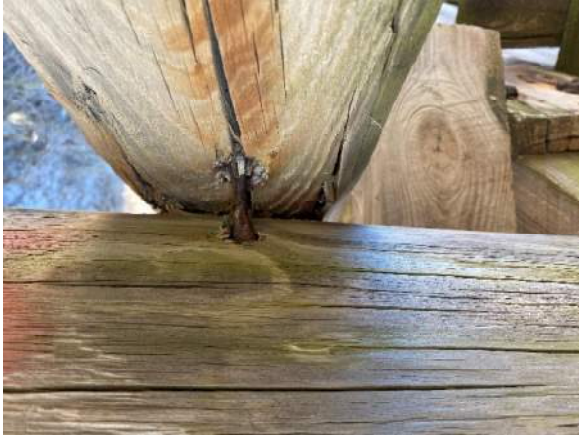
Photo 61: Typical Corroded Bolt Between Pile and Bracing Member near station 0+75

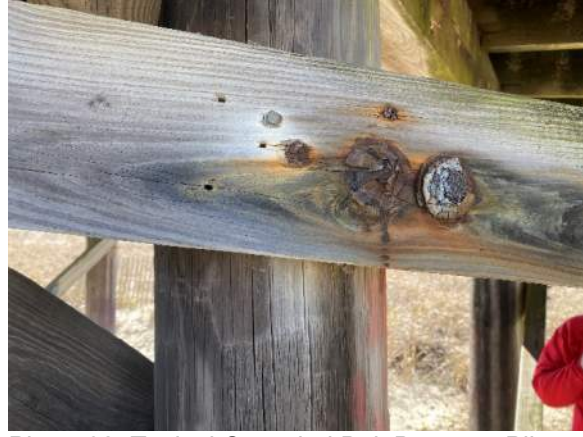
Photo 62: Typical Corroded Bolt Between Pile and Bracing Member near station 0+75

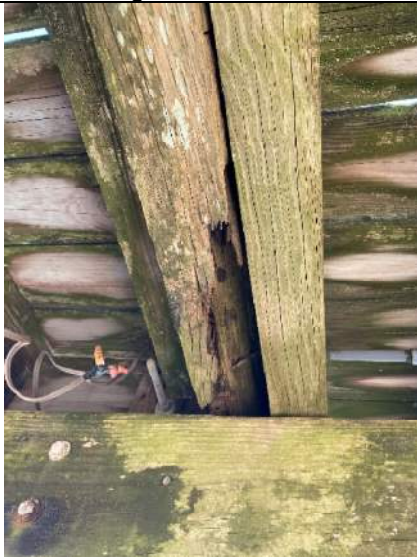
- Corroded connections and steel hardware
- Rotted and deteriorated members (Photos 63, 65, and 66)
- Detached railing includes a disconnection of joist from pile cap (Photo 64)
- Checking and splitting of cross-bracing and support members (Photos 67 and 68)

Photo 63: Typical Rotting Joist / Supports near station 0+90 Balcony

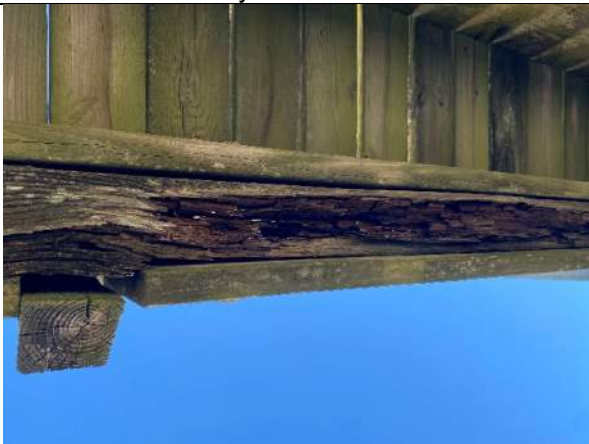
Photo 65: Typical Rotting Joist near station 0+90 Balcony

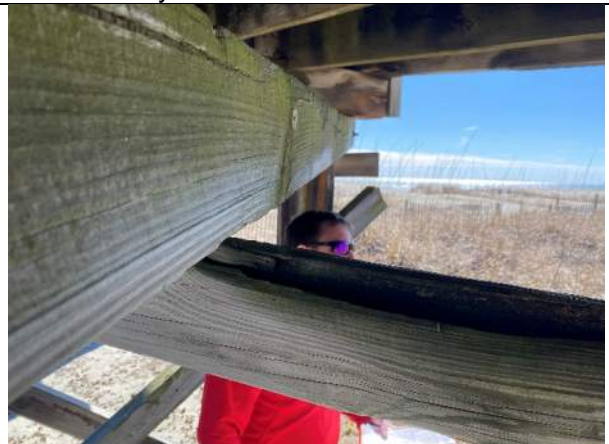
Photo 66: Typical Rotting / Hollow Bracing Member near station 0+90 Balcony

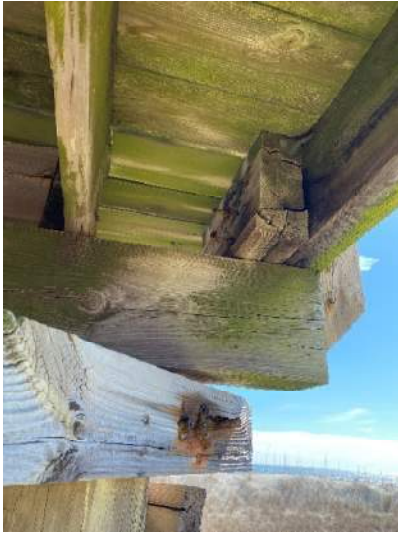
Photo 67: Typical Support Checking and Splitting near station 0+90 Balcony

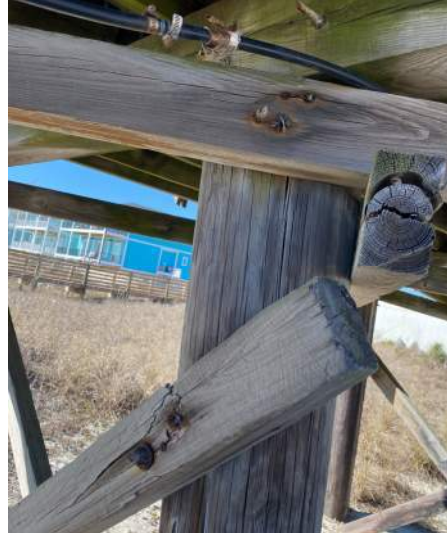
Photo 68: Typical Bracing Member Checking and Splitting near station 0+90 Balcony

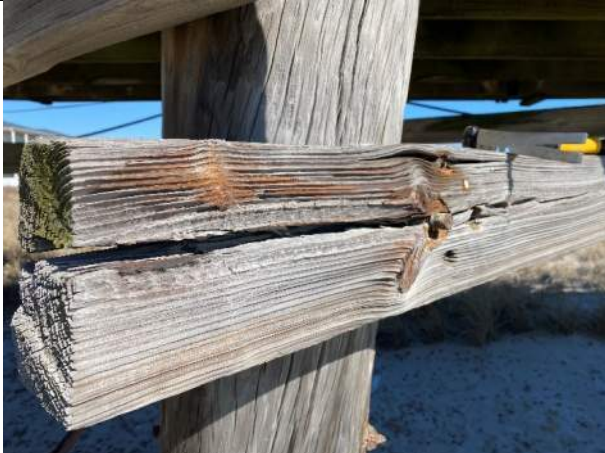
- Disconnected and failed bracing (Photo 73)
- Rotting pile caps (Photos 71, 72, and 74)
- Rotting and split joists (Photo 70)
- Checking and splitting of cross-bracing and support members (Photos 69 and 74)
- At least 3 hollow piles
- Corroded connections and steel hardware (Photos 75 and 76)

Photo 69: Cross Bracing Checking and Splitting near station 1+00

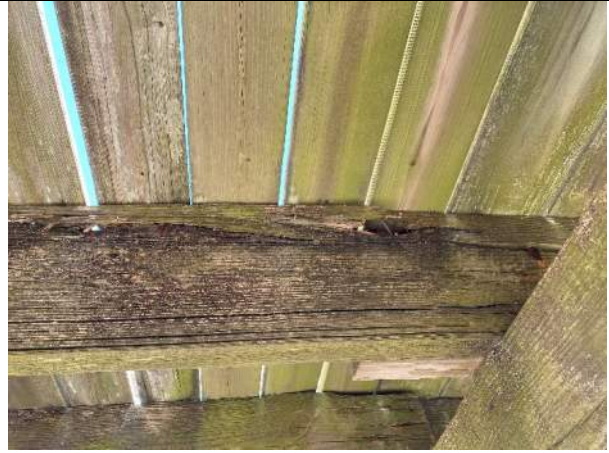
Photo 70: Typical Disconnected and Split Joist near station 1+00

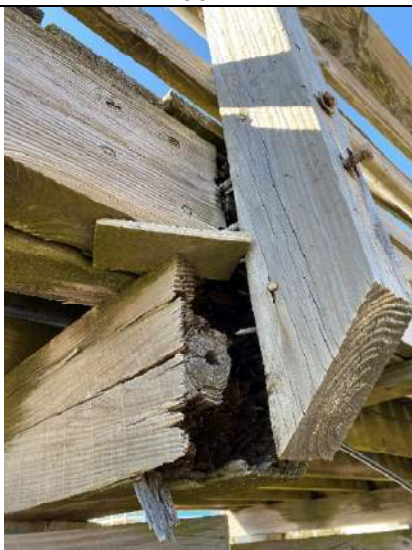
Photo 71: Typical Pile Cap End Rot and Detached Railing Post near station 1+25

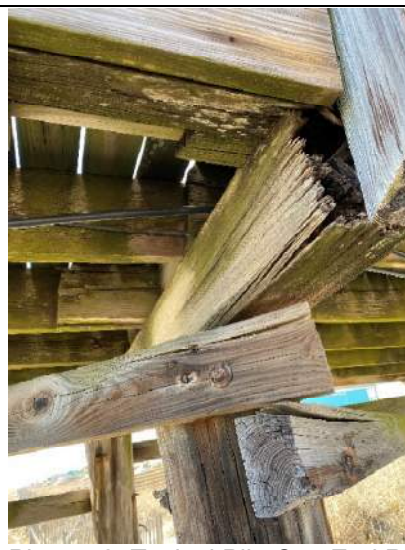
Photo 72: Typical Pile Cap End Rot near station 1+50

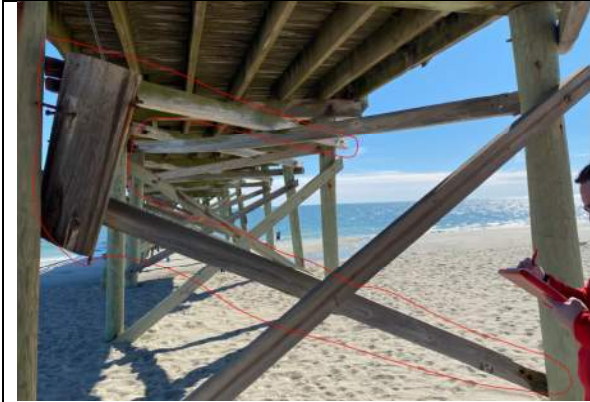
Photo 73: Disconnected Cross Bracing near station 2+25

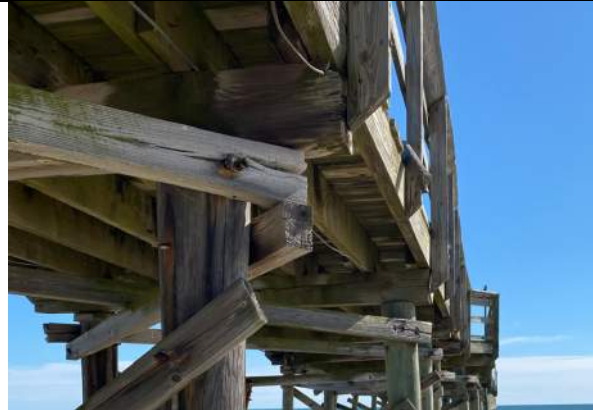
Photo 74: Split / Checked Cross Bracing and Pile Cap End Rot near station 2+25

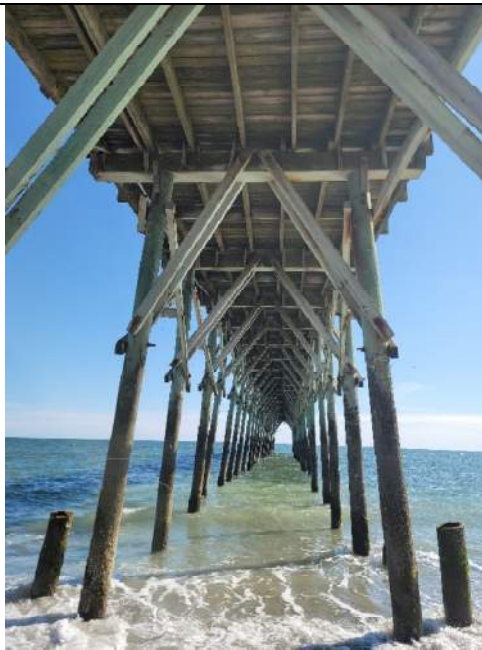
Photo 84: End of Observable Substructure Investigation near station 4+00

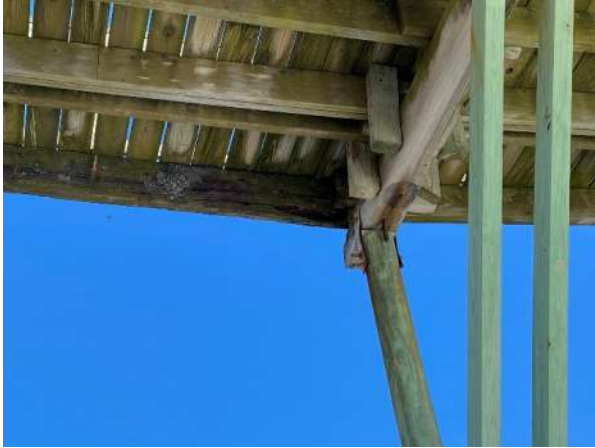
Photo 85: Typical Rotting Joist near station 4+00

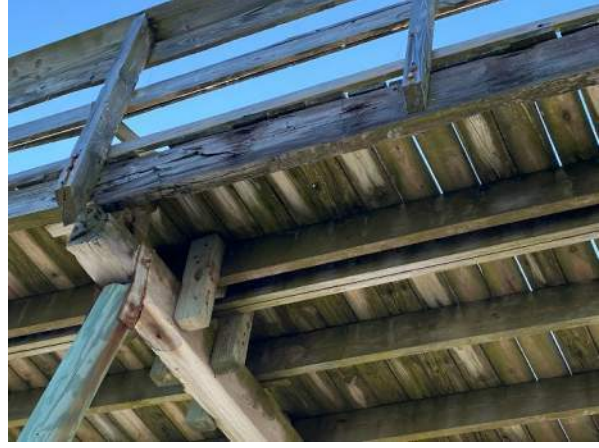
Photo 86: Rotting Joist and Pile Cap End Rot near station 4+00

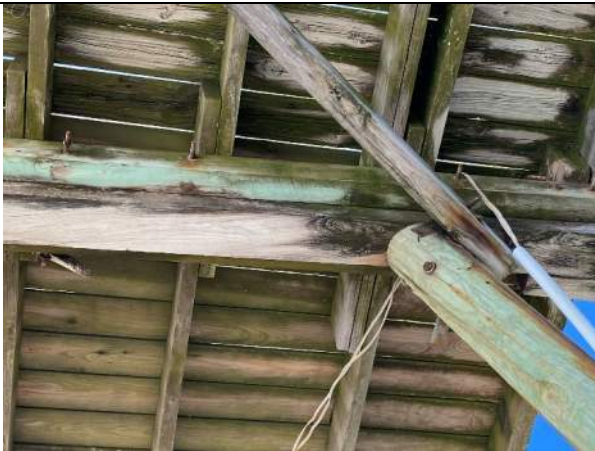
Photo 87: Pile Cap Splicing / Repair near station 4+00

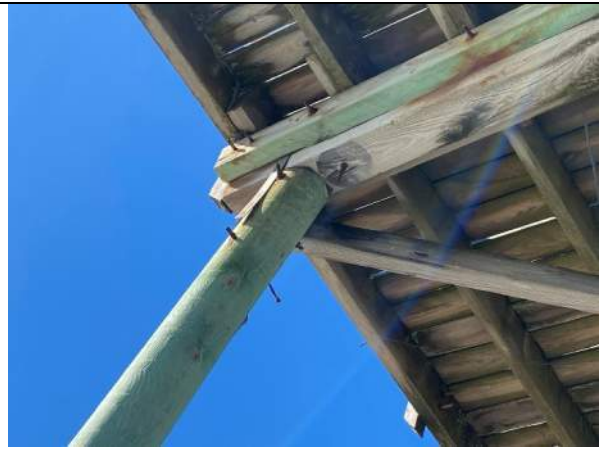
Photo 88: Disconnected Pile / Pile Cap Connection and Corroded Bolts near station 4+00
