# INSPECTION REPORT

For the Property at:  
**282 ##### AVE**  
TORONTO, ON #####

Prepared for: Client  
Inspection Date: Thursday, August 5, 2021  
Prepared by: DAN LIU

Report No. 1021

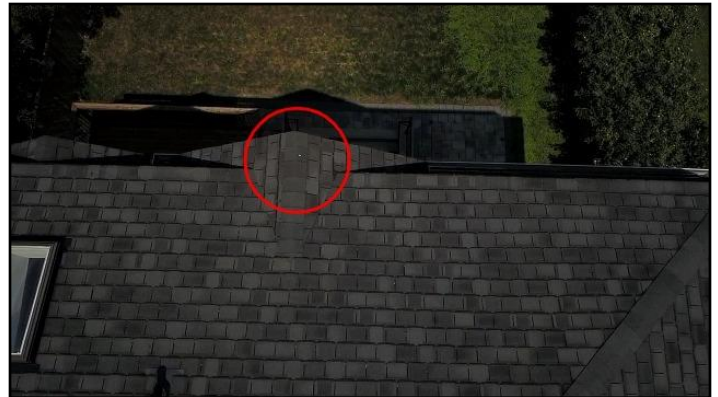
2. Exposed fasteners

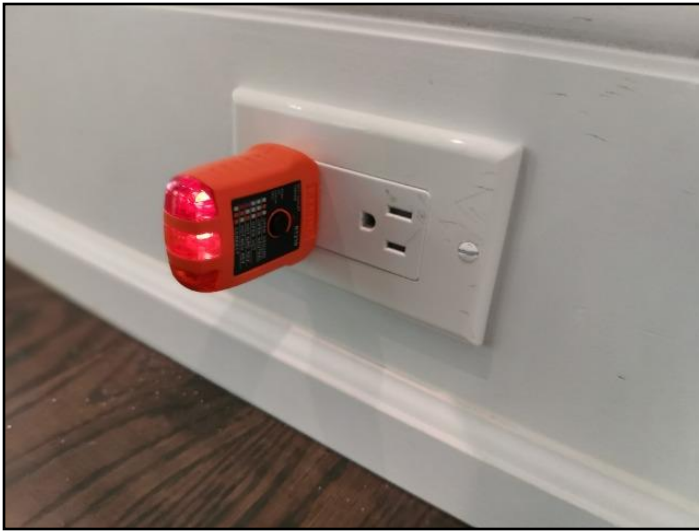
**14. Condition:** • [Reversed polarity](#)

28. Reversed polarity

**Task:** Repair

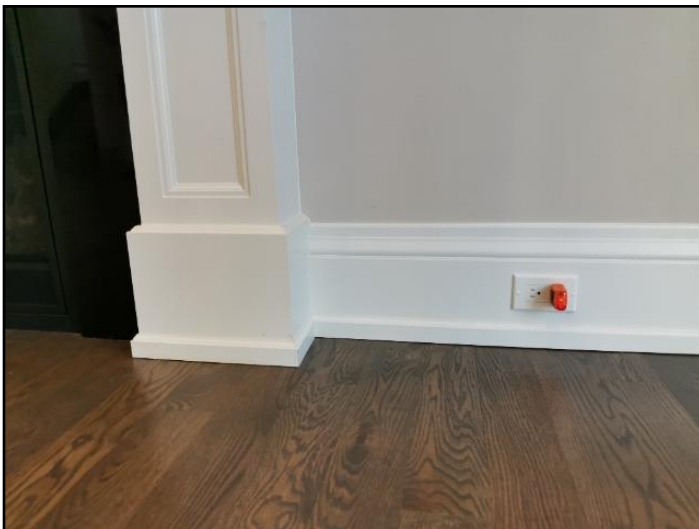
30. Reversed polarity
