INSPECTION REPORT

SAMPLE REPORT

VAUGHAN, ON L0D 6J9

RE: Report No. 1041, v.3
Sample Report
Vaughan, ON
L0D 6J9

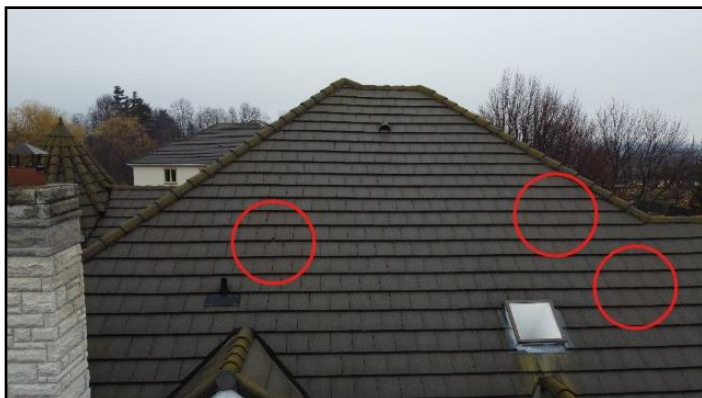
Condition: • Missing, loose or broken pieces

Implication(s): Damage or physical injury due to falling materials | Chance of water damage to structure, finishes and contents

1. Missing, loose or broken pieces

Task: Repair

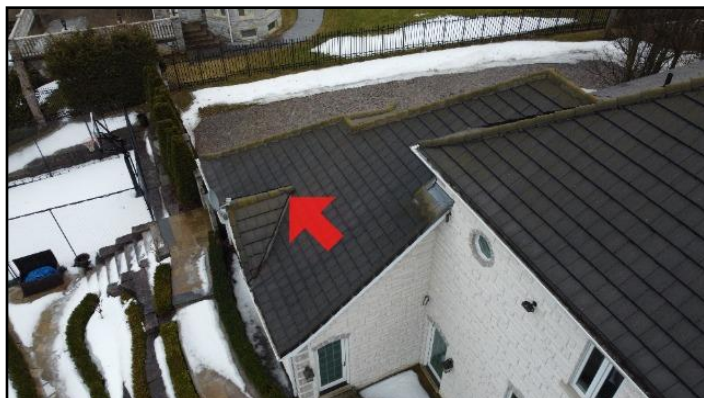
2. Missing, loose or broken pieces

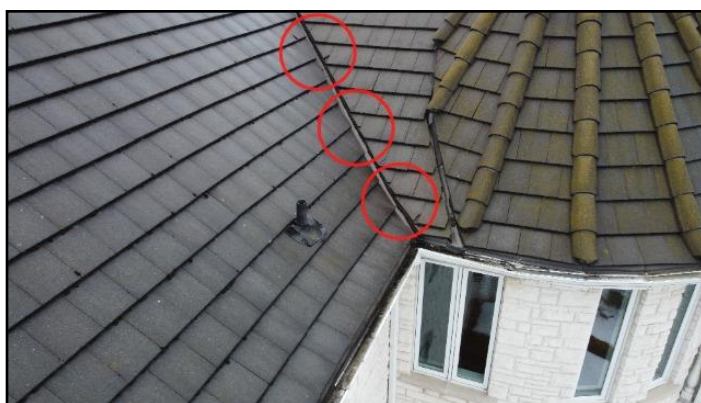
3. Missing, loose or broken pieces

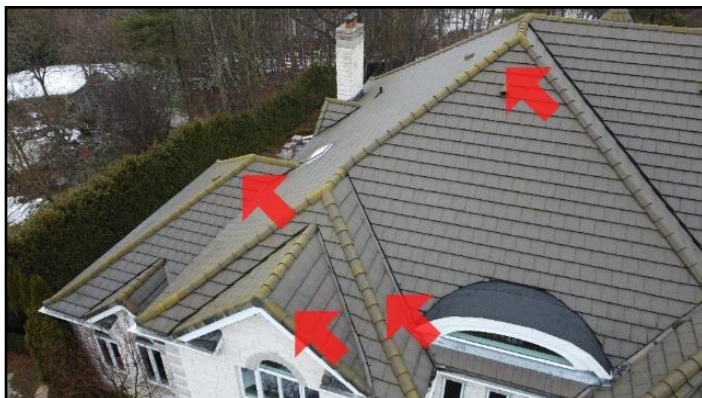
2. Condition: • Moss/debris

4. Moss/debris

Task: Clean

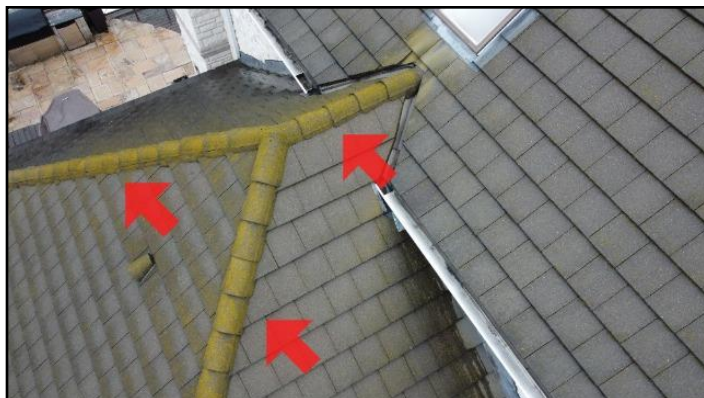
5. Moss/debris

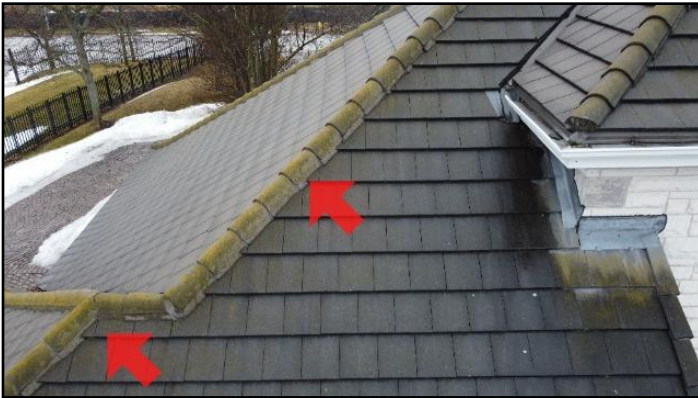
6. Moss/debris

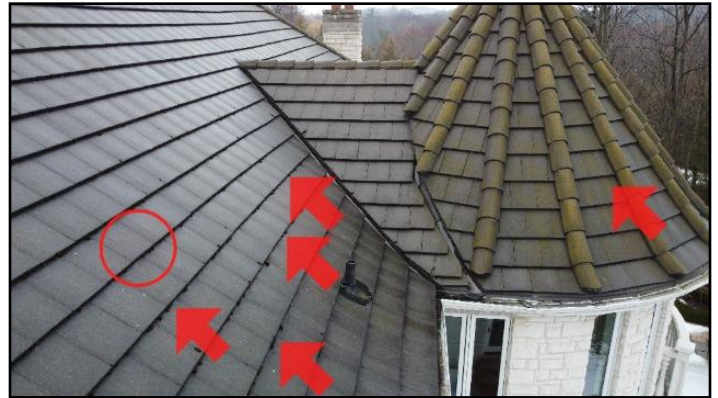
7. Moss/debris

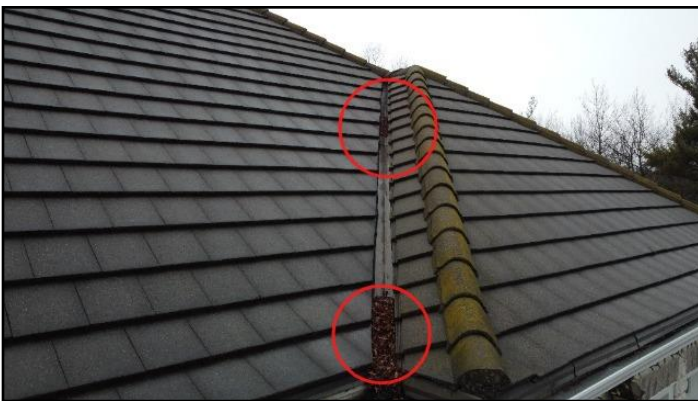
8. Moss/debris

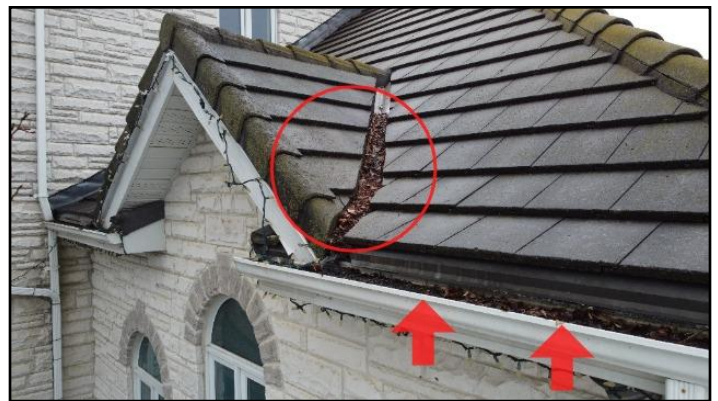
9. Moss/debris

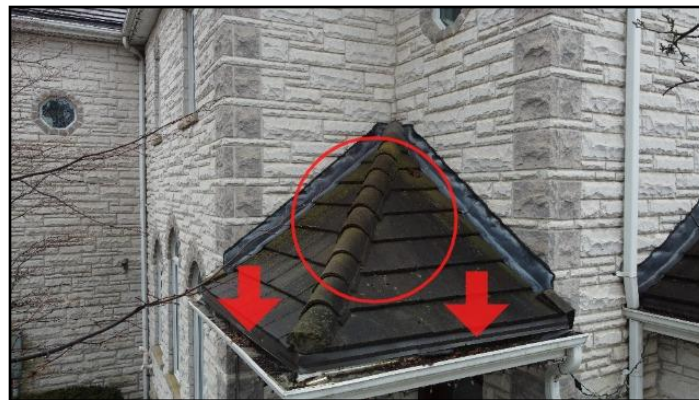
10. Moss/debris

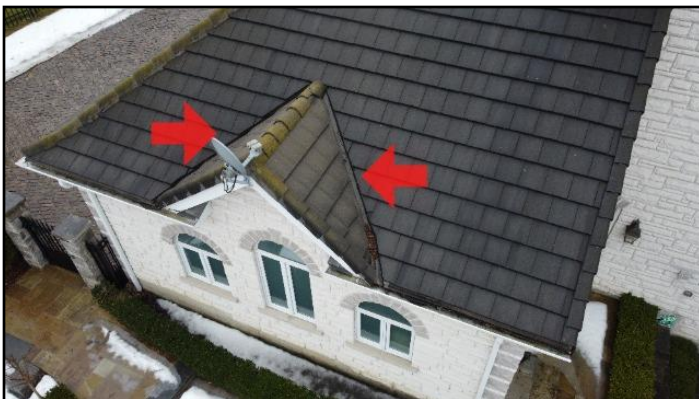
11. Moss/debris

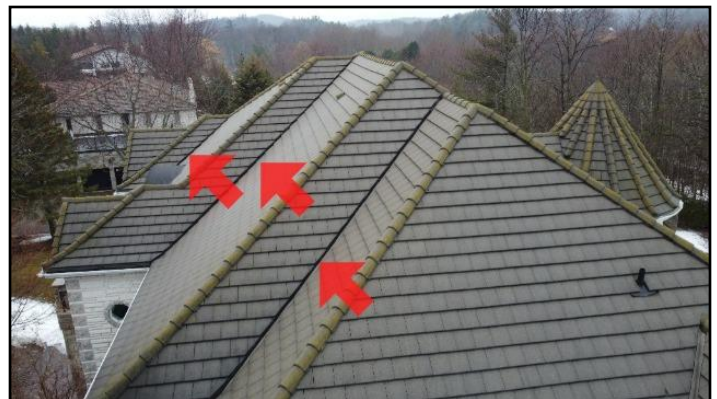
12. Doesn't widen at bottom

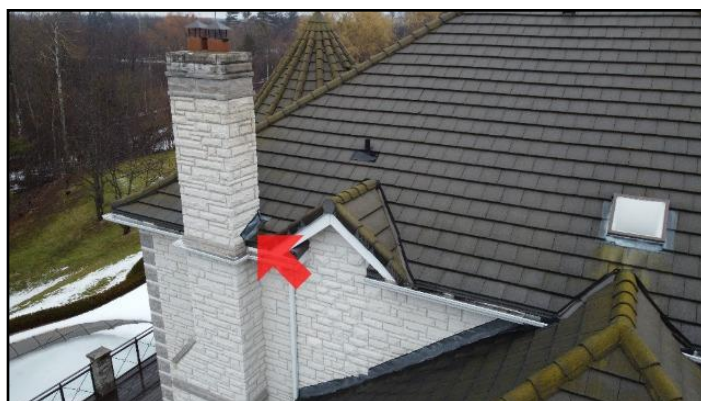
13. Not let into mortar joints

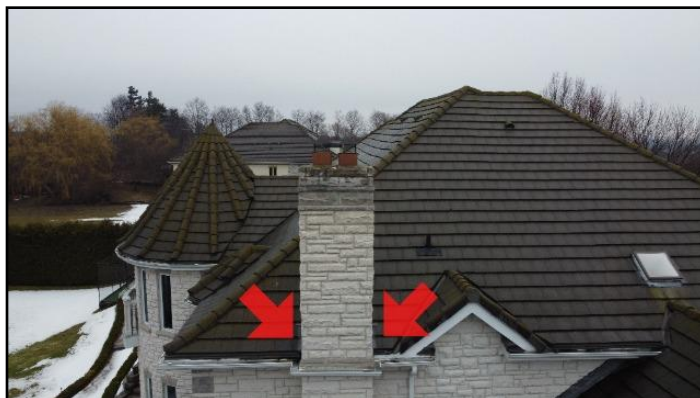
5. Condition: • Side flashings not set into shingles properly

14. Side flashings not set into shingles properly

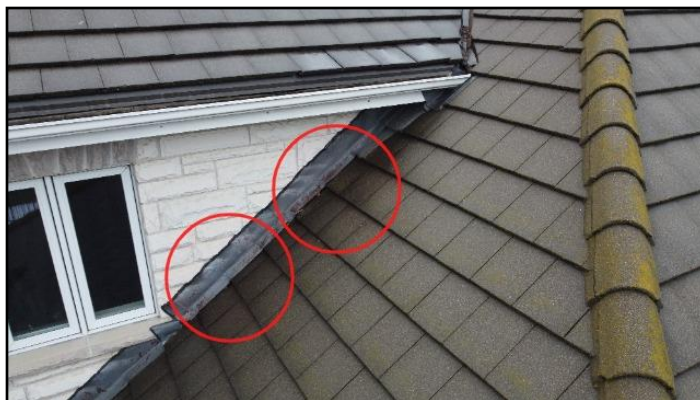
15. Rust

Task: Repair or replace

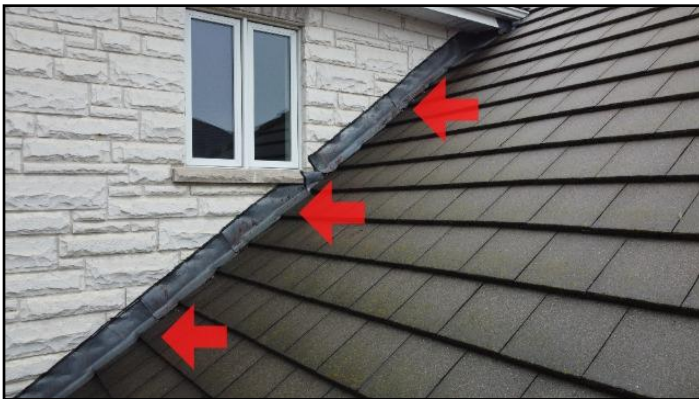
7. Condition: • Step flashings not set into shingles properly

16. Step flashings not set into shingles properly

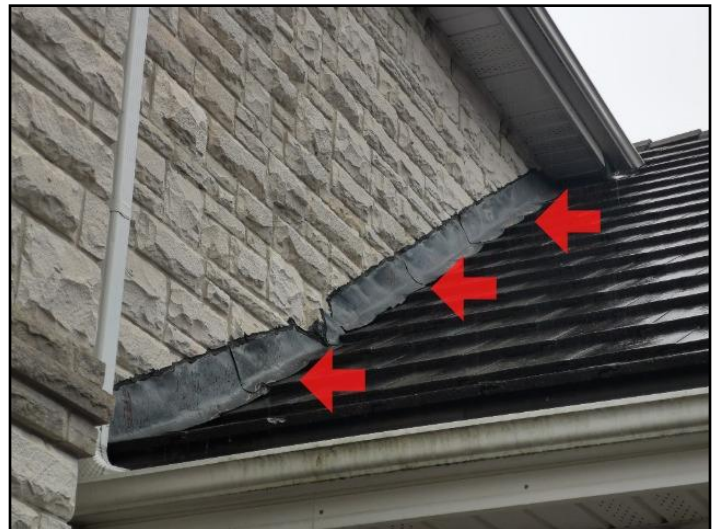
17. Step flashings not set into shingles properly

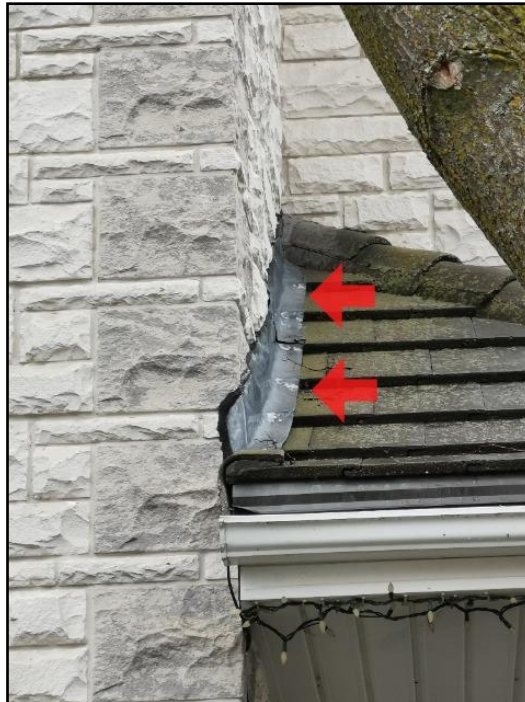
18. Step flashings not set into shingles properly

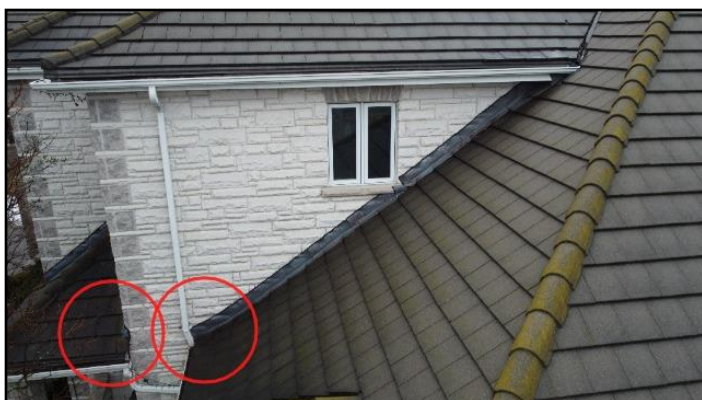
8. Condition: • Kickout flashing - missing

19. Kickout flashing - missing

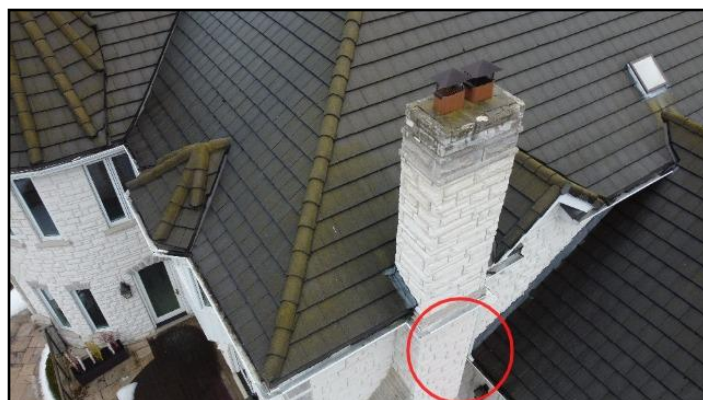
20. Kickout flashing - missing

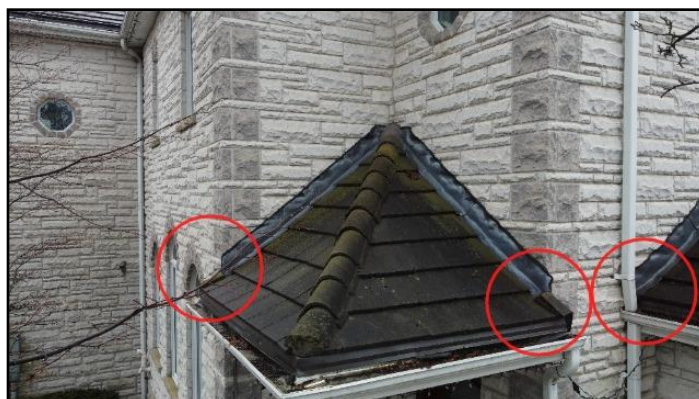
21. Kickout flashing - missing

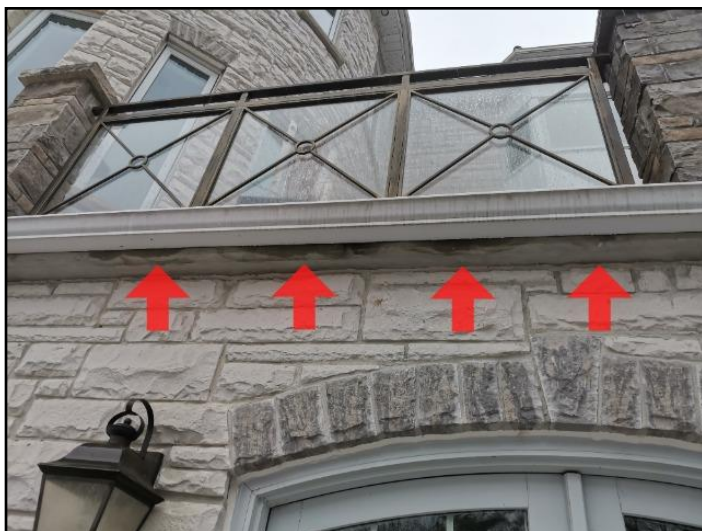
Condition: • Leak

Implication(s): Chance of water damage to structure, finishes and contents

22. Leak

Task: Repair

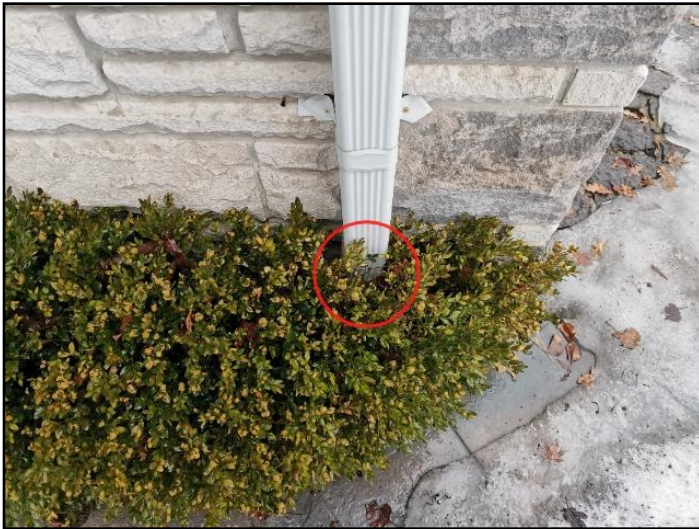
27. Discharge below grade

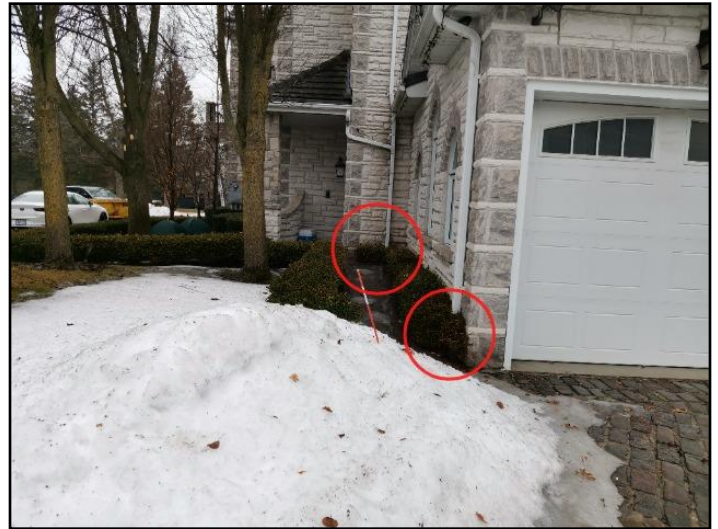
28. Discharge below grade

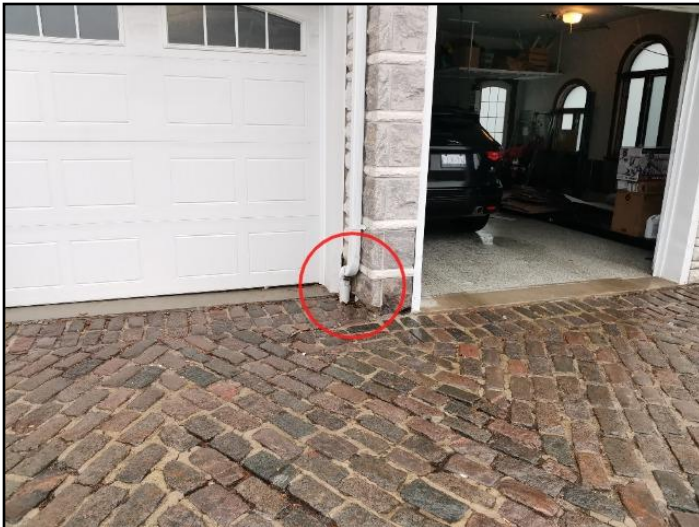
29. Discharge below grade

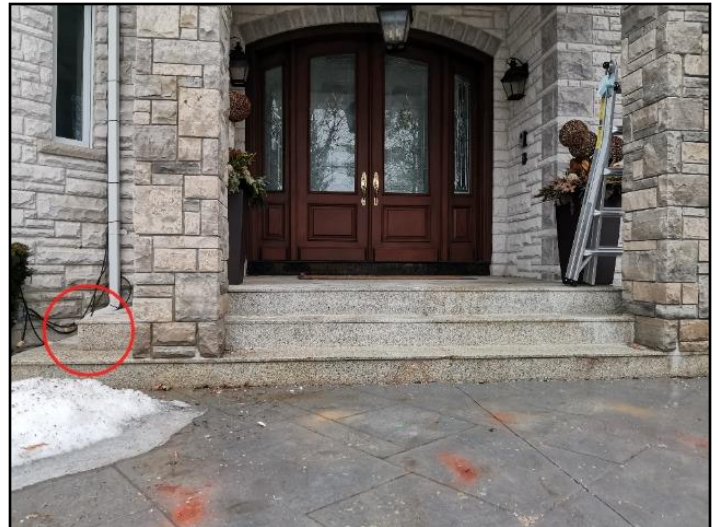
30. Discharge below grade

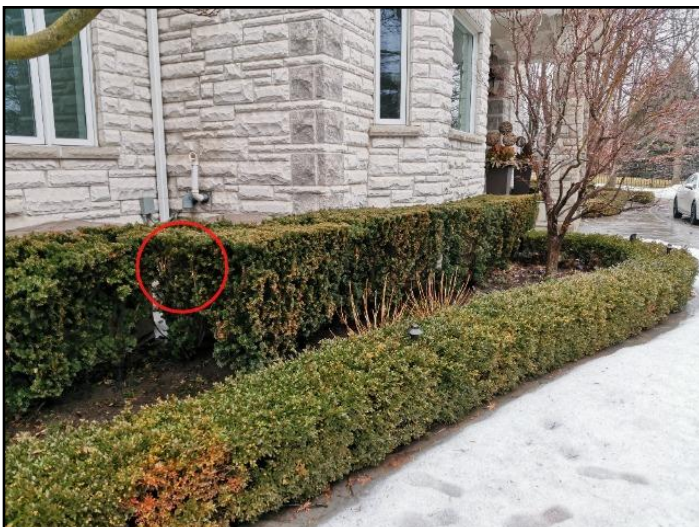
31. Discharge below grade

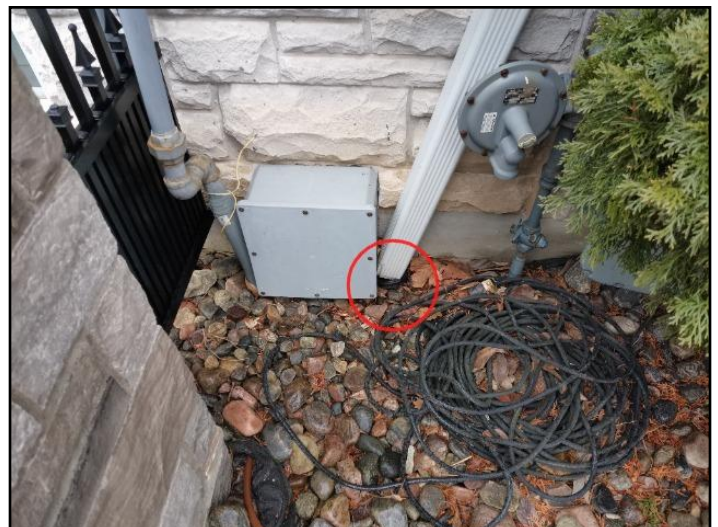
32. Discharge below grade

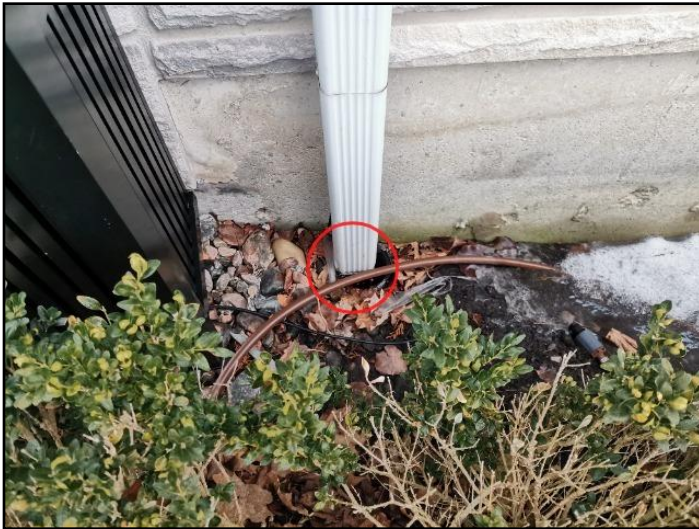
11. Condition: • Discharge below grade

Implication(s): Chance of water damage to structure, finishes and contents

33. Discharge below grade

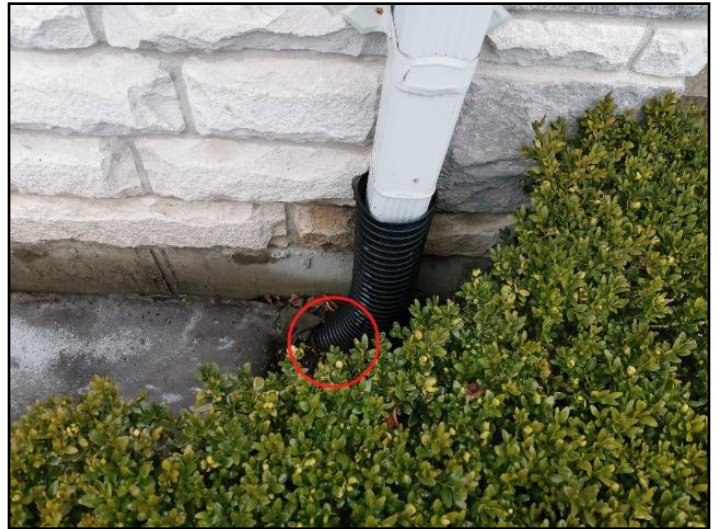
34. Discharge below grade

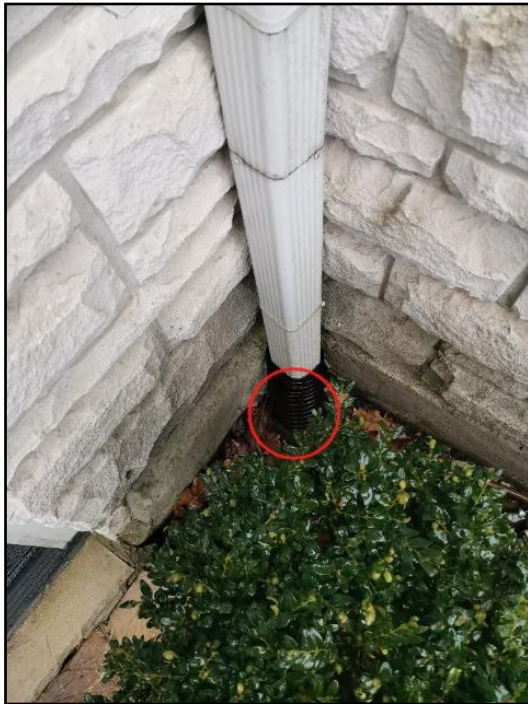
35. Discharge below grade

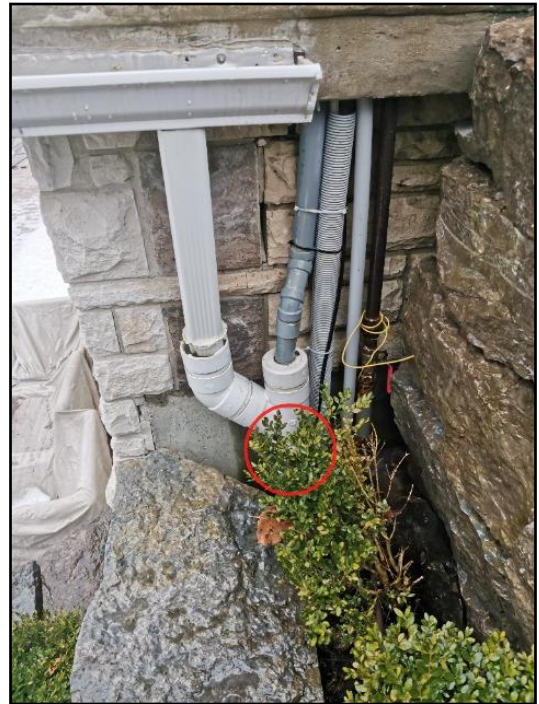
36. Discharge below grade

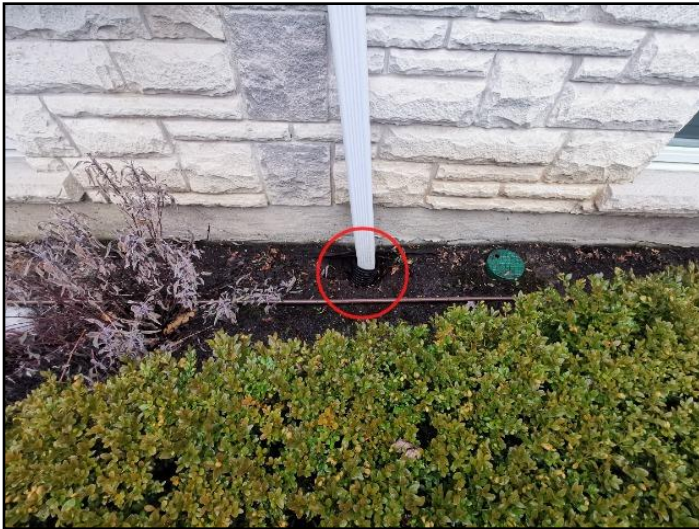
37. Discharge below grade

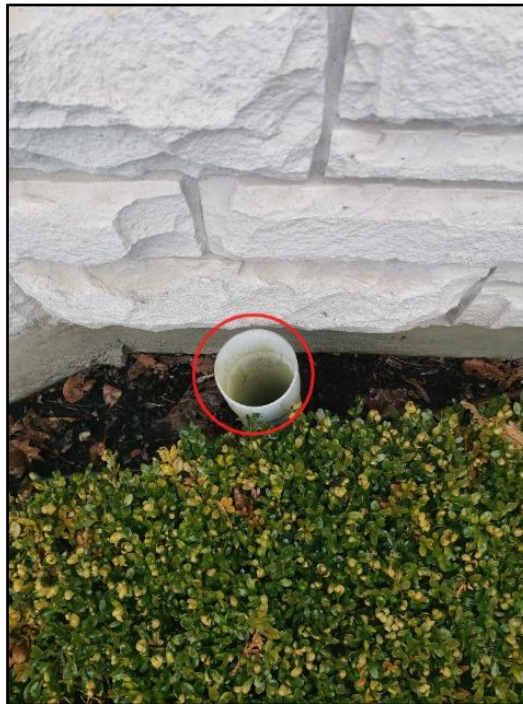
39.

12. Condition: • Banned downspout drain.

Task: Seal

Time: As soon as practical

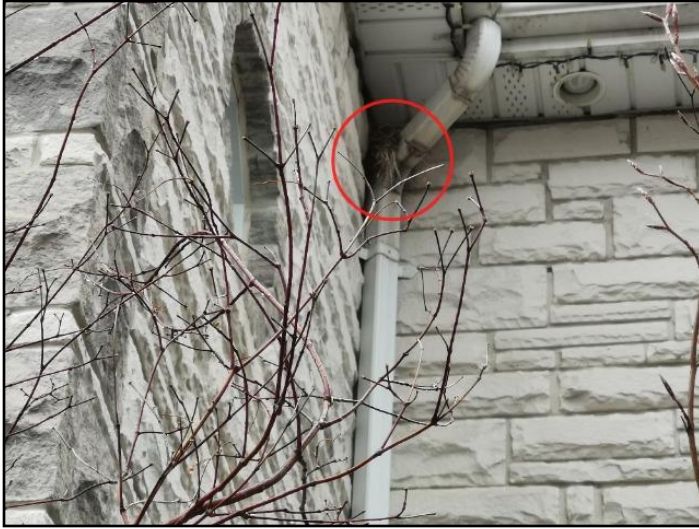
13. Condition: • Nestling

40. Bird nest

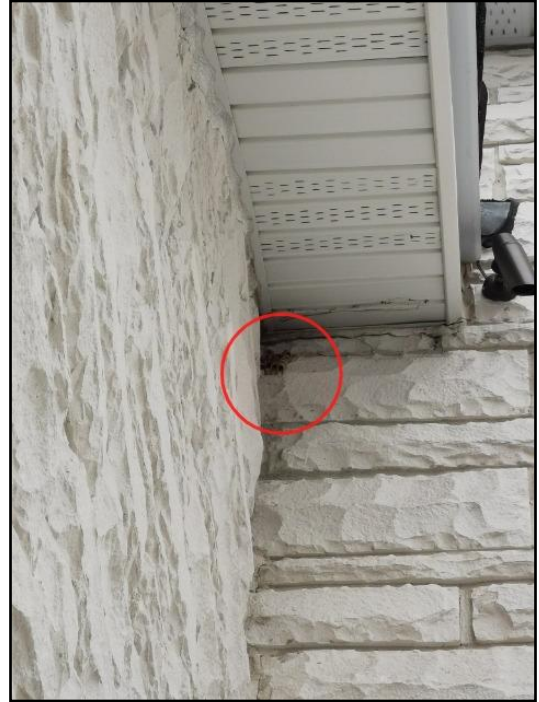
41. Wasp hive

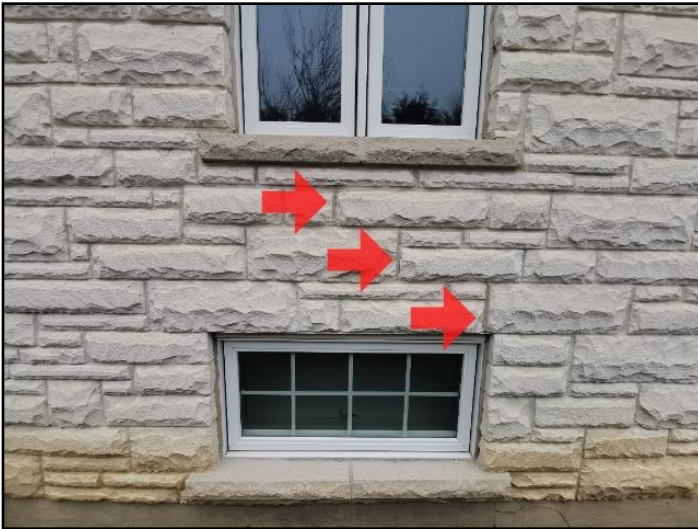
14. Condition: • Cracked

50. Cracked

Task: Repair Inspect annually

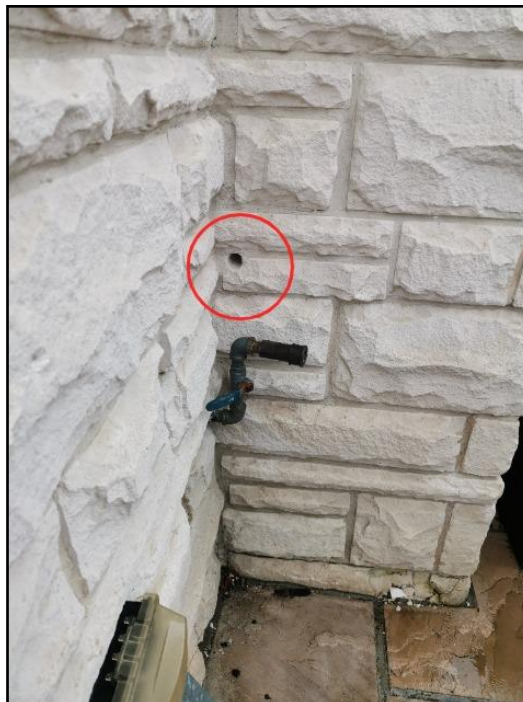
15. Condition: • Mechanical damage

52. Mechanical damage

Task: Repair

Time: As soon as practical

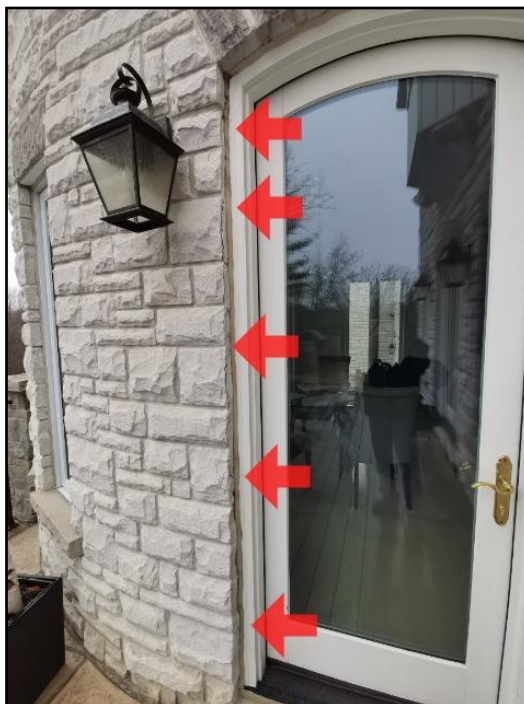
16. Condition: • Spalling

53. Spalling

Task: Repair

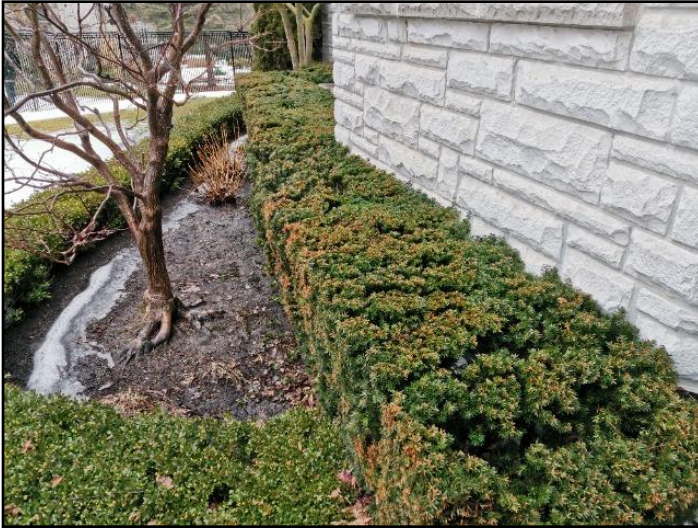
21. Condition: • Trees or shrubs too close to building

Implication(s): Chance of pests entering building | Material deterioration | Chance of water damage to structure, finishes and contents

58. *Trees or shrubs too close to building*

Task: Correct

Time: As soon as practical

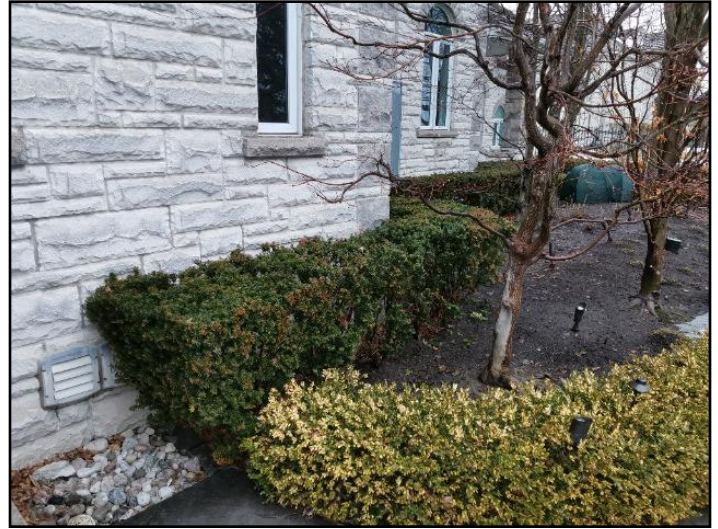
59. *Trees or shrubs too close to building*

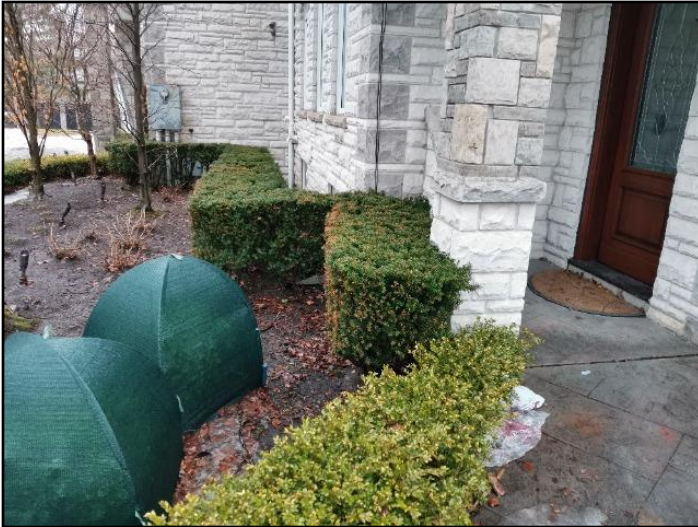
60. *Trees or shrubs too close to building*

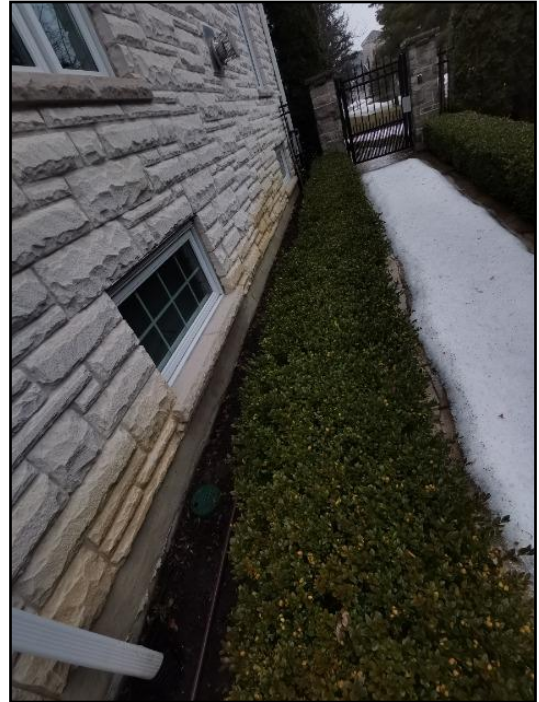
61. *Trees or shrubs too close to building*

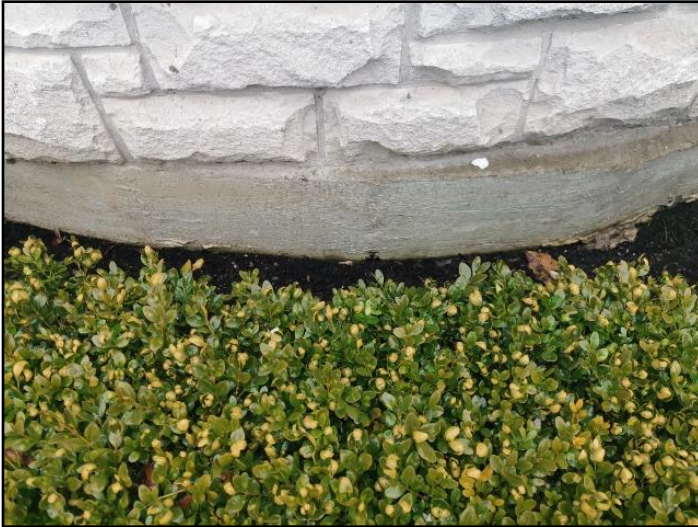
62. Trees or shrubs too close to building

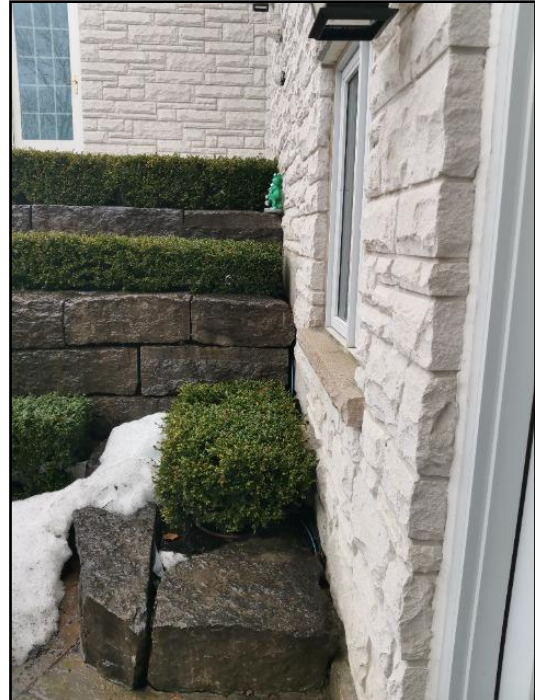
63. Trees or shrubs too close to building

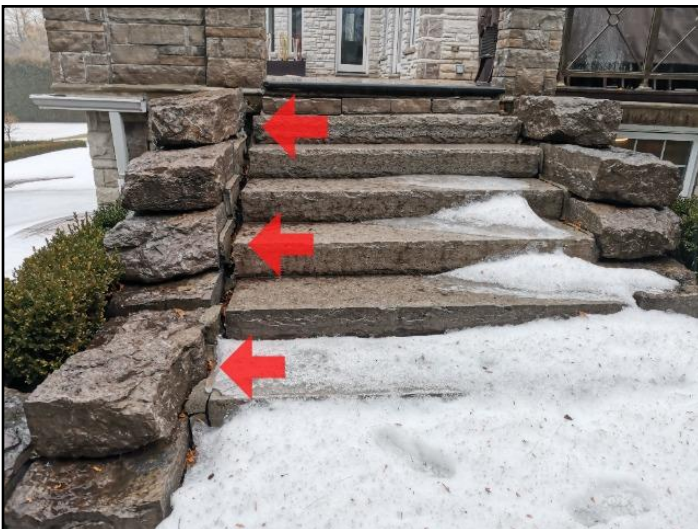
22. Condition: • Leaning

64. Leaning

Task: Repair

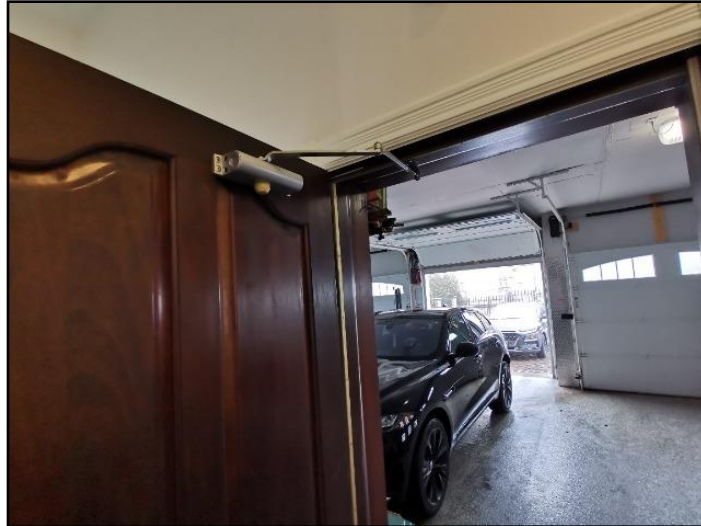
23. Condition: • Opens into bedroom

Implication(s): Hazardous combustion products entering home

66. Opens into bedroom

Task: Correct

Time: Discretionary

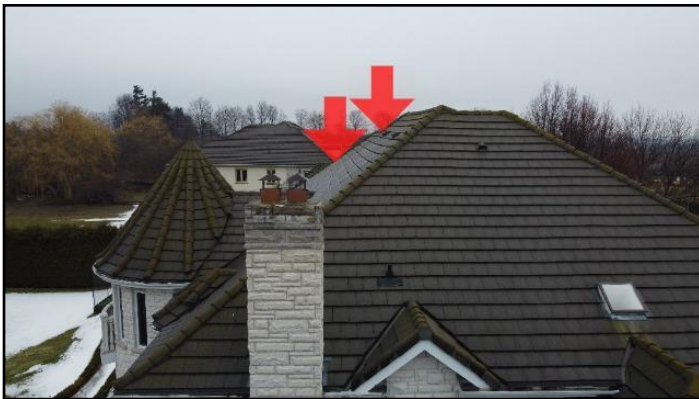
26. Condition: • Sagging

70. Sagging

Task: Improve Inspect annually

Time: When necessary

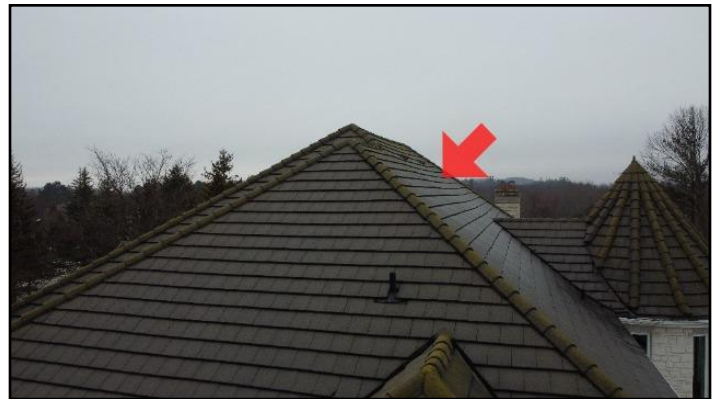
71. Sagging

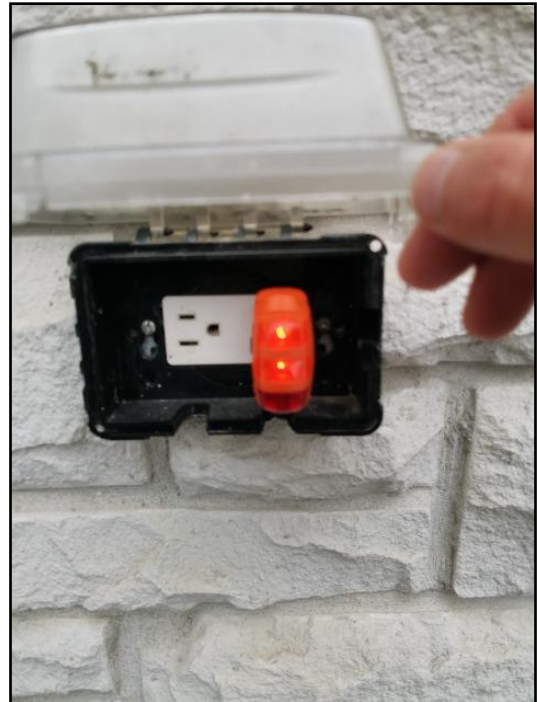
27. Condition: • Not suitable for outdoor (exterior) use

Implication(s): Shock hazard or interruption of electrical service

73. Not suitable for outdoor (exterior) use

Task: Replace

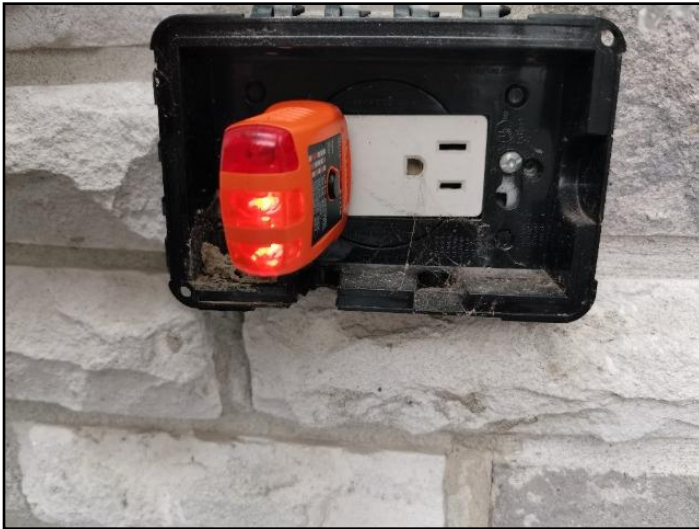
74. Not suitable for outdoor (exterior) use

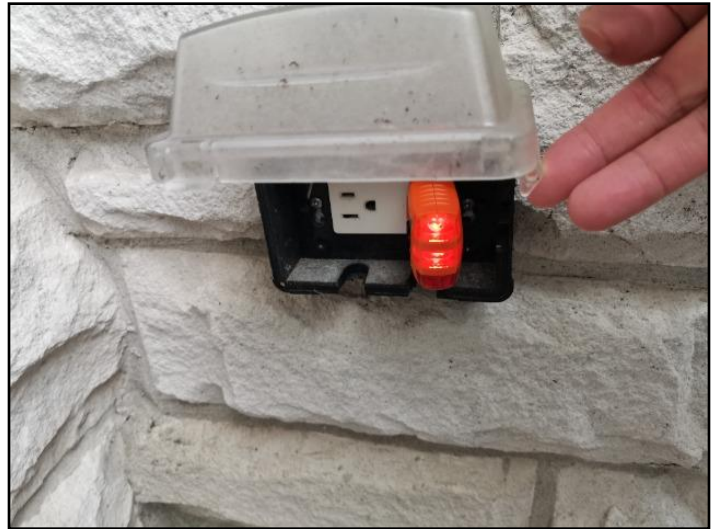
75. Not suitable for outdoor (exterior) use

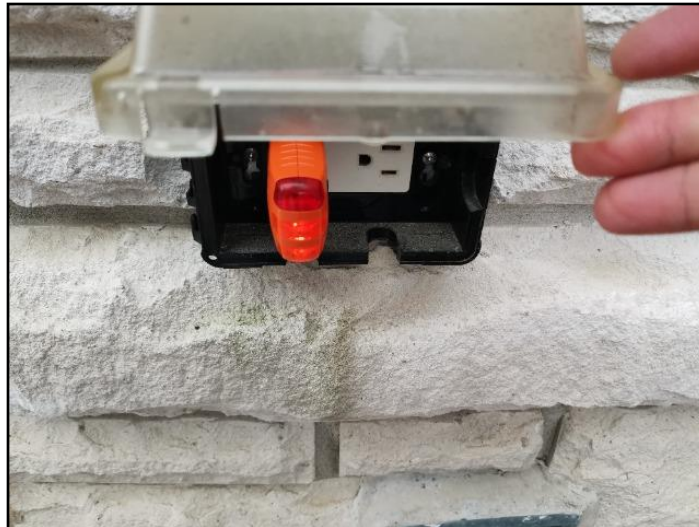
76. Not suitable for outdoor (exterior) use

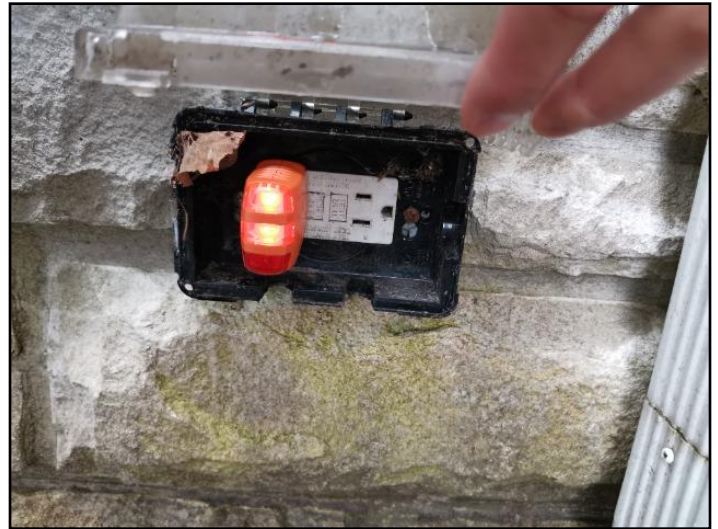
28. Condition: • Test faulty on GFCI/GFI (Ground Fault Circuit Interrupter)

78. Test faulty on GFCI/GFI (Ground Fault...

Task: Repair or replace

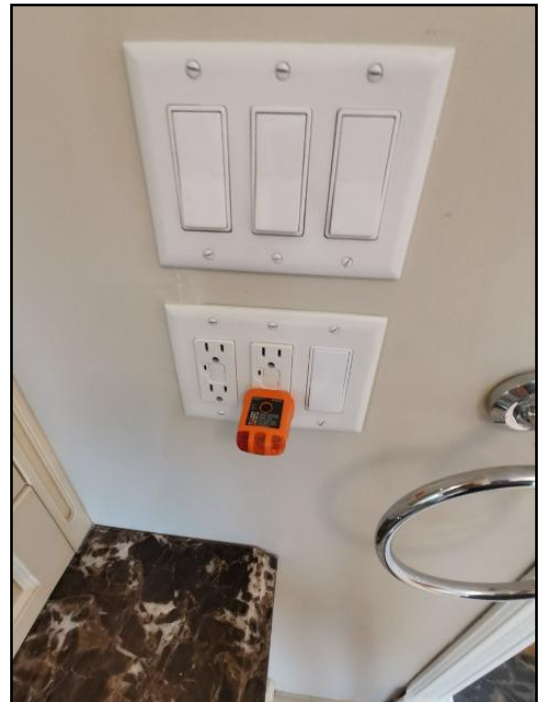
80. Test faulty on GFCI/GFI (Ground Fault...

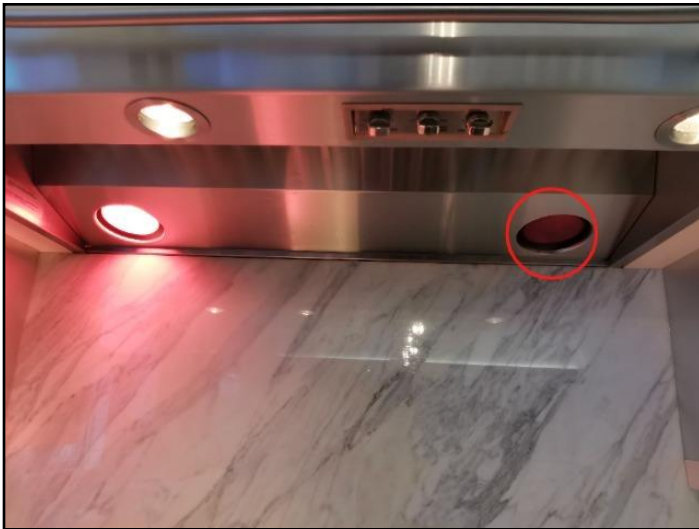
31. Condition: • Inoperative

86. Inoperative

Task: Replace

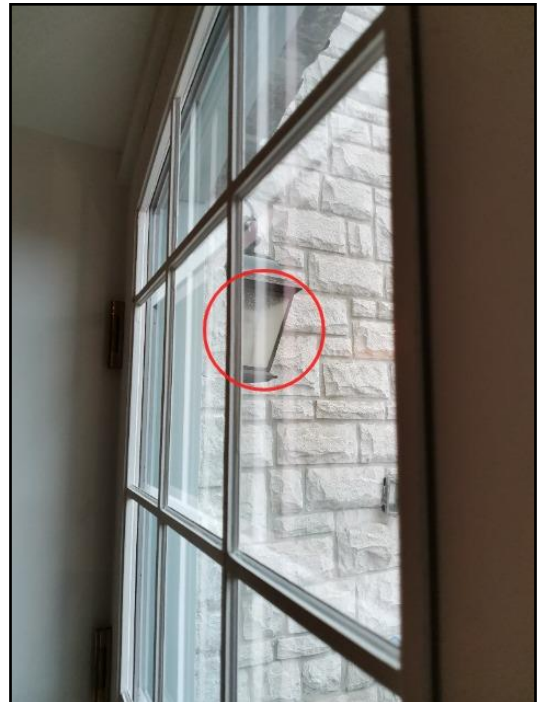
Implication(s): Inadequate lighting

87. Inoperative

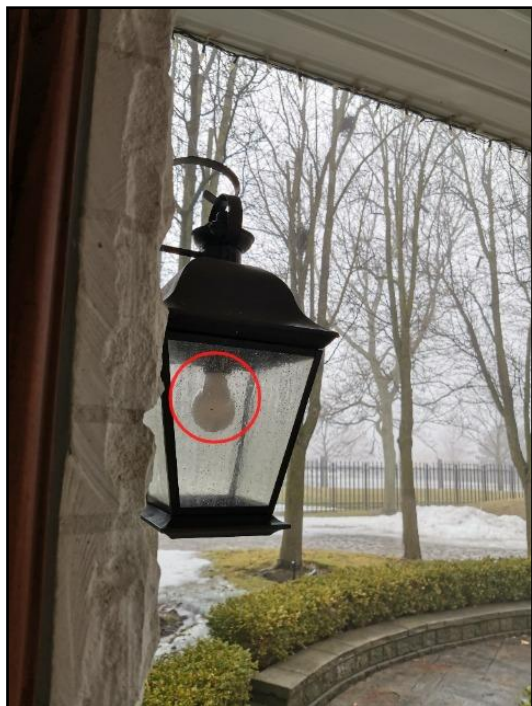
88. Inoperative

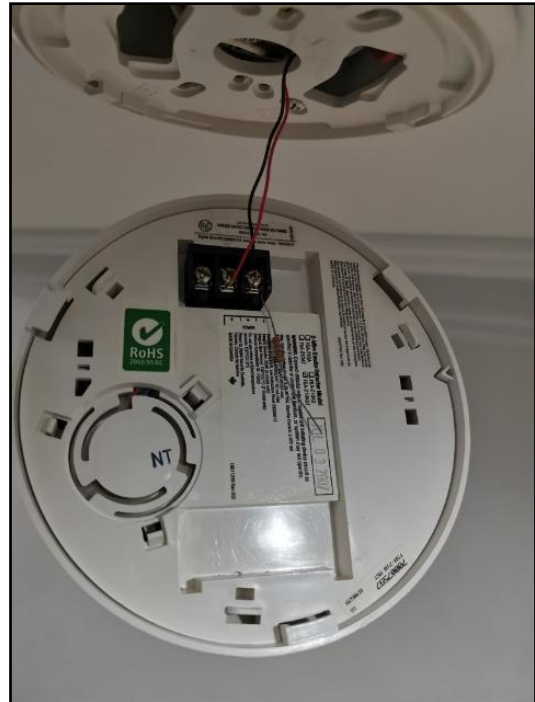
DISTRIBUTION SYSTEM \ Smoke alarms (detectors)**32. Condition:** • Past life expectancy**Implication(s):** Life safety hazard**Location:** Throughout**Task:** Replace**Time:** Immediate

91. Past life expectancy

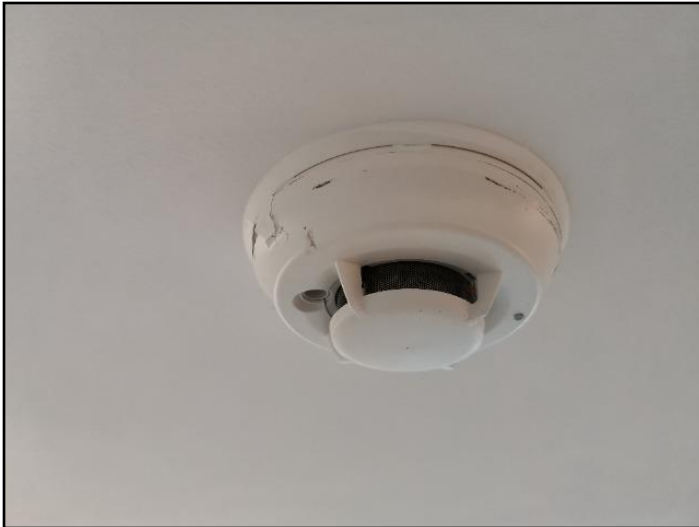
92. Past life expectancy

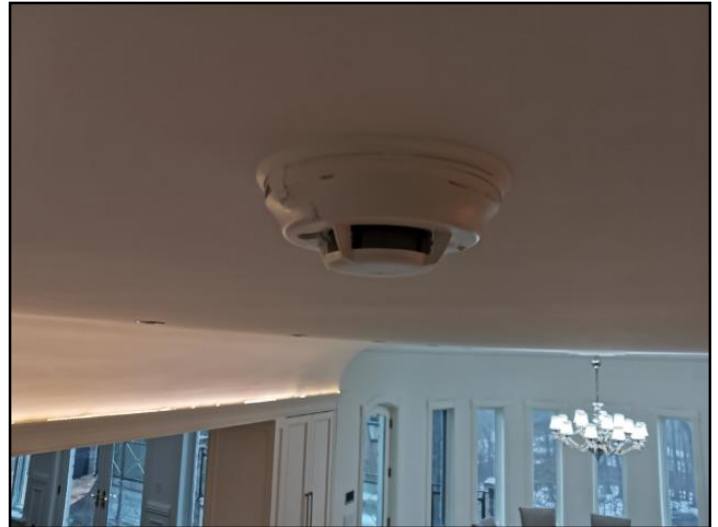
93. Past life expectancy

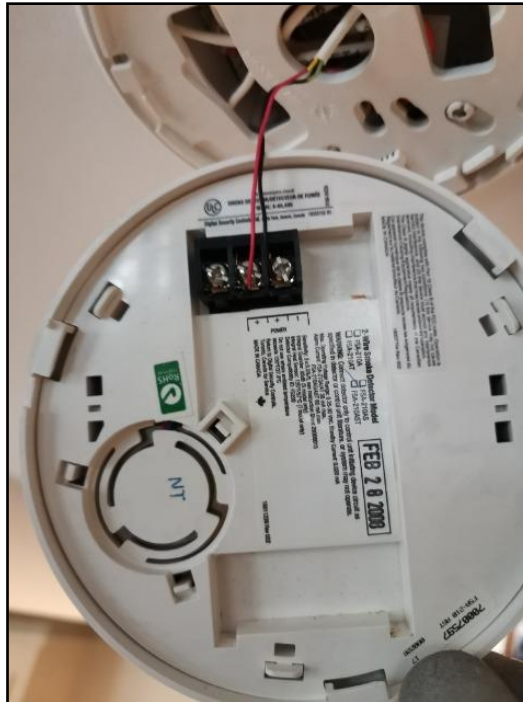
94. Past life expectancy

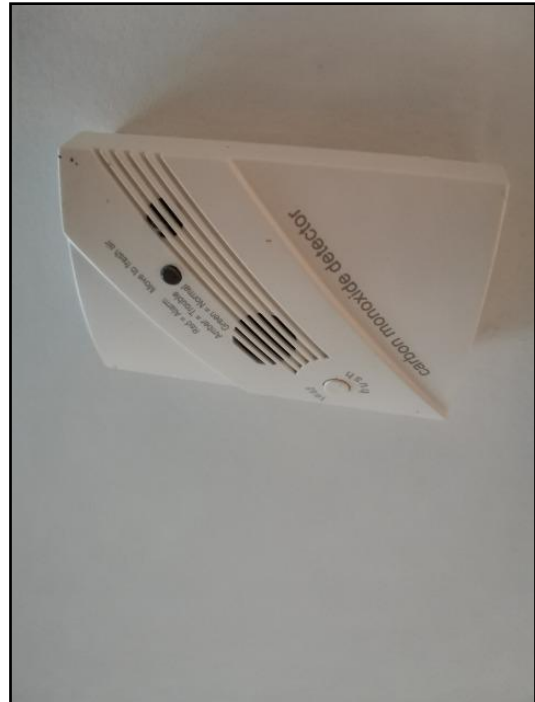
33. Condition: • Past life expectancy

Implication(s): Health hazard | Life safety hazard

96. Past life expectancy

Task: Replace

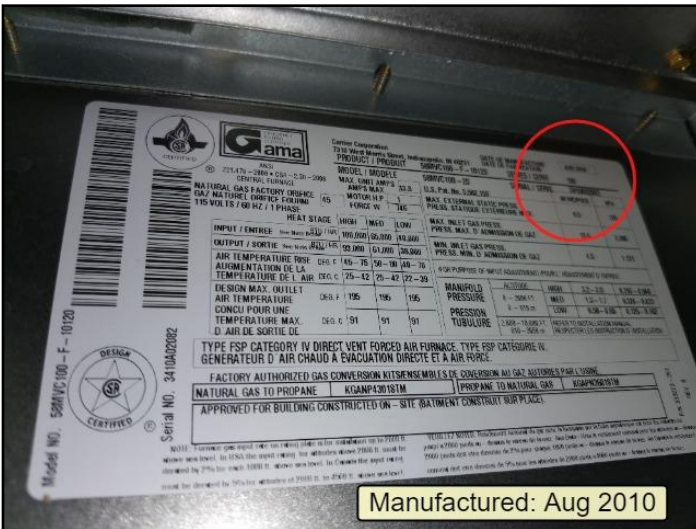
34. Condition: • Near end of life expectancy

Implication(s): No heat for building | Equipment failure

97. Near end of life expectancy

Task: Replace
