INSPECTION REPORT

SAMPLE REPORT

VAUGHAN, ON L0D 6J9

RE: Report No. 1041, v.3
Sample Report
Vaughan, ON
L0D 6J9

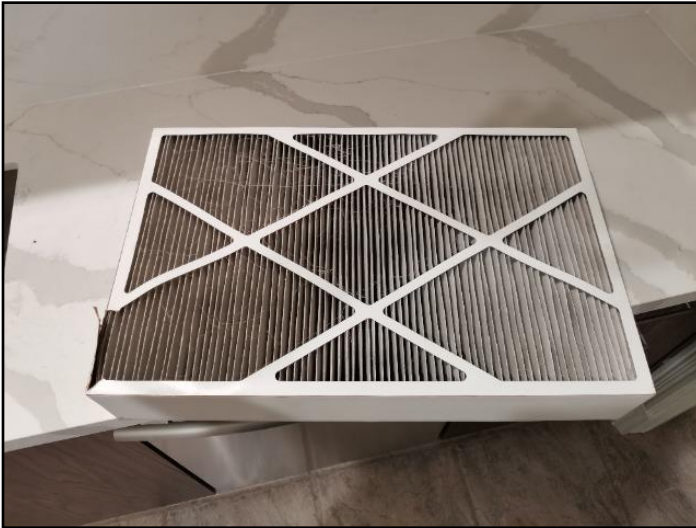
35. Condition: • Dirty

99. Dirty

Task: Replace

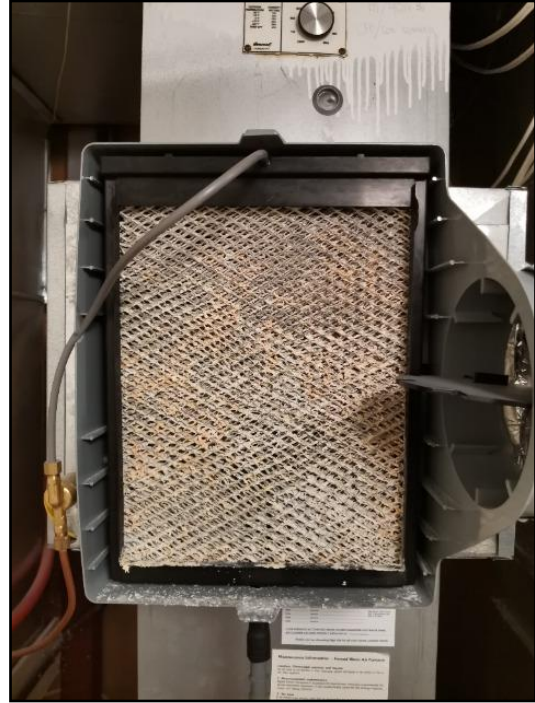
36. Condition: • Clogged pad, mesh or nozzle

102. Clogged pad, mesh or nozzle

Task: Replace

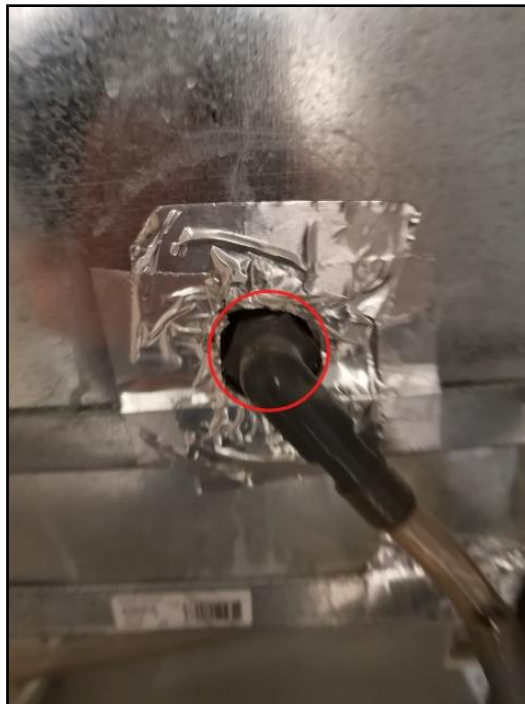
38. Condition: • Leaky joints

103. Leaky joints

Task: Repair

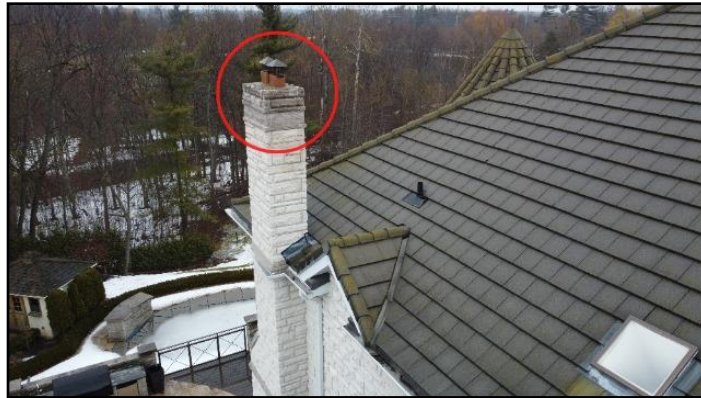
39. Condition: • Missing

Implication(s): Shortened life expectancy of material | Chance of water damage to structure, finishes and contents

104. *Missing*

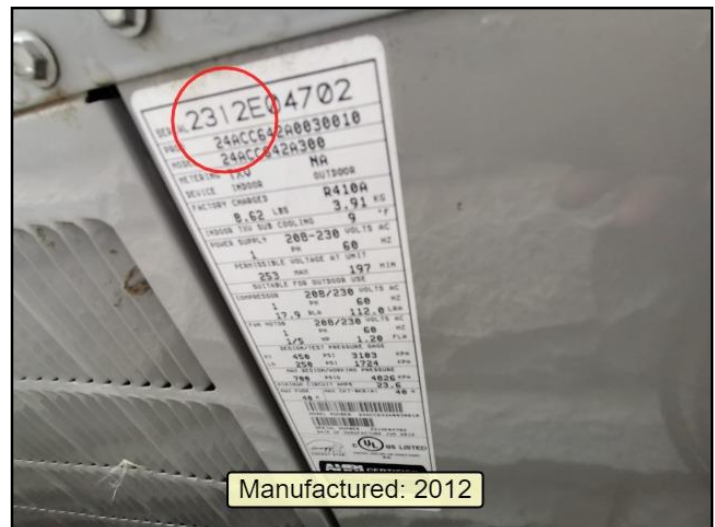
40. Condition: • Near end of life expectancy

Implication(s): Reduced comfort | Equipment failure

106. Near end of life expectancy

Task: Replace

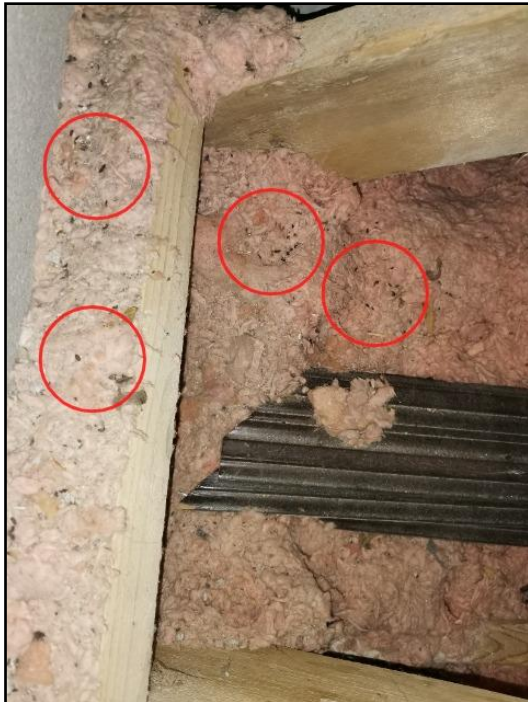
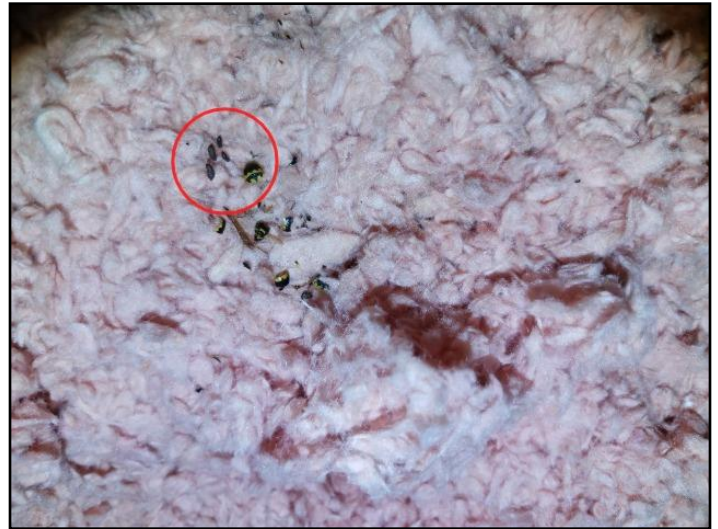
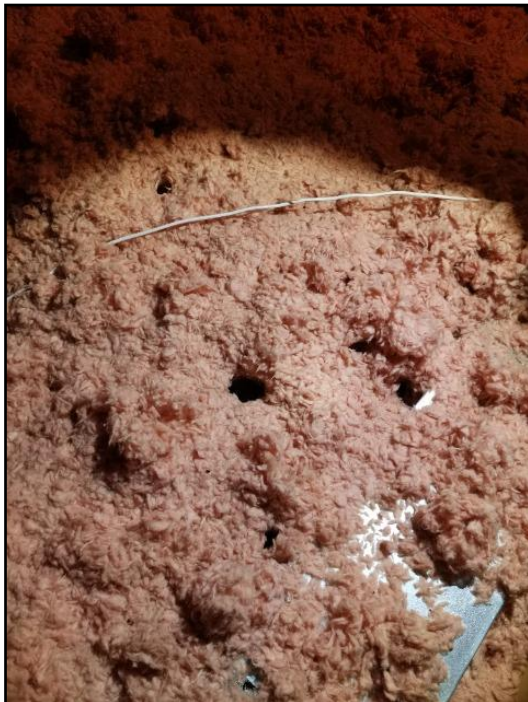
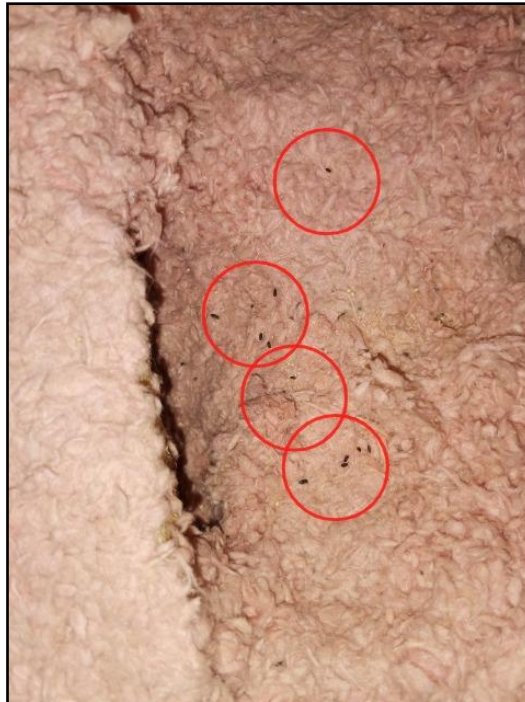
42. Condition: • Animal/pest droppings in attic

Implication(s): Health hazard

107. Animal/pest droppings in attic

108. Animal/pest droppings in attic

109. Animal/pest droppings in attic

110. Animal/pest droppings in attic

111. Animal/pest droppings in attic

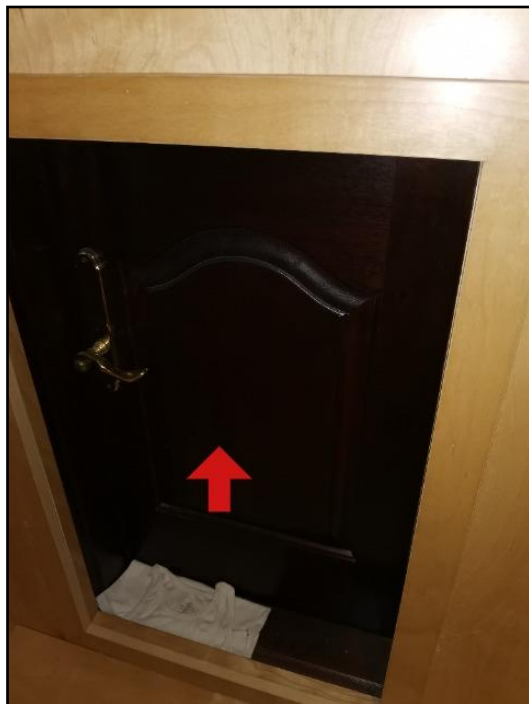
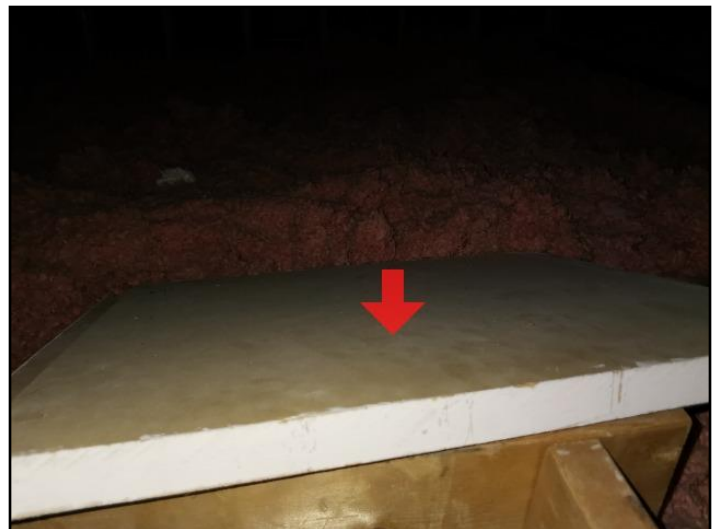
43. Condition: • Not insulated and not weatherstripped

Implication(s): Increased heating and cooling costs | Reduced comfort | Chance of condensation damage to finishes and/or structure

112. Not insulated and not weatherstripped

113. Not insulated and not weatherstripped

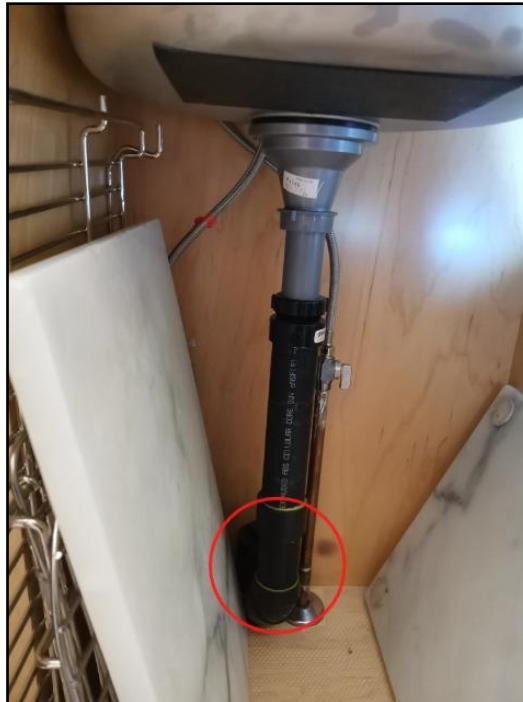
45. Condition: • Missing

115. Missing

Task: Correct

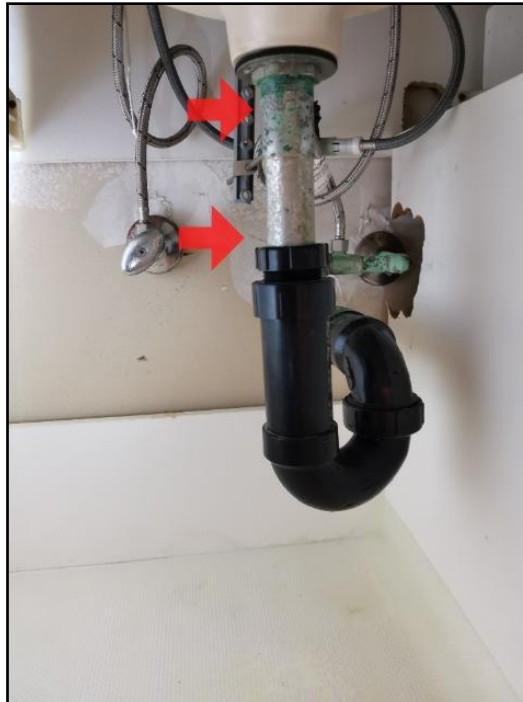
46. Condition: • Leak

Implication(s): Chance of water damage to structure, finishes and contents | Sewage entering the building

116. Leak

Task: Repair

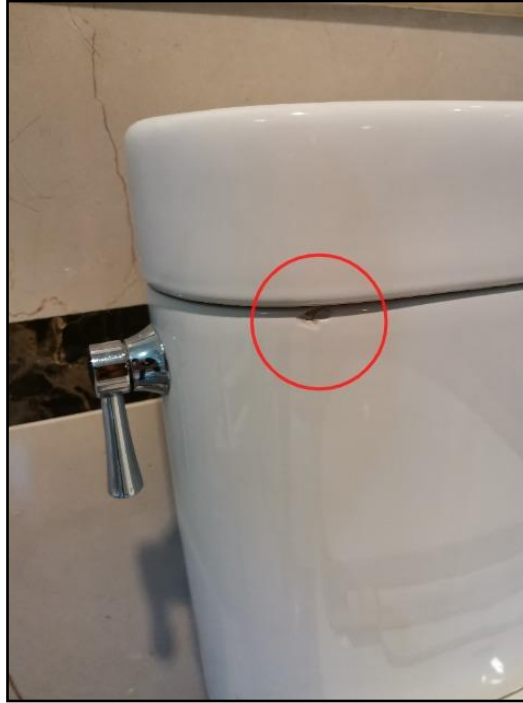
48. Condition: • Surface defects

Implication(s): Physical injury | Chance of water damage to structure, finishes and contents

118. *Surface defects*

Task: Repair or replace

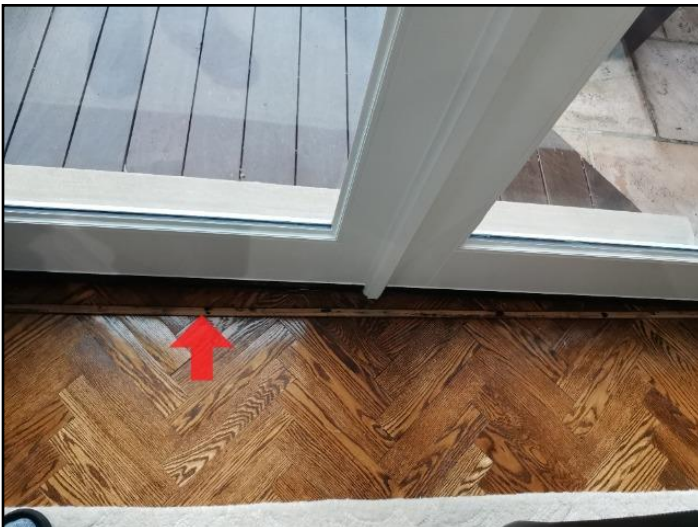
49. Condition: • Loose or missing

119. Loose or missing

Task: Repair

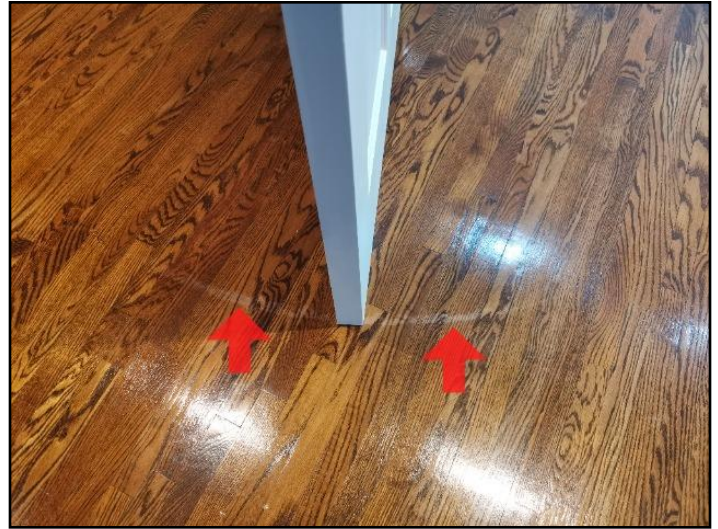
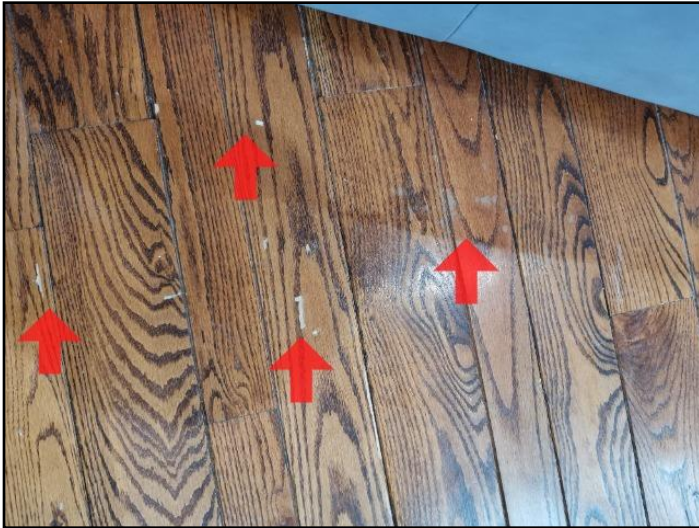
50. Condition: • Typical flaws

122. Typical flaws

123. Typical flaws

Task: Repair

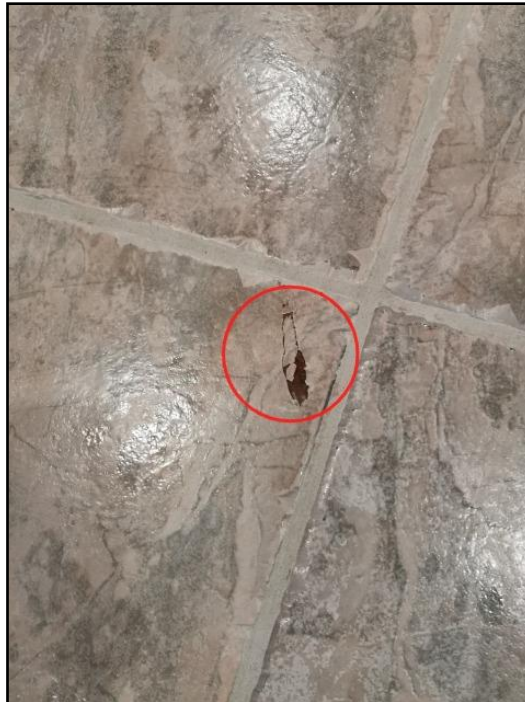
51. Condition: • Cracks

125. Cracks

Task: Repair or replace

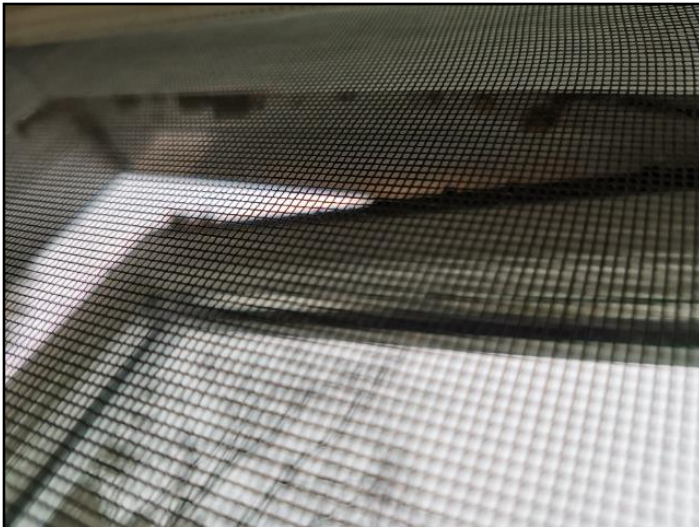
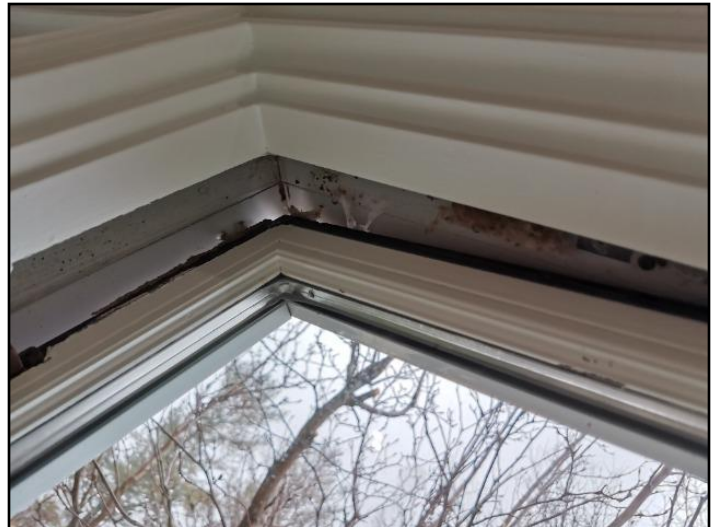
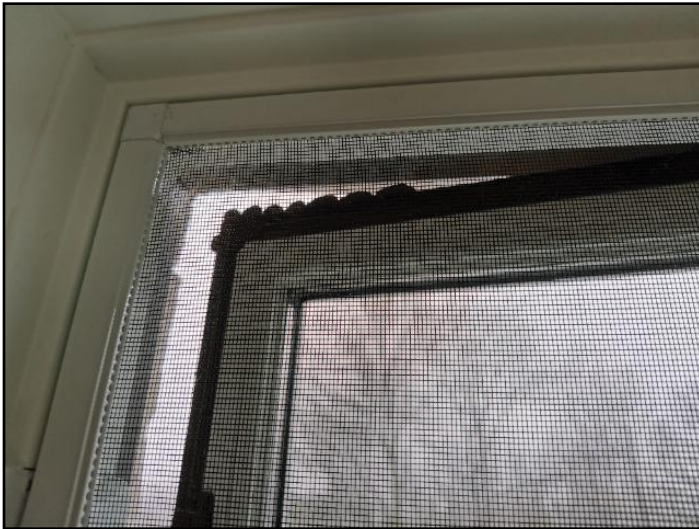
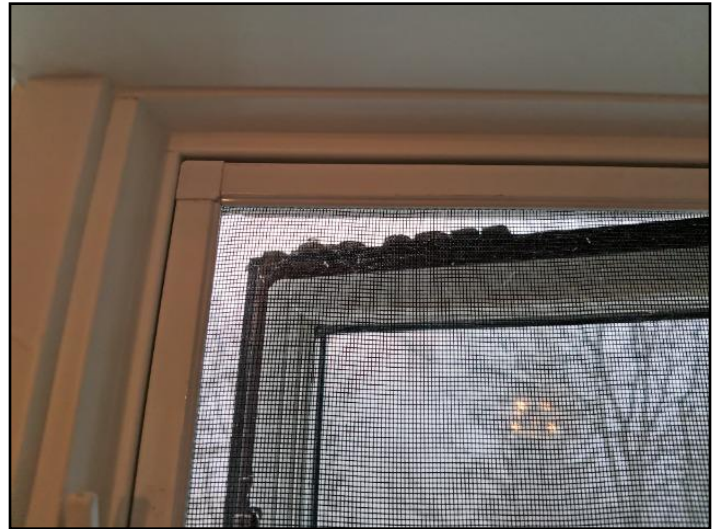
52. Condition: • Debris between windows sash and frame.

126. Debris

127. Debris

128. Debris

129. Debris

Task: Clean

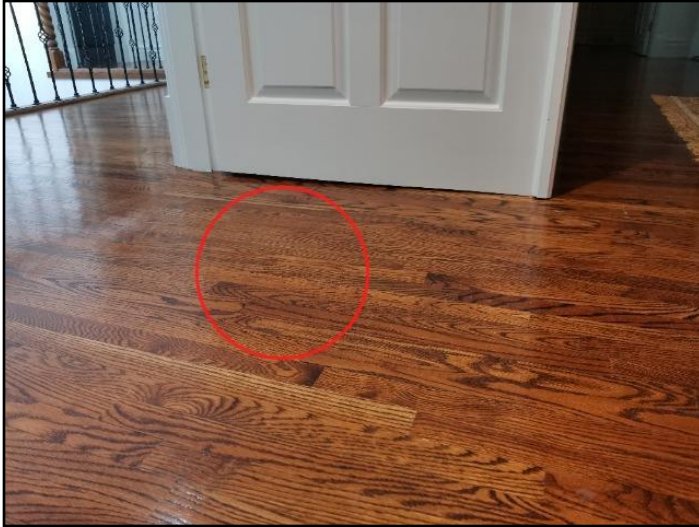
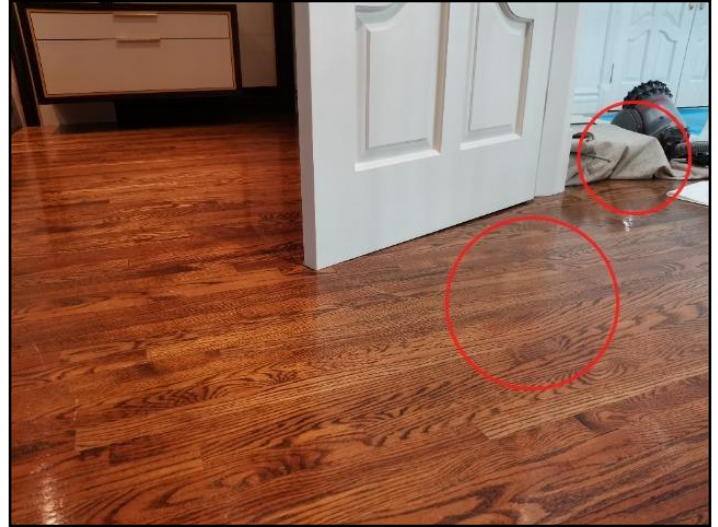
54. Condition: • Sagging

131. Sagging

132. Sagging

Task: Repair

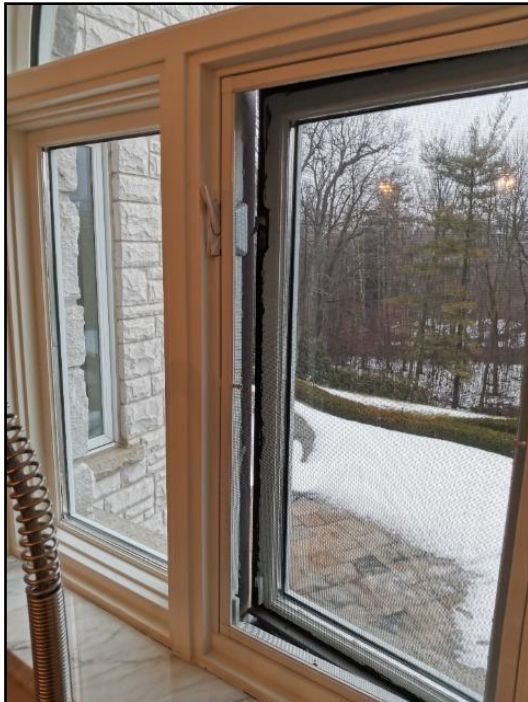
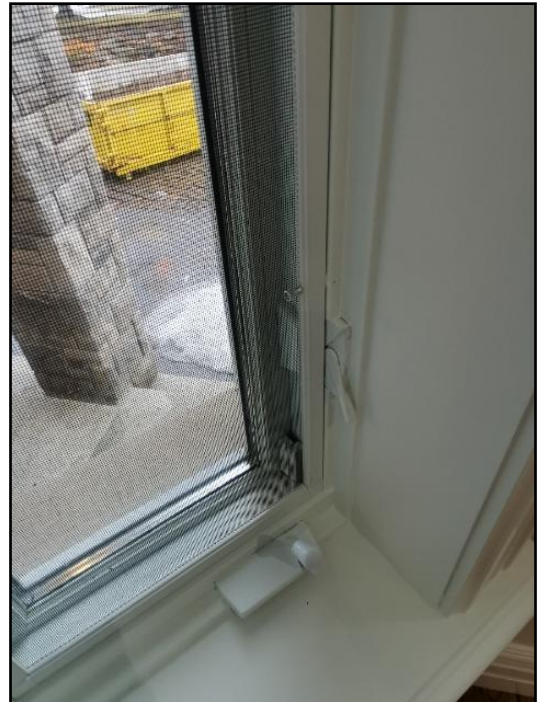
55. Condition: • Difficult to operate

New painting caused windows stuck to sashes.

133. Difficult to operate

134. Difficult to operate

Task: Repair

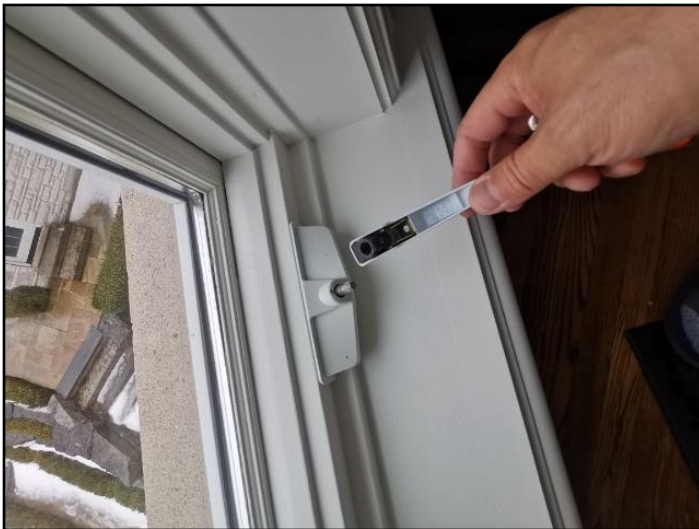
143. Broken

56. Condition: • Broken

Task: Repair or replace

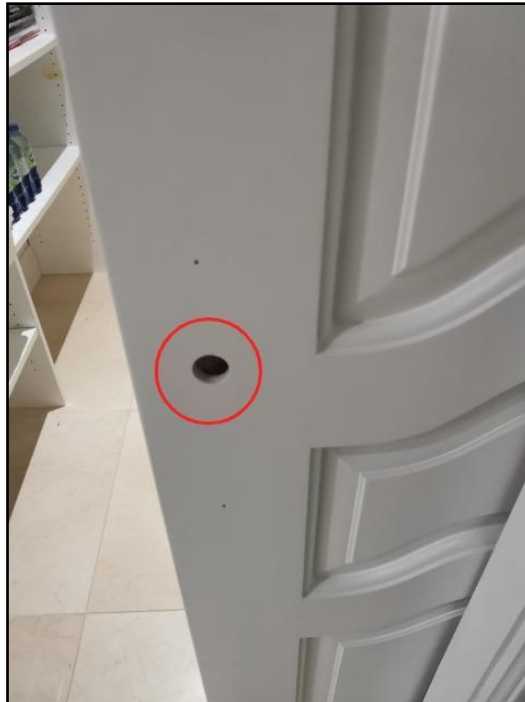
156. Missing

58. Condition: • Missing

Task: Provide

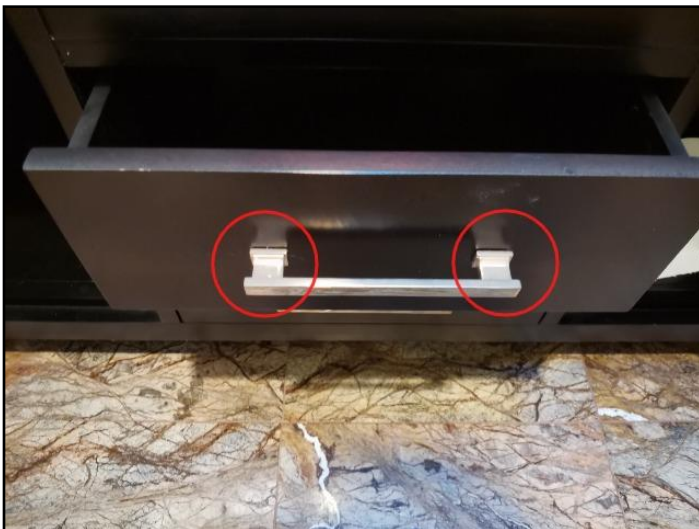
157. Pieces missing or loose

59. Condition: • Pieces missing or loose

Implication(s): Damage or physical injury due to falling materials

Task: Repair or replace

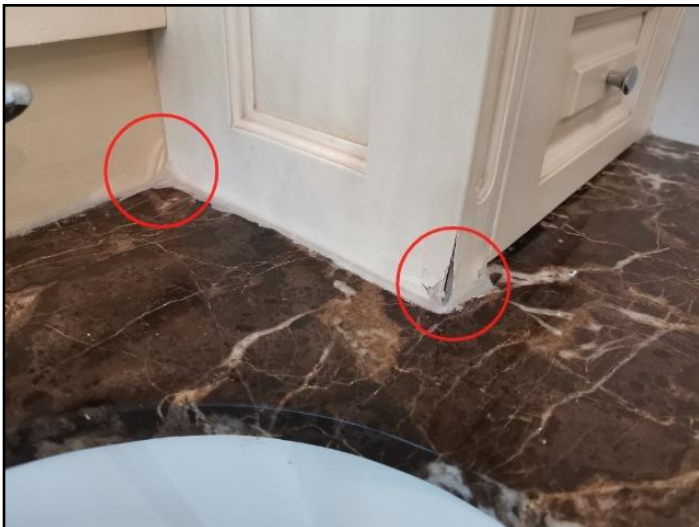
159. Water damage

60. Condition: • Water damage

Implication(s): Material deterioration

Task: Repair

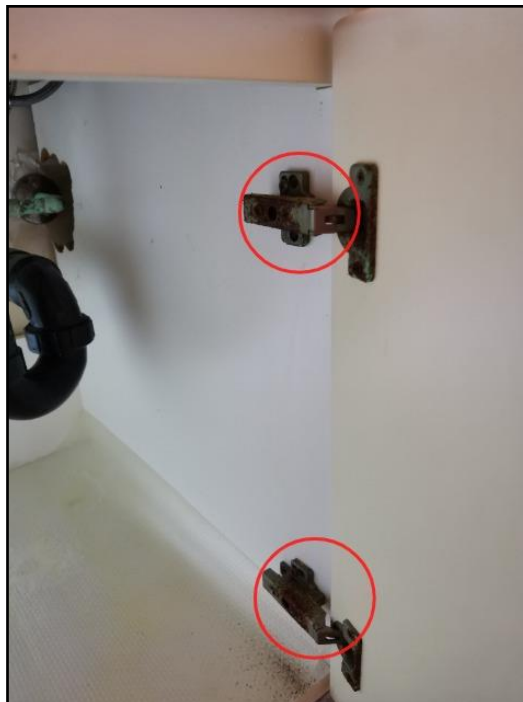
162. Rust

61. Condition: • Rust

Implication(s): Material deterioration

Task: Repair or replace

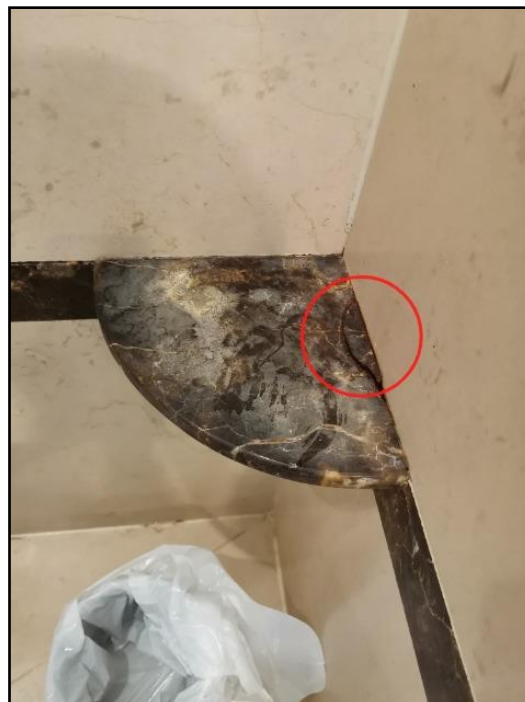
163. Tiles loose, missing, cracked, stained or...

62. Condition: • Tiles loose, missing, cracked, stained or broken

Marble countertop cracked.

Task: Repair or replace

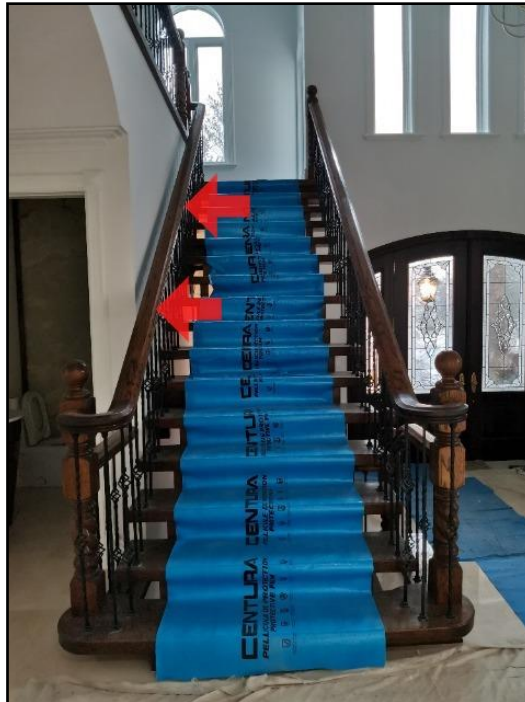
164. Loose

63. Condition: • Loose

Implication(s): Fall hazard

Task: Repair

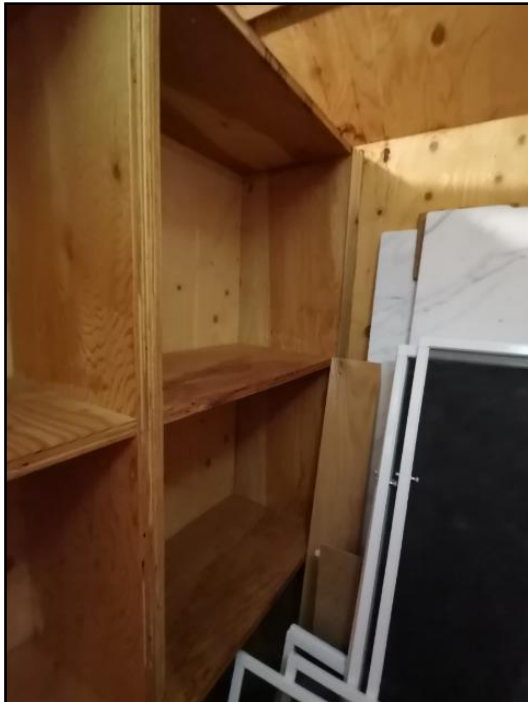
165. Finished: risk of condensation problems

64. Condition: • Finished: risk of condensation problems

Implication(s): Odors, molds, etc. | Material deterioration

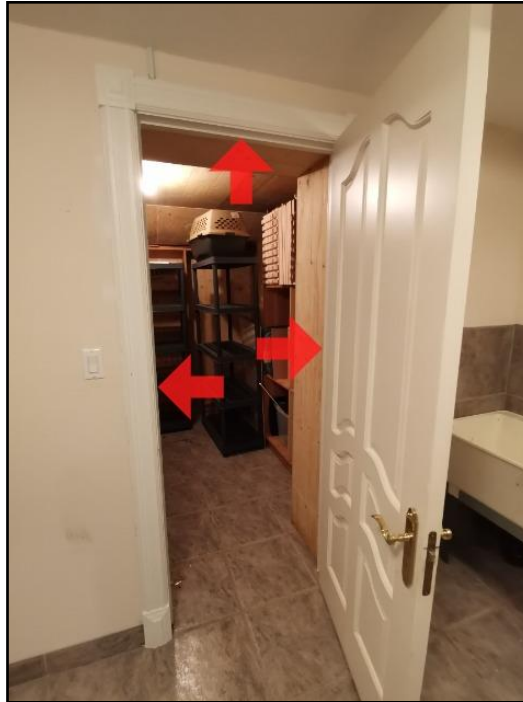
168. Weatherstripping missing around door

66. Condition: • Weatherstripping missing around door

Task: Provide

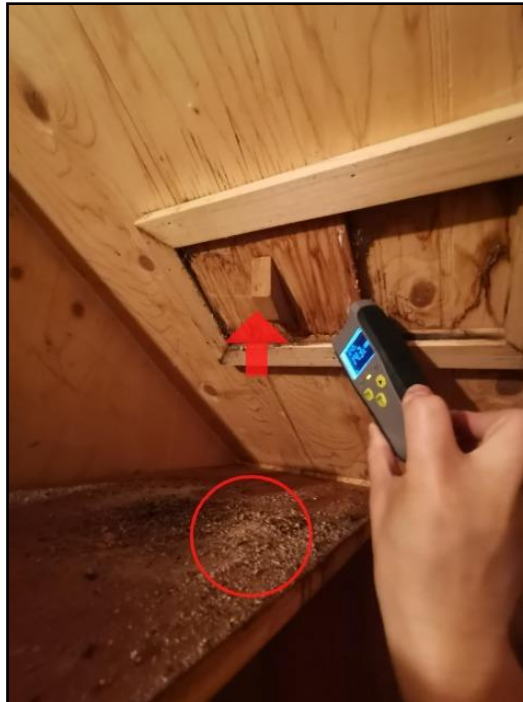
169.

67. Condition: • Vent closed and may be blocked by dybris. Clean and keep opened recommended.

Task: Clean

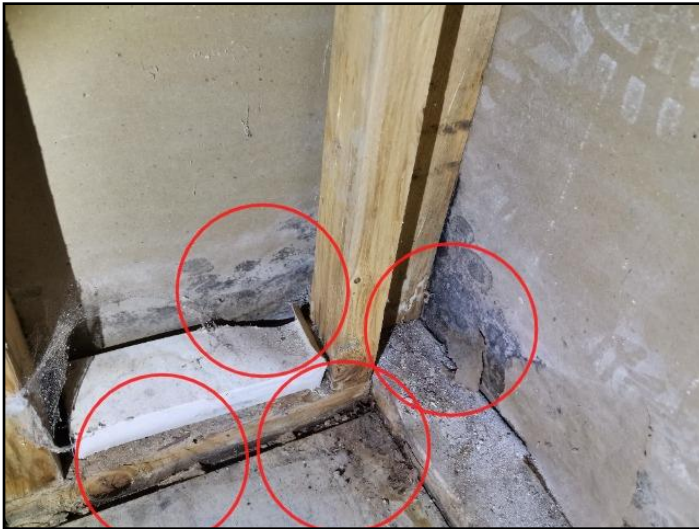
170. Mold

68. Condition: • Mold

Mold drywall spalling caused by previous long term water damage, currently dried, change the damaged drywall and wood part recommended.

Implication(s): Contaminants may enter building air | Chance of water damage to structure, finishes and contents

Task: Repair

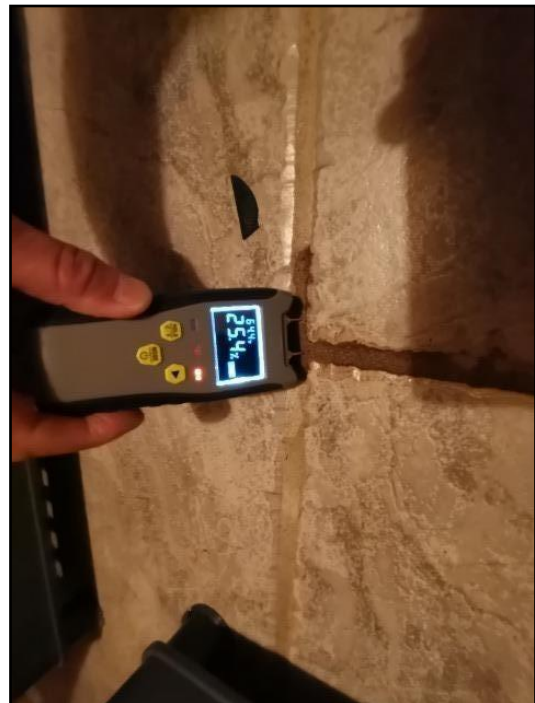
173. Water marks

69. Condition: • Water marks

Implication(s): Chance of water damage to structure, finishes and contents

Task: Repair

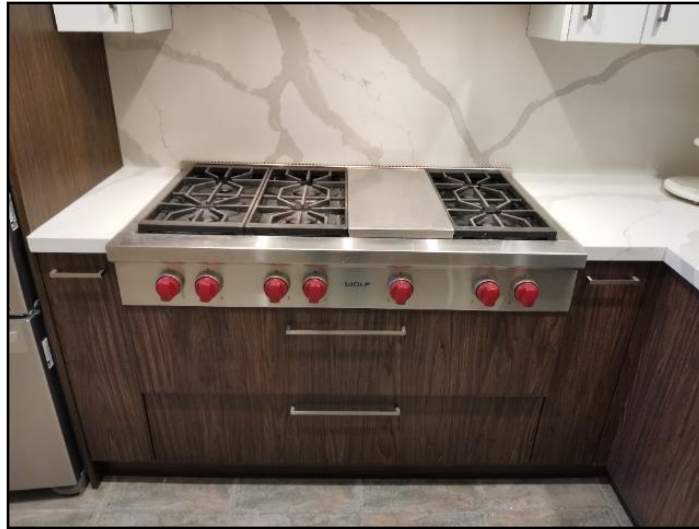
174. Inoperative

70. Condition: • Inoperative

Task: Service
