All-Star Inspection Report
1001 Sample Drive
Parma, OH 44130

Inspected By: Joe Sanzone

Prepared For: Sample Report
Inspected On Thu, Jul 11, 2024 at 2:00 PM

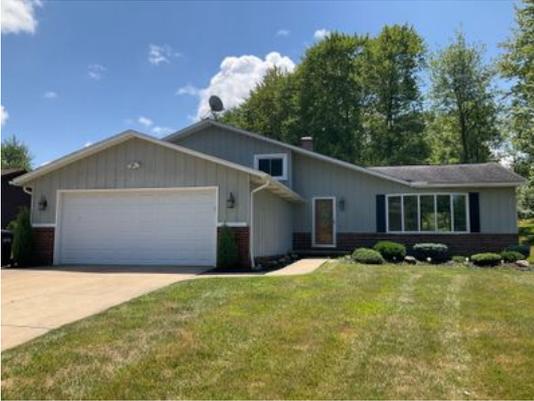
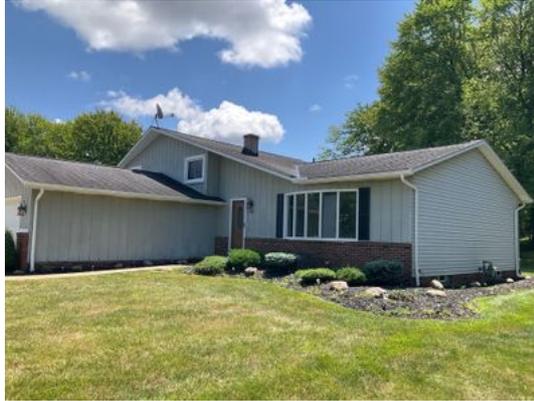
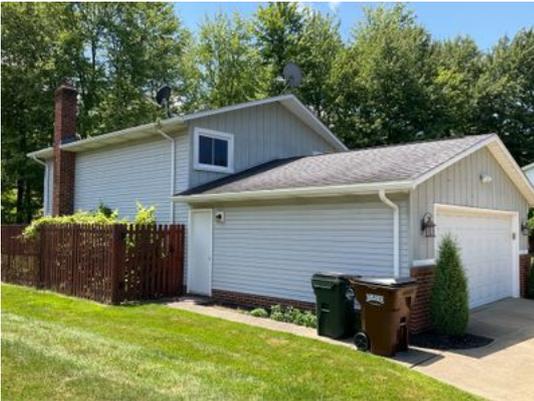
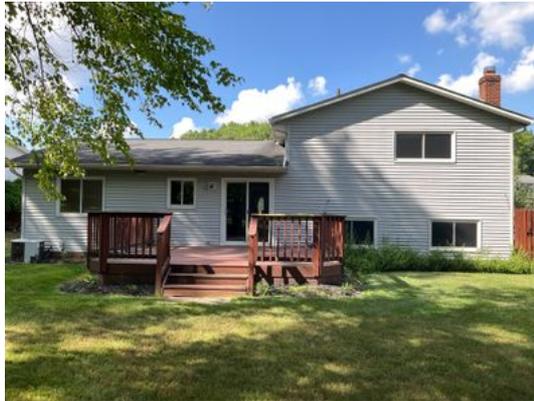
General pictures of exterior of house.

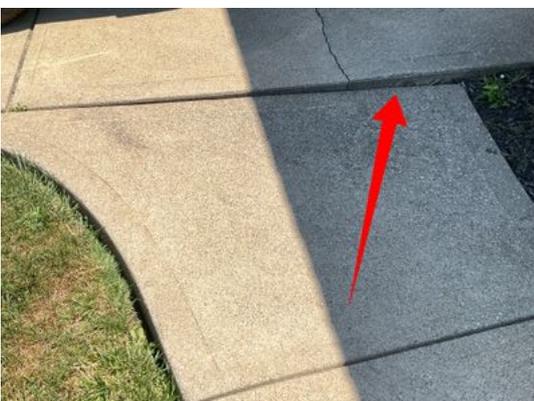
Comment 2
Safety Hazard

Front walkway has settled, creating a potential trip hazard where it meets the driveway. Safety Hazard. Recommend repairing.

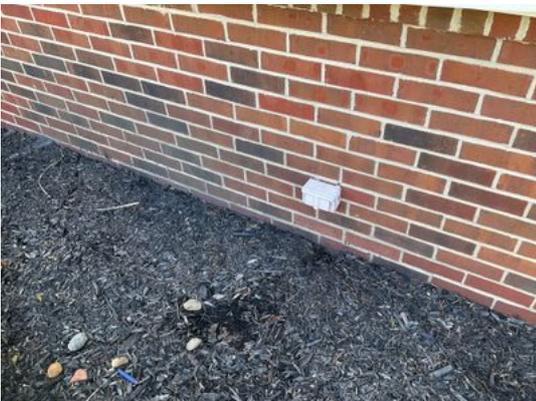
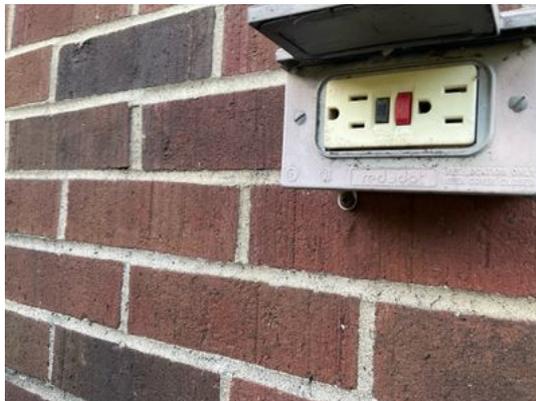
Deficiency

No power at this exterior GFCI protected outlet at front of house. Recommend repairing or replacing as needed.

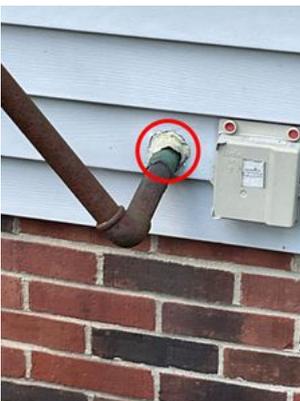
Comment 9
Maintenance Item

Recommend sealing all house penetrations (gas line pictured) to prevent water intrusion or pests.

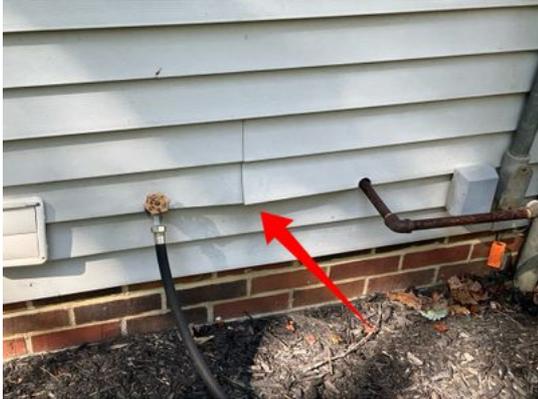
Comment 10
Deficiency

Loose section of vinyl siding at rear of house. Recommend repairing.

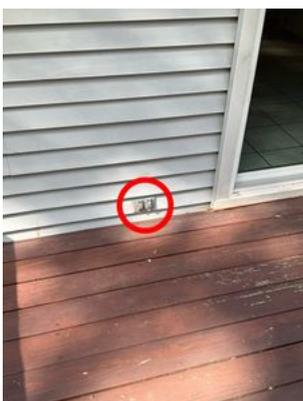
Comment 12
Safety Hazard

Exterior outlet at rear of house is not GFCI protected. Safety Hazard. Recommend upgrading to a GFCI protected outlet.

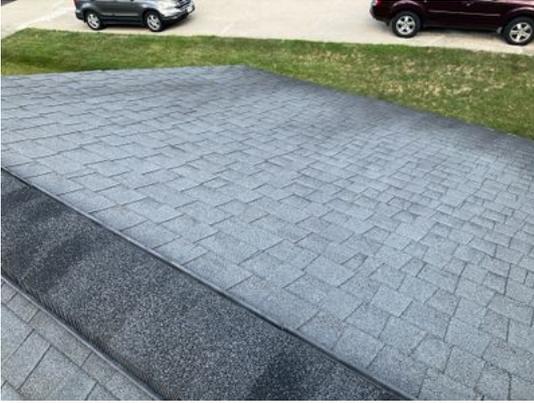
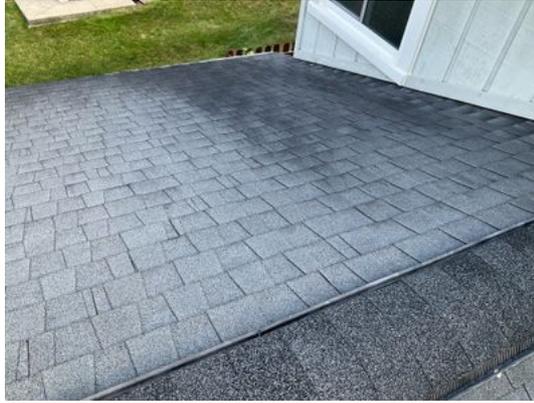
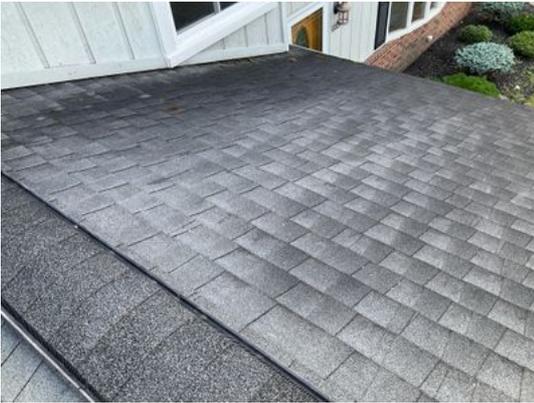
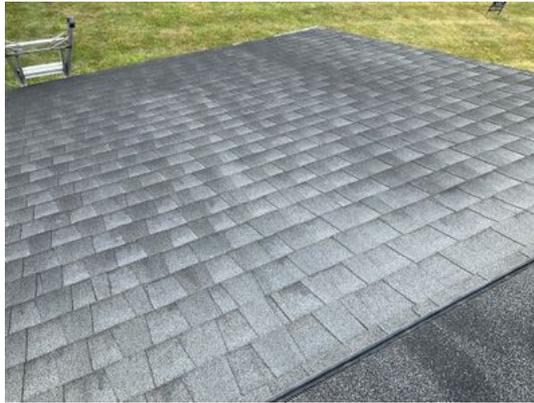
Comment 13
Information

General pictures of garage roof.

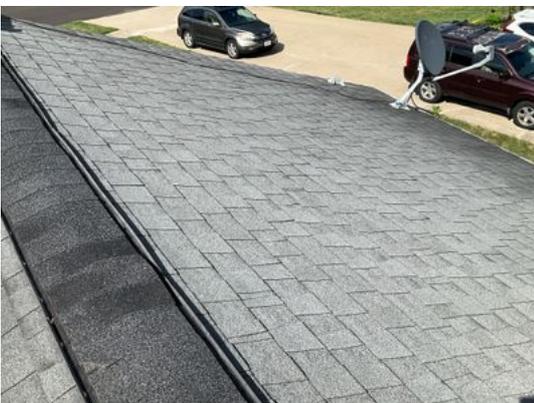
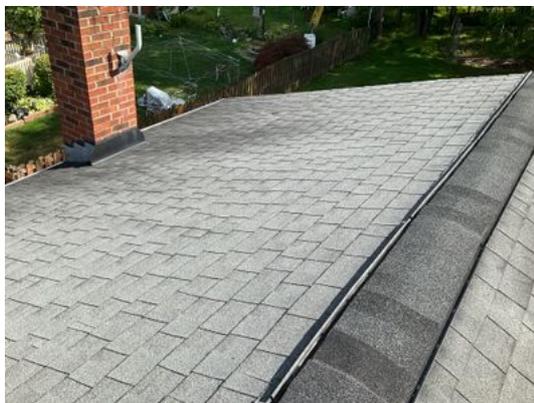
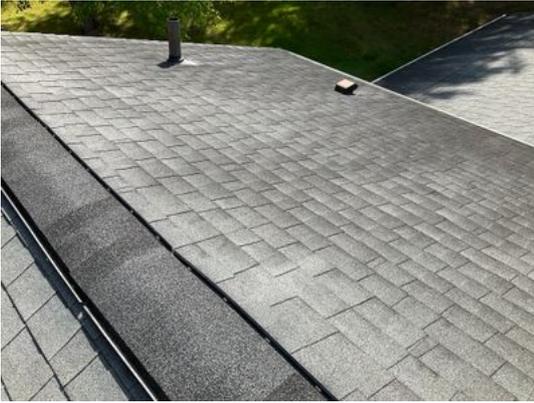
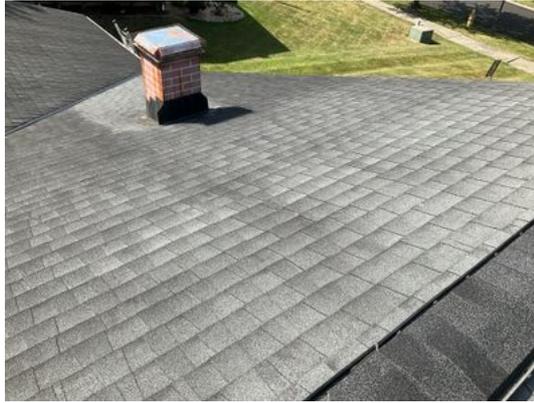
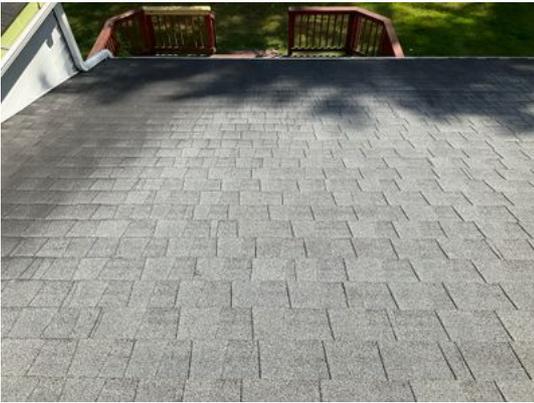
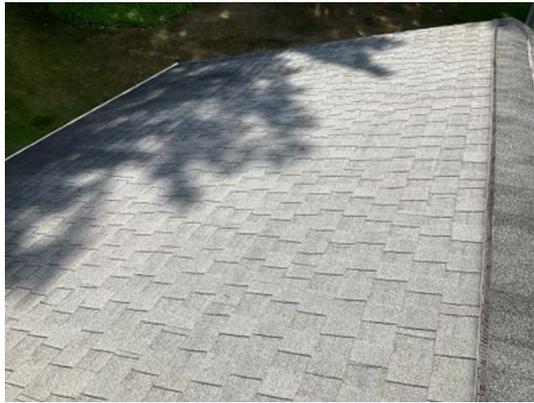
Comment 14
Information

General pictures of house roof.

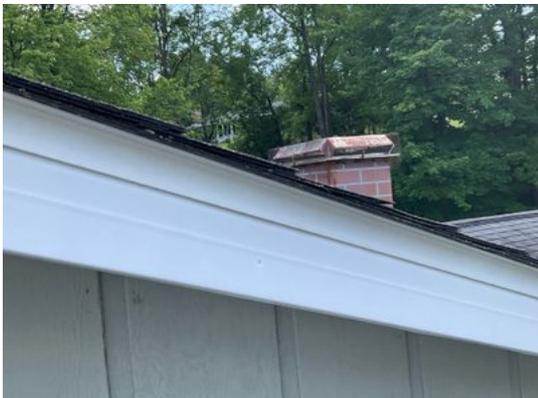
Comment 15
Information

1 layer of roofing material present at roof.

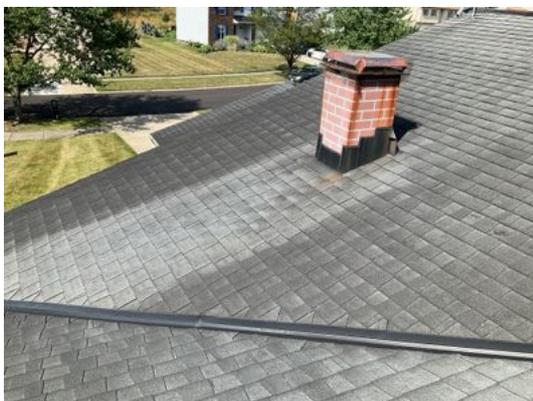
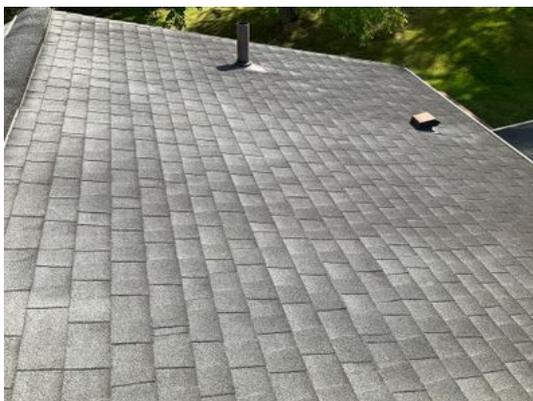
Comment 16
Deficiency

Algae staining (black streaks) present in multiple areas of the house and garage roof. Moss developing at the garage roof.

Recommend having a professional roof cleaning company perform a low pressure roof cleaning to remove any algae and moss from the shingles.

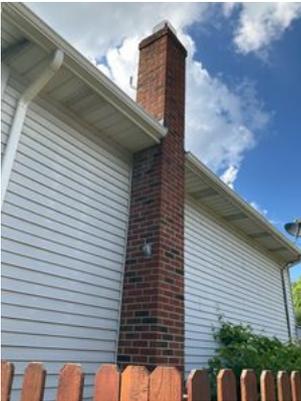
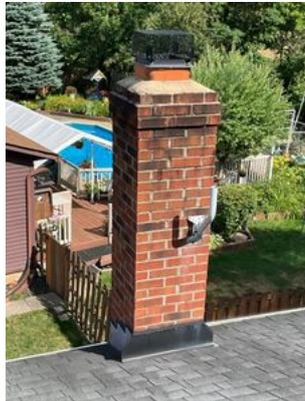
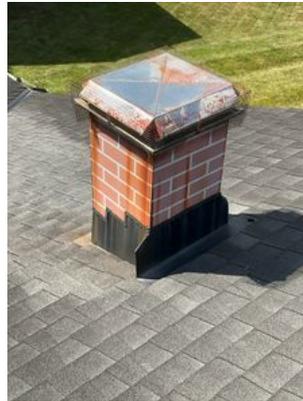
**Comment 18
Information**

General pictures of chimneys.

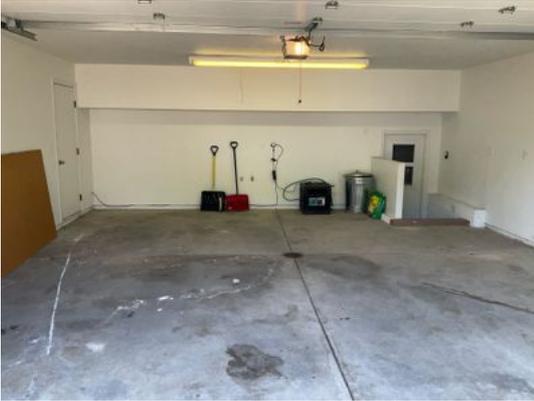
Comment 19
Information

General picture of garage.

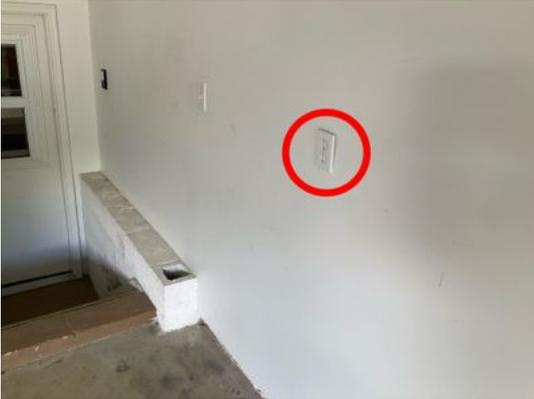
Deficiency

Loose electrical outlet. Recommend repairing.

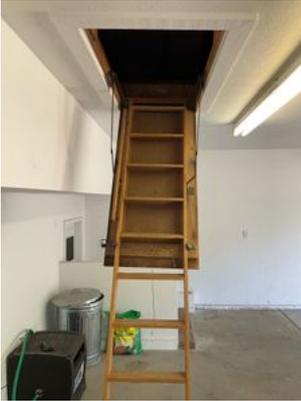
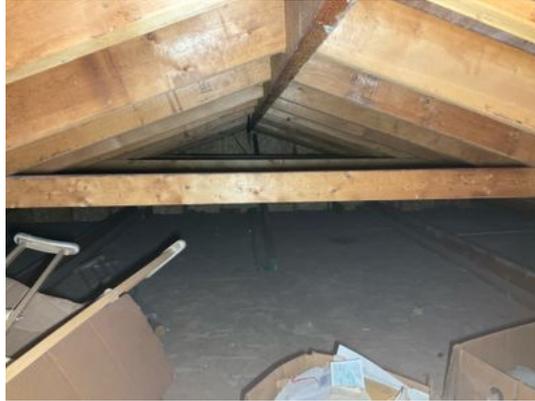
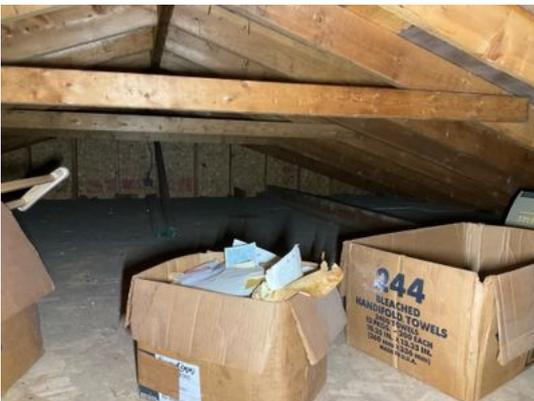
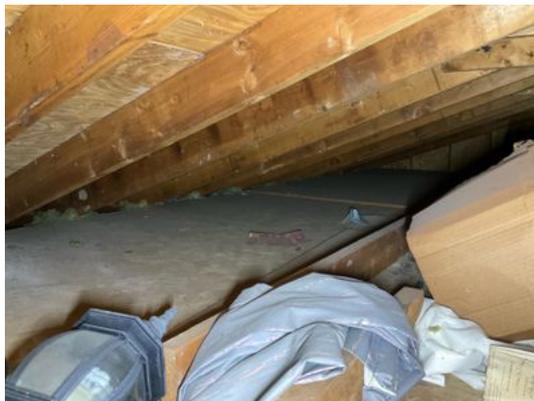
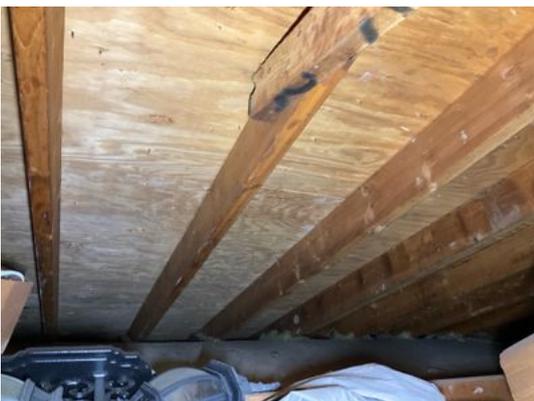
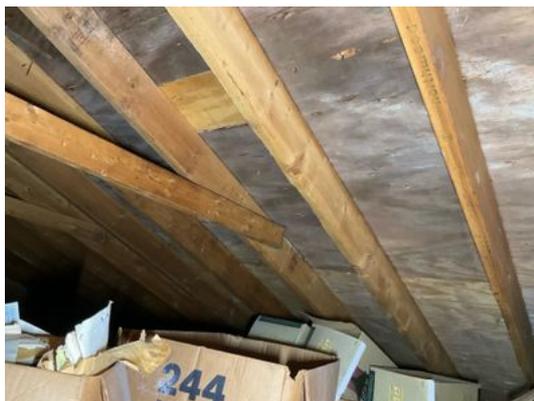
Comment 22
Information

General pictures of attic space above garage.

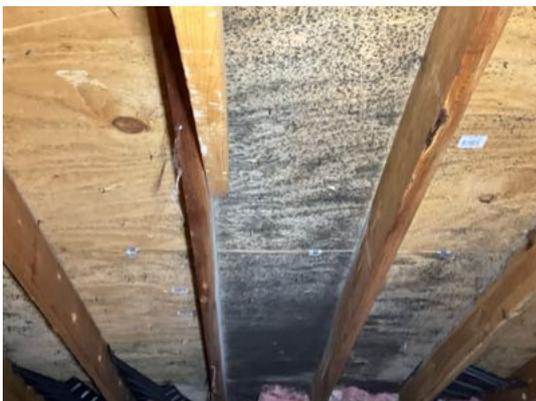
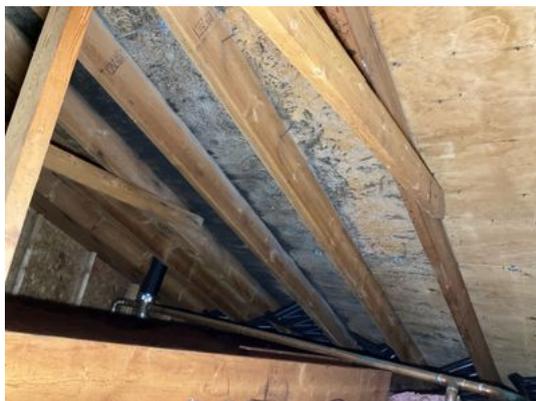
Comment 24
Deficiency

Evidence of potential microbial growth/mold present at roof sheathing in several areas. Recommend mold remediation by a qualified mold remediation contractor.

The staining appears to be isolated to the West facing side of the upper tier roof.

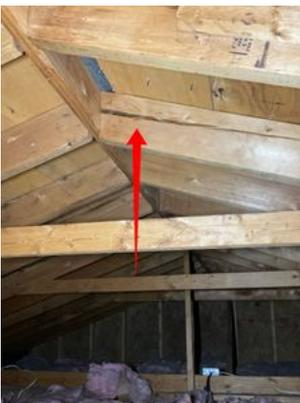
Comment 25

Cracked rafter. Recommend repairing

Cracked rafter at the roof. Recommend repairing.

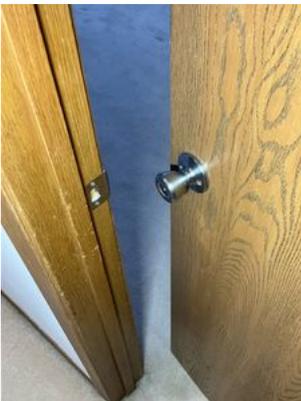
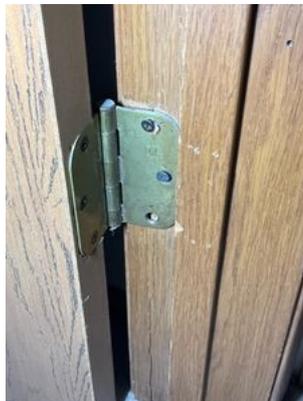
Comment 28
Deficiency

Entry door does not properly latch and the bottom hinge is loose and missing a screw. Recommend repairs.

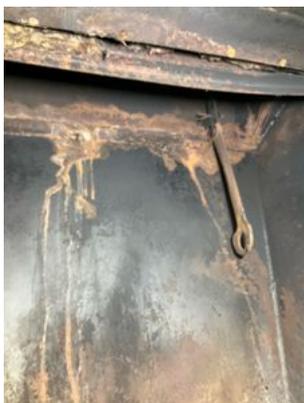
**Comment 36
Information**

Damper door present. Tested and operated properly.

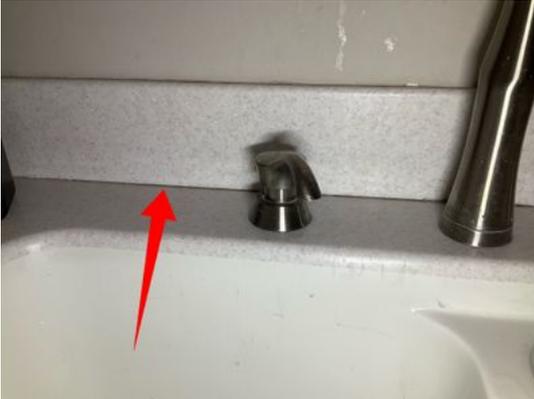
Comment 40
Maintenance Item

Countertop backsplash seam needs sealed to prevent water intrusion. Recommend sealing.

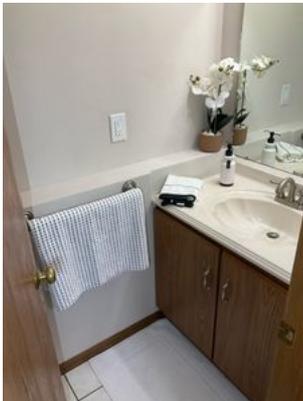
Comment 44
Information

Half Bathroom.

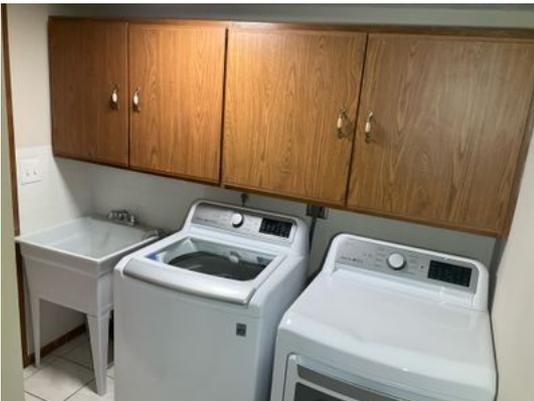
Laundry area with washer & dryer (not tested).

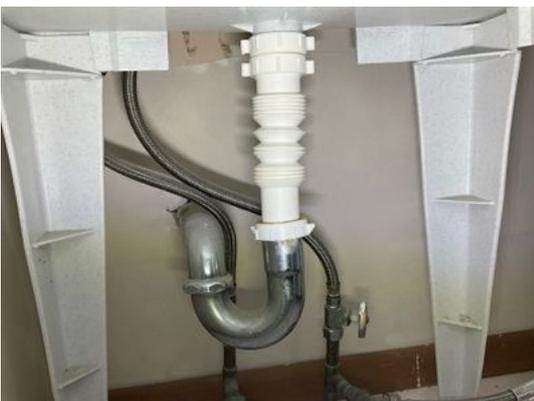
Comment 47

Improper drain line present at utility sink. Corrugated flexible drain lines are prone to clogging and leaking. No active leaks at time of inspection. Recommend replacing with a solid PVC drain line.

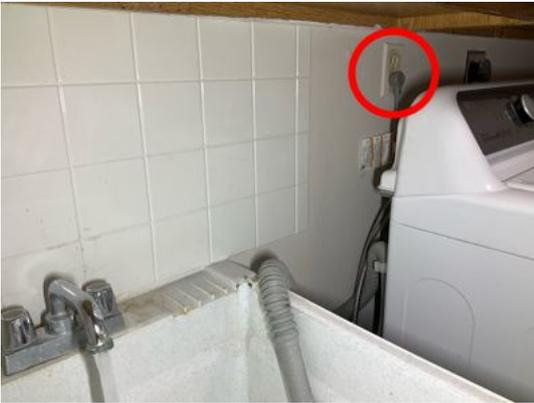
Comment 48

Laundry area outlet is not GFCI protected. Safety Hazard. Recommend upgrading to a GFCI protected outlet

Laundry area outlet within 6 feet of a water source is not GFCI protected. Safety Hazard. Recommend upgrading to a GFCI protected outlet.

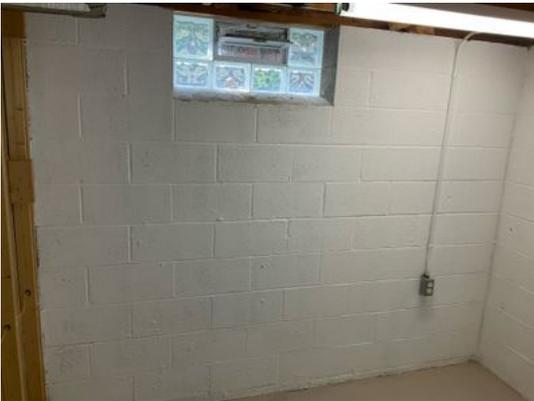
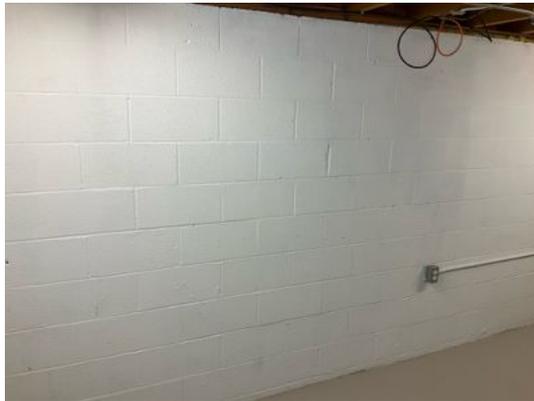
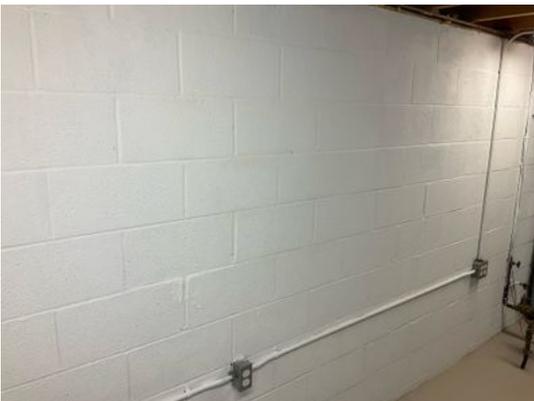
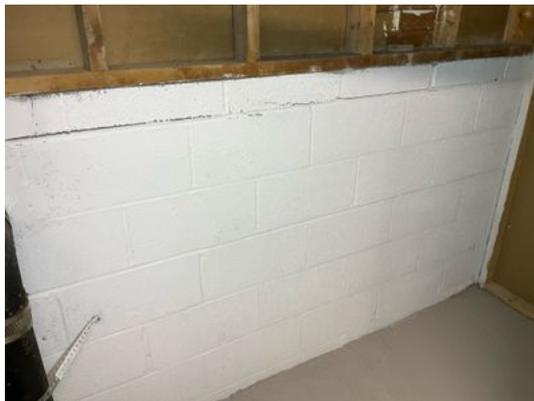
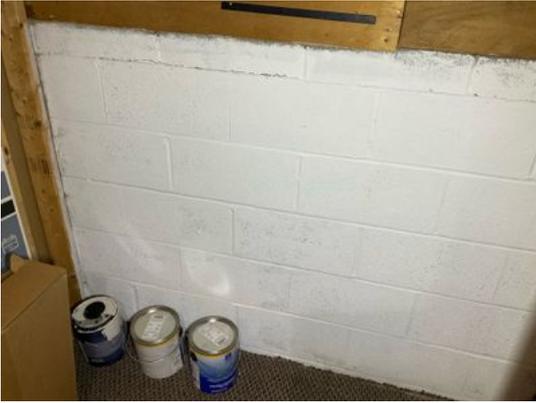
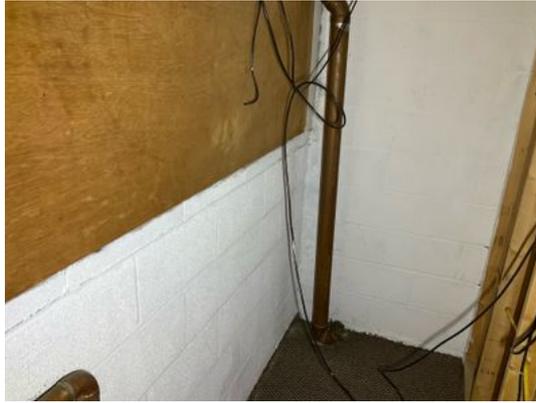
General pictures of visible interior foundation walls.

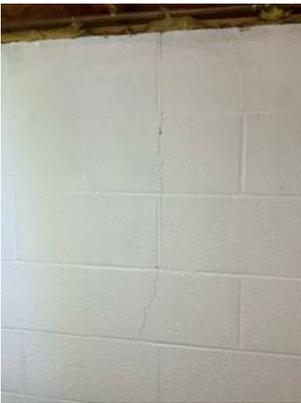
Comment 51

Vertical and horizontal settling cracks present at the visible foundation walls. No structural deficiencies or concerns observed. Recommend monitoring and repairing as needed.

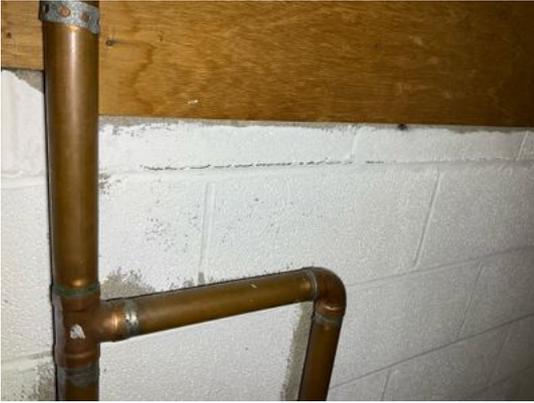
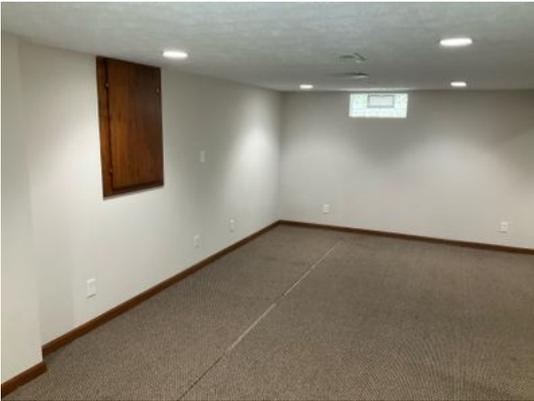
Comment 52
Information

Some of the interior foundation walls were not visible due to the finished walls.

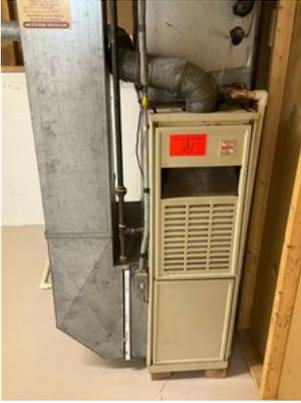
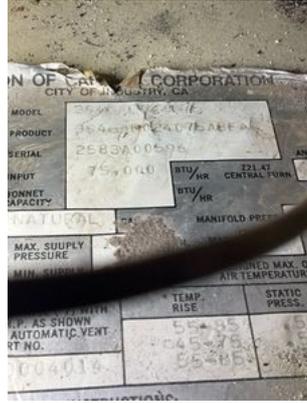
Comment 53
Information

Furnace and manufacturer's data label.

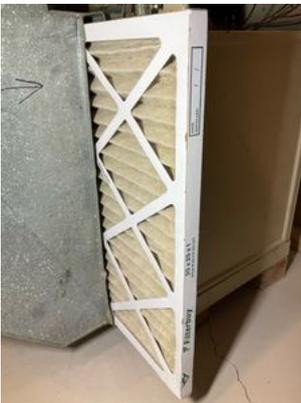
Comment 54
Deficiency

Air filter size - 20x25x1.

Air filter needs replaced. Recommend replacing with a new air filter.

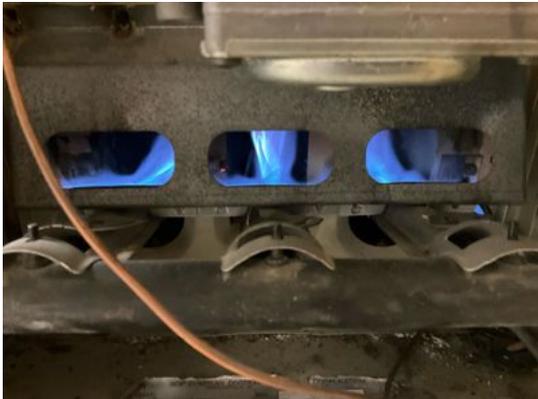
Comment 55
Information

Furnace operation was satisfactory at time of inspection.

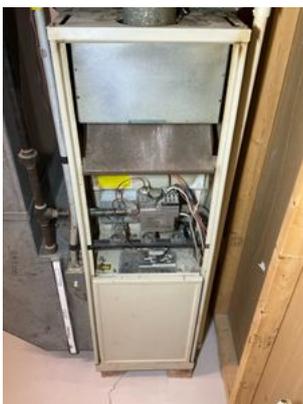
Comment 56
Information

Due to age (1983), recommend having the furnace evaluated and serviced by an HVAC technician upon initial acquisition.

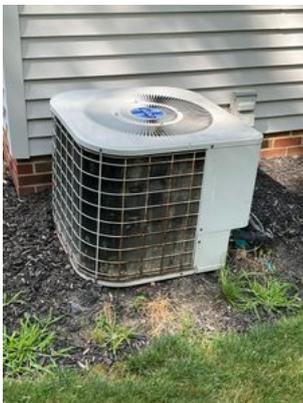
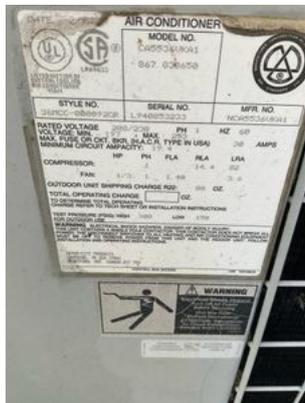
Comment 59
Information

A/C unit and manufacturer's data label.

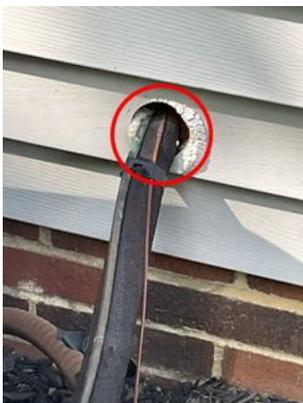
Comment 60
Deficiency

Needs sealed at house penetration, Recommend sealing

Refrigerant line needs sealed at house penetration. Recommend sealing.

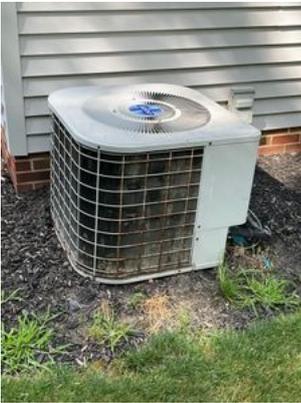
Comment 61

Due to age (1994), recommend having the air conditioning evaluated and serviced by an HVAC technician upon initial acquisition.

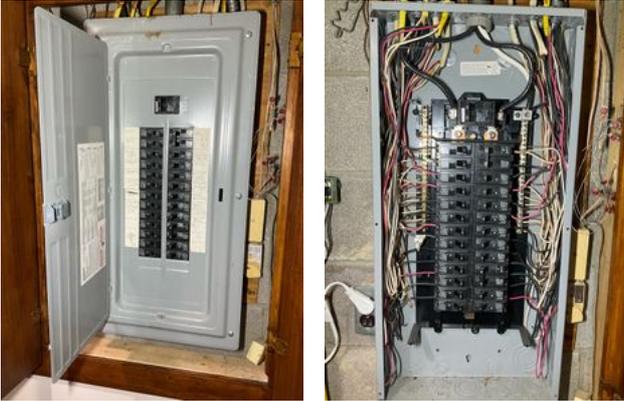
Comment 62
Information

Electrical Panel.

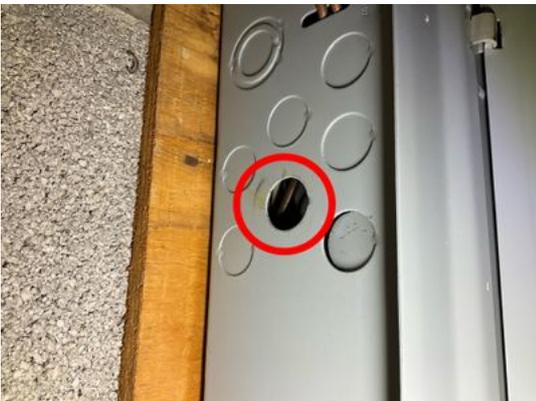
Comment 63
Safety Hazard

Satisfactory, Missing knockout cover at left side of panel. Safety Hazard. Recommend adding a knockout cover

Missing knockout cover at left side of panel. Safety Hazard. Recommend adding a knockout cover.

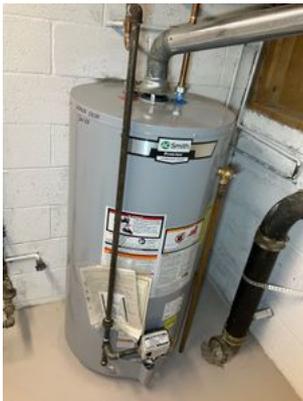
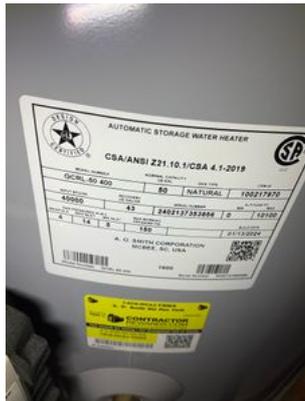
**Comment 64
Information**

Water heater and manufacturer's data label.

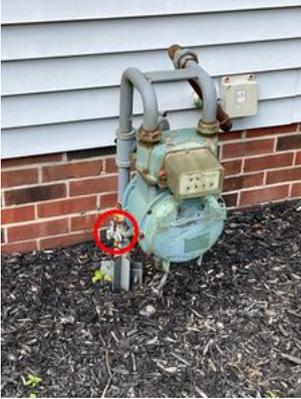
Comment 66
Information

Main gas meter and shutoff, located outside.

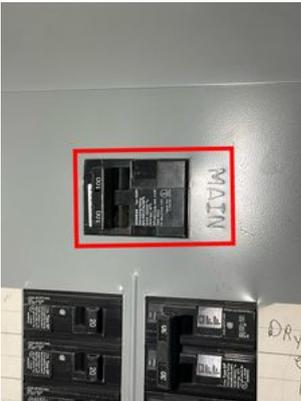
Comment 67
Information

Main electrical shutoff, located in the basement.

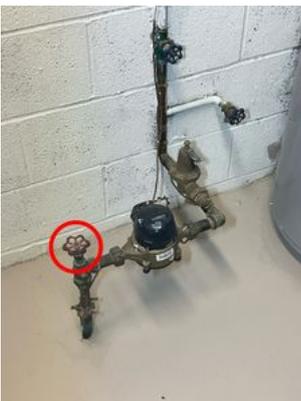
Comment 68
Information

Main water shutoff, located in the basement.

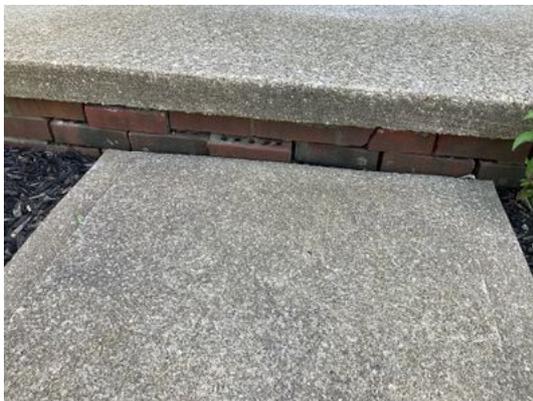
Deteriorated/missing mortar joints and loose bricks present at the front stoop. Recommend tuck pointing repairs.

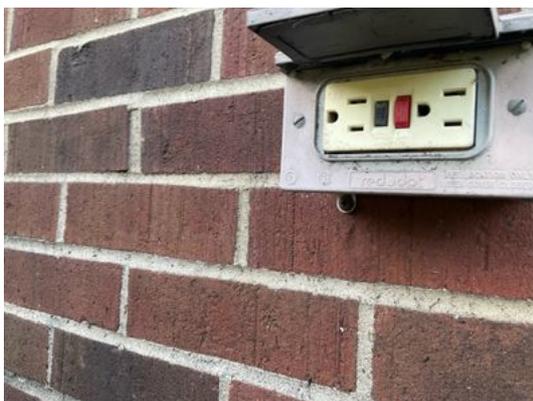
No power at this exterior GFCI protected outlet at front of house. Recommend repairing or replacing as needed.

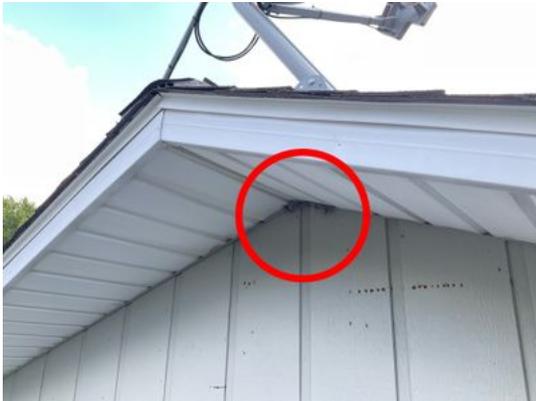
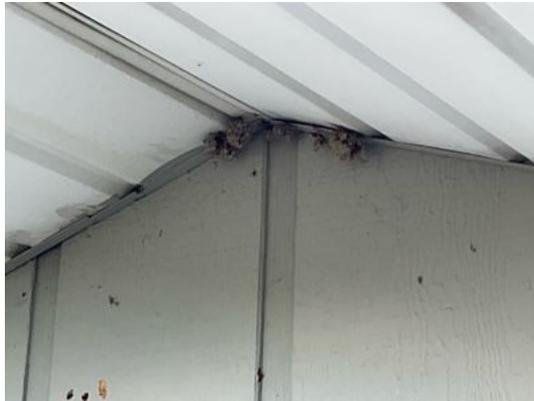
Stinging insect hives present at front of house. Hives appear to be dormant at time of inspection. Recommend removing.

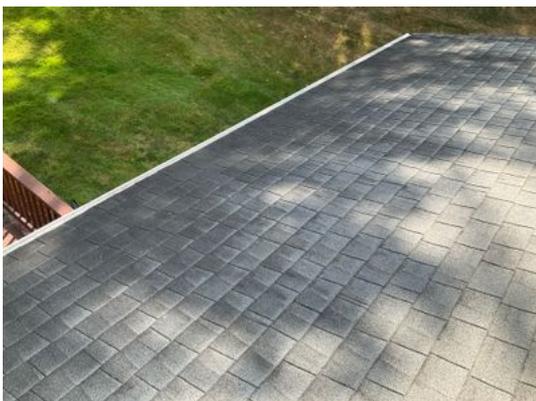
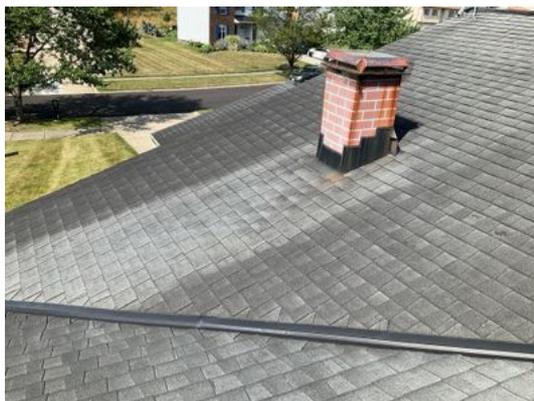
Algae staining (black streaks) present in multiple areas of the house and garage roof. Moss developing at the garage roof.

Recommend having a professional roof cleaning company perform a low pressure roof cleaning to remove any algae and moss from the shingles.

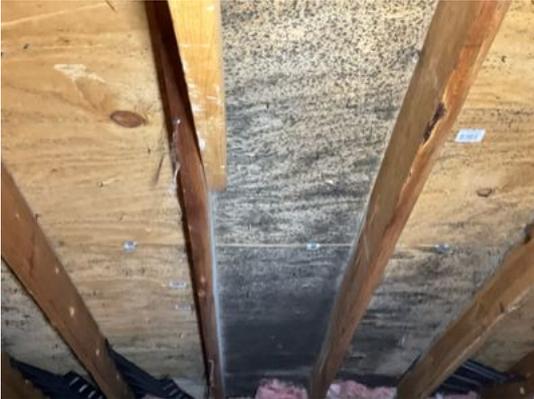
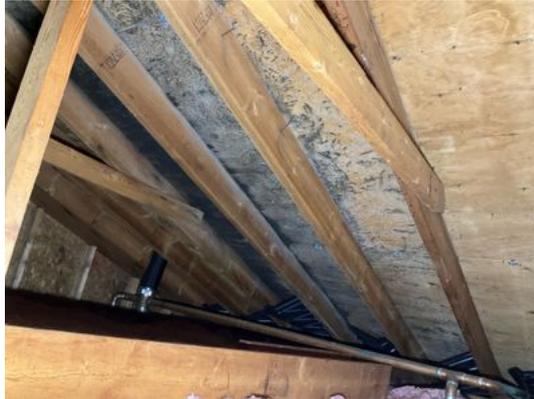
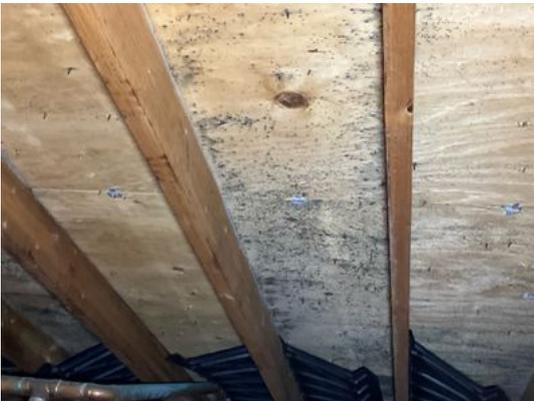
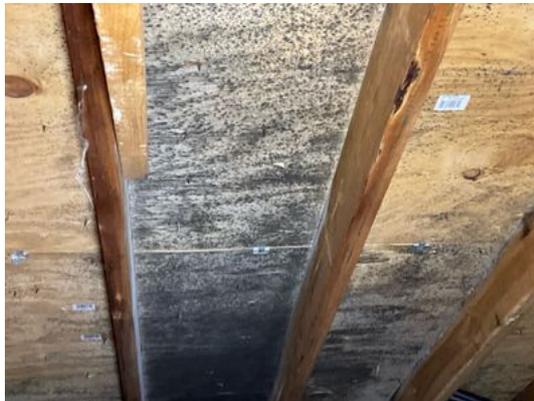
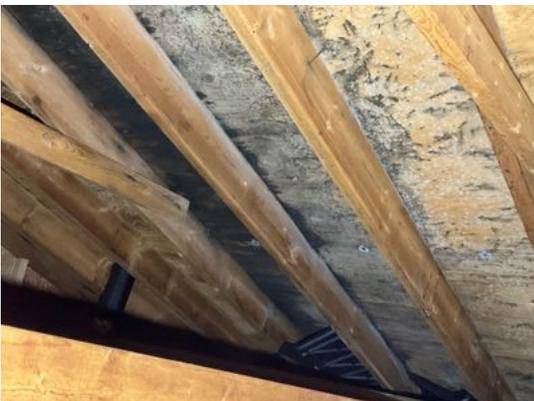
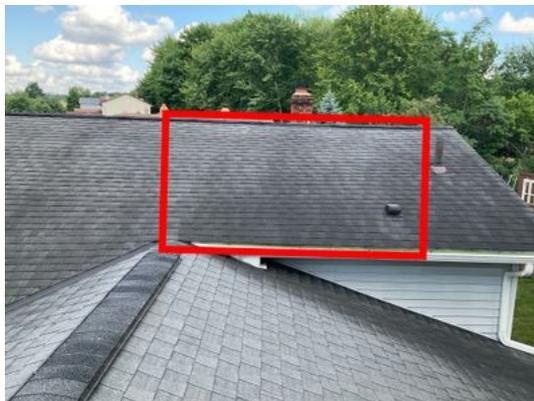
Evidence of potential microbial growth/mold present at roof sheathing in several areas. Recommend mold remediation by a qualified mold remediation contractor.

The staining appears to be isolated to the West facing side of the upper tier roof.

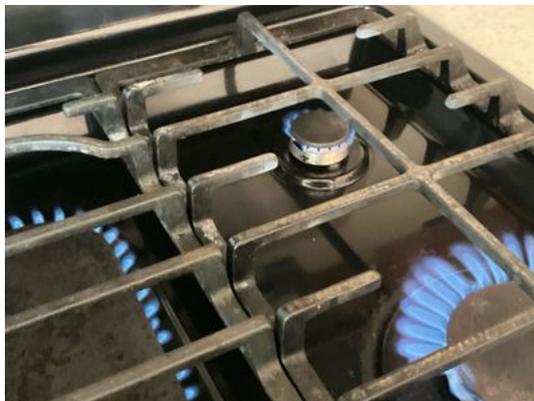
Kitchen: Appliances

Low flame output at the right rear burner. Recommend repairing as needed.

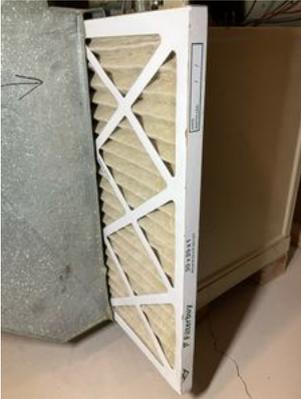
Heating

Air filter size - 20x25x1.

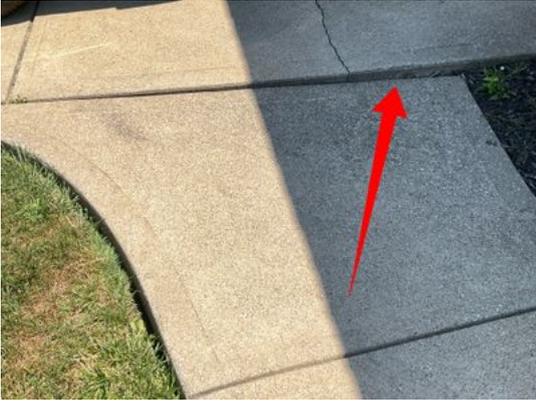
Exterior

Front walkway has settled, creating a potential trip hazard where it meets the driveway. Safety Hazard. Recommend repairing.

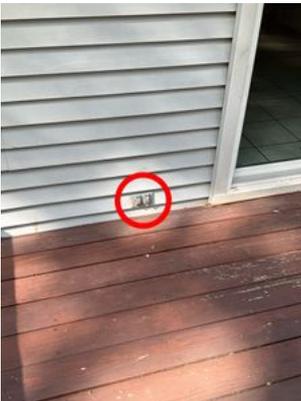
Exterior outlet at rear of house is not GFCI protected. Safety Hazard. Recommend upgrading to a GFCI protected outlet.

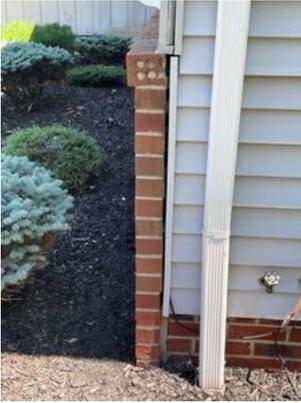
Recommend sealing gaps where brick veneer and siding join to prevent moisture and/or pest intrusion.

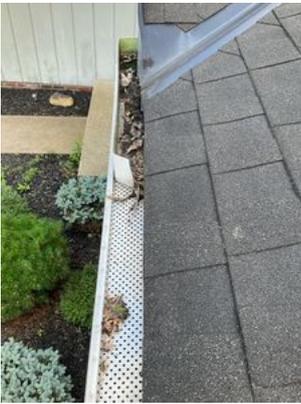
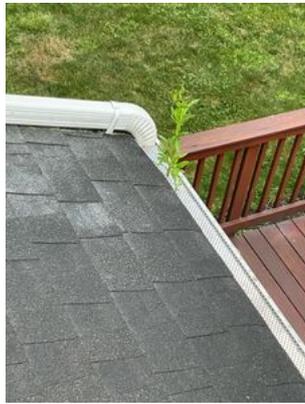
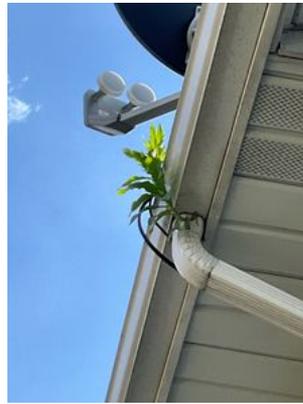
Exterior

Gutters need cleaned out. Recommend cleaning out gutters and gutter screens to ensure proper water drainage.

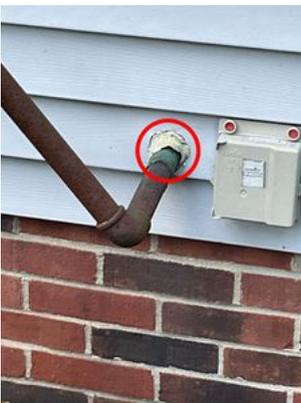
Exterior

Recommend sealing all house penetrations (gas line pictured) to prevent water intrusion or pests.
