Test Report For:
SPIG Industries, LLC
SGET End Terminal

TESTED TO:
Manual for Assessing Safety Hardware (MASH 2016)
Test 3-37b

TEST REPORT NUMBER:
TR-P38033-01-NC

REPORT DATE:
August 17, 2018

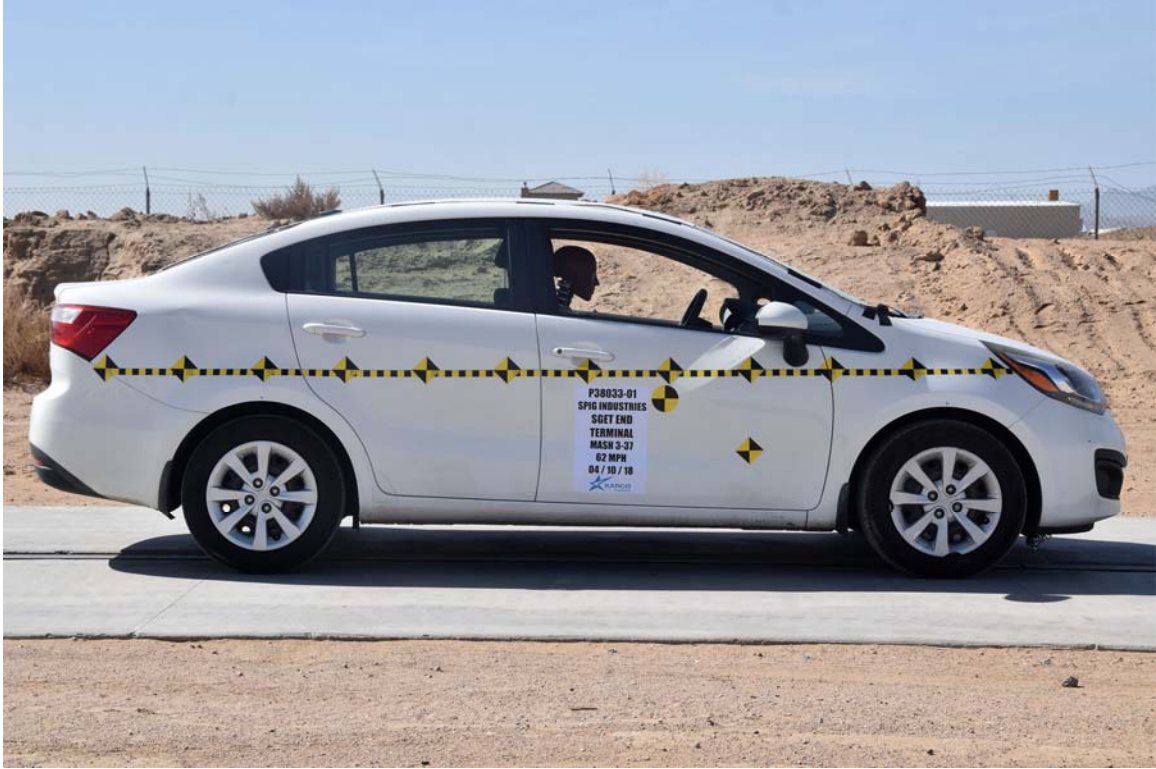
FIGURE 45. Pre-Test Right View of Test Vehicle

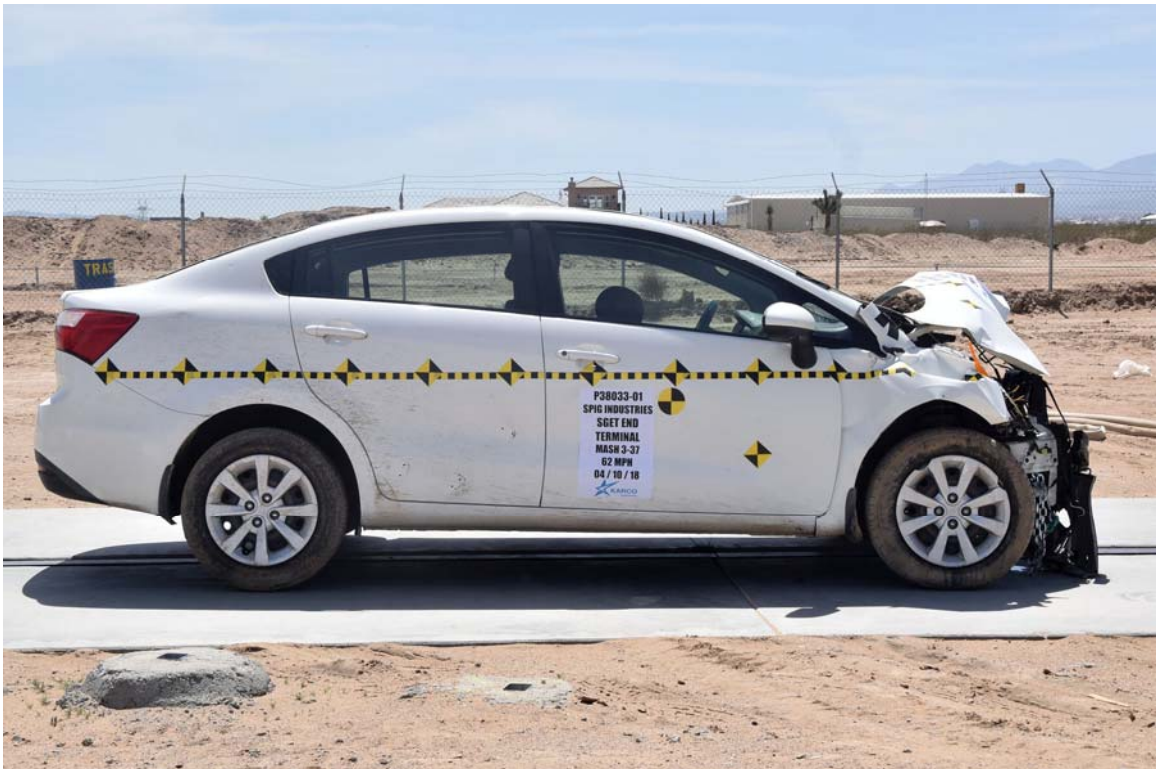
The majority of the vehicle damage occurred at the front end. The bumper fascia, bumper beam, quarter panels, and hood were all damaged due to the impact. The bumper fascia separated from the vehicle and the bumper beam deformed and detached from the driver side crush can. The quarter panels and hood were also subject to deformation. Both headlights were broken and separated from the vehicle.

FIGURE 46. Post-Test Right View of Test Vehicle

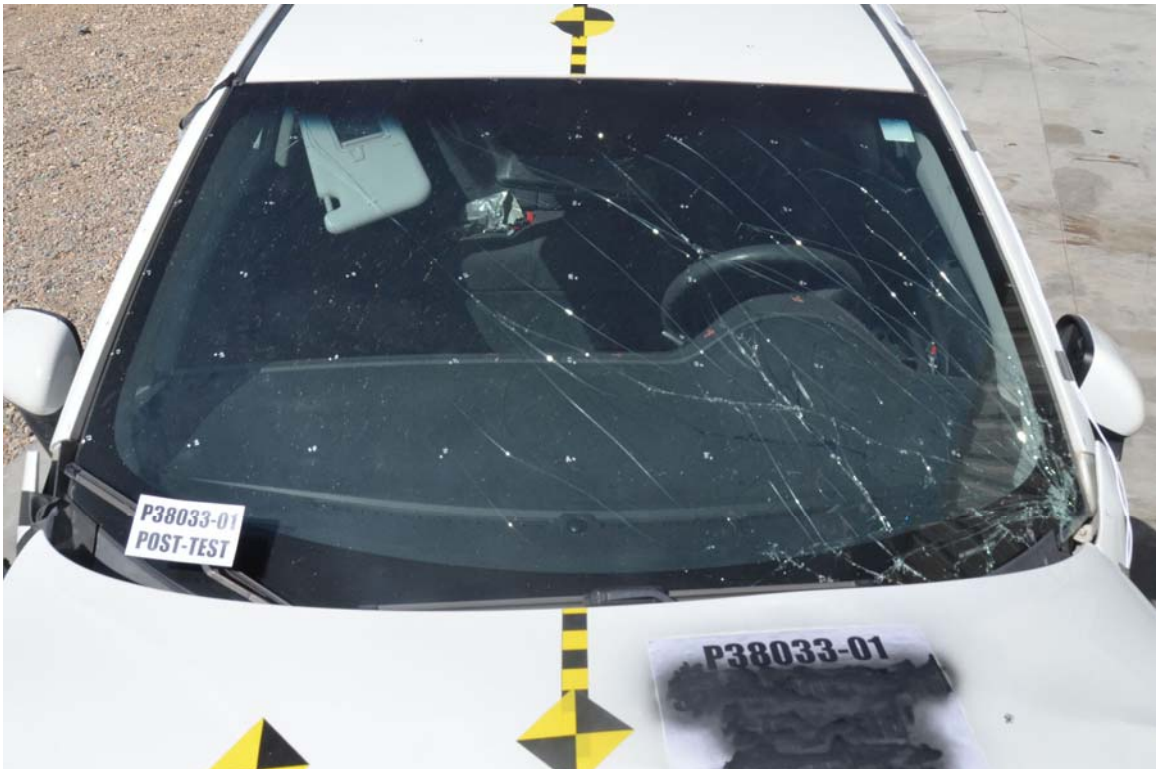
FIGURE 48. Post-Test Windshield

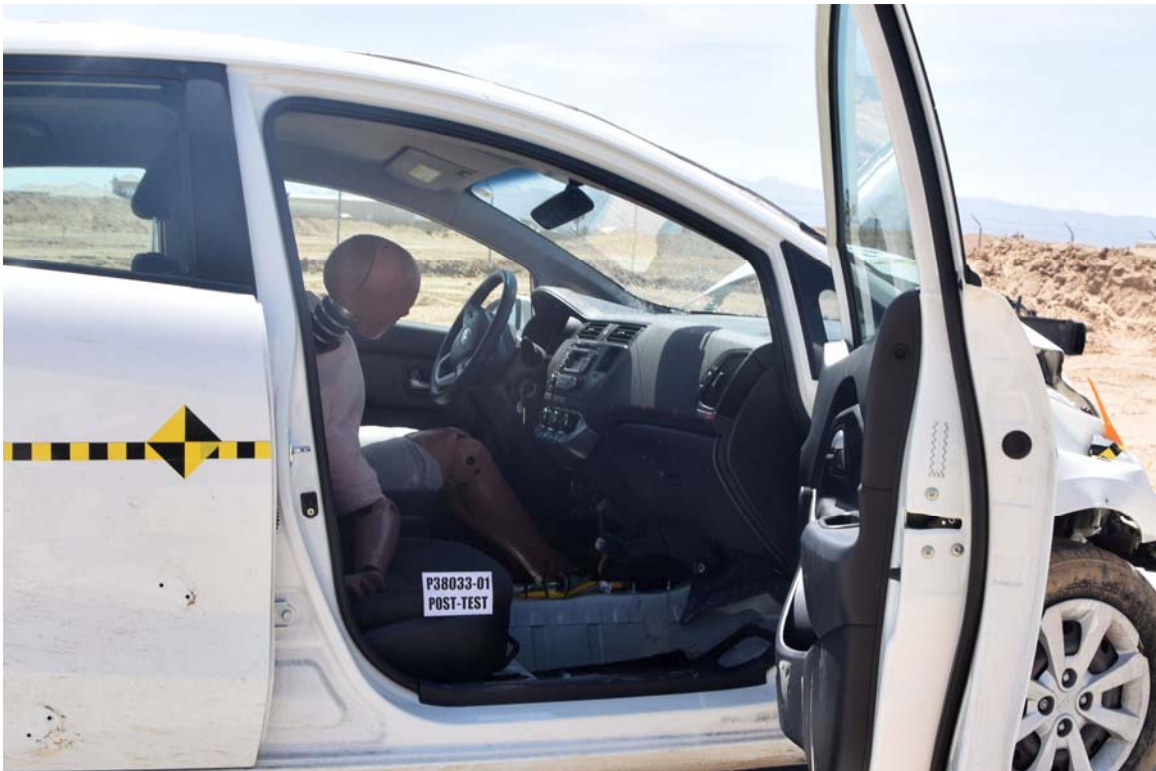
FIGURE 54. Post-Test Passenger Side Occupant Compartment

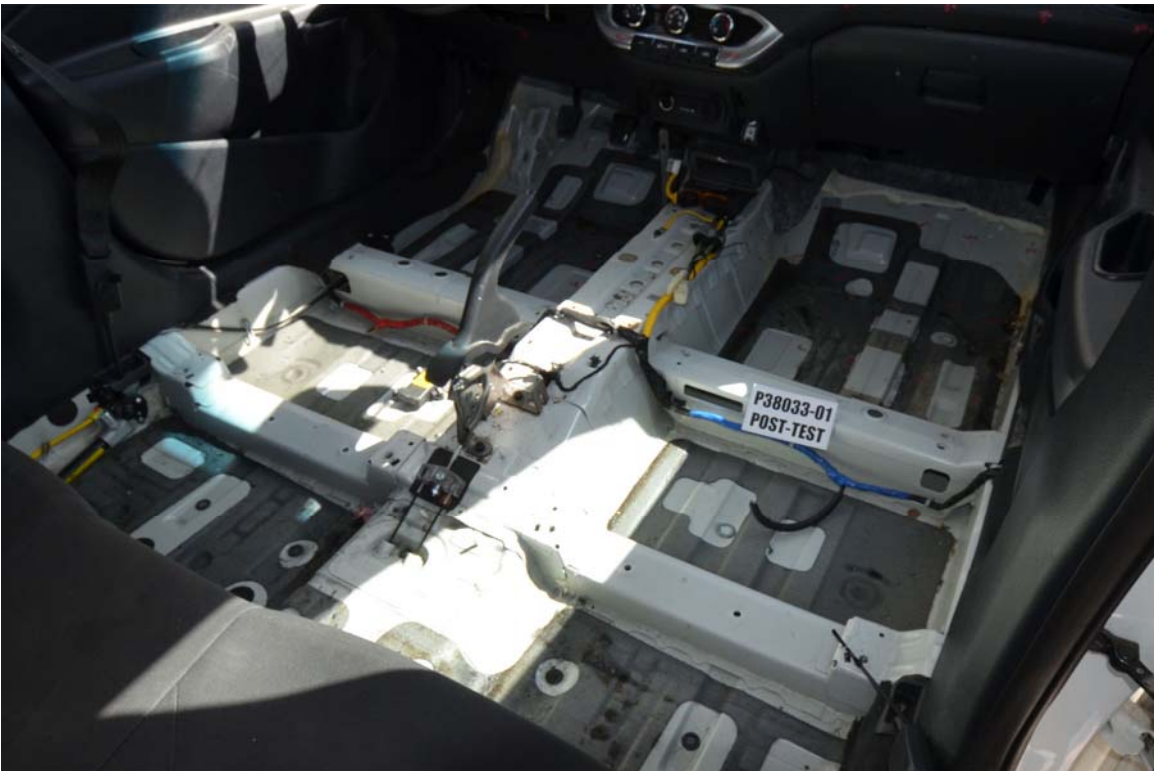
FIGURE 56. Post-Test Passenger Side Floorpan
