Test Report For:
SPIG Industries, LLC
SGET End Terminal

TESTED TO:
Manual for Assessing Safety Hardware (MASH 2016)
Test 3-31

TEST REPORT NUMBER:
TR-P38108-01-B

REPORT DATE:
September 22, 2022

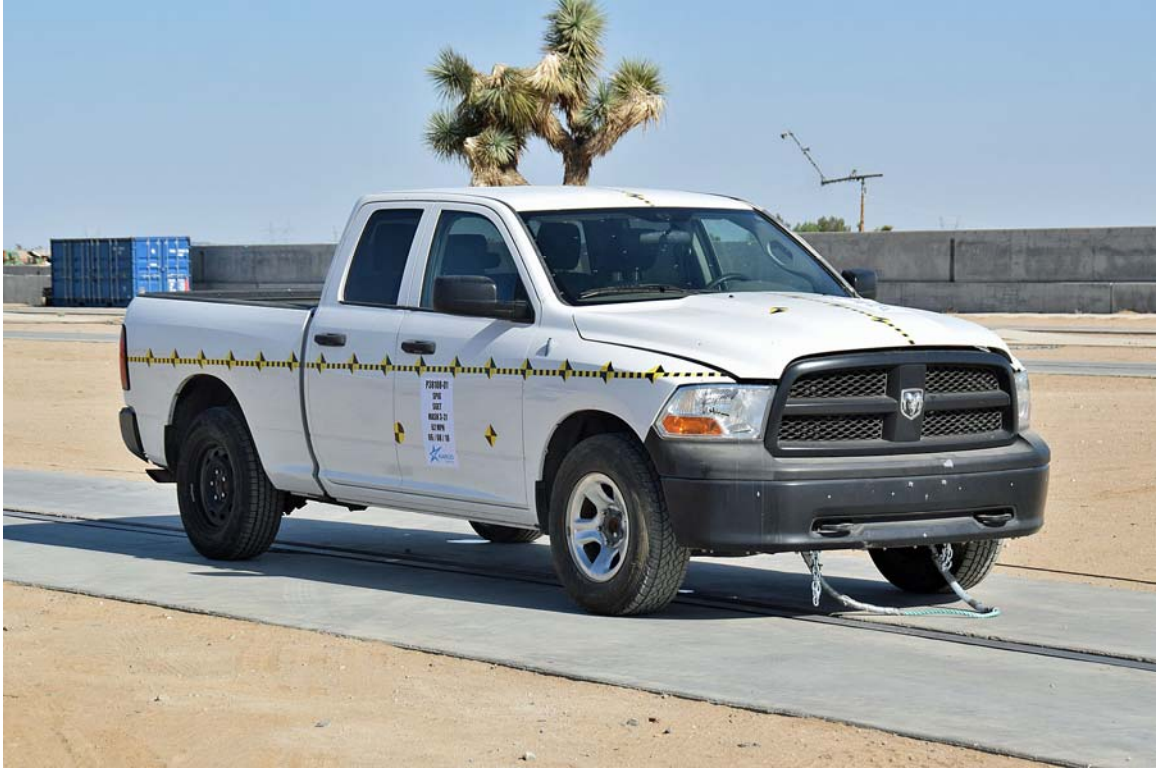
FIGURE 42. Post-Test Front View of Test Vehicle

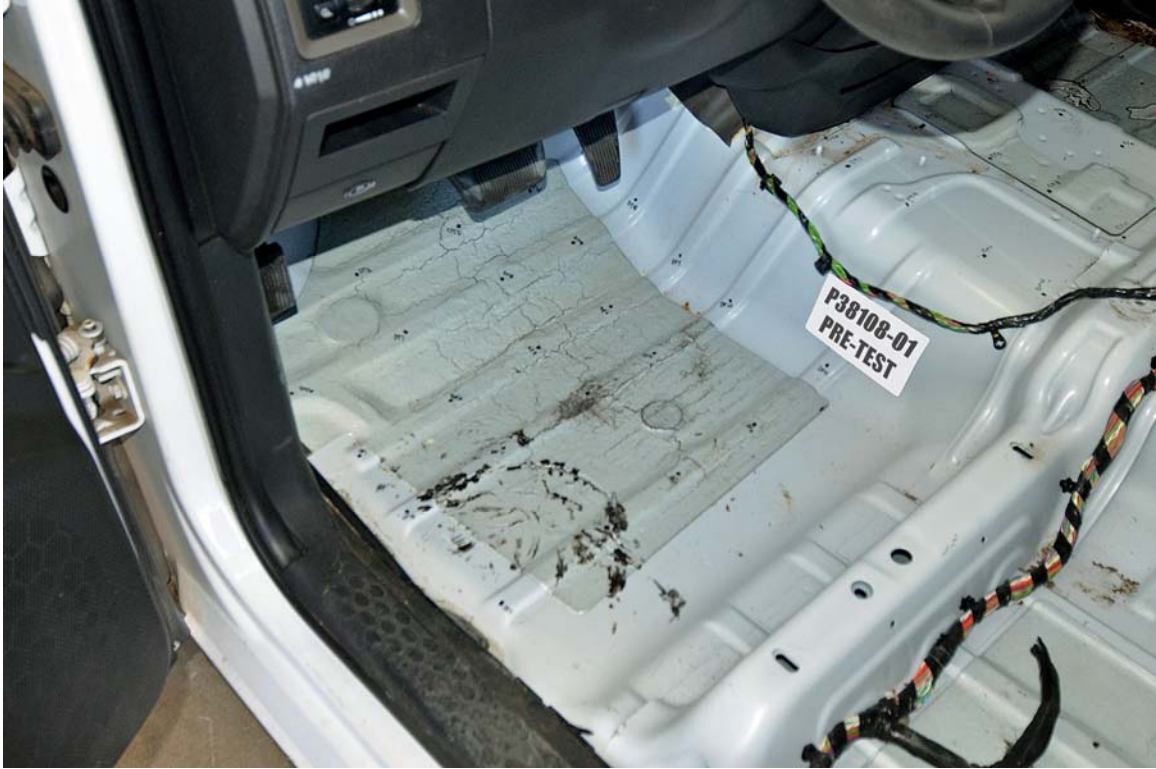
FIGURE 50. Post-Test Driver Side Occupant Compartment
