OnPoint Property Inspections, LLC

Home Inspection Report

2252 Know Your Home Dr
Chattanooga, TN 37343

Inspected on Tue, Jun 8 2021 at 2:00 PM

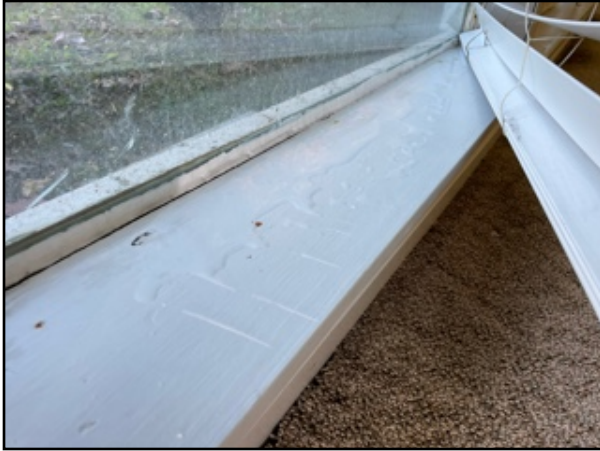
Figure 5-5

Observed water on the window sill located in the lower level back dining room. The large glass windows appeared to have excessive amount of condensation on the glass. This condensation looks to be building up on the window sill and running down into the carpet. This moisture is causing damage around the lower window sill. Recommend further evaluation and repair by a qualified contractor.

Attached: Thermal images to show the areas with moisture.

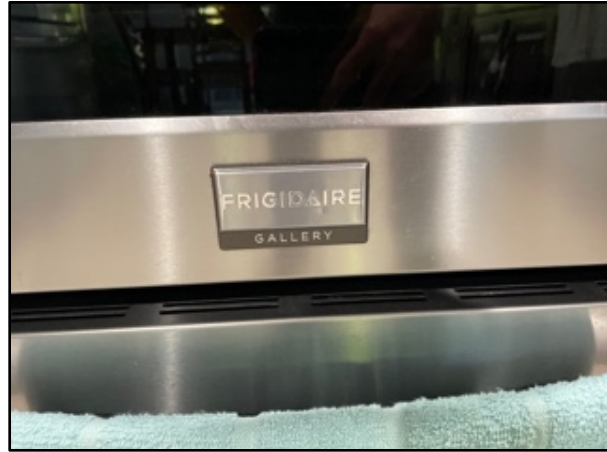
Comment 9:

The anti-tip was not installed on the appliance. Recommend having the anti-tip device installed for child safety.

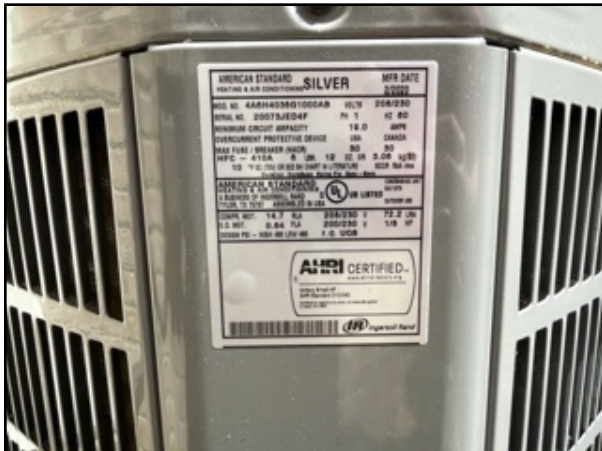
Figure 22-1

Comment 22:
American Standard Unit 2020.

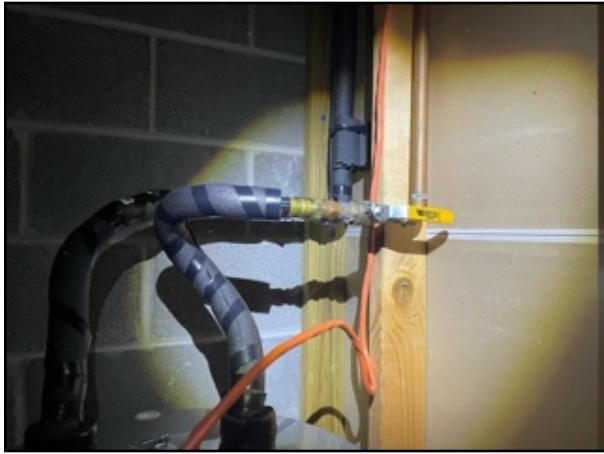
Figure 26-1

Comment 26:
Rheem 2016 Water Heater.

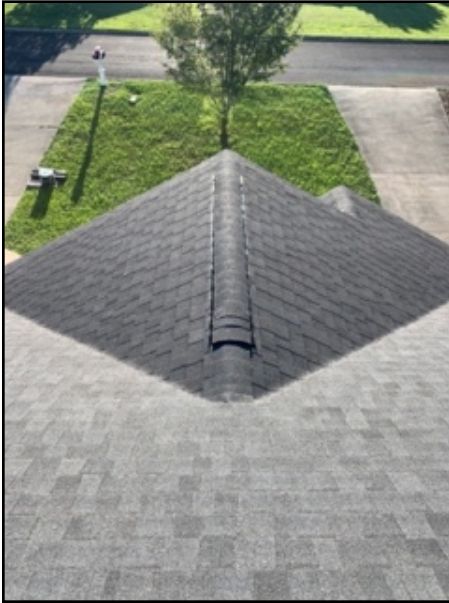
Figure 28-1

Comment 28:
The roofs shingles were recently replaced.
