BORESCOPE INSPECTION REPORT

GAS TURBINE ENGINE
TAURUS 65
COLD END DRIVE

Engine Serial Number
OHI21-D0140

Inspection Date
Tuesday, January 16, 2024

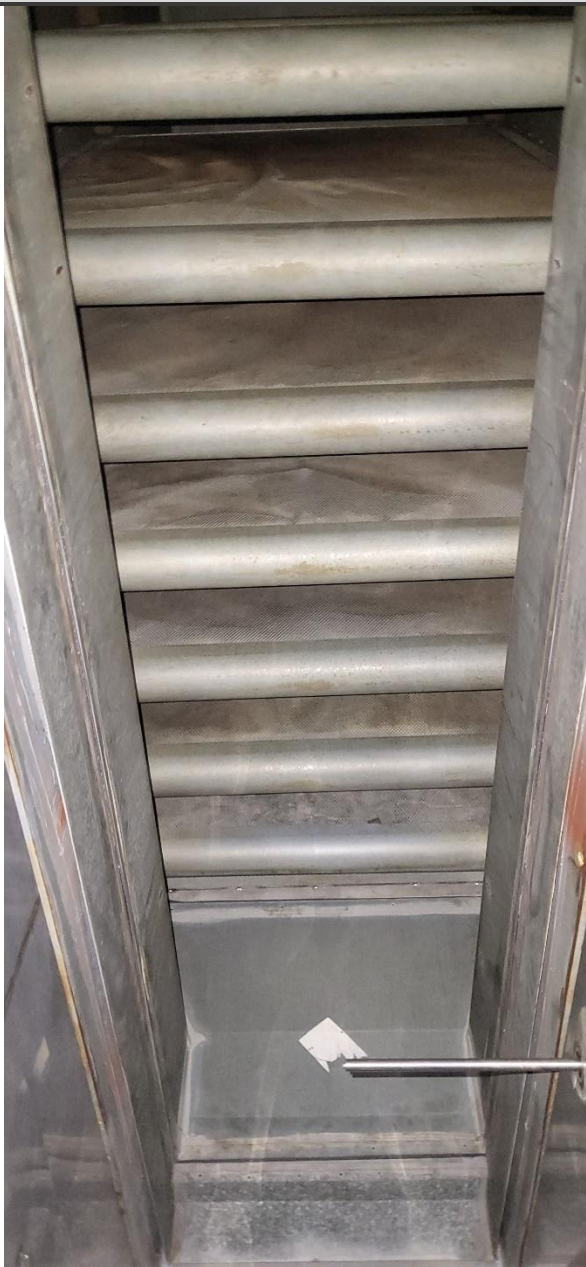
- a)Potential FOD
- b)Corrosive Pitting
- c)Cracks
- d)Excessive fouling

Normal Condition

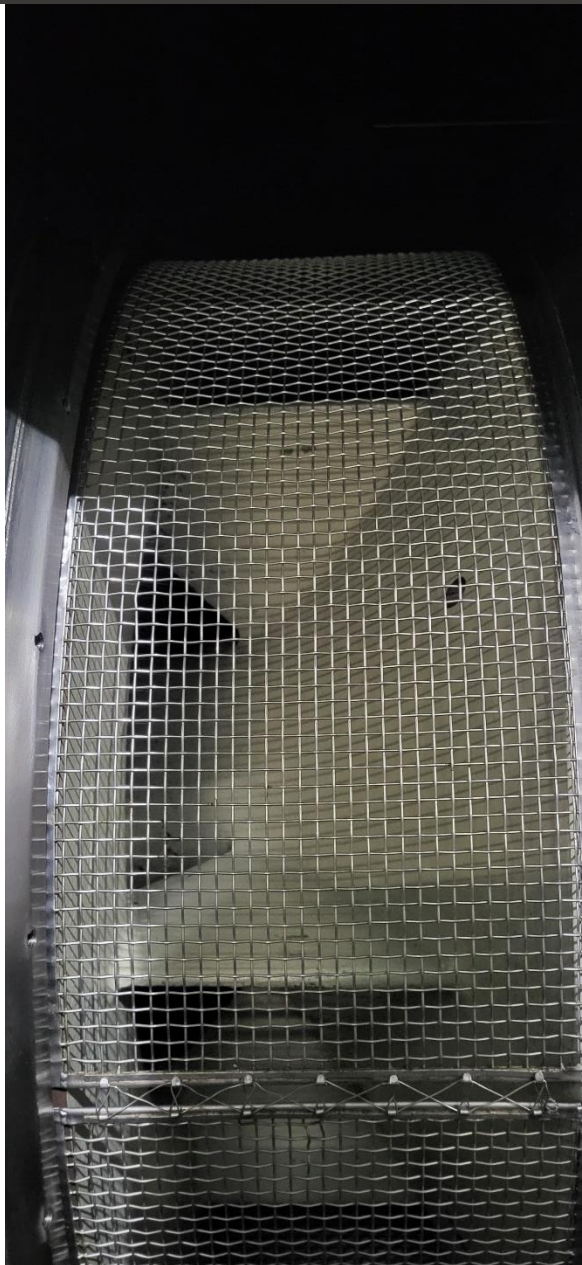
A

a)Potential FOD
b)Cracks, damaged mesh

Normal Condition

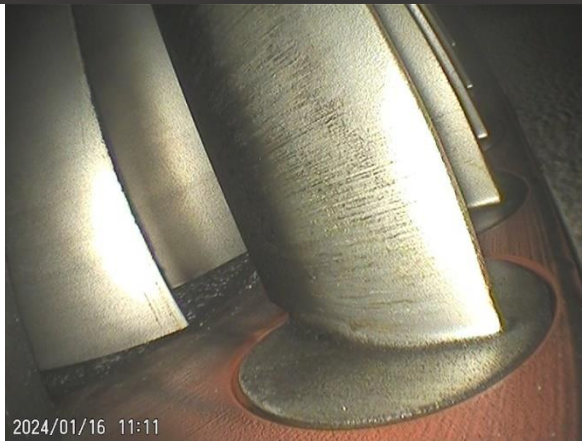
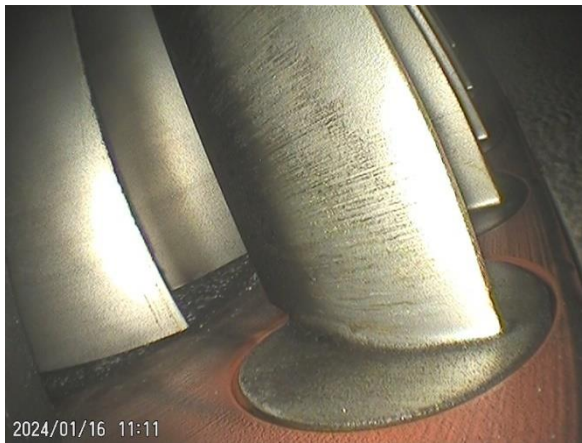
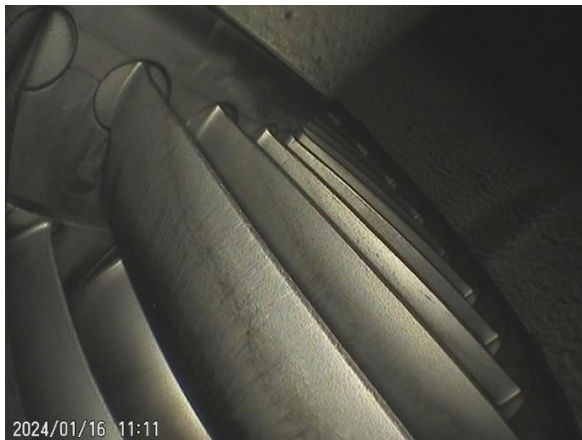
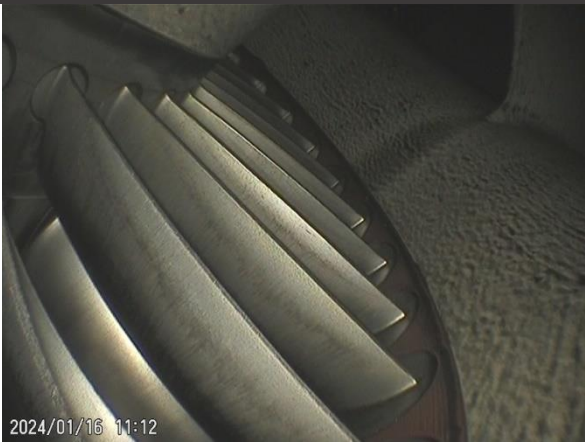
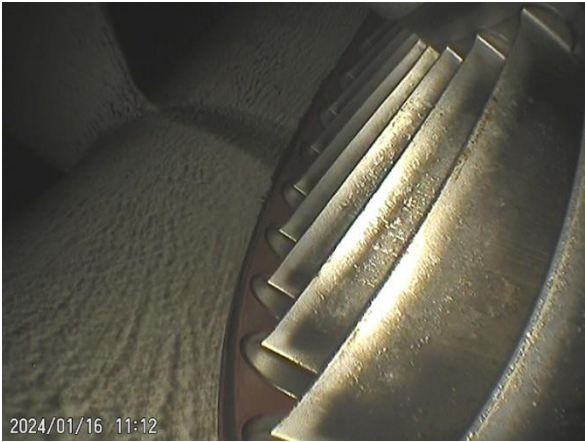
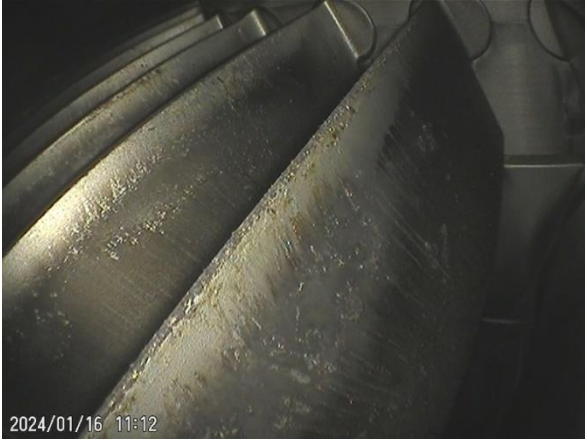
- a)Nicks and dents, Qty and size
- b)Excessive fouling
- c)Corrosive pitting. Affected Area

Normal Condition

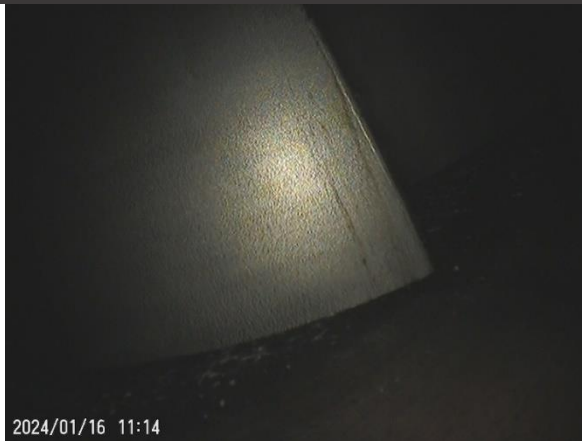
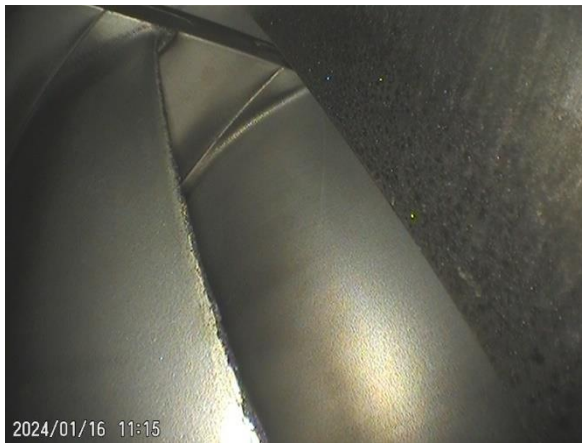
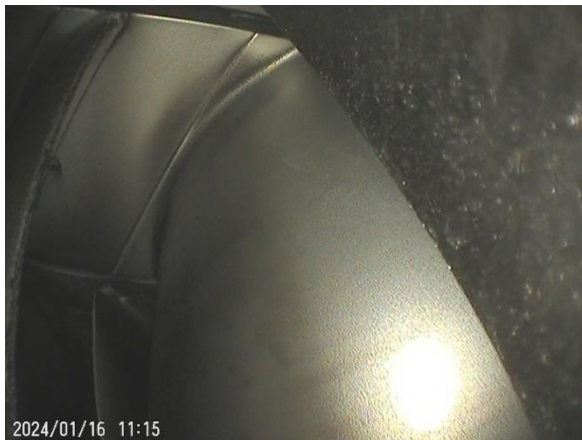
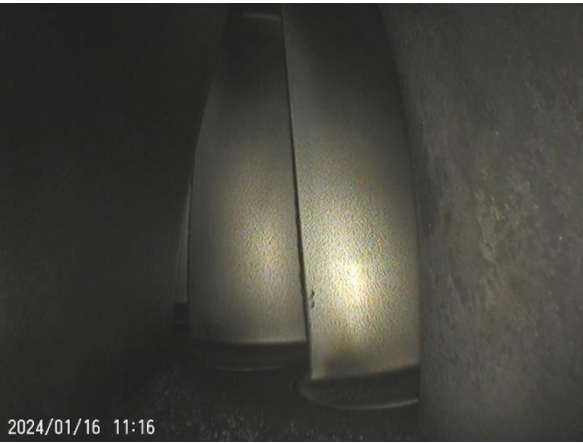
A

- a)Nicks and dents, Qty and size
- b)Excessive fouling
- c)Corrosive pitting. Affected Area
- d)Tip rub, Gap & curling

Normal Condition

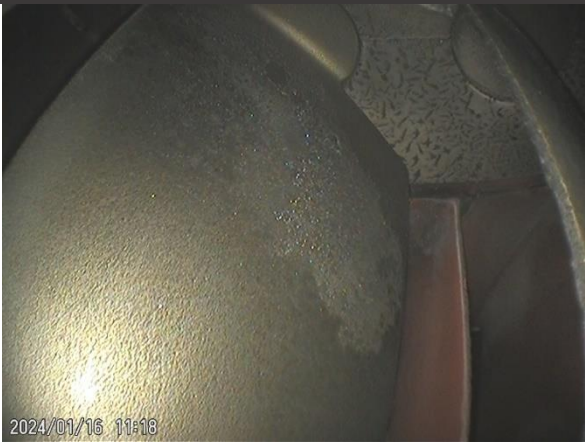
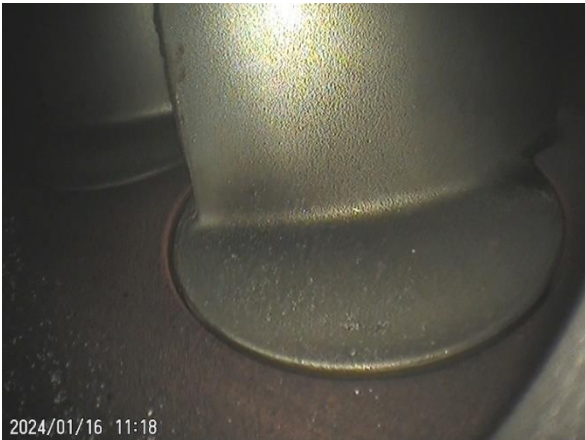
A

a)Nicks and dents,
Qty and size
b)Excessive fouling
c)Corrosive pitting.
Affected Area

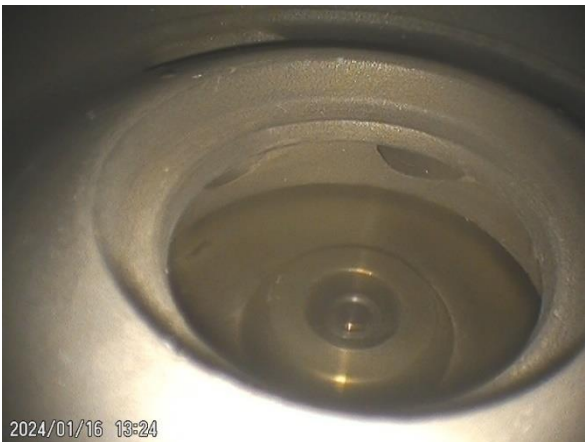
Normal Condition
a)Thermal erosion
Not applicable

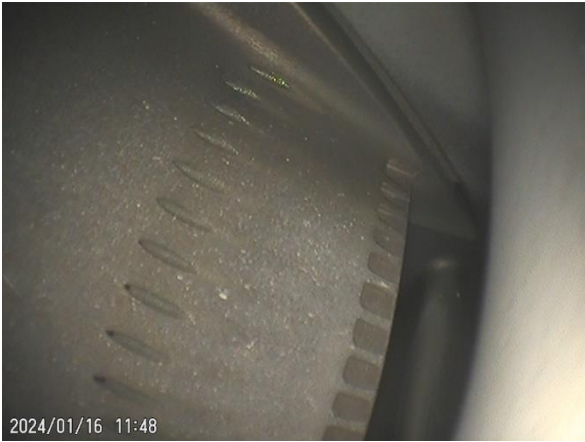
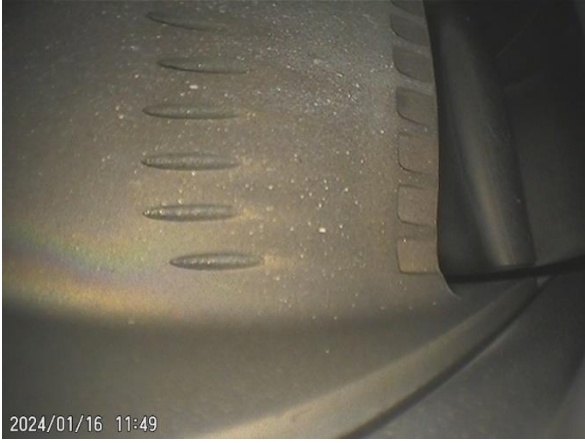
D

- a)Cracks, Qty, length, orientation
- b)Thermal erosion, Depth and area
- c)FOD Affected area

Normal Condition

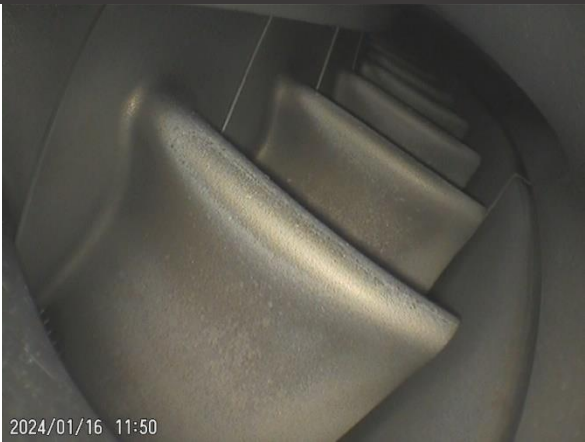
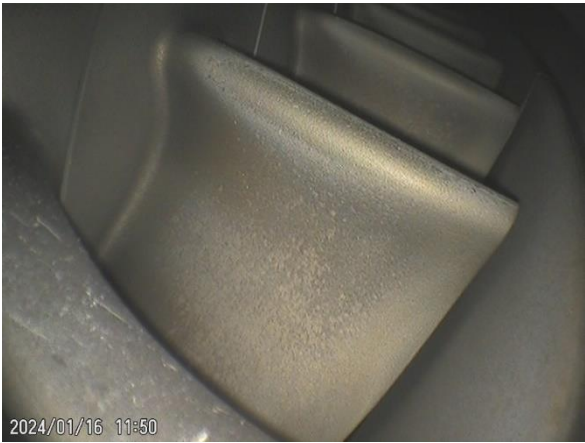
a)Cracks, Qty, length, orientation	Normal Condition
b)Thermal erosion, Depth and area	Not applicable
c)FOD Affected area	
d)Tip rub, gap width

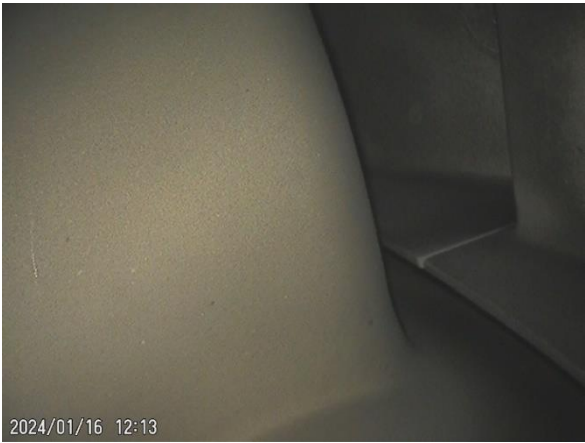
E

- a)Cracks, Qty, length, orientation
- b)Thermal erosion, Depth and area
- c)FOD Affected area

Normal Condition

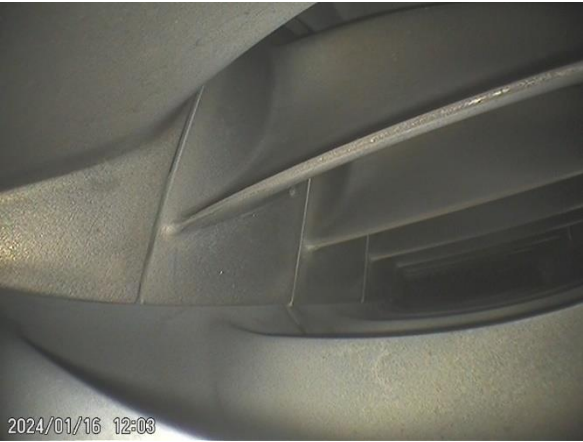
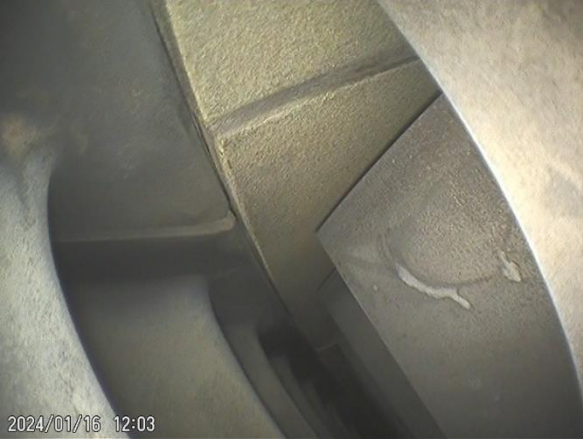
a)Cracks, Qty, length, orientation	Normal Condition
b)Thermal erosion, Depth and area	Not applicable
c)FOD Affected area	
d)Tip rub, gap width

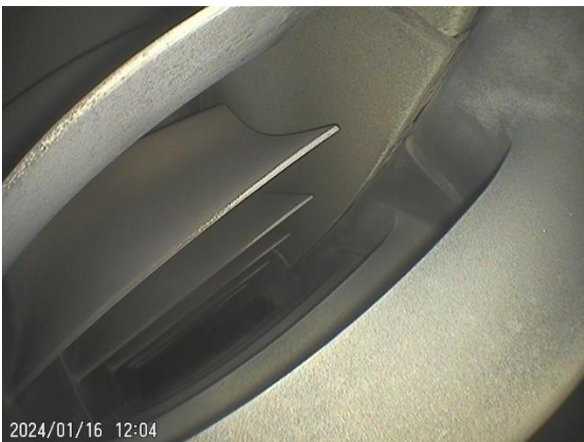
Access location Description	Picture	Inspection for	Severity / Comments
E 3rd Stg Turbine Nozzles

a)Cracks, Qty, length, orientation b)Thermal erosion, Depth and area c)FOD Affected area	Normal Condition Not applicable
