Your Inspection Report

8230 South Elizabeth Street
Chicago, IL 60620

INSPECTION DATE:
Saturday, August 25, 2018

RE: Report No. 1260, v.0
8230 South Elizabeth Street
Chicago, IL
60620

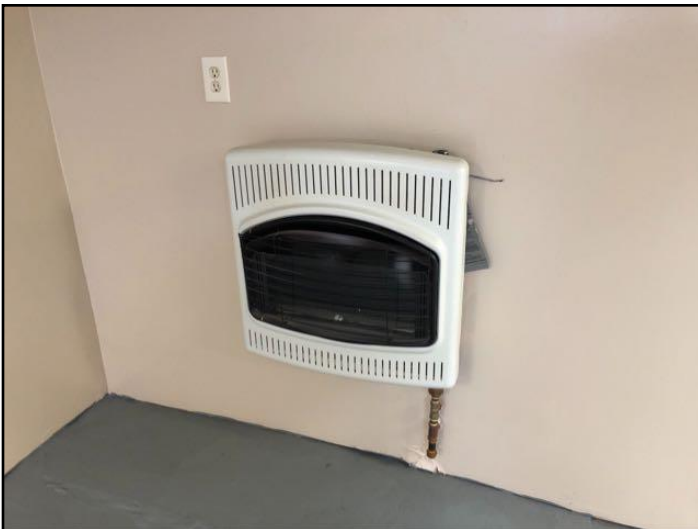
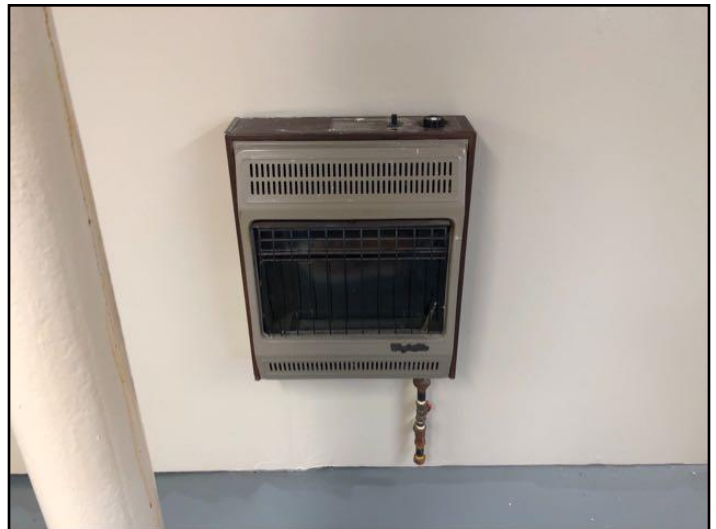
- Gas space heater
