Kirkpatrick Dam and Spillway Condition Assessment September 2015

Inspection Date: July 27-28, 2015

Subject: Florida Department of Environmental Protection Contract No. DC 827
Task Assignment No. 4
Kirkpatrick Dam and Spillway Condition Assessment Report, September 2015

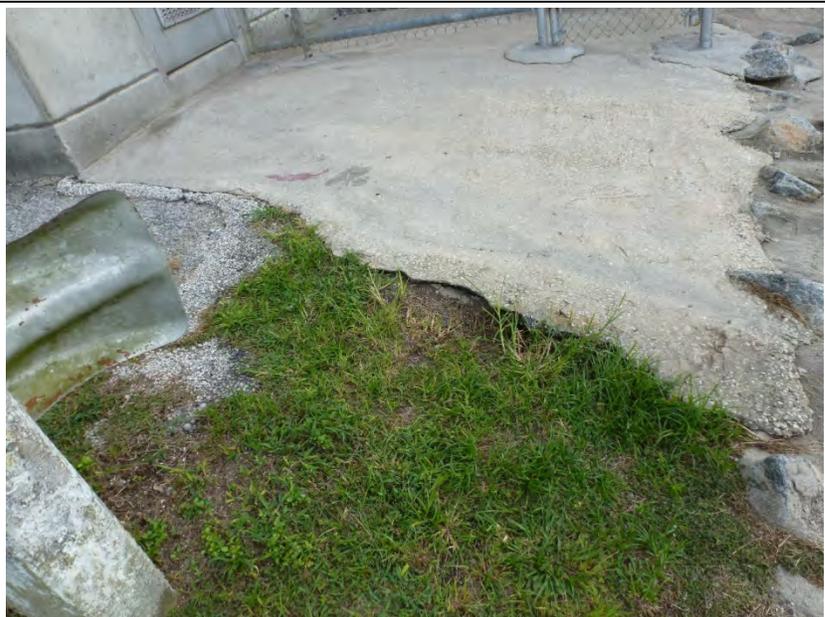
Description:
Minor undercutting of concrete infilled riprap revetment on upstream east side of structure.

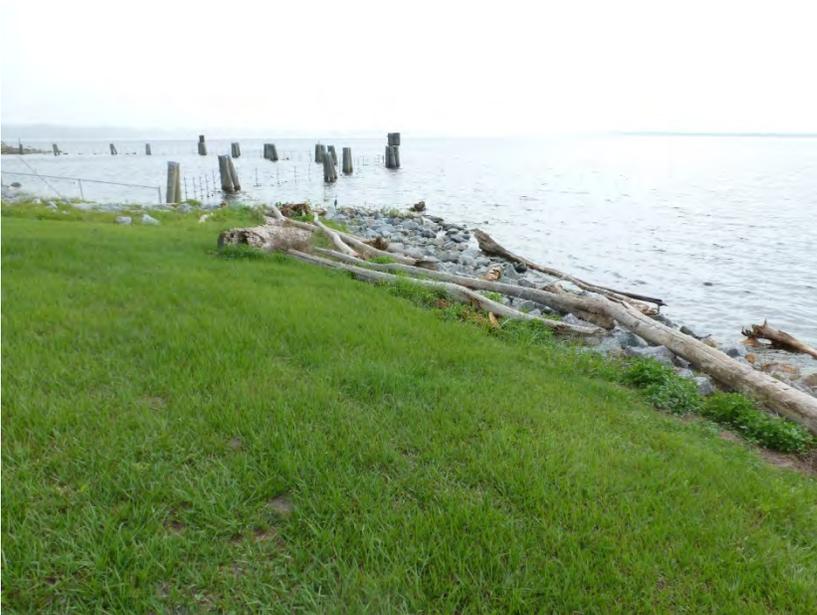
Description:
Logs (dead trees) and debris in revetment on upstream east and west side of structure.

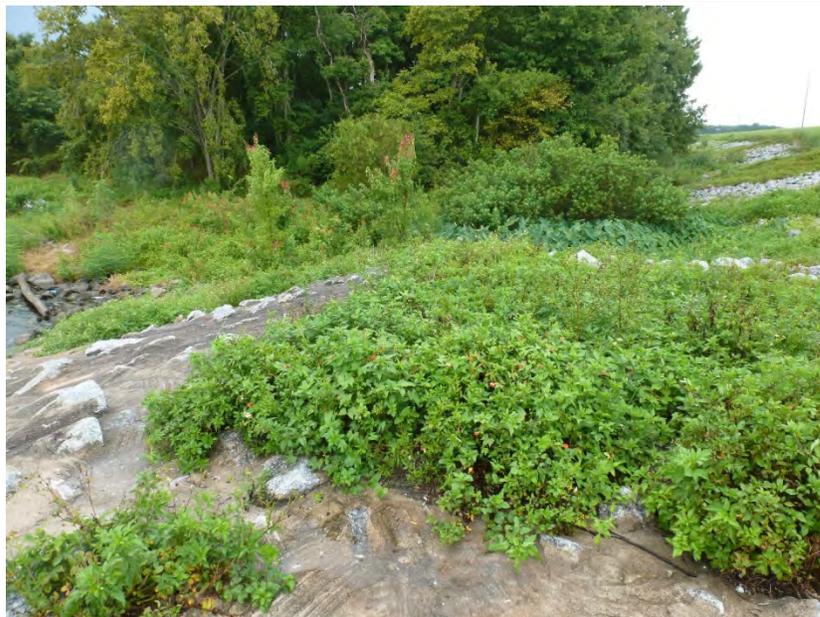
Description:
Vegetation growing in riprap revetment on downstream west side of structure.

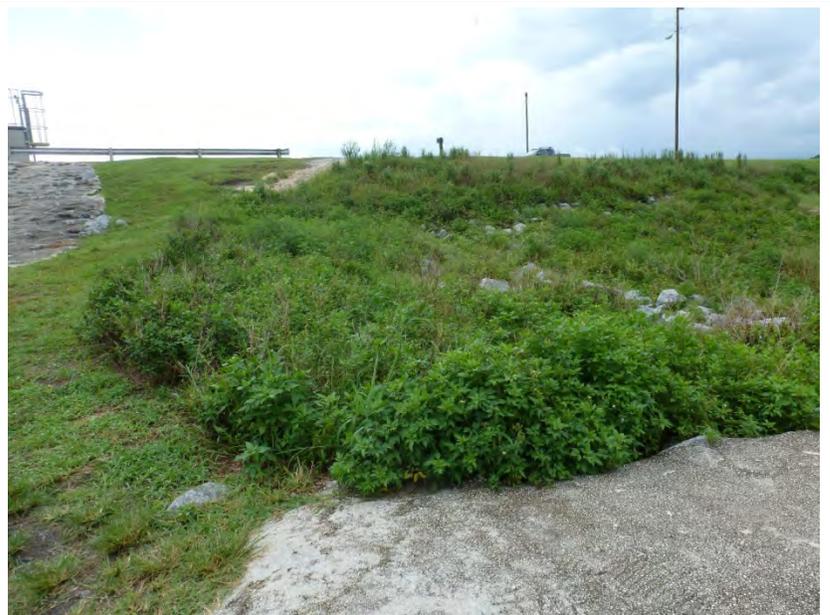
Description:
Vegetation growing in riprap revetment on downstream east side of structure.

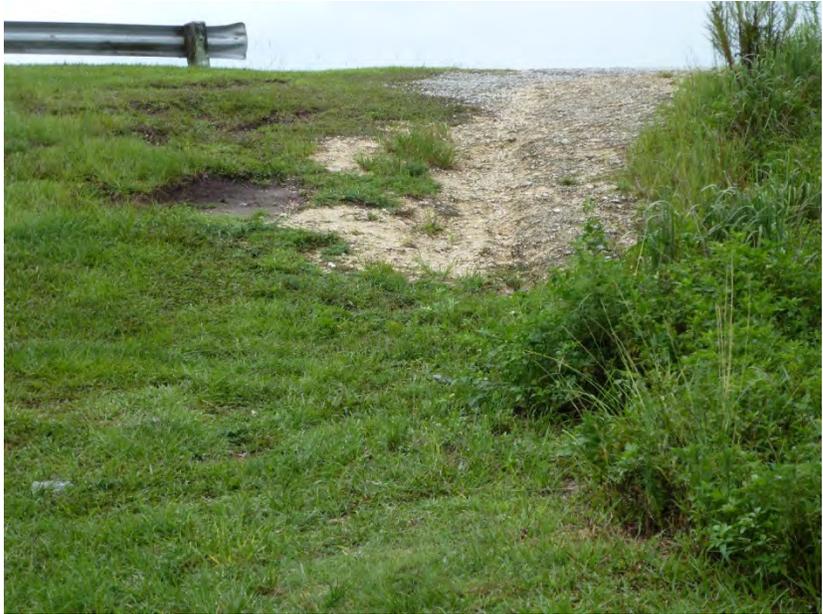
Description:
Erosion of embankment adjacent to riprap revetment on downstream east side of structure.

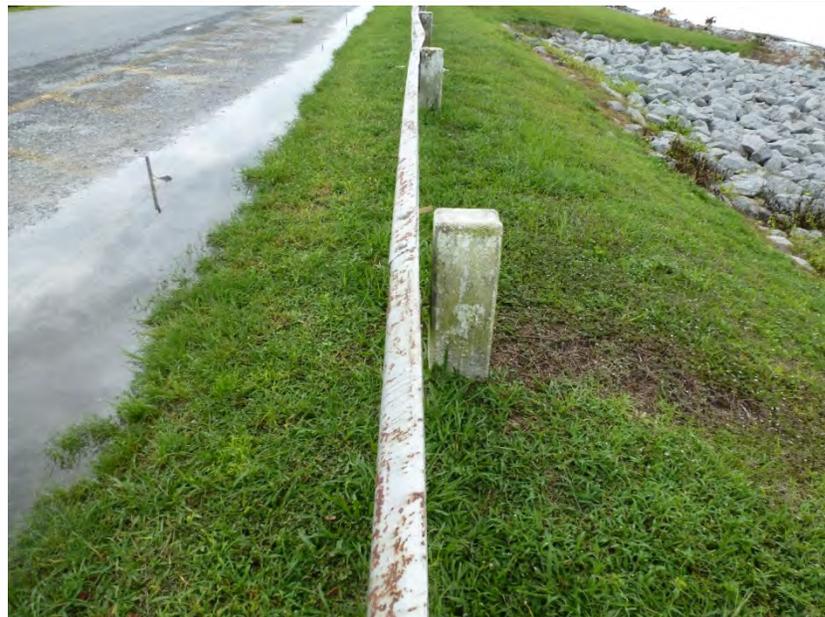
Description:
Guardrail detached from post west side of structure.

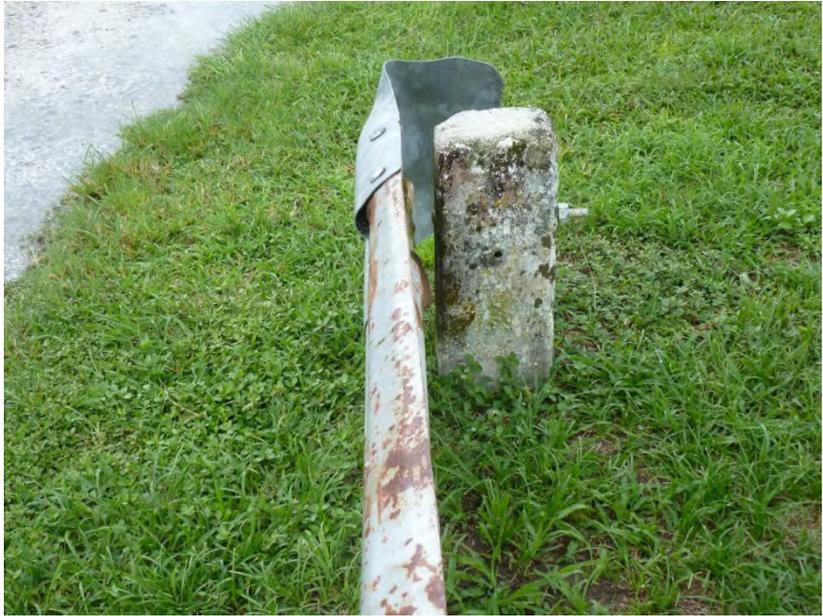
Description:
Guardrail detached from end post west side of structure.

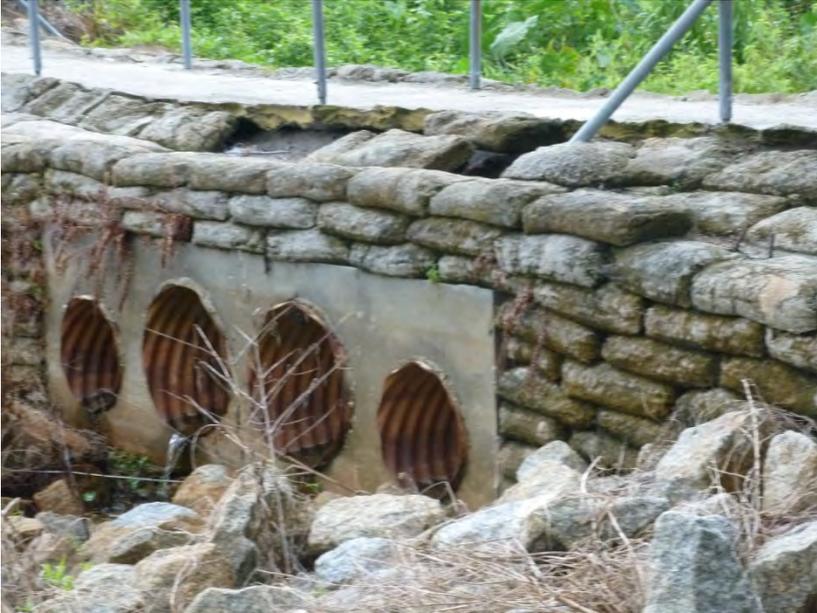
Description:
Some missing culvert headwall revetment.

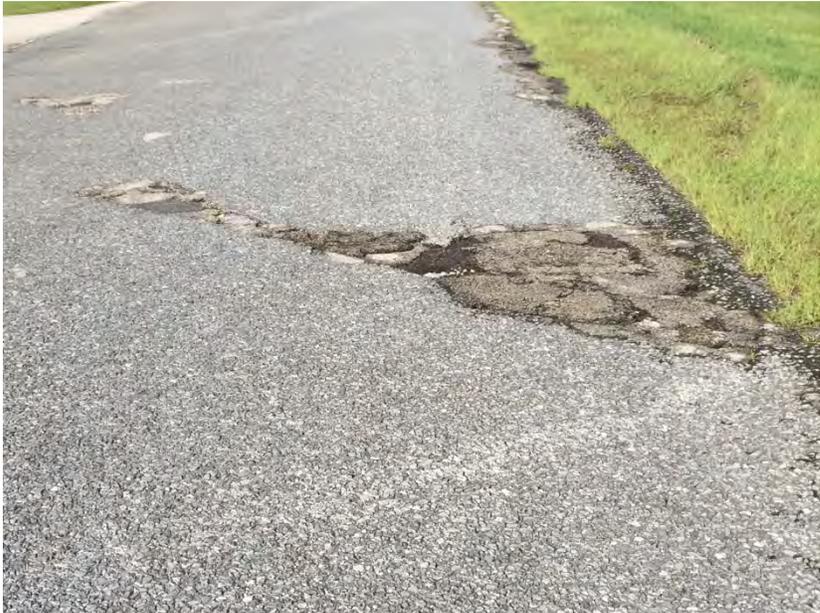
Description:
Multiple roadway patches, some failing with exposed base (P477 near northern downstream access road), typical.

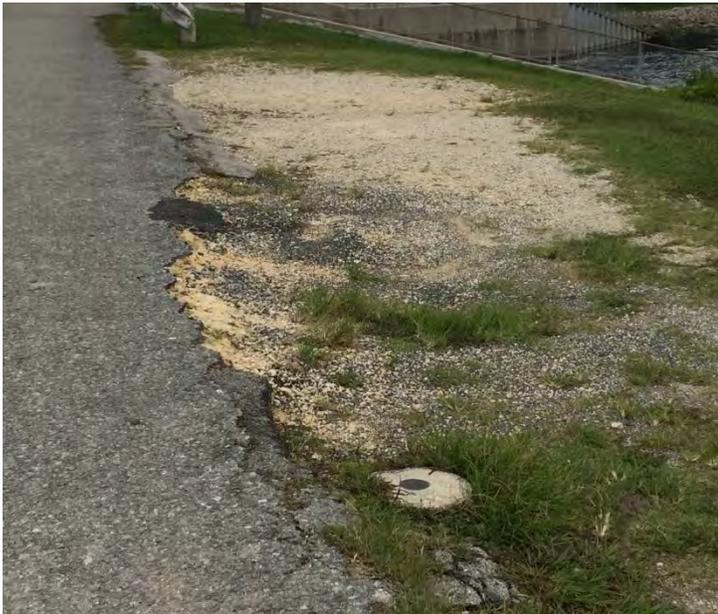
Description:
Crest road pavement edge damage and erosion due to roadway runoff and vehicle parking, south of spillway, downstream side.

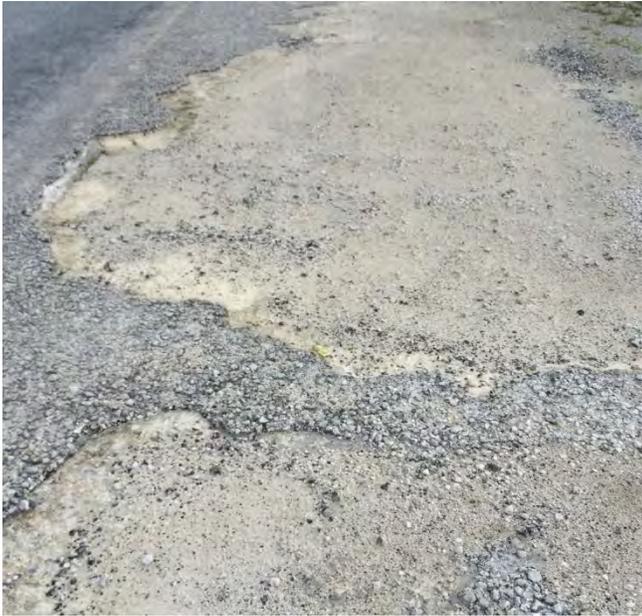
Description:
Deteriorated parking area due to poor drainage, south of spillway, upstream side.

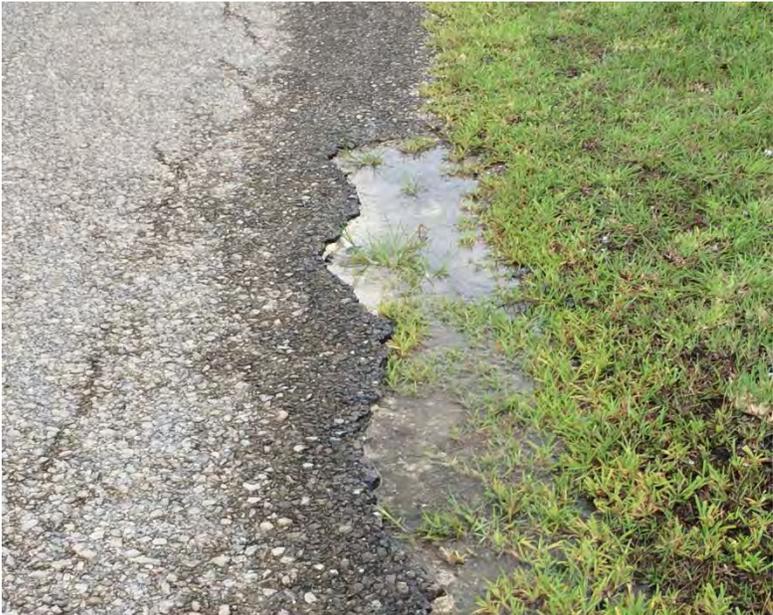
Description:
Typical pavement edge cracking and failure due to poor drainage (P582 between poles #14 and #15).

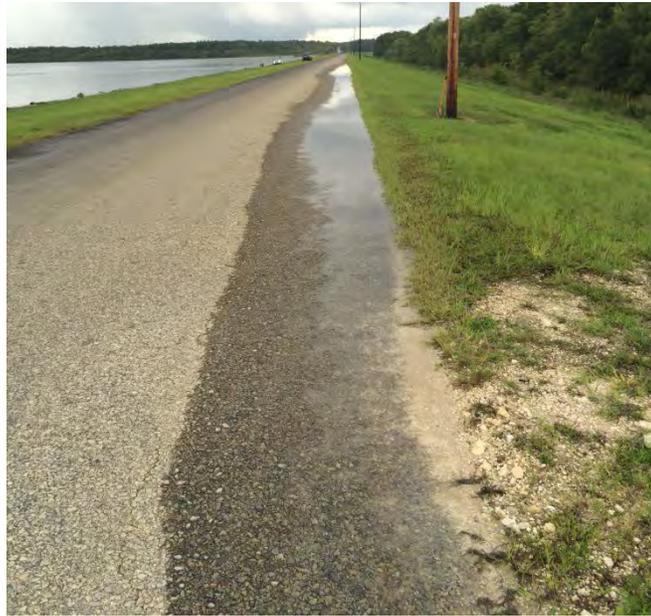
Description:
Typical ponding of water along downstream edge of access road (P589 near pole #16).

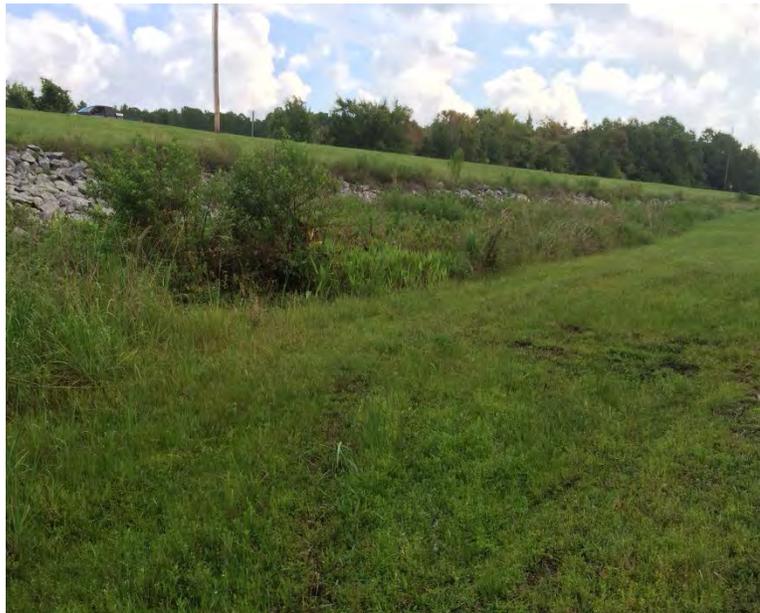
Description:
Heavy vegetation within riprap and toe ditch inhibiting drainage of toe ditch (north of spillway near pole #3).

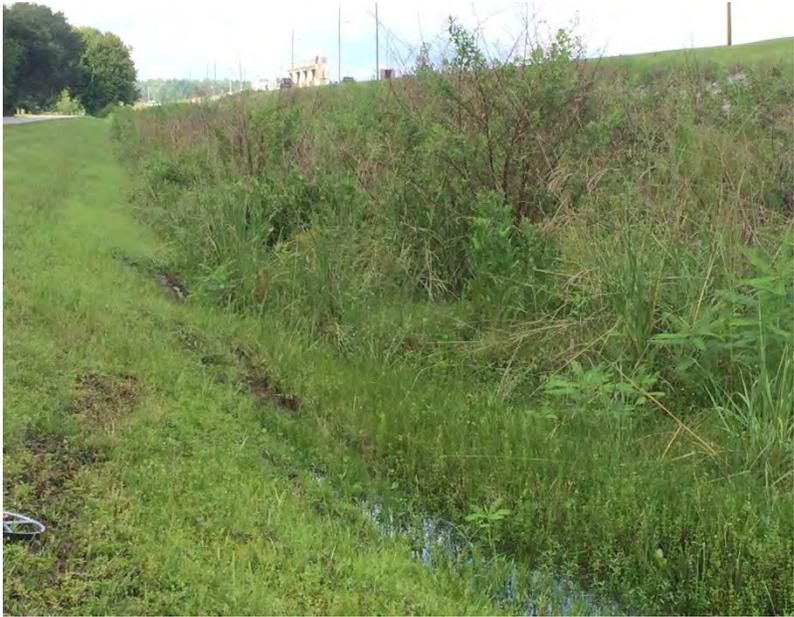
Checklist Item:
CV47

Item/ Discipline	Description	Rating
CV47	Standing water in downstream toe ditch (north of spillway near pole #3).	CV-3
CV48	Heavy vegetation within riprap and toe ditch inhibiting drainage of downstream toe ditch (north of spillway).	CV-3
CV49	Flow from downstream toe ditch north of spillway limited by lack of positive drainage.	CV-3
CV50	Typical erosion caused by equipment ruts and roadway runoff (area of poles #13 and #14).	CV-3
CV51	More severe erosion caused by equipment ruts and roadway runoff (area of poles #16 and #17).	CV-3
CV52	Erosion migrating upslope (area of poles #4 and #5).	CV-3
CV53	Area of deficient shoreline riprap, typical of upstream slope south of spillway.	CV-3
CV54	Erosion gully created by roadway runoff (near pole #18).	CV-3
CV55	Vegetation growing in fractures within concrete south side of spillway.	CV-3
CV56	Severe undermining of concrete covered riprap (south side of spillway).	CV-3

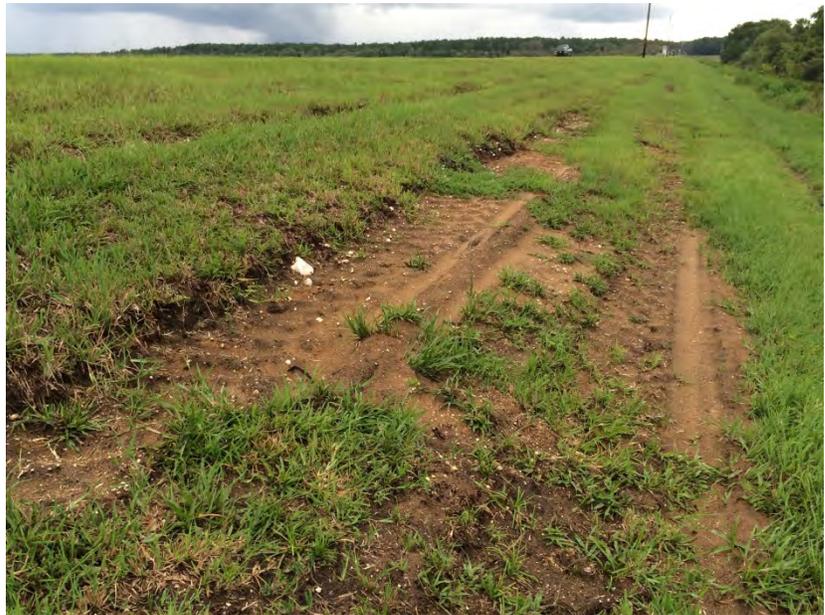
Description:
More severe erosion caused by equipment ruts and roadway runoff (area of poles #16 and #17).

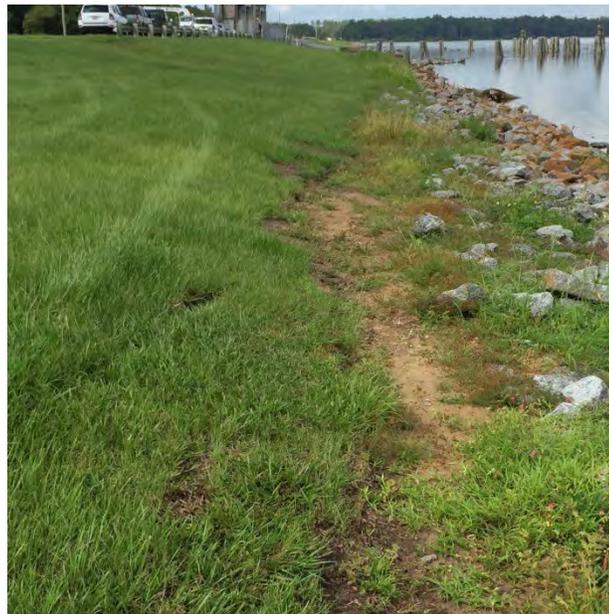
Description:
Erosion migrating upslope (area of poles #4 and #5).

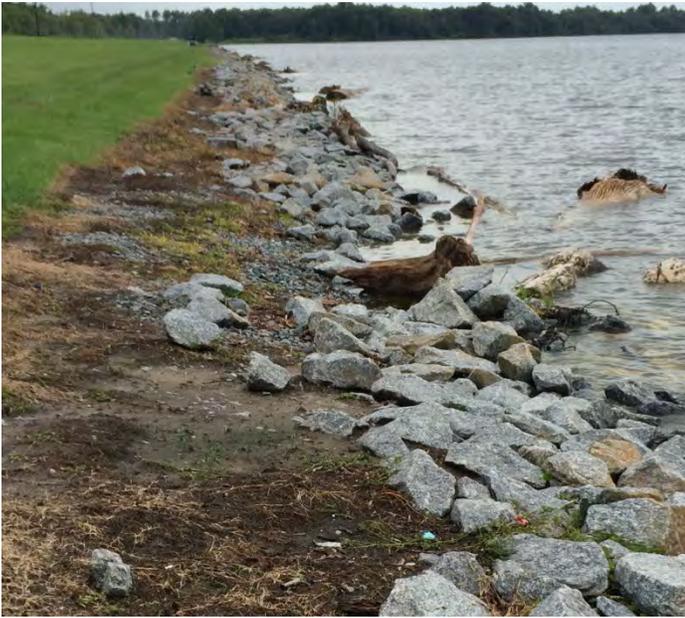
Description:
Area of deficient shoreline riprap, typical of upstream slope south of spillway.

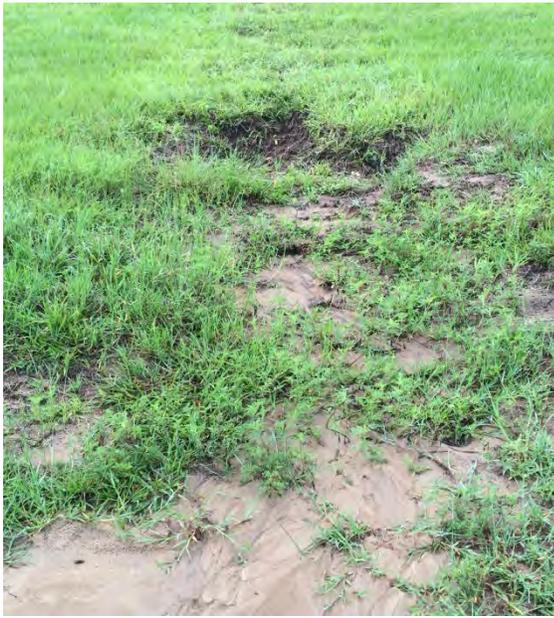
Description:
Erosion gully created by roadway runoff (near pole #18).

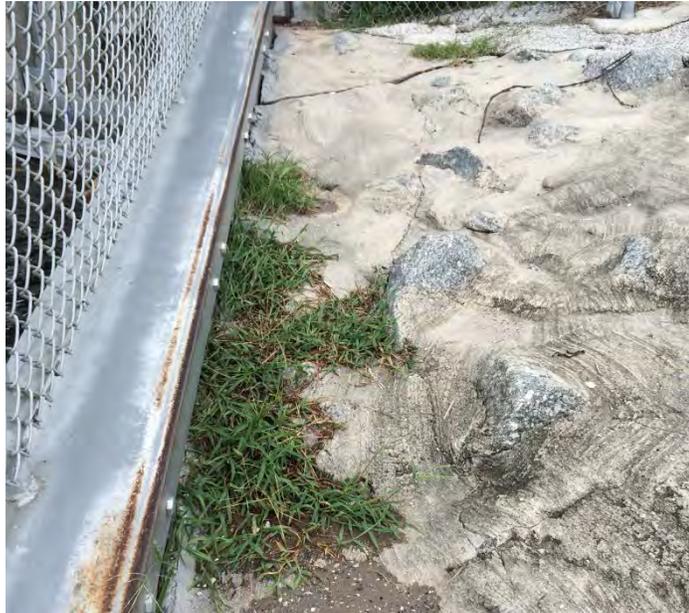
Description:
Vegetation growing in fractures within concrete south side of spillway.

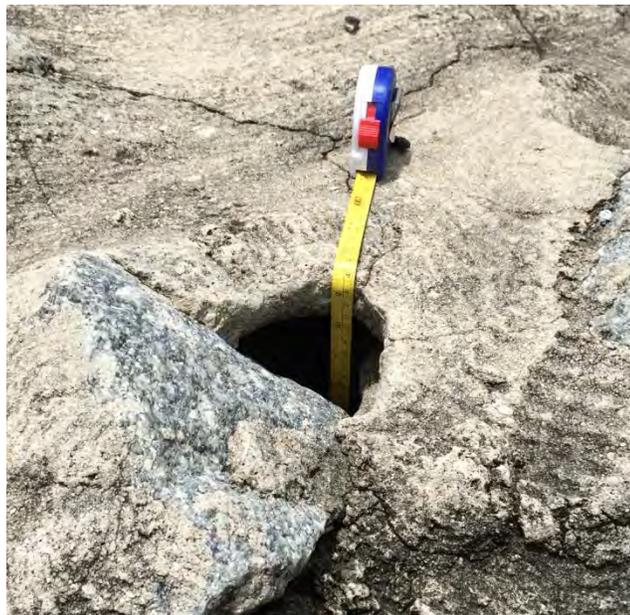
Description:
Severe undermining of concrete covered riprap (south side of spillway).

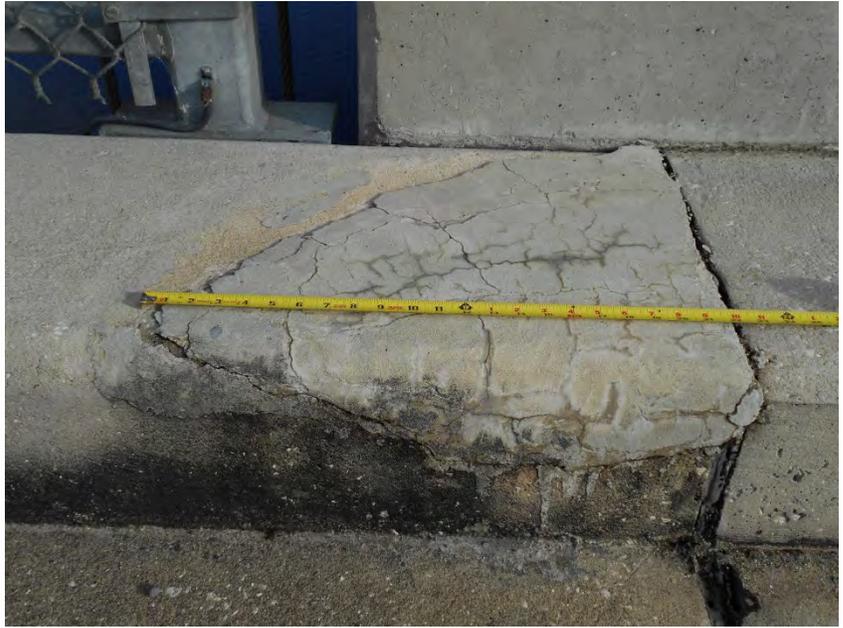
Description:
Incipient spall in the service bridge curb, 22" x 16" x 5", west side, at Pier 3.

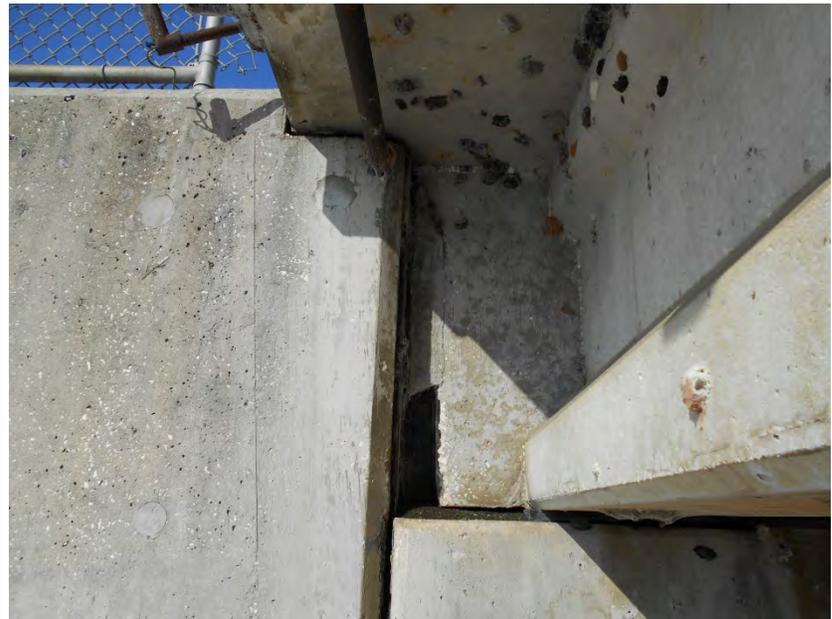
Description:
Spall/incipient spall in the service bridge diaphragm at Abutment 1, 32" x 4", east side.

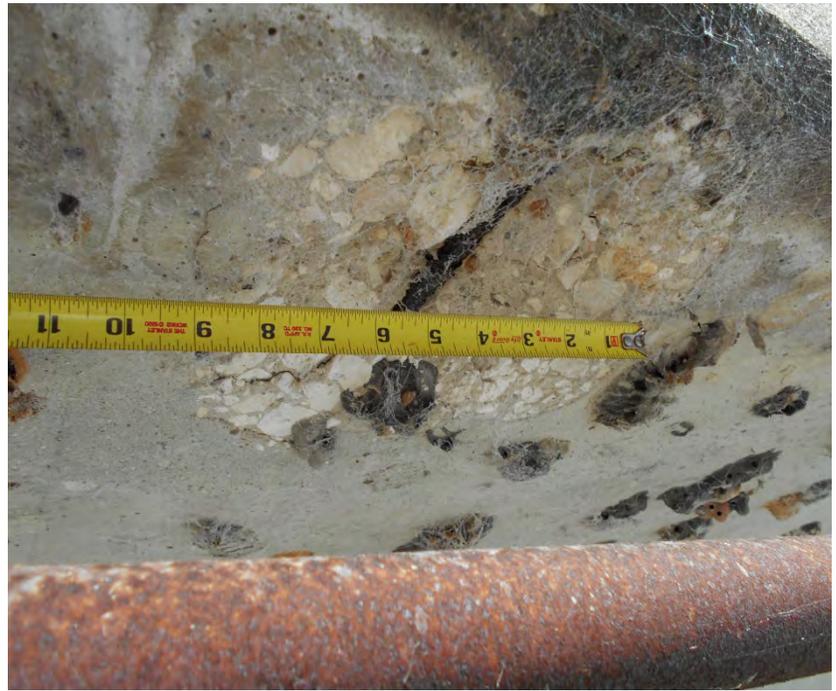
Description:
Spall, 10" x 10" x 1-1/2"
with exposed lightly
corroded transverse steel
in the service bridge east
deck overhang, Span 1,
10 ft. from Pier 1.

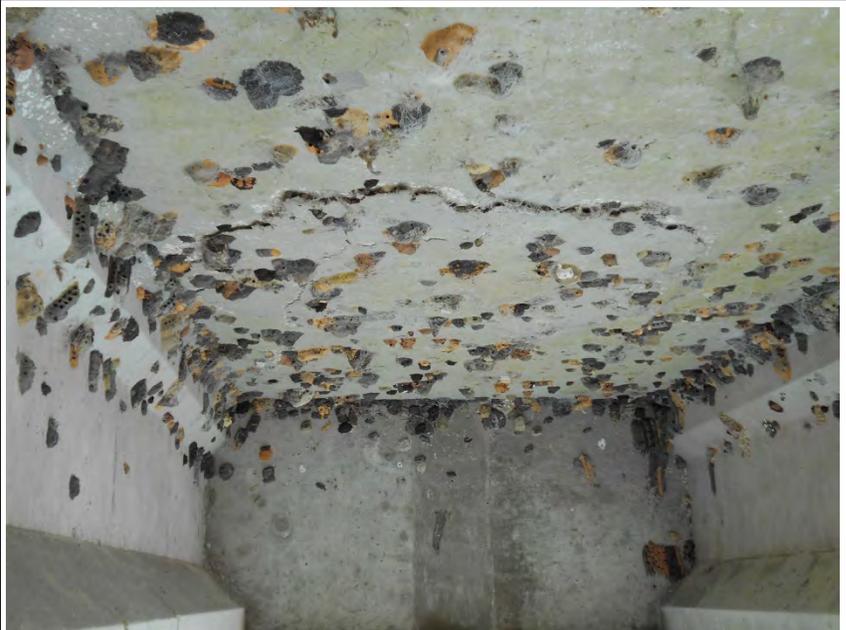
Description:
Large insipient spall,
4 ft. x 3 ft. in the service
bridge deck underside,
Span 1, near Pier 2
between Beams 3 and 4.

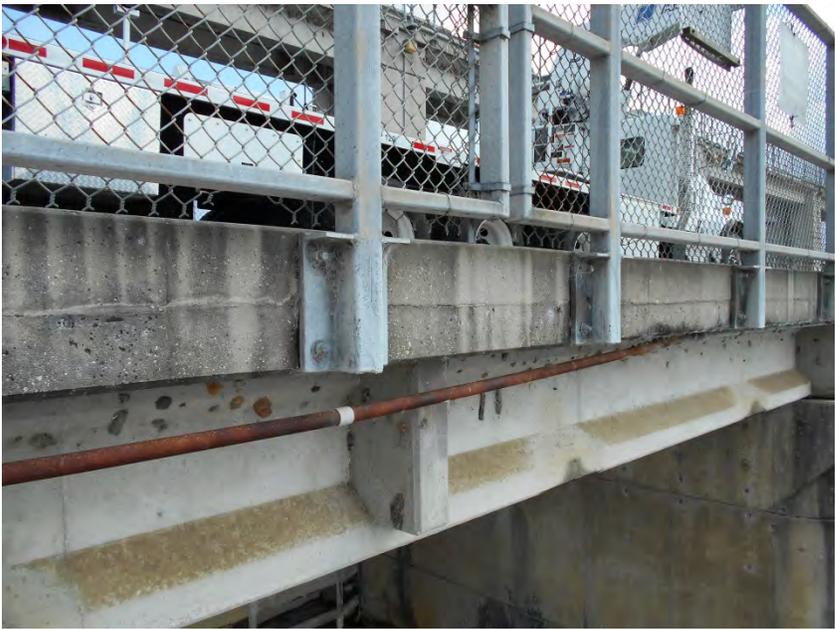
Description:
Horizontal crack along the construction joint in service bridge curb, exterior face, east and west side.

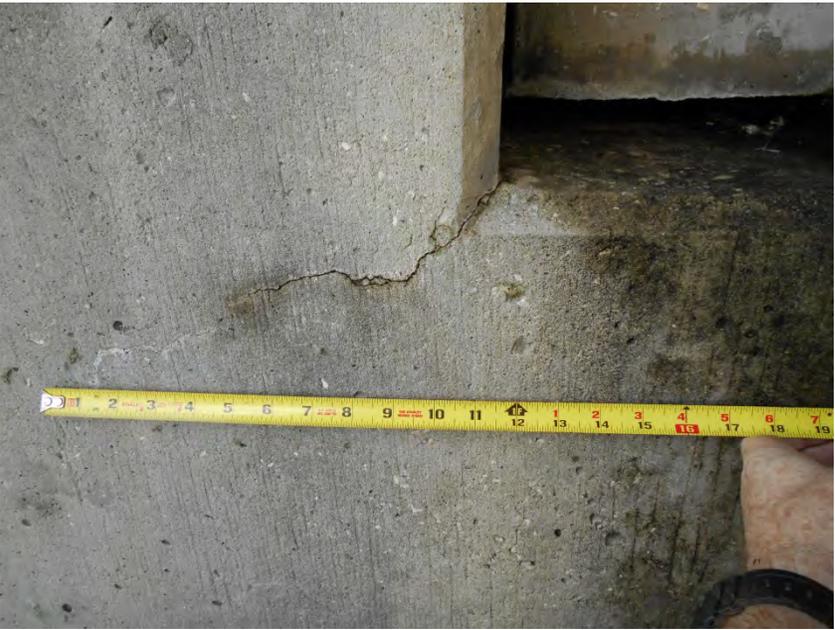
Description:
Diagonal crack in the service bridge stilling wall at Abutment 5, 12" x 1/32", west side at the beam seat.

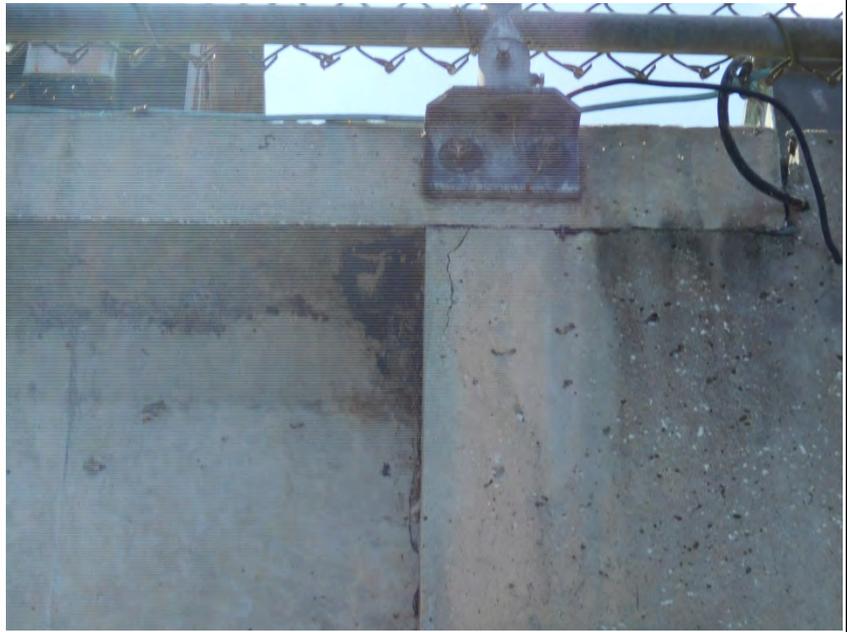
Description:
Crack in the gantry structure column at Pier 1, 6" x 1/32", west column, northwest corner at top.

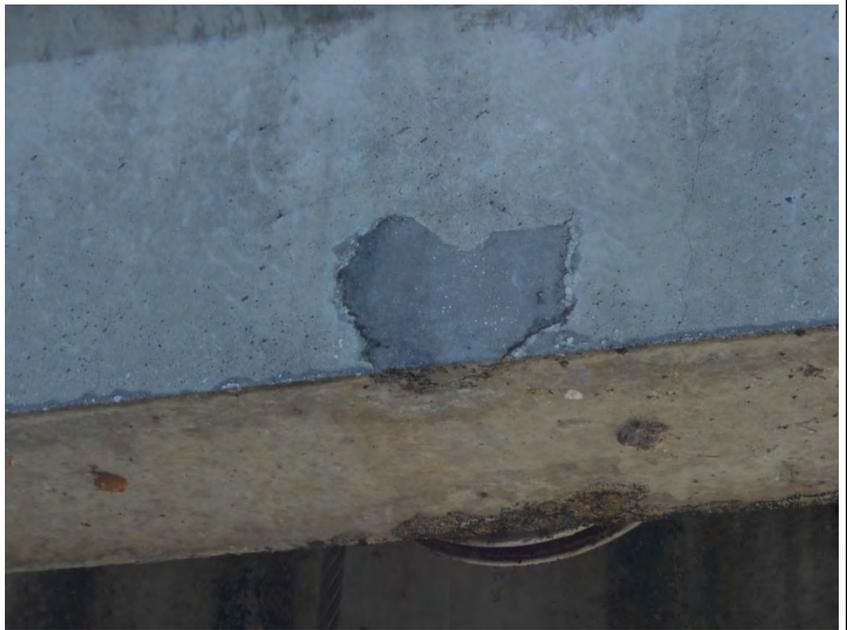
Description:
Delaminated spall repair in the gantry structure beam near Pier 3, 10" x 3", west side.

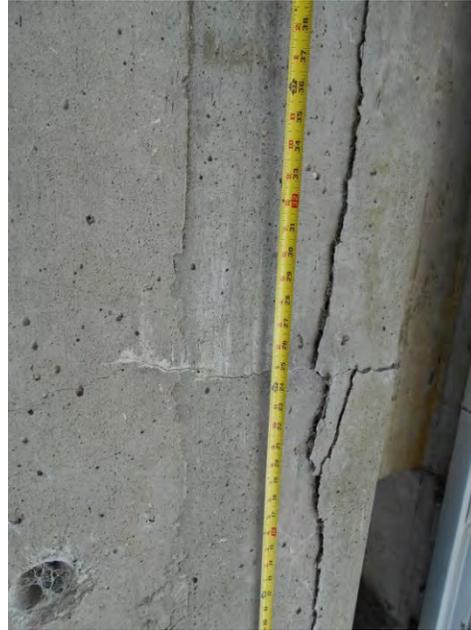
Description:
Incipient spall in the gantry column structure at Pier 4, 48" x 6", southwest corner, adjacent to bridge.

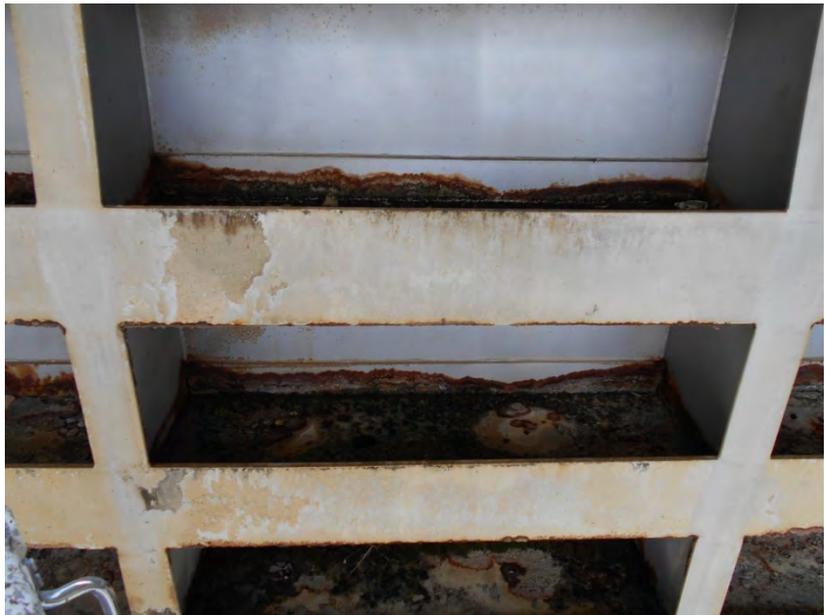
Description:
Accumulation of dirt and debris on the downstream face of the lift gates that has resulted in moderate corrosion in those areas.

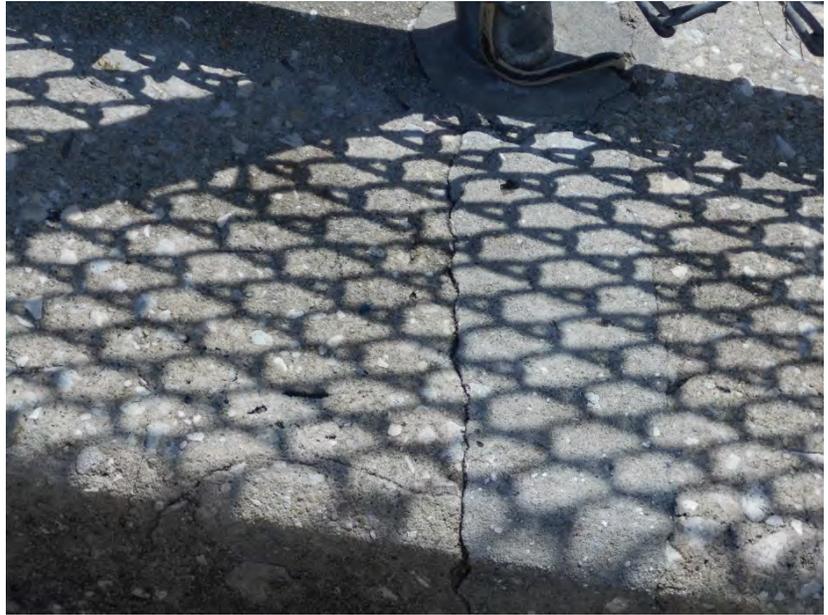
Description:
Intermittent cracks and spalls along the top of the stilling basin walls.

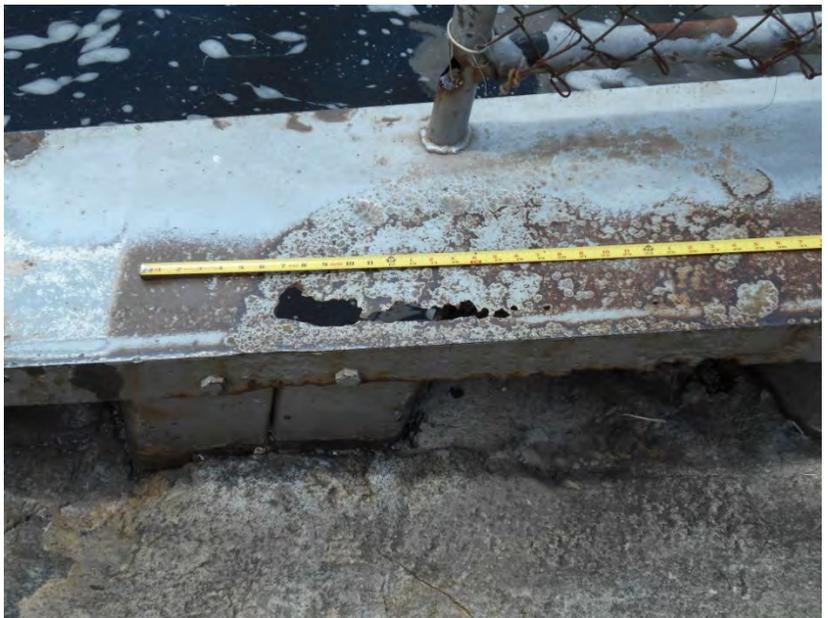
Description:
Area of corrosion with section loss in the stilling basin steel sheet pile steel cap, north side, 10 ft. from waterline.

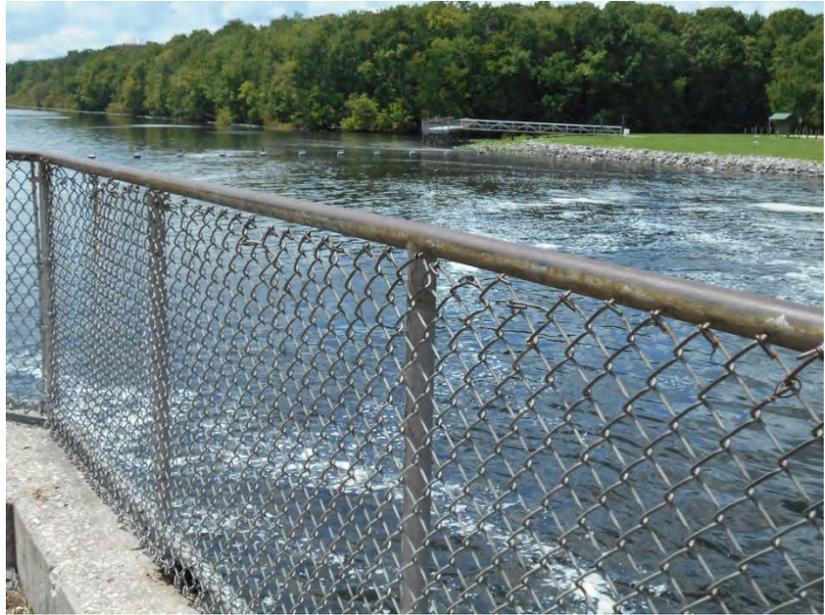
Description:
Portions of chain link fence along top of stilling basin walls not attached to top railing.

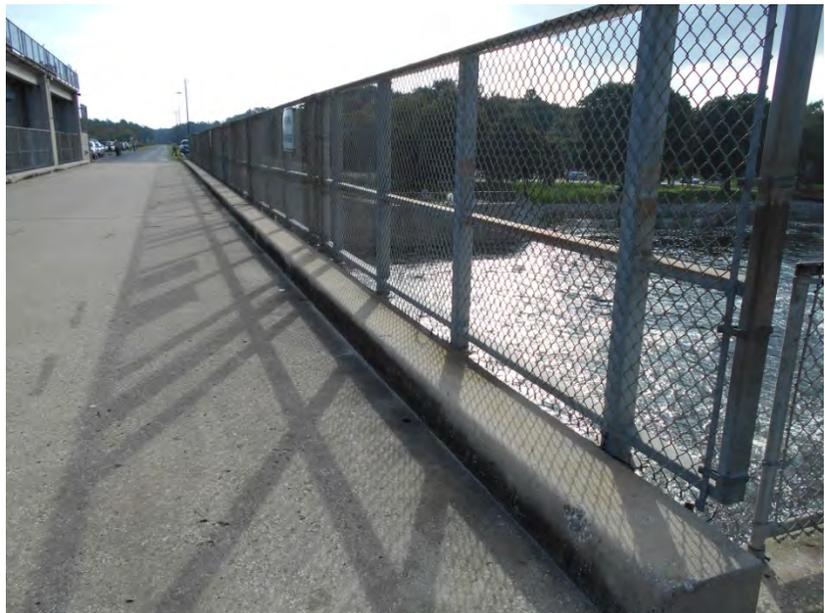
Description:
The service bridge does not have crash resistant barrier rails along the copings.

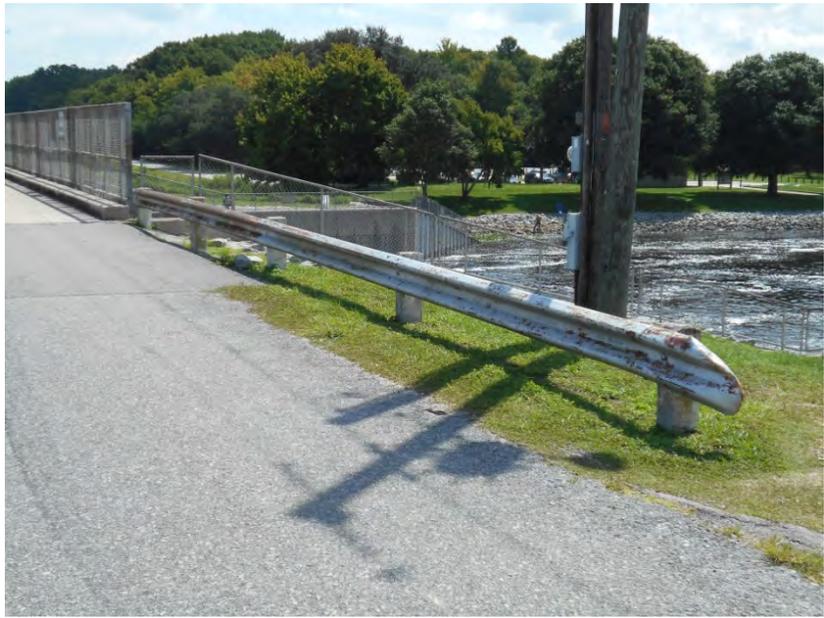
Description:
The guardrail at the bridge approaches does not meet current standards.

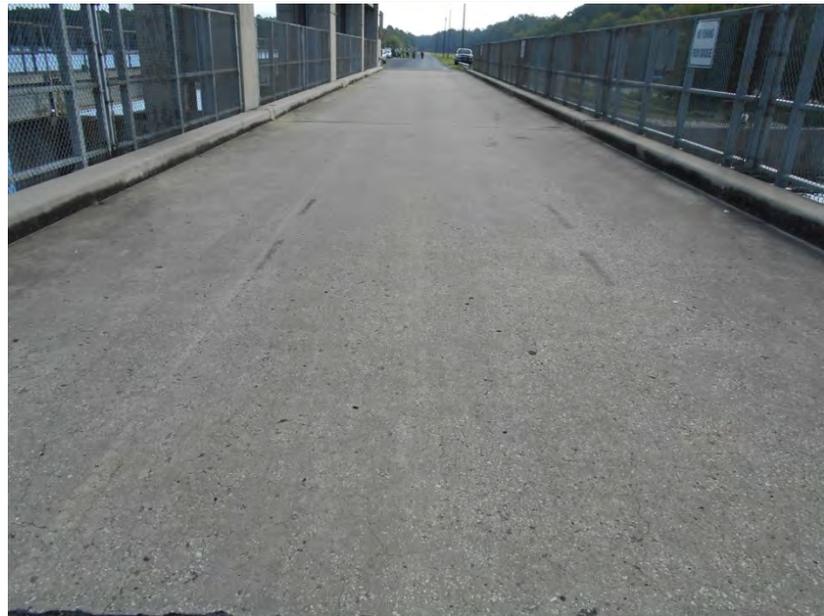
Description:
The service bridge does not have lane striping.

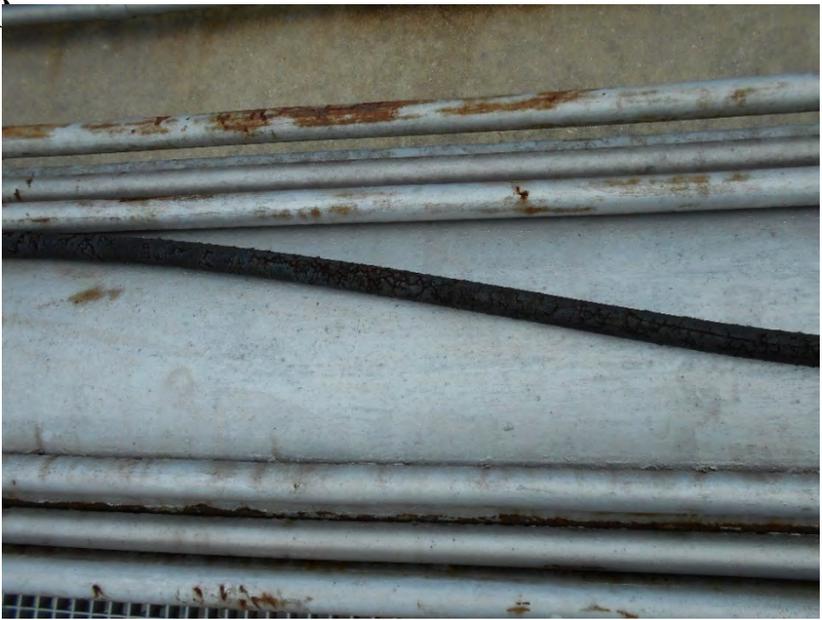
<h2>PHOTOGRAPHIC LOG</h2>	
<p>Structure: Kirkpatrick Dam and Spillway</p> <p>Checklist Item: ME2</p>

<p>Rating: ME-3</p>	<p>Date: 07-27-2015</p>		
<p>Description: Hydraulic Power System: Rotting hose to blind rod end on cylinder No. 4.</p>

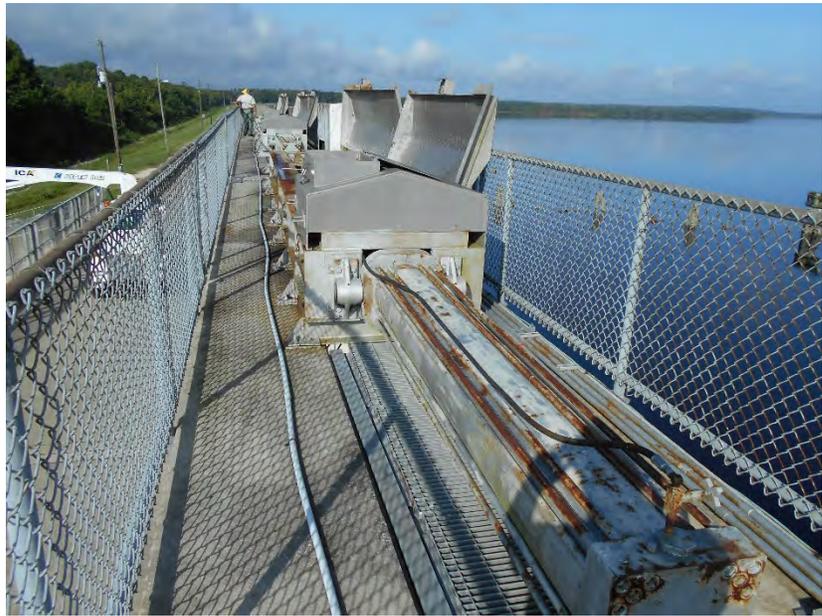
Description:
Hydraulic Power System:
Slight corrosion on hydraulic cylinder, typical all locations.

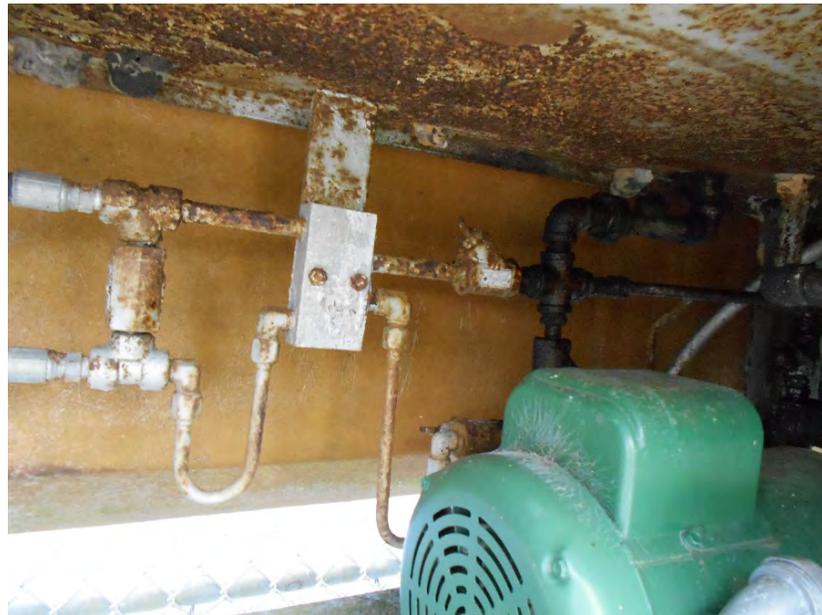
Description:
Hydraulic Power System:
Slight corrosion on hydraulic piping system, typical.

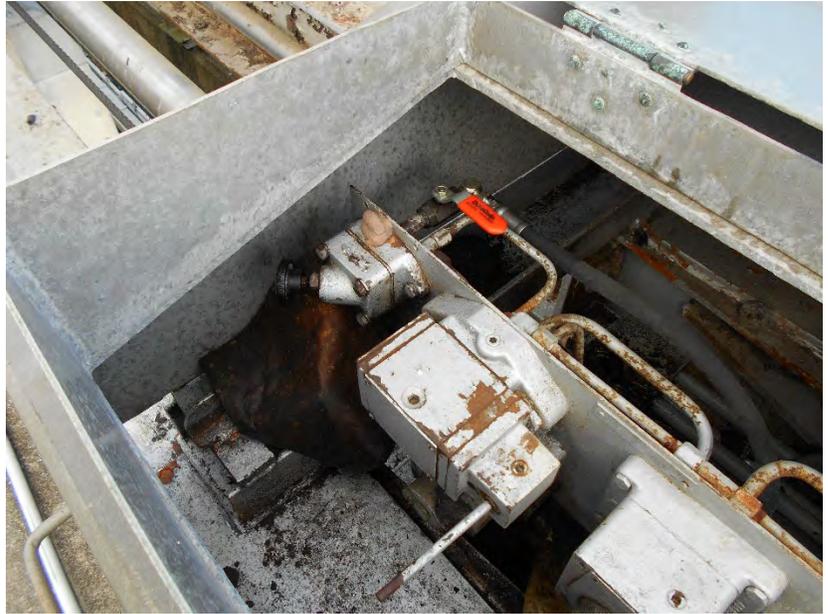
Description:
Hydraulic Power System:
Slight leakage at control
valves, Cylinder No. 3
shown, typical for all.

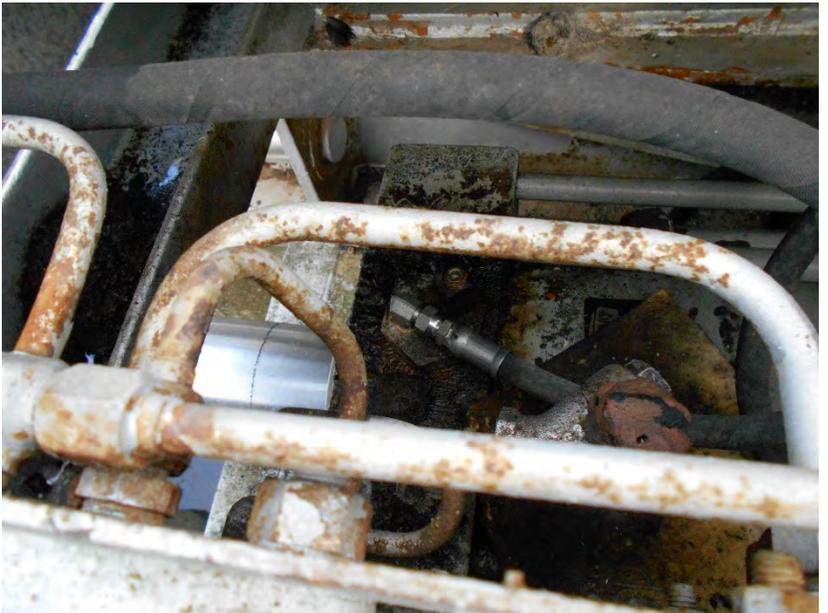
Description:
Hydraulic Power System:
Slight leakage at cylinder
head fitting of Cylinders
Nos. 1 and 3, Cylinder No. 3
shown.

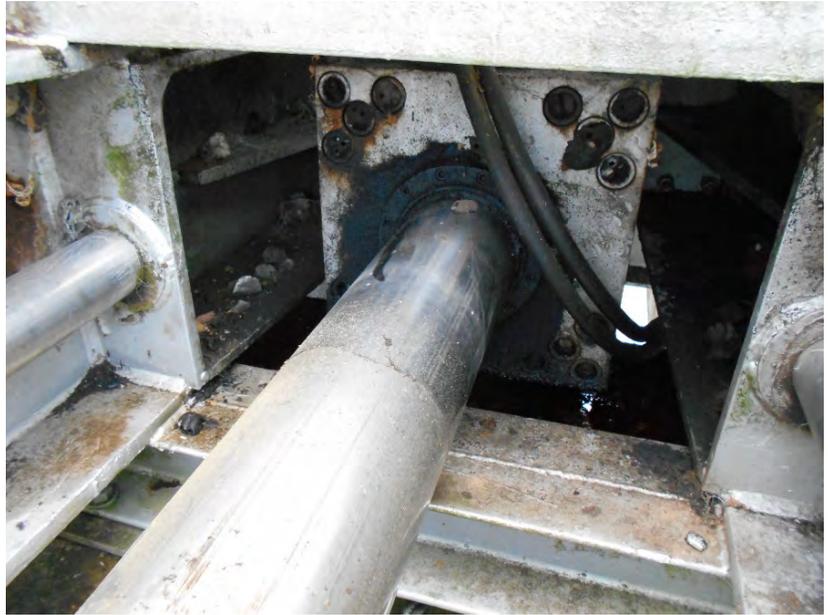
Description:
Hydraulic Power System:
Slight leakage around rod seal of Cylinder No. 4.

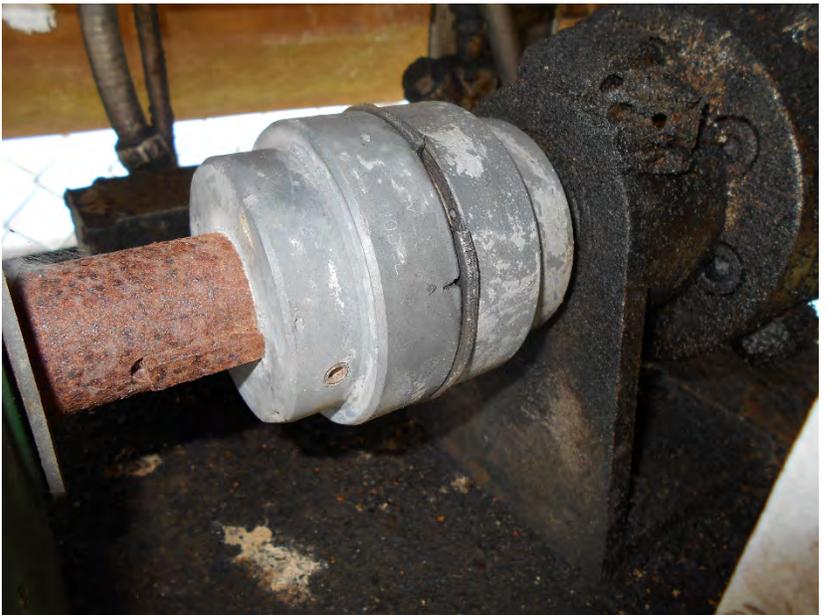
Description:
Hydraulic Power System:
Rubber spider within motor/
pump coupling shows signs
of deterioration.
