Kirkpatrick Dam and Spillway Condition Assessment September 2015

Inspection Date: July 27-28, 2015

Subject: Florida Department of Environmental Protection Contract No. DC 827
Task Assignment No. 4
Kirkpatrick Dam and Spillway Condition Assessment Report, September 2015

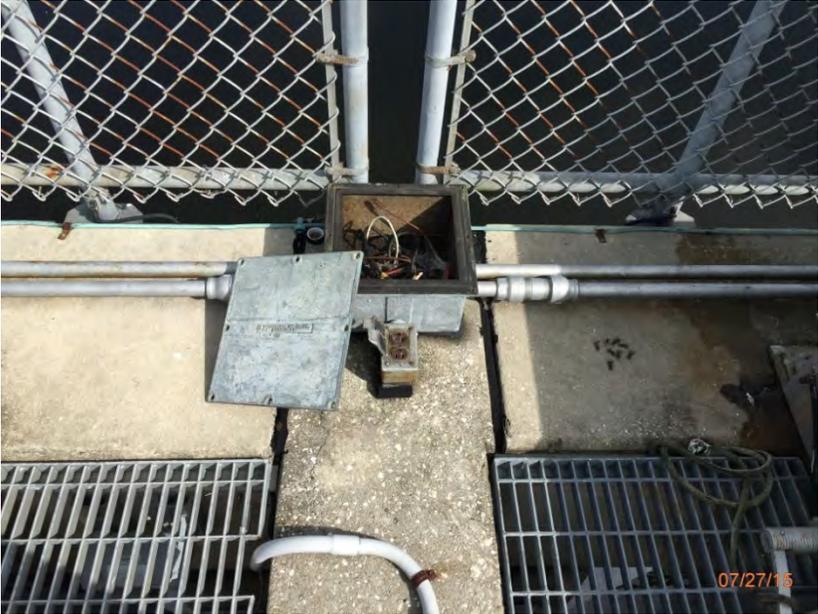
<h2>PHOTOGRAPHIC LOG</h2>	
<p>Structure: Kirkpatrick Dam and Spillway</p> <p>Checklist Item: EL1</p>

<p>Rating: EL-3</p>	<p>Date: 07-27-2015</p>		
<p>Description: Verify receptacles on top of structures are GFCI protected.</p>

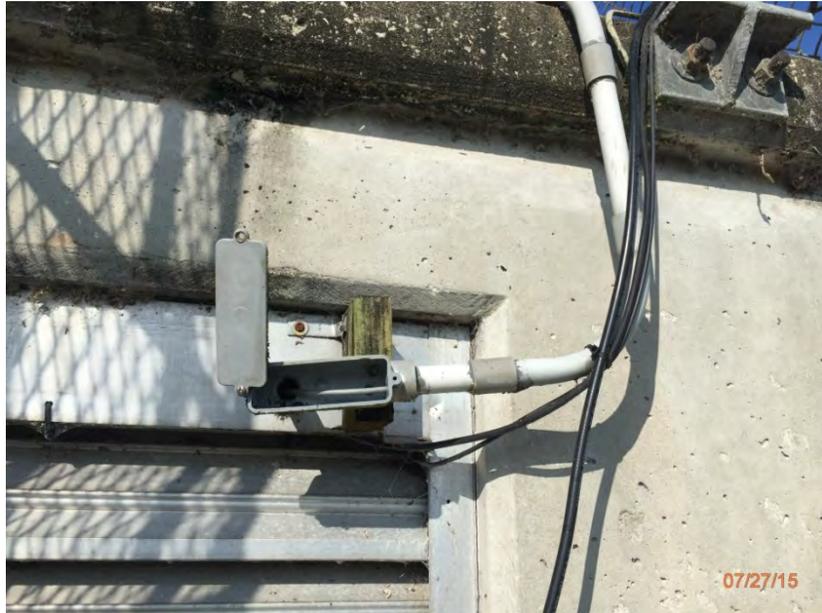
Description:
Conduit body outside generator contained water.

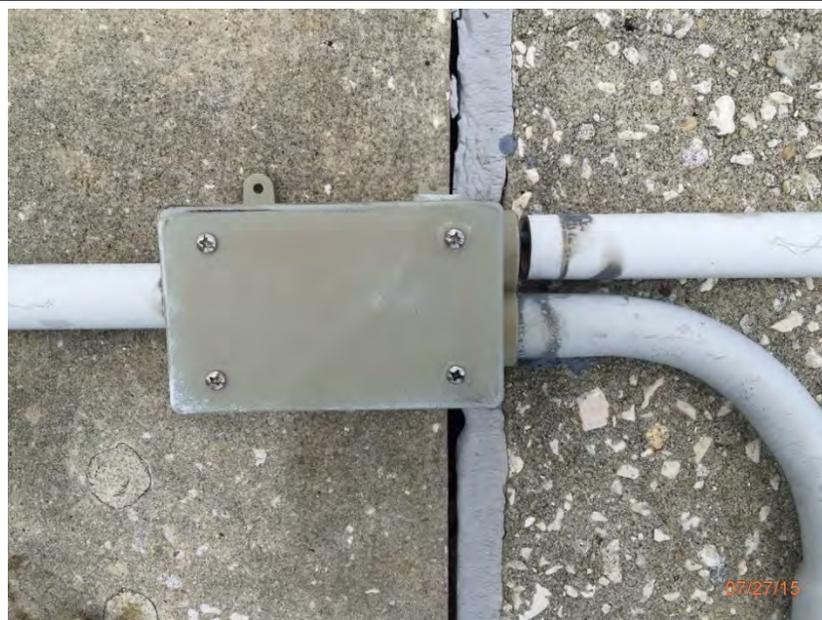
Description:
Conduits on top of structure are pulling away from pull boxes.

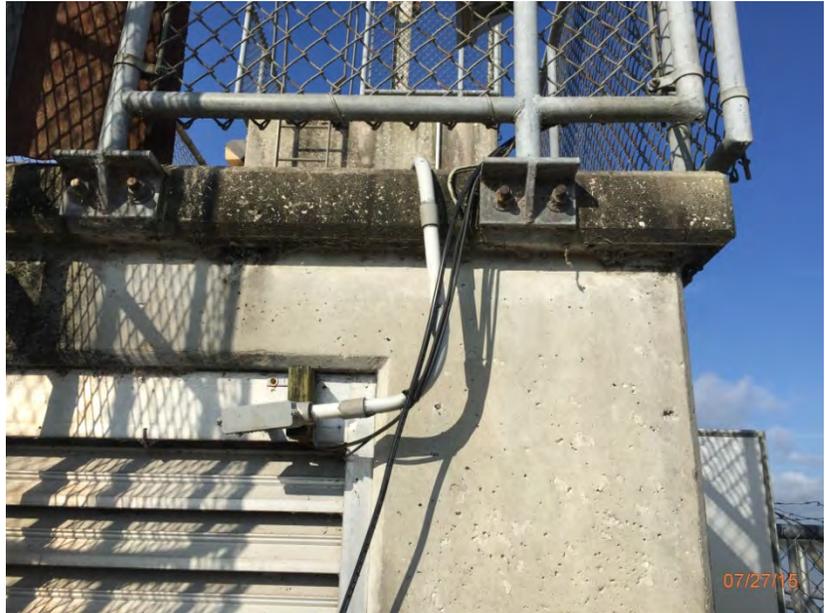
Description:
Conduit is not properly supported.

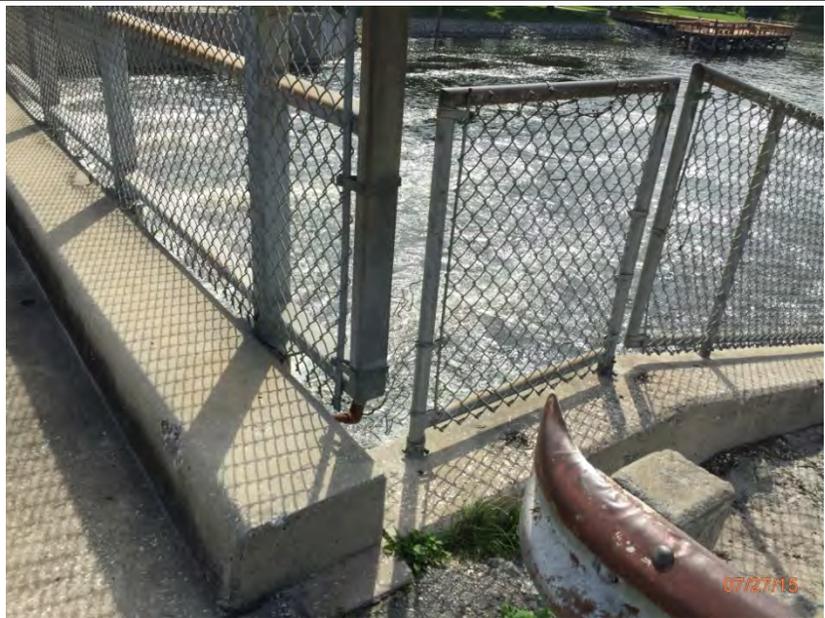
Structure:
Kirkpatrick Dam and Spillway
Checklist Item:
EL8

Description:
Several areas of the fencing are not properly bonded to the lightning protection system.

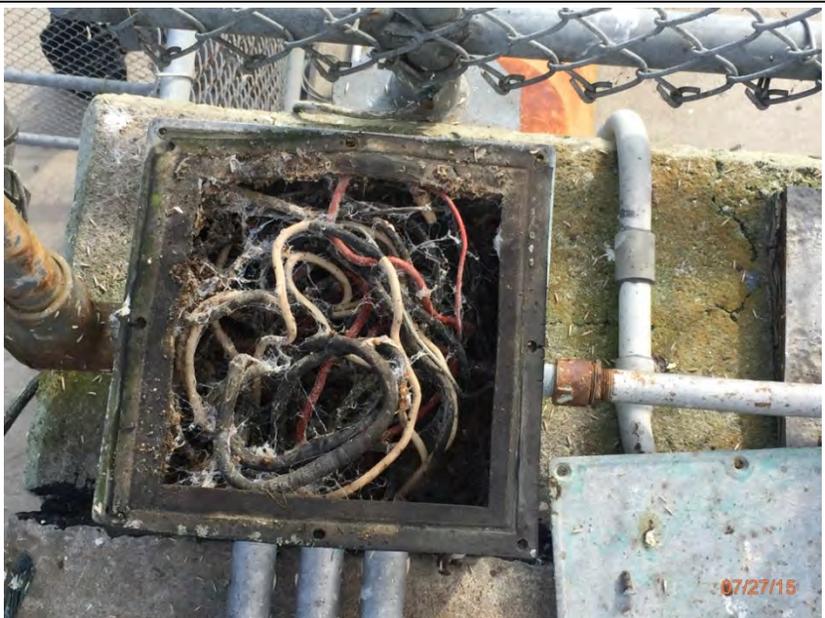
Description:
Several pull boxes and
termination boxes contain
heavy insect debris.

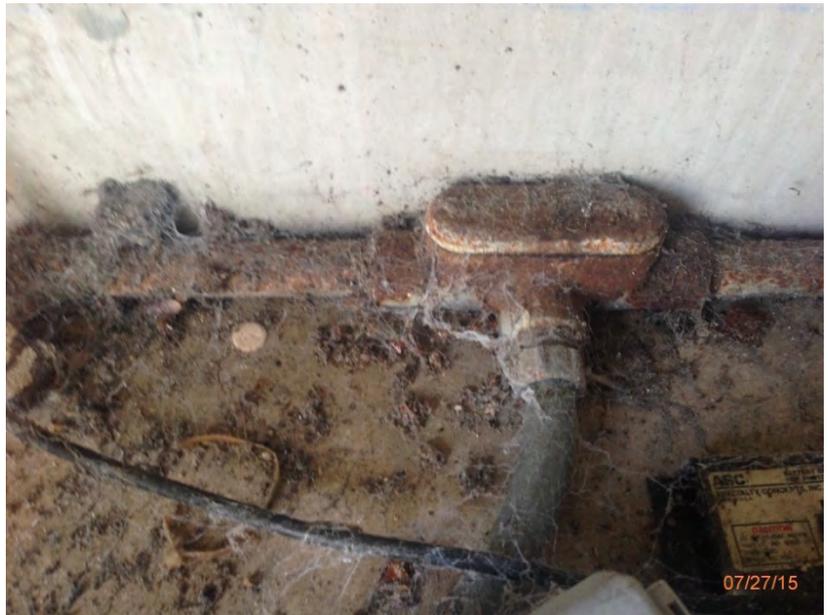
Description:
Several conduit bodies exhibit moderate corrosion and are covered with insect debris.

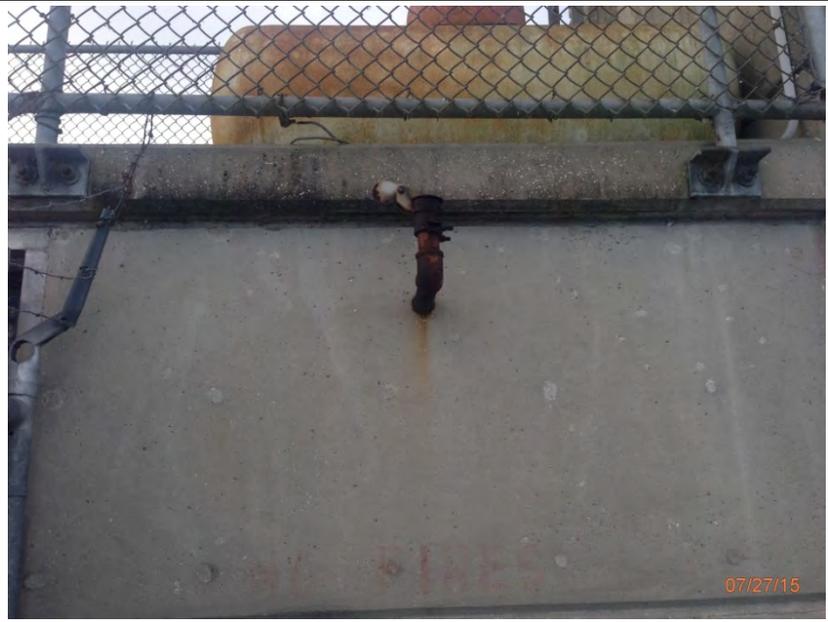
Structure:
Kirkpatrick Dam and Spillway
Checklist Item:
EL12

Description:
Generator exhaust pipe exhibits moderate corrosion.

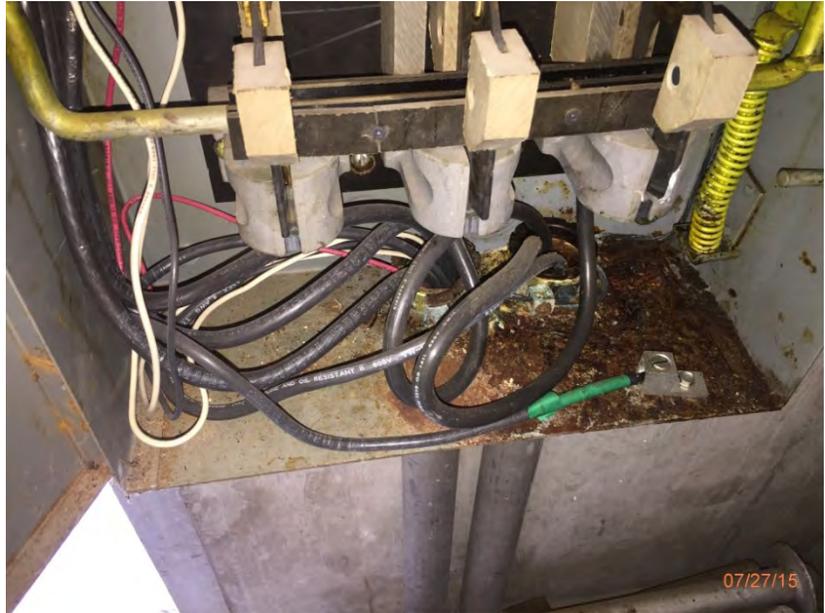
Description:
Ground and neutral should only be bonded at first point of disconnect. Ground not bonded at the main disconnect switch.

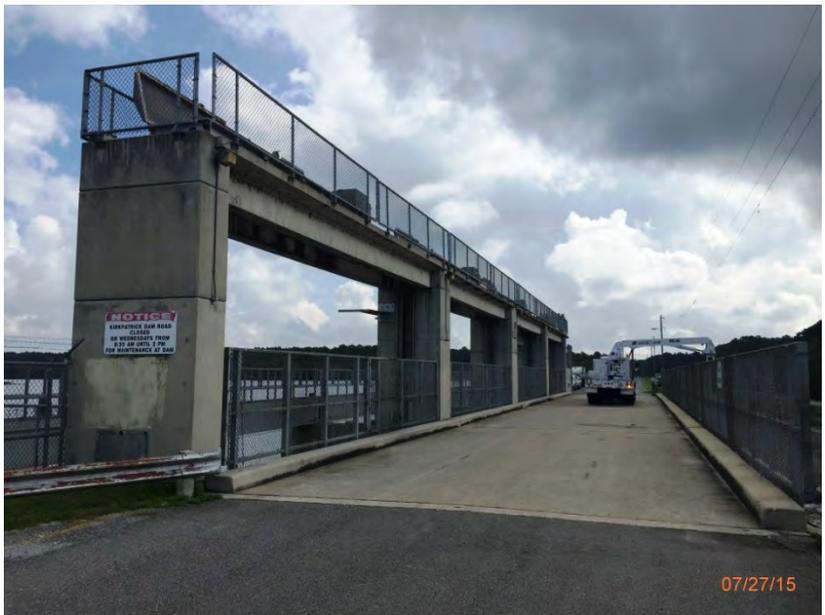
Description:
Missing air terminals.

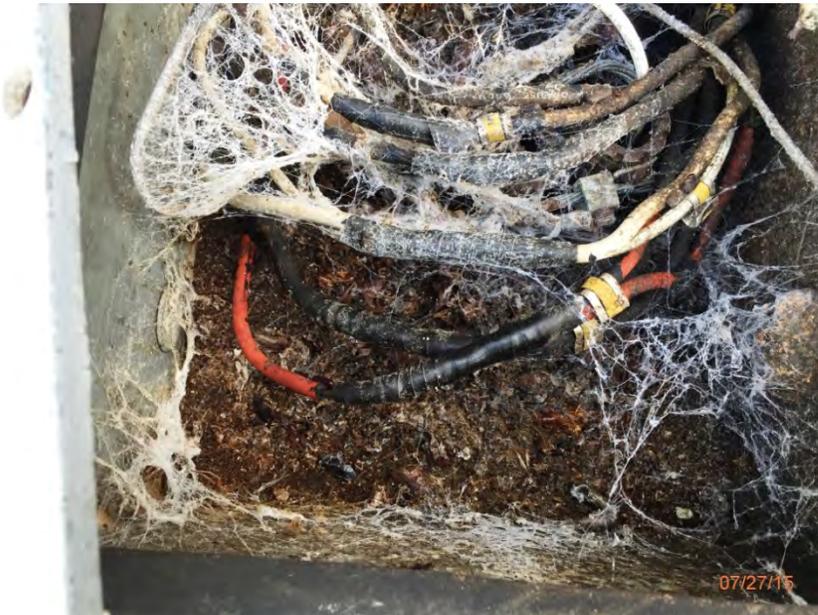
Description:
Several conductors within junction box on top of structure are bare and exposed.

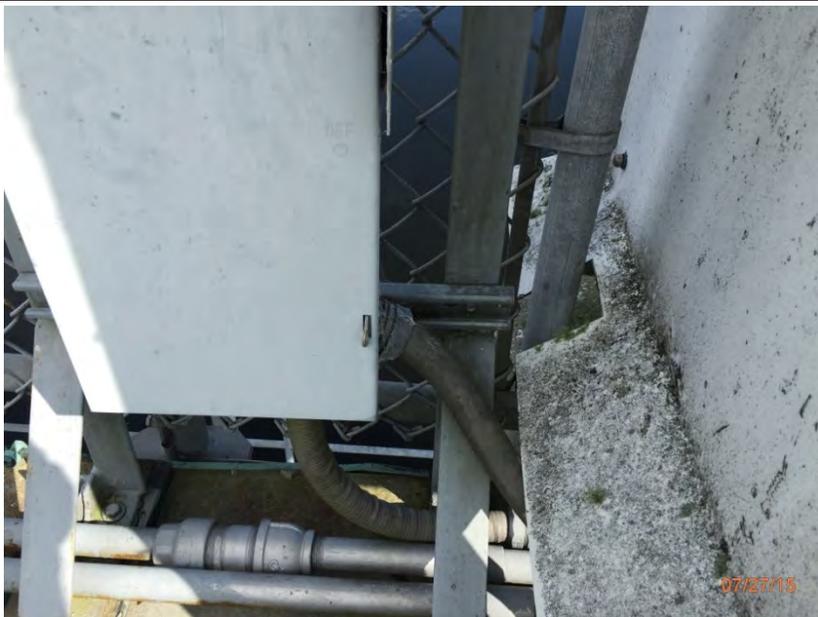
Description:
Conduit entering motor disconnect switch does not have a sufficient bending radius

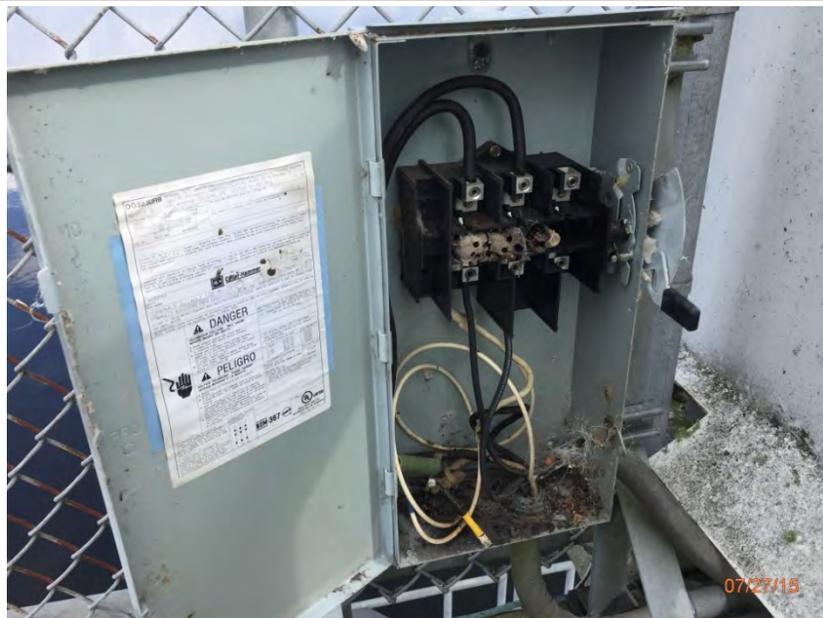
Description:
Motor disconnect switch exhibits light corrosion and contains insect debris.

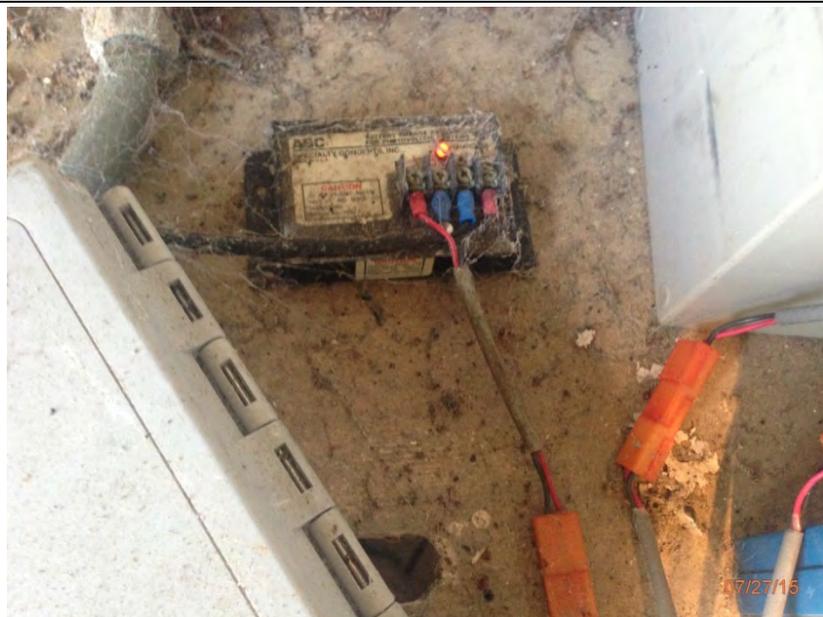
Structure:
Kirkpatrick Dam and Spillway
Checklist Item:
EL19

Description:
Electrical equipment within generator room covered with dirt and debris.

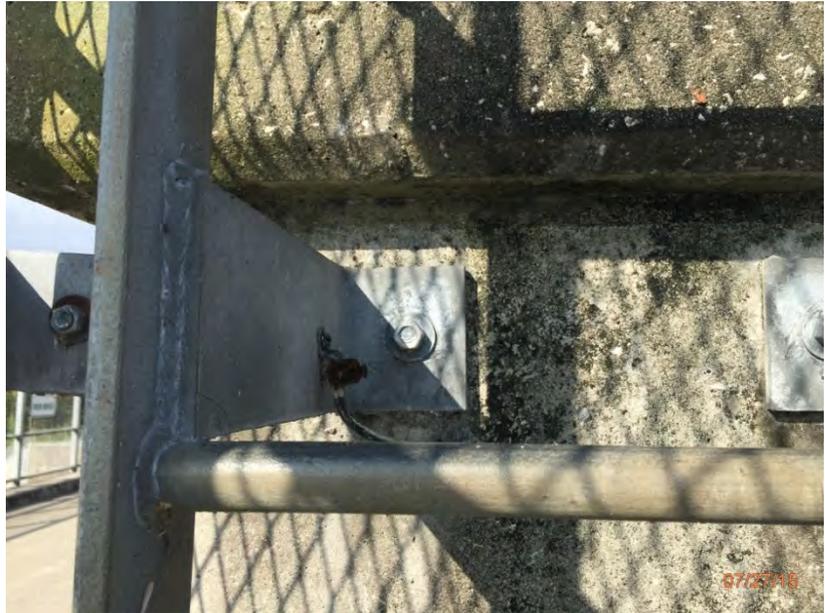
Description:
Lightning protection
grounding connections
exhibit heavy corrosion.

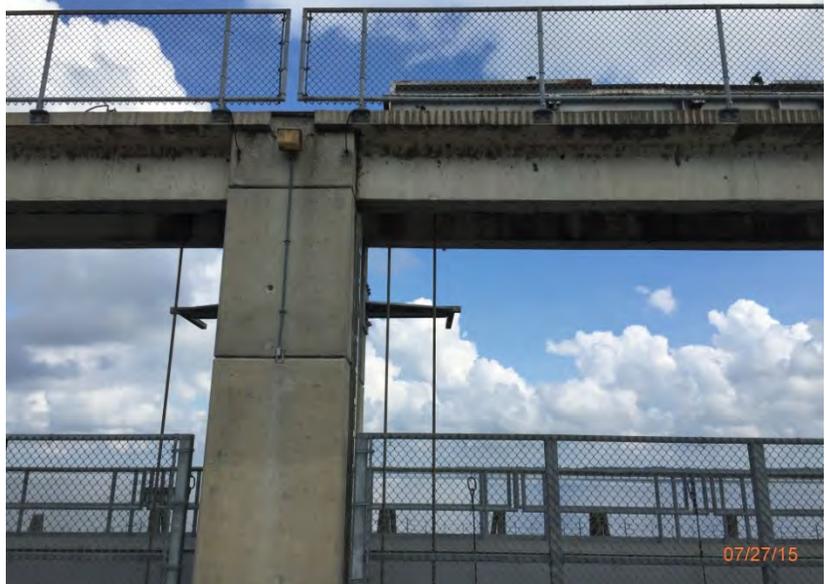
Description:
Outdoor light fixtures do not
appear to be operational.

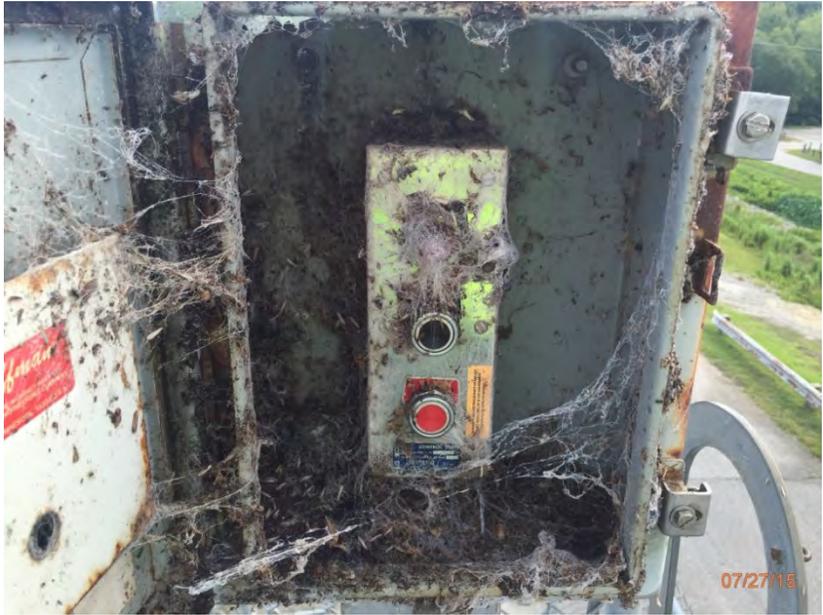
Description:
Control panel at top of structure contains large amounts of insect debris.

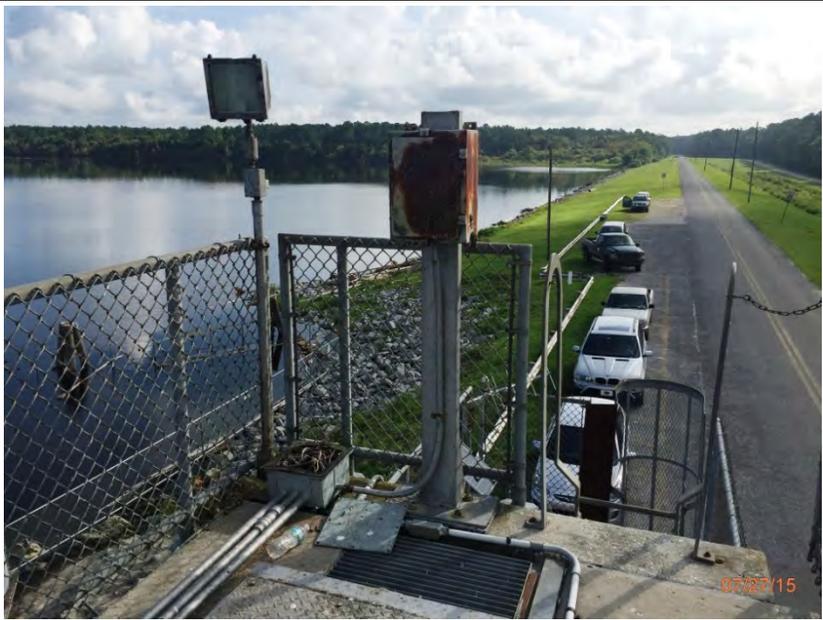
Description:
Control panel junction exhibits severe corrosion.

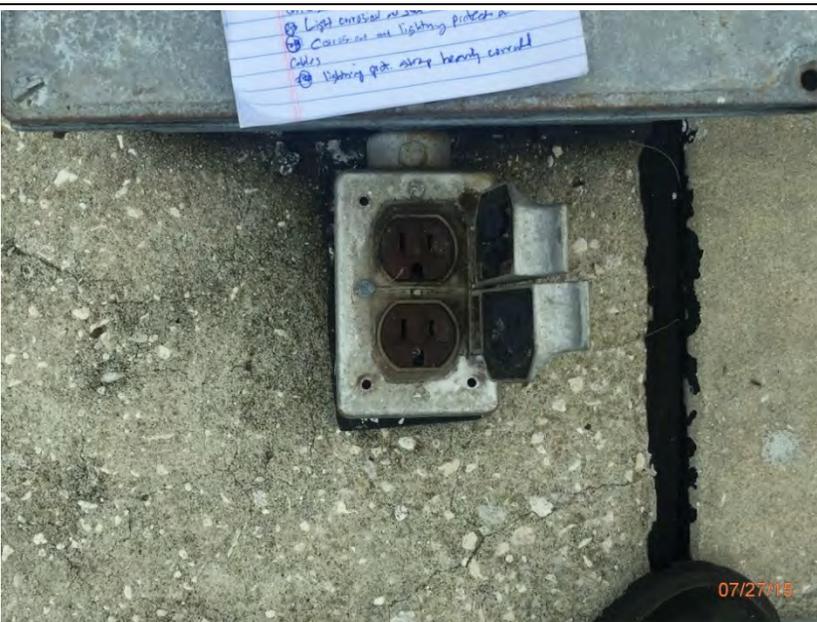
Description:
Several receptacles on top of structure are missing fasteners.

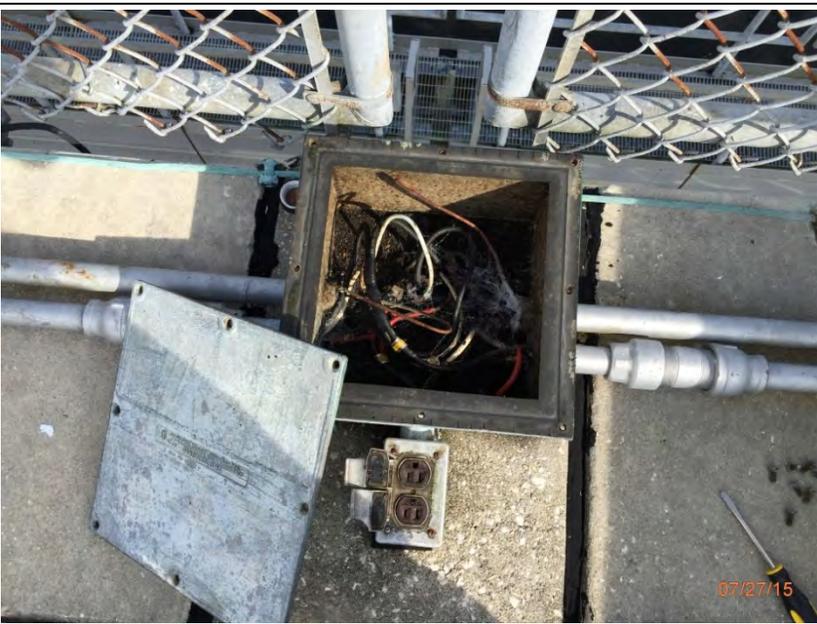
Structure:
Kirkpatrick Dam and Spillway
Checklist Item:
EL29

Description:
Several pull boxes on top structure exhibits moderate corrosion and weather seal and wiring has deteriorated.

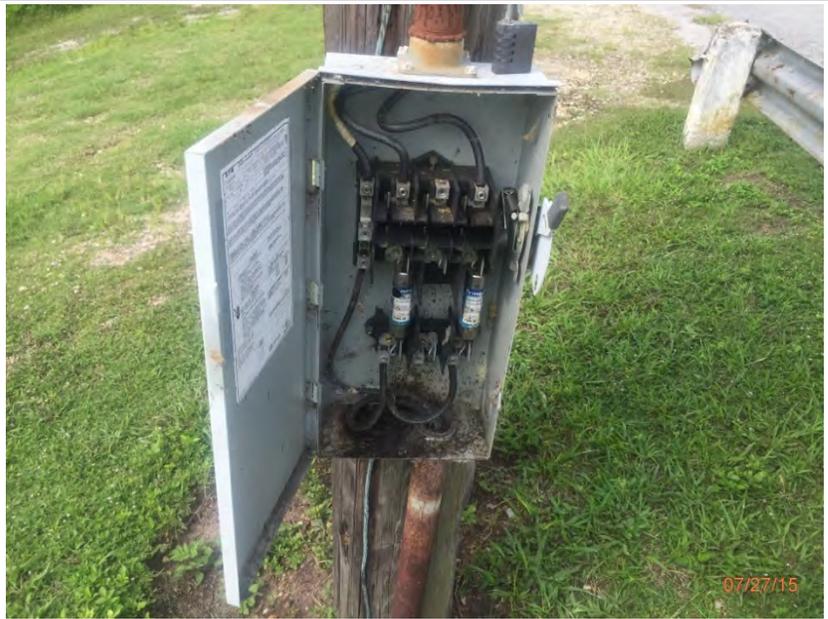
Checklist Item:
EL30

Description:
Service meter disconnect contains insect debris and exhibits light to moderate corrosion.

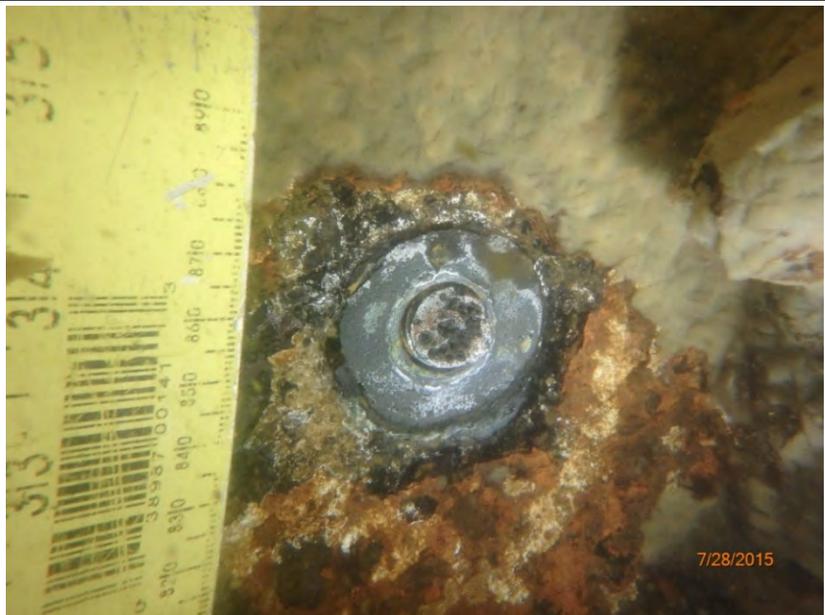
Item	Description	Action
UW1	The upstream bolts holding the side seal on all four (4) gates have severe corrosion with up to 90% section loss.	Repair
UW2	Upstream steel sheetpile wingwall has random areas of corrosion.	Do Nothing
UW3	Upstream manatee barriers (frames and gratings) have several areas of minor corrosion (several logs were cleared to gain access to the gates and lower gratings down all the way to their seat).	Monitor
UW4	All the upstream concrete surfaces have scale up to 1/4-inch deep.	Do Nothing
UW5	There are numerous logs on the channel bottom in front of all four (4) gates and along the boat and debris barriers.	Repair
UW6	The floor slab was inaccessible downstream of the weirs due to the logs.	Repair
UW7	The boat barrier is comprised of vertical supports and horizontal cables (10 feet high in some areas). In the majority of the areas, the cables are corroded through and hanging.	Repair

Rating: UW-3 **Date:** 07-28-2015

Description:
The bolts holding the side seal on all four (4) upstream gates have severe corrosion with up to 90% section loss.

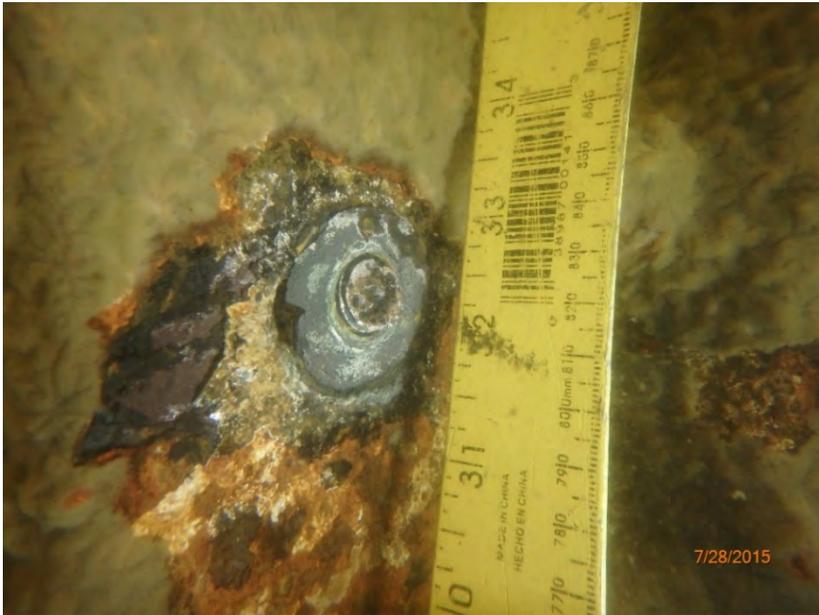
Rating: UW-3 **Date:** 07-28-2015

Description:
The bolts holding the side seal on all four (4) upstream gates have severe corrosion with up to 90% section loss.

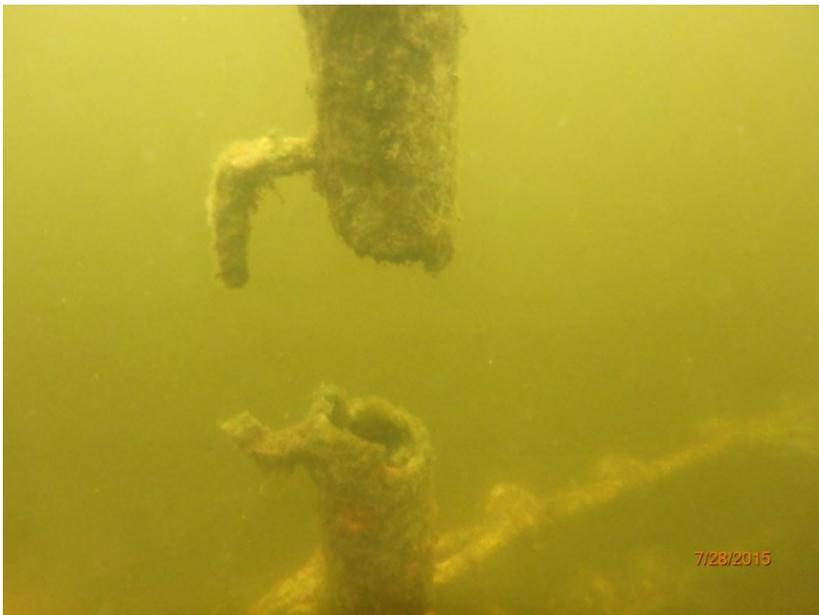
UW8	The majority of the vertical cable supports at the boat barrier are broken or corroded through below water.	Repair
UW9	Several of the eye bolts at the timber piles are loose or are corroded through at the boat barrier.	Repair
UW10	Timber piles are in good condition at the boat barrier.	Do Nothing
UW11	All the downstream concrete surfaces have scale up to 1/2-inch deep with up to 1-1/2-inch deep along the top of the weir in front of the gates.	Monitor
UW12	Several gates have minor leakage under full head.	Monitor

Rating: UW-3 **Date:** 07-28-2015

Description:
The majority of the vertical cable supports at the boat barrier are broken or corroded through below water.

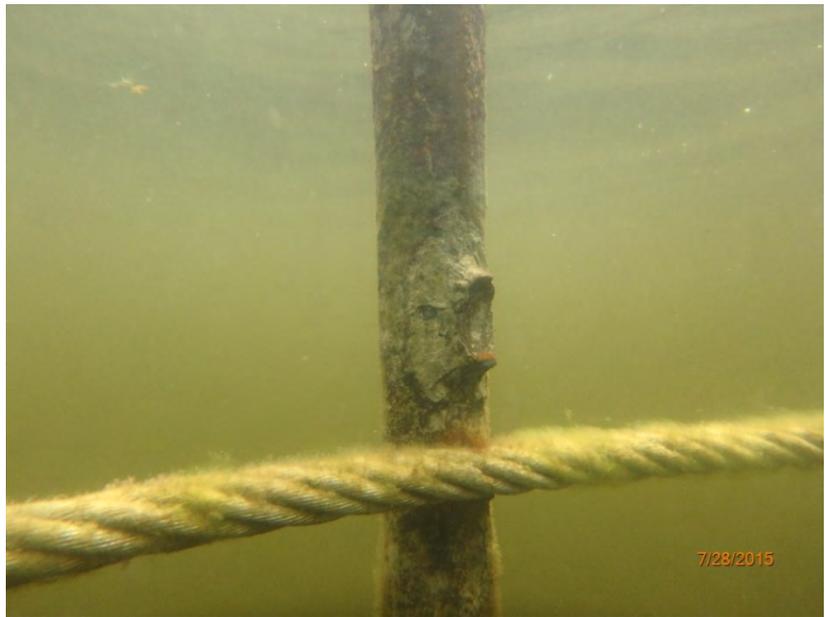
Description:
The majority of the vertical cable supports at the boat barrier are broken or corroded through below water.

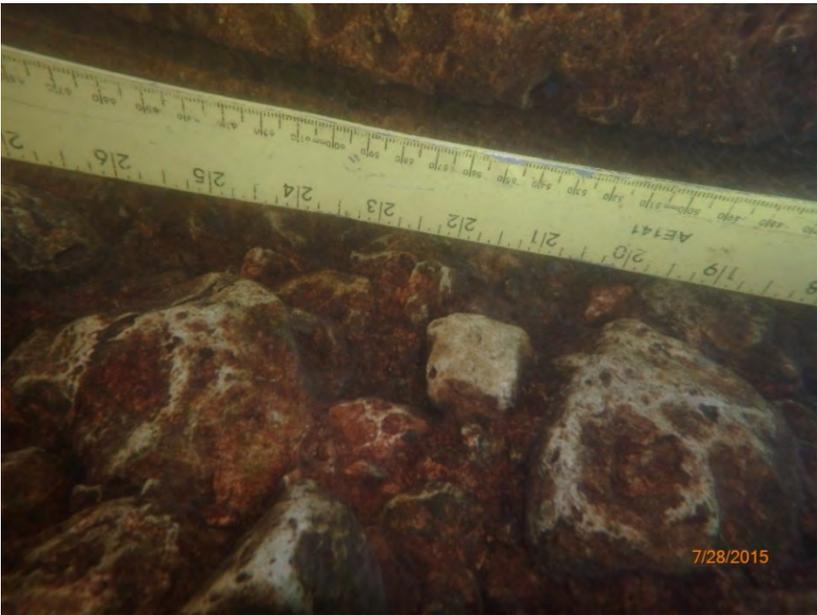
Description:
All the downstream concrete surfaces have scale up to 1/2-inch deep with up to 1-1/2-inch deep along the top of the weir in front of the gates.

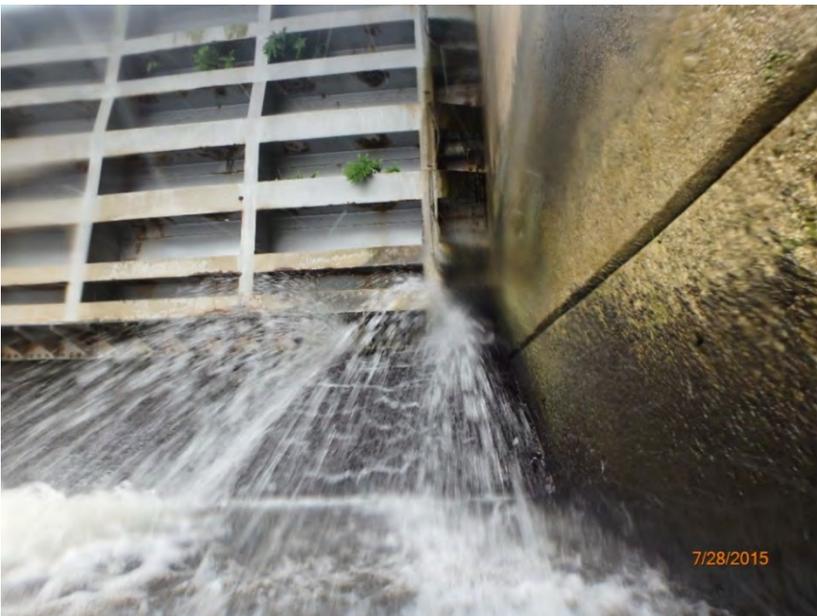
Description:
Several gates have minor leakage under full head.

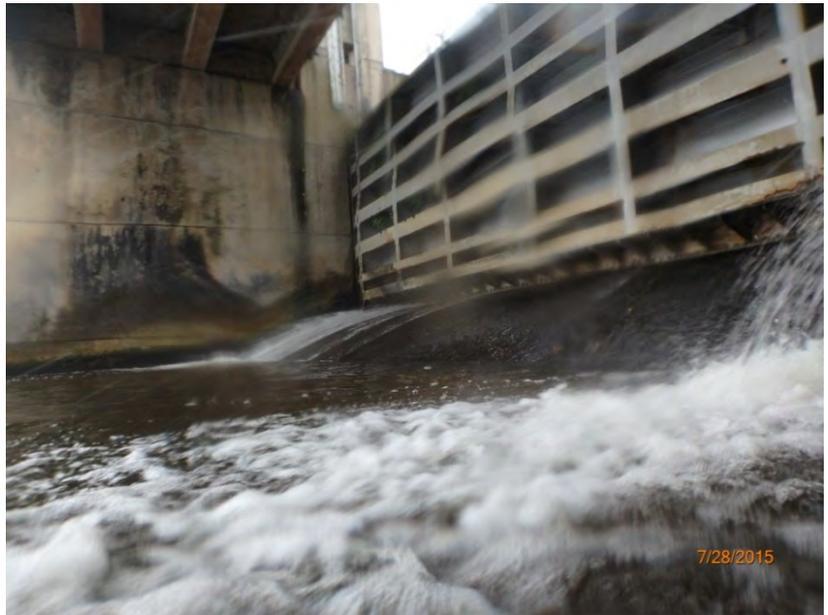
Description:
Several gates have minor leakage under full head.

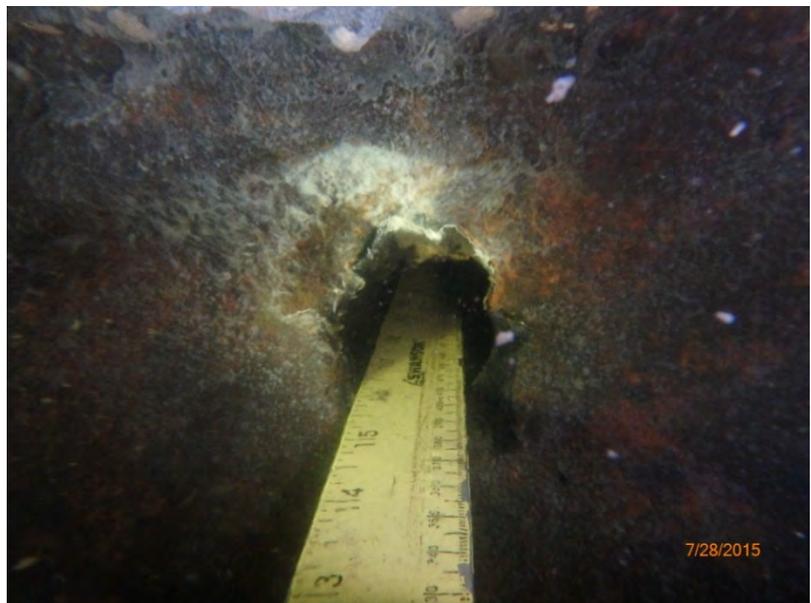
Description:
Along the end sill of the stilling basin, starting 15 feet from the east end, the stilling basin floor is undercut for a length of 100 feet up to 3 feet high extending back to a steel sheetpile wall. There are fifteen (15) lifting holes in the steel sheetpile located just below the concrete floor. The holes are up to 2 -inch diameter and can be probed 5 feet and light water flow can be felt through the holes.

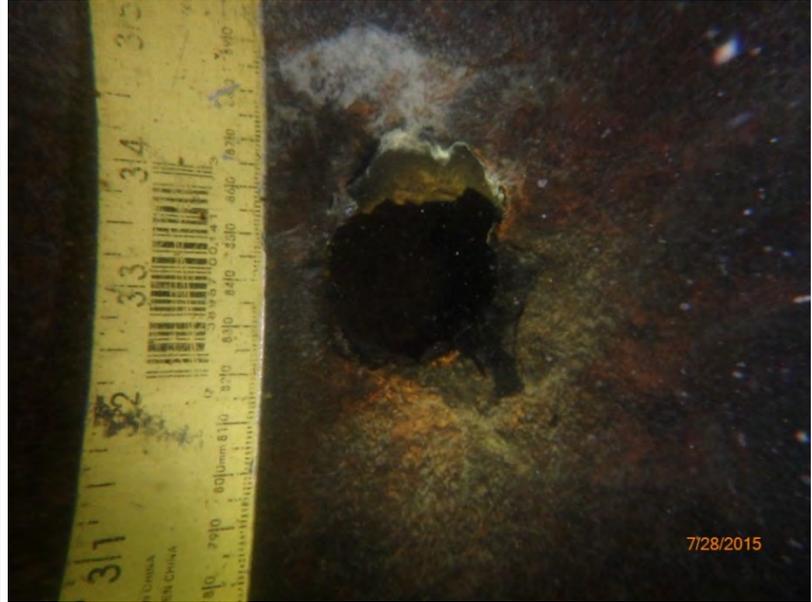
Description:
Along the end sill of the stilling basin, starting 15 feet from the east end, the stilling basin floor is undercut for a length of 100 feet up to 3 feet high extending back to a steel sheetpile wall. There are fifteen (15) lifting holes in the steel sheetpile located just below the concrete floor. The holes are up to 2 -inch diameter and can be probed 5 feet and light water flow can be felt through the holes.
