## Leaks Report -Level 0 and 1 East

Site Inspection 16.03.23  
Rainy Condition  
Prepare by P. Mazur

### Leaks Observation Report

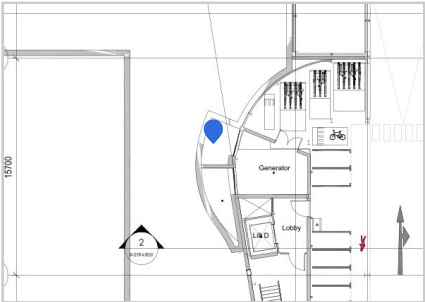
MISSING HATCH/PANEL

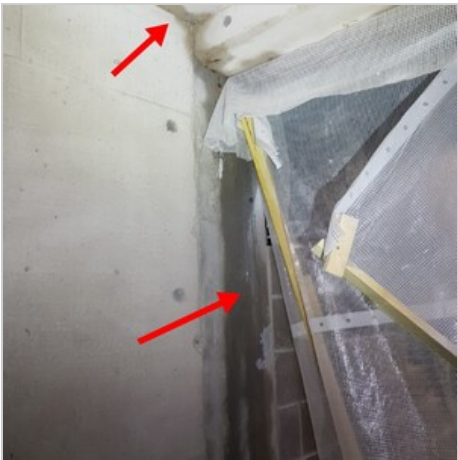
WET CONCRETE

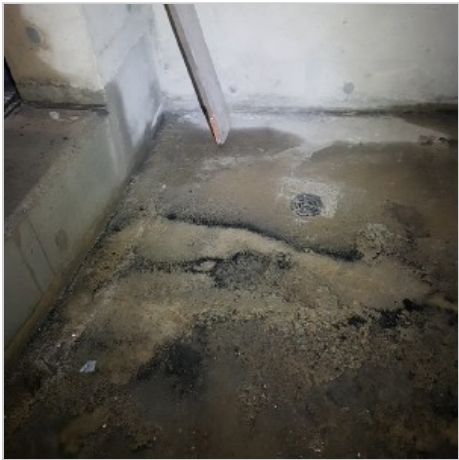
WET CONCRETE

NOT COMPLETED TO BE  
EXPOSED AND WEATHER  
PROOF MEMBRANE ADD

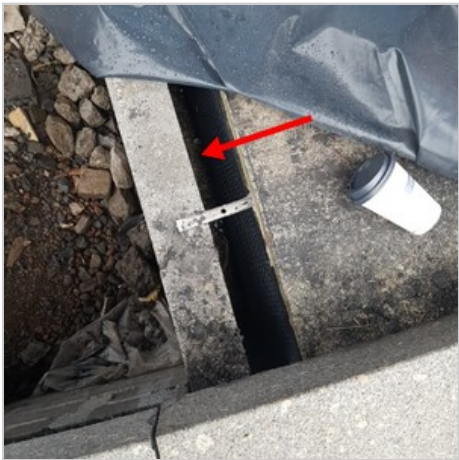
EMPTY CAVITY TO BE  
INFILL

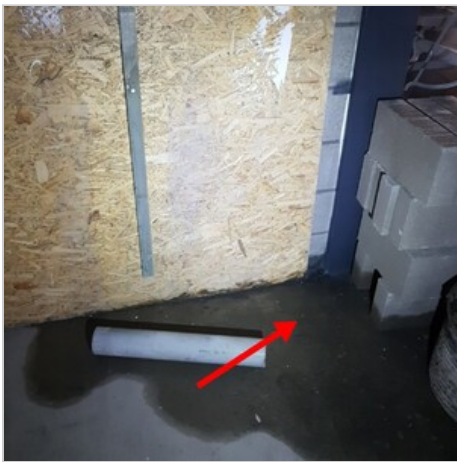
OUTSTNDING WORKS

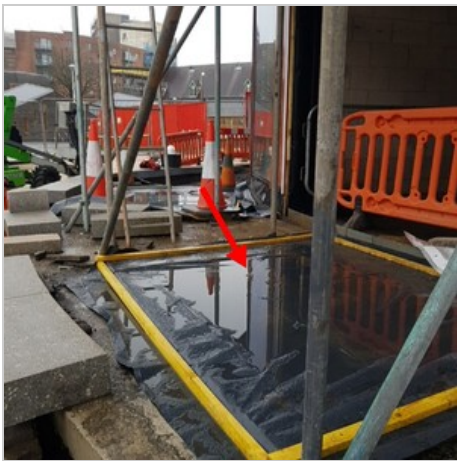
EMPTY CAVITY OUTSTANDING WORKS

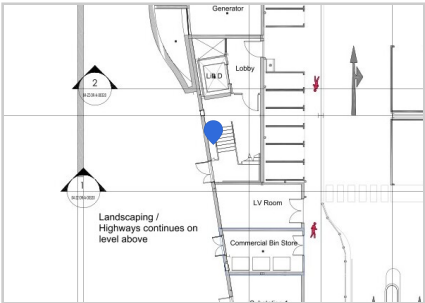
OUTSTANDING WORKS

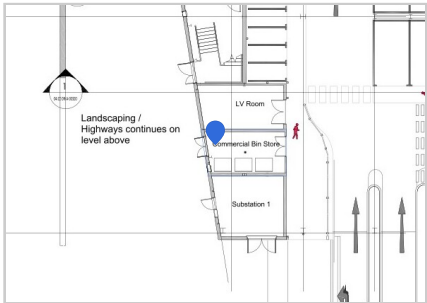
OUTSTANDING WORKS

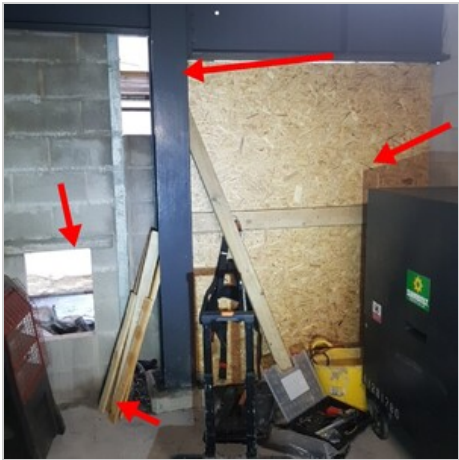
WET BLOCKWORK

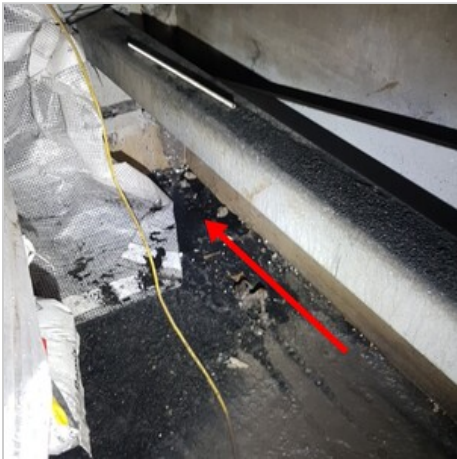
WET CONCRETE

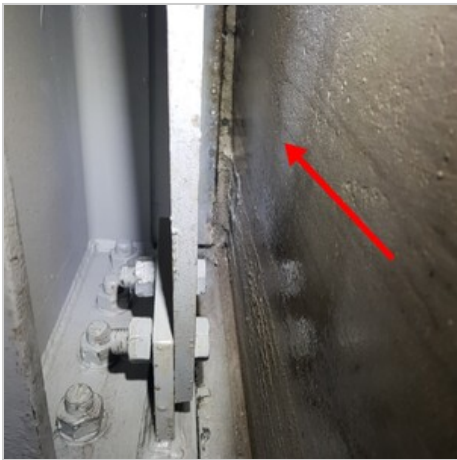
WET CONCRETE

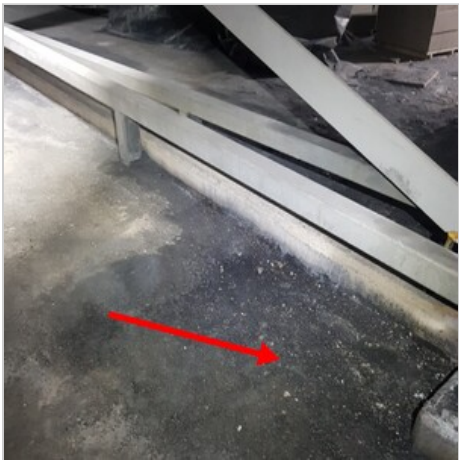
WET STEEL

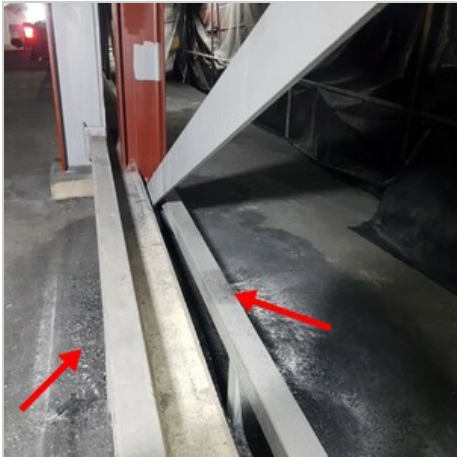
WET STEEL

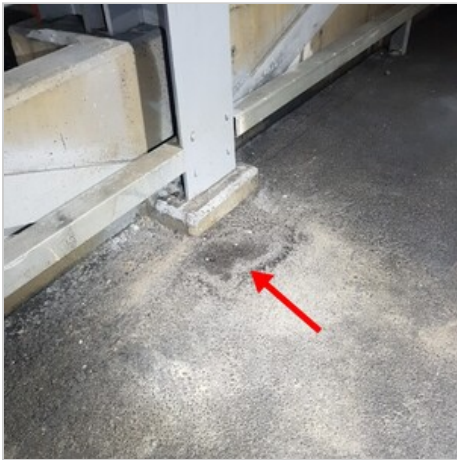
WET CONCRETE

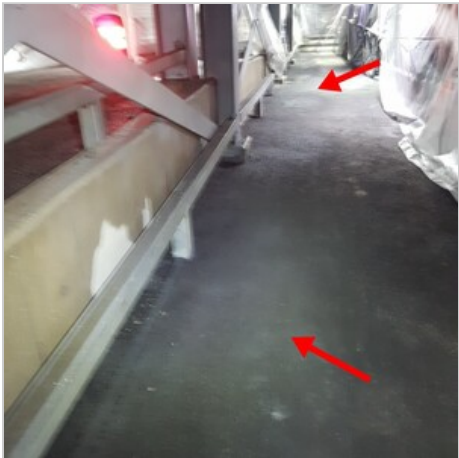
OUTSTANDING WORKS - CLADDING ZEFYR

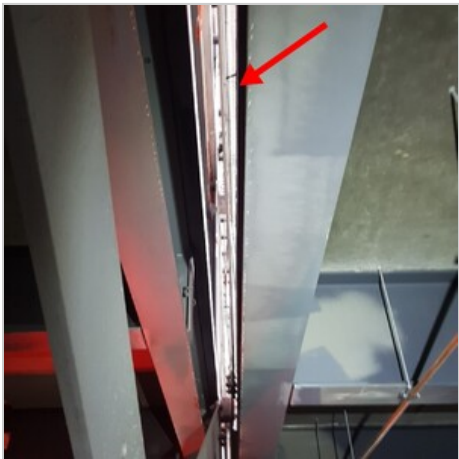
WET CONCRETE

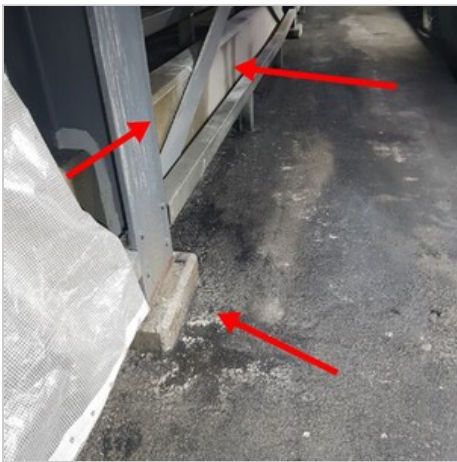
● **#27 - Leaks, Outstanding Works, RWP not connected - Weatherproof Part Complete - Not tested. Details slightly Change - Galv. Plate added-work to be supervise by BGCL . ( incl .Ab Glass and Zefyr )**

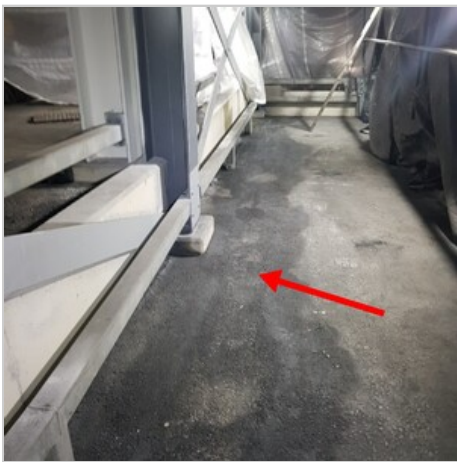
WET CONCRETE

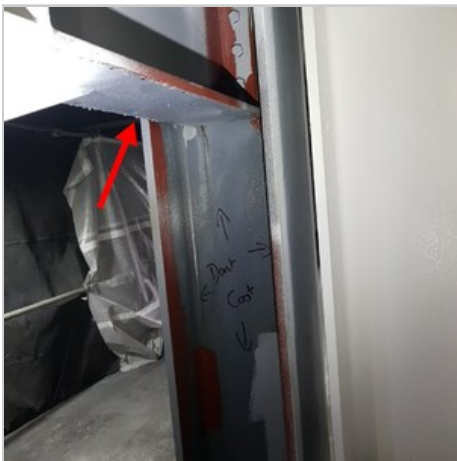
WET STEEL

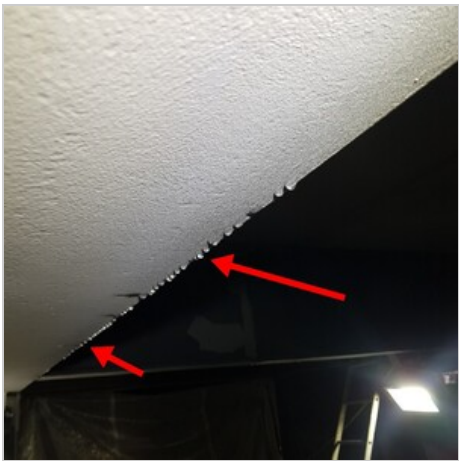
WATER ON THE STEEL

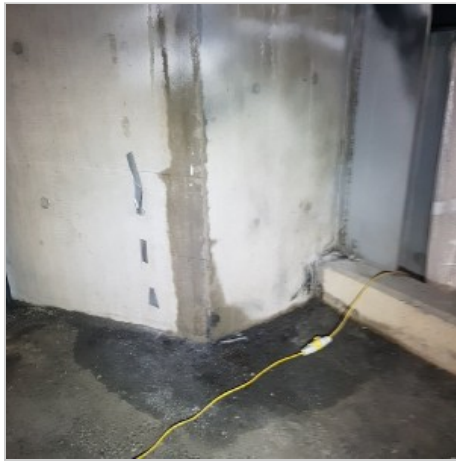
● **#33 - Leaks, Outstanding Works, RWP not connected - Weatherproof Part Complete - Not tested. supervise by BGCL . ( incl .Ab Glass and Zefyr )**

WET CONCRETE

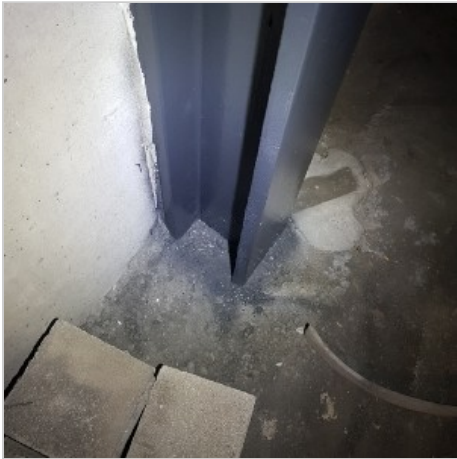
WET CONCRETE

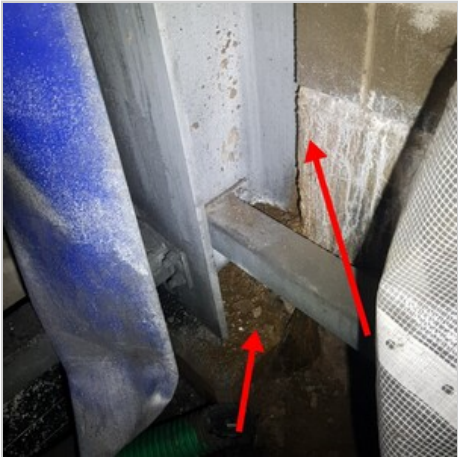
● #29 - Heavy leak behind Corner Column and Blockwork Damp/Wet .Leaks - Footpath Movement Weatherproof Joint, Drainage outlets TBC . Missing Weatherproof tests - To be investigate .

WET CONCRETE

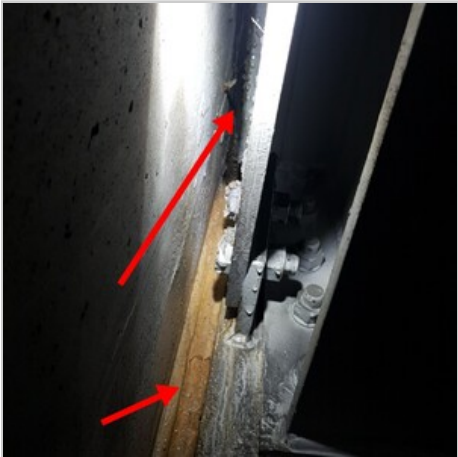
WET CONCRETE

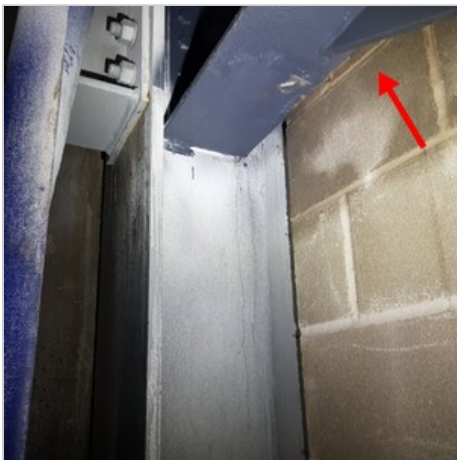
WET BLOCKS

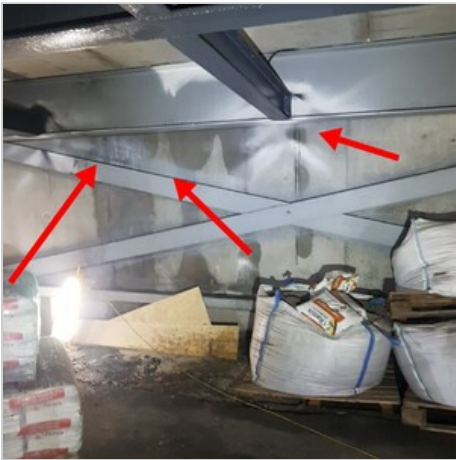
● **#30 - Leaks - Footpath Movement Weatherproof Joint, Drainage outlets TBC . Missing Weatherproof tests . To be investigate .**

WET CONCRETE

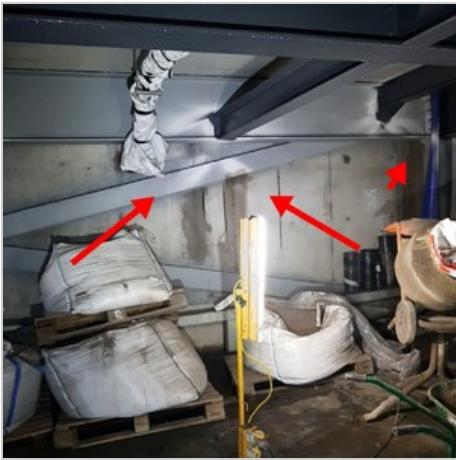
WET CONCRETE

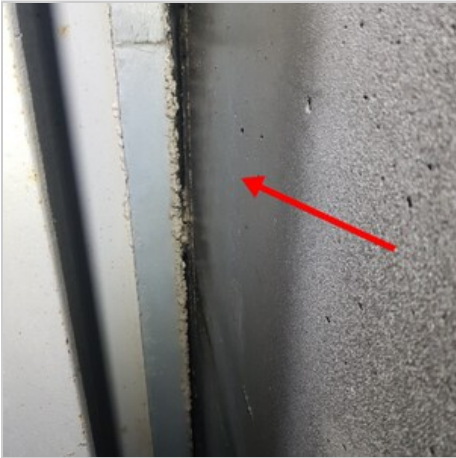
WET CONCRETE

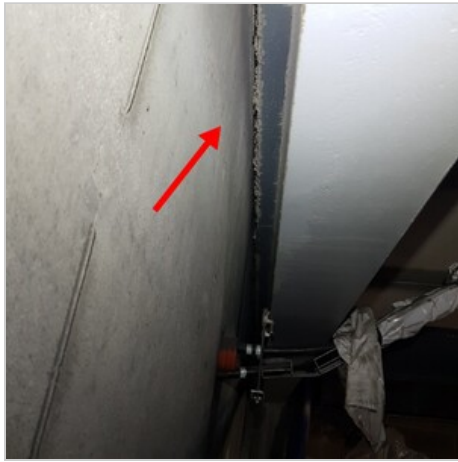
WET CONCRETE

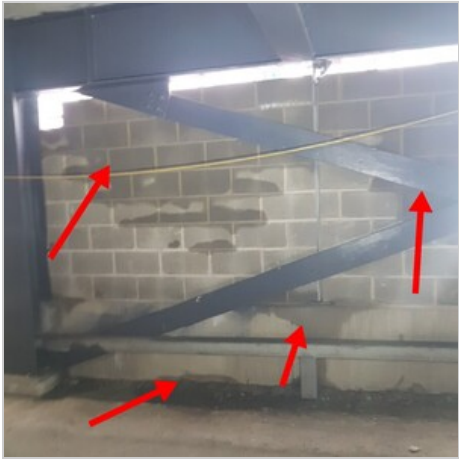
#32 - Outstanding Works - To be complete as per details

WET BLOCKS

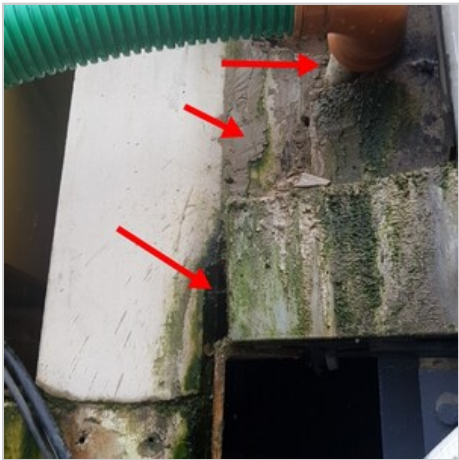
● **#43 - Corner Closures not completed and Water/Air penetrate along cavity. Not as per details. Missing Membrane/Weatherproof, EPDM, Flashings. Need to be remediate ASAP.**

DRAINAGE TO BE CHECK  
NOT COMPLETE WORKS

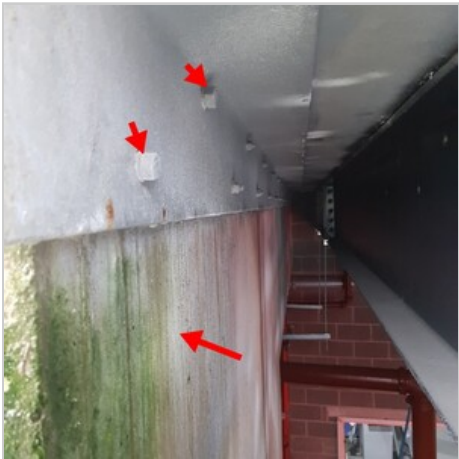
BOLTS CUT TO SHORT

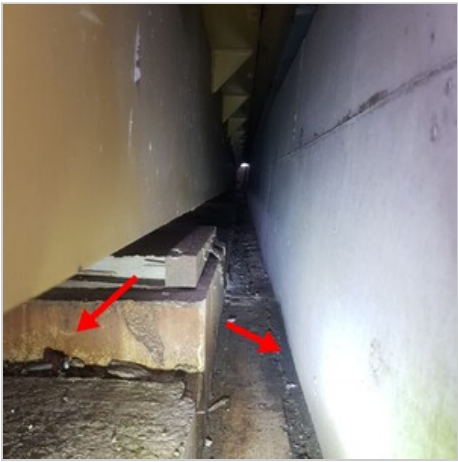
WATERPROOFING SHOWN  
ON DRAWINGS 21457 AND  
SECONDARY DRAINAGE  
PIPES

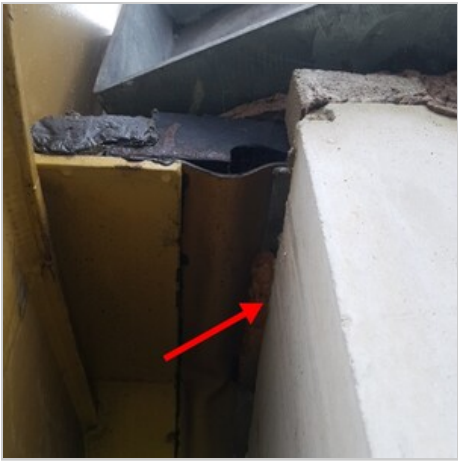
MOVEMENT LINE

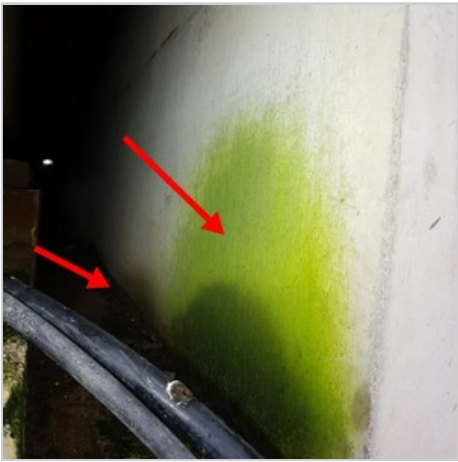
VISSIBLE MOSS AND GAPS

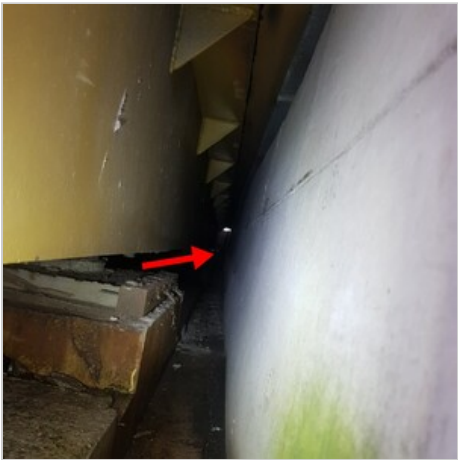
DAYLIGHT ON OTHER SITE

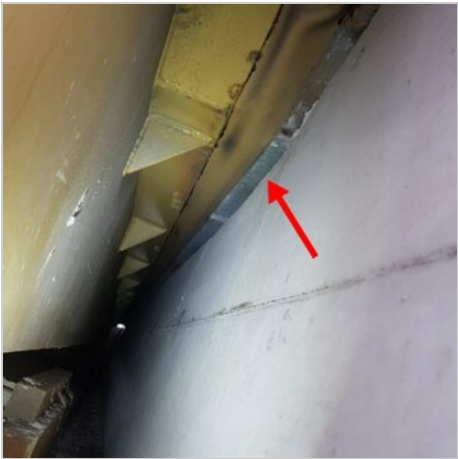
WATER PENETRATE  
THOROUGH THE GAPS ,  
VERTICAL AND  
HORIZONTALY

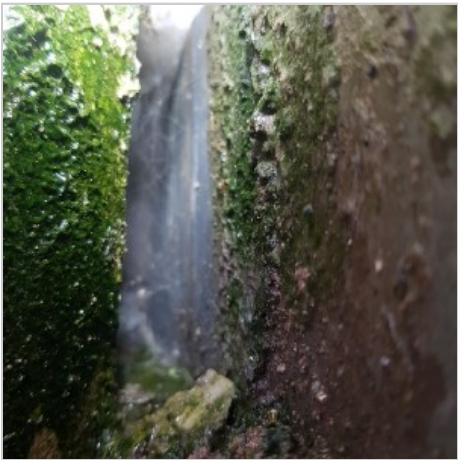
POOR FINISHED - NO  
WEATHERPROOF VISIBLE.

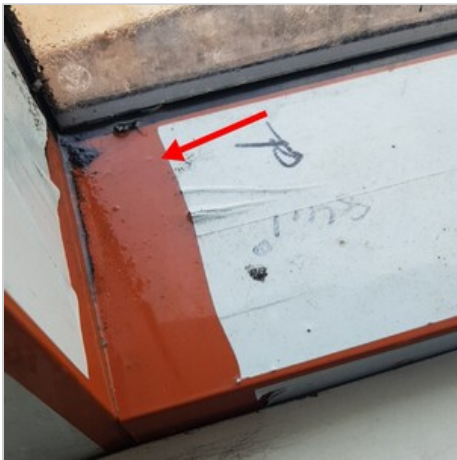
WATER ON CW

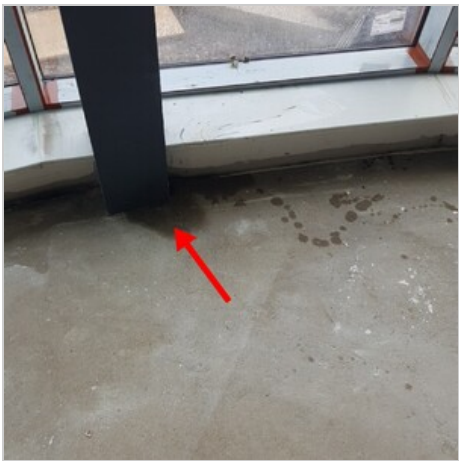
WET CW

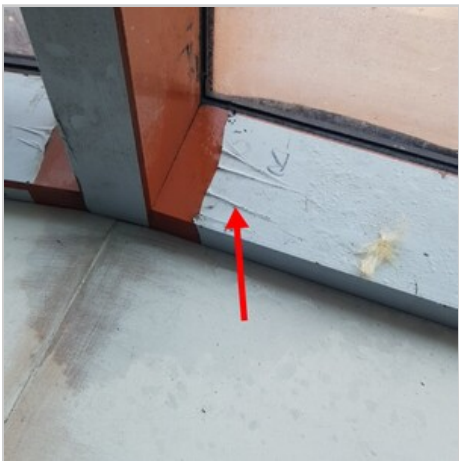
CW WET

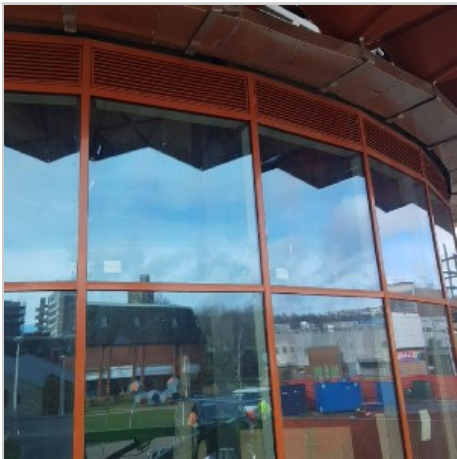
POOR WORKMANSHIP

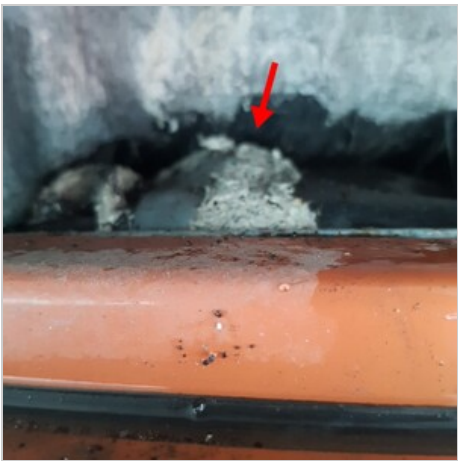
PROBLEM EVERY GRID  
LINE

SHARP OFFCUTS LEFT  
ON THE EPDM - QUALITY  
OF EPDM TO IMPROVE

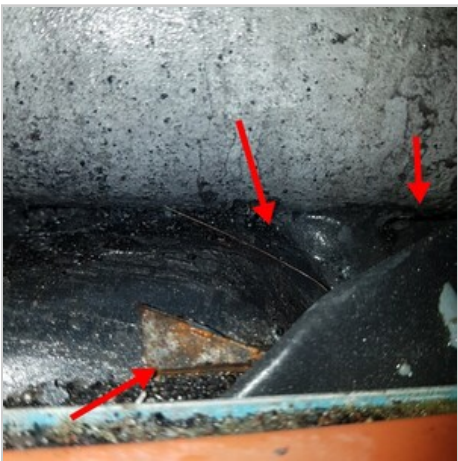
EPDM TO IMPROVE

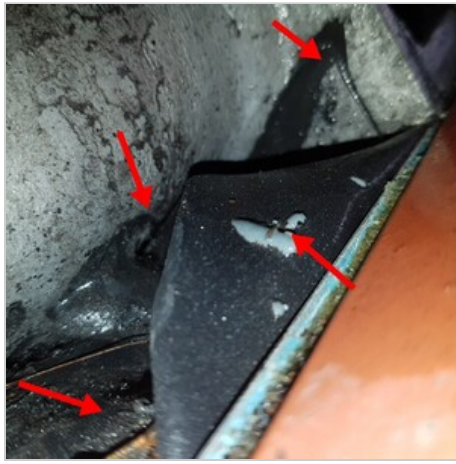
TYPICAL EPDM DETAILS  
RISK OF PONDING WATER

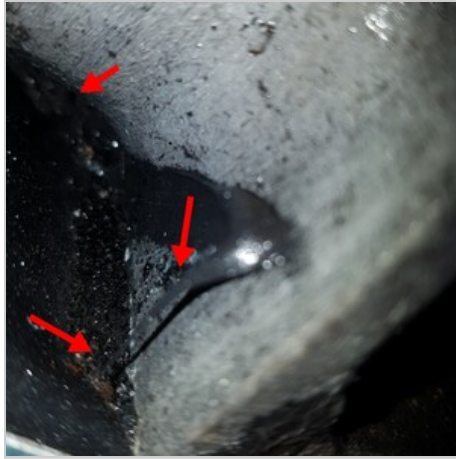
TYPICAL EPDM DETAILS  
WATER PONDING

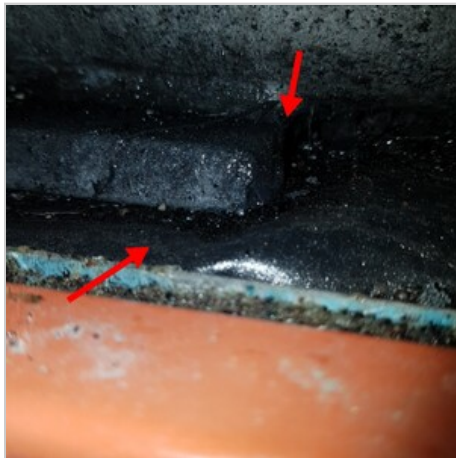
NO WEATHERPROOFING  
AND DRIP FLASHINGS

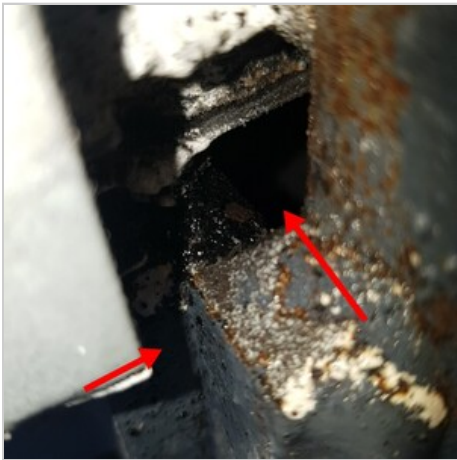
TYPICAL CLADDING AND  
WATER PROOFING INSTALL  
BY ZEFYR. FIXINGS  
OPENETRATE THOROUGH  
THE FLASHINGS AND  
WATER BARRIER

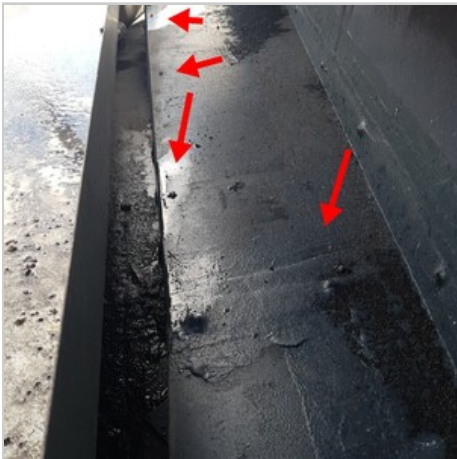
FLASHING NOT OVER  
GUTTER - VISIBLE GAP AND  
WATER PONDING ON TOP  
OF CW.  
NO SLOP ON FLASHING'S

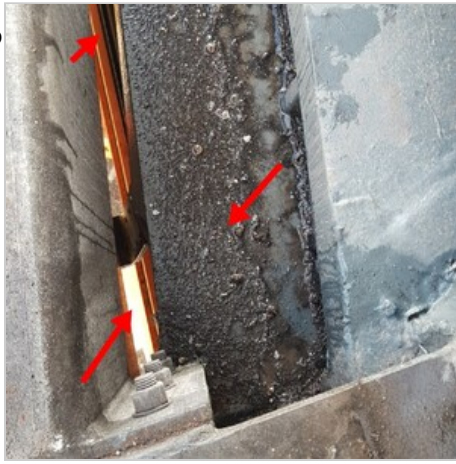
WATER STAY ON THE  
FLASHINGS - NON  
CONSISTENCE  
FIXINGS

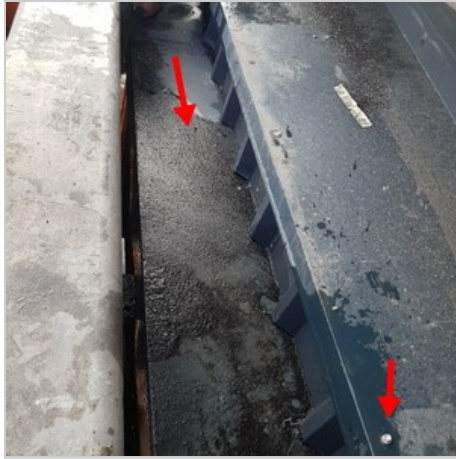
WATER PONDING ON TOP  
OF CW

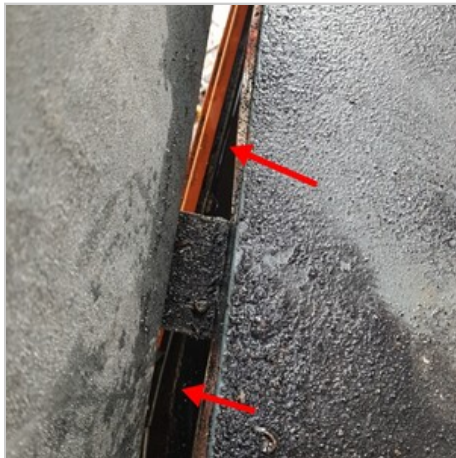
WEAK POINTS ON THE  
WEATHER PROOF  
JUNCTIONS  
NO SLOP ON FLASHING  
FOR WATER DRIOP TO THE  
GUTTER

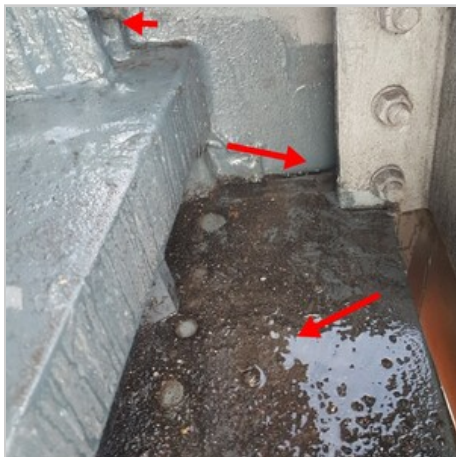
WEAK SPOT UNDER THE  
CLADDING

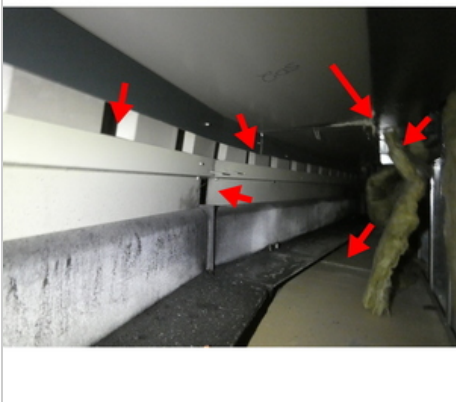
WEAK POINT - DAYLIGHTS  
VISIBLE. WATER MARKS

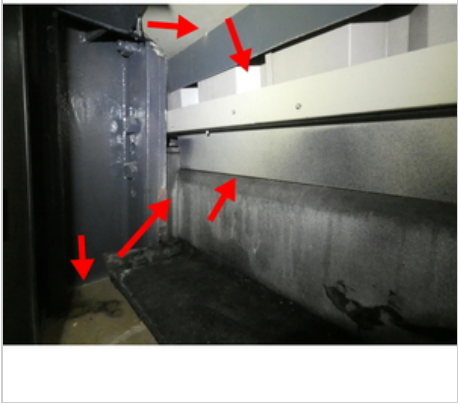
SAME AS PHOTO ABOVE

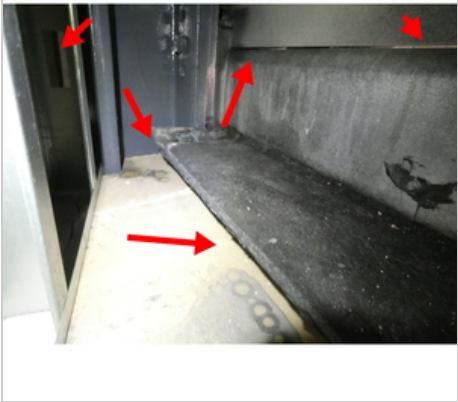
WATER MARKS

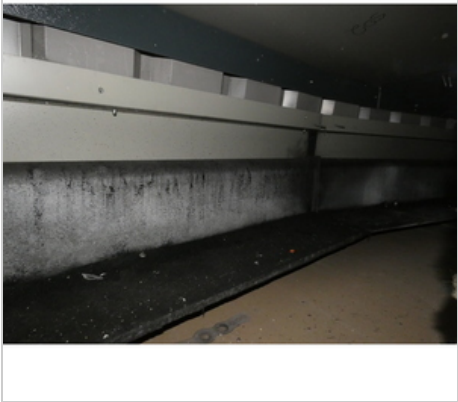
DAYLIGHT BETWEEN STEEL  
AND FLASHINGS

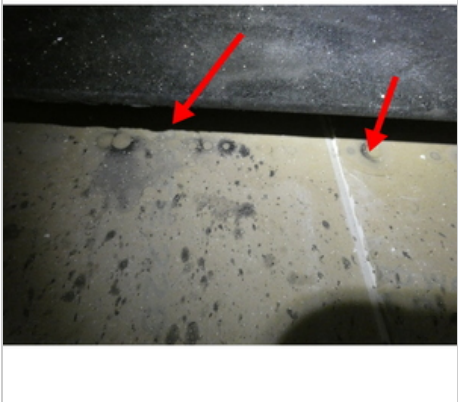
DAYLIGHT BETWEEN STEEL  
AND FLASHING'S

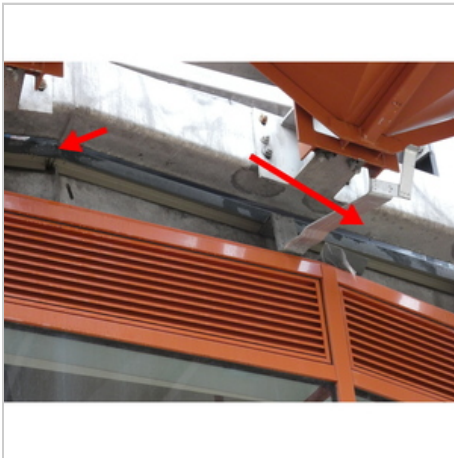
EXTERNAL VIEW - WEAK  
POINTS
