Sameera Thantirige  
Build Estimate Limited

# Sample Snagging

19 Sep 2024

## 6 George Dewhurst Way

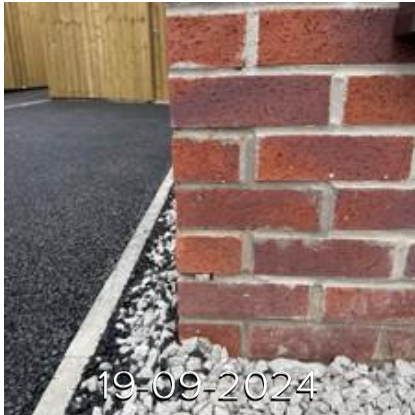
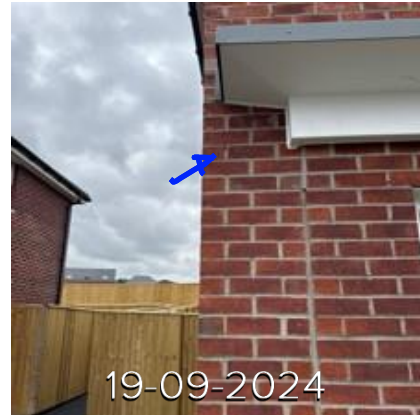
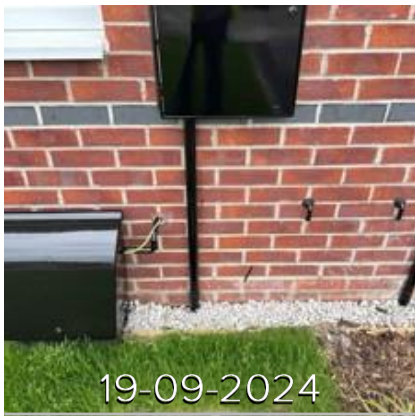
1

Repointing is required to restore the integrity of the mortar joints and ensure a clean, finished appearance.

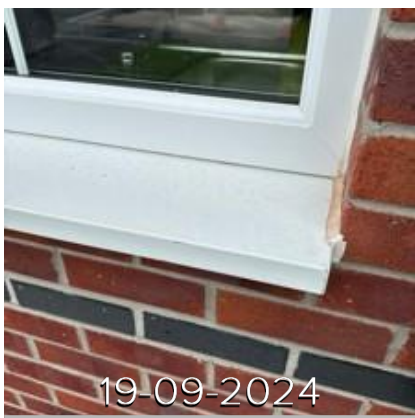
2

Painting marks need to be cleaned to achieve a neat and professional finish.

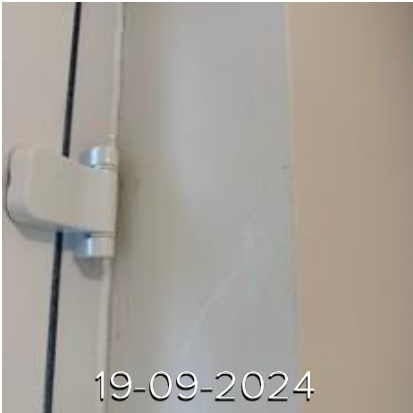
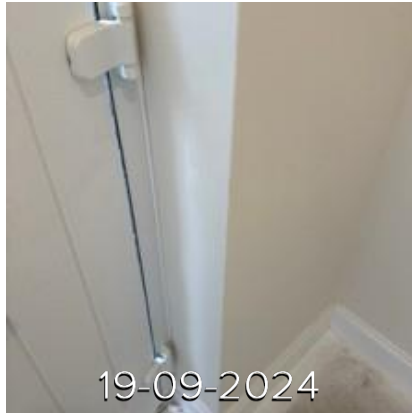
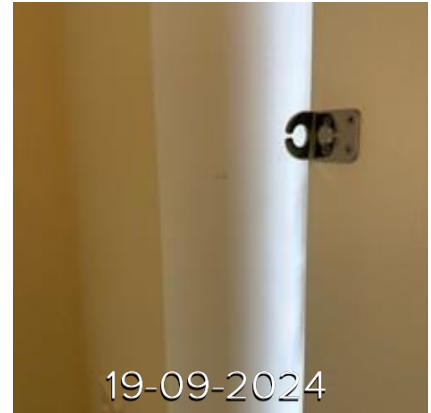
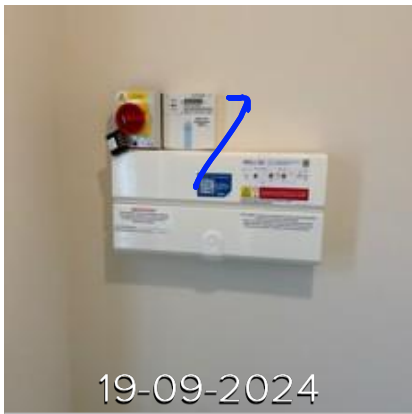
The paint on the main door reveal needs to be renewed to achieve a clean and finished look.

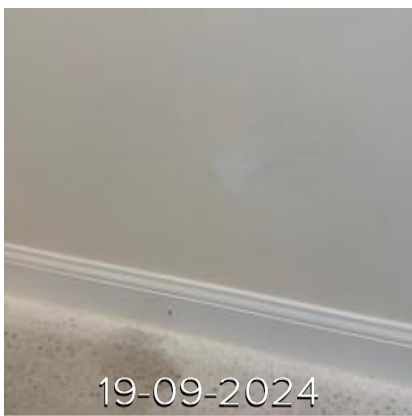
8

Visible paint marks need to be removed to ensure a clean and finished surface.

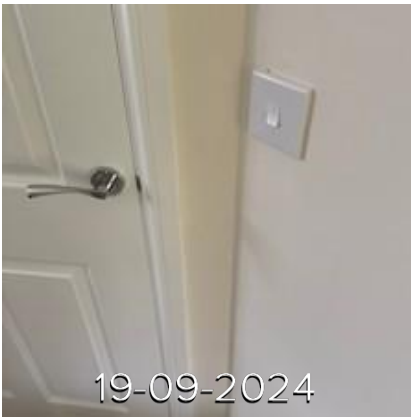
Paint scratches around the kitchen door need repairing and repainting for a smooth finish.

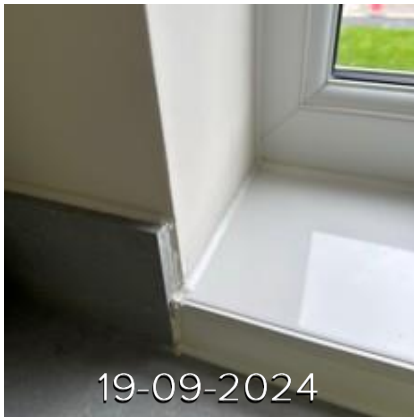
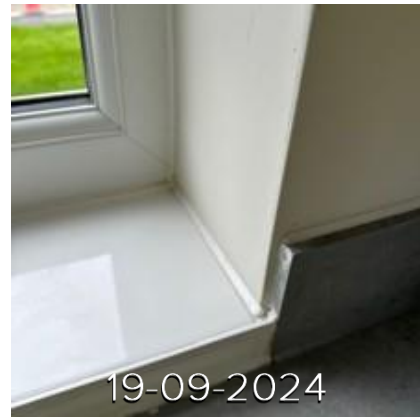
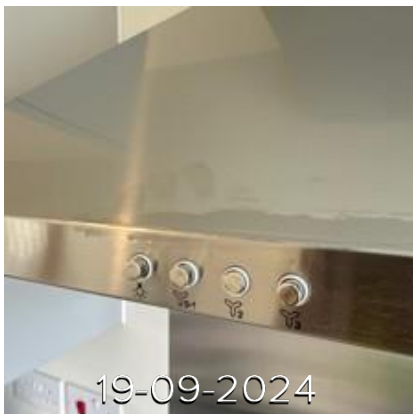
Kitchen window board mastic requires refinishing to ensure a clean and durable seal.

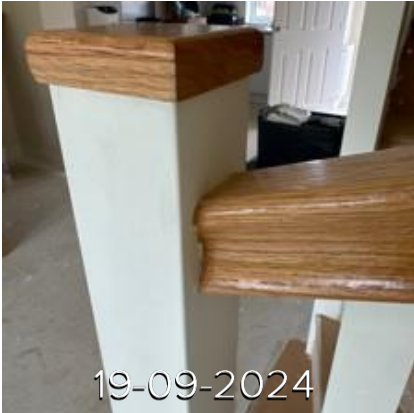
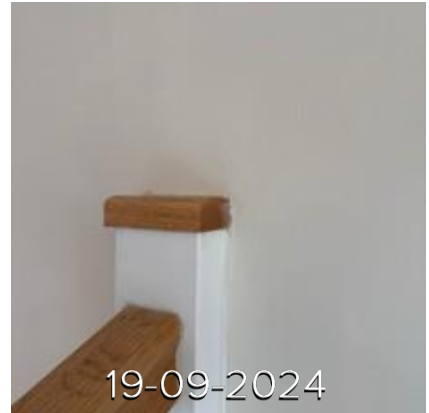
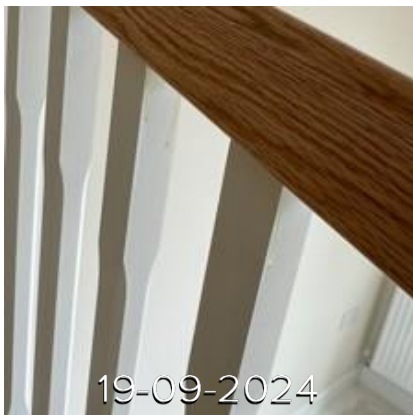
Repaint the area and remove all paint marks to ensure a clean, uniform finish.

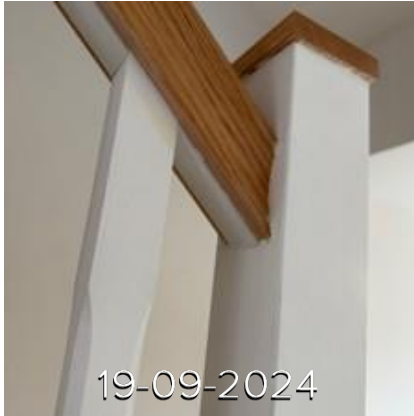
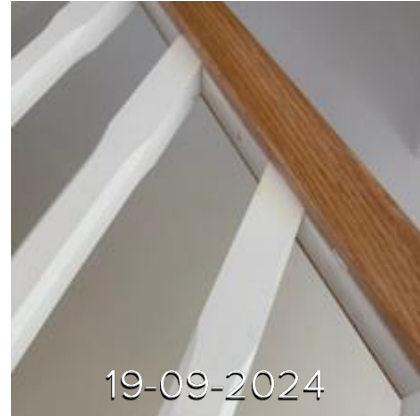
Paint and glue residues need to be cleaned to ensure a clean and finished surface.

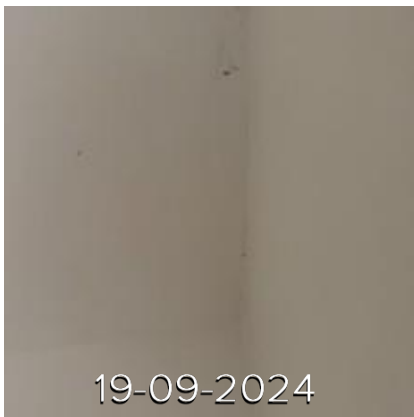
33

Paint inside the staircase cupboard needs refinishing to restore a clean and uniform appearance.

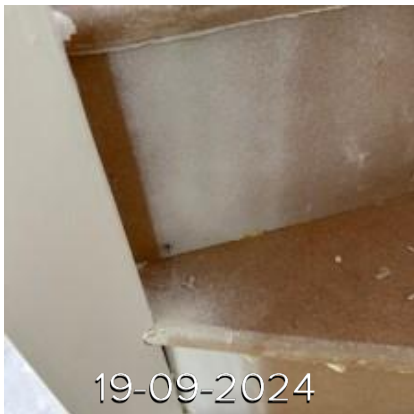
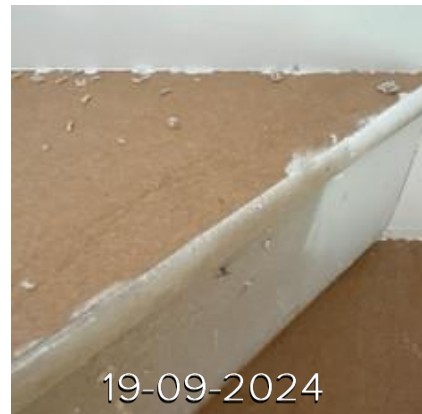
Exposed screws on the staircase need to be refinished to ensure a neat and polished appearance.

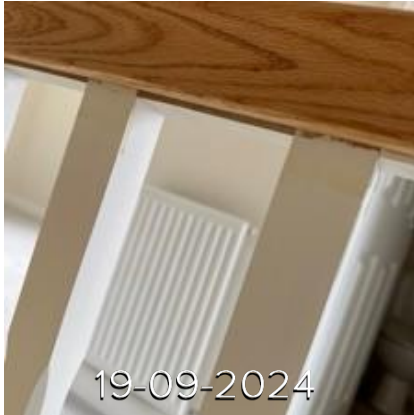
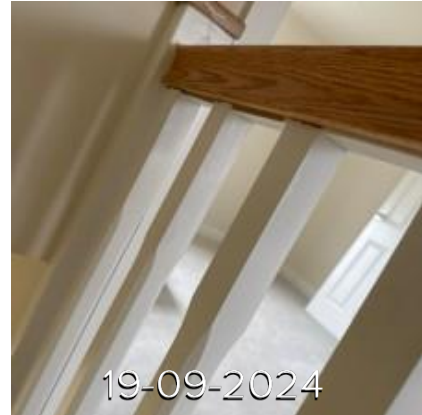
ISSUE 36

Remove paint and glue residues on the staircase to restore a clean and finished surface.

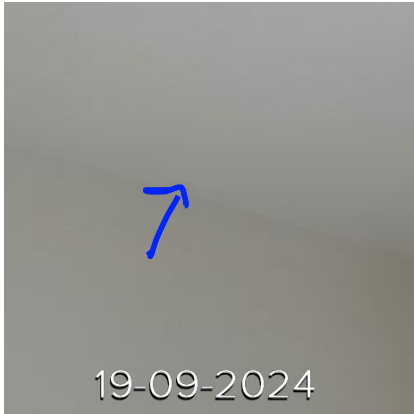
Refinish paint patches to achieve a smooth and uniform surface.

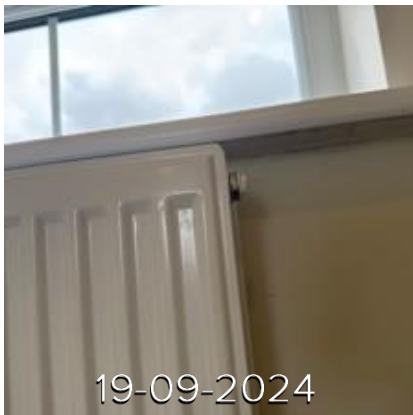
### ISSUE 40

Remove pencil marks behind the radiator in the rear bedroom to restore a clean surface.

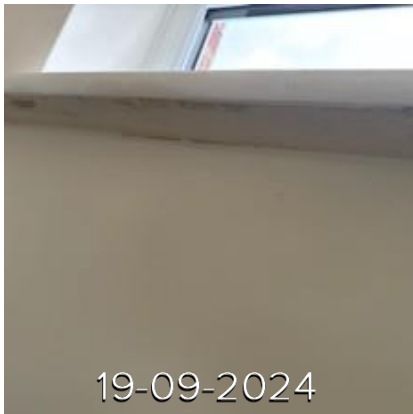
Painting patches required in the front bedroom to ensure an even and smooth finish.

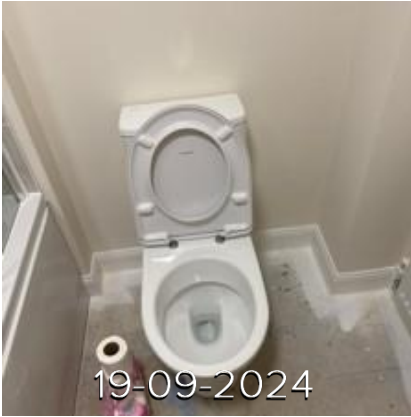
**ISSUE 46**

Toilet paper holder is missing and needs to be installed.

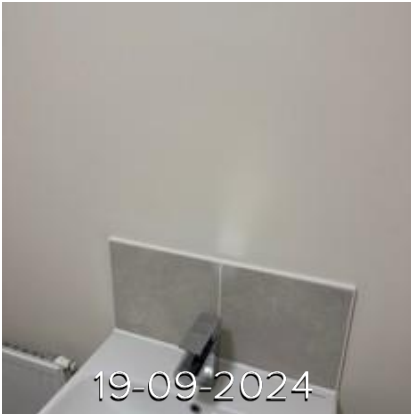
**ISSUE 47**

Bathroom mirror is missing and requires installation.

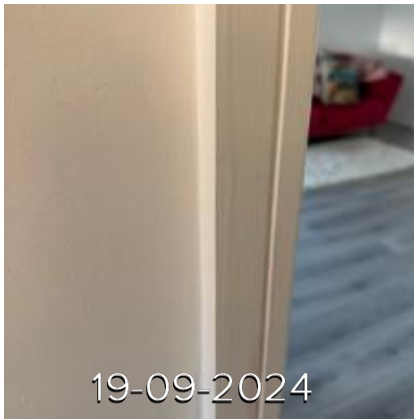
**ISSUE 48**

Living Entrance door mastic crack

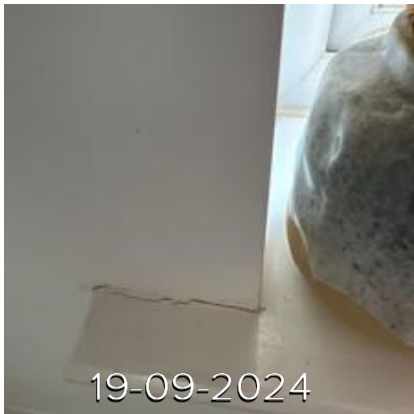
**ISSUE 50**

Leaving main window board mastic damage

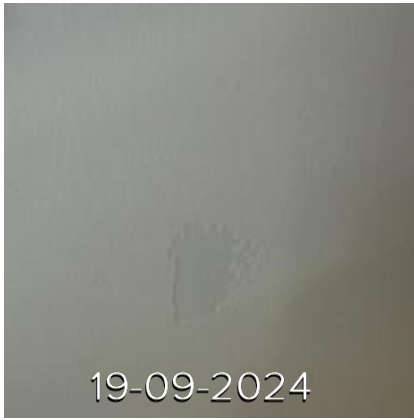
**ISSUE 62**

Office room paint touchup needed

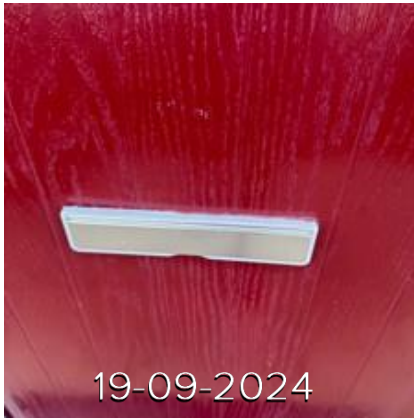
**ISSUE 66**

Main door painting finish need to be redone

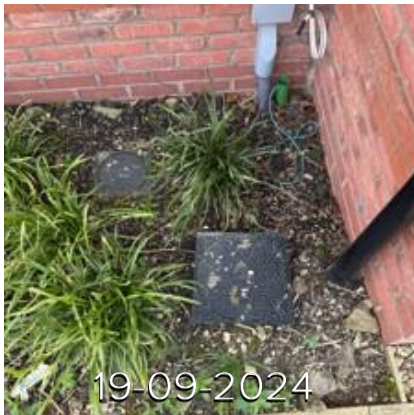
**ISSUE 67**

Outdoor hullies are not leveled and finished

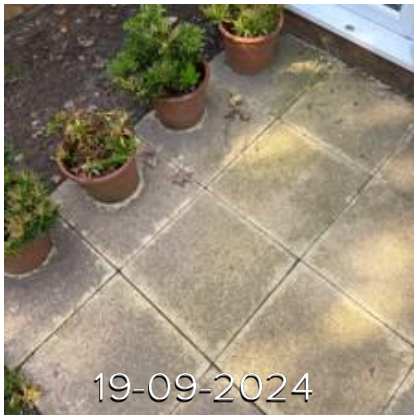
**ISSUE 68**

Rearside flooding during rain season

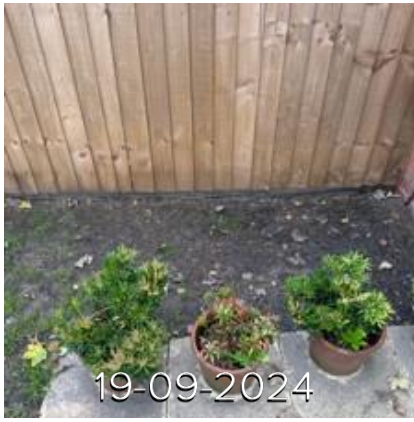
**70**

Part of the turf need to be relayed

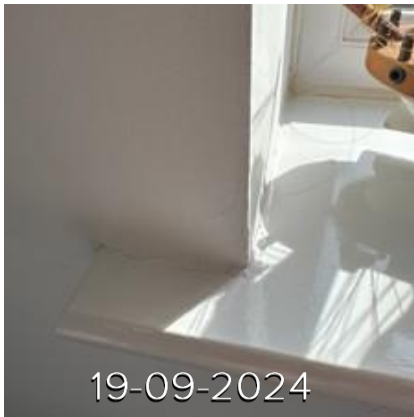
**71**

Second bedroom window board mastic need to be redone

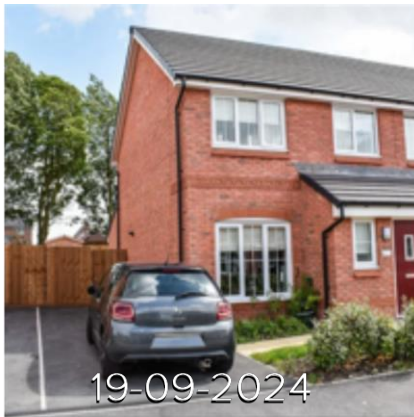
**72**

Mastic finish around all the windows need to be redone

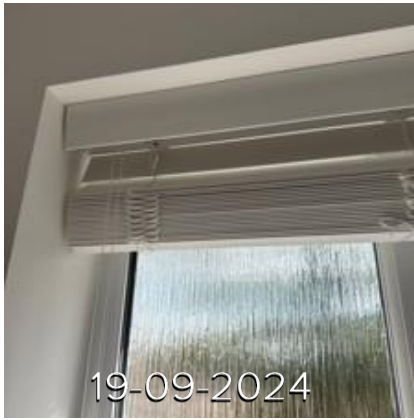
**74**

Bathroom window blind not working

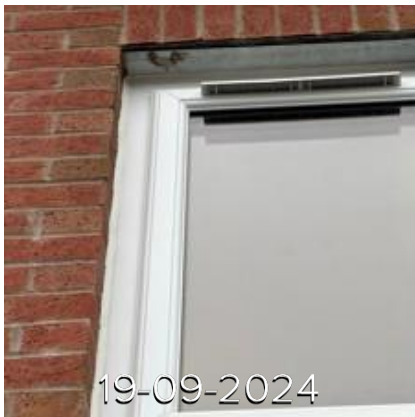
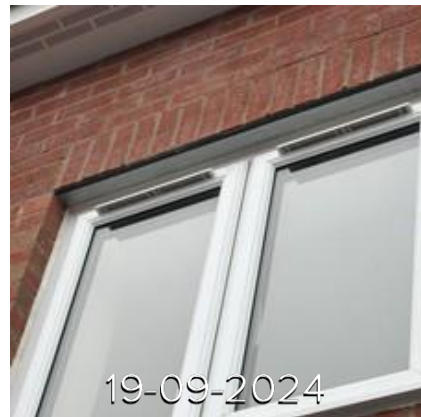
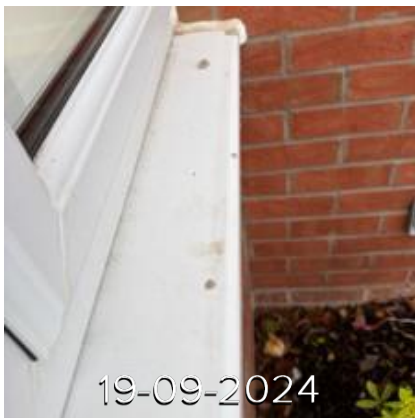
**79**

Exposed lintel requires painting.

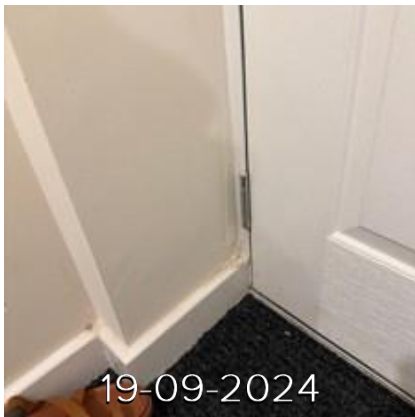
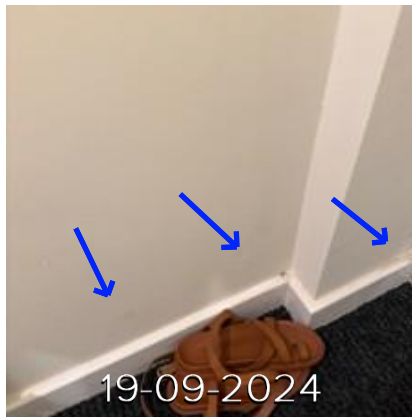
**86**

Entrances to living area require paint touch-ups.

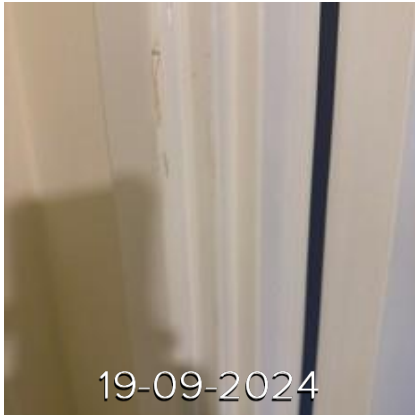
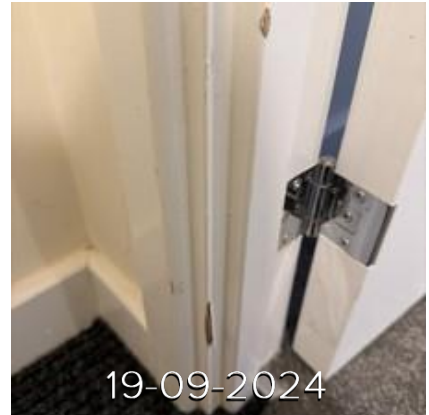
**87**

Living entrance door requires paint touch-ups.

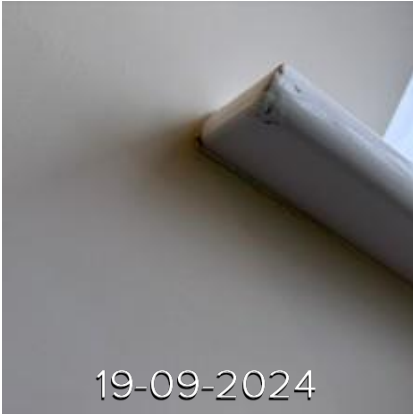
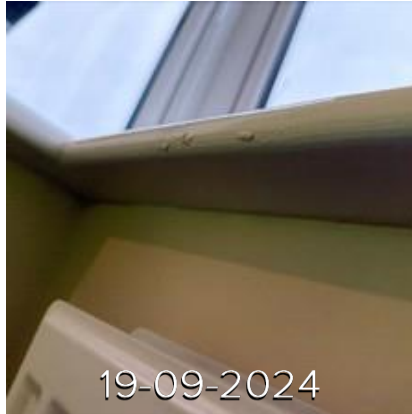
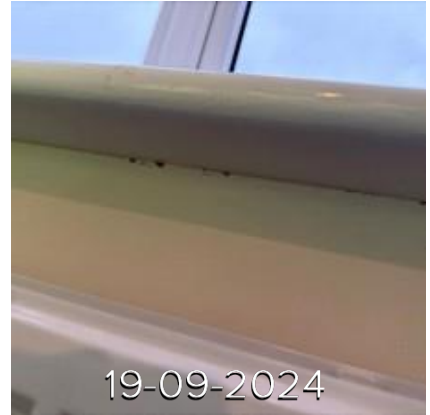
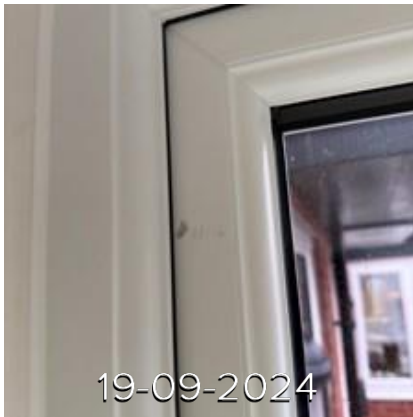
90

Damage observed on bay window frame.

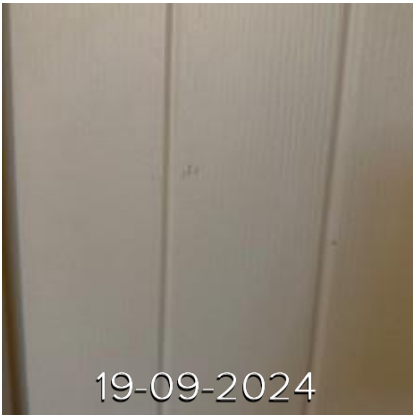
**94**

Under-staircase room requires paint touch-ups.

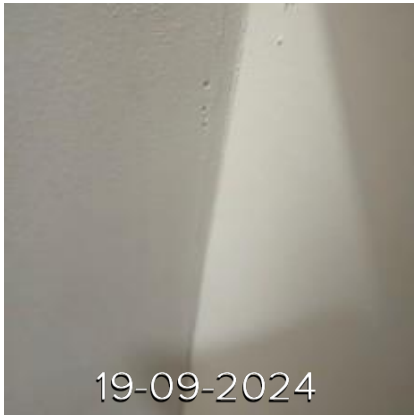
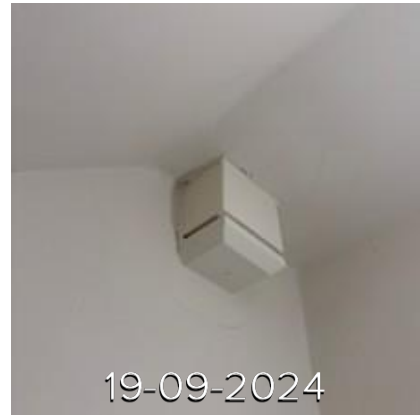
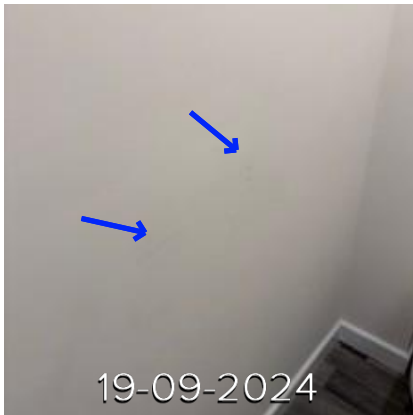
**95**

WC wall requires paint touch-ups.

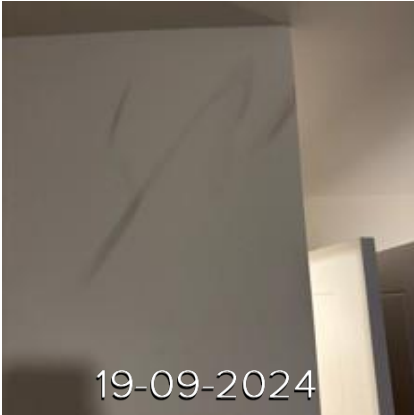
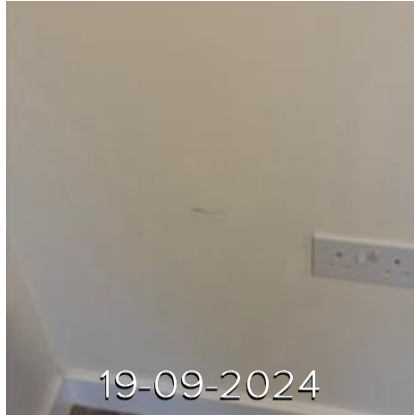
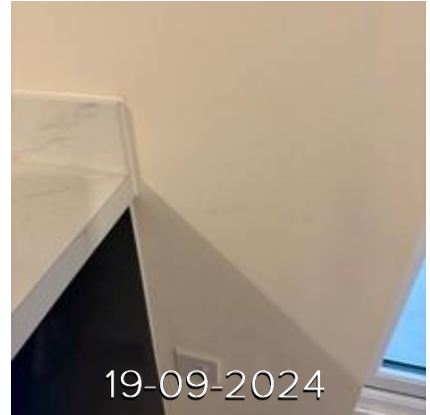
Kitchen requires paint touch-ups.

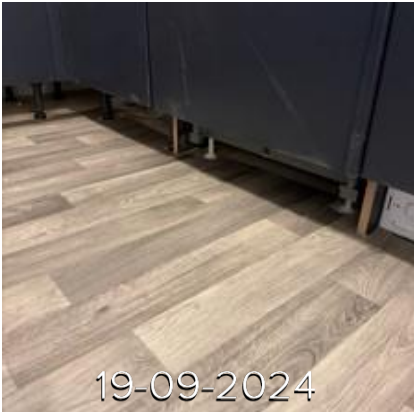
98

Kitchen bottom panel requires fixing.

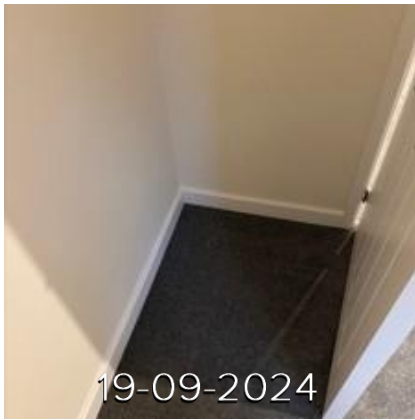
Crack observed in under-staircase area.

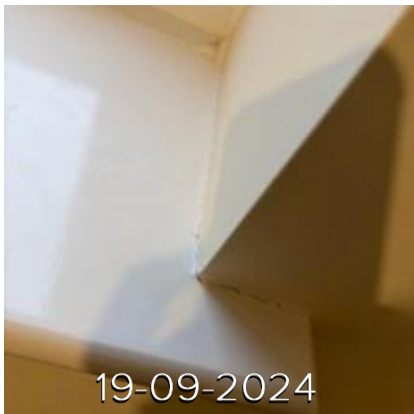
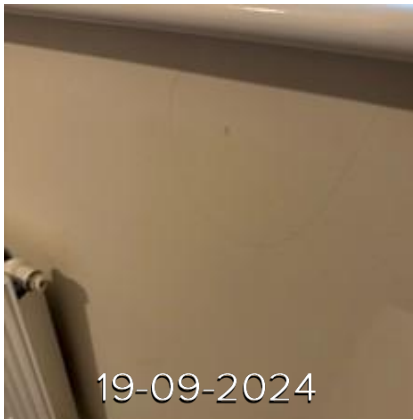
Crack observed on upper rear bedroom window board.

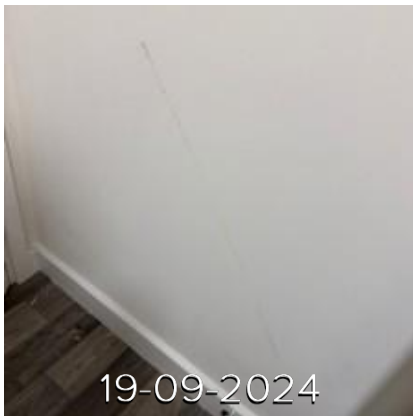
109

Upper rear bedroom requires paint touch-ups.

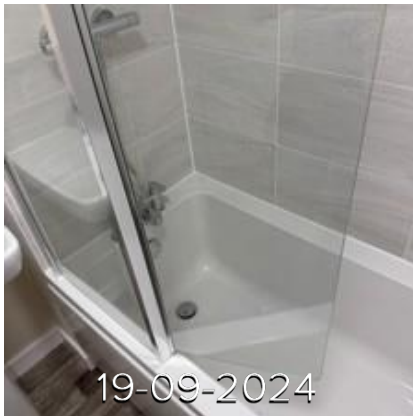
112

Silicone on upper bathroom wall requires cleaning.

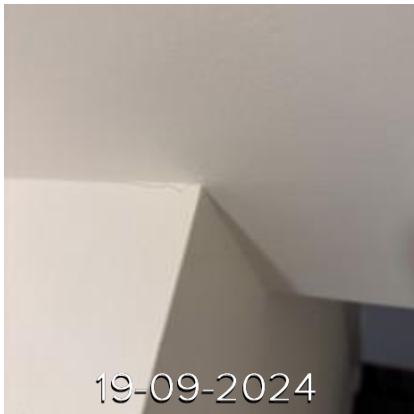
Crack observed at stairwell corner on entrance to second floor.

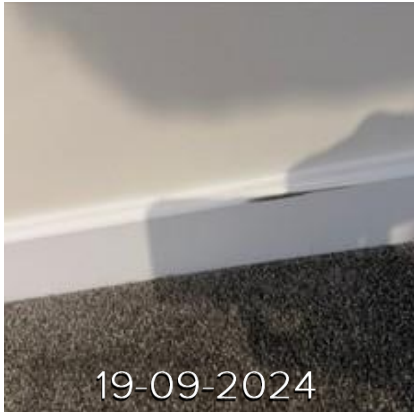
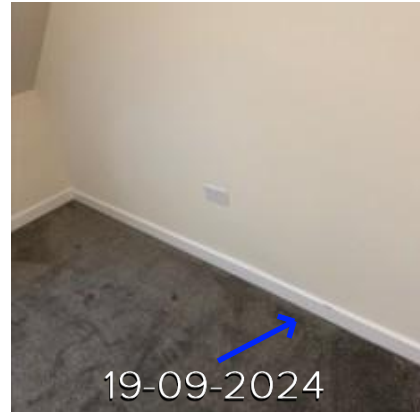
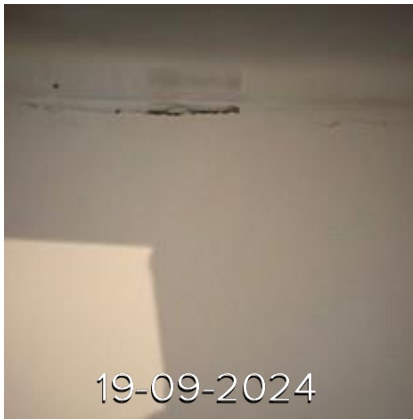
Second floor skirting requires paint touch-ups.

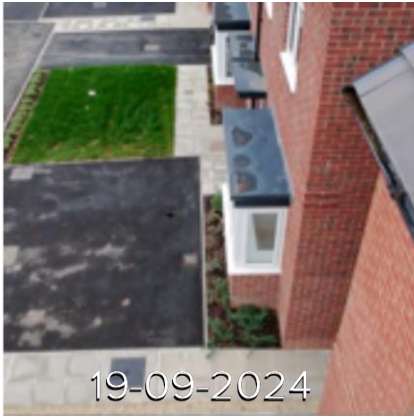
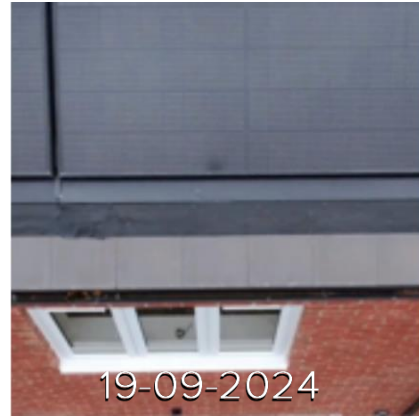
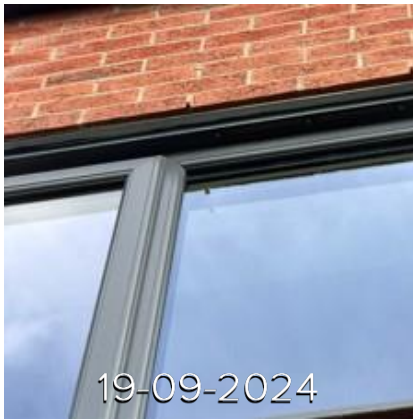
Gutters require cleaning of debris.

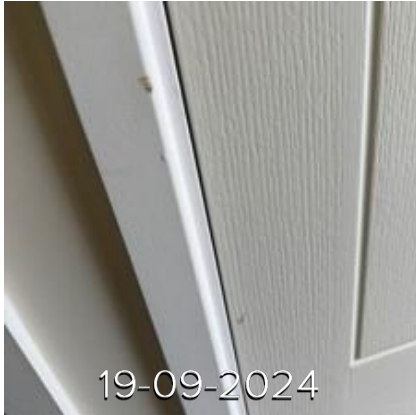
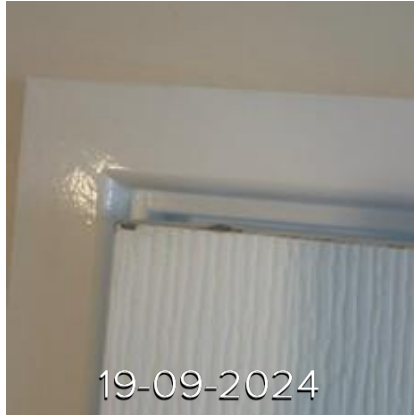
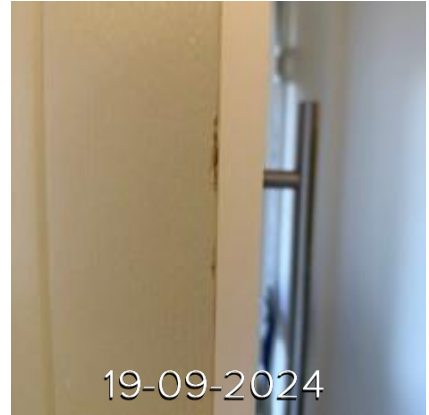
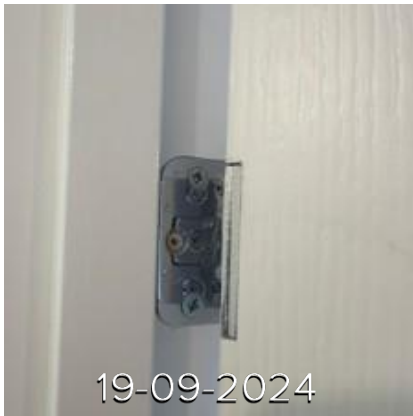
**128**

Paint touch-ups are required on the WC door frame to ensure a smooth and uniform finish.

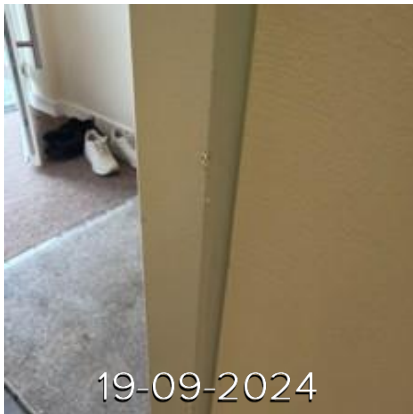
133

Paint touch-ups are required on the kitchen door to ensure a smooth and uniform finish.

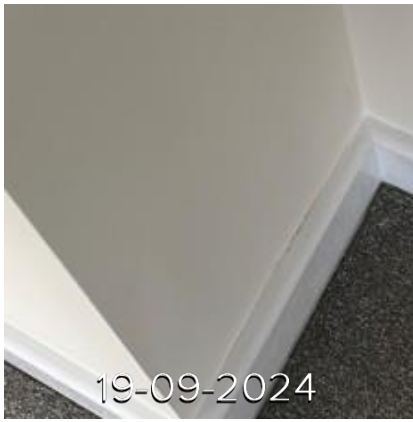
138

Living area skirting requires mastic application.

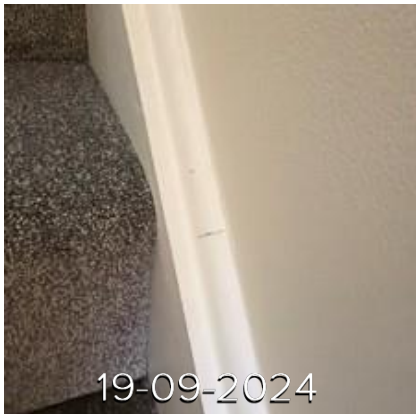
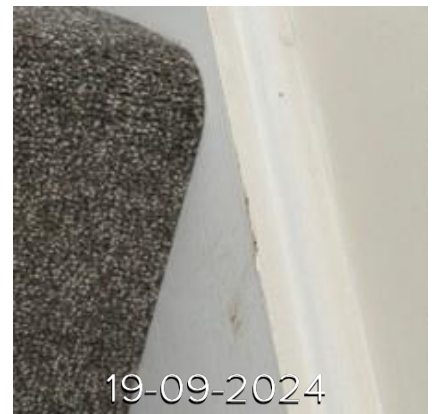
146

Cracks observed on staircase sideboard.

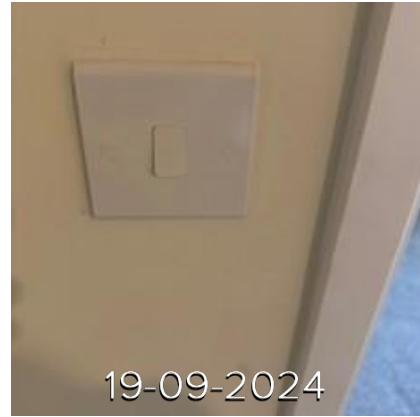
149

Paint touch-ups required on rear bedroom wall.

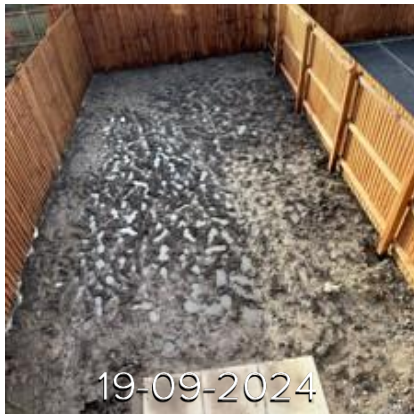
151

External ground area requires preparation for turf installation.

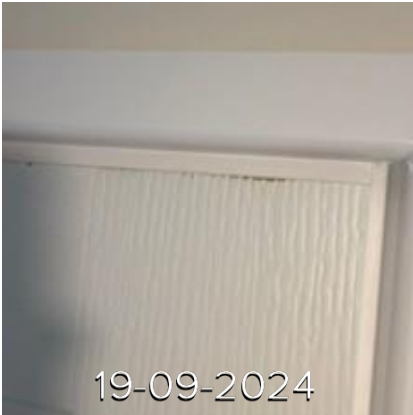
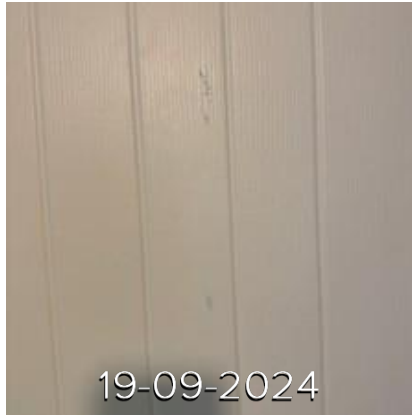
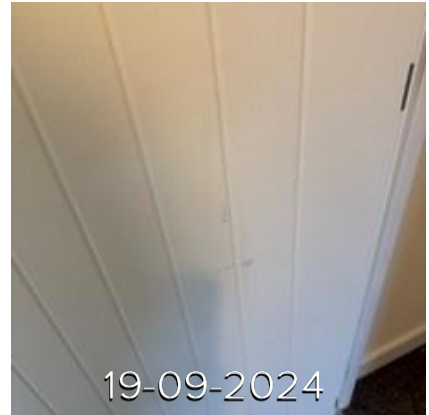
154

Screws missing from hallway and utility room doors.

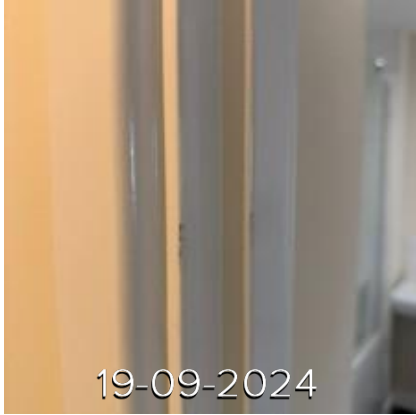
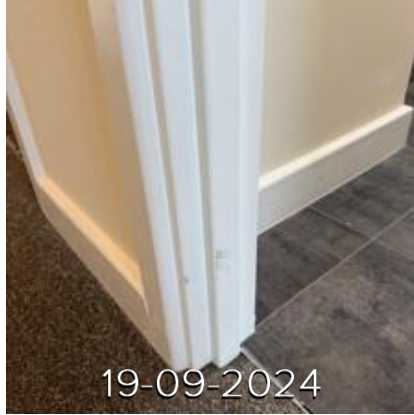
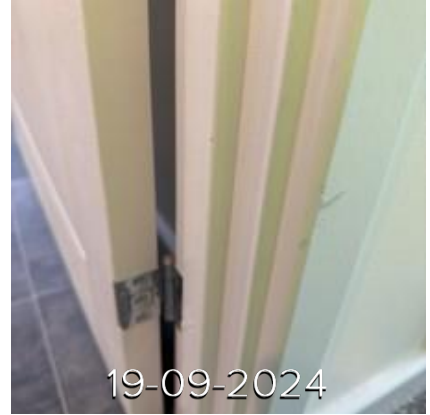
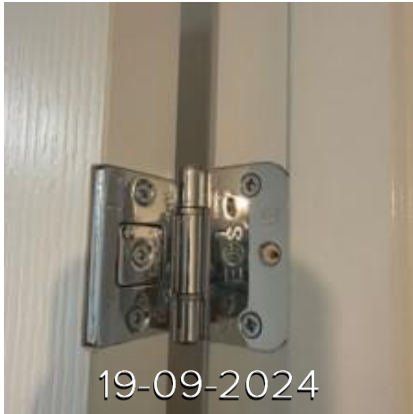
**156**

Screw missing from common bathroom door.

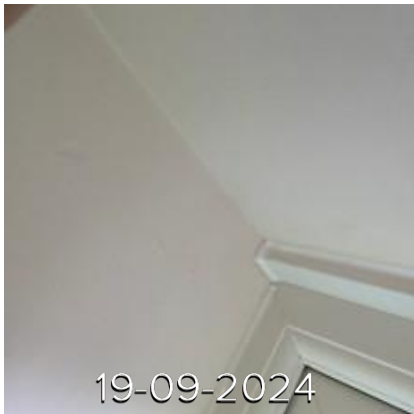
**161**

Front left-hand side bedroom door requires paint touch-ups.

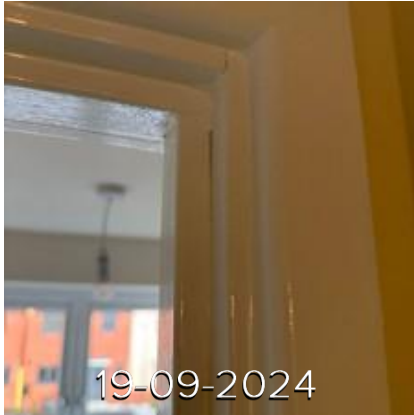
**162**

Screw missing from front left-hand side lobby door.

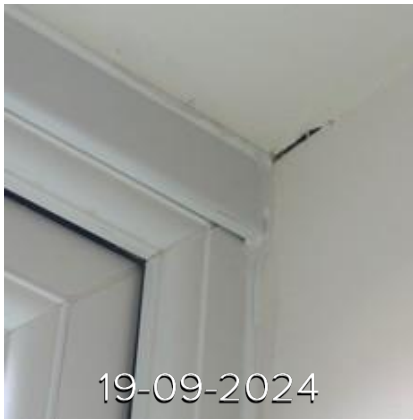
**169**

Second floor window reveal requires filling of exposed gap.

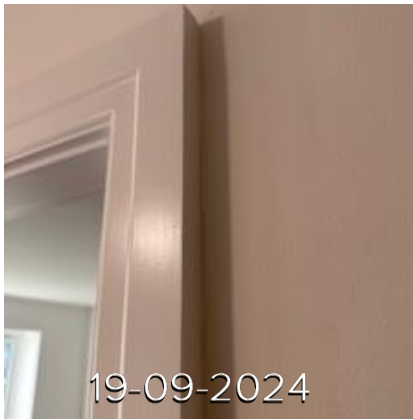
175

The living room door frame has a crack that requires repair to ensure structural integrity and a finished appearance.

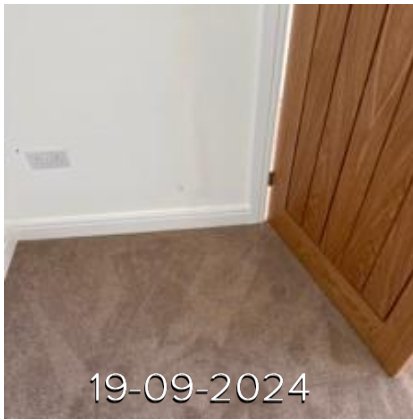
178

The living room door stopper is missing and needs to be installed to prevent damage to the door and surrounding surfaces.

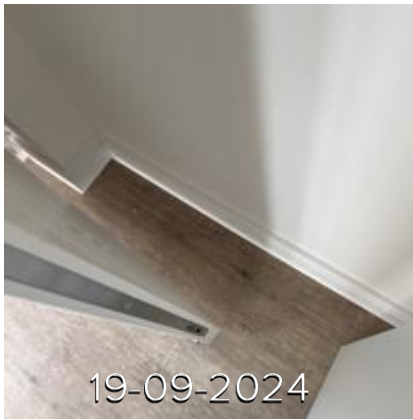
181

The main door stopper is missing and needs to be installed to prevent damage to the door and surrounding surfaces.

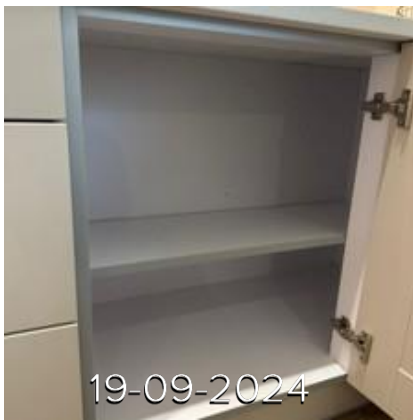
**188**

The kitchen cabinet shelf is not level and has a broken stud, requiring adjustment and repair to ensure proper support and functionality.

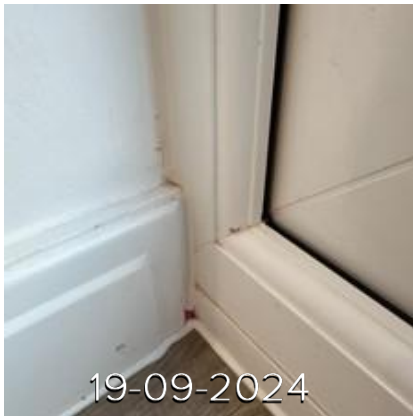
193

The gap between the French door and skirting requires filling to ensure a neat and finished appearance.

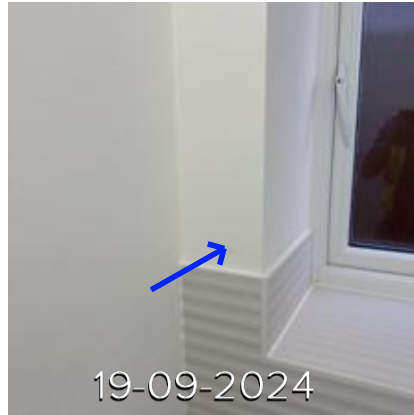
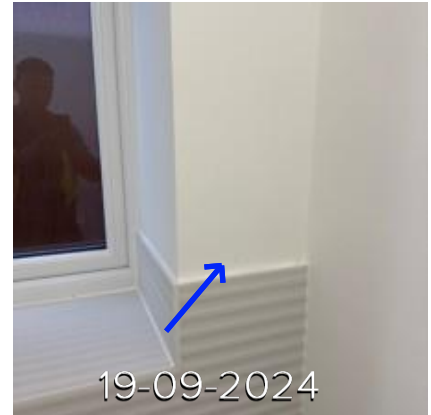
200

The stairwell walls have paint scratches that require touch-up or repainting to restore a clean and uniform finish.

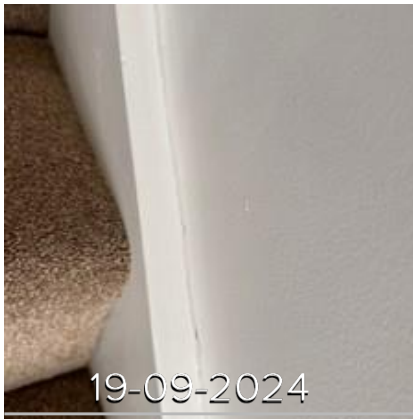
201

There is a crack on the stair and adjoining wall that requires repair to ensure structural integrity and a smooth finish.

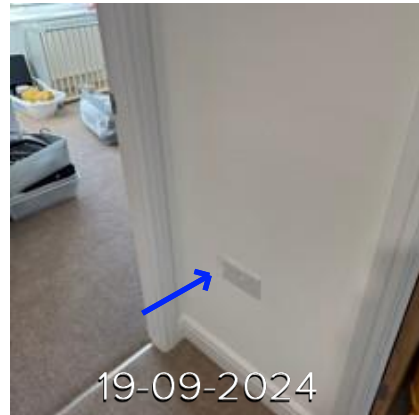
204

The front left bedroom door frame around requires painting to restore a neat and uniform finish.

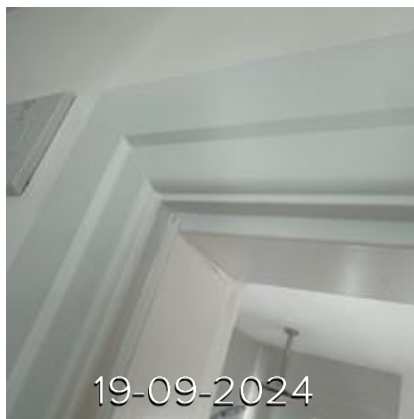
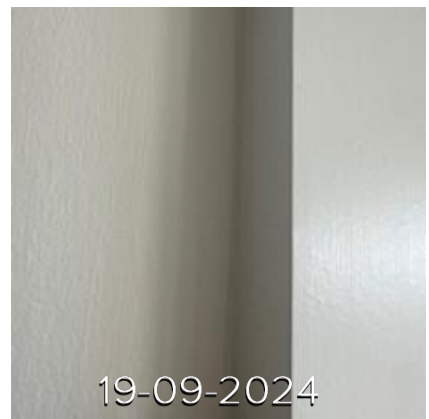
**208**

The front left bathroom requires cleaning and paint touch-ups to restore a neat and polished appearance.

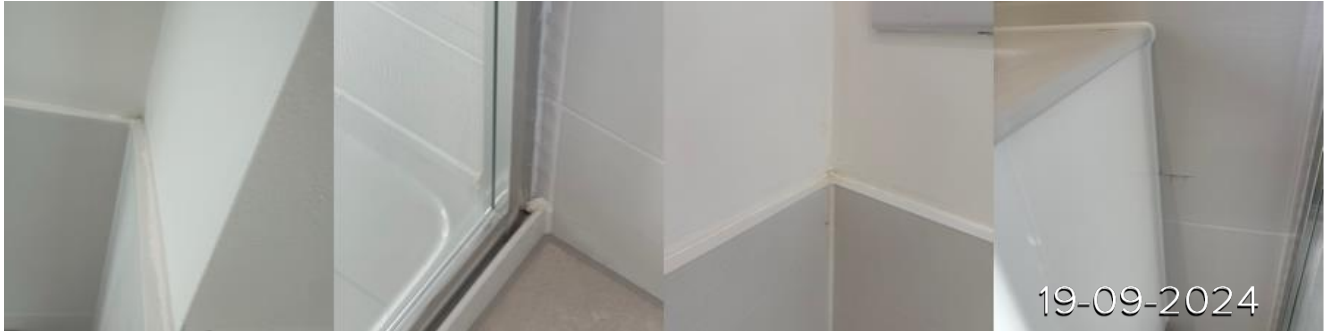
**209**

The rear left bedroom door frame has a crack that requires repair to ensure a smooth finish.

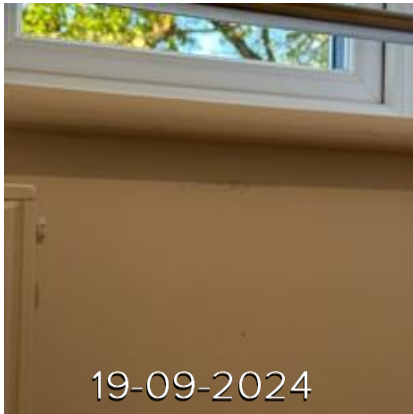
211

The rear left bedroom wall requires paint touch-ups to restore a smooth and uniform finish.

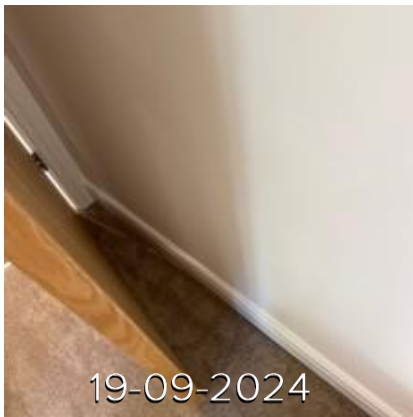
212

The rear left bedroom door stopper is missing and needs to be installed to prevent damage to the door and surrounding surfaces.

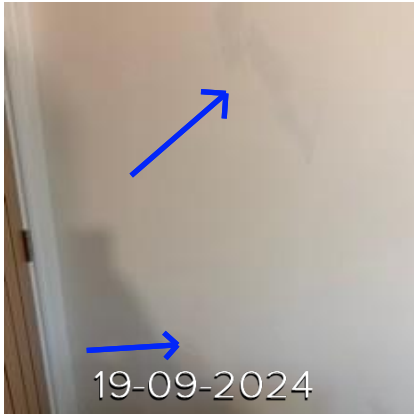
219

The upper plant room door has paint scratches that require repair or repainting to restore a smooth and uniform finish.

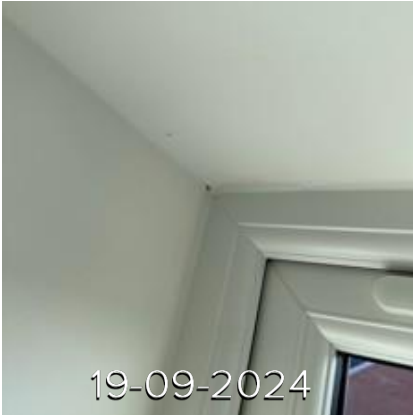
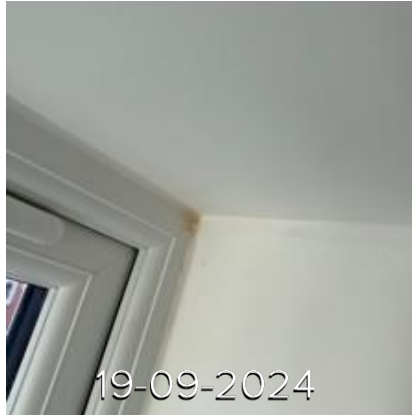
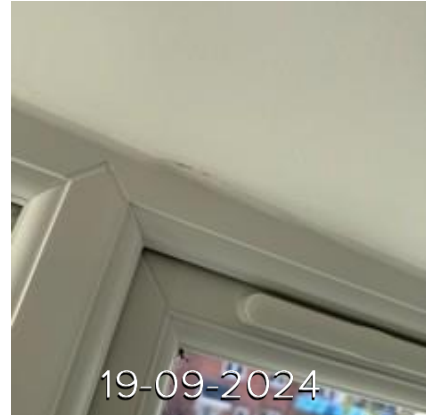
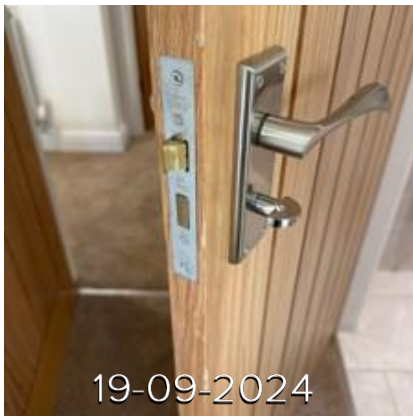
223

The upper right front bathroom door frame has scratches that require repair or repainting to restore a smooth and finished appearance.

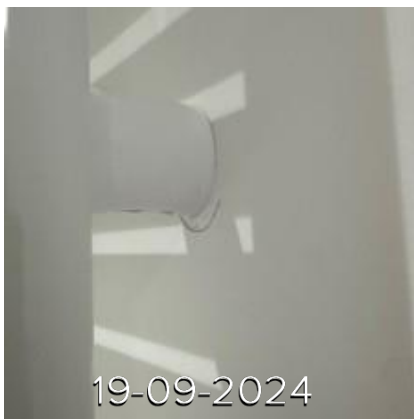
227

Unattended screw observed on the front wall.

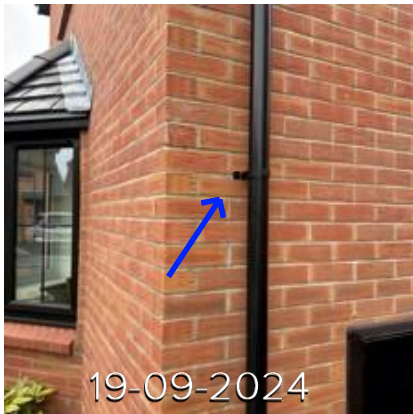
228

Rear downpipe bracket broken.

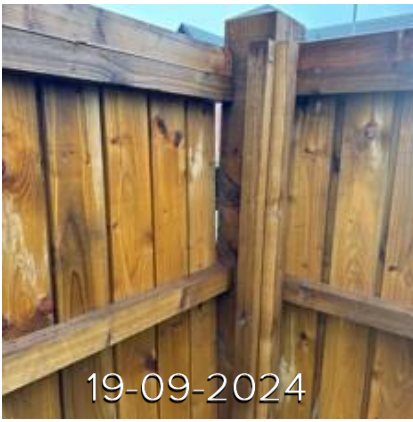
**230**

Gap observed in garden fence.

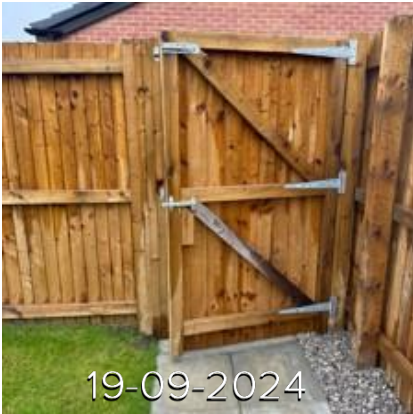
**231**

Garden door is too tight and requires adjustment.

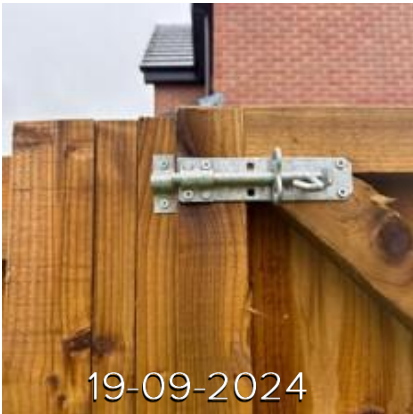
**232**

Lock is not leveled and requires adjustment.

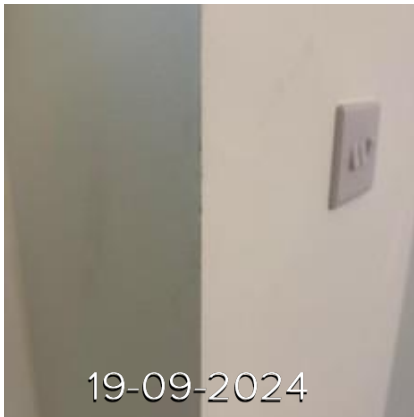
236

Painting touch-ups required on front wall.

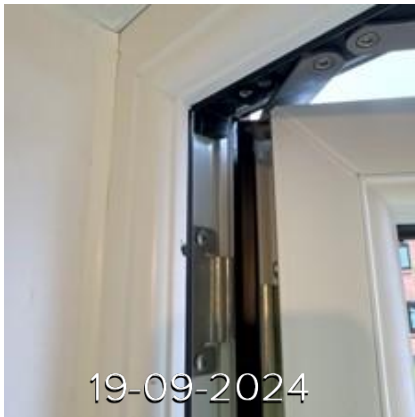
**237**

Paint removal required on living room window.

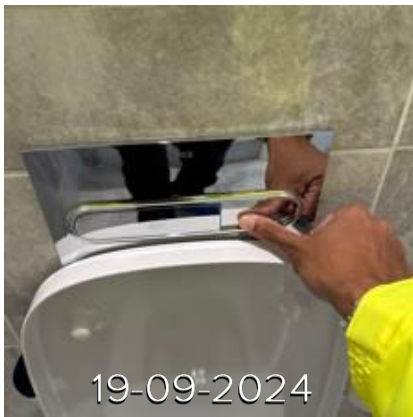
**245**

Ground WC small flush button is too tight and requires adjustment.

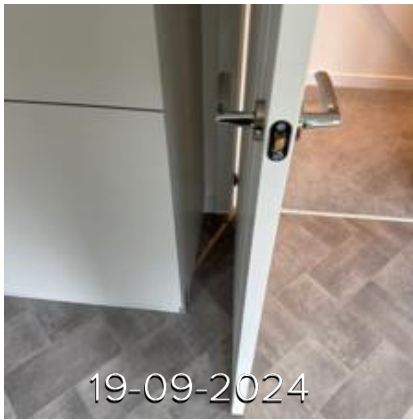
**247**

Kitchen door stopper is missing and needs installation.

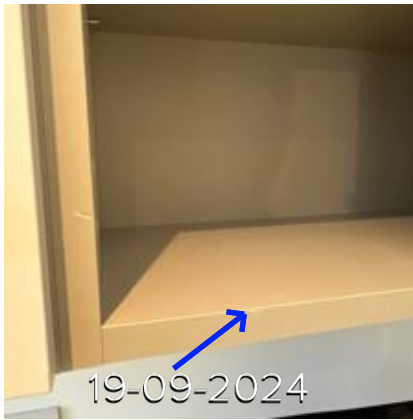
**250**

Damage observed on kitchen cabinet.

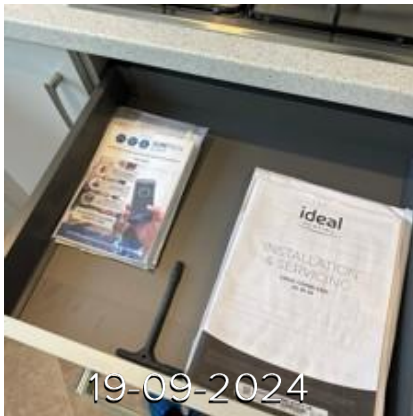
**251**

Cutlery tray is missing and needs to be provided.

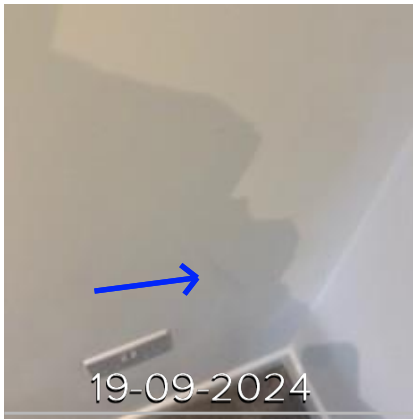
**255**

Painting touch-ups required in upper corridor.

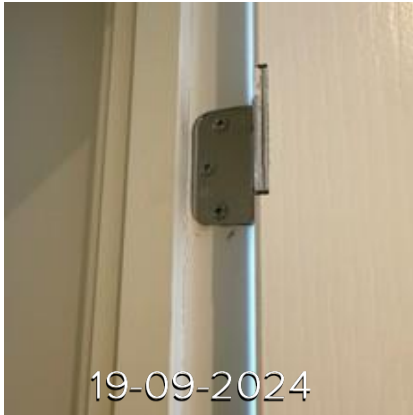
**256**

Crack observed on upper storeroom door.

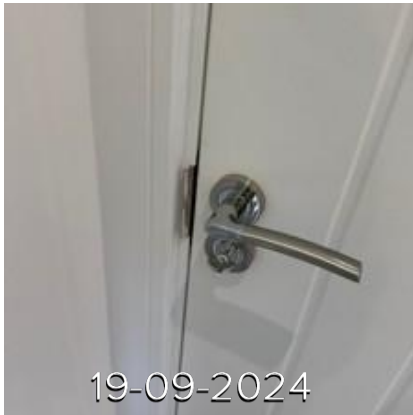
**257**

Upper bathroom lock is too tight and requires adjustment.
