Sameera Thantirige  
Build Estimate Limited

# Sample Snagging

19 Sep 2024

## 6 George Dewhurst Way

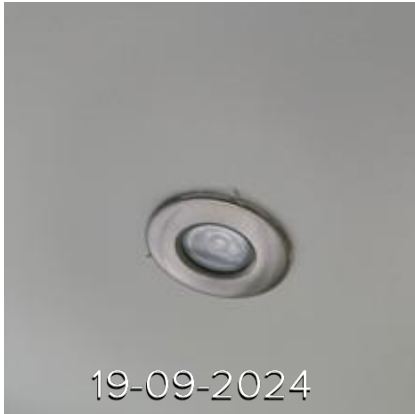
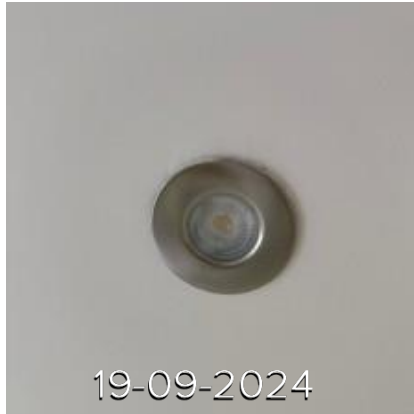
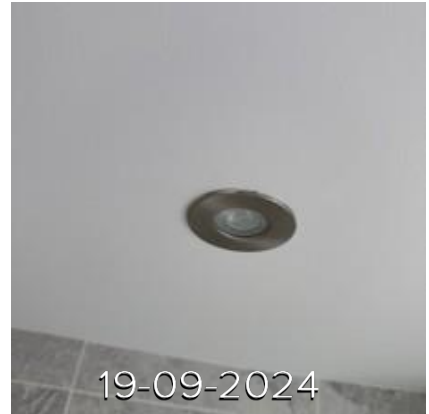
Cleaning required on bathroom light paint.

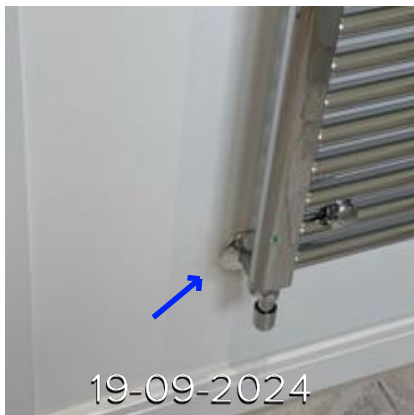
**ISSUE 266**

Cleaning required on master ensuite isolator paint.

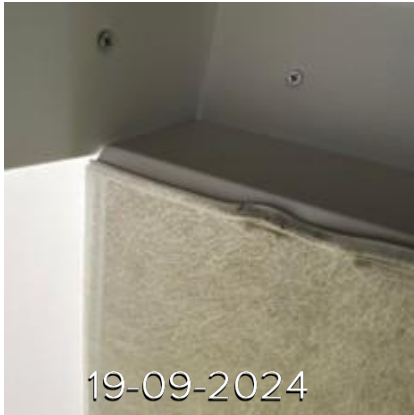
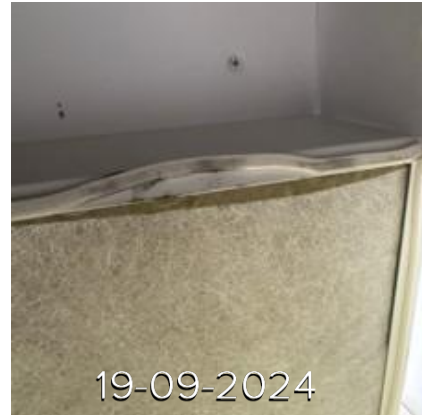
ISSUE 269

Screw missing on loft hatch and requires replacement.

Loft hatch seal requires proper fixing.
