# MARINO STRUCTURAL SOLUTIONS

NICHOLAS MARINO, P.E.

RE: **Building Evaluation**  
Vineland Historical Society  
108 S. 7<sup>th</sup> Street  
Vineland, Cumberland Co., NJ  
**MSS #18167**

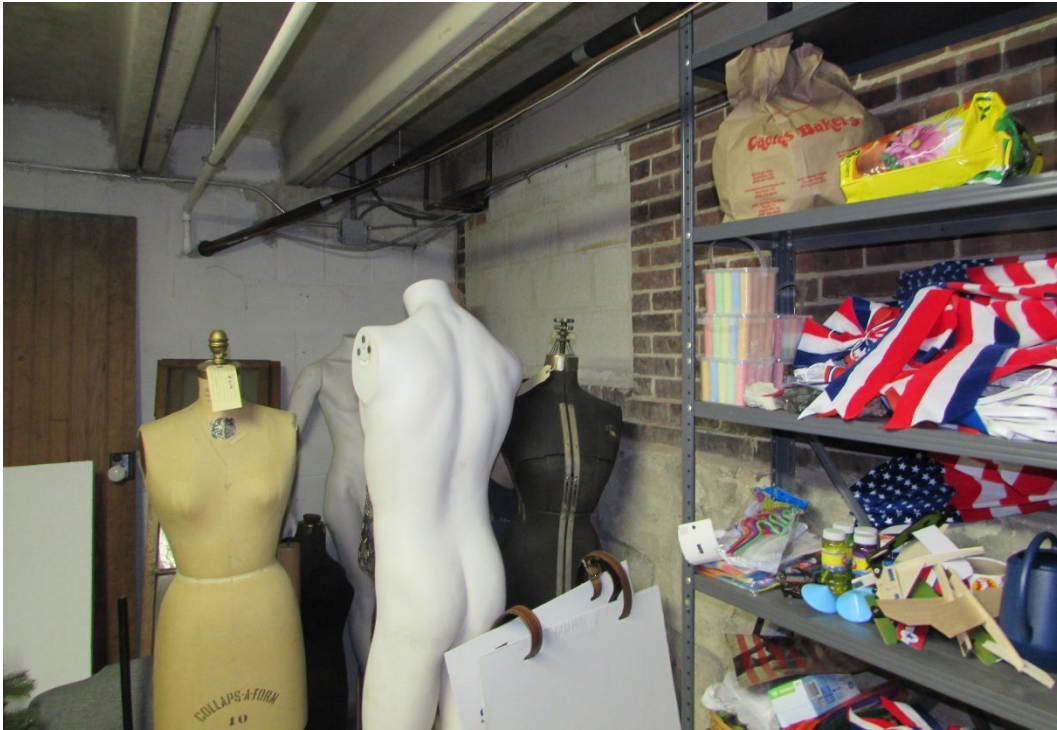
The rear 1933 and 1964 additions were found to consist of concrete masonry block. The masonry block walls were found to be in good condition with minor hairline cracks. No evidence of bowing, separation or displacement were observed.

**Photo #16** – Rear 1933 addition, foundation wall of original structure on right side of photo

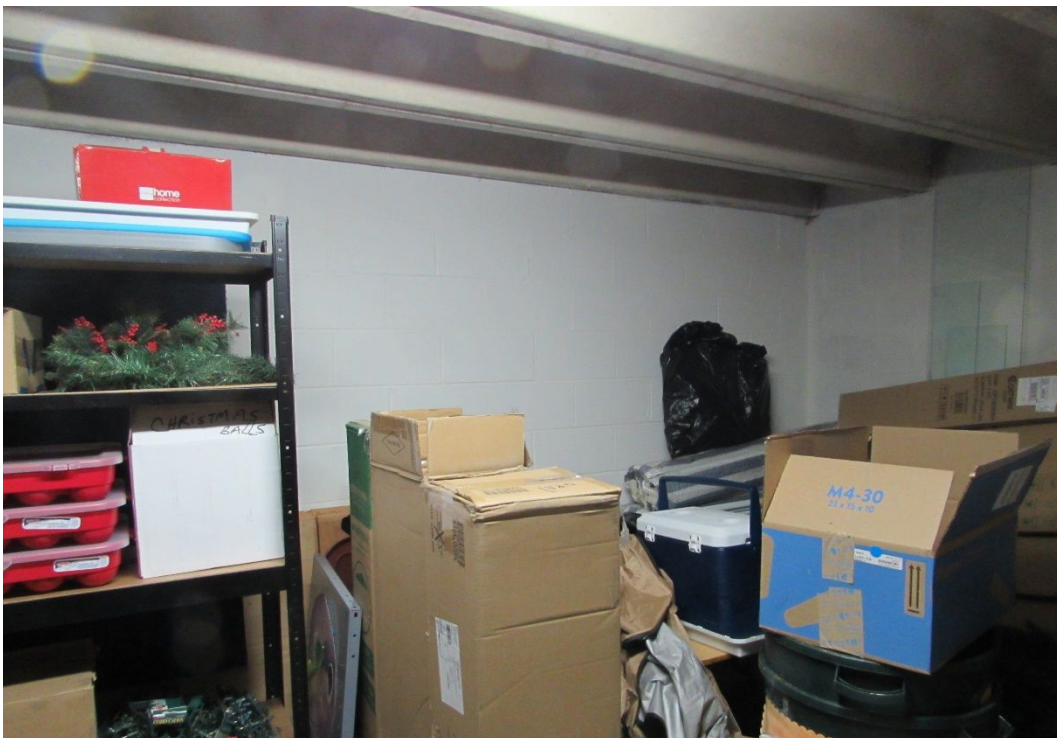
**Photo #17** – Rear wall of 1933 addition

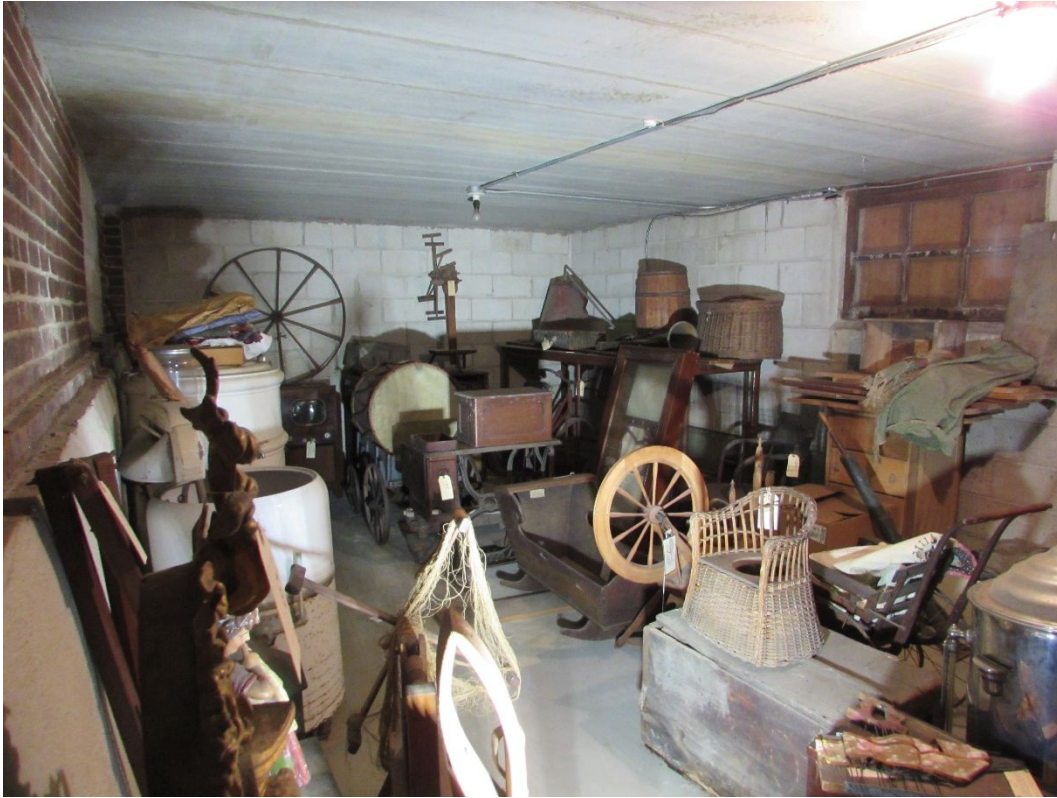
**Photo #18** – Overview of 1964 addition

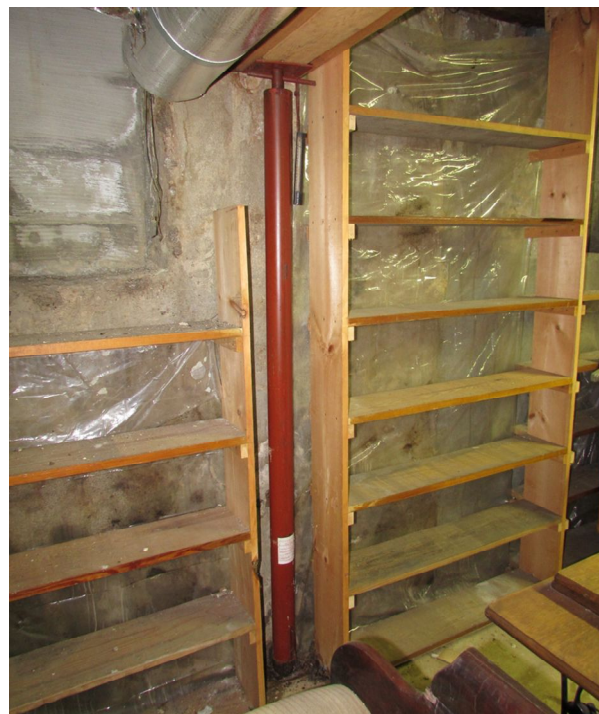
**Photo #25** – Corroded steel column

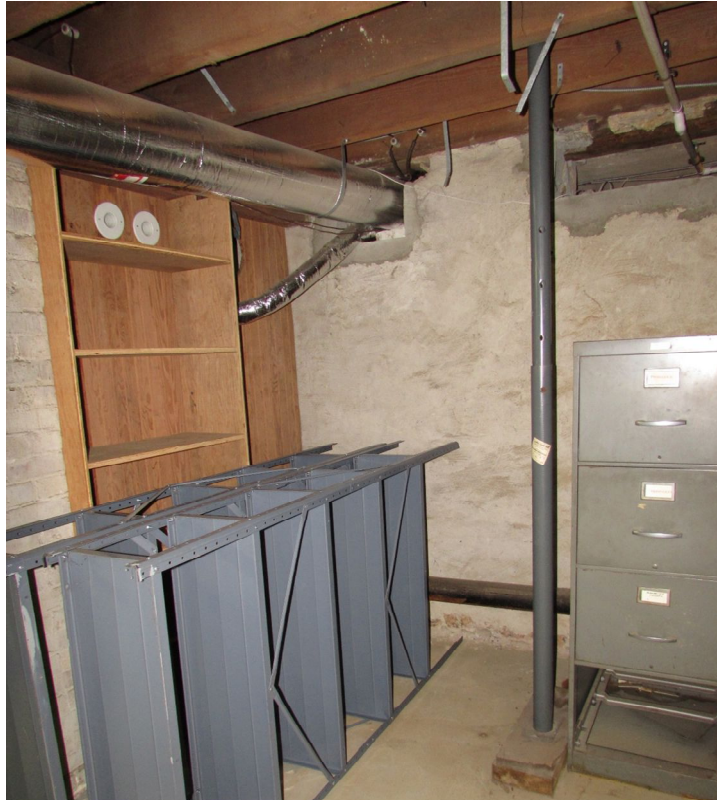
**Photo #27** – Column beneath first floor safe

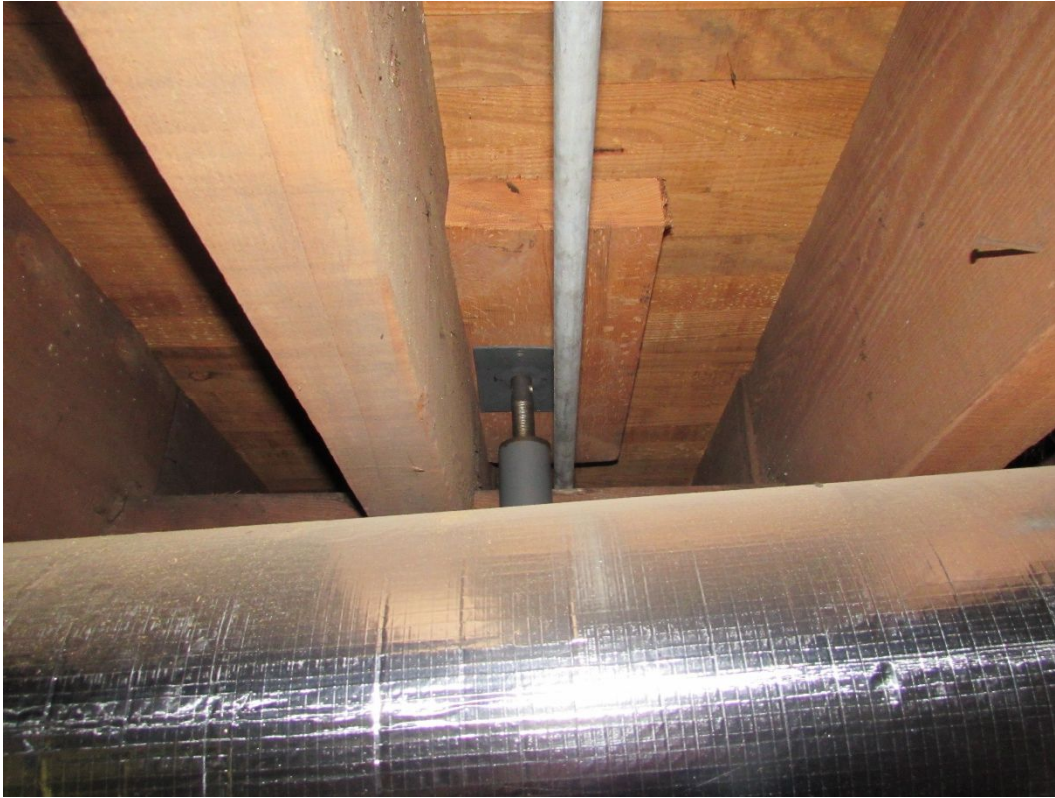
**Photo #28** – Deformed cap plate of column depicted in photo #27

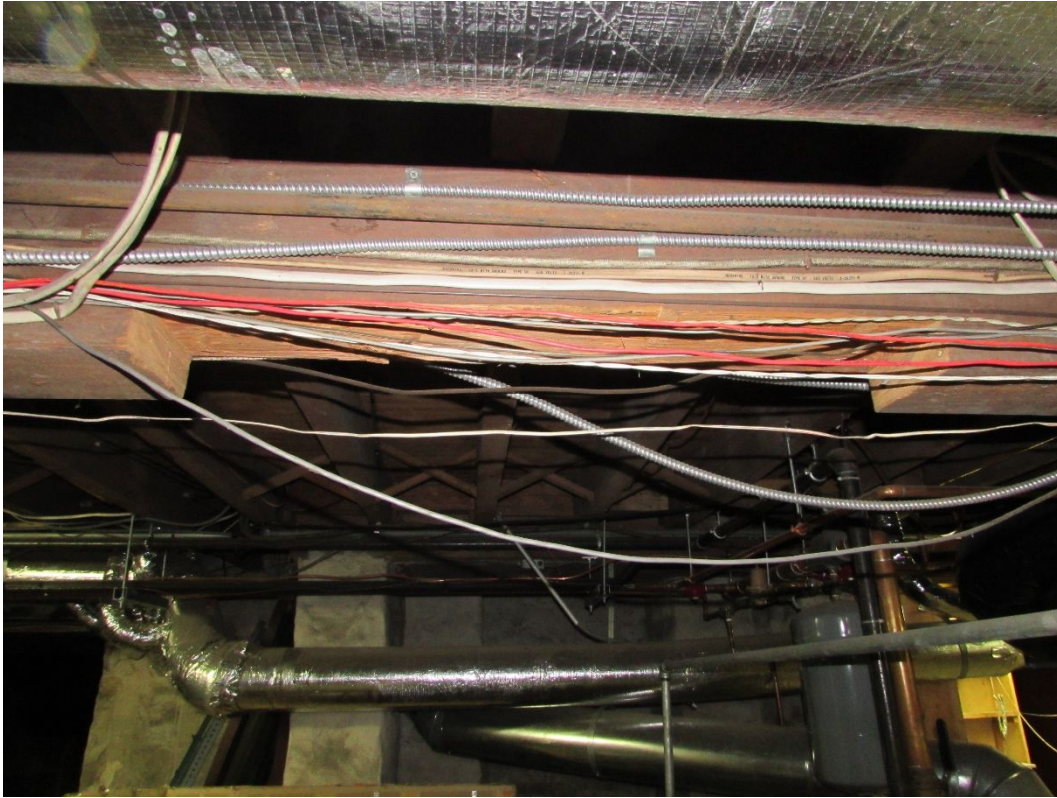
**Photo #31** – Heavily notched girder

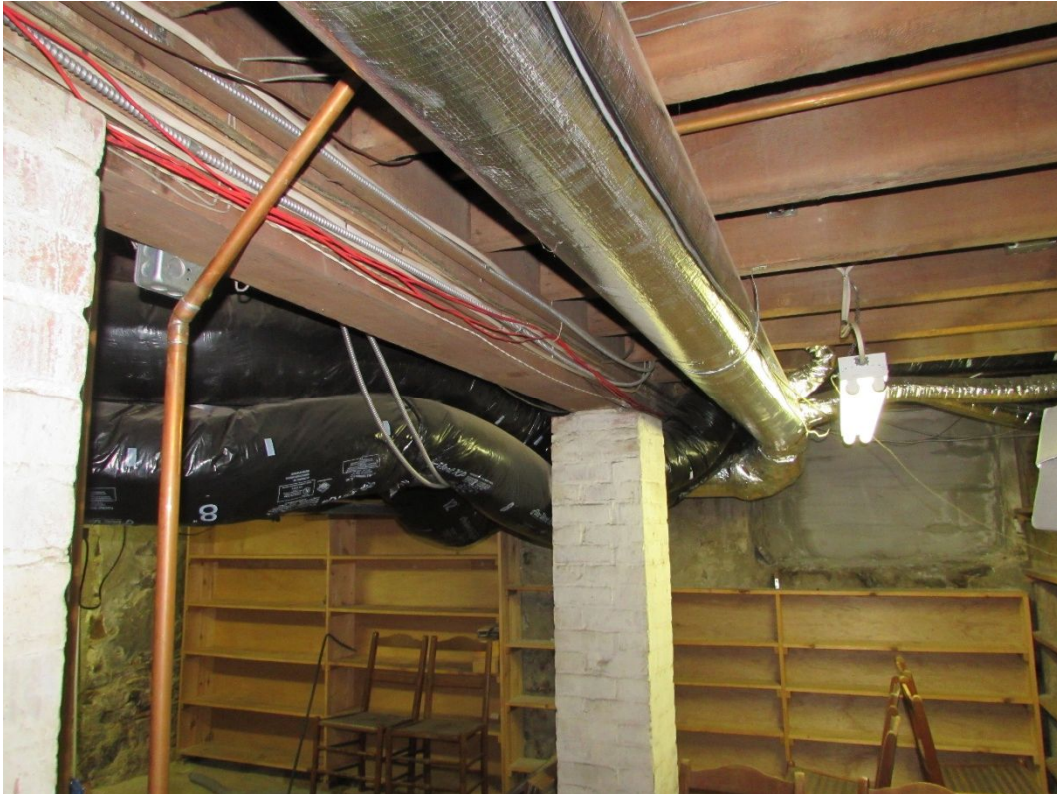
**Photo - #32** – Girder along right sidewall (front wall in background)

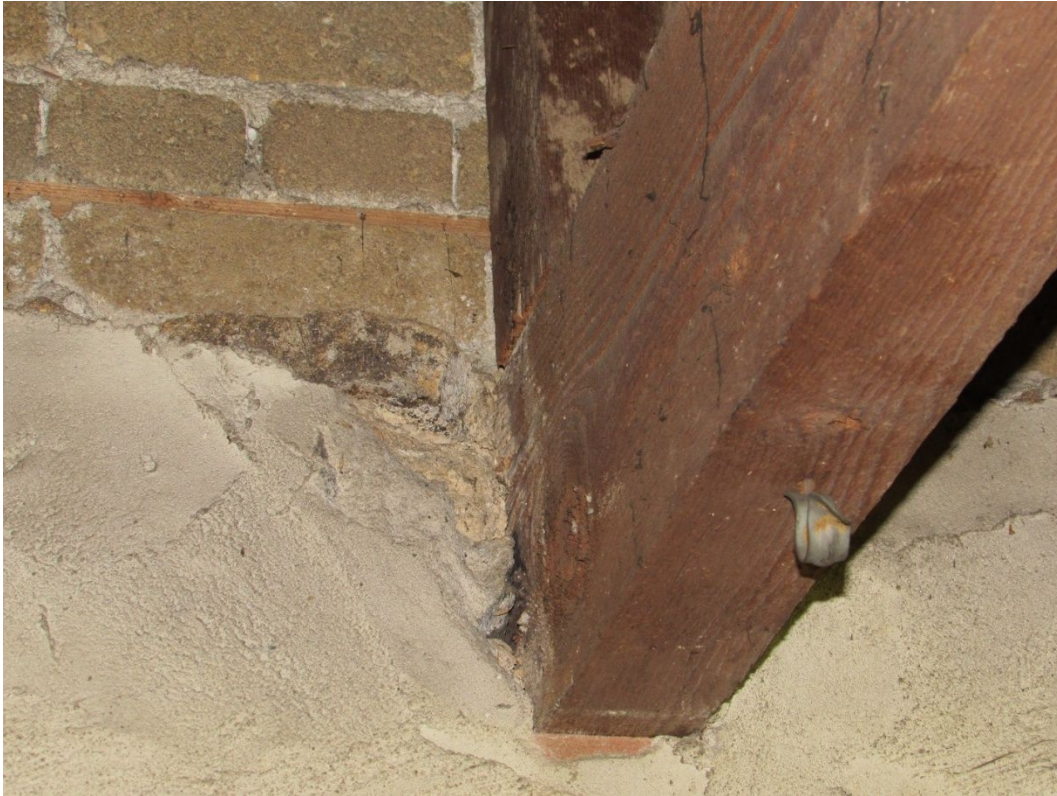
The ends of the floor joists along the left and right sidewalls are embedded in the exterior walls. Moisture staining was observed at the joist ends, several joists were probed at the face of the foundation wall and found to be sound; the condition of the embedded sections is not known. Along the left sidewall, two (2) joists were found to be cracked at natural knots. Two (2) joists were also found to be cracked at the right side of the basement. Approximately 8-10 3” x 12” floor joists were found to be cracked beneath the center of the exhibition room. It appears that a steel beam and column system were installed to provide supplemental support to these cracked floor joists by reducing their span lengths.

**Photo #35** – Embedded joist end

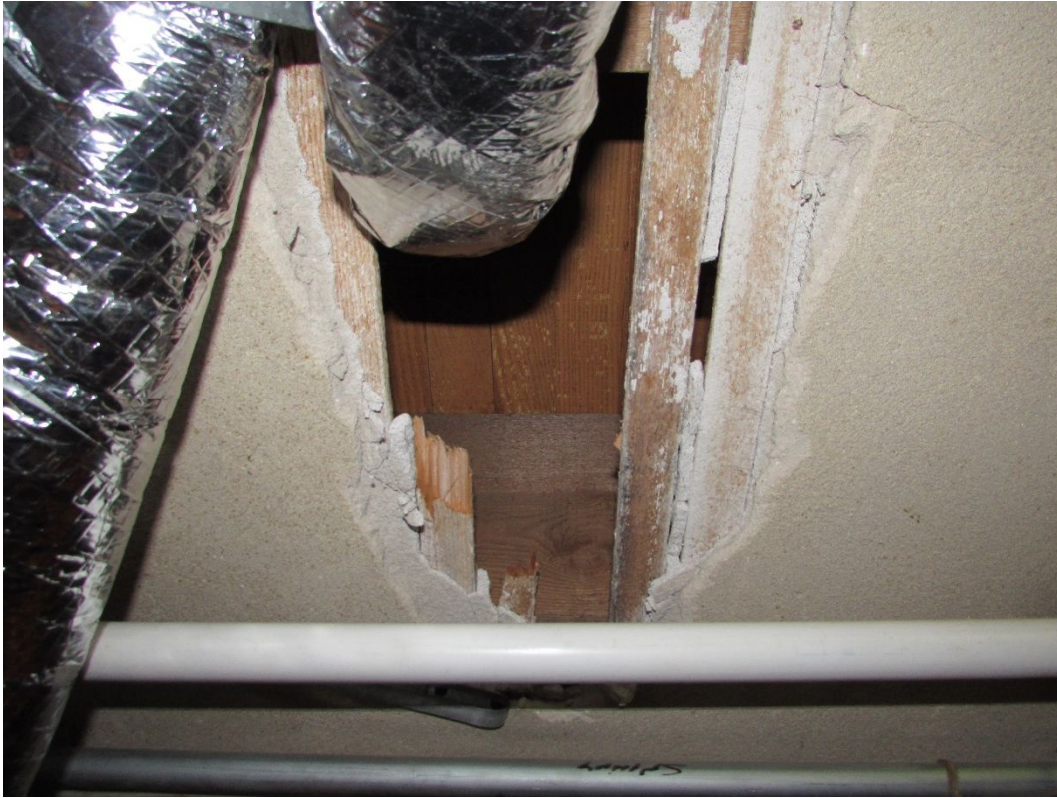
The floor framing at the rear half of the original structure is hidden from view by plaster ceilings. Subsequently, no comments can be provided. Openings were frequently found in the plaster ceilings and the ceilings were found to be cracked and loose indicating separation from the underlying framing.

**Photo #44** – Opening in plaster ceiling

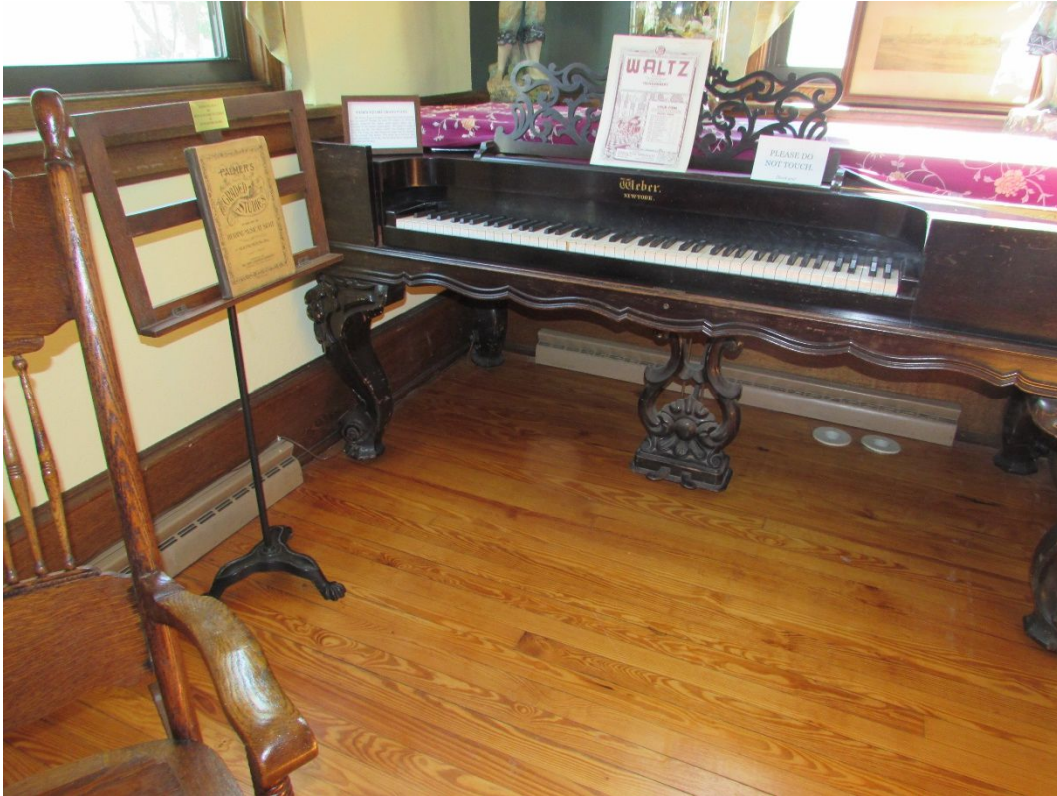
The first floor of the original building and the subsequent additions were found to be in good condition with evidence of minor cracking on each of the walls. The floor surface was found to be uneven adjacent to the safe, beneath the piano at the front left building corner and above girder lines; the floor movement at the piano coincides with decay found at the basement level.

**Photo #53** – Floor movement beneath piano

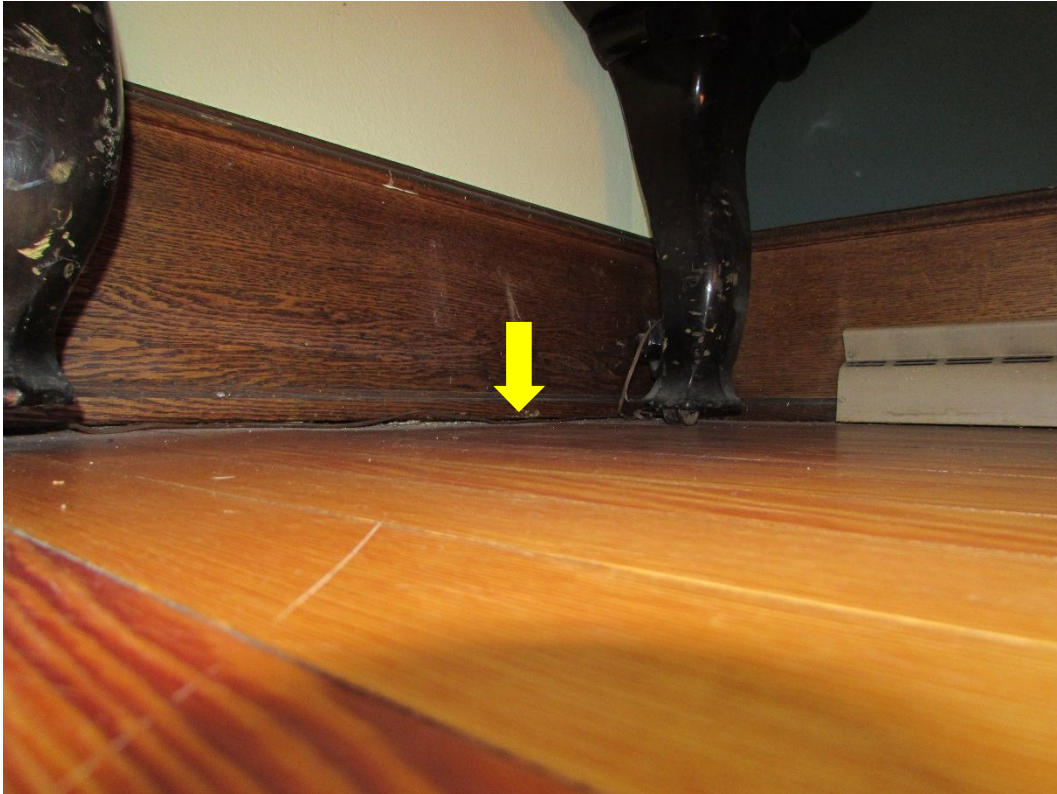
**Photo #54** – Gap between wall trim and floor depicting floor movement

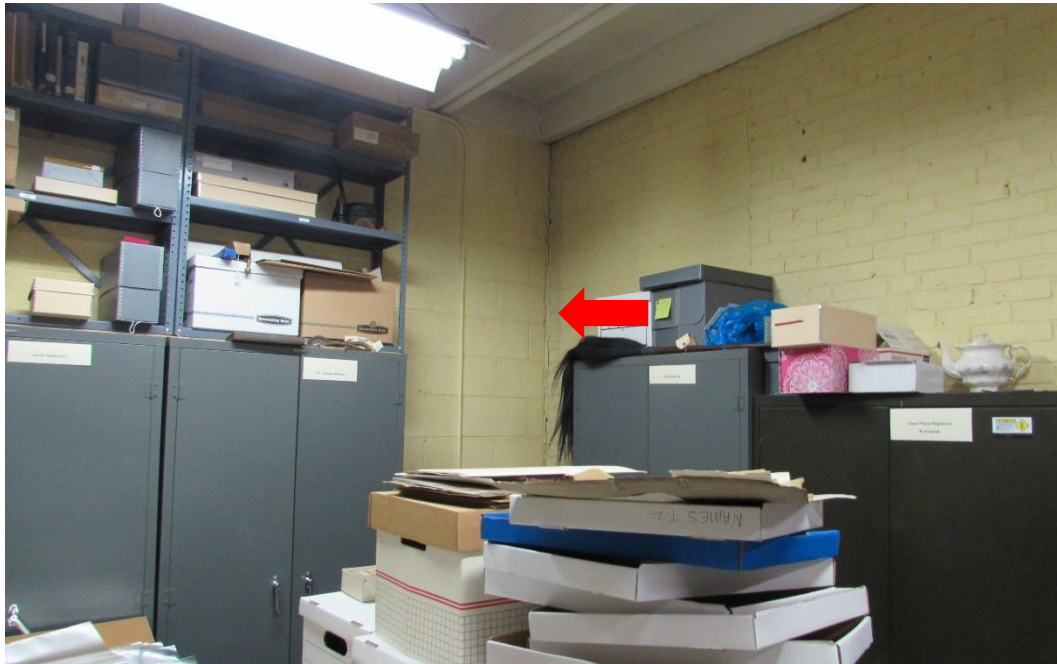
A separation was found where the right sidewall of the 1933 (vault) addition abuts the rear wall of the original structure.

**Photo #61** – Wall separation

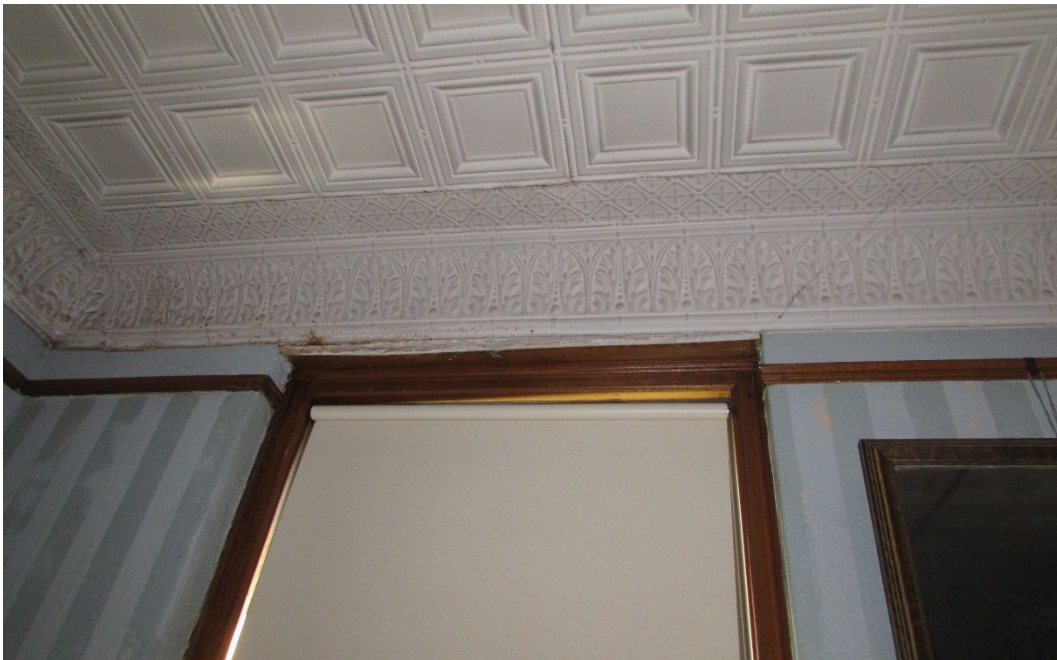
Light corrosion of the ceiling tile and trim was found at the front right corner of the 1931 addition.

**Photo #64** – Close up view of photo #63

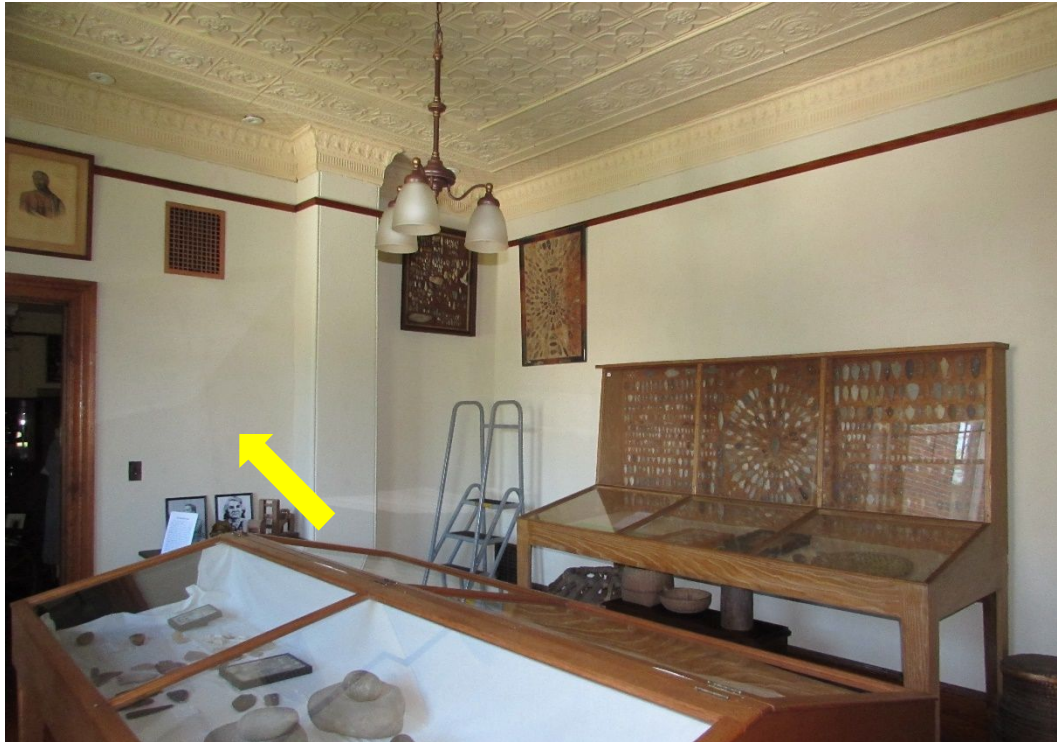
**Photo #72** – Cracked loose plaster at Indian Artifacts Gallery

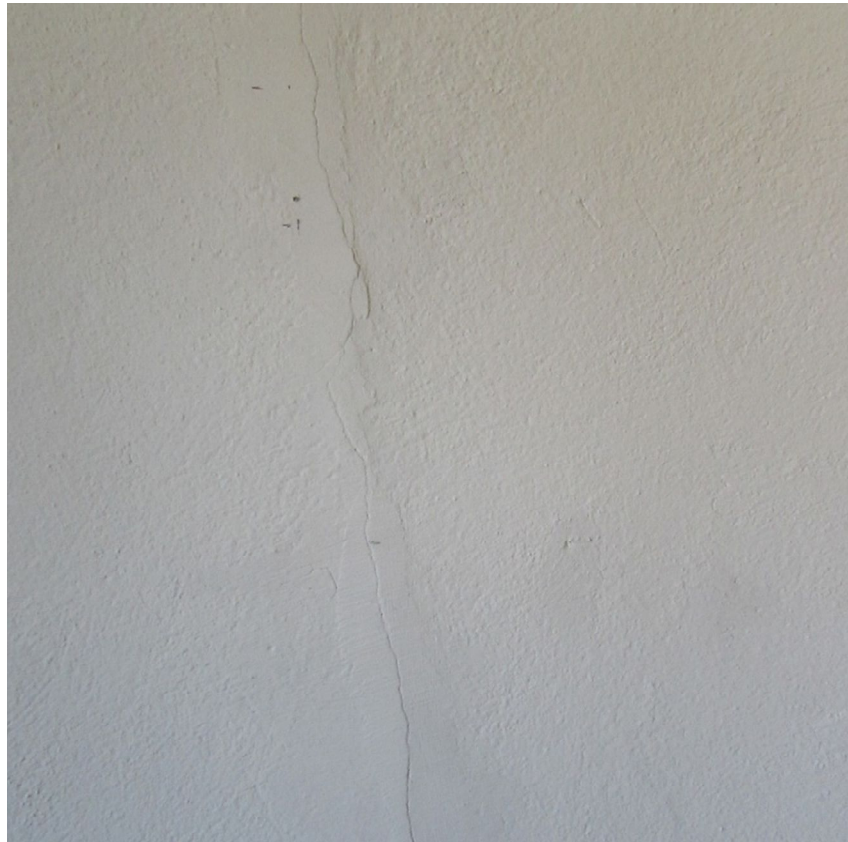
**Photo #73** – Close up view of photo #72

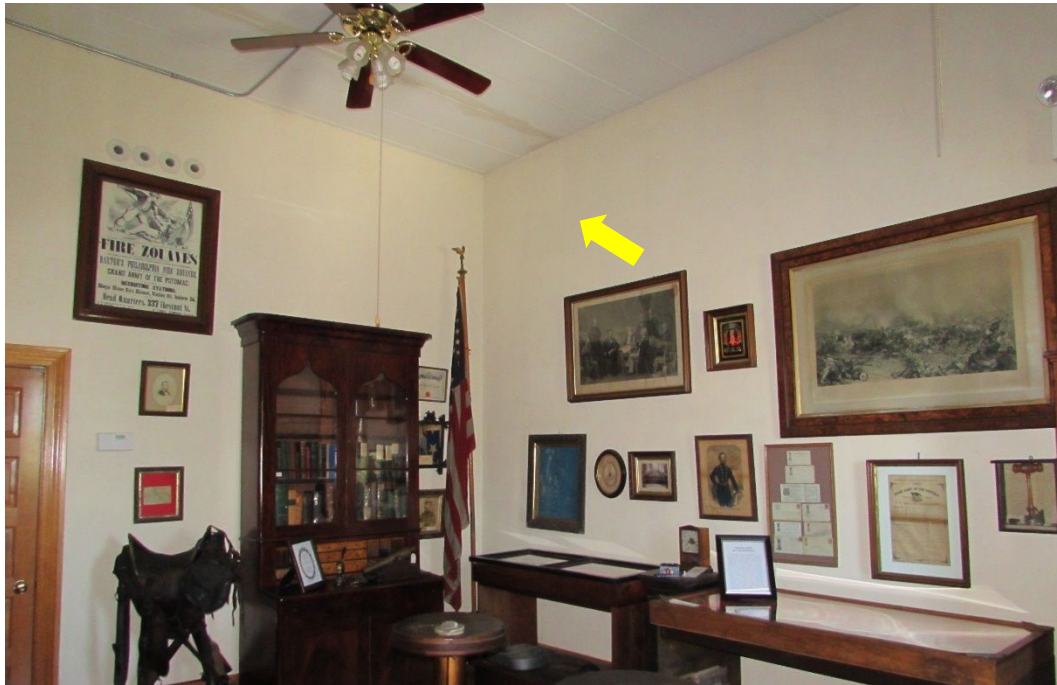
Evidence of water infiltration was found at the rear right corner of the Civil War Gallery (1964 addition above the 1933 addition). Minor settlement cracking was noted at the rear left corner of the Civil War Gallery. The finished wood floor was found to be approximately ½” – 1” below the base of the wall trim.

**Photo #74** – Location of settlement cracking in Civil War Gallery

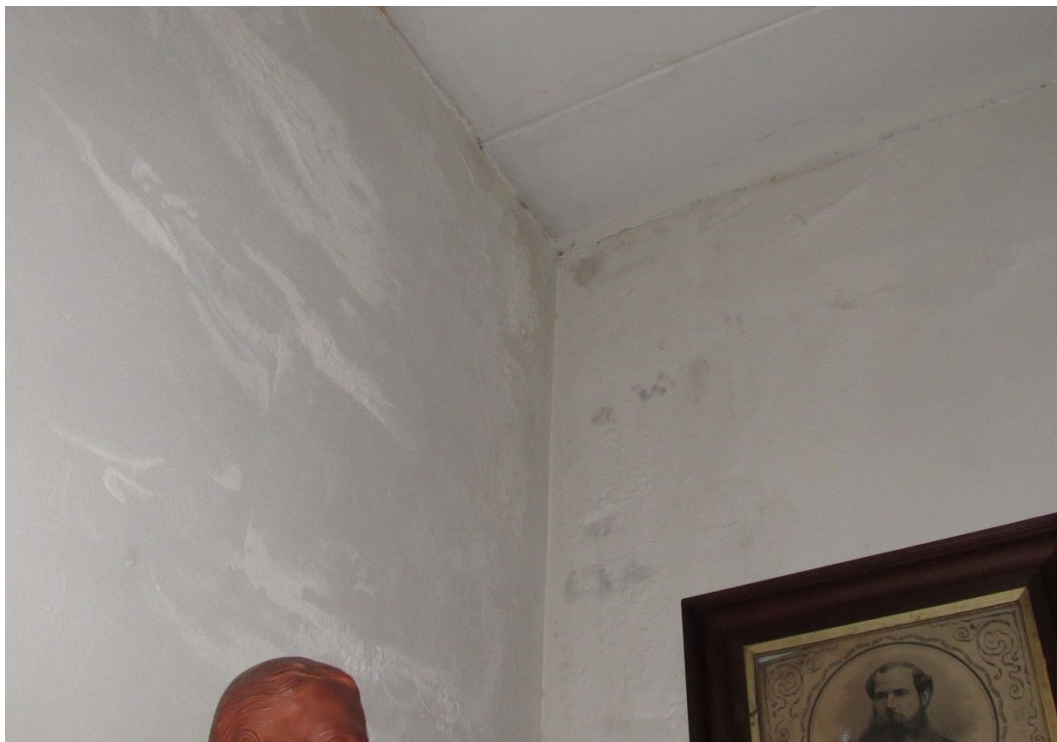
**Photo #75** – Water infiltration (paint blisters and staining) at Civil War Gallery

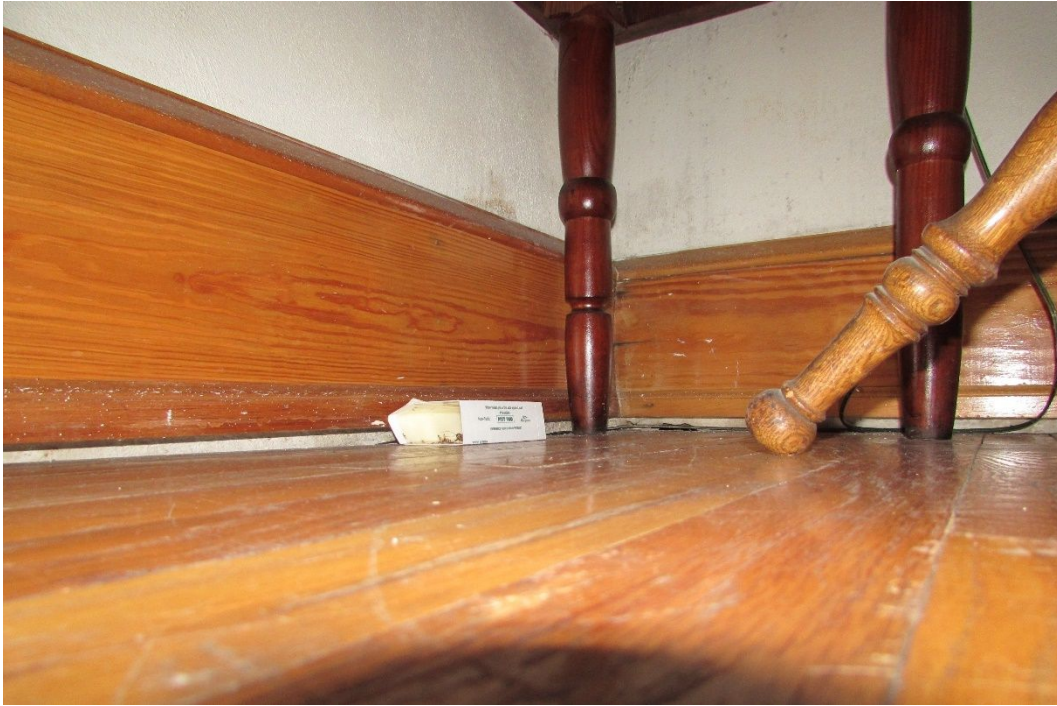
**Photo #76** – Gap between wood floor and wall trim at Civil War Gallery

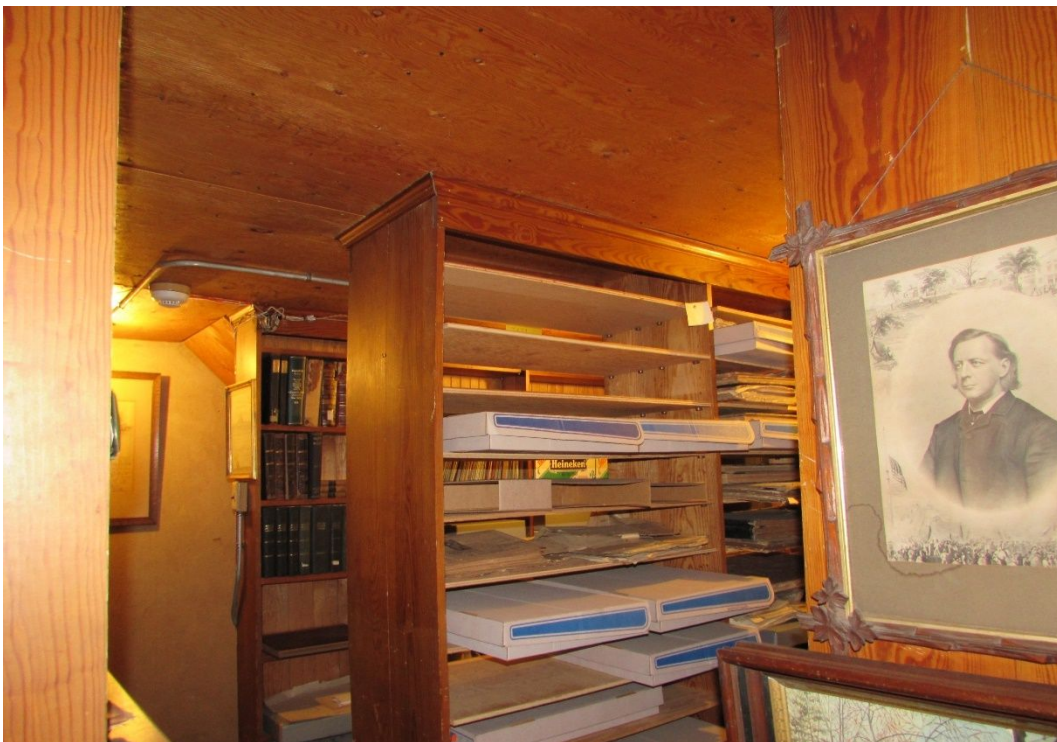
The second floor Stack Room contained a plywood ceiling, indicating that the original plaster ceiling had been removed and replaced. An unprotected opening was noted in the HVAC chase.

**Photo #79** – Plywood ceiling at 2<sup>nd</sup> floor Stack Room

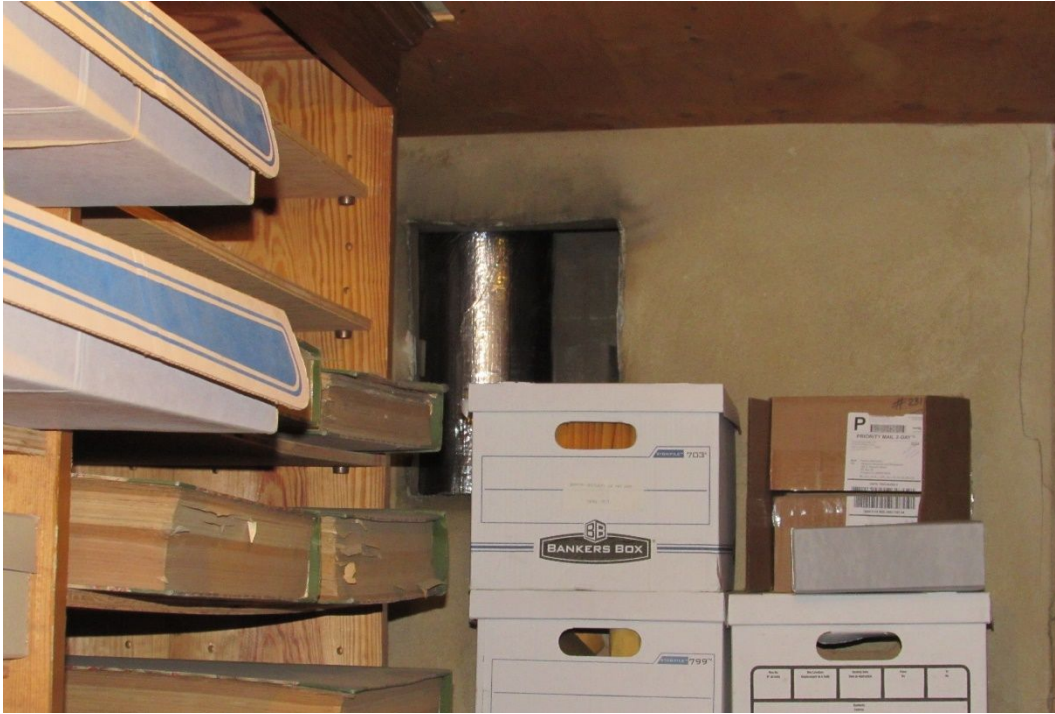
**Photo #80 – Opening in HVAC chase**

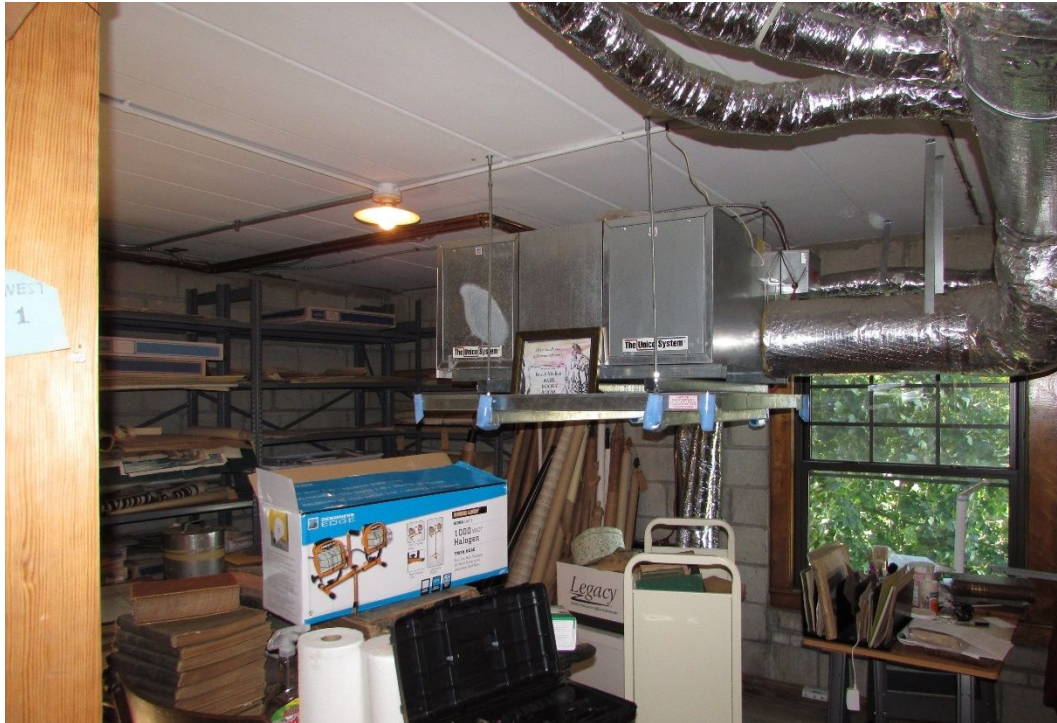
The 3<sup>rd</sup> floor of the 1964 addition was found to be in good condition with the exception of a bearing crack at each end of a window header. Water intrusion was also noted at the emergency exit door.

**Photo #84** – Overview of 3<sup>rd</sup> floor level, 1964 addition

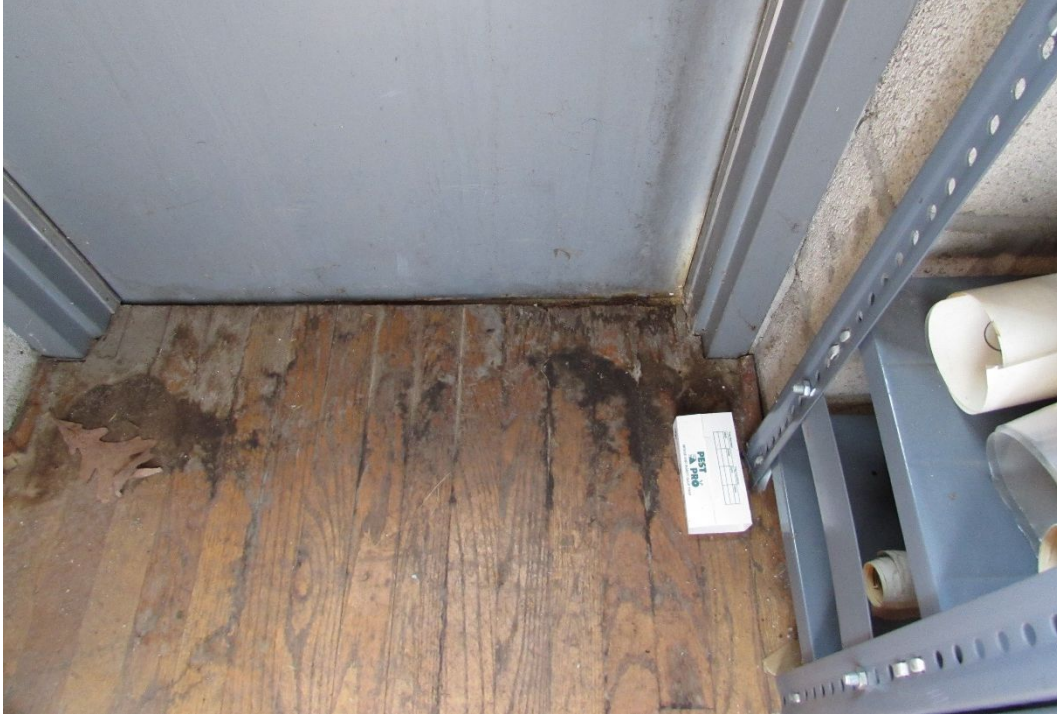
**Photo #86** – Water intrusion at emergency exit

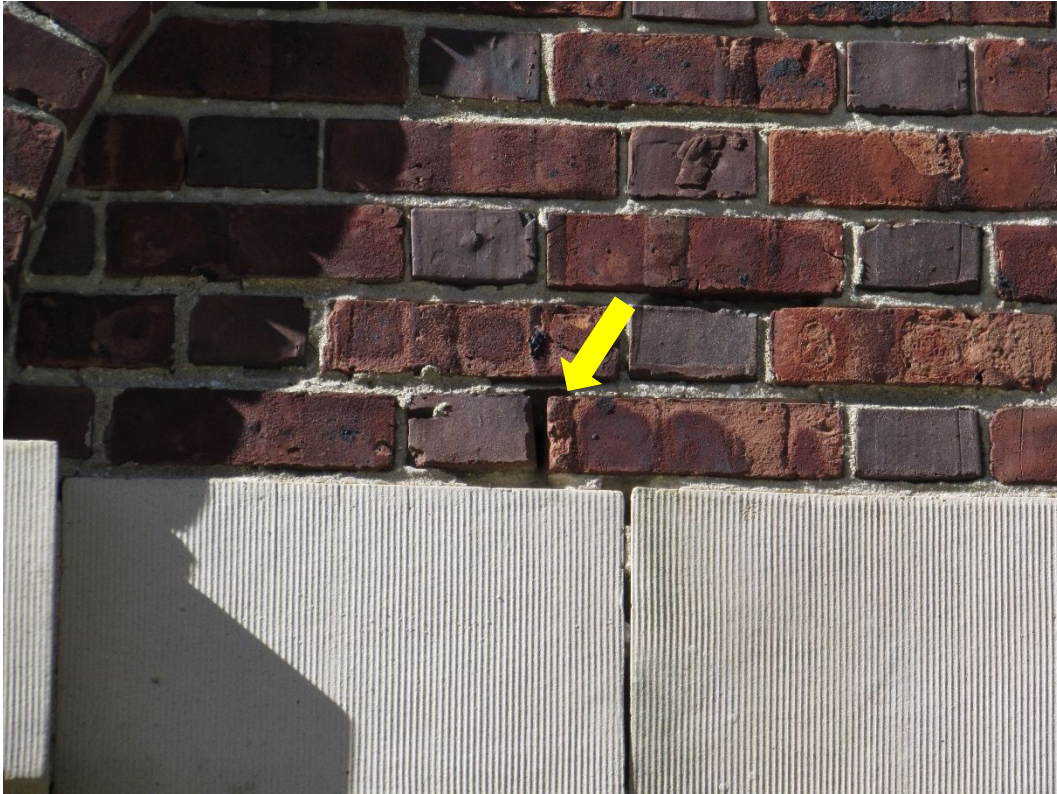
**Photo #90** – Close up view of photo #89

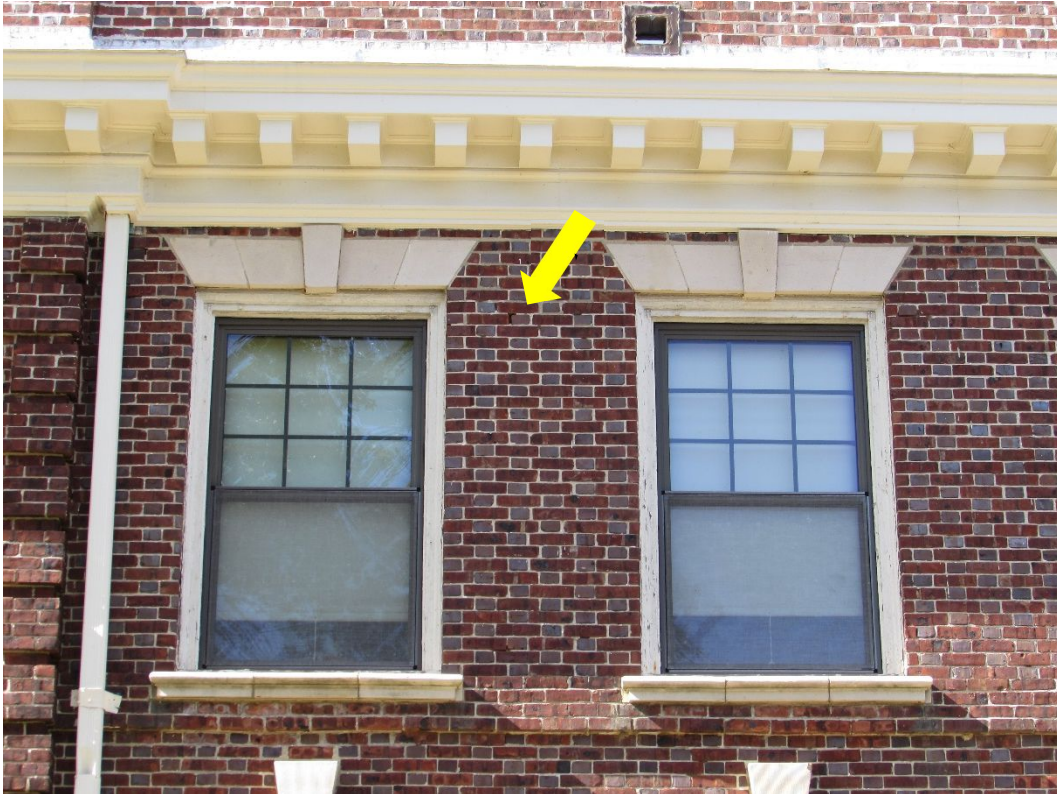
**Photo #92** – Open mortar joint

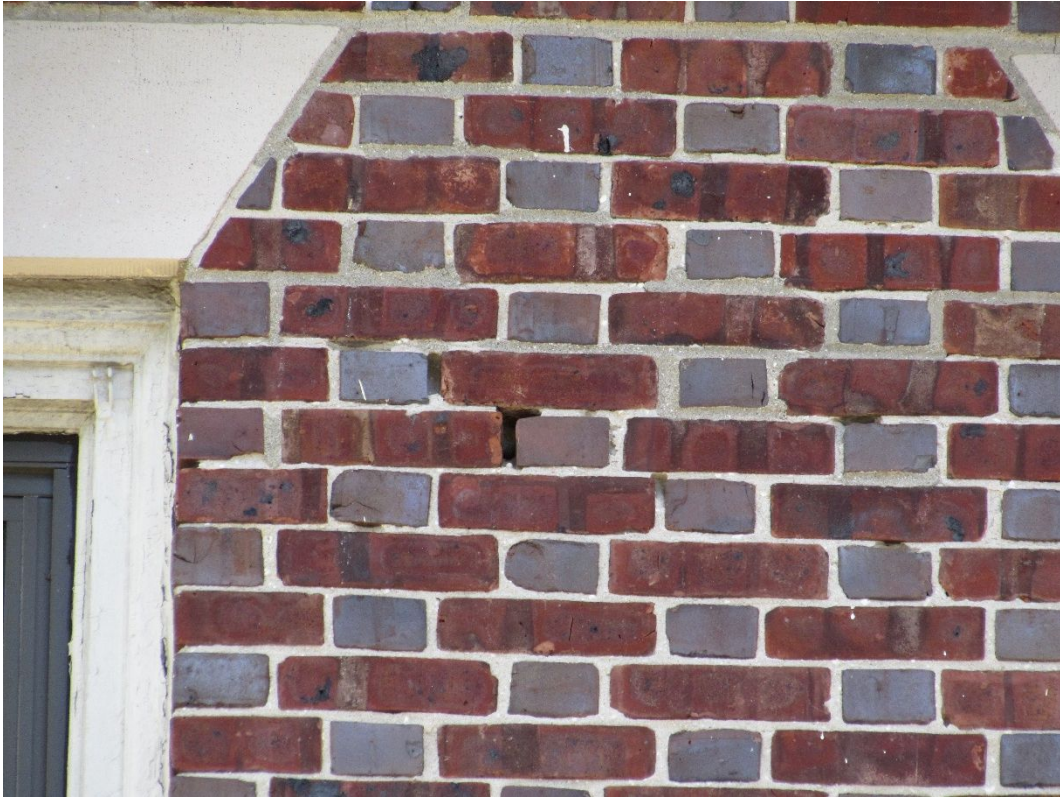
**Photo #93** – Close up view of photo #92

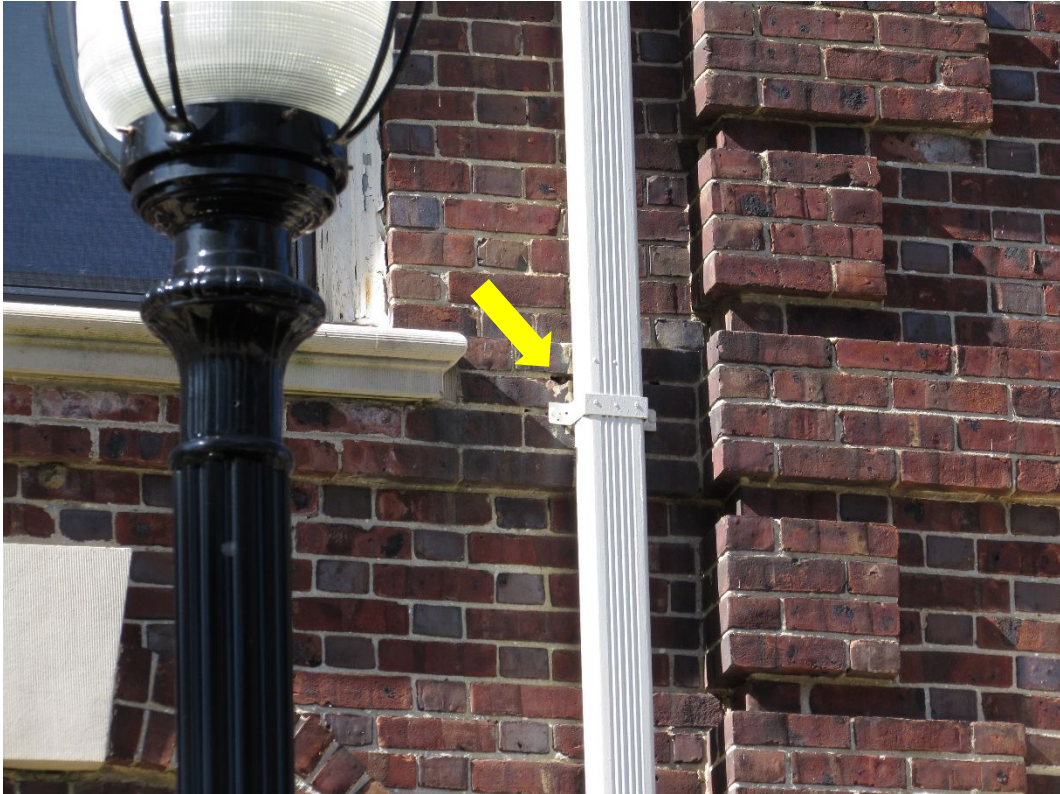
**Photo #94** – Open mortar joint

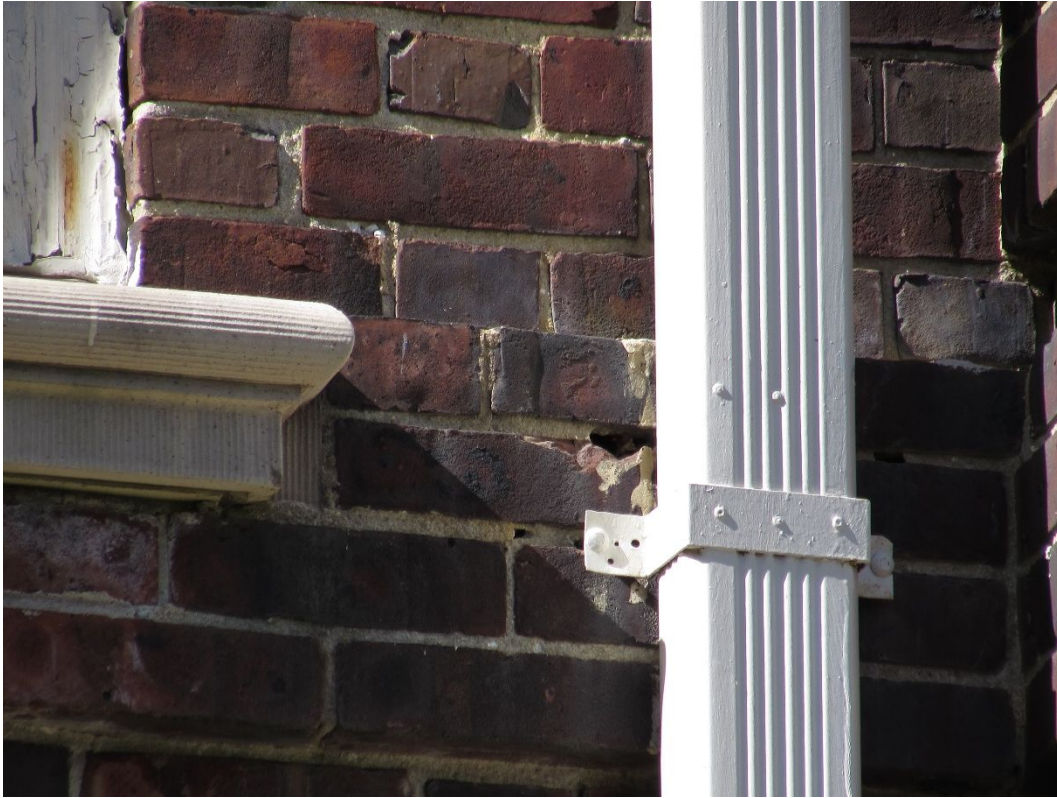
**Photo #95** – Close up view of photo #94
