# MARINO STRUCTURAL SOLUTIONS

NICHOLAS MARINO, P.E.

RE: **Building Evaluation**  
Vineland Historical Society  
108 S. 7<sup>th</sup> Street  
Vineland, Cumberland Co., NJ  
**MSS #18167**

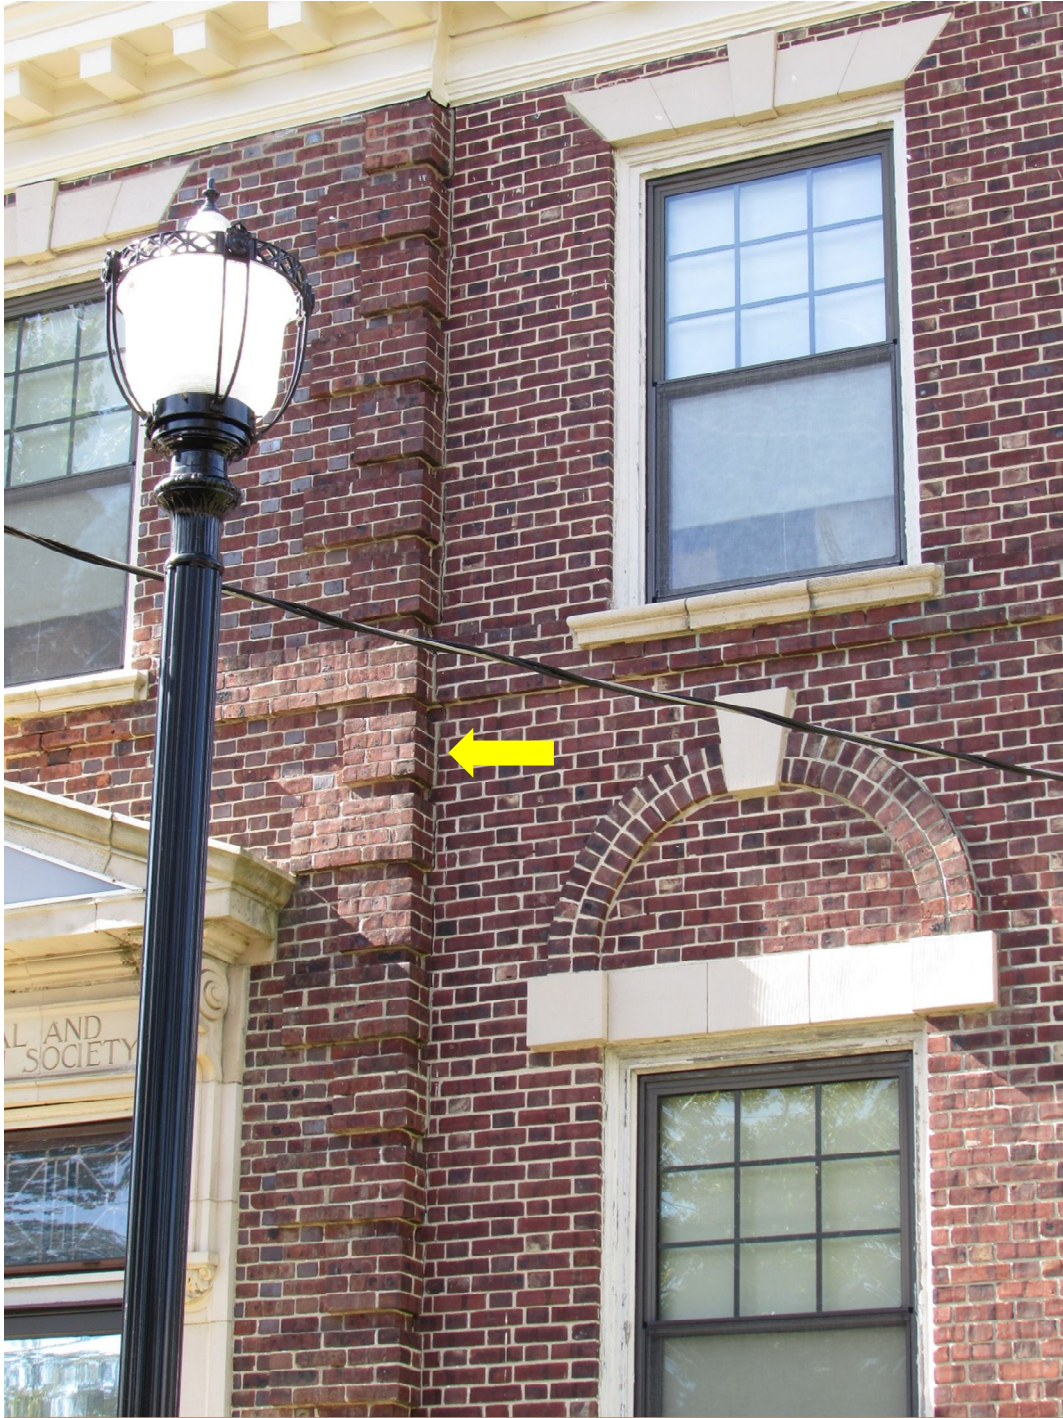
**Photo #96** – Open joint between 1931 addition and original structure

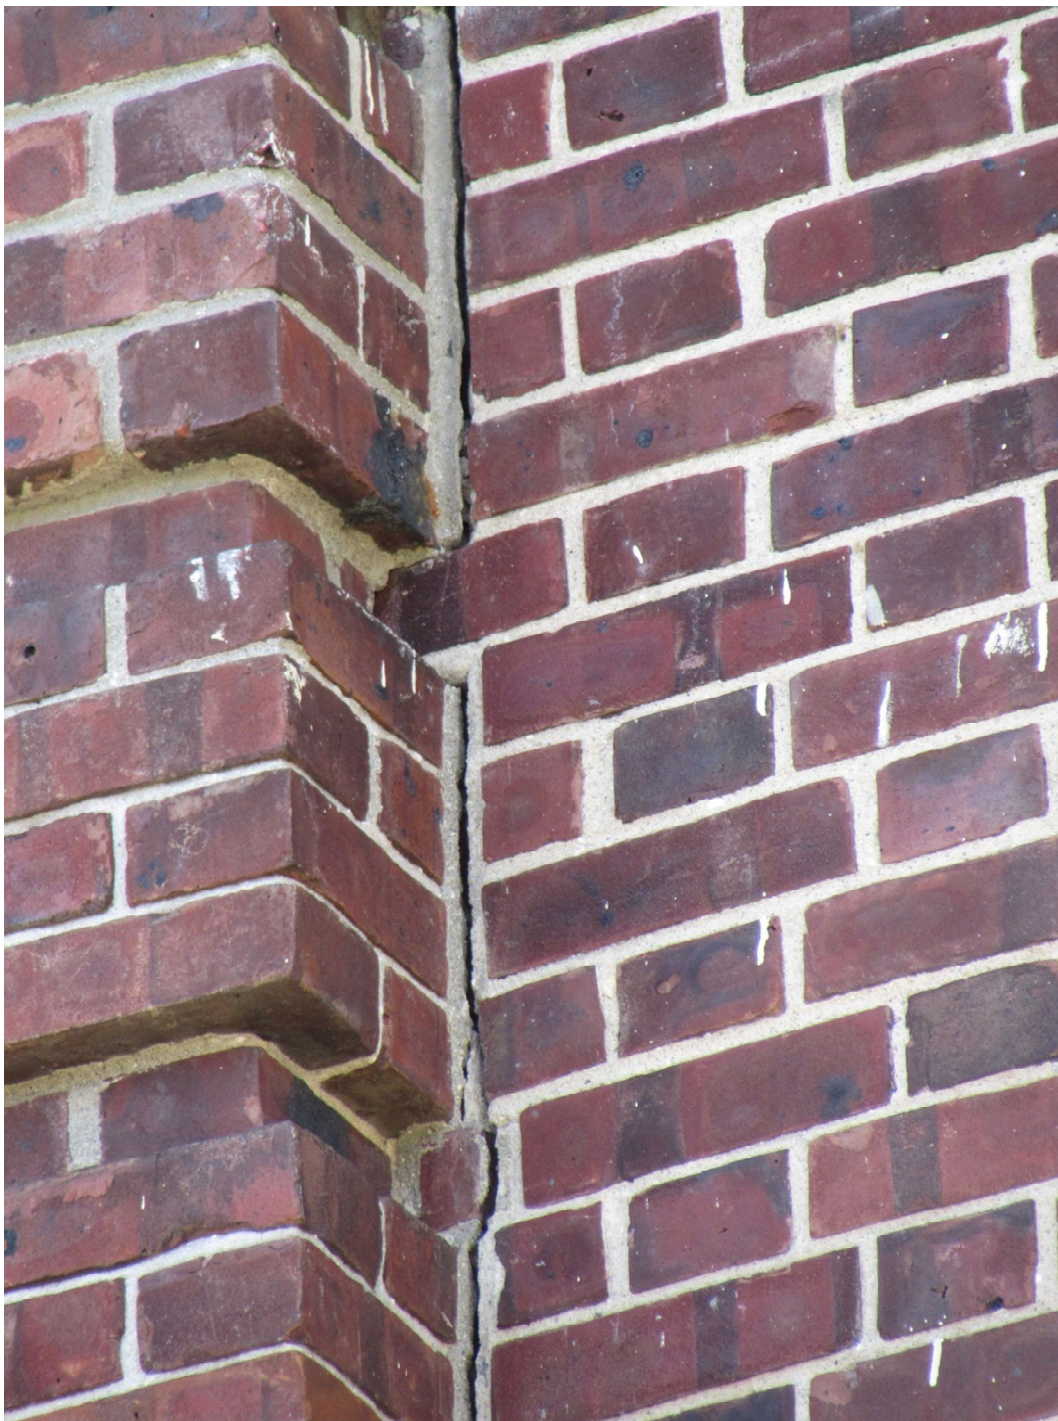
**Photo #97** – Close up view of photo #96

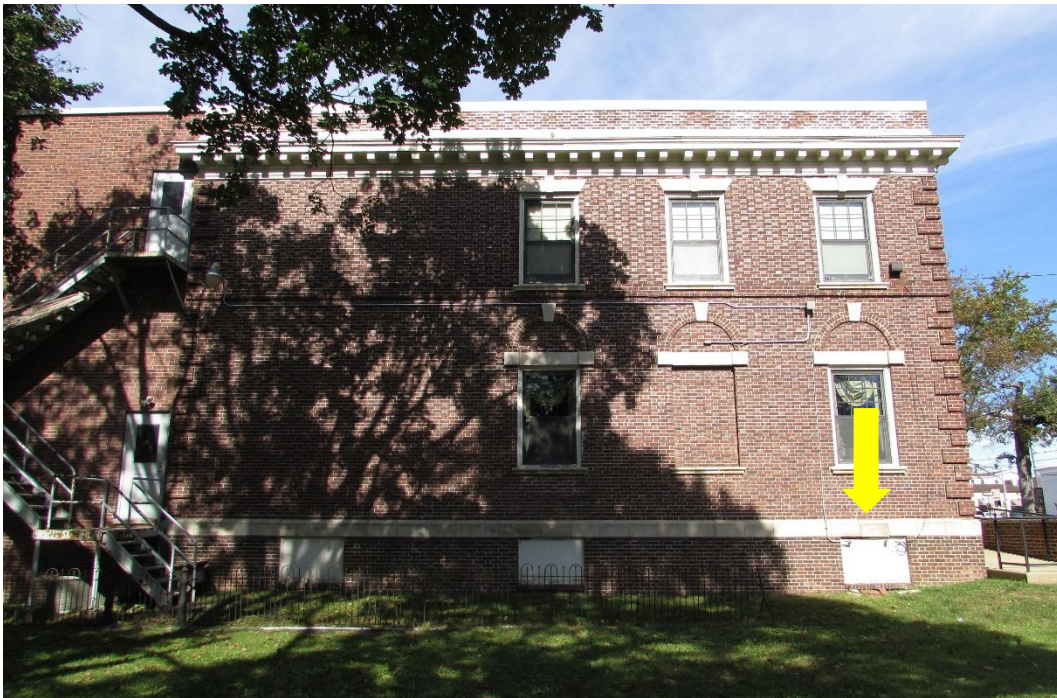
A precast concrete segment on the left façade was found to be dislodged; the location of this precast segment coincides with a decayed wood header above a basement window.

**Photo #99** – Location of dislodge precast concrete trim

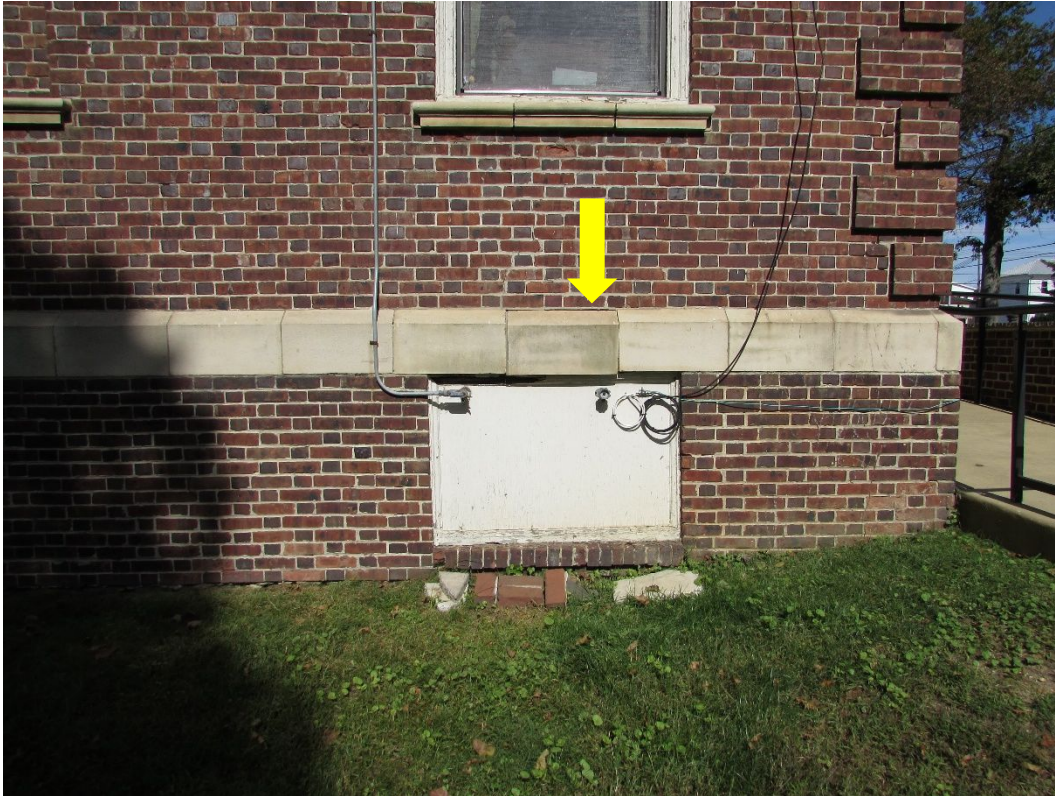
**Photo #100** – Close up view of precast concrete segment in photo #99 above

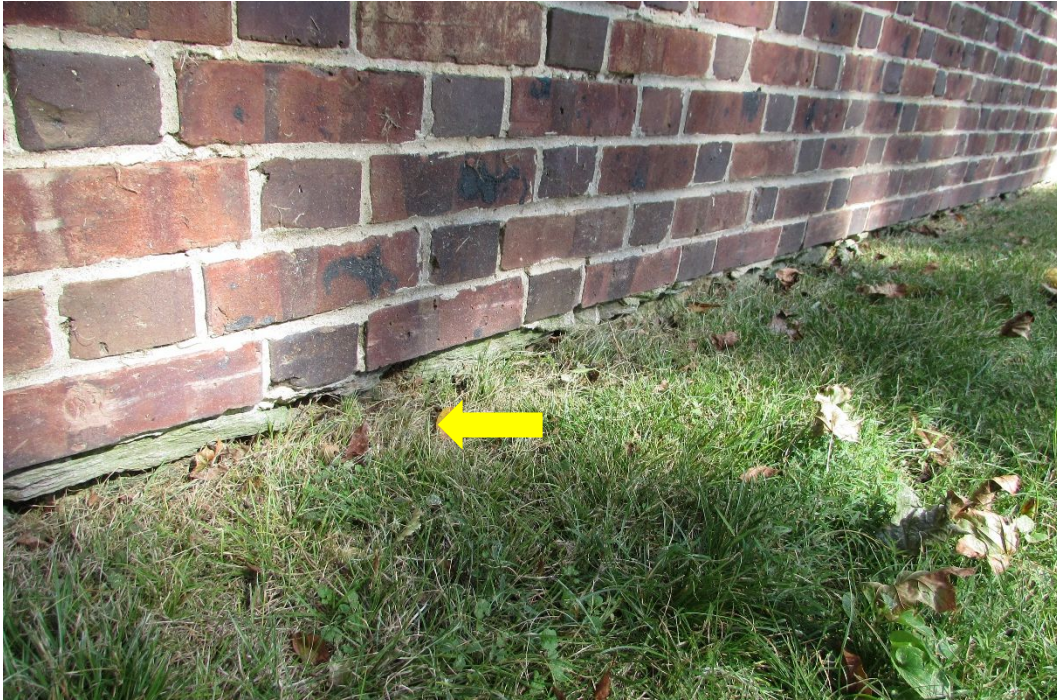
The stone foundation was found to be exposed at grade level along the left sidewall; the exposed mortar joints were well eroded.

**Photo #102** – Eroded joints of stone foundation wall

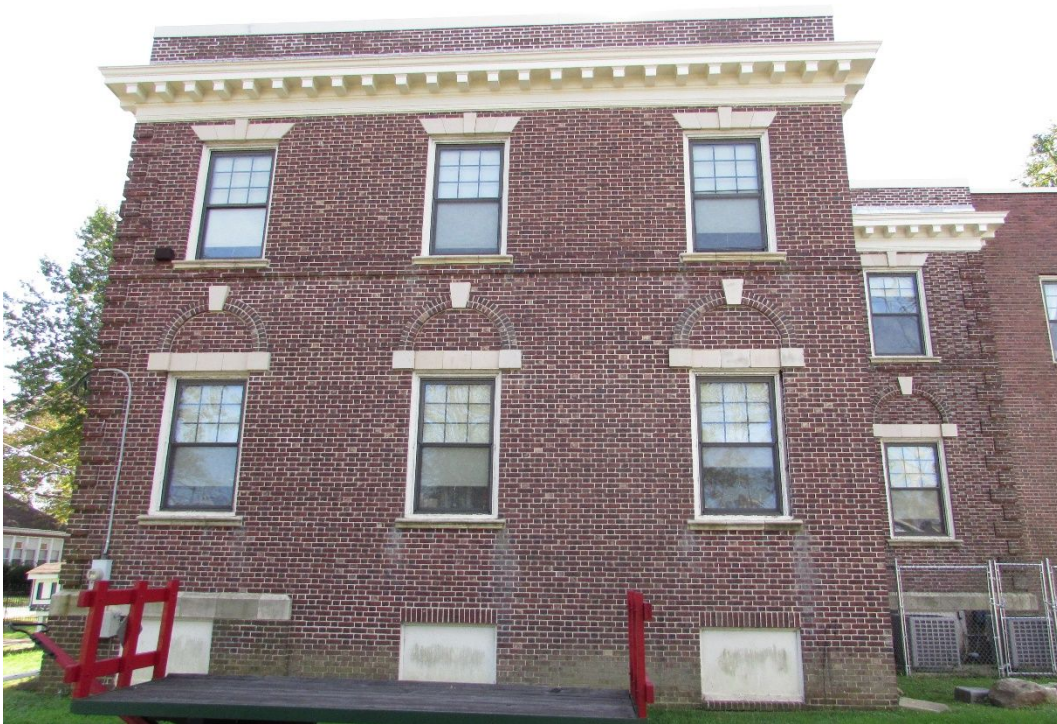
**Photo #103** – Overview of right side wall

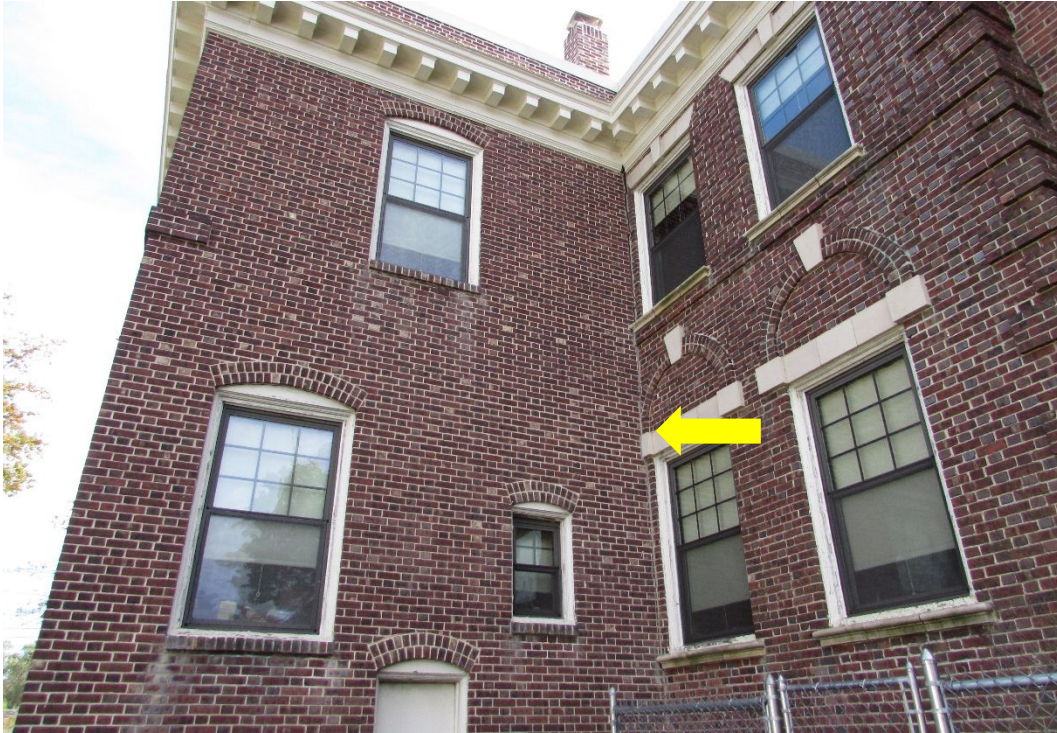
**Photo #104** – Open joint (separation) of rear left corner of 1931 addition

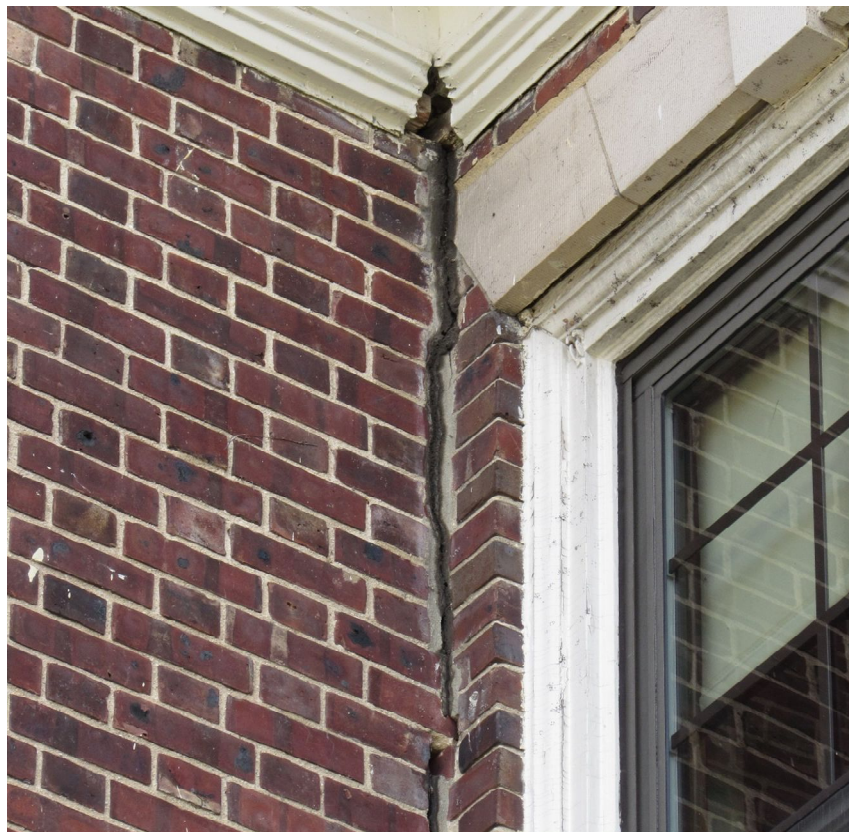
**Photo #105** – Close up view of photo #104 above

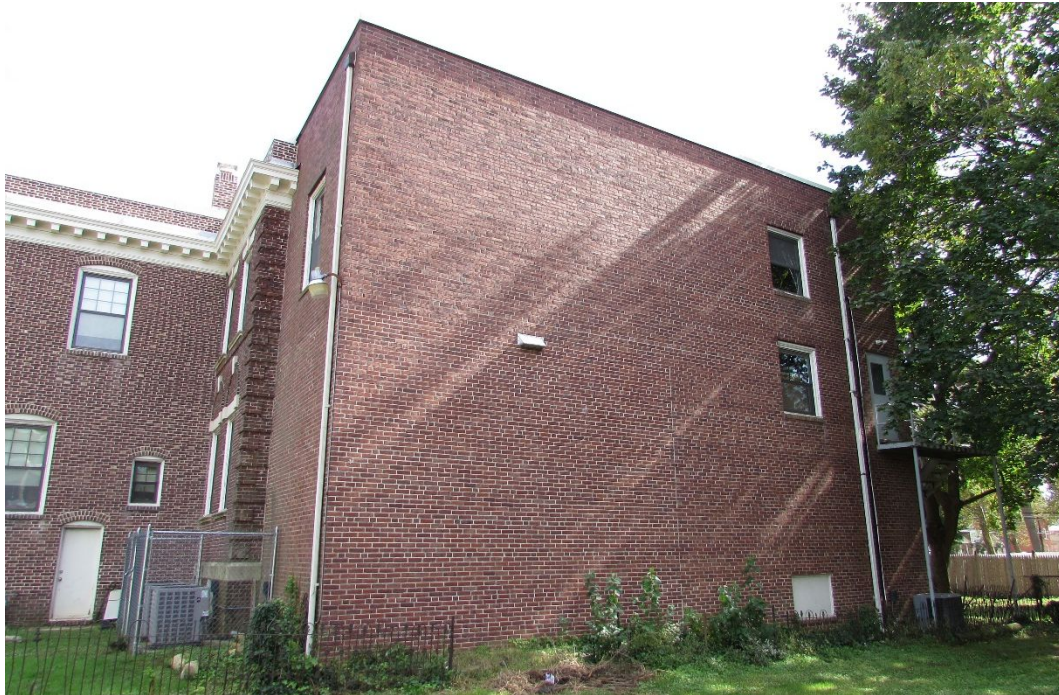
The rear wall of the 1933 and 1964 additions generally appeared to be in good condition. Open joints were noted at steel lintels above window openings. Minor lateral displacement was noted surrounding the roof scupper.

**Photo #106** – Overview of rear wall

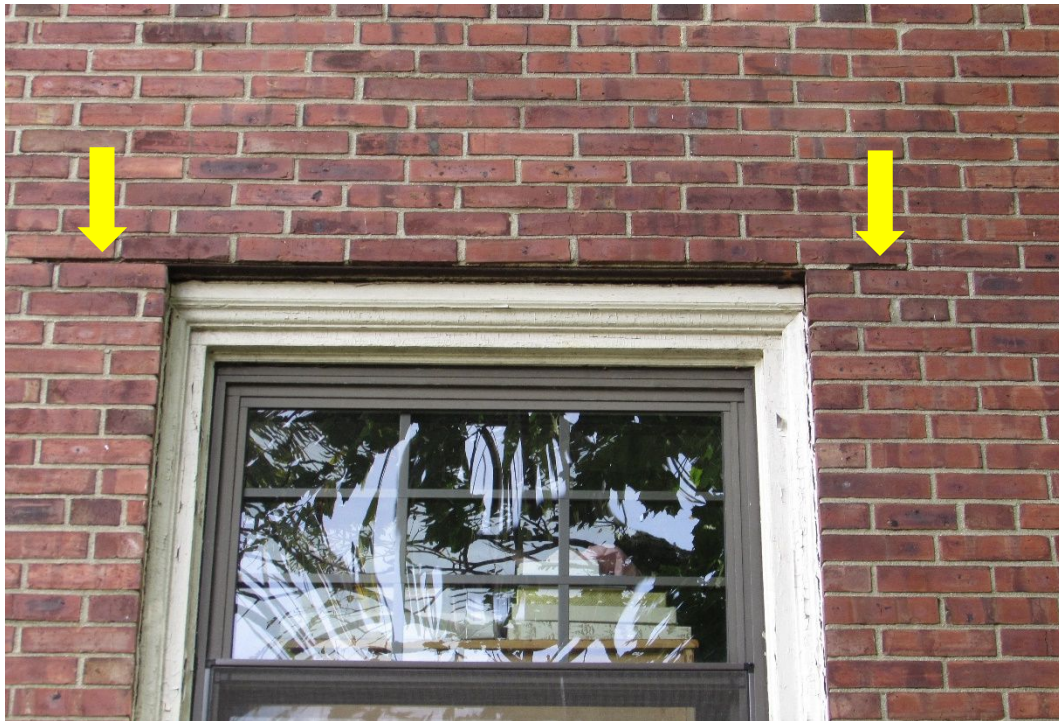
**Photo #107** – Open joints at steel lintel

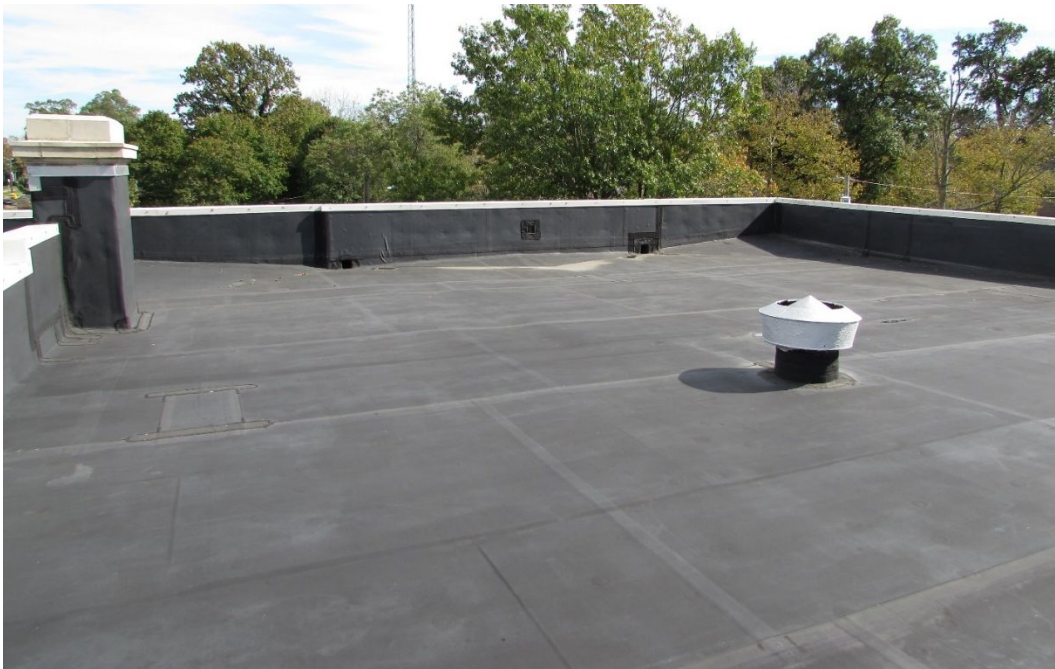
Roof Surface - The roof surface (membrane) generally appeared to be in good condition. No low areas or significant evidence of ponding were observed. No loose or open seams were readily observed with the exception of a potential open seam at the chimney base.

**Photo #109** – Roof overview looking towards front wall

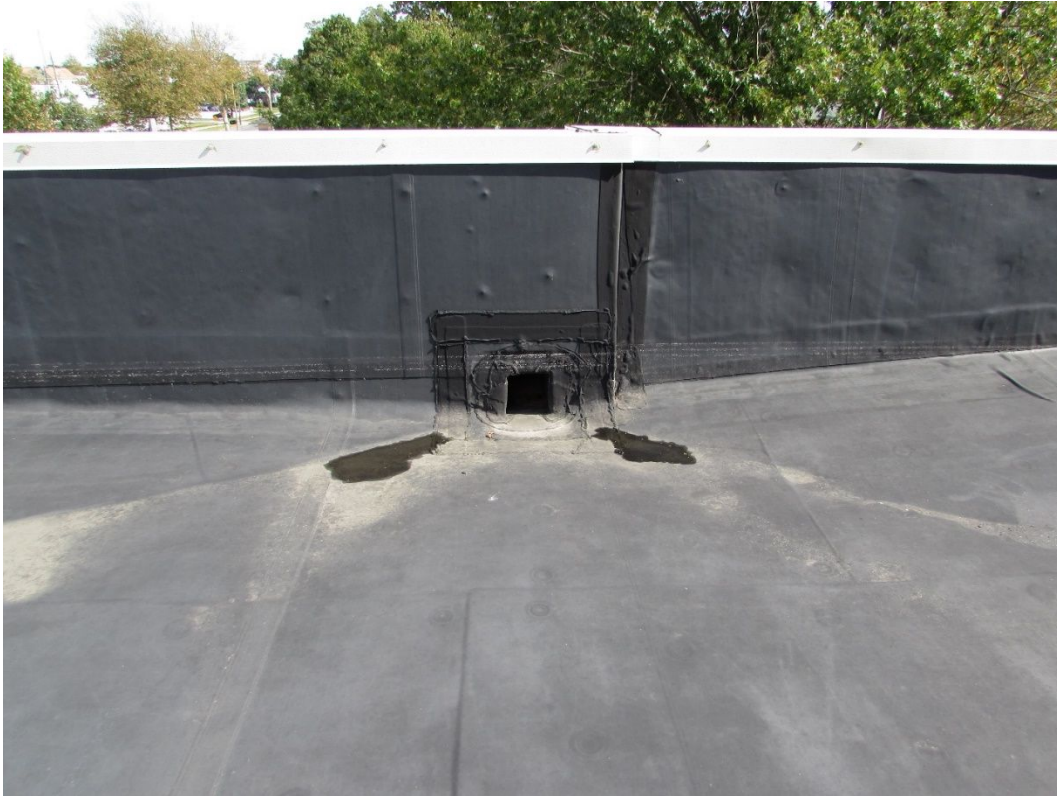
**Photo #110** – Front roof scupper

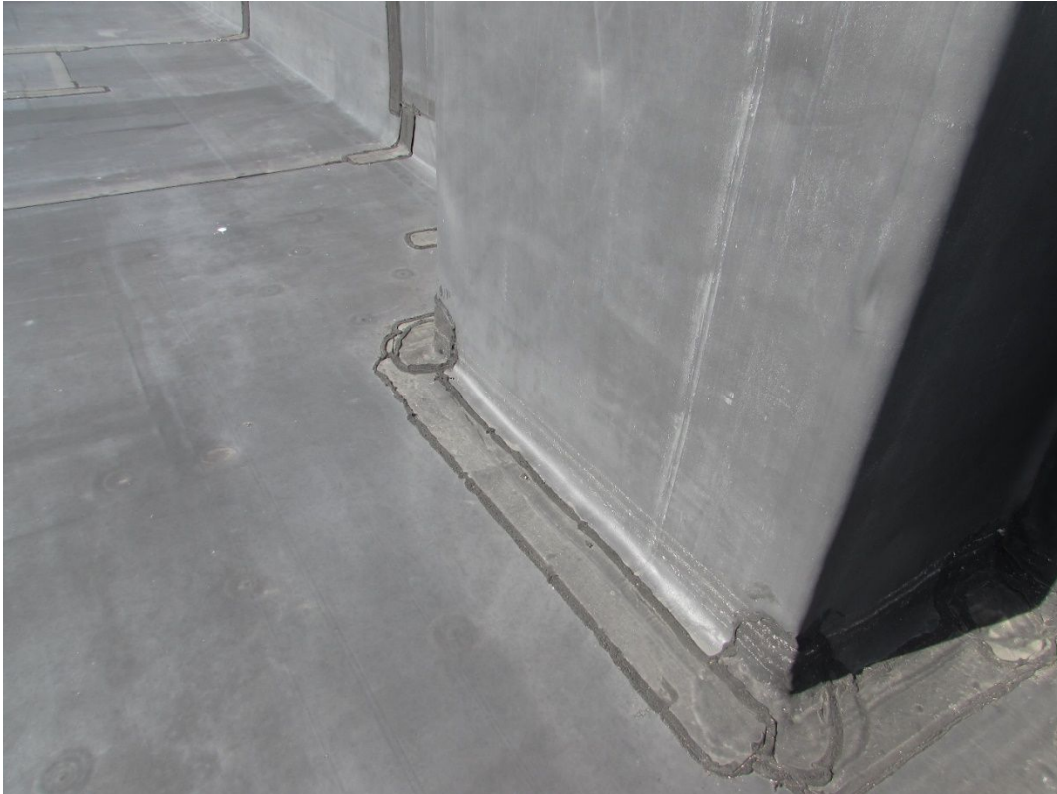
**Photo #111** – Chimney base

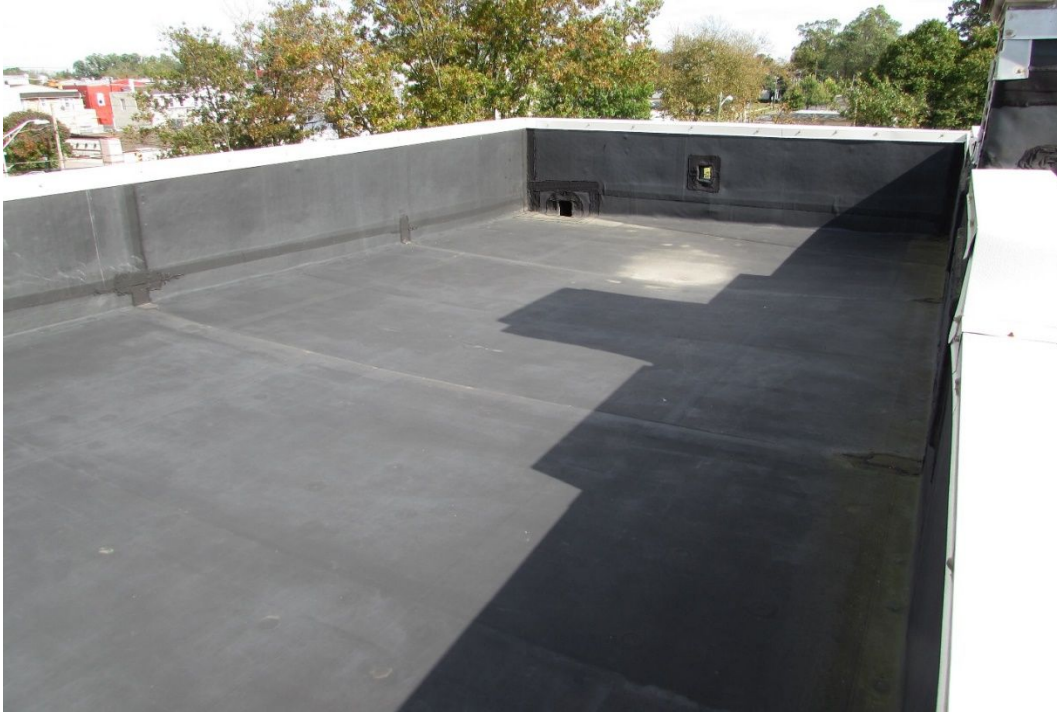
**Photo #114** – Roof conditions above 1931 addition
