# INSPECTION REPORT

For the Property at:  
**1 ANY STREET, A**  
OTTAWA, ON

Prepared for: JOHN SMITH  
Inspection Date: Saturday, July 1, 2023  
Prepared by: Michael Francis

RE: Report No. 1507

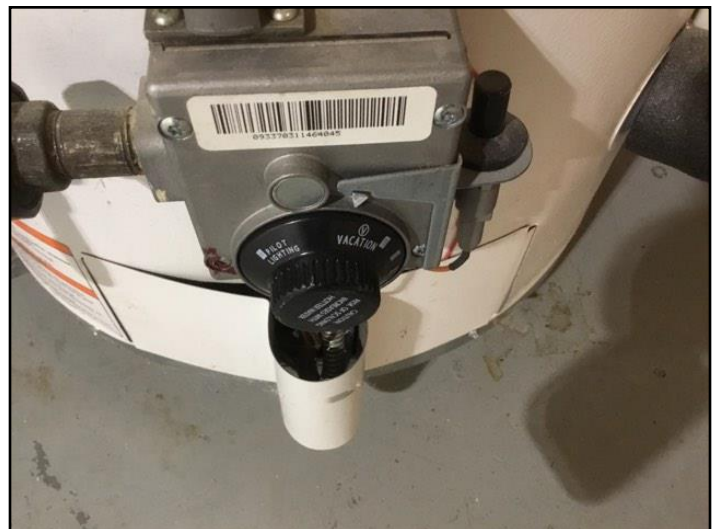
62. Less than 100° F

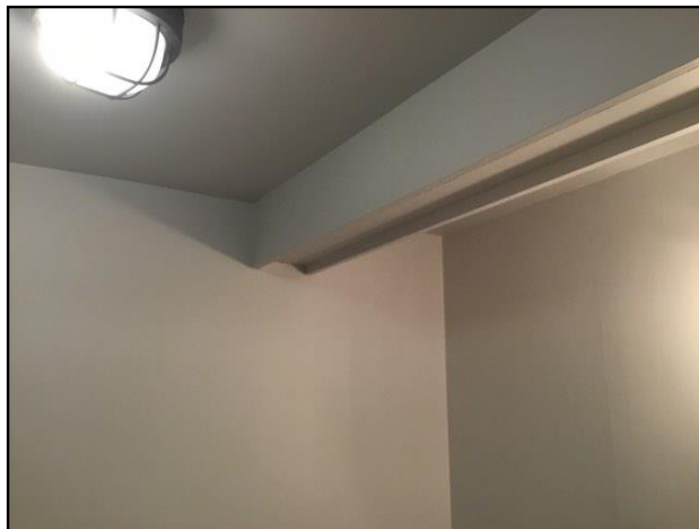
In basement bathroom

75. None

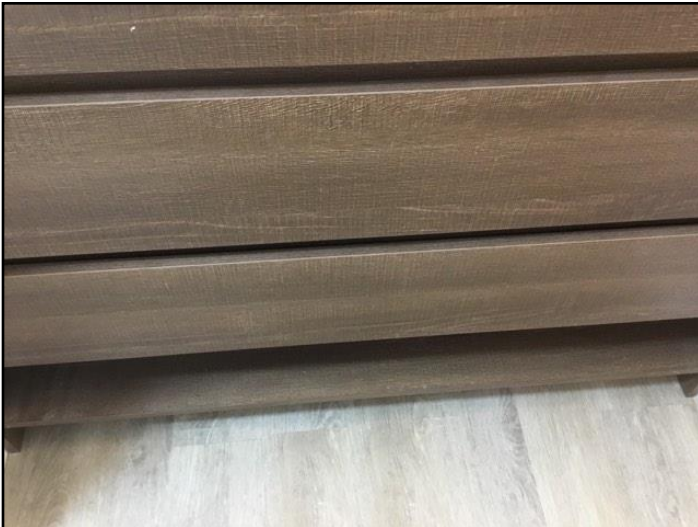
**18. Condition:** • Stiff or inoperative drawers

**Location:** Second floor bathroom

80. Stiff or inoperative drawers

**Task:** Correct
