# ASBESTOS INSPECTION REPORT

**Building #1803**

Fort, Sill, OK 73503

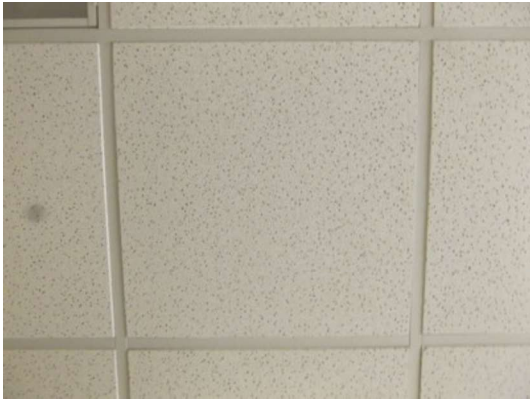
**(HA-01)**  
**No Asbestos Detected**

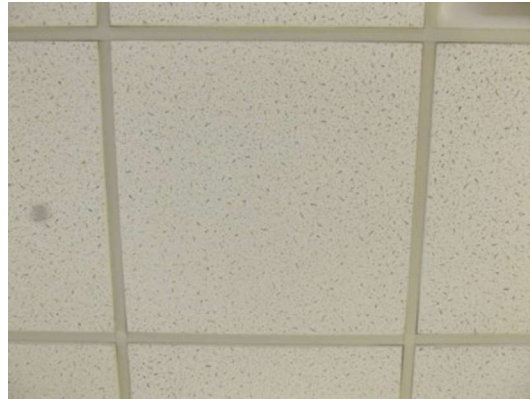
**(HA-02)**  
**No Asbestos Detected**

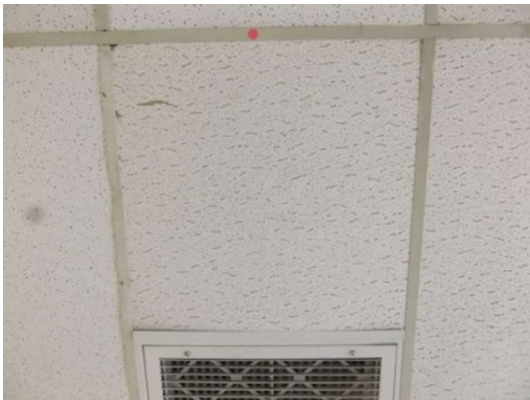
**(HA-03)**  
**No Asbestos Detected**

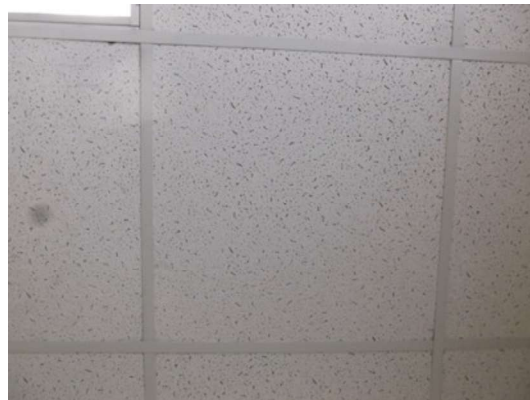
**(HA-04)**  
**No Asbestos Detected**

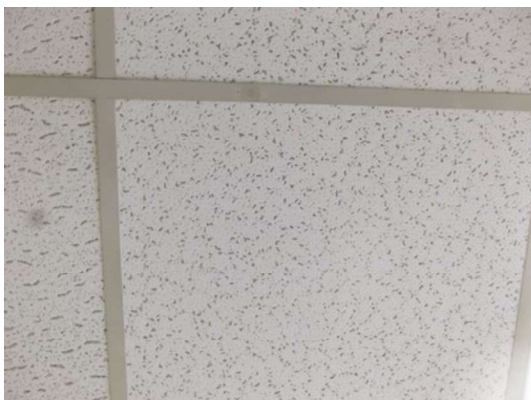
**(HA-07)**  
**No Asbestos Detected**

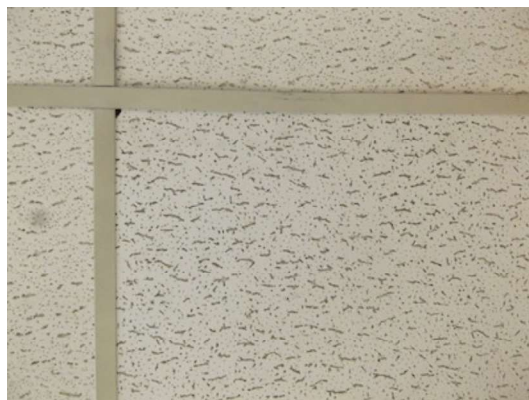
**(HA-08)**  
**No Asbestos Detected**

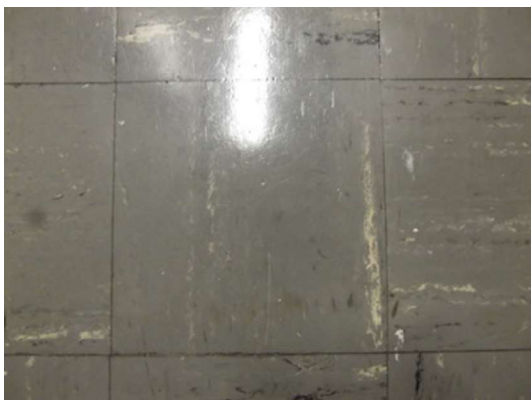
HOMOGENEOUS AREA ID#	DESCRIPTION	% ASBESTOS	FRIABLE F / NF	CONDITION (GOOD, DAMAGED, SIGNIFICANTLY DAMAGED)	EXPOSURE POTENTIAL (LOW, MED, HIGH)	QUANTITY	LOCATION # (Functional Spaces)
HA-11a	9x9” Floor Tile	10% Chrysotile	NF	Good	Low	45 ft <sup>2</sup>	110
HA-11b	Black Mastic	8% Chrysotile	NF	Good	Low		
HA-12a	9x9” Floor Tile	7% Chrysotile	NF	Good	Low	115 ft <sup>2</sup>	112
HA-12b	Black Mastic	4% Chrysotile	NF	Good	Low		
HA-27	Pipe Run Insulation	25% Chrysotile 10% Amosite	F	Good	Low	20 ft	111
HA-29b	Brown Mastic	3% Chrysotile	NF	Good	Low	500 ft <sup>2</sup>	206
HA-31	Transite Piping	PACM	NF	Good	Low	30 ft	Attic, 1 <sup>st</sup> & 2 <sup>nd</sup> Floors

**(HA-11)**  
**Asbestos Detected**

It is recommended that all ACBM be maintained in place.

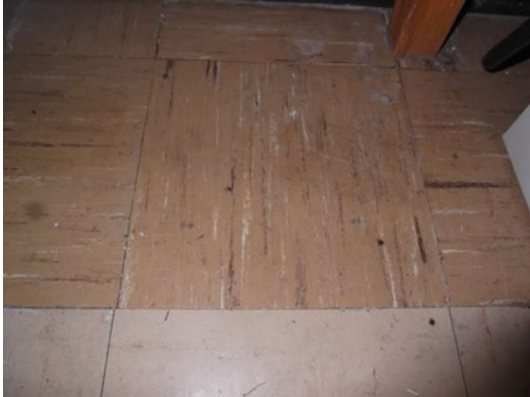
**(HA-13)**  
**No Asbestos Detected**

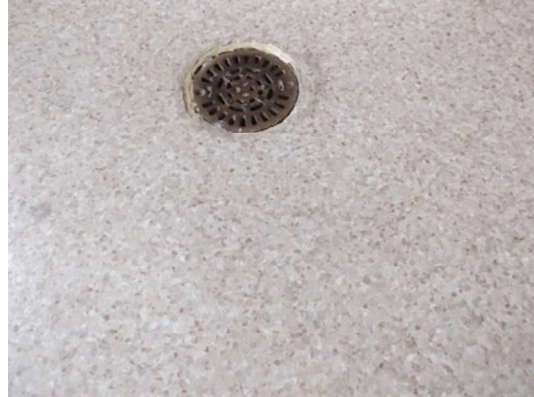
**(HA-14)**  
**No Asbestos Detected**

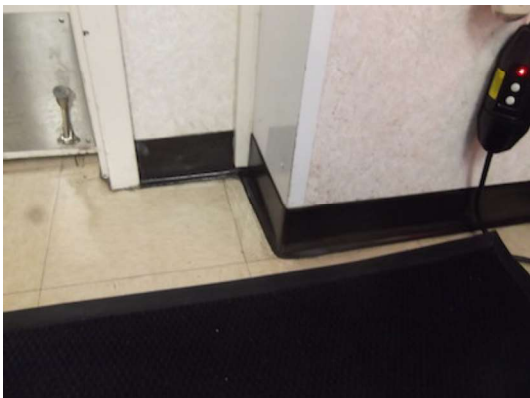
**(HA-17)**  
**No Asbestos Detected**

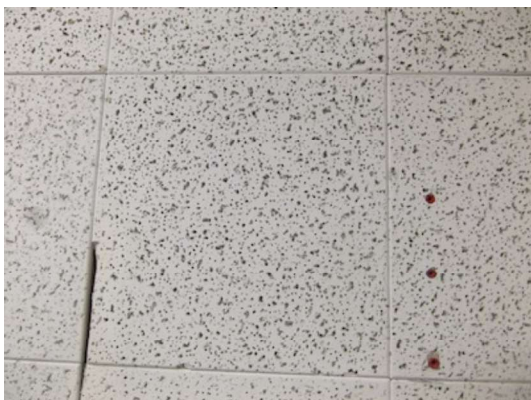
**(HA-19)**  
**No Asbestos Detected**

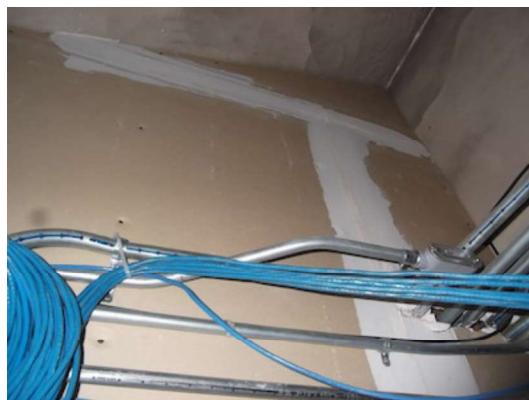
**(HA-20)**  
**No Asbestos Detected**

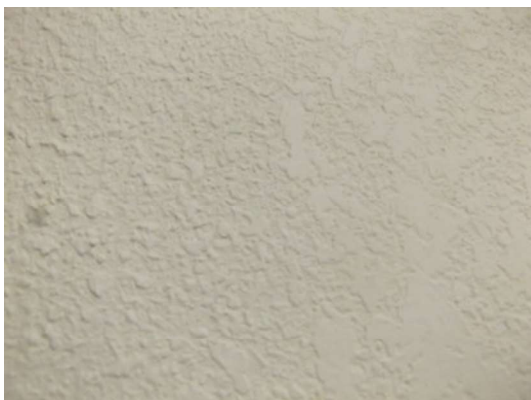
**(HA-23)**  
**No Asbestos Detected**

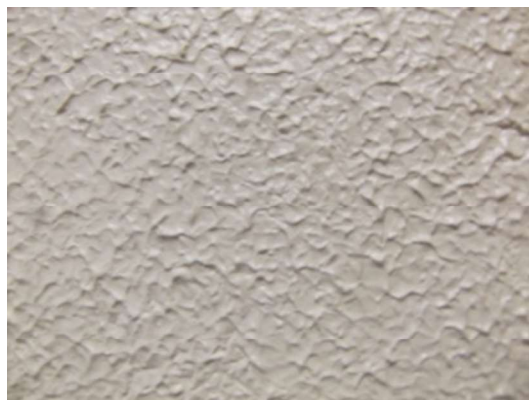
**(HA-24)**  
**No Asbestos Detected**

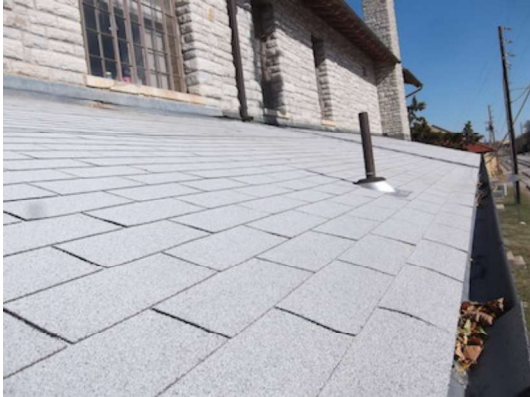
**(HA-25)**  
**No Asbestos Detected**

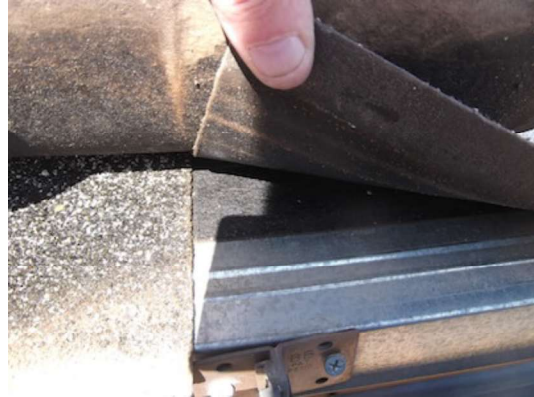
**(HA-26)**  
**No Asbestos Detected**

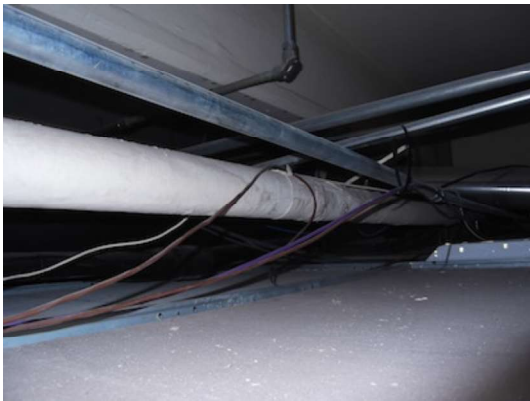
**(HA-27)**  
**Asbestos Detected**

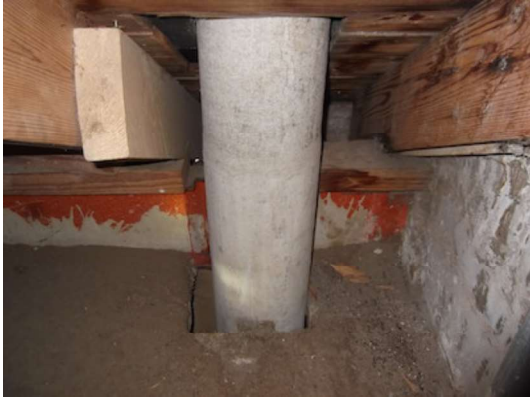
**(HA-31)**  
**Transite Flue -PACM-**

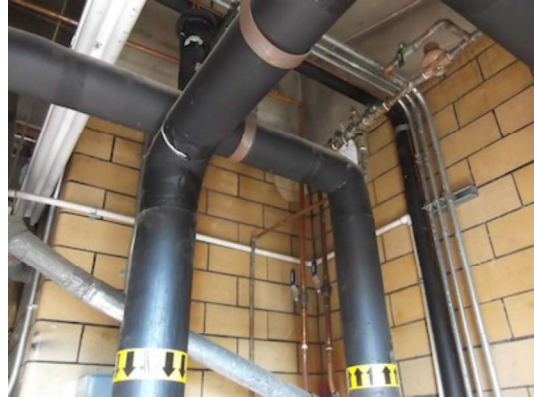
**(HA-32)**  
**Black Foam**

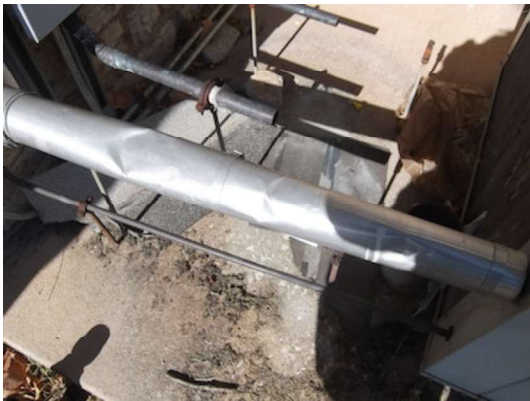
**(HA-33)**  
**Jacketed Fiberglass**

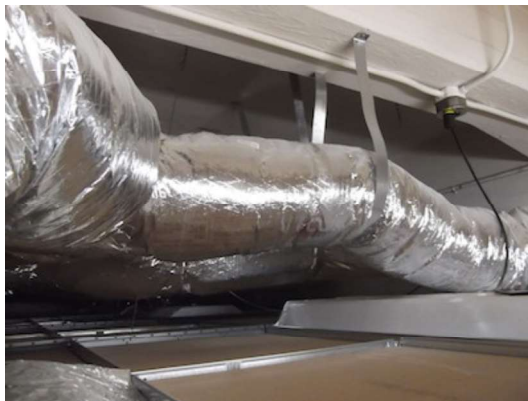
**(HA-35)**  
**Fiberglass**

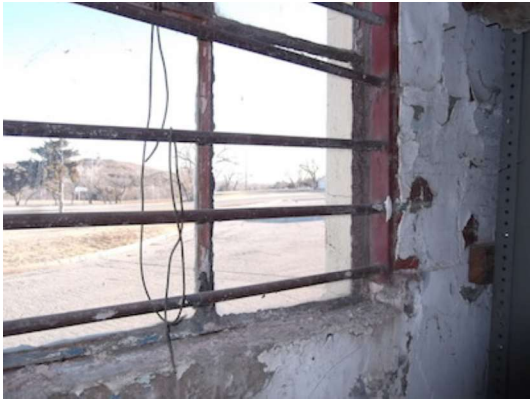
**(HA-01)**  
**No Asbestos Detected**

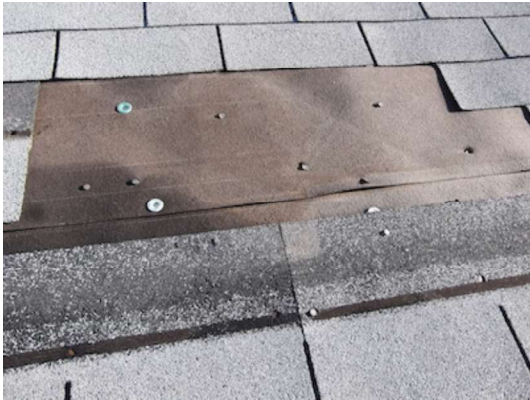
**(HA-03)**  
**No Asbestos Detected**

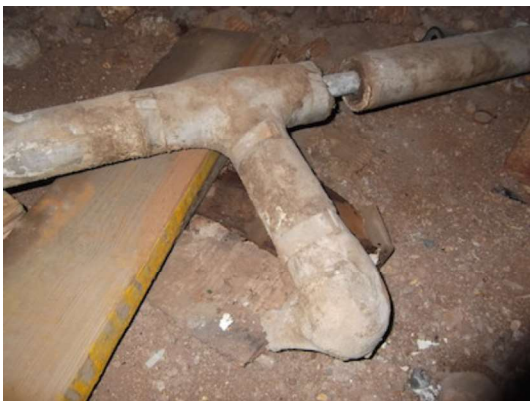
**(HA-05)**  
**Asbestos Detected**

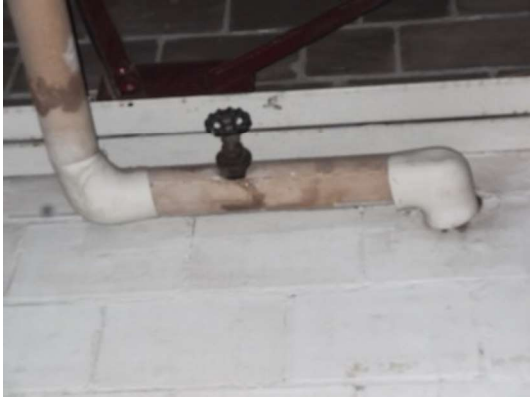
**(HA-07)**  
**Fiberglass**

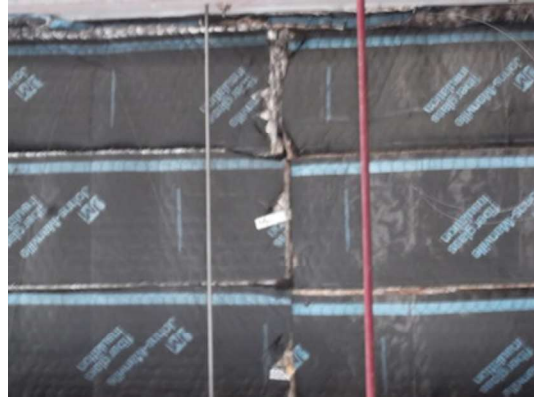
**(HA-08)**  
**Fiberglass**

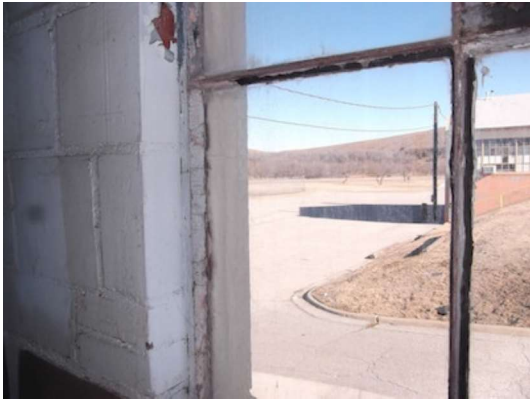
**(HA-01)**  
**No Asbestos Detected**

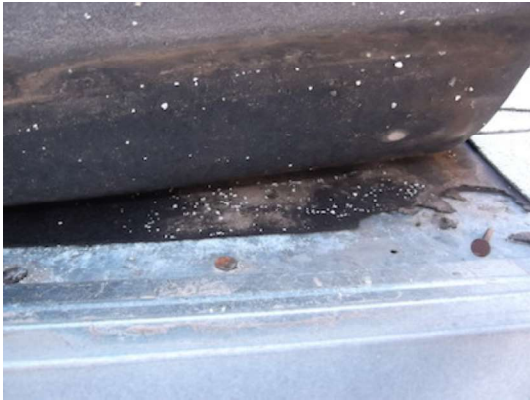
**(HA-03)**  
**No Asbestos Detected**

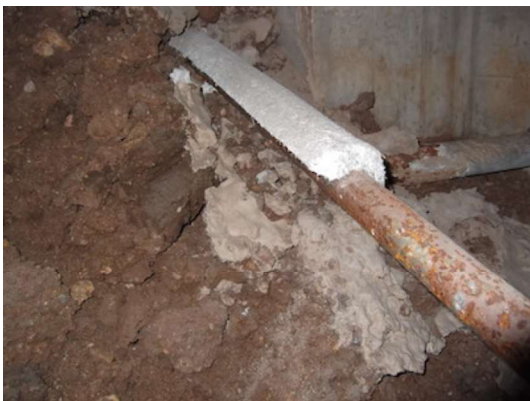
**(HA-05)**  
**Asbestos Detected**

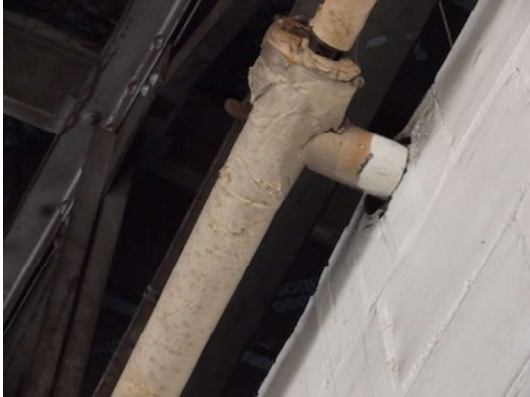
**(HA-07)**  
**No Asbestos Detected**

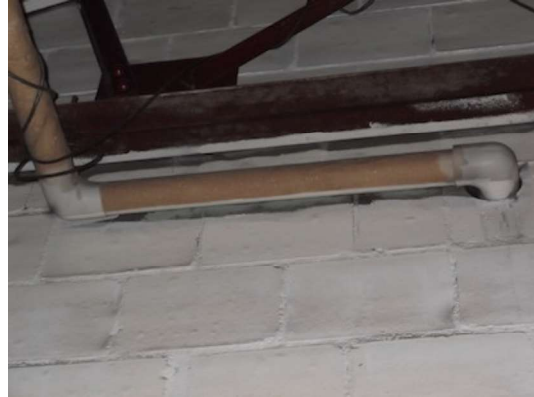
**(HA-08)**  
**No Asbestos Detected**

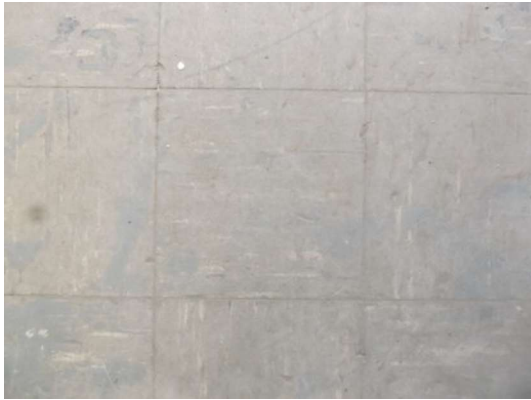
**(HA-01)**  
**Asbestos Detected**

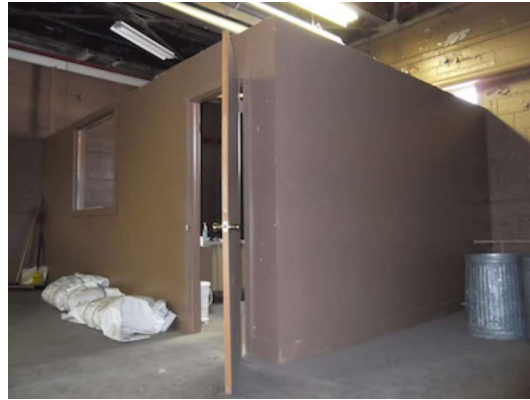
**(HA-02)**  
**No Asbestos Detected**

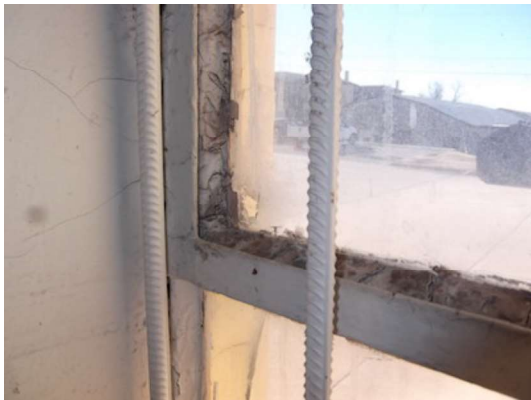
**(HA-03)**  
**≤1% Asbestos Detected**

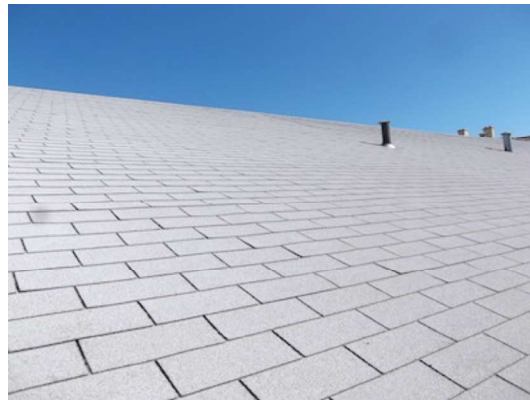
**(HA-04)**  
**No Asbestos Detected**

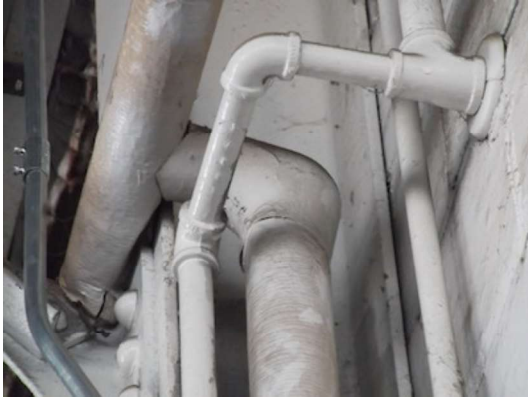
**(HA-07)**  
**Fiberglass**

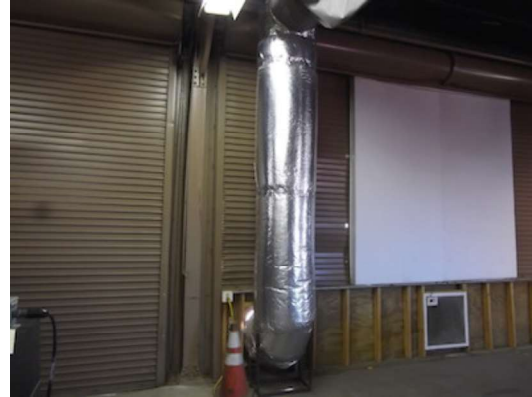
**(HA-08)**  
**Fiberglass**

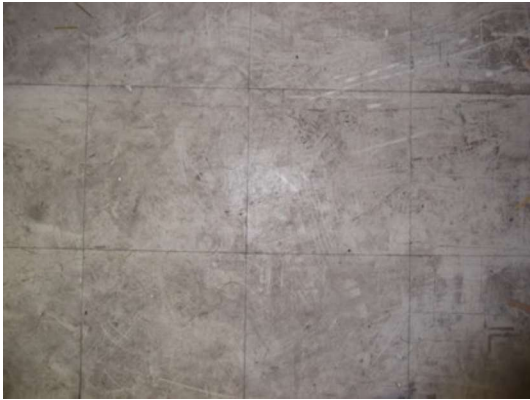
**(HA-01)**  
**Asbestos Detected**

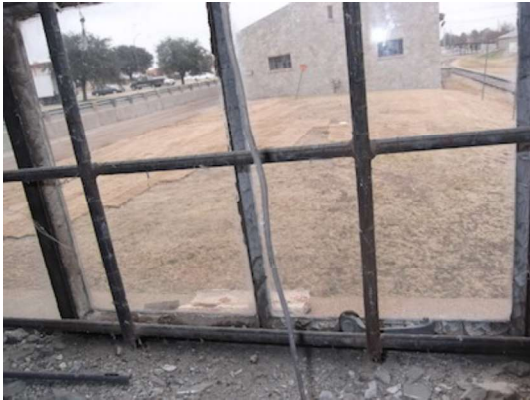
**(HA-03)**  
**No Asbestos Detected**

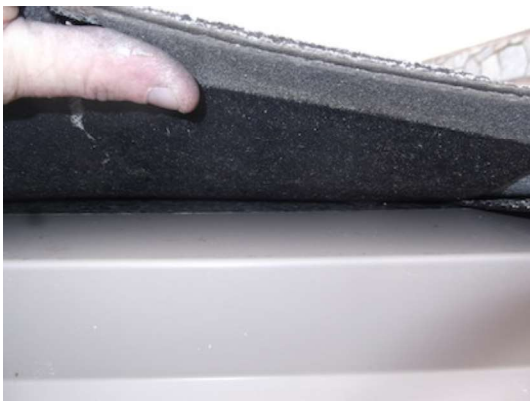
**(HA-05)**  
**No Asbestos Detected**

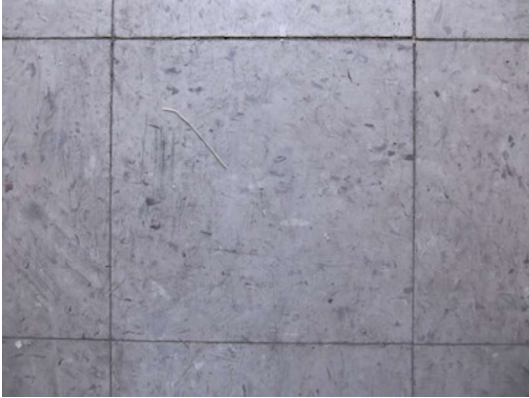
**(HA-01)**  
**Asbestos Detected**

It is recommended that the ACM floor tiles and mastics be maintained in place.

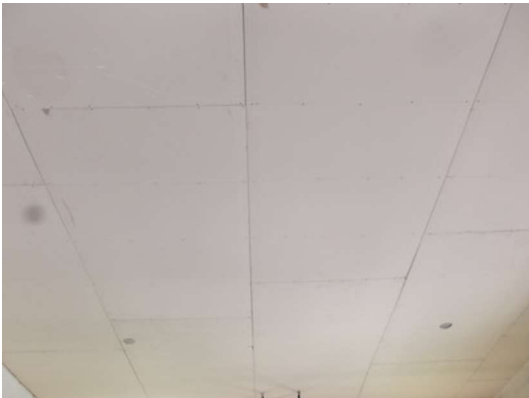
**(HA-03)**  
**No Asbestos Detected**

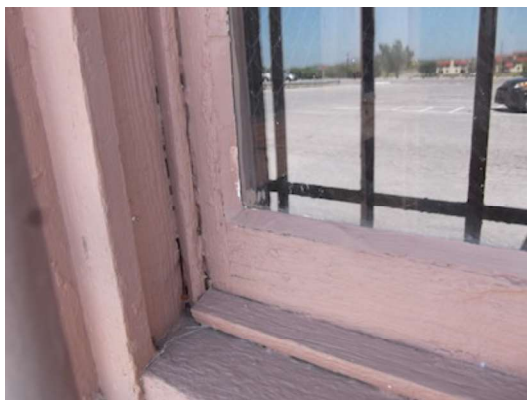
**(HA-05)**  
**No Asbestos Detected**
