Eye Spy Home Inspection

Home Inspection Report

2390 Valley View

Inspected on Wed, Oct 7 2020 at 8:00 AM

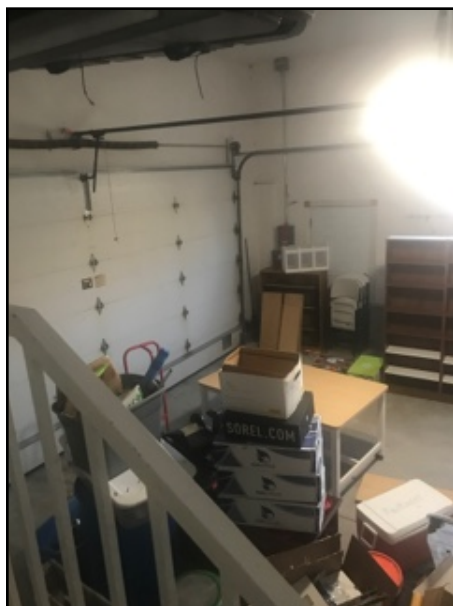
Figure 7-1

Comment 7:
2 car garage.

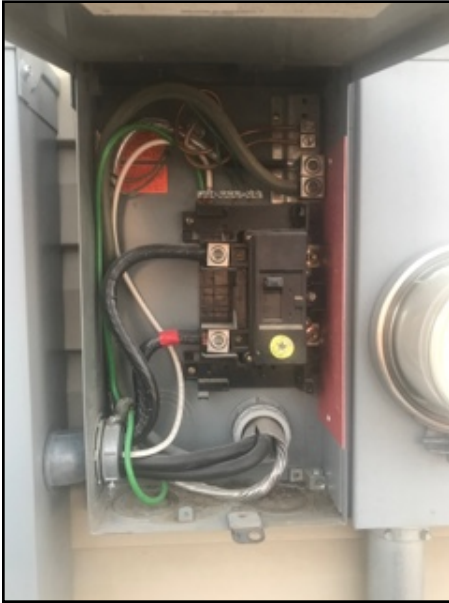
Figure 16-1

Comment 16:
Main service panel.

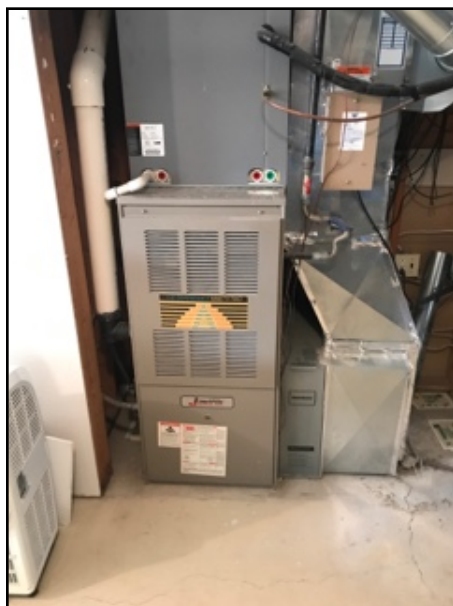
Figure 19-1

Comment 19:
Furnace.

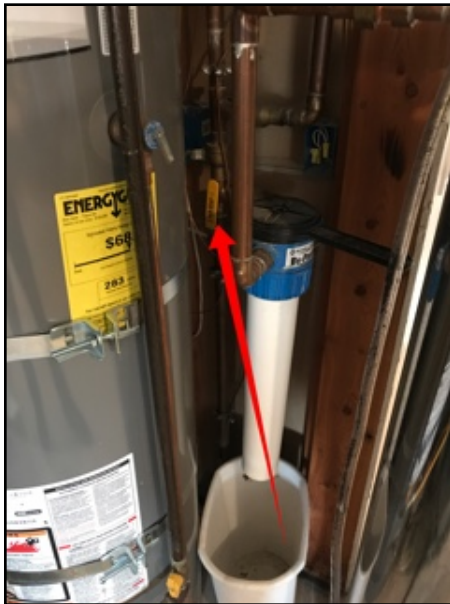
Figure 21-1

Comment 21:
Main water shutoff .

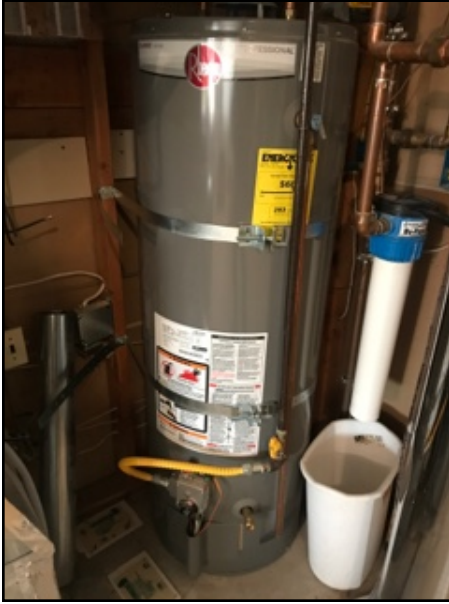
Figure 22-1

Water heater missing expansion tank recommend installing one.

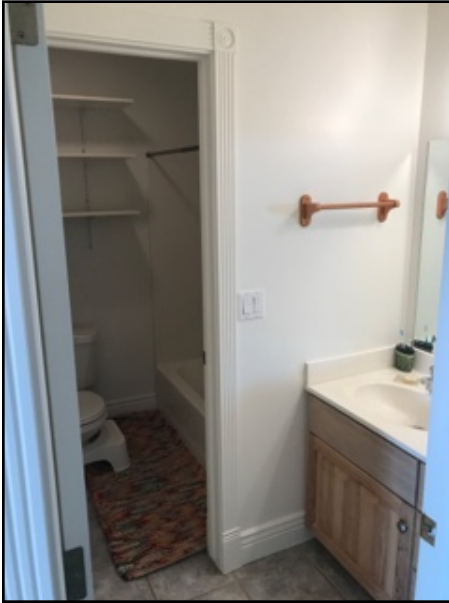
Figure 26-1

Comment 26:
Upstairs main bath.

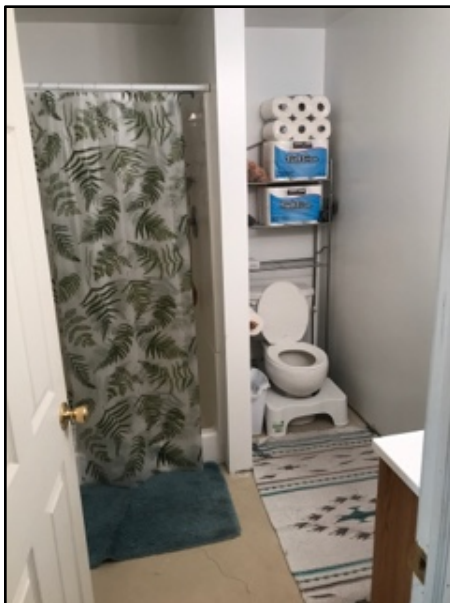
Figure 28-1

Comment 28:
Basement 3/4 bath.

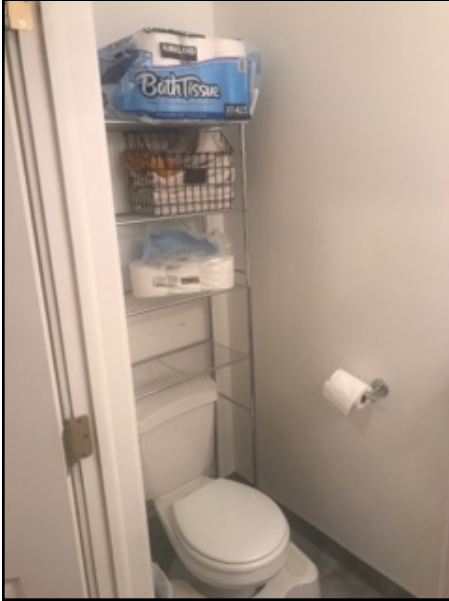
Figure 30-1

Comment 30:
Water closet .

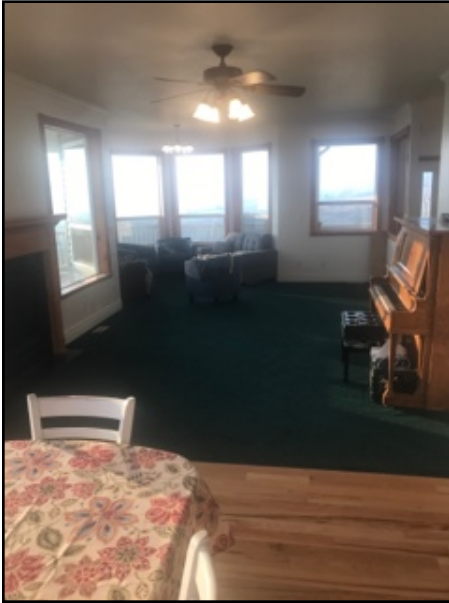
Figure 33-1

Comment 33:
Family room.

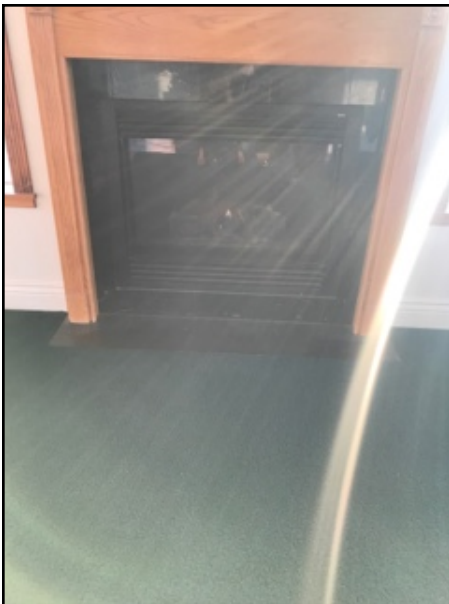
Figure 34-1

Comment 34:
Fireplace and blower both work.

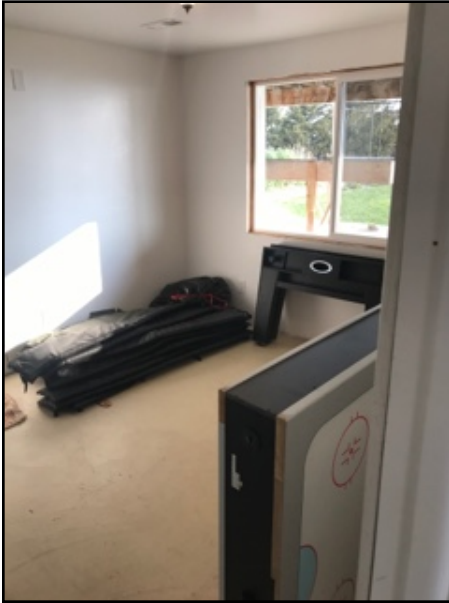
Figure 38-1

Comment 38:
Basement East bedroom .

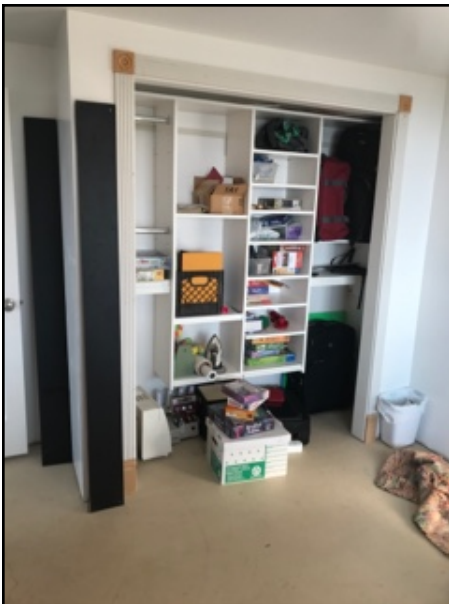
Figure 39-1

Comment 39:
Closet needs doors.

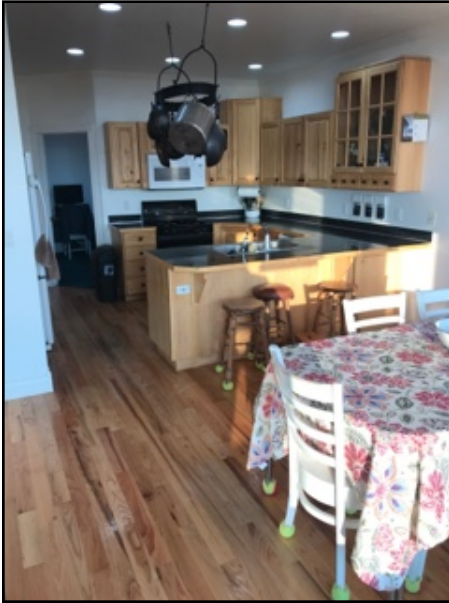
Figure 44-1

Comment 44:
Kitchen .

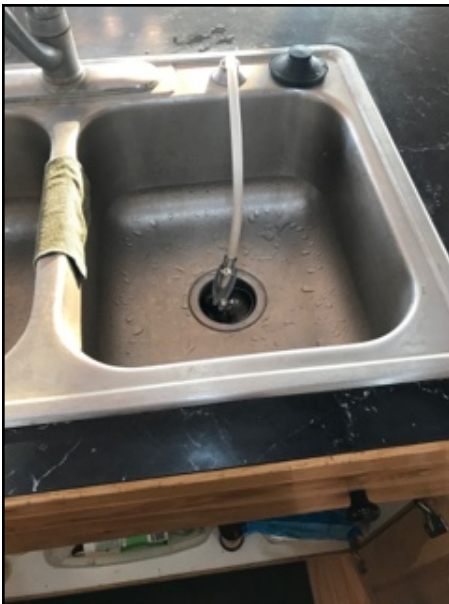
Figure 45-1

Comment 45:
Sink sprayer is stuck in the on position.

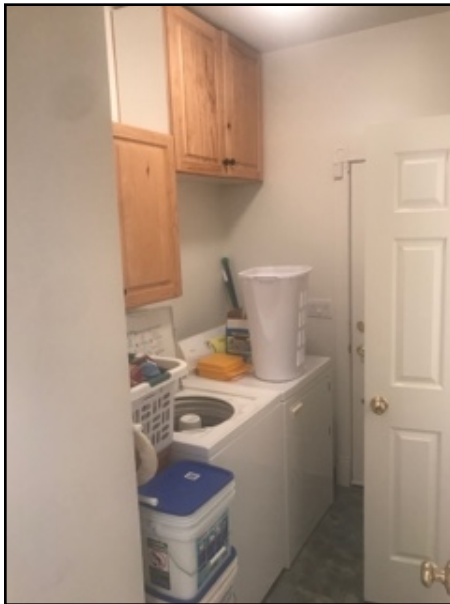
Figure 46-1

Comment 46:
Laundry room .

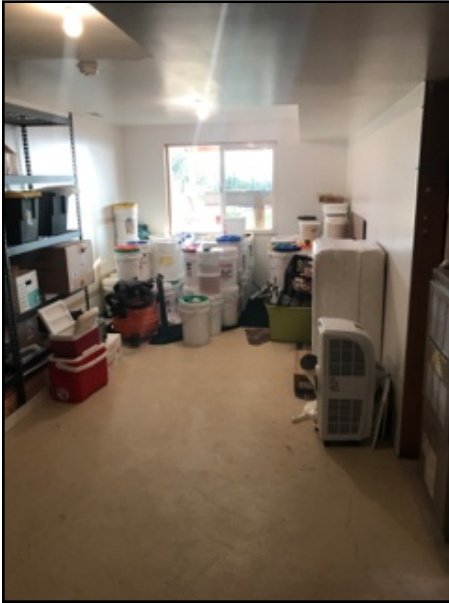
Figure 47-1

Comment 47:
Storage/utility room .

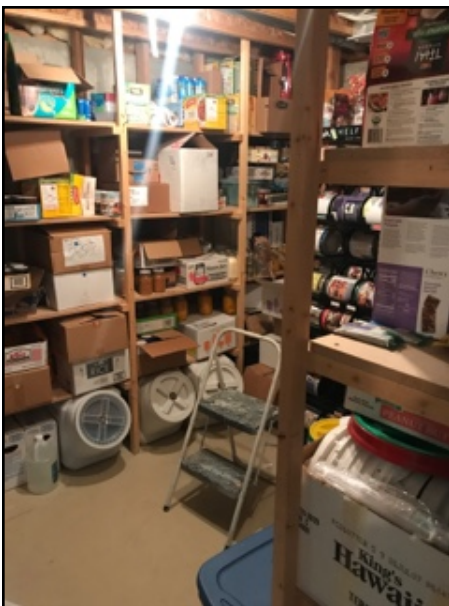
Figure 48-1

Comment 48:
Food pantry in basement .

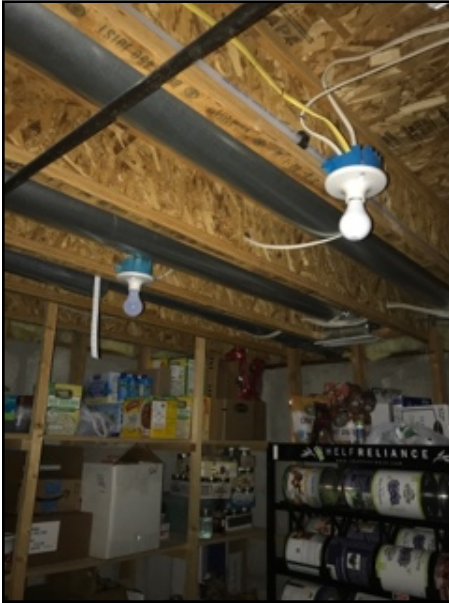
Figure 49-1

Comment 49:
Bare bulbs in basement area need covers.

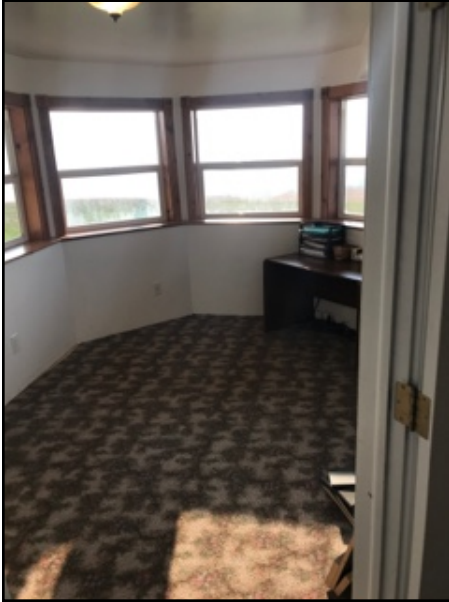
Figure 50-1

Comment 50:
5 window room
Phone jack needs cover .

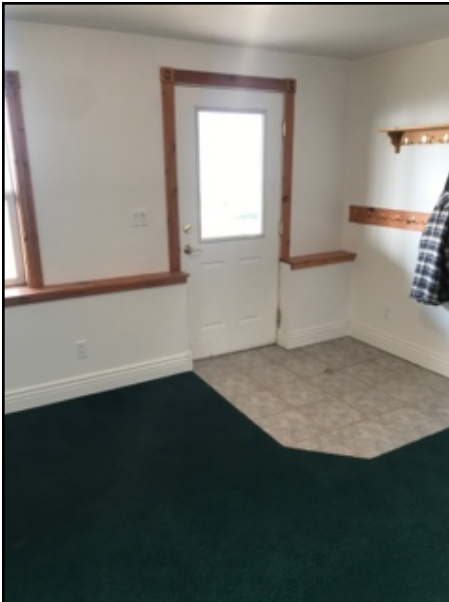
Figure 51-1

Comment 51:
Basement entry.

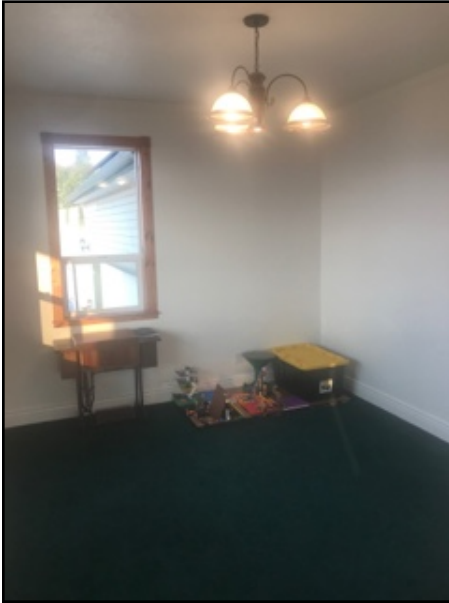
Figure 53-1

Comment 53:
Sitting room.

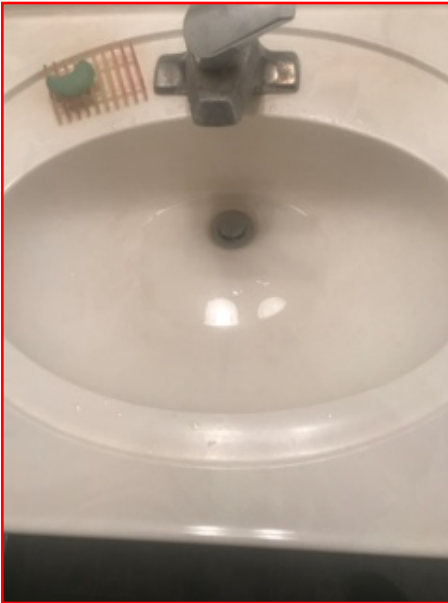
Figure 32-1

17) Sink drains slowly.

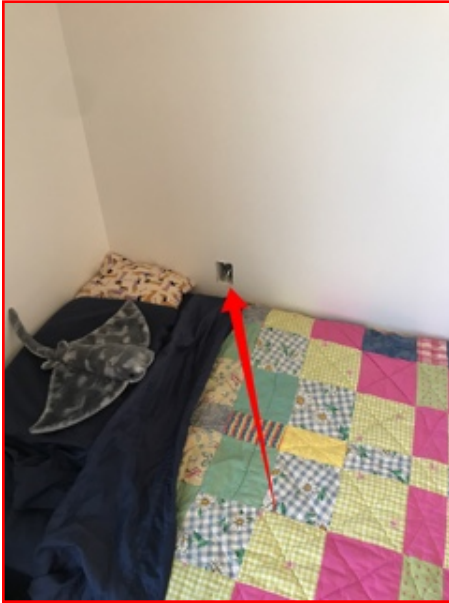
Figure 37-1

18) Outlet needs to be covered.

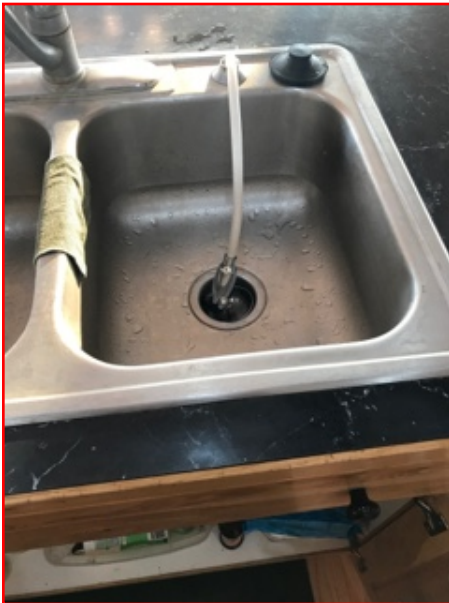
Figure 45-1

21) Sink sprayer is stuck in the on position.

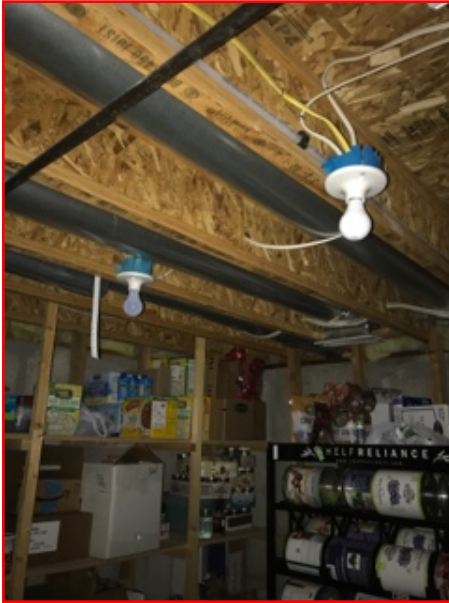
Figure 49-1

22) Bare bulbs in basement area need covers.
