# Existing Condition Report

**KEG File: 18RS-0416**  
**October 8, 2018**

***Royal St. Andrew Association,  
Inc.***

**RE:    *Royal St. Andrew  
KEG Project P18RS-0416 REV02  
Professional Engineering Services – Existing Conditions Survey***

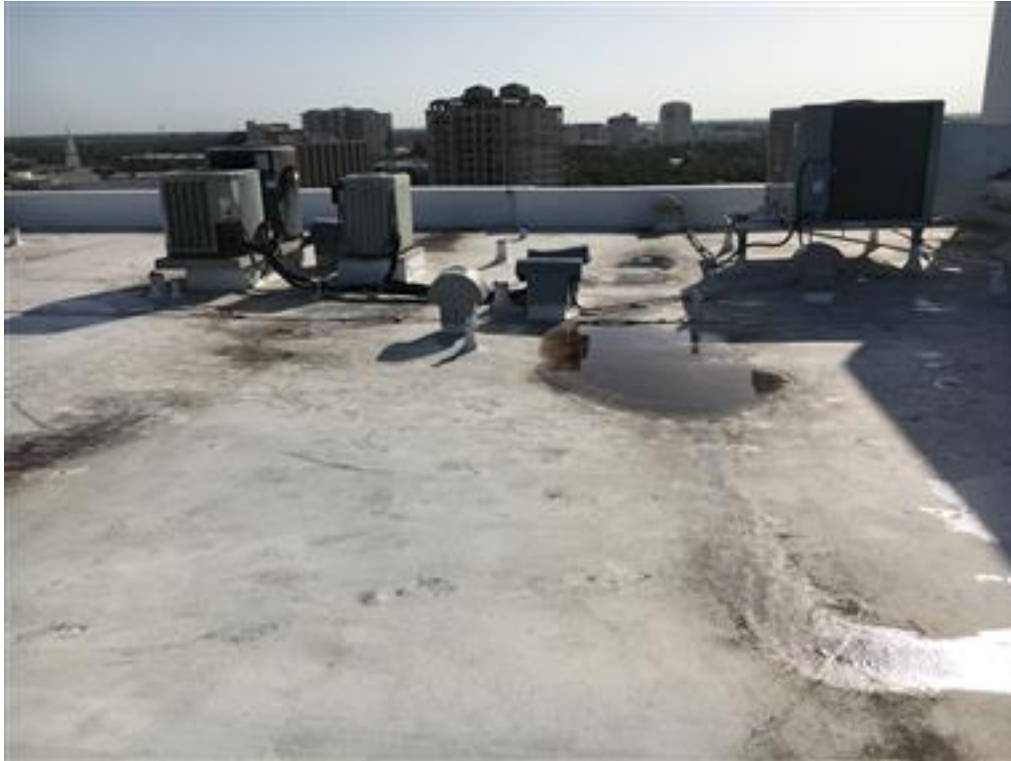
Photo 7-General view, ponding

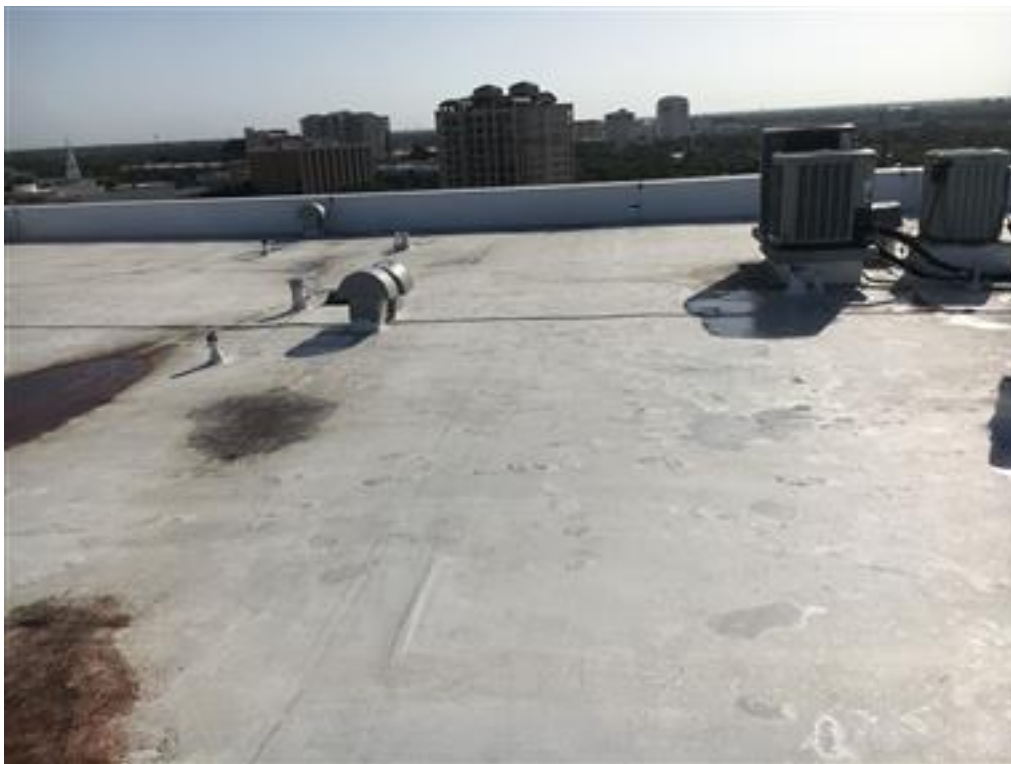
Photo 8-General view, ponding

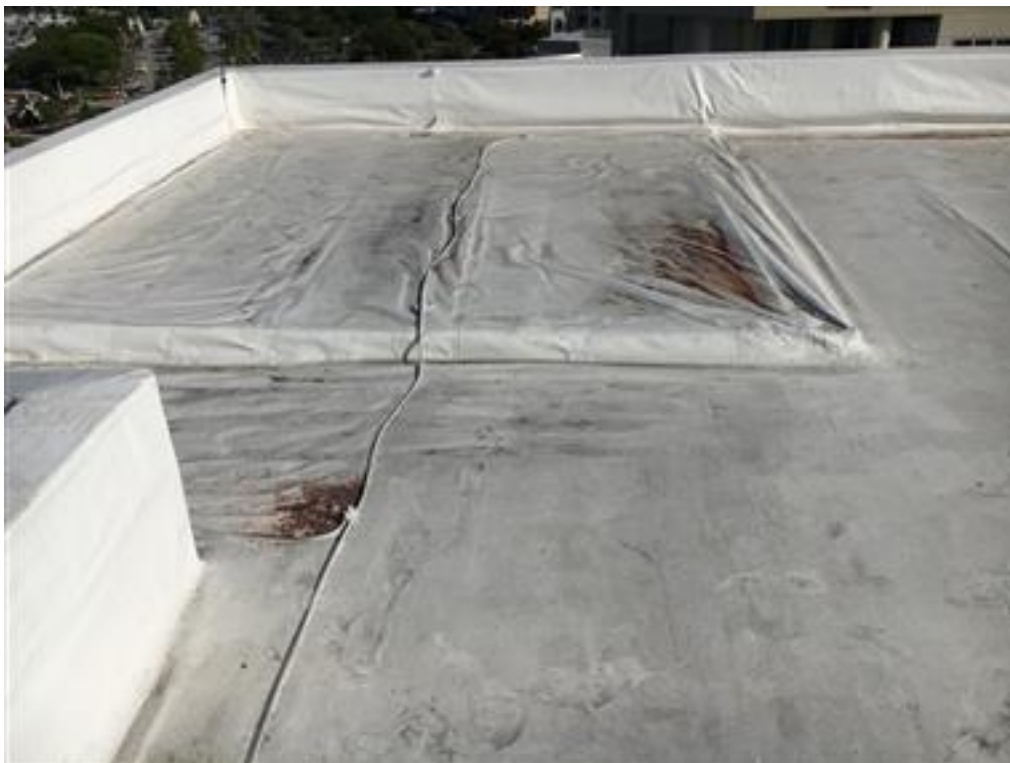
Photo 9-Raised corner pad

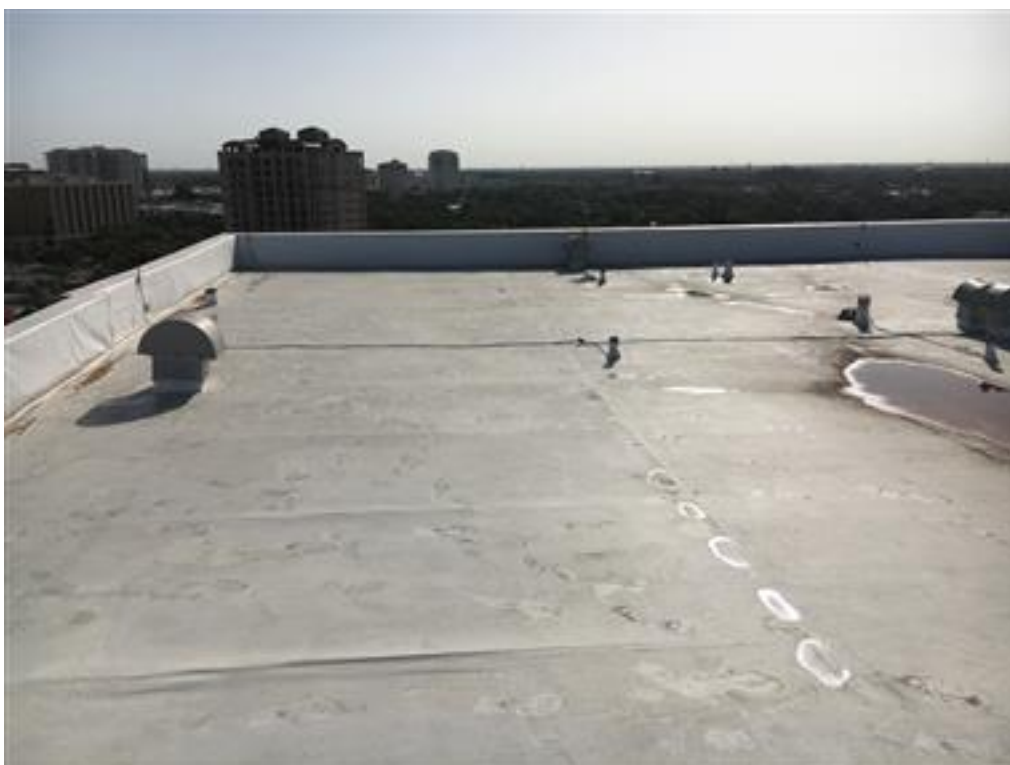
Photo 10-General view, ponding

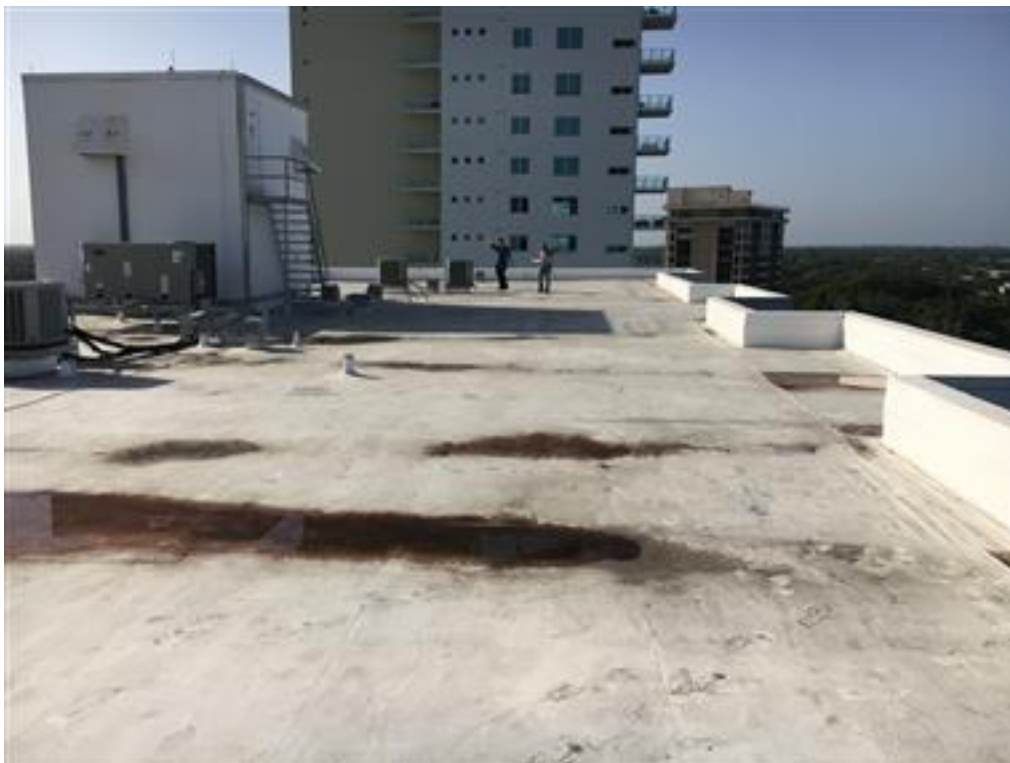
Photo 11-General view, ponding

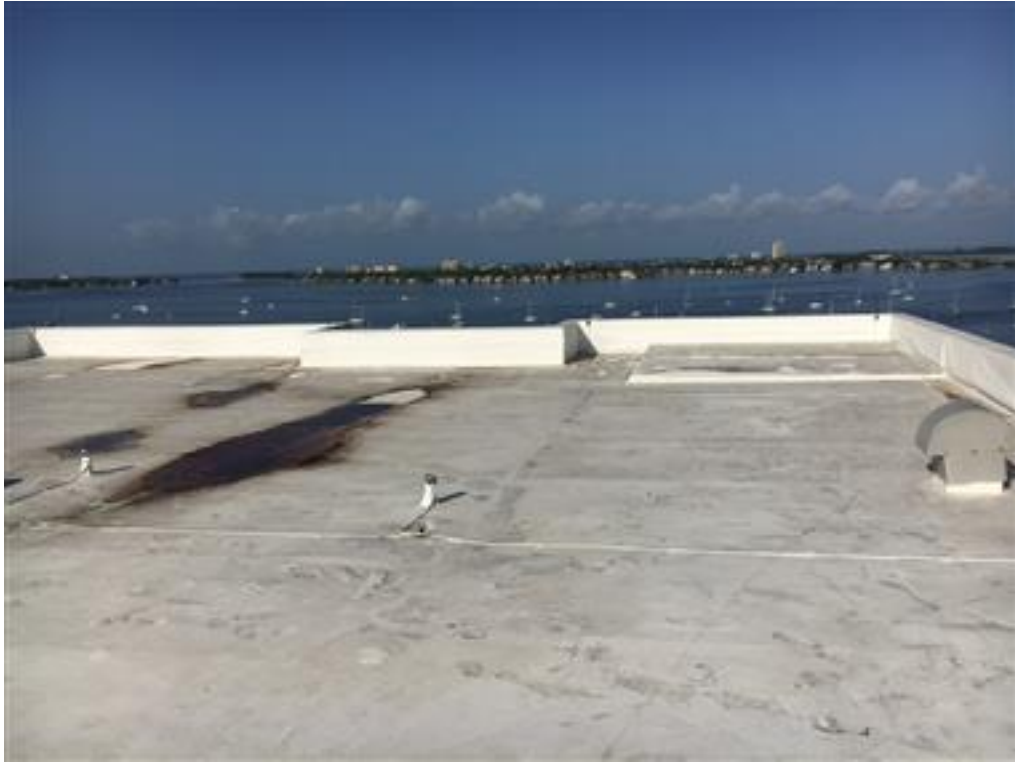
Photo 13-General view, ponding

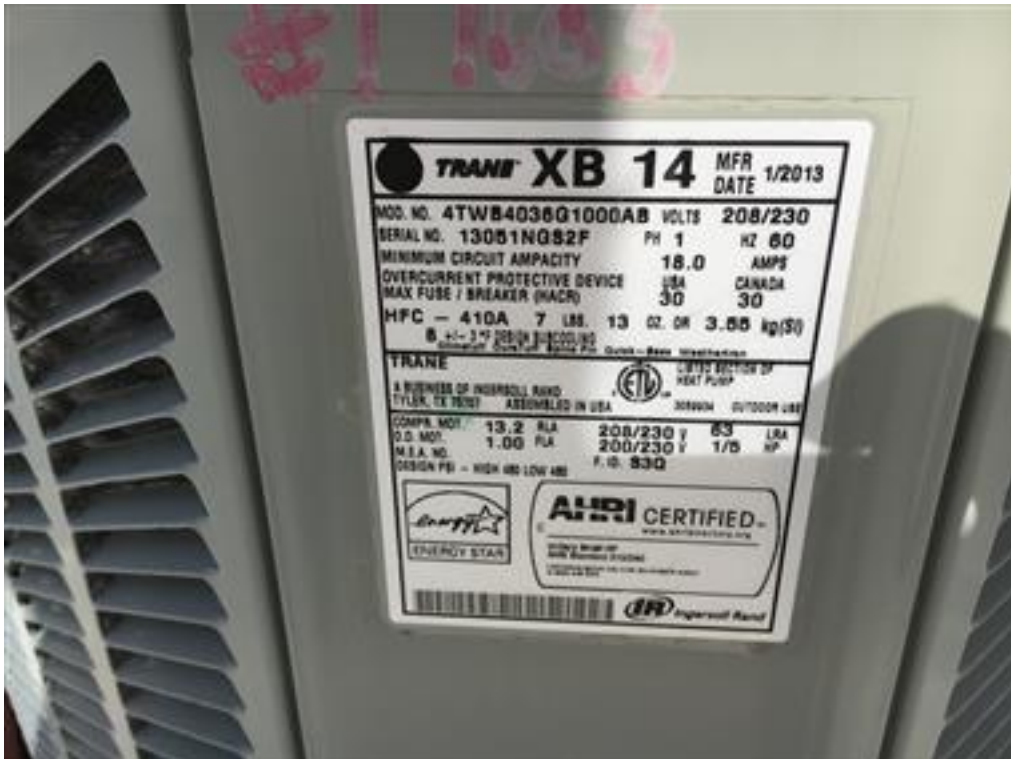
Photo 30-Unit 1-1603 good condition

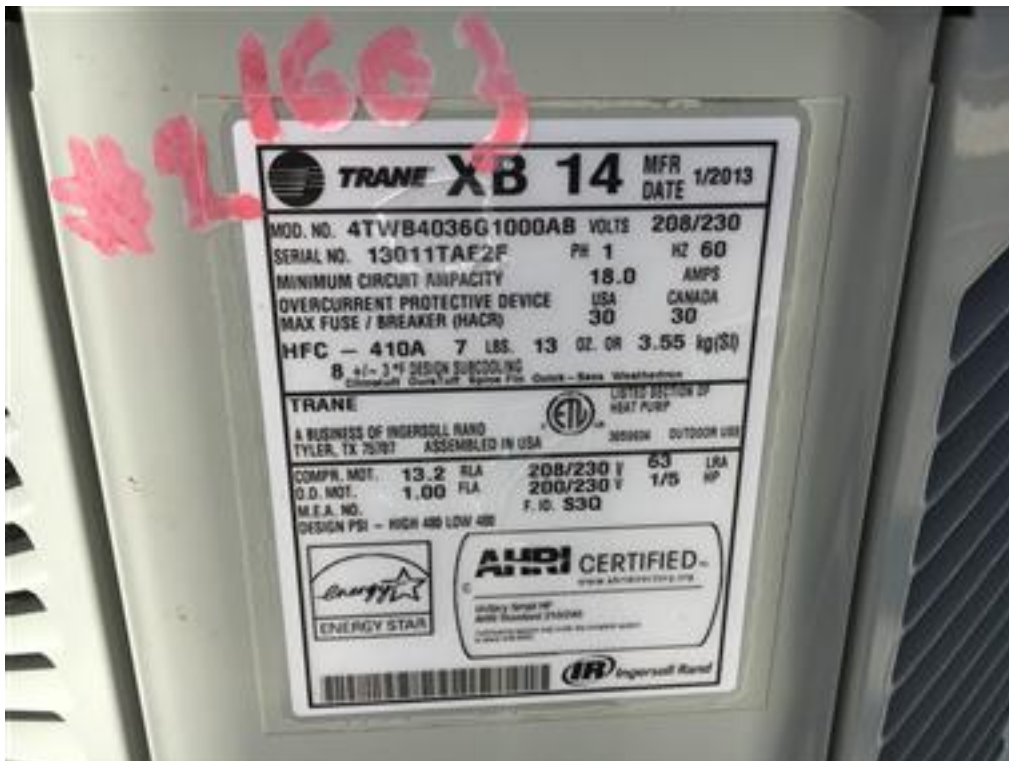
Photo 31-Unit 2-1603 good condition

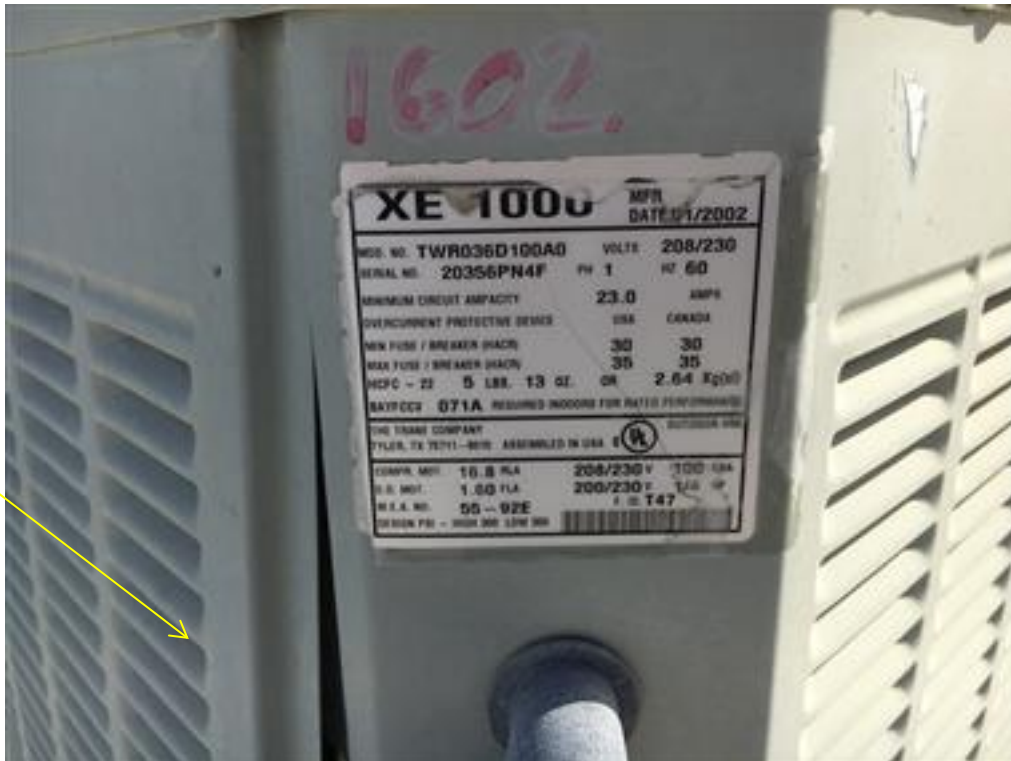
Photo 35-Unit 1602, loose panel

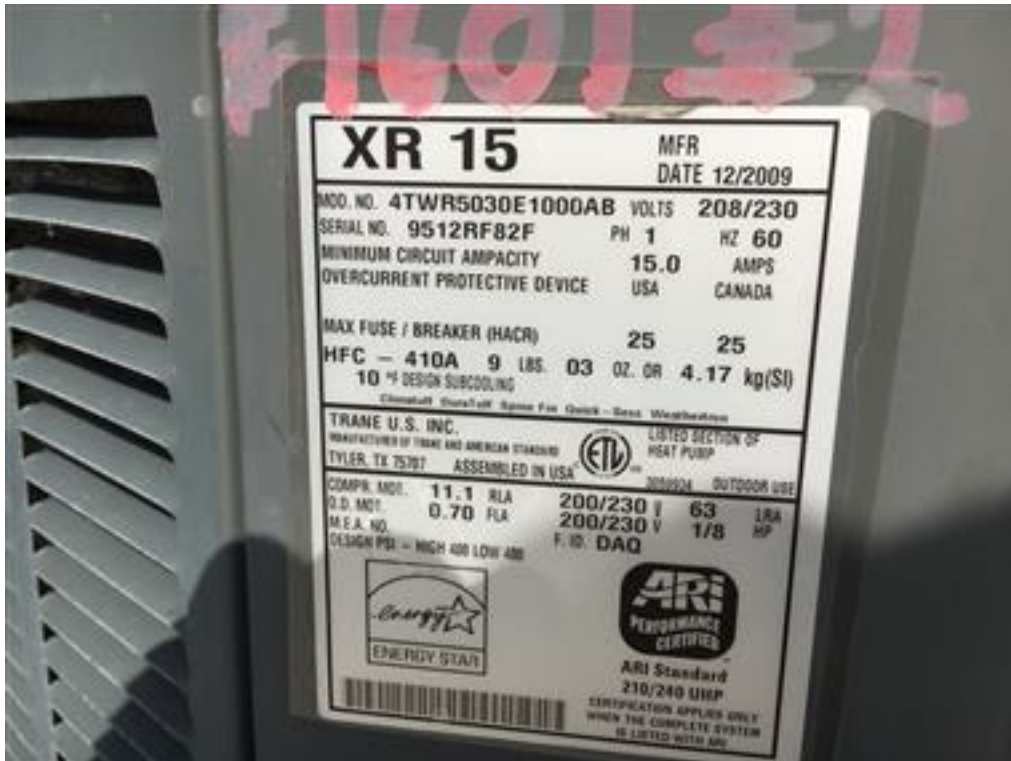
Photo 37-Unit 2-1601 good condition

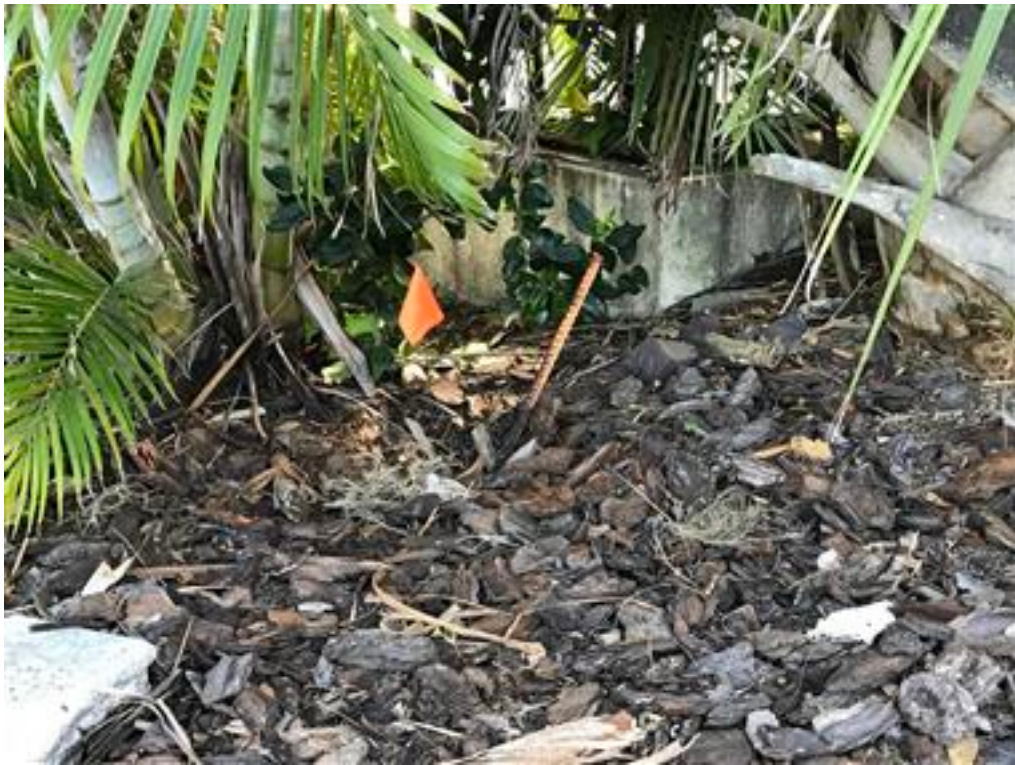
Photo 8- FRONT PROPERTY LINE MARKER

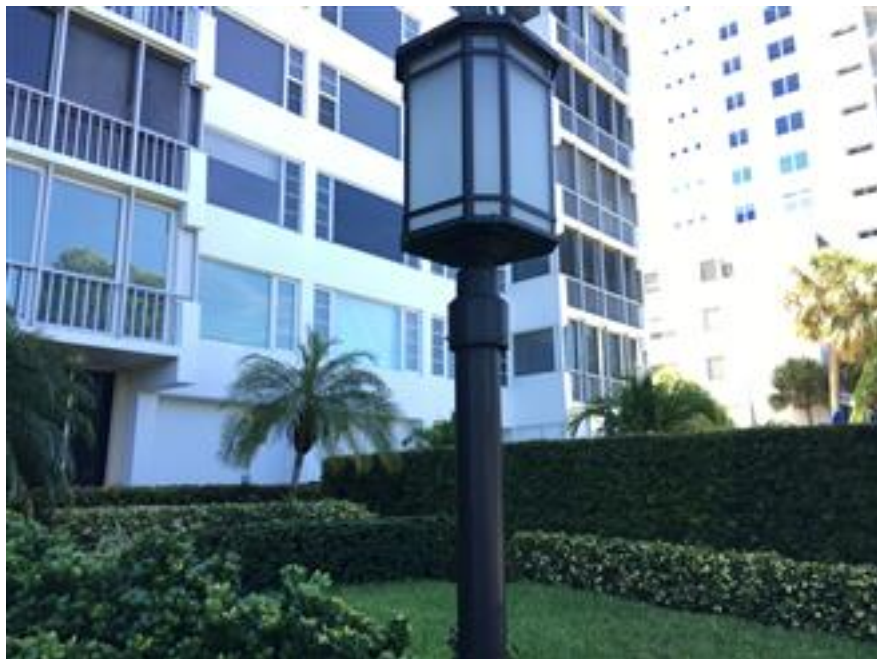
**Photo 6- FRONT LAMP**

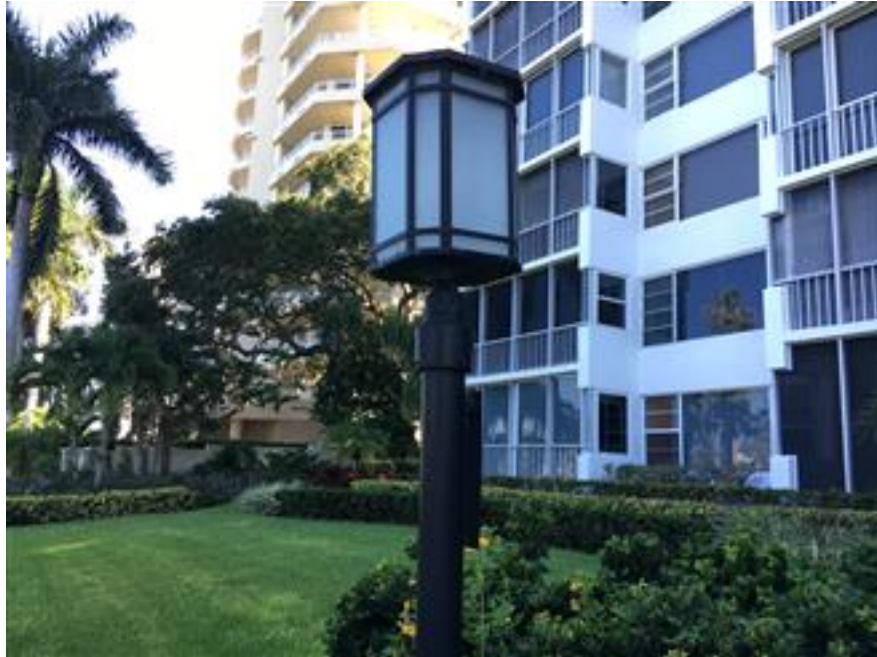
**Photo 7- FRONT LAMP**

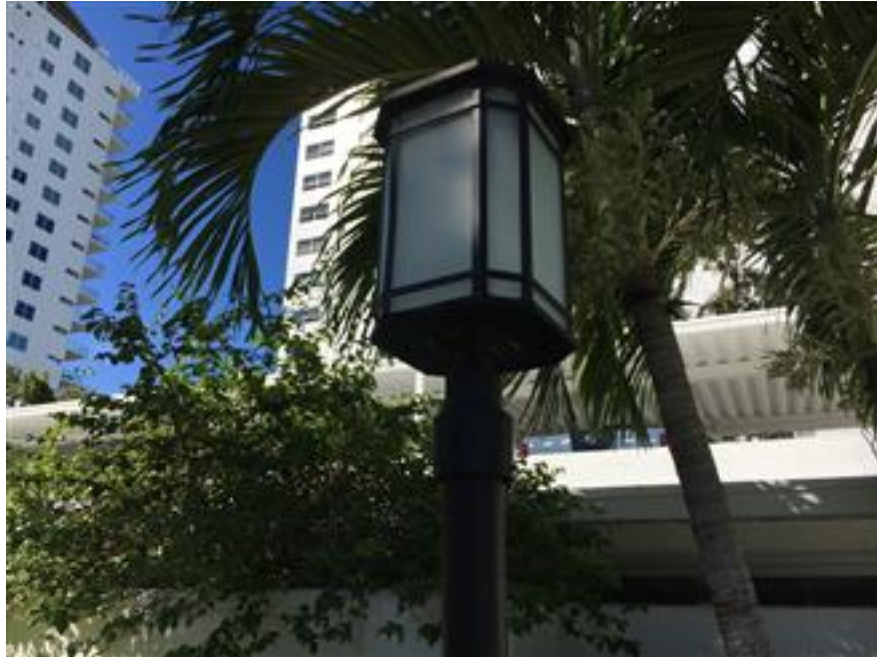
Photo 9- REAR LAMP

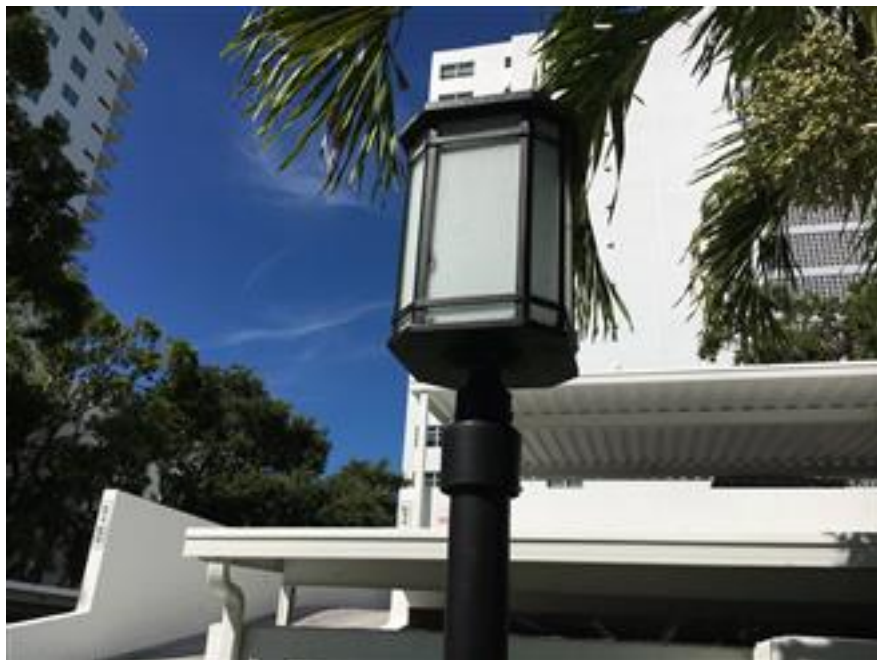
Photo 10- REAR LAMP

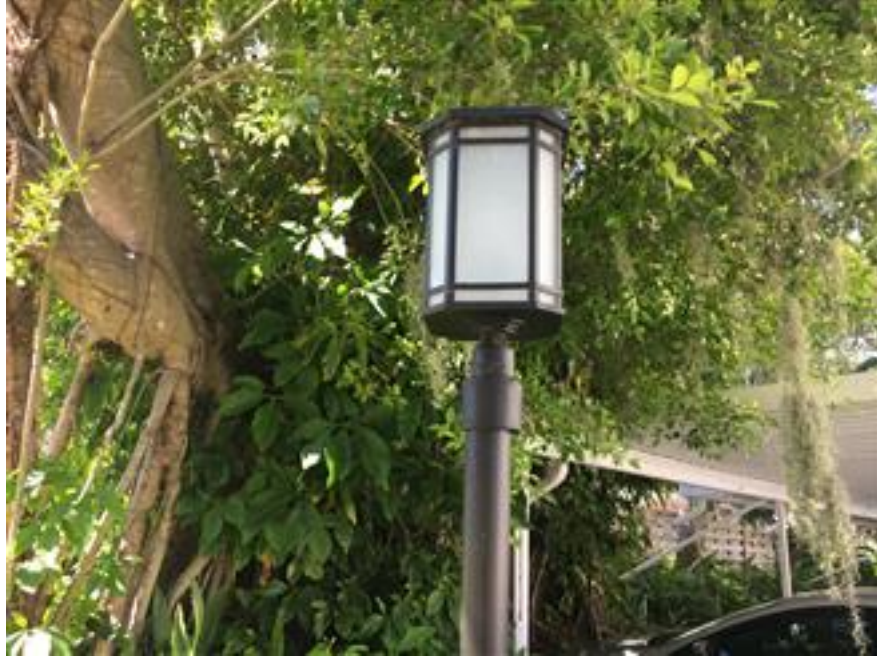
**Photo 11- REAR LAMP**

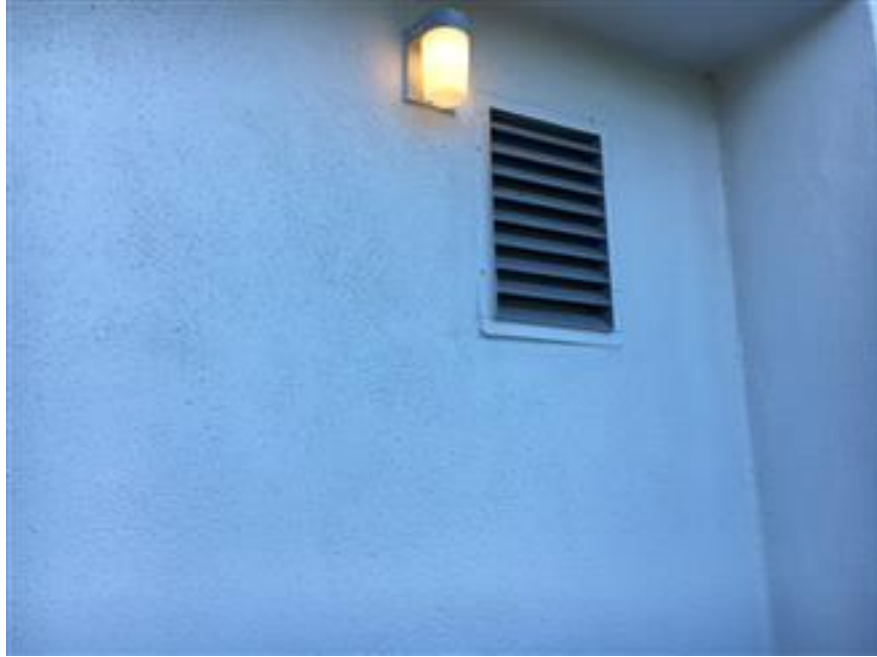
**Photo 13- EXTERIOR LIGHT AT REAR WALKWAY**

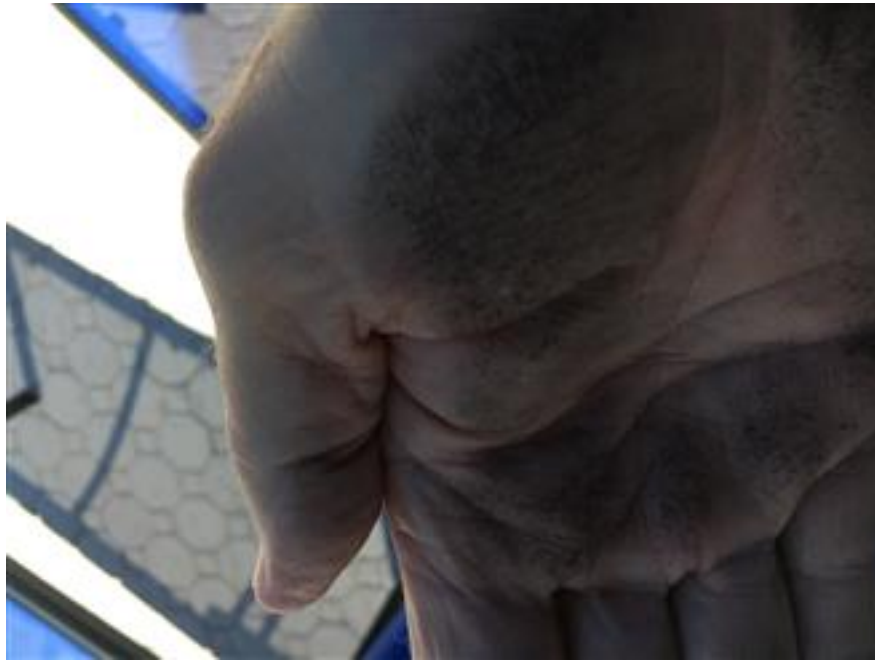
Photo 1- SURFACE DIRT ALL SIDES

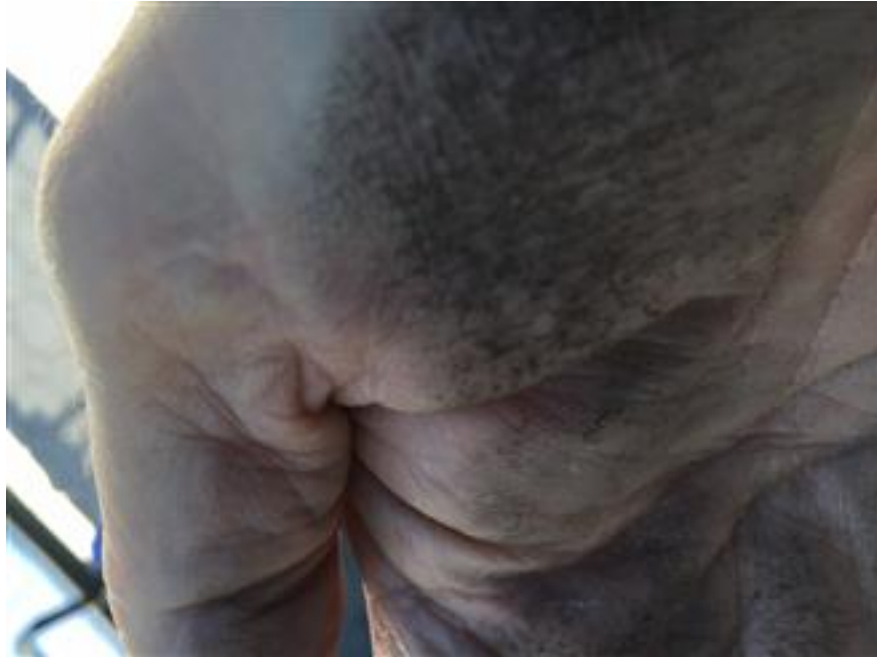
Photo 3- SURFACE DIRT ALL SIDES

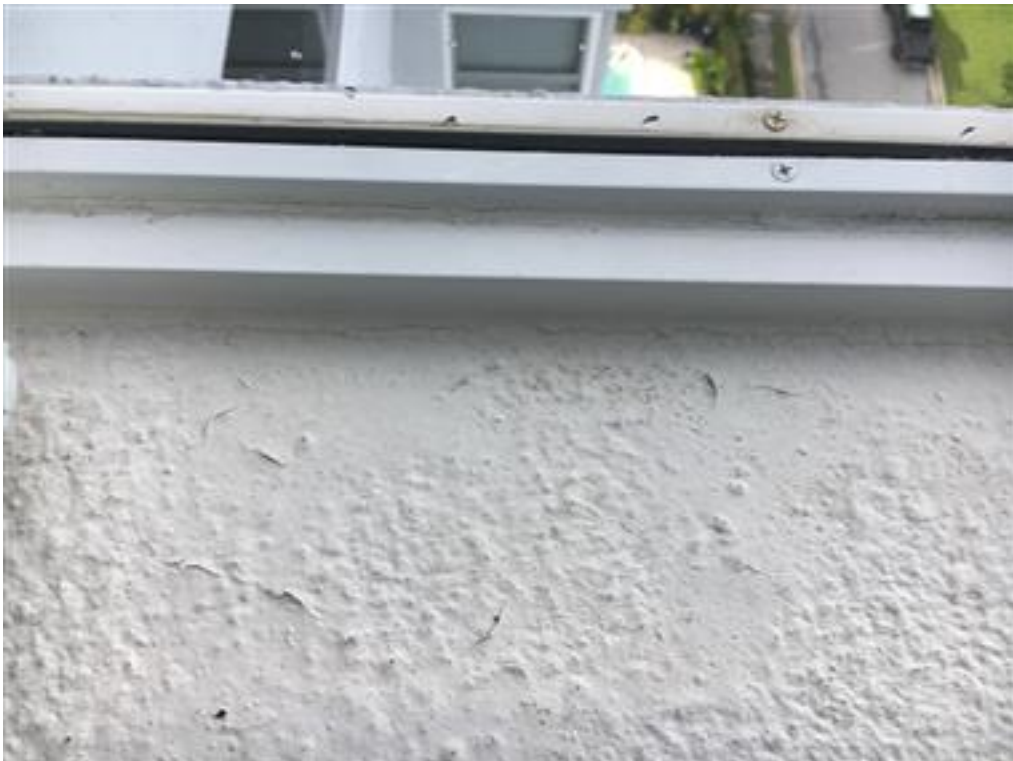
Photo 14-Unit 1502, blistering paint

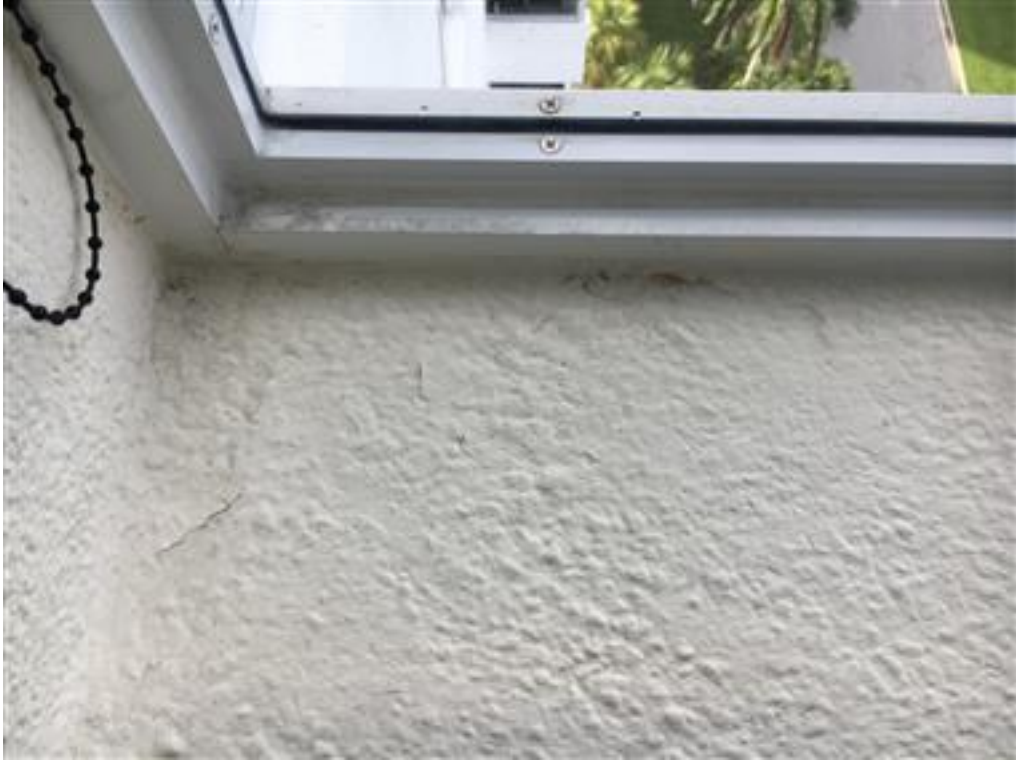
Photo 17-1502, blistering paint

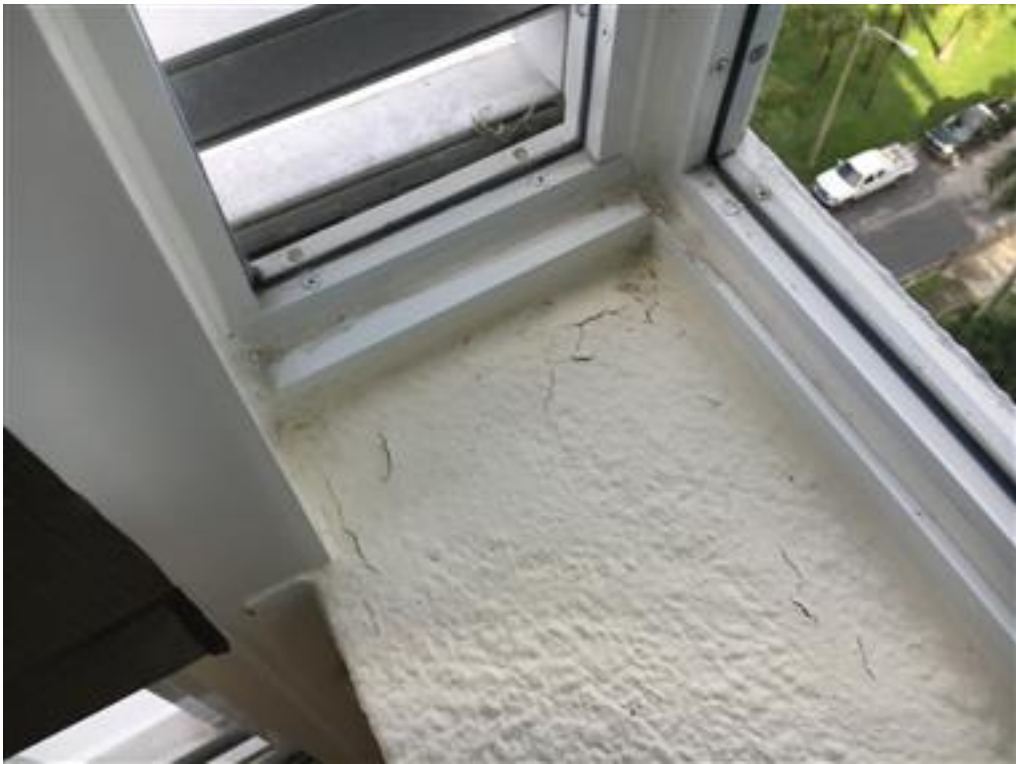
Photo 18-1502, blistering paint

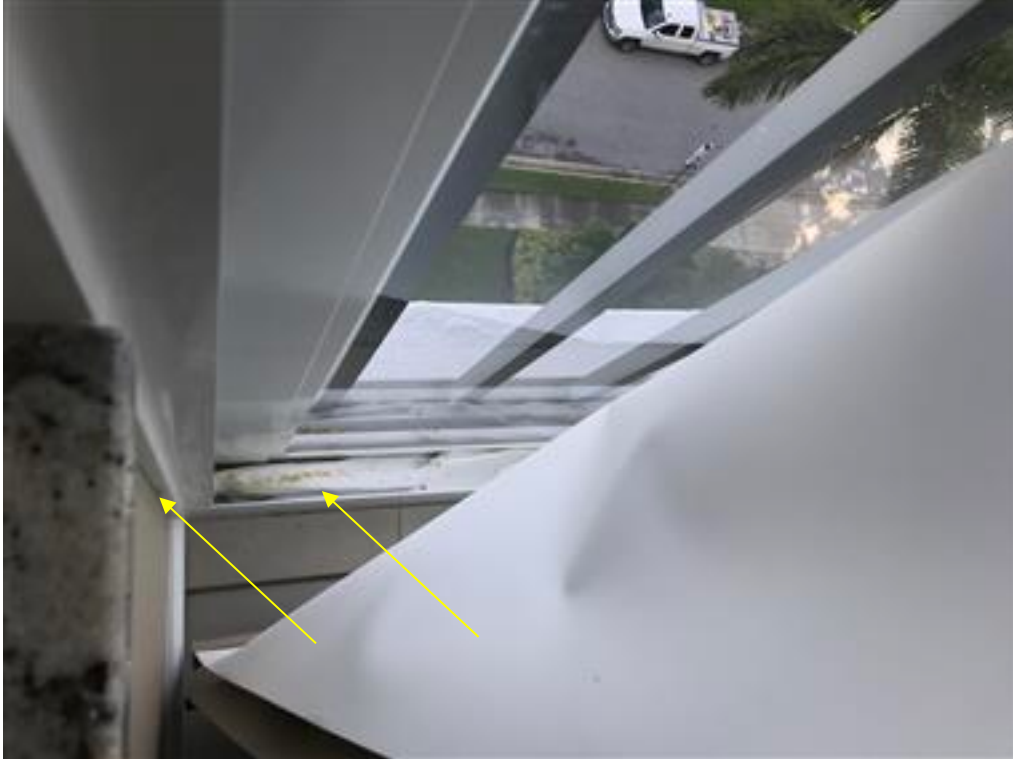
Photo 61-1001, material used for water absorption at SGD

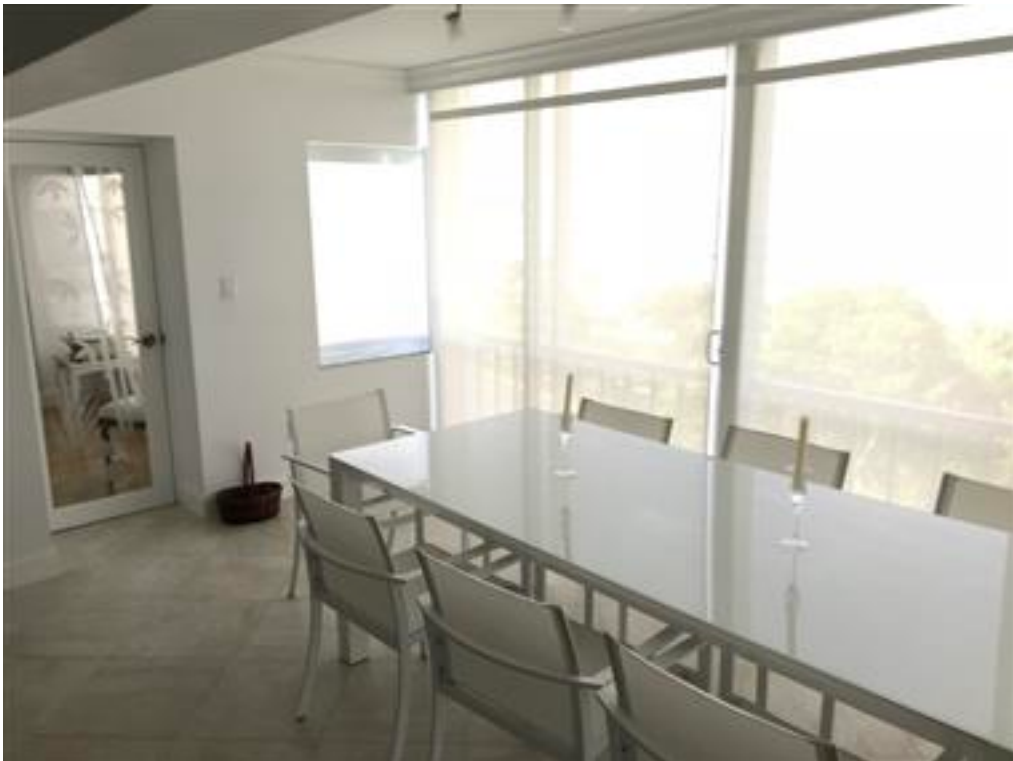
Photo 96-802, unfamiliar joint at SGD, typical

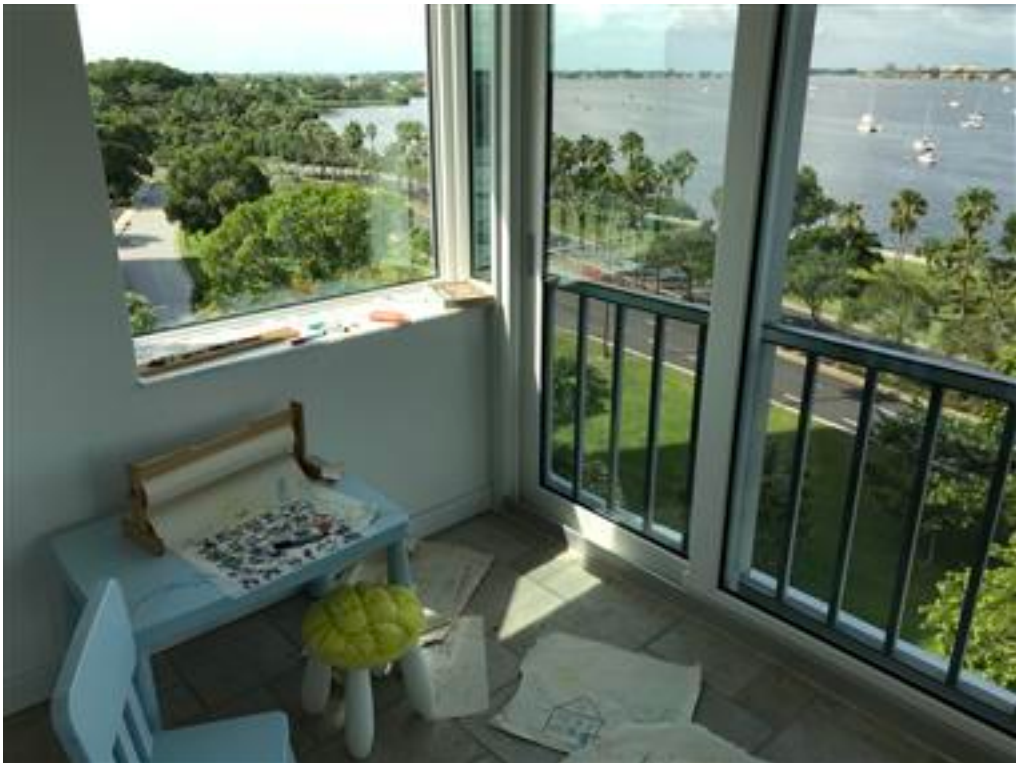
Photo 100-802, unfamiliar joint at SGD

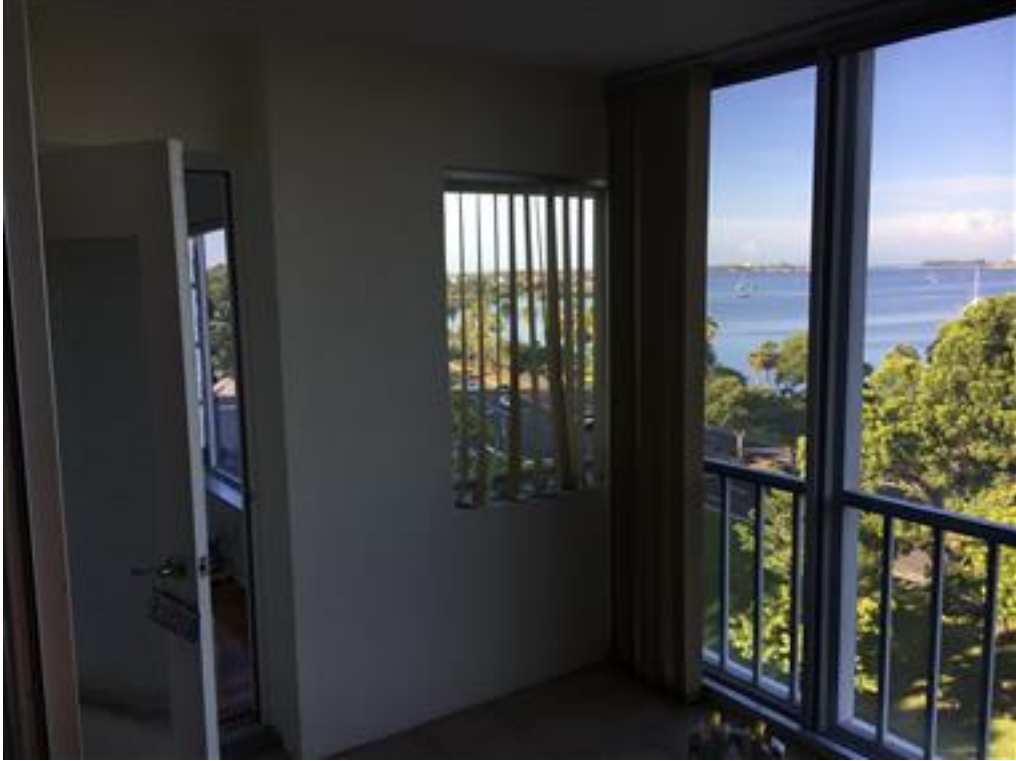
Photo 105-Unit 704, water marks on ceiling

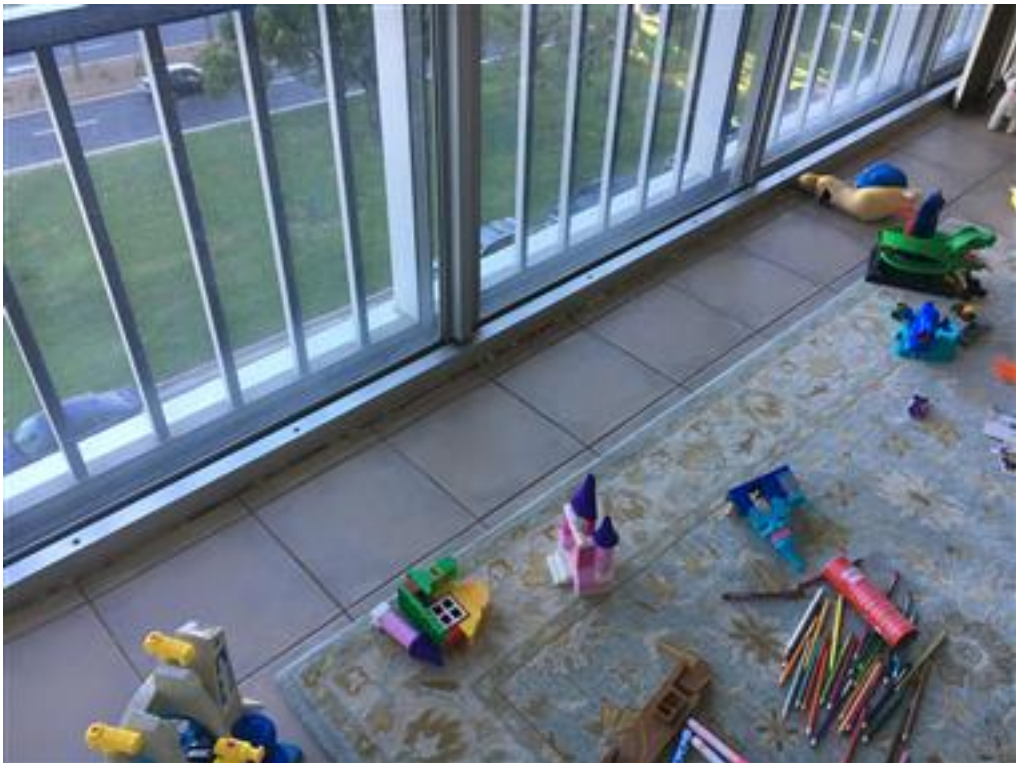
Photo 108-Unit 703 lifted tiles

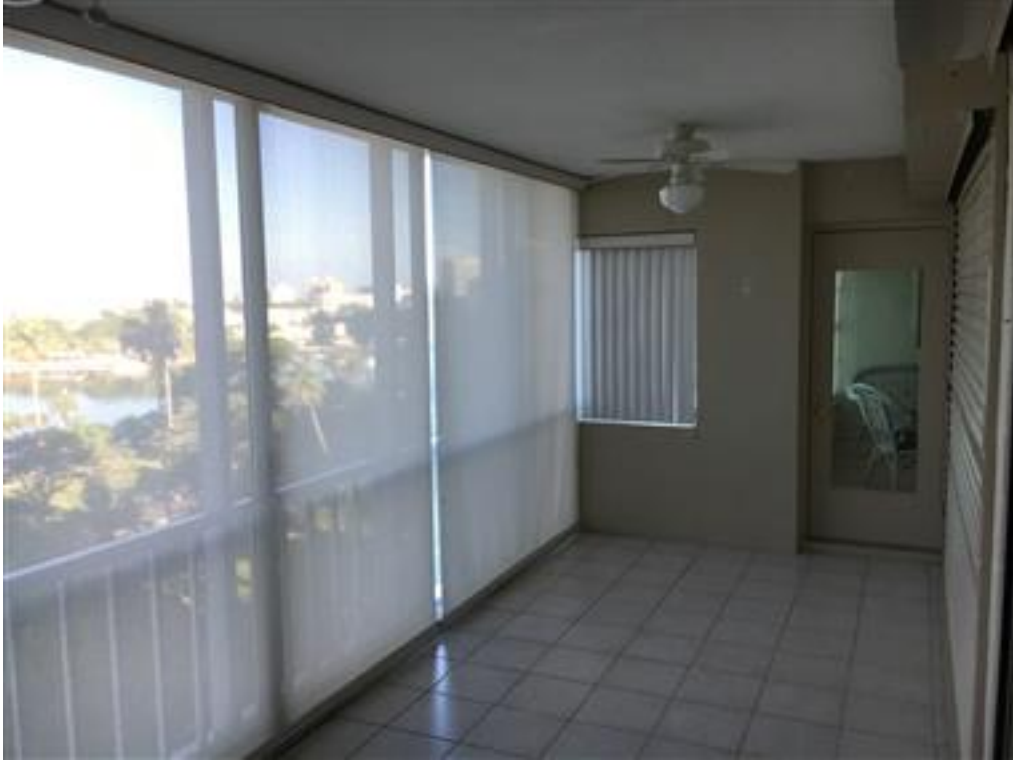
Photo 115-Unit 601, evidence of water intrusion at window

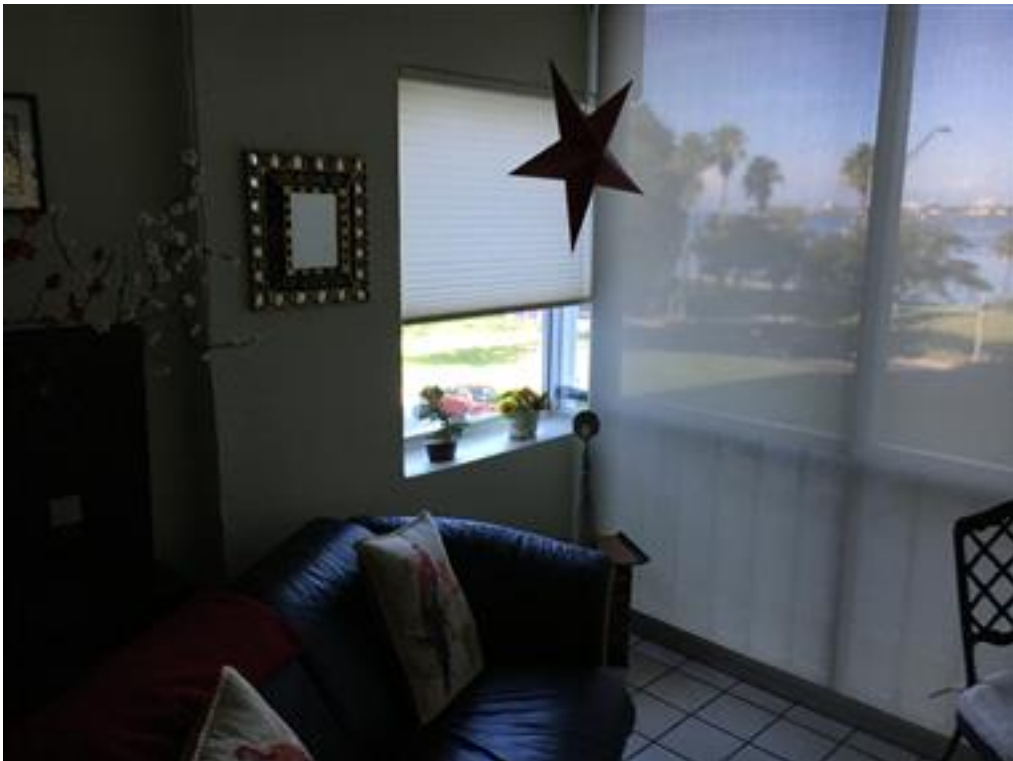
Photo 155-Unit 301

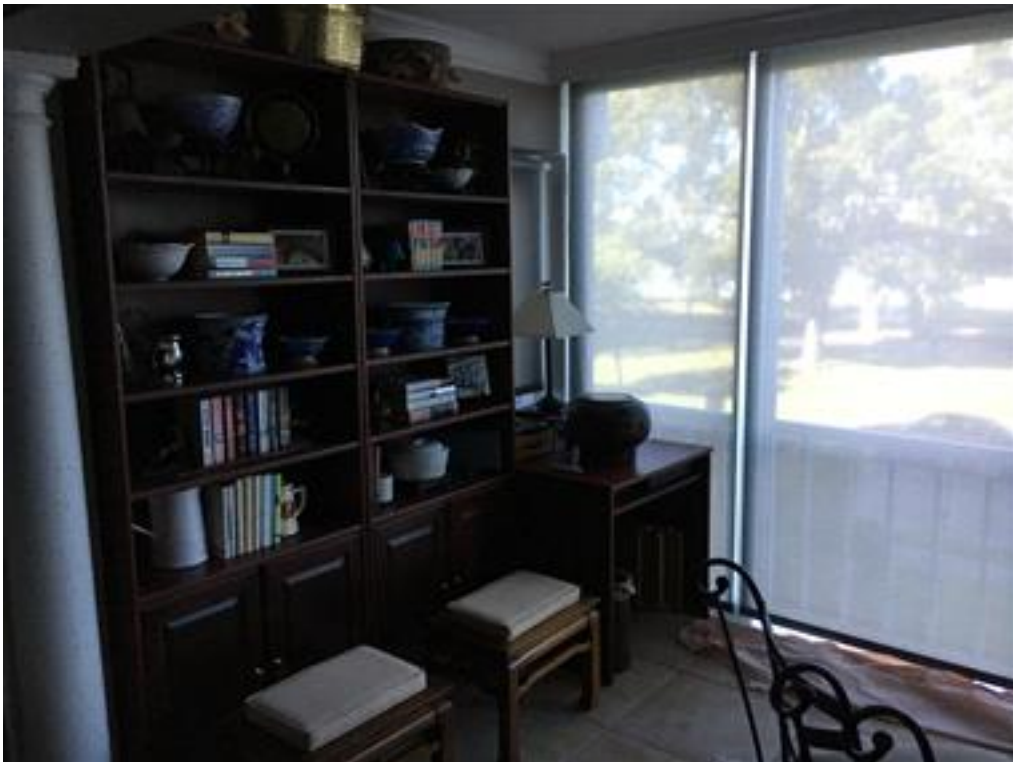
Photo 164-Unit 203, water intrusion at window sill

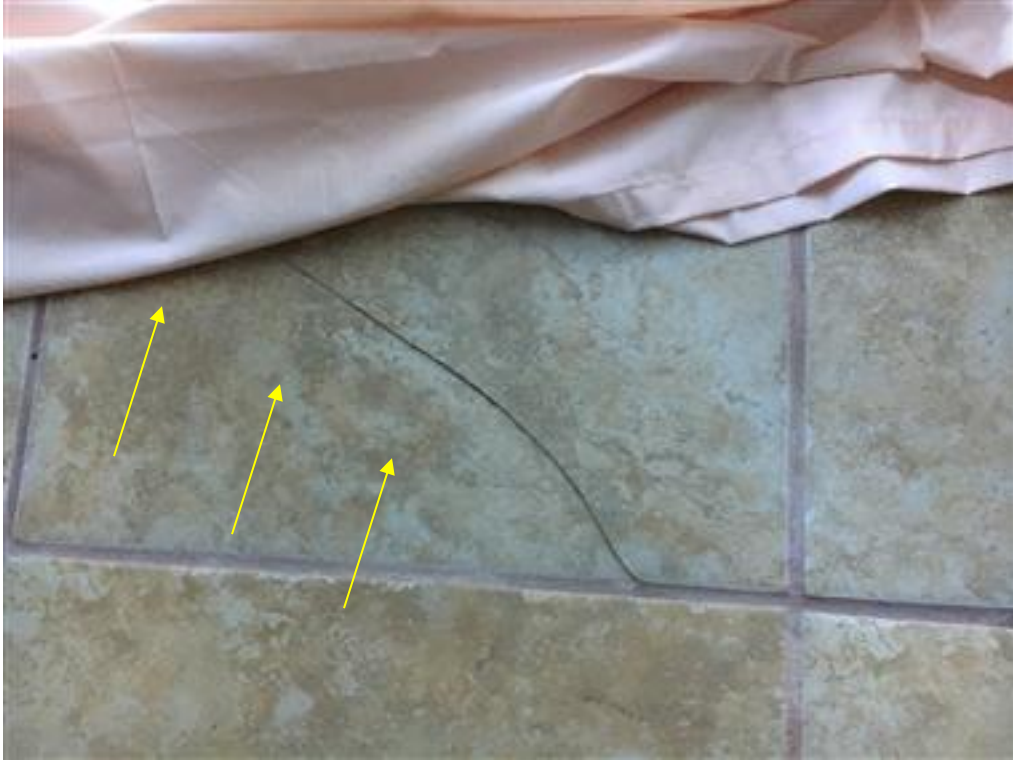
Photo 168-Unit 204, cracked tile
