# Existing Condition Report

**KEG File: 18RS-0416**  
**October 8, 2018**

***Royal St. Andrew Association,  
Inc.***

**RE:    *Royal St. Andrew  
KEG Project P18RS-0416 REV02  
Professional Engineering Services – Existing Conditions Survey***

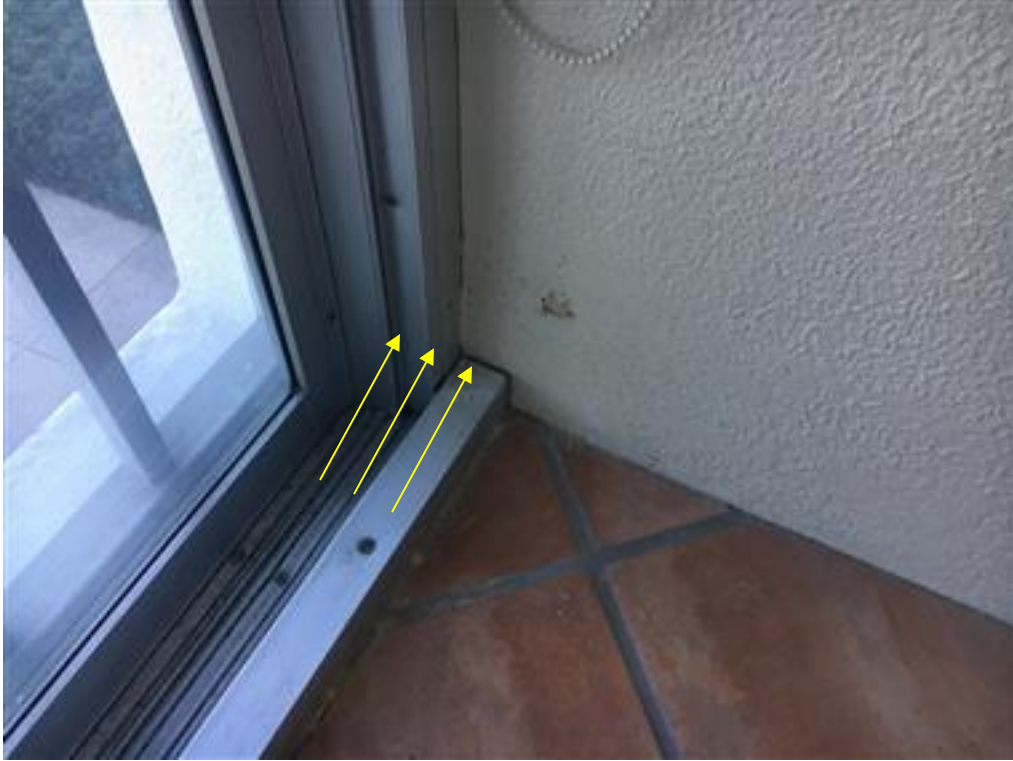
Photo 176-Unit 304, peeling paint

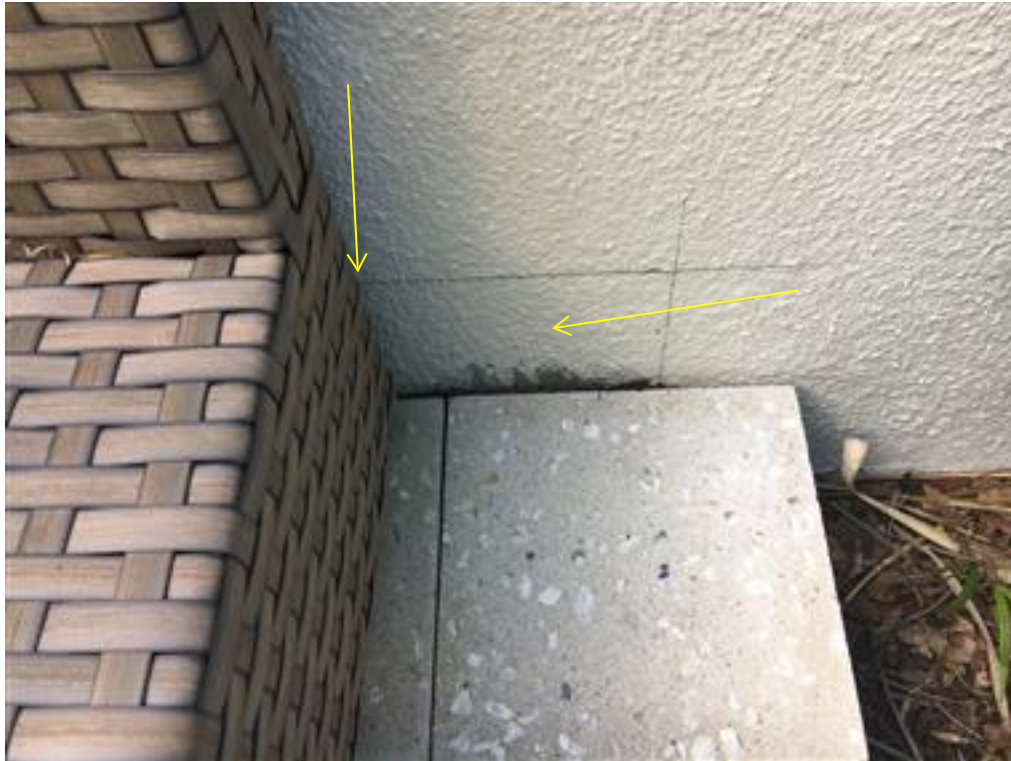
Photo 182-EXTERIOR, stucco cracks

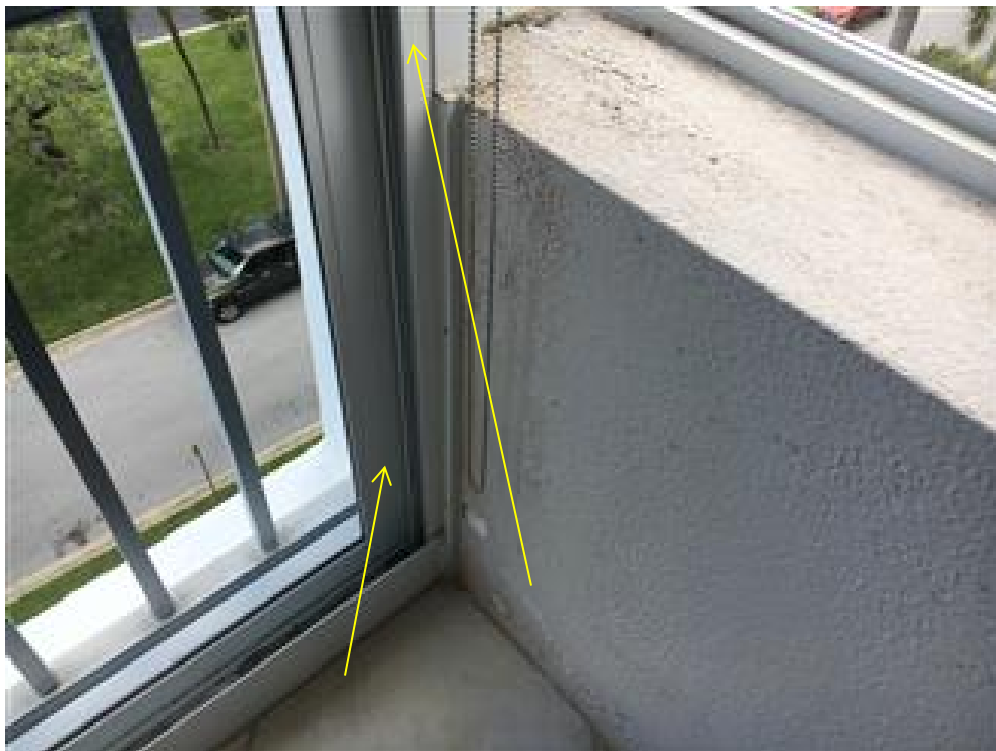
Photo 187-701- water damage

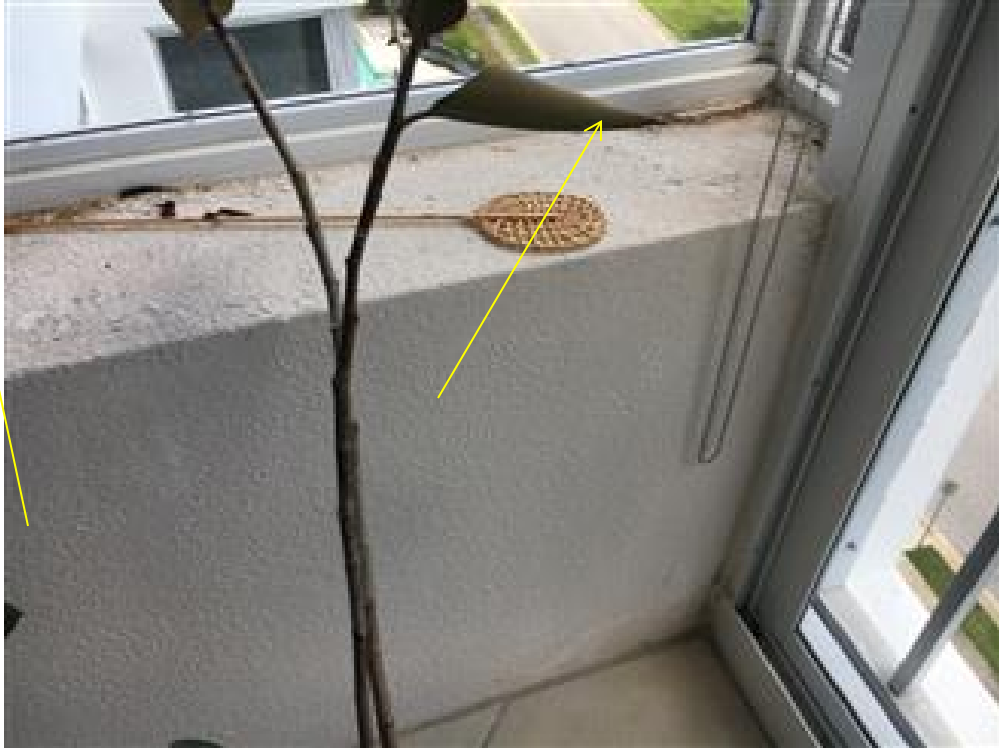
Photo 188-701- water damage

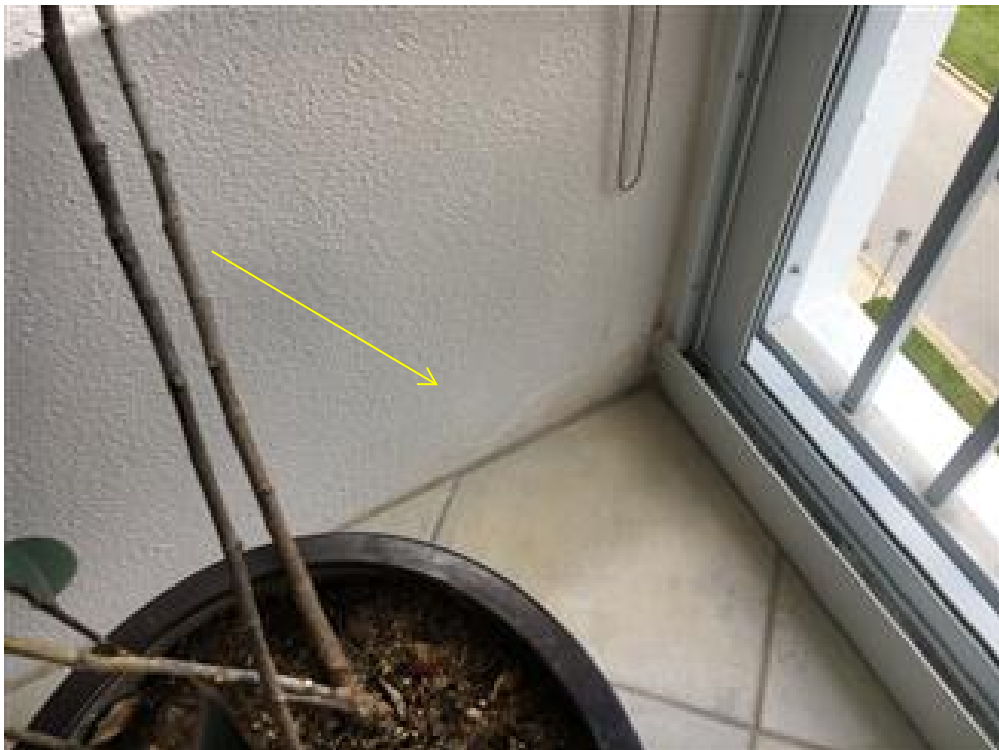
Photo 189-701- water damage
