2019 ROOF INSPECTION REPORT

Las Casas Contentas
8450 N. 59th Avenue
Glendale, Arizona 85302

July 10, 2019

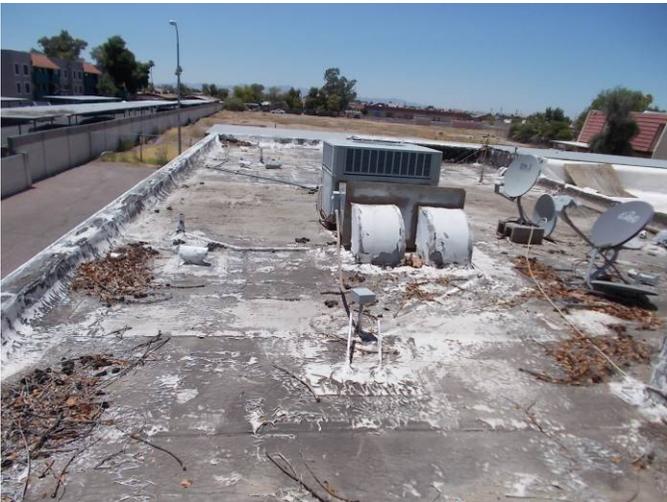
This is an overview of the BUR roof system at 8315 N. 59th Dr. which is in very poor condition.

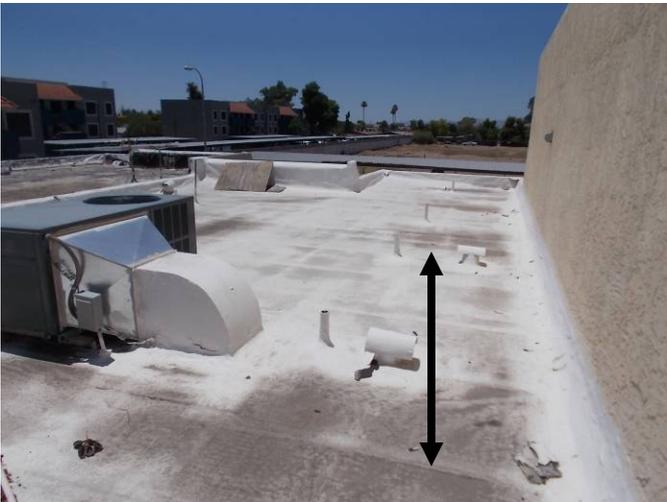
This is an overview of the BUR roof system on 8319 N. 59th Dr. which is in fair condition. Considerable ponding taking place

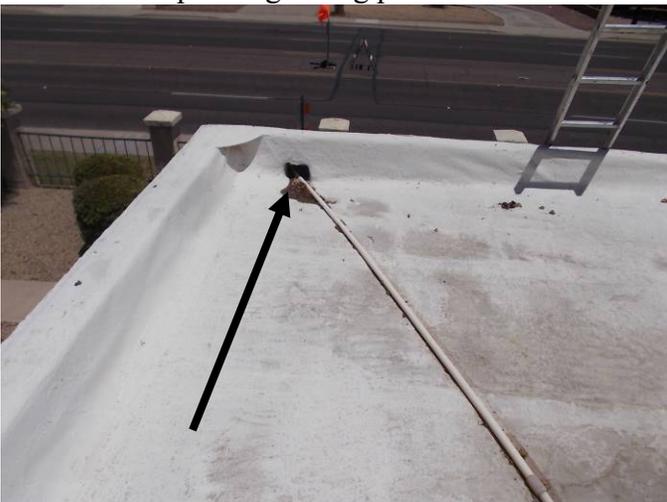
The PVC line has been run through the scupper which impedes the flow of water off the roof and promotes debris build up in front of the scupper.

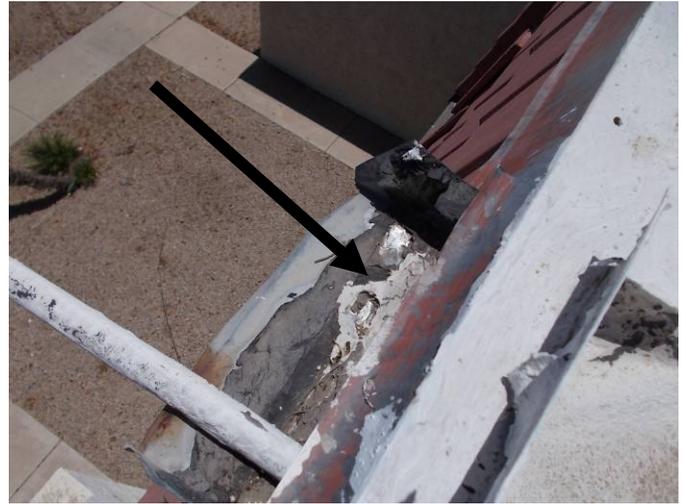
The seal around the scupper at the BUR system and the tile mansard are not watertight.

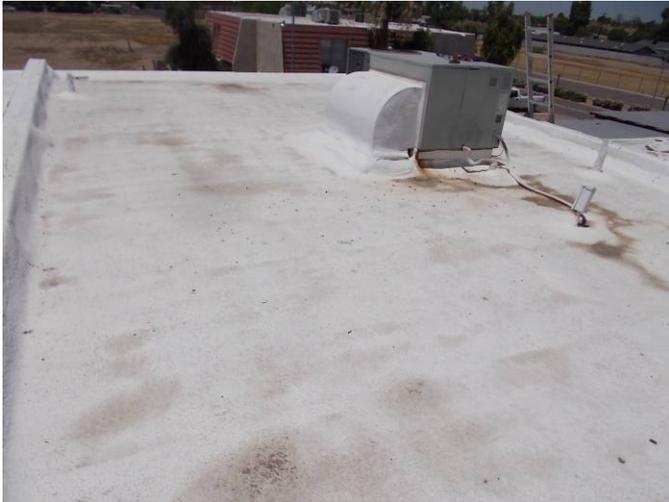
This is an overview of the foam roof system on 8327 N. 59th Dr. which is in fair condition.

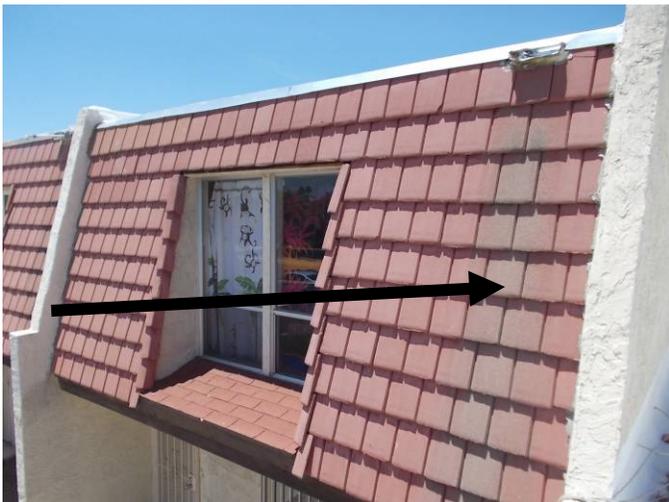
This is an overview of the tile mansard on the east side of the residence. The tile is stained from the water coming from the scupper above.

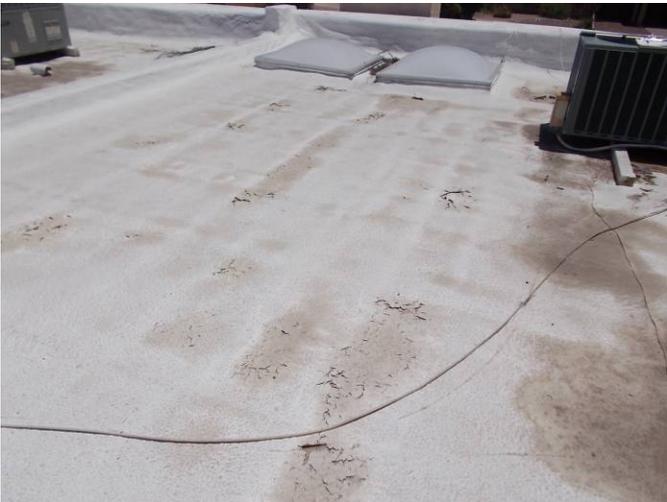
This is an overview of the foam roof system on 8331 N. 59th Dr. which is in very poor condition. The coating is cracking, peeling, & splitting. The coating is severely deteriorated.

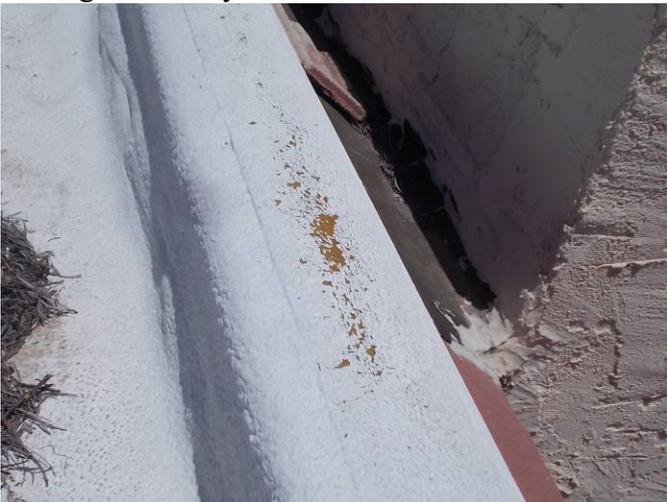
The foam below the coating is exposed to the UV rays which will decrease the life of the roof.

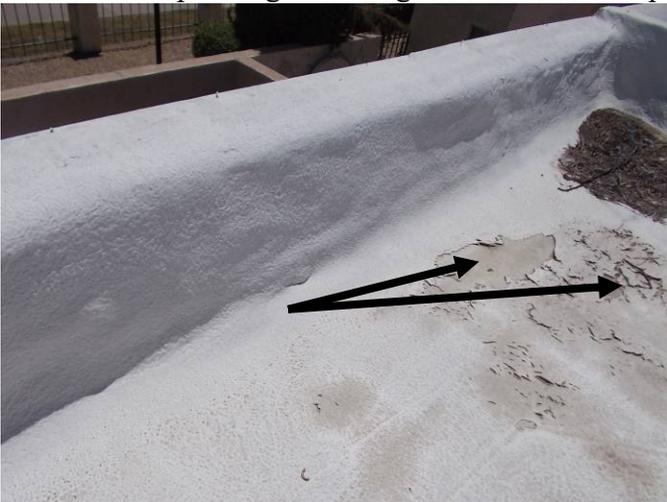
The coating has peeled up and is deteriorated which is accelerating the deterioration of the roof system.

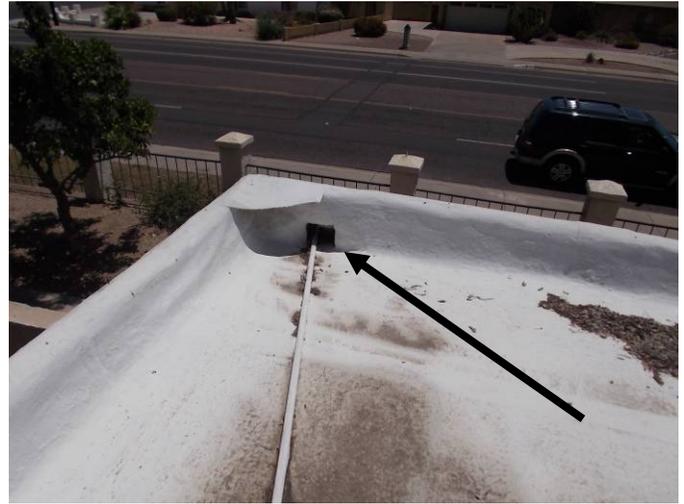
The PVC condensate line should not be run through the scupper as it impedes water flow off the roof.

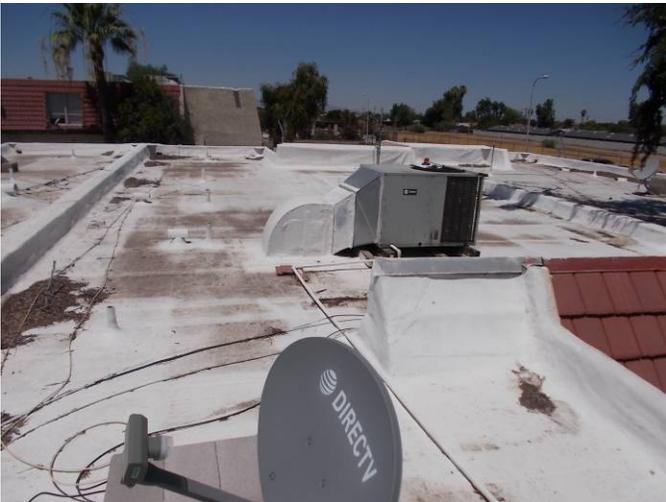
This is an overview of the BUR system on 8339 N. 59th Dr. which is in poor condition. Considerable ponding and debris build up.

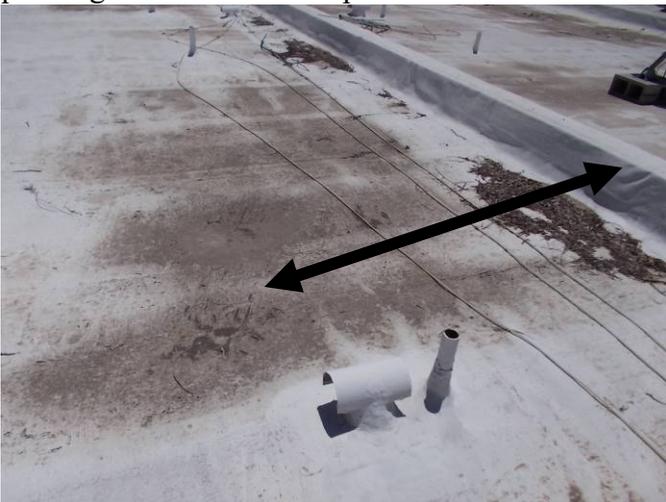
This area ponds water and it has deteriorated the coating which is flaking and peeling up. Ridging occurring in the wall flashings.

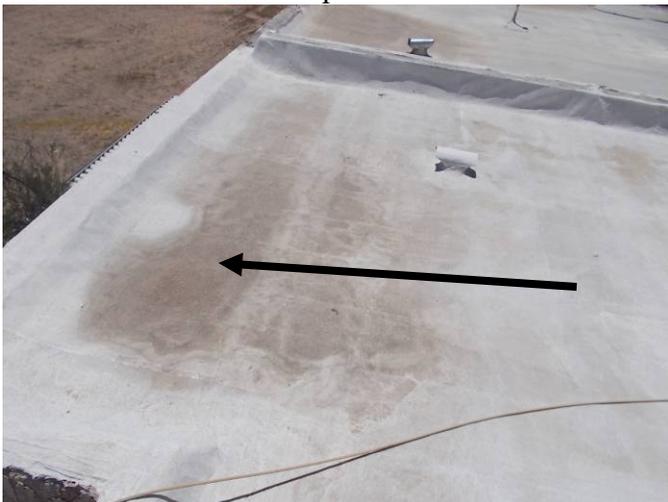
Water is ponding on this roof system which has deteriorated the elastomeric coating.

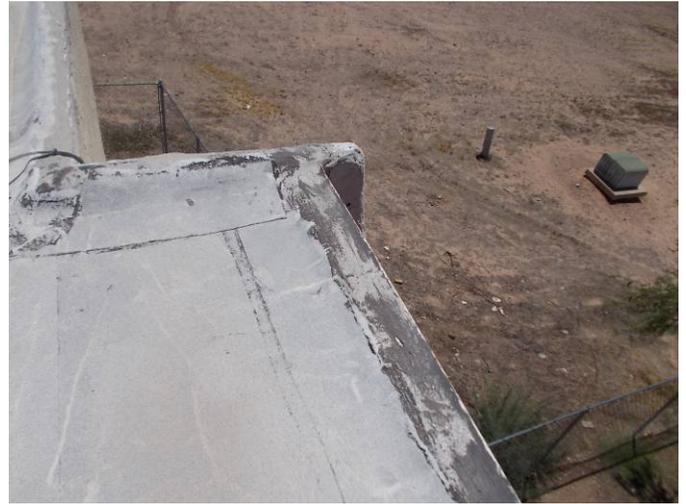
The top of the wall flashing is coming apart and susceptible to water penetration.

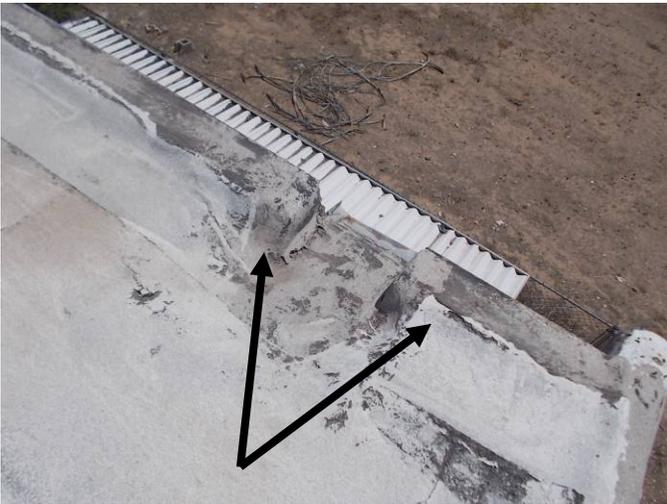
The seal around the scupper is not watertight. The wall flashing is splitting apart.

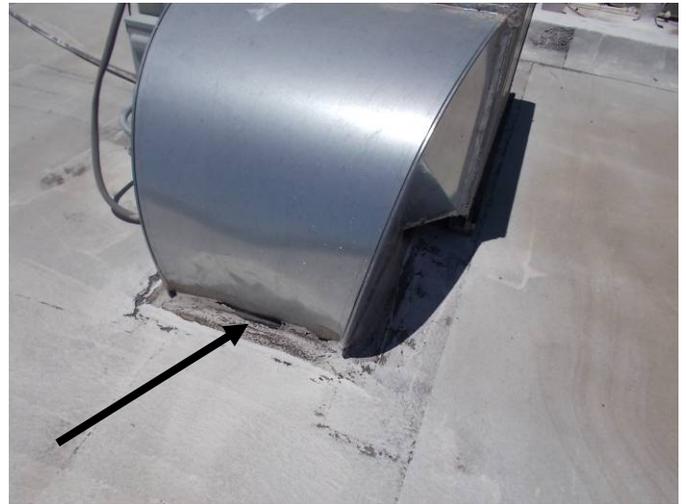
The seal around the base of the HVAC duct work is wide open and allowing water penetration.

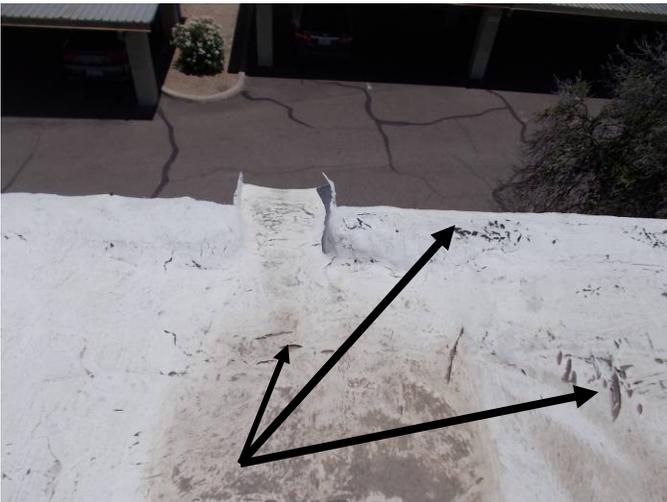
Multiple splits and cracks in the coating and the roofing membrane and is susceptible to leaks.

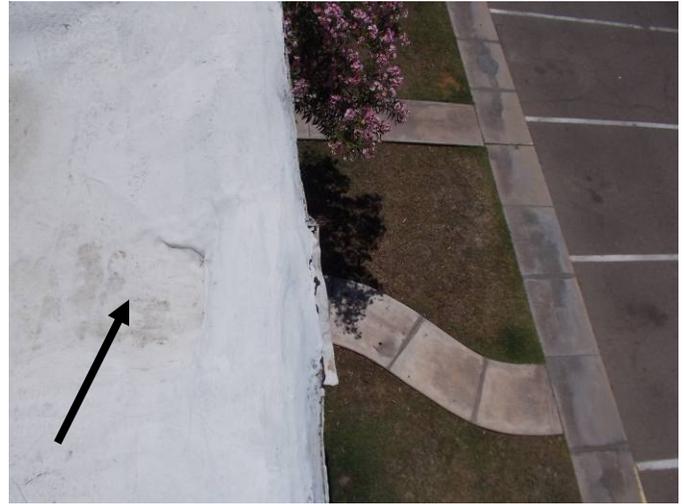
There are splits in the coating and roof system in front of the scupper.

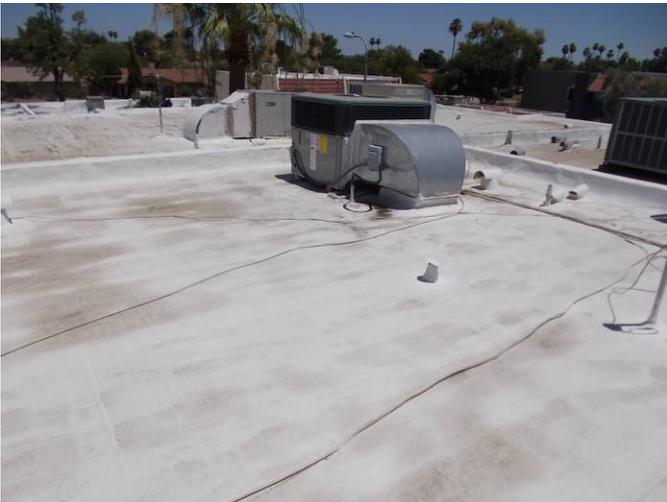
This is an overview of the BUR system on 8340 N. 59th Dr. The roof is in poor condition.

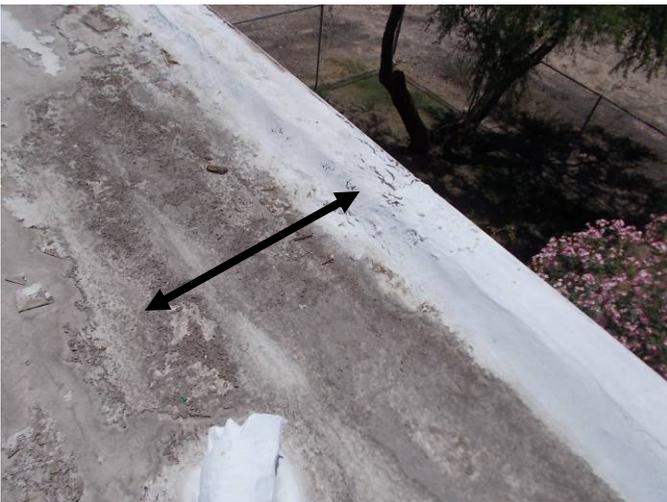
Ponding and coating deterioration occurring along this section of parapet wall. Cracking in top of wall.

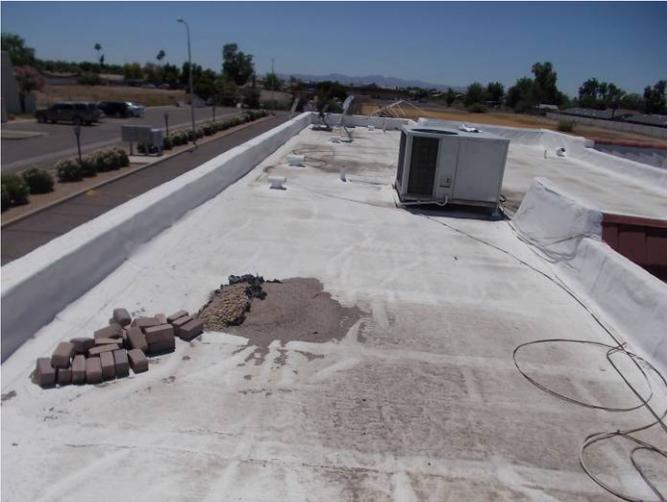
This is an overview of the BUR system on 8401 N. 59th Drive which is in poor condition. Large amounts of debris on roof. 3 roof systems exist.

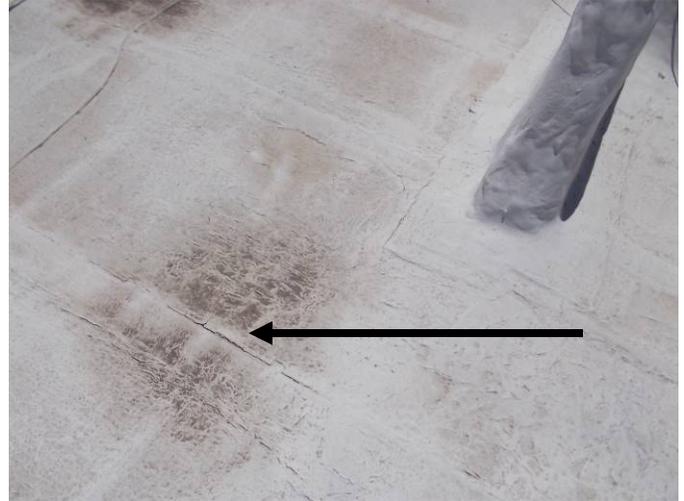
The roofing membrane has split open and is allowing water penetration.

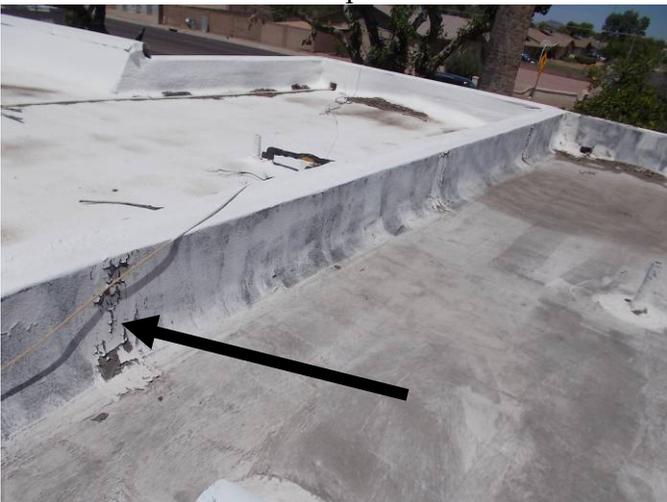
The wall flashing laps are cracked apart. The aluminum coating has completely deteriorated.

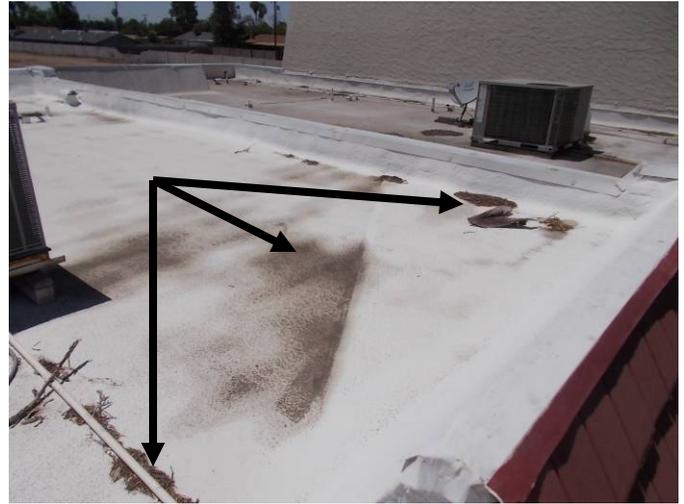
There is some ponding occurring at the base of the cricket. Some debris on the roof.

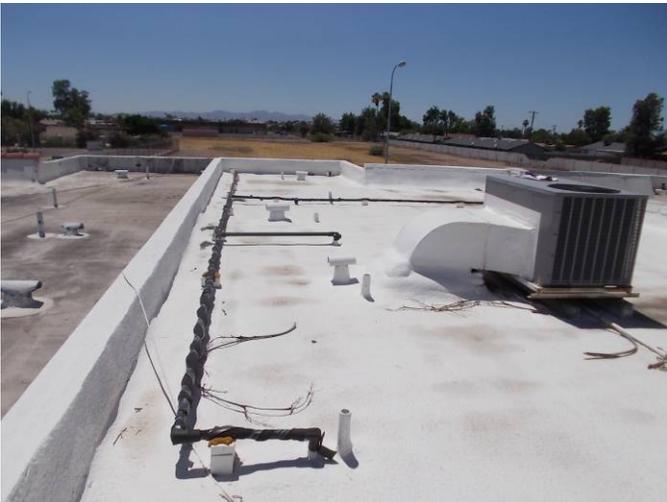
This is an overview of the foam roof system on 8409 N. 59th Dr. Roof is second layer and in fair condition.

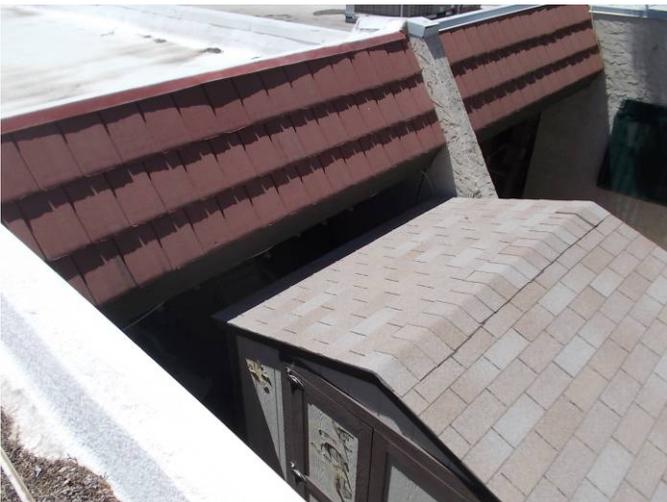
This is an overview of the tile mansard in the front of the residence and a shed shingle roof in the front yard area. Mansard has no scupper coming through.

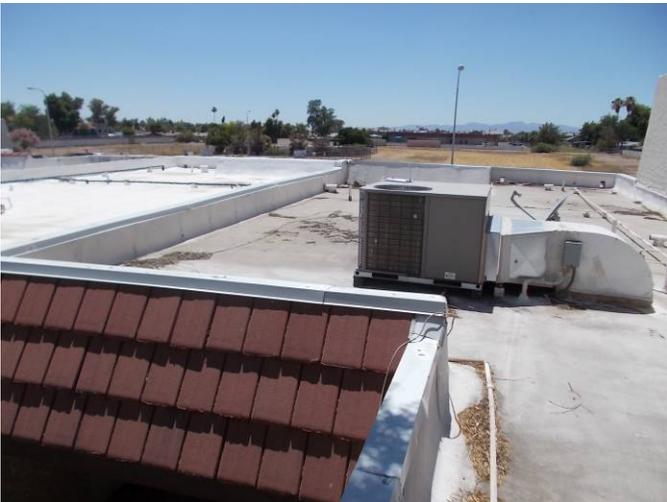
This is an overview of the tile mansard roof and the BUR system on the low-slope deck which is in fair to poor condition.

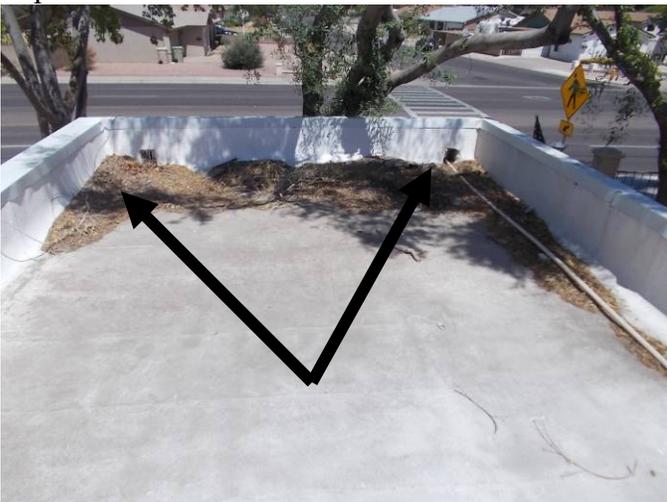
Large amount of debris on the roof deck. PVC line running through scupper which is promoting debris build up and is impeding water flow off roof.

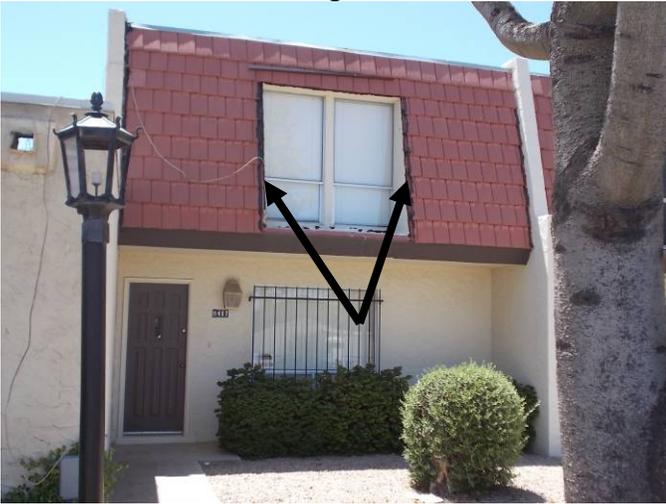
This is the view of the front of the residence at 8417 N. 59th Drive, Glendale, Arizona 85302. Tile mansard is missing trim tile around window area.

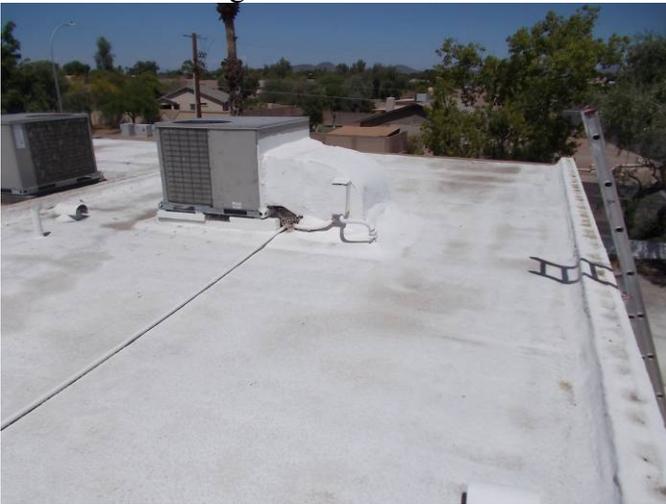
This is an overview of the single layer foam roof system on 8417 N. 59th Dr. which is in fair to poor condition.

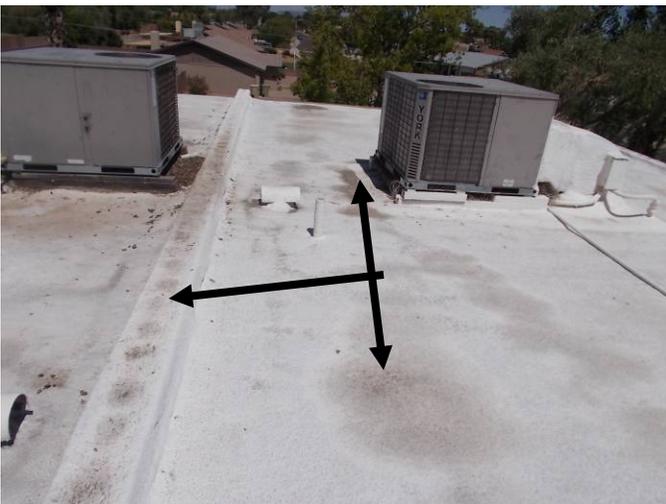
Another view of the foam roof showing some ponding areas and the top of the firewall exposed.

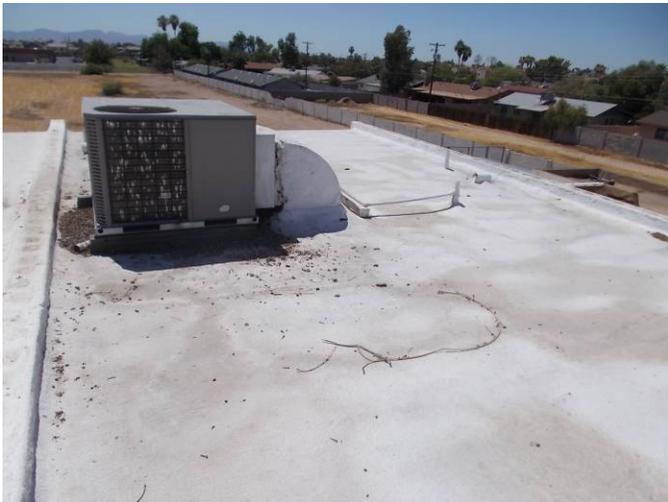
This is an overview of the single layer foam system on 8421 N. 59th Dr. which is in poor condition.

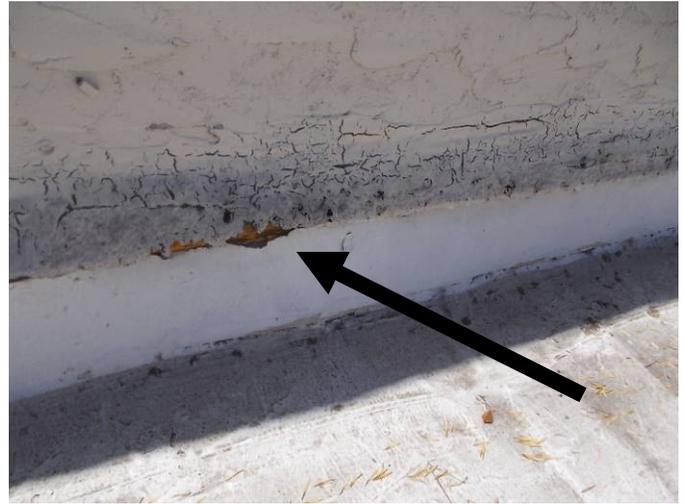
The wall flashing is separating and the foam is exposed to UV rays.

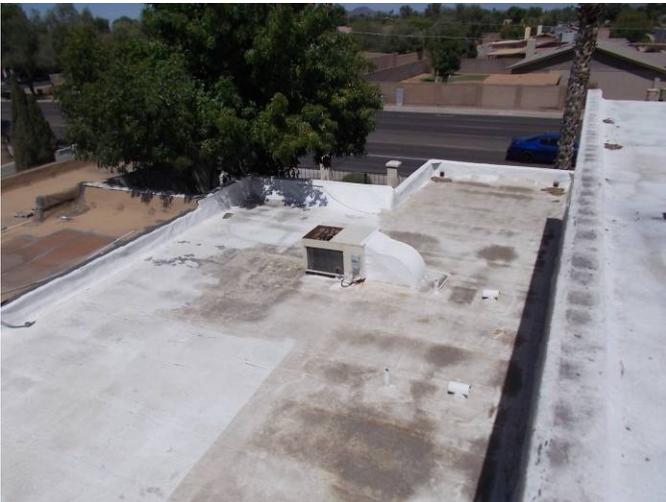
This is an overview of the multi-layer BUR system on 8425 N. 59th Dr. which is in very poor condition.

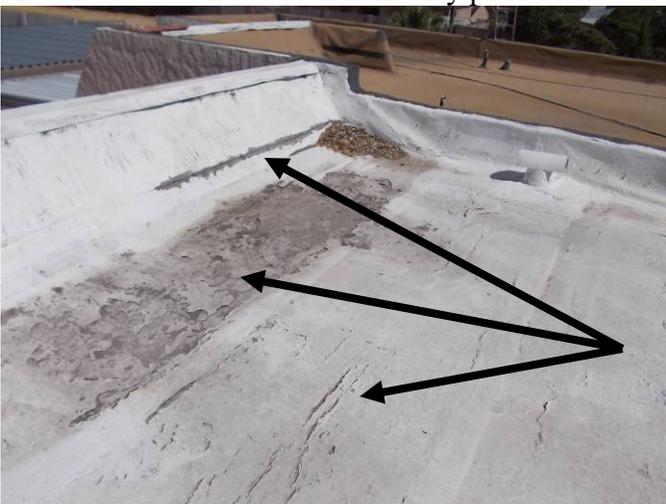
Both the coating and the roofing membrane is cracking and splitting apart and is susceptible to water penetration. Wall flashing is separating.

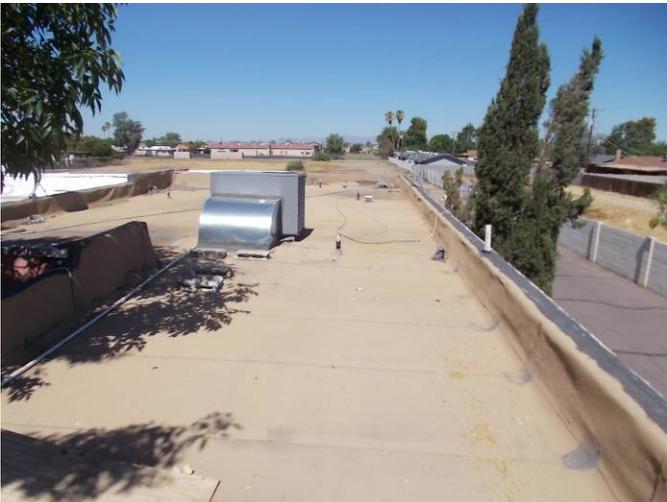
This is an overview of the second layer of BUR system on 8429 N. 59th Dr. and it is in fair to poor condition.

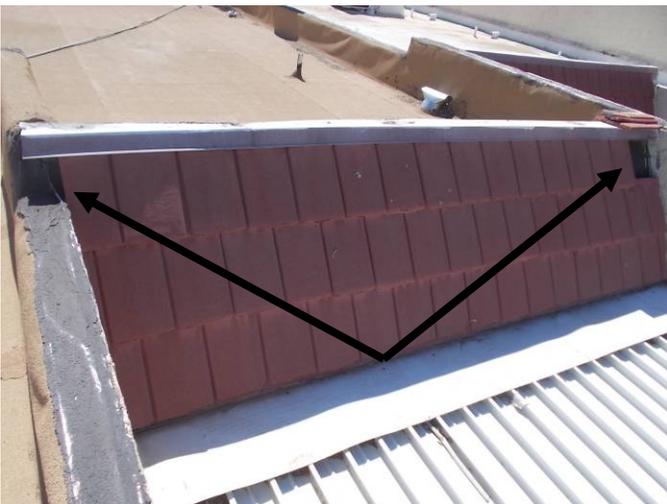
The tile mansard has some tile missing and does not have a scupper running through it.
