RV Inspection Report

**Prepared for: Michelle P
2003 THOR FUNMOVER**

**Inspection Date / RV Model:
Nov 16, 2024-2003 Thor Fun Mover**

Mobiltek RV Services LLC

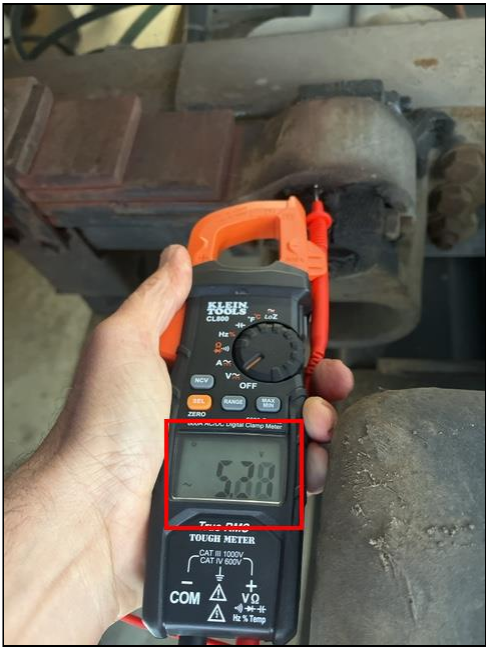
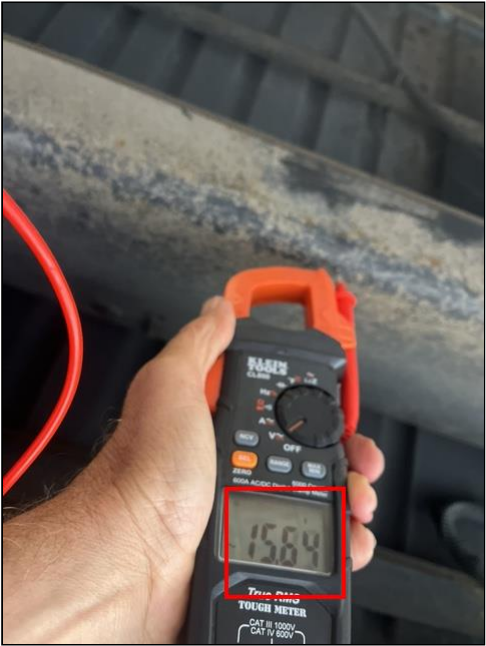
Hot Skin Test

(1) There is over 5 volts AC on the tested exterior walls.. This is a LIFE SAFETY issue. It is recommended that this be further evaluated by qualified RV technician prior to occupancy.

(2) This hot skin test video show minimal stray voltage of 1.4 volts prior to contacting the exterior wall adjacent to the driver door. The voltage immediately increases to over 26 volts upon contact. This is a LIFE SAFETY issue. It is recommended that this be further evaluated by qualified RV technician prior to occupancy.

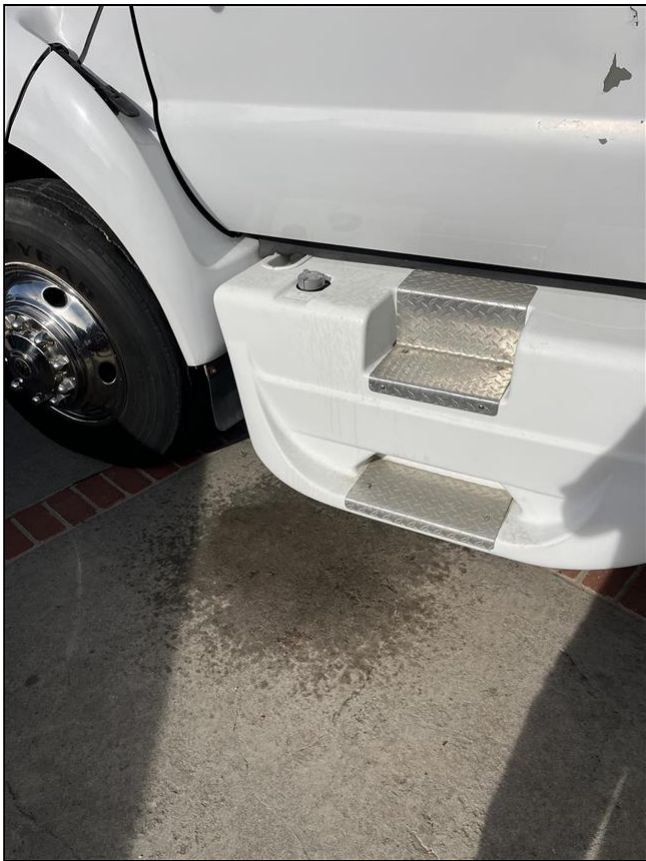
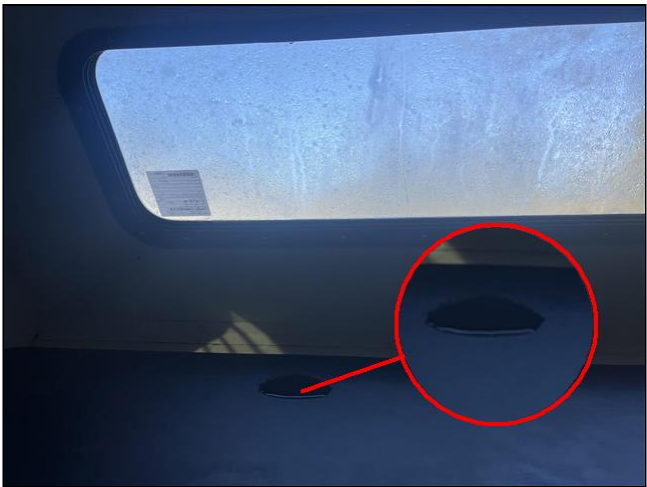
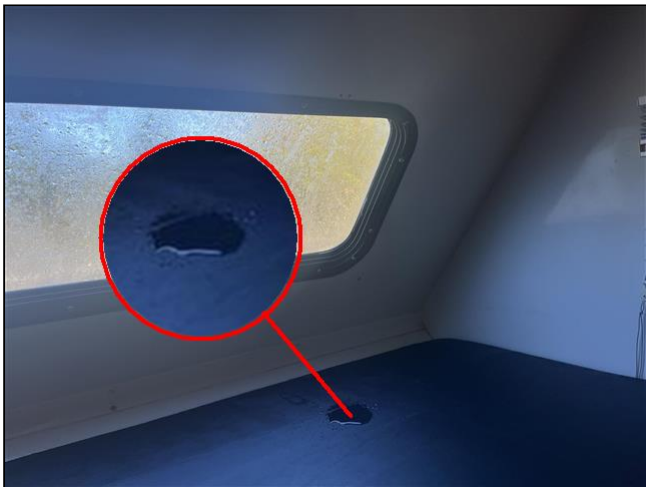
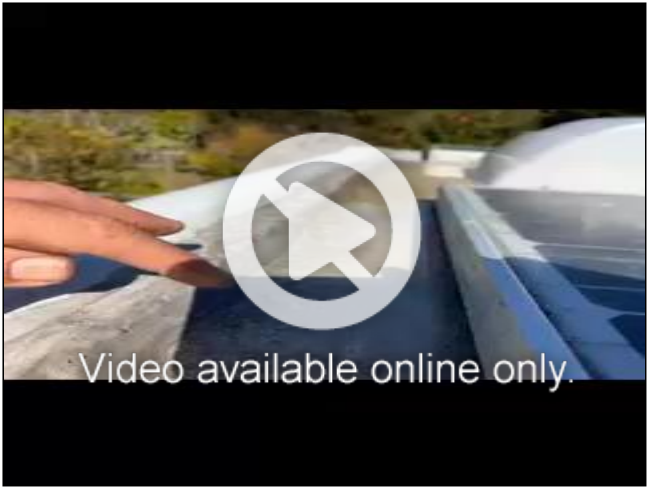
There is a puddle of water approximately 1/2 deep along the front cap trim, under the solar panels, surrounding the front half of the exterior vent. This water drained down the streetside sidewall over the driver door, fuel tanks and onto the ground. There was water on the interior cabover bunk on both sides as well.

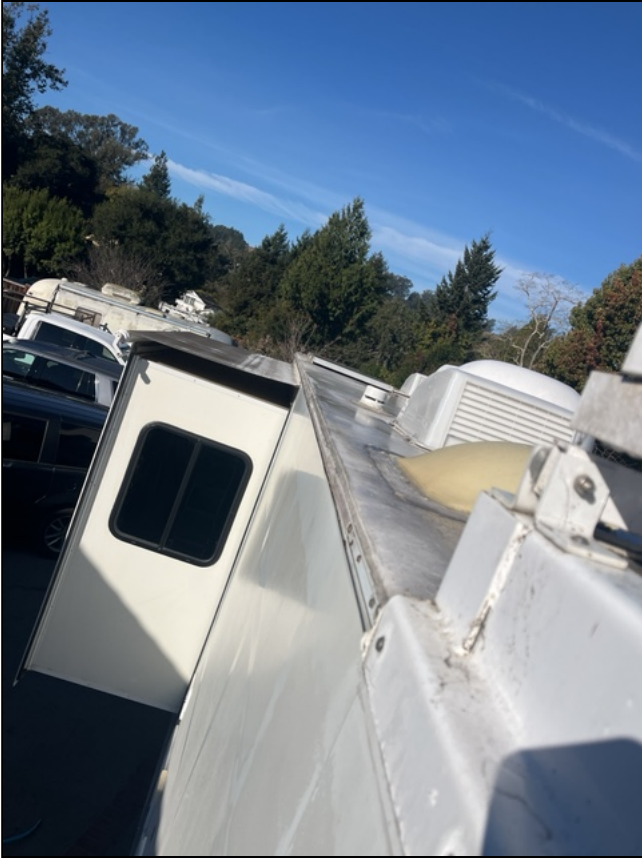
Streetside Trim Rail

(2) There is trim missing and are two holes at the trim rail over driver door. There is excess sealant blocking free draining of the rail as water runs over and through. This is the segment that the puddle on roof drains over. This could allow water intrusion. It is recommended that this be further evaluated by a qualified RV technician.

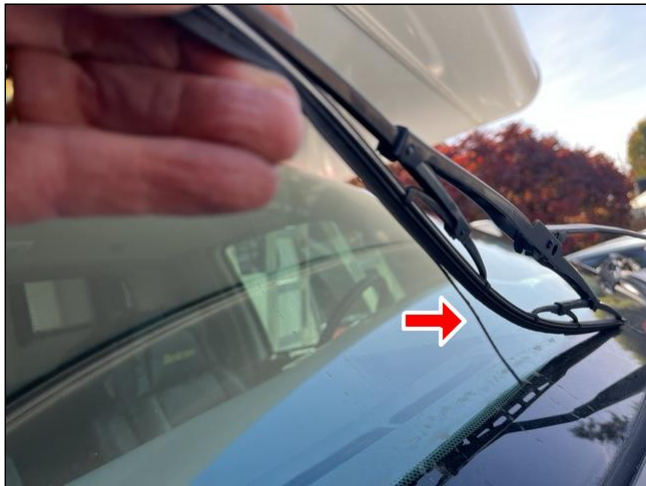
Passenger Side Wiper Blade

(2) The wiper blade on the passenger side is dried and fraying.

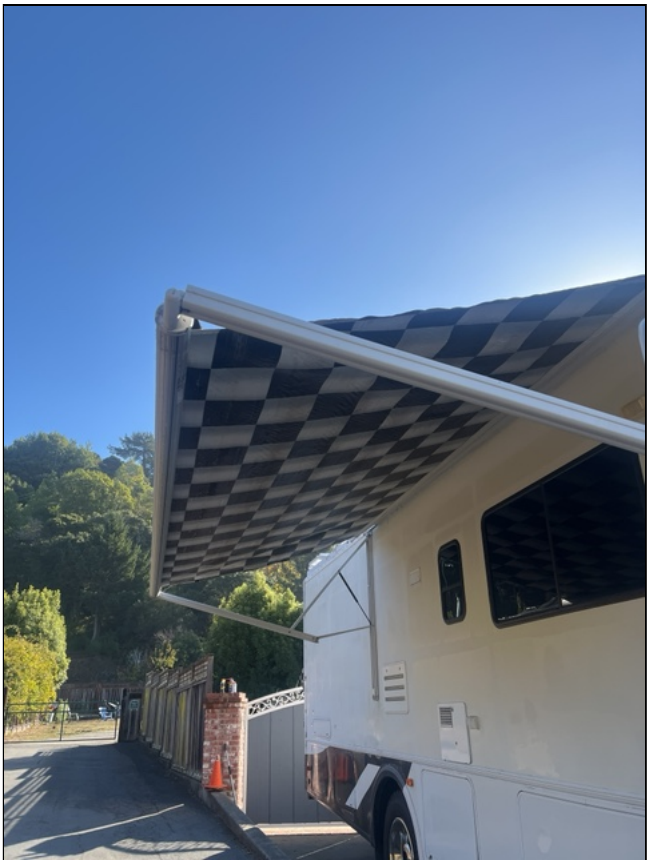
Awning

Fabric condition of awning is good. It is dirty and some stains.

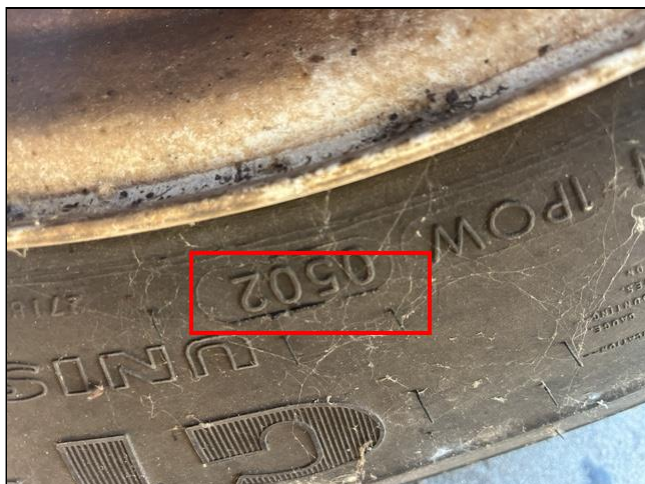
DOT Date Code

The age of the tire is listed as fifth week of the year 2002, which is beyond the NTSB and some tire manufacturer's replacement age. It is recommended that this be further evaluated by a qualified tire technician. This is a LIFE SAFETY ISSUE.

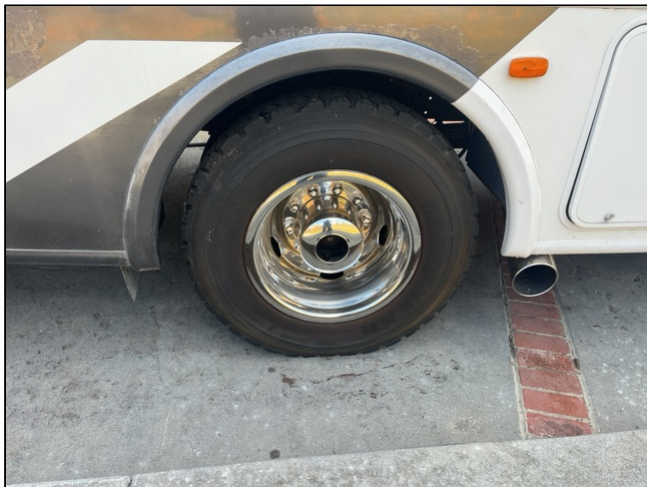
Curbside Rear Outer Wheel Assembly

Poor

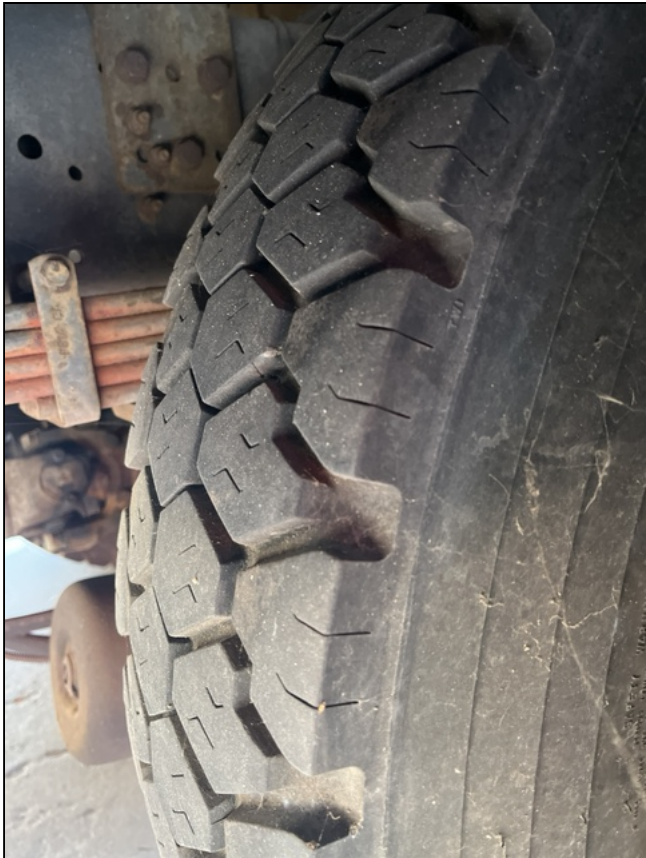
Curbside Rear Tire Tread

Poor

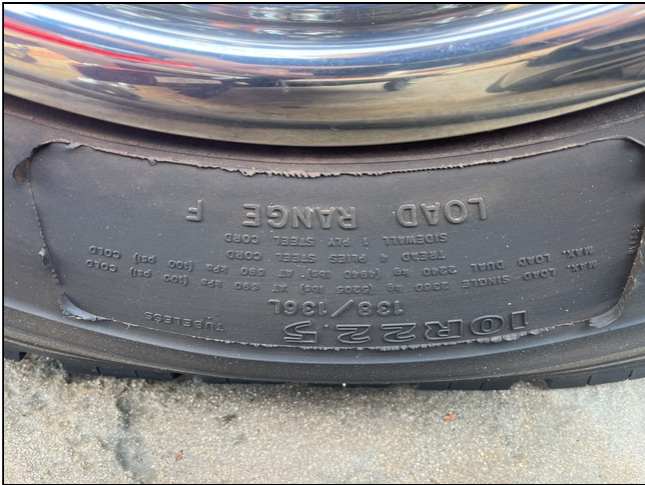
Tire Data Stamp

Poor

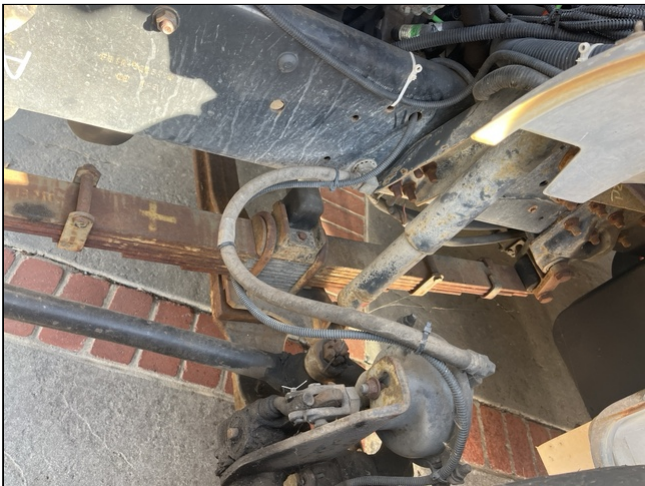
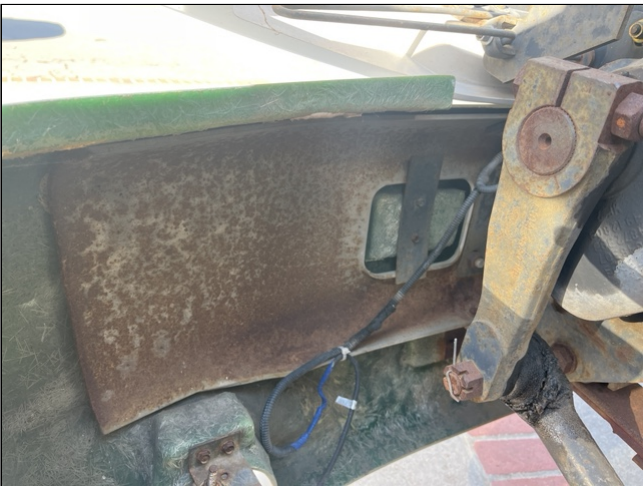
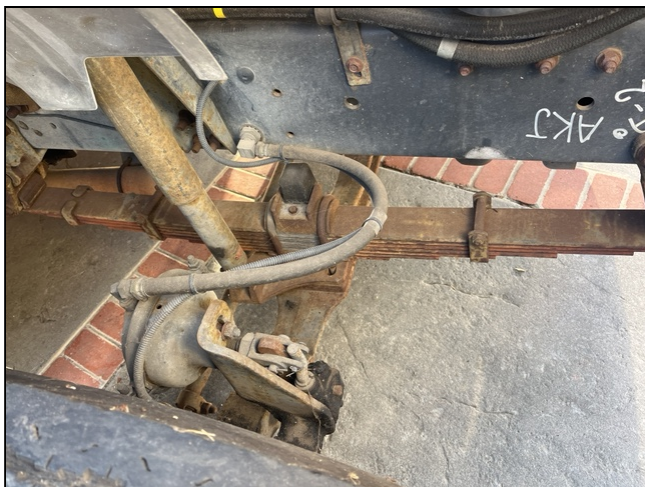
There are visible signs of rust

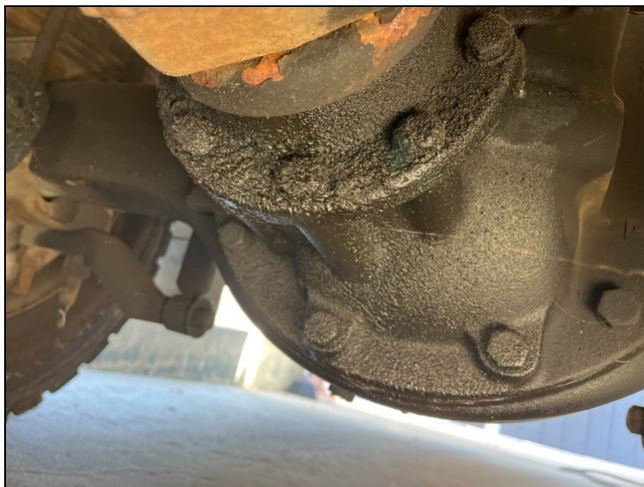
Rear Differential

(2) There are signs of leaking at the rear differential.

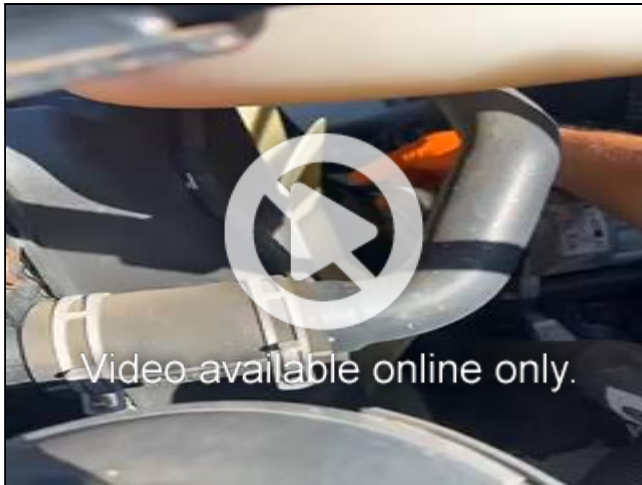
Fan Belt

12.7 Belts(s) - Condition

Poor

The belt is dry, stiff and loose. It is recommended that this be further evaluated by a qualified automotive specialist.

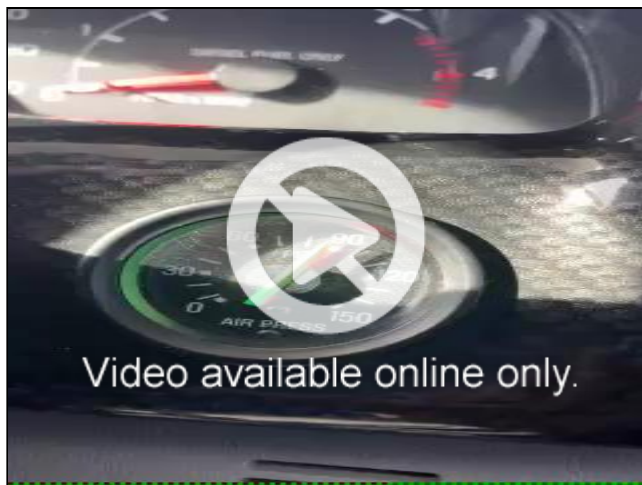
Low Air Warning Test Attempt #2

(2) During the low air warning test, the front brakes (green needle) leaked air suddenly and completely drained the tank. This is a life safety issue. It is recommended that this be further evaluated by a qualified automotive specialist prior to operating the vehicle.

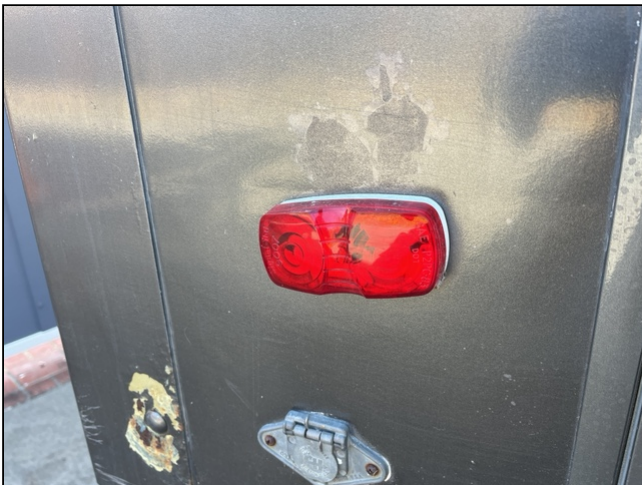
Curbside marker lights

13.3 Marker Lights - Curbside

Poor

The curbside marker lights do not illuminate

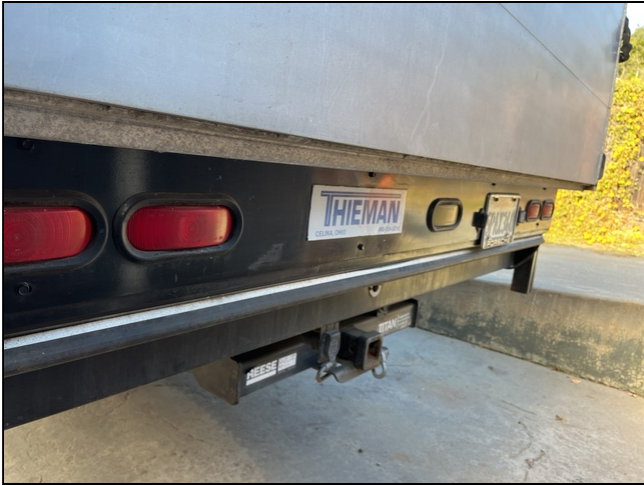
Back up lights

13.10 Backup Lights

Poor

The backup light is not working. It is recommended that this be further evaluated by a qualified mechanic prior to driving the unit.

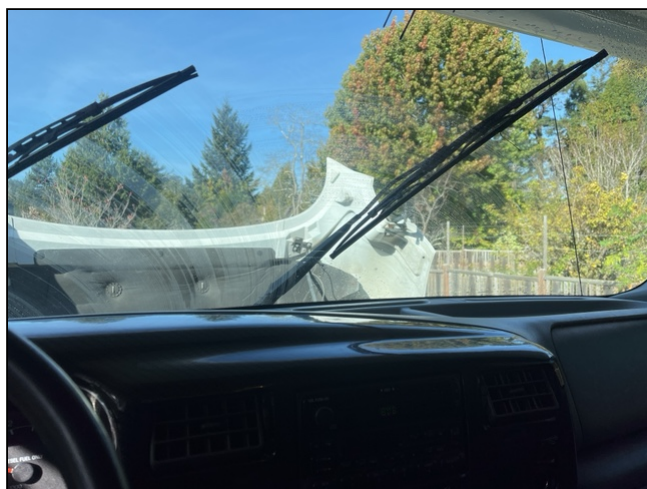
Wiper Blades

14.8 Windshield Wipers - Condition and Operation

Poor

Windshield wipers smear. Curbside smeared all over window. Street side smeared bottom part of window.

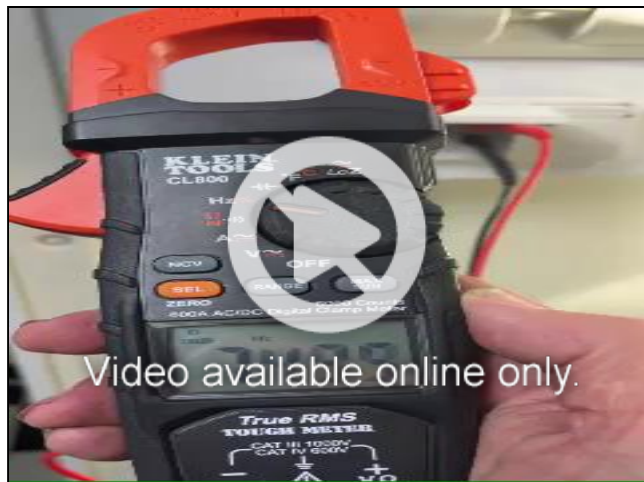
Generator Hertz Test

(1) The generator frequency was erratic.

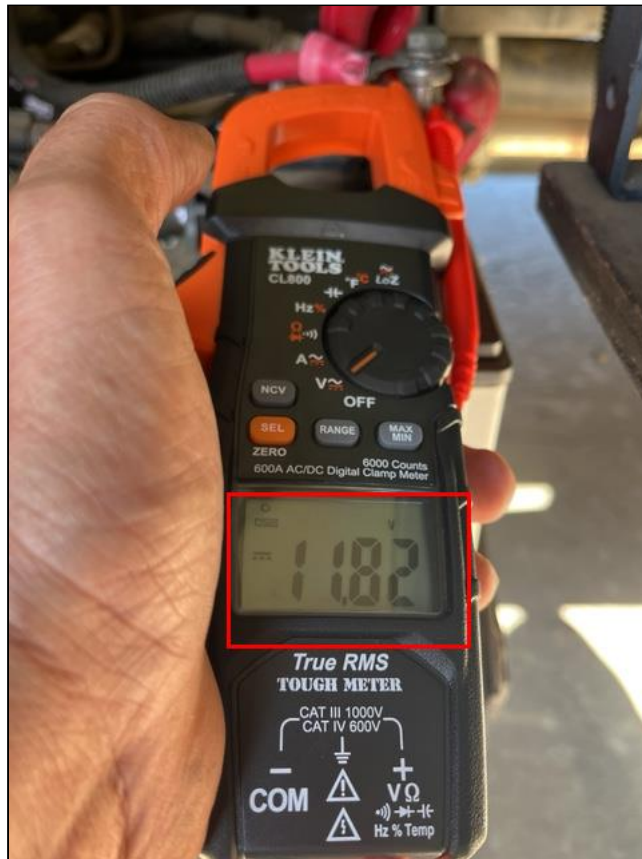
Chassis Battery Voltage

15.52 12-Volt DC Chassis Battery(s) - Condition

Poor

The chassis battery had low voltage after engine had been shut off for 3 hours. Inspector started rig again using the battery boost from house batteries.

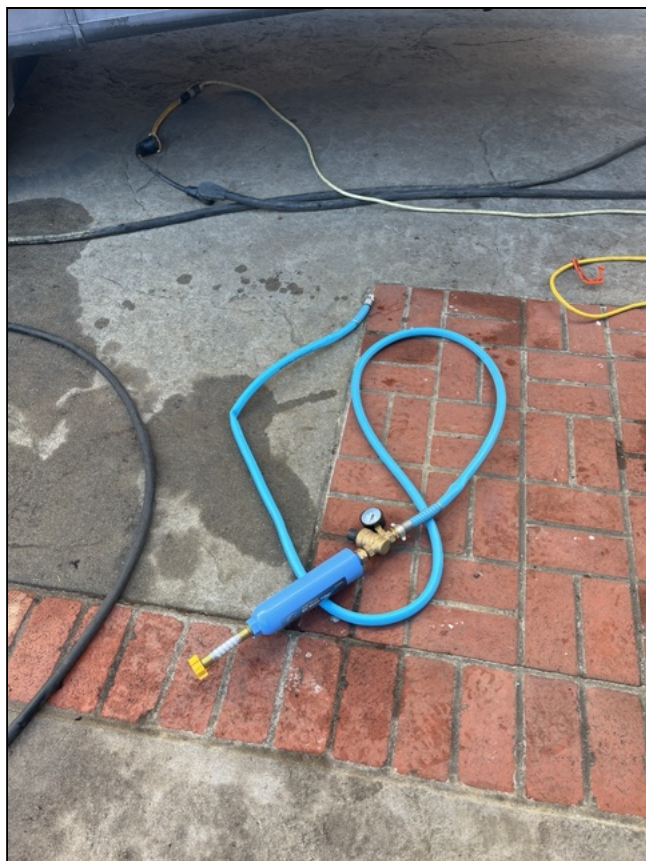
Water Filter

The water filtration was not on board but present.

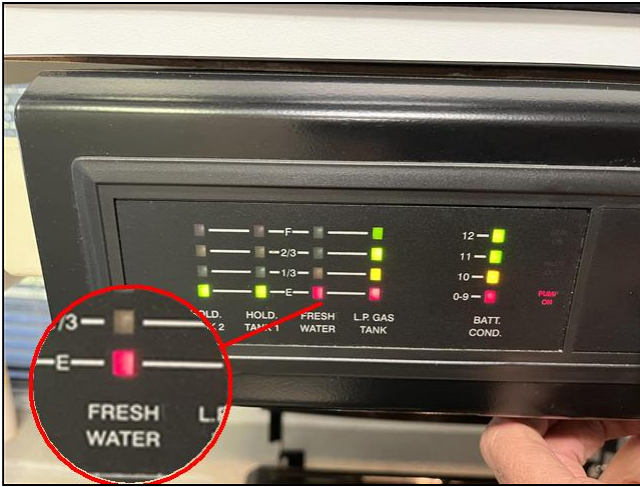
Tank and Battery Level Monitor

(2) Overview. Note fresh water tank level.

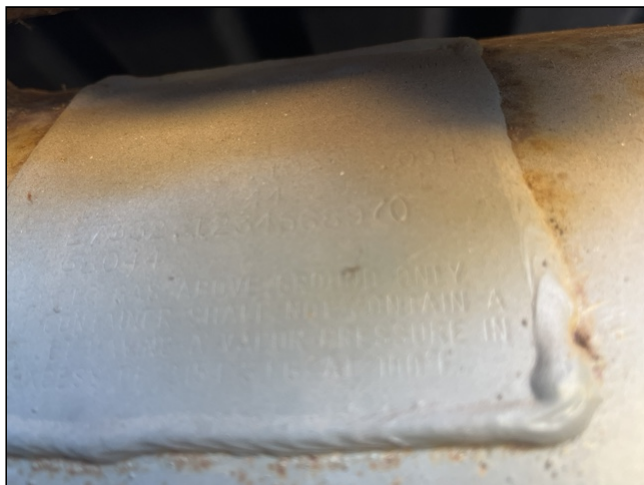
**18.1 ASME Tank - Rust or Damage**

There was minimal rust evident on the tank.

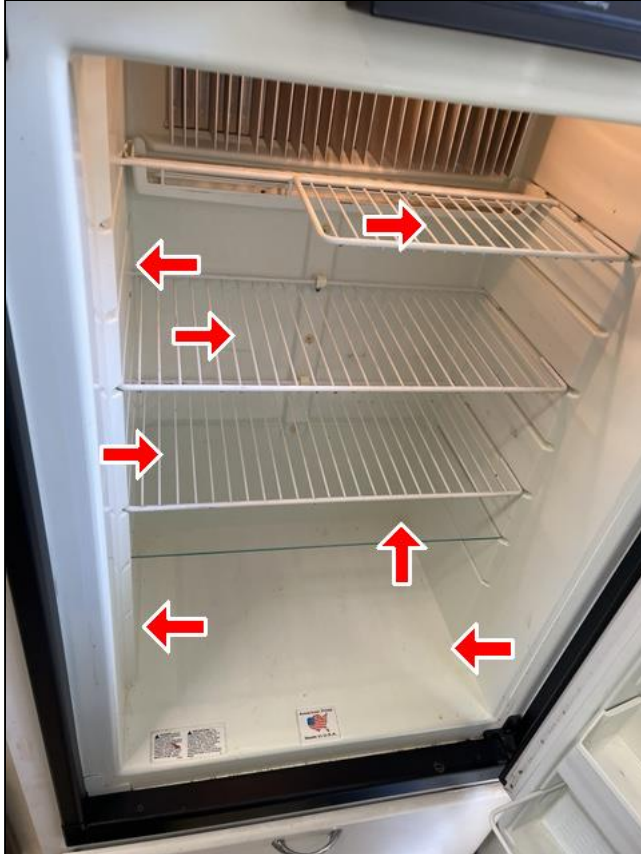
Refrigerator Interior

Fair

There are some markings inside refrigerator.

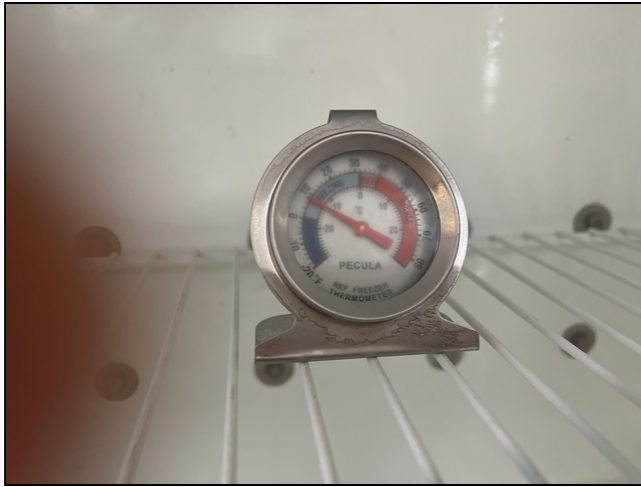
Freezer Temperature

Freezer temperature 8°.

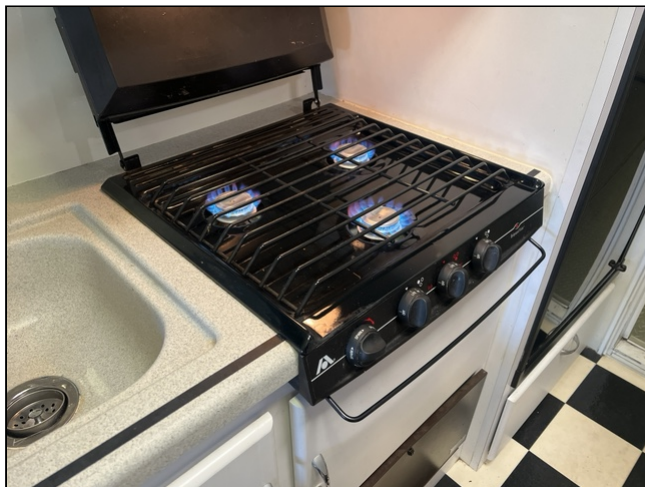
Burner Flame Color

The cooktop flames were blue with yellow tips.

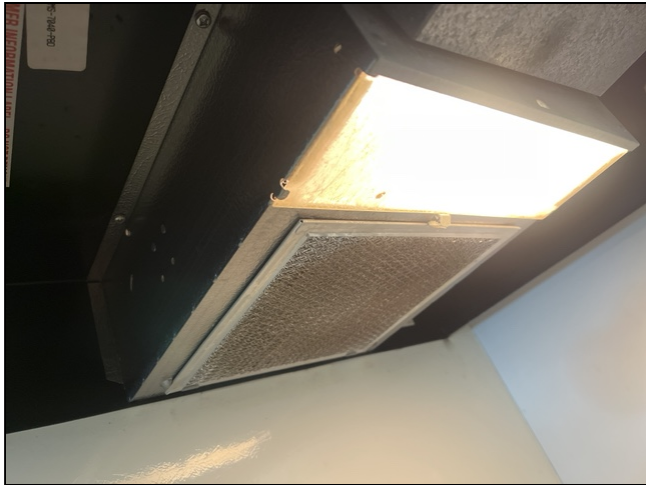
Exhaust Vent

The Cooktop exhaust filter and light lens are dirty.

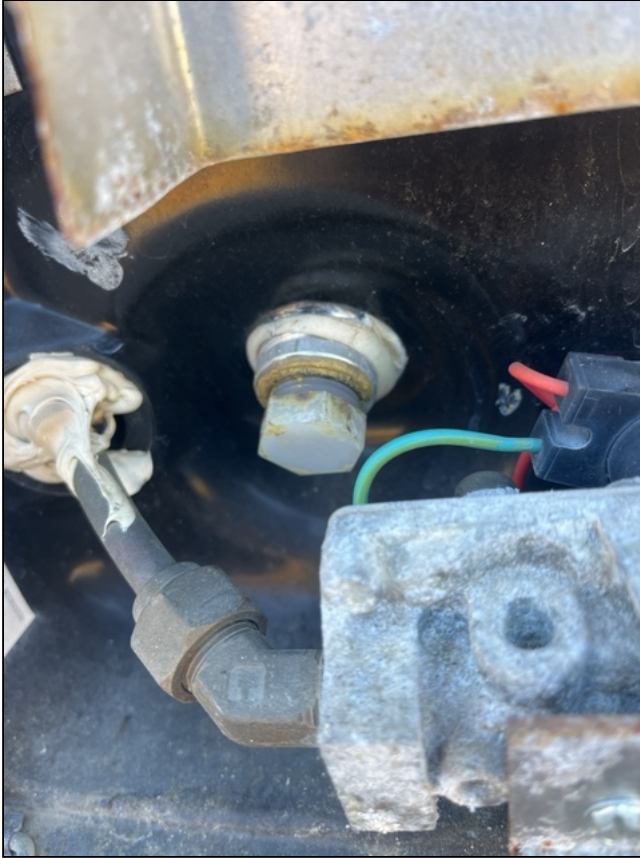
Water heater drain plug

The drain plug is the correct style for the water heater

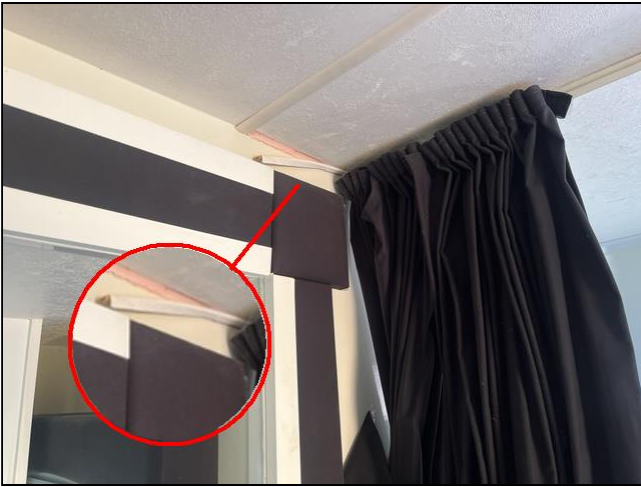
Trim Above Slideout Front

(1) Ceiling trim above the slideout front side is loose.

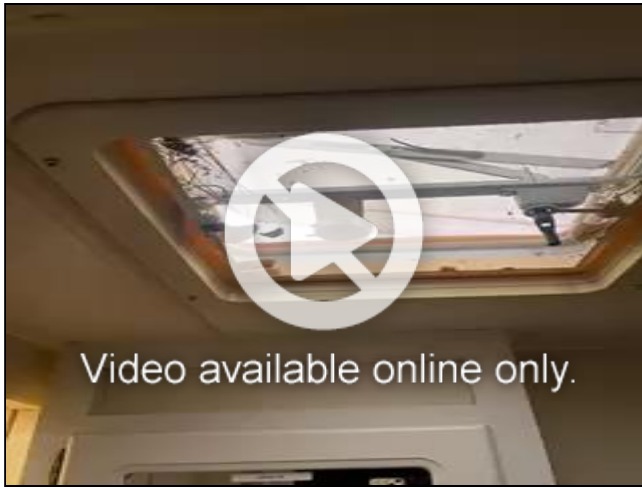
Bathroom Vent

(3) The vent in bathroom is dirty. Fan blades are broken off and it makes a high-pitched noise when turned on.

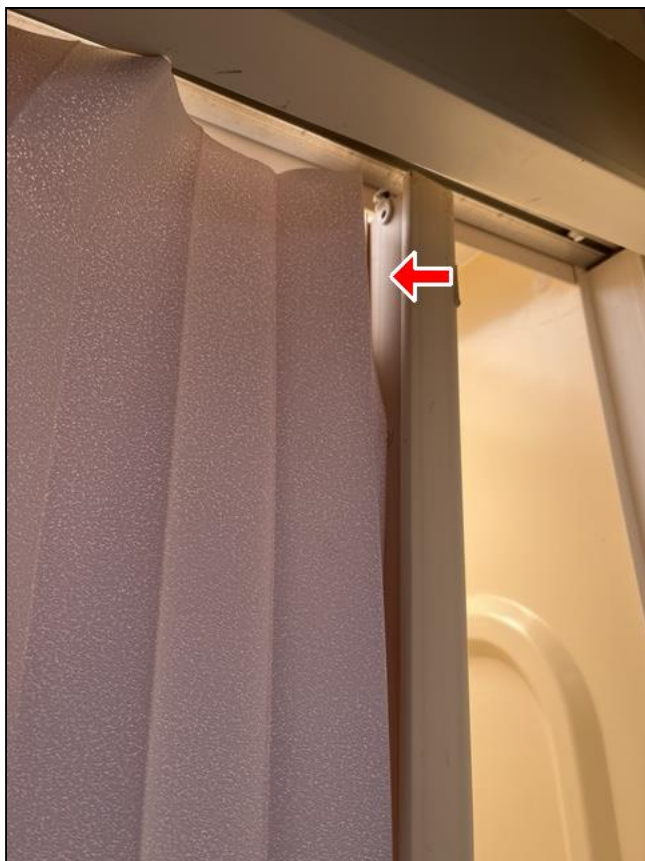
Shower Curtain

The shower curtain is pulled away from the frame at the top right corner

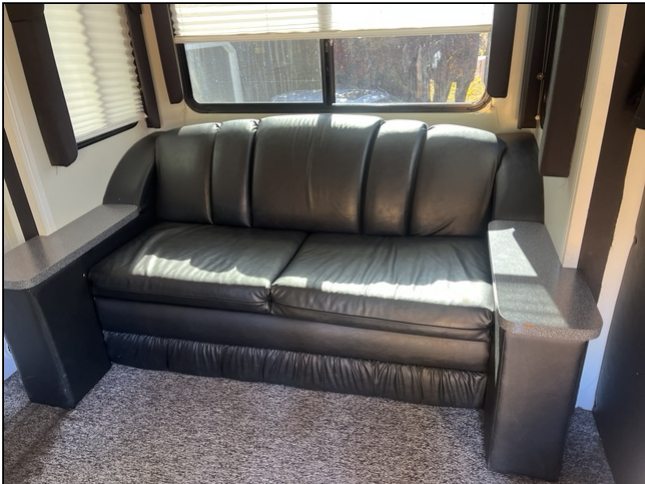
Sofa has a few steps around the side tables. Right side side table has a chip in front.

Sofa has a few stuffs and markings. Right side side table of sofa has a small chip.

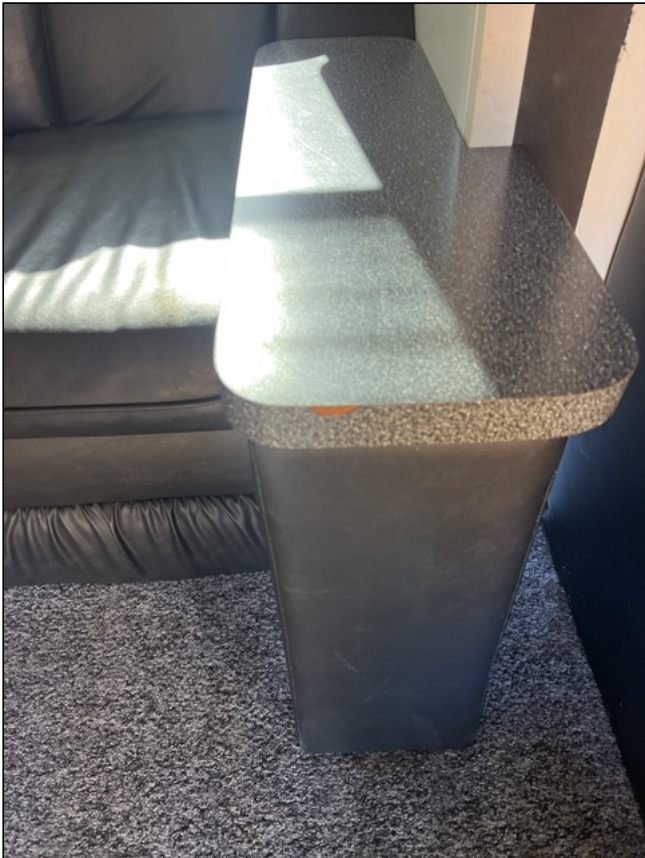
Side table of sofa has a small chip

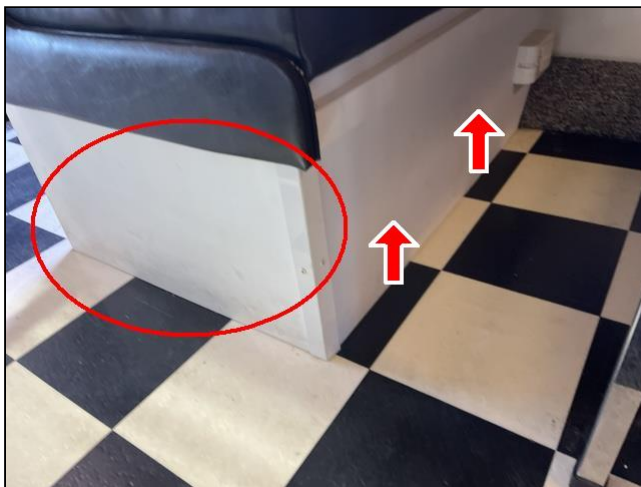
Dinette Chair Left Side

(2) There are markings on bottom part of dinette chair on both right and left sides

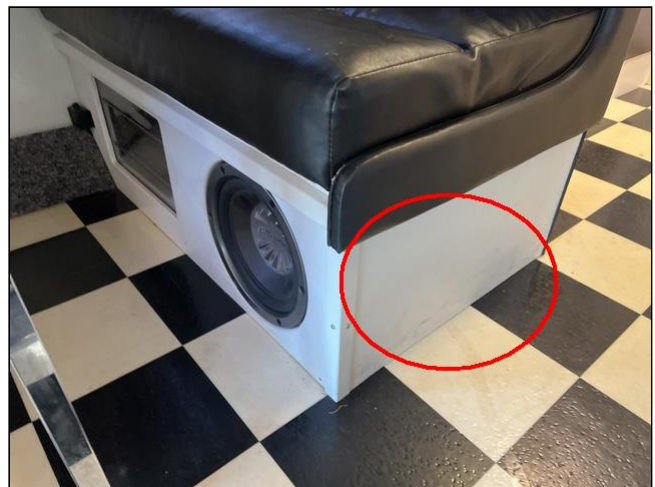
Scuffs on right side of dinette table

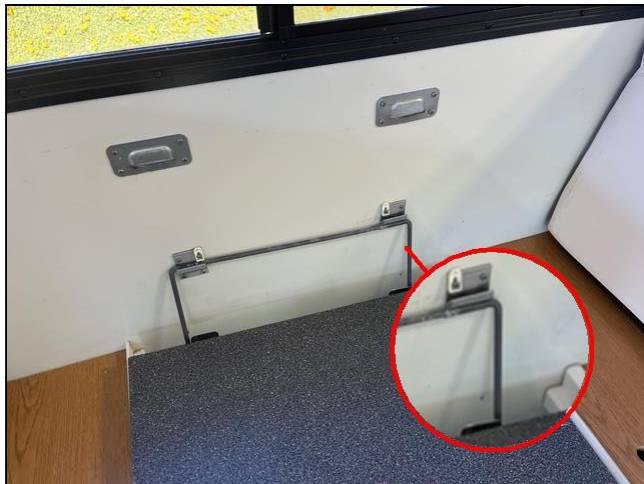
Dinette Table Mounts

The dinette mount on the left side is loose.

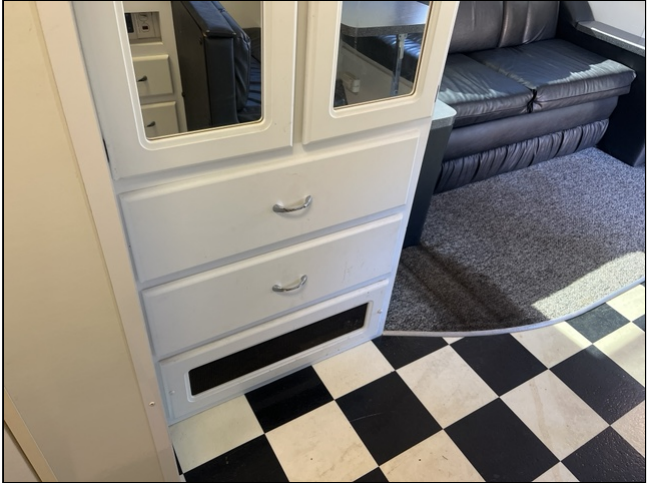
Cabinet /Closet

Acceptable
Bottom drawers are difficult to open.
